HERITAGE IMPACT ASSESSMENT: PROPOSED GRID CONNECTION INFRASTRUCTURE FOR THE NAMAS WIND FARM, NAMAKWALAND MAGISTERIAL DISTRICT, NORTHERN CAPE

Required under Section 38 (8) of the National Heritage Resources Act (No. 25 of 1999).

SAHRA Case No.: 13835

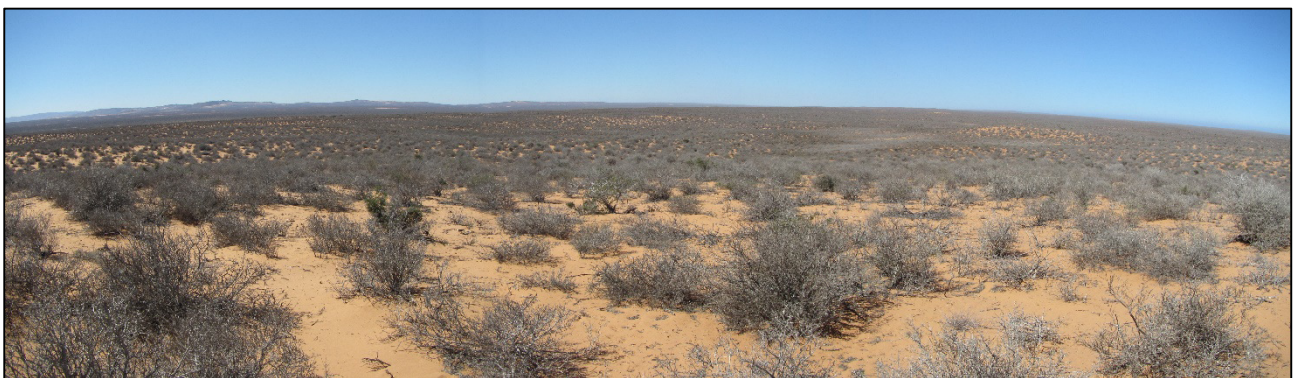
Figure 3: View towards the northeast across the dune cordon in the southern part of the 300m corridor.

In the south the 300m corridor largely traverses a belt of tall red dunes (Figure 3) and in the far north crosses an area where many open deflation hollows occur (Figure 4). Hereafter it crosses an area of exposed *heuweltjies*, passes over the Buffels River then runs a short distance up the slope to the existing Gromis Substation (although the substation is not visible, its access road can be seen in Figure 5). The vicinity of the Buffels River is the only place in the entire 300m corridor that rock outcrops occur but these are very low (Figure 5) with the exception of some bedrock in the river bed.

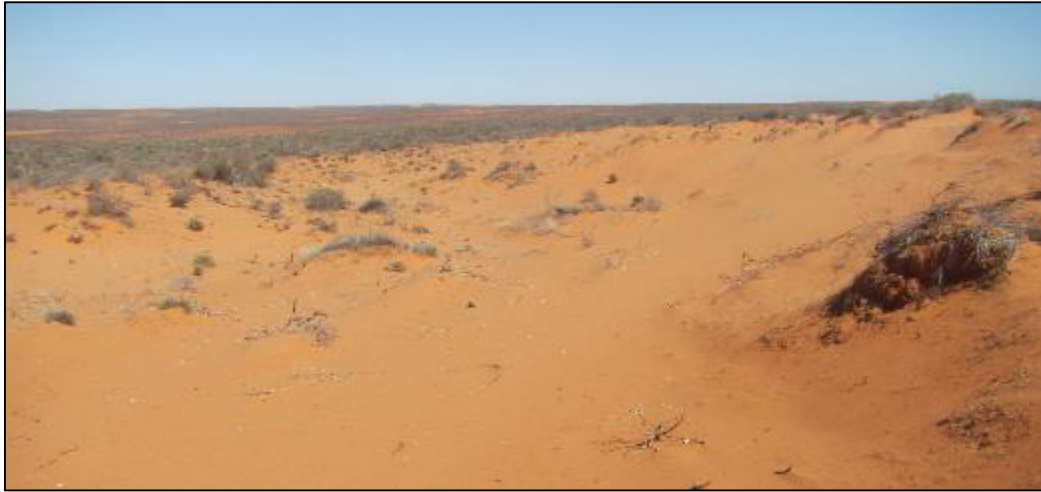
Figure 4: View across a deflation hollow with other similar hollows in the background marked by orange sandy patches on the landscape. This is at site MV2018/026 (waypoint 089).

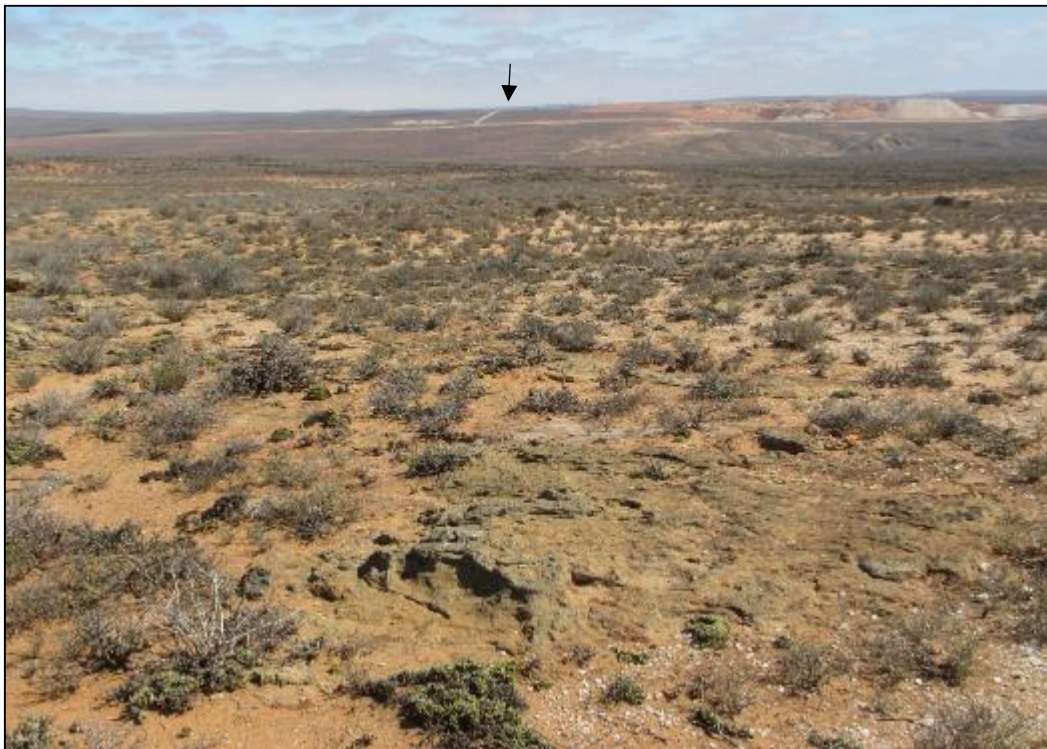
Figure 5: View along the 300m corridor over the Buffels River valley towards the existing Gromis Substation (arrowed). An abandoned mining area lies to the right (east) of the Substation. A low bedrock exposure is visible in the foreground.

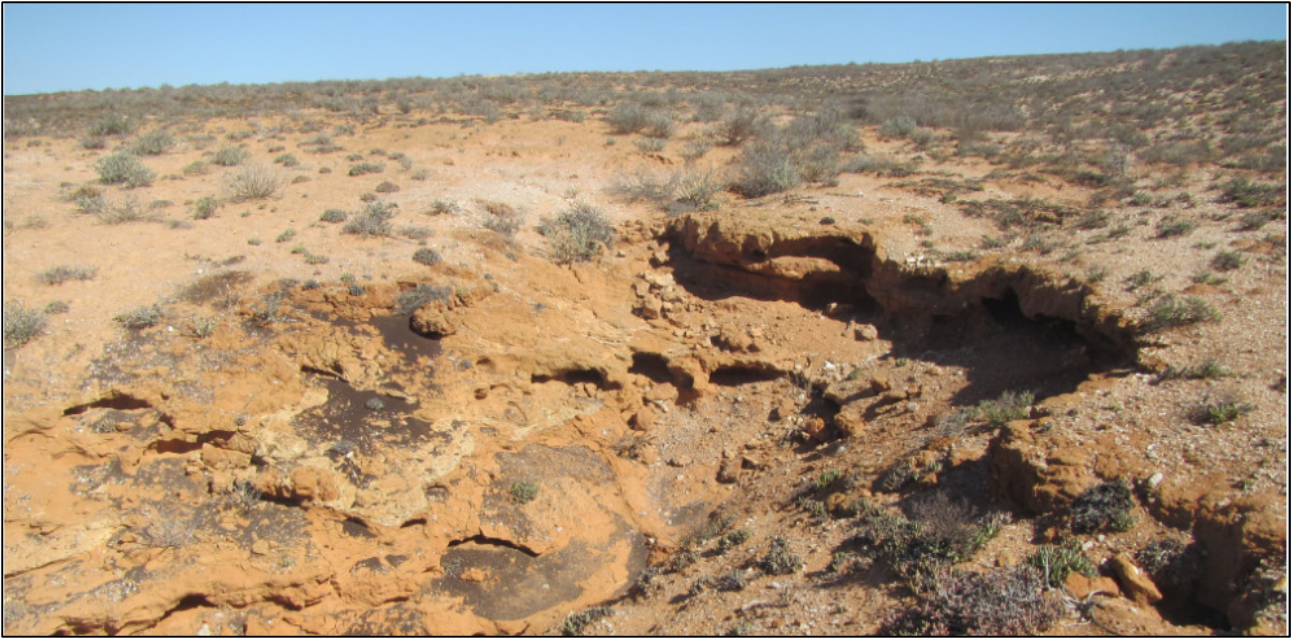
Figure 6: View of an exposed area of Dorbank to the south of the Buffels River.

An important component of Namaqualand is the presence of a hardened soil horizon – known as dorbank – below the cover sands. This dorbank is revealed in borrow pits which have been excavated into it and occasionally in other areas where erosion has removed the aeolian cover sands, such as on the southern bank of the Buffels River (Figure 6).

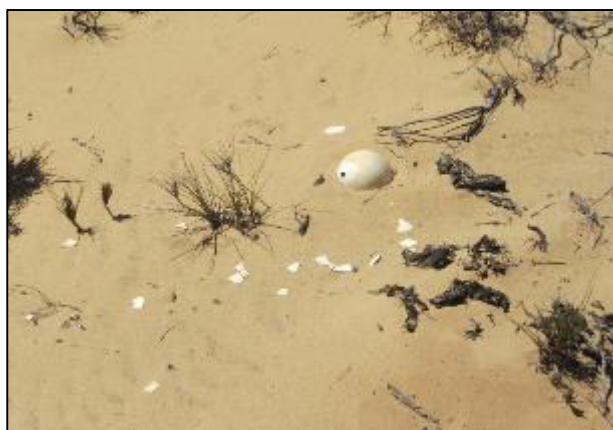
Figure 8: View of the ostrich eggshell cache as it was found.

Inland of this dune belt is an area of low-lying flat terrain characterised by pale sand. Although only a small section of this area was surveyed where it is traversed by the 300m corridor, work on the neighbouring Zonnequa Wind Farm site shows that this band is generally devoid of archaeological sites, even in places where low sand hills occur. Two occurrences were recorded in this zone, but both outside of the 300m corridor. One was of some background scatter artefacts in quartz and CCS and some ostrich eggshell fragments at an area where the cover sands had been removed (waypoint 057). The second, ZK2018/003 (waypoint 103), was on a low sand hill at the eastern edge of the flat plain and about 200 m east of the 300m corridor. It consisted of a small cache of two ostrich eggshells, one of them whole and one broken (Figure 8). The flask mouths were not as smoothly rounded as is normally expected (Figure 9).

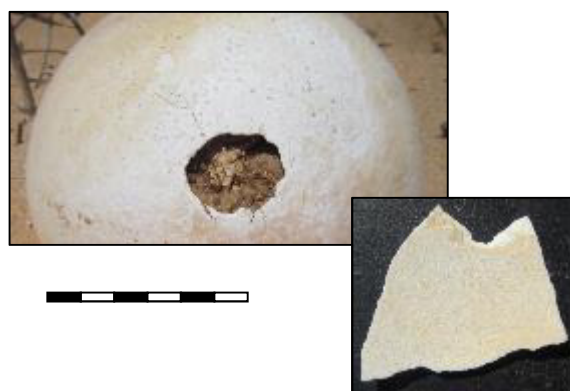
Figure 9: The mouth of the whole eggshell and the fragment of a second mouth. Scale in 5 mm intervals.

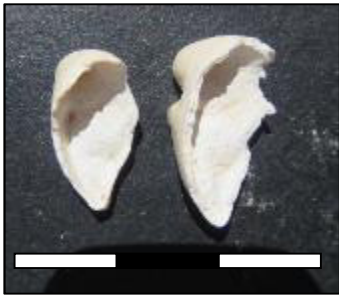
Figure 10: Two crayfish mandibles from MV2018/017 (waypoint 080B). Scale in cm.

At the north end of the 300m corridor there is a red dunefield with many large deflation hollows. These hollows also contained many artefact scatters but again with very dense sites generally rare. The finds in these hollows included scatters of flaked artefacts, largely in quartz but with other materials also present, occasional grindstones and hammer stones, some pottery, and some historical glass and ceramics. Retouched tools were rare and the nature of the assemblages suggest that all or most were from the late Holocene. Whether the historical material is overprinted or related to the LSA material remains unknown. Figure 4 shows an example of one of these deflation hollows, while Figures 10 to 15 show a selection of items found at these sites.

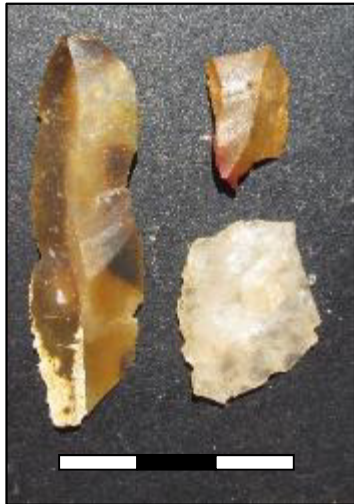
Figure 12: CCS and quartz artefacts from MV2018/018 (waypoint 081). Scale in cm.

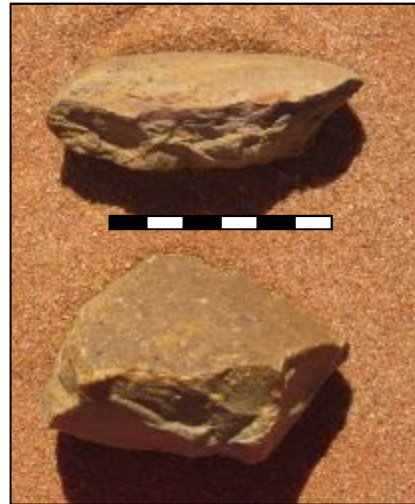
Figure 13: Two large quartzite cores from MV2018/026 (waypoint 089). Scale in cm.

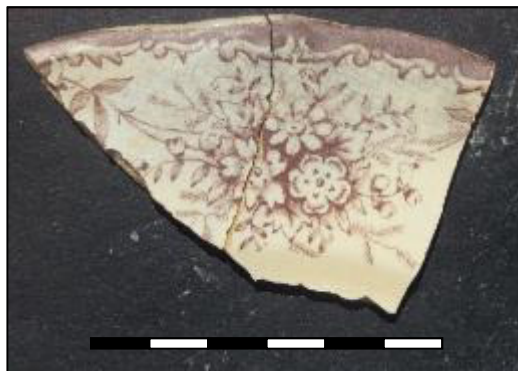
Figure 14: Two refitting plate fragments from MV2018/017 (waypoint 080A). Scale in cm.

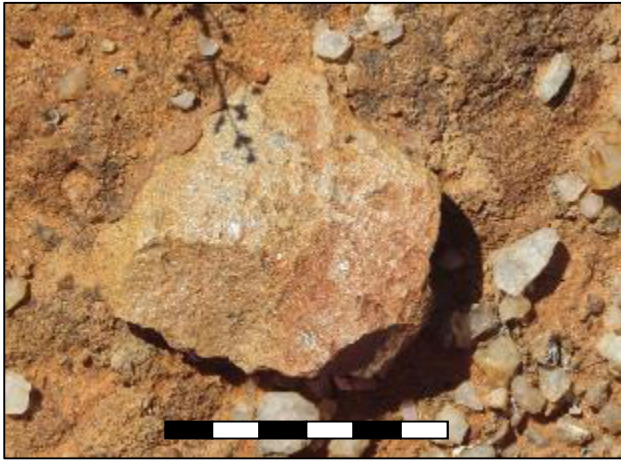
Figure 16: A large flake trapped in the dorbank to the south of the Buffels River. Scale in cm.

In the far north, on either side of the Buffels River, there were places where the dorbank was exposed at the surface. In these areas MSA and ESA artefacts were seen. An example of an artefact stuck into the dorbank was noted to the south of the river (Figure 16), while to the north an area stripped of topsoil during mining activities displays an extensive scatter of Pleistocene-aged material, including handaxes (Figures 17 to 19). Within a few hundred metres on either side of the Buffels River there were a few light shell scatters. It was not possible to tell whether there

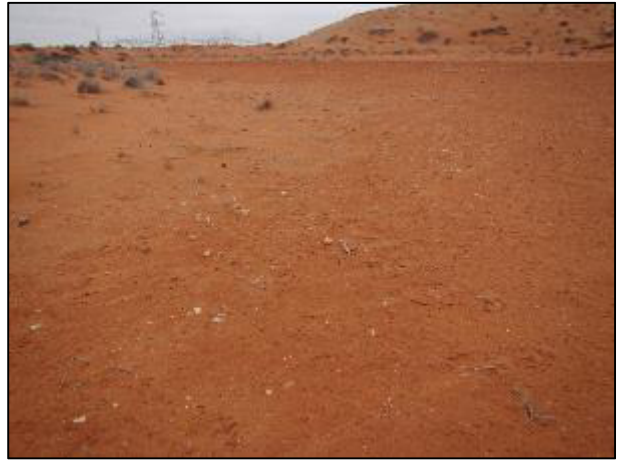
Figure 17: The dorbank surface at waypoint 059 with artefacts scattered over it.

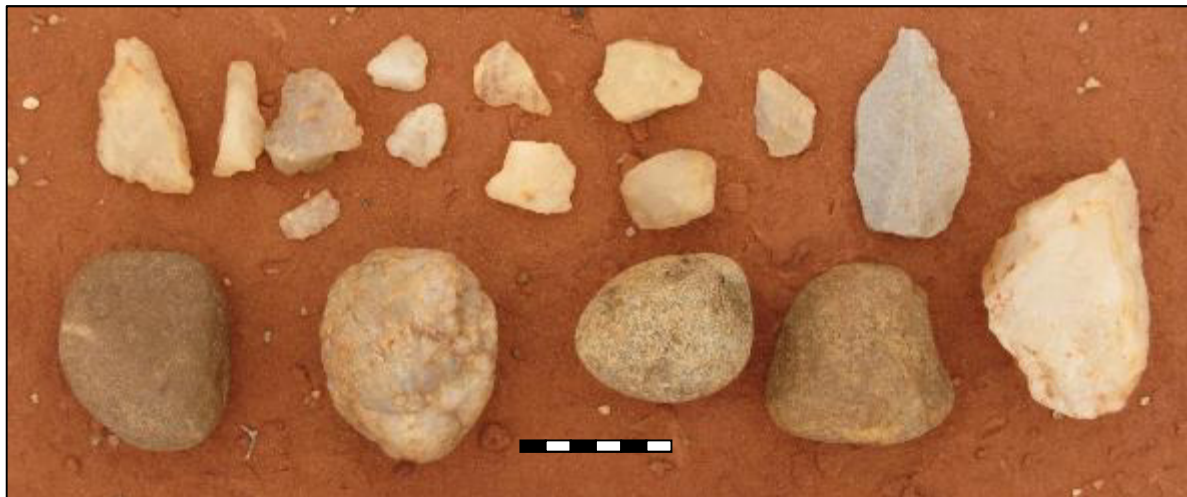
Figure 18: Selection of stone artefacts and cobbles from the surface of the dorbank at waypoint 059. Scale in cm.

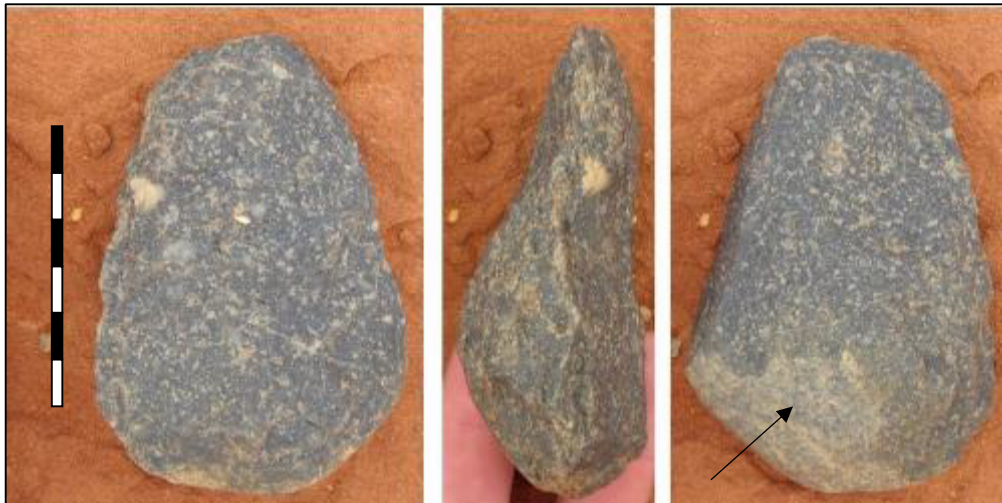
Figure 19: Three views of a small handaxe with basal cortex preserved (arrowed in right hand image) from waypoint 059. Scale in cm.

were stone artefacts associated with them because of both the natural quartz gravel and the low density background scatter of quartz artefacts present. Figure 19 shows an example of one such scatter which also had pottery on it (MV2018/034; waypoint 97). Two small quartz outcrops displaying flaking were also noted to the south of the river.

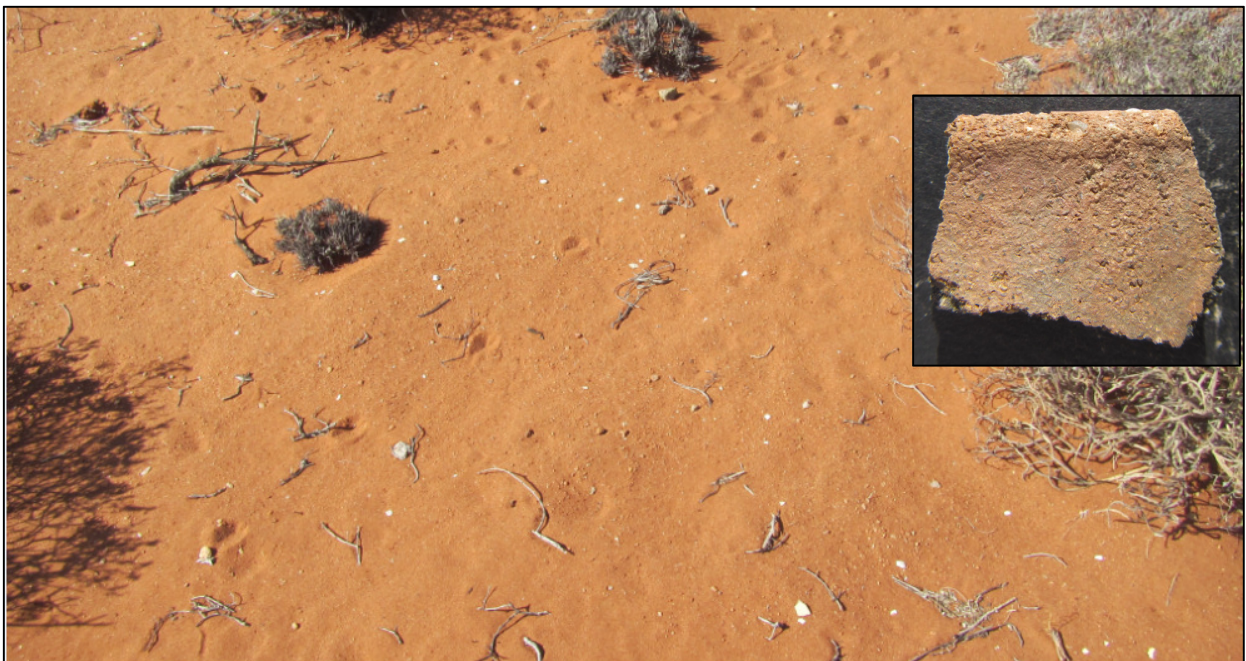
Figure 20: The shell scatter at MV2018/034 (waypoint 97) with the inset showing a rim potsherd (rim length = 23 mm).

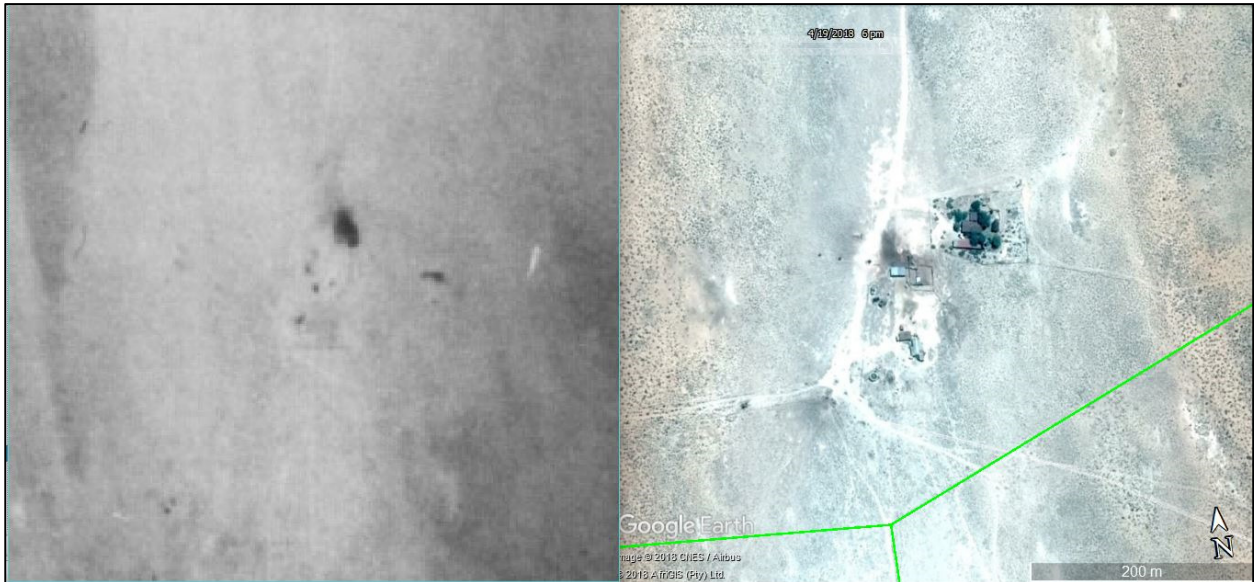
Figure 21: Aerial views of the Zonnekwa 326 farm complex from 1942 (Source: Chief Directorate: National Geo-Spatial Information. Website: www.ngi.gov.za) and 2004 (Source: Google Earth) showing the complex to be much smaller in 1942

No buildings will be directly impacted by the proposed project. Only one farm complex, that on Zonnekwa 326, lies close to but outside of the 300m corridor (the nearest structures are about 100 m west of the edge of the 300m corridor). Although not examined in detail on site, it is evident from the 1942 aerial photograph that a complex was present but was very much smaller than that of today (Figure 21). The majority of structures are clearly relatively modern (Figures 22 & 23).

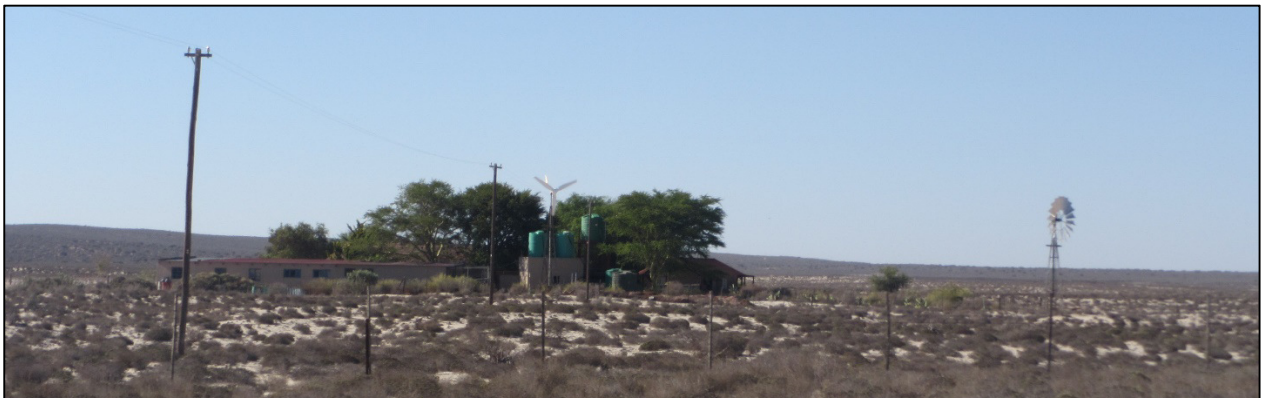
Figure 22: View of the main farm house at Zonnekwa 326 as seen from the south.

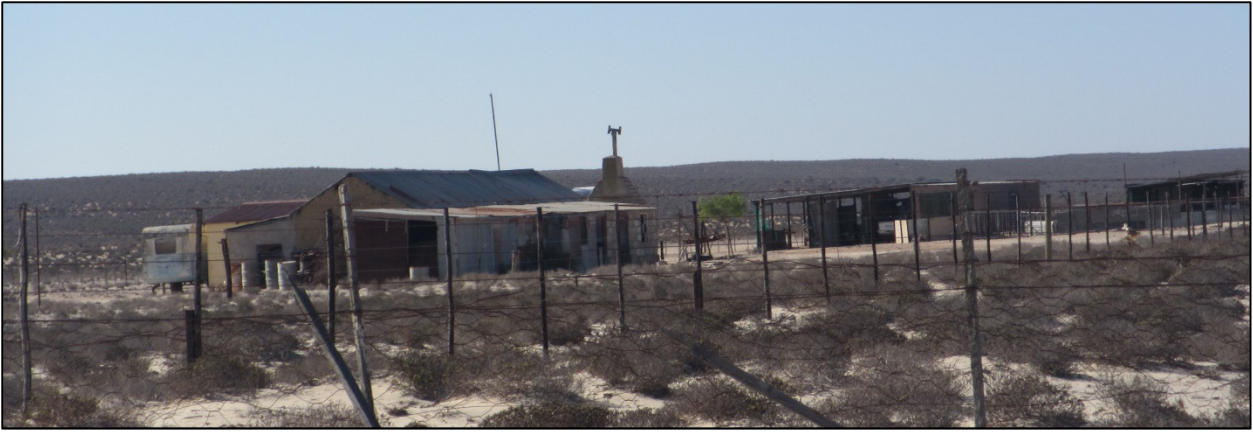
Figure 23: View of the outbuildings at Zonnekwa 326 as seen from the southeast. The main structure here may be the oldest in the complex.

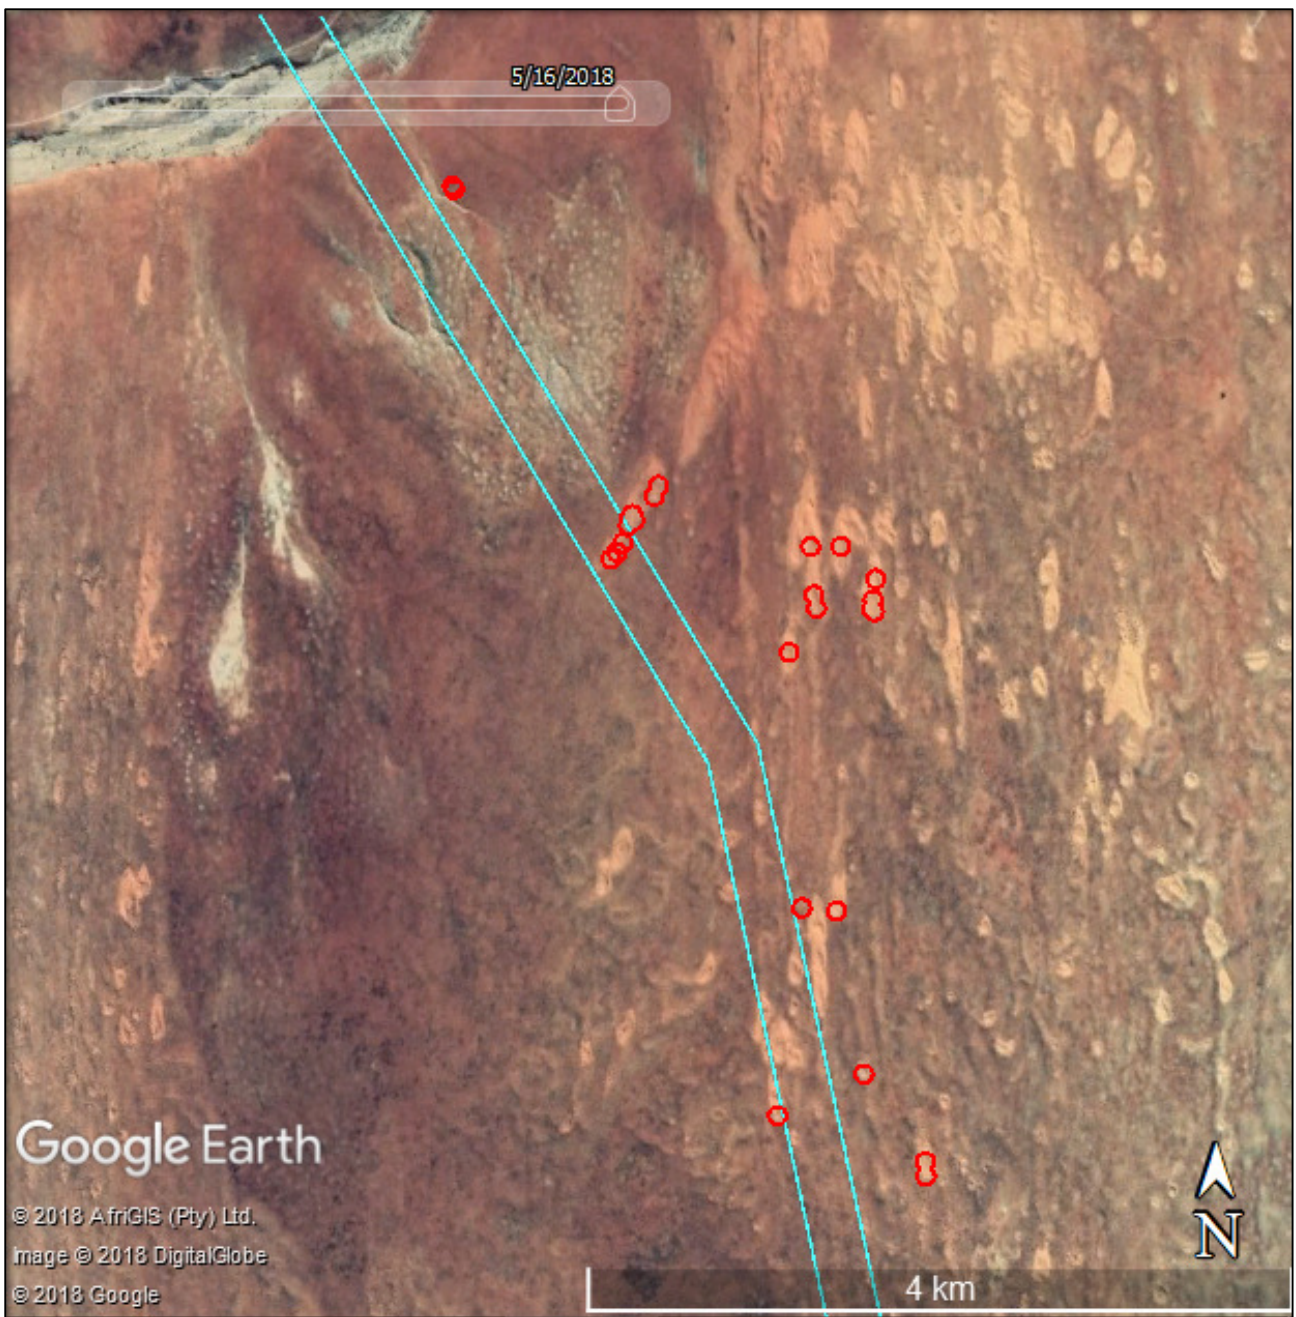
Figure A3.6: Map showing 50 m buffers from the centre point of all significant archaeological sites (red circles) relative to the northern section of the 300m corridor.
