Phase 1 Heritage Impact Assessment Report

NDANYANA ROAD UPGRADE PROJECT, NEAR
POMEROY, KWA ZULU NATAL PROVINCE

Date of Report: 21 September 2015

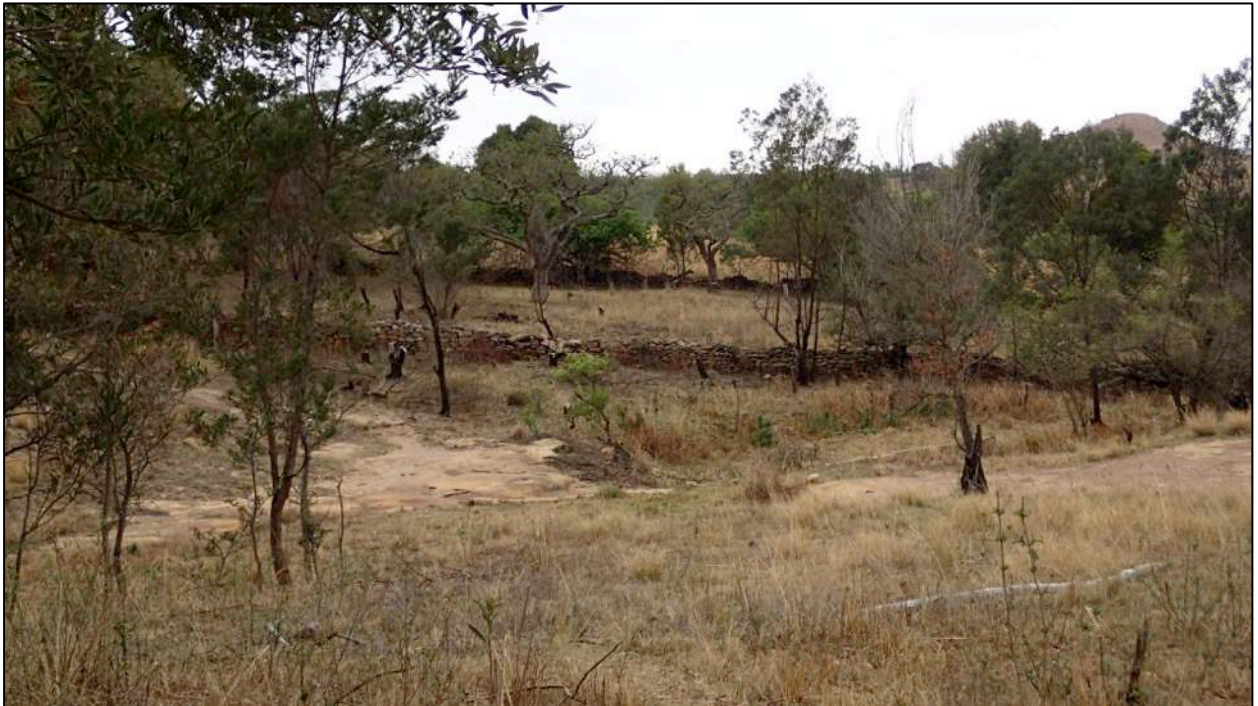
Figure 3: Stone wall at Site 001

GPS S28° 28' 50"
E30° 30' 01"

This site is located on the southern side of the road along section 1. A stonewall site with extensive walling that is still in a good state of repair in most areas, most probably a livestock enclosure.

Mitigation measure	<p><i>The indicated stone walls should be marked by barrier tape before construction to prevent possible damage. No excavations should be undertaken within 10 meters of the sites. A heritage practitioner should monitor the excavation work at the sites.</i></p> <p><i>Operators of excavation equipment should be made aware of the possibility of unmarked graves in the area. Procedures for the handling of unmarked, exposed graves should be included in the environmental management plan (EMP) and should be implemented by the environmental control officer (ECO).</i></p>
--------------------	--

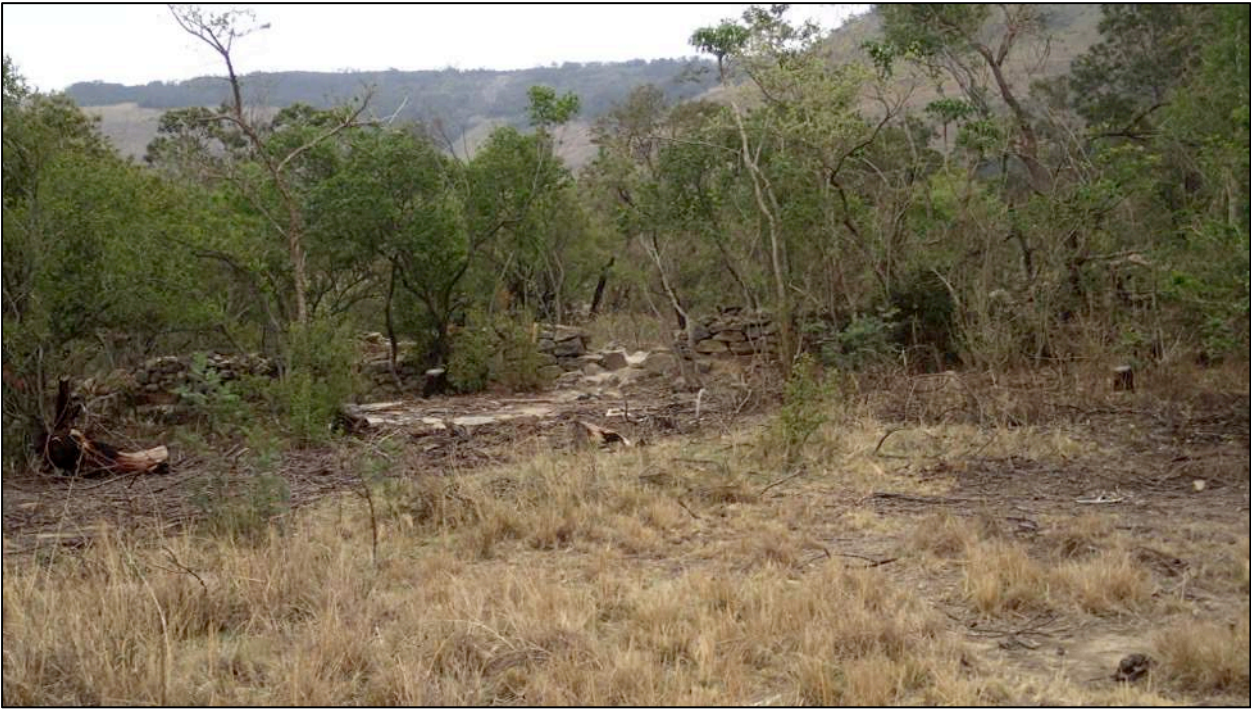
Figure 6: Stone wall at Site 002

GPS S28° 28' 50"
E30° 30' 00"

This site is located along section 1 of the road. A stonewalled site very similar in appearance to Site 001. Also most likely the roadway entrance to a site.

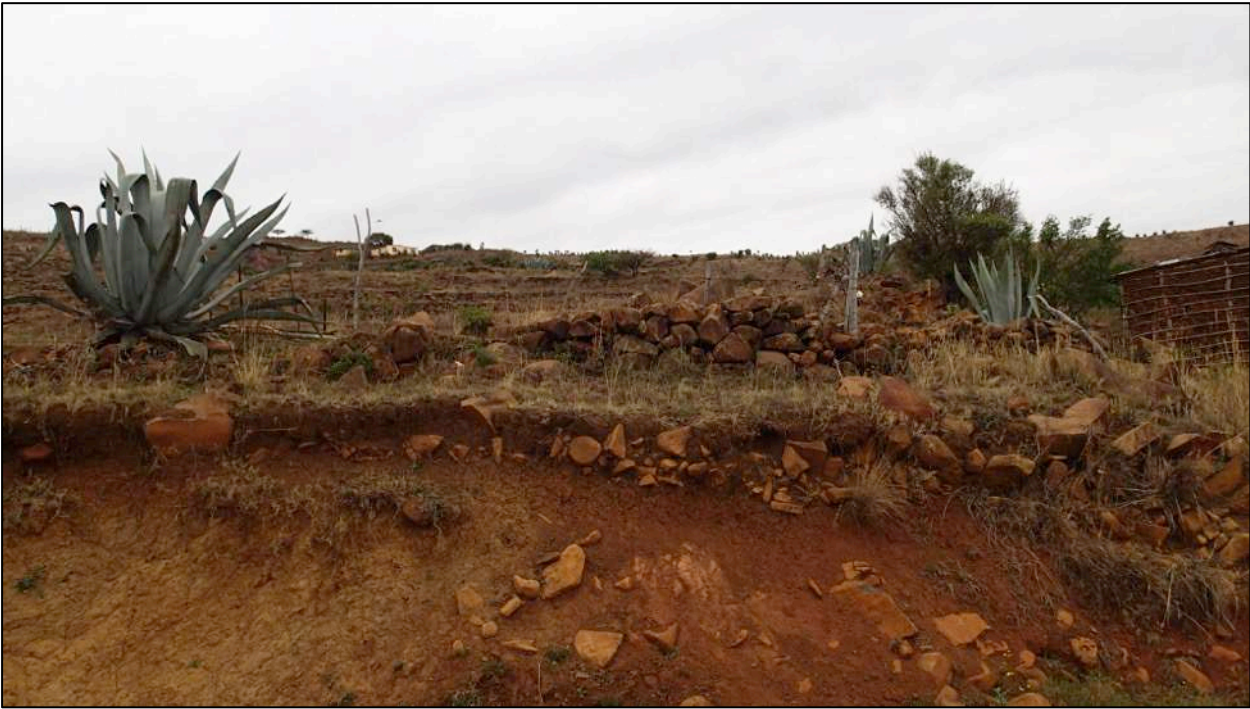
Figure 9: Stone wall at Site 003

GPS S28° 29' 46"
E30° 30' 32"

This site is located along section 2 of the road and is also a stonewalled site of more recent origin.

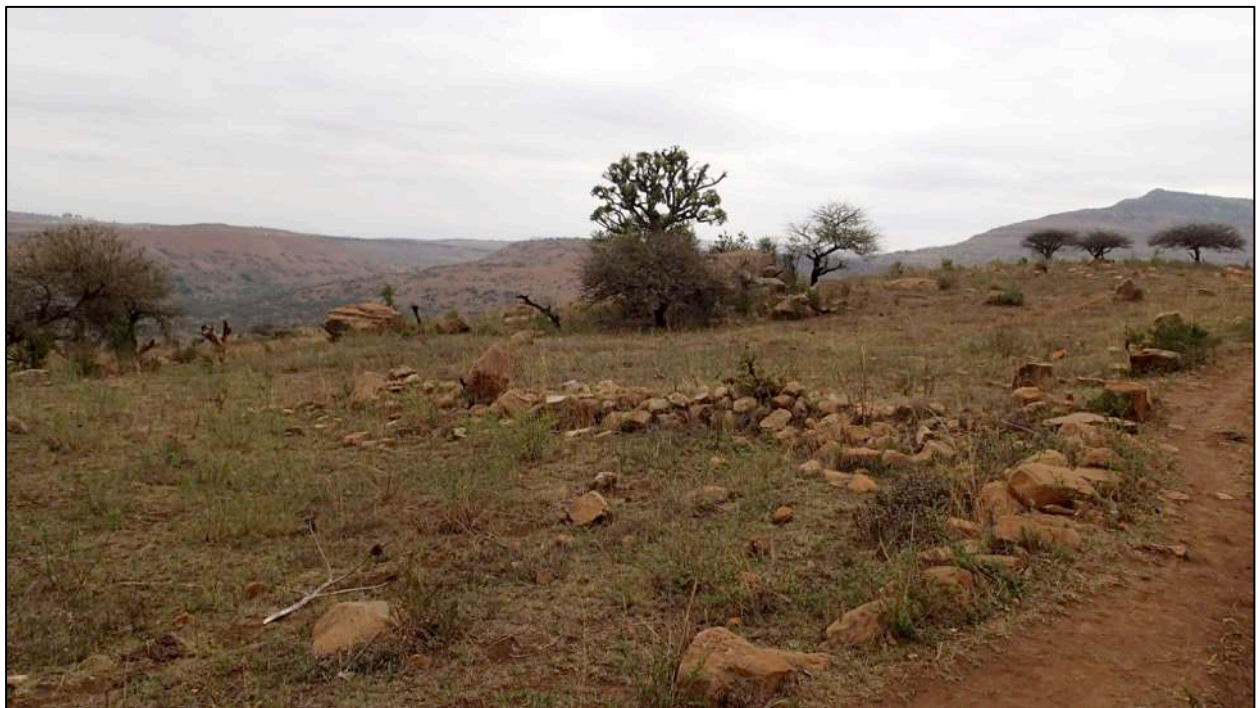
Figure 12: Kraal at Site 004

GPS S28° 29' 44"
E30° 30' 05"

This site is located along section 2 of the road. Kraal structures of low stonewall. The site is around 600m² in size. Several different enclosures suggests several varying activities at the site.

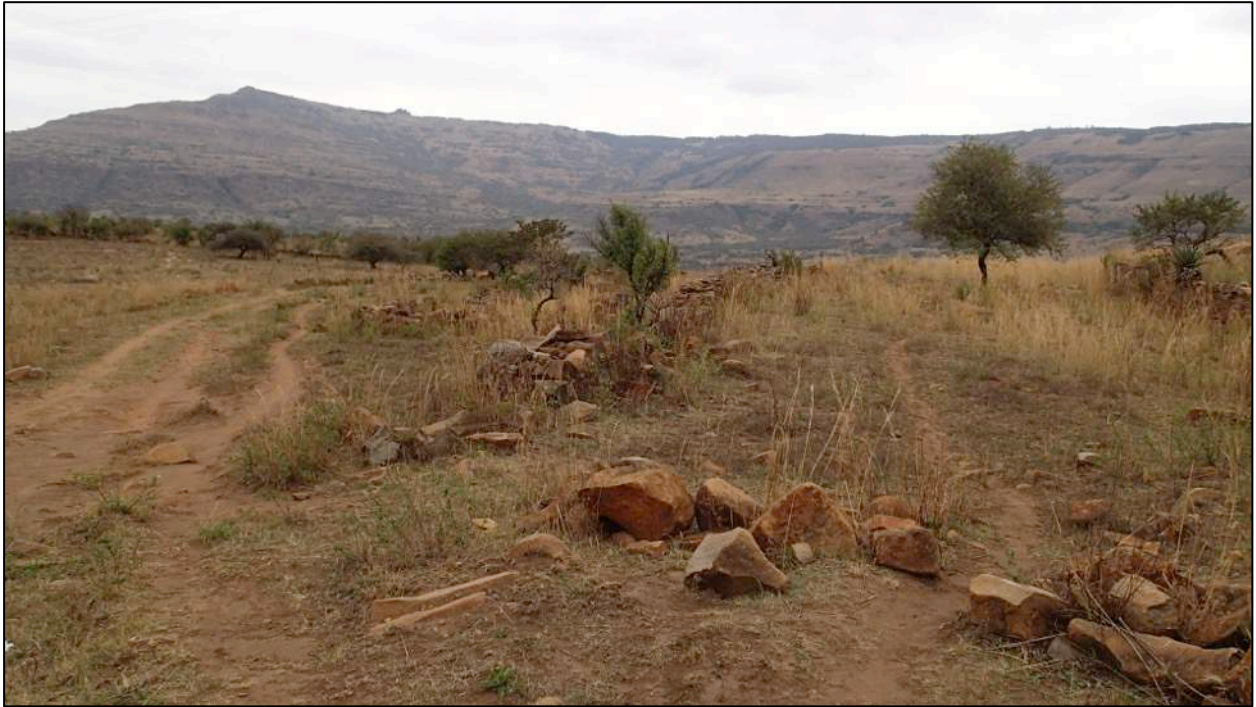
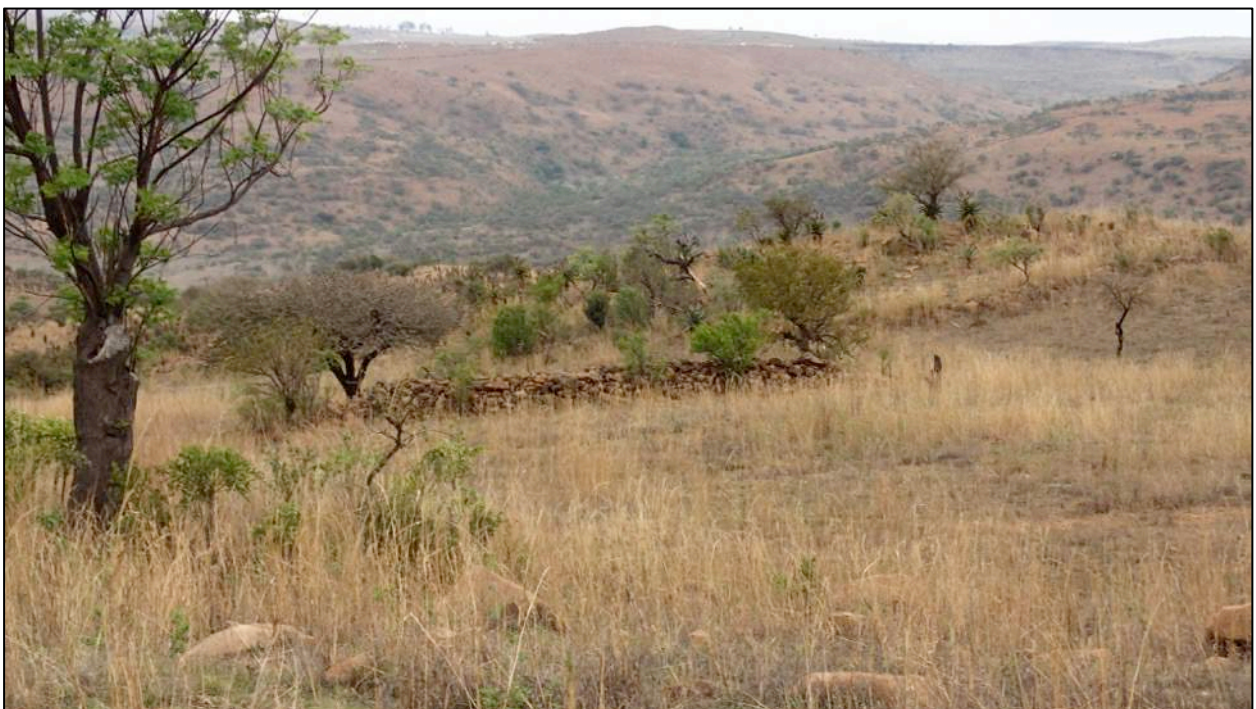
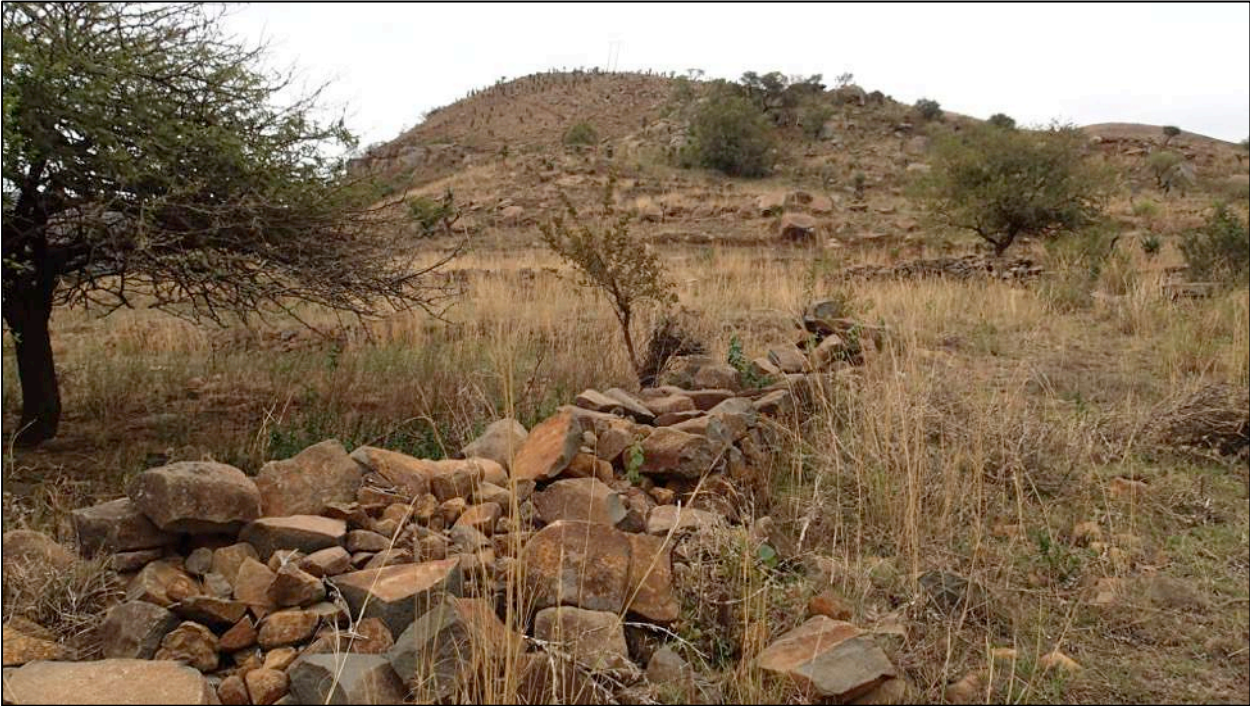
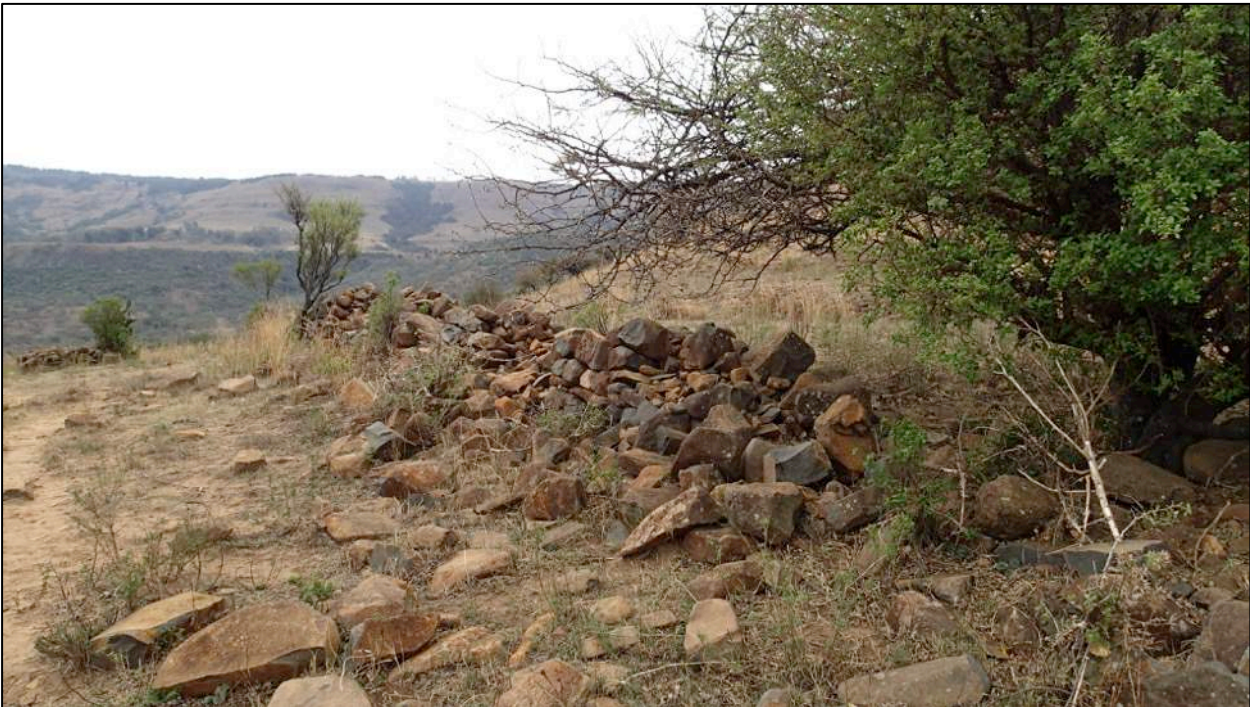
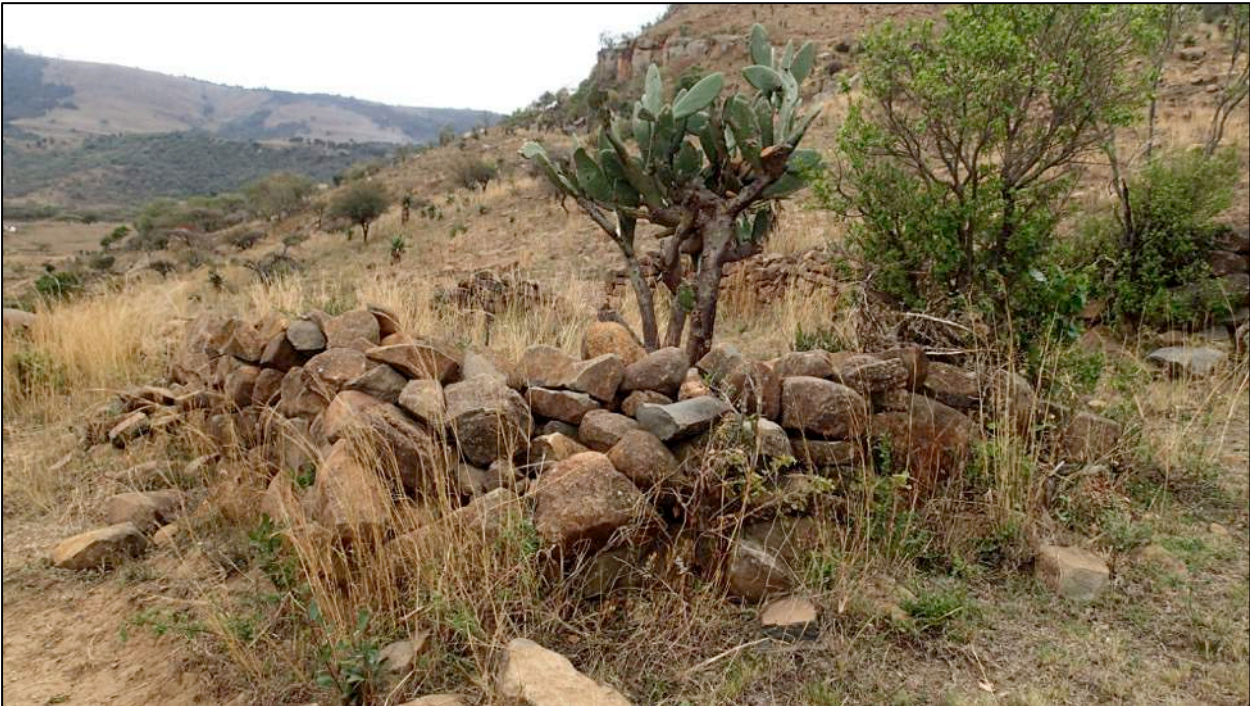
GPS S28° 29' 44"
E30° 29' 57"

This site is located along section 2 of the road on both sides of the proposed upgrade. Big site of stonewalls and terraces. This could be a further extension of Sit 004.

Figure 15: Stone walls and terraces at Site 005

Figure 16: Stone walls at Site 005

Figure 17: Stone walls and terraces at Site 005

Figure 18: Stone walls at Site 005

Figure 19: Stone walls at Site 005

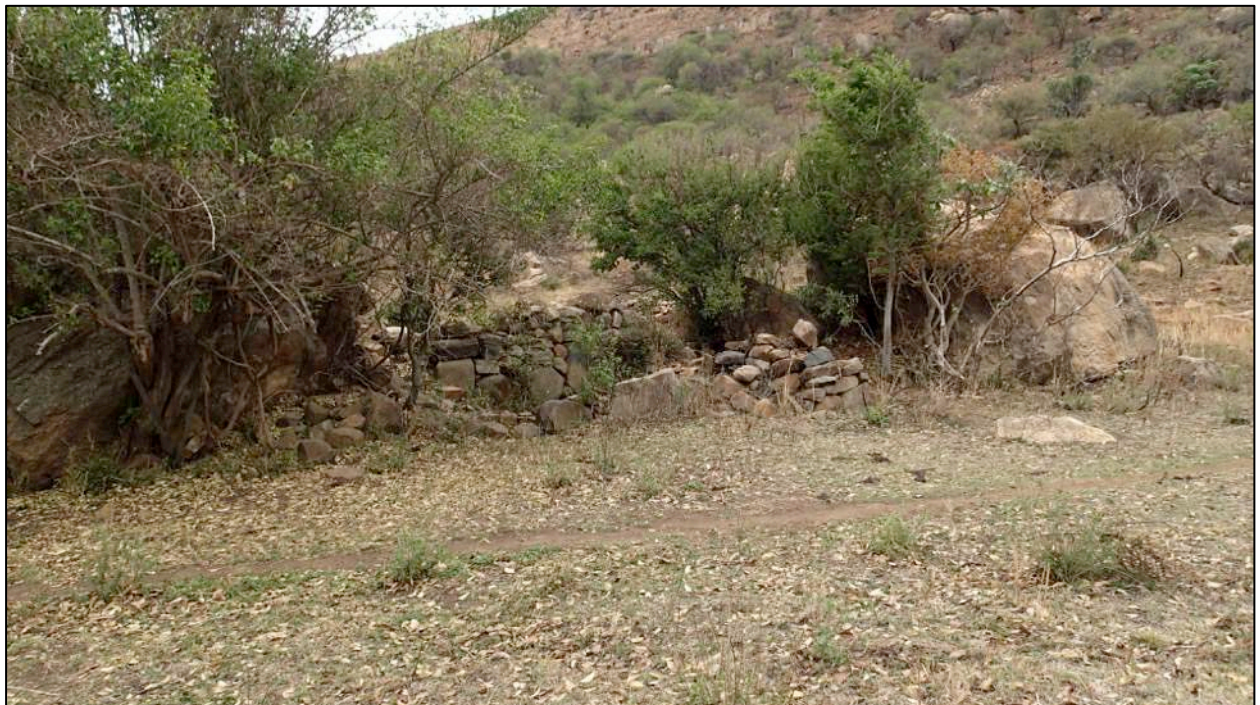
Figure 22: Stone wall at Site 006

GPS S28° 29' 34"
E30° 29' 51"

This site is located along section 2 of the road. A stonewalled enclosure incorporating the natural stone.

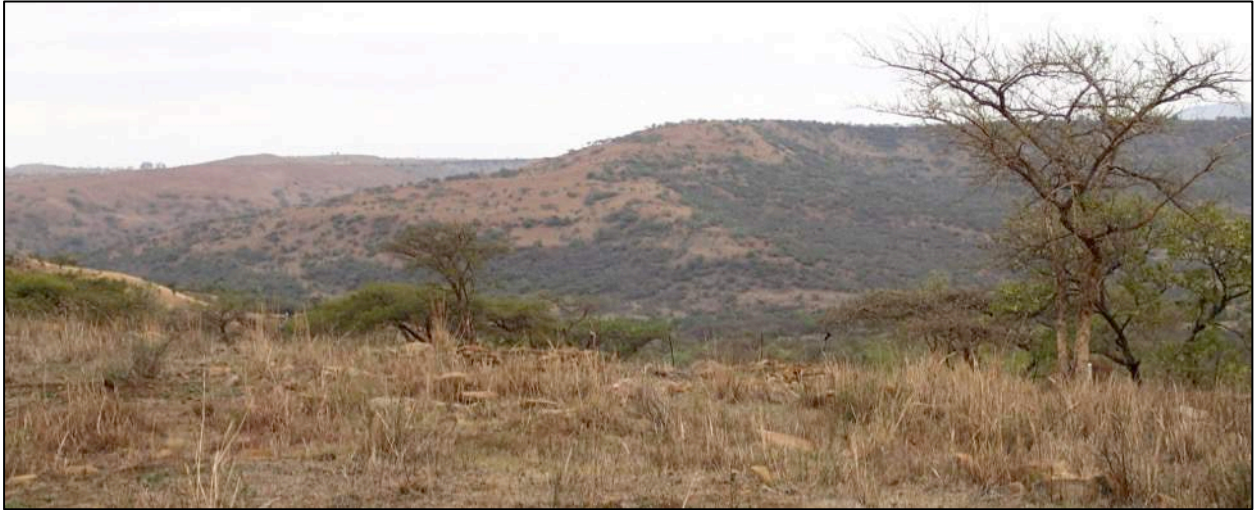
Figure 25: Graves at Site 007

GPS S28° 29' 29"
E30° 29' 46"

This site is located along section 1 of the road. Graves approximately 15m north of the road.

Reversibility	4	2
Irreplaceable loss	3	1
Duration	2	2
Cumulative effect	3	1
Intensity/magnitude	3	1
Significance rating	51 (high negative)	8 (low negative)
Mitigation measure	<i>The indicated graves should be marked by barrier tape before construction to prevent possible damage. No excavations should be undertaken within 10 meters of the gravesites. A heritage practitioner should monitor the excavation work at Site 001. Operators of excavation equipment should be made aware of the possibility of unmarked graves in the area. Procedures for the handling of unmarked, exposed graves should be included in the environmental management plan (EMP) and should be implemented by the environmental control officer (ECO).</i>
