Heritage Impact Assessment of the Nessie Knight Hospital near Qumbu, Eastern Cape

Heritage Impact Assessment of the Nessie Knight Hospital near Qumbu Eastern Cape

F. Nessie Knight Hospital, Sulenkama

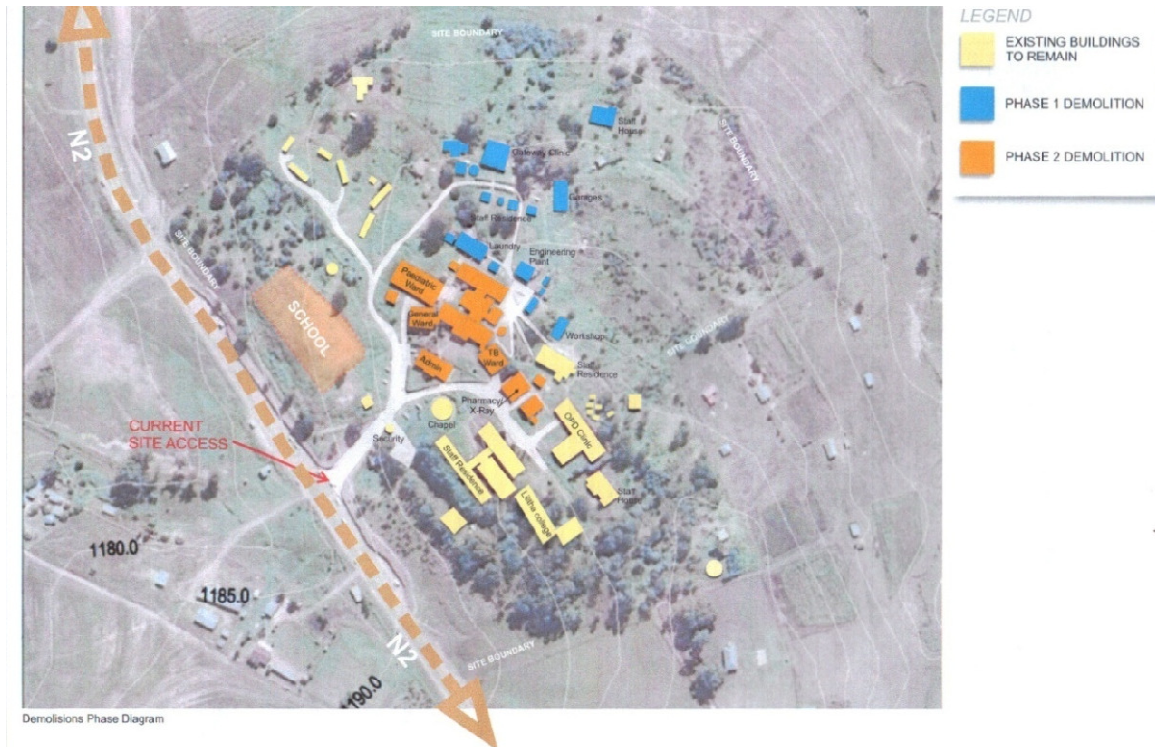
There are two proposed development options, both of which involve the destruction of heritage buildings. Option 1 (see Fig 2), ultimately involves total demolition of all of the older buildings on the site, whilst Option 2 (see Fig 3) involves the demolition of some of the old Nurses Quarters, Patterson's cottage and the old house at the bottom of the site.

Fig 2: Proposed development option 1 (from: Nessie Knight Hospital 26 April 2013 Draft Master Plan Report)

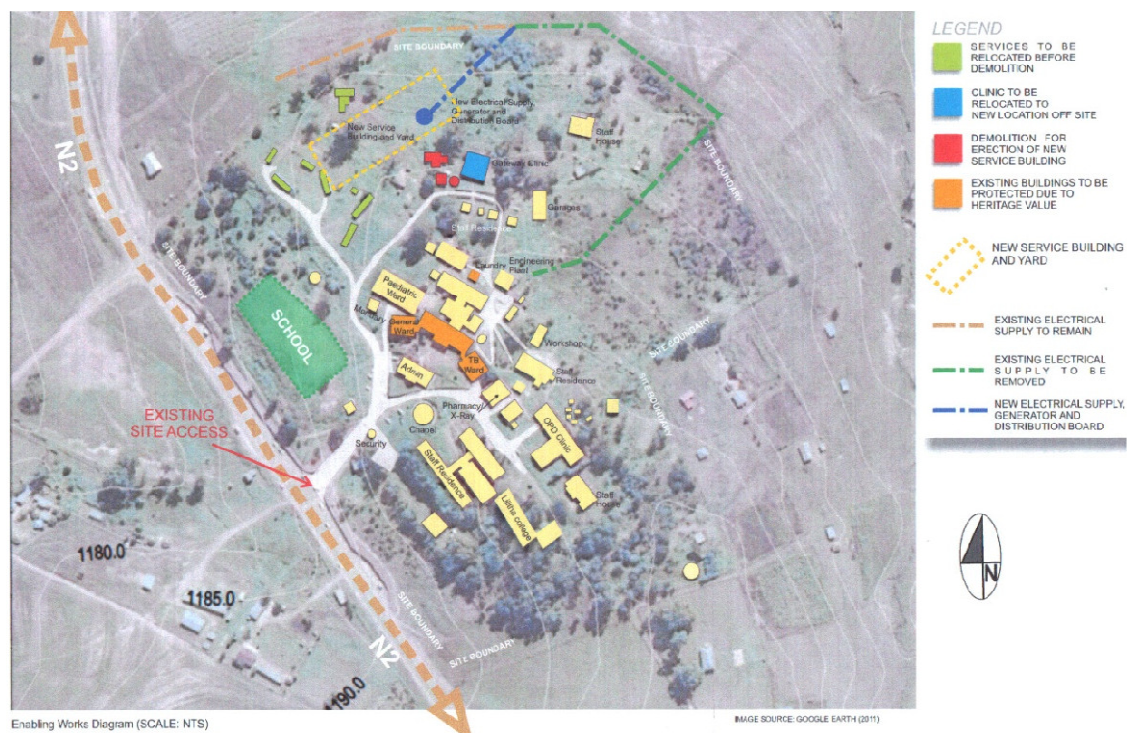
Fig 3: Proposed development option 2 (from Nessie Knight Hospital 08 July 2013 Master Plan Report CDC-CD-Rep-003-13)

The proposed development Option 2 for Nessie Knight Hospital has much less impact on the site and its heritage resources, and it is highly recommended that this option is pursued.

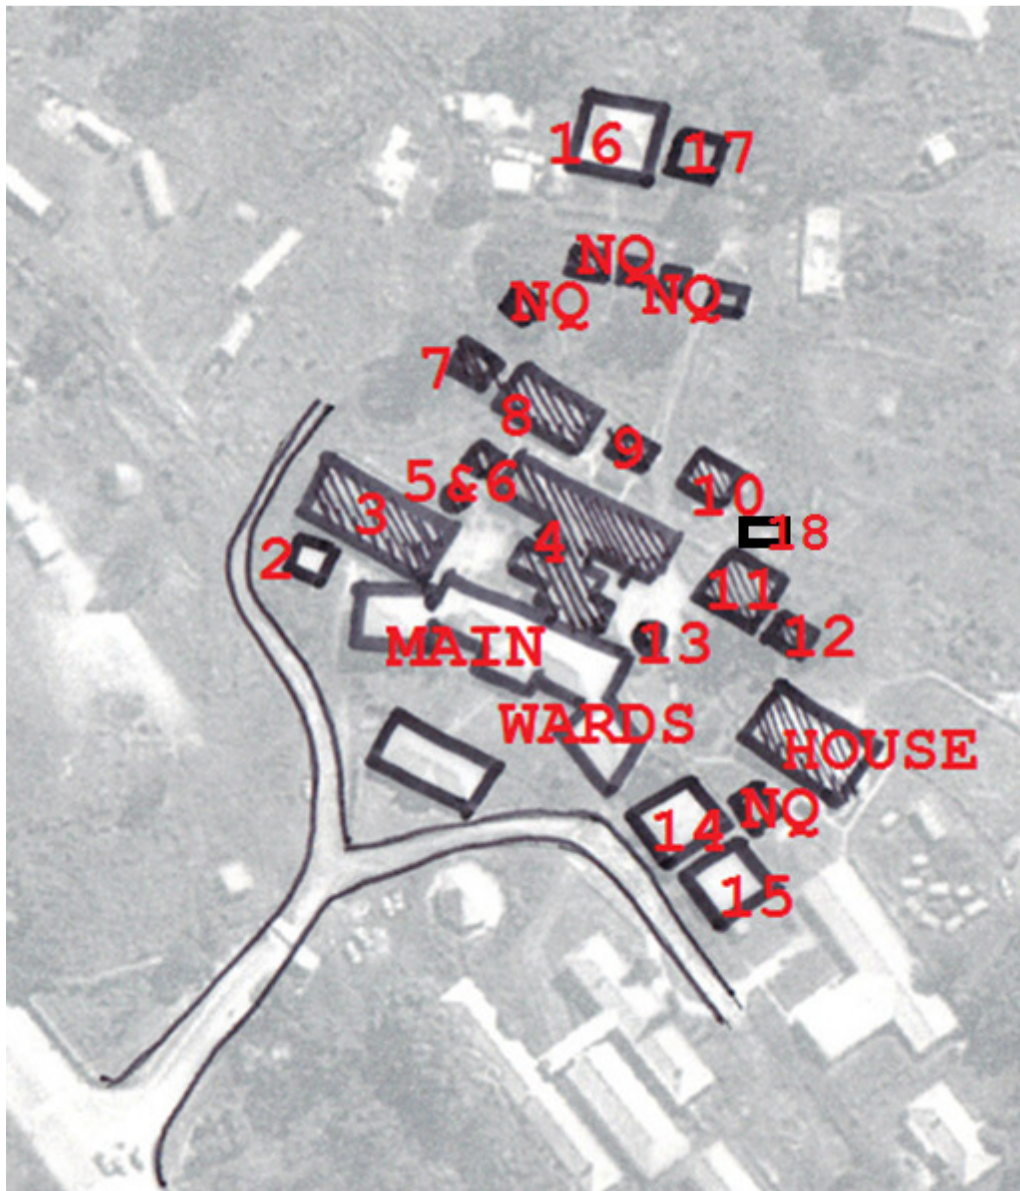
Fig 4: Aerial view of Nessie Knight Hospital complex showing affected buildings hatched.

general wards (Main wards on Figure 4 above) operating theatres (Building 4 on Figure 4 above), and nurse's quarters (Building 5 and others under the appendage 'NQ' on Figure 4 above) was opened

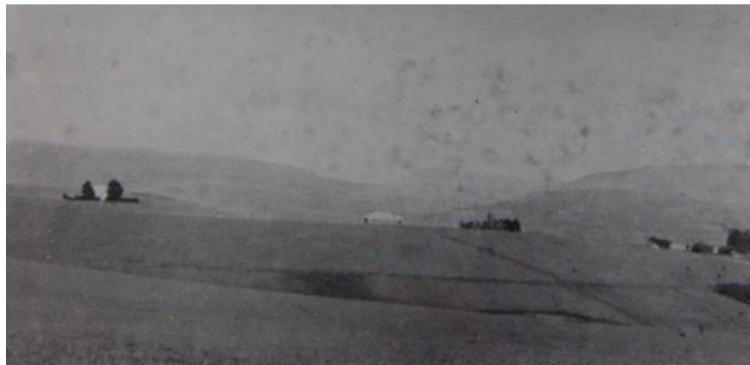
Figure 5: Sulenkama showing Mission House in the centre and school to the right – ca 1920 (Sulenkama Pamphlet, Killie Campbell Collections)

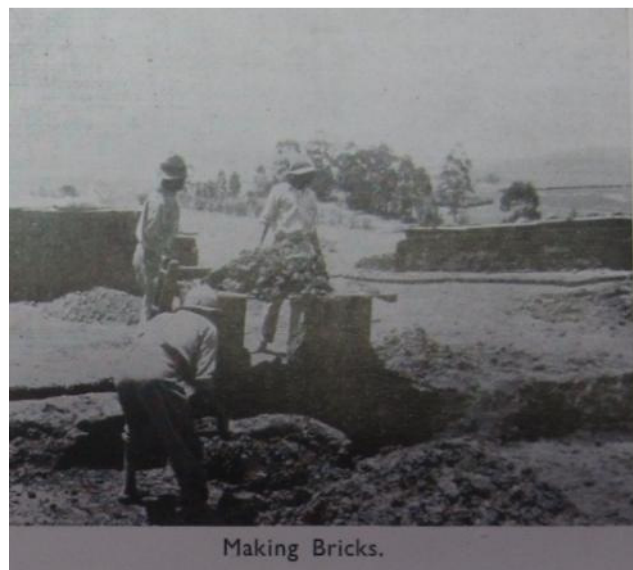
It is important to reinforce that this hospital was distant from Qumbu, and as such, its development relied on use of local resources. The bricks were all made on site, out of a dark clay with a large amount of coarse material, and it is probably this material constitution that has led to the degradation of many of the bricks on the buildings. A photograph from the pamphlet on Sulenkama published by the Nessie Knight Club is evidence of this work (see figures 6 and 7 below).

Fig 7: Brickmaking

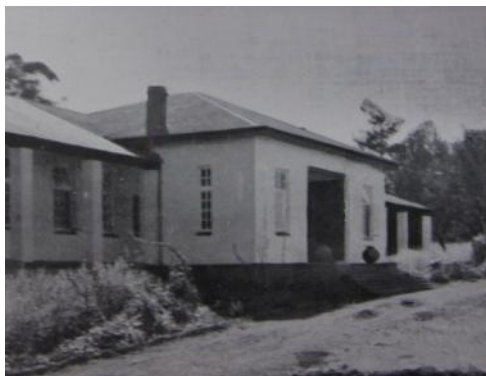
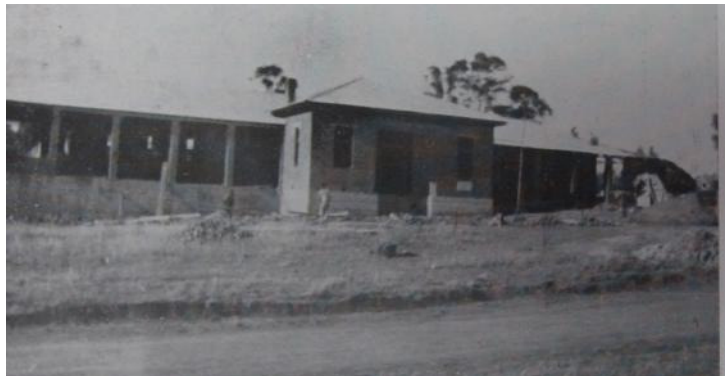
The main wards, as noted, are symmetrical around a central projecting entrance. This entrance is simply articulated, with a graceful staircase rising to floor level before entering a portico lined with stretcher bond brick and leading through mahogany half-glazed doors. To each side is a steel cottage pane casement window with a precast cill. At the top of the steps is a raised landing on each side on which stands matching jardinières. Symmetrical brick chimneys top this section.

**Fig 9: Completed entrance from the north Fig 10: Main wards under construction
Photos from Sulenkama Pamphlet ca 1940, KCC.**

Set back from the entrance are two deep verandas topped with a painted and polished granolithic screed with brick columns. The walls are lined with cottage pane steel windows, matching the ones in flanking the entrance. Due to the change in ground level, the veranda to the south has a set of steps, whilst the one to the north has a steel ladder.

Demolition is not an option at this point. The building is solid and well built, but at the same time needs urgent and well supervised maintenance. The services of an appropriate heritage architect should be engaged in informing the links between the old building and the proposed new extension in line with prevailing conservation charters. A defined but negative junction must separate the two buildings, and it is recommended that the new building take some clues such as massing and proportion of fenestration, openings and structure from its existing precedent.

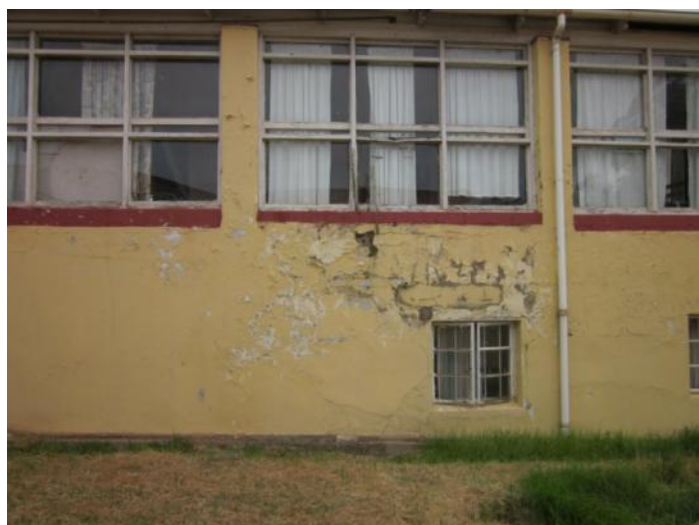
The rear of the building consists of a massive glazed veranda with timber framed window enclosures. Low level steel framed casement windows allow light into basement rooms. Given the lack of maintenance to these timber frames, many are rotting and need repair. However, it appears that this part of the building will be sutured onto the new extension. As noted earlier in this report, water damage at foundation level is severely affecting elements of this elevation.

Fig 13: Enclosed veranda on rear elevation of main building

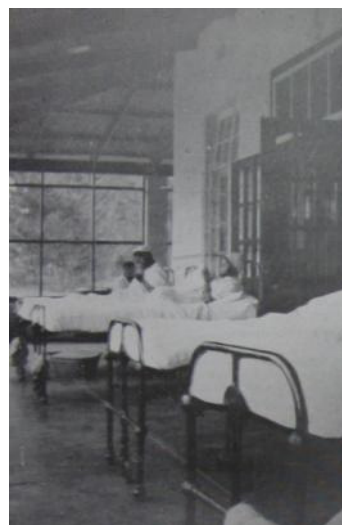
Fig 14: Veranda from Sulenkama Pamphlet (ca 1940) KCC

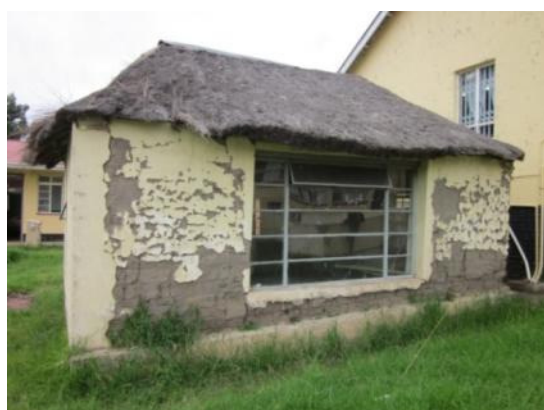
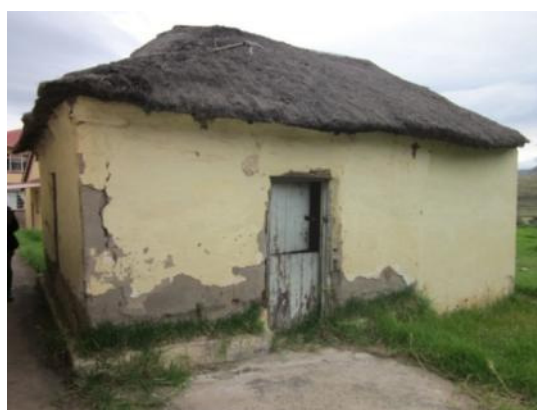
Figs 25 & 26: Mud brick building showing steel windows and wooden stable door

Given diagnostic features, this square mud brick building is very likely to be over the age of 60 years and thus subject to protection in terms of the South African National Heritage Act.

This example is located distant from the other examples, and is different as it has a steel window inserted on the south western façade. The south eastern façade has a small 6/6 sliding sash window, and the north-eastern façade a wooden stable door. The north-western façade has had top-hung steel section windows inserted. The roof is still thatched, and the walls comprise mud bricks which have been plastered. It has had a heavy concrete dado inserted which has possibly added to the degradation of the building. Attempts have been made over the years to repair the building, but with cement plaster.

Recommendation: OLD MUD BRICK BUILDING (6)

Due to its condition and location within the extended development, demolition is an option

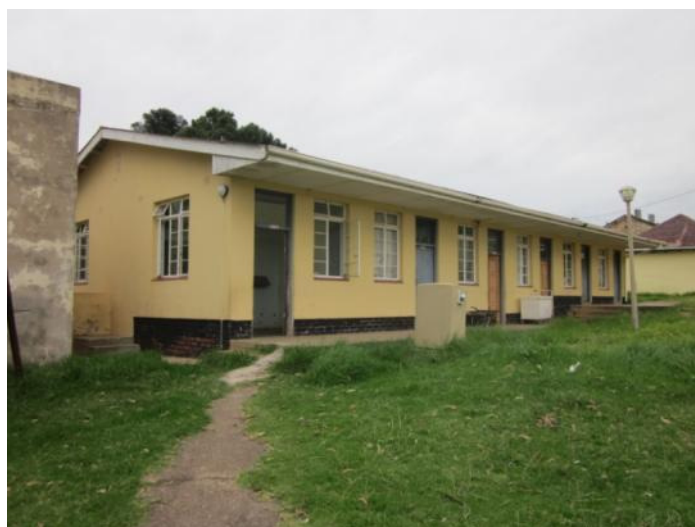
Fig 28: New hospital building

Possibly built at the same time as buildings 2 and 3 above, this building is of recent construction. It has a simple double-pitched corrugated sheeting roof, and is constructed to standard details using standard materials. It has meranti doors and steel windows and is unremarkable; it has no heritage value.

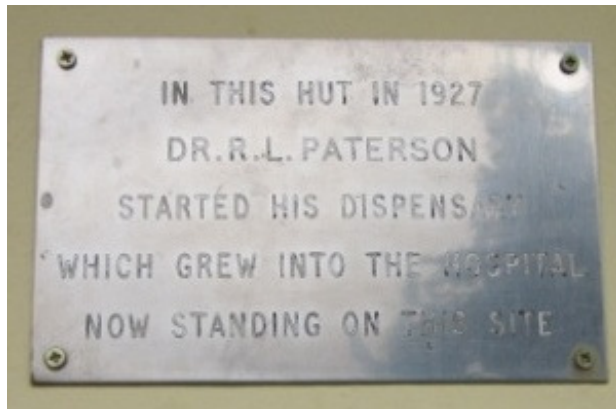
This is perhaps the most important building on the site. This plastered and painted mud brick building has a hipped thatched roof which has been covered with corrugated sheeting. At its entrance is a plaque noting that this was the first dispensary at Sulenkama. 6/6 timber sash windows are found to 3 elevations. It served as the first dispensary on the site, dating to 1927. It was from this that the rest of the hospital developed.

Fig 29: Plaque at entrance to dispensary

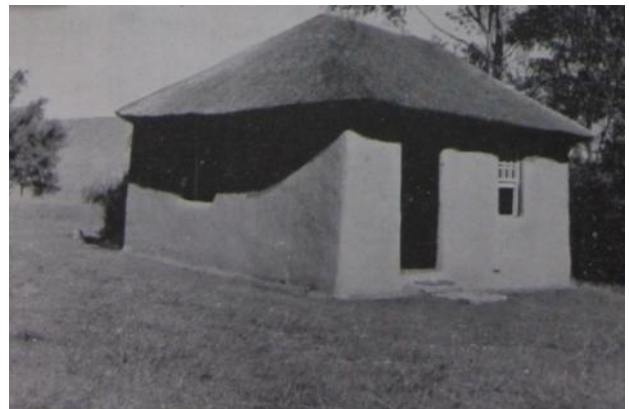
Photographs of the dispensary are found in the Nessie Knight Club pamphlet 'Sulenkama' from the Killie Campbell Collections (See Figs 30 and 31 below).

Fig 30: Photograph of dispensary ca 1940 (KCC)

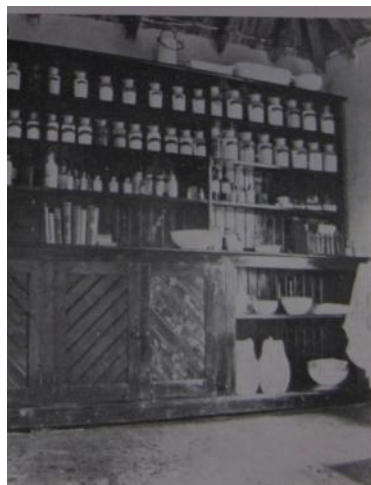
Fig 31: Interior of dispensary ca 1940 (KCC)

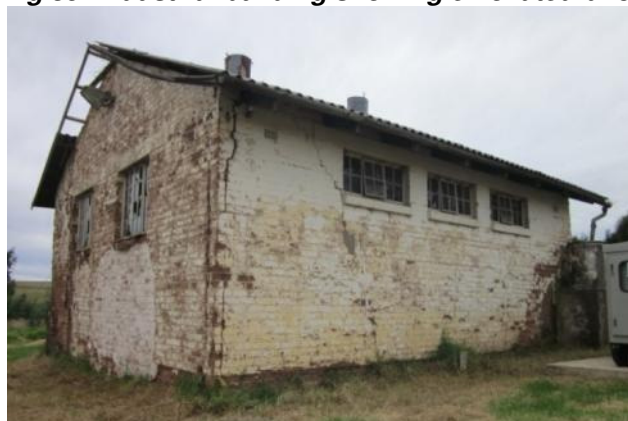
Fig 35: Industrial building showing exfoliated brick skin Fig 36: Industrial building from north

Fig 37: Industrial building from west

This structure is an old industrial building, possibly functioning as a mill or similar. It is of locally-made brick, with a double pitched corrugated-iron roof and steel windows. Its condition is extremely dilapidated: on the southern side the brick has collapsed to such a degree that the external skin has fallen away, compromising structural integrity.

Statement of significance: Although this building is most likely over the age of 60 years, it has limited heritage significance and is in a dilapidated condition.

Recommendation: INDUSTRIAL BUILDING (10)

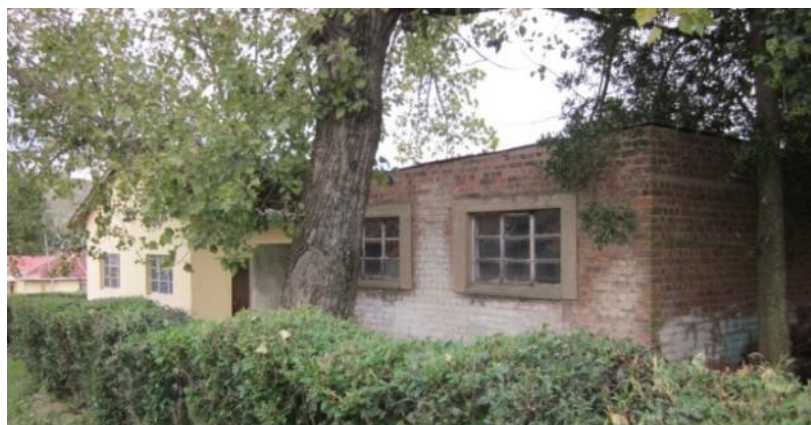
This building is also an industrial type building of relatively recent construction, but still using locally made bricks. It has steel windows and these have plastered bands surrounding them. It has a mono-pitch corrugated iron roof. It is architecturally unremarkable.

Fig 39: Building behind workshop

Recommendation: BUILDING BEHIND WORKSHOP (12)

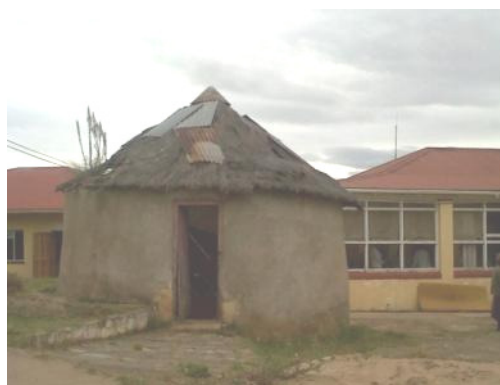
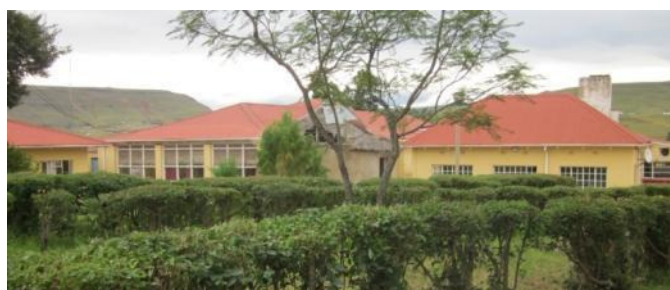
See comments for similar building in F.5 above. Despite it being in better repair than its counterpart, the practicality of its repair and reuse is limited, and it is felt that it is important to concentrate the repair and reuse of such buildings to other parts of this site.

Fig 40: Old rondawel against hospital

Fig 41: Old mud brick rondawel against main wards

Recommendation: OLD RONDAWEL (13)

Due to its condition and location within the extended development, demolition is an option

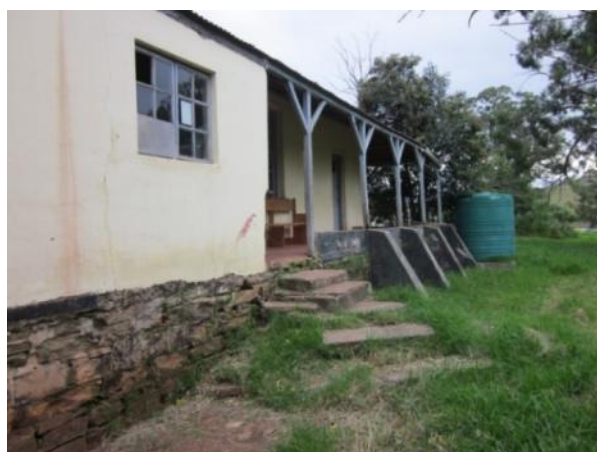
Fig 45: Old Mission Building, east north east

Fig 46: South west elevation

The building is of uncertain construction, most likely a mixture of mud and fired brick, under corrugated sheeting. Windows vary from original sash to standard steel sections, added at a later stage. It is founded on a mixture of shale and sandstone, much of which is exfoliating. Verandas have a simple 'Y' post, and the veranda to the north east is heavily buttressed to prevent it overturning.

Fig 47: Old Mission building from south east

Fig 48: Veranda and foundations

Recommendation: OLD MISSION BUILDING (16)

Given the position on the periphery of the site and level of alteration, in the opinion of the author demolition could be sought should the context determine the preservation of other more significant buildings or complexes. If so, it should be completely documented. If it is to be repaired, all renovation works should be supervised by an appropriately qualified heritage architect. Further research needs to be carried out on the role of the Church of Scotland in the establishment of Sulekama Mission

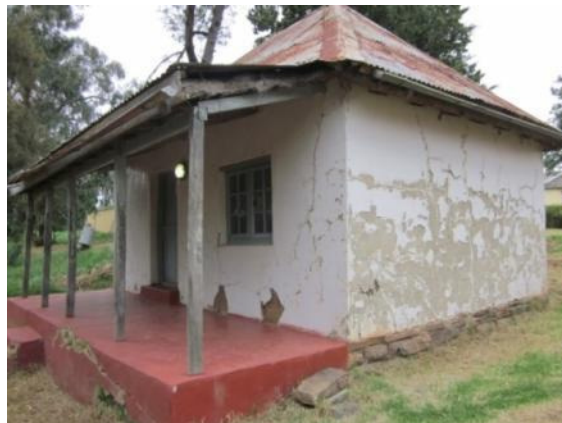
An old mission cottage is situated adjacent to the building described in F16 above. It is most likely of mud brick, given the examples surrounding it, and, like the others, has a thatched roof that has been covered latterly with corrugated iron. The windows are timber casement and the veranda posts are simple timber.

Fig 49: Old mission Cottage

Fig 50: Cottage, front elevation

Recommendation: OLD MISSION COTTAGE (17)

Given the position on the periphery of the site, in the opinion of the author demolition could be sought should the context determine the preservation of other more significant buildings or complexes. If so, it should be completely documented. If it is to be repaired, all renovation works should be supervised by an appropriately qualified heritage architect.

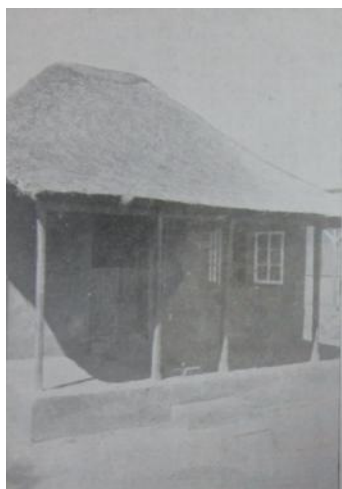
Fig 51: Front of cottage ca 1927

Certainly, this building was extant in the time of Robert Lamb Paterson as this was his home for two years when he first arrived at Sulenkama (see Fig 51 and 52, both from the pamphlet 'Sulenkama').

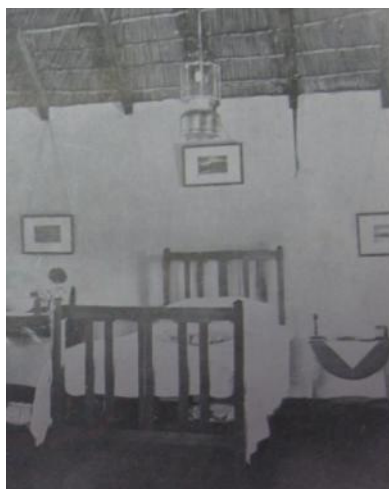
Fig 52: Interior ca 1927

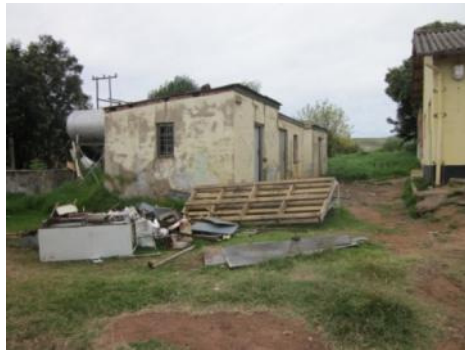
This building consists of a row of utilitarian accommodation of mixed construction, plastered under a mono-pitch corrugated sheeting roof. It has timber casement windows, but its origins are much more recent than the examples in F16 and F17 above. It has had attempts at maintenance over the years, and is currently in need of further attention. It is architecturally unremarkable and does not contribute in any major way to the cultural landscape of the site.

It is in line for demolition in the new development.

Recommendation: ACCOMMODATION BLOCK ADJACENT TO WORKSHOP (18)

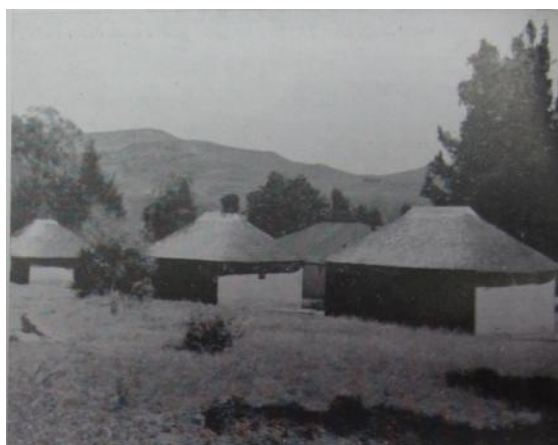
A series of square mud brick cottages is found across the site. Below the main hospital on the eastern slope is a continuous group of four with one located further up the slope, and two which form part of the main complex on the crest of the hill. One of these has been addressed in F6 and the other is situated close to the old mission house, and backing onto hospital buildings of more recent construction. Most, except for the latter, are either totally derelict, or in a sorry state of repair.

Fig 54: Nurses accommodation ca 1940 (Sulenkama pamphlet) Fig 55: Row of cottages

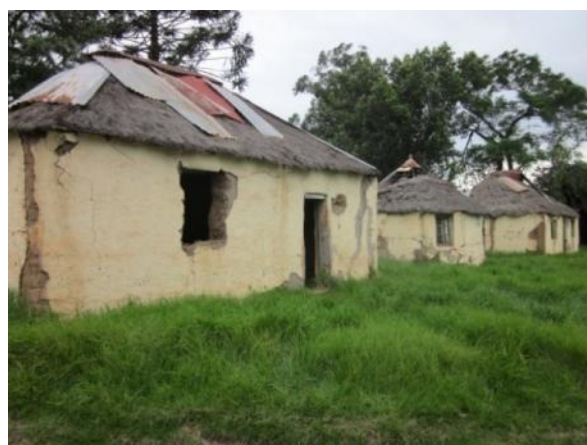
Fig 56: Typical state of cottages

Fig 57: Finger decorations to wall

Fig 58: Building below main wards

Fig 59: Example most likely candidate for rehabilitation

Recommendation: OLD NURSE'S QUARTERS

Given the position on the periphery of the site and the general dereliction of the buildings, in the opinion of the author demolition could be sought should the context determine the preservation of other more significant buildings or complexes. However, prior to this they should be fully documented, and measured up, and the information form part of a display in the museum. It is highly recommended that one of these buildings should be identified for rehabilitation as an example in the new development. The building situated behind the mission house is possibly the best option. All renovation works should be supervised by an appropriately qualified heritage architect. Further research needs to be carried out on the role of the Church of Scotland in the establishment of Sulenkama Mission

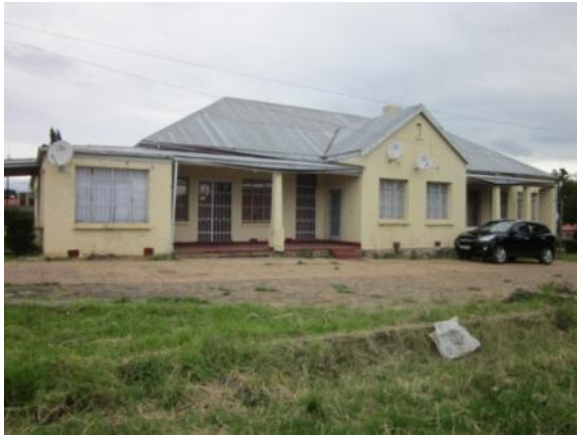
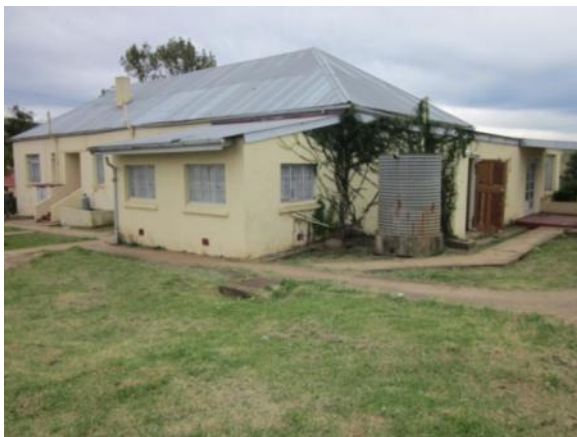
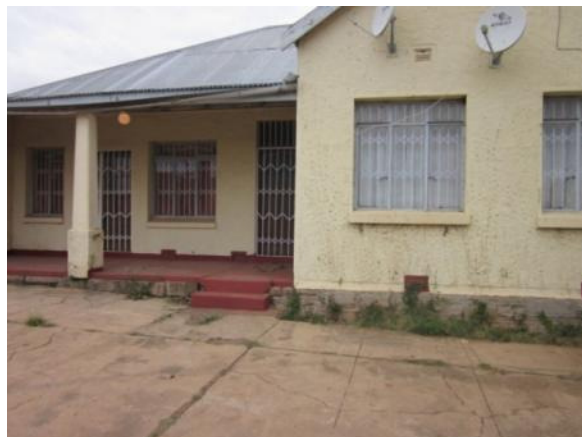
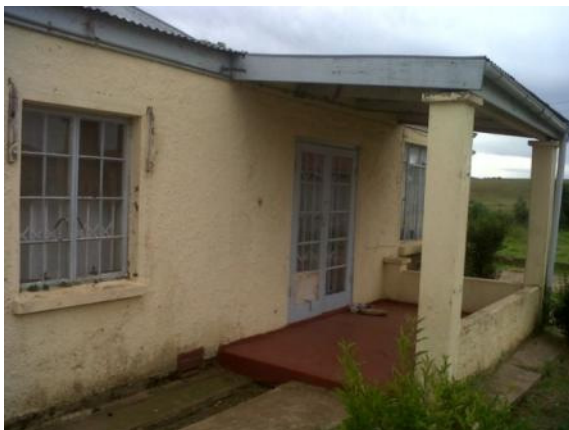
Fig 60: Main elevation from east

Fig 61: View from north east

Fig 62: View from south east

Fig 63: View of veranda and columns

Fig 64: View of veranda on south

This building is a substantial but simple late Edwardian style house, possibly constructed as the second mission house on the property. It is of locally made brick and mortar, rough-cast plastered and painted. The building is founded on stone, and evidence of this is seen in the rough dressed and pointed stone at dado level. Windows are all of steel, and there is little evidence of these replacing earlier timber ones. Cills are brick on edge, and the variant sub-floor ventilators tell of different stages in its development. Veranda columns are cumbersome tapered columns on a square base. The roof is hipped, with a central projecting bay to the main elevation containing a matching pair of windows.

Recommendation: OLD MISSION HOUSE

It is noted that a portion of this building will fall within the footprint of the new development. It is recommended that the proposal be slightly altered in order to accommodate this house, and prevent its demolition. As a threatened building it should also be fully documented, and measured up, and the information form part of a display in the museum. All renovation works should be supervised by an appropriately qualified heritage architect. Further research needs to be carried out on the role of the Church of Scotland in the establishment of Sulenkama Mission

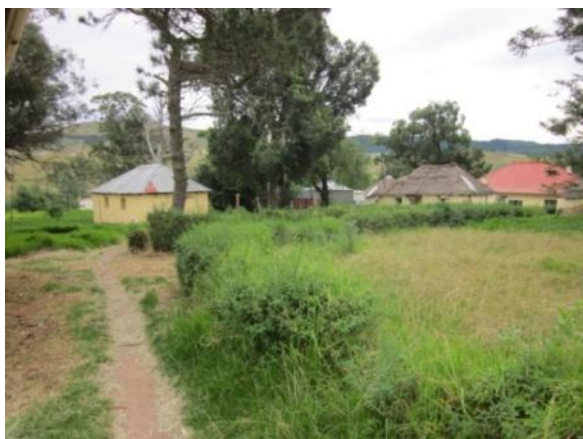
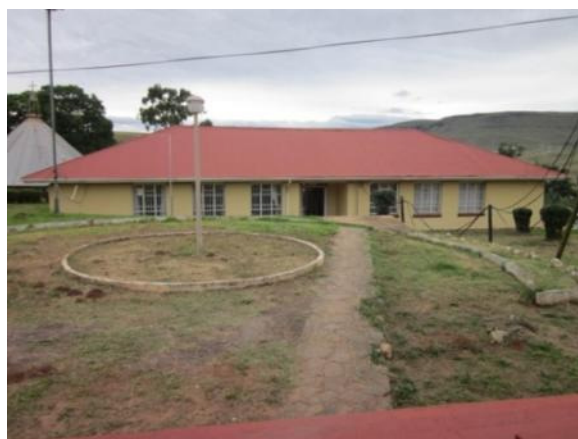
The most important feature of the entire complex at Nessie Knight is not the specific buildings themselves, but the overall endeavour that they represent. From its establishment as a Church of Scotland Mission station in the late 19th century, the bulk of the development was connected to the directorship of Dr Robert Lamb Paterson, who, together with his wife, the former Nessie Knight, developed a large mission hospital from funds actively sought both here and abroad. That some of these early buildings are still maintained, and, in fact recognised for their place in the development of this mission, is an important fact to note. This adds to the layers of importance, removing the value from a distant historical and paternalistic position to one which is recent, local and relevant. This forms part of the larger cultural landscape, in which the buildings and the tales that they tell in their positions on the site have value in memory.

Fig 65: View to east showing May-lined parterres Fig 66: Hard landscaping outside main wards

Fig 67: Hard landscaping outside Mission House

Fig 68: Parterres

emphasising the outlines of former rose gardens and parterres. This vestigial ethos should be recognised, and landscaping carried out on the site which recognises the historical patterns, yet reinterprets it in a contemporary, perhaps more sustainable manner.
