**HERITAGE SURVEY OF THE NGQAMAKWE WATER
RETICULATION, EASTERN CAPE**

FOR AURECON

DATE: MAY 2009

**By Gavin Anderson (MPhil)
Umlando: Archaeological Tourism and Resource
Management**

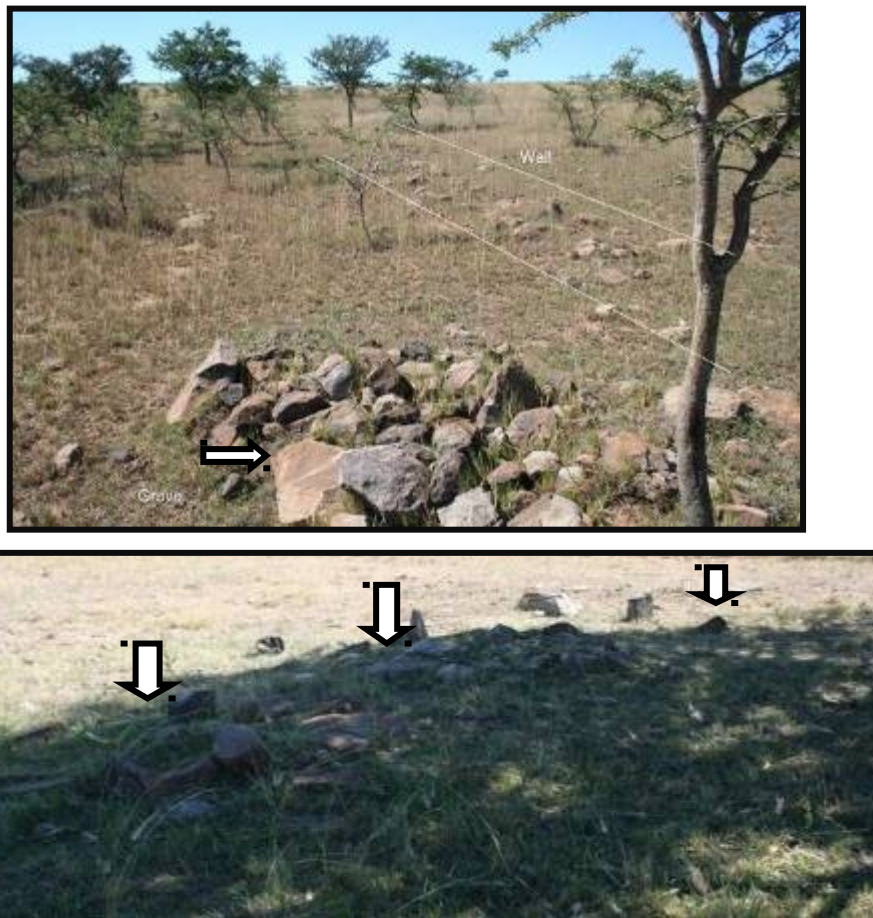
FIG. 4: HUMAN GRAVES & STONE WALLING AT NGQ03

The site consists of two old settlements and ~ 18 human graves. The western part of the site consists of rows of 15 human graves. The graves vary in size and do not appear to have headstones. There is a low stone wall near these graves. The area has not been used for a while as acacia trees have grown on some of the graves. The eastern part of the site consists of ~3 graves with headstones, two house foundations and a kraal. He graves appear to have headstones and postdate the western part of the site.

Significance: The graves are of high significance, while the rest of the site appears to be of low significance.

Mitigation: The graves should not be disturbed as the pipeline can be realigned.

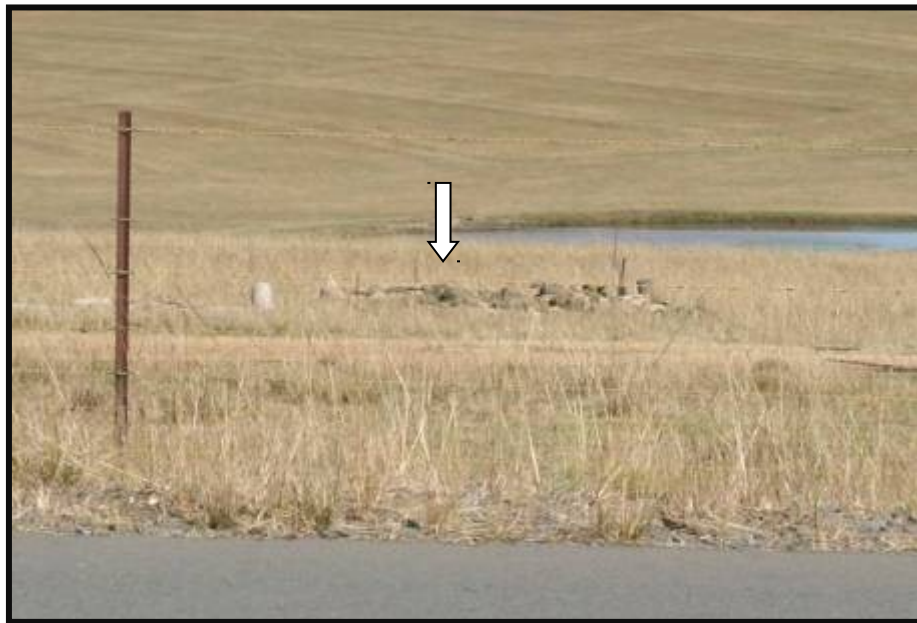
FIG. 5: RECENT HUMAN GRAVE AT NGQ04

The site consists of a recent grave ~50m west of the road. The grave is less than 60 years old and has a headstone.

Significance: The grave is of high significance.

Mitigation: The grave should not be disturbed as the pipeline can be realigned.

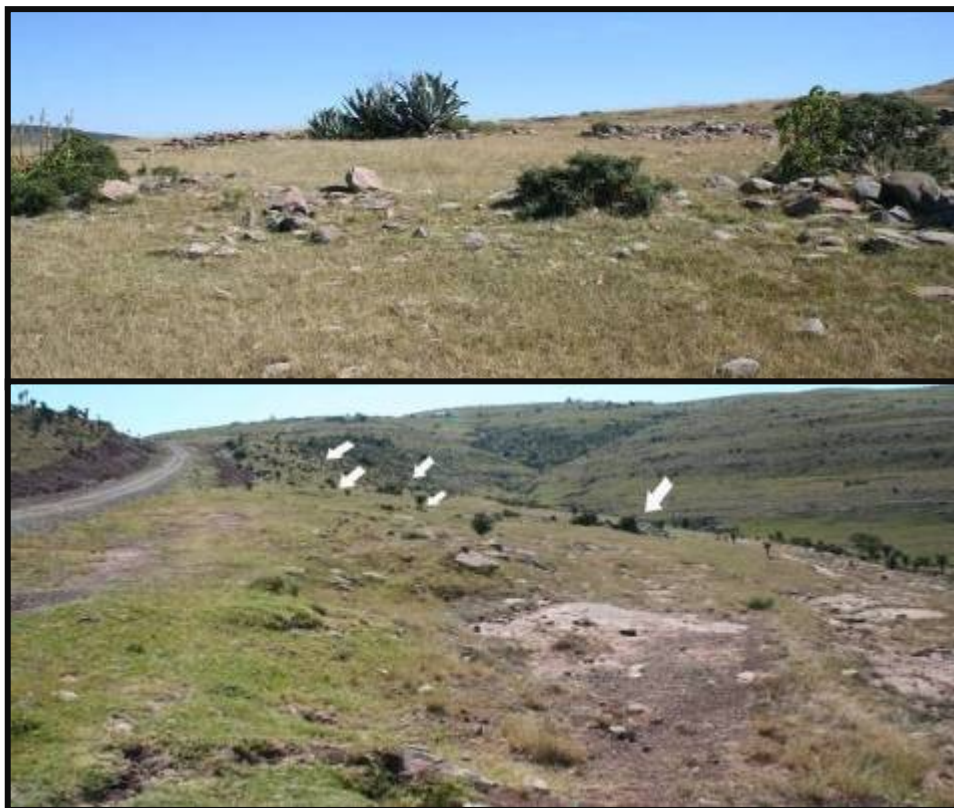
FIG. 6: STONE WALLING ON EACH SIDE FO THE ROAD AT NGQ05

The site is located near the end of long and narrow spur, and walling occurs on both sides of the road (fig. 6). The main part of the site occurs on the western

side of the road. It consists of four house foundations and a large rectangular kraal with a middle wall. There is a large sisal plant growing on top of the one wall. Several smaller stone walled kraals occur on the eastern part of the road. We did not locate any graves. All stone walling occurs more than 20m from the road.

Significance: The site is of low significance.

Mitigation: No further mitigation is required.

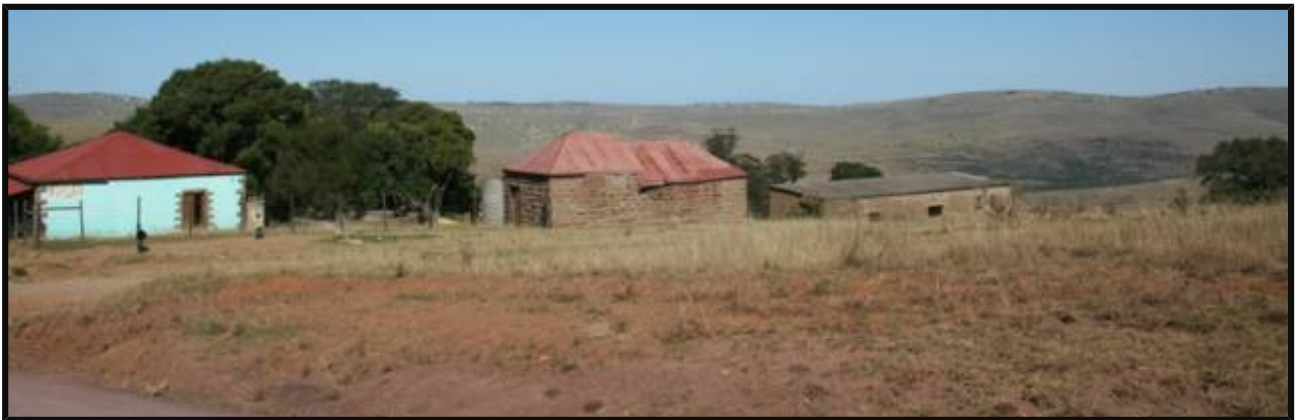
FIG. 7: MNYIBASHE STORE AT NGQ07

This site is located on one of the main dirt roads leading off the R409. The site is a building complex of apparent late 19th century or early 20th century colonial buildings. It is currently referred to as the Mnyibashe Store and may be one of the original trader's posts. There are several other buildings in this complex that is 100m x 160m in size. Fig. 7 illustrates dome of the buildings.

Significance: the buildings will need to be assessed by a historical architect if they are to be damaged in any manner. This is unlikely to occur for this project.

Mitigation: While the buildings are unlikely to be damaged, the pipeline may unearth old rubbish dumps. An ECO should be on site when this area is excavated and report ANY artefacts. These then should be reported to SAHRA and or the heritage practitioner for comment. If historical artefacts, such as bottles and plates, were located, the excavations would need to stop and continue further along the line, until the artefacts have been assessed. Any rubbish dump exposed in this area will need a heritage assessment as well.

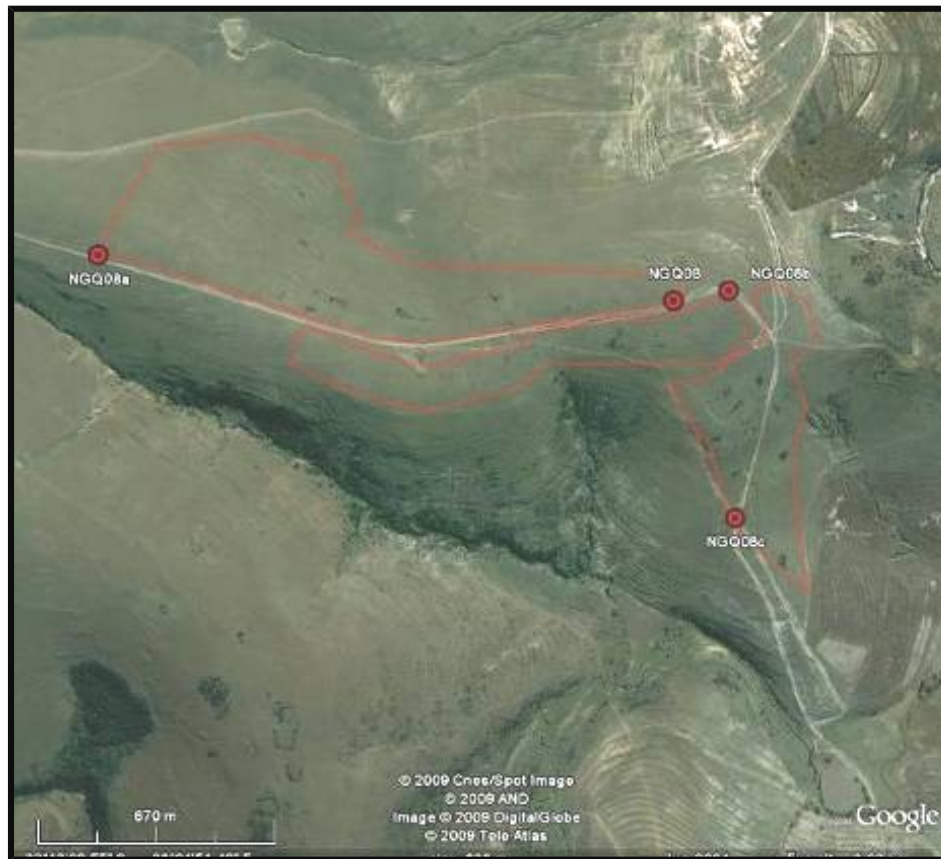
FIG. 8A: EXTENT OF THE SETTLEMENTS AT NGQ08

This site is a series of sites on the top of a hill. The main part of the site is approx. 1.5km long, with additional settlements making the entire area 2.5km in length (fig. 8a). The site consists of a series at least 43 family households, each confirming to the basic settlement pattern.

The site became too large to record on the existing timetable and thus we recorded the site as a whole. This pattern is the norm for settlements in this area and thus assists in identifying the various settlements (see fig. 8b). Unfortunately, the norm is also for graves to occur in these settlements and is often not easily discernable (see fig. 8c). This specific grave (in fig. 8c) occurs within 5m of the road.

Significance: The area is of high significance because of the graves. The occurrence of visible spatial patterns in an (recent) historical settlement is of some significance, as I do not believe there are archaeological records of these sites.

Mitigation: The impact of the pipeline tends to be within 5m servitude. There is no reason for the pipelines to affect the settlements and especially the graves.

The final route would need to be re-assessed in terms of these settlements. I would suggest that the pipeline remains as close to the existing dirt road as possible, and that excavated material is placed on the road. The dirt road is minimally used and in disrepair, especially when it reaches these sites and would thus not inconvenience traffic. The Google Earth image makes the dirt road appear bigger than what it actually is.

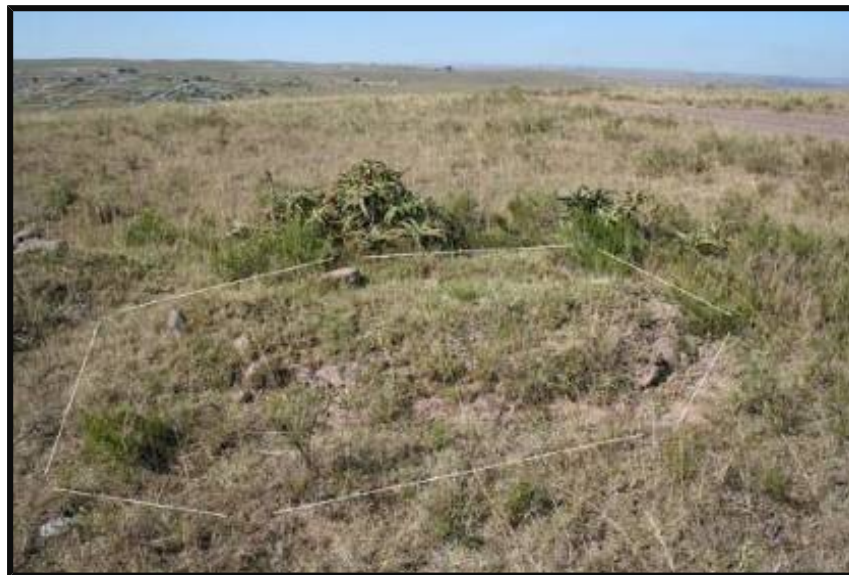
FIG. 8c: EXAMPLE OF A GRAVE AND STONE WALLING AT NGQ08³

³ Grave outlined in white with walling directly behind

The final route should also be reassessed in one of two ways:

1. A site inspection to ensure that the graves and structures will not be affected by the pipeline; or,
2. High-resolution aerial photographs can be used where the pipeline is overlaid on the photographs. Any 'problem areas' can thus be easily seen, their location noted, and the pipeline can be deviated. This would minimise costs for actual fieldwork. **An ECO will need to be on site for this area.**

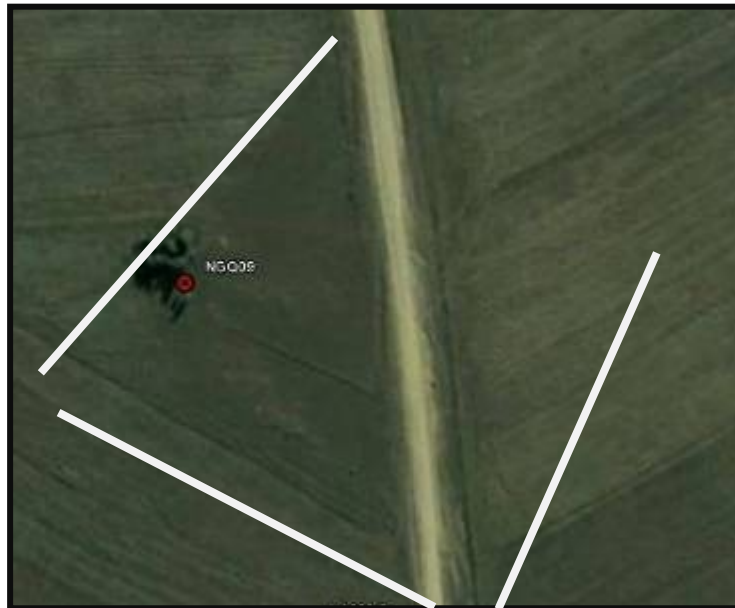
FIG. 9a: PARTIAL OUTLINE OF OLDER SETTLEMENT AT NGQ09⁴

The site is located near two large wattle trees. While I did not observe any obvious signs of human habitation, there was a distinct appearance that there was a settlement. The aerial imagery clearly shows that there was a square agricultural field in the area (fig. 9a). Any houses would have been destroyed by ploughing the fields; however, graves would occur near the trees (in fig. 9a). The occurrence of rocks not immediately local to the area, in the shape of a 'cairn', thus warrants further attention. I believe these rocks may be part of a grave.

Significance: The site is of high significance until the potential graves is proved to be a grave or not. The rest of the site is of low significance.

⁴ Settlement outlined in white

Mitigation: The site will probably not be affected by the pipeline, as it is ~ 40m far from the road.

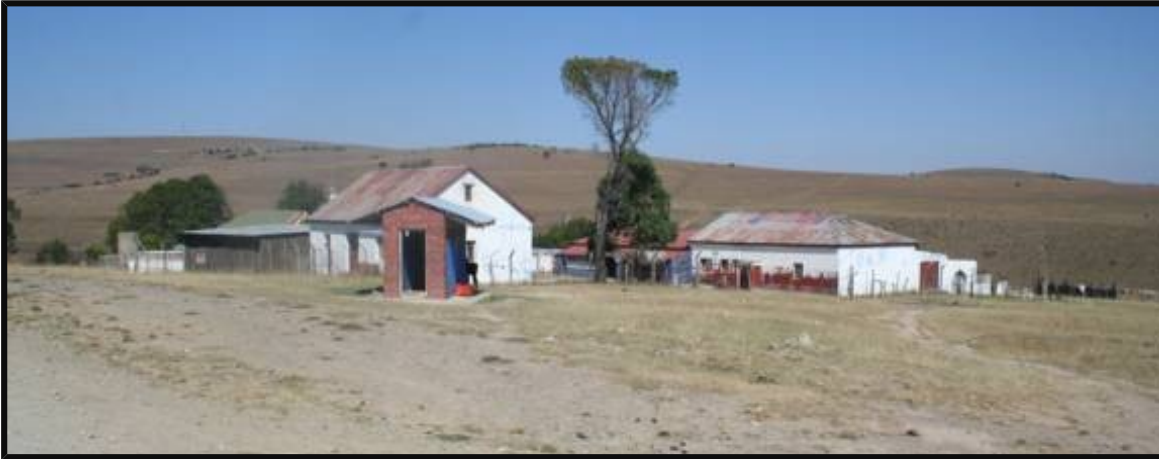
FIG. 10: ST BENFORT MISSION AT NGQ012

The site consists of a mission: the St Benfort mission (fig. 10). The buildings are probably older than 60 years, thus making it historical. A Deeds search and/or oral history would obtain a more precise date for the buildings.

Significance: The site cannot be assessed now, as it would require specialist investigation. The buildings will need to be assessed by a historical architect if they are to be damaged in any manner. This is unlikely to occur for this project.

Mitigation: While the buildings are unlikely to be damaged, the pipeline may unearth old rubbish dumps. An ECO should be on site when this area is excavated and report ANY artefacts. These then should be reported to SAHRA

and or the heritage practitioner for comment. If historical artefacts, such as bottles and plates, were located, the excavations would need to stop and continue further along the line, until the artefacts have been assessed. Any rubbish dump exposed in this area will need a heritage assessment as well.

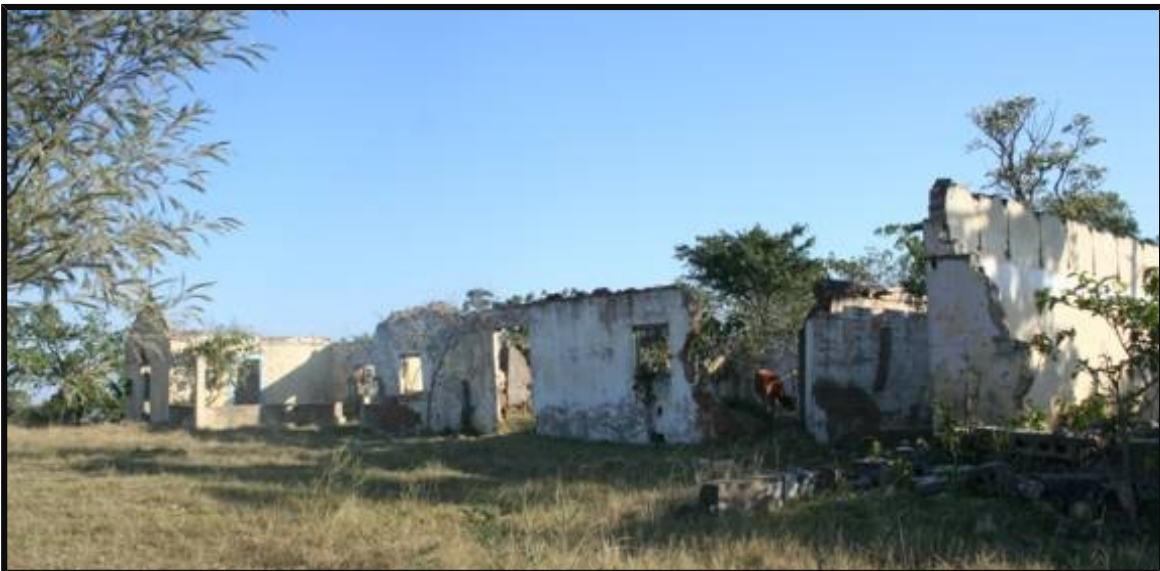
FIG. 11: HISTORICAL BUILDINGS AT NGQ015

The site consists of a series of old buildings ~4km away from the R409. The 1:50 000 map labels this site as: Tyinira. The buildings appear to be a farm complex and/or trading store (fig. 11). The buildings appear to be a series off add-on structures of which some have wooden window frames. There are several large willow trees on the periphery of the buildings. The main, and original, buildings may be older than 60 years.

Significance: The site cannot be assessed now, as it would require specialist investigation. The buildings will need to be assessed by a historical architect if they are to be damaged in any manner. This is unlikely to occur for this project.

Mitigation: While the buildings are unlikely to be damaged, the pipeline may unearth old rubbish dumps. An ECO should be on site when this area is excavated and report ANY artefacts. These then should be reported to SAHRA and or the heritage practitioner for comment. If historical artefacts, such as bottles and plates, were located, the excavations would need to stop and

continue further along the line, until the artefacts have been assessed. Any rubbish dump exposed in this area will need a heritage assessment as well.

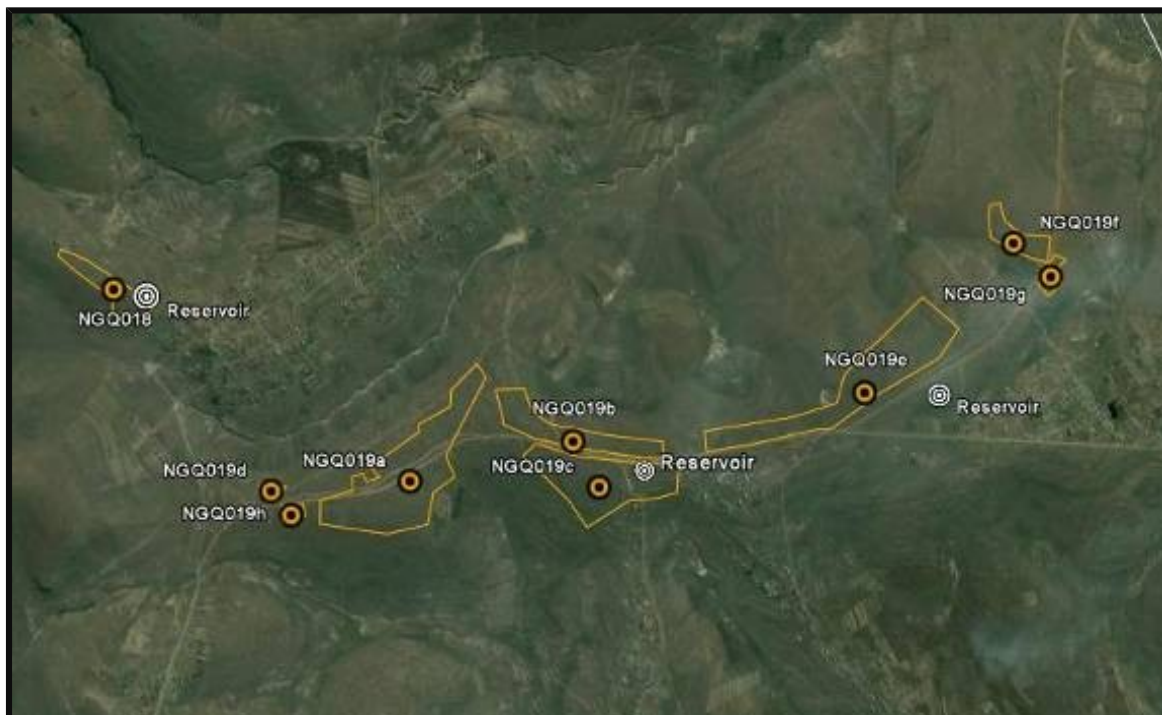
FIG. 12: SETTLEMENTS AT NGQ018 AND NGQ019

The site is located on a small hill northwest of a current village. The site consists of seven settlements with the basic settlement pattern that are placed

along a narrow ridge (fig. 12). There are more recent historical settlements on the hills to the northwest and west. As with the other settlements in the study area, graves may occur that we did not observe. There are good examples of the settlement pattern (with slight variations) at this site.

Significance: the site is of medium significance in terms of its settlement patterns, but may be high if graves do occur.

This site is a series of settlements that run along the entire ridge for 5km (fig. 12). I recorded the site as one large site and did not have time to record each settlement in detail: the aerial photography clearly outlines the various recent historical settlements. Each settlement conforms to the standard pattern of household settlements observe throughout the area. However, some these settlements differ in that the houses are surrounded by a wall that connects to the main rectangular kraal: other settlements did not have this wall.

Significance: The settlements are of medium significance in that they differ slightly in their spatial pattern of houses in the study area. Graves are also likely at the various settlements thus making the site highly significant.

Mitigation: I suggest that the proposed reservoir is moved to one of two alternative locations (32° 7' 13.71"S, 27° 56' 56.68"E or 32° 06' 52.46"S, 27° 57' 15.24"E) so that it does not affect NGQ018. The alternative areas are at similar altitudes, have no obvious evidence of human occupation, and are in ploughed fields. It would be preferable not to damage heritage sites even if they are not directly protected by heritage legislation.

Mitigation: The pipeline will have minimum (if any) impact if it keeps to the southern side of the road and then within 10m of that road. The houses of each settlement occur closest to the road, and thus any potential graves would occur even further from the road.

The more western reservoir (approx. 32° 07' 28.10"S, 27° 59' 07.06"E) should be moved slightly east to 32° 07' 27.70"S, 27° 59' 10.71"E. In this way it will avoid a settlement.

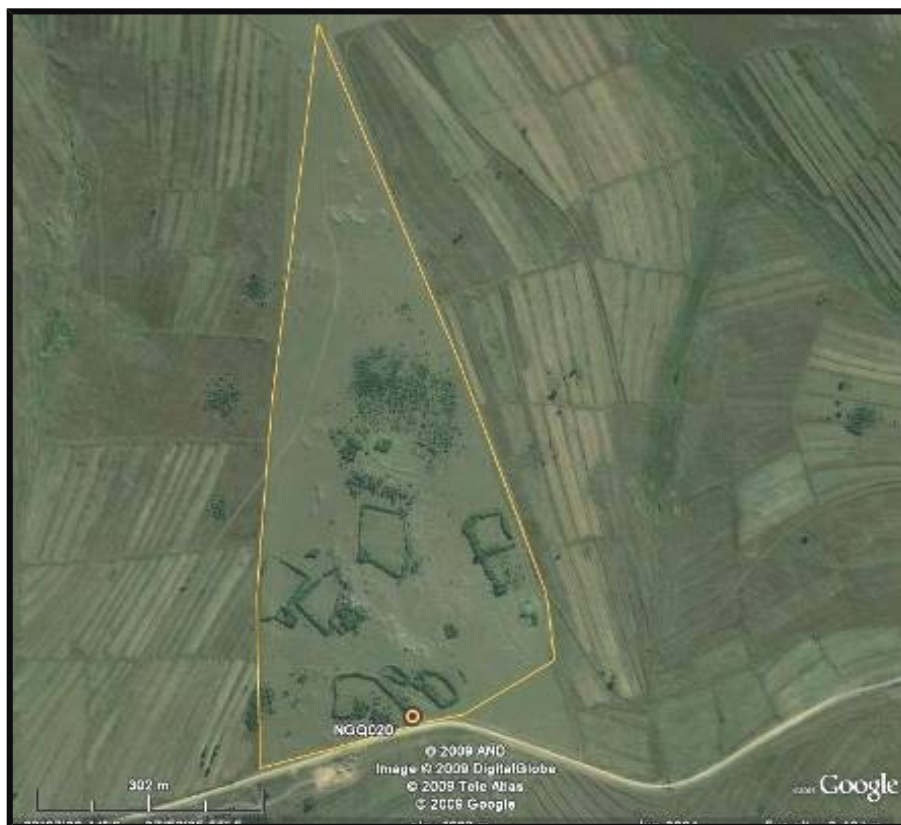
FIG. 13: SETTLEMENTS AT NGQ020

This site is located near the edge of a ridge before the valley drops into the Tsomo River Valley. The site consists of several recent historical settlements that conform to the general settlement pattern (Fig. 13). The site is over 600m long (north-south). There are eleven of the settlements that are clustered near each other and some have secondary wattle woodlots. Some of the settlements use

natural rock outcrops as a “wall”. We did not observe any graves at the southern settlements, and did not survey the northern half of the site as it was well beyond the 50m buffer zone.

Significance: The site is of medium significance as it has well preserved features that clearly show the spatial patterns of each settlement.

Mitigation: The pipeline will occur on the southern part of the road and thus avoid the site.

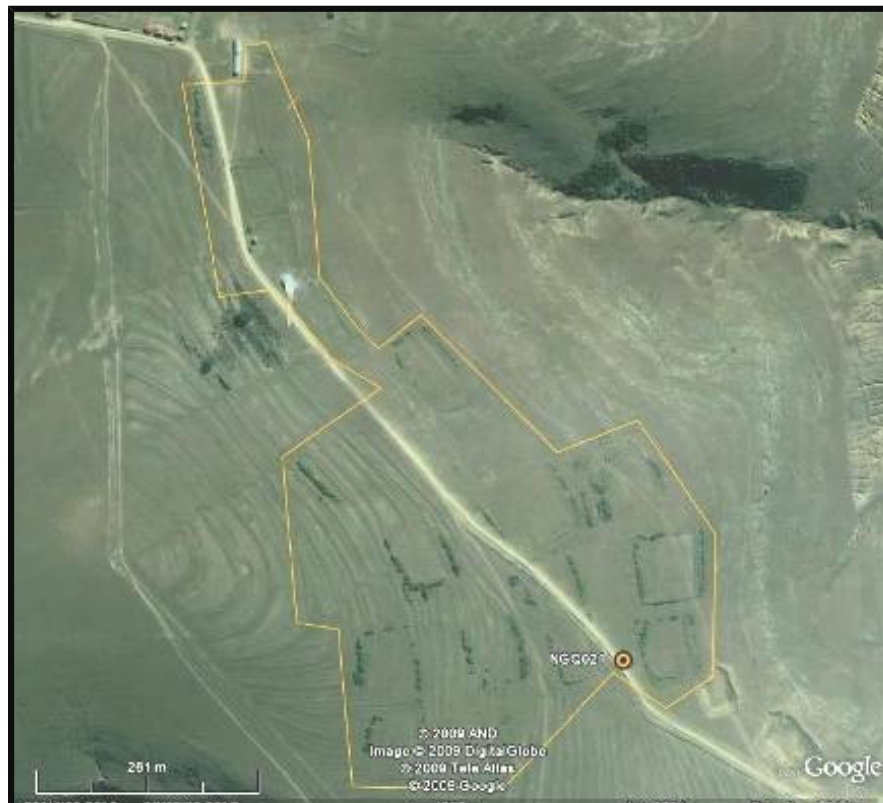
FIG. 14: SETTLEMENTS AT NGQ021

The site is located at the base of one of the higher hills in the study area. The site consists of seventeen settlements conforming to the standard settlement pattern. The current dirt road (fig. 14) bisects the site. This road has affected some of the settlements in that it has been placed through walling and/or kraal

demarcations. The southern side of the road is an agricultural field that has been ploughed, however, the settlements appear to have minimally affected by ploughing activity.

Significance: The site is of medium significance. It has preserved spatial features and most of the houses occur in batches of four. There is thus a variation to the general settlement pattern. Unfortunately, the dirt road has partially damaged a few settlements.

Mitigation: If the pipeline stays within 10m of the dirt road then it would not affect any potentially sensitive area. The grading of the dirt road has already damaged this 10m boundary, for each side of the road.
