Phase 1 Palaeontological Impact Assessment of a
proposed new borrow pit near Ludeke, EC Province.

Report prepared for:
CSS Environmental Consultants
P O Box 346
East London 5200

Lloyd Rossouw
National Museum Bloemfontein
PO Box 266
9300

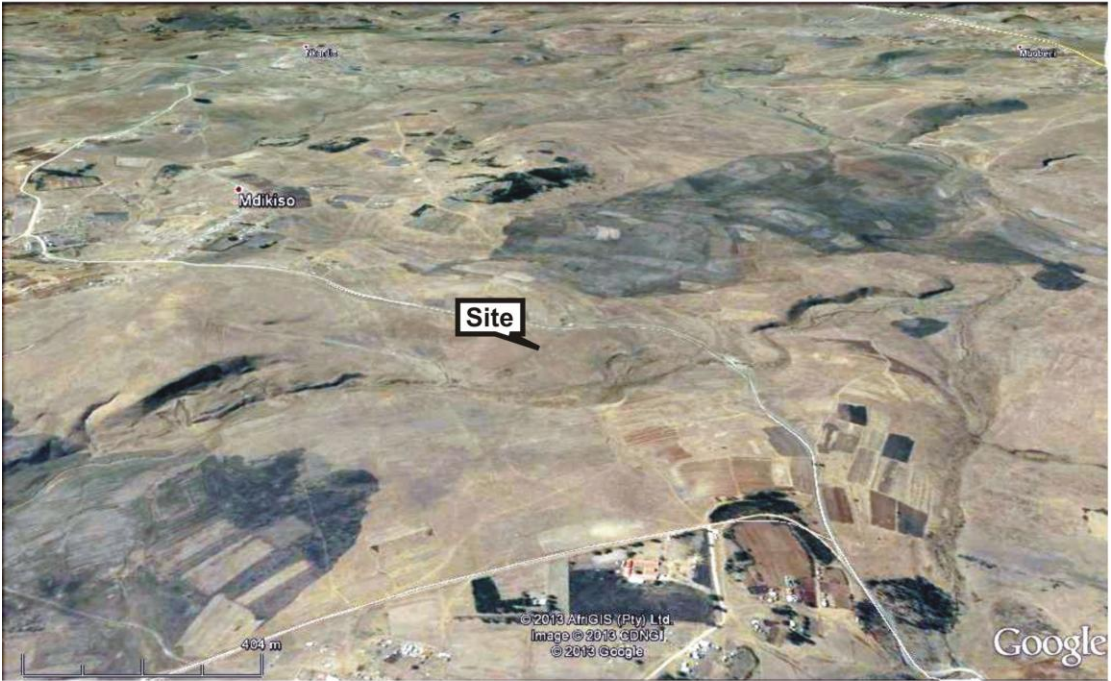
Figure 2. Aerial view of the affected area.

The site is located off the R61 road to Bizana, and about 4 km north of the town of Ludeke (**Fig. 2**).

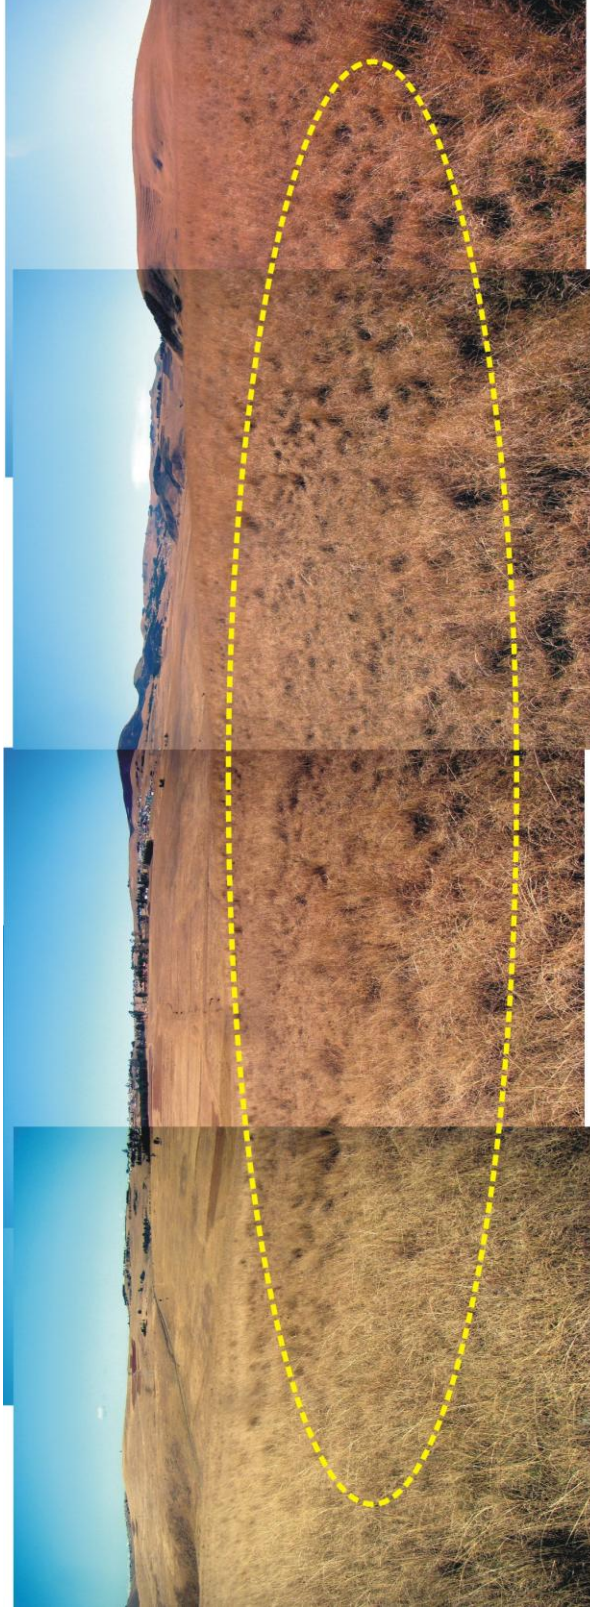
Figure 3 Panoramic view of the proposed borrow pit site, looking south
(GPS30°47'58.07"S 29°43'22.67"E).

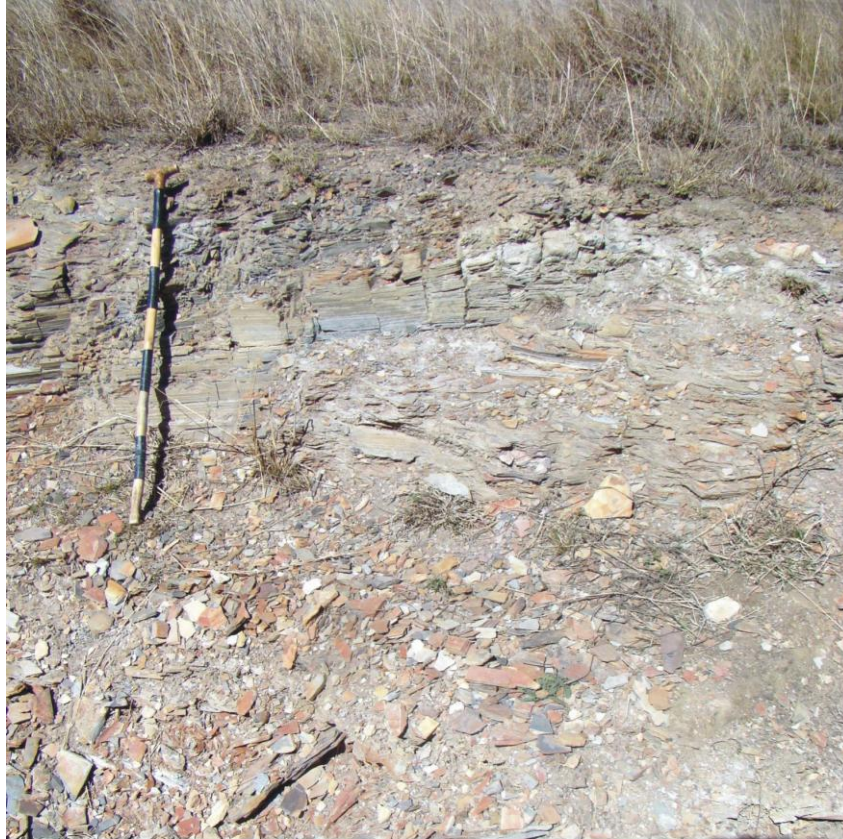
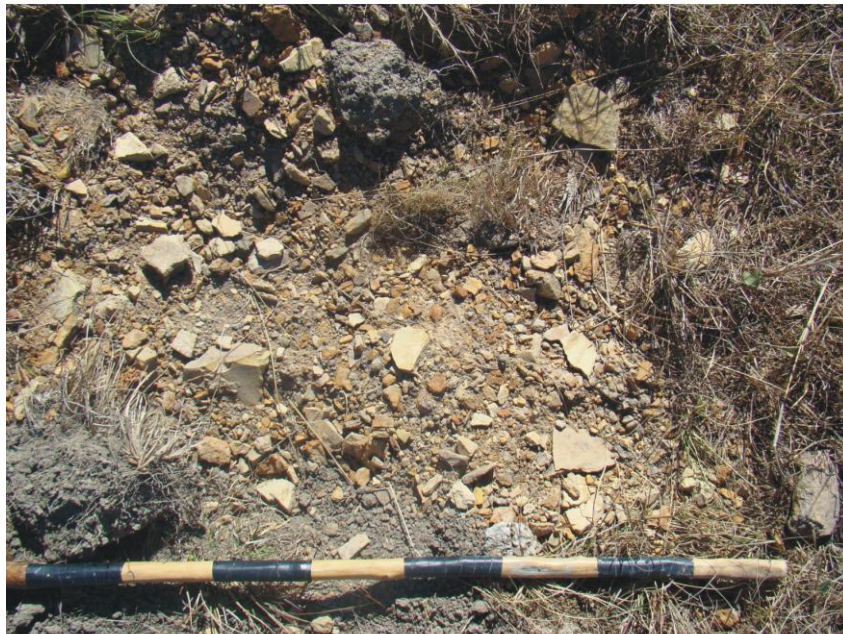
There is a general lack of outcrop at the site, but laminated Ecca shales are exposed in an old borrow pit located nearby (**Fig 4**; GPS 30°47'58.07"S 29°43'22.67"E). The Ecca Group along the eastern flank of the Karoo basin has not been studied in detail because of poor exposures and repeated faulting. Fossils are relatively scarce in the Ecca beds in comparison with the underlying Dwyka Formation. Rare vertebrate fossil remains from the upper part of the Ecca Group include the mesosaurid reptile *Mesosaurus tenuidens* and *Stereosternum tumidum* (Oelofsen and Araujo 1987) as well as crustaceans (*Notocaris tapscotti*) and palaeoniscoid fish. Rare ichnofossils have been recorded in the central part of the Group. Plant and invertebrate fossils include wood and leaves (*Glossopteris*), sponge spicules and rare insect wings (Anderson and McLachlan 1976; McLachlan and Anderson 1977).

Figure 4. Laminated shales and sandstone partially exposed in an old borrow pit located nearby (GPS 30°47'58.07"S 29°43'22.67"E).
