Management Plan: Noka rock art site
Noka Camp
Lapalala Wilderness
Limpopo Province
South Africa

Compiled for Lepogo Lodges

For submission to the South African Heritage Resources Agency (SAHRA)

September 2023

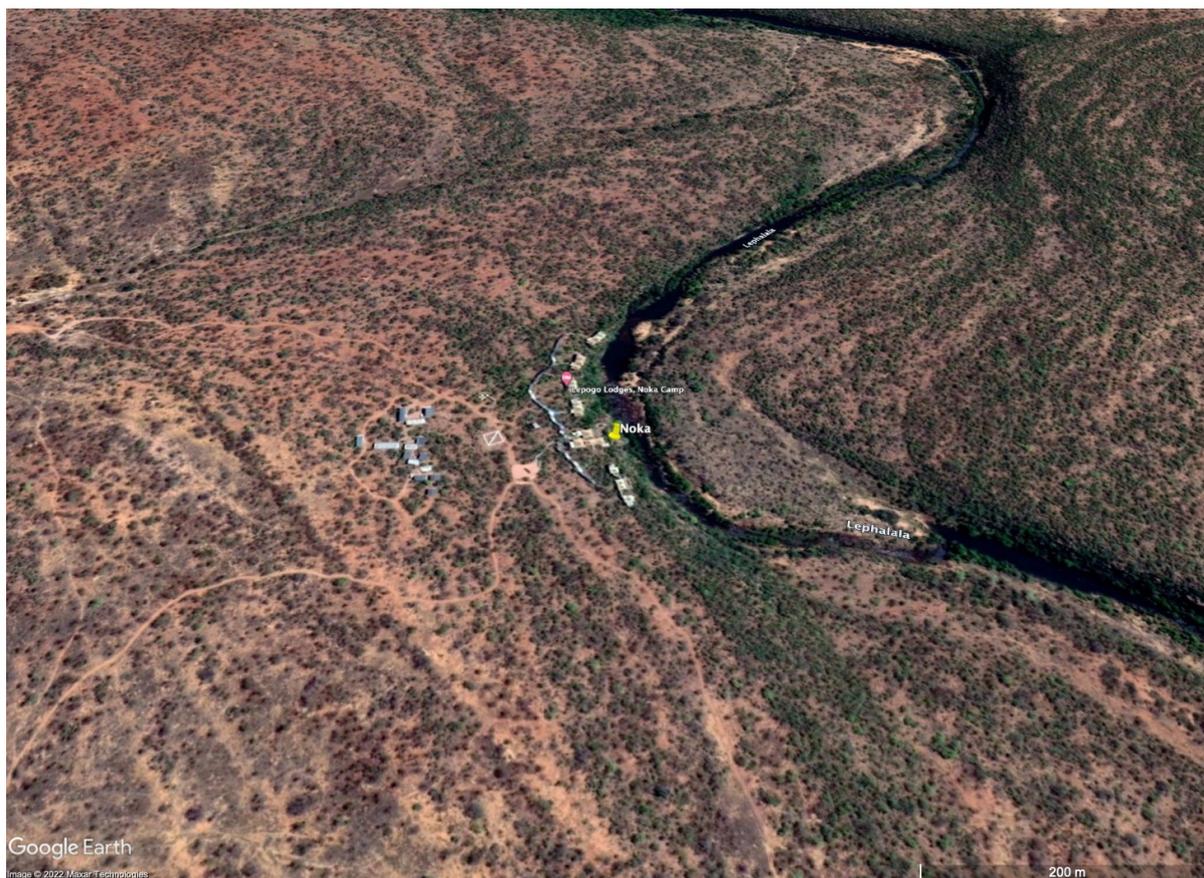
Figure 3. Noka rock art site (yellow pin) is an overhang at the base of an east-facing cliff. Noka Camp (red marker) is immediately to the west of the rock art site

Noka rock art site is located at the foot of a 15 m cliff that overlooks the Lephalala River. The Noka Camp is situated on the plateau about 15 m above the rock art site and about 10 m west of the rock art site.

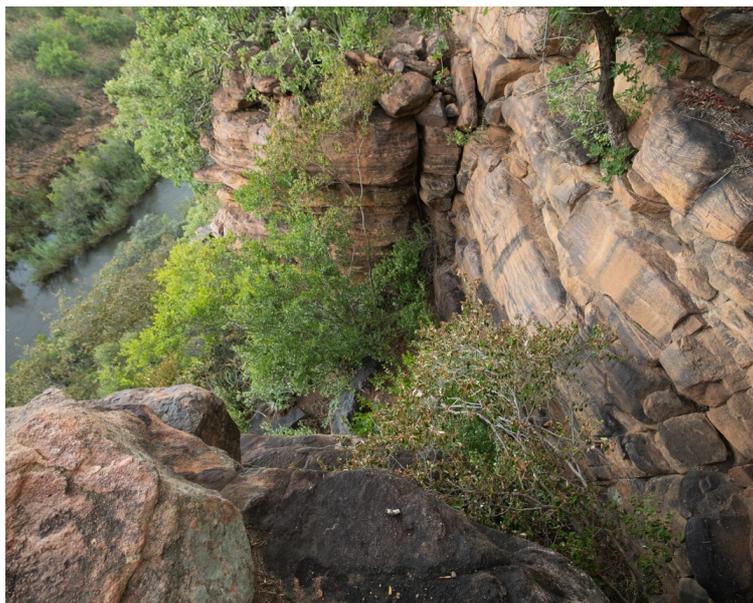
Figure 4. View from the plateau down into the gulley that affords access to the Noka rock art site. The bush at bottom right of the photograph marks the approximate location for the proposed spiral staircase down into the gulley below (the green bushes in the centre). Noka rock art site is not visible here. It is 25 metres around the corner at the bottom left of the photograph

From the plateau on top of the cliff the route proceeds for about 10 m in a westerly direction to the head of a gulley on the southern end of the rock art site. The proposed route to descend from the cliff top and to access Noka rock art site is via this gulley (Figure 4, Figure 5, Figure 6, Figure 7, Figure 8).

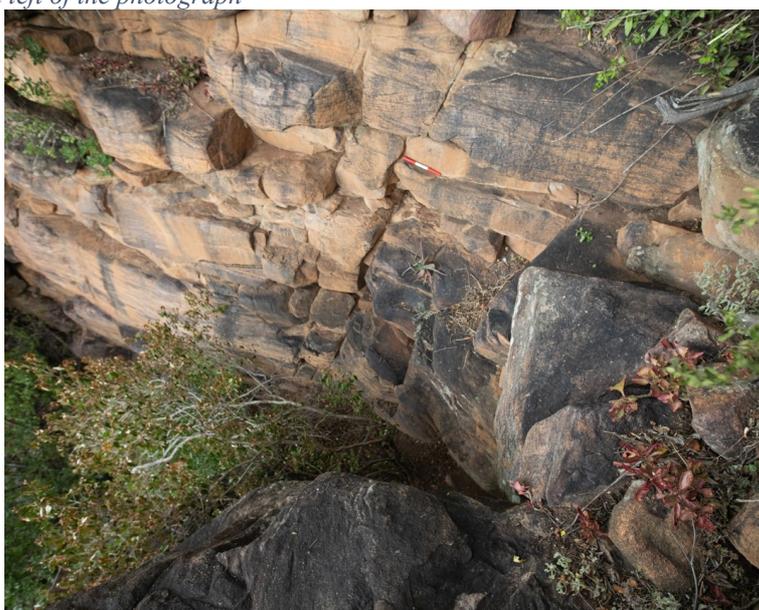
Figure 5. The gulley in which it is suggested that the proposed spiral staircase be placed. The drop down into the gulley from the top of the cliff is about 3 m. The small tree/bush (Croton gratissimus) would need to be removed

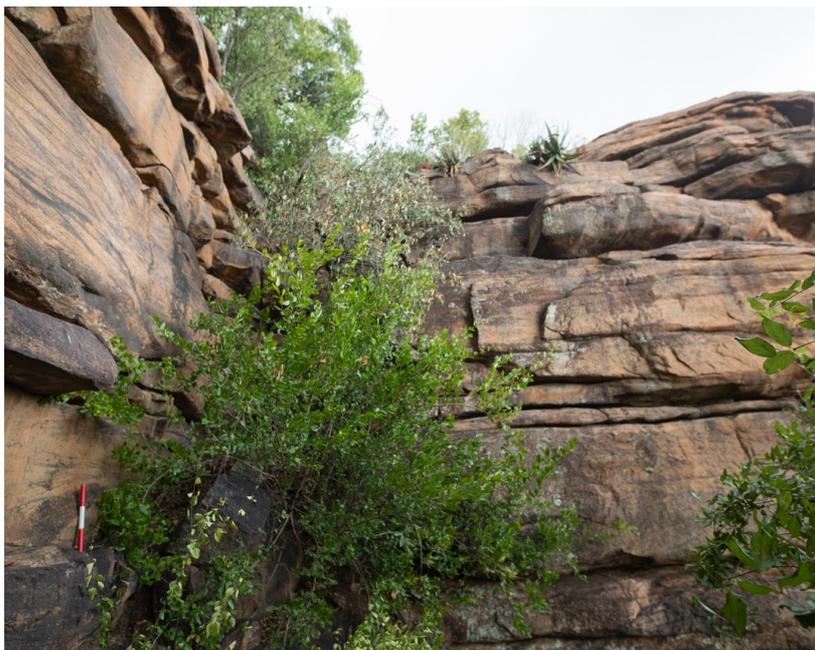
*Figure 6. Looking back at the gulley in the previous photograph and to the cliff top above. This photograph shows where the proposed spiral staircase would be installed to allow visitors to descend from the cliff top down into the gulley below. The small tree/bush in the foreground (*Combretum apiculatum*) would need to be removed*

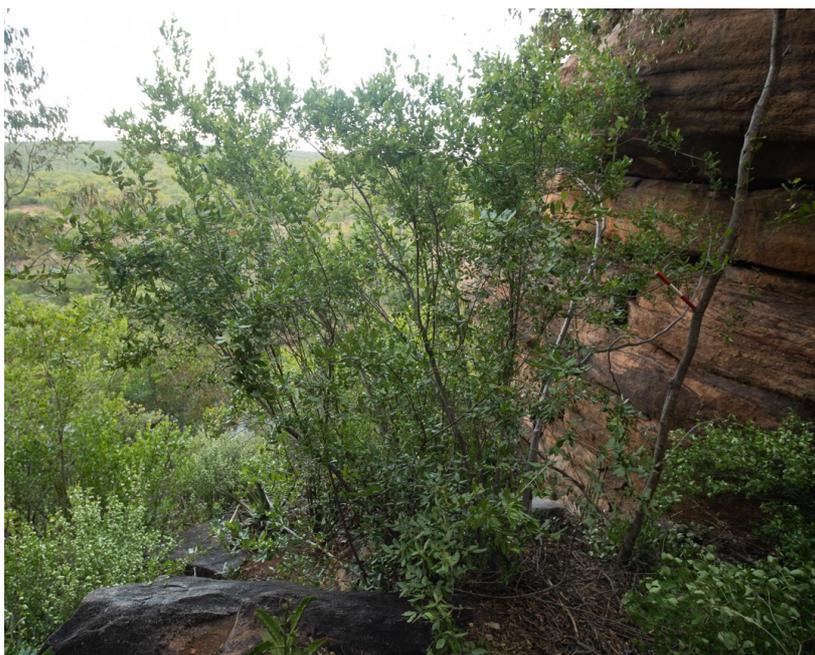
*Figure 7. Having dropped down into the gulley the proposed 30 m long stepped path with a gradient of about 1:3 would descend to the rock art site. The small tree/bush (*Combretum apiculatum*) in the middle of the picture would need to be removed. the site is not visible in this photograph. It is about 20 metres to the left of the lefthand side of the photograph*

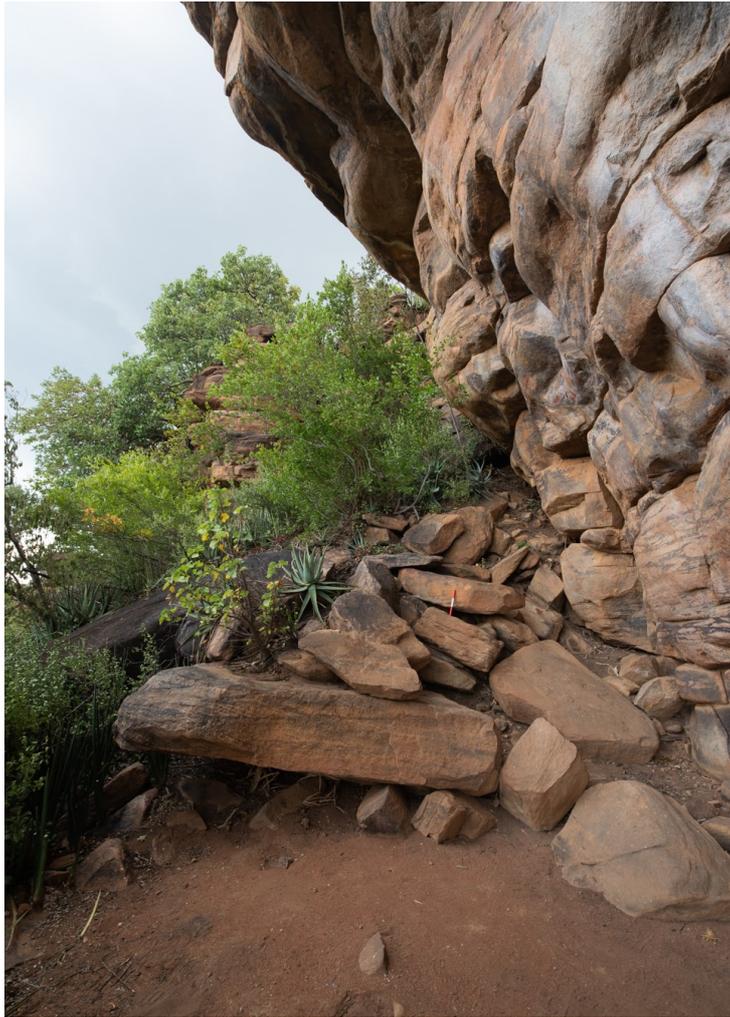
*Figure 8. View of the proposed route for the path from within the Noka rock art site. The path up the gulley to the cliff top would begin at the rocks at the bottom centre of the picture and then continue upwards to the left of the scale indicator in the photograph. The small tree/bush (*Combretum apiculatum*) and shrub above the aloe would need to be removed*

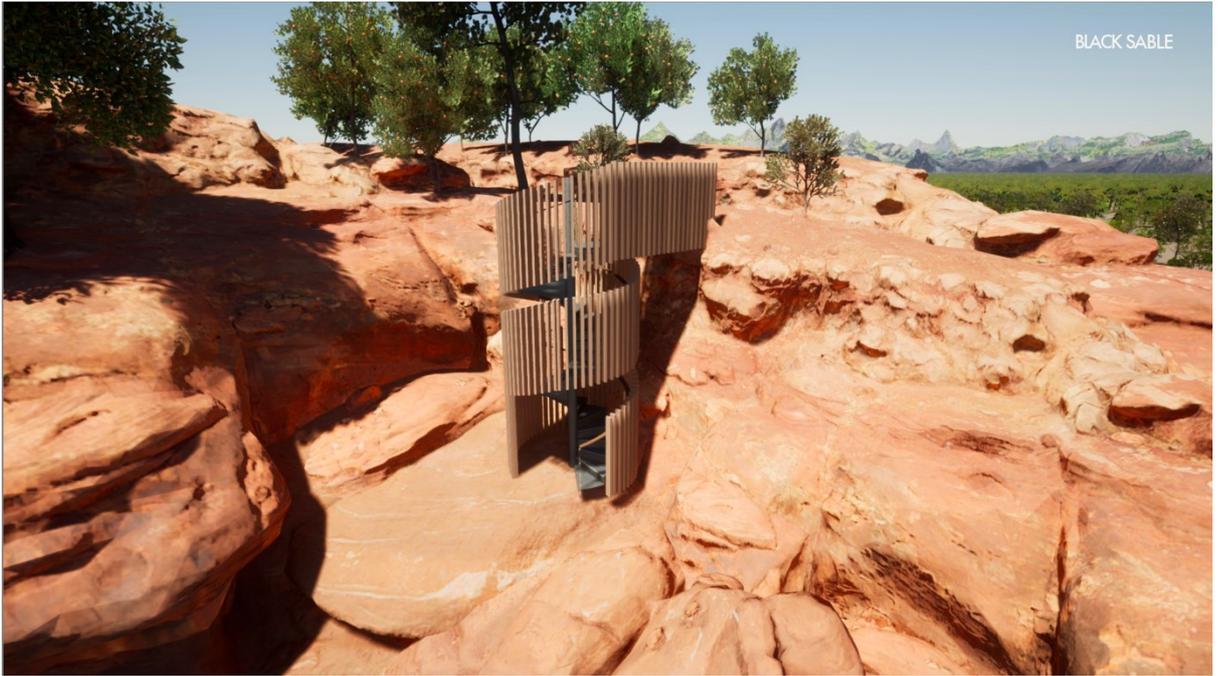
Figure 9. Architect's impression of the proposed spiral staircase that would convey visitors to Noka rock art site from the top of the cliff to the head of the gully below. Design for Noka Camp by Black Sable Architects

It is proposed that a spiral staircase be positioned here to enable visitors to descend the approximately 3 m to the head of the gulley (Figure 9; Figure 10). The structure should be made from materials that are not visually intrusive. The structure should be removable against a possible time in the future when access is no longer required. Lepogo Lodges must budget for annual service and maintenance of the staircase.

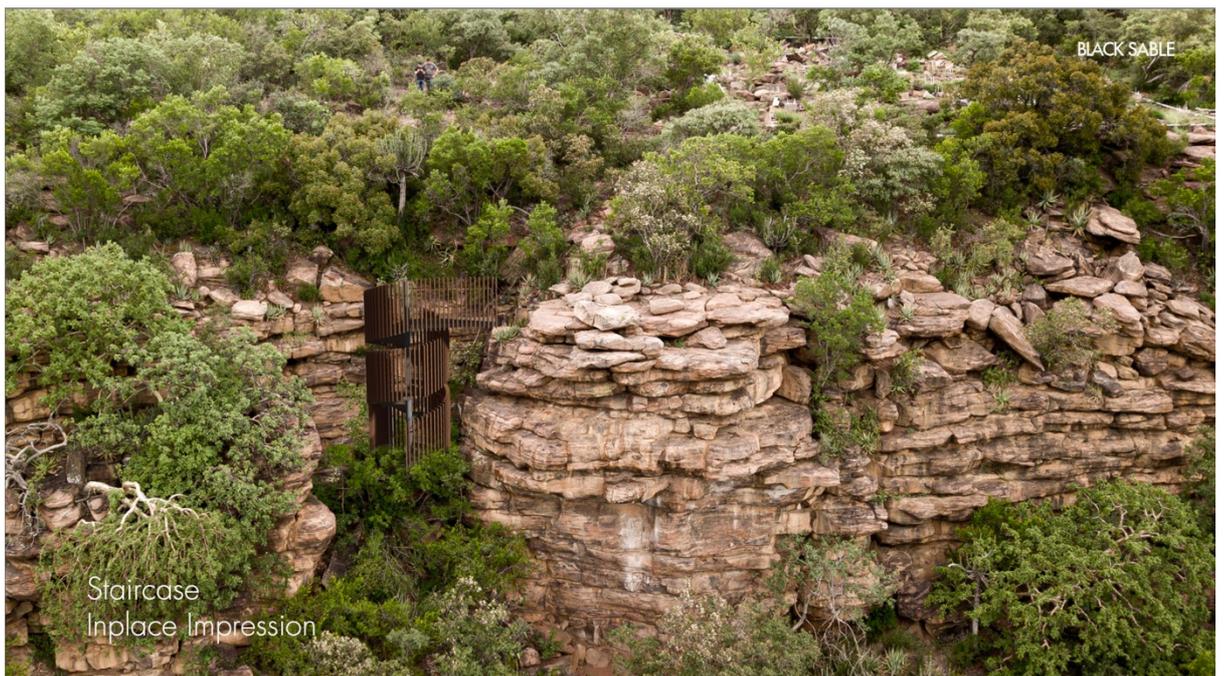
Figure 10. Architect's impression of the proposed spiral staircase at the head of the 30 m gulley south of Noka rock art. Noka rock art site is in the bottom centre of the picture below the large white stain on the cliff. This recreated drone's eye view shows that when inside the site the staircase and proposed path down to the rock art site are not visible. Black Sable Architects

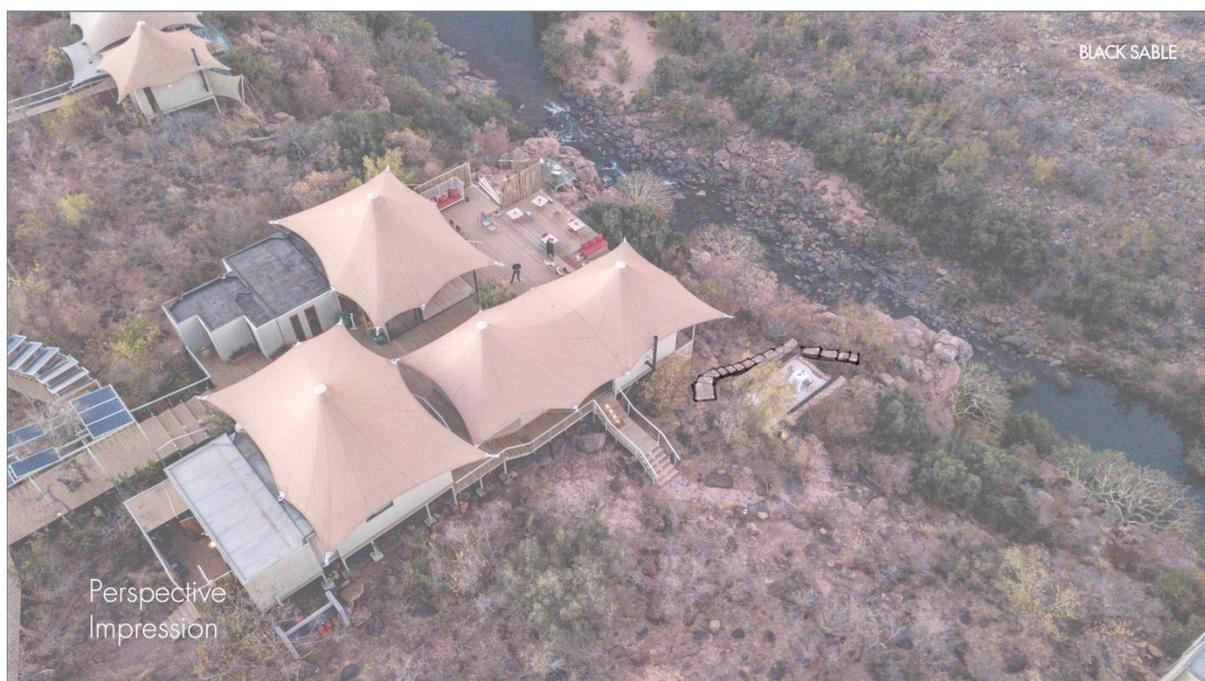
Figure 11. Perspective impression drawing showing the reception and dining areas at Noka Camp and the proposed pathway (outlined in black) leading down from the camp to the top of the cliff above Noka rock art site.

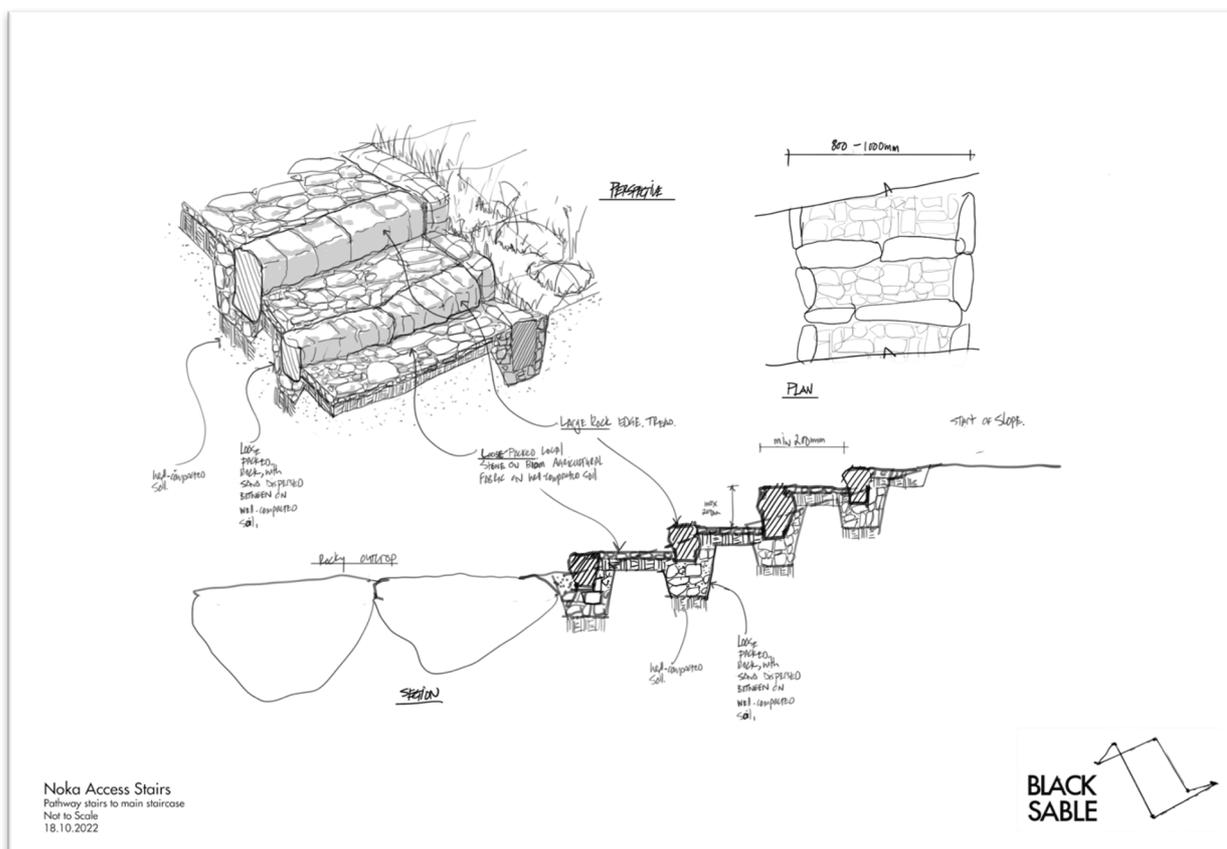
Figure 12. Concept design for the footpath leading from the foot of the 30 m long stepped path down the gully to within 3 m of the Noka rock art site. The stairs in this design would be local stone placed on compacted soil. Naturally occurring rocks would be incorporated into the path. Gaps between the stones would be filled with sand. Banisters and guard rails are not recommended as these would need to be dug in and possibly cemented. This construction work would have a more noticeable impact on the wilderness aesthetic. Design by Black Sable Architects

Naturally occurring rocks would be incorporated into the path. The footpath surfacing at Noka would make use of existing locally occurring stone. The stairs in the proposed design (Figure 12) would comprise local stone placed on compacted soil. Gaps between the stones would be filled with sand. Banisters and guard rails are not recommended as these would need to be dug in and possibly cemented. The footpath would be easy to remove and would leave little or no trace behind.

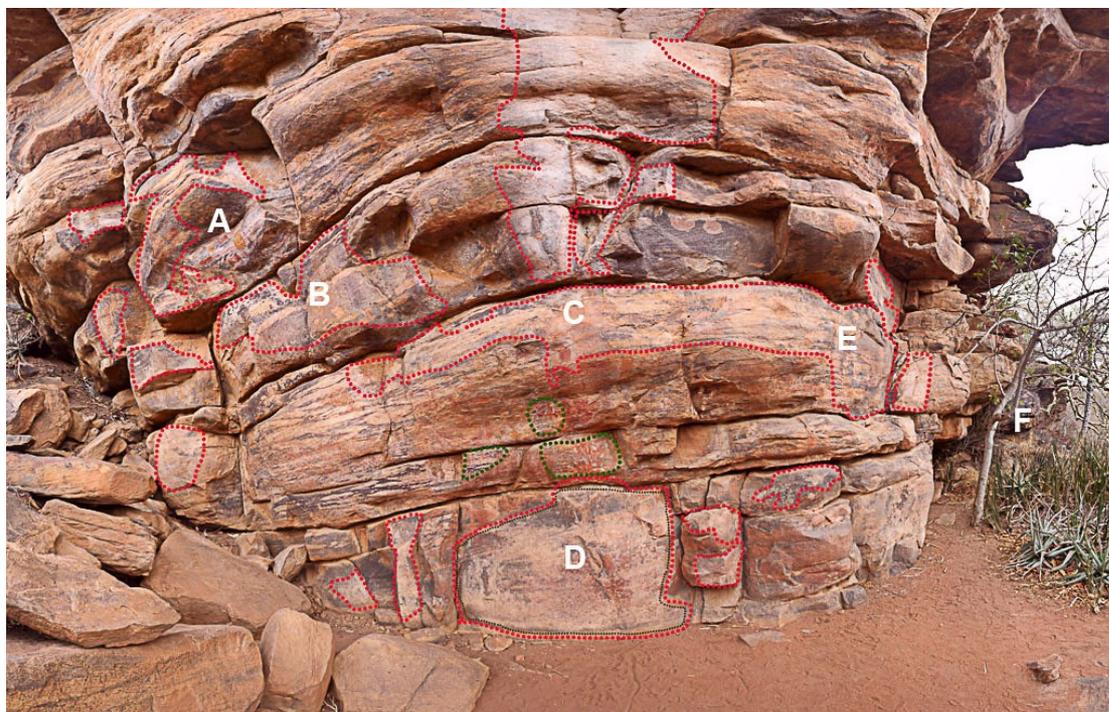
Figure 13. Rock paintings at Noka rock art site occur in six areas, labelled A to F.

There are paintings in two main areas. The first is about 10 m wide and can be divided into 5 clusters of paintings, or panels (A-E). The second (Panel F) is much smaller and on the back wall of a low overhang (about 1 m high) located at northern end (i.e. right-hand side) of the site). The classification of the paintings into panels is done in order to document and discuss the images.

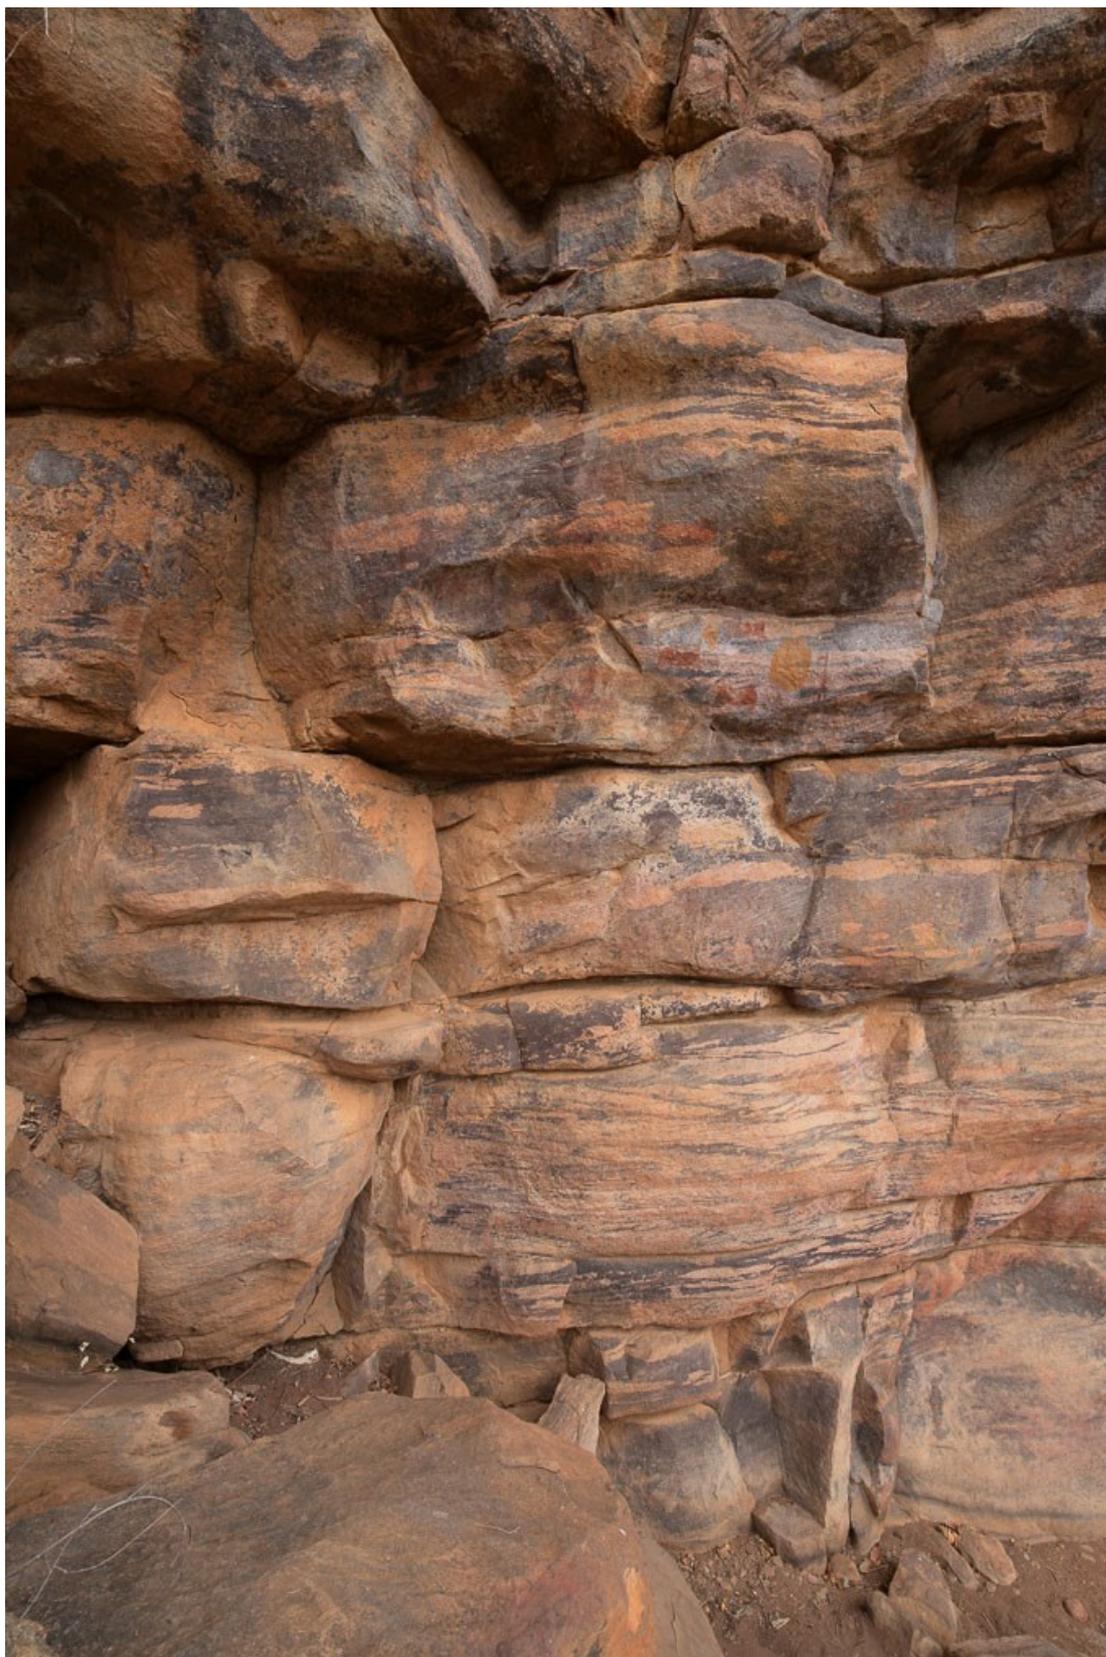
Figure 14. Panel A. These images are at the left-hand side (southern end) of the overhang, on a protruding rock about 2,4 m above ground level. Unless the floor level at the site has changed since the paintings were made, the painters would have needed to find a way of reaching this height in order to make the paintings. They might have sat on somebody's shoulders or devised a ladder or some other kind of support to get access to the surface.

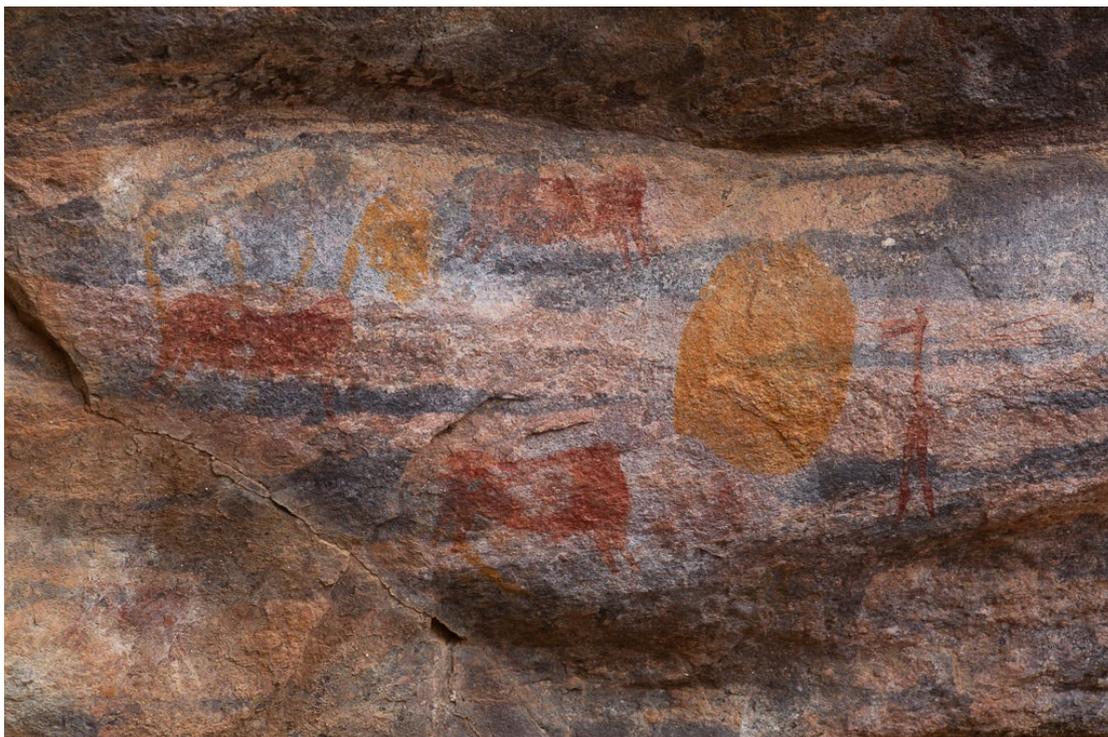
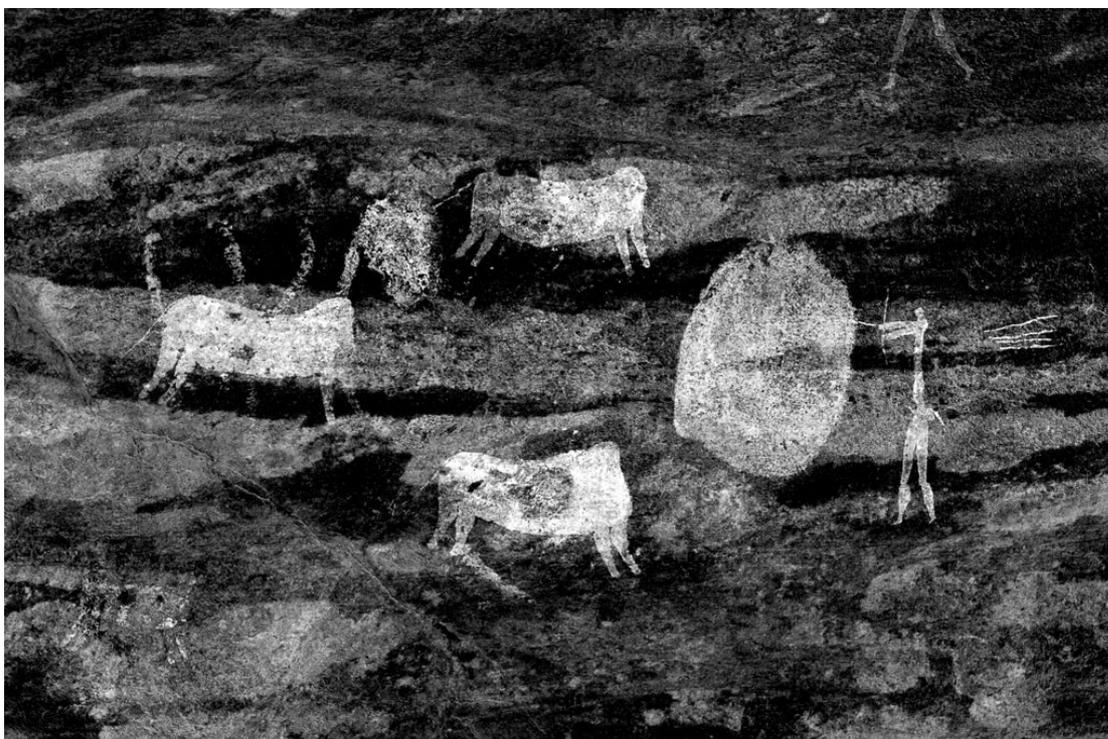
Figure 15. Well preserved rock art. There are three animal bodies painted in red, with short legs and no heads. There is a figure, also painted red, facing to the left holding a bow with an arrow. Amongst the red-painted images are paintings in yellow. A large circular patch of yellow paint partly overlies the tip of the bowman's arrow

Figure 16. Grayscale image of previous picture (Figure 15)

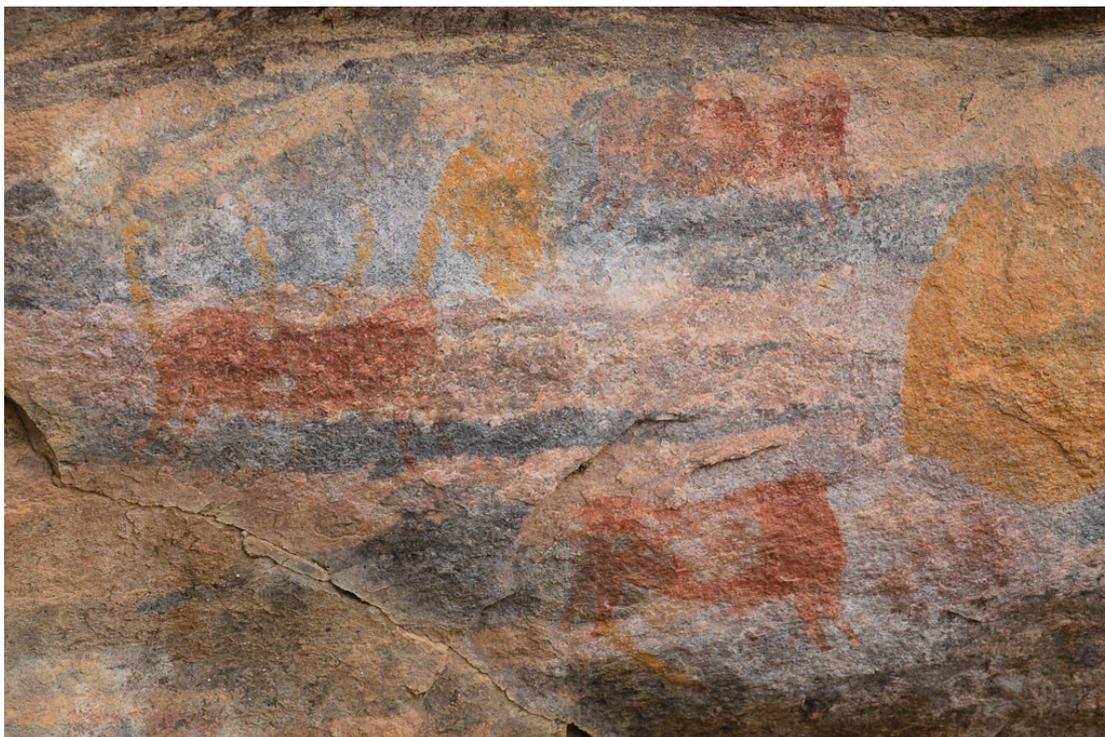
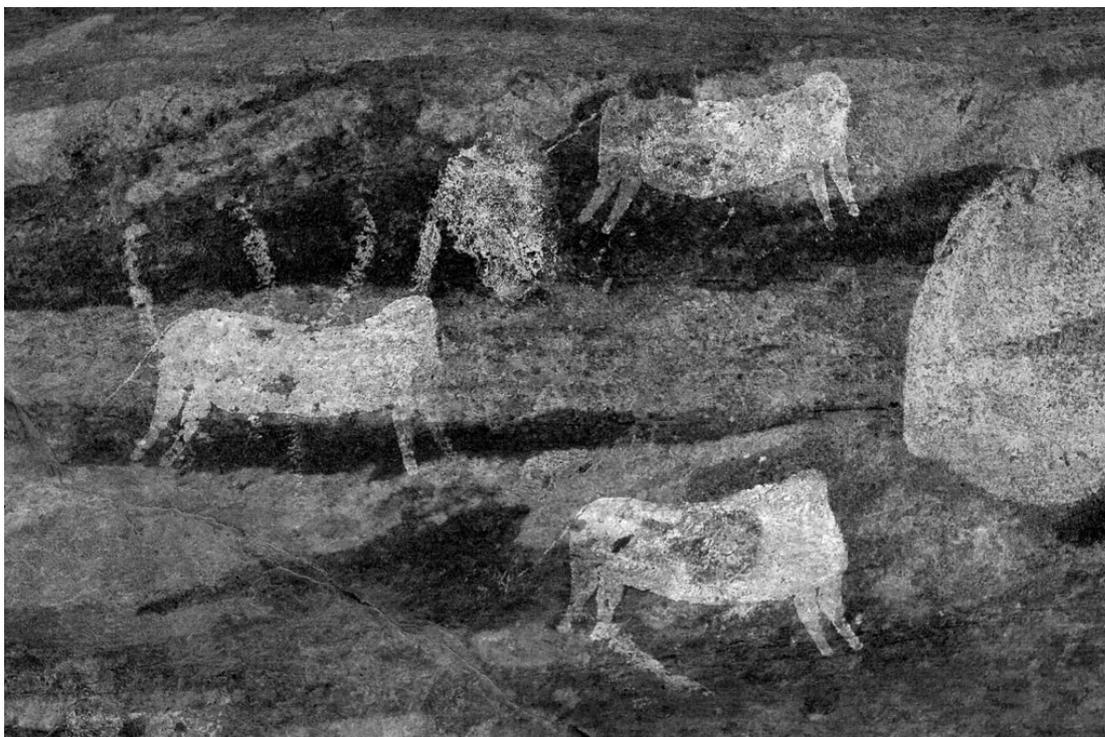
Figure 17 The three large red shapes are the remnants of animals. To judge by the hump at the shoulder (the right-hand side of each of the red shapes), the shape of the rump, and their tails, these are eland that are facing to the right. The lower legs and the heads of these images were originally painted in white, which has now weathered away

Figure 18. An grayscale enhancement of the previous picture (Figure 17) that shows the bodies of the eland more clearly

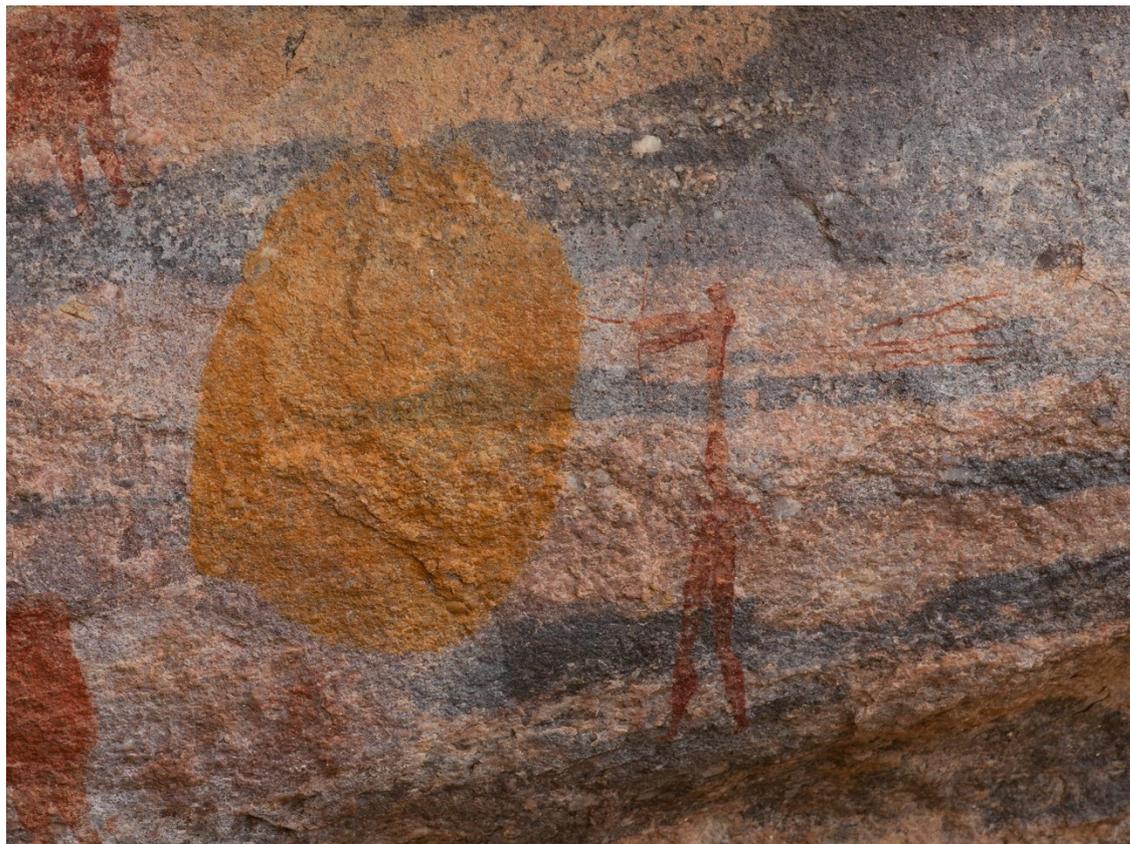
Figure 19. Eland hunting A hunter (immediately to the right of the circular shape painted in yellow, at left) takes aim at one of three eland. There are another two bowmen that are not in this picture. The yellow patch was painted after the hunter because it overlaps the tip of the hunter's arrow. The yellow patch may therefore not have anything directly to do with the 'hunting scene'

In the midst of the red-painted images are paintings in yellow. Most prominent is the large circular patch of yellow paint that seems to have been painted over the tip of the bowman's arrow (Figure 19; Figure 20). There is a much smaller yellow shape to the left, between two of the animal bodies. To the left are finger strokes made in yellow, over one of the animal bodies. Because portions of the yellow paint are on top of the red paintings one may conclude that the yellow paintings and finger strokes were made after the red paintings, although by whom and how long afterwards is not known.

Immediately to the right of the figure with the bow and arrow are four horizontal thin lines (Figure 19; Figure 20). These probably represent arrows. The figure is depicted with a penis and has a short, curved line just above its buttocks: this probably depicts the back portion of a loincloth that would have covered the buttocks. This figure, together with similar paintings of two other hunters seems to be hunting the eland.

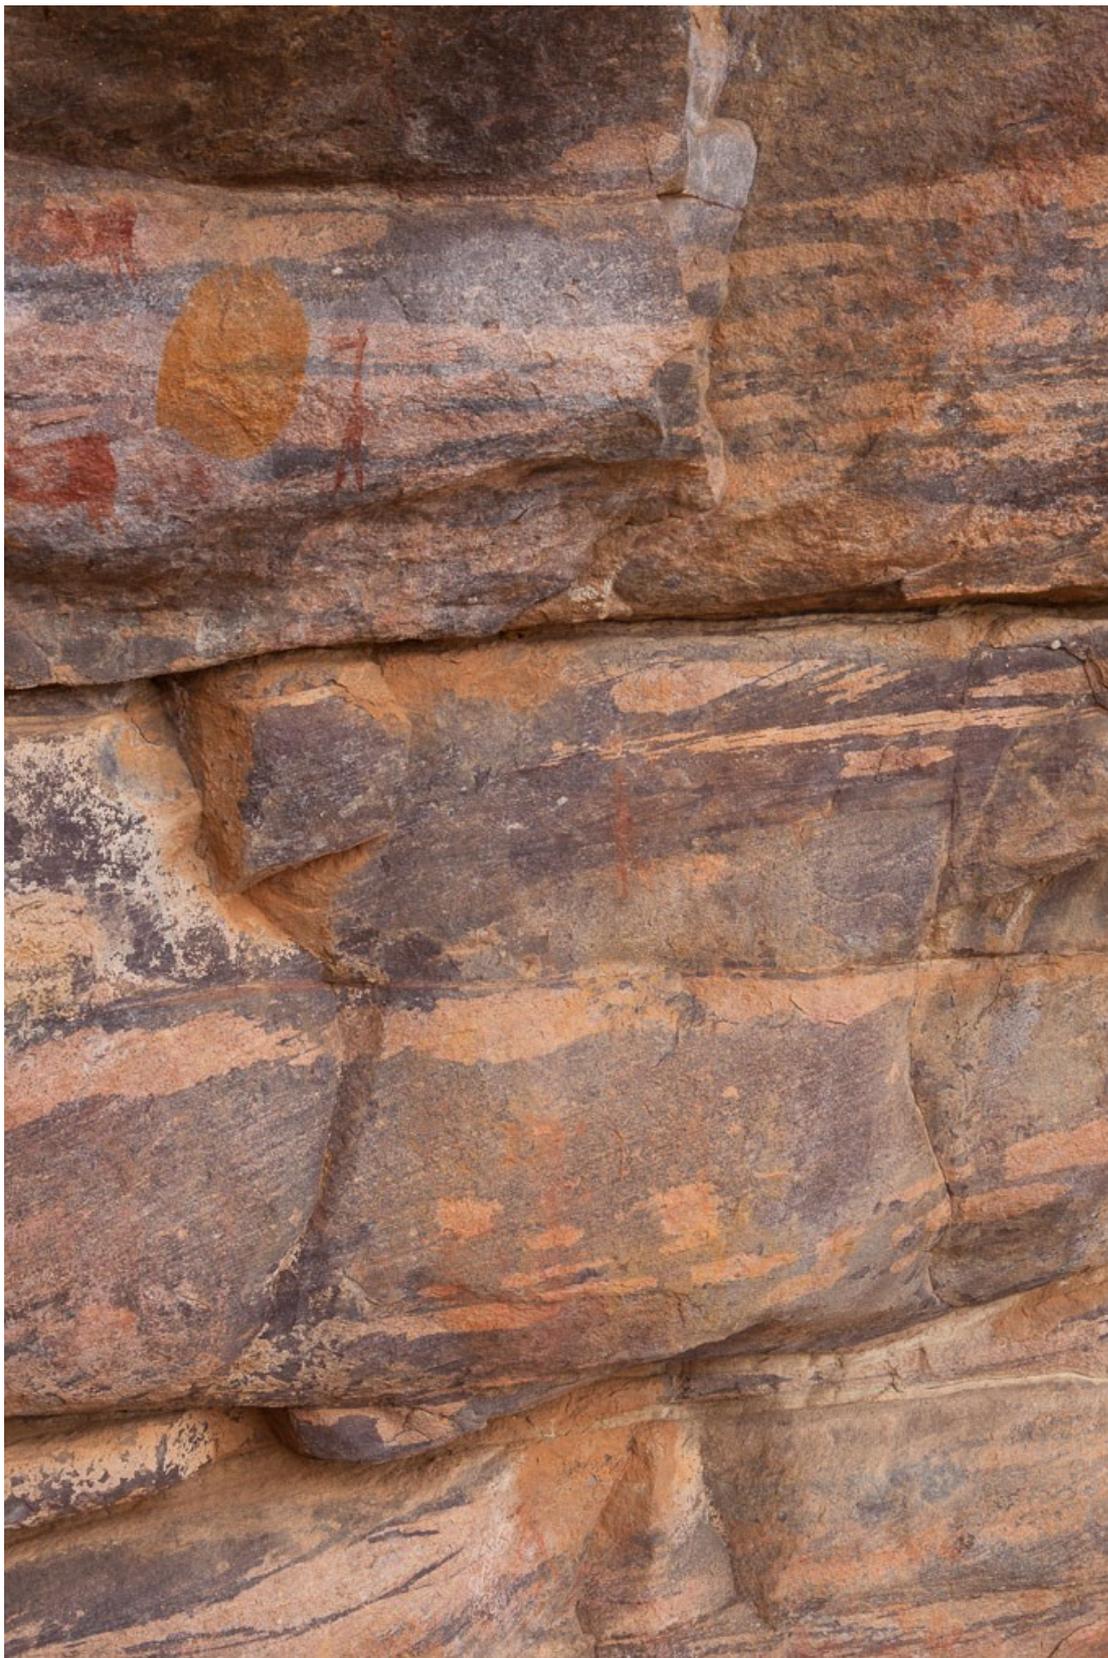
Figure 21. Panel B comprises only one faint red image that is visible in the centre of the picture

Panel B is about 0,25 m below Panel A on a surface about 1,6 m wide and 1 m high (Figure 21; Figure 22). The panel comprises a single human figure painted in much the same style and size as the other two in Panel A (Figure 23; Figure 24). All three of these figures (i.e. those in Panels A *and* B)

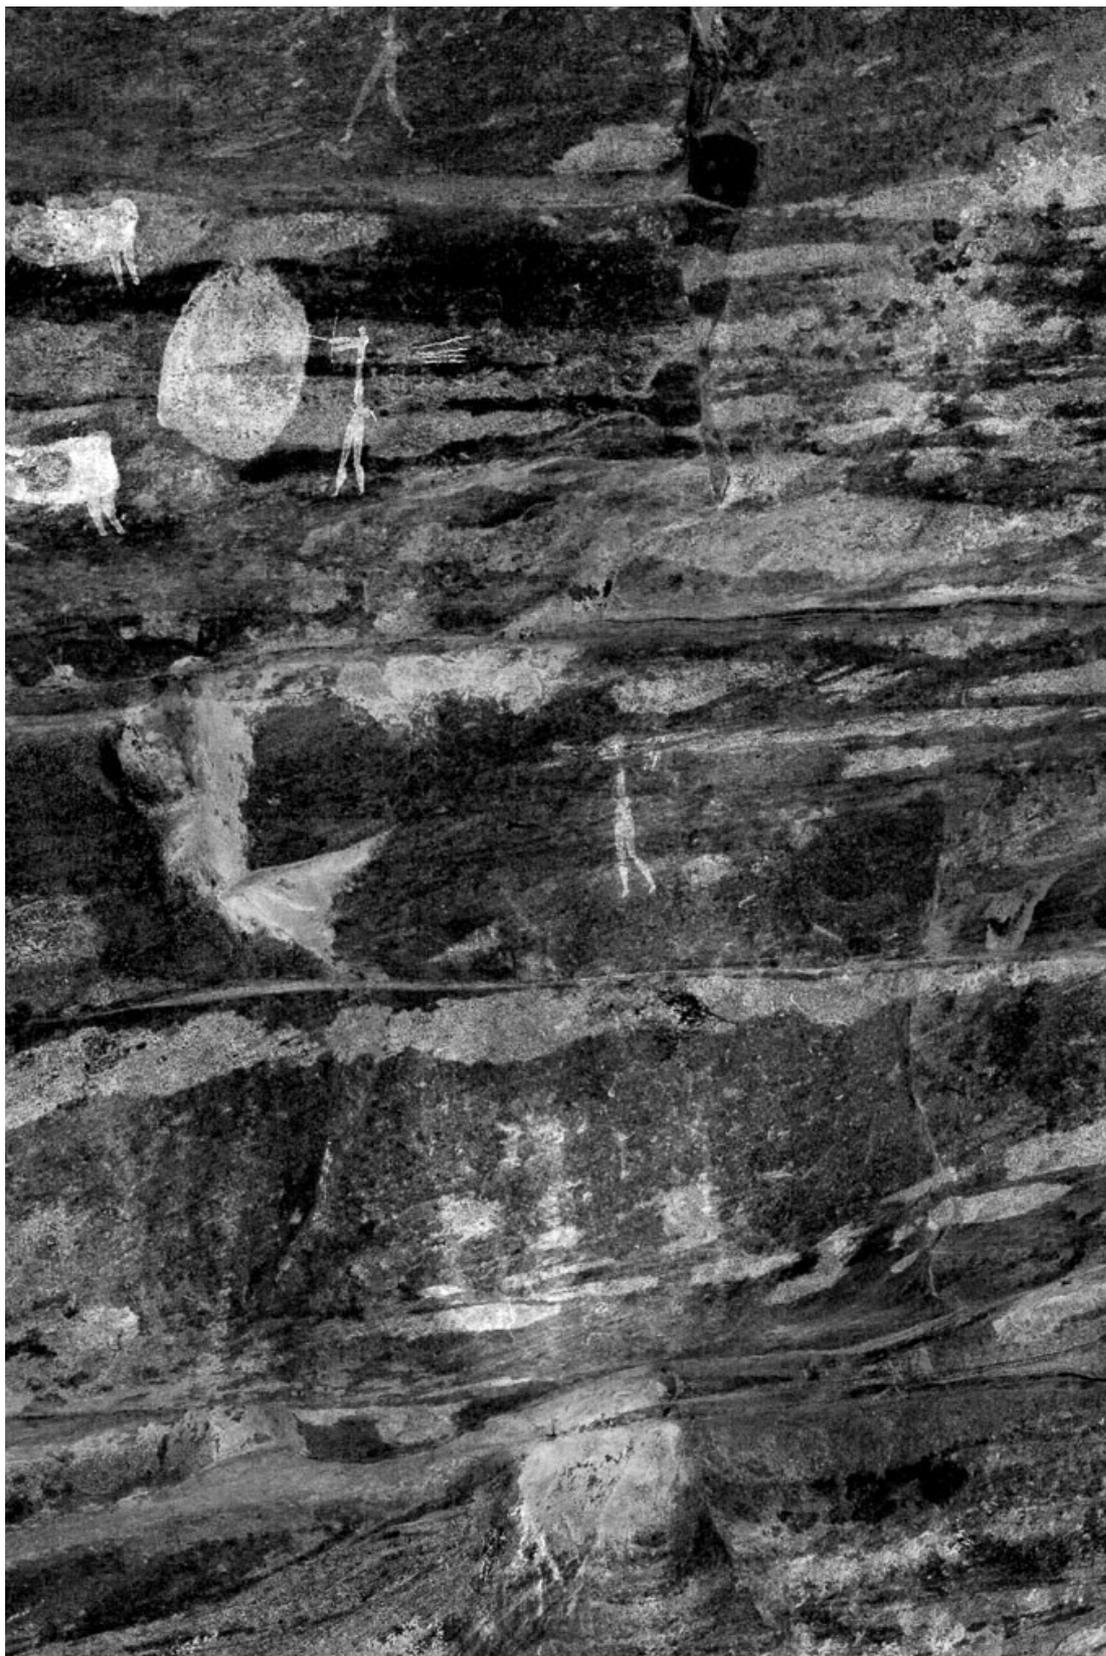
Figure 22. Grayscale enhancement of Panel B

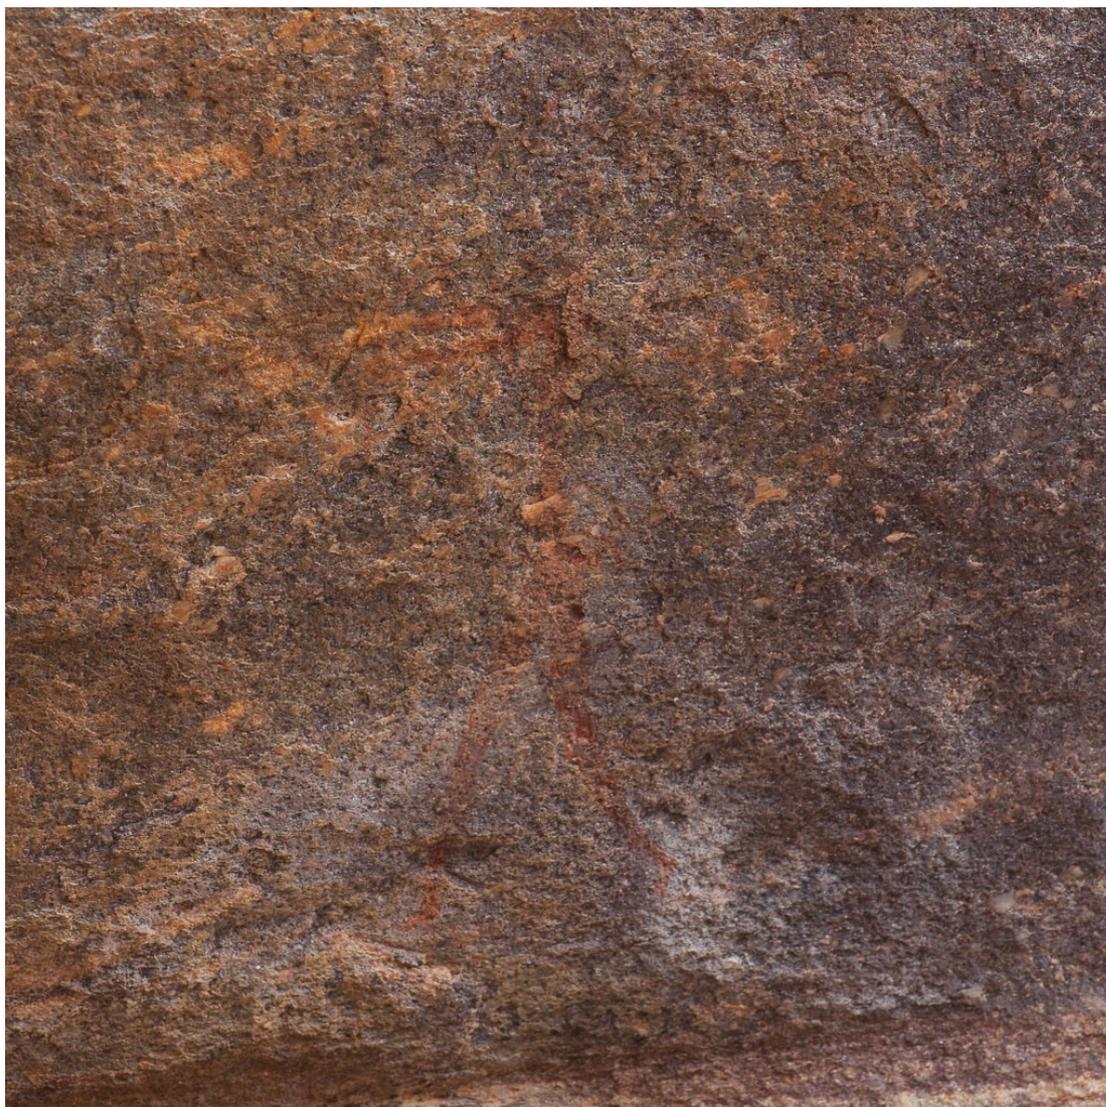
Figure 23. Panel B: A single figure in red obscured by a naturally occurring white deposit

The figure in Panel B also has a penis and holds two stick-like objects in its hand. These are almost certainly arrows as one of them has a tapered arrowhead. This figure is not as well preserved as the other two and so further details, such as the absence/presence of a loincloth, cannot be distinguished.

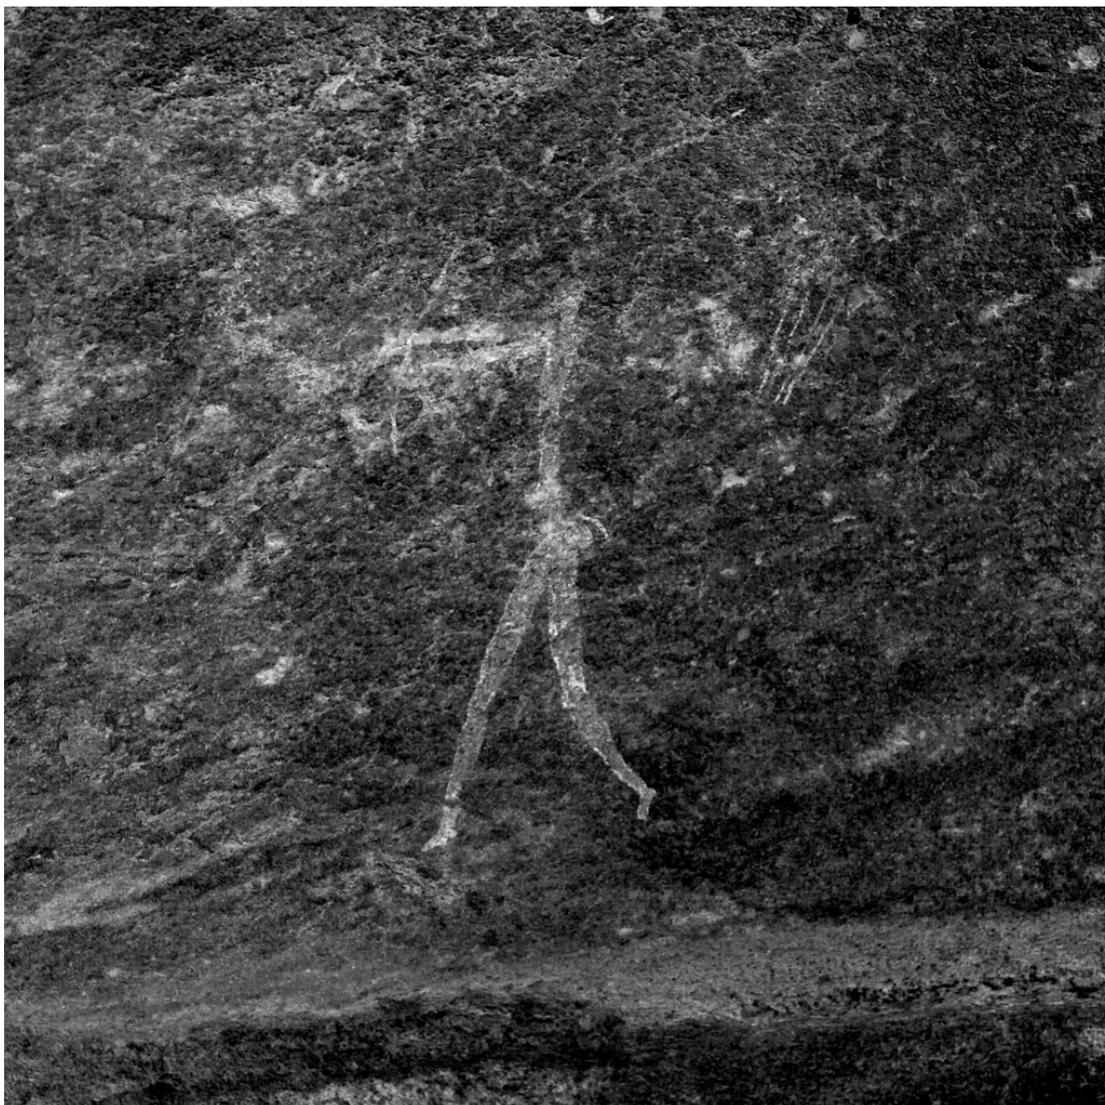
Figure 24. Panel B: Grayscale enhancement of previous picture (Figure 23)
