Management Plan: Noka rock art site
Noka Camp
Lapalala Wilderness
Limpopo Province
South Africa

Compiled for Lepogo Lodges

For submission to the South African Heritage Resources Agency (SAHRA)

September 2023

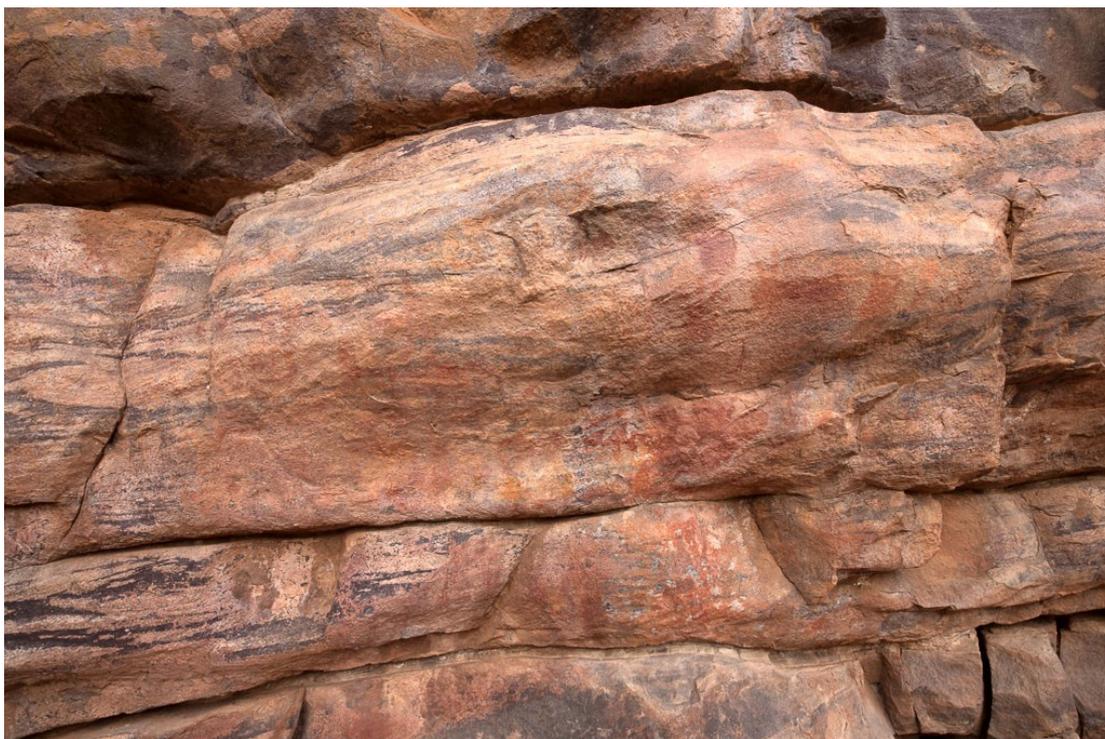
Figure 25. Panel C is the most densely painted area in the site and has many interesting details

Panel C is about 0,25 m below Panel B and is about 2,8 m wide and 0,75 m high (Figure 25; Figure 26). This is the most densely painted area in the site and has many interesting details. The paintings on the left-hand side (i.e. southern end) of the painted surface are quite obscured and it not easy to see details of the paintings. The right-hand side is clearer.

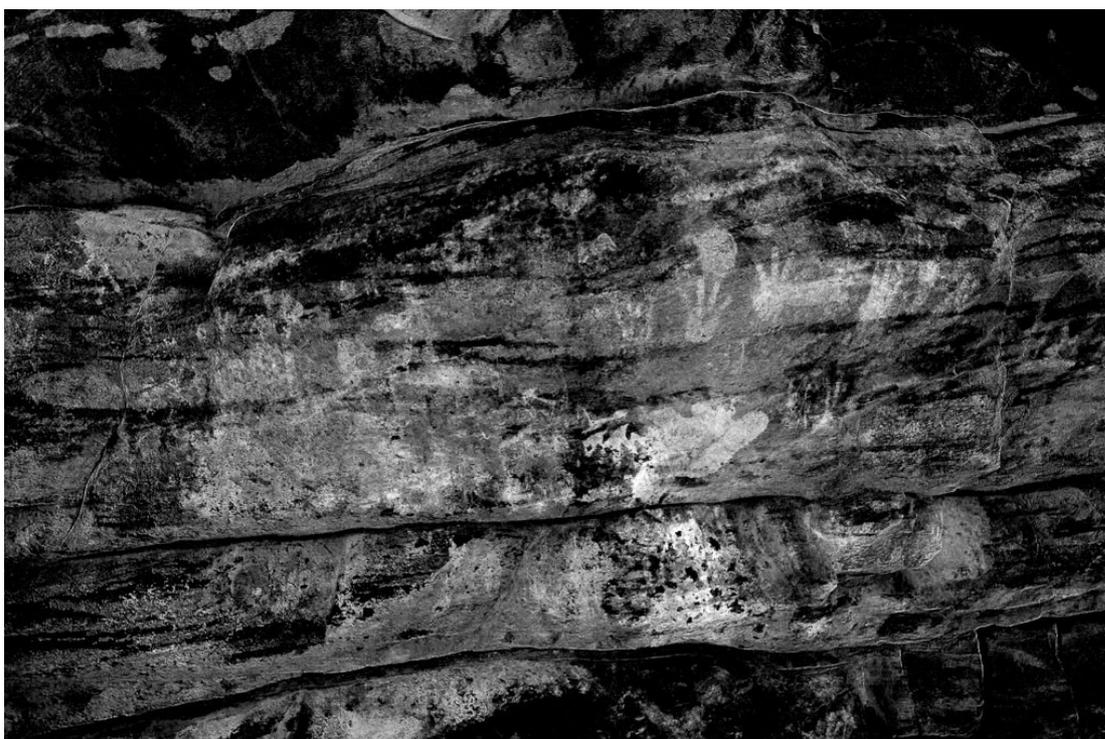
Figure 26. Panel C: Grayscale enhancement of the previous picture (Figure 25)

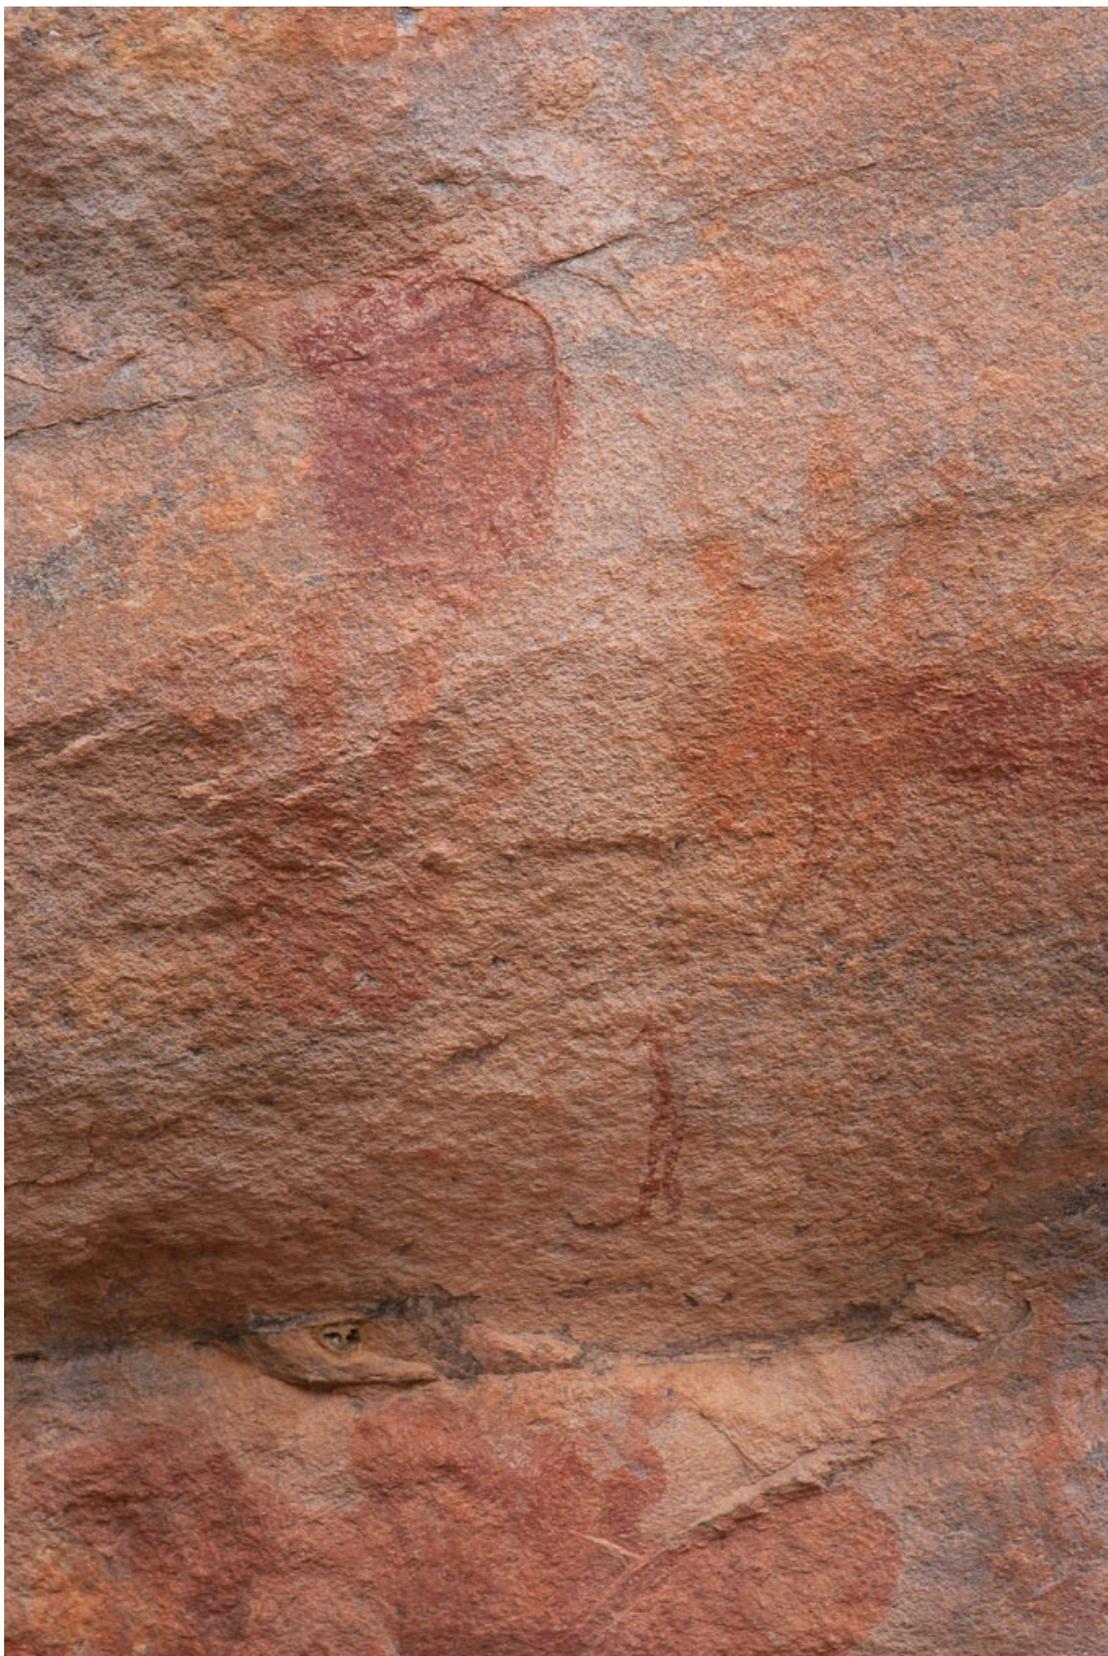
Figure 27. Panel C: Handprints made in red paint. Note the red circular shape above the handprints. Below the handprints is the painting of a dancing figure.

There are five handprints in light red (Figure 27; Figure 28). Handprints were made at several sites in the Waterberg (e.g. Willcox 1959: 292). They were probably made by covering the palm of the hand with pigment then pressing the hand onto the rock face using a rolling action to make a full imprint of

the hand (Willcox 1959: 292). It is not known why people made handprints. Research suggests that the handprints are of smaller people, perhaps juvenile members of the community (Manhire 1998: 98). One possibility is that initiates made handprints as part of initiation rituals. At rock art sites where paintings and handprints are superimposed, the handprints are made over the paintings, not the other way round. This suggests that the handprints could be a later form of rock art, perhaps with a different significance. However, little has been written about who painted the handprints and what they could mean. Here two of the handprints have been made over the body of a large animal without head or legs (probably an eland).

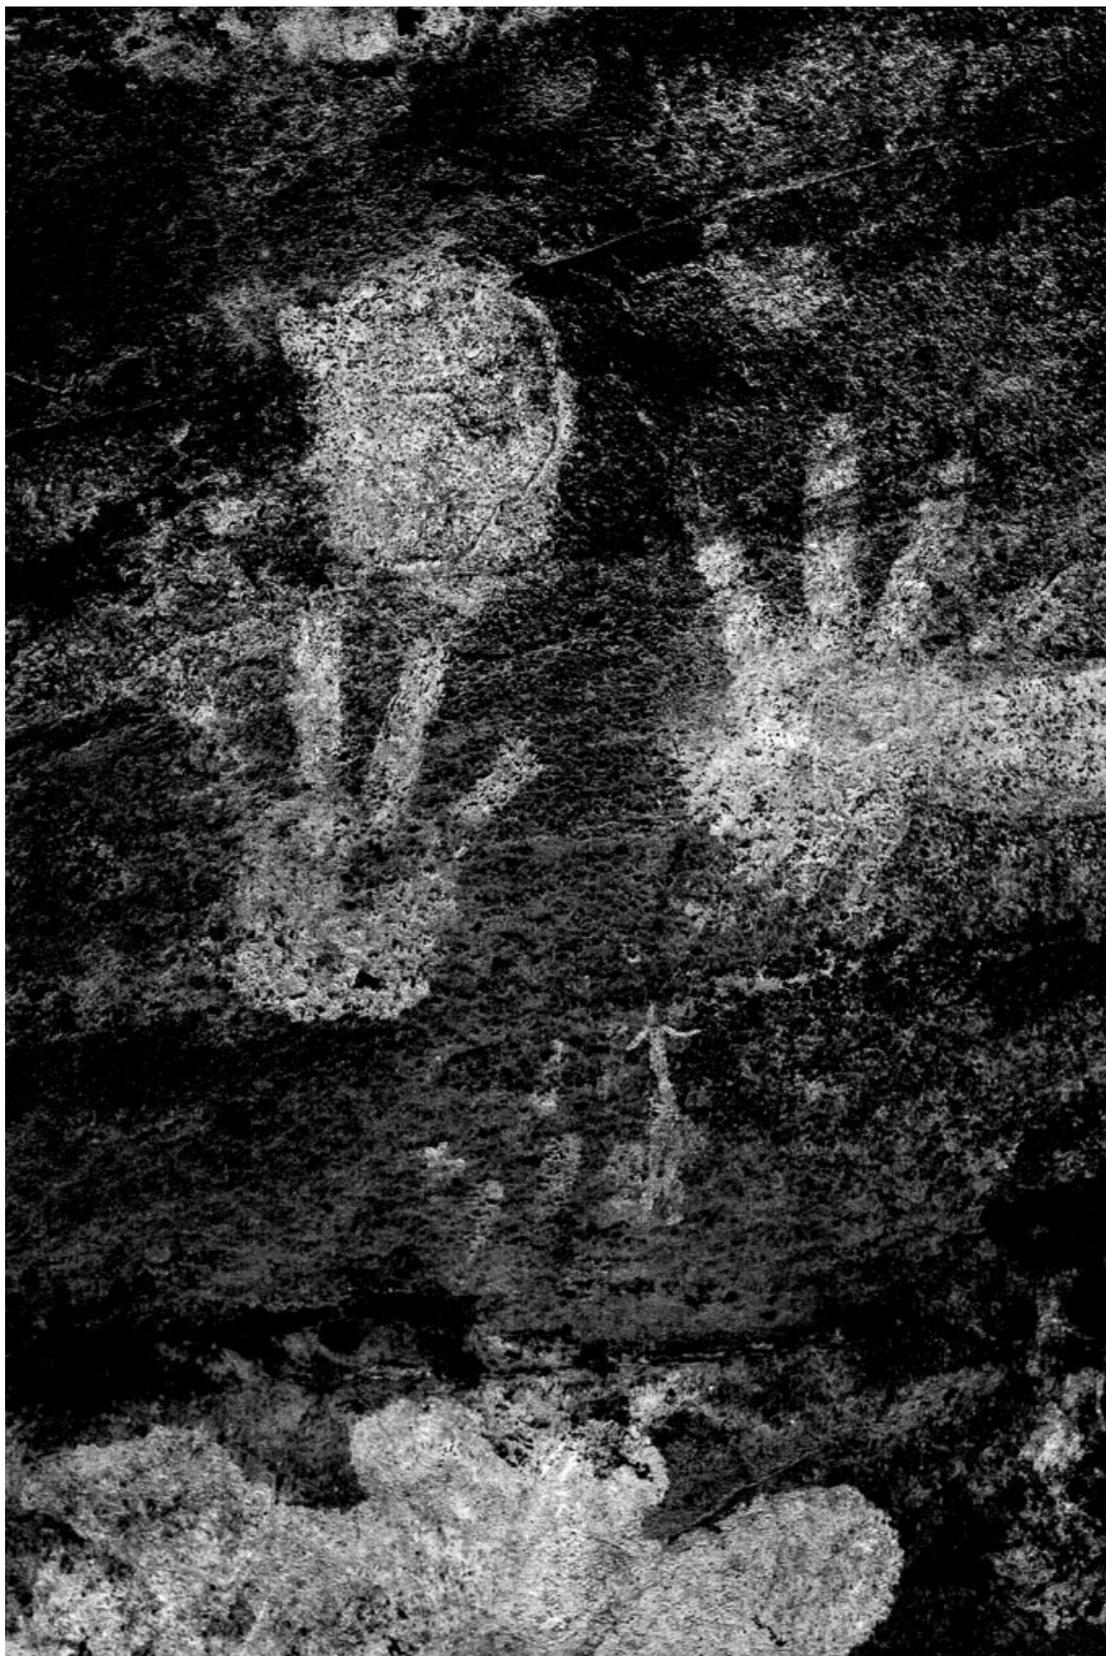
Figure 28. Grayscale enhancement of previous picture (Figure 27)

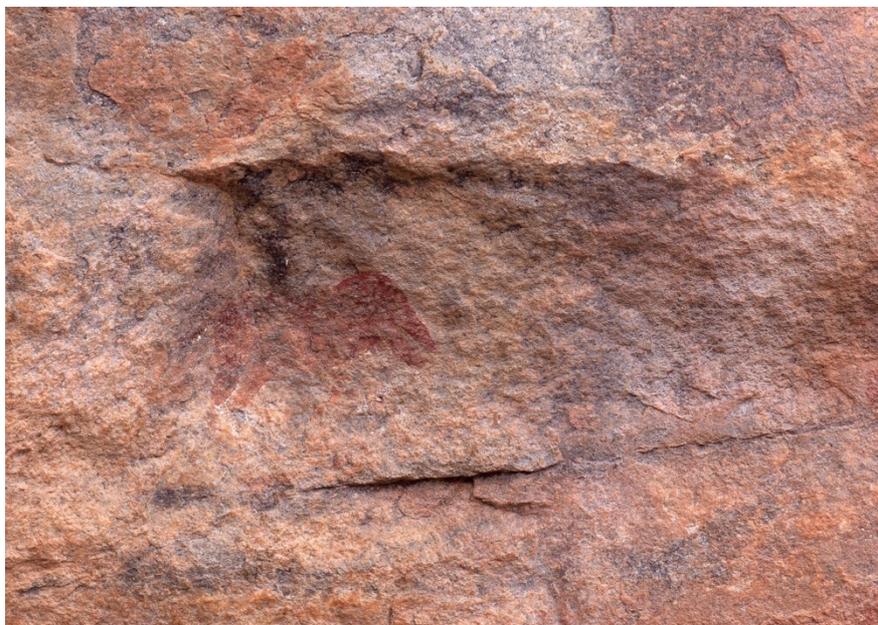
Figure 29. Panel C: Painting of eland without a head located within a small alcove in the rock

To the left of and immediately above the handprints is a painting of an incomplete eland (Figure 29; Figure 30). There are still minute traces of the white paint that was used to outline the body. Interestingly, the painter deliberately chose to make this image in a small alcove in the rock. The practice of painting figures in alcoves and entering and leaving cracks in the rock is a widespread

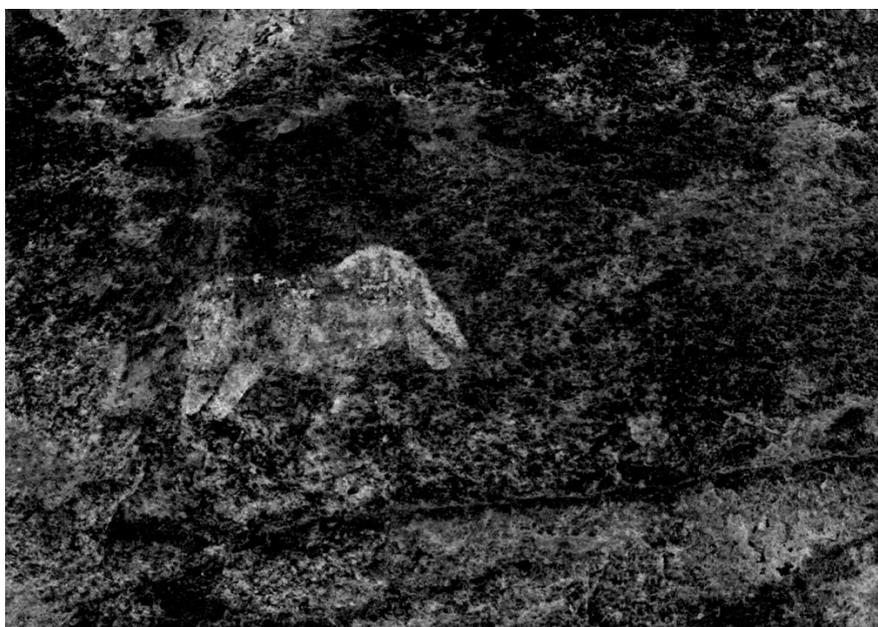
Figure 30. Panel C: Grayscale enhancement of the previous picture (Figure 29)

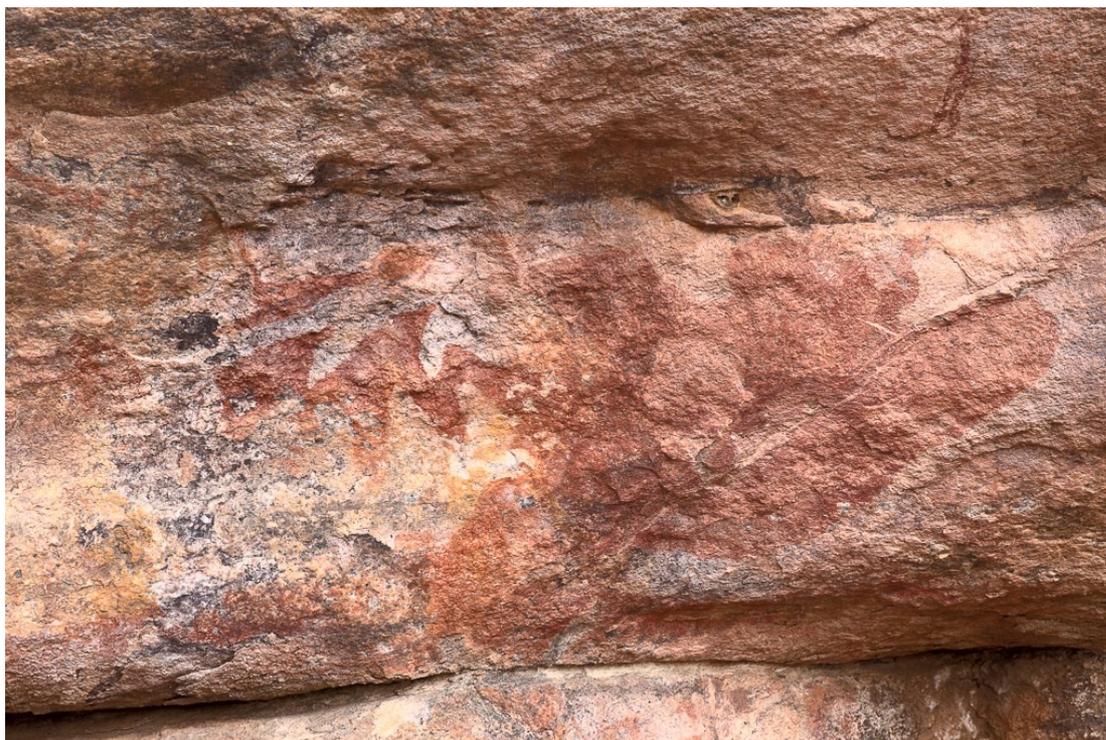
Figure 31. Panel C: An arrangement of several shapes parts of which might have been smudged. These might be what researchers call a 'formling'

Just below the handprints, at the lower edge of the rock is an arrangement of several shapes, including some that are roughly triangular. Some of the other shapes might have been smudged (Figure 31;

Figure 32). Researcher Bert Woodhouse called them 'amorphous shapes' (1987:7). He has since interpreted them as 'maps' of hunter-gatherer territory.

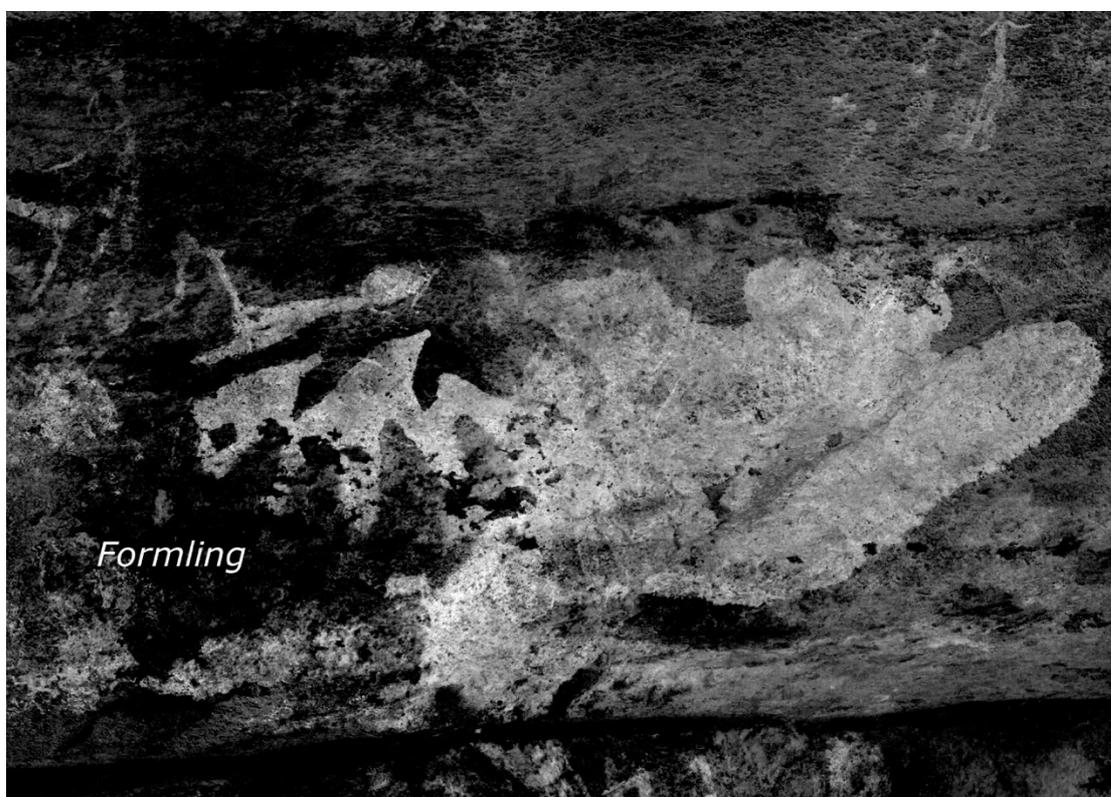
Figure 32. Panel C: Grayscale enhancement of the oblong shapes in the previous picture (Figure 31)

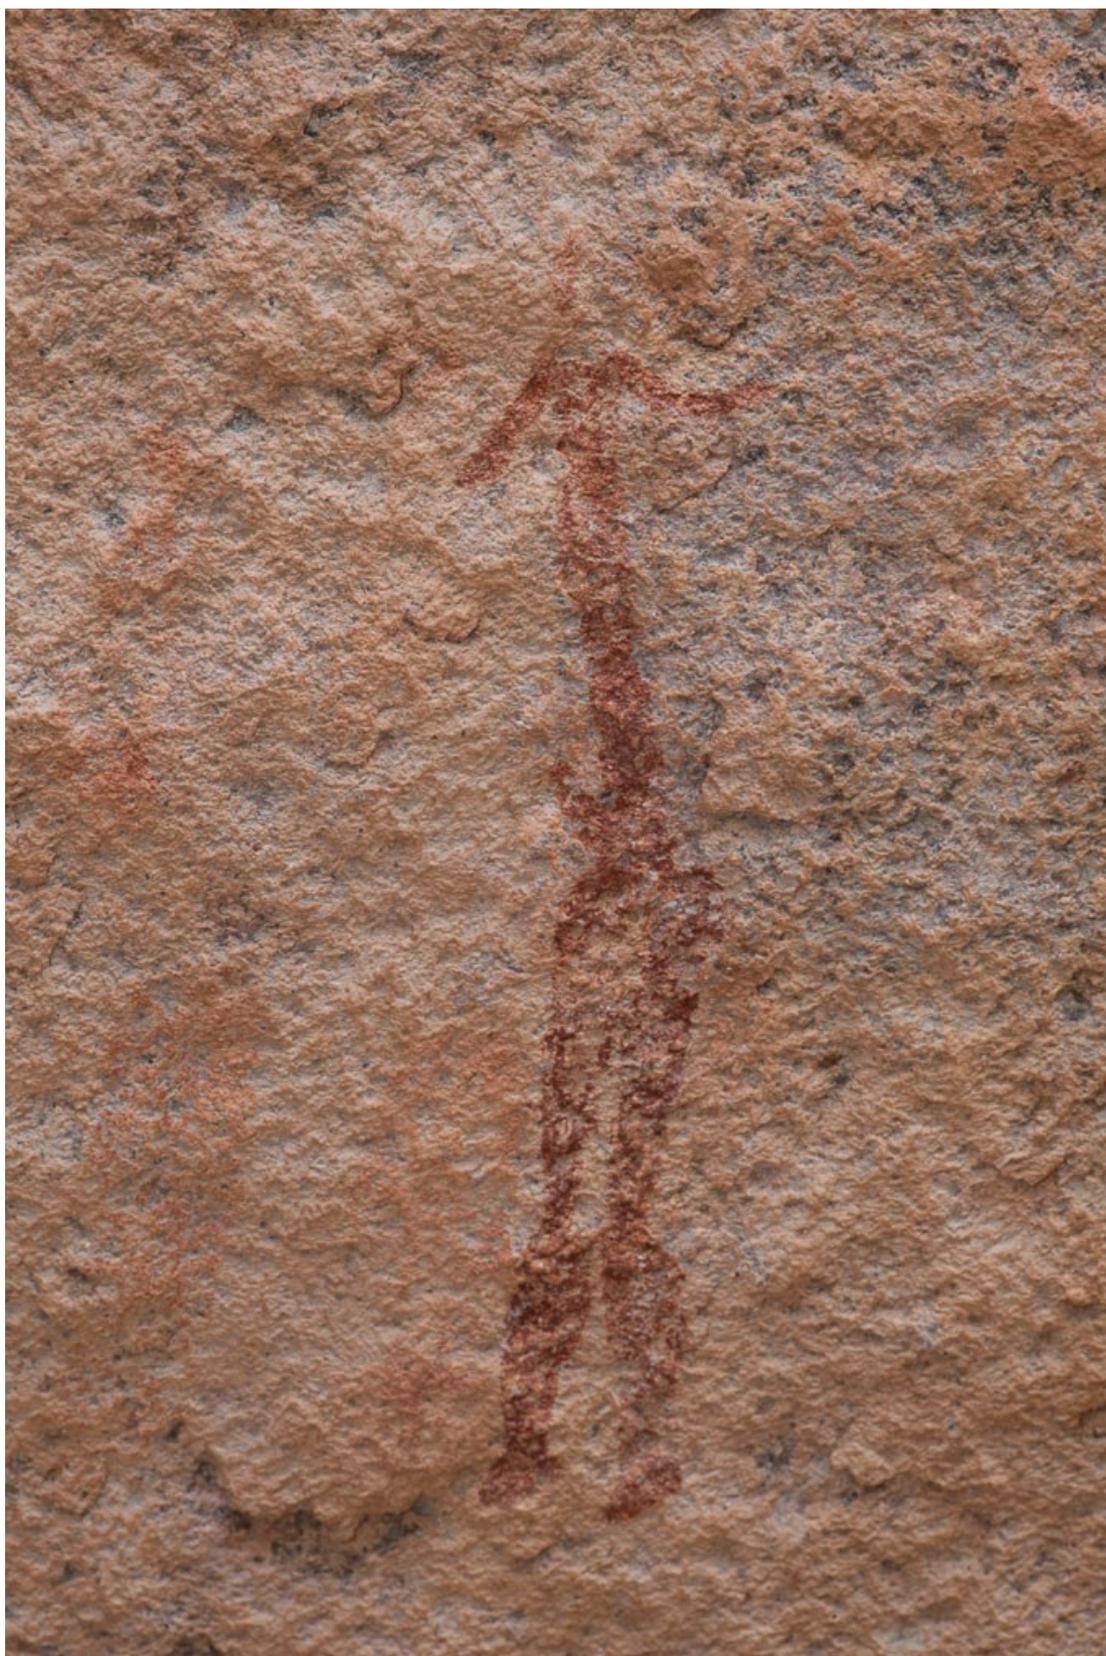
Figure 35. Panel C: A figure with arms raised, possibly dancing

On the right-hand side of the oblong shapes and below the handprints is a human figure with penis and arms raised and bent at the elbow in what is possibly a dance posture (Figure 35).

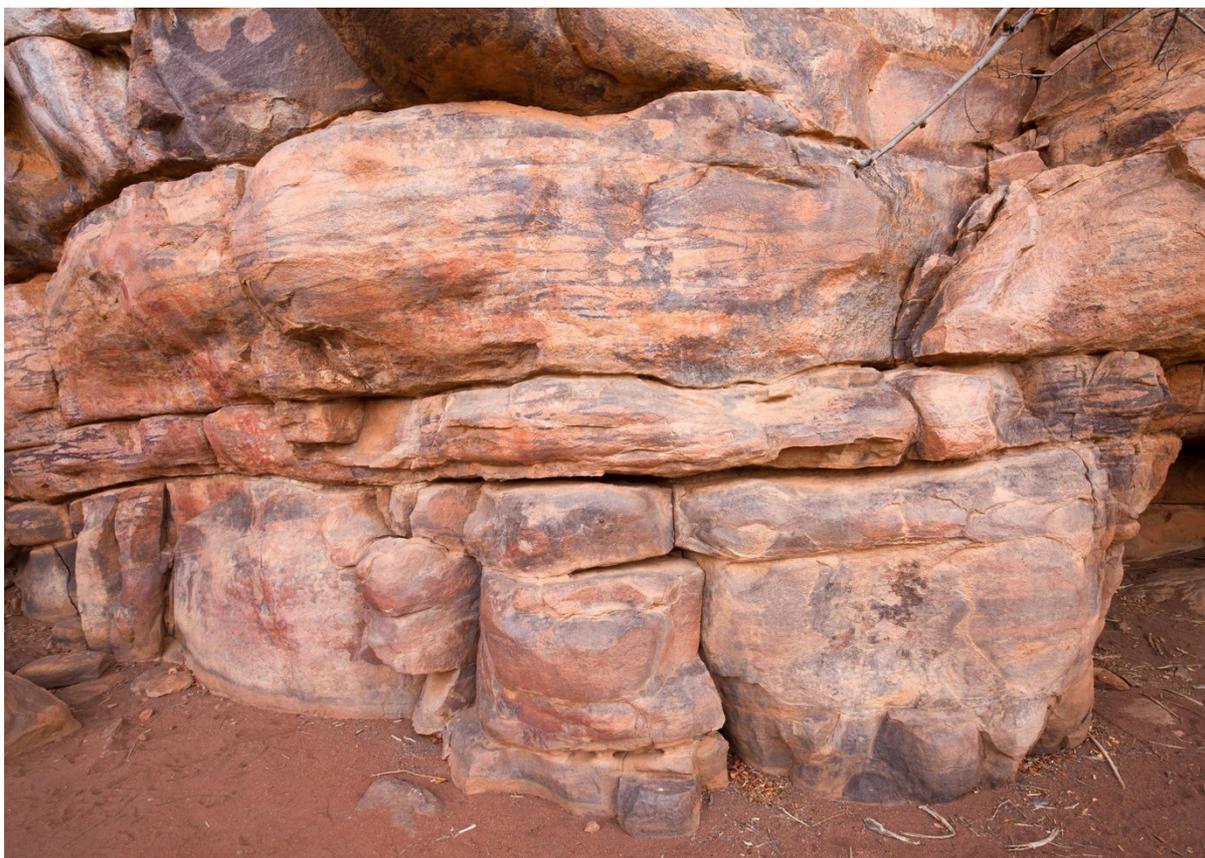
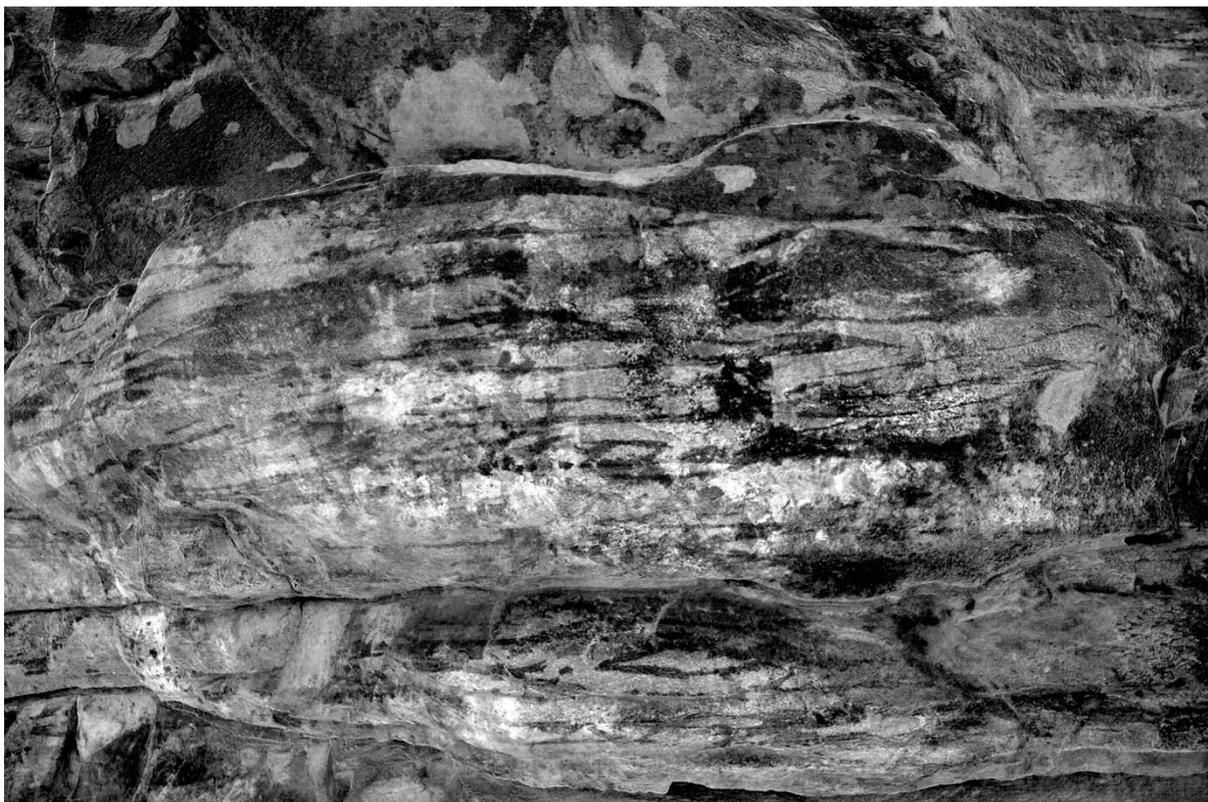
Figure 36. Panel E is 1,5 m above ground level and has several paintings, but they have become obscured by weathering of the rock and the accumulation of dust

Figure 37. Panel E: Grayscale enhancement of previous picture (Figure 36)

Panel E is immediately to the right of Panel D and about 1,5 m above the ground level. The rock surface on which the paintings were made is flaking off and there is also a white deposit that obscures the remaining rock art.

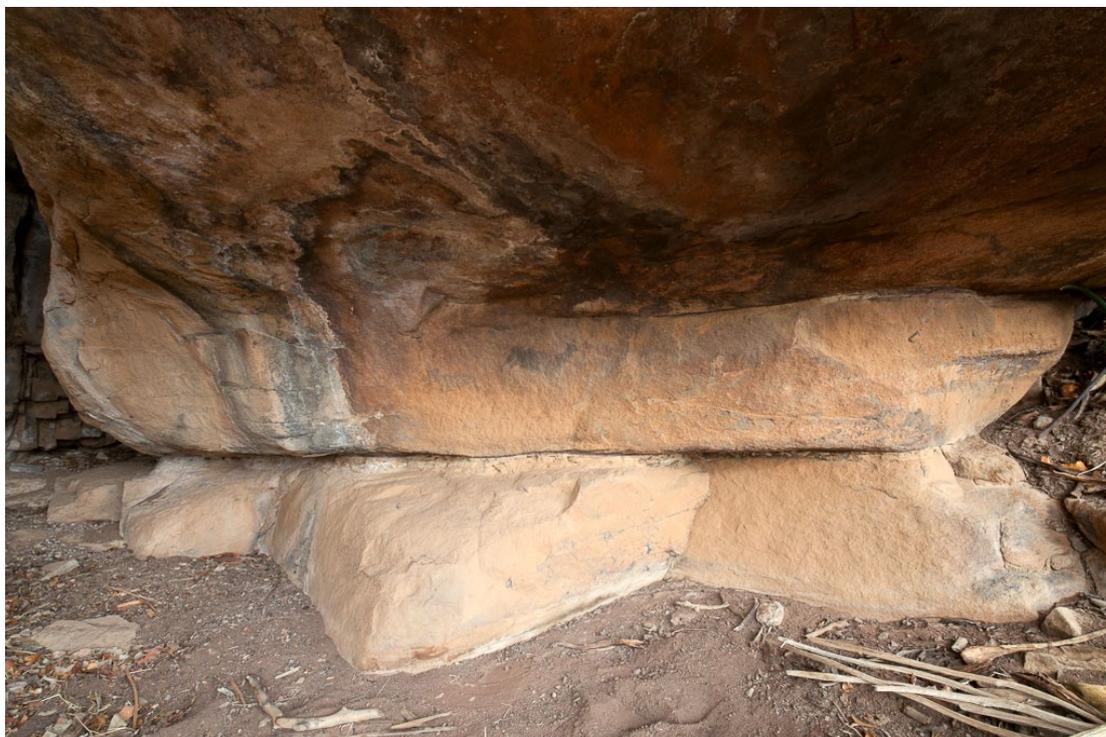
Figure 38. Panel F: Paintings in a small corner at the right-hand (northern) end of the rock art site

These paintings are located on the back wall of a 1 m high overhang at the right-hand end (i.e. the northern end) of the site, as one enters the overhang (Figure 38). The rock on which the images are painted is about 0,5 m high and 1,3 m long.

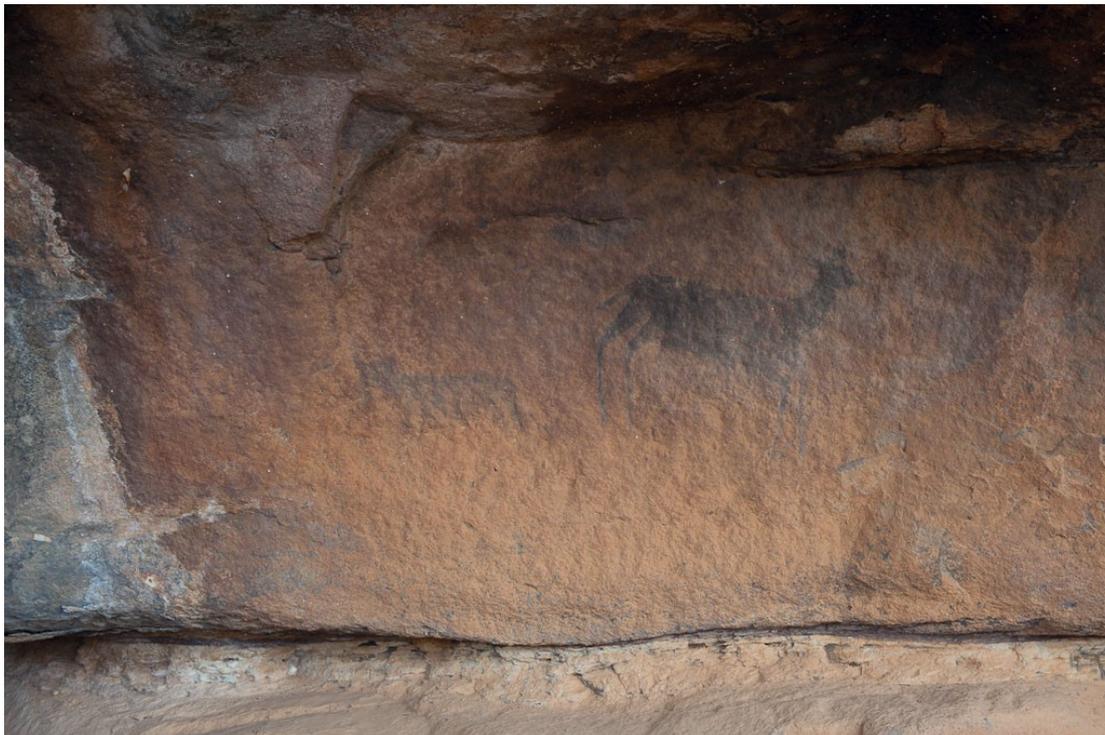
Figure 39: Panel F: Paintings of two animals, a wildebeest and a small antelope

Two images are painted here (Figure 39; Figure 40). At the right is an image of a small antelope species with spindly legs, a bulky body, and a short tail (Figure 41; Figure 42). The antelope painting has ears but no horns. There may be a stroke of paint in front of the antelope's muzzle or perhaps some of the paint in this area has weathered.

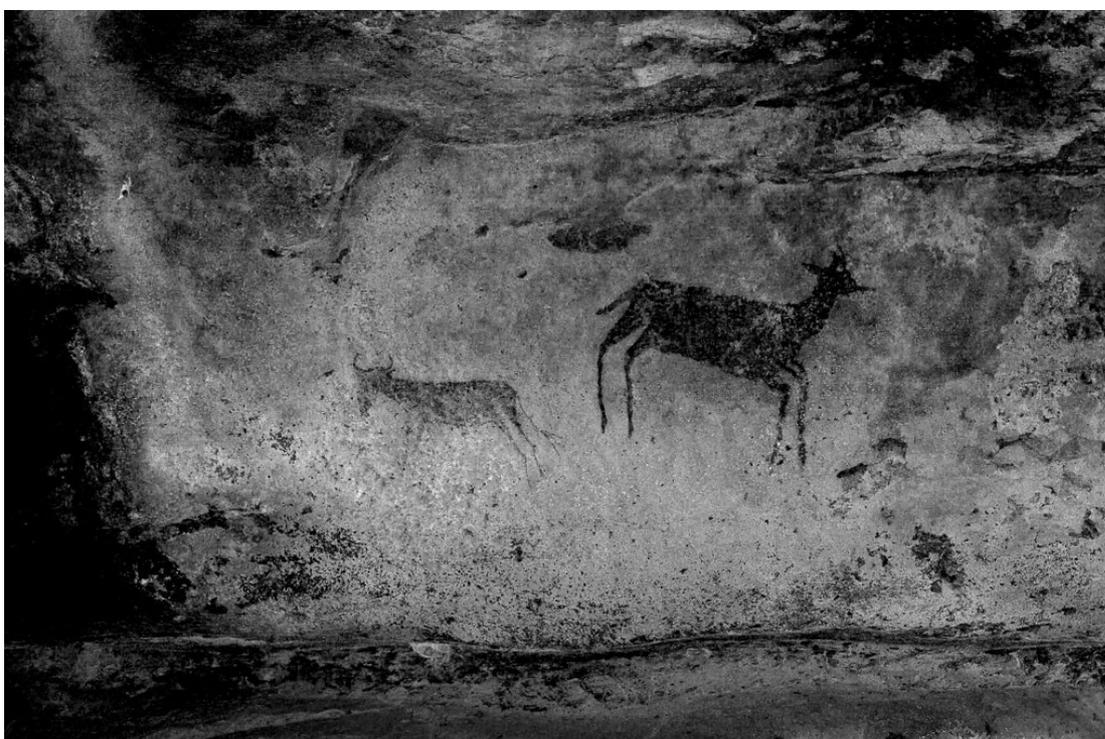
Figure 40. Panel F: Grayscale enhancement

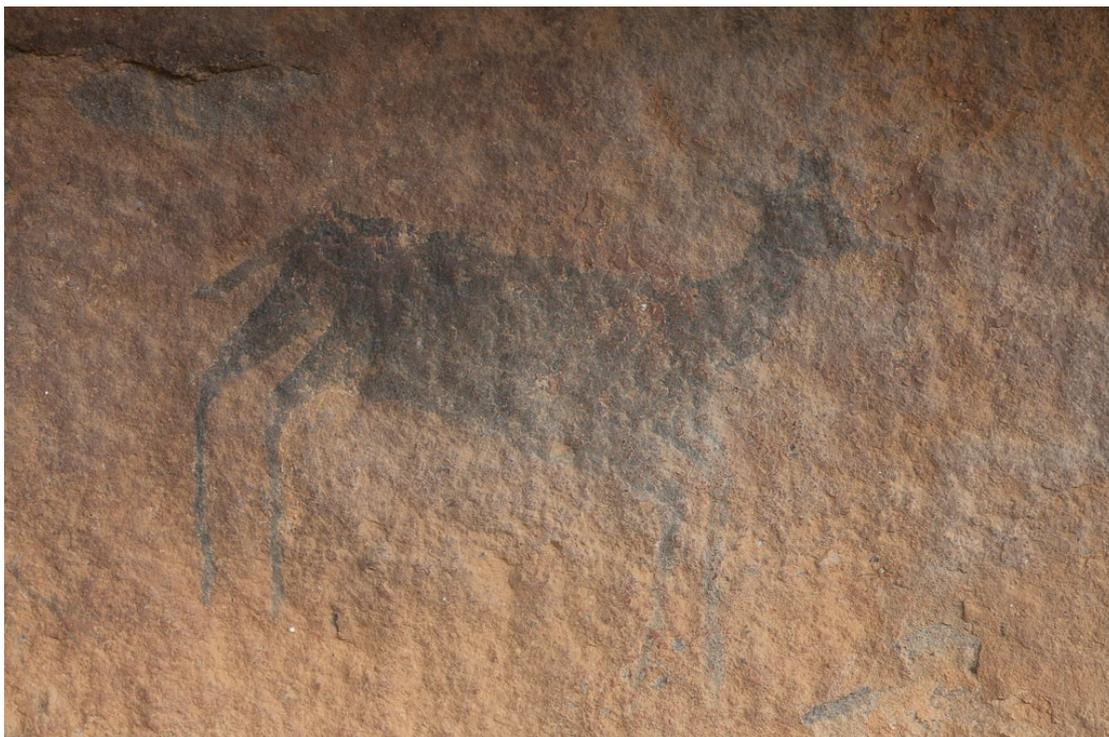
Figure 41. Panel F: painting of a small antelope

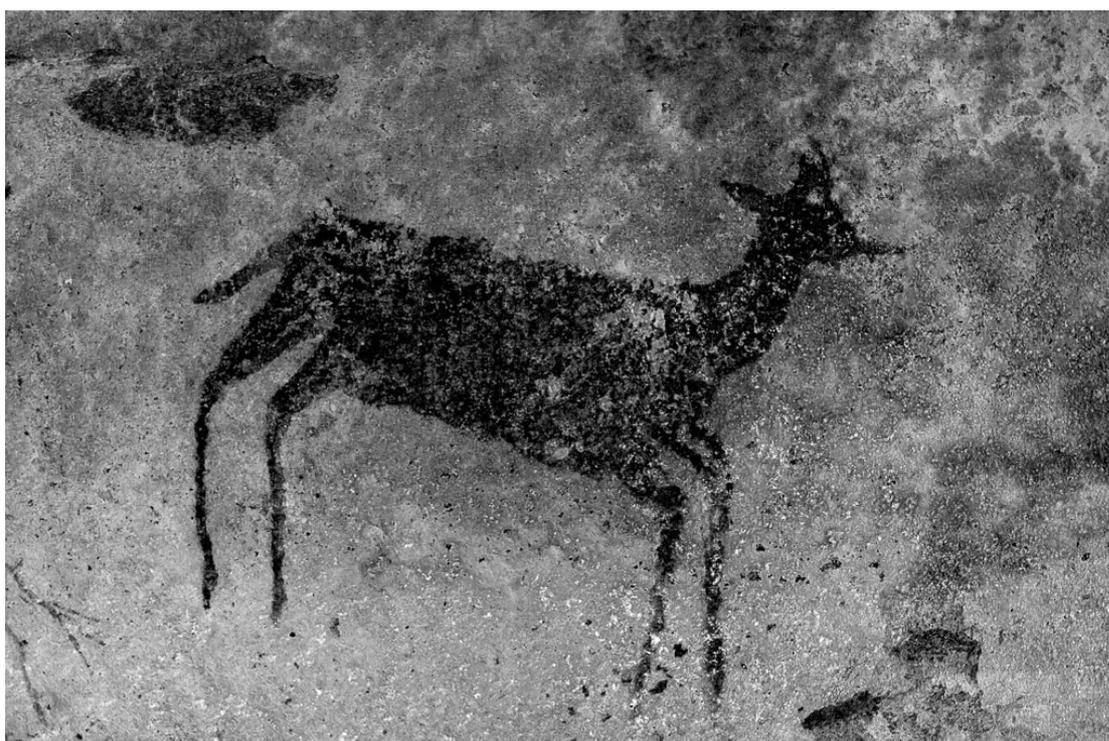
Figure 42. Panel F: Grayscale enhancement

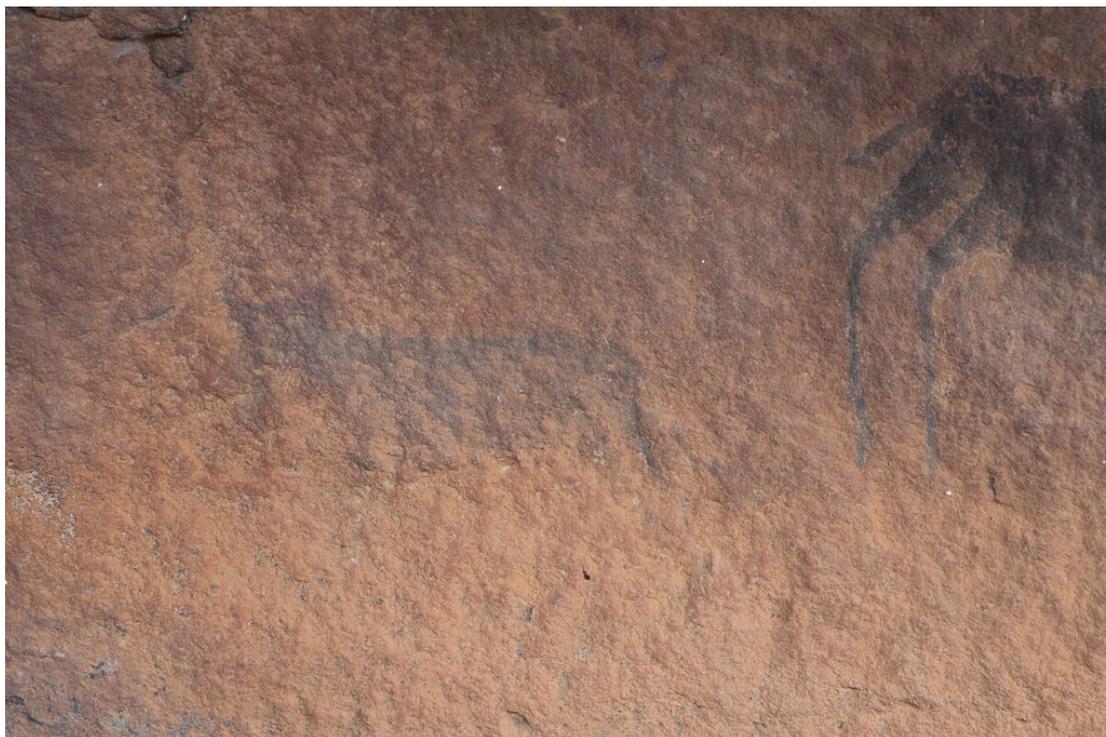
Figure 43. Panel F: painting that has been obscured by a layer of dust

A few centimetres to the left of this antelope image is a smaller animal image (Figure 43) that is not as easy to see as the antelope. Enhancement shows that this is a wildebeest facing to the left (Figure 44). The image has the horns and the tail that are characteristic of this species.

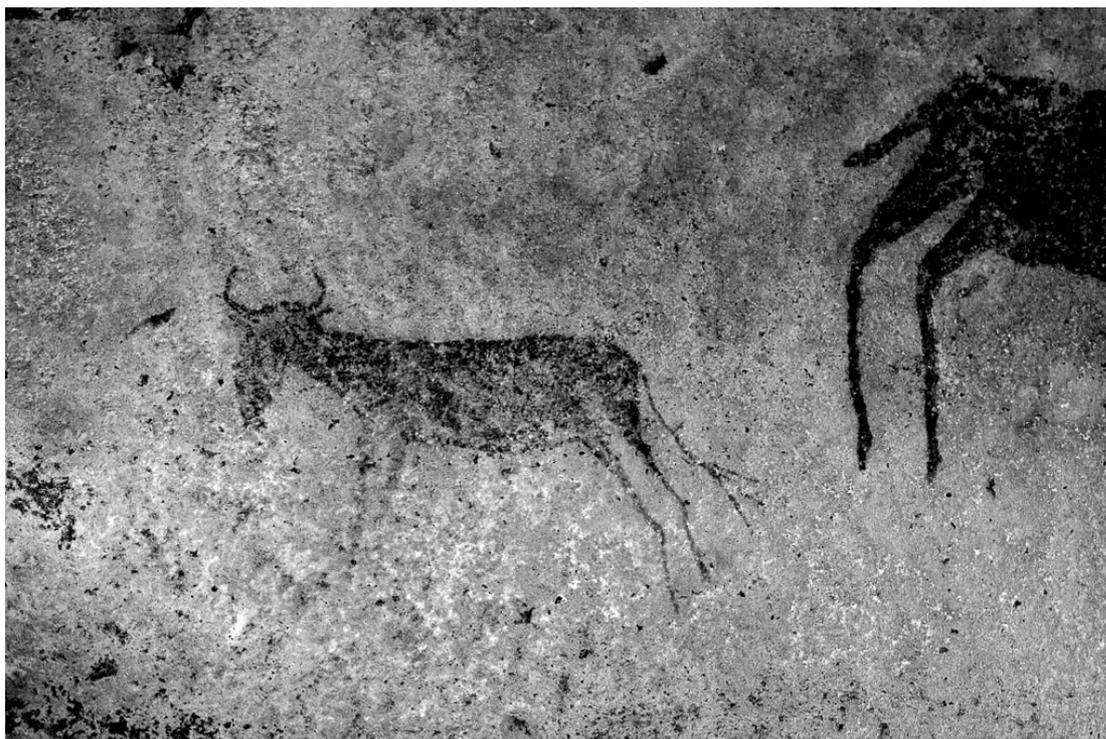
Figure 44. Panel F: Grayscale enhancement shows a painting of a wildebeest

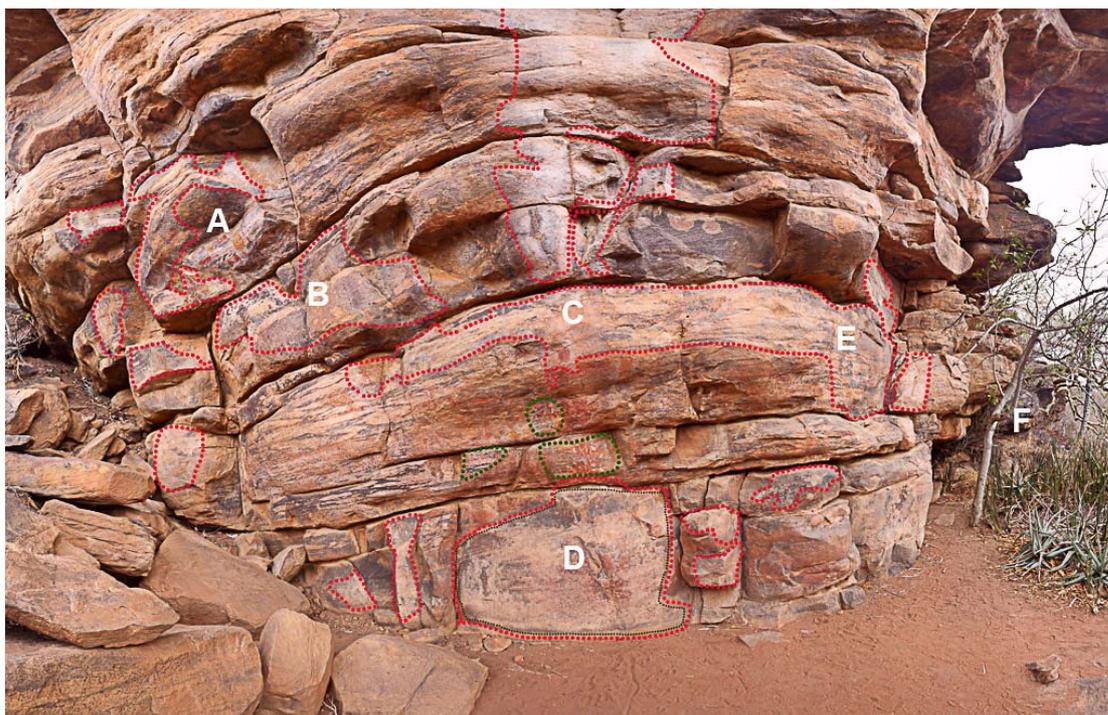
Figure 45. Diagram of physical conditions at Noka Shelter. Red = white deposits; Green = rock flaking; Brown = dust. Panel numbers are in white.

This area has deteriorated considerably. A large area of rock surface has flaked off and in places the rock surface is covered with dust that seems to have bonded with the rock.

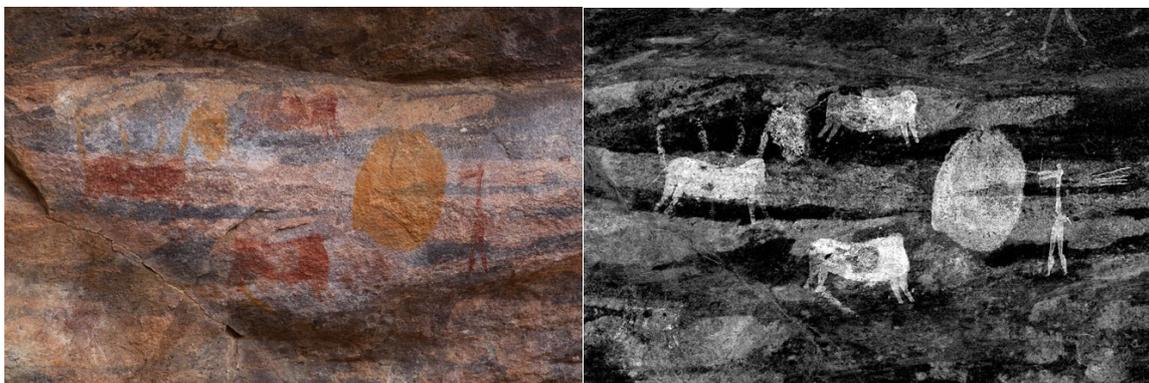
Eland hunting A hunter (immediately to the right of the circular shape painted in yellow, at left) takes aim at one of three eland.

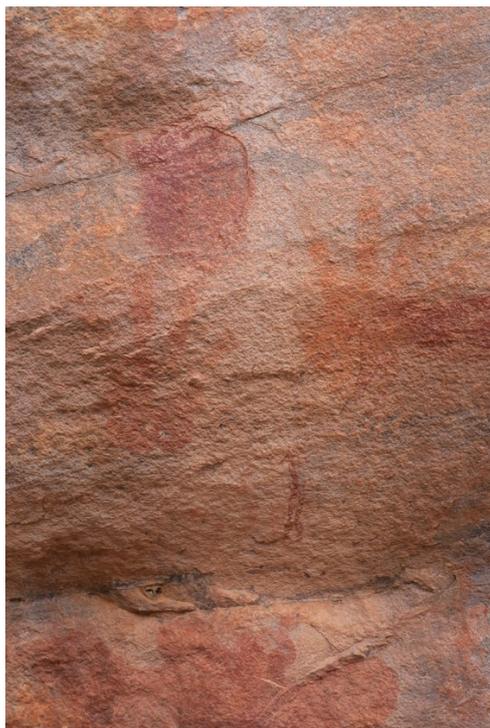
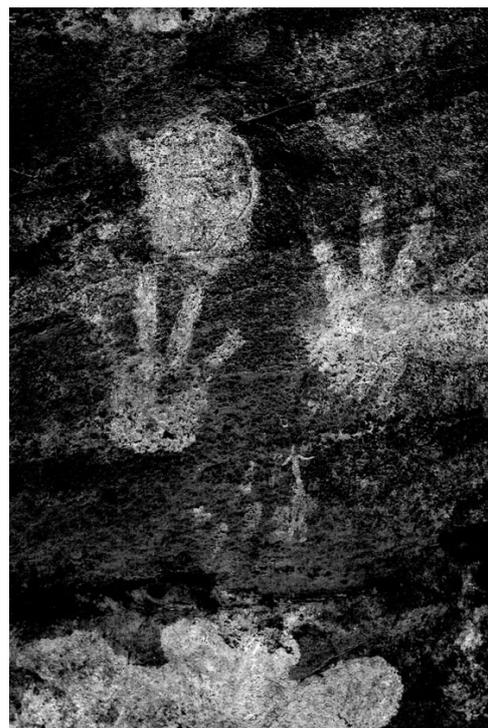
Handprints and a small dancing figure
