**HIA FOR THE UPGRADE OF WATER SUPPLY
INFRASTRUCTURE FOR NTAMBANANA SUPPLY
AREA, KZN.**

FOR CIVTECH ENGINEERS

DATE: 17 APRIL 2022

**Umlando: Archaeological Surveys and Heritage
Management**

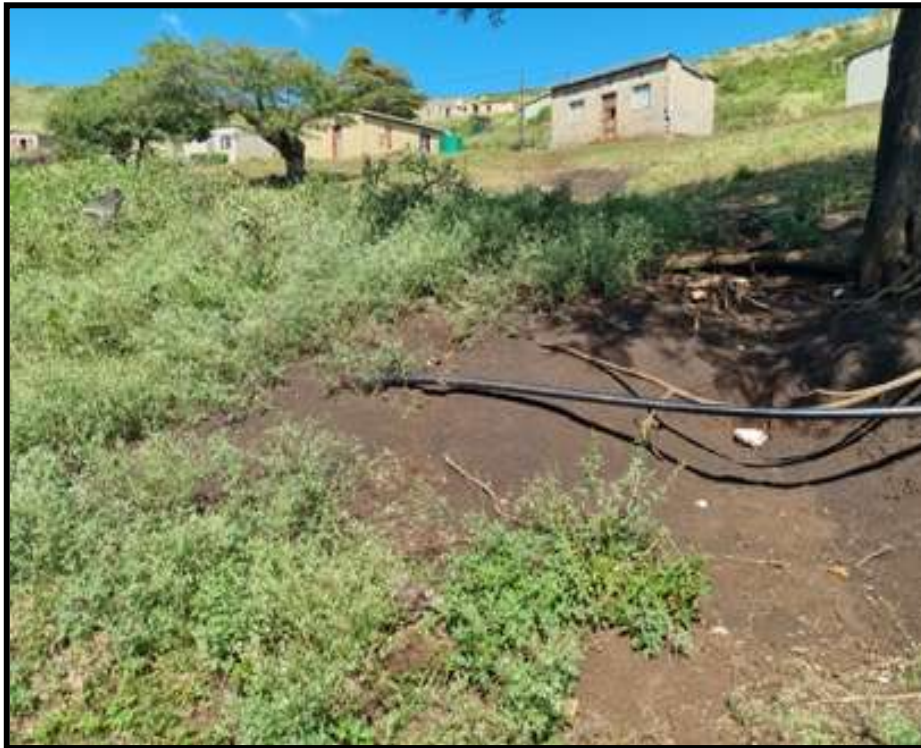
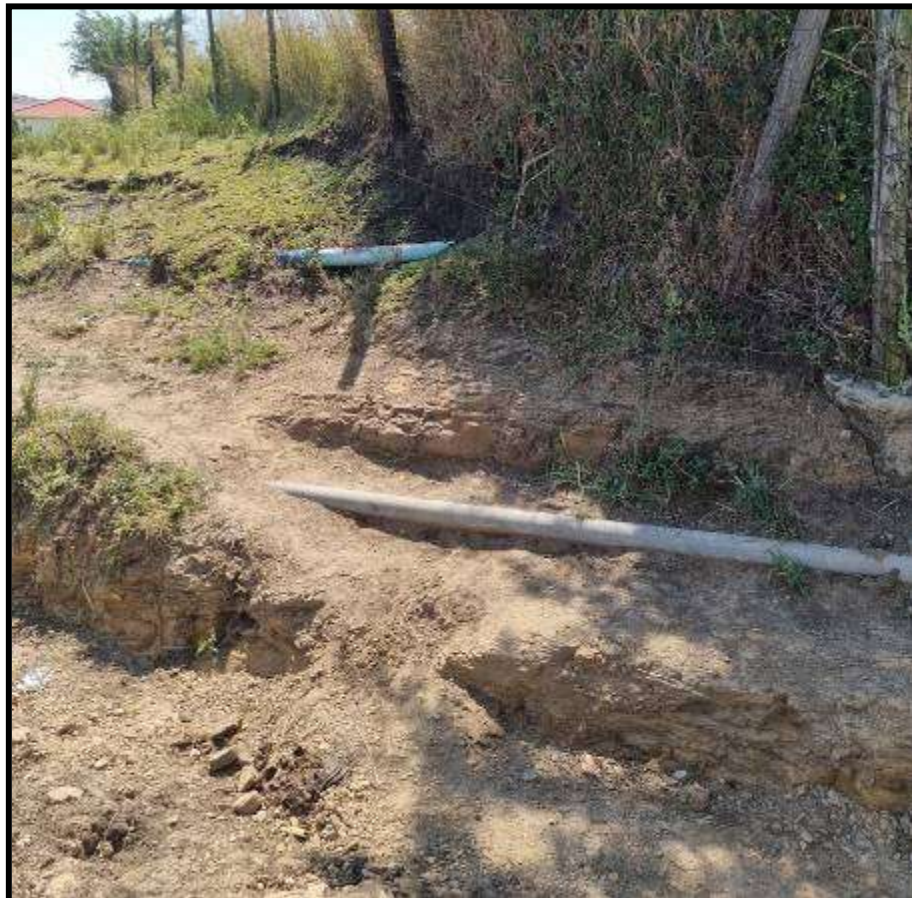
FIG. 11: EXAMPLES OF CURRENT PIPELINES TO BE REPLACED

The field survey was undertaken in April 2022. Site visibility was good in most places, especially where the pipes will be replaced (e.g. fig. 11). In most areas, the pipelines will run adjacent to the road or track, and thus not be more than 2-3m from the edge. In other areas, it is a case of upgrading and/or replacing existing pipelines. Some areas were inaccessible due to dense *Acacia* spp. and other vegetation regrowth. These few areas were not surveyed; however, they do not fall into sensitive areas. One section occurs in older ploughed agricultural fields in a floodplain. This is now impenetrable *Acacia* regrowth and was not surveyed, due to its low heritage value.

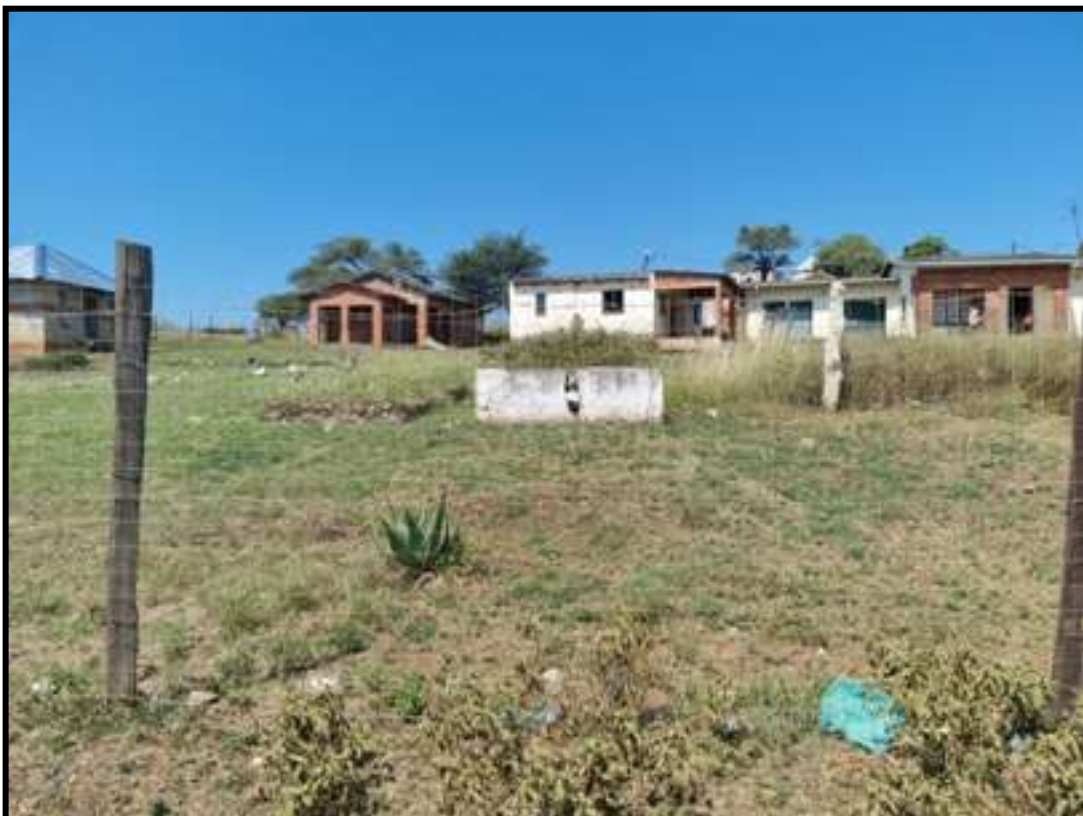
FIG. 13: GRAVES AT NTA339

NTA339 consists of two graves 8m south of the road (fig. 13). They will not be affected the pipeline as it is on the opposite side of the road.

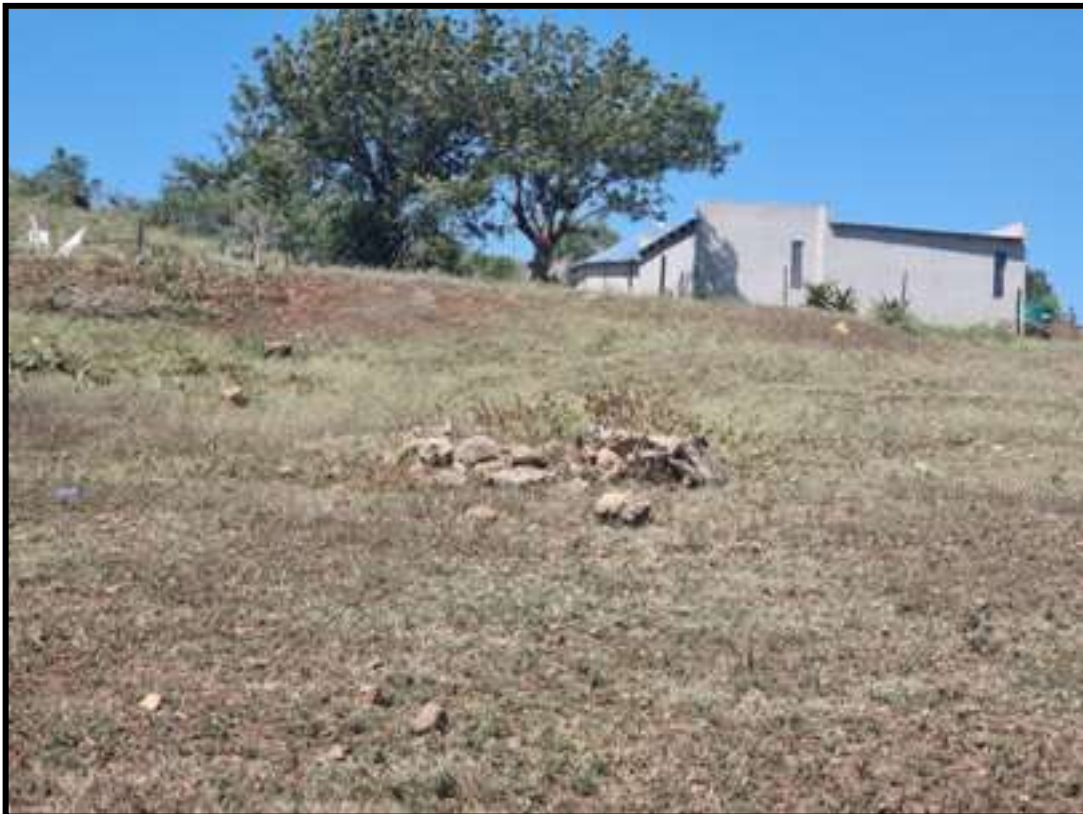
FIG. 14: GRAVES AT NTA339

NTA337 consists of one grave 7m south of the road (fig. 14). It was initially thought to be the base for a Jo-Jo tank; however, the stones are not level and follow the slope of the ground. The grave will not be affected by the pipeline.

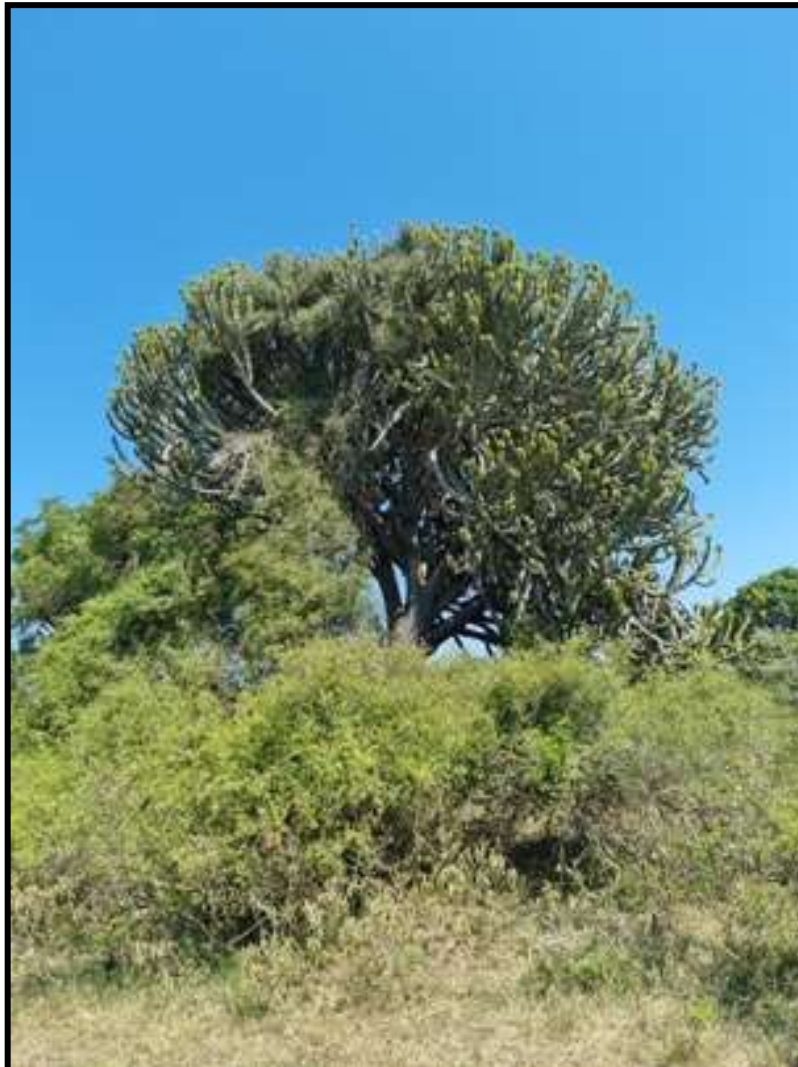
FIG. 15: E. INGENS AT NTA334

NTA334 consists of two large *Euphorbia ingens* of which one is 3m from the pipeline (fig. 15). The potential grave may be affected by the pipeline.

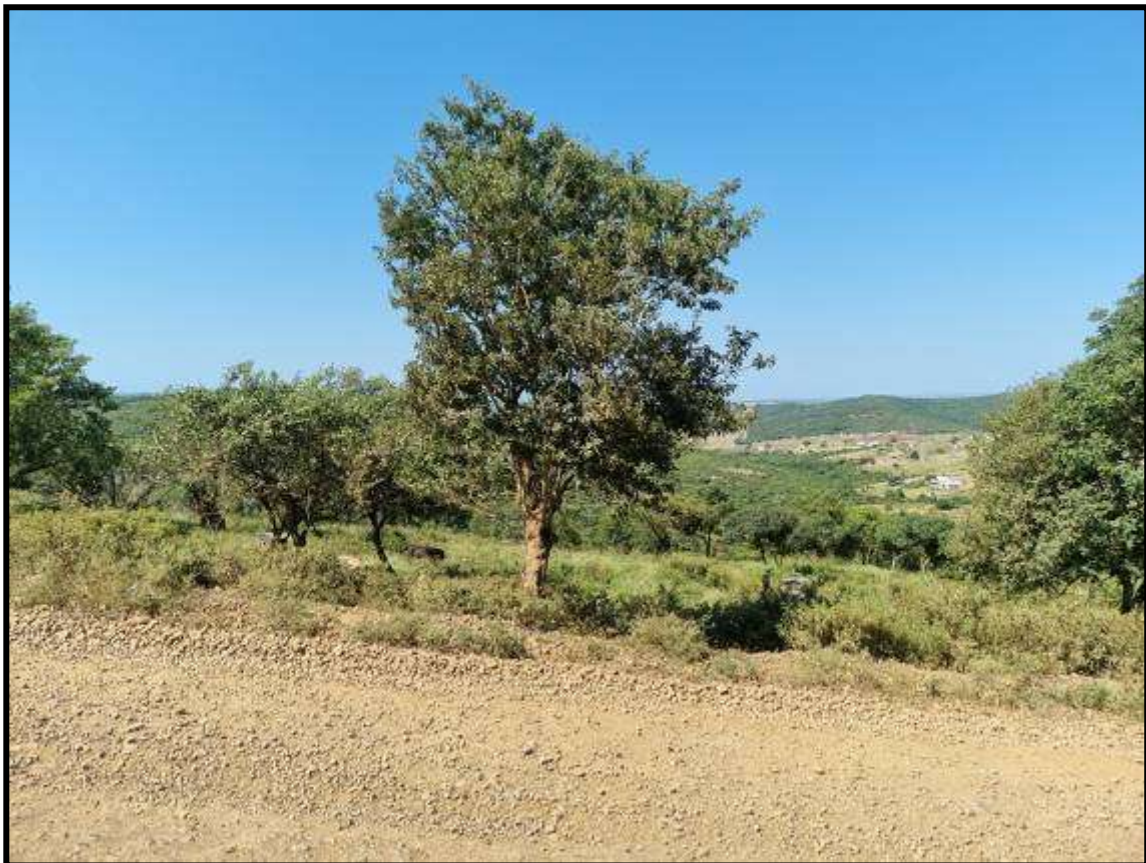
FIG. 16: CEMETERY AT NTA332

NTA332 consists of a cemetery of several graves 15m from the road (fig. 16). The pipeline occurs ~10m from the graves and should be moved, as it is a bulk water pipeline.

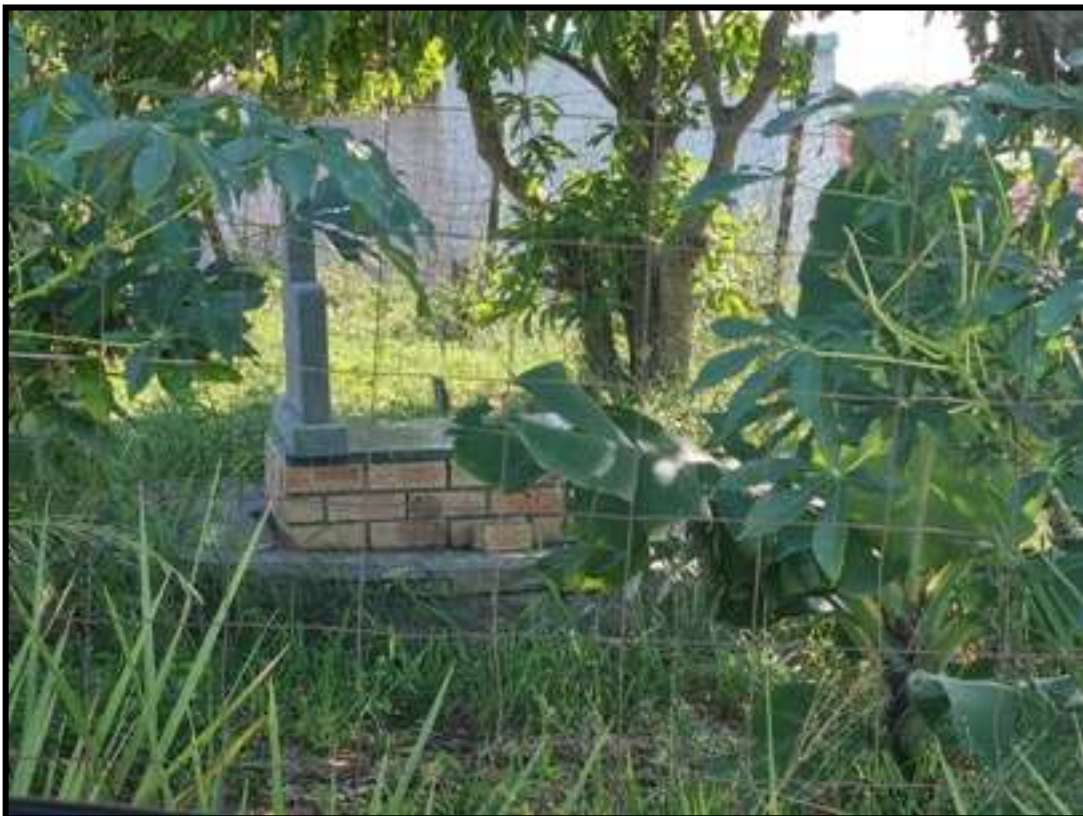
FIG. 17: GRAVE AT NTA321

NTA321 consists of one grave 4m north of the road behind a fence (fig. 17). The grave will not be affected by the pipeline.

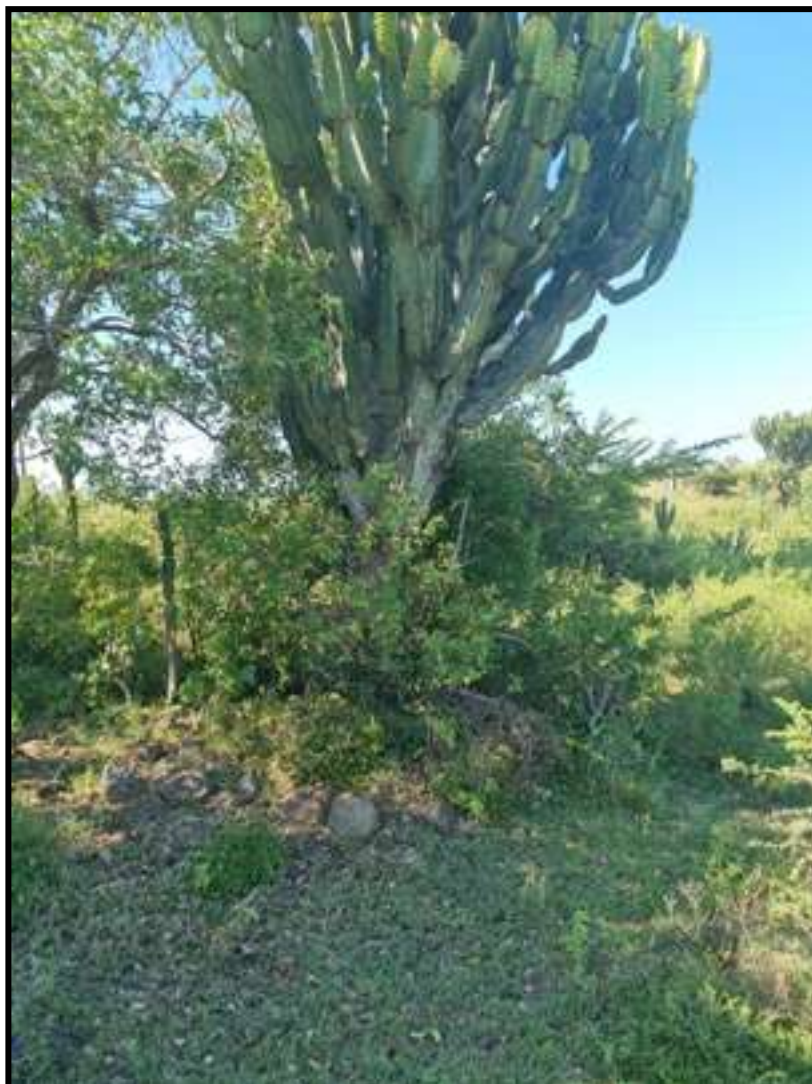
FIG. 18: E. INGENS AT NTA320

NTA320 consists of a large *E. ingens* on the edge of the track (fig. 18). The area is associated with H38 from the desktop study. The *E. ingens* will not be affected by the pipeline as it is on the opposite side of the road.

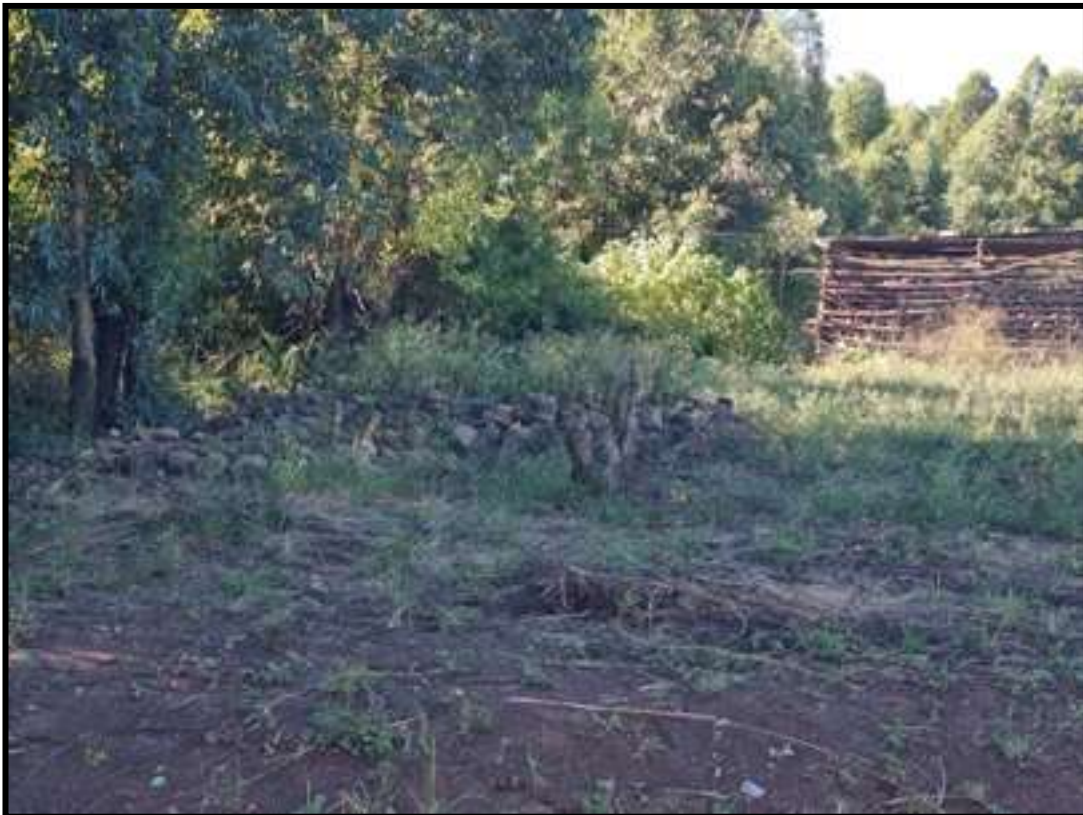
FIG. 19 GRAVE AT NTA312

NTA312 consists of one grave 10m north of the road (fig. 13). The pipeline will not affect the grave if it remains within 2m of the road reserve...

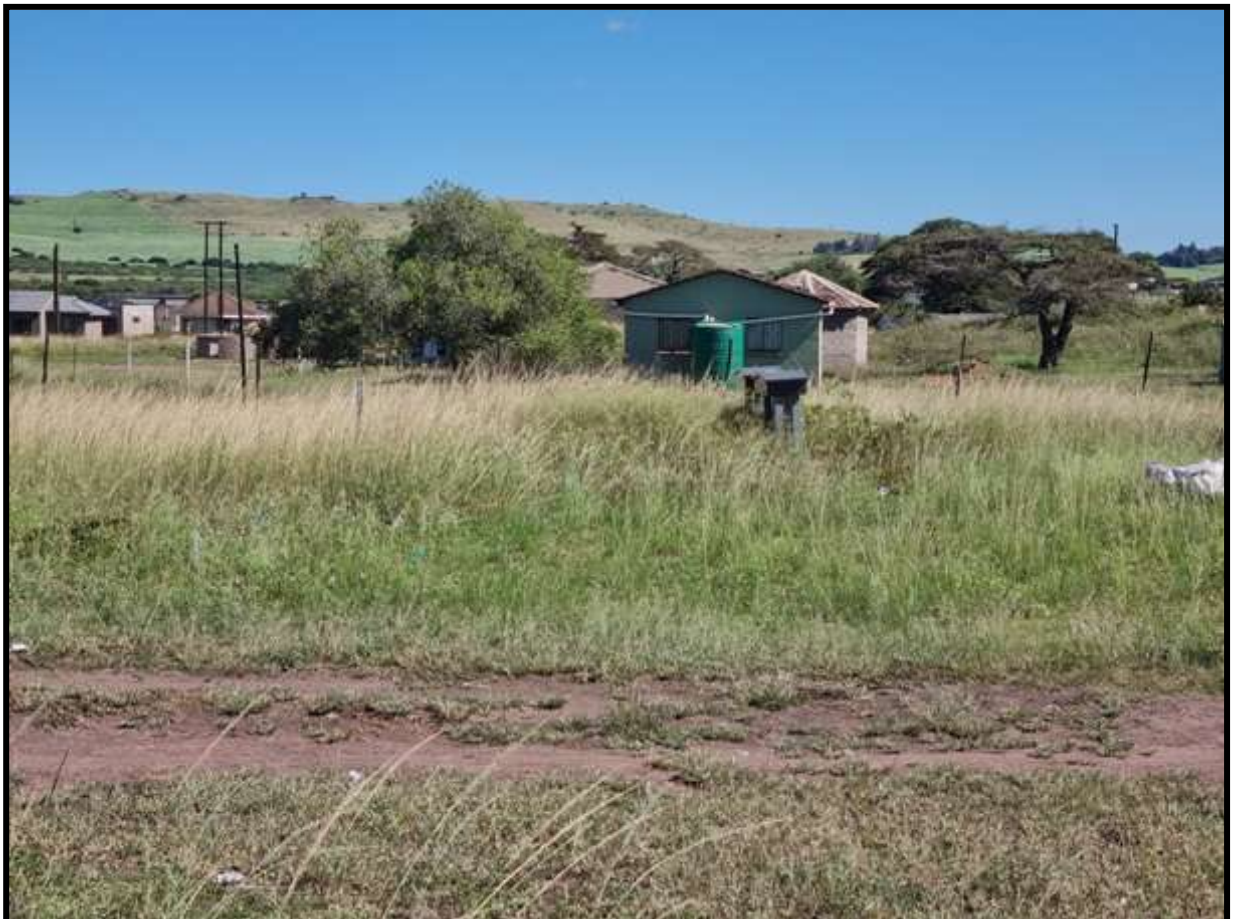
FIG. 20 GRAVE AT NTA313

NTA313 consists of one grave 5m north of the road (fig. 20). The pipeline will occur within 3m of the grave and will need to be moved to the opposite side of the road.

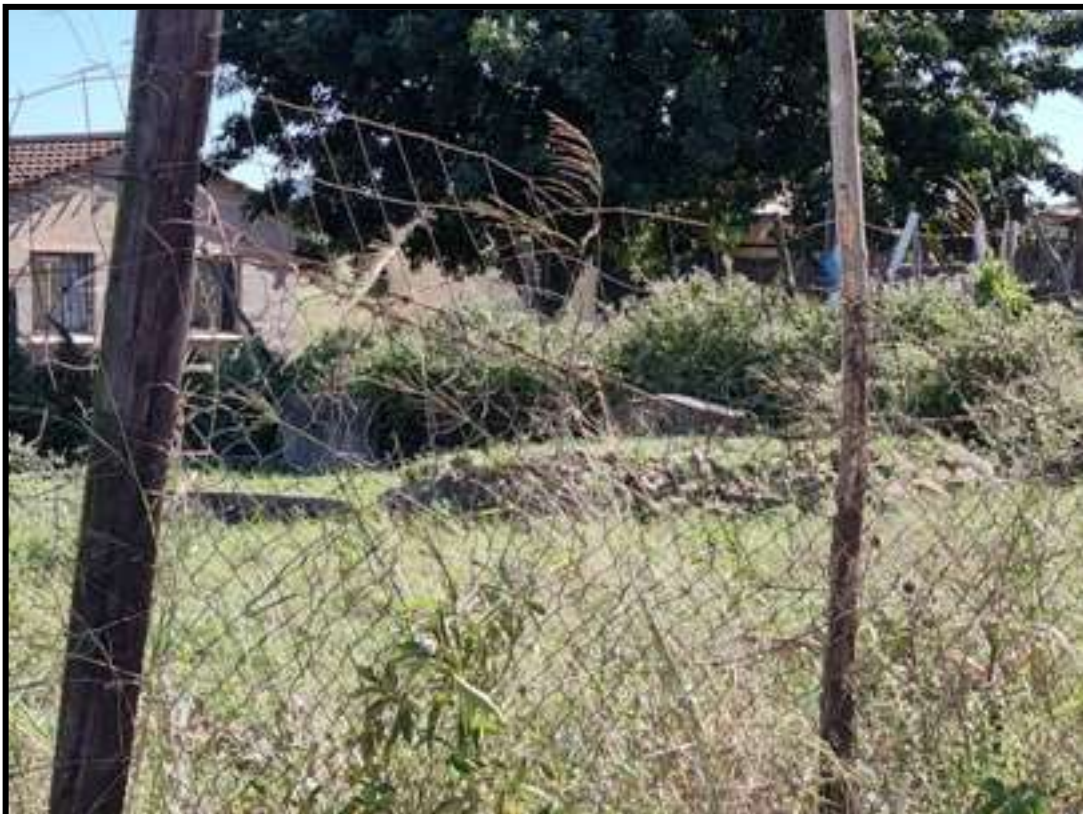
FIG. 21 GRAVE AT NTA308

NTA309 consists of one grave 5m north of the road (fig. 21). The pipeline will occur within 3m of the grave and will need to be moved to the opposite side of the road.

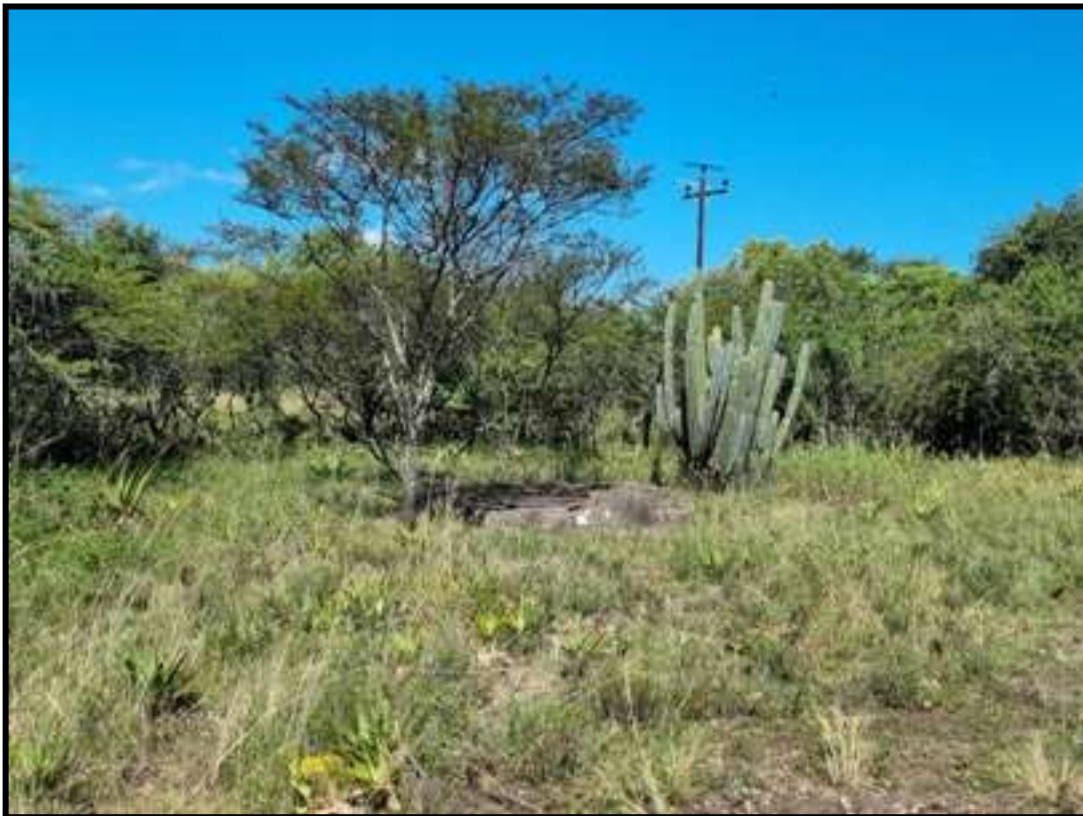
FIG. 23 GRAVE AT NTA302

NTA304 consists of one grave 7m from the road (fig. 23). The pipeline will occur on the opposite side of the road and will not affect the grave.

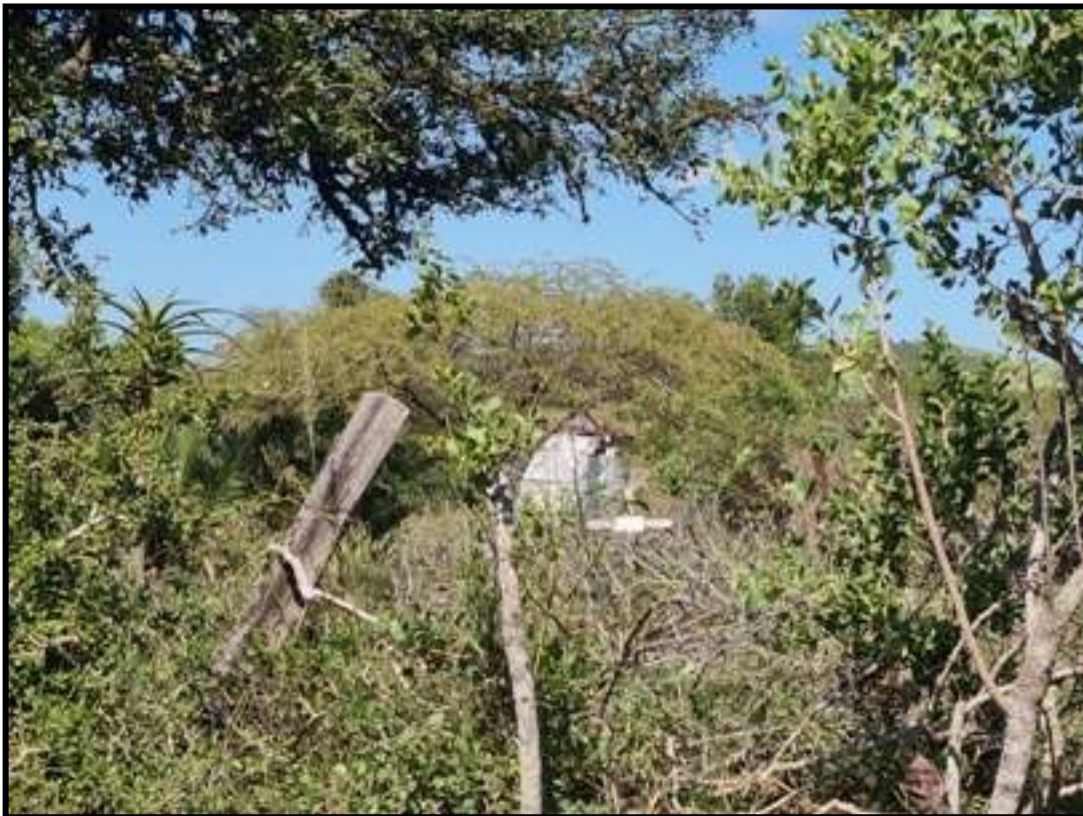
FIG. 24 GRAVE AT NTA300

NTA300 consists of one grave 7m from the road (fig. 24). The pipeline will occur on the opposite side of the road and will not affect the grave.

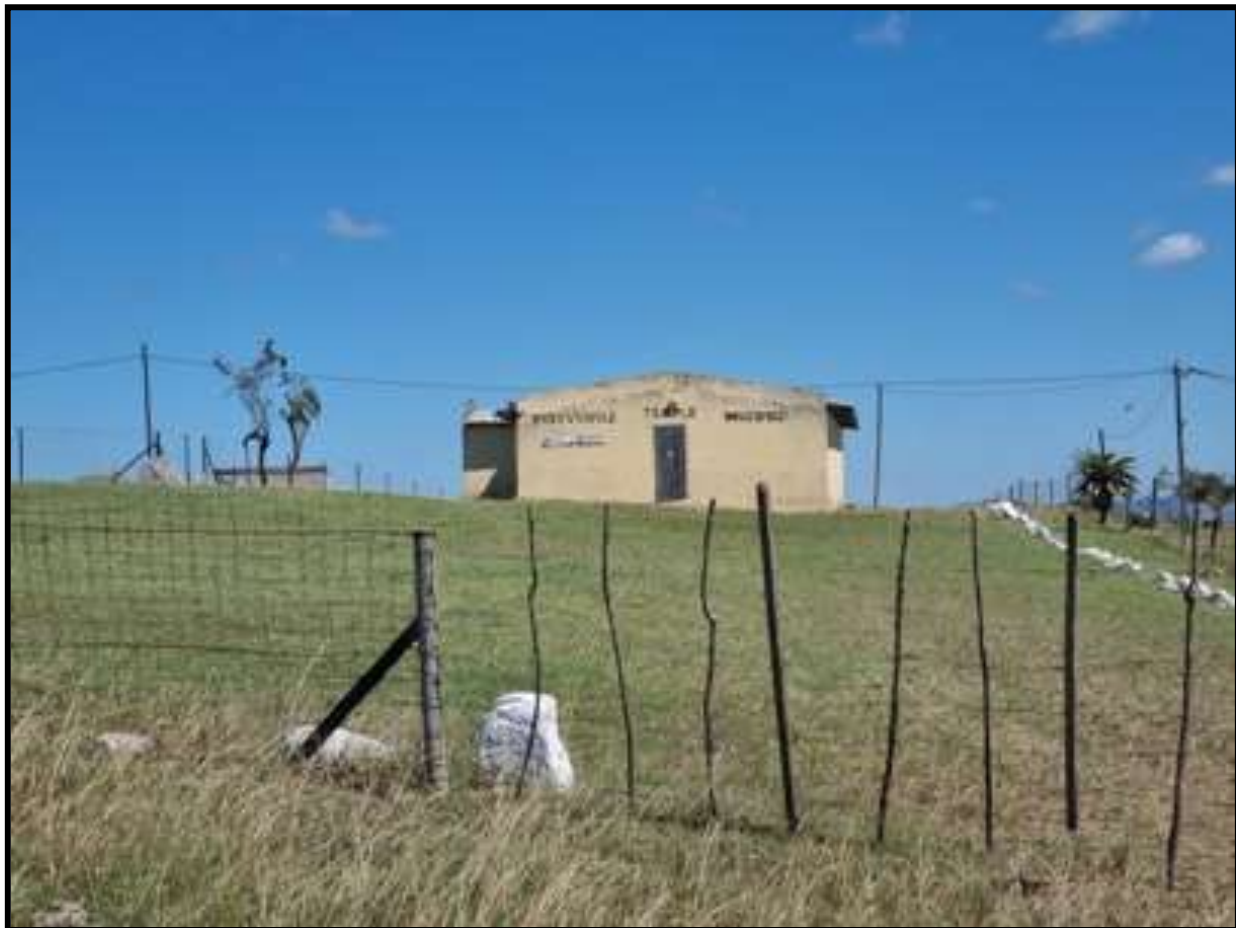
FIG. 25 TEMPLE AT NTA298

NTA298 is the Vukuvunule Temple (fig. 25). The pipeline will occur in the corner of the Temple's property.

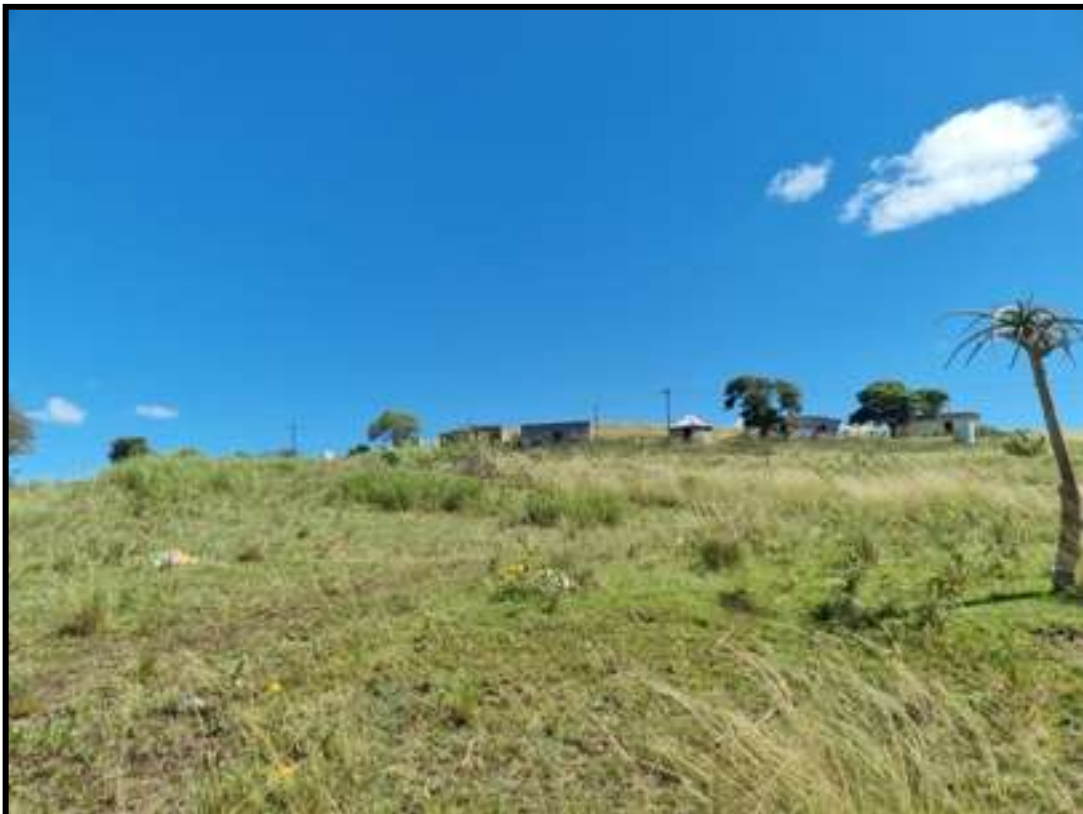
FIG. 26 CCEMETERY AT NTA304

NTA295 is a cemetery at least 5m – 10m from the road (Fig. 26). Some of the graves are demarcated while others appear to be mounds of sand or stone. The cemetery is approx. 50m x 35m in size. The pipeline will not affect the cemetery.

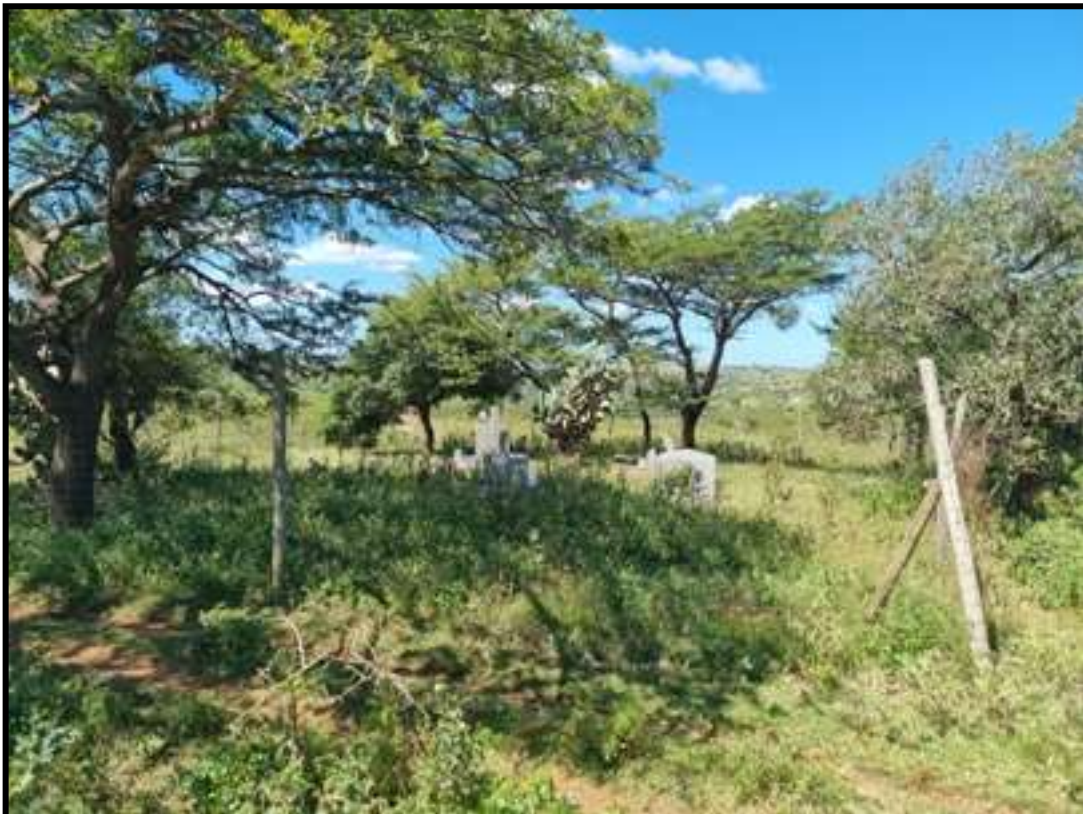
FIG. 27 CEMETERY AT NTA294

NTA304 consists of a cemetery 8m from the road (fig. 27). The pipeline will occur between the cemetery fencing and the road and will not affect the grave.

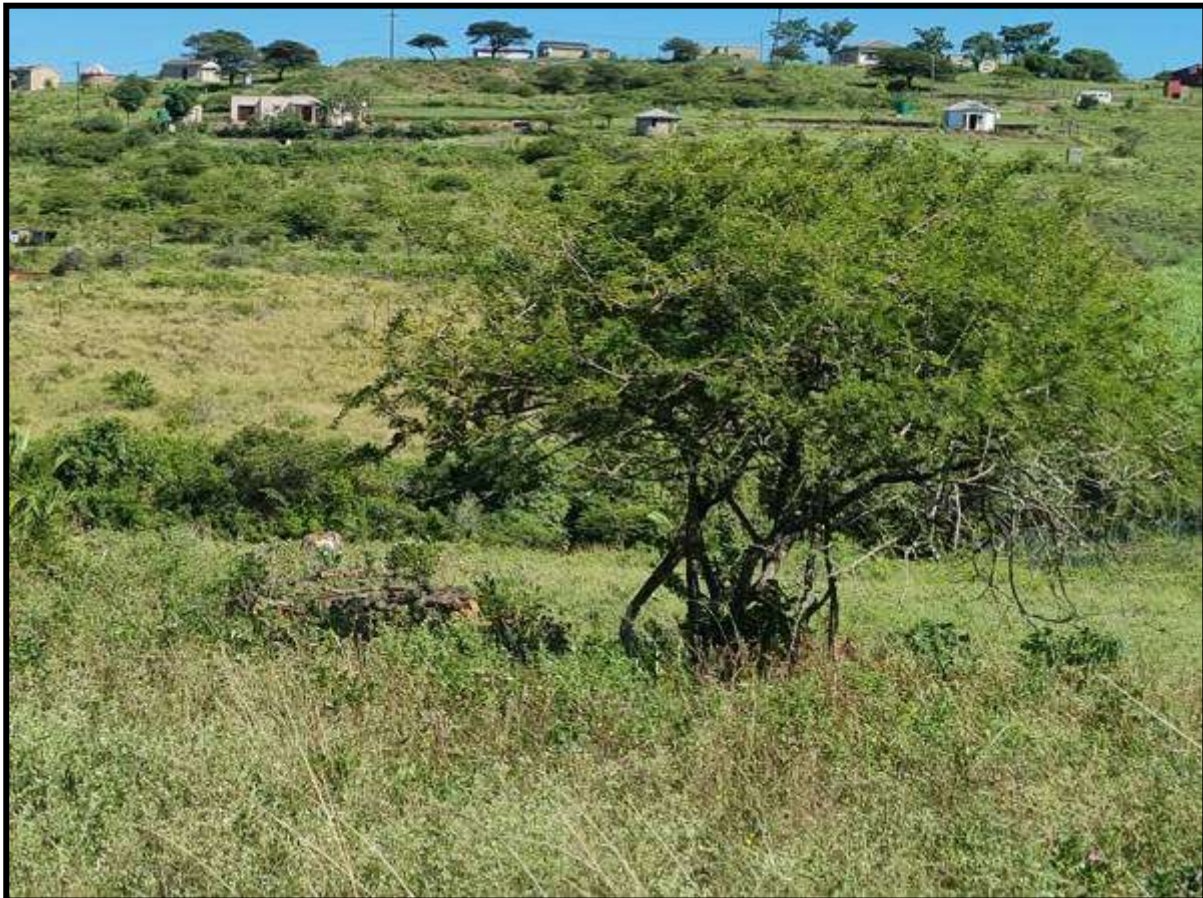
FIG. 30: GRAVE AT NTA283

NTA283 consists of one grave 10m from the road (fig. 30). The pipeline will occur on the opposite side of the road and will not affect the grave.

SAHRA Rating: 3A

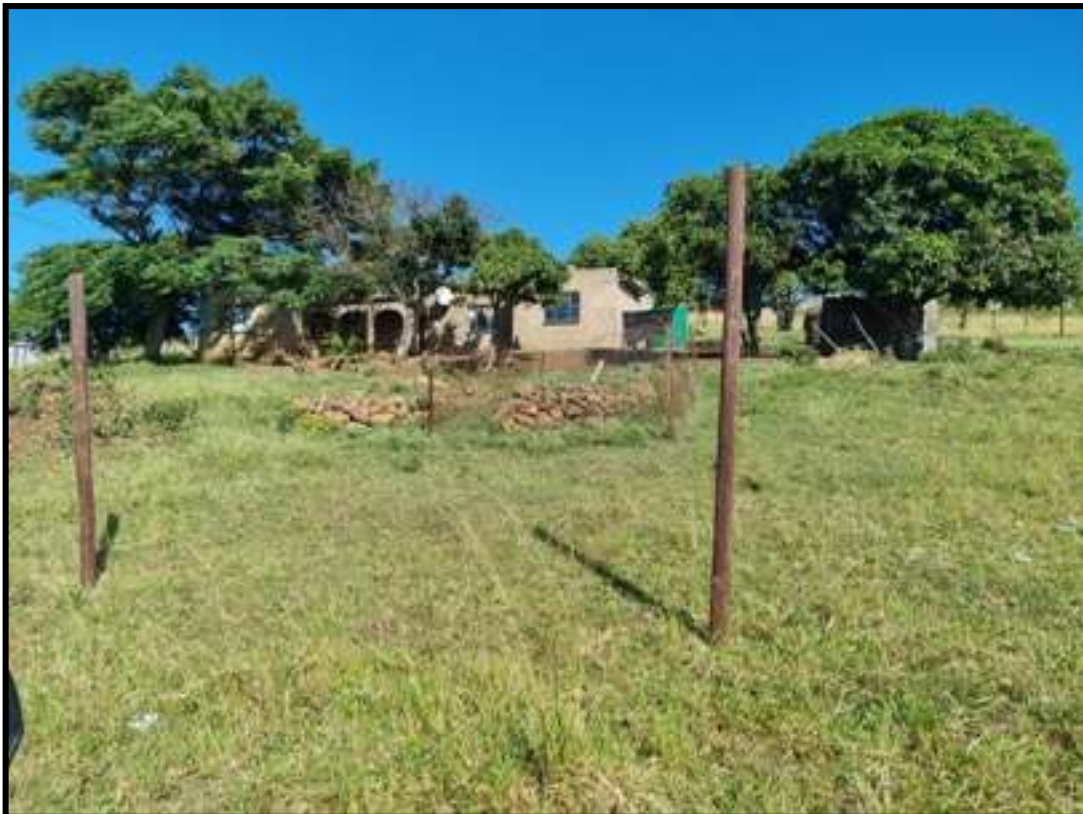
FIG. 31: GRAVES AT NTA276

NTA276 consists of one grave 15m from the road and behind fencing (fig. 31). The pipeline will occur on the opposite side of the road and will not affect the grave.

SAHRA Rating: 3A

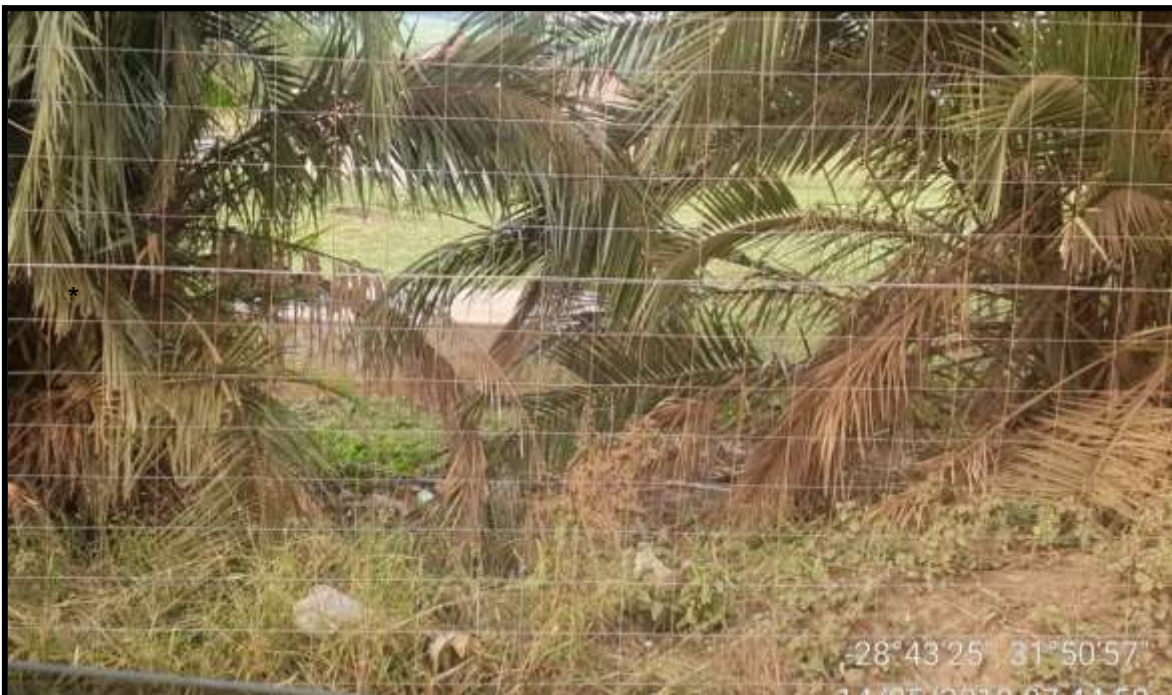
FIG. 32: GRAVE AT KHOZ494

KHOZ494 is a single grave within a fenced of garden (fig. 32). It is ~5m south of the road. The grave should not be affected by the pipeline

SAHRA Rating: 3A

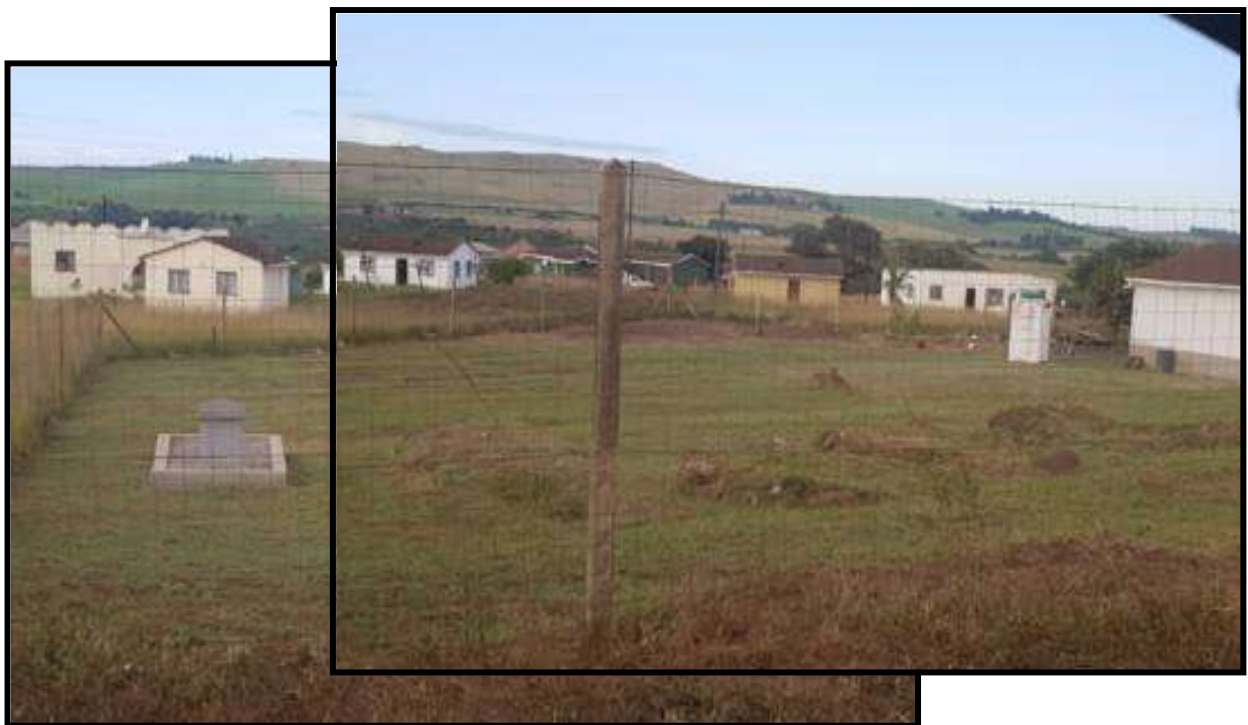
FIG. 33: GRAVES AT KHOZ495

KHOZ495 is a group of six graves in a fenced of yard (fig. 33). They are about ~15m west of the road. The pipeline will not affect these graves

SAHRA Rating: 3A

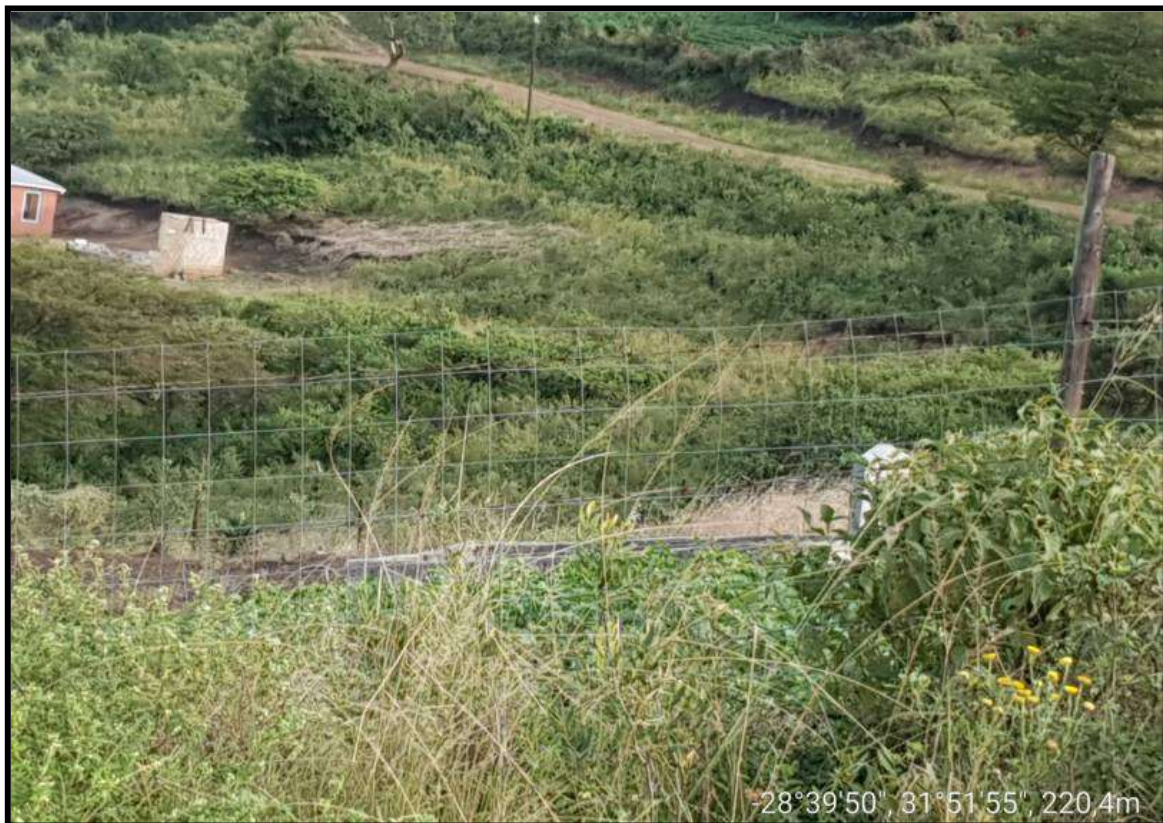
FIG. 34: GRAVE AT KHOZ496

KHOz496 is a single grave to the west of the road (fig. 34). The grave is ~6m from the road reserve and proposed pipeline.

SAHRA Rating: 3A

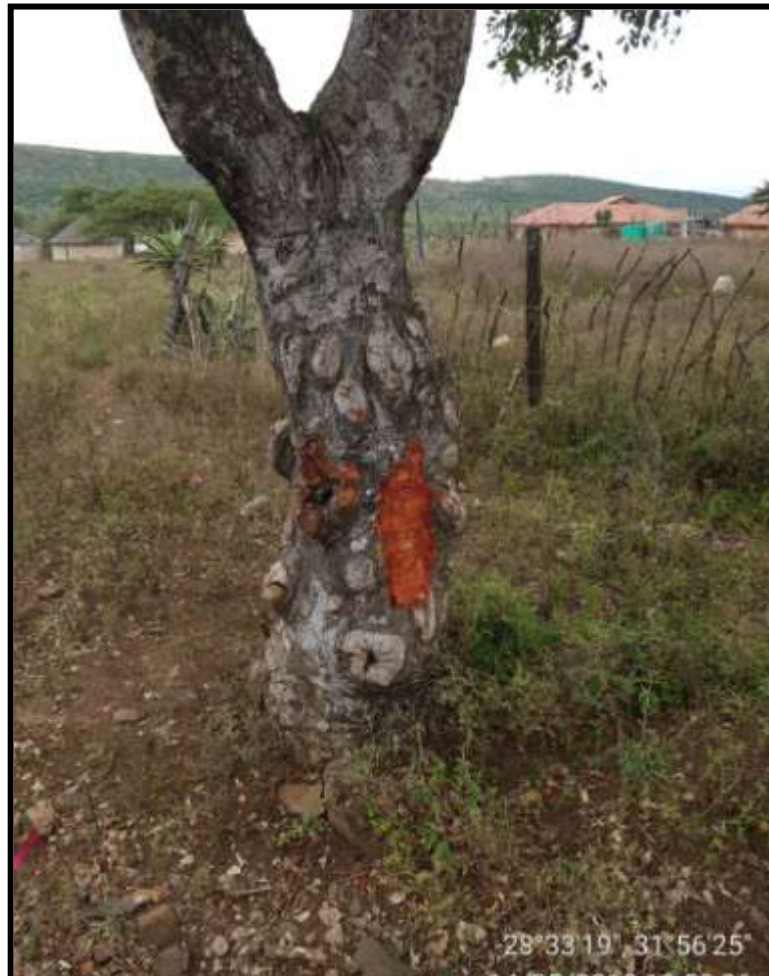
FIG. 36: MARULA TREE USED FOR MUTHI AT KHOZ

KhOZ498 is an example of a tree being used for traditional medicine, or *muthi*, and is thus a heritage resource. The bark of the *Sclerocarya birrea* (Marula) has been shaved off several times and is re-used (fig. 36). Most of the trees in the area have been utilised in a similar manner.

SAHRA Rating: 3C

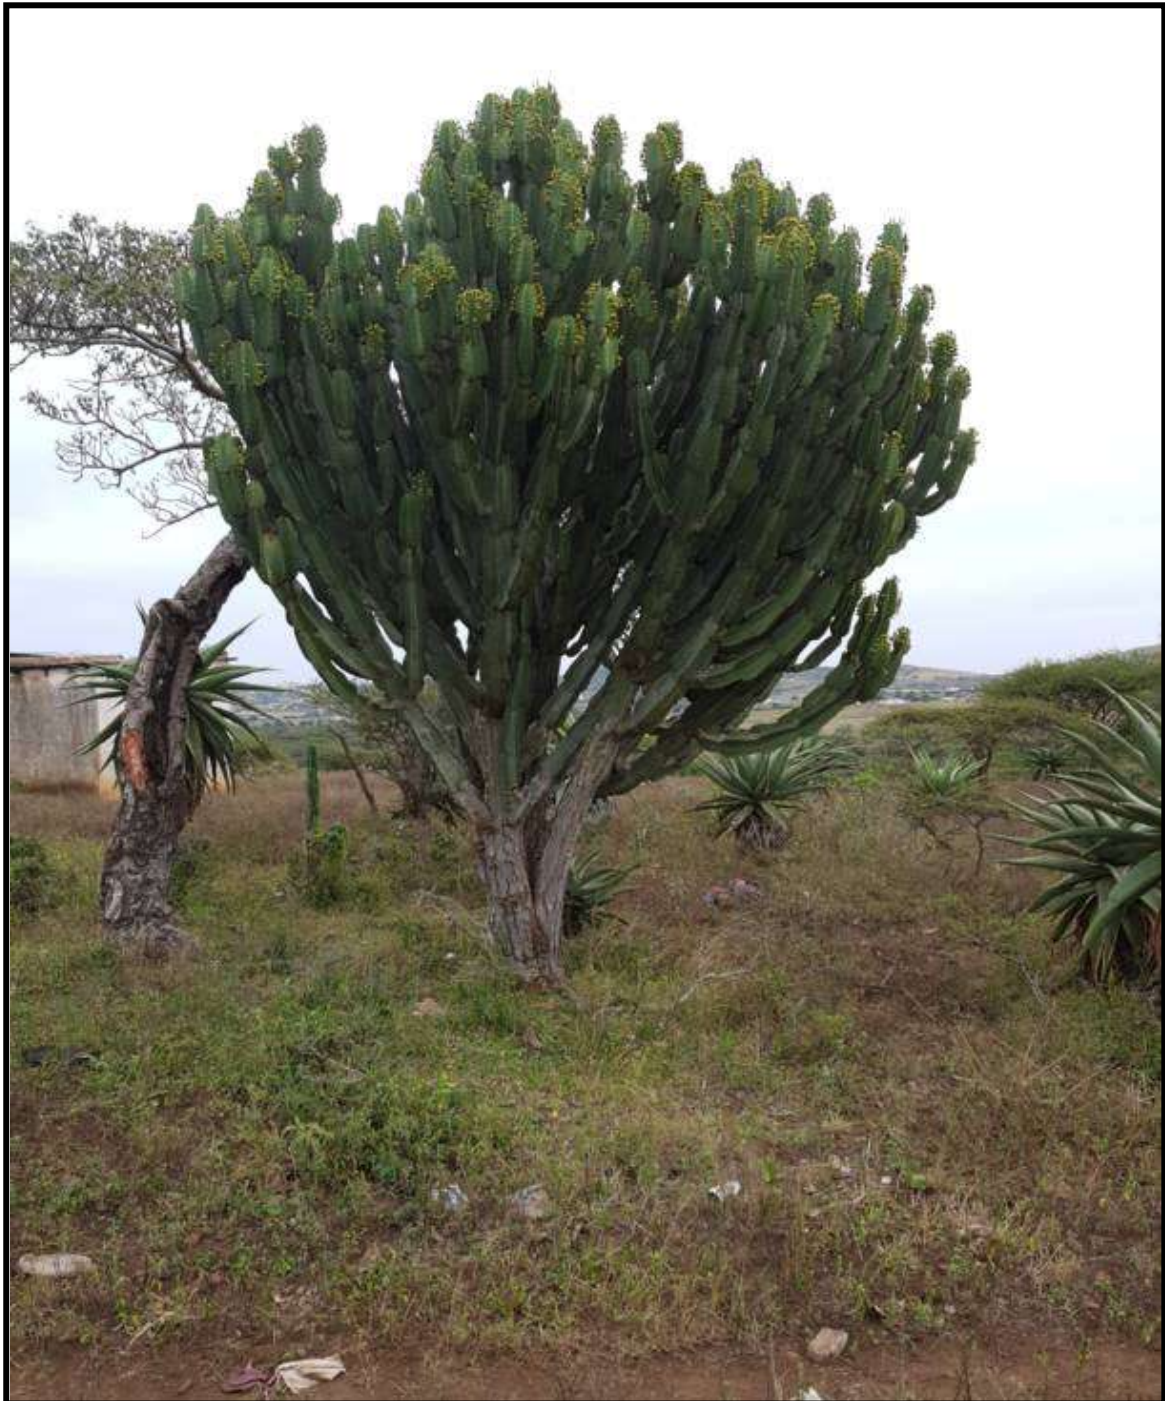
FIG. 37: EUPHORBIA MARKING POSSIBLE GRAVE AT KHOZ499

KHOZ499 and KHOZ450 are examples of another tree of cultural importance. The *Euphorbia ingens* (pin-cushion euphorbia) is traditionally associated with human graves (fig. 37). That is, the plant was placed on top of a grave. The older *E. ingens* along the study route need to be treated as possible graves, except for those in the flood plain north of KHOZ499. The obvious younger plants are not grave markers unless they are on a cairn.

SAHRA Rating: 3A until proven otherwise.
