**HIA FOR THE UPGRADE OF WATER SUPPLY
INFRASTRUCTURE FOR NTAMBANANA SUPPLY
AREA, KZN.**

FOR CIVTECH ENGINEERS

DATE: 17 APRIL 2022

**Umlando: Archaeological Surveys and Heritage
Management**

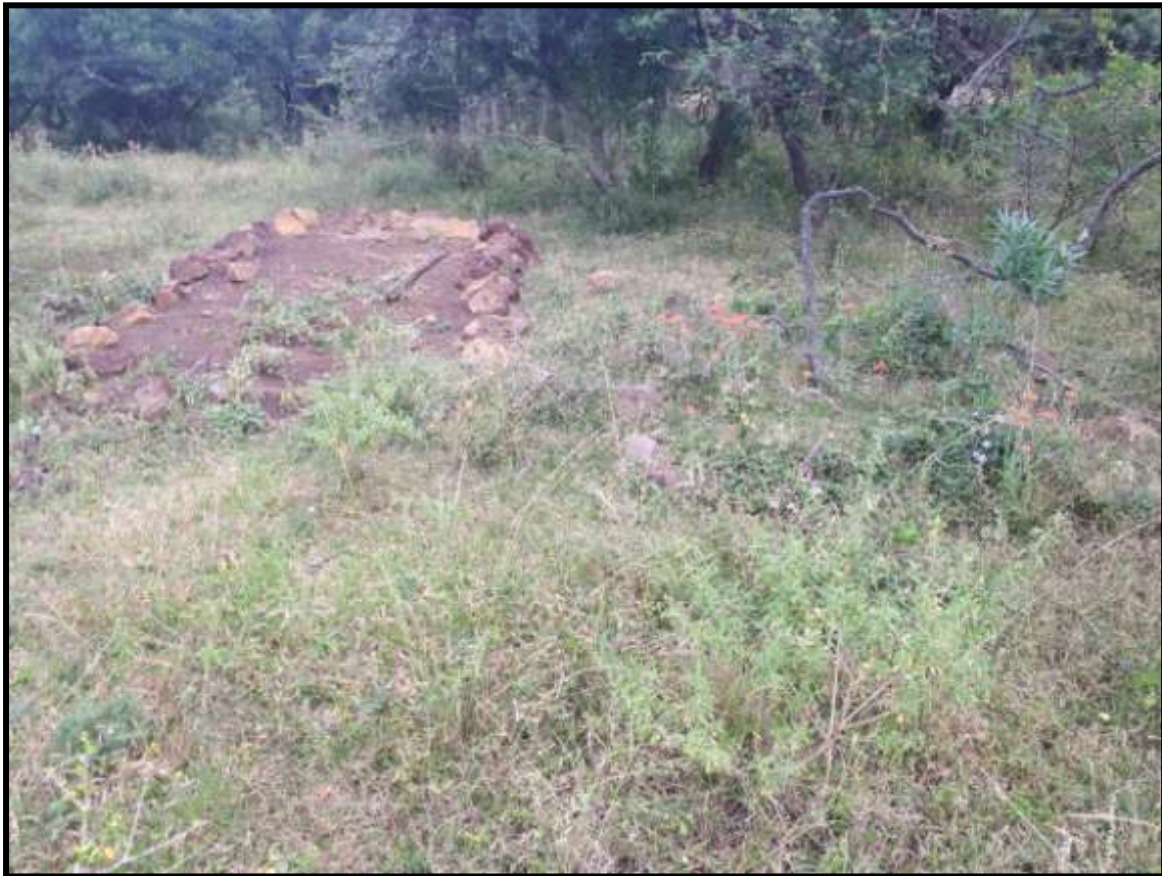
FIG. 38: GRAVES AT KHOZ551

KHOZ551 are two graves near the Hlaza Reservoir (fig. 38). They are located 60m to the west of a track that might be an access road. .

SAHRA Rating: 3A.

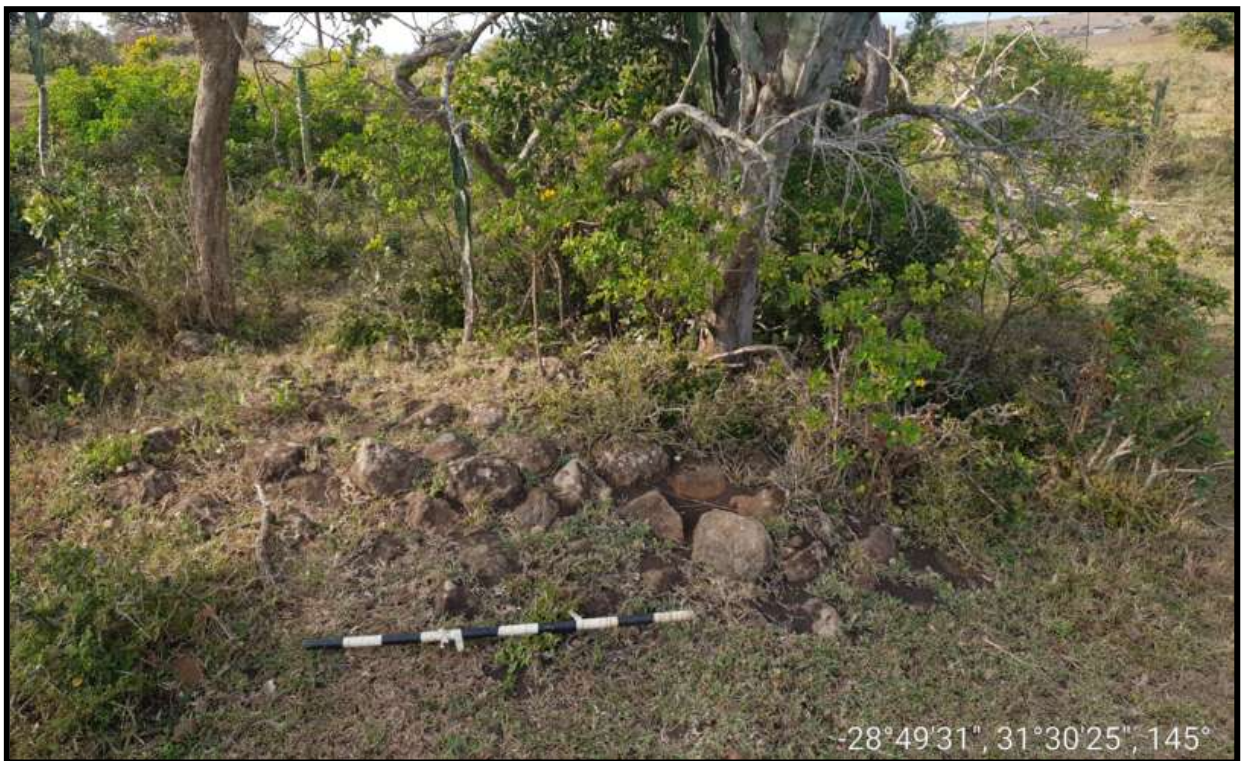
FIG. 39: GRAVES AT KHOZ575 & KHOZ576

The site is located near the base of the hill and beside the access road. The site consists of at least two graves under vegetation of which one is an *E. ingens* (fig. 39). The pipeline occurs 60m to the north of the graves

SAHRA Rating: 3A.

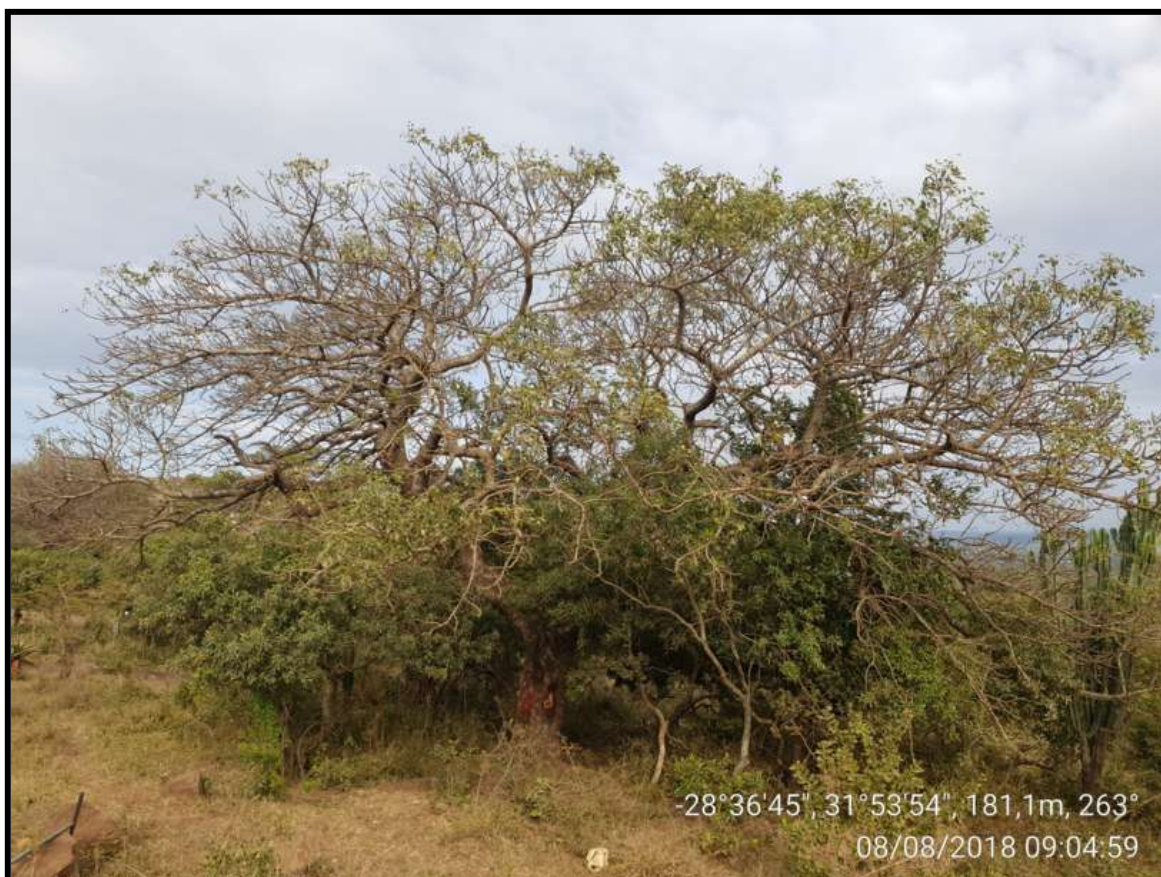
FIG. 40: MARULA TREE AT KHOZ577

The site is located near the base of the hill and beside the access road. The site consists of very large Marula tree used for *muthi* (fig. 40). The pipeline occurs 30m to the north.

SAHRA Rating: 3C

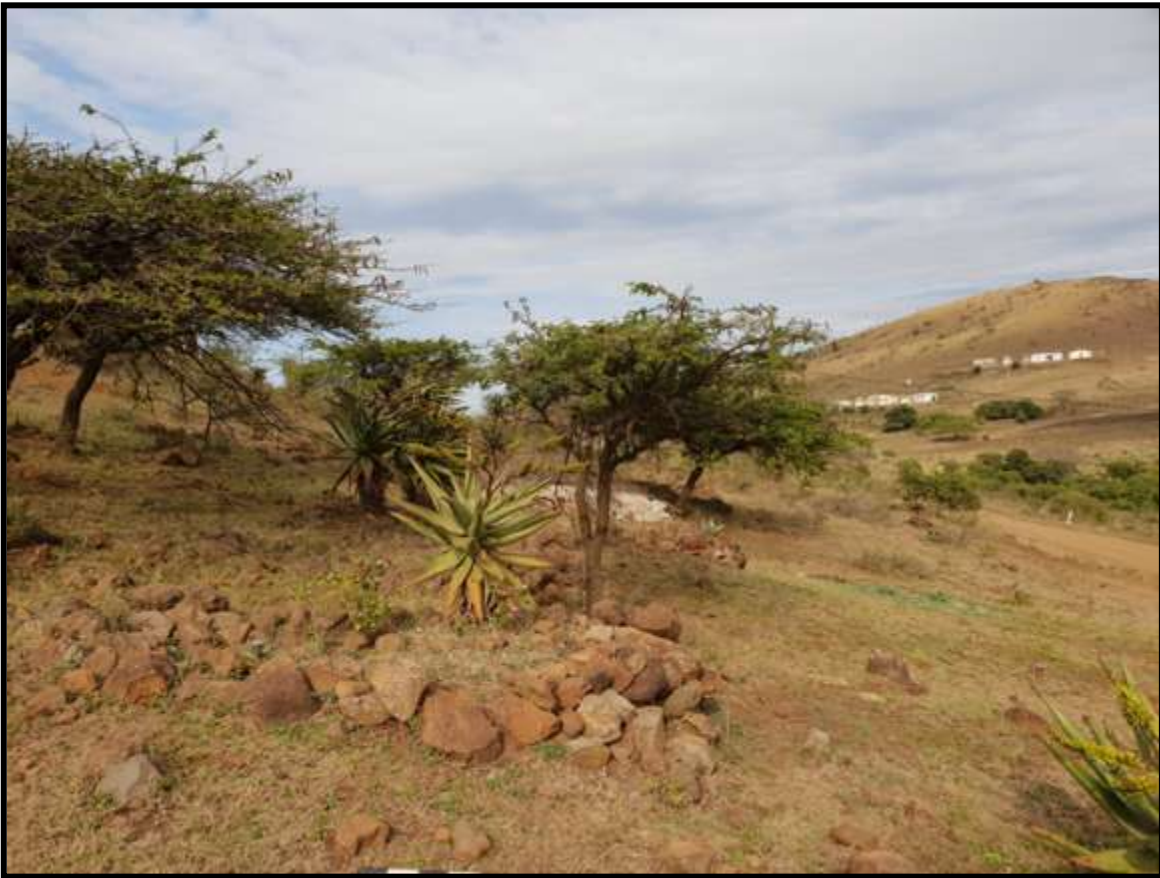
FIG. 41: GRAVES AT KHOZ578

The site is located on the base of a hill and next to a ruined settlement. The site consists of a cemetery of 10+ graves (fig. 41). The graves range in age and are in an approximate east-west orientation.

SAHRA Rating: 3A.

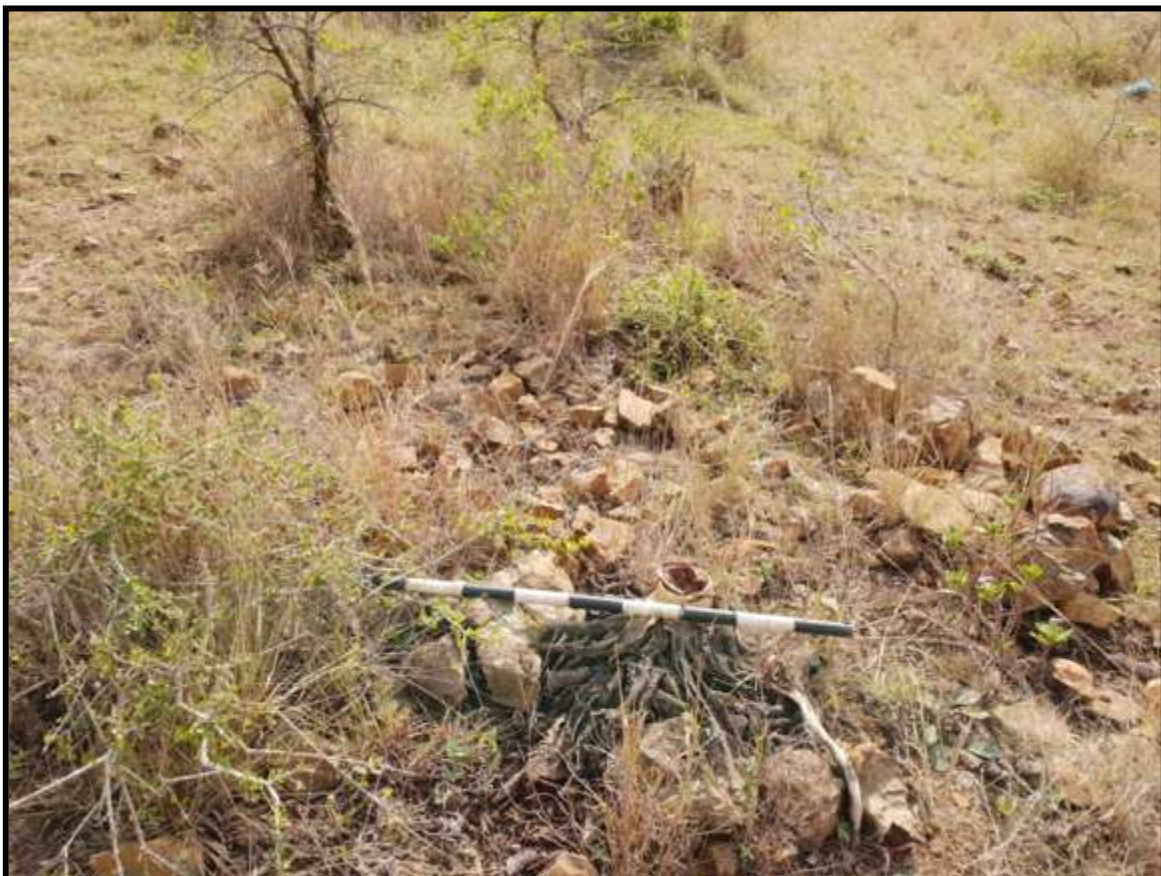
FIG. 42: A GRAVE AT KHOZ579

The site is located on the west side of the road and ~4m from existing water servitude. The site consists of two graves that have been disturbed over time (fig. 42). The graves have sunken and the upper stone have been displaced; however, the outlines are still visible. The graves are in an east-west orientation.

SAHRA Rating: 3A.

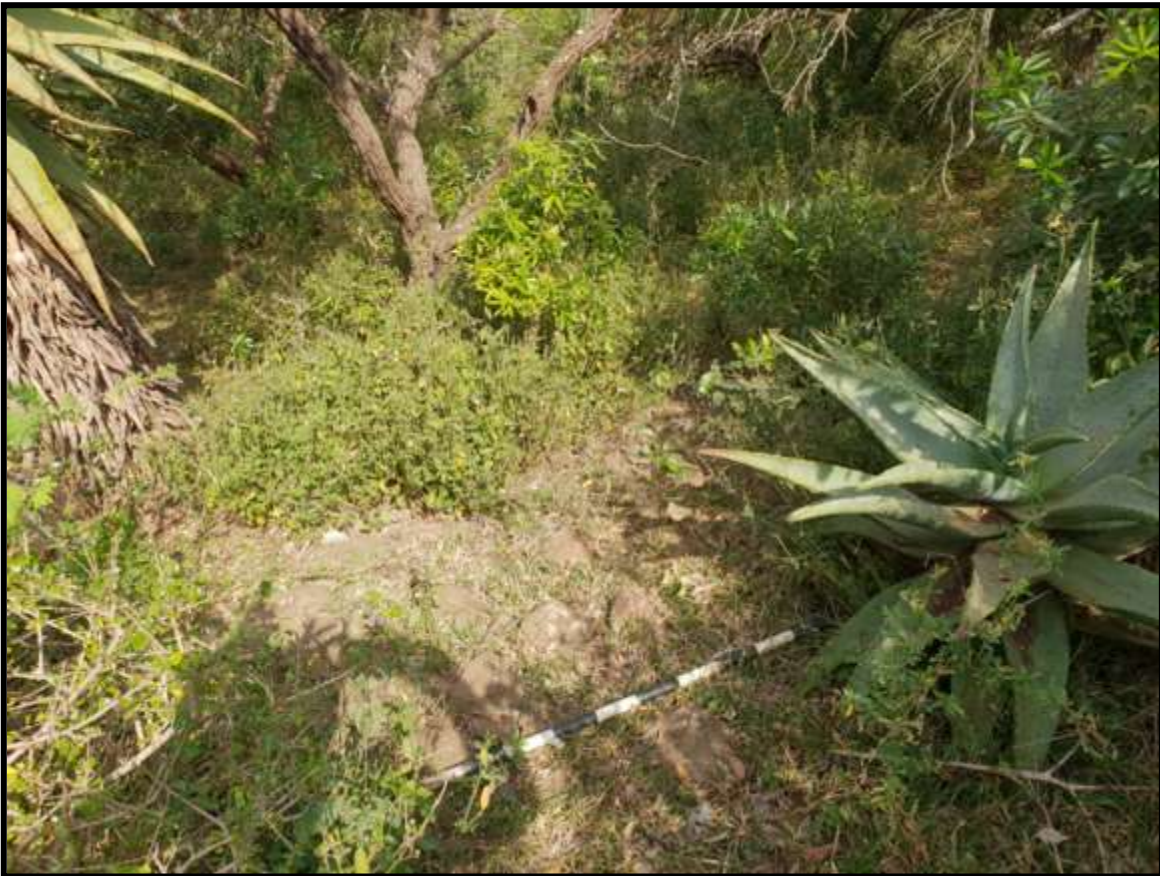
FIG. 43: GRAVE AT KHOZ580

The site is located ~5m uphill from the road. The site consists of a grave amongst aloes and bushes (fig. 43). The grave is an east-west orientation. The grave correlates with the site 'h32' from the desktop study.

SAHRA Rating: 3A.

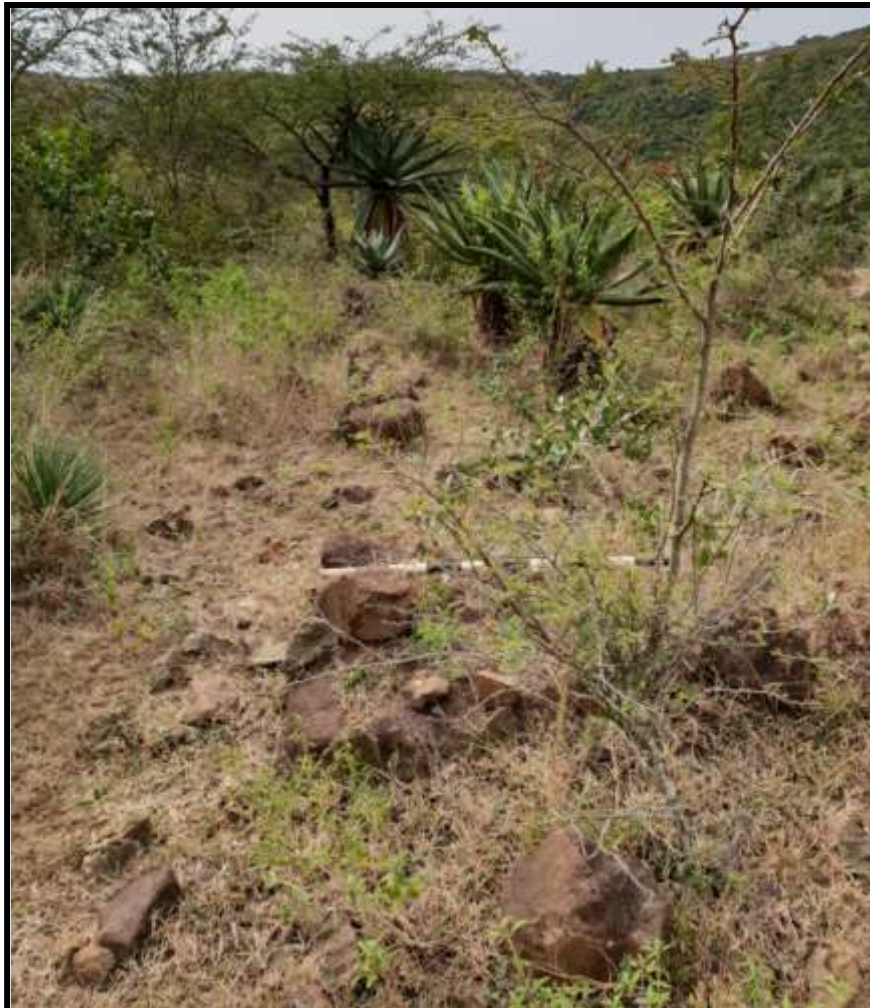
FIG. 44: KRAAL AT KHOZ581

The site is located uphill of the existing track. The site consists of a rectangular stone walled kraal (fig.44). There are many 1970s to recent bottles around the kraal area as well as a few pottery shards.

SAHRA Rating: 3C.

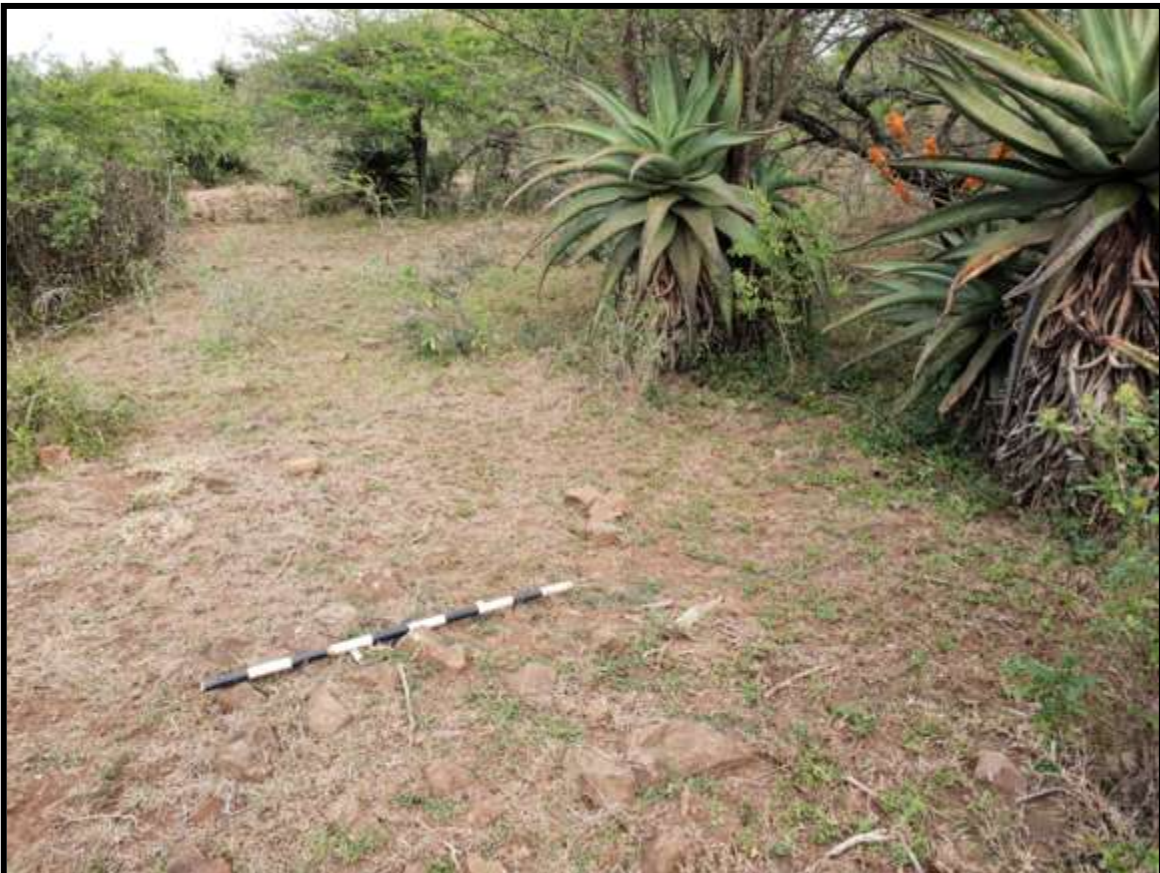
FIG. 45: GRAVES AT KHOZ582

The site is located on the northwestern side of the servitude and is probably from the same settlement of KHOZ583. The site consists of five sunken stone cairns that are graves (fig. 45). The graves post date the 1960s.

SAHRA Rating: 3A.

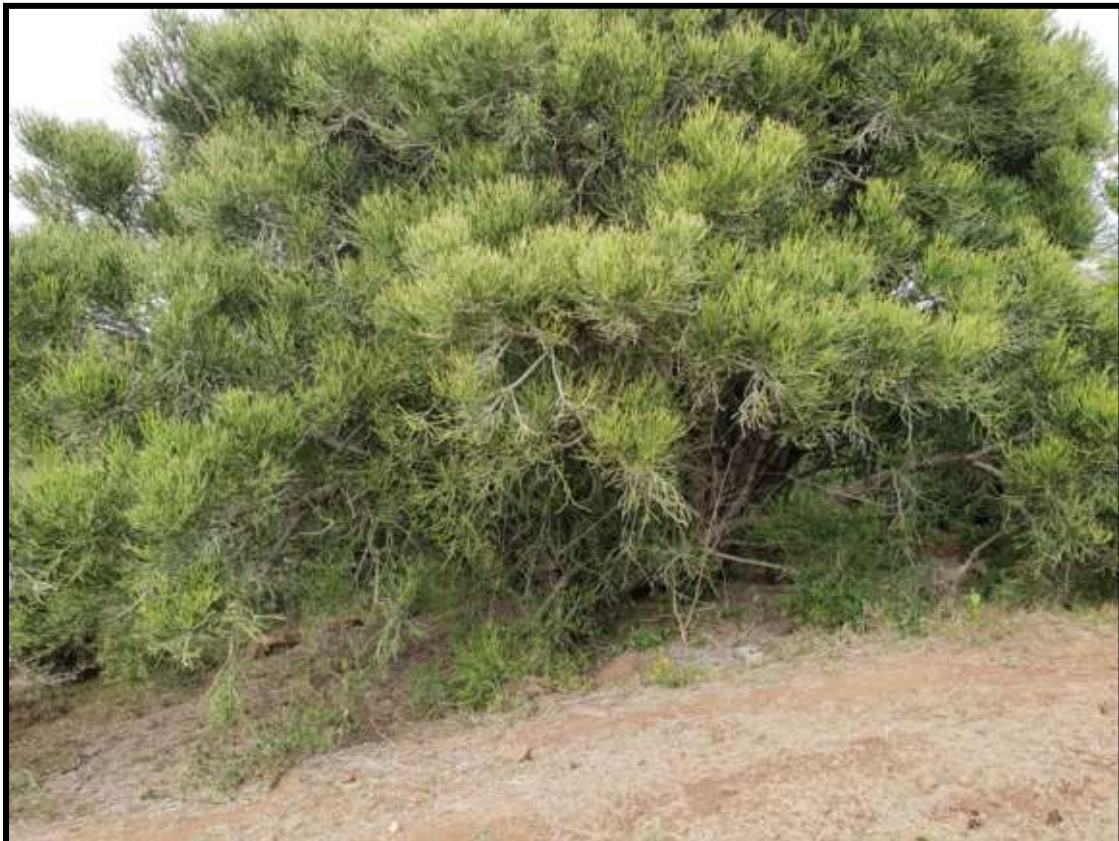
FIG. 46: TERRACING AT KHOZ583

The pipeline occurs along the northern part of the site, and will probably damage the terracing.

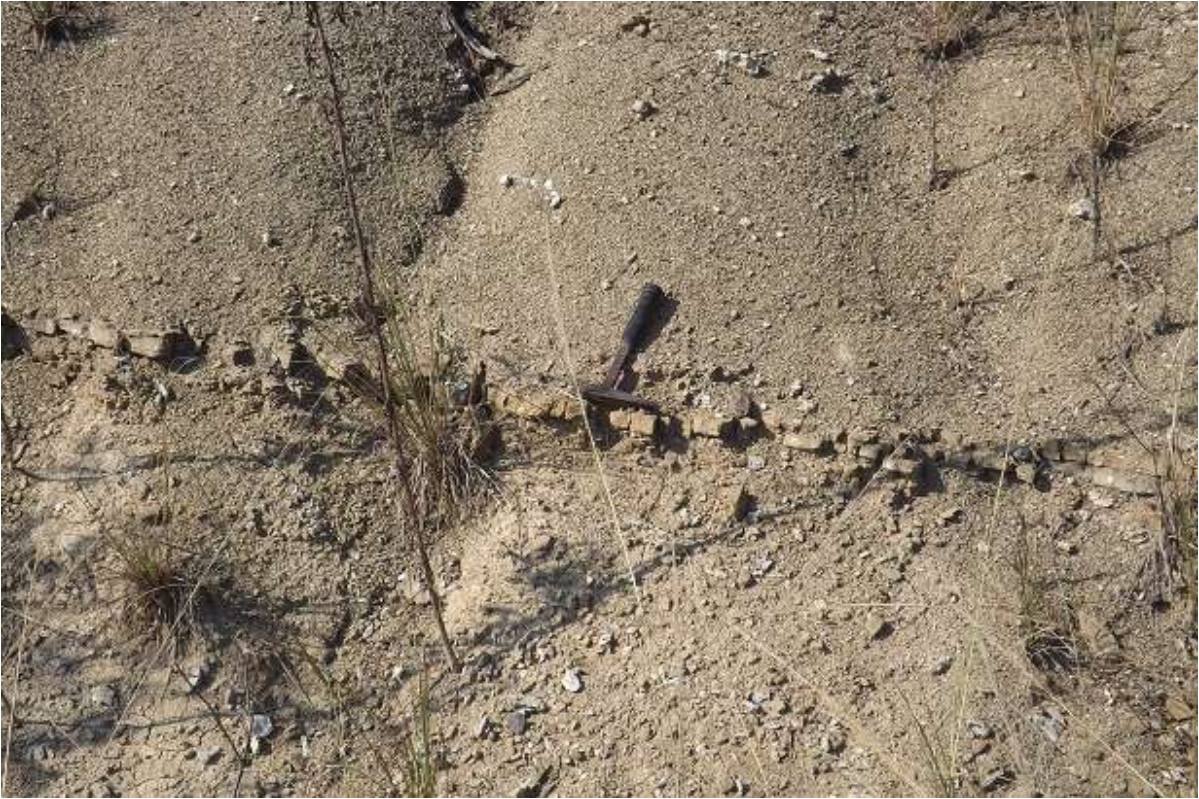
Figure 5: Nyoka Formation from station NTAM-6. This is correlated with the Elliot Formation in the Main Karoo Basin, which is known to be fossiliferous (SACS, 1980). This image comprises a red shale containing a 5cm thick sandstone bed (see hammer).

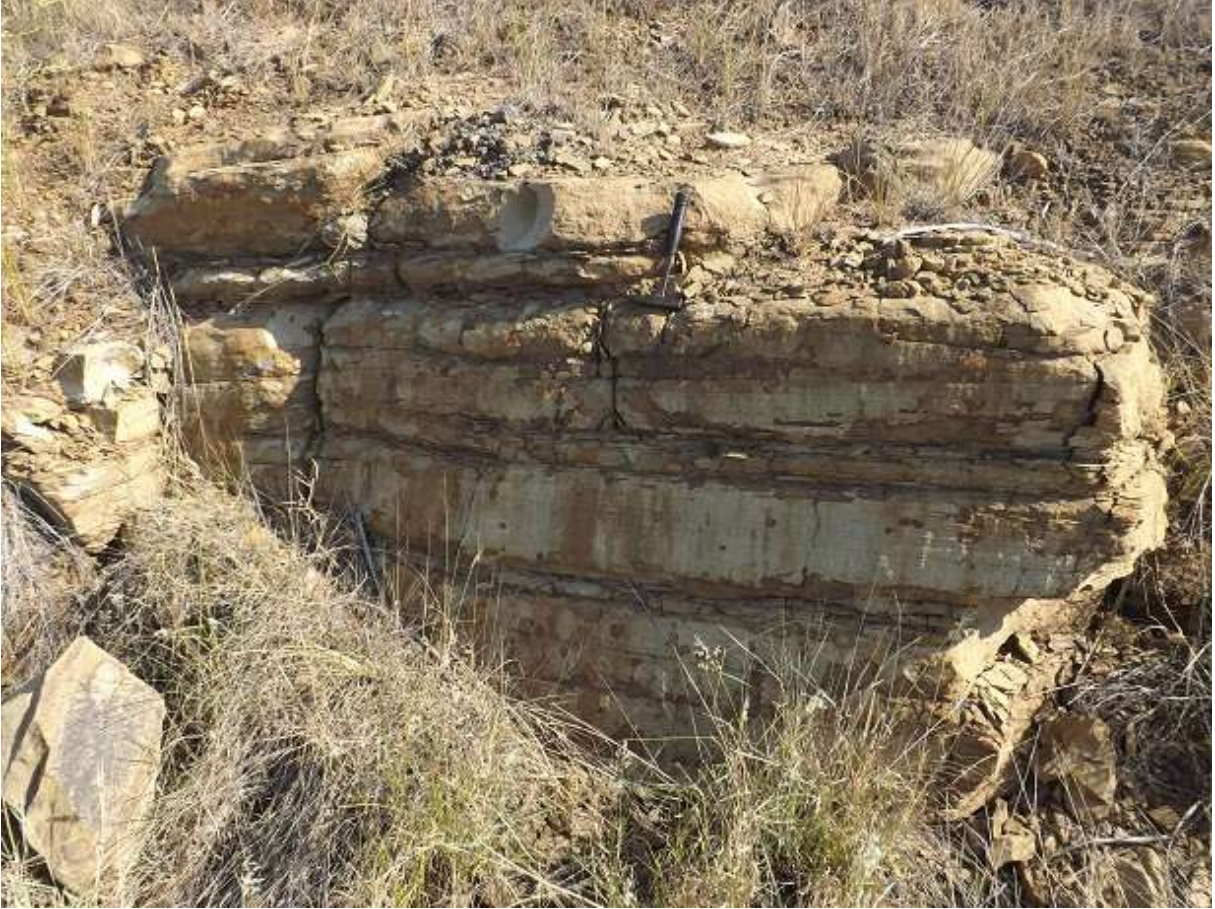
Figure 6: Ntabene Formation from station NTAM-7. This is correlated with the Molteno Formation from the Main Karoo Basin which is known to be fossiliferous. Here this is a medium-grained sandstone, with thin mud chip conglomerate layers (few cms thick). This sandstone is flat-laminated with low-angle scours and thin planar crossbeds. It is interpreted as a fluvial deposit.

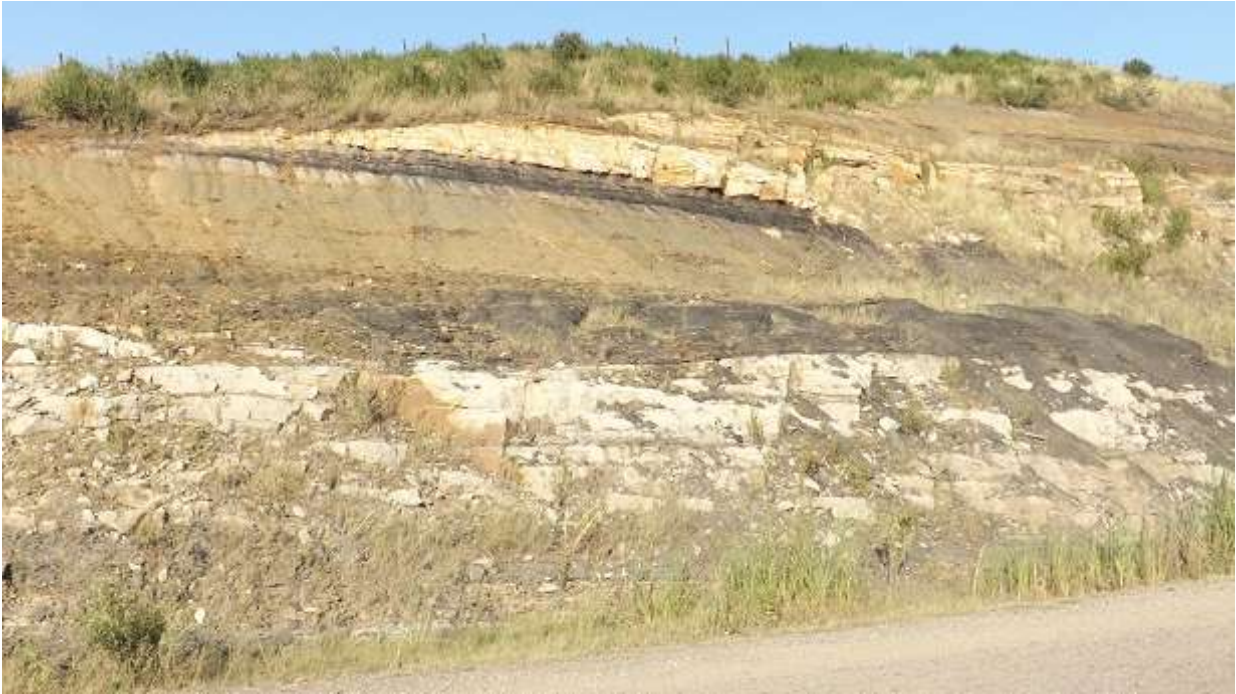
Figure 7: Emakwezini Formation from station NTAM-12. This comprises a mixture of greenish to black shale with fine-to-medium-grained sandstone and coal seams. Wave ripples with no preferred orientation and interference ripples observed.

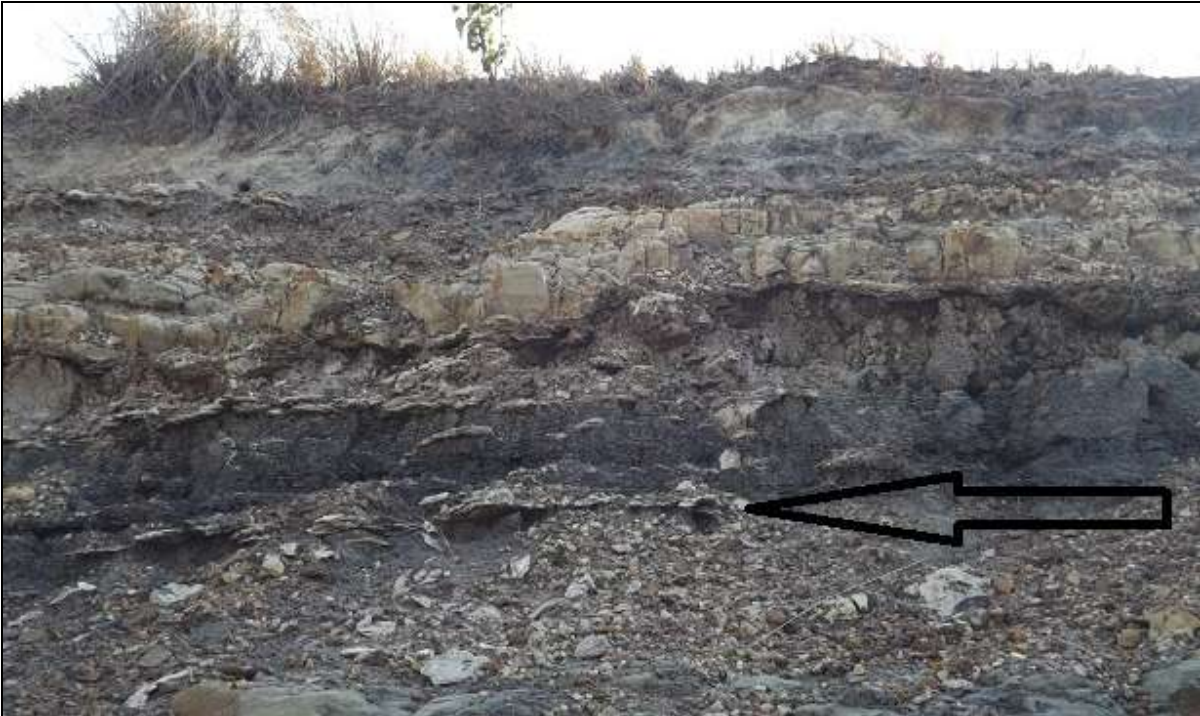
Figure 8: Emakwezini Formation containing thin coal seams and fossil wood horizons (arrowed) at station NTAM 12. Refer also Fig. 14.

The carbonate-mineralised wood found at NTAM-12 should also be inspected when this part of the pipeline trench has been dug but the rock spoil is still in place. This inspection should be centred on station NTAM – 12, but not restricted to it (see Appendix 3).

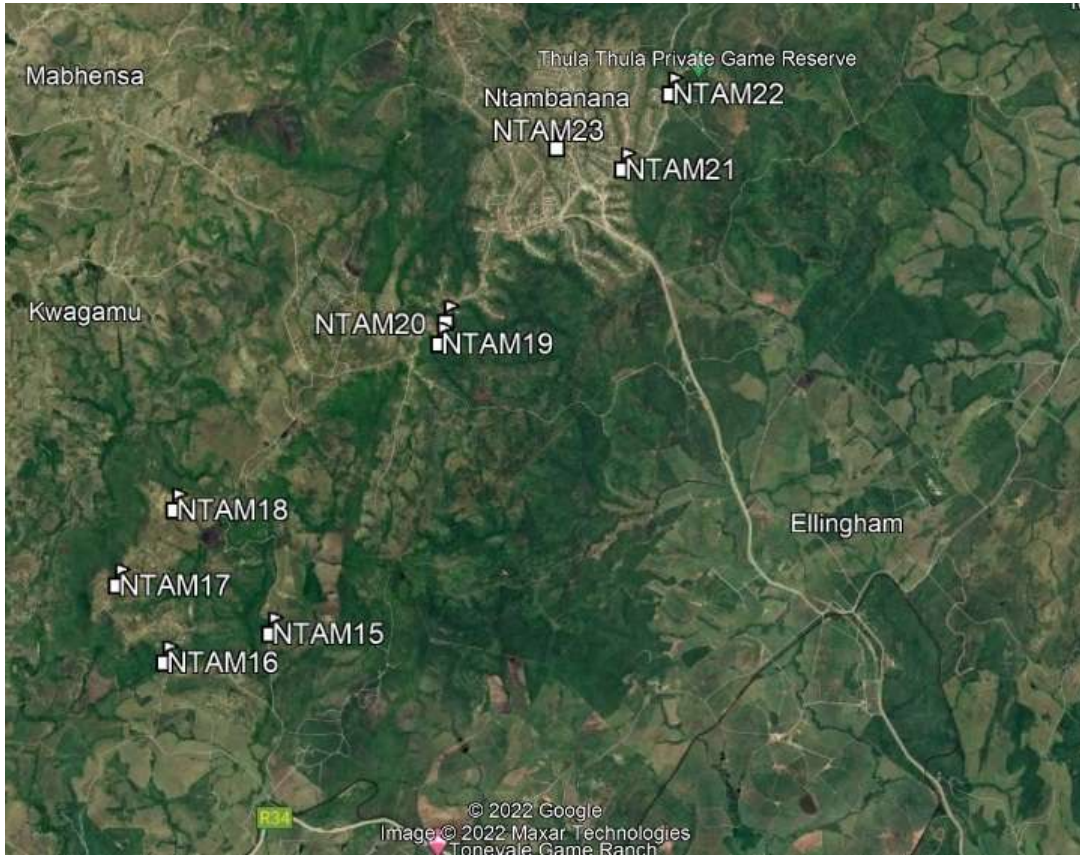
Figure 10: Day two stations visited during field visit.

The gps locations for Day 2 are illustrated in Figure 10. For the most part, the northwest pipeline reticulation (Figure 2) will be constructed almost Emakwezini Formation, which is potentially fossiliferous (Figure 11). Karoo Dolerite and Volksrust Formation may be encountered to a lesser extent.

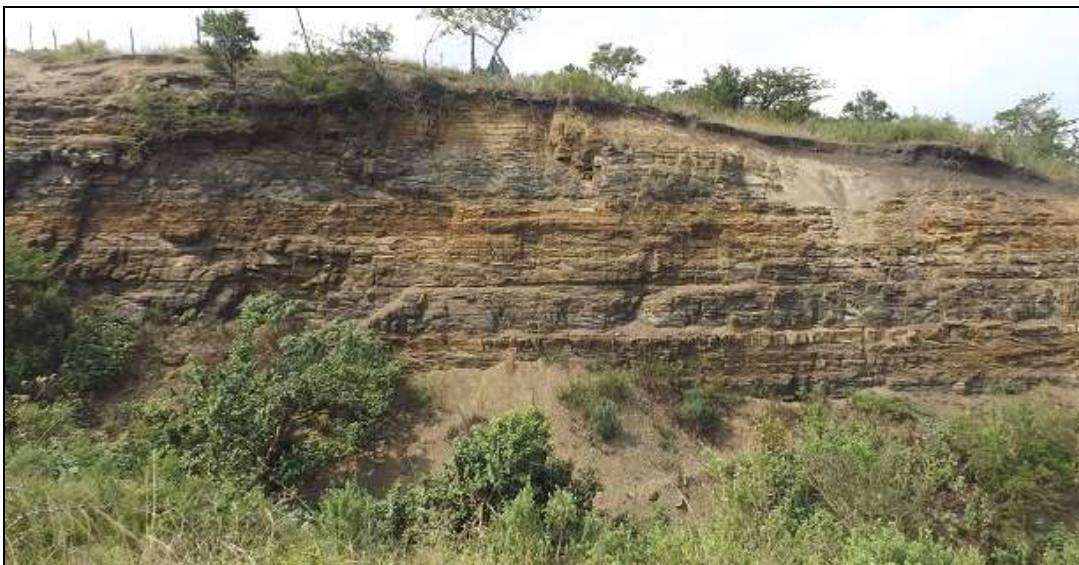
Figure 11: Emakwezini Formation exposed in borrow pit (NTAM 19). This comprises a mixture of sandstone and siltstone. No fossil evidence was found in this quarry.

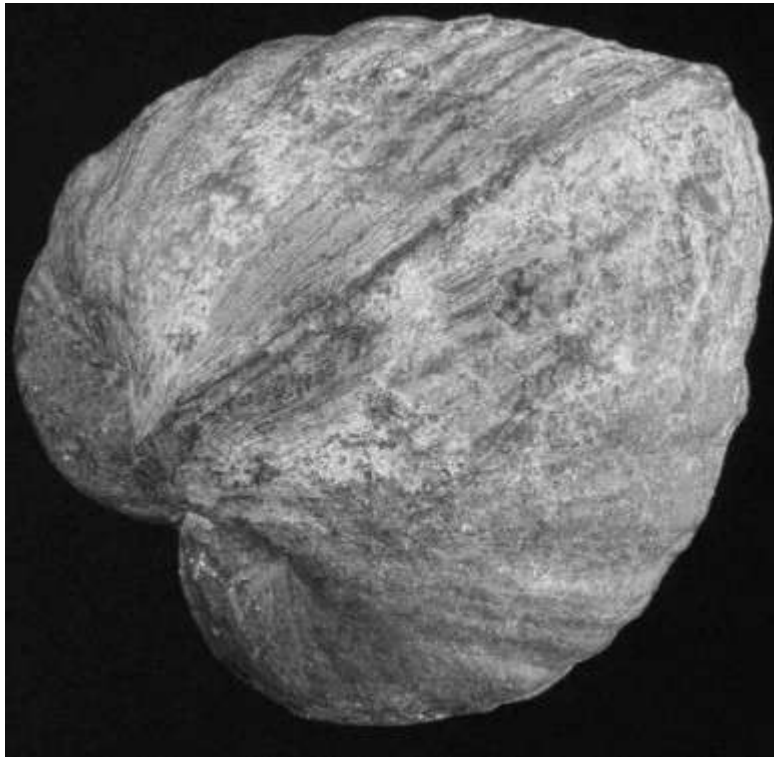
The bivalve, *Megadesmus*, has been recorded from the Volksrust Formation near Newcastle (Cairncross et al., 2005). This fossil is large, 9 cm dorsally and 8.4 cm laterally (Figure 14). *Megadesmus* is known from other parts of the Gondwana Supercontinent (Australia, India, Siberia, South America and Tasmania). Its presence indicates exclusively marine conditions. The implication for the northeastern Karoo Basin during the Late Permian is that a marine enclave still existed in this geographic area and that terrestrial conditions did not yet prevail, as in the southern basin region (Cairncross et al, 2005).

Figure 14: *Megadesmus bivalve*. This image was obtained from Cairncross et al. (2005).

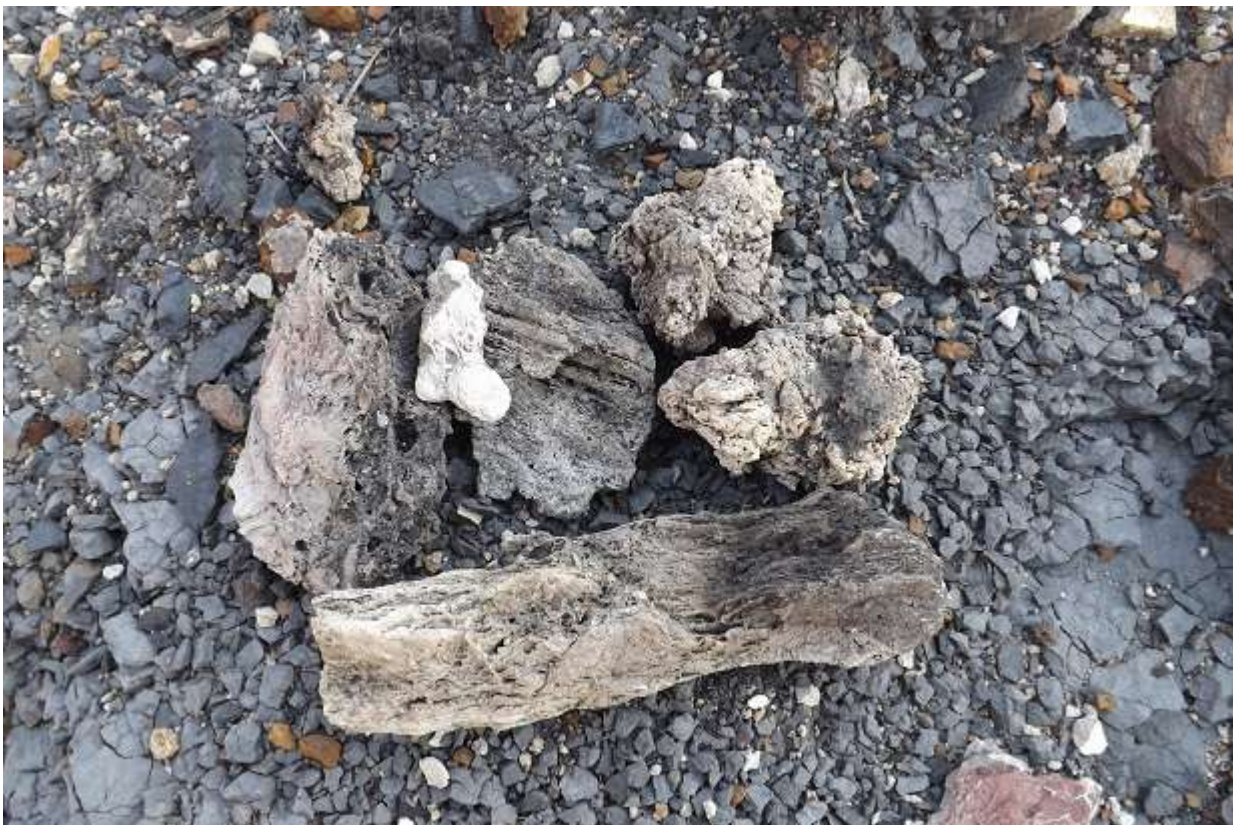
Figure 15: Examples of unidentified fossil woods from the Emakwezini Formation. They typically occur in layers a few centimetres thick (NTAM-12).

Some of these shales are calcareous. In one of these locations carbonate-mineralized plant material was found. These samples have been taken for further study. To this authors knowledge these have not been reported before. Carbonate mineralized wood is not in its

self-unusual but it has not been reported before. I recommend that a competent Palaeontologist visit this site after trenching has taken place and the spoil is still on site.

It is a further recommendation of this report that the carbonate mineralized wood material be further investigated by suitably qualified palaeontologist. This visit should take place when trenching has taken place and the rock spoil still in place.

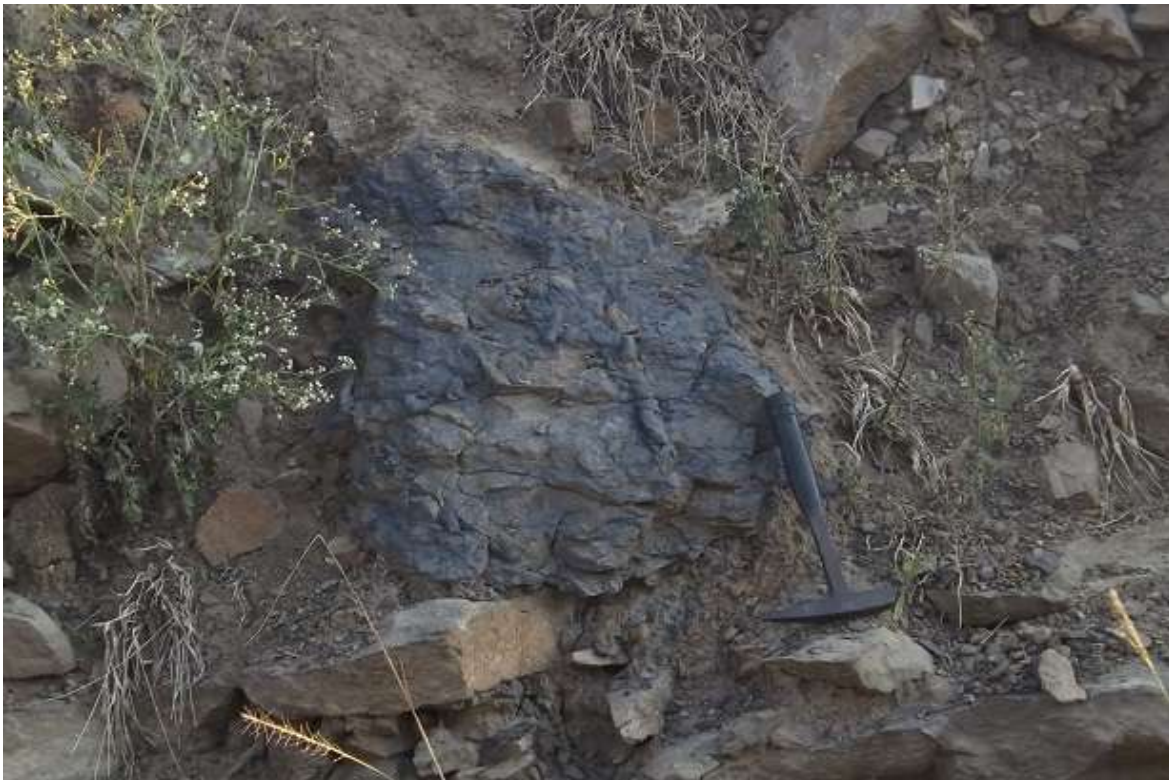
Plant stem impressions were also observed in mudstone of the Emakwezini Formation (Figure 16). These fossils are usually bedding-plane parallel. While these are interesting they are common and not Palaeontologically significant.

Figure 16: Note the imprint of stem parallel to (and to the left of) the rockpick in this Emakwezini Formation rock (NTAM-13).

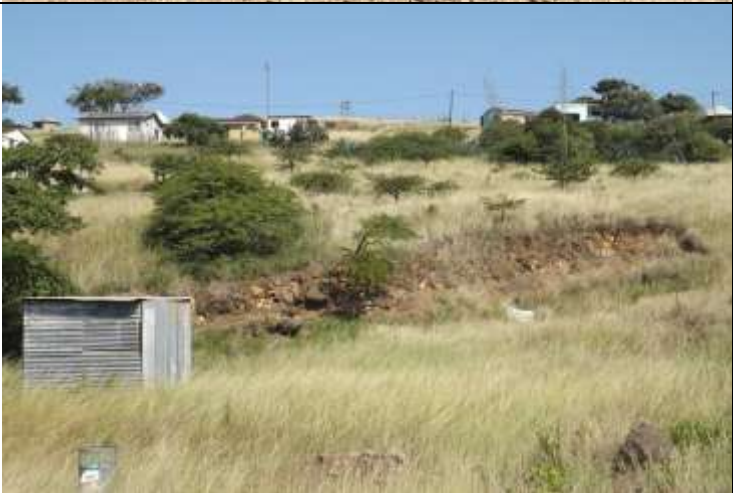
2	Letaba Fm, this comprises basalts which are highly weathered.

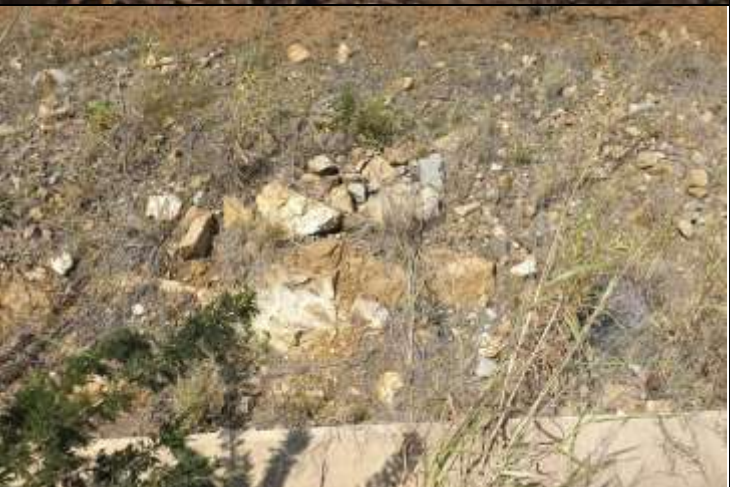
5	Letaba Fm basalt exposed along the roadside. White colour is due to weathering.

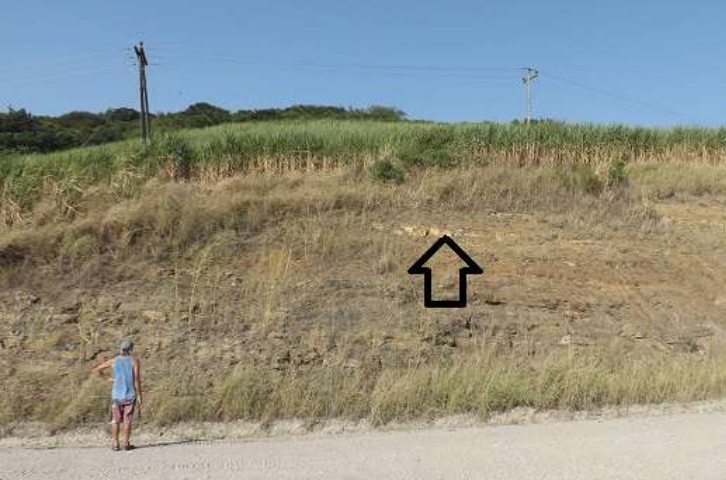
9	Ntabene Fm (above arrow) and Emakwezini Fm (below arrow).

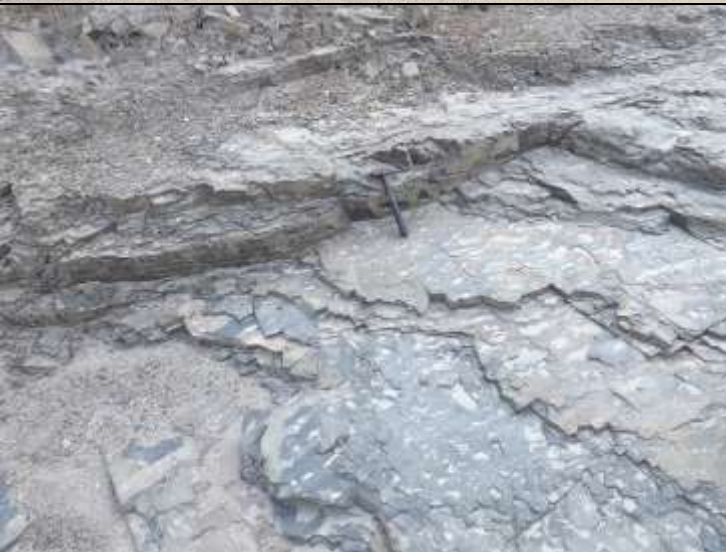
10	Emakwezini Fm, note the bedding and wave ripples. See also Figure 7 in report.

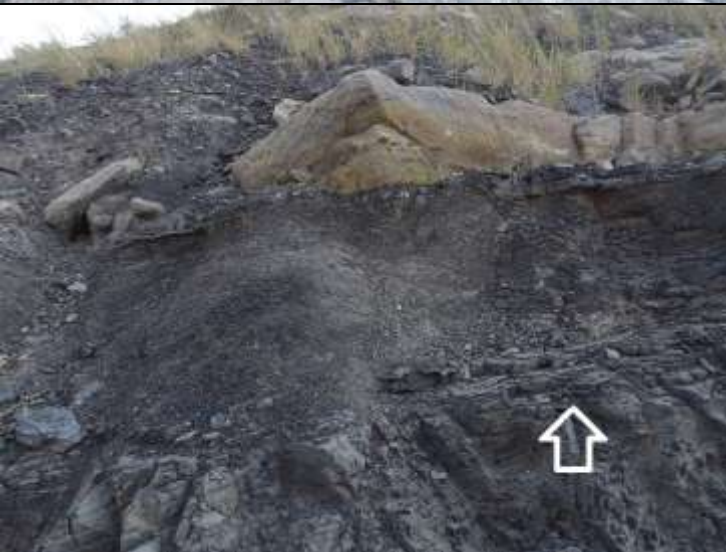
11	Emakwezini Fm, note the thin coal seam arrowed.
