**AN ARCHAEOLOGICAL WALKTHROUGH SURVEY OF THE FINAL OPTIMISED LAYOUT OF THE AUTHORISED NXUBA WIND FARM NEAR COOKHOUSE, BLUE CRANE ROUTE LOCAL MUNICIPALITY, SARAH BAARTMAN DISTRICT MUNICIPALITY, EASTERN CAPE PROVINCE.**

**Date:** July 2015

**Note:** This report follows the minimum standard guidelines required by the South African Heritage Resources Agency for compiling Archaeological Phase 1 Impact Assessment (AIA) reports and forms part of an Environmental Impact Assessment.

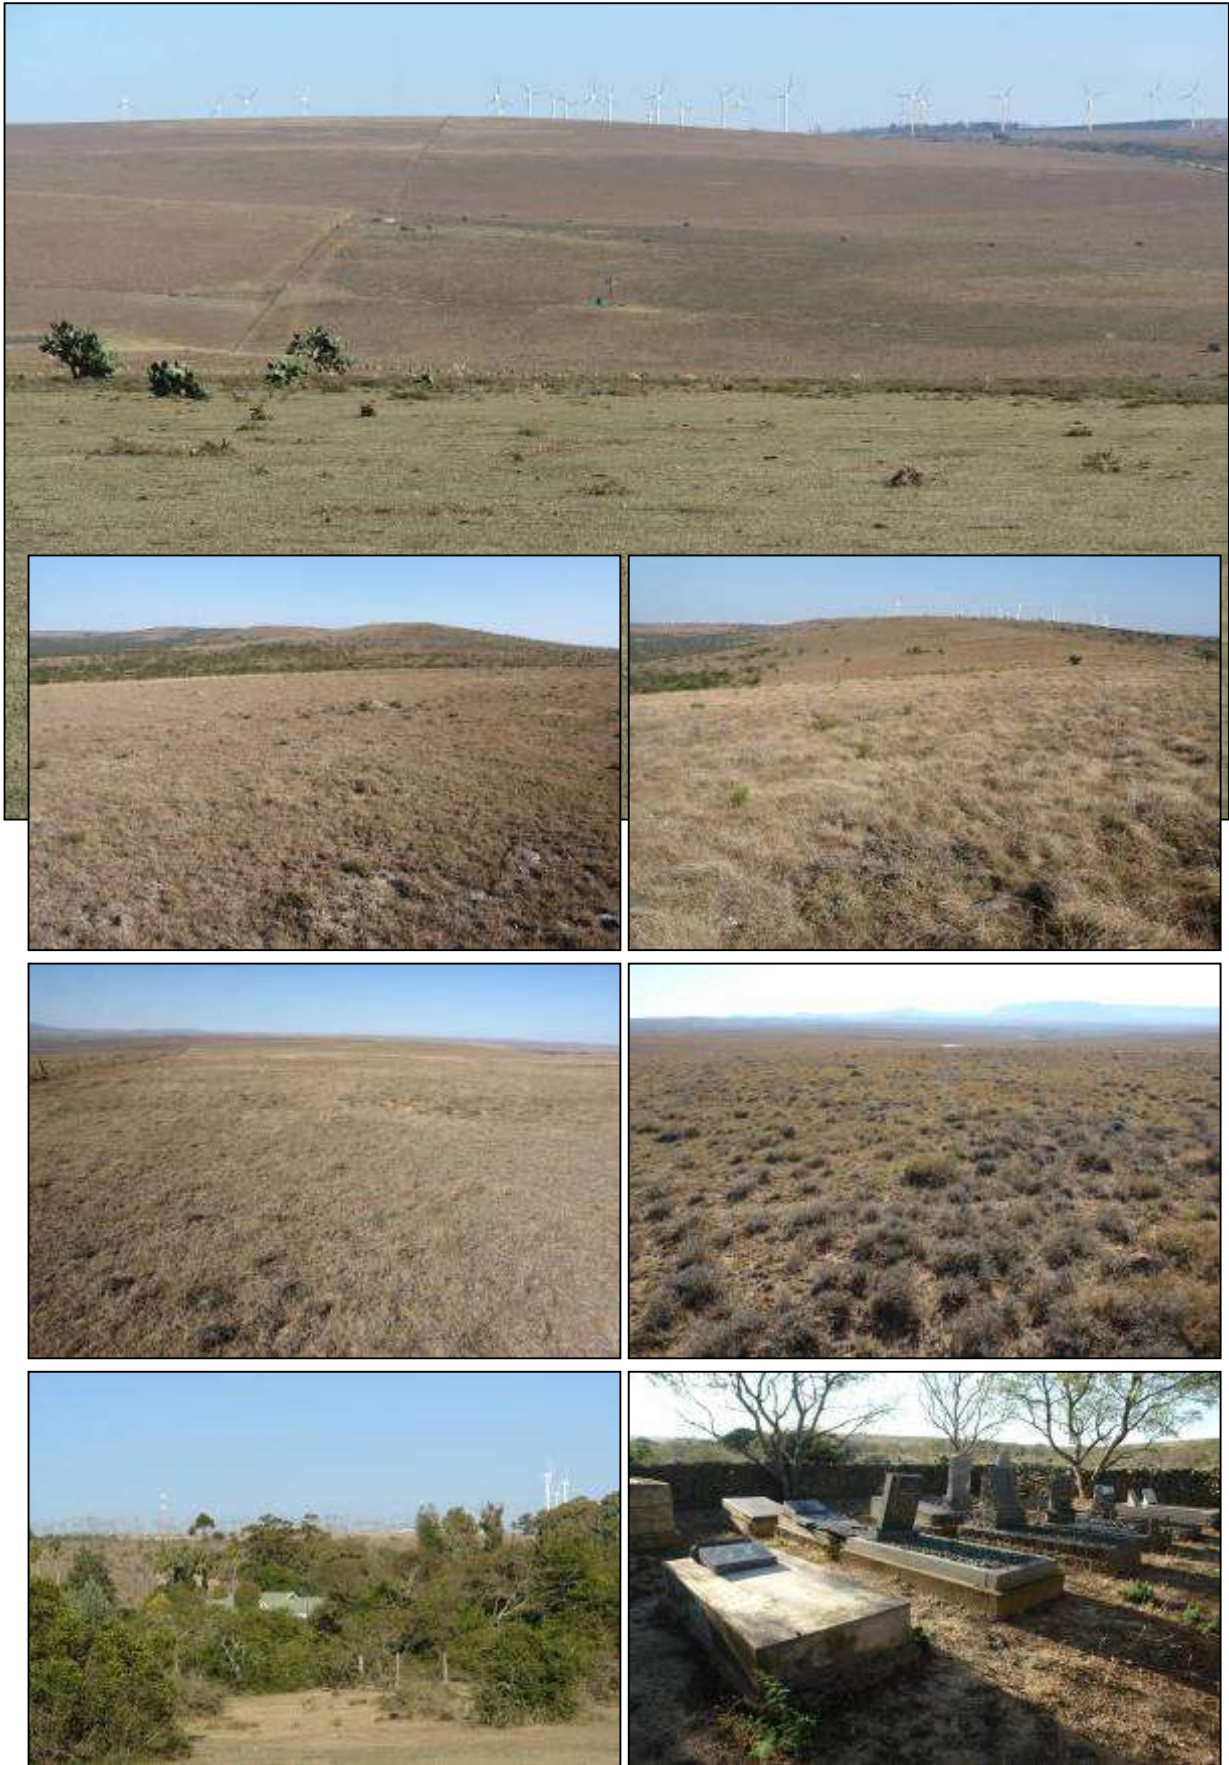
**Figure 1. General views of the Nxuba Wind Farm site and the historical homestead and graveyard (bottom row).**

4. Although the development is well-removed from the historical Van Wyks Kraal homestead and graveyard (which date from 1805), care must be taken that no damage occur to these buildings and features. It must be listed as a 'no-go zone'.

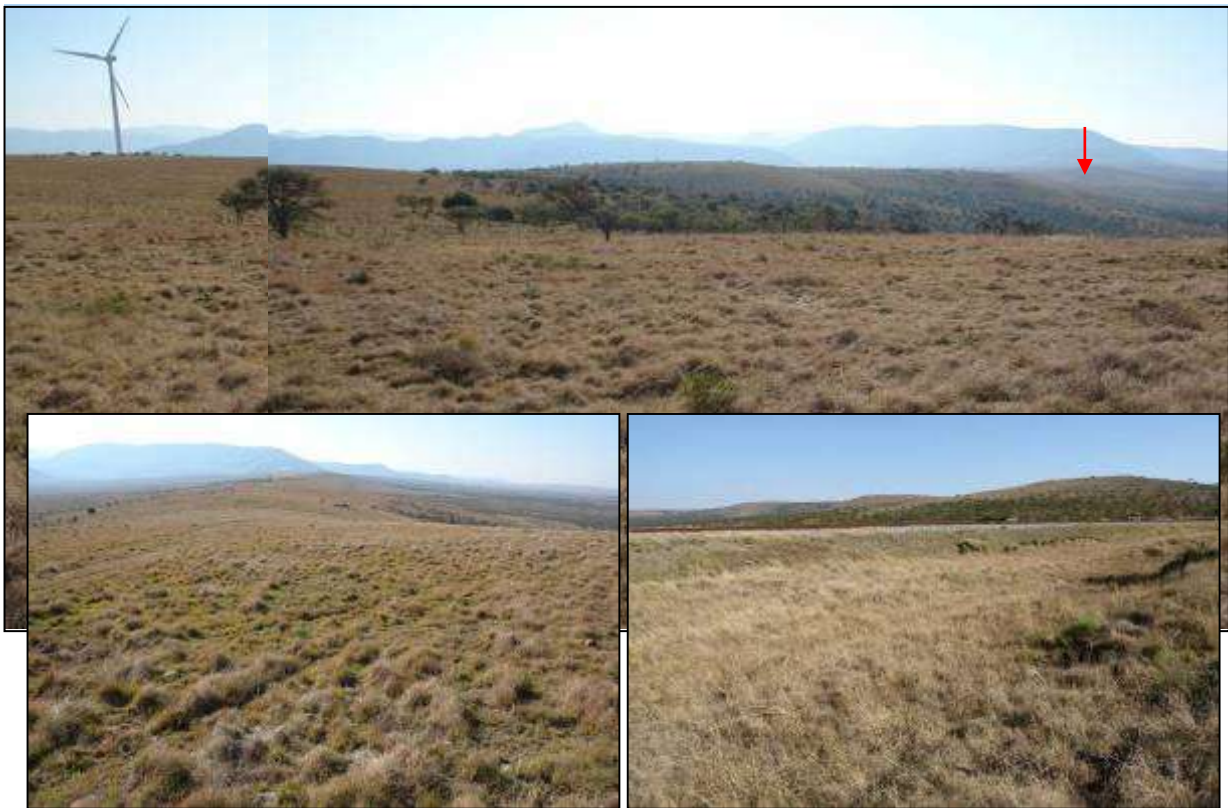
**Figure 2.** A view from Point B towards turbine positions 011 - 01 (main image), from 06 to 01 (left insert) and a reverse view from near 02/railway line to Point B (right insert). The red arrow marks turbine position 01.

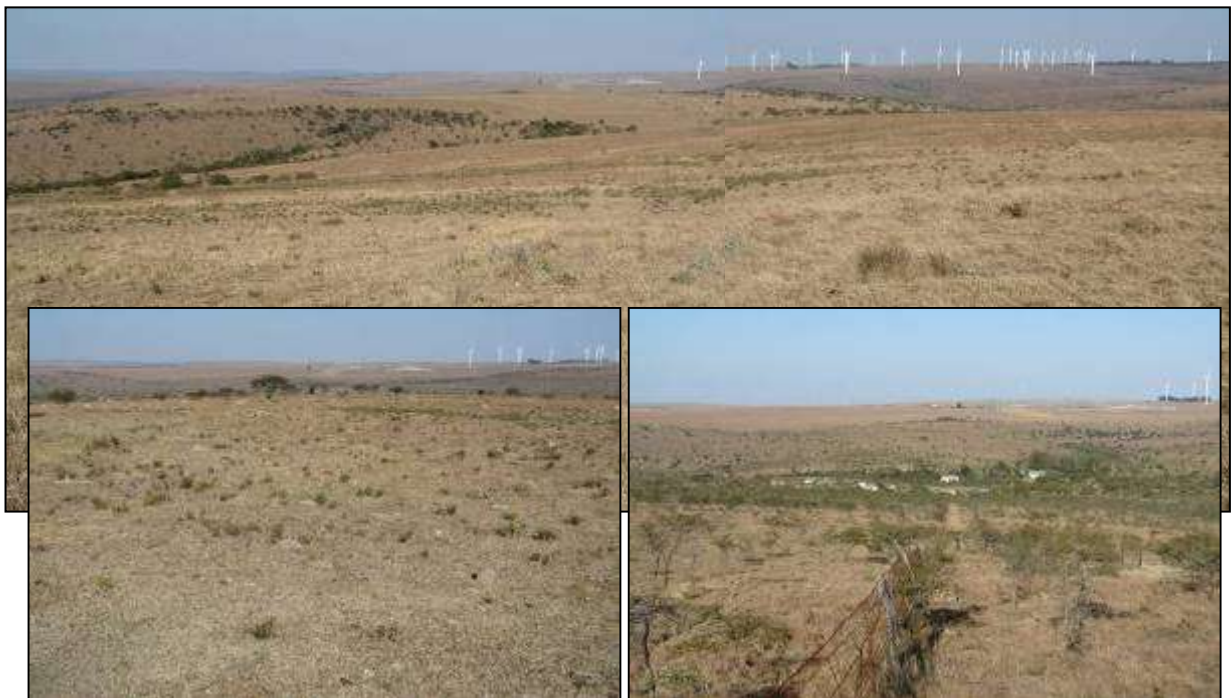
**Figure 3. A view from Point B towards turbine positions 012-020 (main image and left insert) and a view from 020 towards 021 to 022 (right insert). The historical farmyard is visible in the background and the Poseidon Substation on the horizon.**

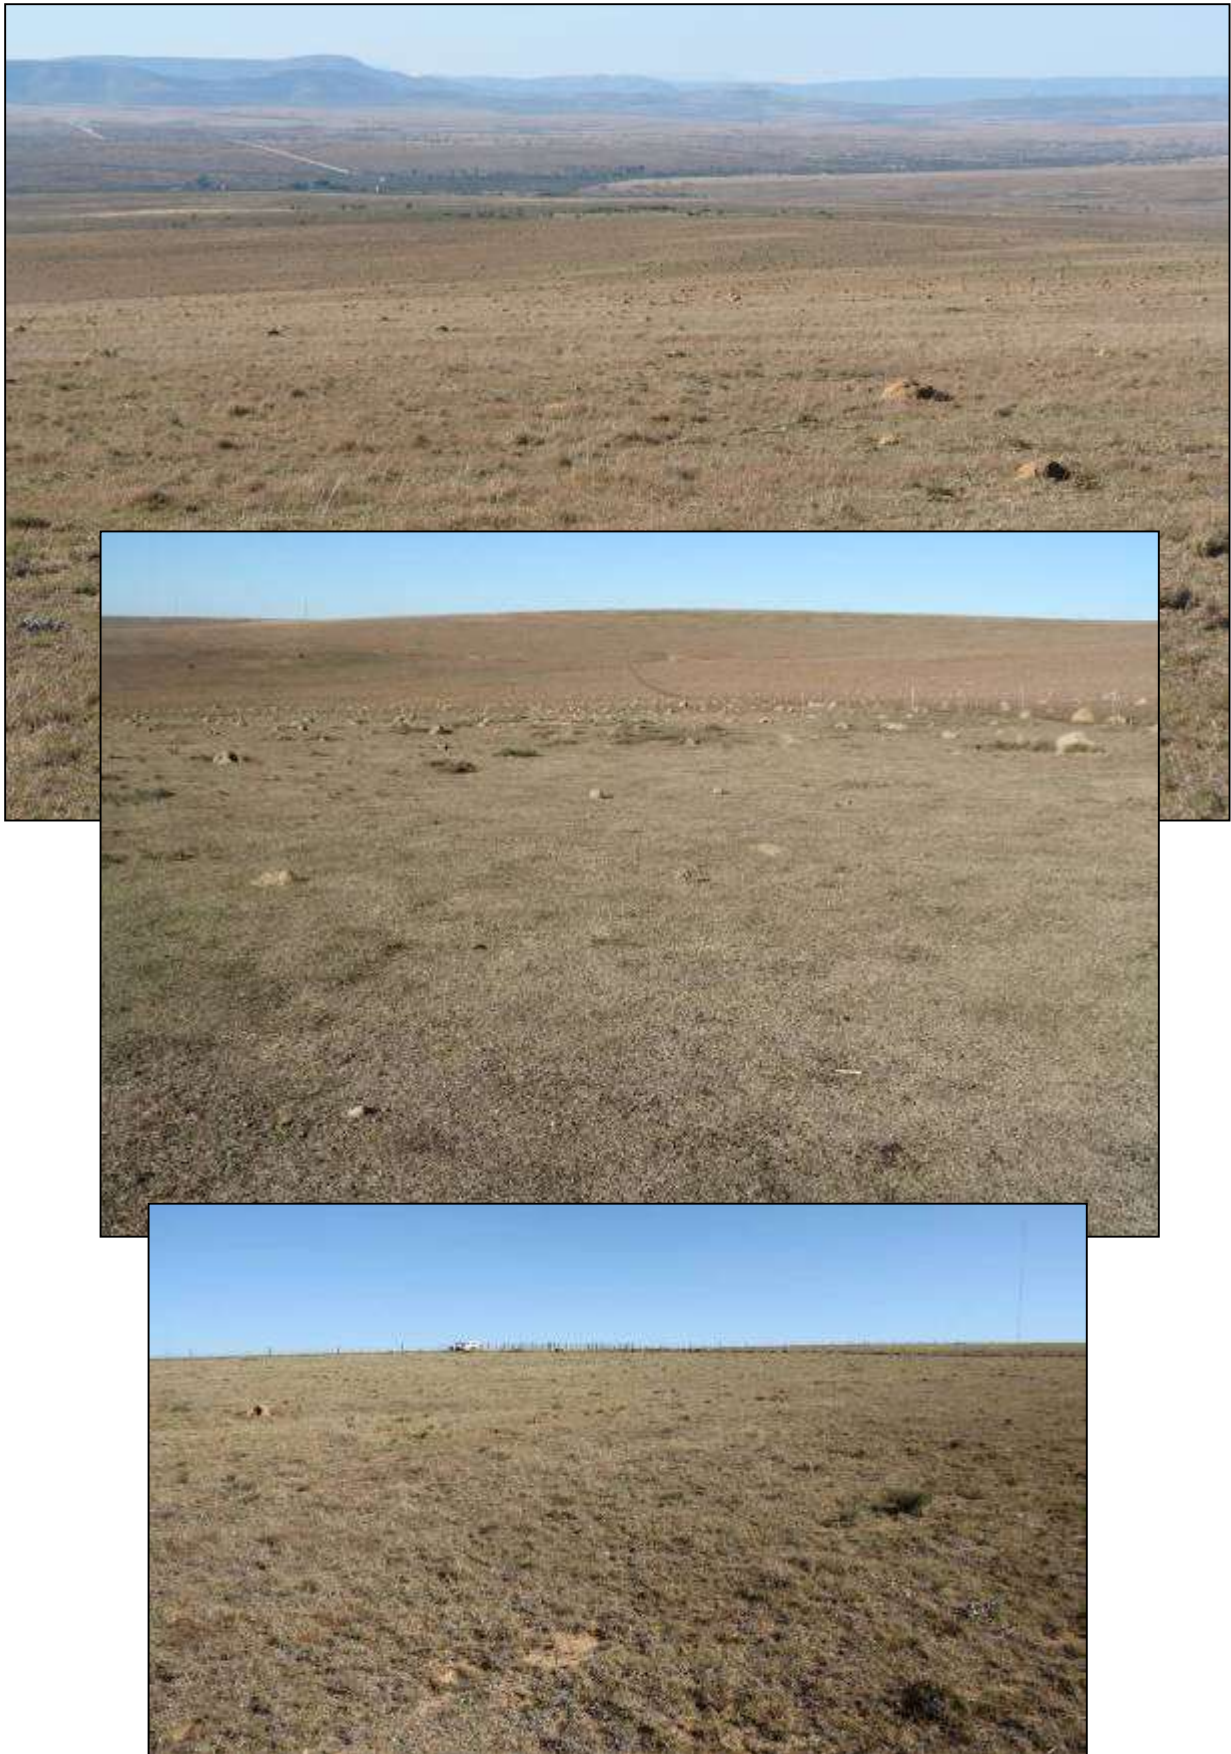
**Figure 5. A view from turbine position 028 towards positions 029-033 (main image), a reverse view from 032 toward turbine positions 031-28 (middle insert) and 029 to 027 (bottom insert).**

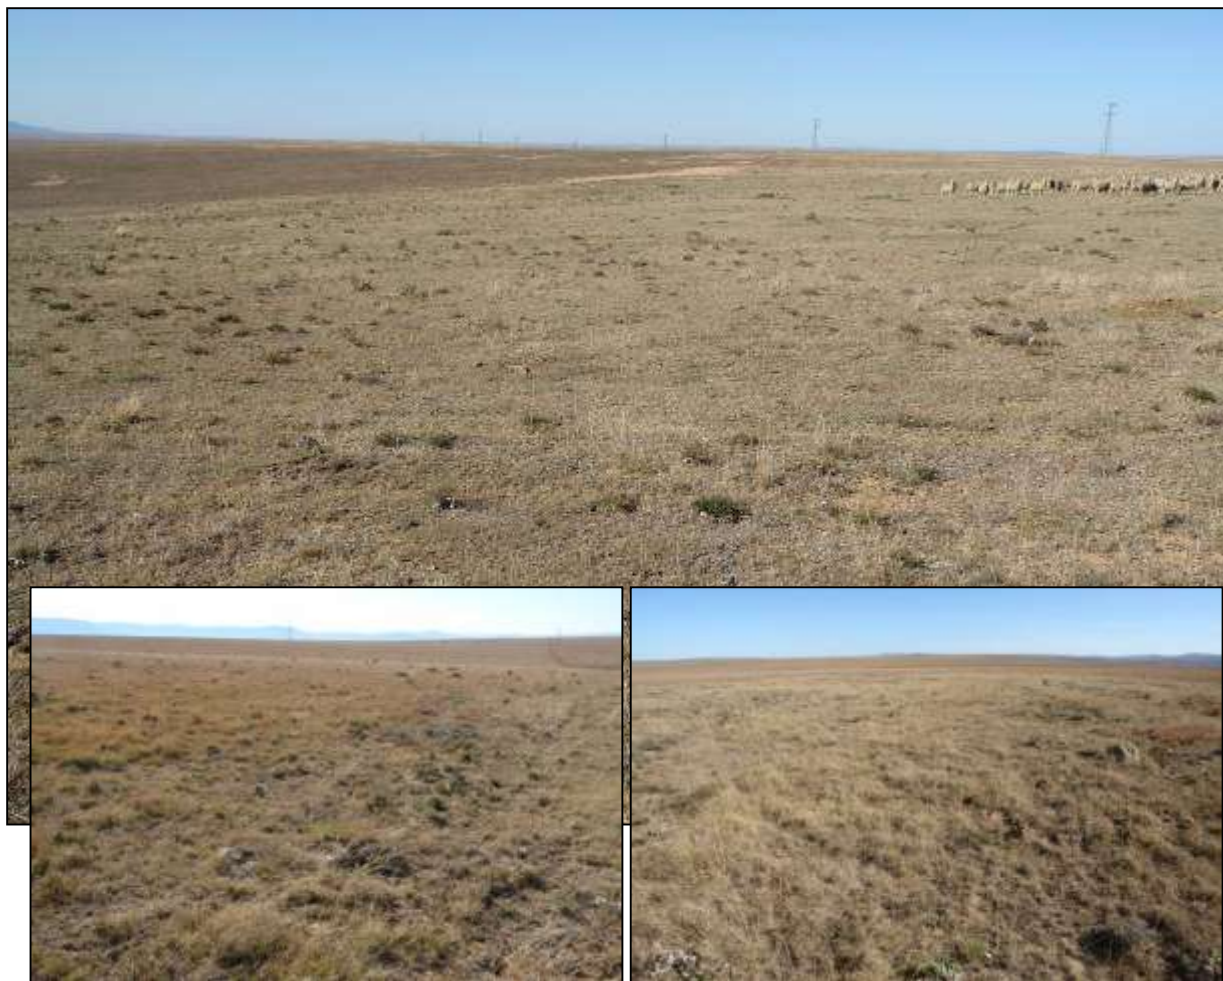
**Figure 7. A view from turbine position 037 towards positions 040-043 (main image), 038-047 (left insert) and a reverse view from position 047 towards 039 (right insert).**

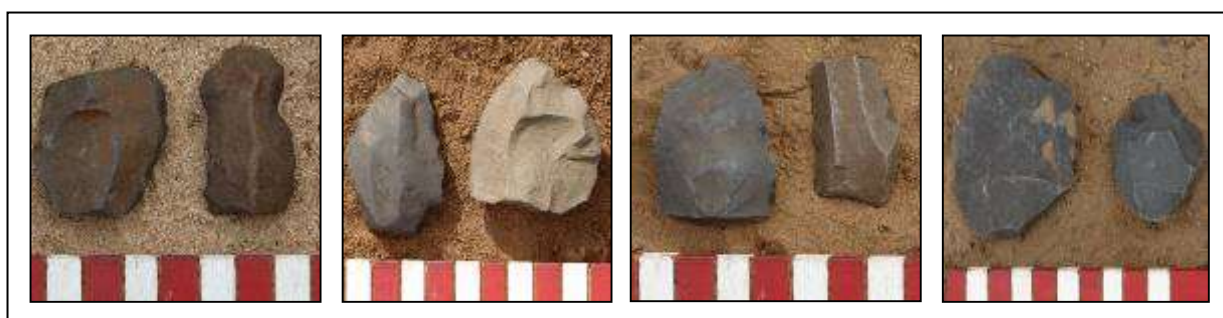
Apart from a few isolated weathered Middle Stone Age stone tools observed in vehicle tracks (Figure 8), no other significant archaeological sites/materials were observed during the walkthrough. The tools, mainly flakes with typical faceted striking platforms, date between 250 000 – 30 000 years old and were manufactured on hornfels. They were in secondary context and not associated with any other archaeological material and of **low** cultural significance. No further action is required.

**Figure 8. An sample of the few Middle Stone Age stone tools observed during the walkthrough in the layout zones.**
