**ARCHAEOLOGICAL IMPACT ASSESSMENT REPORT**

**INVESTIGATIONS FOR THE PROPOSED CONSTRUCTION OF A WATER  
STORAGE FACILITY IN THE MEULSPRUIT NEAR ROSENDAL AS  
WELL AS THE WATER PIPELINE TO SENEKAL WITHIN THE THABO  
MOFUTSANYANE DISTRICT OF FREE STATE PROVINCE**

**SEPTEMBER 2011**

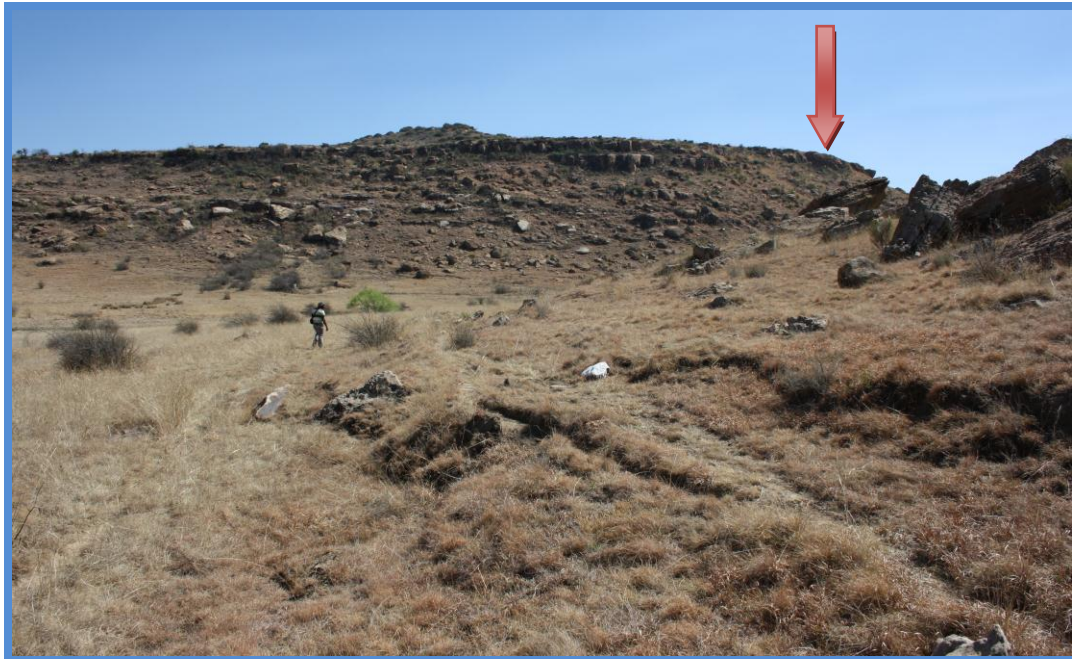
**Figure 1:** View of the Meulspruit gorge (Morgenzon123 farm) where the proposed dam wall will be constructed indicated by an arrow located in between sandstone rocky outcrop area (GPS S28°.54071 & E 27°.87552).

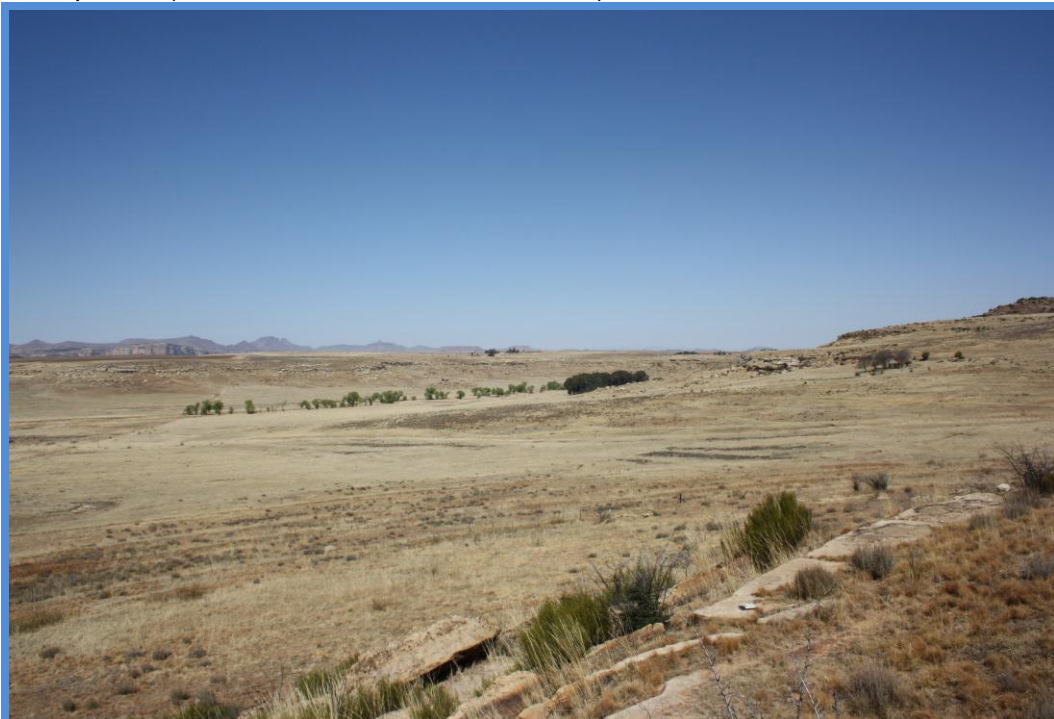
**Figure 2:** View of the proposed dam basin towards the southern section

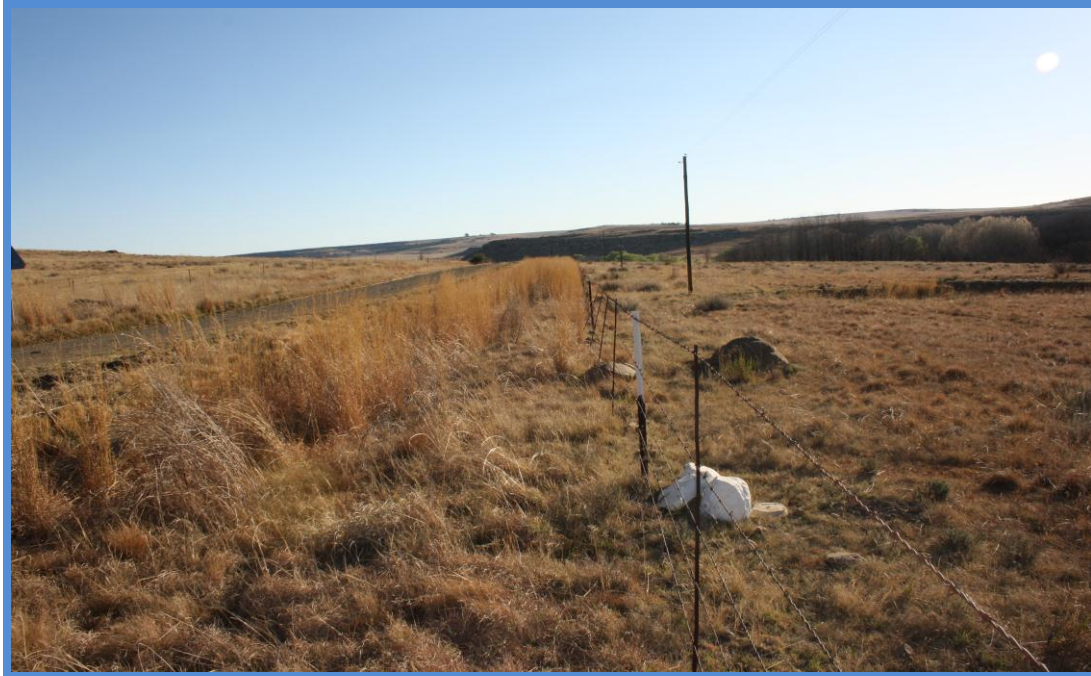
**Figure 3:** The proposed pipeline route has been marked, indicated by white washed stones north of the gravel road parallel the farm fence boundary.

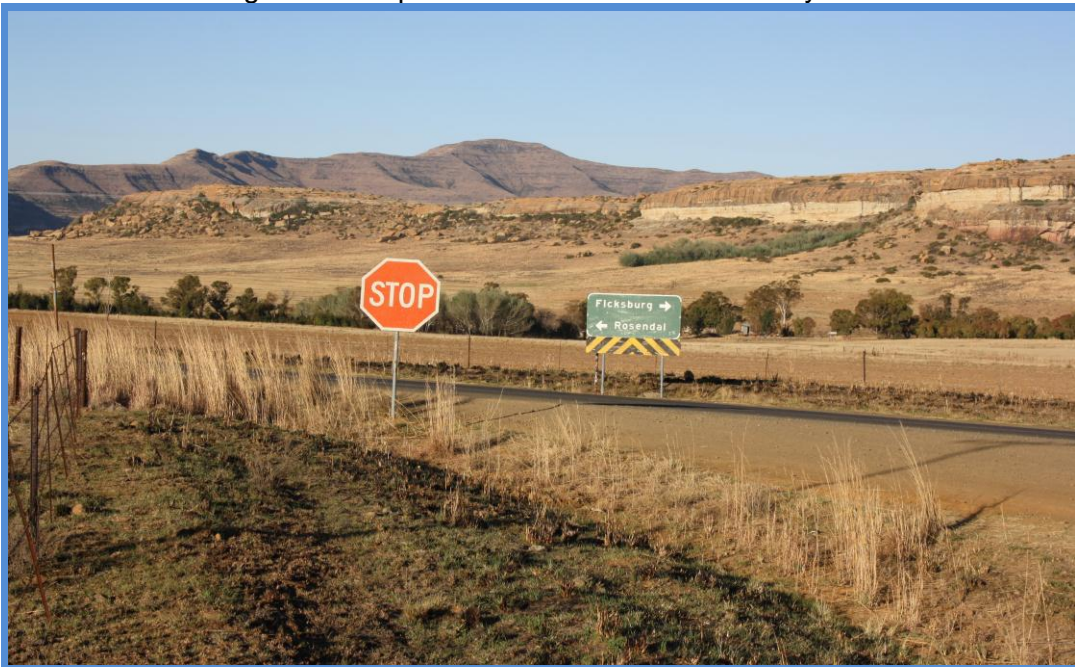
**Figure 4:** View of the main tarred road and gravel intersection at a distance R70 from Rosendal to Ficksburg, the proposed pipeline have been earmarked parallel the tarred road still on the inside of the farm boundary fence.

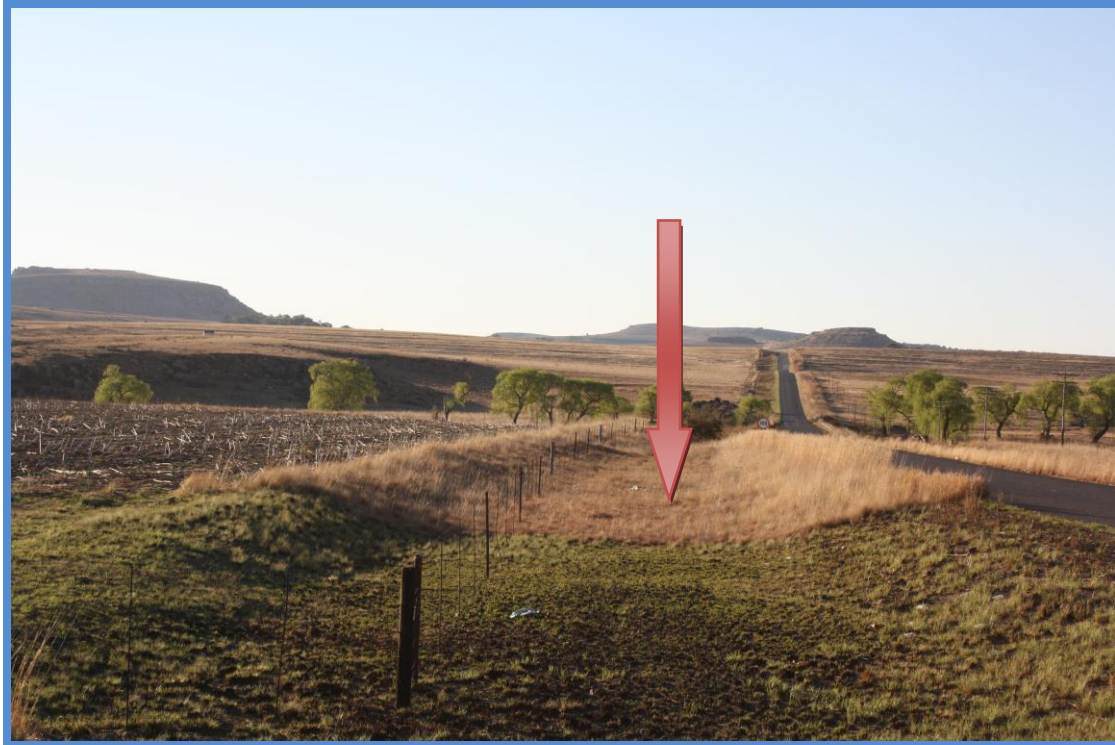
**Figure 5:** The proposed pipeline route along the R70 from Rosendal to Senekal.

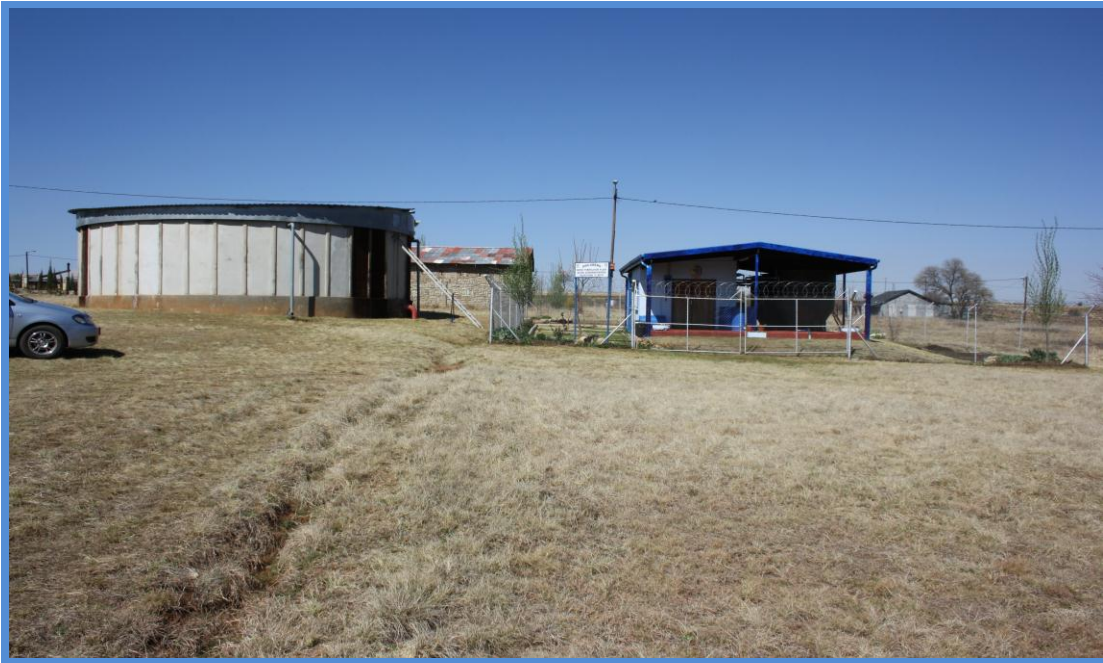
**Figure 6:** View of Rosendal water purification plant characterized by concrete reservoirs and water treatment house.

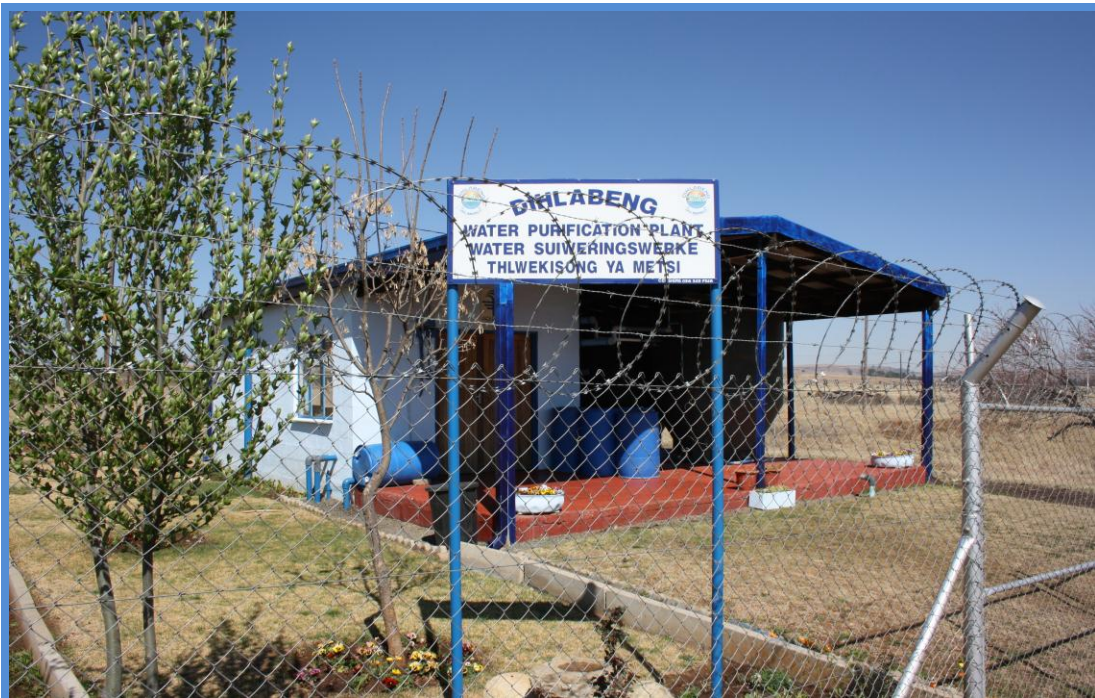
**Figure 7:** View of the existing water treatment plant

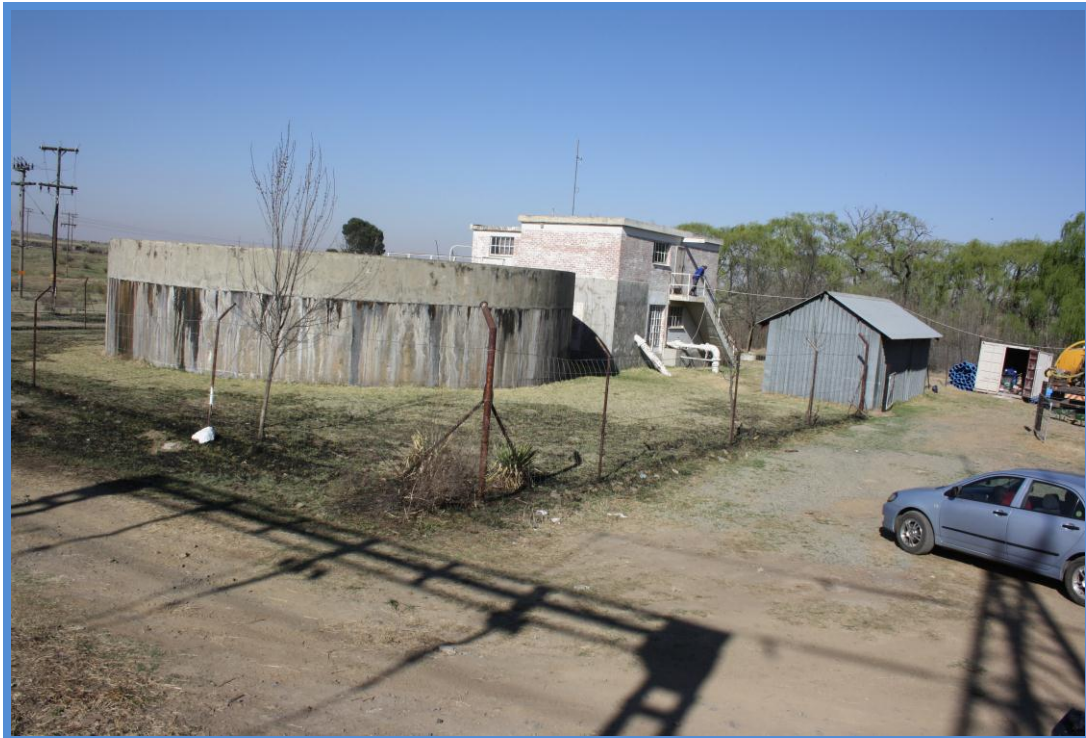
The Senekal Water Treatment Works is located south of the Senekal Central Business District (CBD); the area is located in close proximity to Senekal industrial site located on farm De punt. The area is situated western section adjacent to Eskom power substation, characterized by a single story building with one concrete reservoir and galvanized store

**Figure 8:** View of the Senekal water treatment plant, the area is located at Senekal industrial site.

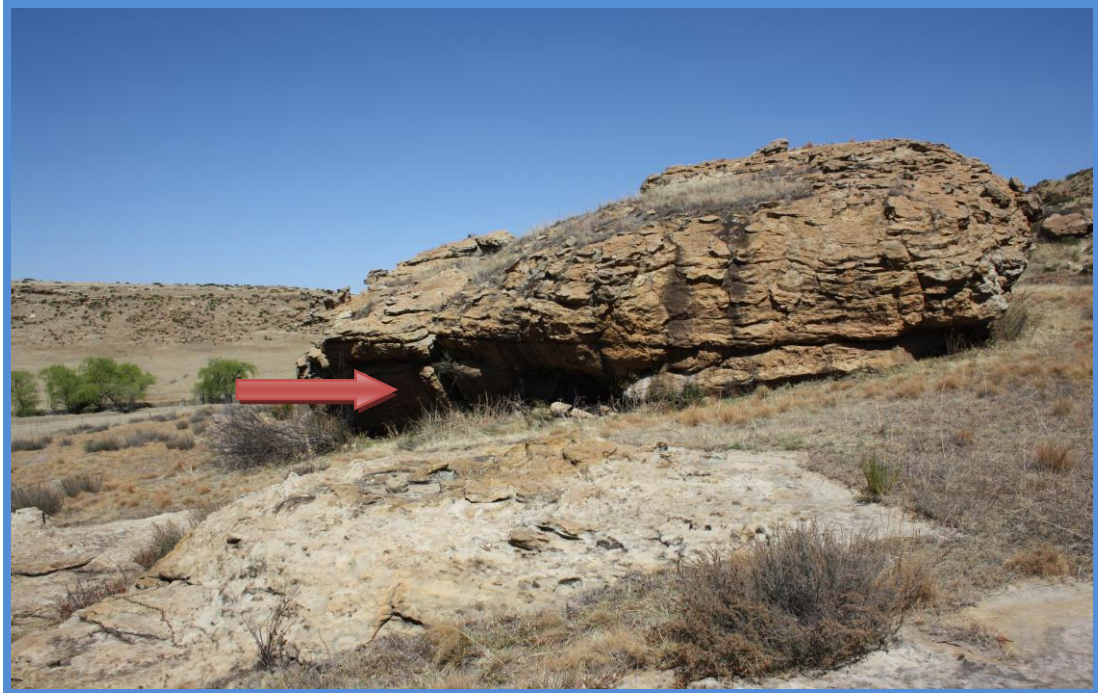
The site is characterized by shelter with dilapidated remains of stone walling. The stone walling covers approximately 1metres long, constructed in a half circular form forming an

enclosure against the rock boulder. No associated cultural remains such as potsherds, rock paintings or historical artifacts were noted on the surface of the vicinity

**Plate 01:** Sandstone boulder where a rock shelter with dilapidated stone wall enclosure has been noted.

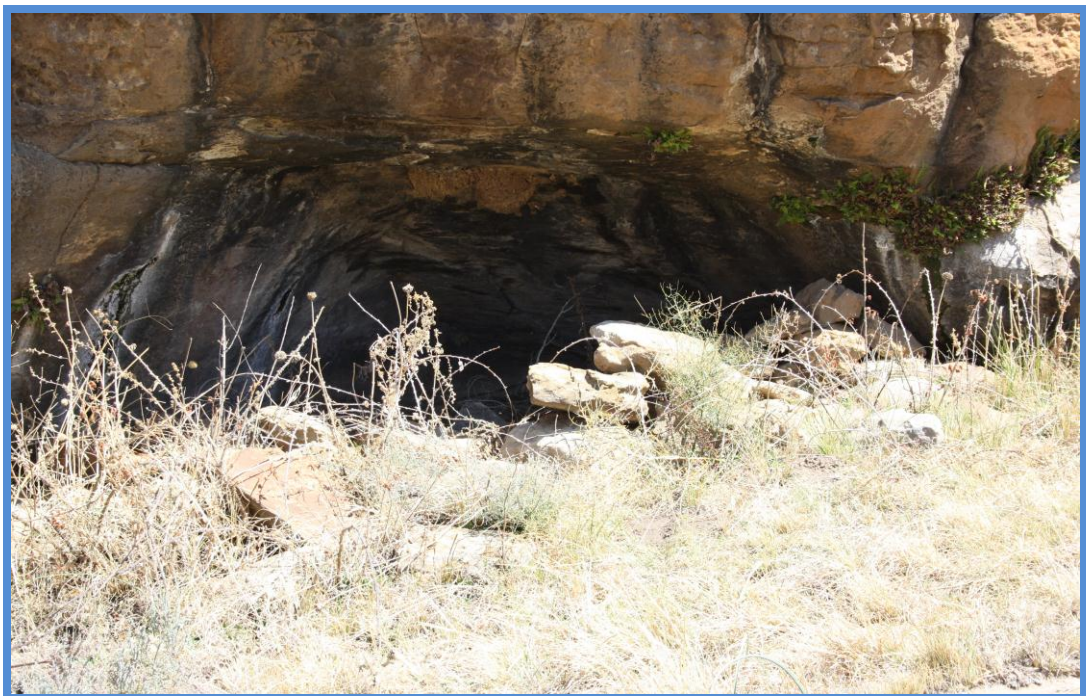
**Plate 02:** Rock shelter with section of the dilapidated stone wall enclosure.

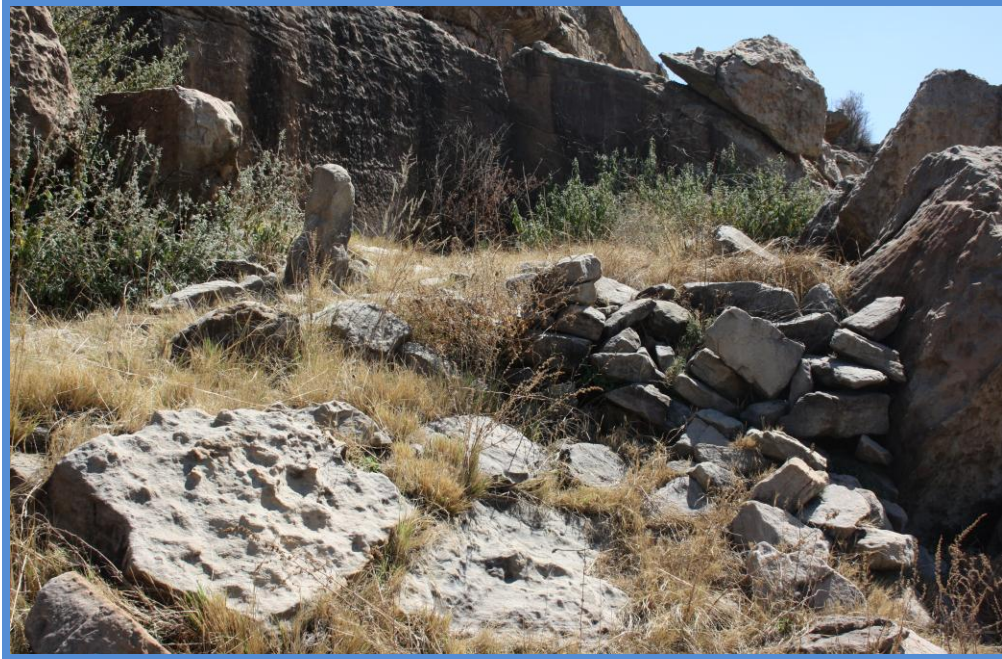
**Plate 03:** View of the section of the collapsed stone wall

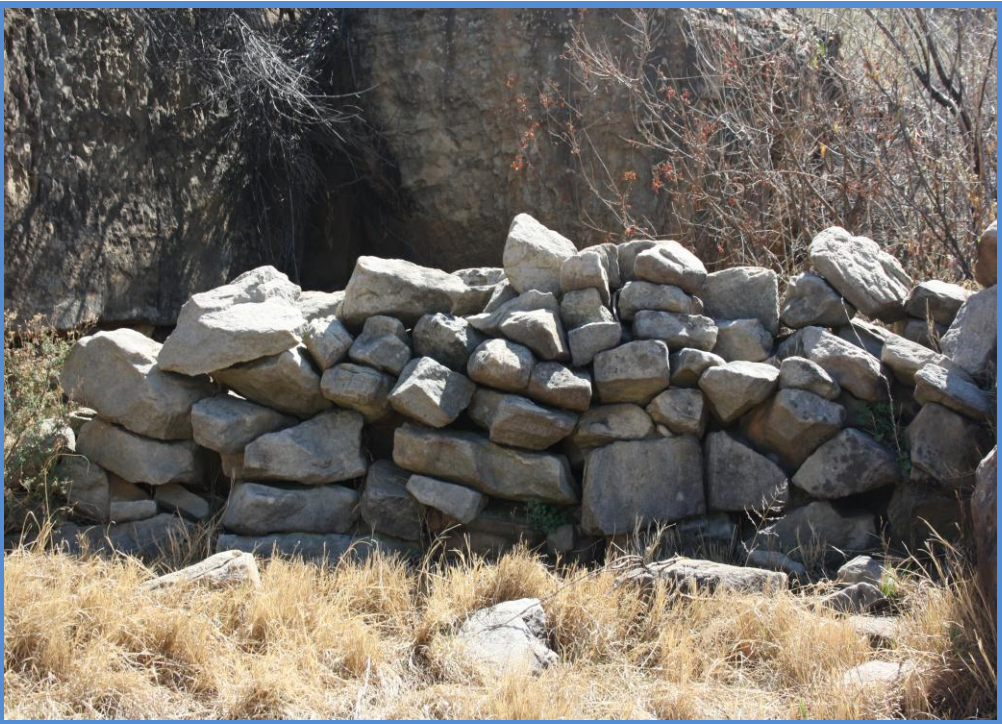
- The second enclosure (Plate 4) is located further west of the noted stone enclosure situated approximately 6 meters another line of stone walling enclosure was noted characterized by triangular form of stone walling with dilapidated section, a still intact stone walling section measured approximately 4 meters in length and 1 meter high. In between this two enclosures, quarried and polished sand blocks were noted at the bottom of the slope, an indication that some of the building materials were collected here. No associated cultural remains such as potsherds, rock paintings or historical artifacts were noted on the surface of the vicinity.

**Plate 04:** View of the still intact stone wall

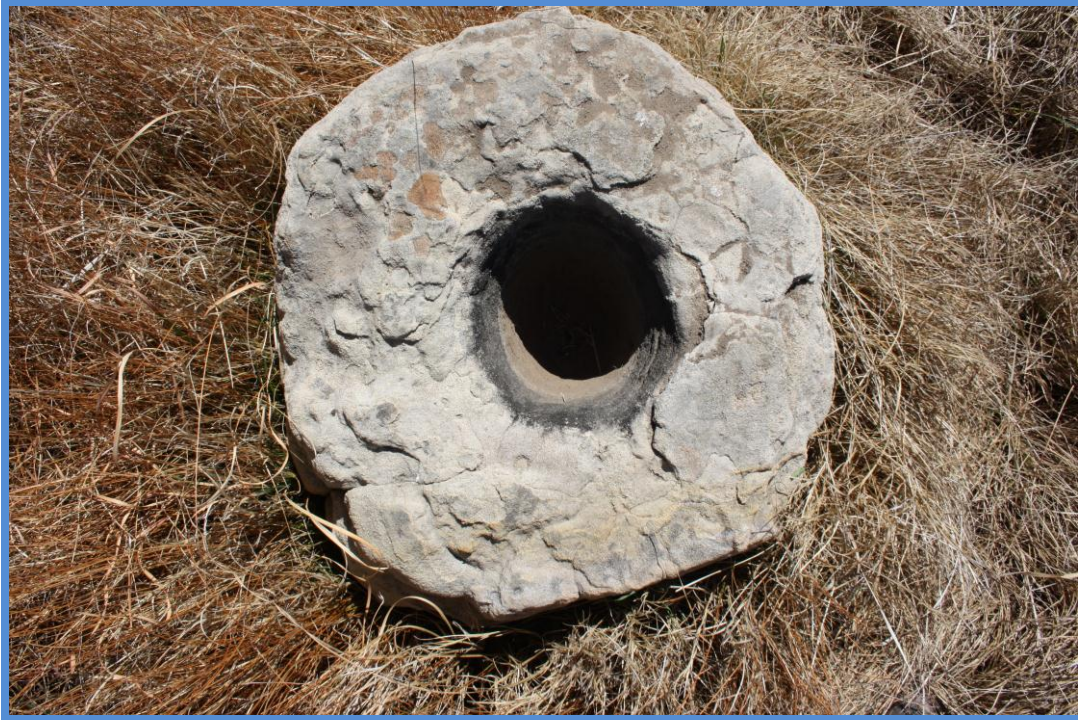
Just further south of the identified stone walling enclosures a single hollow sand stone was noted, the stone had similar features with some of the stones noted on top of Mapungubwe and Leokwe hill sites in the Limpopo Province which were interpreted and associated with rain making rituals (Plate 5).

**Plate 05:** View of the hollow sand stone noted on the lower lying area below the stone wall.

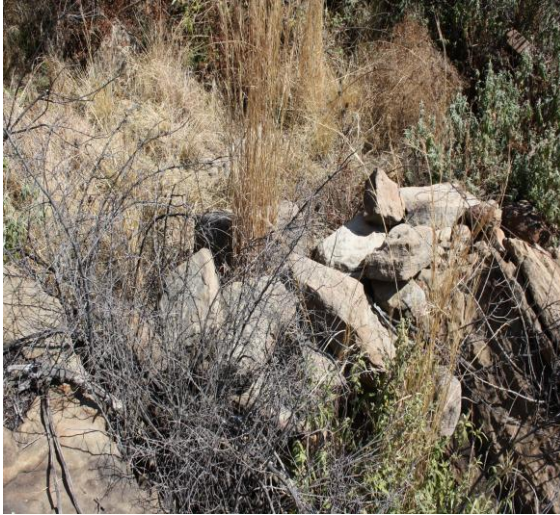
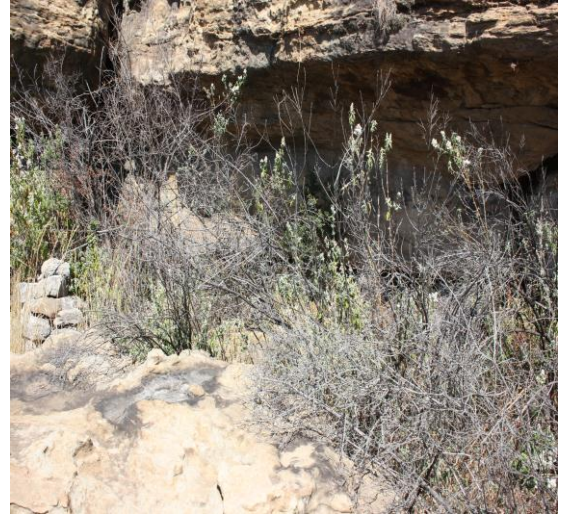
The site is located at the following global positioning system co-ordinates (GPS S28°.53292 & E 27°.87274). The third enclosure is located below the bottom slope, further approximately 100 meters north of the identified two stone walling enclosures. The area is characterized by displaced rock boulders that rest below the slope creating an open space in the middle, two separate stone walling have been noticed closing up with nearby rock boulders. Adjacent another stone enclosure covering approximately 60 X15 metres. The enclosures has an open central part presumably used to keep livestock. No associated cultural remains such as potsherds, rock paintings or historical artifacts were noted on the surface of the vicinity.

**Plate 06:** view of the stone wall closing access against the sand stone boulders.

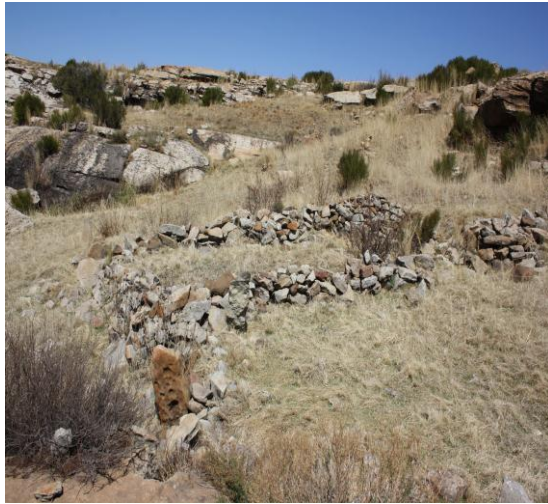
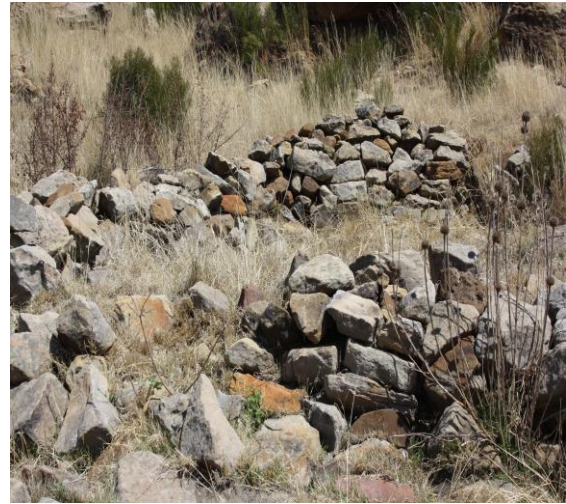
**Plate 07:** Sections of one of the identified stone walling enclosure.

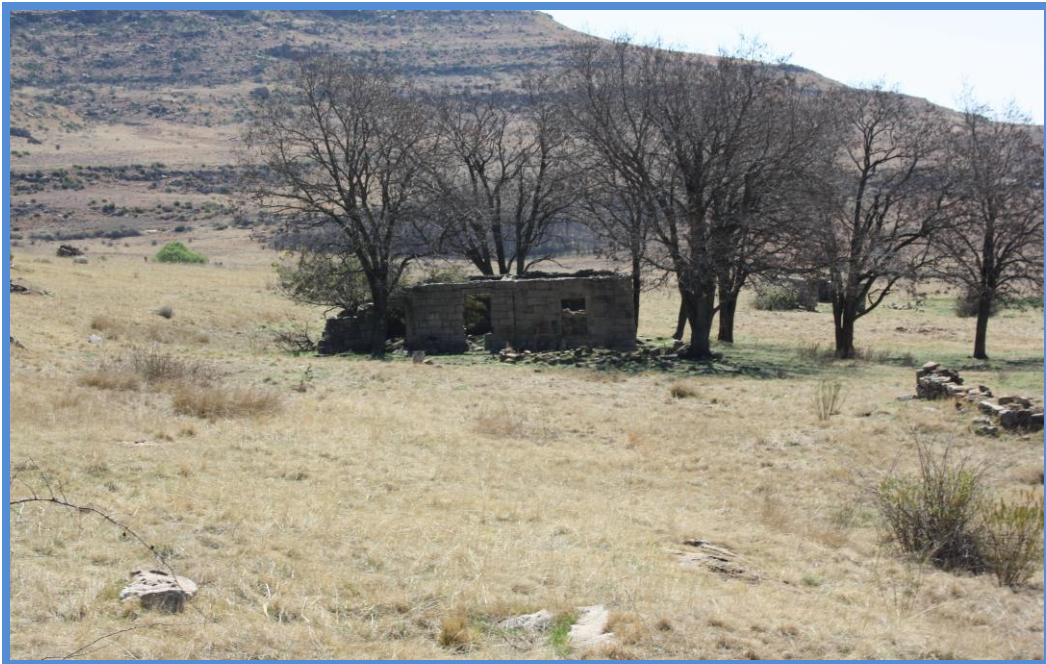
The site is located at the following global positioning system co-ordinates (GPS S28°.53177 & E 27°.87132).The area is located approximately 500 meters north east of the Occasional line of *Eucalyptus plantation*. The site is characterized by existing big trees (presumed to be historical site marker), dilapidated, roundavel and rectangular house structure foundations. Further north of the structures at approximately 10 meters from the foundations a farm house structure occur, constructed out of well quarried sand stone shaped blocks packed on top of each other without the use of cement mixtures. From the inside of the historical house structure a mud and small size stone wall can be seen. Approximately 5 rooms were noted with each having its own outside entrance. Further north east of the main historical house and several outbuildings structures constructed out

of sand stone blocks were noted including an ablution block. Associated single grave have been noted on site see below for more detailed grave description.

**Plate 08:** View of the homesteads indicated by a house and associated out buildings Constructed out of sandstone blocks without and cements mixture.

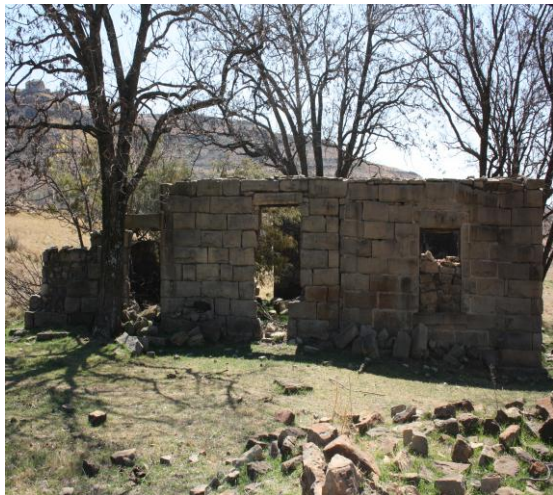
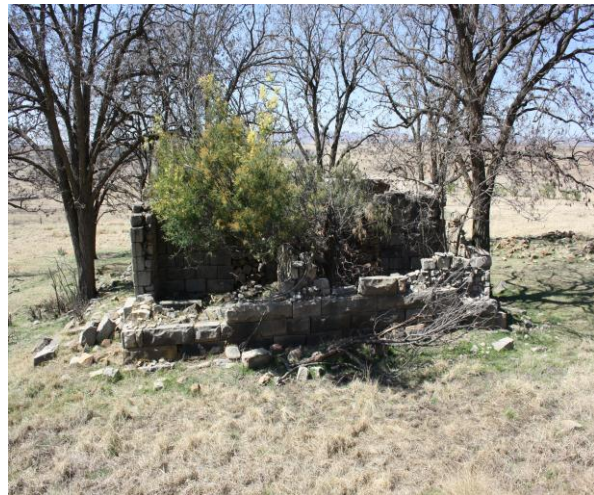
**Plate 09:** Front and collapsed back view of the main building

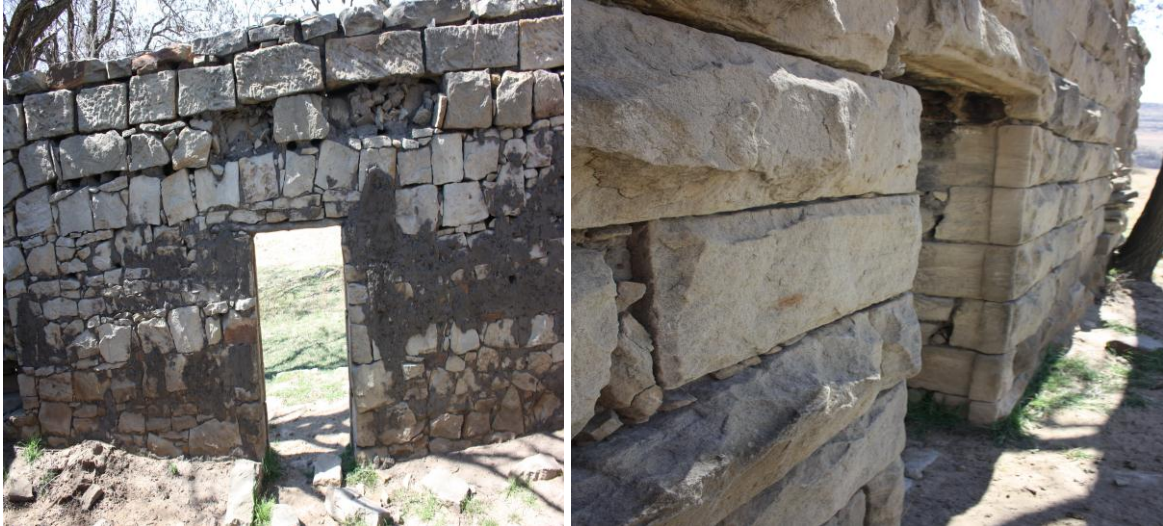
**Plate 10:** The inside of the main house to the left and the entrance towards the southern section where Meulspruit is located.

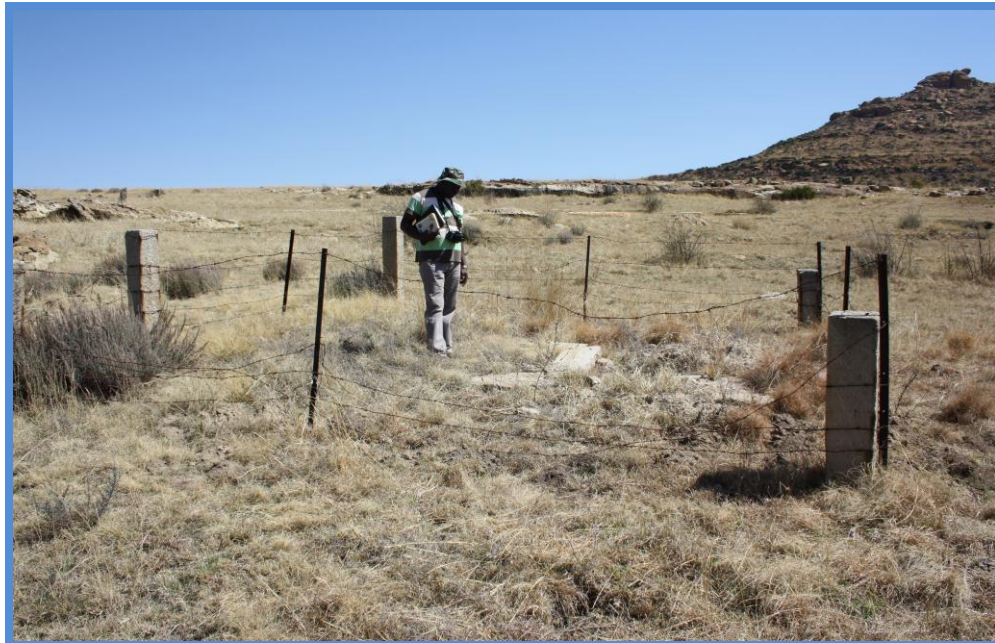
Further north east of the main homestead and associated buildings, a well fenced off section of approximately 3x3 meters occur. Sands stone monoliths have been used as fencing corner post. The central part of the fenced off section is characterized by well constructed burnt stock bricks forming grave dressing outline. Currently the central part of grave dressing have been dug open creating a ditch in the middle section of the grave an indication that the area have been previously vandalized or disturbed. A cement chunk with zinc grooves impression markings have been on the surface. Two cent copper coin (dated 1981) has been noted on top of the surface area possibly grave goods offering. The site is located at the following global positioning system co-ordinates (GPS S28°.53079 & E 27°.87052).

**Plate 11:** View of the grave area located a distance from the main house.

The marked individual and cluster of graves are a major source of concern before any work on the dam construction proceeds every attempt should be made to determine their location, flagging and putting danger tapes around the grave sites for visibility while facilitating for their exhumation and reinterred into the safe community cemetery. We would like to suggest that since the identified graves are located inside the proposed dam basin footprint it is strongly recommended that the identified graves sites should be exhumed and reinterred to the safe local cemetery.

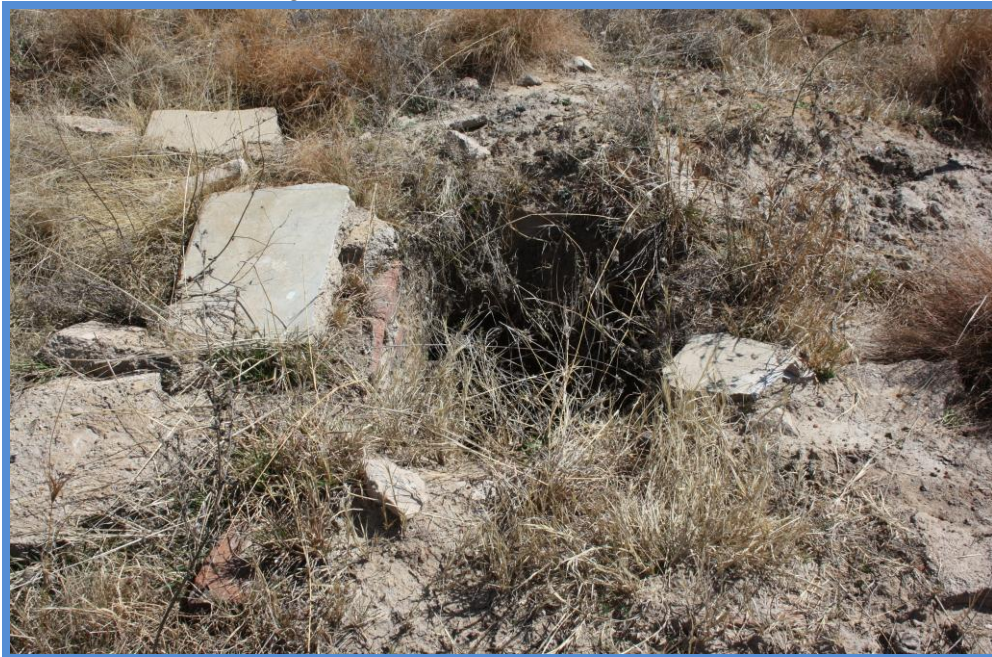
**Plate 12:** The disturbed grave represented by open ditch, and broken cement rubble.

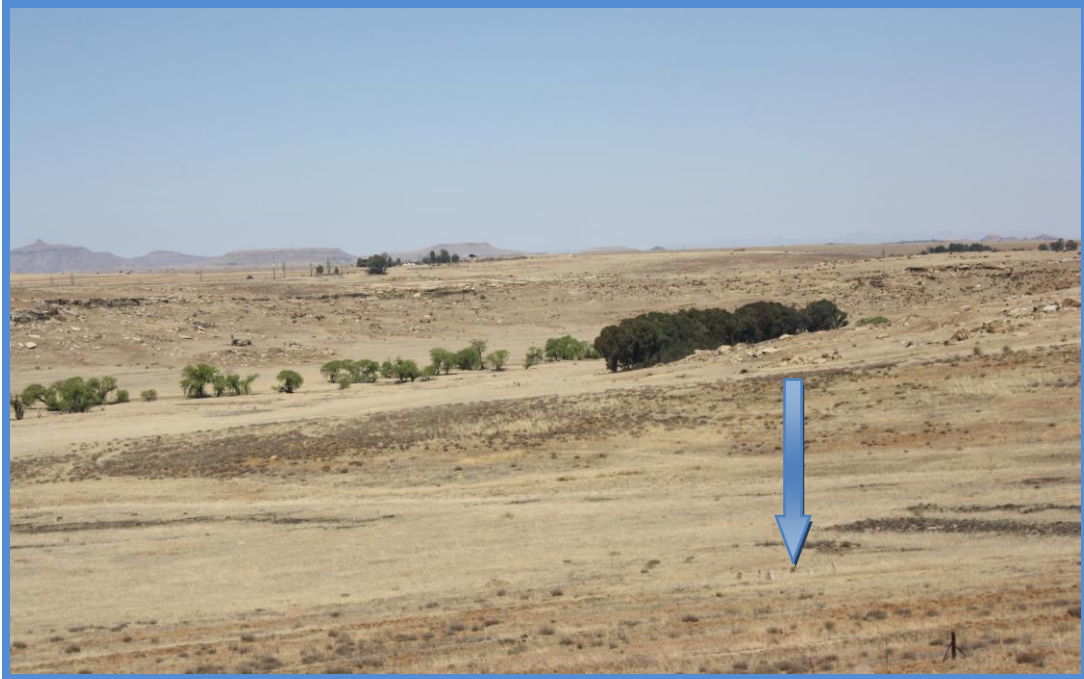
Further north east of the homestead and associated buildings, a well fenced off section of approximately 4x3 meters occur northeast of swamps and marshes area. The area is presumed to have been previously used as cultivated section of land indicated by visible agricultural contour bands. The site has been indicated by eight (8) sand stone monoliths blocks used as fencing corner post. The single grave occurs in the central part of the area indicated by sand stone outline with dilapidated sand stone headrest. No inscription on the headrest was noted, which helps to determine and establish the age of the grave. The site

**Plate 13:** View of the single grave located in the middle of the well fence off site.

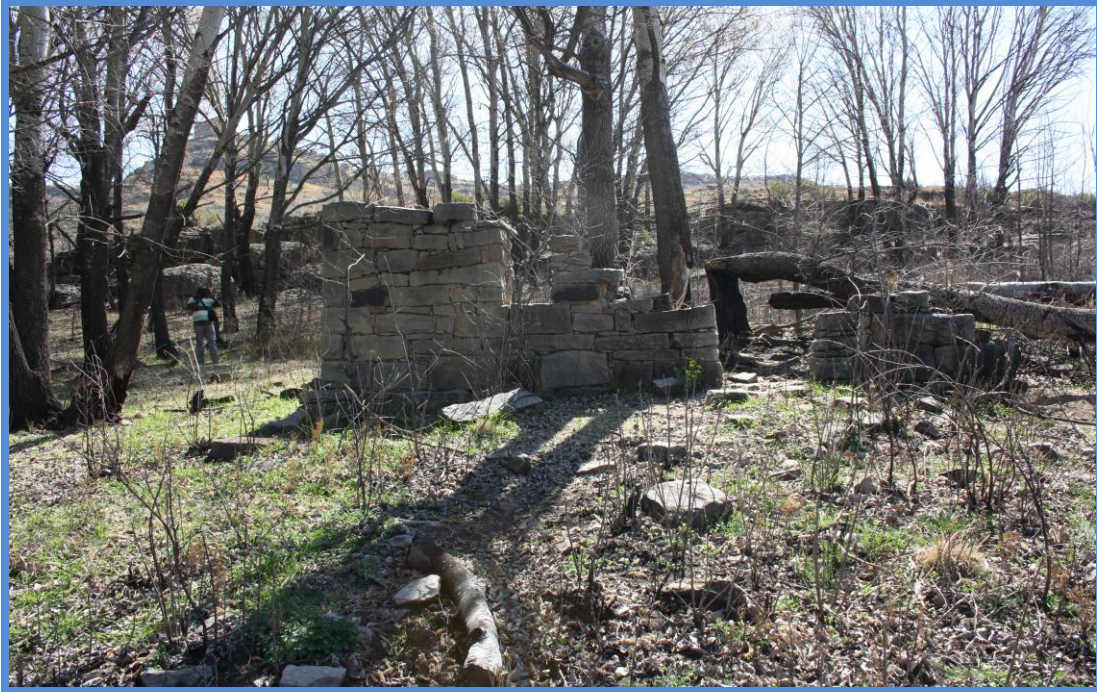
Just approximately 100metres further west of the identified grave, and abandoned cultivated land indicated by agricultural contour bands, a homestead occur in the middle of densely infested tall trees, the site occur south of the bottom slope overlooking the abandoned cultivating area and the Meulspruit. The site is located approximately 300metres from the identified historical farm homestead, characterized by a square shaped three roomed house, represented by foundation with section of dilapidated sand stone walls. The remains represented by free standing wall shows already observed architectural building techniques recorded from other homesteads ruins. No associated midden, potteries were noted on the surface of the site. The site is located at the following global positioning system co-ordinates (GPS S28°.52740 & E27°.86965).

**Plate 14:** View of the homestead represented by dilapidated house

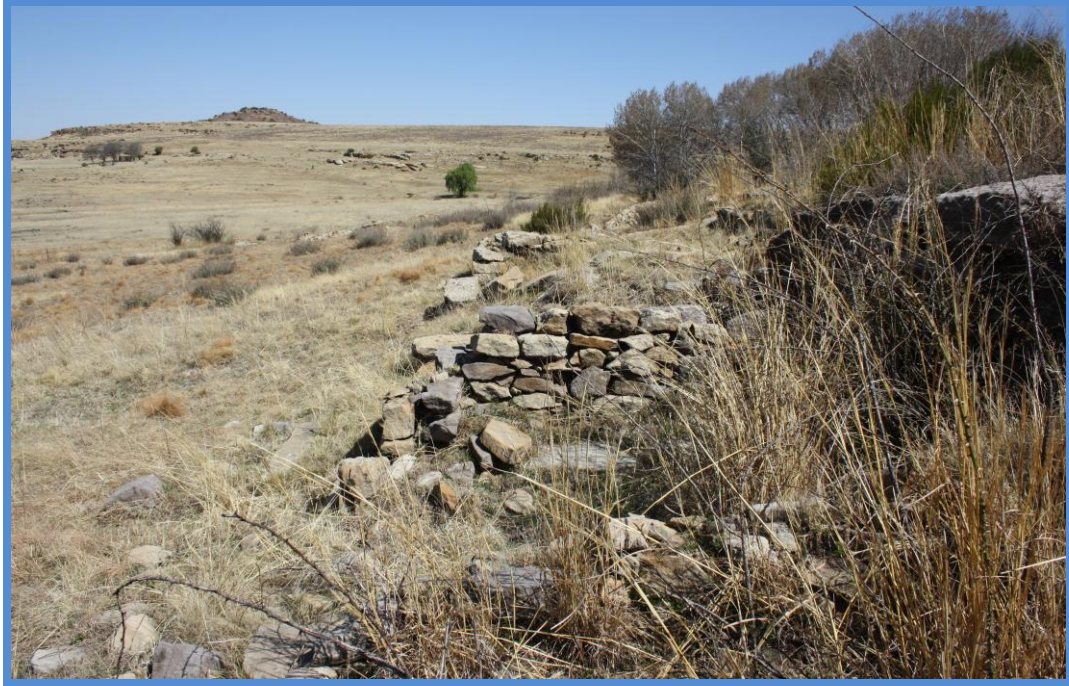
Approximately 150 meters north east from the identified homestead (site 007) at the bottom slope of the ridge two separate square stone walling enclosure constructed against sand stone rock boulders were noted. Section of the stone wall measures 1 meter high. Above the identified rectangular stone wall enclosures a long stone wall line with three free standing monolith occur in the vicinity, possibly the line of stone represent a boundary separating residential with grazing area. The site is located at the following global positioning system co-ordinates (GPS S28°.52640 & E27°.87007).

**Plate 15:** View of the stone walling north east of the identified homestead

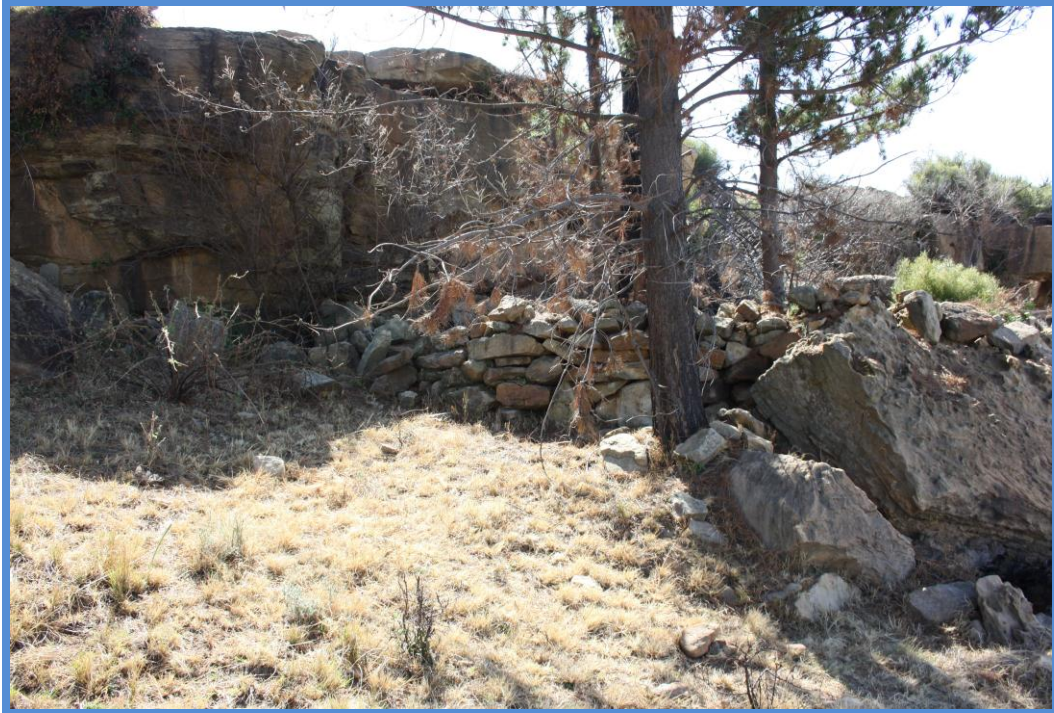
A circular stone wall enclosure covering approximately 10metres radius was noted, with sections of the parked stone wall covering approximately 1.2 meters high, with thickness of approximately 1meter. The stone walling rest at the bottom of the slope against the slope cliff and rock boulder with dilapidated sections. The central part of the stone walling is open with pine trees. A rectangular well carved sand stone was noticed at the main entrance to the enclosure. The site is located at the following global positioning system coordinates (GPS S28°.51888 & E27°.87484).

**Plate 16:** Section of the stone wall enclosure constructed against the boulders and Cliff overlooking the Meulspruit.

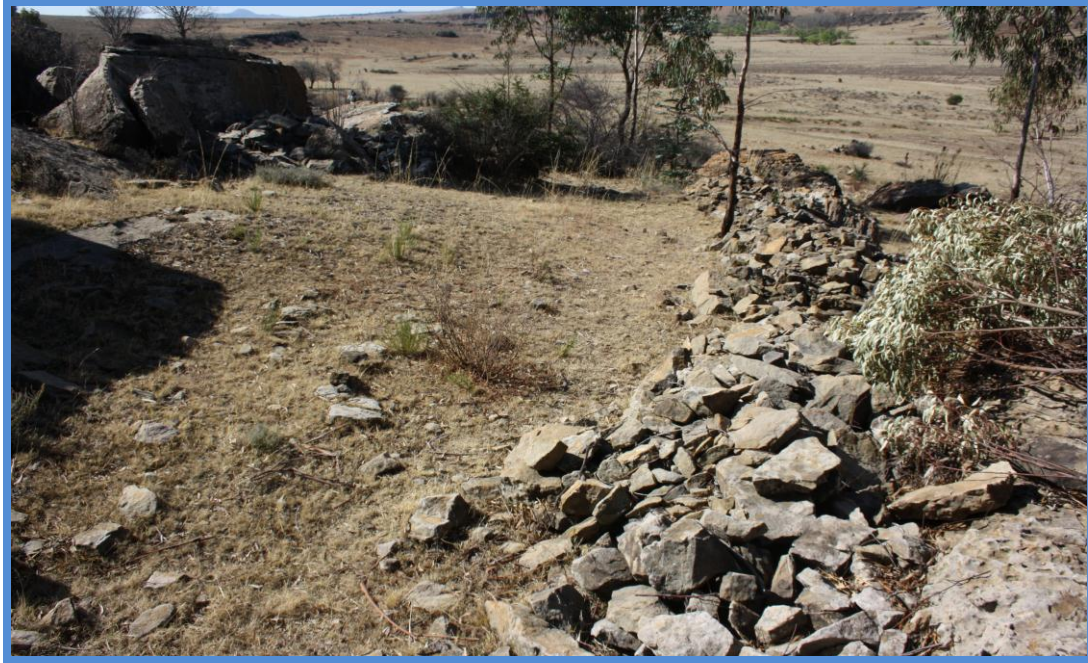
The site is situated north east of the existing *Eucalyptus* plantation that occur north of the Meulspruit, located not far from the identified stone enclosure site with a big pine tree at the central part of the enclosure (site 009). The area is characterized by concentrations mounds of discarded sand stone flakes and core and displaced sand stone rock boulders. The site might have been used for quarrying sand stone blocks noted in close proximity used for house, fencing post and marking graves and other construction related activities. The site is located at the following global positioning system co-ordinates (GPS S28°.51730 & E27°.87551).

**Plate 17:** Discarded chunks of the sandstone rock produced during the sand stone blocks manufacturing process.

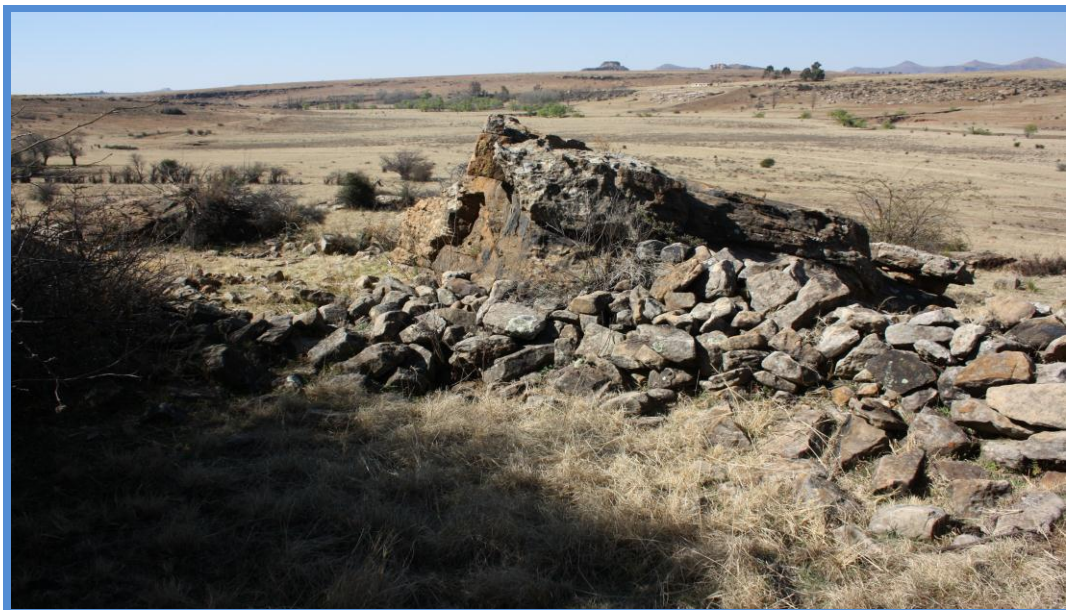
Just several meters from the quarry site a circular stone enclosure occur, enclosing sandstone rock boulders, the circular stone walling measures approximately 10 meters radius, half a meter height and 10meters long. The site is located at the following global positioning system co-ordinates (GPS S28°.51704 & E27°.87551).

**Plate 18:** View of the stone walled enclosure where a single grave was noted in the middle section.

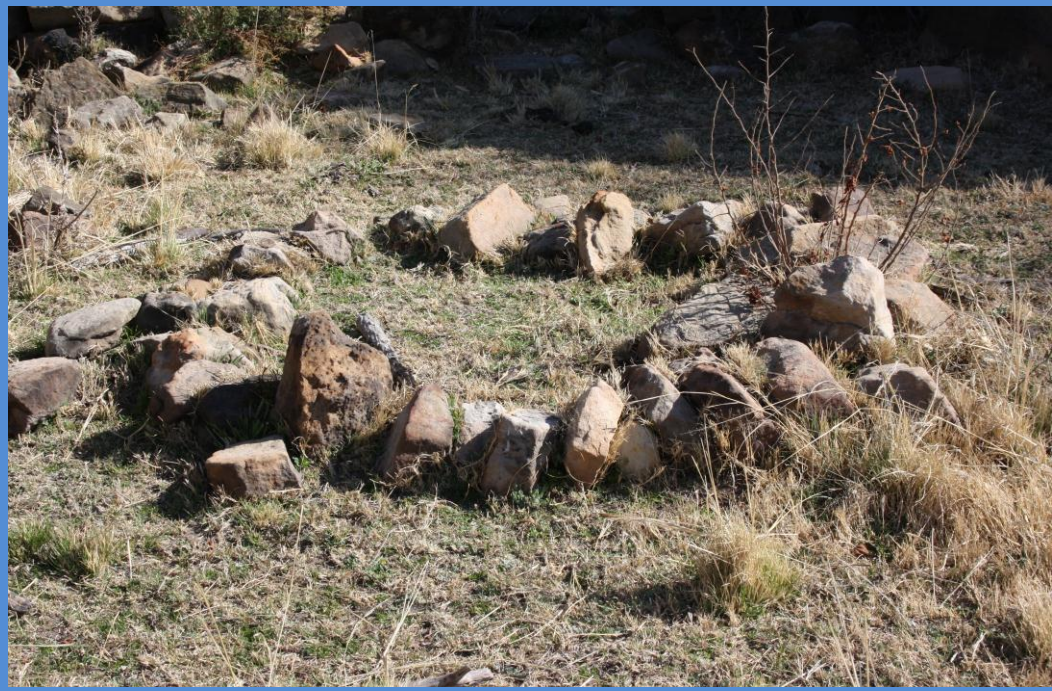
Within this stone walling enclosure within the central part, a single grave occur indicated by oval parked stones outline as grave dressings. The site is located at the following global positioning system co-ordinates (GPS S28°.51704 & E27°.87551).

**Plate 19:** View of the oval parked stone outline representing grave dressings
