**ARCHAEOLOGICAL IMPACT ASSESSMENT REPORT**

**INVESTIGATIONS FOR THE PROPOSED CONSTRUCTION OF A WATER  
STORAGE FACILITY IN THE MEULSPRUIT NEAR ROSENDAL AS  
WELL AS THE WATER PIPELINE TO SENEKAL WITHIN THE THABO  
MOFUTSANYANE DISTRICT OF FREE STATE PROVINCE**

**SEPTEMBER 2011**

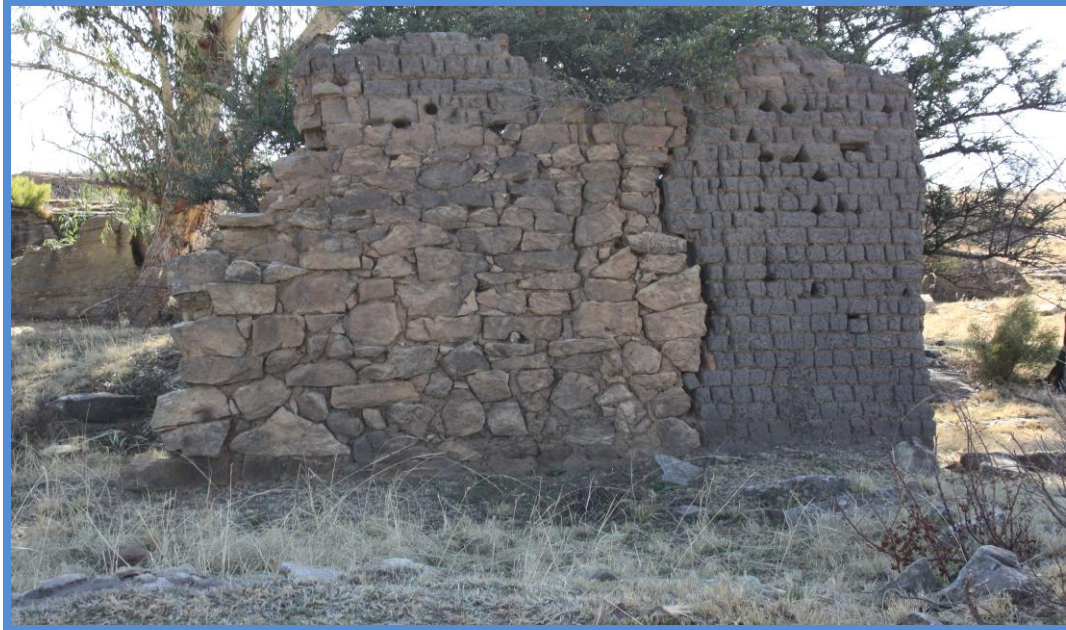
At approximately 200 meters north east of the identified quarry and stone wall enclosure sites, north of the small earth dam a homestead occur, indicated by *Eucalyptus* and pine trees as site marking trees. Just below the identified homestead and earth dam a pocket of alien tree species occur in a watershed area. The homestead is characterized by dilapidated house structure represented by its foundation with a single free standing wall showing two types of construction techniques( with stones constructed wall connected with mud brick wall section) see photograph for detail. The site is located at the following global positioning system co-ordinates (GPS S28°.51557 & E27°.87555).

**Plate 20:** View of the dilapidated house represented by a free standing wall showing two types of construction techniques.

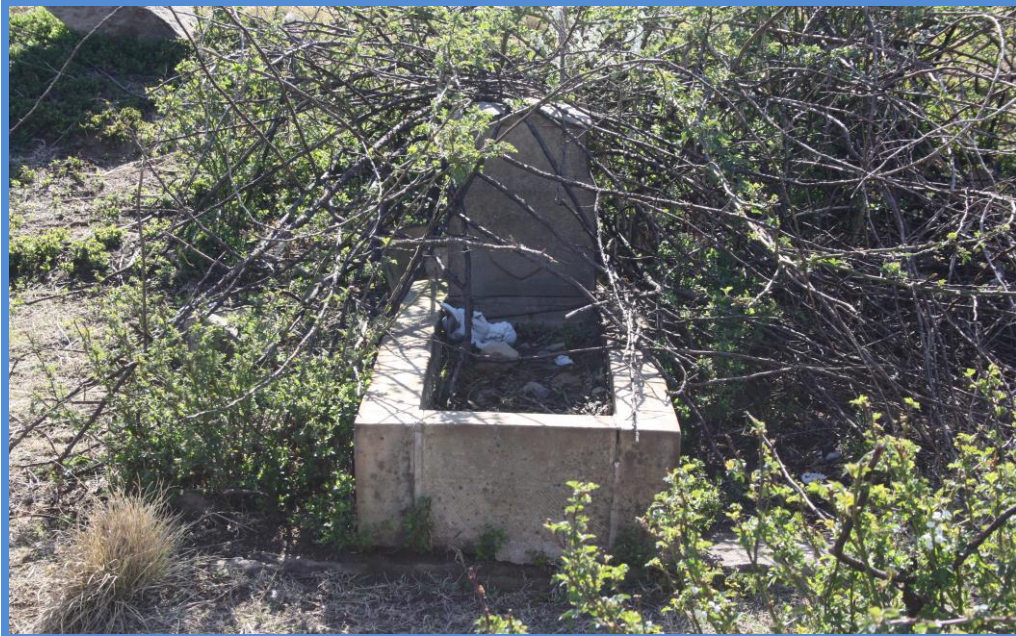
The single grave is located approximately 200m north east of the identified homestead. The area has been indicated by sand stone block corners post; there are no more fences around the site. The central part of the site is characterized by dense rose plants concentration. The grave has been indicated by constructed cement outline with cement head rest. The headrest inscription has faded out completely only 1924 is visibly. The site is located at the following global positioning system co-ordinates (GPS S28°.51476 & E27°.87641).

**Plate 21:** View of the grave indicated by cemented outline with raised headrest, located in the middle of rose plant, on top of the grave there were ceramic grave offering goods

The marked individual and cluster of graves are a major source of concern before any work on the dam construction proceeds every attempt should be made to determine their location, flagging and putting danger tapes around the grave sites for visibility while facilitating for their exhumation and reinterred into the safe community cemetery. We would like to suggest that since the identified graves are located inside the proposed dam basin footprint it is strongly recommended that the identified graves sites should be exhumed and reinterred to the safe local cemetery.

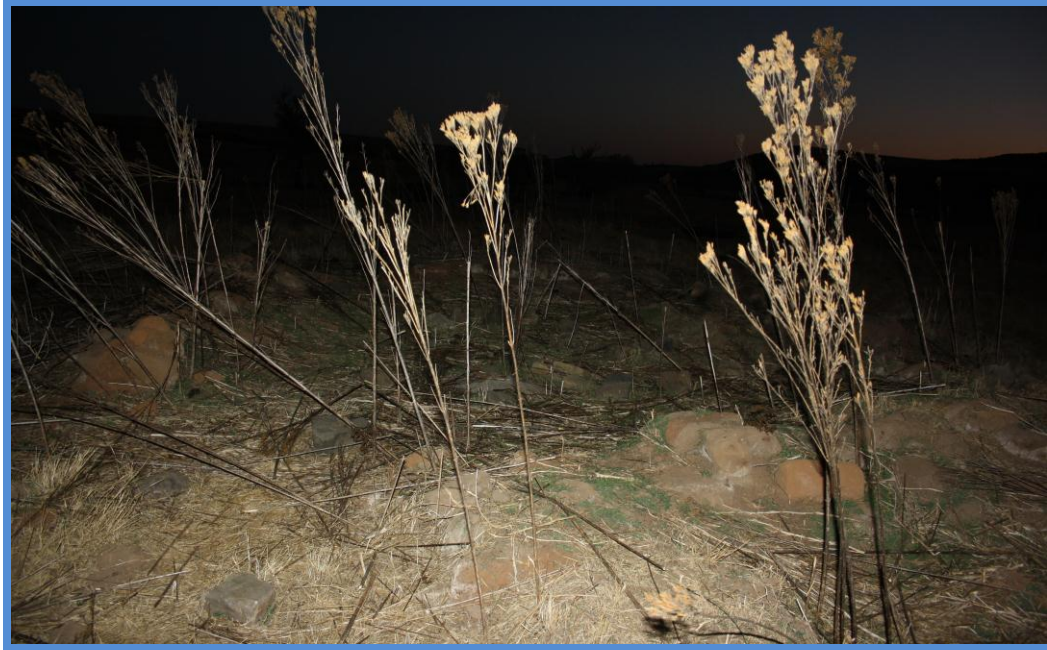
At approximately 5.5kilometers from the proposed dam wall on the western section of the Meulspruit bank dilapidated homestead was noted located west of the Meulspruit bridge and further south of the gravel road. The site is situated on the lower lying area, adjacent to the Meulspruit bank. The area is characterized by several dilapidated mud house structures. Two old cars (scrap) were noted in the vicinity. The site is located at the following global positioning system co-ordinates (GPS S28°.49203 & E27°.88243).

**Plate 22:** Dilapidated homestead represented by house foundations

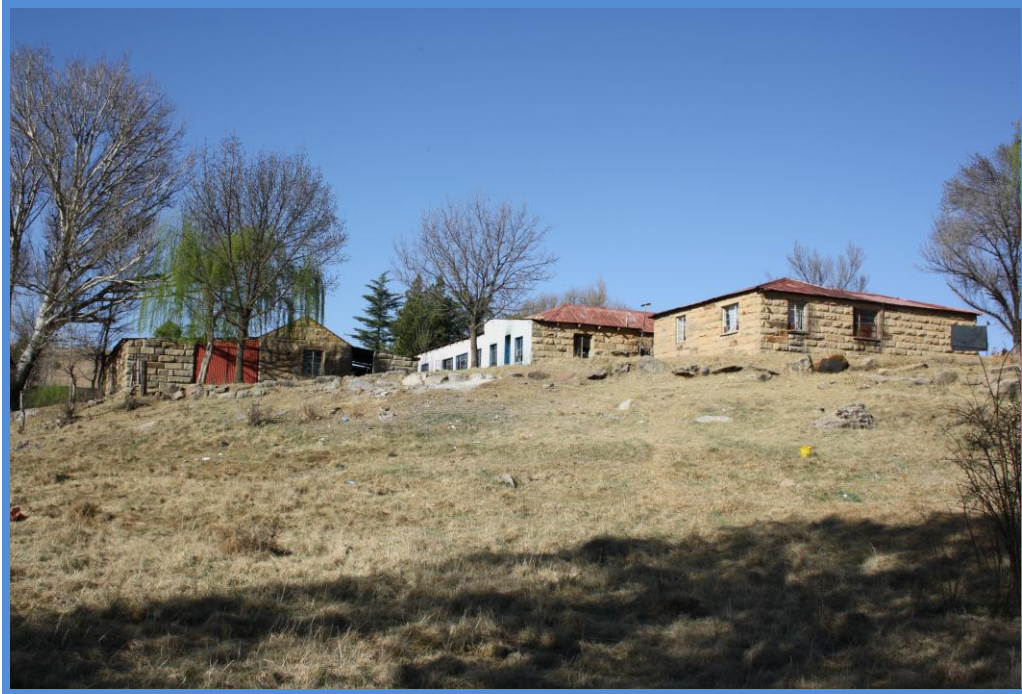
At approximately 3.5kilometers from the proposed dam wall on the eastern section of the Meulspuit bank on a promontory ridge located in close proximity to the river an existing farm homestead represented by main house structure characterized by gable roof and associated out buildings constructed by quarried sand stone blocks was noted. The site is located at the following global positioning system co-ordinates (GPS S28°.50927 & E27°.88257).

**Plate 23:** View of the existing farm homestead towards the south eastern side, Characterized by old house and associated out buildings.

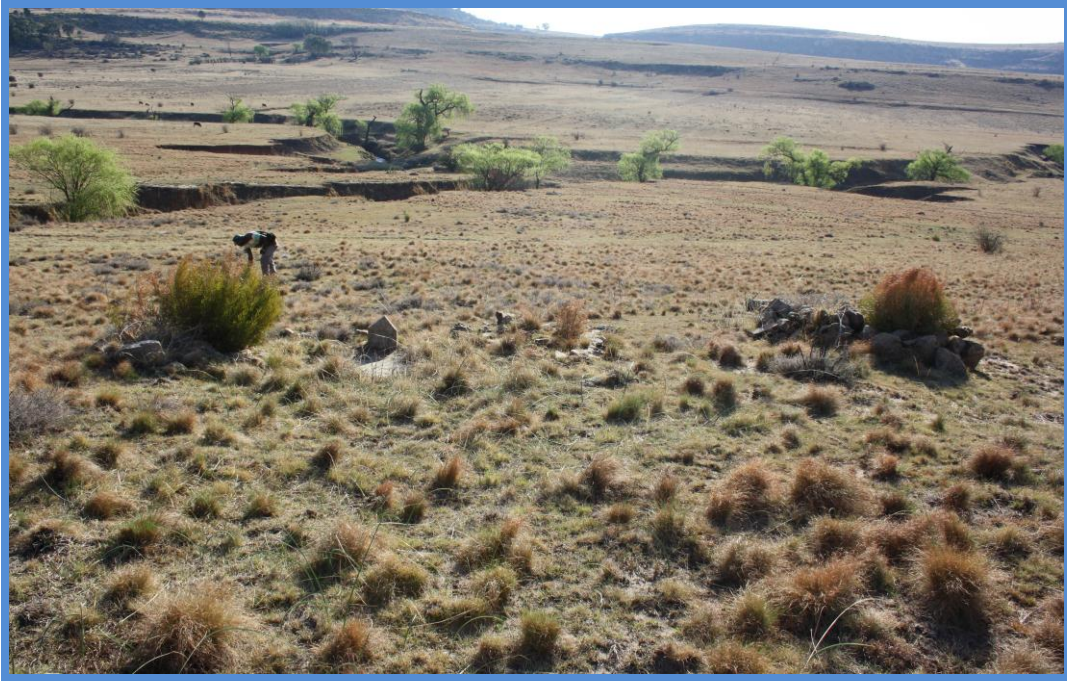
A cluster of four graves were noted further south of the identified exiting farm homestead buildings. The graves were noted approximately 200meters south of the Meulspruit banks. Three of the identified graves have been indicated by parked stones as grave dressings while the fourth grave have been indicated by cemented slab and cement headrest in scripted : Nkopane Thonemohlomi Dhlokahe 7 Sekadi- 12. The site is located at the following global positioning system co-ordinates (GPS S28°.51474 & E27°.88312).

**Plate 24:** Cluster of four graves three of which have been indicated by parked stone as grave dressings while one has been indicated by cement lab with raised head rest.

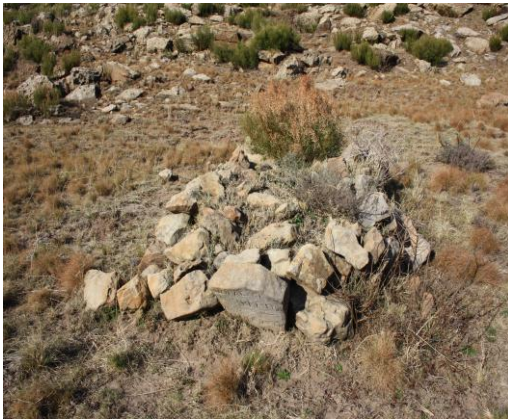
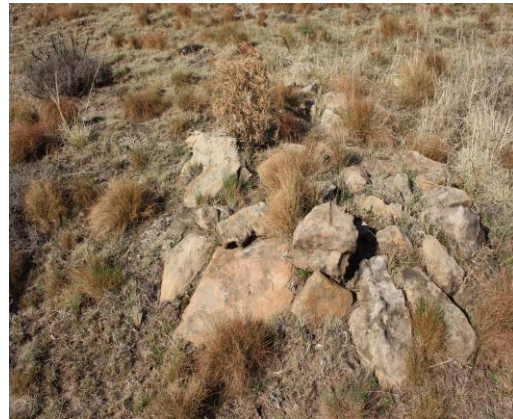
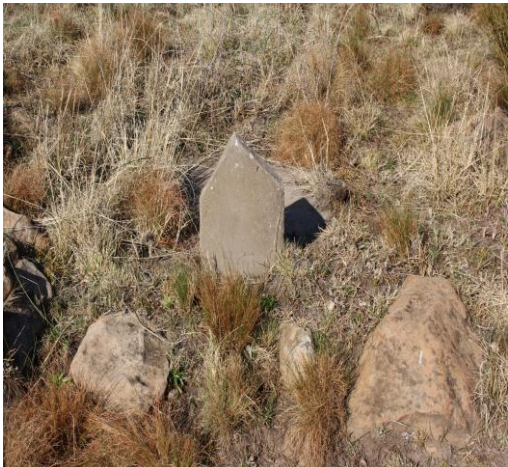
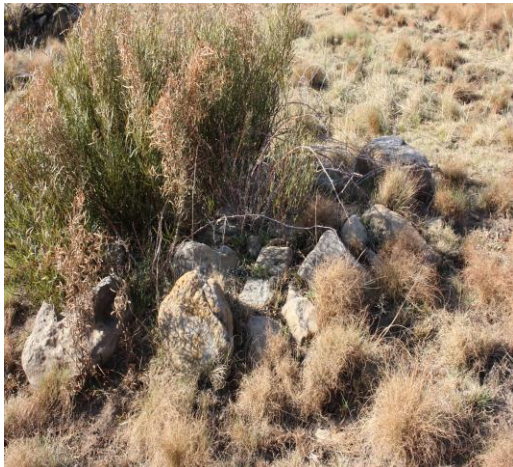
**Plate 25:** View of individual four graves

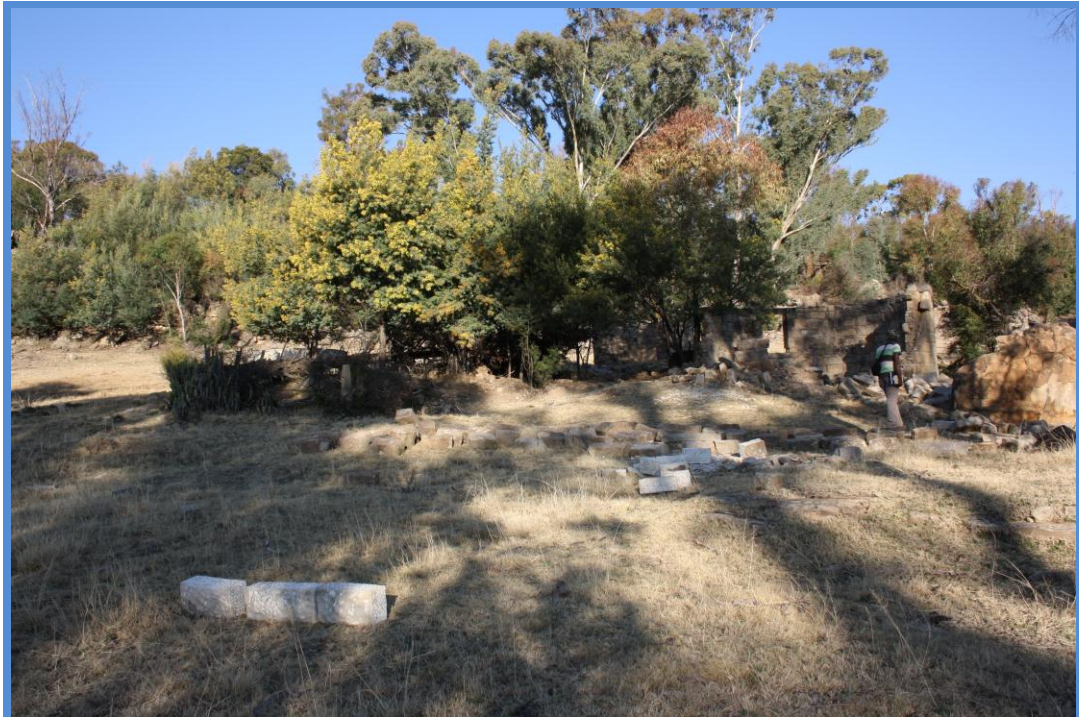
The farm homestead has been indicated noted adjacent to the concentration of *Acacia mearnsii* and *Eucalyptus trees* species. The site is characterized by scattered dilapidated stone structures; two of the structures are roundavel in shape while the other two are square shape. A cement reservoir has been noted just south of the identified structures. The site is located at the following global positioning system co-ordinates (GPS S28°.52401 & E27°.88579).

**Plate 26:** View of the homestead characterized by dilapidated buildings in the middle of *Acacia mearnsii* and *Eucalyptus trees*

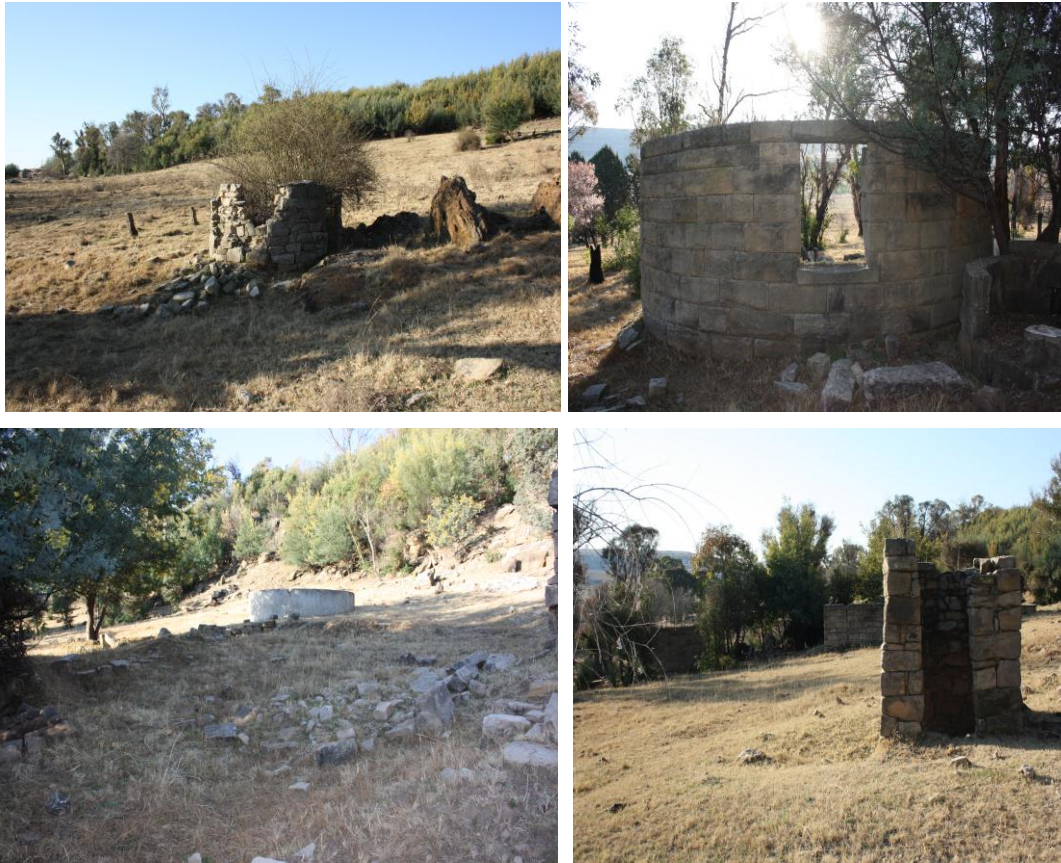
**Plate 27:** These are some of the individual structure that forms the identified homestead.
