HERITAGE REPORT

TO ACCOMPANY A PERMIT APPLICATION FOR ALTERATIONS & ADDITIONS

submitted in terms of Section 34 of the NHRA (1999) for
STABLES & BARN, OLD BETHLEHEM, FARM NO 6/153, STELLENBOSCH

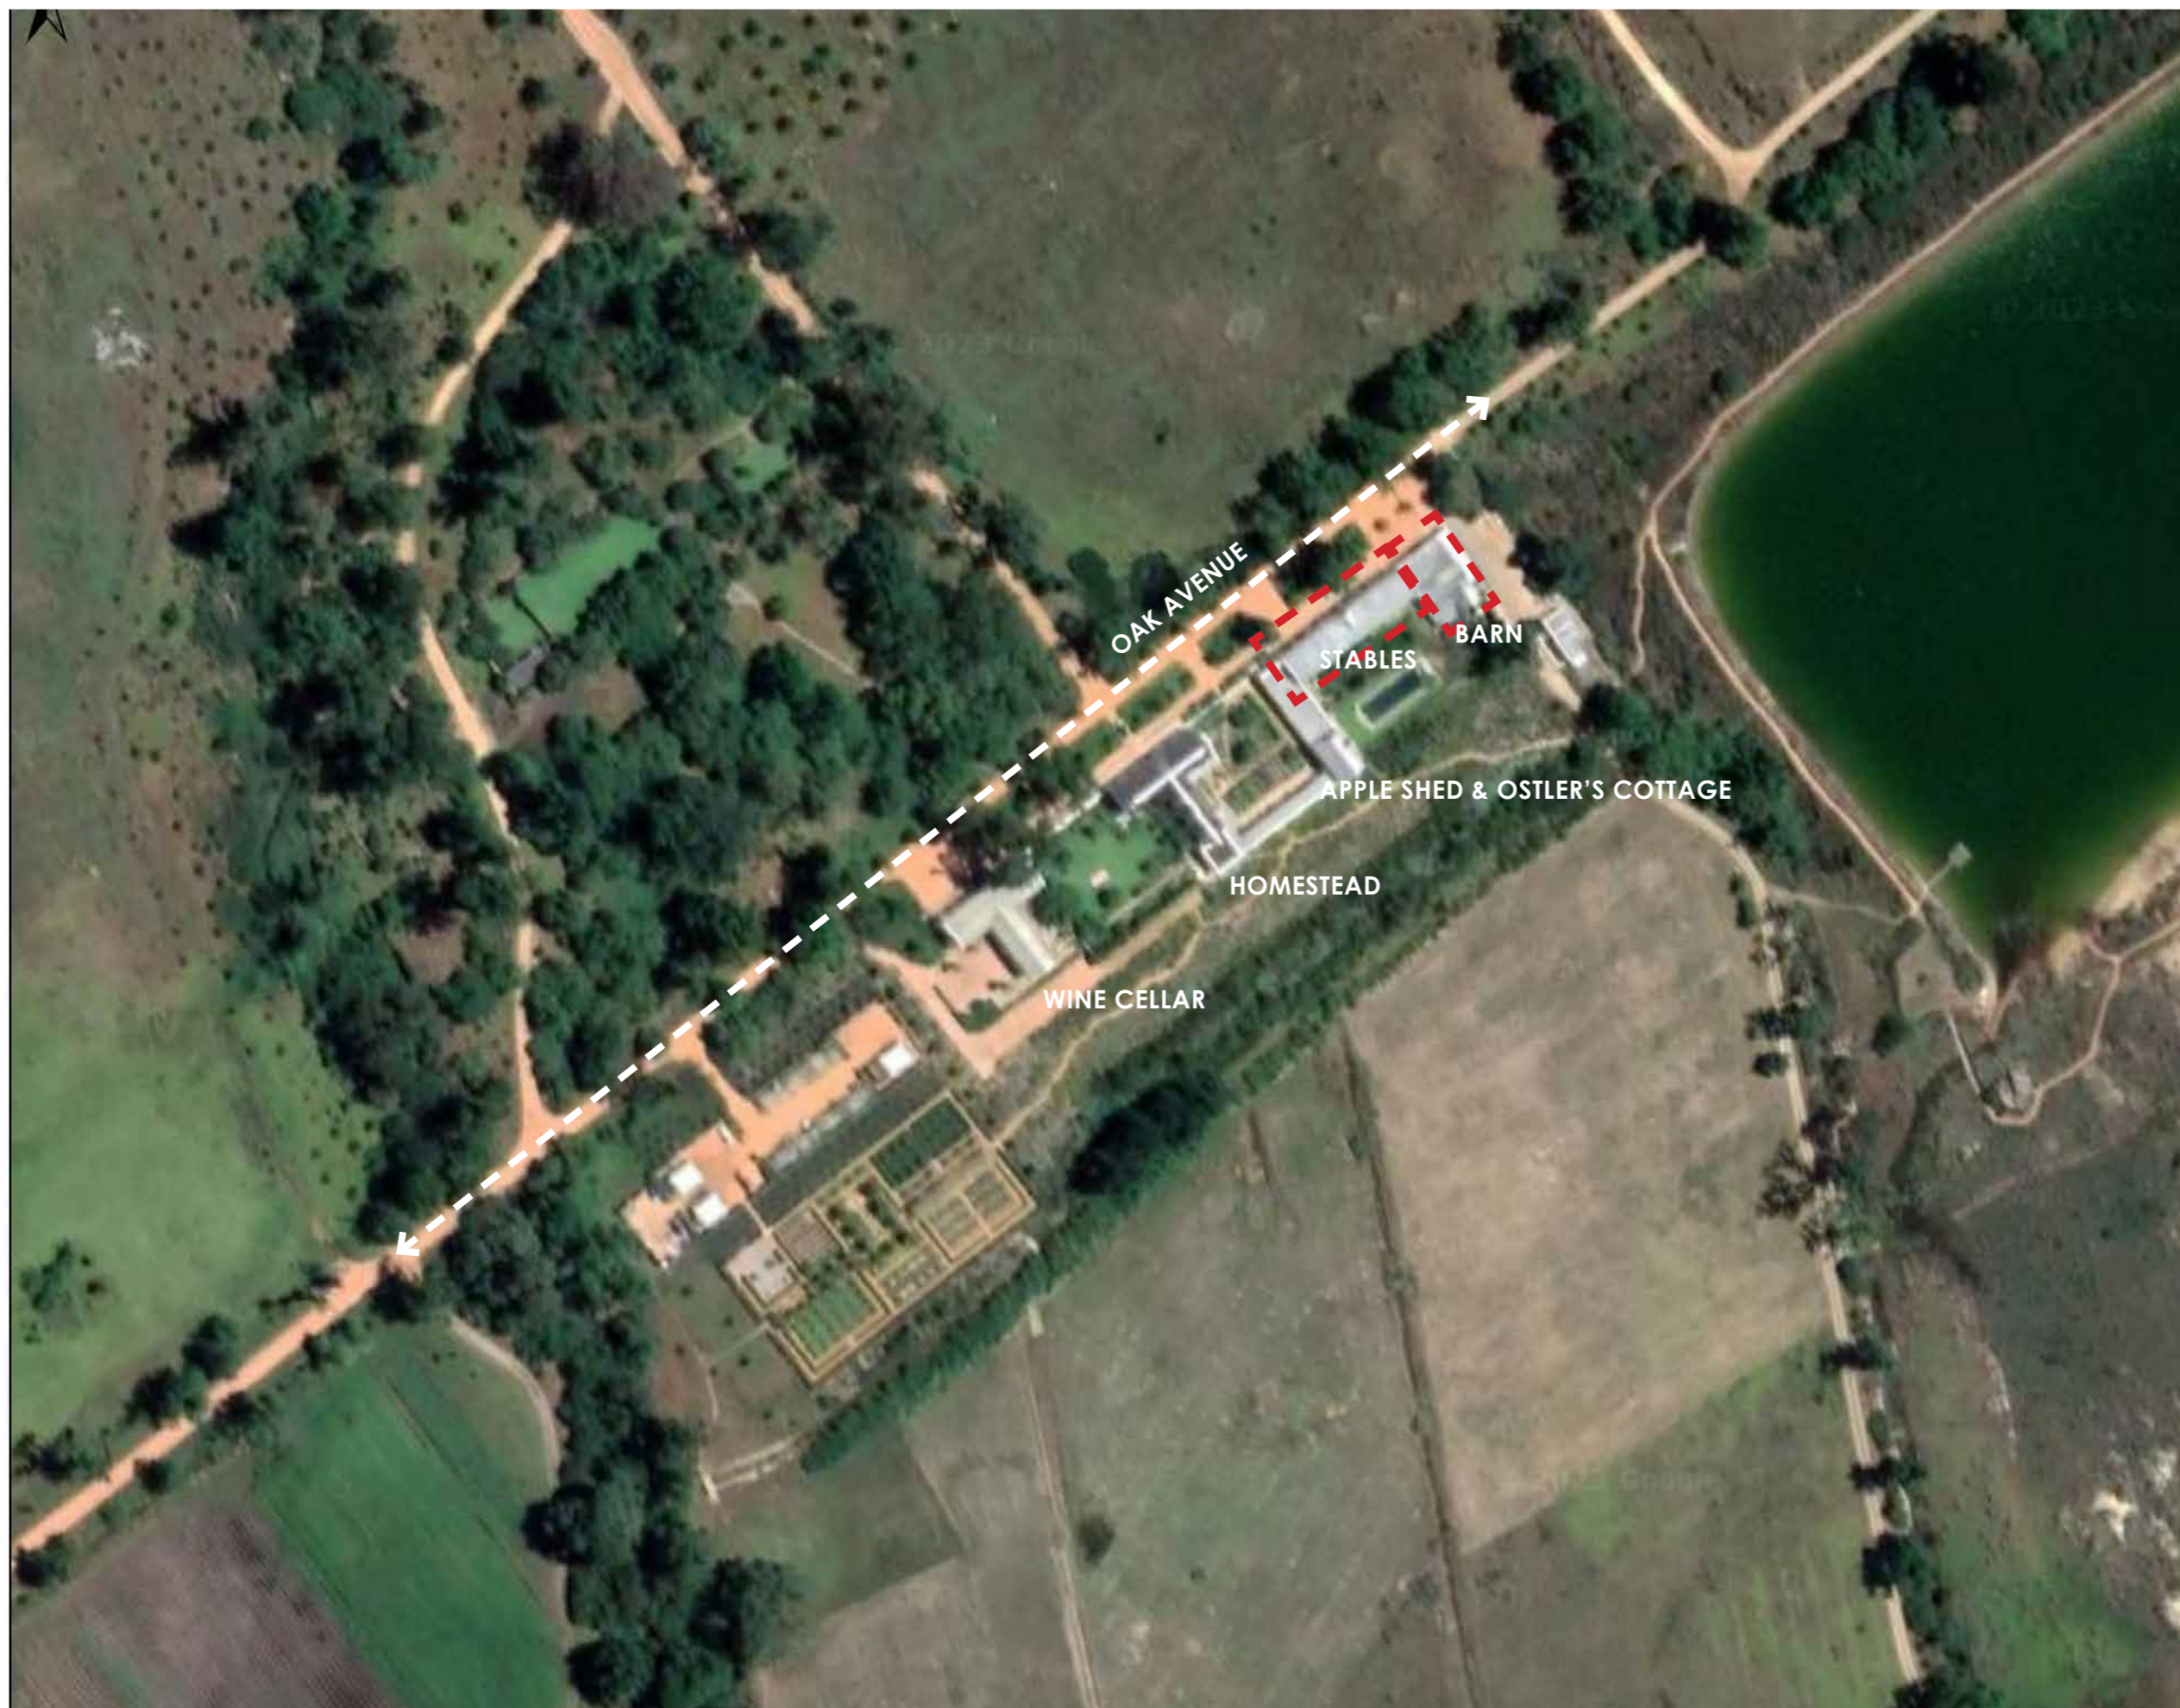
Figure 3. Farmstead group of buildings since recent renovation works, with stables outlined red (Image: Google 2023)

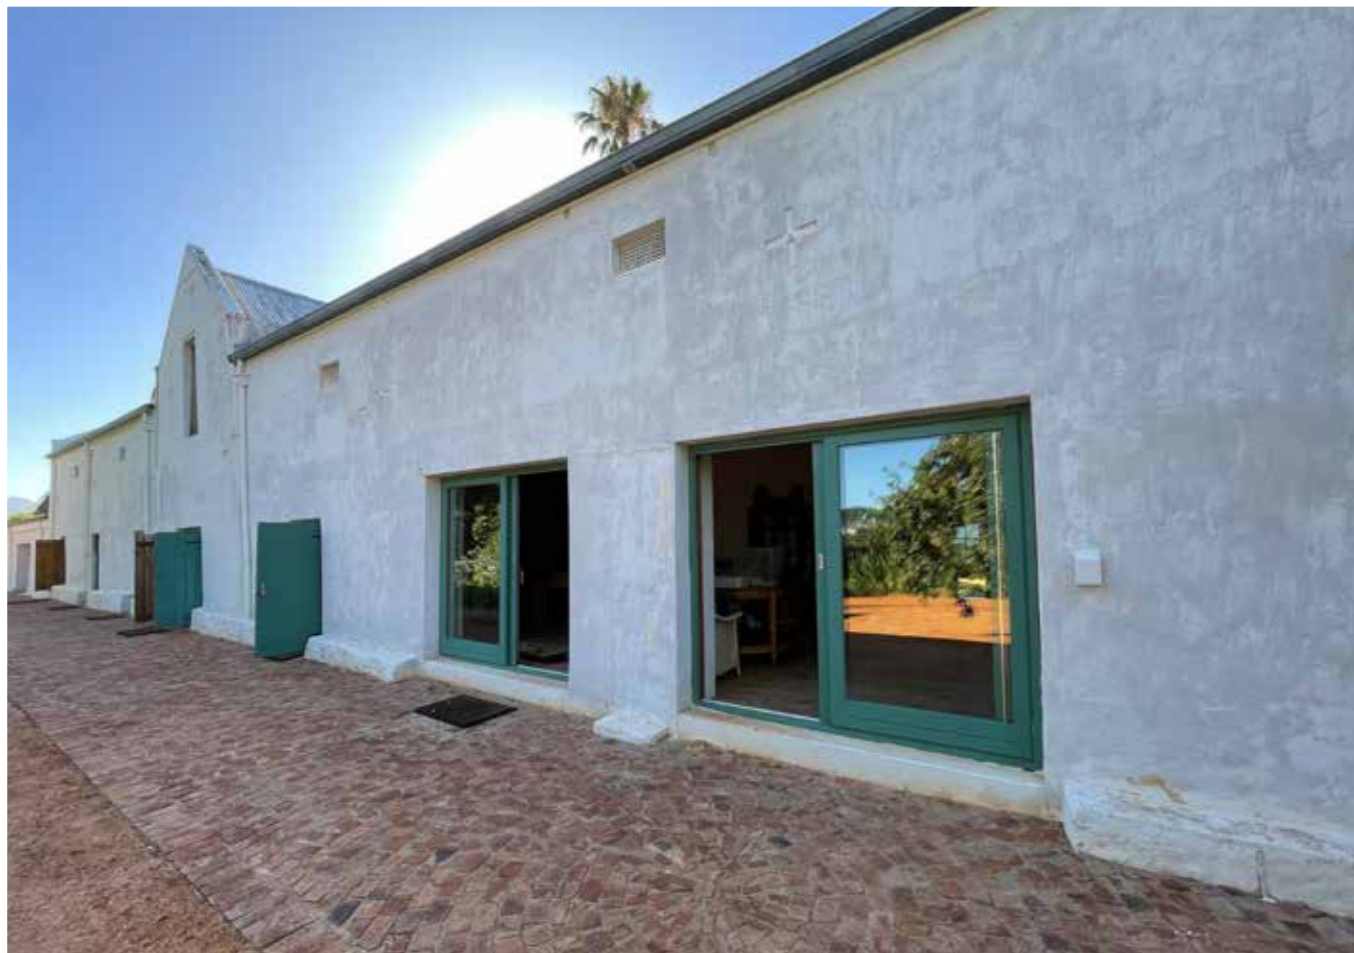
Figure 6. Front facade viewed from homestead/west side (Image: RSA 2023)

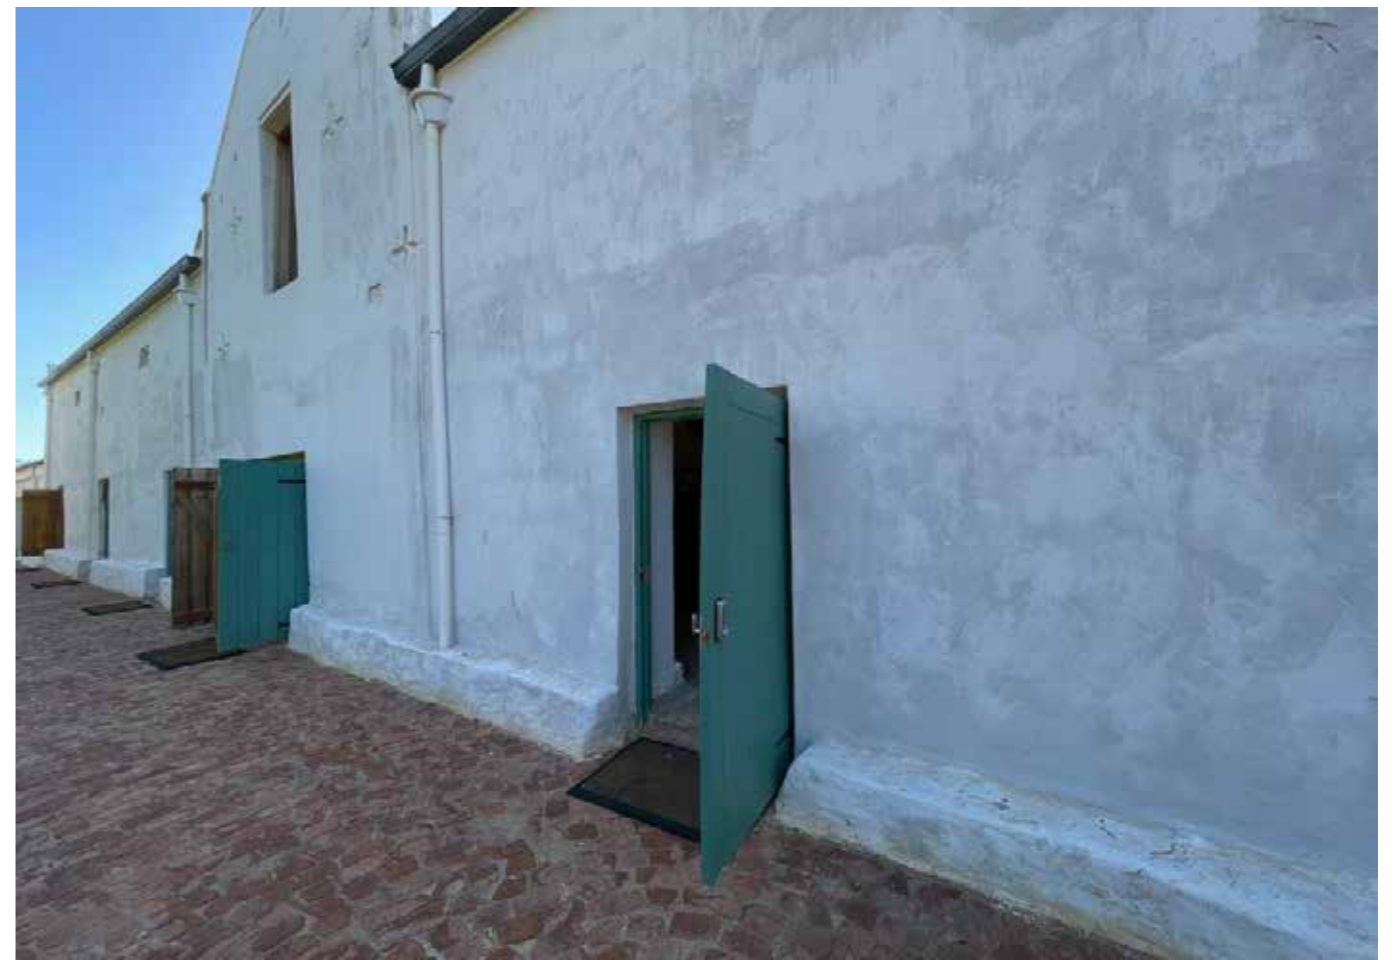
Figure 4. Front facade seen from the homestead/west side (Image: RSA 2018)

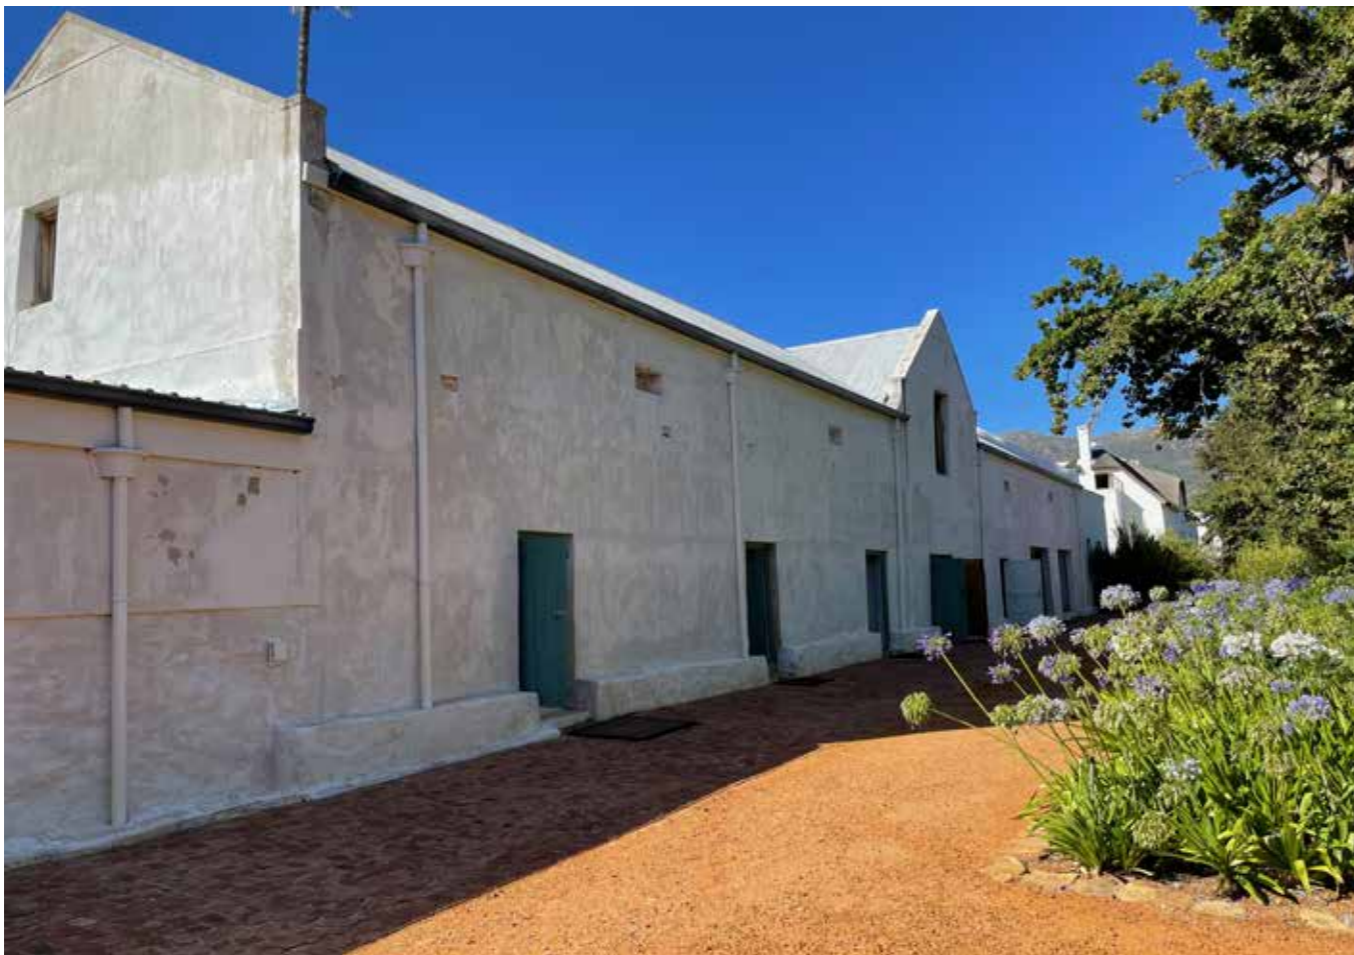
Figure 5. East end gable and front facade 2018 (Image: RSA)

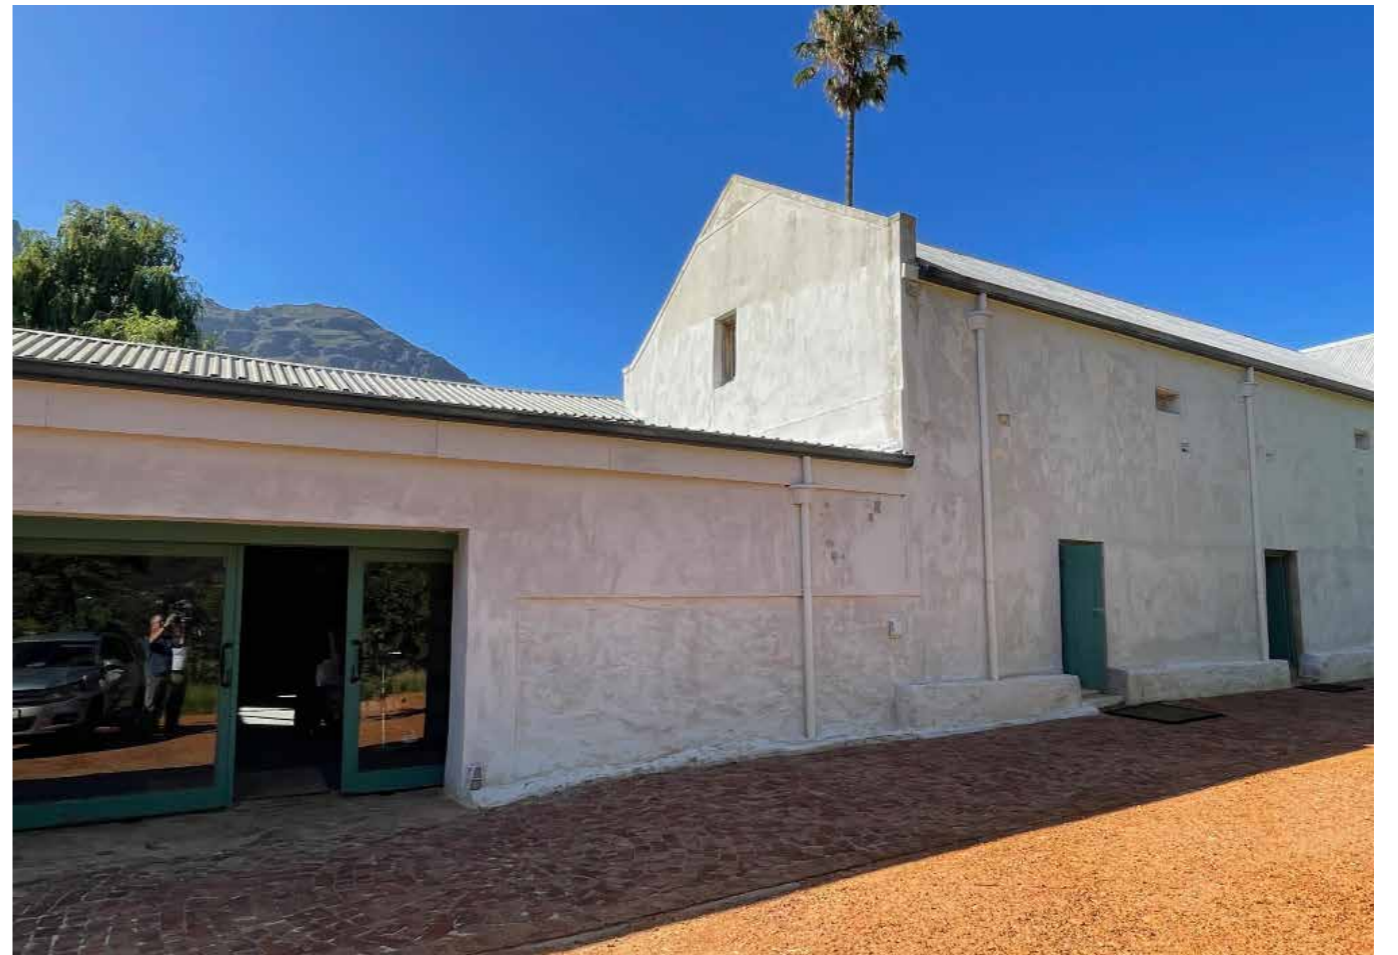
Figure 7. Front facade of barn and stables seen from the east side (Image: RSA 2018)

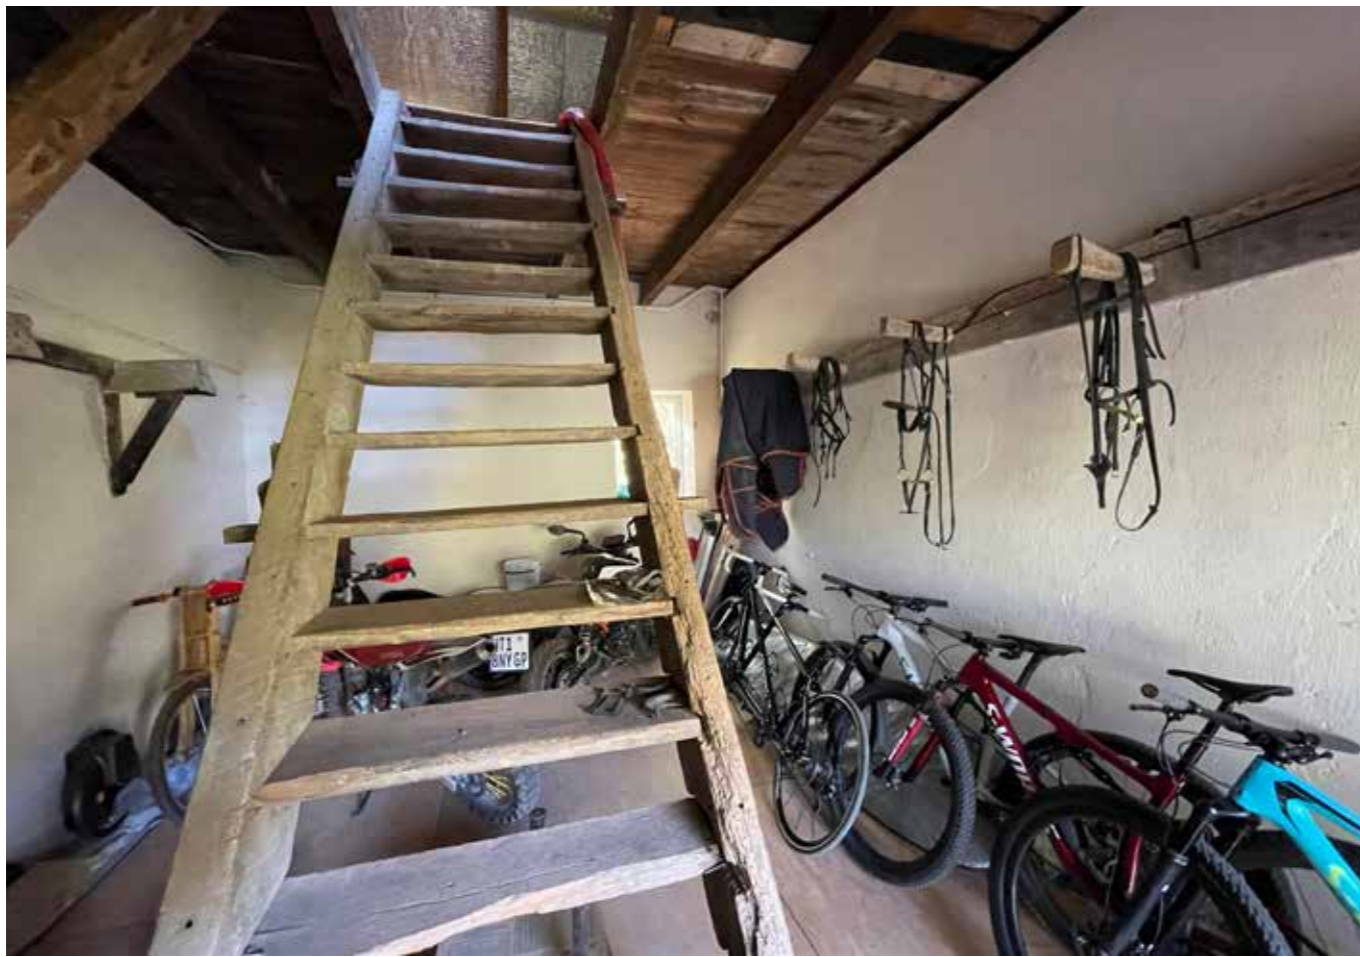
Figure 13. Central entrance space with access to attic and intact artefacts c1900 (Image: RSA 2023)

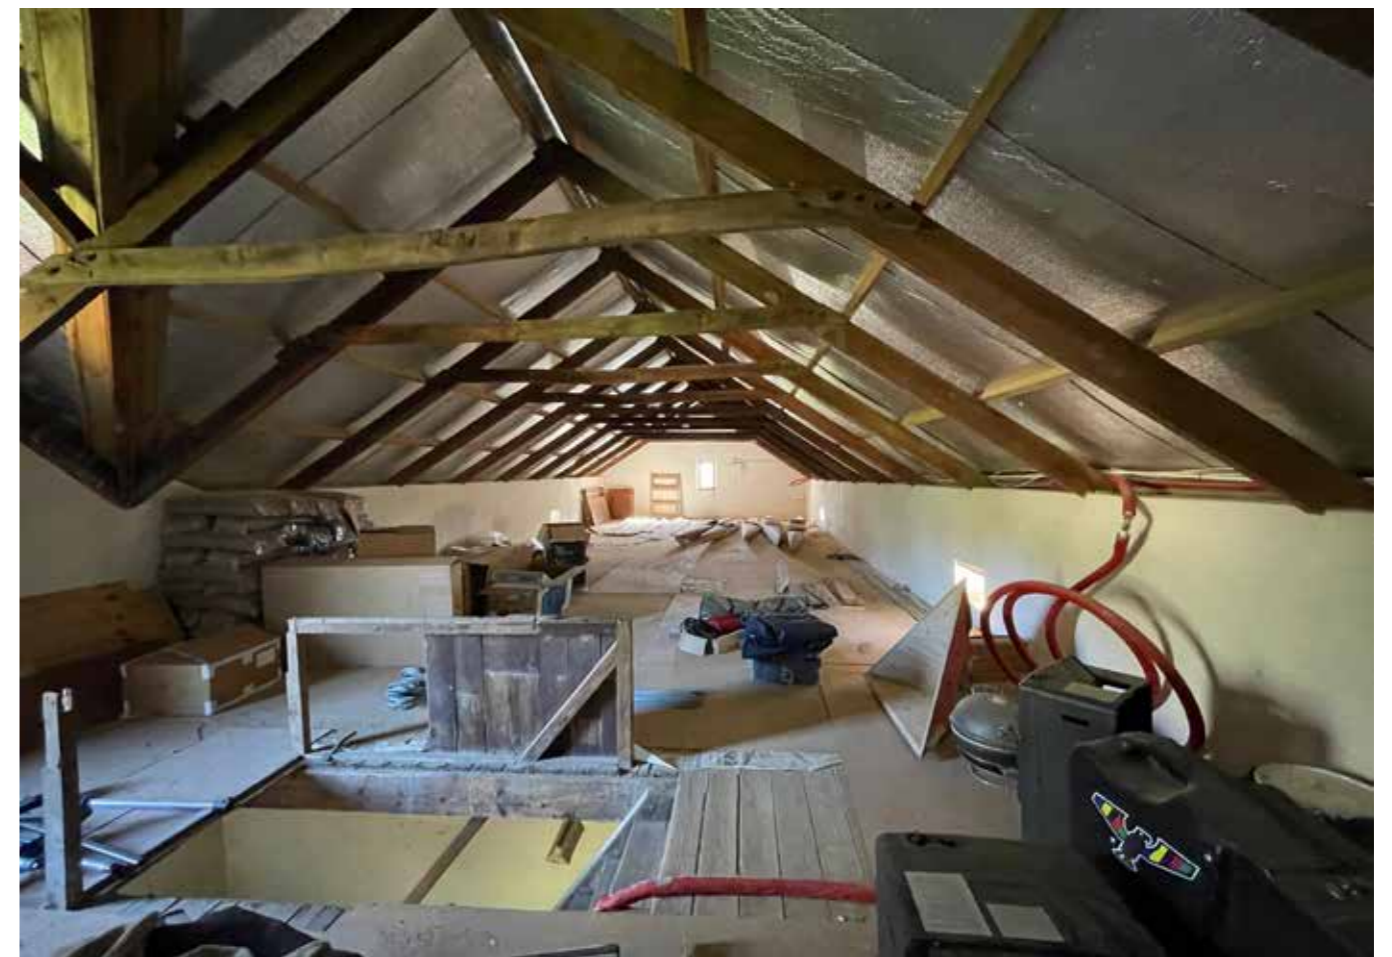
Figure 12. Open attic space with central gable and end gable windows (Image: RSA 2023)

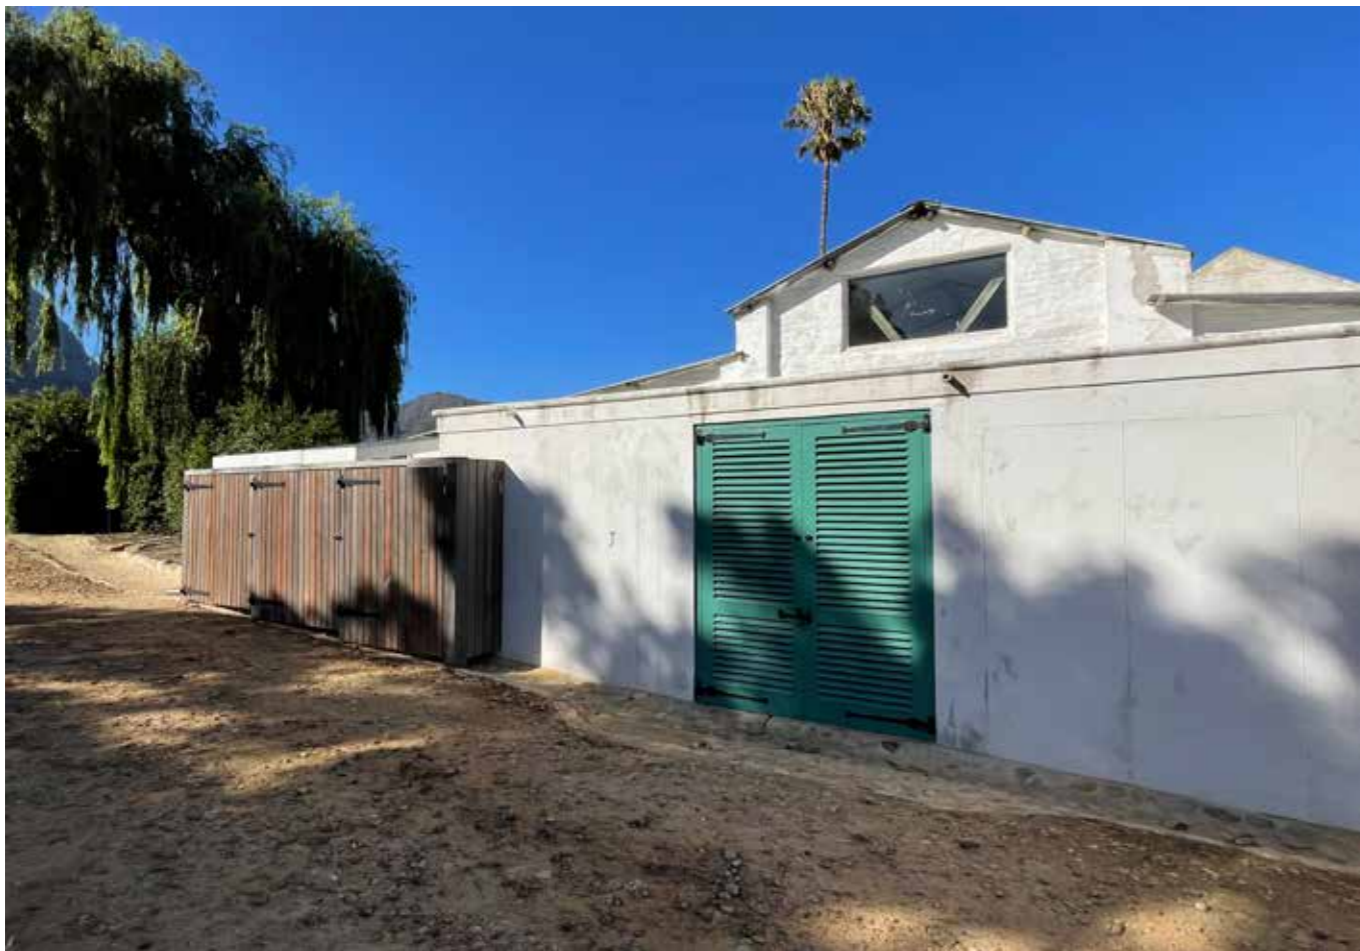
Figure 14. North east end wall of barn (Image: RSA 2023)

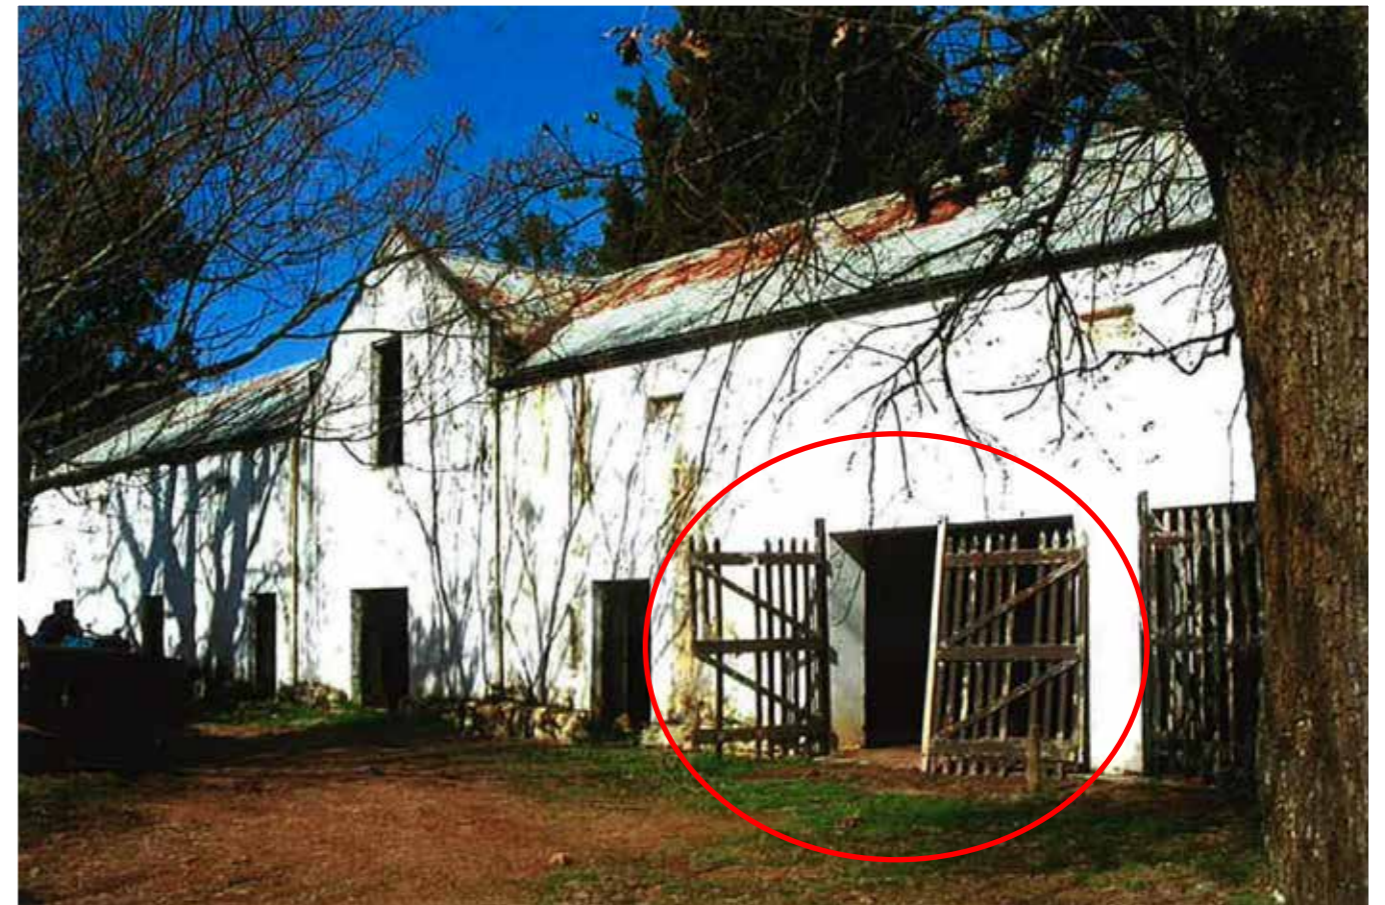
Figure 18. Front elevation with slatted garage doors; detail of shutters (indicated in red) to be replicated and reinstated (Image: Vos 2011)

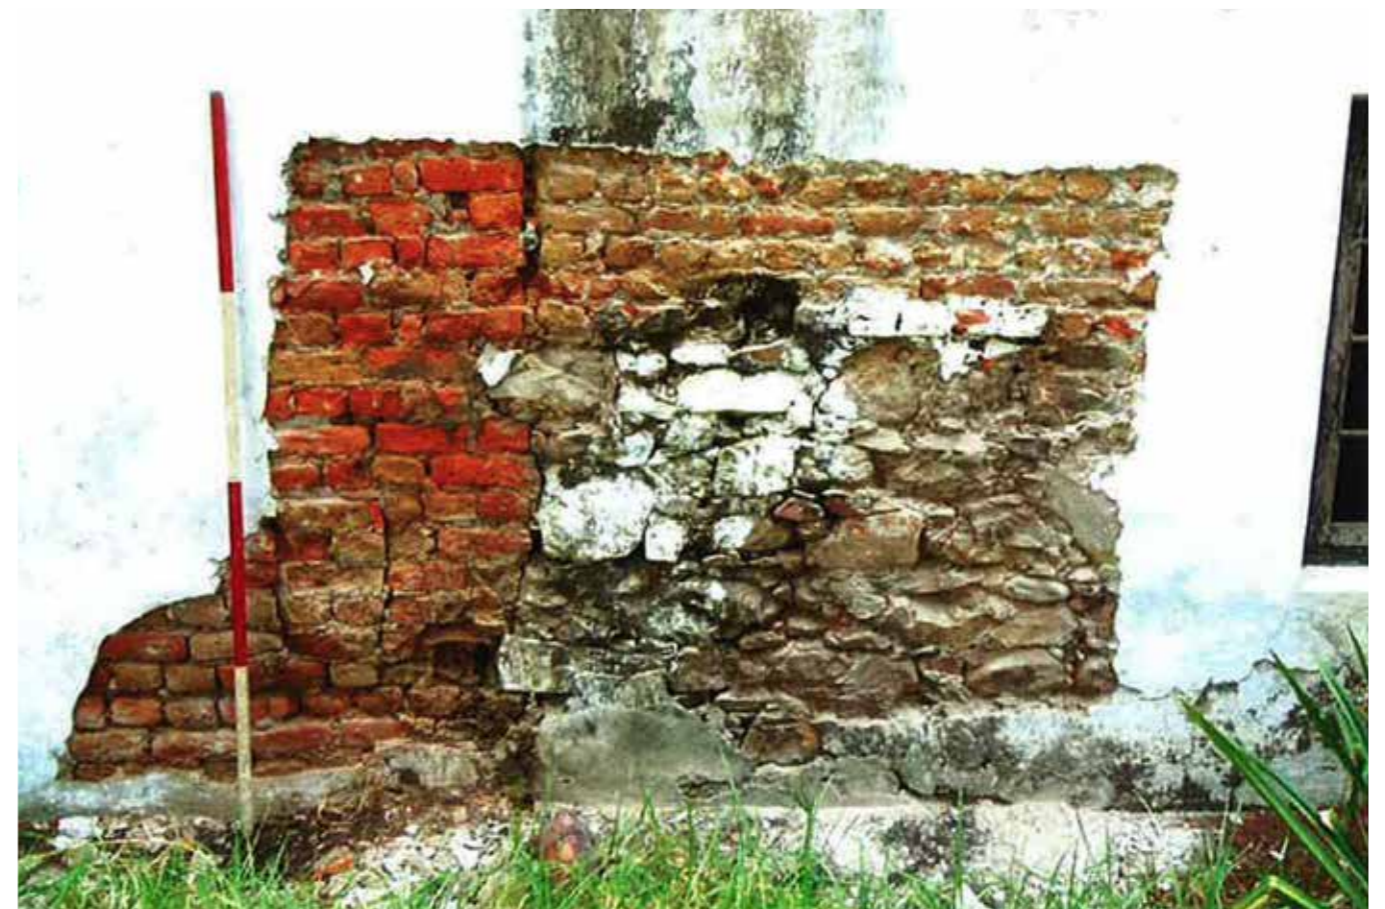
Figure 19. Building morphology: stone walling of phase 1 meets brick walling of phase 2 c1780+. (Image: Vos 2011)

Vos noted that the fabric demonstrates informal reuse of materials, and the integration, and occasionally merging, of old with new in each phase of redevelopment. He highlighted the presence and evocative quality of well worn threshold stones, and iron straps reinforcing a cracked c1800 ceiling beam.

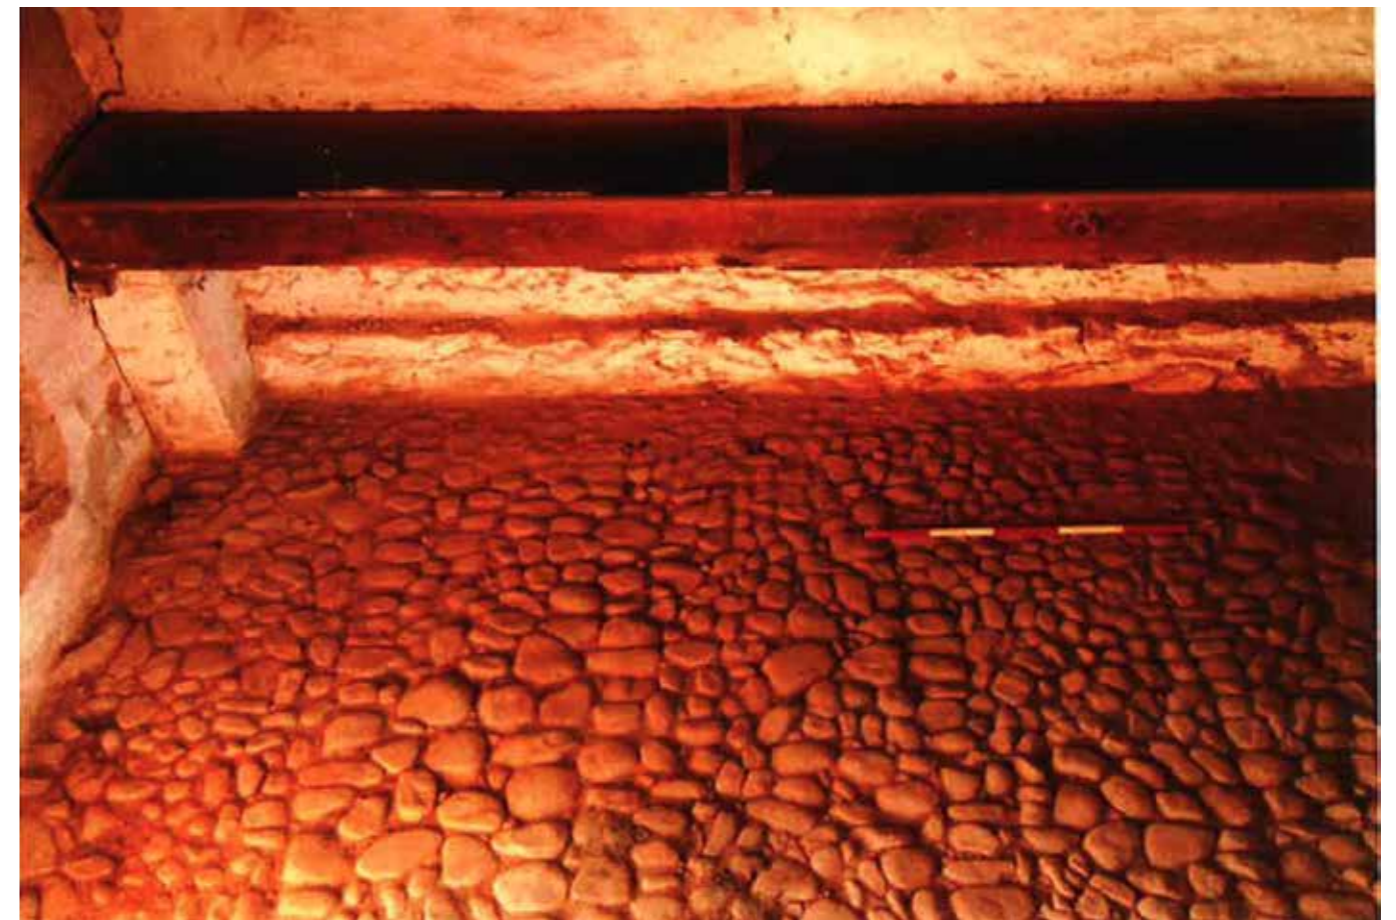
Figure 20. Cobble floor and timber crib (Image: Vos 2011)

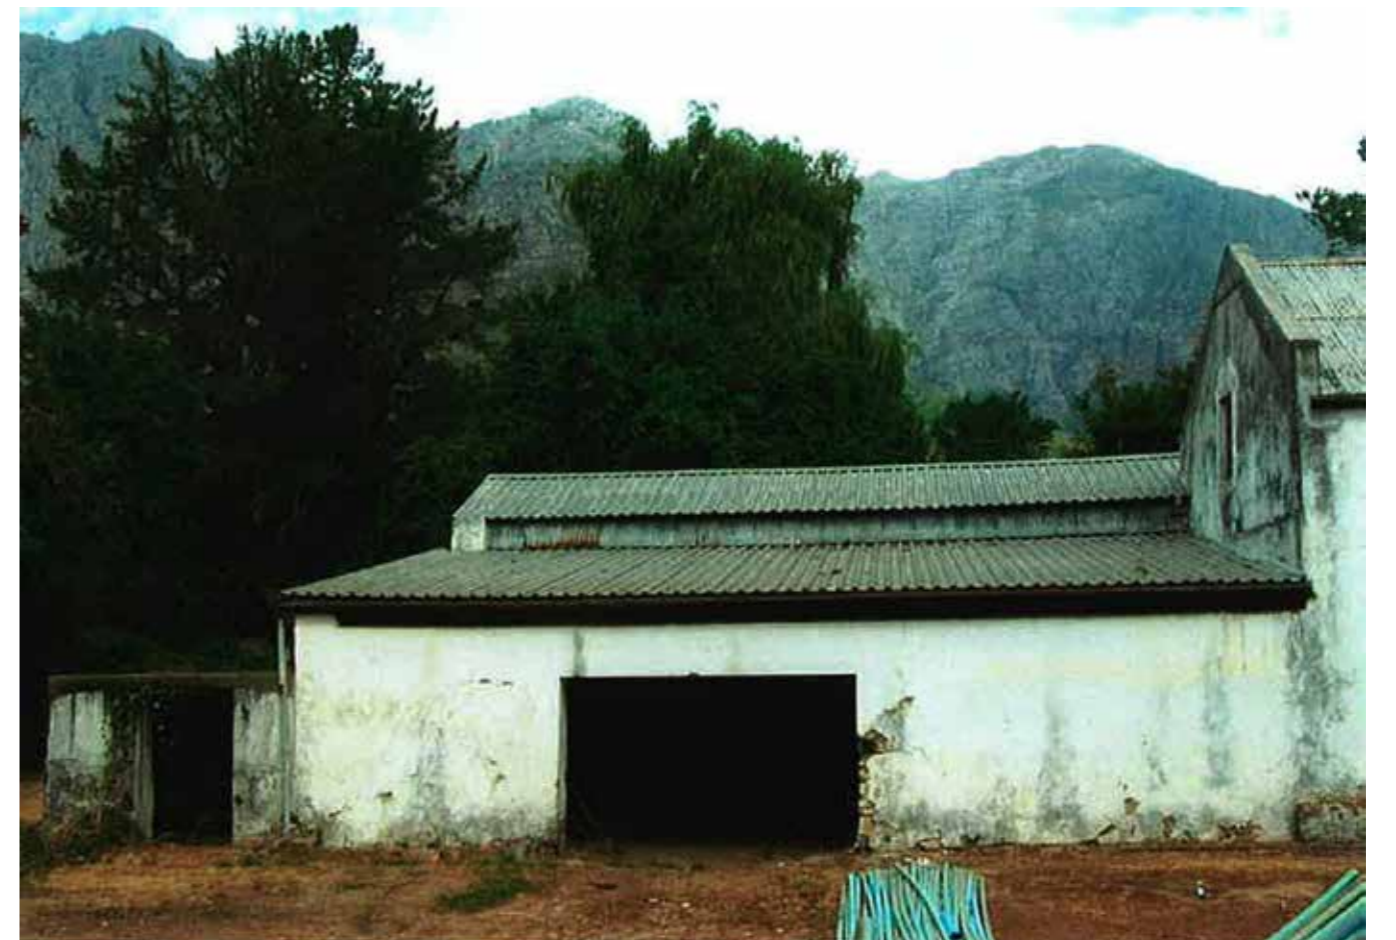
Figure 21. Barn viewed from front, axial road (Image: Vos 2011)

Described as barn-cum-kraal by Vos (2011), like the stables, the barn building has evolved in an ad hoc manner from the mid-18thC to mid-20thC. It abuts the stable building as a slightly later addition. Fabric evidence suggest a utilitarian, agricultural use throughout. The earliest walling is dressed stone on a stone footing (no plinth), to a height of 2m, suggesting first use as a kraal.

The upper walls, added a little later, are brick built with evidence of there once being a thatch roof, possibly half-hipped at the east end. Evidence of lean-to animal enclosures abut the outer walls. Given the large size of the barn building, it may follow the plan of similar valley farm settlement barns described by Vos as a pioneer period tripartite barns. In these examples, the internal floor plan has dividing walls and flooring for unique functions: storage of cereals and animal feed, animals and other uses. However, the evidence for this not clear in the remaining fabric.

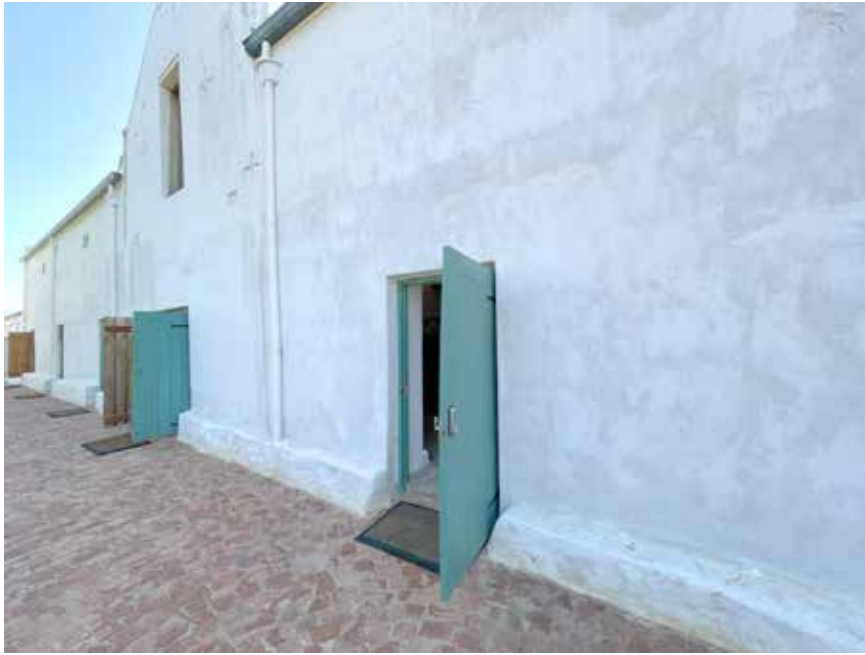
Careful intervention with stone plinth and thresholds on front/north elevation

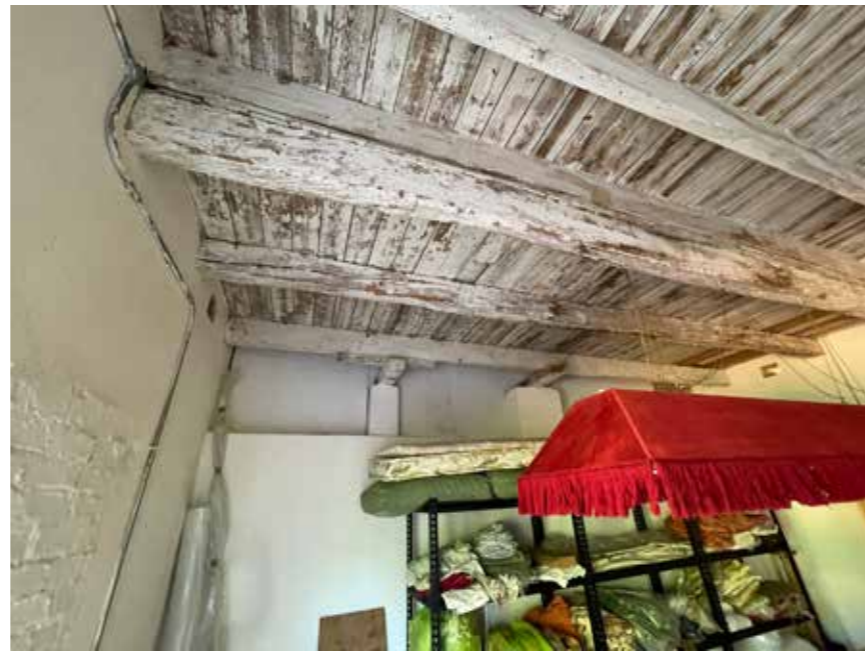
Retain and celebrate evidence of layering

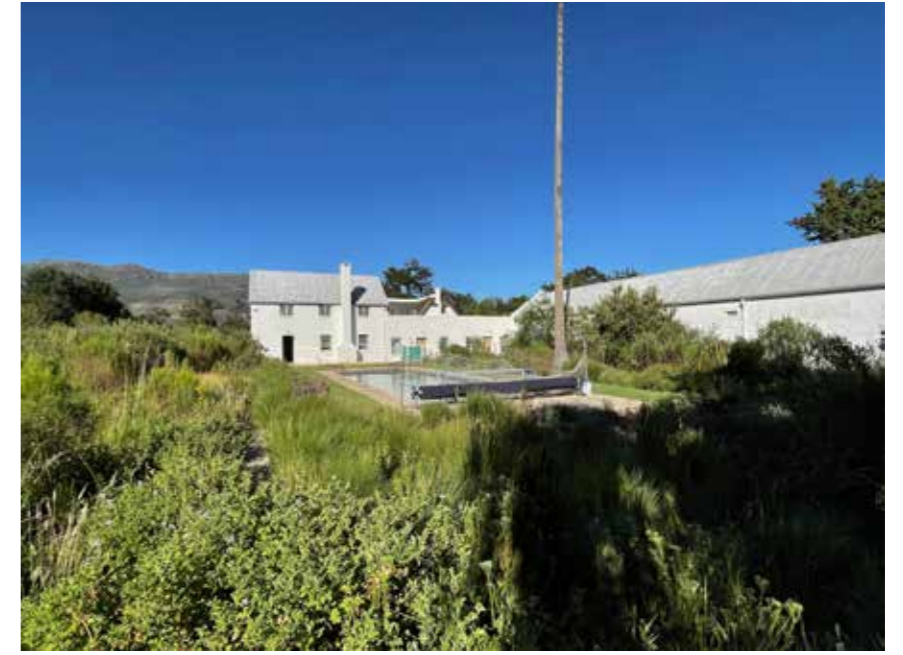
Rear/south werf garden area: has the capacity to comfortably absorb a new intervention

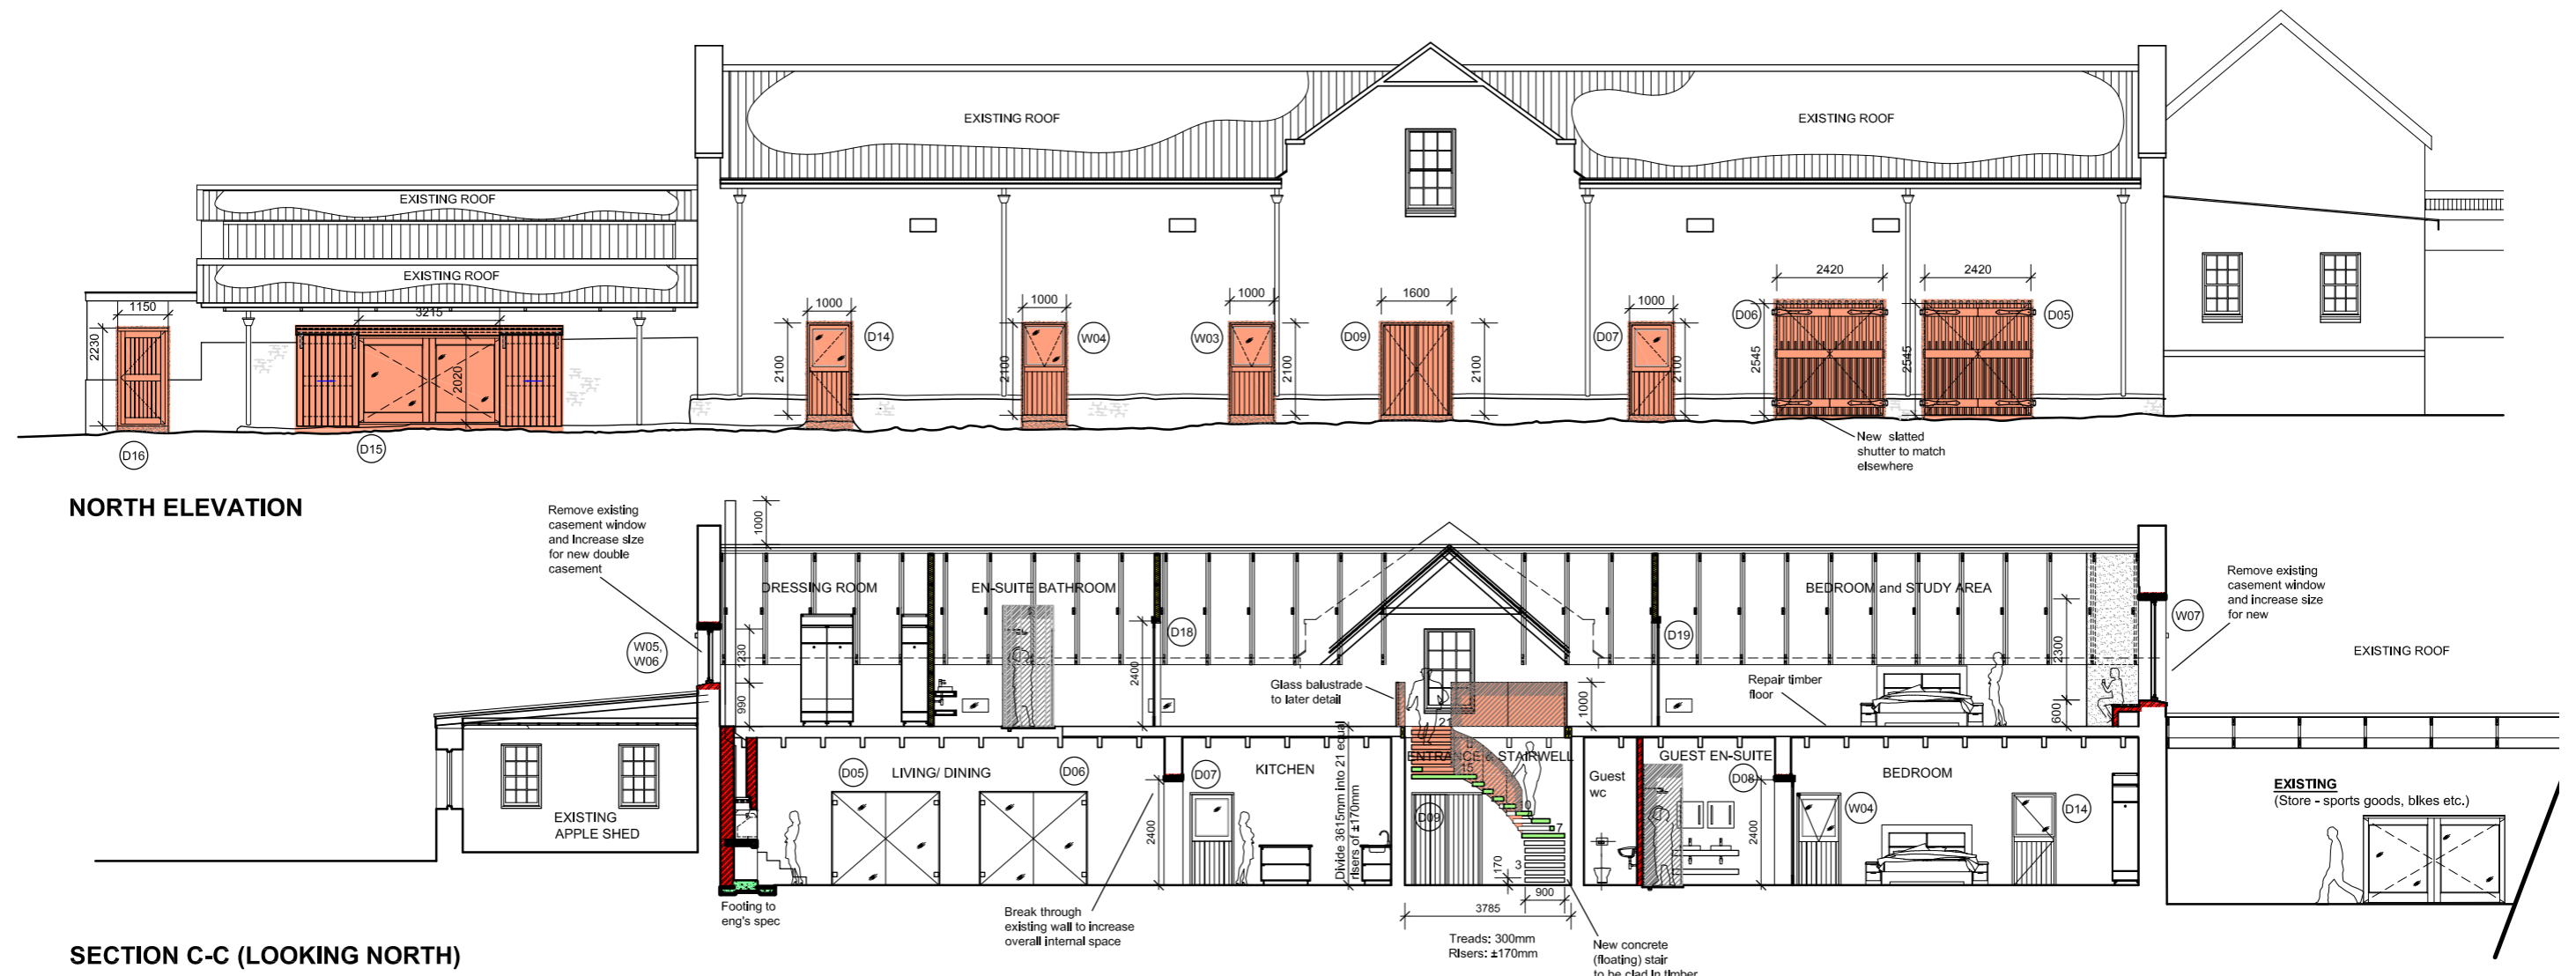
Figure 27. Development proposal: front elevation and section (RSA 2023)

- 2 doors are replaced by windows with glazed upper half set on fixed timber slat lower half, to replicate the appearance of a stable door. Stone plinth and existing threshold stones are retained with no impact to fabric or appearance.
- Timber slat garage/barn doors to be re-instated to cover the large, existing openings of what becomes the lounge space.

- Walling is opened to accommodate 3 new double frameless glass doors with sliding barn shutters open to the rear/south-east.
- Existing fixed windows: 3 are removed, with openings bricked closed; 2 openings remain with new windows inserted.
- Three large dormer windows are added to the rear elevation as part of the attic conversion.
