**HERITAGE RESOURCES
IDENTIFICATION AND ASSESSMENT.**

Olifants River Water Resources

Development Project Phase 2

Name and geographical location of the site(s) and/ or project: ORWRDP Phase 2B to 2F of the proposed pipelines and associated borrow pits in the Steelpoort and Olifants River Valleys respectively.

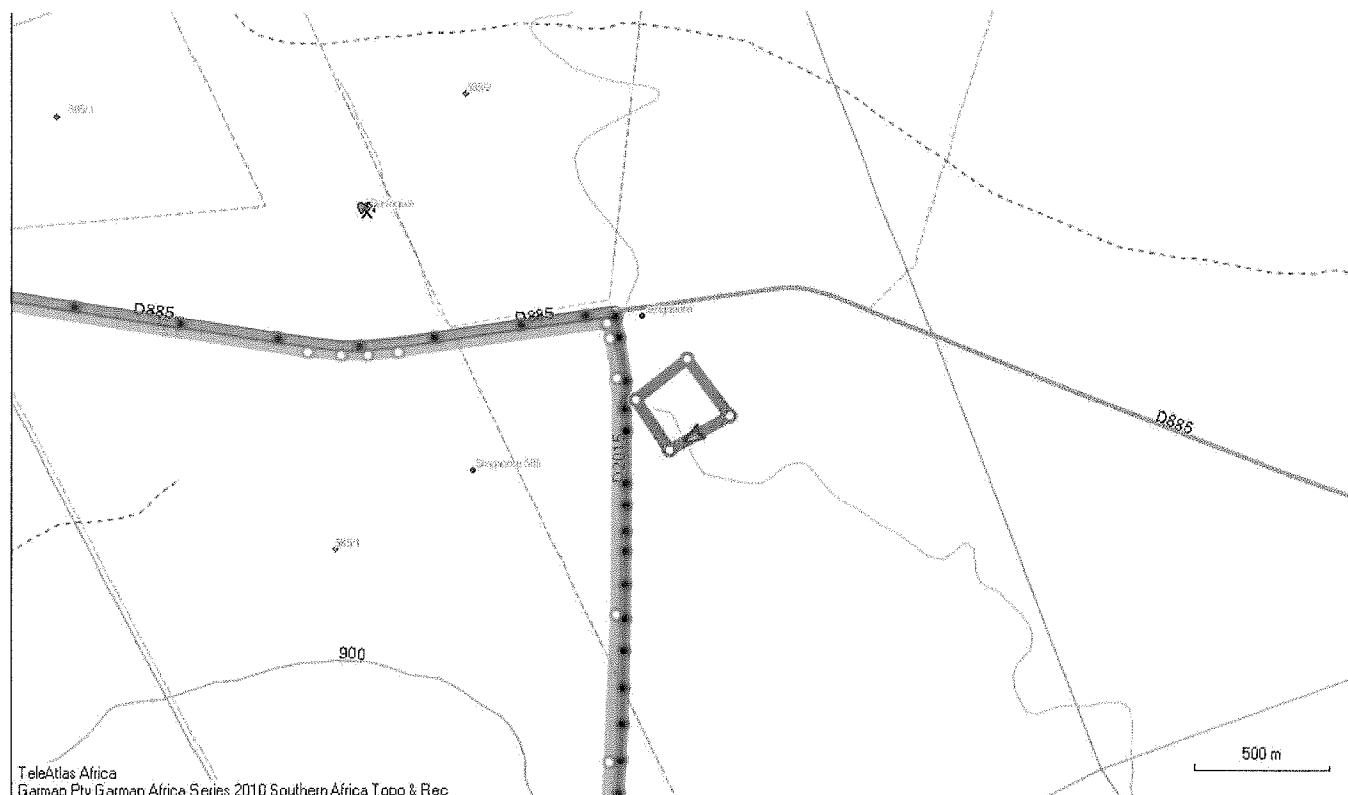
Figure 11. Transect log plot indicating the survey.

The area surveyed corresponds directly with the indicated proposed borrow pit area. Refer Figure 11 for a transect log plot indicating the survey.

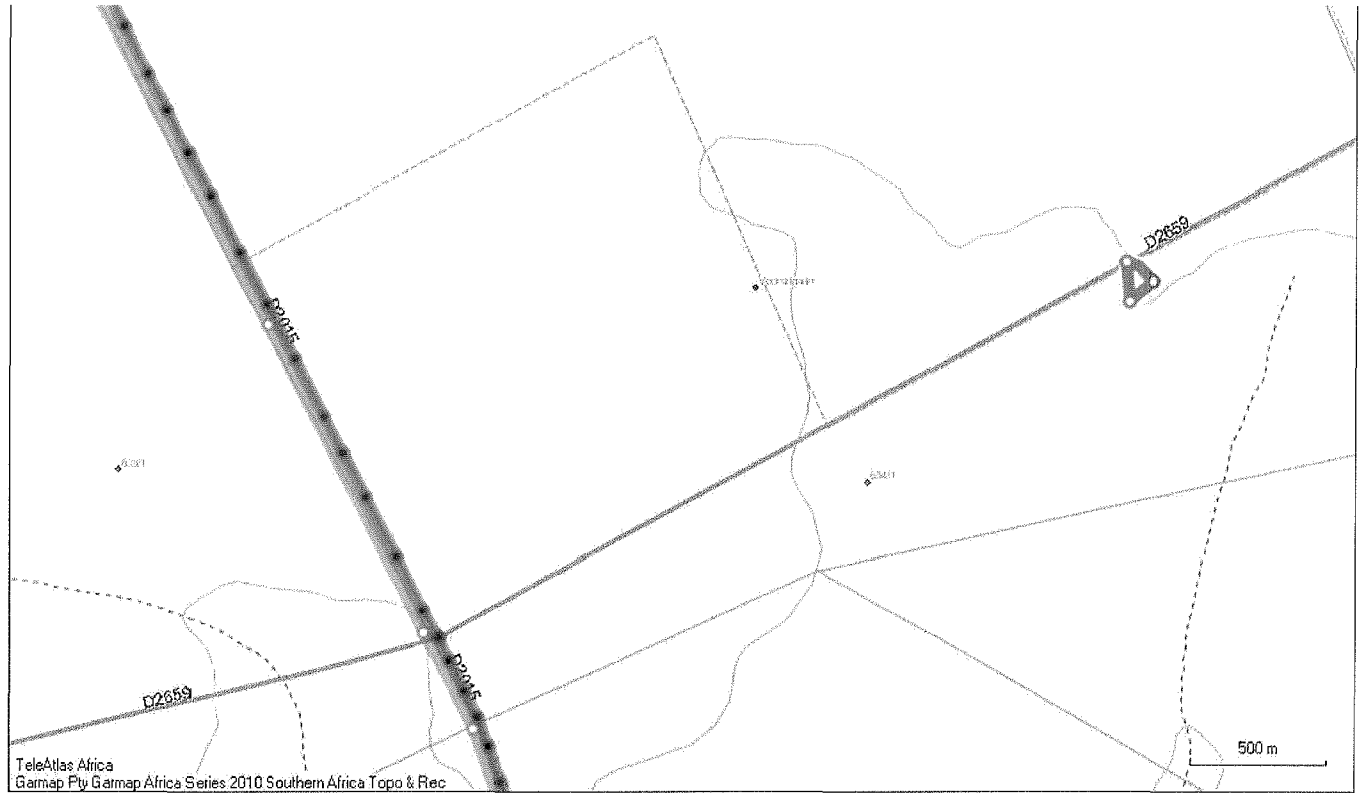
Figure 13. Transect log plot indicating the survey.

The area surveyed corresponds directly with the indicated proposed borrow pit area. Refer Figure 13 for a transect log plot indicating the survey.

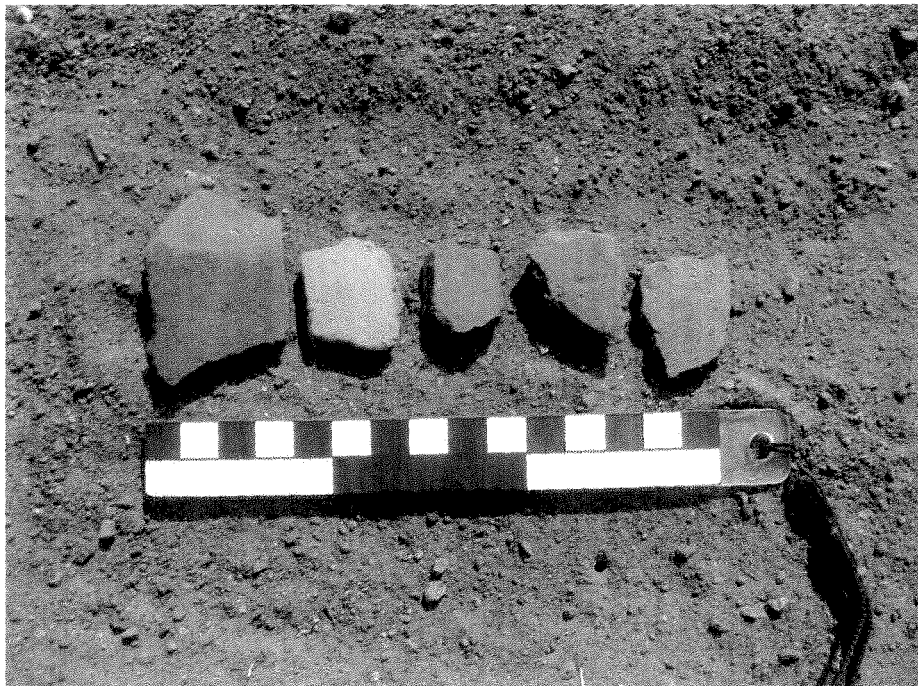
Figure 33. Artifacts at Site ORW 2.

- Non-diagnostic potsherds were found at the site (Fig. 33).

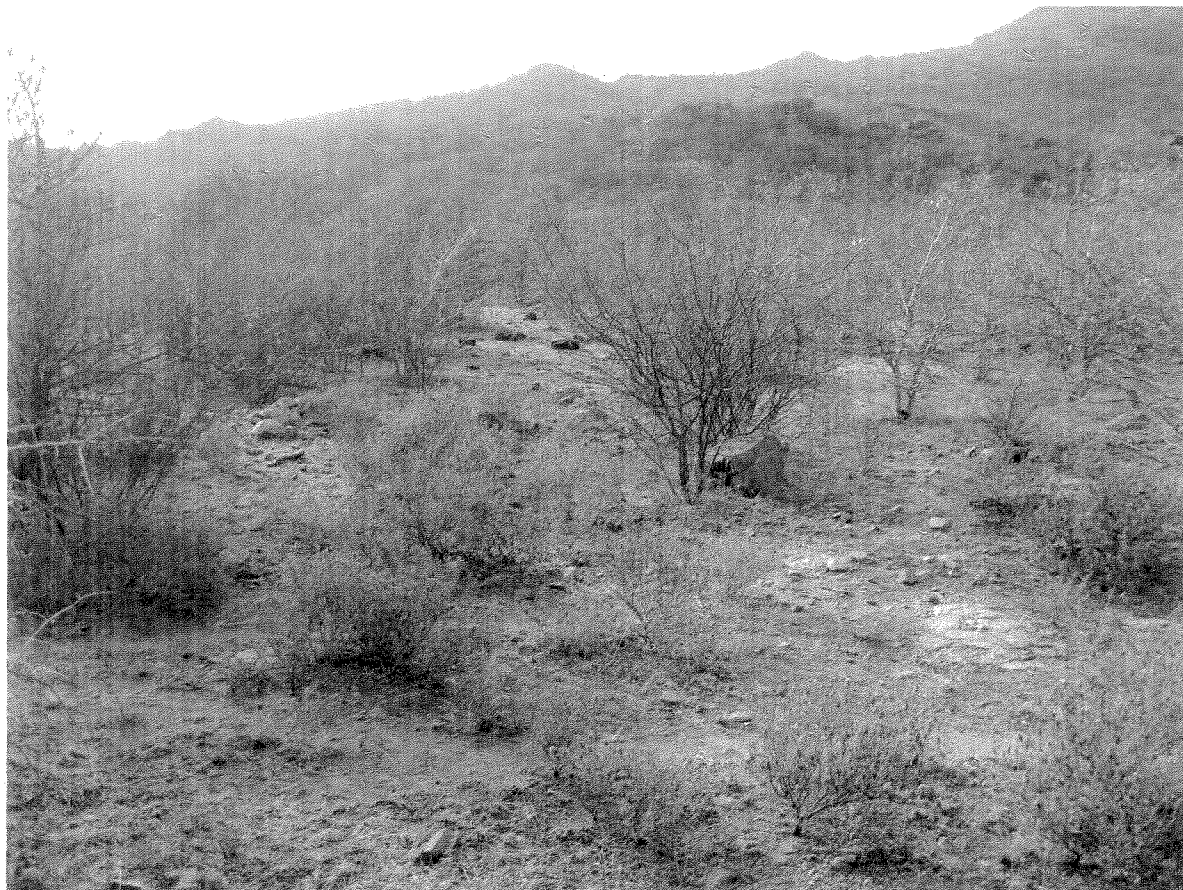
Figure 35. Artefacts at site ORW4.

- Non-diagnostic ceramics (Fig. 35).

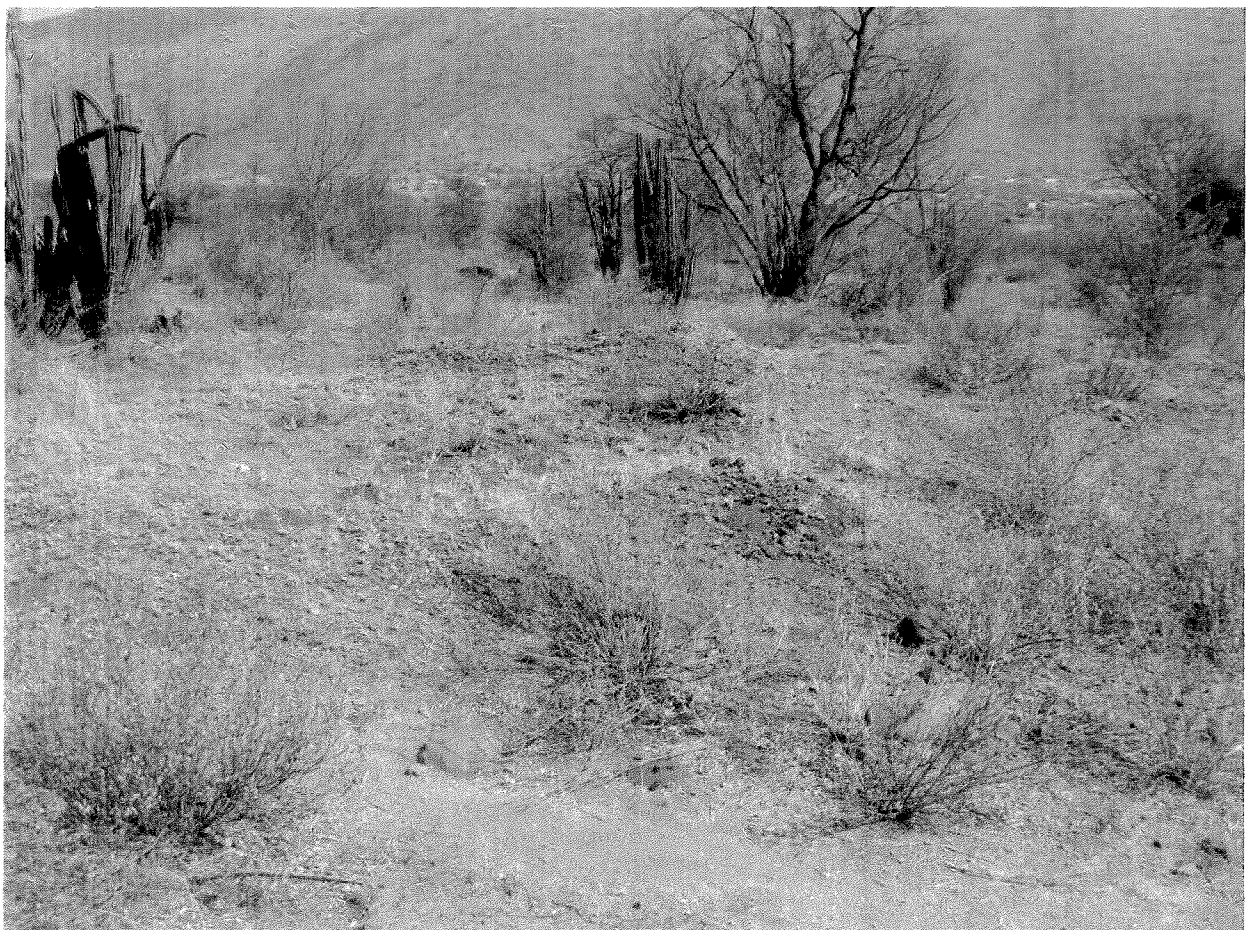
Figure 37. General photograph of Site ORW 5.

The remains and the foundations of a cluster of dilapidated structures were identified at this location. The remains consisted basically of packed lines of rocks which were used in the foundations of these structures on which mud-brick walls were built. These structures were predominantly square or rectangular in shape and the rooms measured approximately 5m x 5m. A few metal artefacts such as wire and cans were observed amongst the remains of the structures.

Significance: Moderate significance. The structures themselves have little or no heritage value or significance due to their relevant recent origins from within the last 60 years. The structures, however should be avoided, but if this deems not to be possible, a watching brief is recommended due to the possibility of infant human remains underneath the remains of the structures.

- Appoint a suitably accredited archaeologist on a watching brief to monitor construction activities.

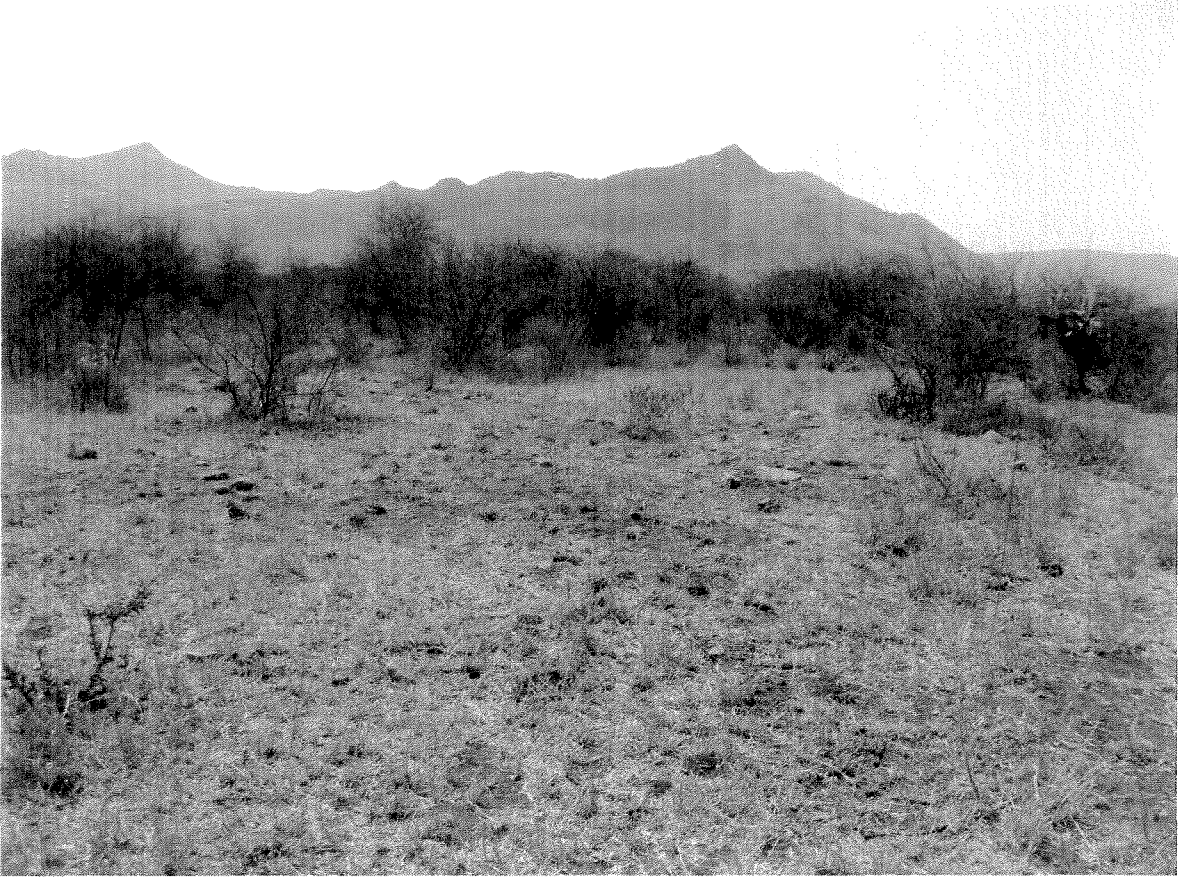
Figure 39. Site ORW 10.

- Due to the disturbance by previous ploughing the sub-terranean features of the site has been destroyed. Some indications of possible grain bin foundations and habitational structures were observed, but none are intact.

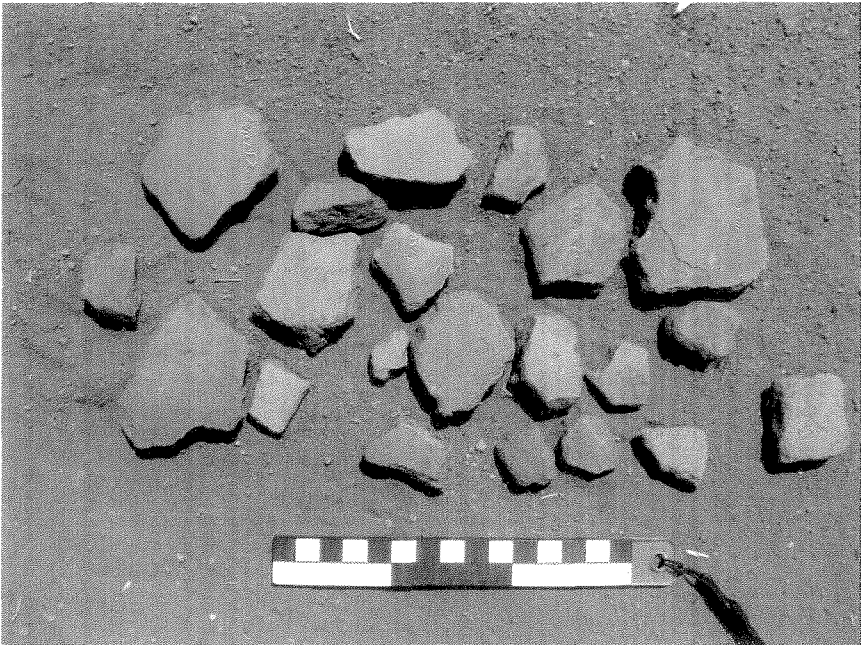
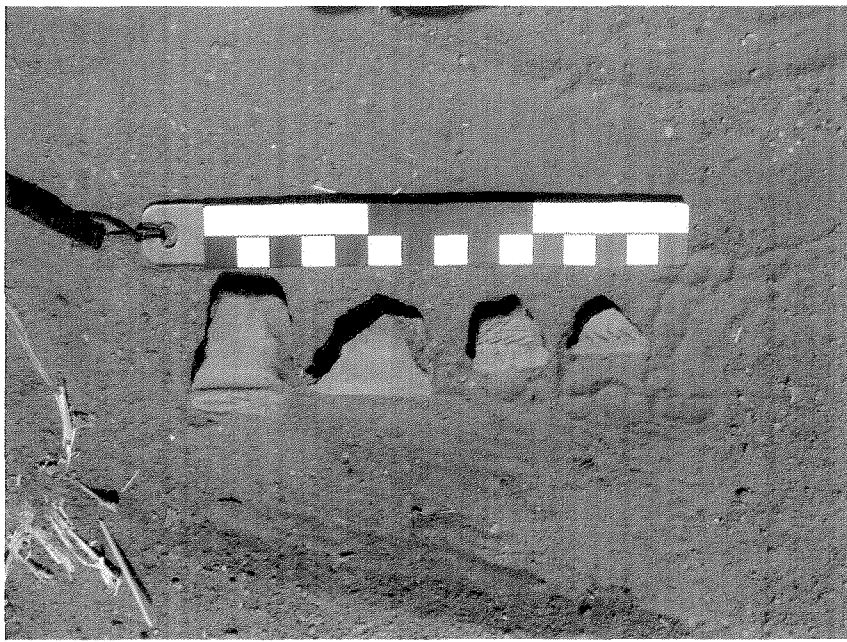
Figure 40(a). Artefacts at Site ORW 10.

- Non- diagnostic potsherds were found at the site (Fig. 40). Although some fragments showed possible decoration, this was not sufficient to ascribe the site to a particular ceramic facies or tradition.

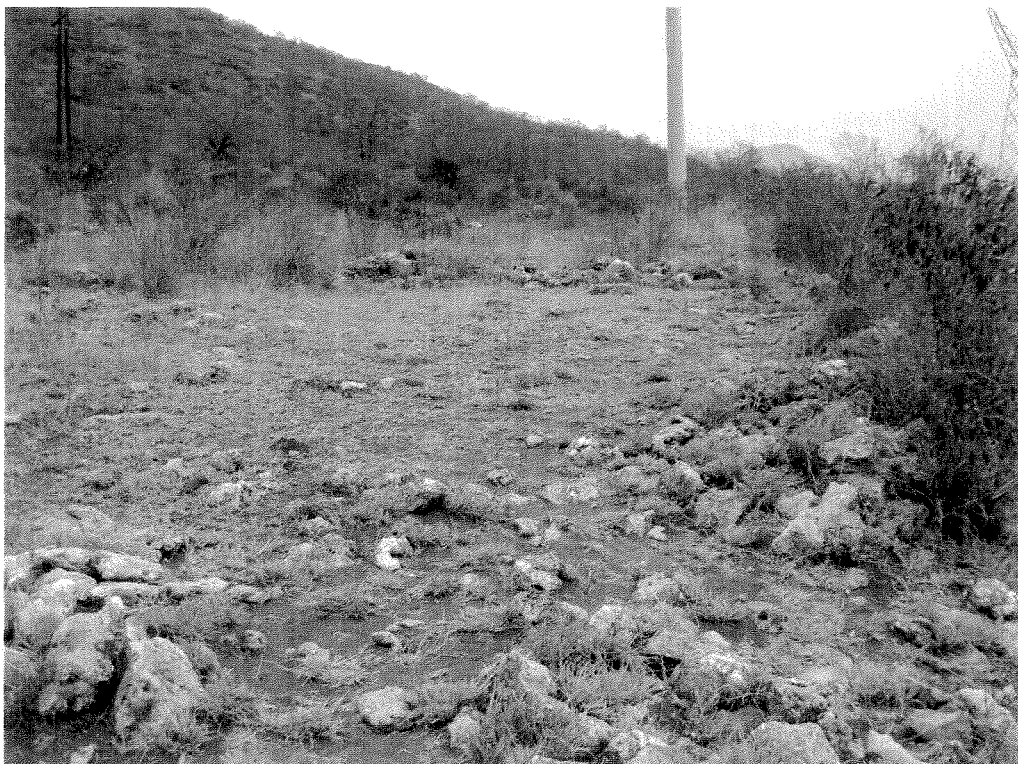
Figure 41. General photograph of Site ORW 11.

The remains and the foundations of a cluster of dilapidated structures were identified at this location. The remains consisted basically of packed lines of rocks which were used in the foundations of these structures on which mud-brick walls were built. These structures were predominantly square or rectangular in shape and the rooms measured approximately 5m x 5m. A few metal artefacts such as wire and cans were observed amongst the remains of the structures.

Significance: Moderate significance. The structures themselves have little or no heritage value or significance due to their relevant recent origins from within the last 60 years. The structures, however should be avoided, but if this deems not to be possible, a watching brief is recommended due to the possibility of infant human remains underneath the remains of the structures.

- Appoint a suitably accredited archaeologist on a watching brief to monitor construction activities.

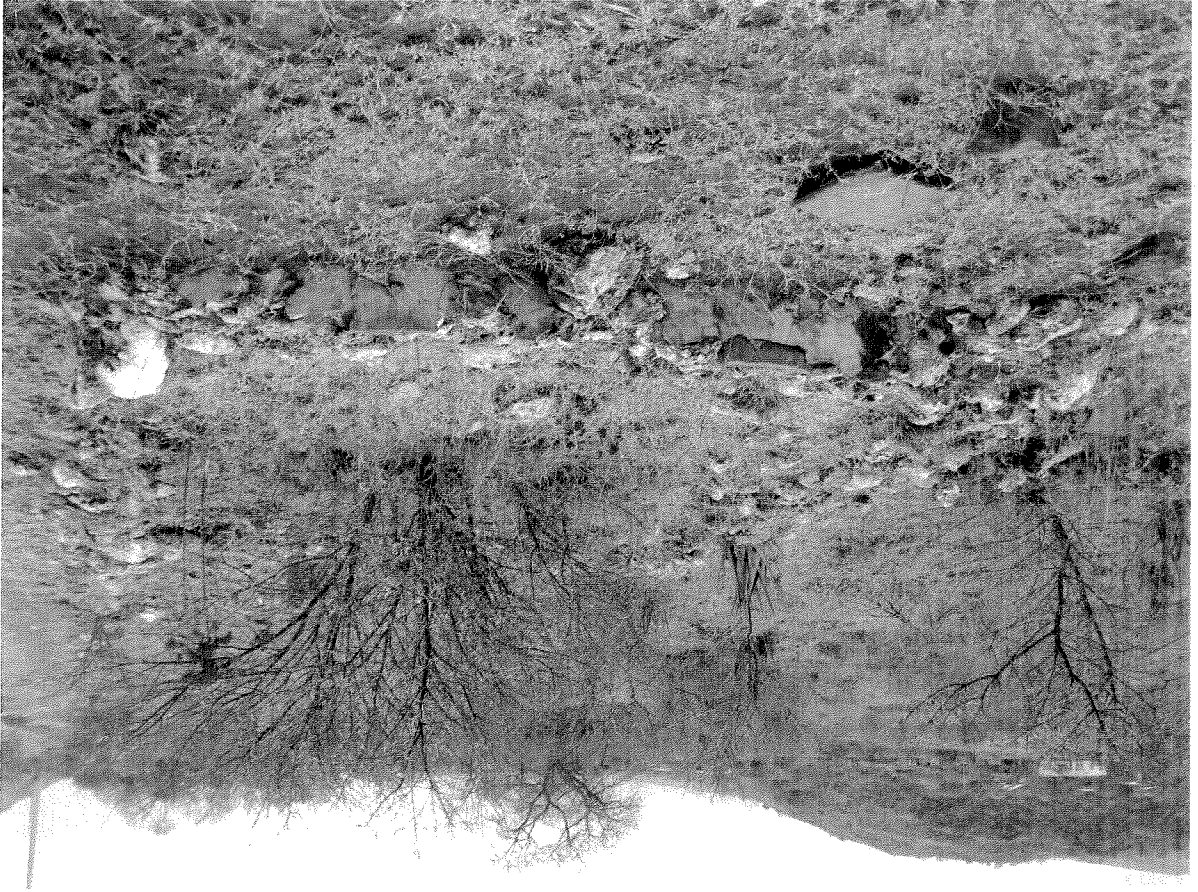
Figure 43. General photograph of Site ORW 12.

The remains and the foundations of a cluster of dilapidated structures were identified at this location. The remains consisted basically of packed lines of rocks which were used in the foundations of these structures on which mud-brick walls were built. These structures were predominantly square or rectangular in shape and the rooms measured approximately 5m x 5m. A few metal artefacts such as wire and cans were observed amongst the remains of the structures.

Significance: Moderate significance. The structures themselves have little or no heritage value or significance due to their relevant recent origins from within the last 60 years. The structures, however should be avoided, but if this deems not to be possible, a watching brief is recommended due to the possibility of infant human remains underneath the remains of the structures.

- Appoint a suitably accredited archaeologist on a watching brief to monitor construction activities.

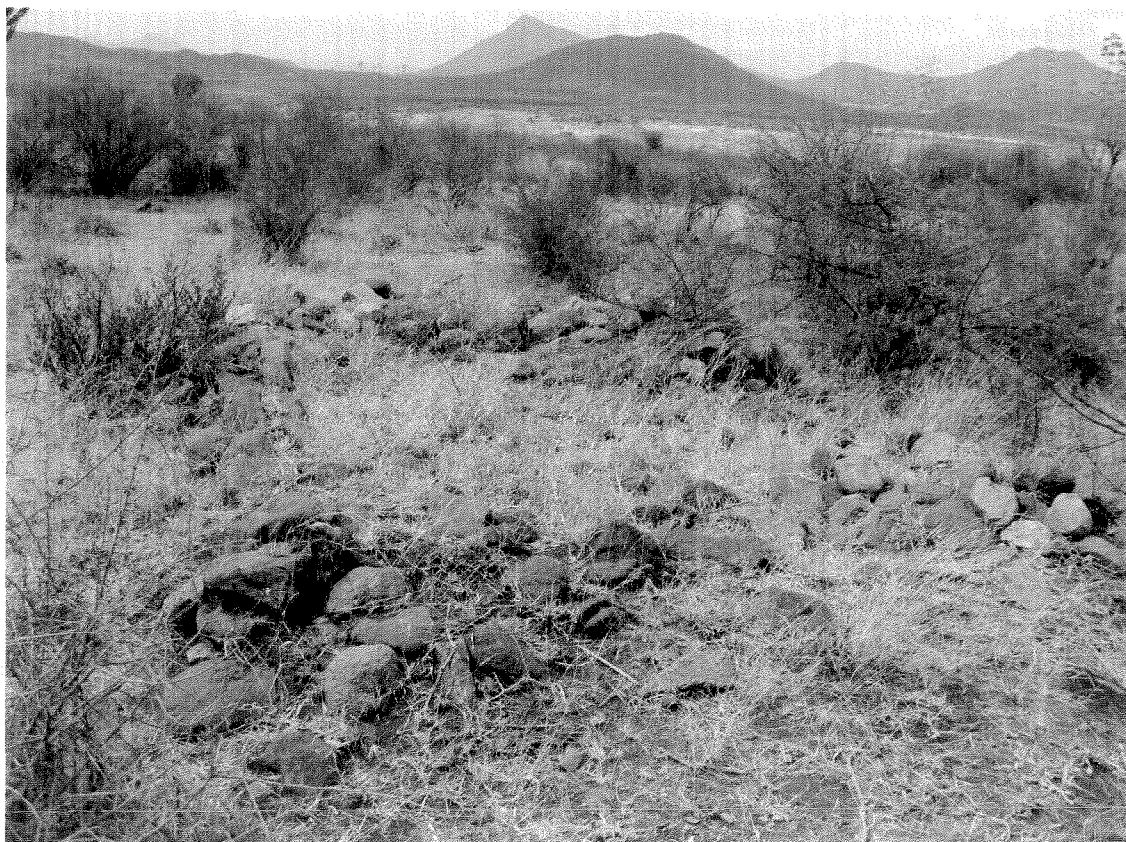
Figure 45. General photograph of Site ORW 14.

The remains and the foundations of a cluster of dilapidated structures were identified at this location. The remains consisted basically of packed lines of rocks which were used in the foundations of these structures on which mud-brick walls were built. These structures were predominantly square or rectangular in shape and the rooms measured approximately 5m x 5m. A few metal artefacts such as wire and cans were observed amongst the remains of the structures.

Significance: Moderate significance. The structures themselves have little or no heritage value or significance due to their relevant recent origins from within the last 60 years. The structures, however should be avoided, but if this deems not to be possible, a watching brief is recommended due to the possibility of infant human remains underneath the remains of the structures.

- Appoint a suitably accredited archaeologist on a watching brief to monitor construction activities.

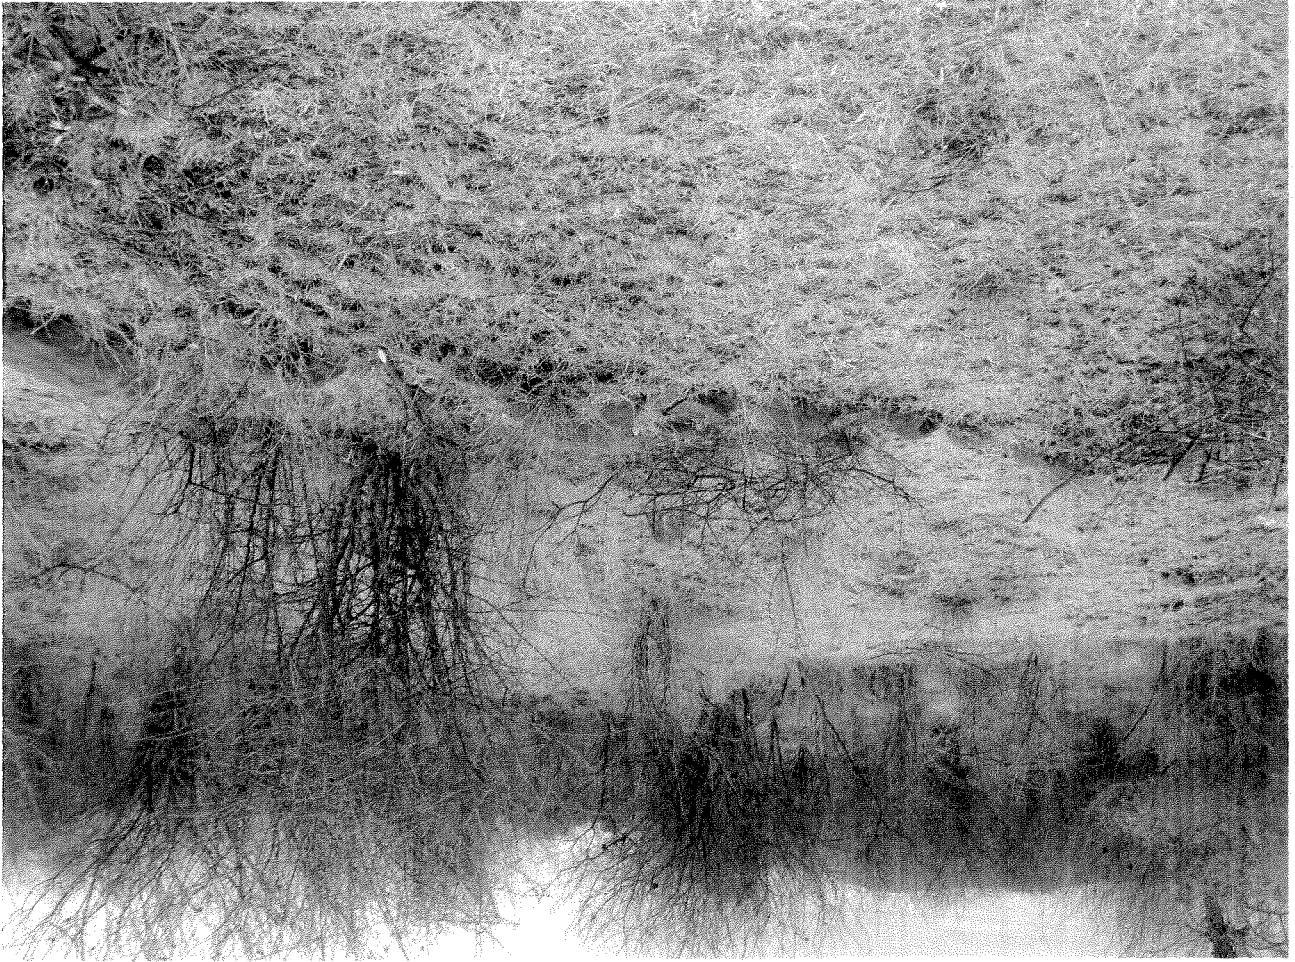
Figure 46. General photograph of Site ORW 15.

The remains and the foundations of a cluster of dilapidated structures were identified at this location. The remains consisted basically of packed lines of rocks which were used in the foundations of these structures on which mud-brick walls were built. These structures were predominantly square or rectangular in shape and the rooms measured approximately 5m x 5m. A few metal artefacts such as wire and cans were observed amongst the remains of the structures.

Significance: Moderate significance. The structures themselves have little or no heritage value or significance due to their relevant recent origins from within the last 60 years. The structures, however should be avoided, but if this deems not to be possible, a watching brief is recommended due to the possibility of infant human remains underneath the remains of the structures.

- Appoint a suitably accredited archaeologist on a watching brief to monitor construction activities.

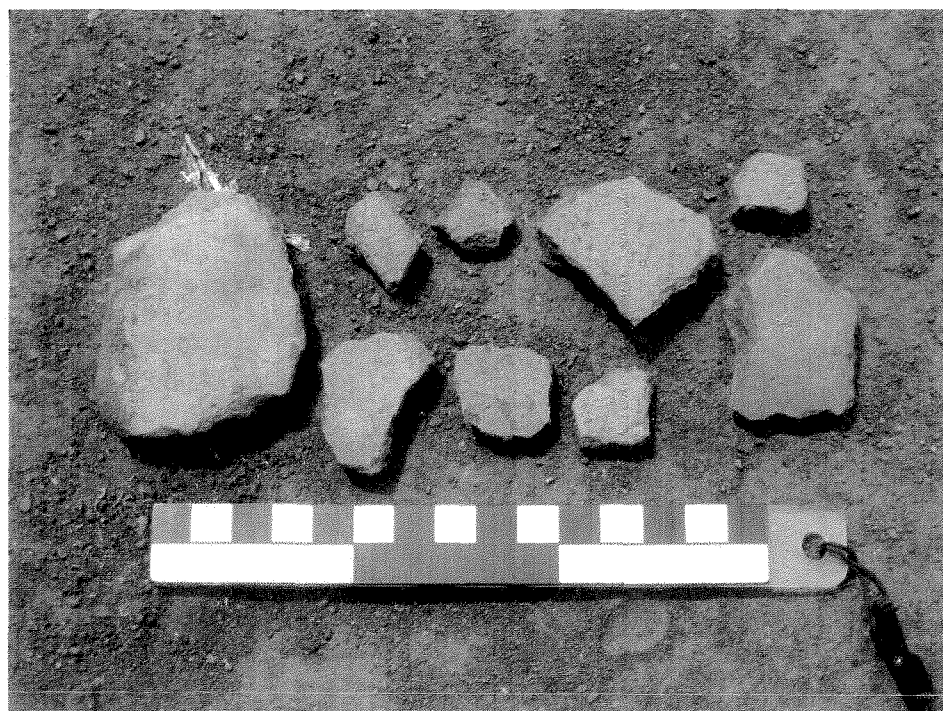
Figure 49. Artefacts at site ORW18.

- Non-diagnostic ceramics (Fig. 49).

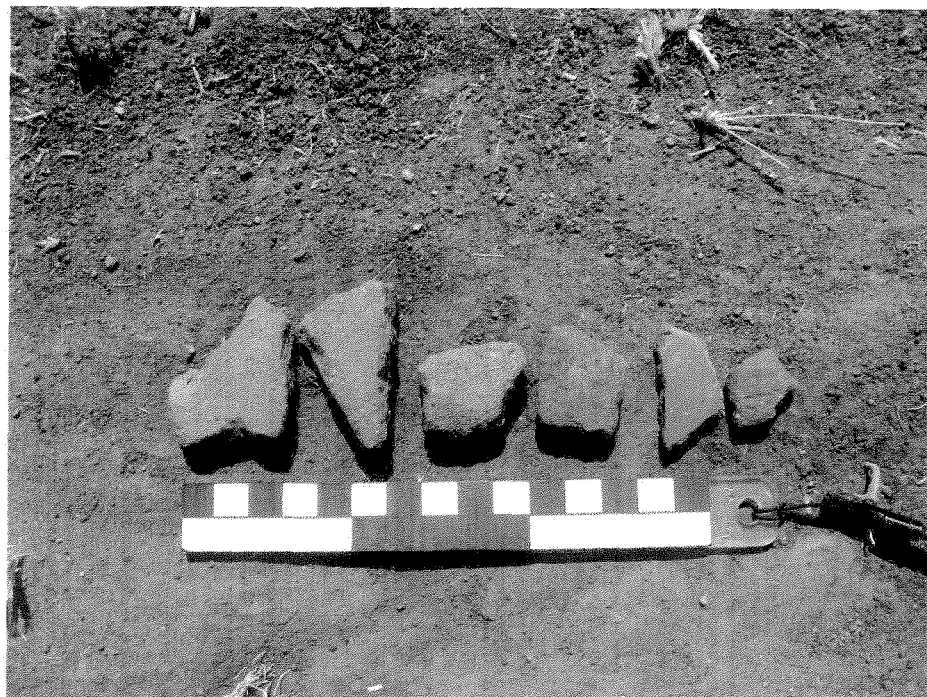
Figure 51. Artefacts at site ORW 19.

- Non-diagnostic ceramics (Fig. 51). Some fragments of ceramic display graphite burnishing which might indicate an affinity with the Marateng facies.

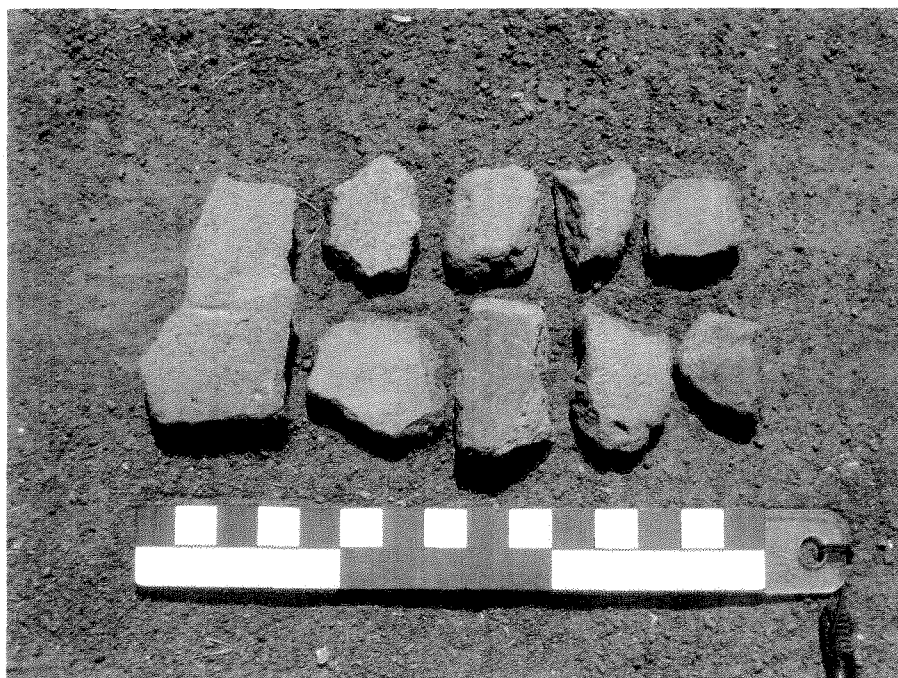
Figure 53. Artefacts at site ORW 20.

- Non-diagnostic ceramics (Fig. 53).

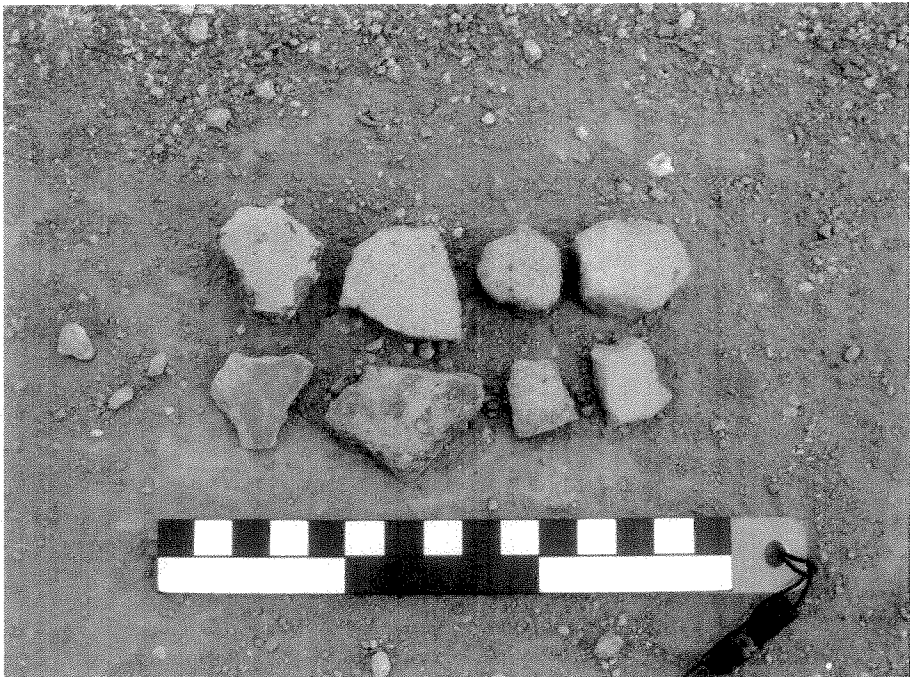
Figure 59. Artefacts at site ORW 26.

6.17.5 Non-diagnostic ceramics (Fig. 59). Two of the potsherds identified were coloured/decorated with ochre (Marateng).

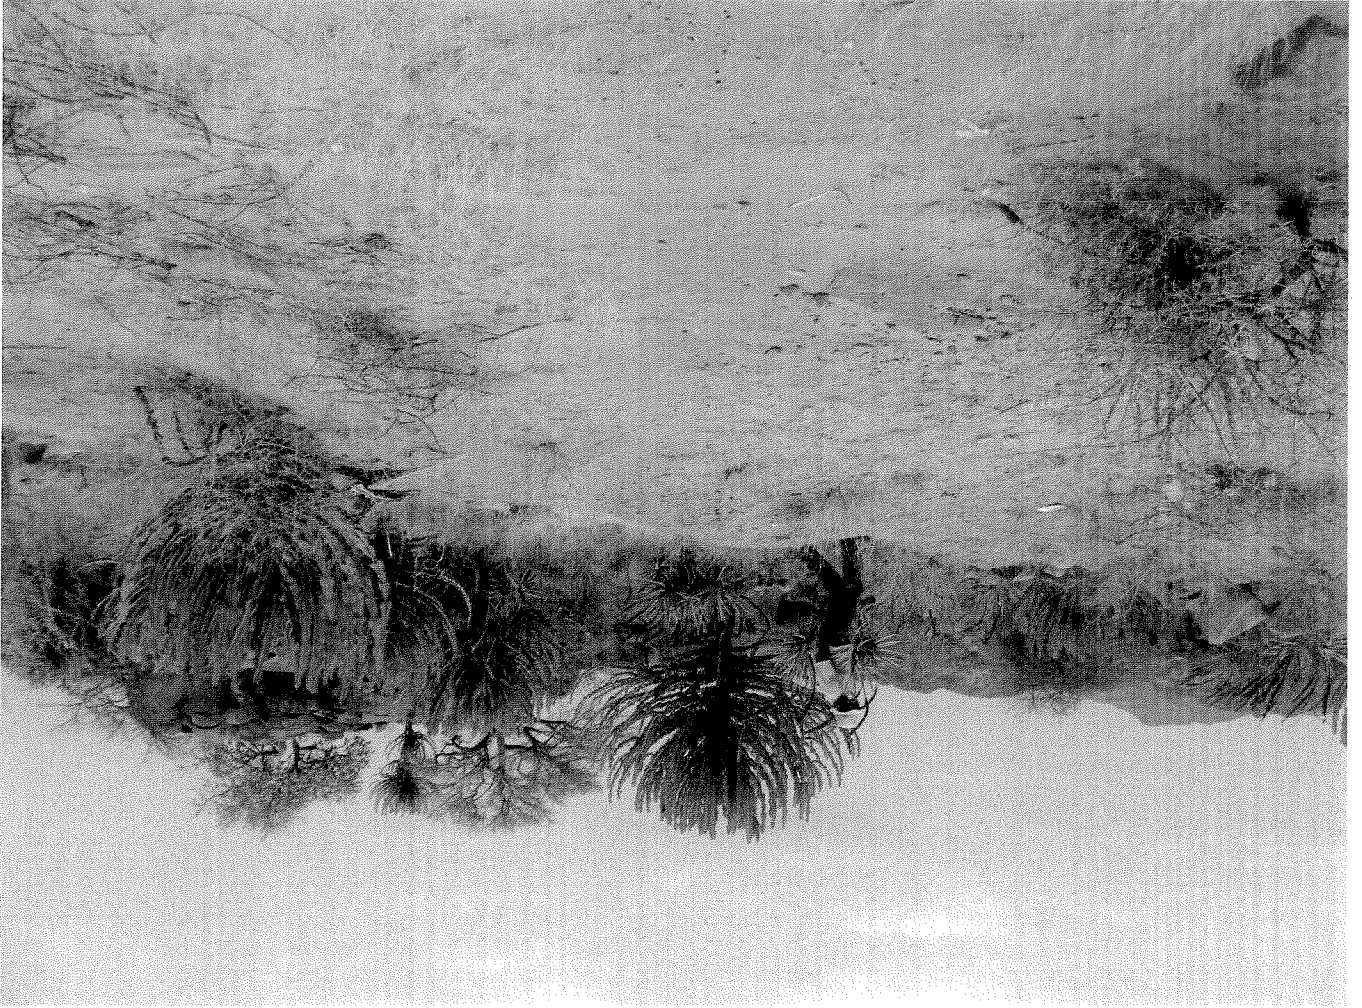
Figure 64. General photograph of Site ORW 29.

The remains and the foundations of a cluster of dilapidated structures were identified at this location. The remains of these structures were situated approximately 15m from the gravel road. The remains consisted basically of packed lines of rocks which were used in the foundations of these structures on which mud-brick walls were built. These structures consisted of one or more rooms which were predominantly square or rectangular in shape and the rooms measured approximately 5m x 5m. These structures served as home or as a homestead for their previous occupants. A few metal artefacts such as wire and cans were observed amongst the remains of the structures.

- Appoint a suitably accredited archaeologist on a watching brief to monitor construction activities.
