**A CULTURAL HERITAGE MANAGEMENT PLAN FOR THE
WONDERBOOM NATURE RESERVE, CITY OF TSHWANE**

***THE CITY OF TSHWANE, DEPARTMENT OF HOUSING, CITY PLANNING
AND ENVIRONMENTAL MANAGEMENT, DIVISION NATURE
CONSERVATION AND RESORTS***

REPORT: AE810

December 2008

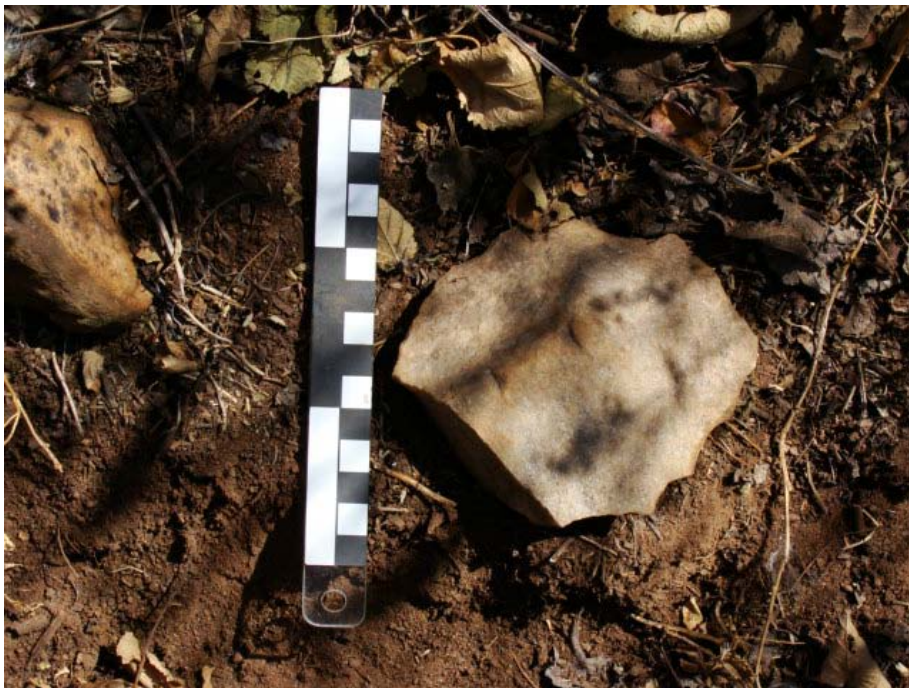
Although only two Stone Age sites were identified during the survey, a number of stone tools were found throughout the reserve. The lithic tools represent all three phases of the Stone Age and it therefore is clear that the hunter-gatherers associated with these extensively utilized the area.

Figure 4 Middle Stone Age tool identified during the survey.

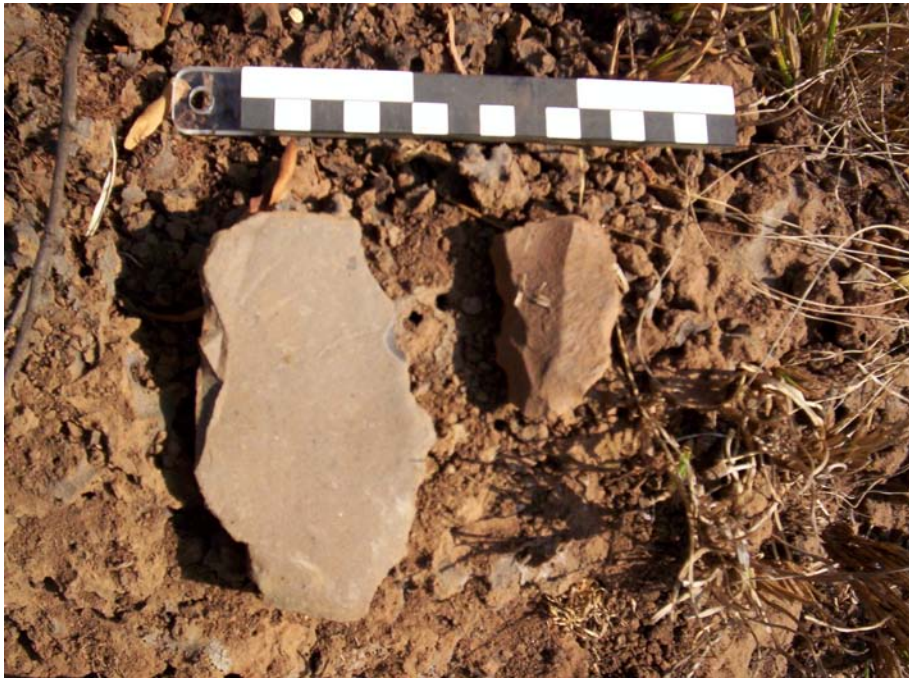
Figure 6 Middle Stone Age tools from site no 1.

The site is of a medium cultural significance as it may only be loose stone tools. The importance thereof is that it indicates that MSA people were present in this environment.

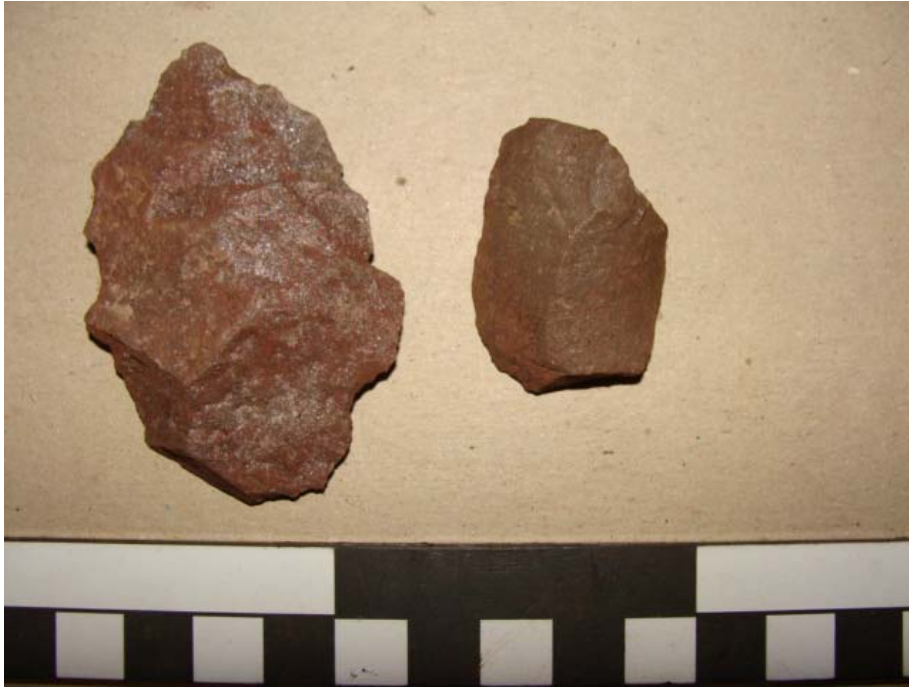
Site no 2 consist of the well-known cave just above the waterfall against the western rock face of the mountain. In front of the cave as well as at a secondary cave south of the main one, some Middle Stone Age tools were identified (Figure 7). Undecorated potsherds here indicate that the cave might also have been used during the Iron Age. Potsherds are also found in abundance in the area around the cave, both above and down slope (Figure 8-9).

Figure 7 Middle Stone Age tools found at the cave.

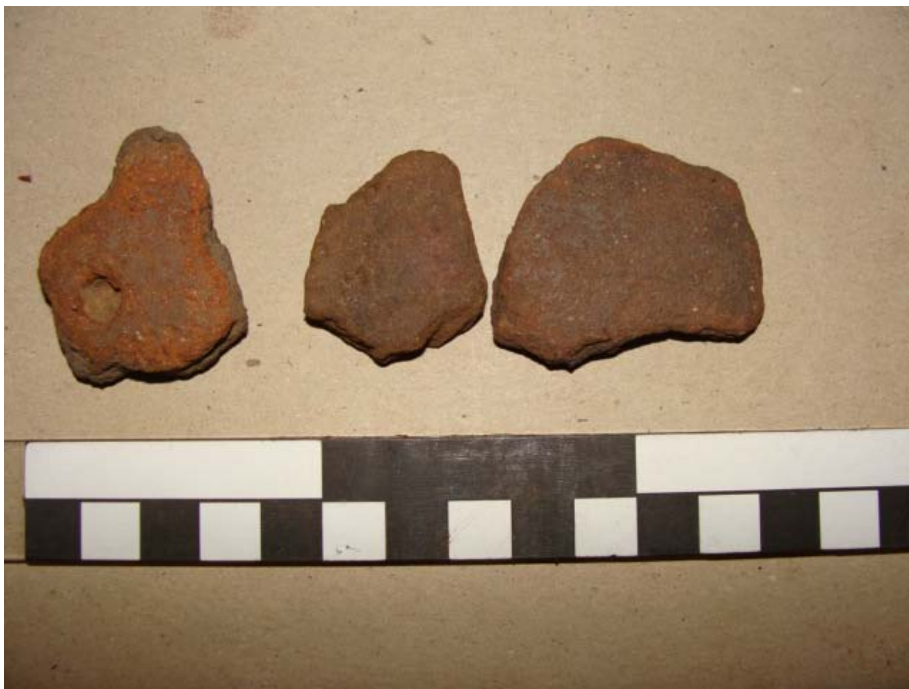
Figure 8 Undecorated potsherds from the cave.

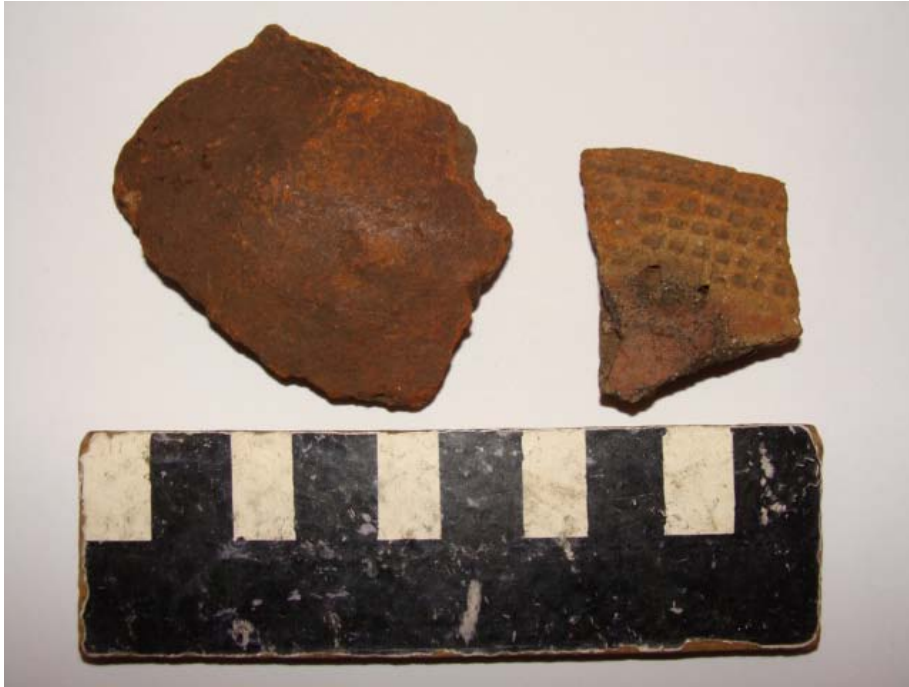
Figure 9 Decorated potsherds from the cave area.

The first one looks similar to Makgwareng facies of the Blackburn branch of the Urewe pottery tradition as described by Huffman (2007: 179-181). These are dated to AD 1700-1820, but are usually found much further south of Wonderboom around the Vaal River and northeast of the Free State. The time frame fits in with people fleeing from Mzilikazi during the Difaquane.

The second shard is similar to the Icon facies of the Moloko branch of the Urewe tradition and is dated from 1300-1500 (Huffmann 2007: 183-185). Other branches of the Moloko have been identified close to Pretoria, but Icon is associated with areas to the north of the Magaliesberg.

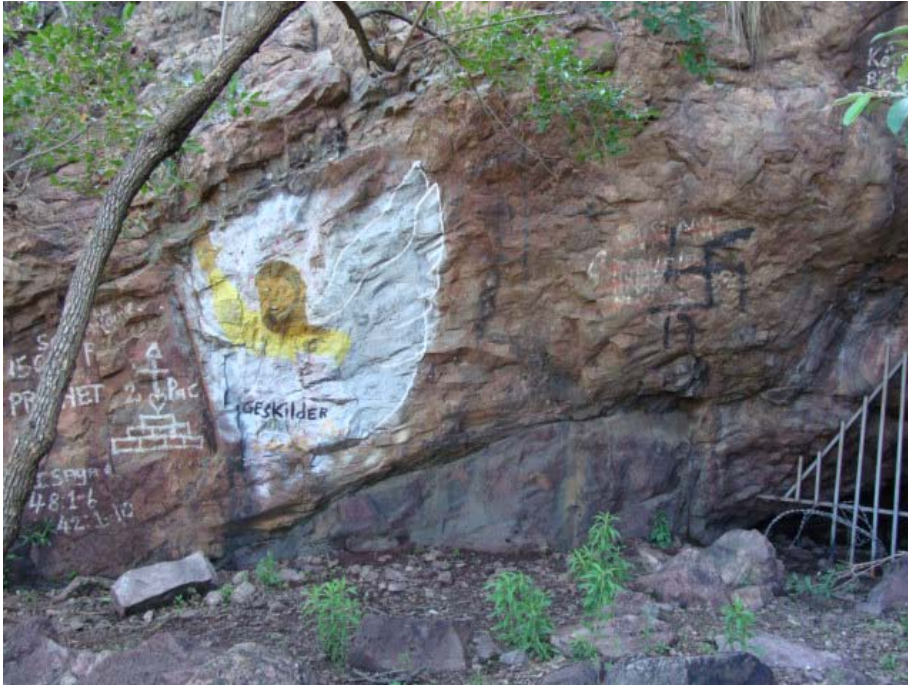
Unfortunately the rock face in front of the cave has been defaced in recent times by graffiti and the painting of slogans, pictures etc (Figure 10). The cave entrance has been closed to visitors by a steel fence, but this is broken and therefore gives access to the cave (Figure 11). Inside of the cave pieces of cloth, shoes and glass indicate that the cave may have been used recently (and may even still be in use) by people.

Figure 10 Defaced rock face at the cave entrance.

1. The rock face should be cleaned by experts in order not to damage the natural environment.
2. The fence should be replaced by a more suitable one. The position of the fence also should be moved a few metres further from the cave entrance as this will enhance the natural beauty of the area. It will also include and therefore protect cultural material contained just outside of the cave. The fence should have a gate giving access to visitors and researchers, but this should be kept under lock.

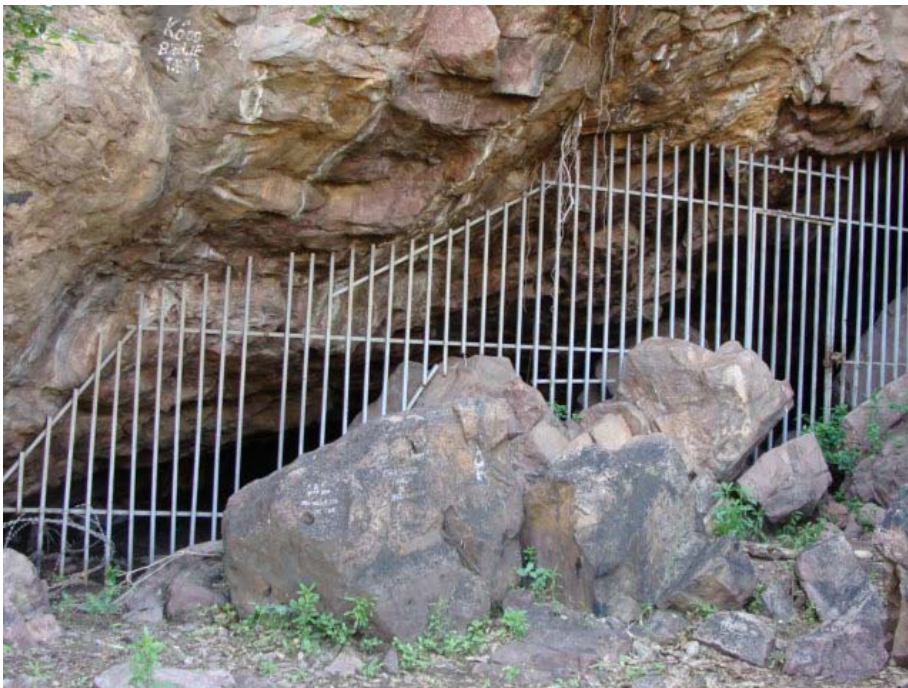
Figure 11 Steel fence in front of the cave entrance.

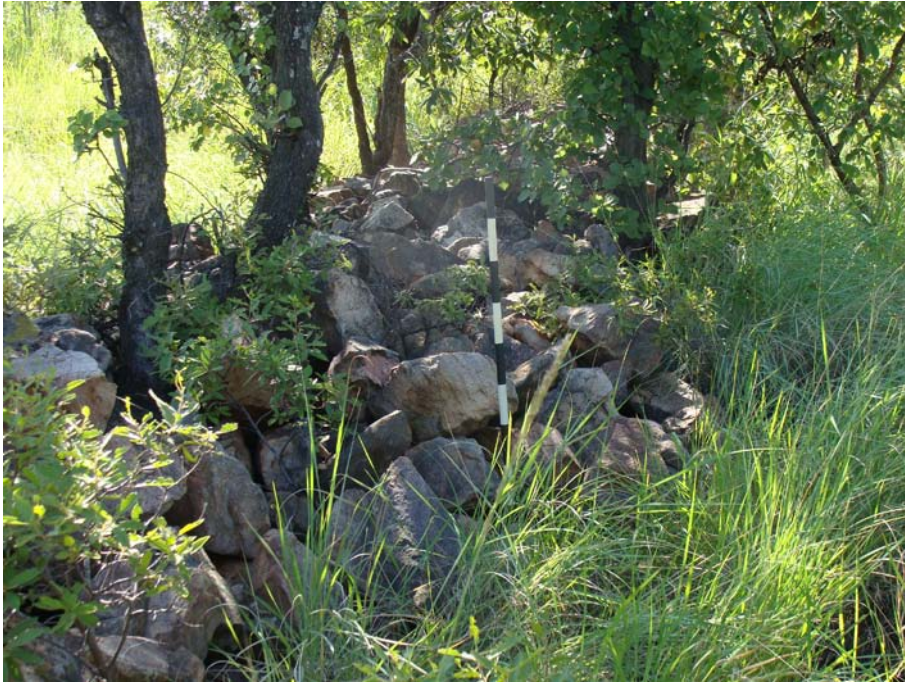
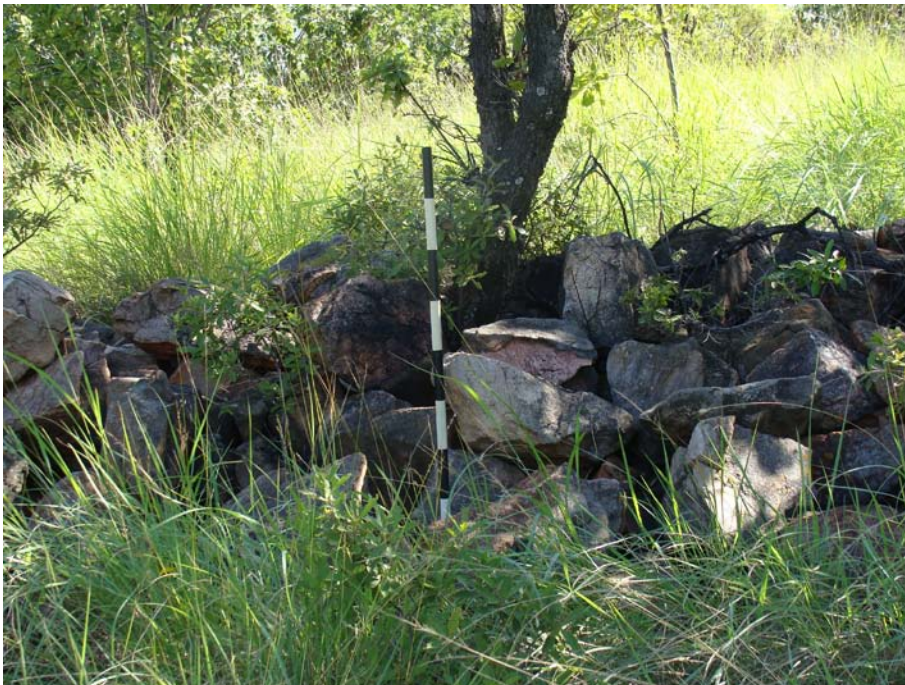
Currently the site is very overgrown making any further interpretation almost impossible. It does seem as if stones from these walls may have been used for later structures such as the pathways for visitors and some fortification walls. There even is a slight possibility that stones from this site may have been used in the building of the fort. The stone paved pathways for visitors leading up the mountain cut through the site.

Figure 12 Stone walling at site no 3.

Figure 13 Another stone wall at site no 3.

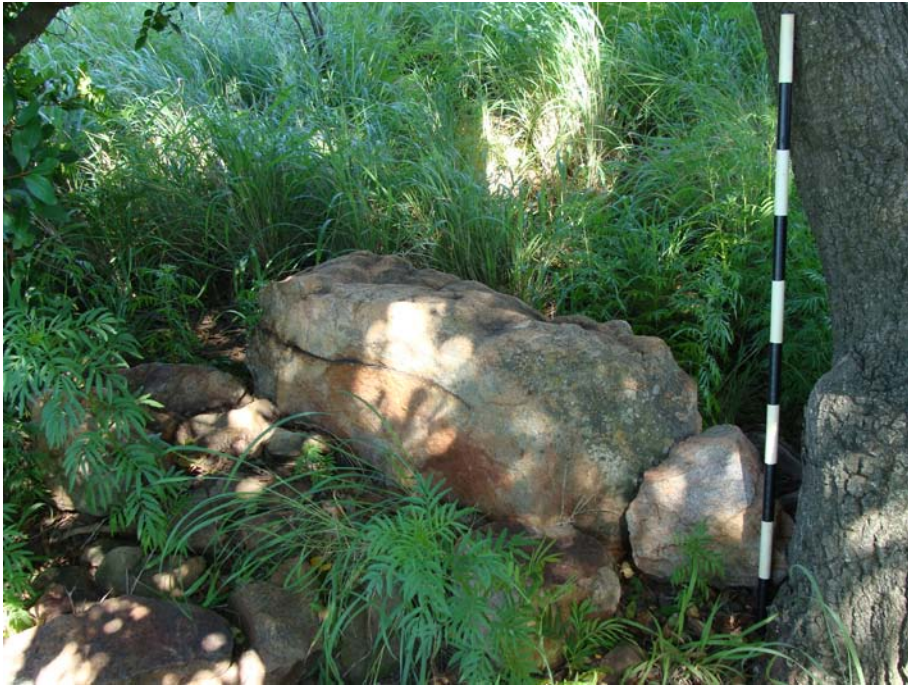
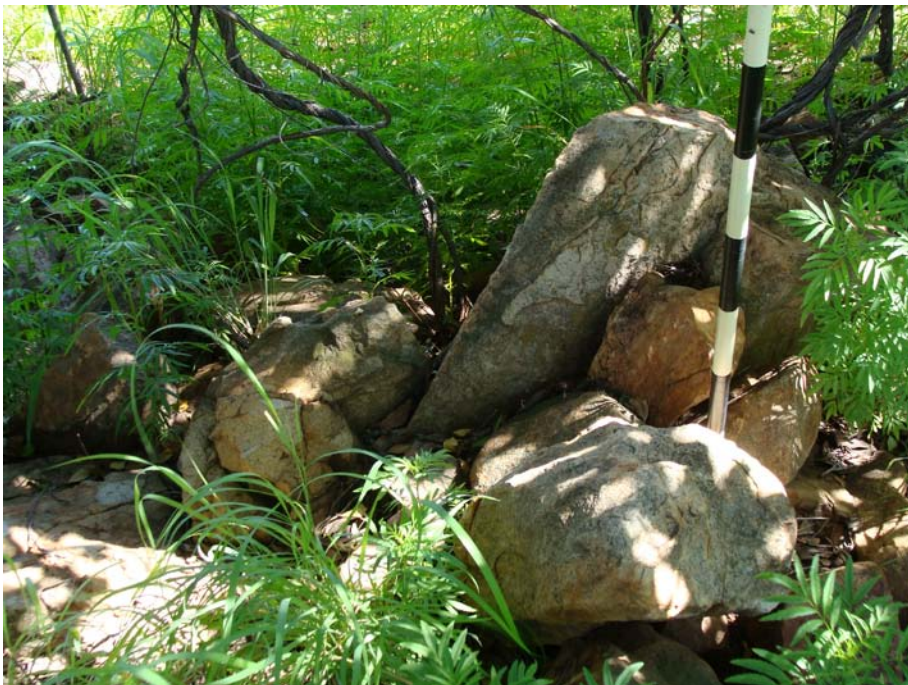
Circular stone wall with entrance to the west. The wall is 1-2m wide and 0,50m high and is linked to other walls of a lesser size. It includes a circular enclosure underneath a tree (Figure 14-15) which probably was used as gathering place (kgoro).

Figure 14 Stone wall that may be part of a kgoro area at site no 3.

Figure 15 Another view on the kgoro wall at site no 3.

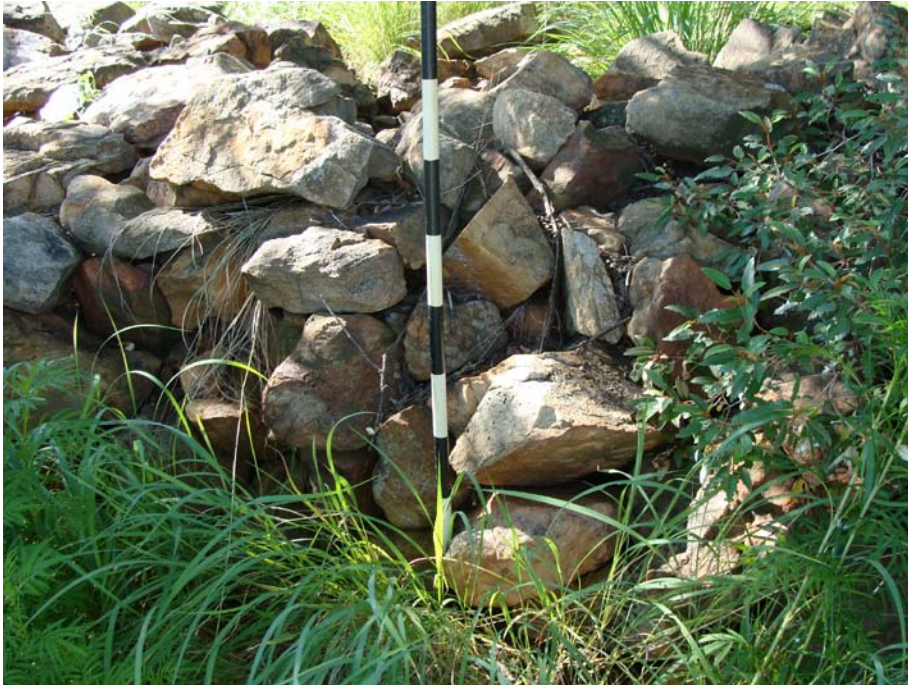
Two loose standing stone walls of approximately 10m in length, 2,50m wide and 0,50-1m high. The construction method seems to differ from the one mentioned above and therefore this wall may be of a younger age (Figure 16-17).

Figure 16 High stone wall at site no 3.

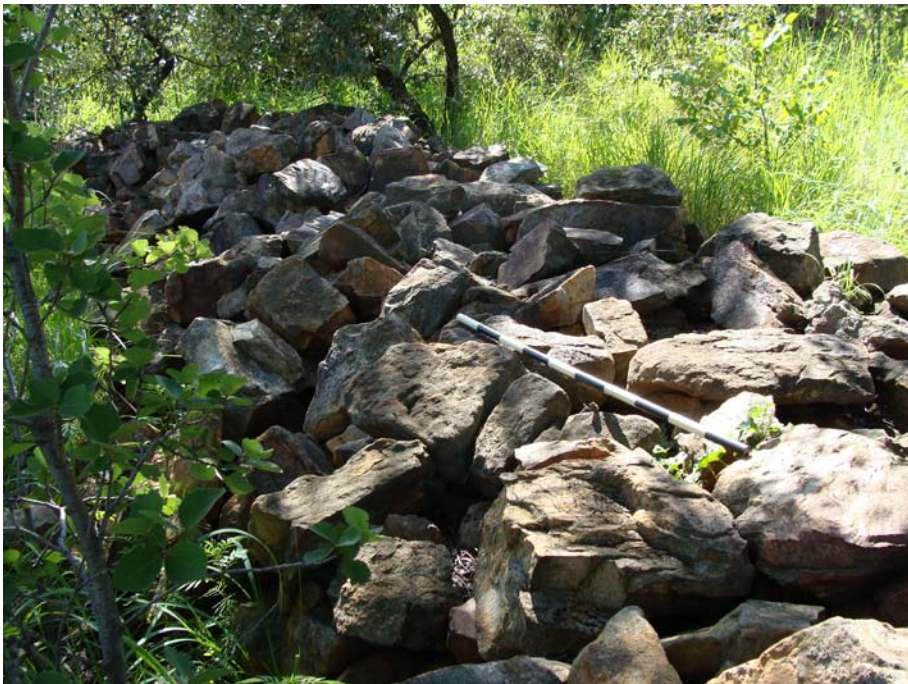
Figure 17 Another high stone wall at site no 3.

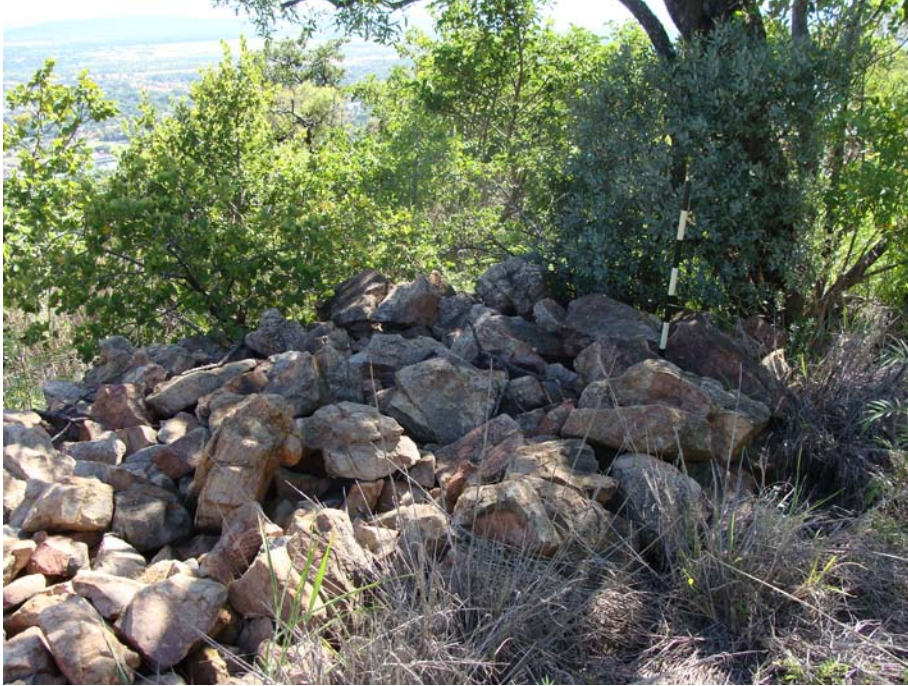
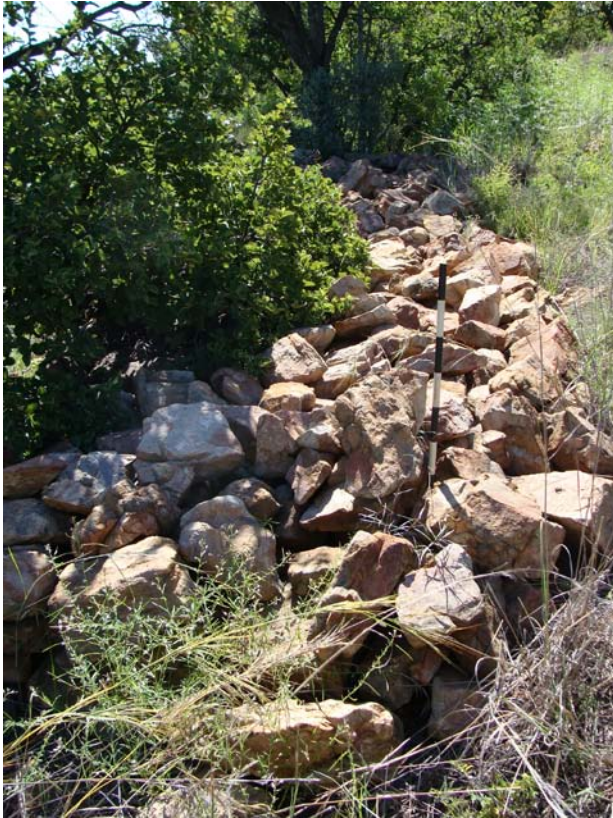
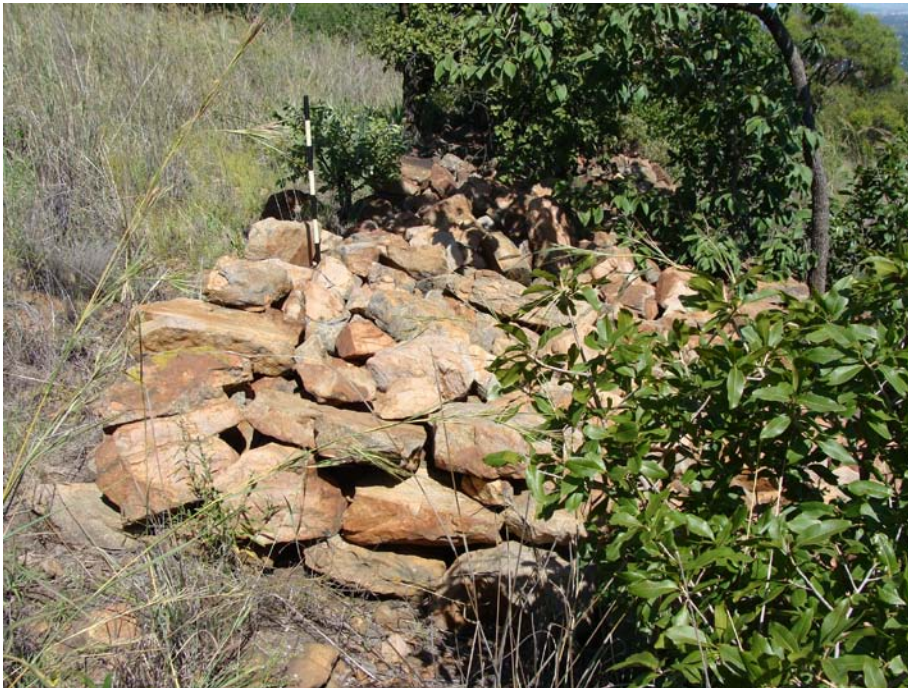
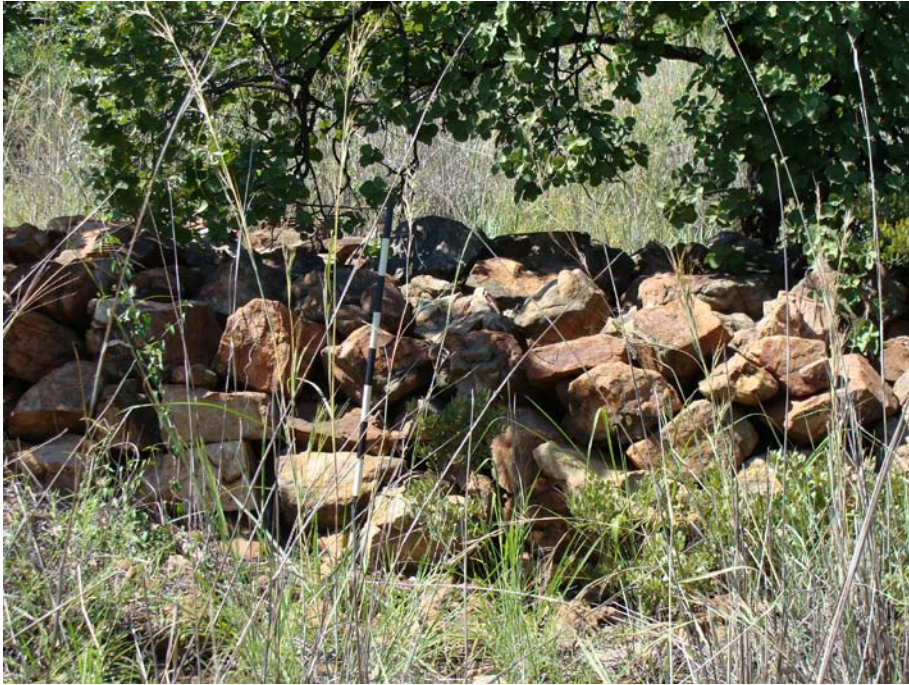
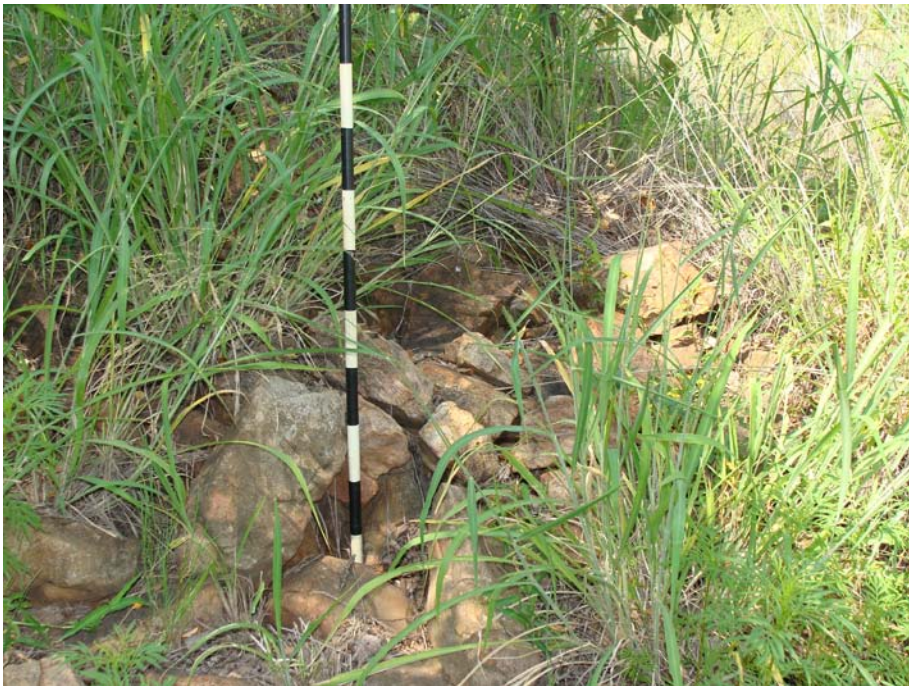
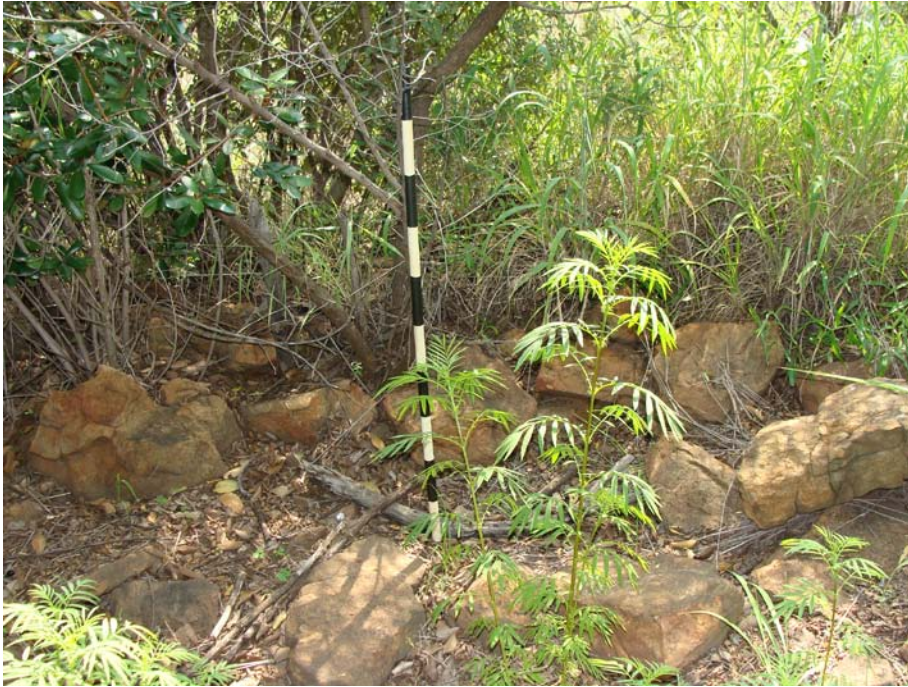
Different walls of more than 1m wide and between 0,20-1m high (Figure 18-23).

Figure 18 Stone wall at site no 3.

Figure 19 Circular stone enclosure at site no 3.

Figure 20 Another stone wall at site no 3.

Figure 21 More stone walling at site no 3.

Figure 22 Low stone wall at site no 3.

Figure 23 Another low stone wall at site no 3.

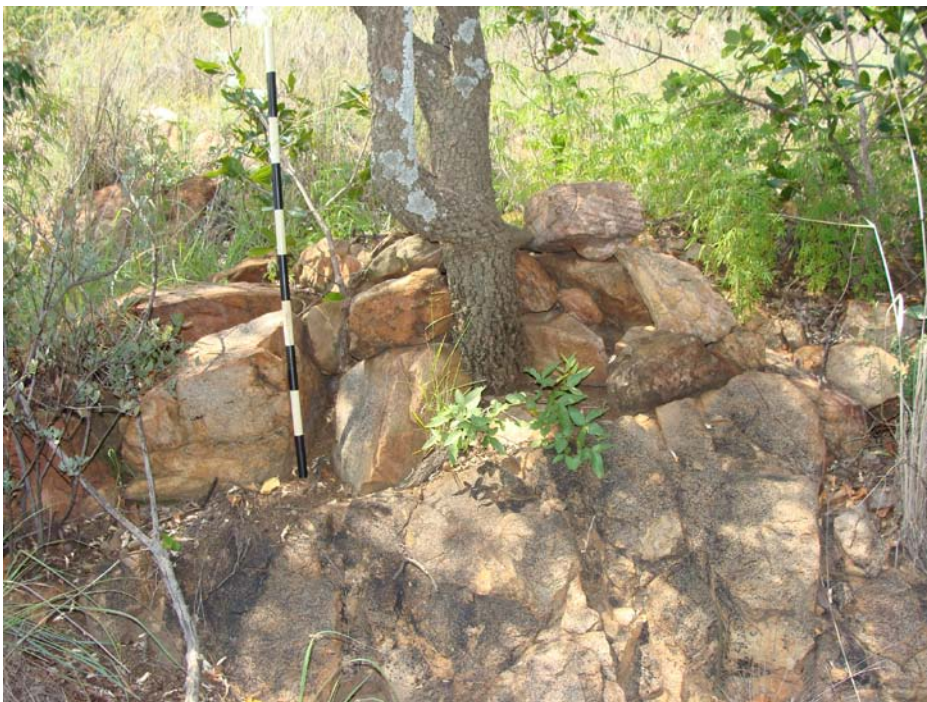
Possible terrace wall (Figure 24).

Figure 24 Possible terrace wall at site no 3.

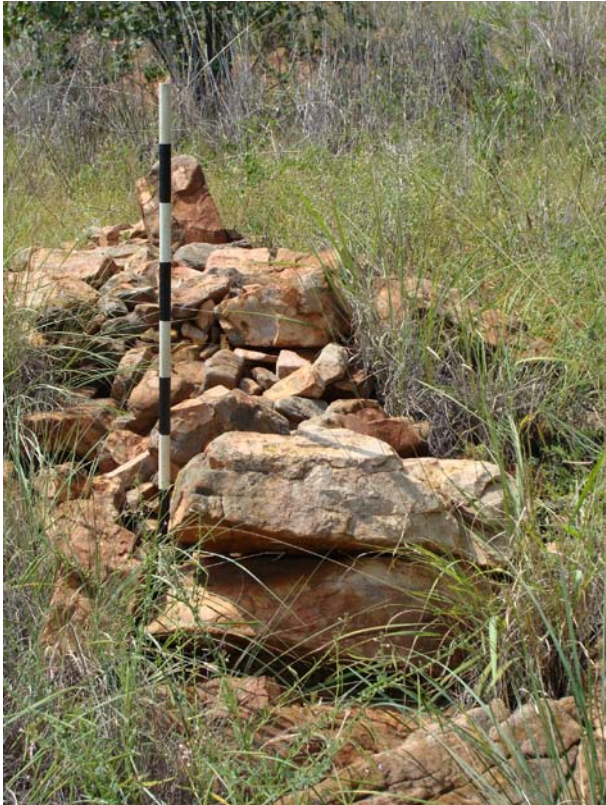
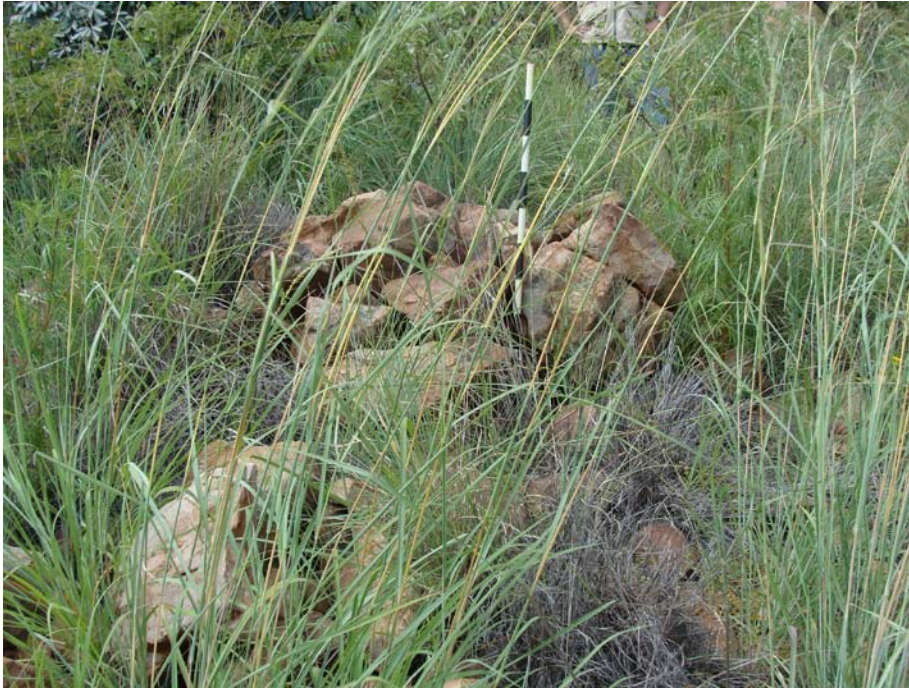
Stone walling including different circular and semi-circular enclosures (Figure 25-26).

Figure 25 More stone walling at site no 3.

Figure 26 Stone wall enclosure at site no 3.

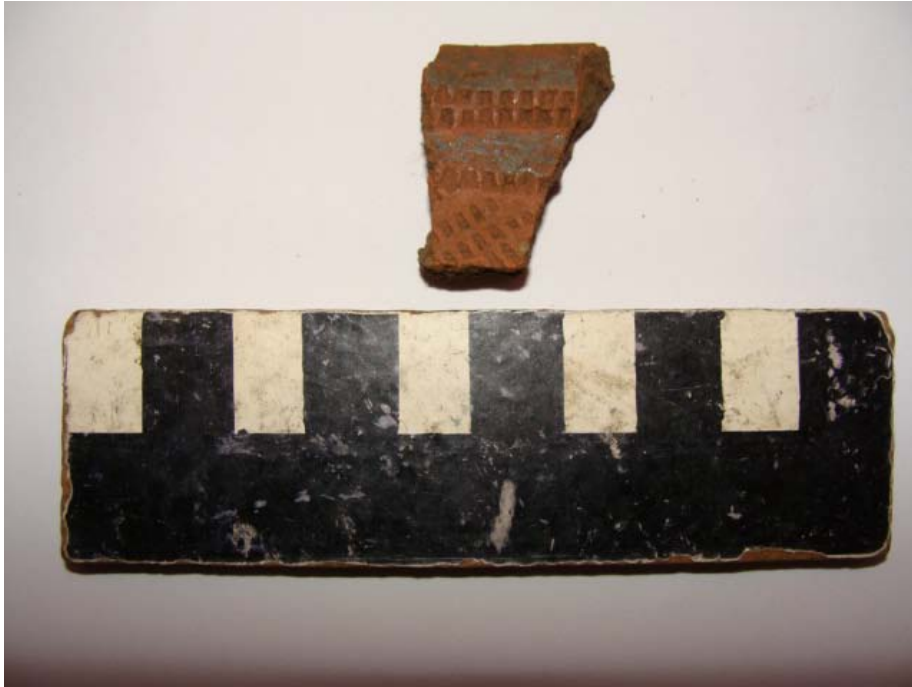
Low stone wall with decorated potsherds nearby (Figure 27). Also a number of terrace walls.

Figure 27 Decorated potsherd found at site no 3. This shard also seems like it belongs to the Icon facies of the Moloko branch of the Urewe tradition and is dated from 1300-1500 (Huffman 2007: 183-185). Other branches of the Moloko have been identified close to Pretoria, but Icon is associated with areas to the north of the Magaliesberg. It also could be Uitkomst pottery, which forms part of the Blackburn branch of the Moloko tradition. This is dated to 1650-1820 (Personal comment: J van der Walt) and makes more sense for this area.

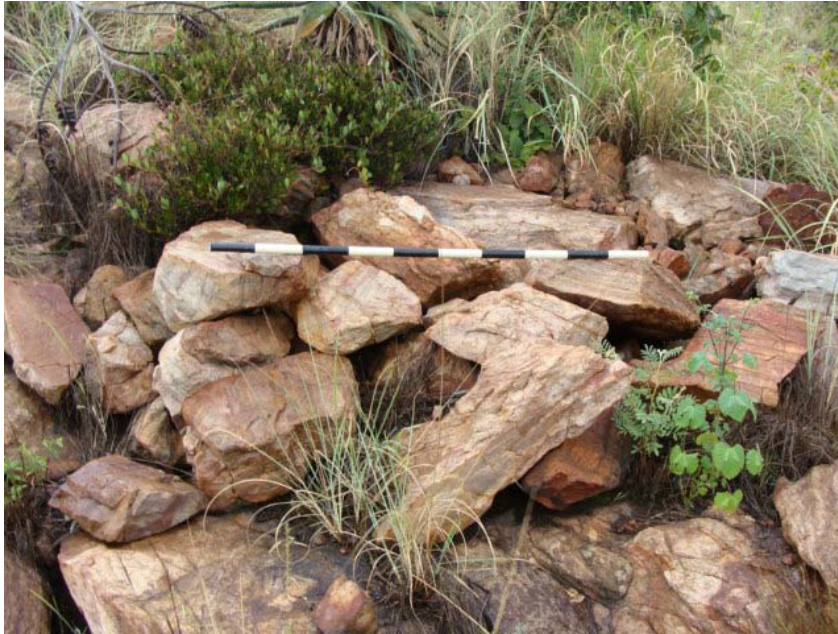
Stone wall linked to natural rock as backdrop to the site (Figure 28).

Figure 28 Stone wall packed on top of natural rock at site no 3.

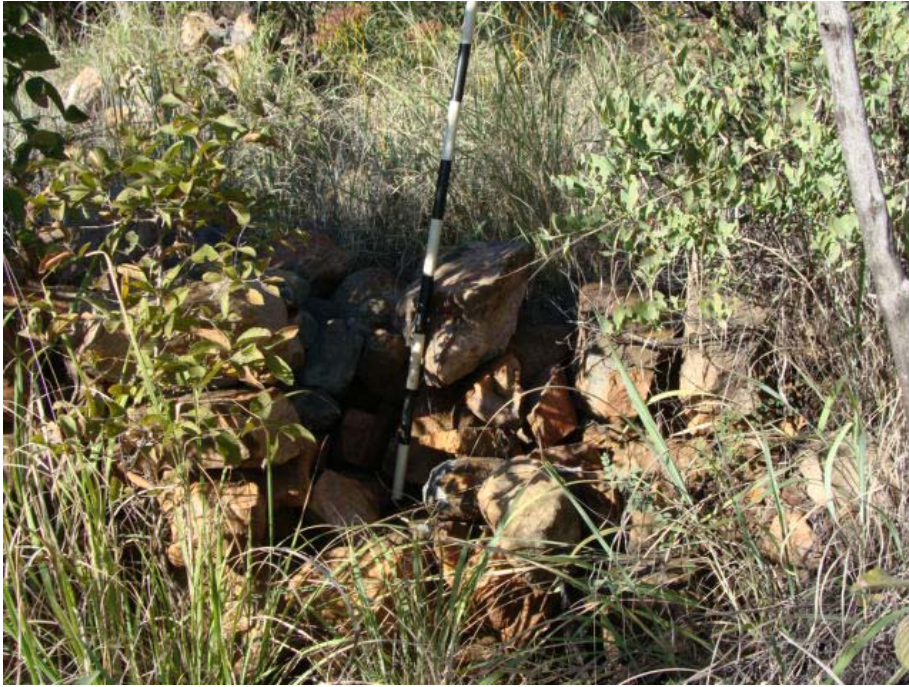
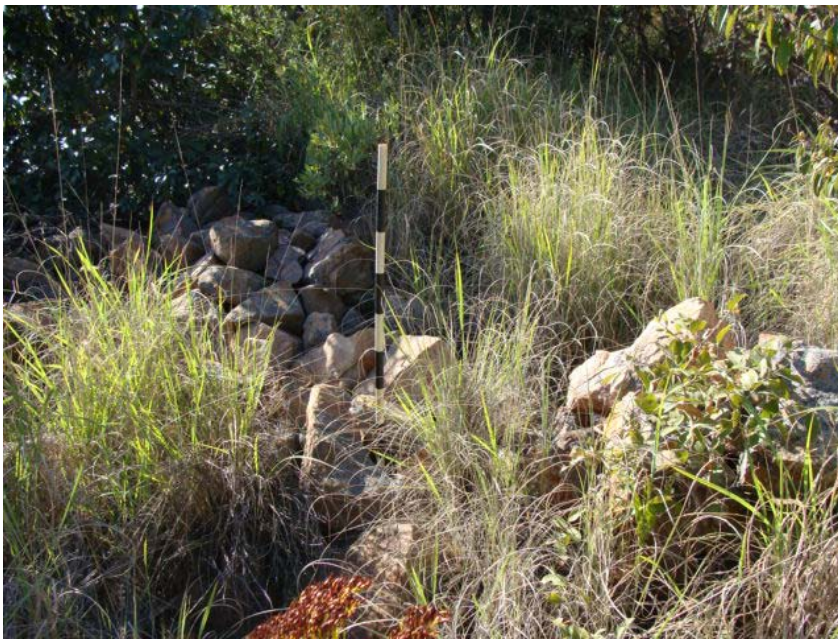
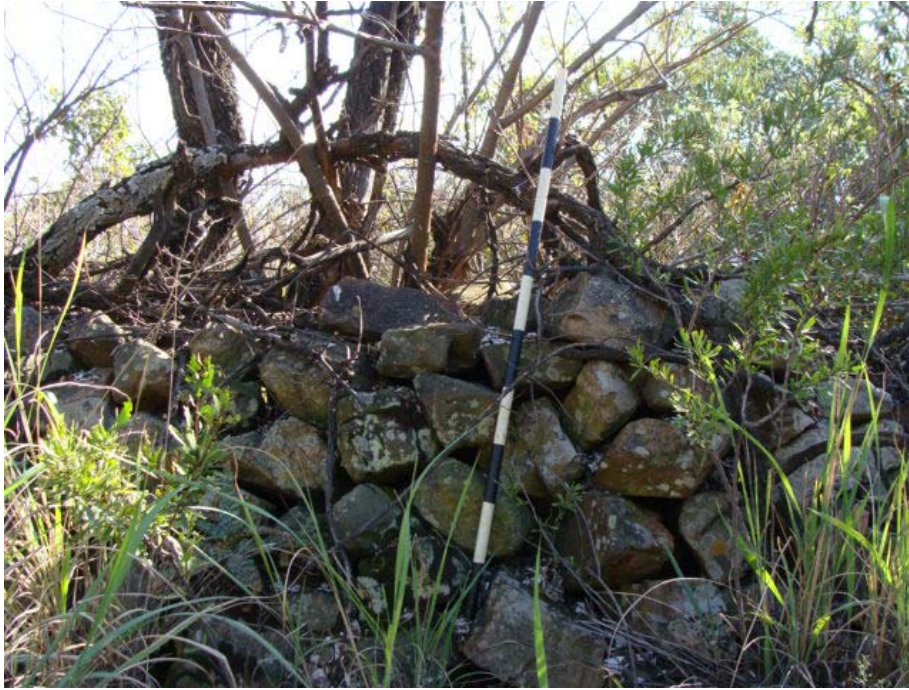
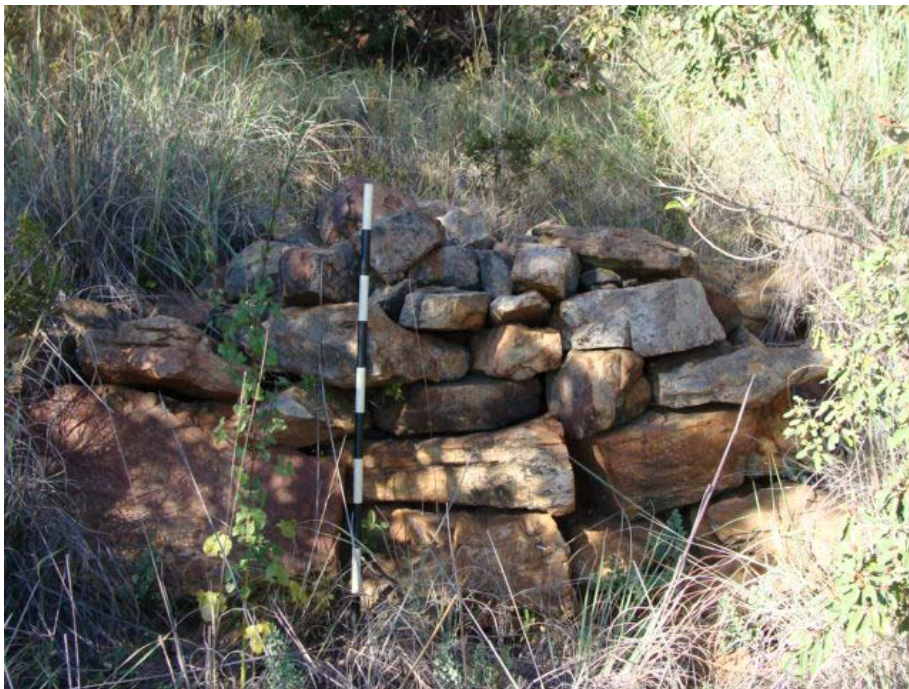
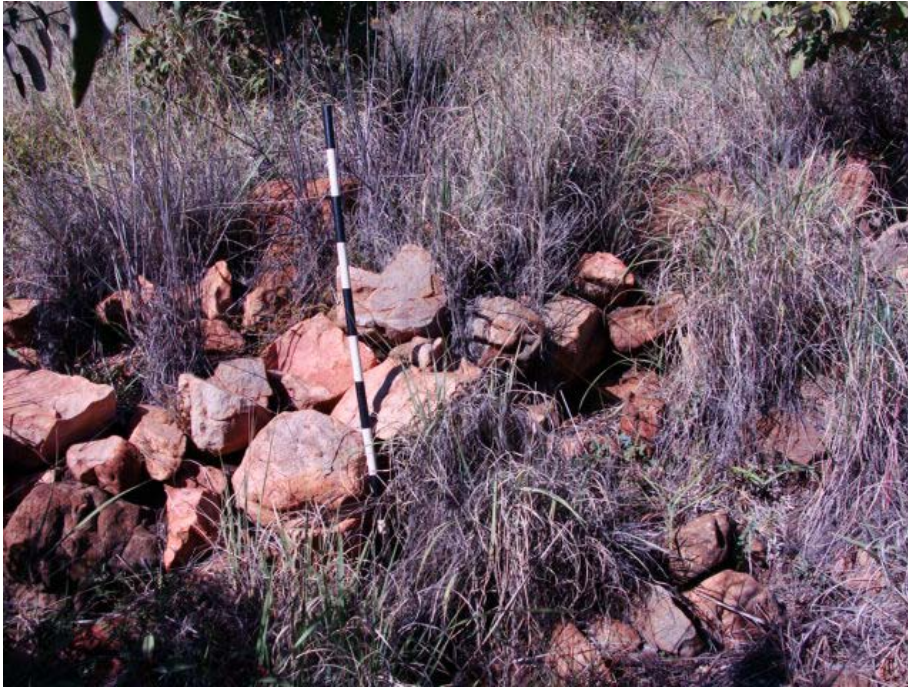
Three large enclosure walls with a few circular stone walls attached to it (Figure 29-33). The walls are between 0,50 and 0,80m high and are on a lower terrace than most of the other walls.

Figure 29 Part of a stone wall at the large enclosure.

Figure 30 Circular stone wall at the large enclosure.

Figure 31 Part of the stone wall at the large enclosure.

Figure 32 Another circular enclosure at the large stone enclosure.

Figure 33 Stone circle at the large enclosure.

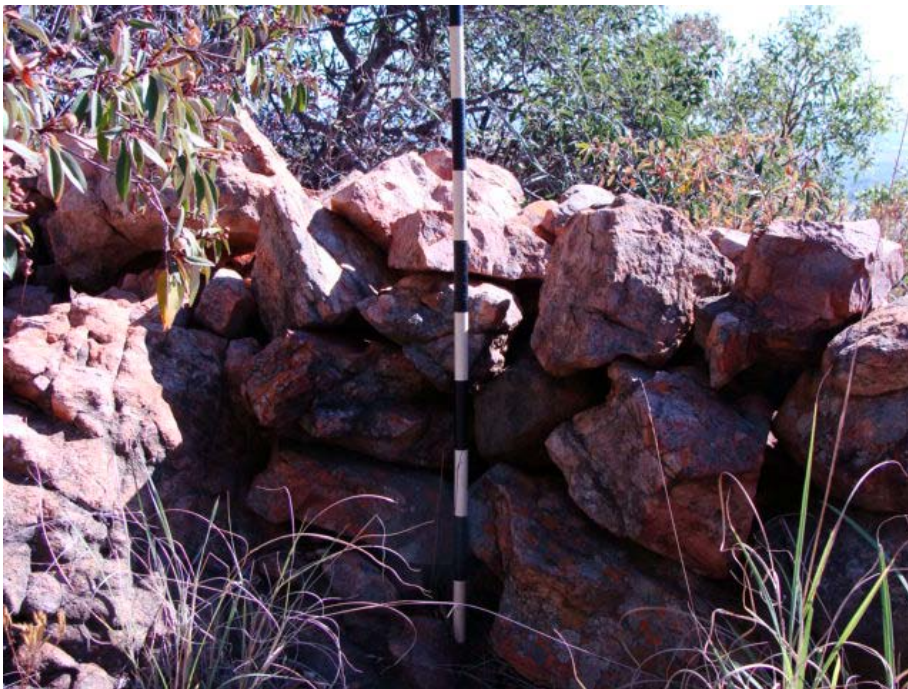
Low semi-circular wall of about 0,30m high. It is incorporated with the natural rock (Figure 34).

Figure 34 Semi-circular wall attached to natural rock.

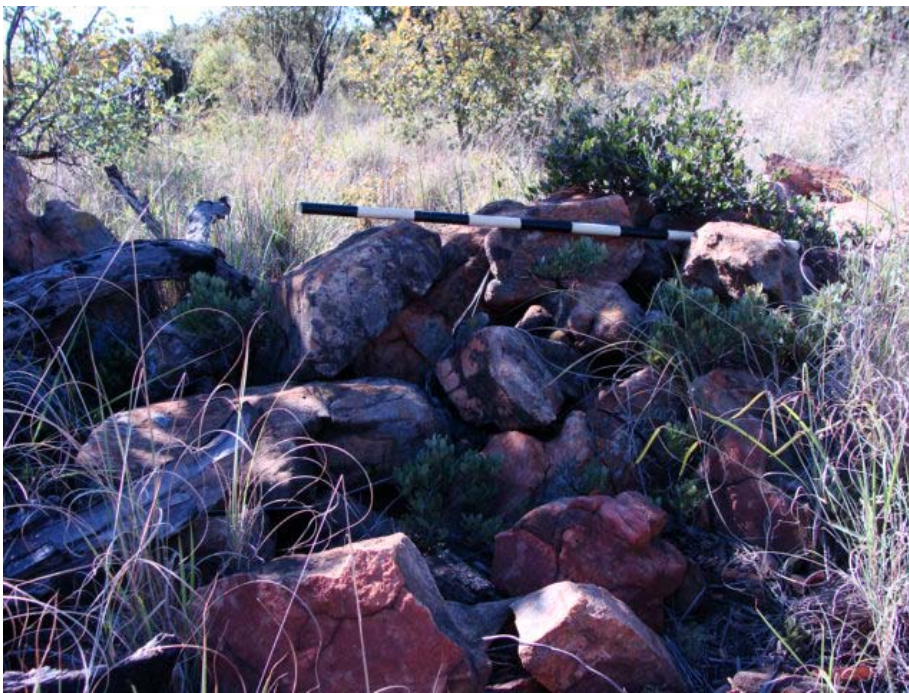
25°41'24"S
28°11'31"E
1385m
Possible furthest point of stone walls to the north and west (Figure 35).

Figure 35 Stone walling at the western side of site no 3.

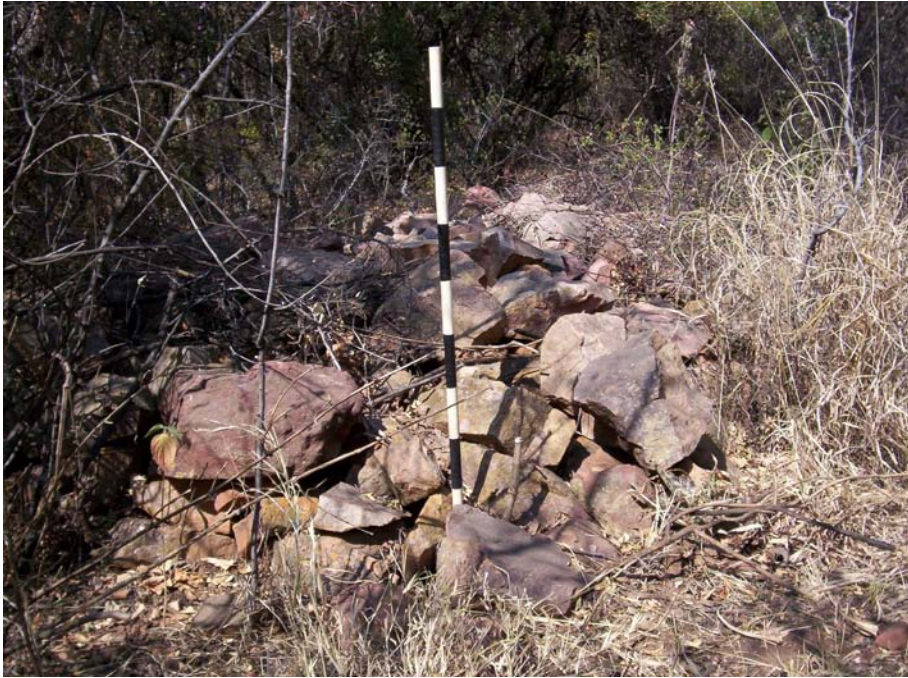
25°41'27"S
28°11'44"E
1312m
Possibly the furthest point of the site to the east (Figure 36).

Figure 36 Stone walling at the eastern part of site no 3.

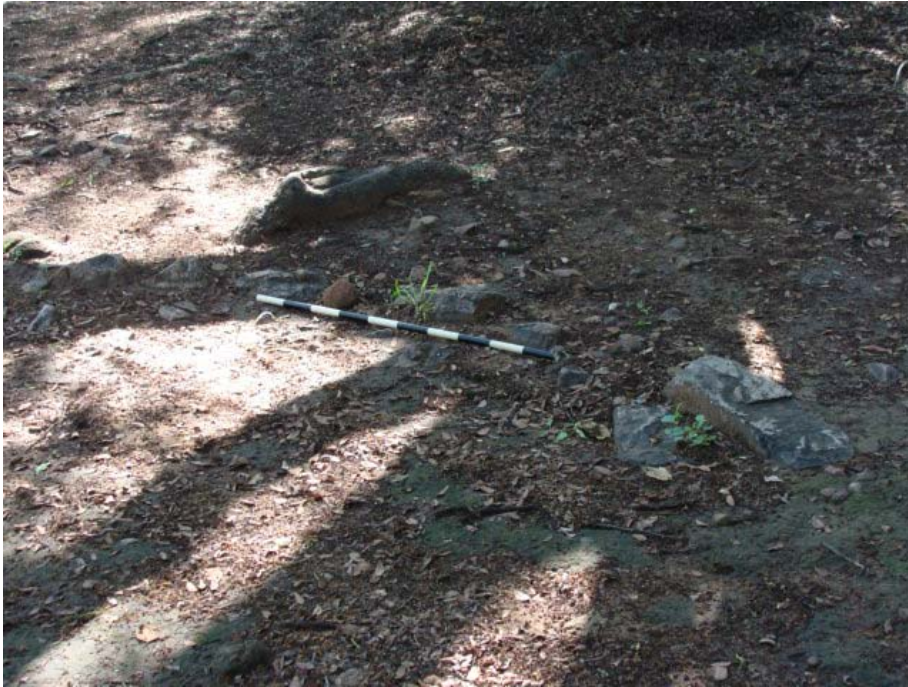
At least three circular stone features are vaguely visible in this area. It may be the remains of Late Iron Age stone walling.

Figure 37 Vague indication of a stone wall reasonably close to the Wonderboom.

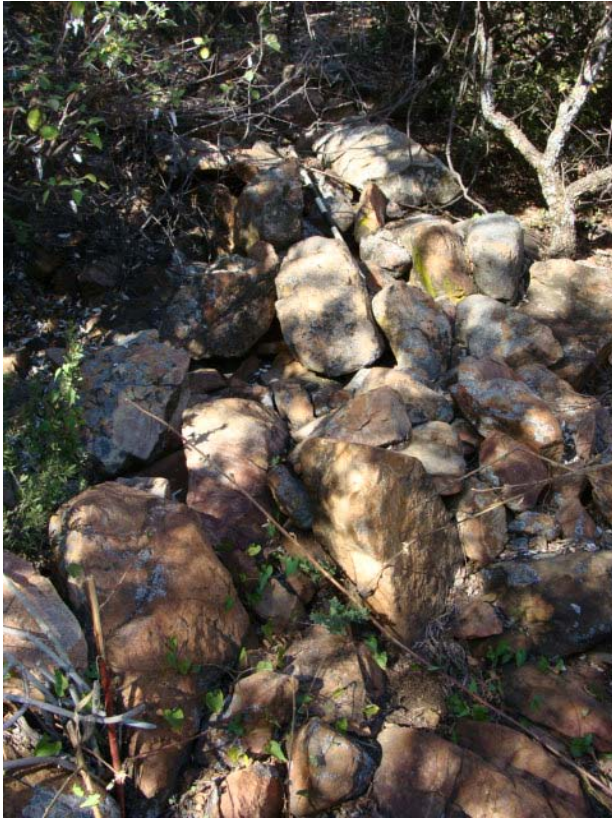
First circular wall (Figure 39).

Figure 39 Circular stone wall at site no 6.

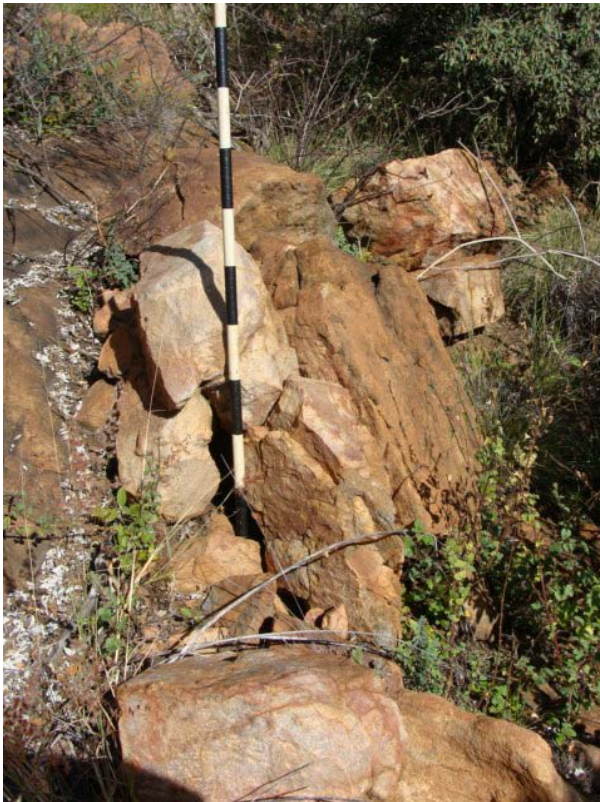
Oval shaped wall (Figure 40).

Figure 40 Oval shaped wall at site no 6.
