**A CULTURAL HERITAGE MANAGEMENT PLAN FOR THE
WONDERBOOM NATURE RESERVE, CITY OF TSHWANE**

***THE CITY OF TSHWANE, DEPARTMENT OF HOUSING, CITY PLANNING
AND ENVIRONMENTAL MANAGEMENT, DIVISION NATURE
CONSERVATION AND RESORTS***

REPORT: AE810

December 2008

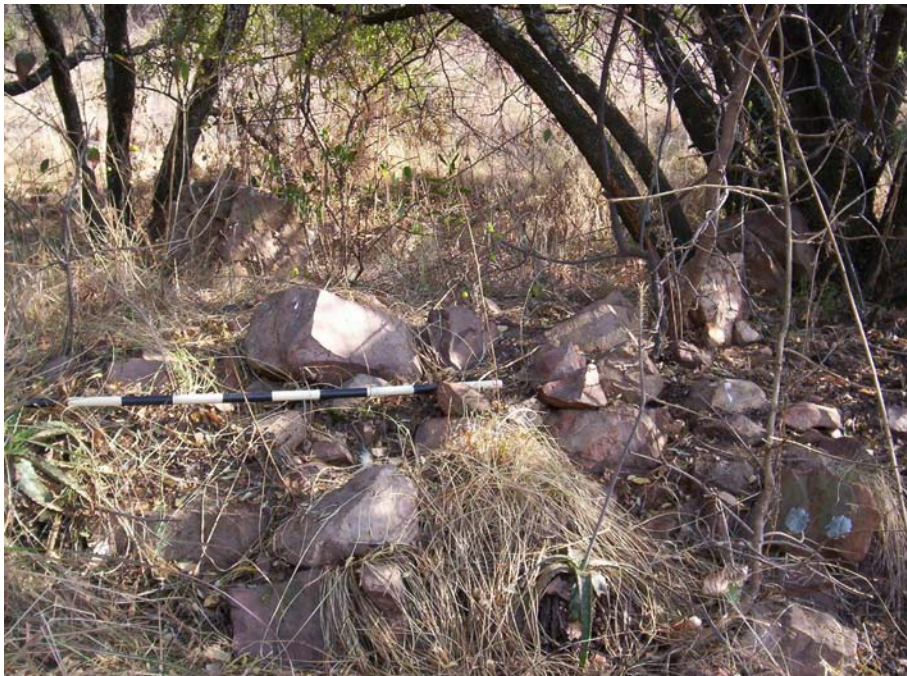
This site probably dates to the Late Iron Age. It consists of two circular stone walls close together on a level area on the southern slope of the mountain (Figure 41). It could have been an outpost for livestock.

Figure 41 Remains of a stone wall at site no 7.

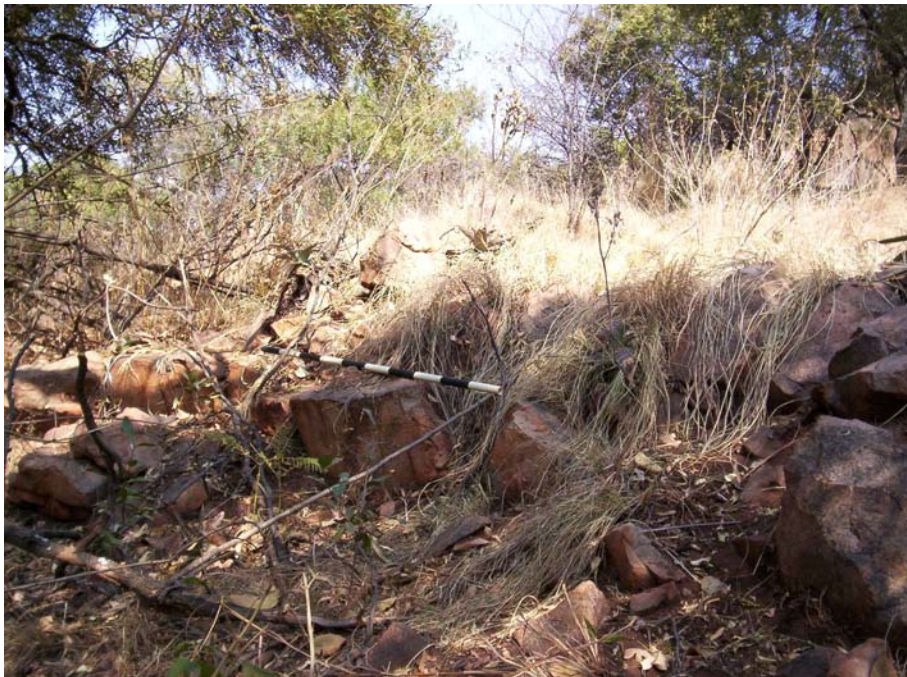
This site consists of a large circular stone walled enclosure of more or less 30 m in diameter (Figure 42). It may have been used as a cattle enclosure.

Figure 42 Stone wall of large enclosure at site no 8.

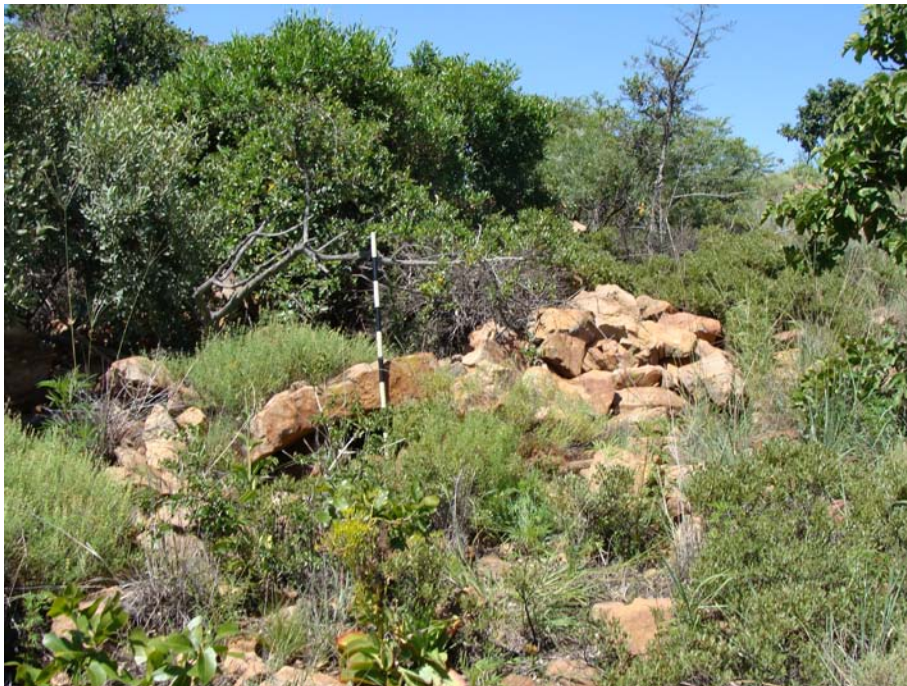
Site no 9 is a circle of stones which probably is the remains of a British blockhouse build during the Anglo-Boer War (1899-1902). On the southern side a smaller circle is situated of which the function is not known at this stage. The walls are 0,50m high and also 0,5 m wide (Figure 43). The features may also have a Late Iron Age origin.

Figure 43 Outer wall of a blockhouse from the Anglo Boer War.

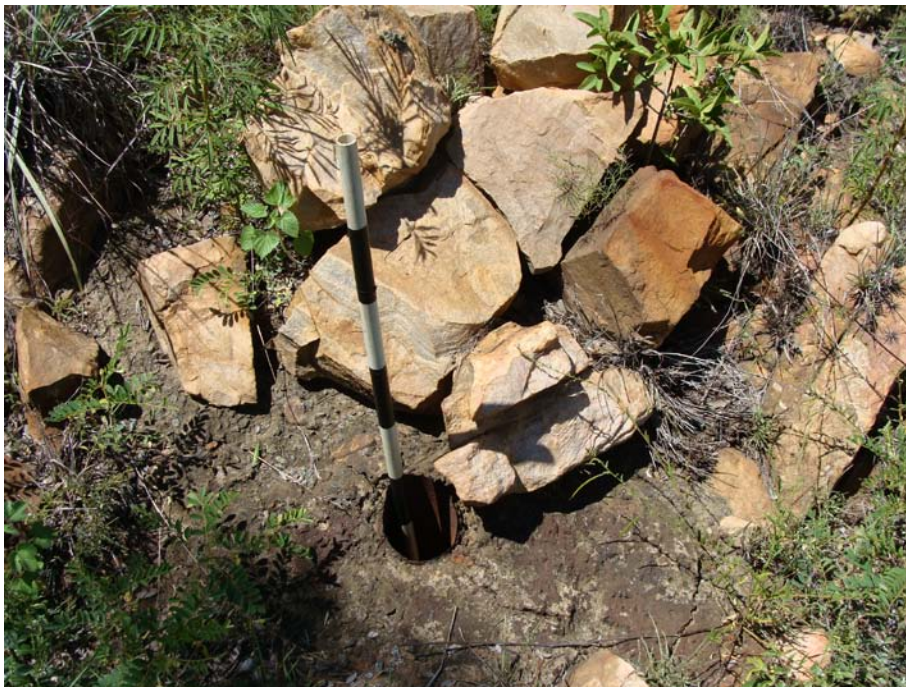
Wire, metal droppers and stones indicate another farm boundary here (Figure 44)

Figure 44 Remains of a farm boundary.

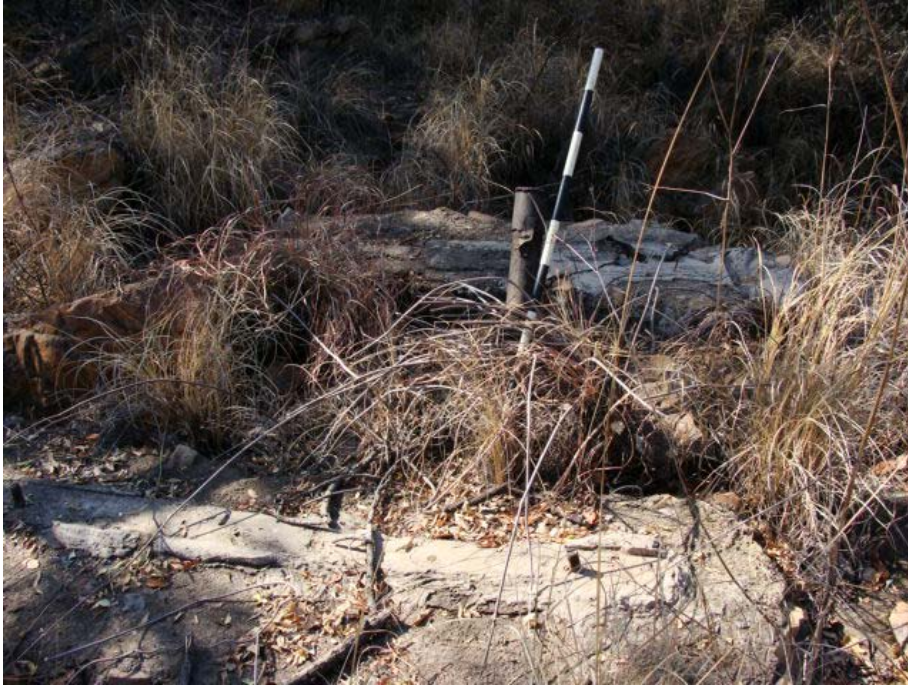
This farm boundary on the small ridge within the valley to the west, is indicated by a large block of concrete and a corner post. Large bolts in the concrete also indicate that some kind of machine was fixed onto the concrete (Figure 45).

Figure 45 Large cement block found with remains of an old farm boundary.

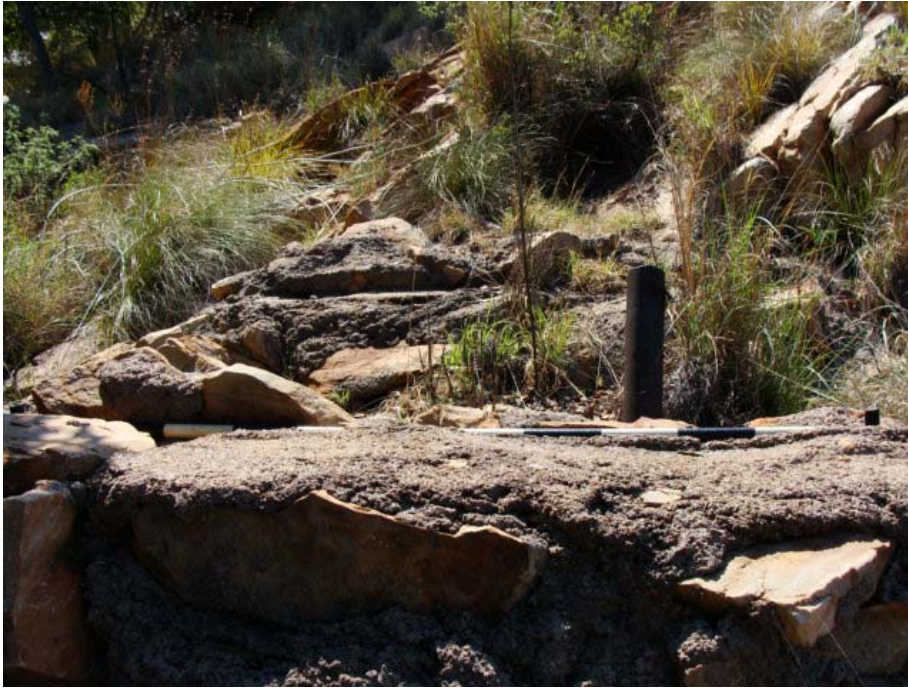
This boundary is on another ridge within the mentioned valley (Figure 46).

Figure 46 Farm boundary on a ridge in the valley to the southwest of the reserve.

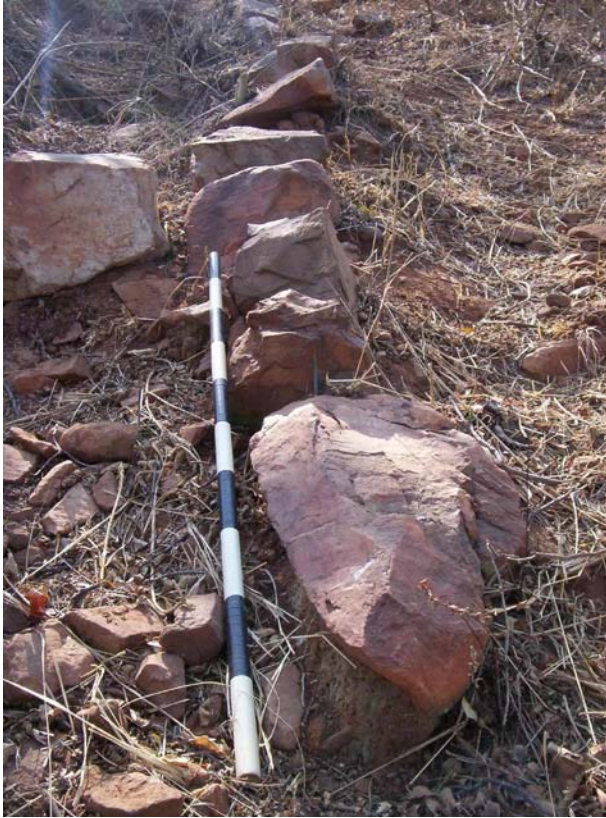
This boundary consists of a row of packed stones against the western slope of the mountain and running in an east-west direction (Figure 47).

Figure 47 Stones indicating another farm boundary.

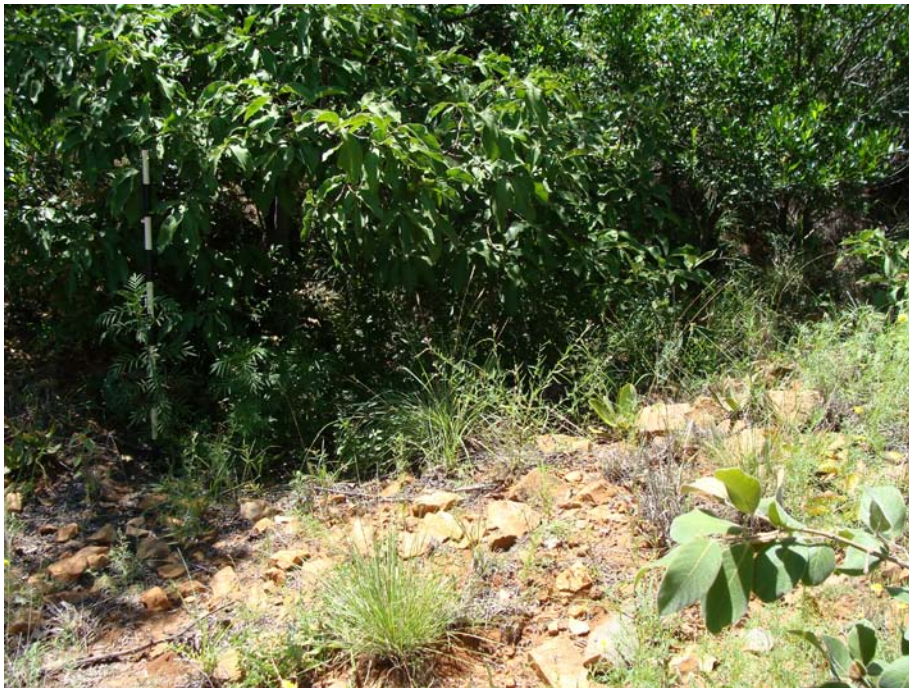
This feature consists of a man-made hole in the ground. It is one of many similar holes found during the survey. This particular one has a diameter of approximately 8m (Figure 48).

Figure 48 Man-made hole in the ground.

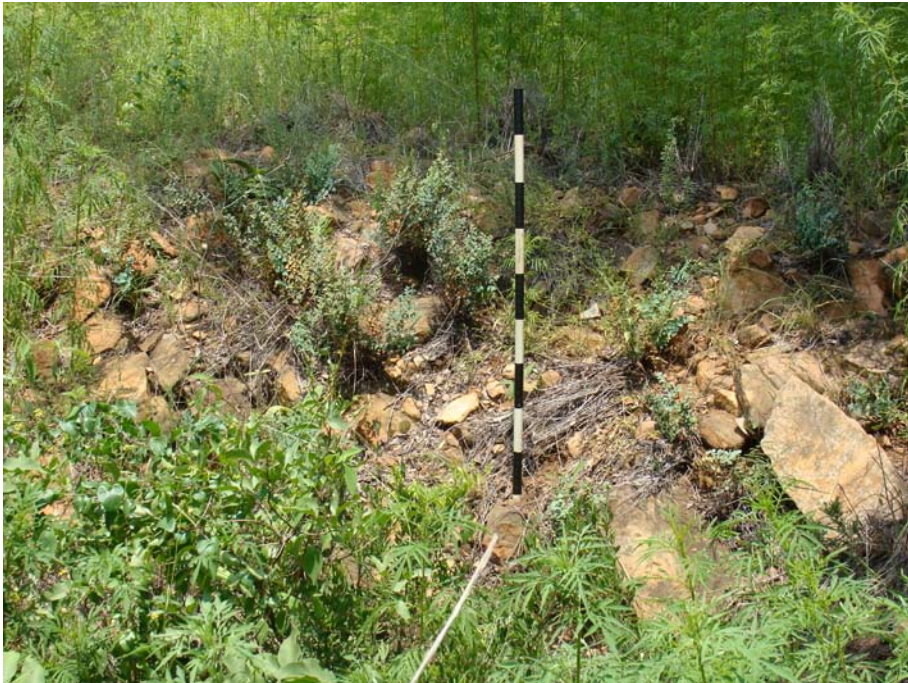
This feature also consists of a man-made hole in the ground (Figure 49). It is one of many similar holes found during the survey.

Unfortunately it is impossible to determine what the purpose of the hole was and when it was dug. It may have been created by prospecting activities both during the Iron Age or the historical era, but it may also have been created when stones were cut to build the fort. Other possibilities are that it was dug to serve as water cistern or for the purpose of a toilet or refuse hole.

Figure 49 Another man-made hole in the ground.

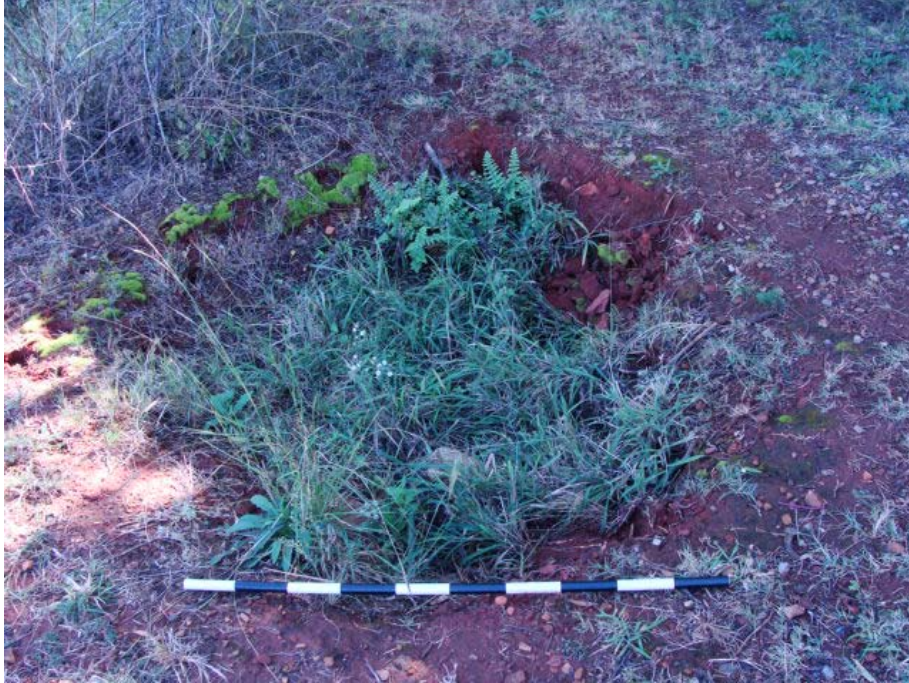
This feature consists of a man-made hole in the ground (Figure 50). It is one of many similar holes found during the survey.

Unfortunately it is impossible to determine what the purpose of the hole was and when it was dug. It may have been created by prospecting activities both during the Iron Age or the historical era, but it may also have been created when stones were cut to build the fort. Other possibilities are that it was dug to serve as water cistern or for the purpose of a toilet or refuse hole.

This one is very close to the fort and probably therefore has an association with it.

Figure 50 This hole probably served some function at the fort.

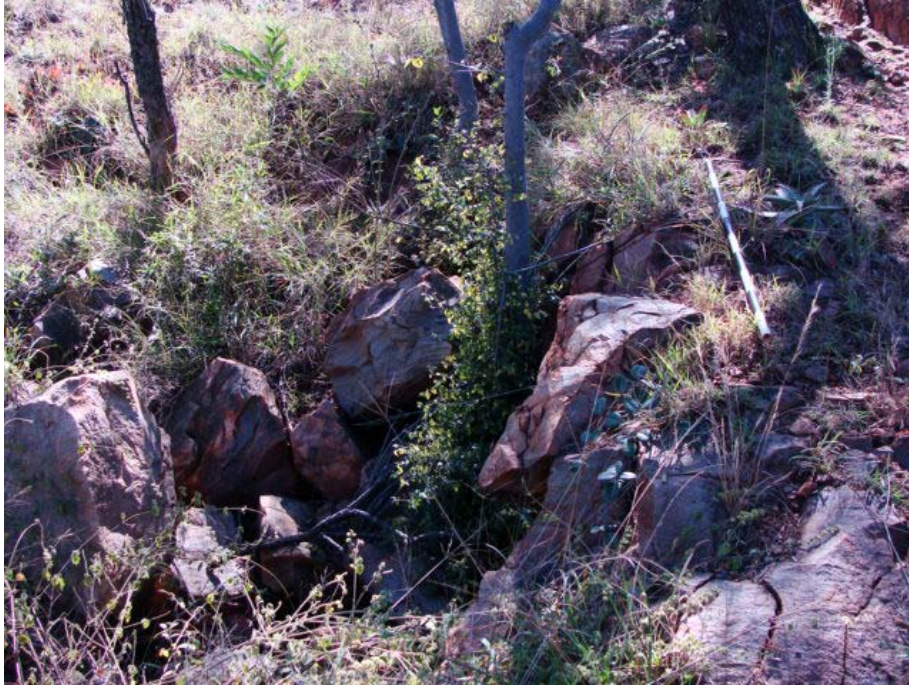
This feature consists of a man-made hole in the ground (Figure 51). It is one of many similar holes found during the survey.

This one is filled with stones which may be an indication that it was a rubbish hole or toilet and that it was filled up at some stage to contain its contents.

Figure 51 Man- made hole behind the fort, filled with stones. It most probably is associated with the fort.

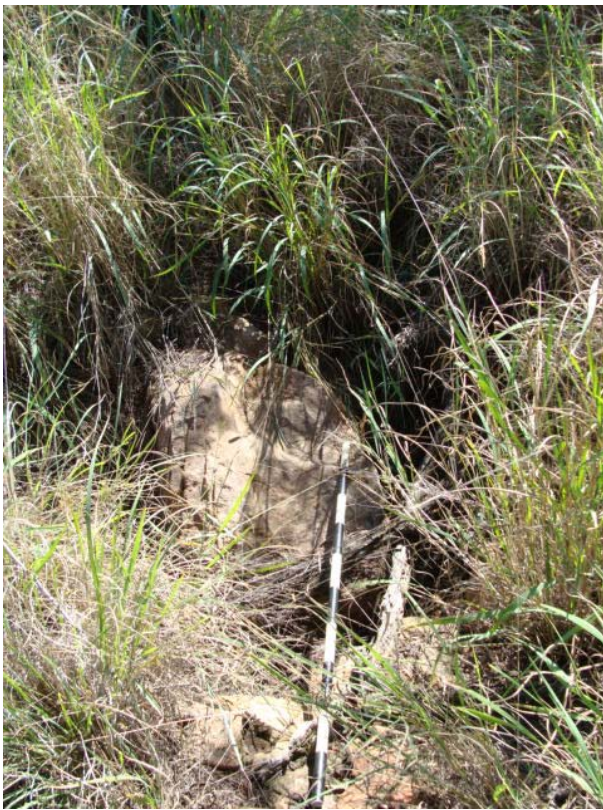
This feature consists of a man-made hole in the ground (Figure 52). It is one of many similar holes found during the survey.

Unfortunately it is impossible to determine what the purpose of the hole was and when it was dug. It may have been created by prospecting activities both during the Iron Age or the

historical era, but it may also have been created when stones were cut to build the fort. Other possibilities are that it was dug to serve as water cistern or for the purpose of a toilet or refuse hole.

Figure 52 Another hole in the ground that possibly has an association with the fort.

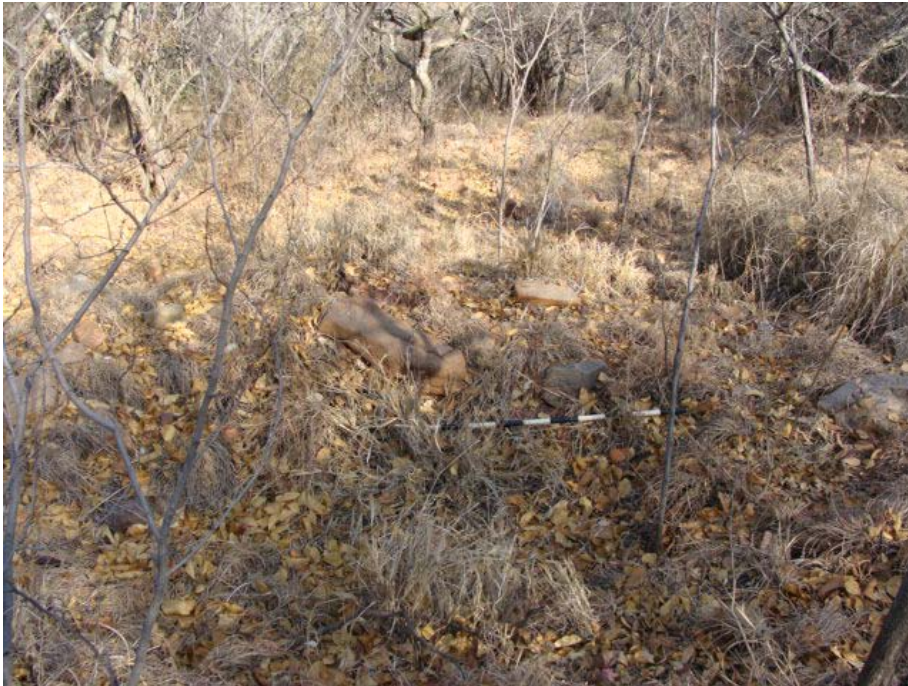
This site consists of four man-made holes found close together in the ground (Figure 53-54). It is similar to others found during the survey.

Unfortunately it is impossible to determine what the purpose of these holes was and when it was dug. It may have been created by prospecting activities both during the Iron Age or the historical era, but it may also have been created when stones were cut to build the fort. Other

possibilities are that it was dug to serve as water cistern or for the purpose of a toilet or refuse hole.

Figure 53 One of four man-made holes in the ground found close together.

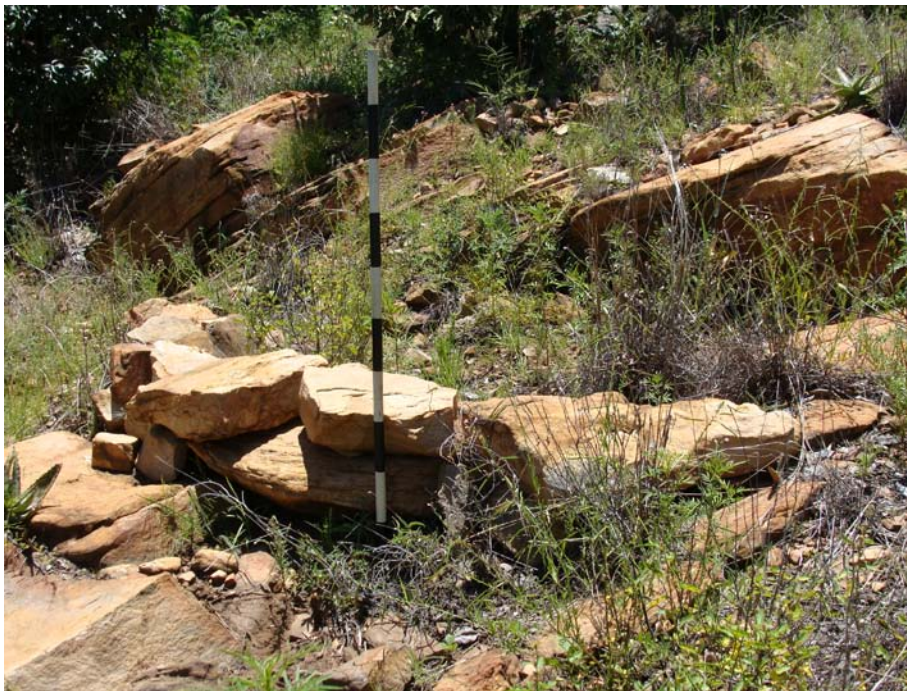
Feature no 17 consist of a half moon-shaped wall of 0,30m high and 0,30 m wide (Figure 55). It probably is some kind of fortification wall which gave cover for one or two persons. The wall is situated to the southwest of the fort and probably defended to the west.

Figure 55 Half moon shaped fortification wall.

The feature is of a high cultural significance as it falls within the context of the fort.

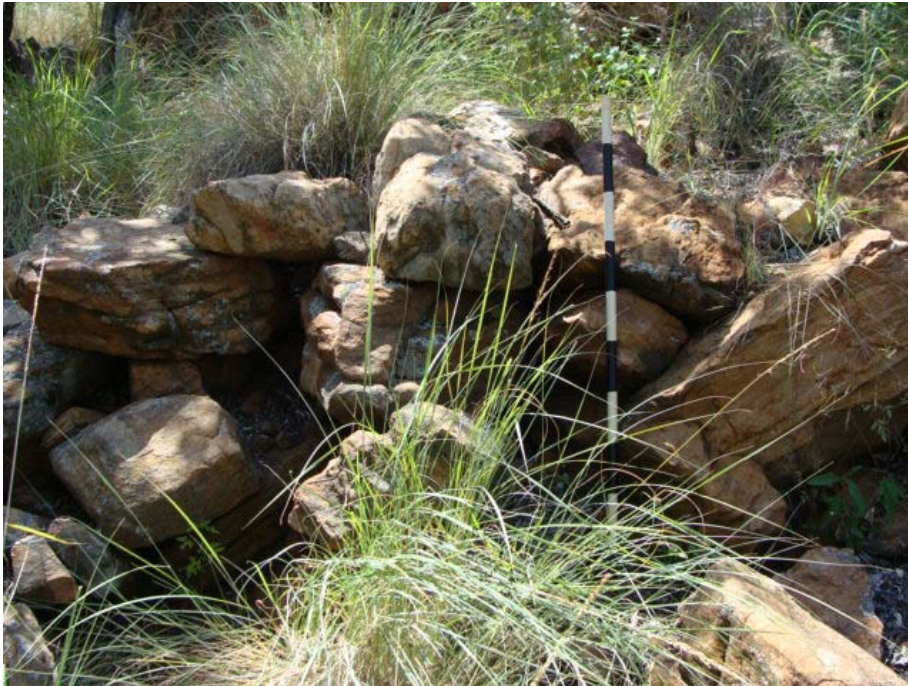
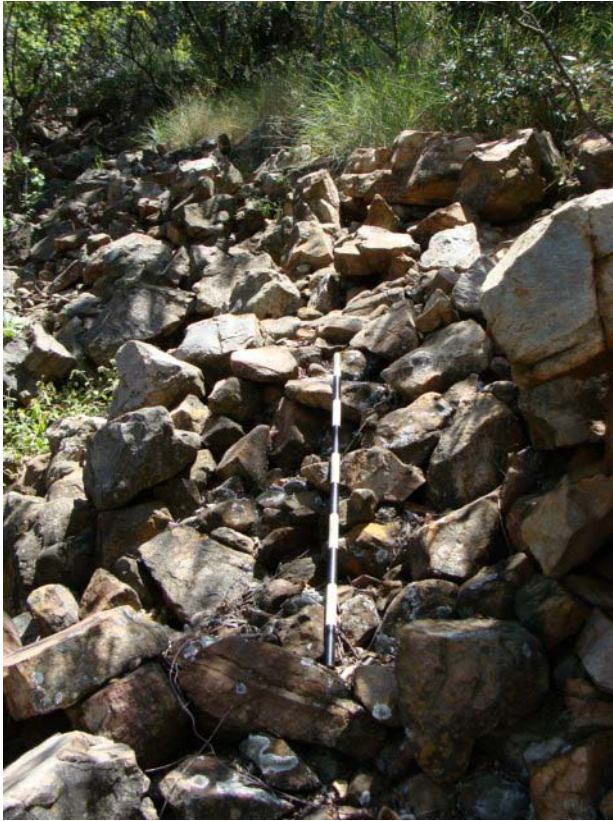
This is another fortification wall to the west of the fort (Figure 56-57). Due to the vegetation it was not possible to measure it, but it is a very long wall probably in order to protect the access to the fort via the valley. The wall runs from the valley up against the slope and ends on the edge to the valley.

Figure 56 Part of a long fortification wall. This part is on the edge of the valley

Figure 57 View of the long fortification wall in the valley to the west.

The feature is of a high cultural significance as it falls within the context of the fort.

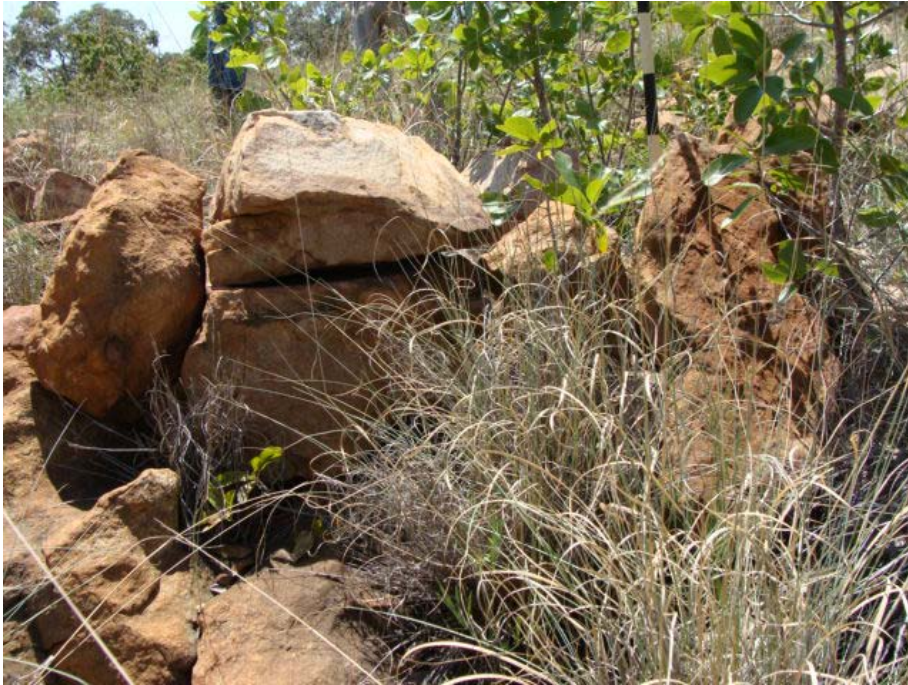
This is yet another fortification wall (Figure 58). It is about 0,50m high and probably only long enough to protect one person. North of the wall some dark green glass, typical of 19th century liquor bottles were found. It may be linked to a blockhouse just east of this wall.

Figure 58 Fortification wall numbered as feature no 19.

The feature is of a high cultural significance as it falls within the context of the fort and other fortifications in the area.

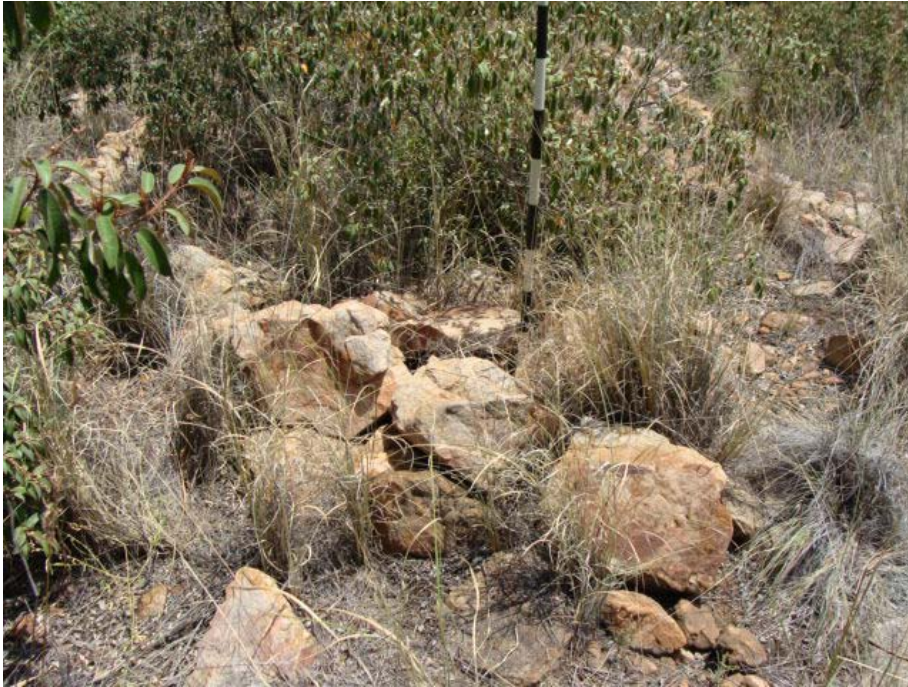
This is another wall, but it is not clear whether it served a fortification function (Figure 59). It is on the western side of the mountain crest where the cliffs start and therefore may have served to protect the fort or even the large Iron Age site mentioned earlier.

Figure 59 Stone wall numbered as feature 20.

The feature is of a high cultural significance as it falls within the context of either the fort or the large Iron Ages site.

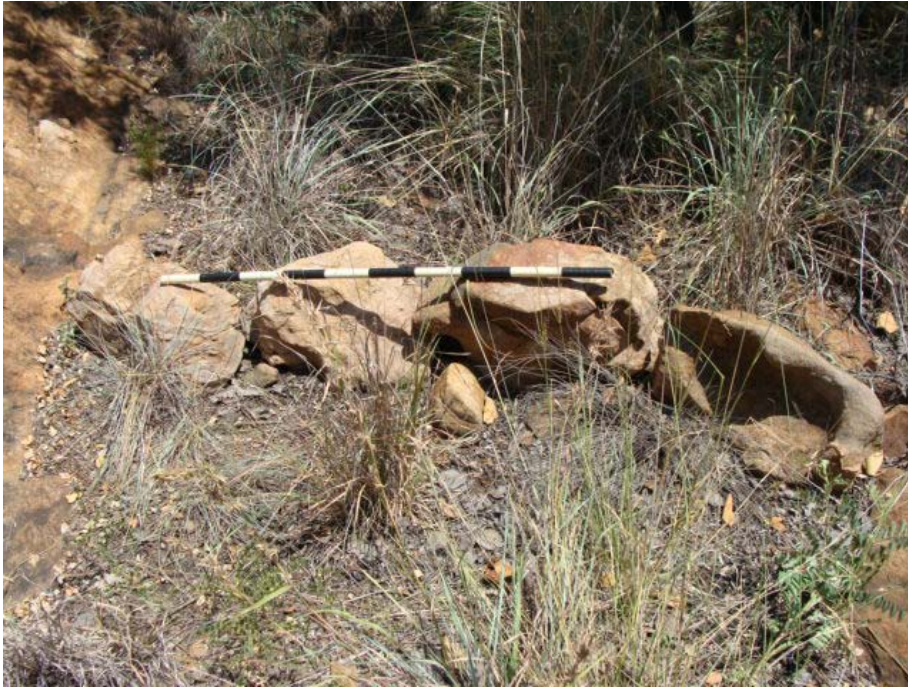
This is another fortification wall (Figure 60). This one is approximately 0,20 m high and 1,20m long. It was found to the east of no 20.

Figure 60 Low fortification wall made of loose stones.

The feature is of a high cultural significance as it probably is associated with the fort.

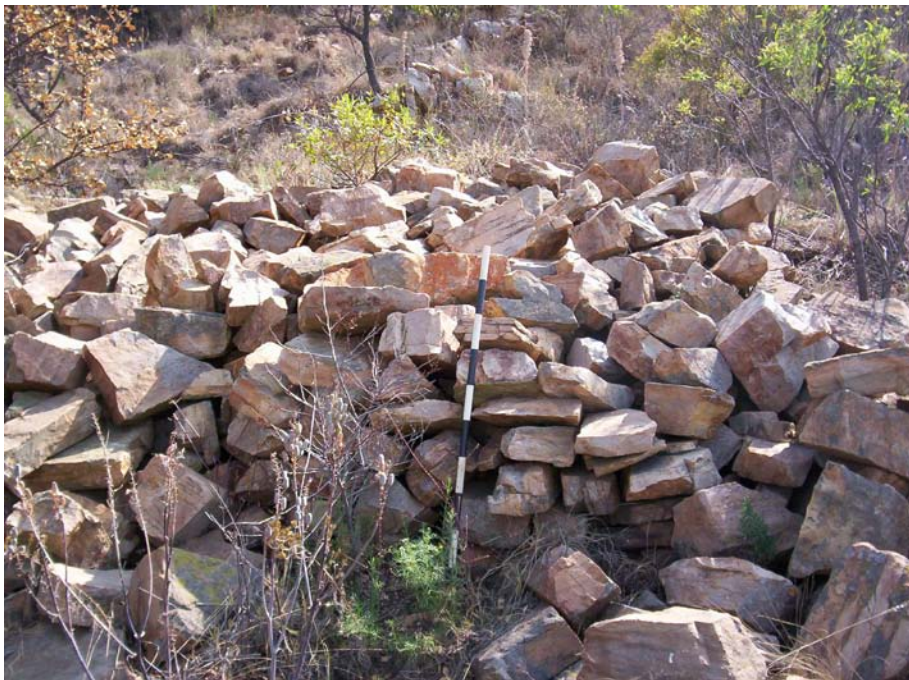
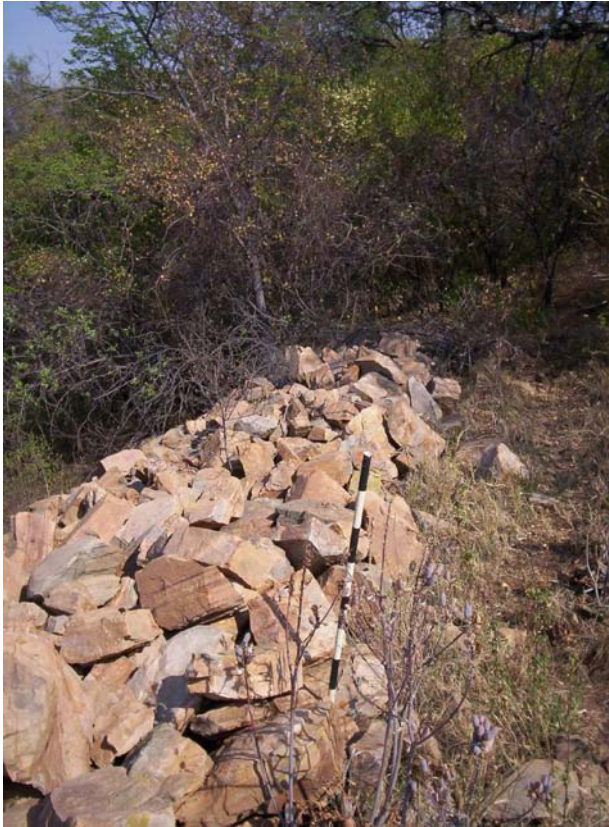
This is two fortification walls found close together and parallel to each other and high up against the southwestern slope of the mountain (Figure 61-62). The walls are approximately 0,50-0,80m high.

Figure 61 One of the fortification walls at site no 23.

Figure 62 The second fortification wall at site no 23.

The site is of a high cultural significance as it most probably is associated with the fort.

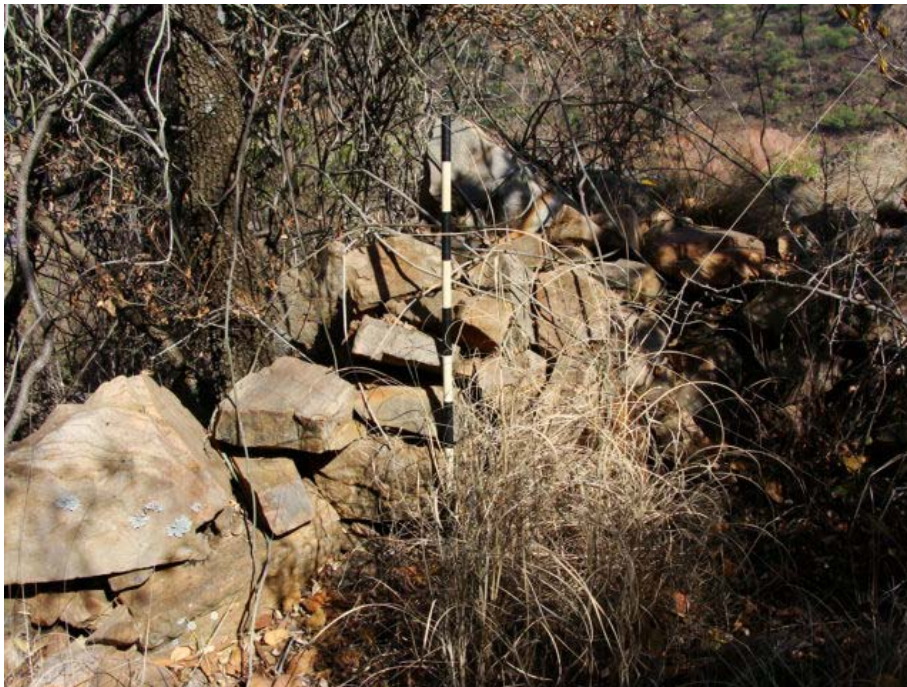
This is a semi-circular fortification wall on a ridge on the western side of the mountain (Figure 63).

Figure 63 Fortification wall numbered as feature no 26.

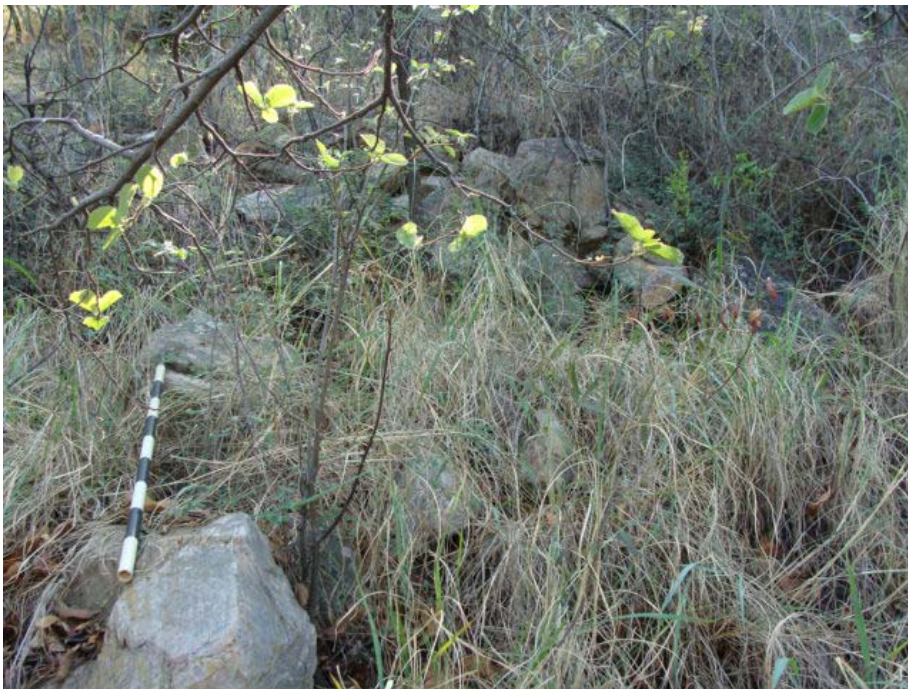
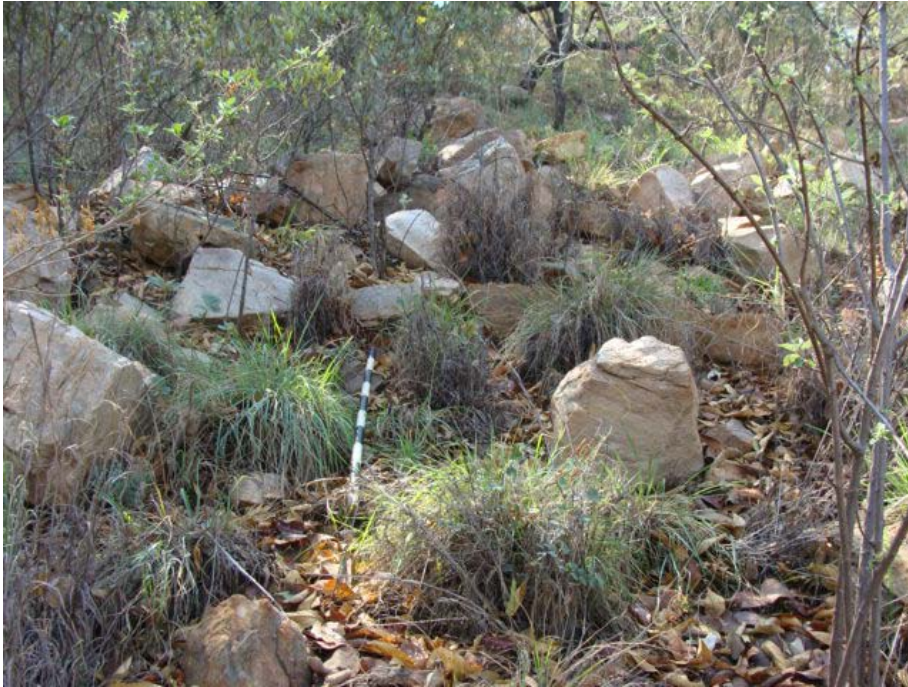
This is a number of walls against the southwestern slope of the mountain (Figure 64-65). It most probably dates to the historical era, but may be from the Iron Age.

Figure 64 One of the walls numbered as site no 27.

Figure 65 Another wall at site no 27.

The site is of a medium cultural significance as it most probably is associated with other features.

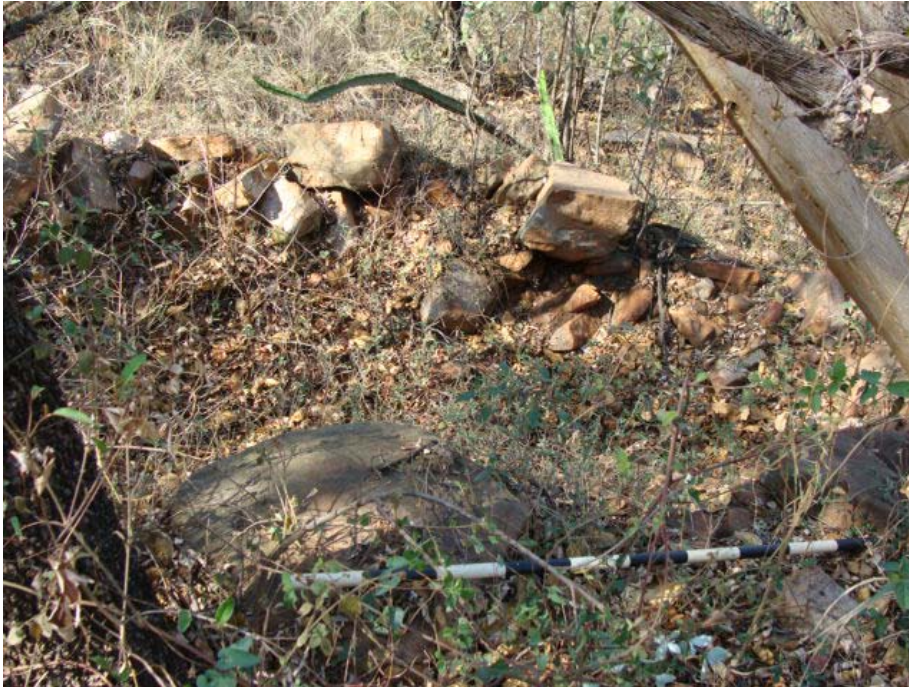
This is a hole in the ground packed out with stones (Figure 66). It is closely associated with no 27 and may therefore be part of this site.

Figure 66 Hole in the ground packed with stones that may be associated with the walls at site no 27.

The site is of a medium cultural significance as it most probably is associated with other features.

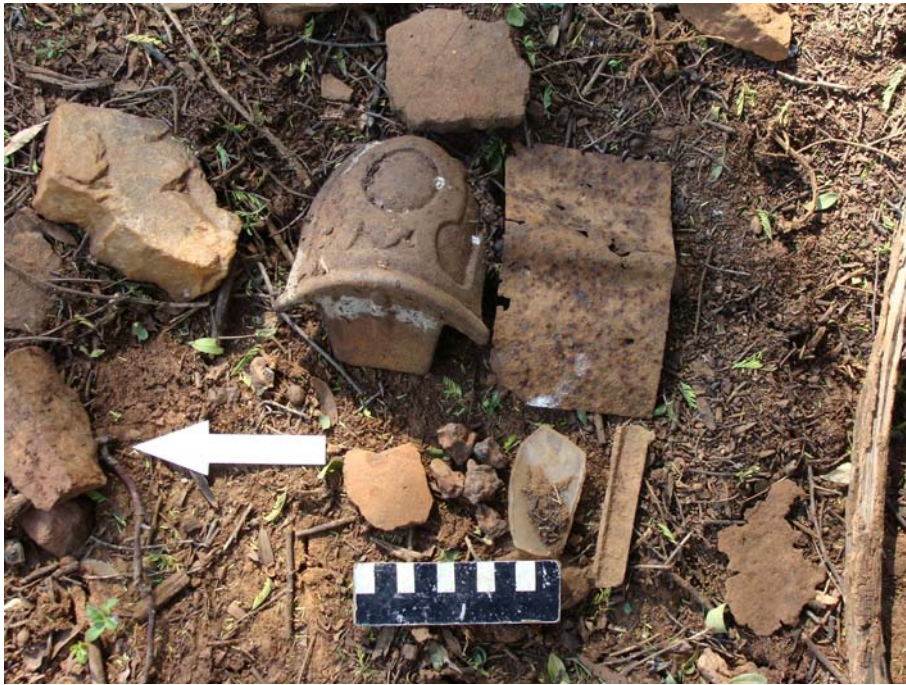
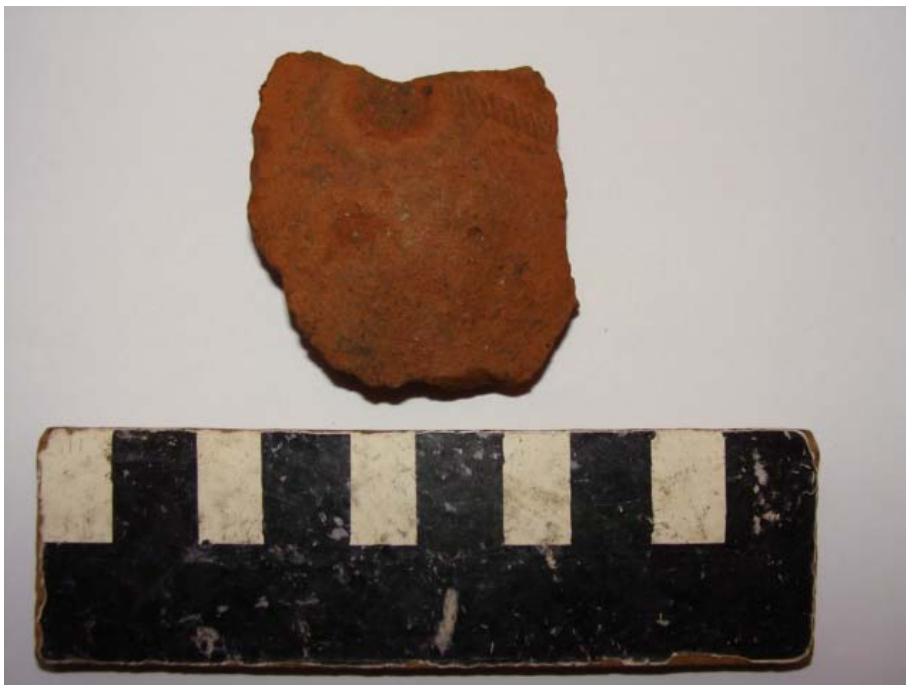
This site consists of the vague remains of a structure build from stone. It is associated with potsherds, pieces of glass, parts of a metal cooking pot (driepootpot) and other artifacts (Figure 67-68). Iron slag was also identified, but no clear indication of a smelting furnace could be identified. It may be a chance find. Middle Stone Age artifacts were also found here.

Figure 67 Artifacts found at site no 29.

Figure 68 Potsherd from site no 29. This potsherd is also similar to those of the Madikwe facies of the Rooiberg phase of the Urewe tradition which are dated to AD 1500-1700 (Huffman 2007: 199). It should be indicated that the known area where Madikwe pottery is found, is more to the northwest of the surveyed area. However one can not really base the correct facies on only one potsherd. The presence of Iron Age material associated with historical artifacts may indicate a period of contact between Bantu speaking people and white travelers.

The site is of a medium cultural significance as it most probably is associated with other features. Should remains of smelting furnaces be identified later the site undoubtedly will be upgraded to having a high cultural significance.

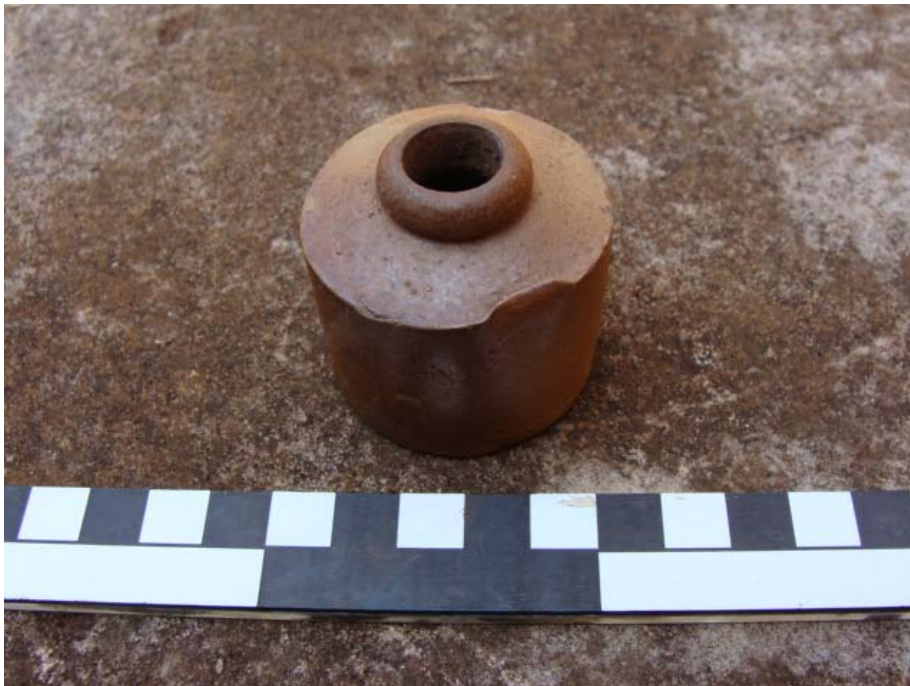
This is a possible refuse midden and includes potsherds, porcelain, metal, concrete and glass pieces. A ceramic inkpot (Figure 69) and ginger pot from the late 19th – early 20th century was also found here as well as the inside parts of an accordion. These artifacts are similar to what has been found at other sites dated to the Anglo Boer War. It seems as if the midden was covered with stones at some stage.

Figure 69 Inkpot found at site no 30.

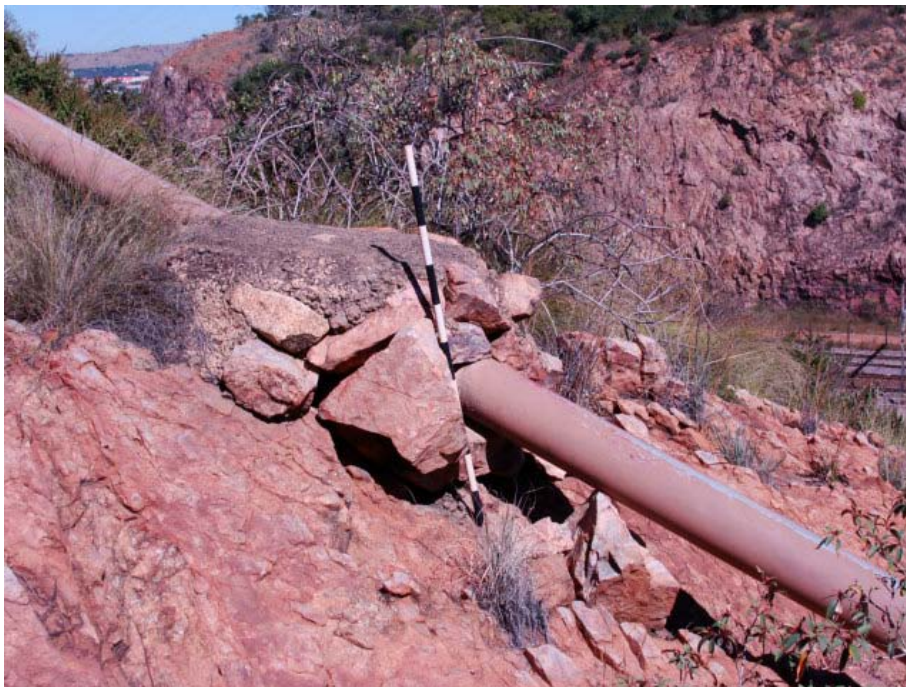
This is a stone feature made of rock that were concreted together and used as pillar for the water pipes feeding the man-made waterfall on the reserve (Figure 70). It is one of a few of these and serves as example as these also are cultural resources.

Figure 70 Pillar to keep water pipe serving the waterfall in position.

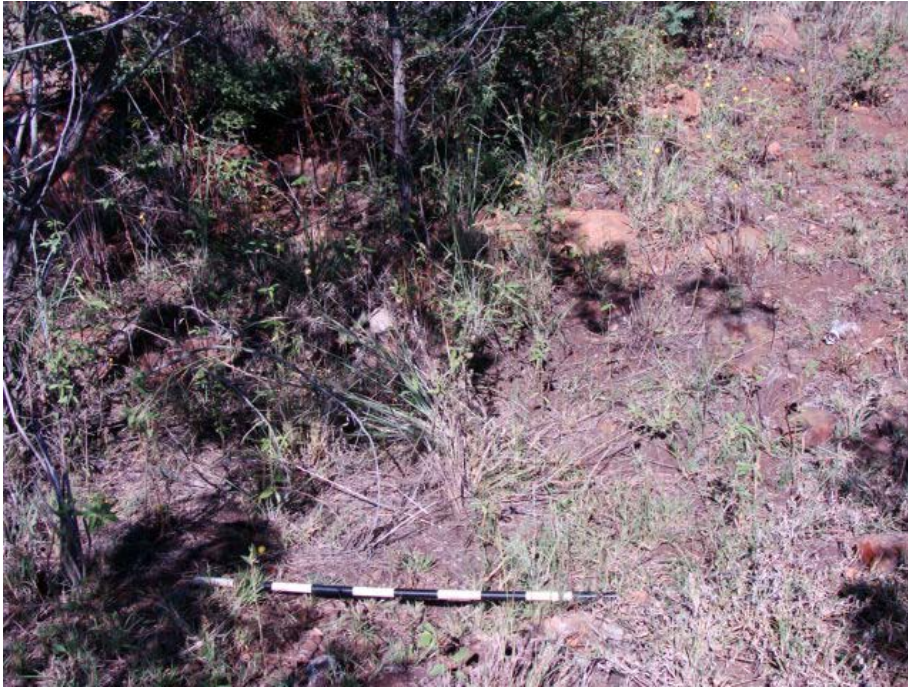
This consists of a ground furrow at the back and northwest of the fort (Figure 73). It may have something to do with the draining of water away from the fort. If site 34 indeed was used for fixing a pump, this furrow may have been used to drain excess water away.

Figure 73 Remains of a furrow behind the fort.

The feature is of a high cultural significance as it has an association with the fort.

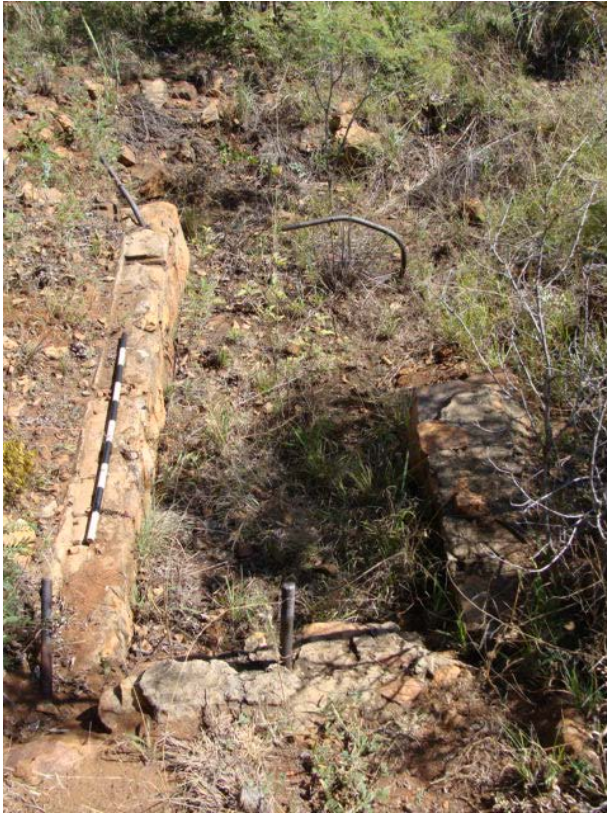
Figure 74 Concrete construction behind the fort which was probably used to fix large machinery on.

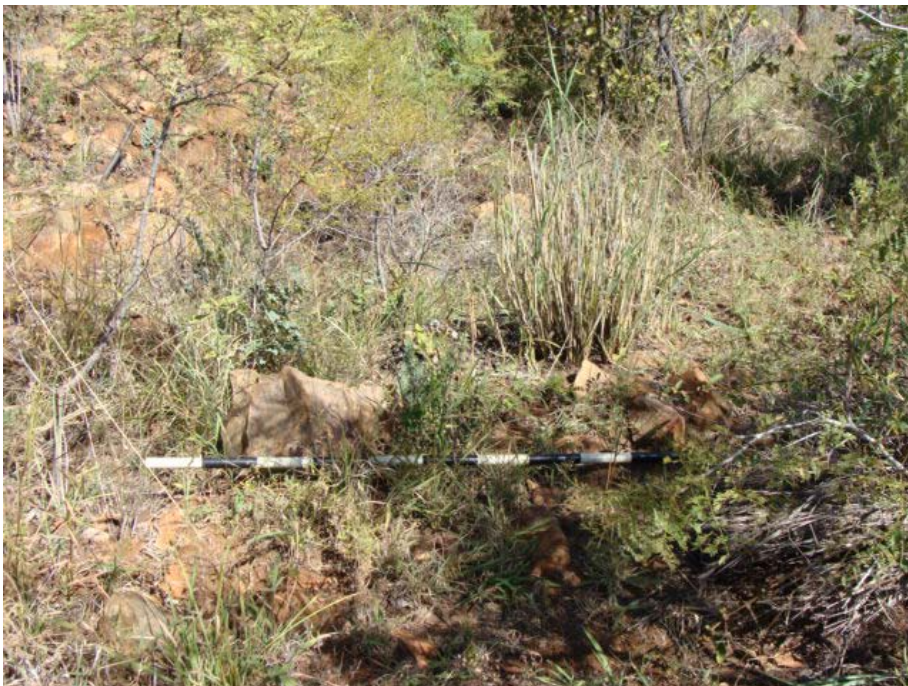
To the northwest of this construction a low semi-circular shaped stone wall was found (Figure 75). This may indicate a kind of barrier to protect such a water pump or perhaps a small canon or gun which may have been placed on the stone and concrete structure.

Figure 75 Low stone wall found at the above concrete construction.

The site is of a high cultural significance as it is associated with the fort.
