**A CULTURAL HERITAGE MANAGEMENT PLAN FOR THE
WONDERBOOM NATURE RESERVE, CITY OF TSHWANE**

***THE CITY OF TSHWANE, DEPARTMENT OF HOUSING, CITY PLANNING
AND ENVIRONMENTAL MANAGEMENT, DIVISION NATURE
CONSERVATION AND RESORTS***

REPORT: AE810

December 2008

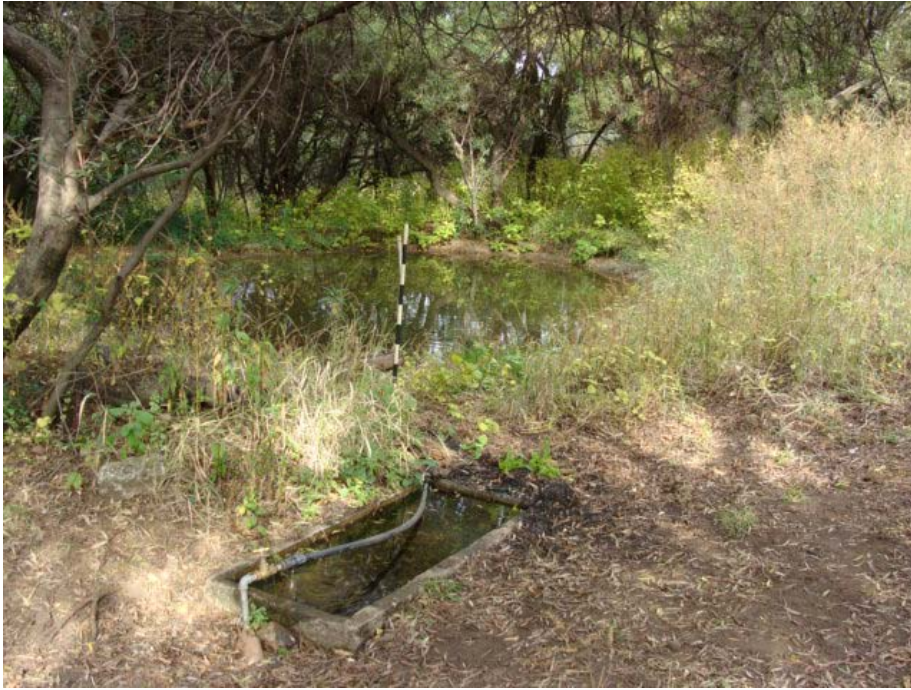
This is a small cement dam and trough made as water drinking place for the wild animals on the reserve (Figure 76). It was found in the southeast of the property next to the gravel road.

Figure 76 Cement dam and water trough at site no 36.

The site is of a low cultural significance as it is not very unique and does not really serve a cultural purpose.

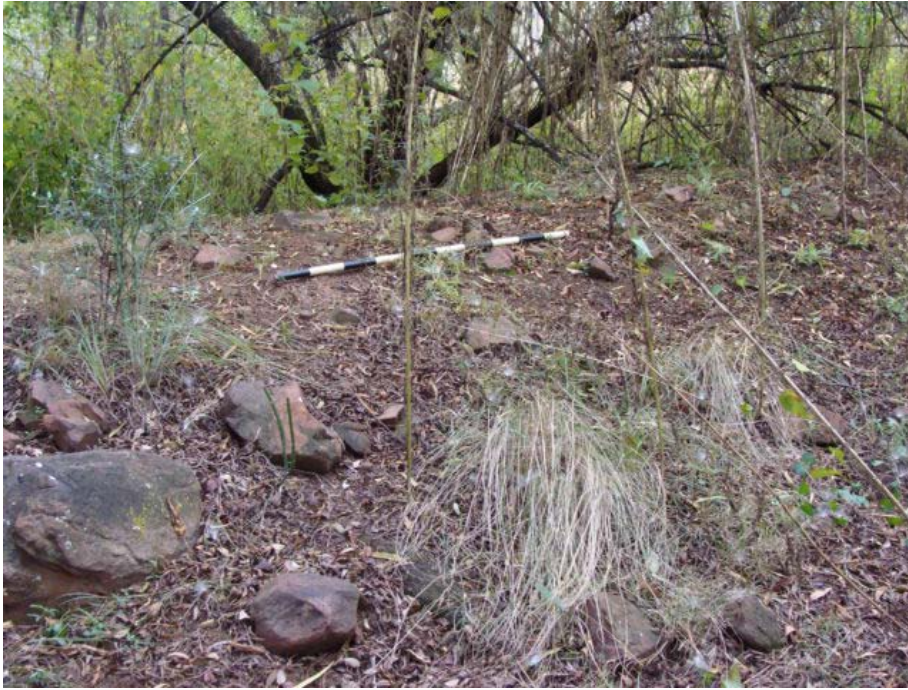
This is either an old ground water furrow or an old wall of a ground dam (Figure 77). It was found to the south of site no 36.

Figure 77 Old water furrow or ground dam at site no 37.

The site is of a low cultural significance as it is not very unique.

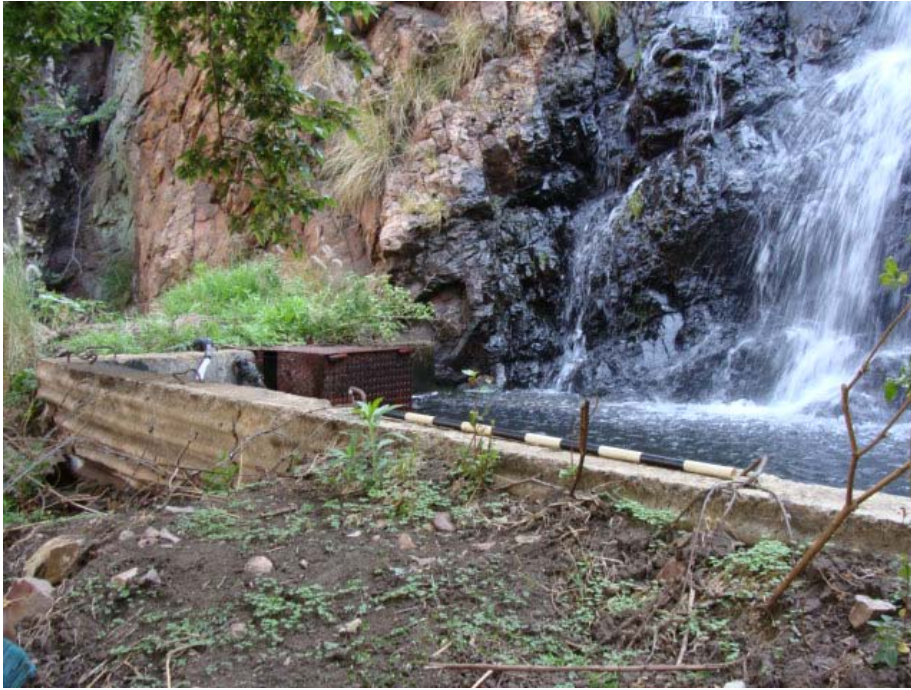
This is the small catchment dam below the waterfall which is used to catch the water and then reroute it back to the top of the waterfall (Figure 78).

Figure 78 Catchment dam below the waterfall.

The site is of a medium cultural significance as it is not very unique, but serve to keep the important man-made waterfall running.

1. As long as no development is planned here the site should just be left as it is.
2. Should developments be planned here the dam should not be demolished, but if it is replaced by another system serving the same purpose, it may be left to deteriorate naturally.

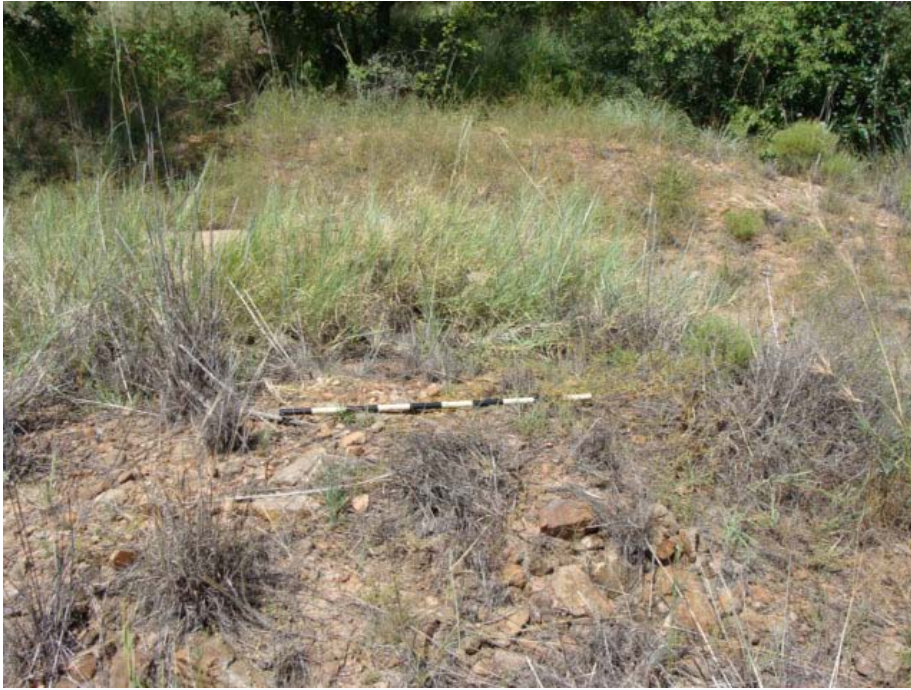
Inside of the structure a drain was dug, but this definitely dates from much later and probably has to do with the radio tower. The building of this structure probably contributed to the damage done to the blockhouse.

Figure 79 Remains of a blockhouse from the Anglo Boer War.

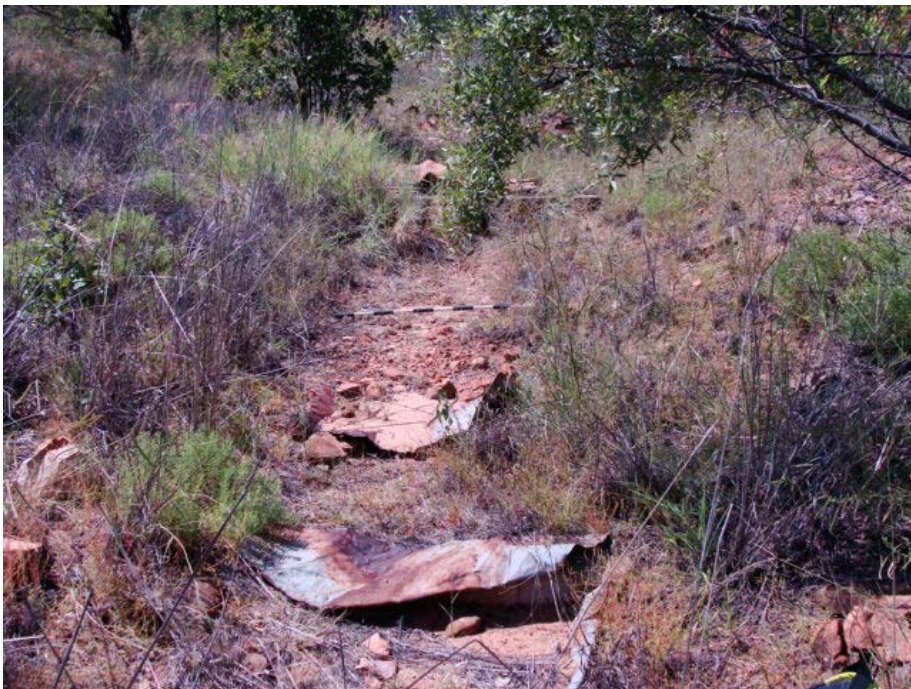
What remains to be seen on site includes a circular wall made from medium to small sized stones (Figure 79). South and east of this other wall remains can be seen. Some corrugated iron is also left on the site (Figure 80). The blockhouse would have been place inside of the mentioned stone walls.

Figure 80 Pieces of corrugated iron at site no 39.

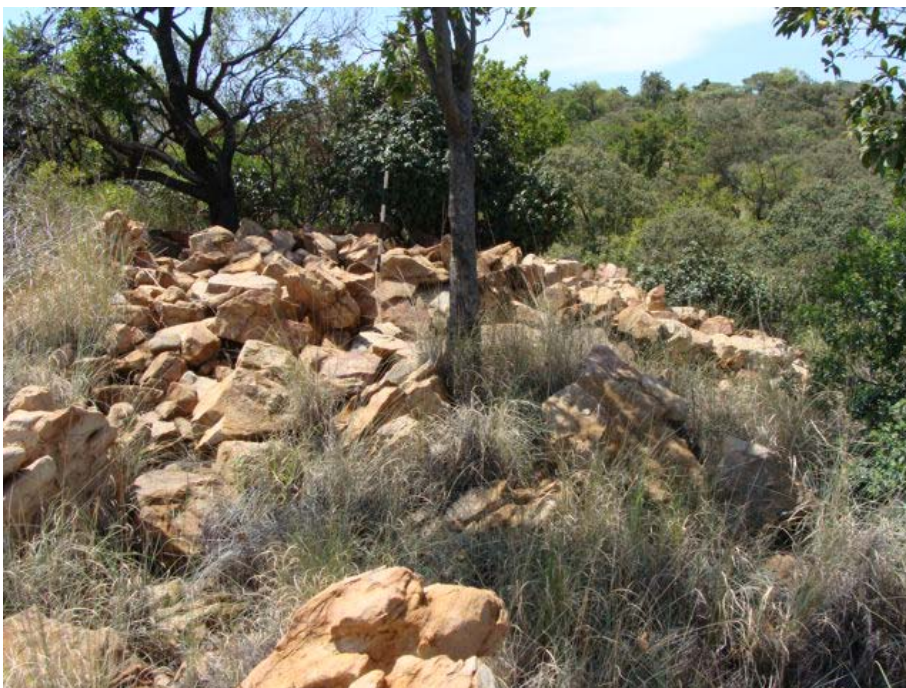
What remains to be seen on site is the stone base on which the blockhouse would have been placed (Figure 81). From the site there is a good view in a southwestern direction.

Figure 81 Remains of a blockhouse from the Anglo Boer War.

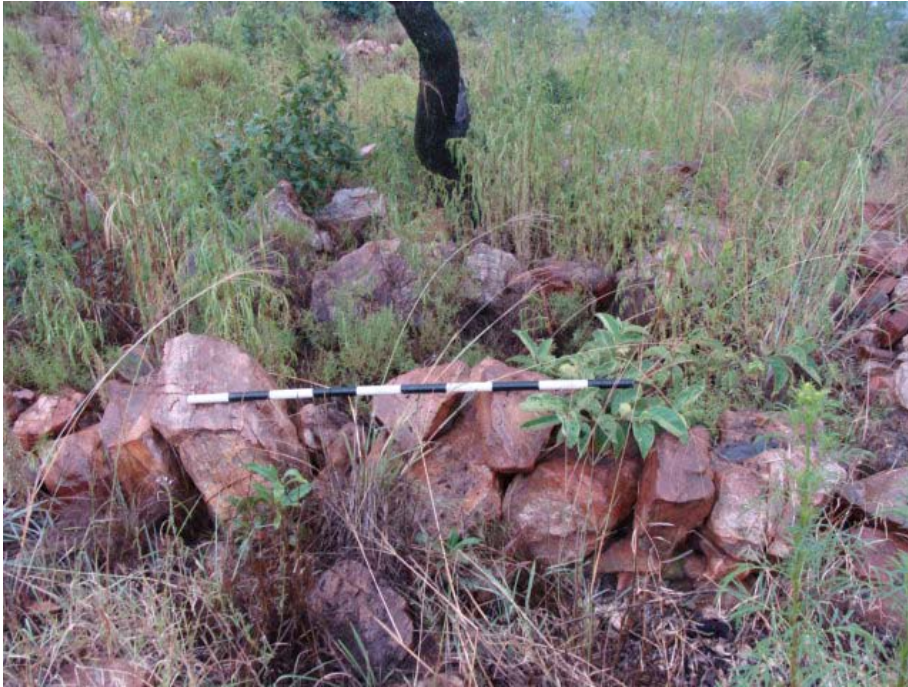
This is the remains of two circular shaped stone walls of more or less 0,20m high (Figure 82). It may have been used for a flag staff or to place a heliograph on during the Anglo Boer War (1899-1902). A heliograph is an instrument used to send signals via mirrors.

The feature is of a high cultural significance as it is connected with the fort and the Anglo Boer War.

Figure 82 Remains of a stone structure that may date back to the Anglo Boer War.

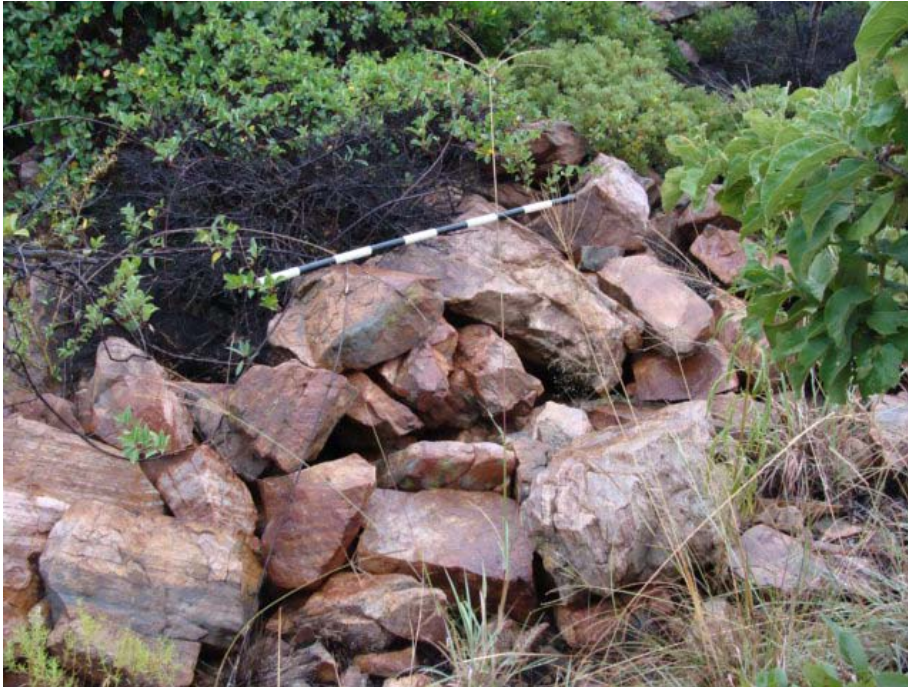
This is the remains of a corrugated iron blockhouse that was built by the British during the Anglo Boer War (1899-1902). What remains to be seen on site includes a base packed with stones and a circular shaped stone wall of 0,50m-0,60m around it (Figure 83). No corrugated iron is left. The blockhouse would have been placed on top of the mentioned base.

Figure 83 Stone walled remains as part of a blockhouse from the Anglo Boer War.

The feature is of a high cultural significance as it is connected with the fort and the Anglo Boer War. A Study done in the 1990's (Van Vollenhoven & Van den Bos 1997) came to the conclusion that not many remains of these blockhouses are left and accordingly what remains should be preserved at all cost.

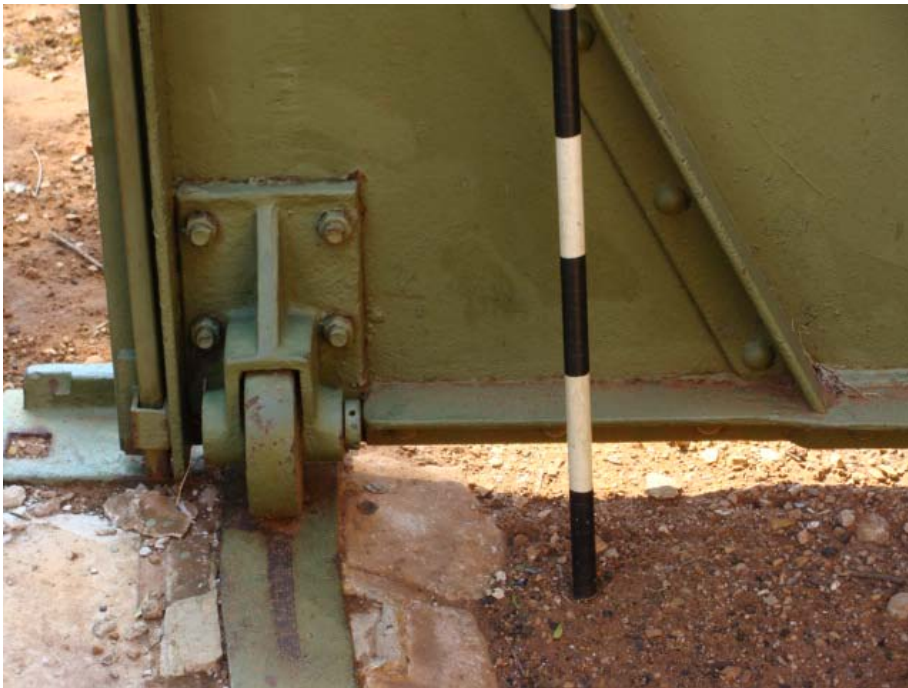
Figure 86 Wheel on which the steel doors of the fort slide into position.

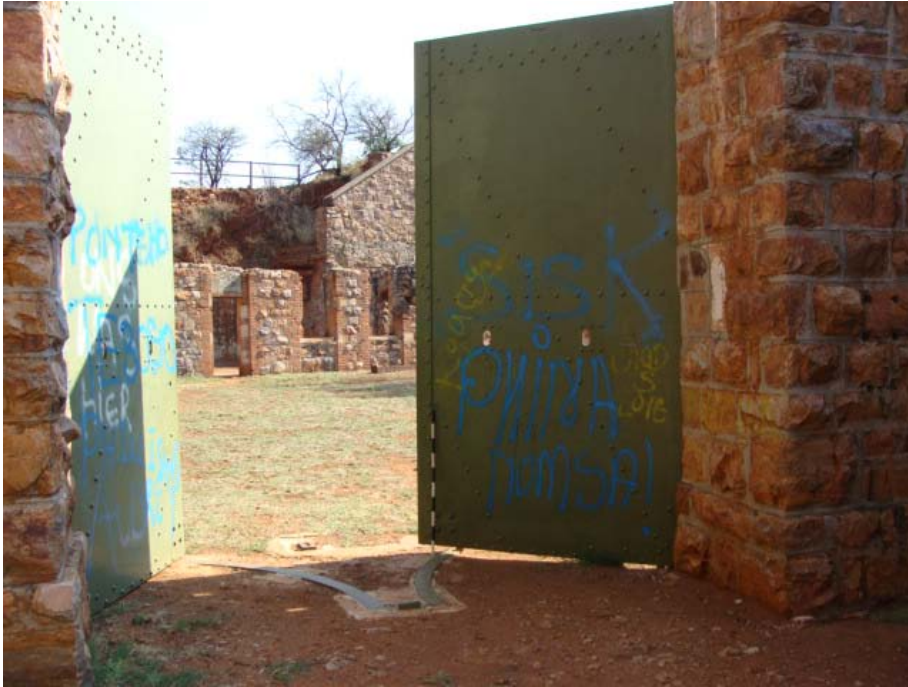
Figure 87 Second set of entrance doors to the fort. Note the very recent graffiti which can also be seen on other parts of the fort.

4. The graffiti at the fort and cave should be cleaned in accordance with this document.
5. Information panels educating visitors with regards to the National Heritage Resources Act and indicating that it is an offence to damage historical resources should be erected as another matter of urgency. Such panels should at least be placed at the fort, the Wonderboom tree and at the cave. The pamphlet given to visitors should also make mention of this.

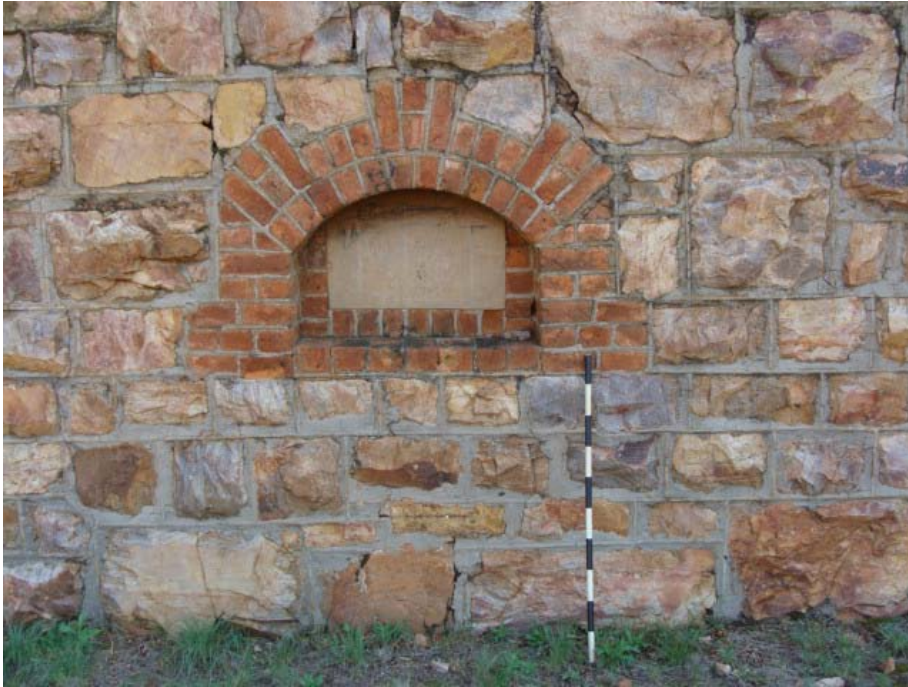
Figure 91 Loophole in the front wall of the fort. It was apparently closed by the former City Council of Pretoria.

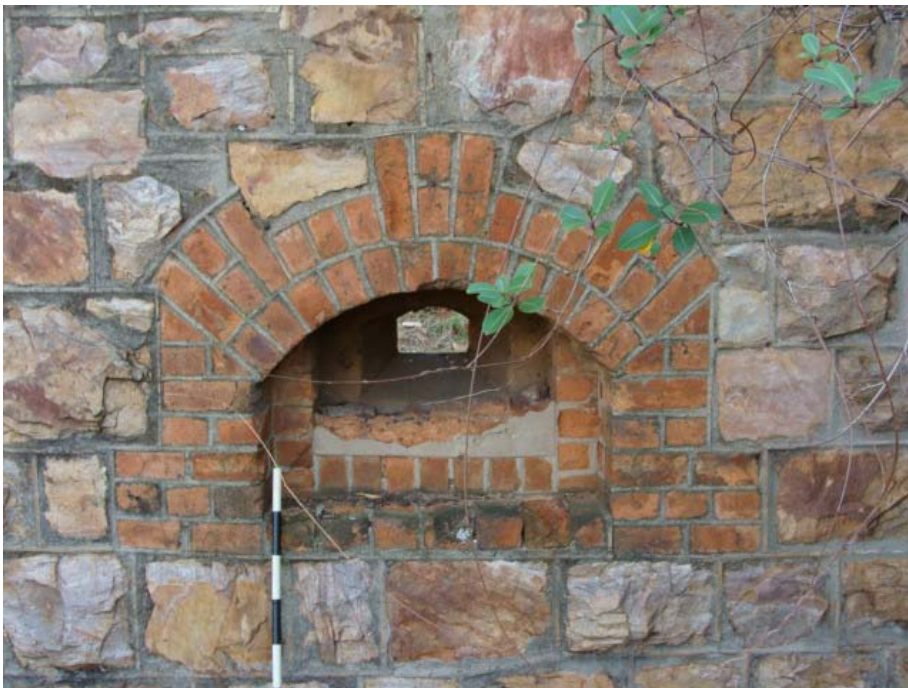
Figure 92 Open loophole in the front wall of the fort.

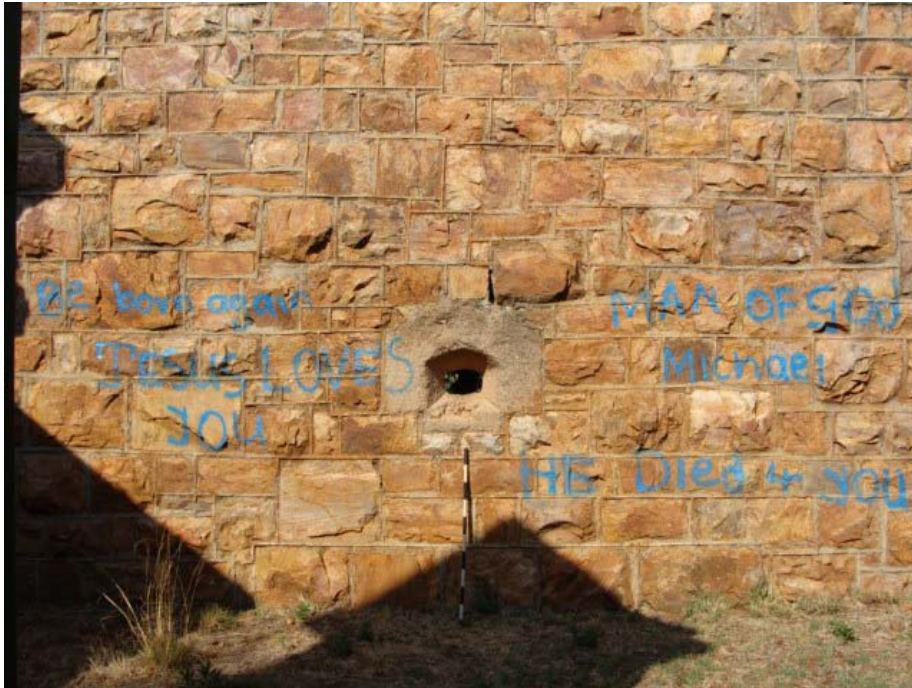
Figure 93 Recent graffiti on the inside of the front wall of the fort.

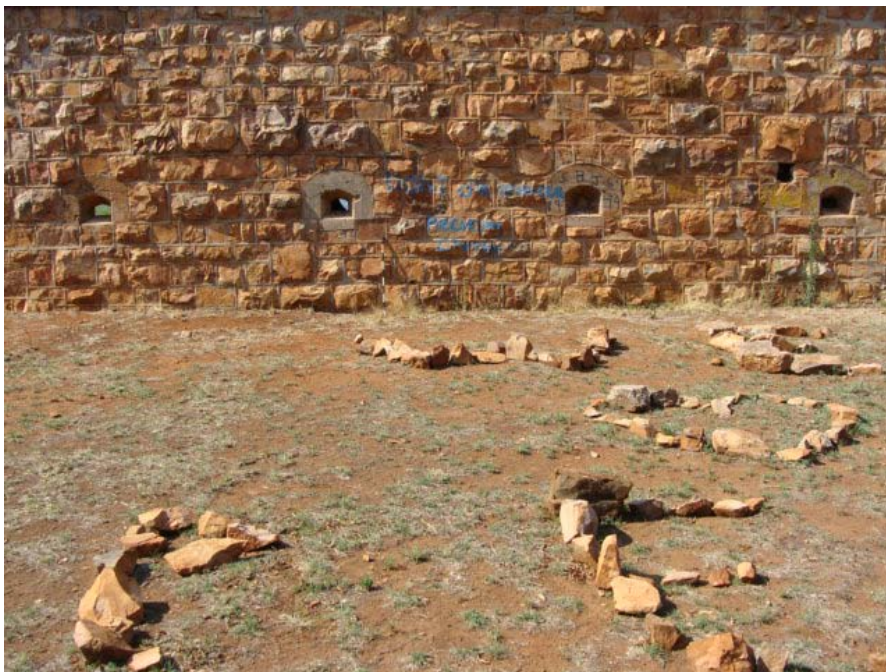
Figure 94 Graffiti against the inside wall of the fort and packed stones in the courtyard indicating recent activities damaging the site.

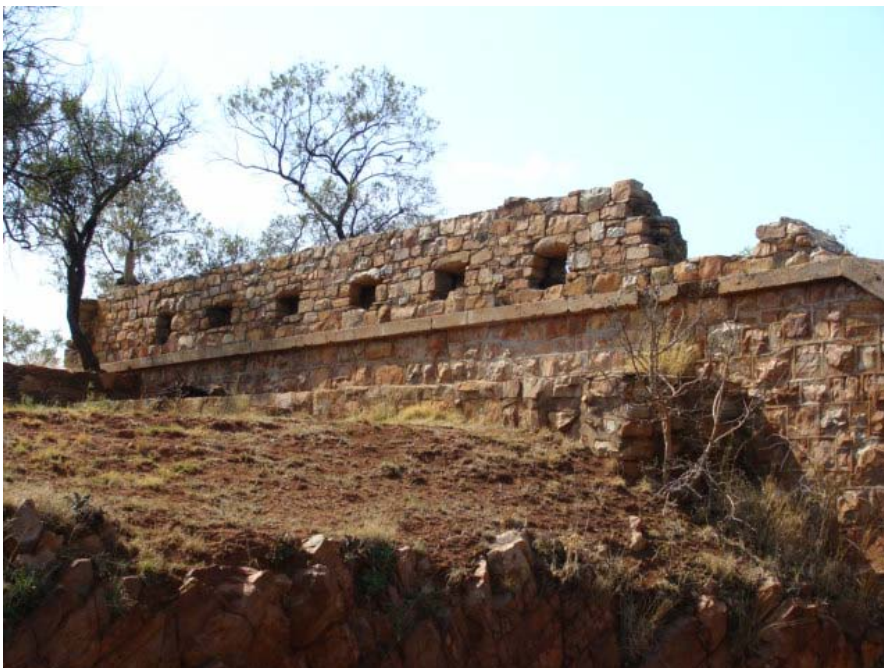
Figure 96 This wall on top of the fort wall was probably built by the British after they took over the fort as the style clearly differs from the rest of the building.

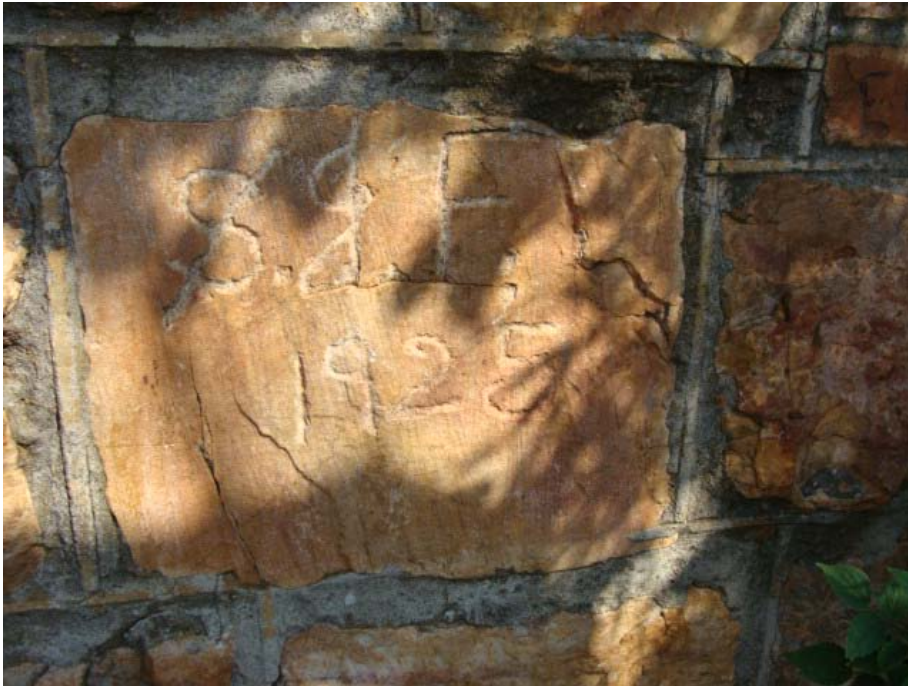
Figure 97 Graffiti from 1925 at the entrance to the fort.

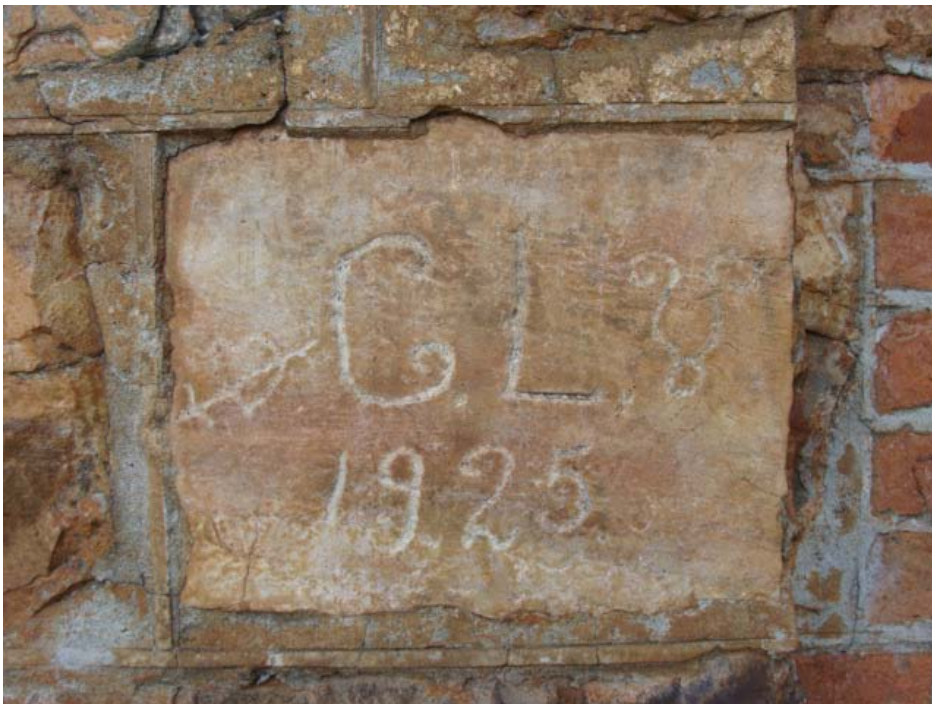
Figure 98 More graffiti from 1925 at the entrance to the fort.

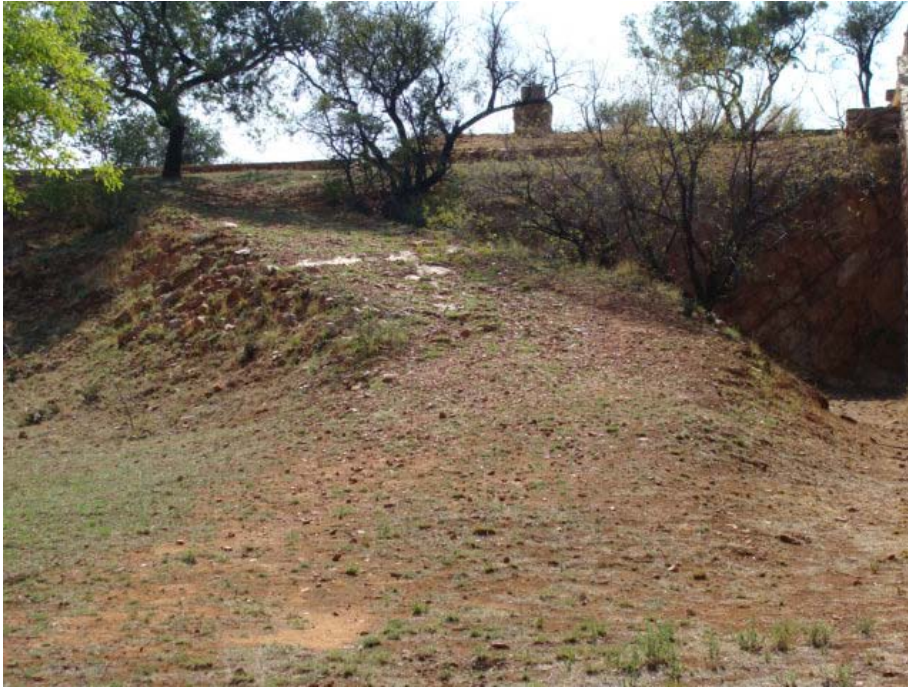
Figure 99 The ramp that gave access to the roof of the fort. It was used to move the canons to the roof. Also note the original rock face on the right hand side that was incorporated into the design of the fort.

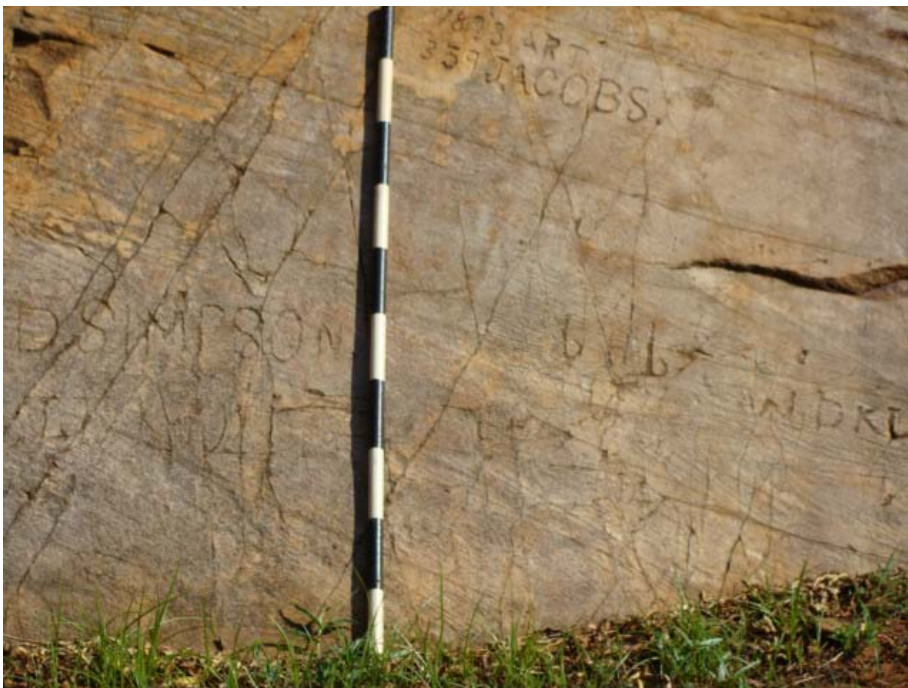
Figure 100 Original graffiti at the fort. It contains the names of some of the soldiers, both Boer and British, who were stationed at the fort. In some cases it also includes regimental numbers. For instance the one on the top reads '1898 ART 359 JACOBS', meaning that Jacobs with force number 359 was a member of the ZAR State Artillery in 1898.

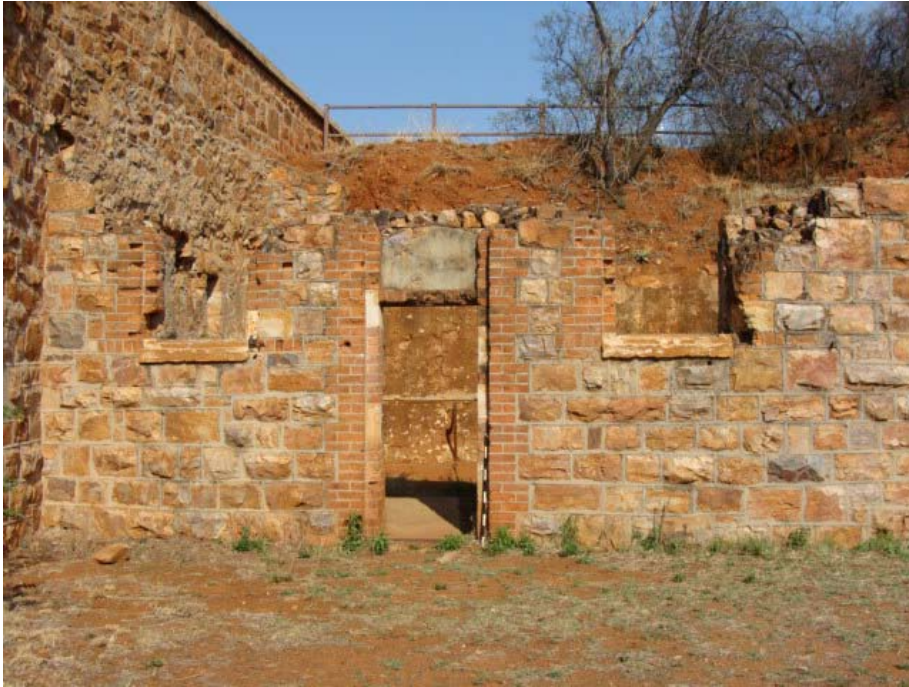
Figure 105 Front view of the stable in the fort.

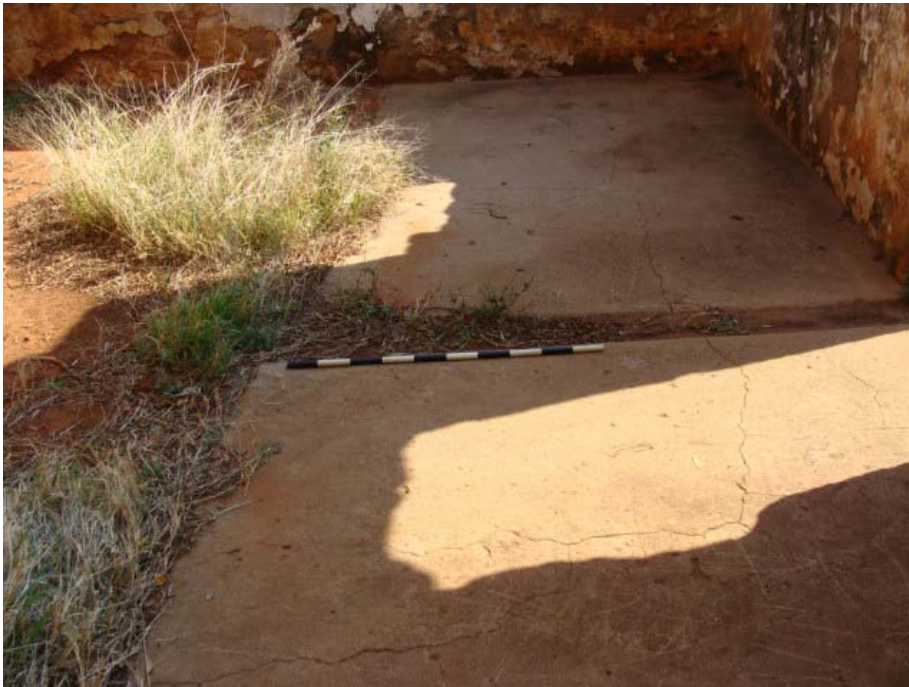
Figure 106 Water furrow inside of the stable at the fort.

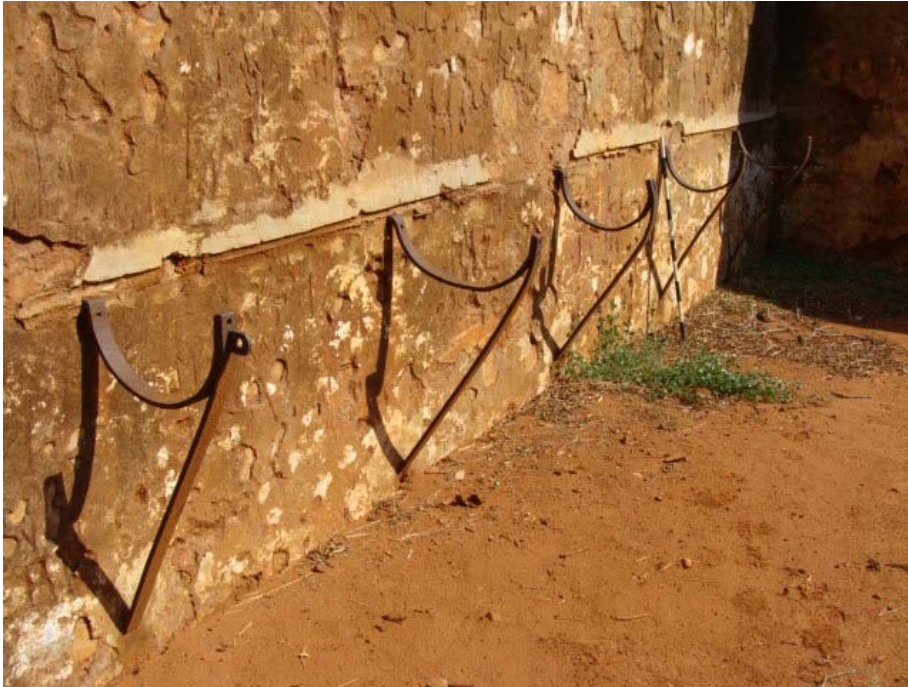
Figure 107 These metal arms are where the troughs were placed in the stable.

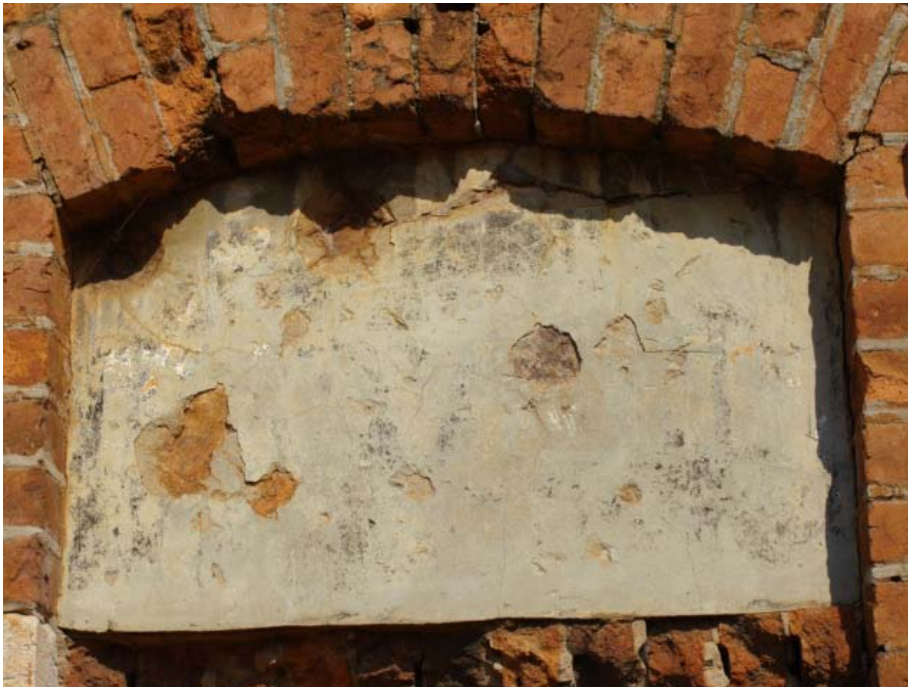
Figure 112 The only room of which the letter work is still legible, although very vaguely. This reads 'PROVIAND' and refers to the provisions store room.

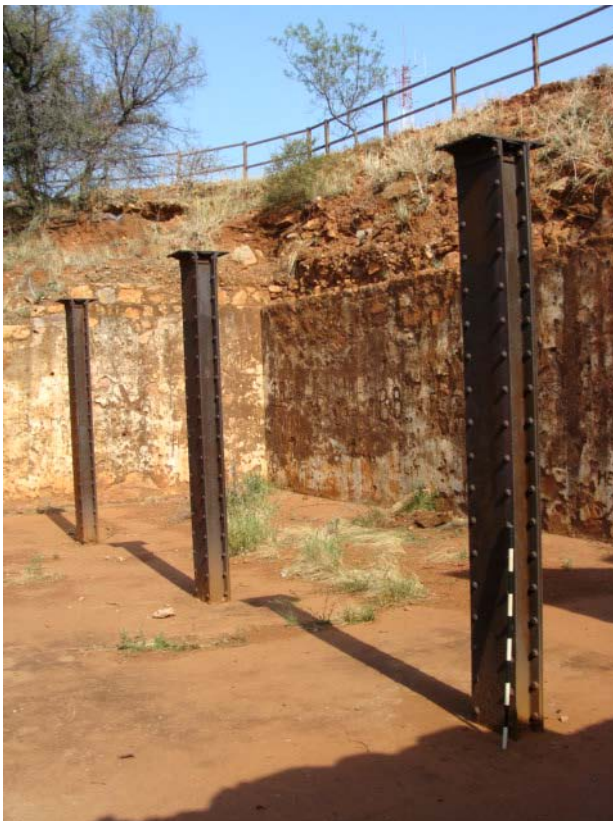
Figure 116 Steel pillars, like these ones in the sleeping quarters, were used to keep the concrete roof in position.

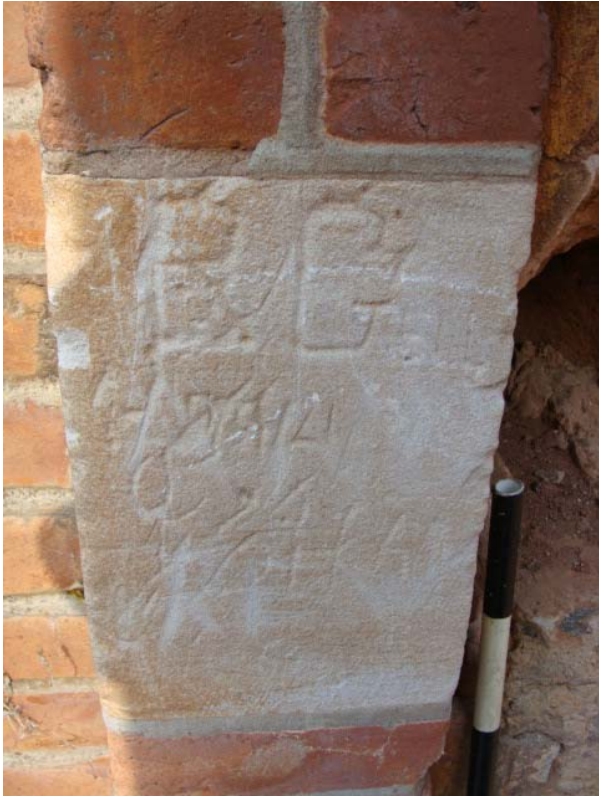
Figure 117 Graffiti at the entrance to the garrison's sleeping quarters. It is reasonably old, but probably does not go back to the time of the Anglo Boer War.

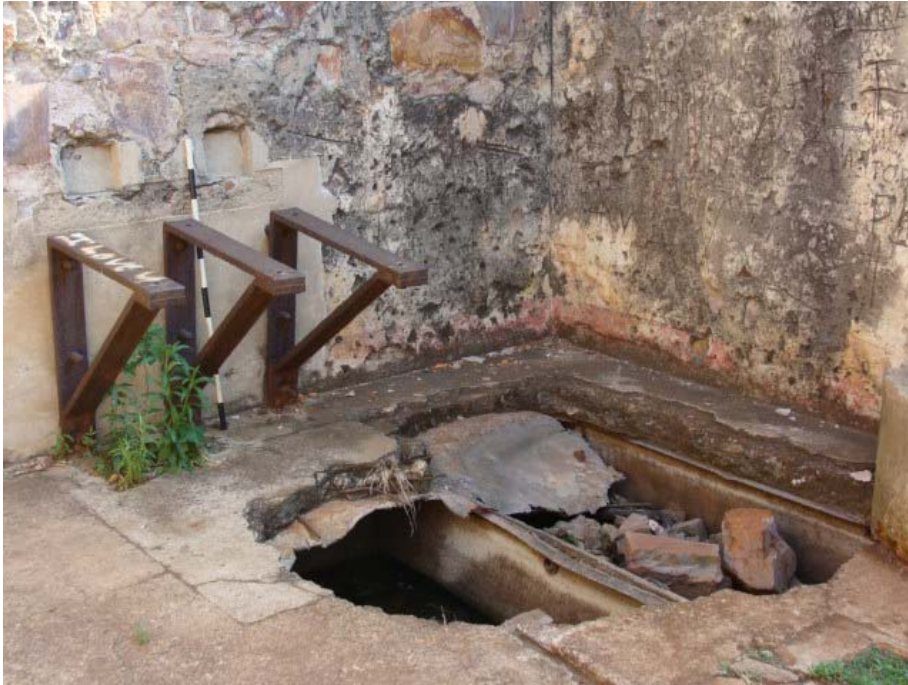
Figure 119 Inside of the machine room at the fort. The steel arms were used to place heavy machinery on and the reservoir beneath the floor was probably used for paraffin.

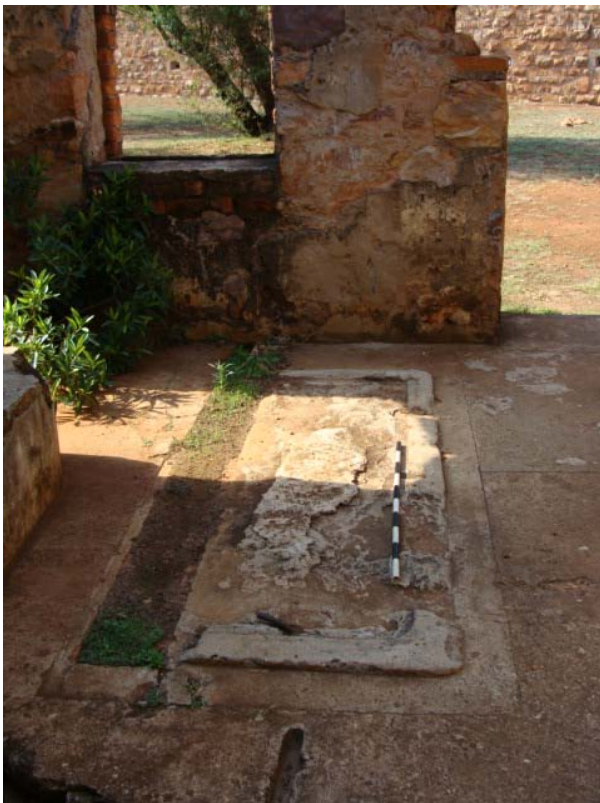
Figure 120 Another view inside of the machine room in the fort. Note the area where the generator possibly was attached.

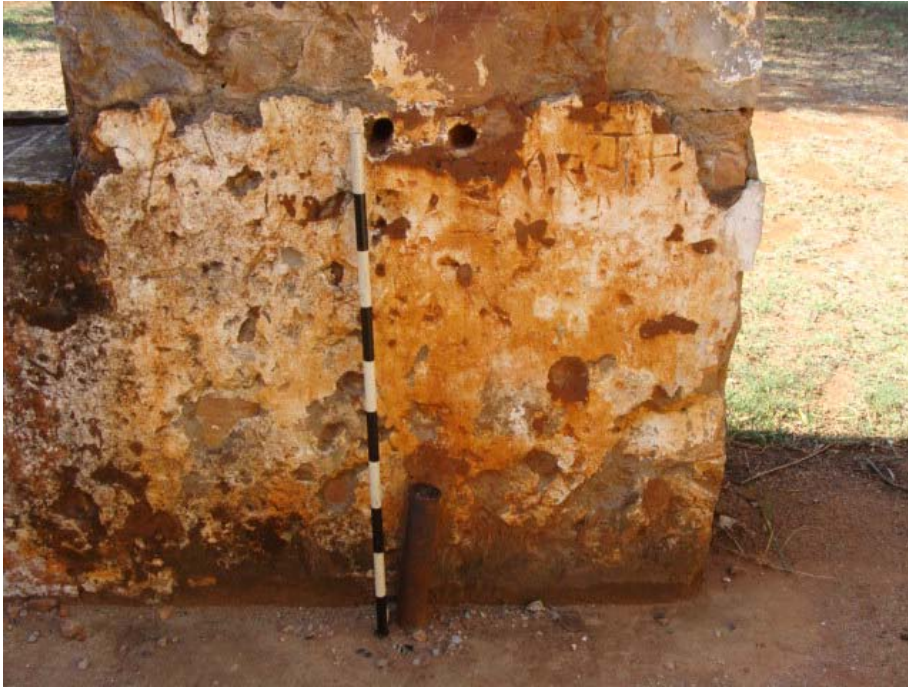
Figure 123 Inside of the telegraph room. The steel pipe was used to protect the electric wiring.

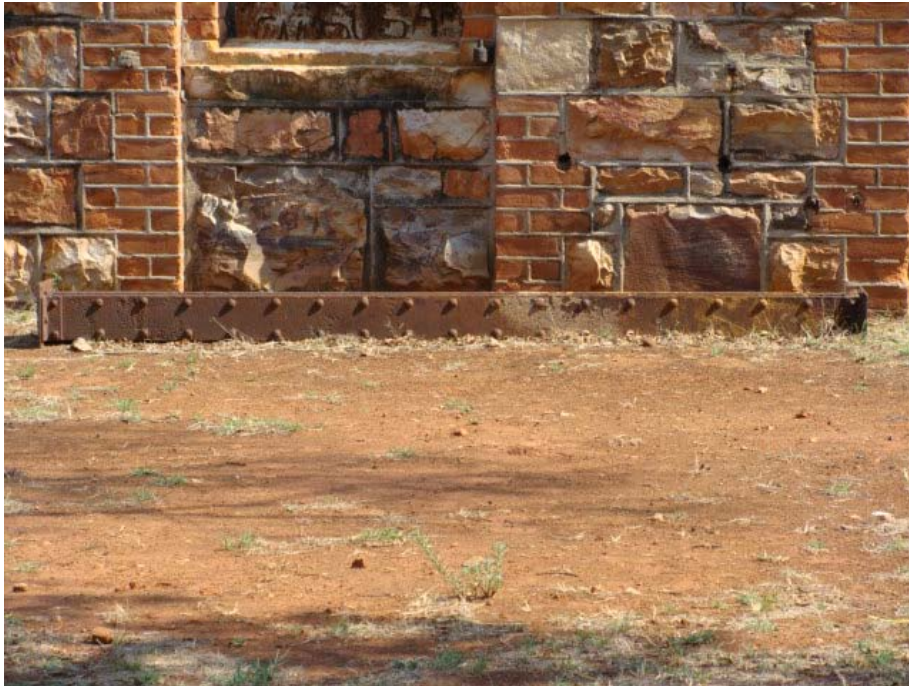
Figure 129 Loose steel pillar in the courtyard.

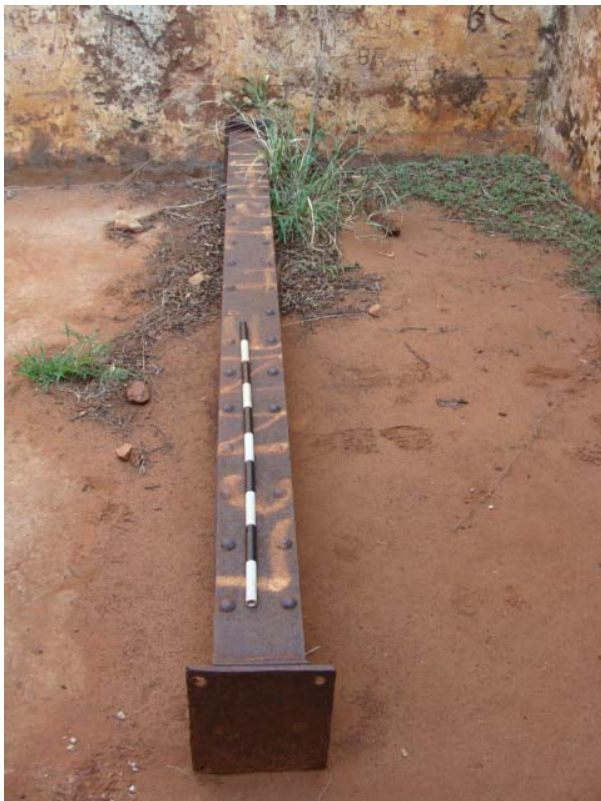
Figure 130 Loose steel pillar in one of the rooms of the fort.

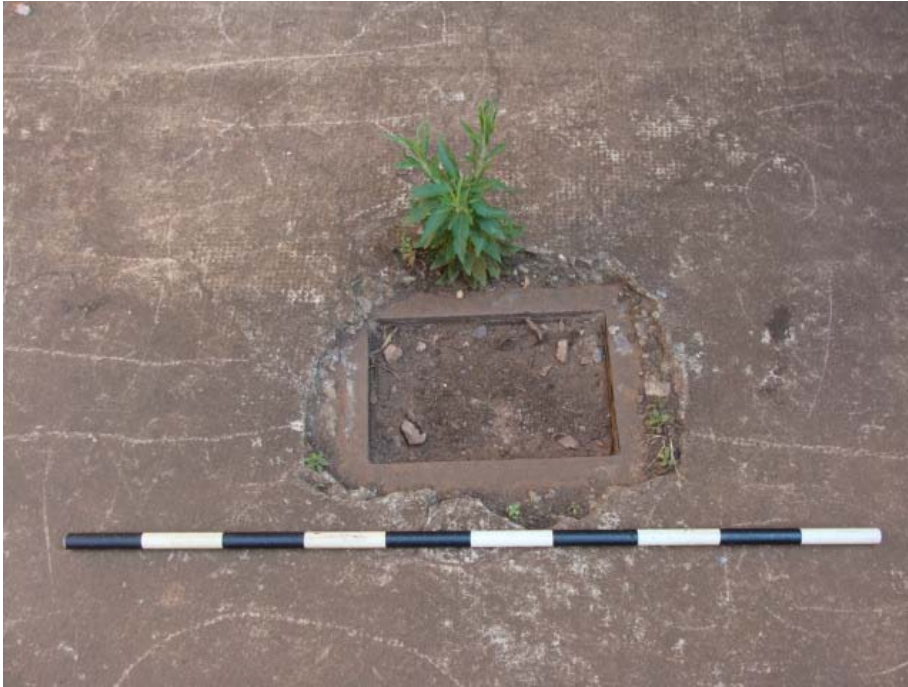
Figure 131 Place where the above steel pillar was removed from.

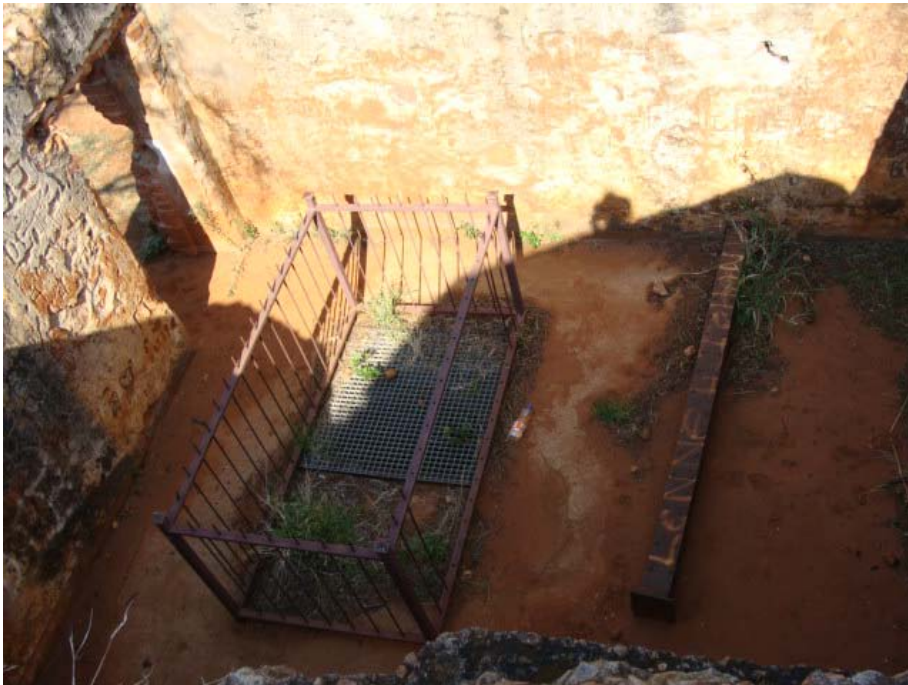
Figure 132 The water reservoir is beneath the ammunition store room. The floor of the ammunition room was damaged by someone trying to gain access to the reservoir. A barrier was erected to make the area safe, but even this was vandalized.

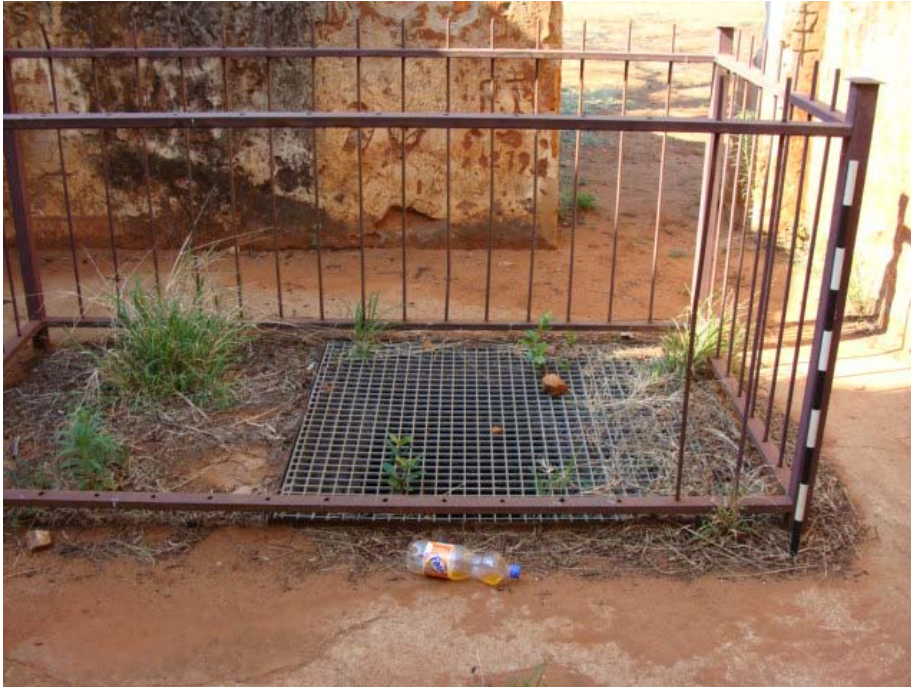
Figure 133 Close-up view of the broken barrier at the water reservoir.

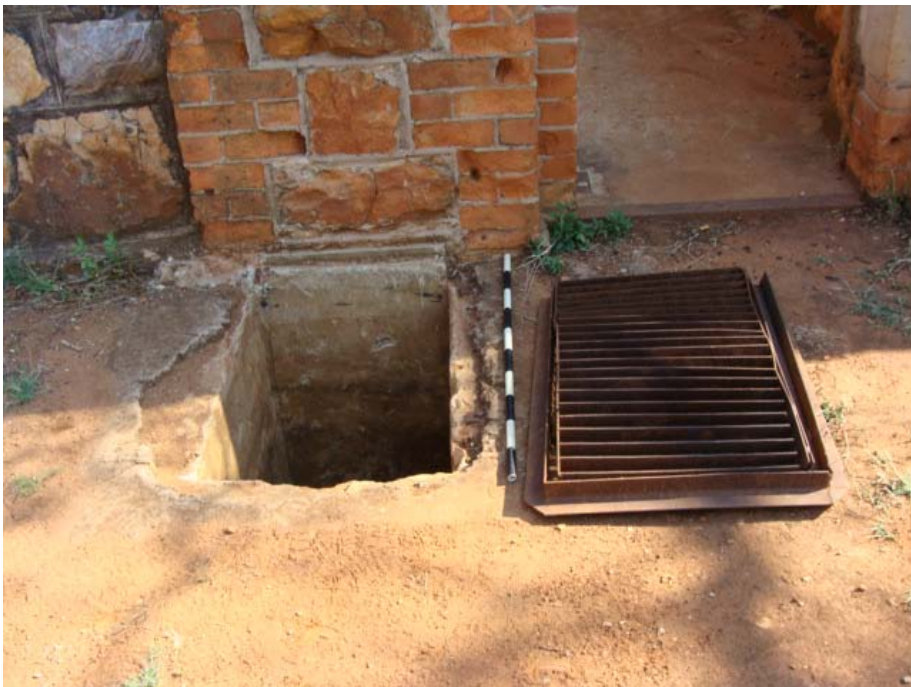
Figure 134 Original entrance to the water reservoir. The grid is a later addition, but even this was vandalized.

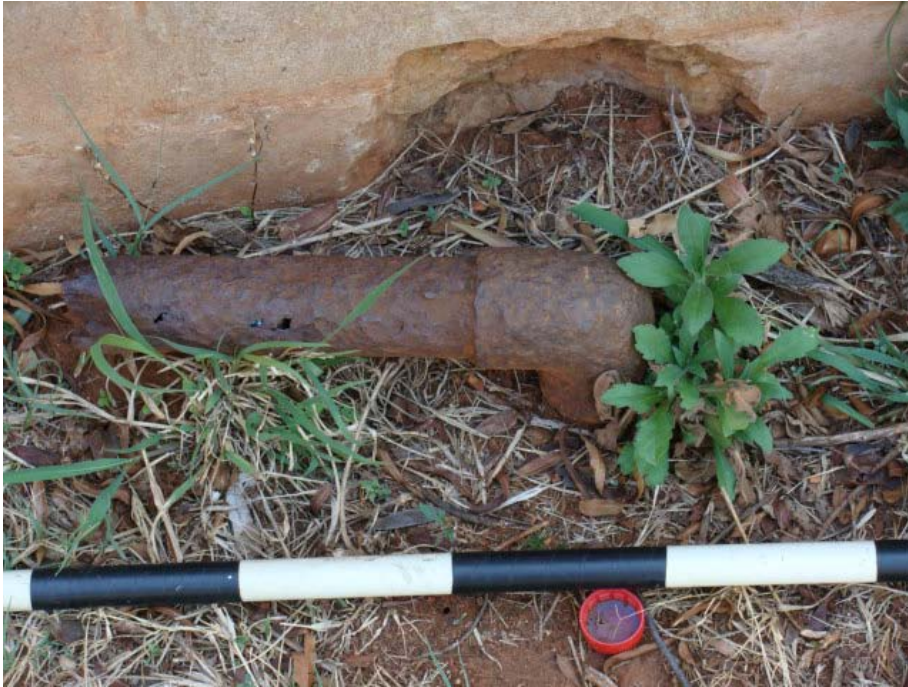
Figure 135 Remains of the water pump at Fort Wonderboompoort.
