**A CULTURAL HERITAGE MANAGEMENT PLAN FOR THE
WONDERBOOM NATURE RESERVE, CITY OF TSHWANE**

***THE CITY OF TSHWANE, DEPARTMENT OF HOUSING, CITY PLANNING
AND ENVIRONMENTAL MANAGEMENT, DIVISION NATURE
CONSERVATION AND RESORTS***

REPORT: AE810

December 2008

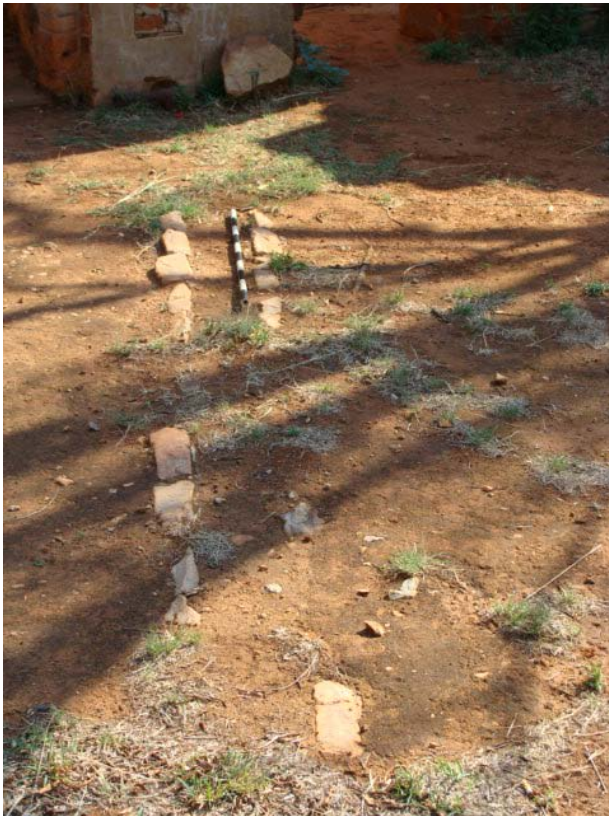
Figure 136 Water furrow running from the water pump.

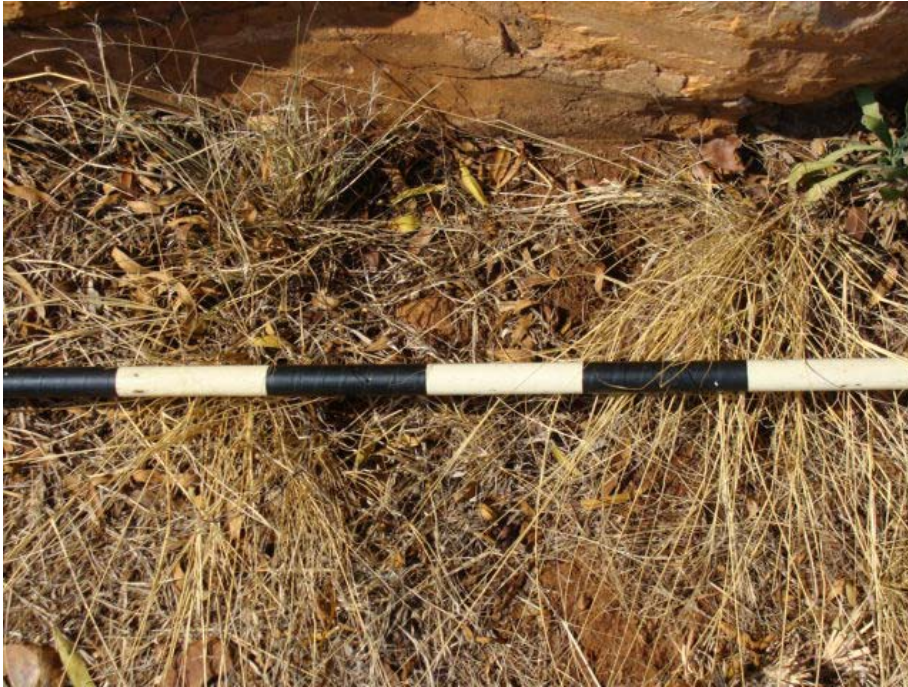
Figure 137 Sump for letting out water from the inside of the fort.

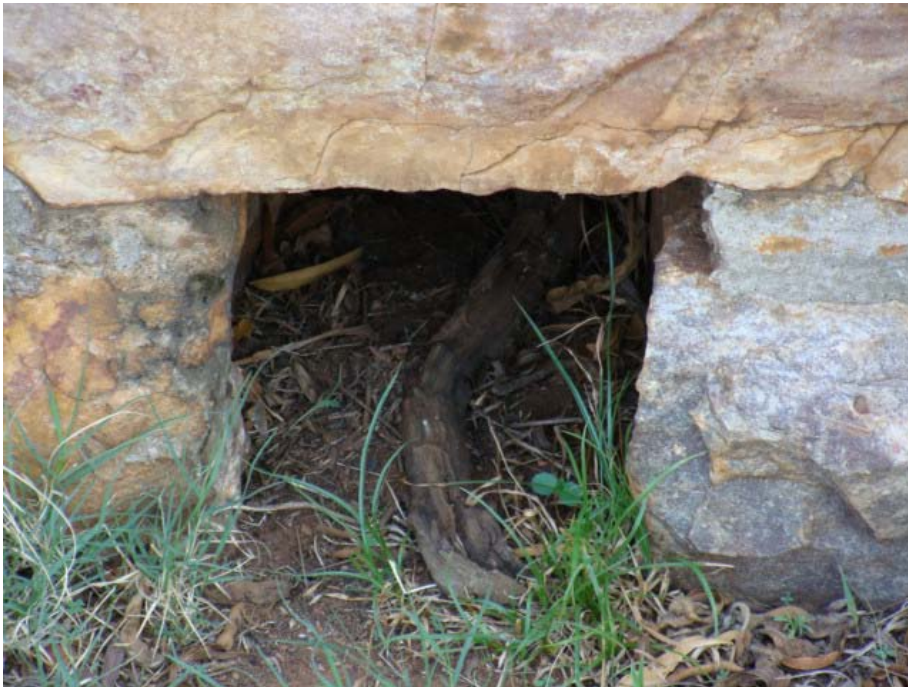
Figure 138 Water outlet in the outside wall of the fort.

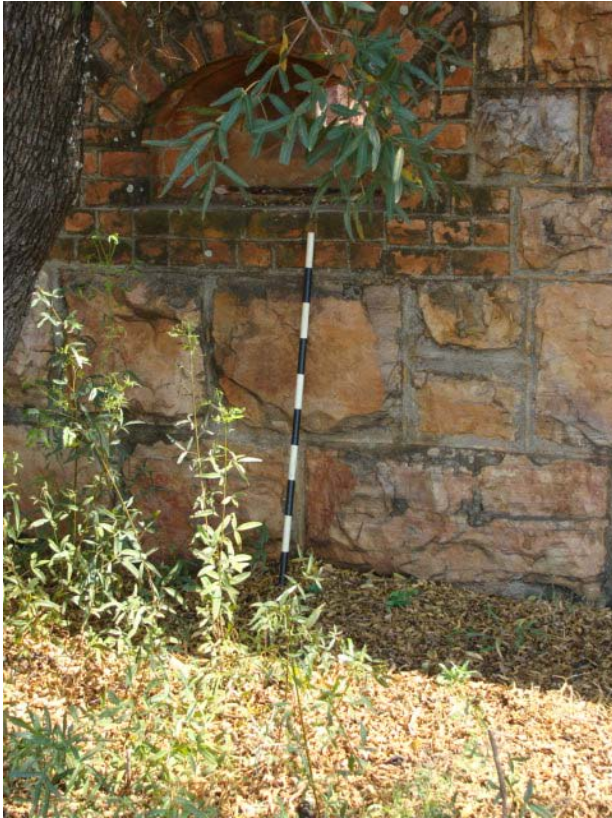
Figure 139 Small furrow running from a water outlet away from the fort.

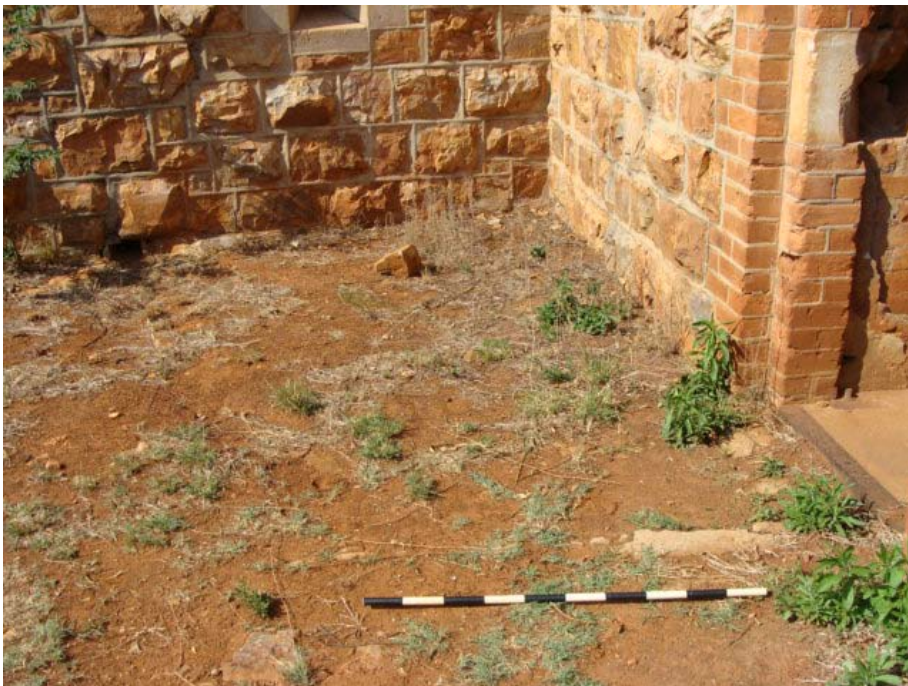
Figure 140 Furrow running from the stable to a water outlet.

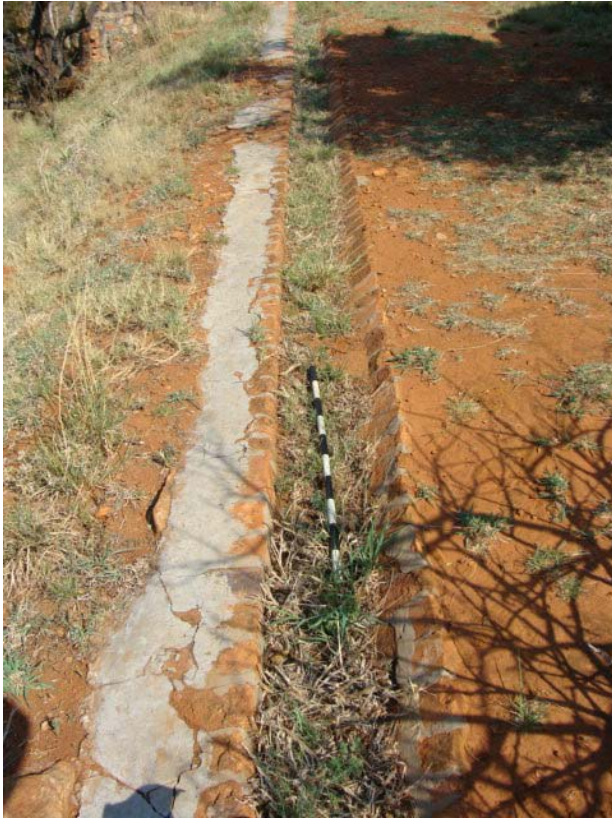
Figure 141 Water furrow on the roof of the fort.

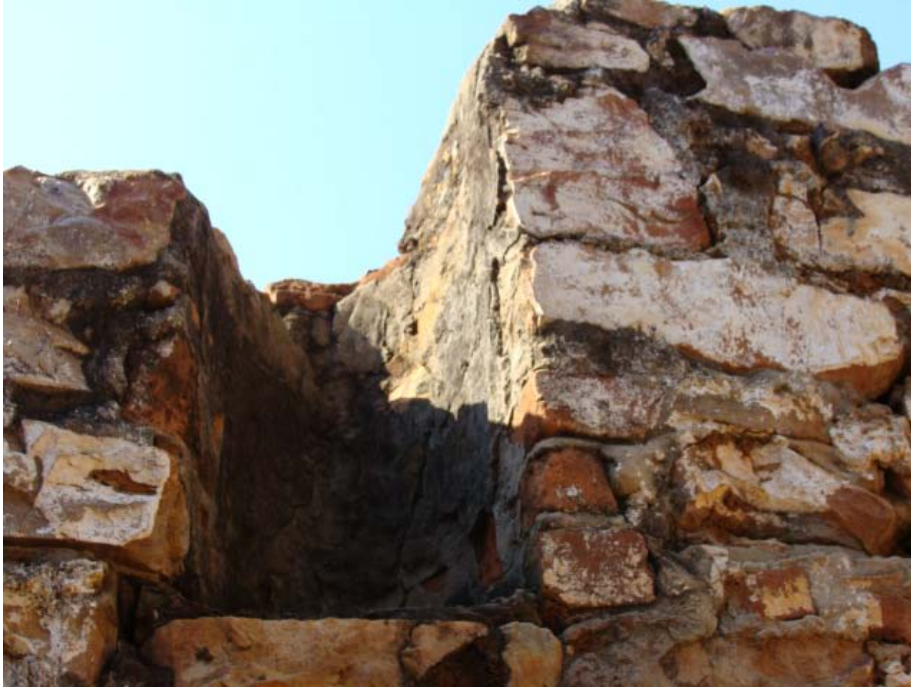
Figure 143 Ventilation shaft in one of the rooms at the fort.

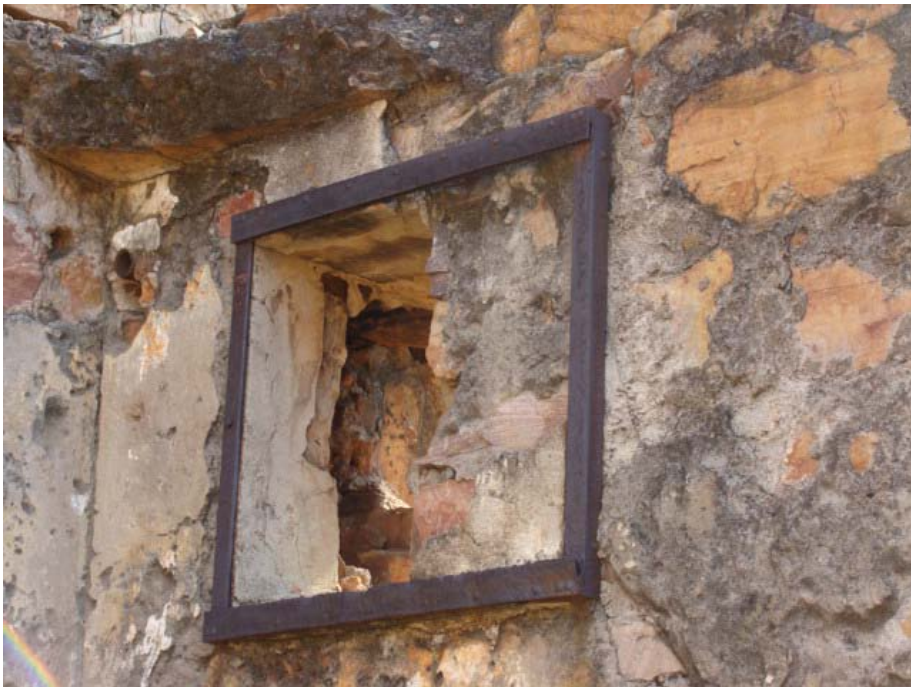
Figure 144 Ventilation shaft with frame for sliding blind still attached to it.

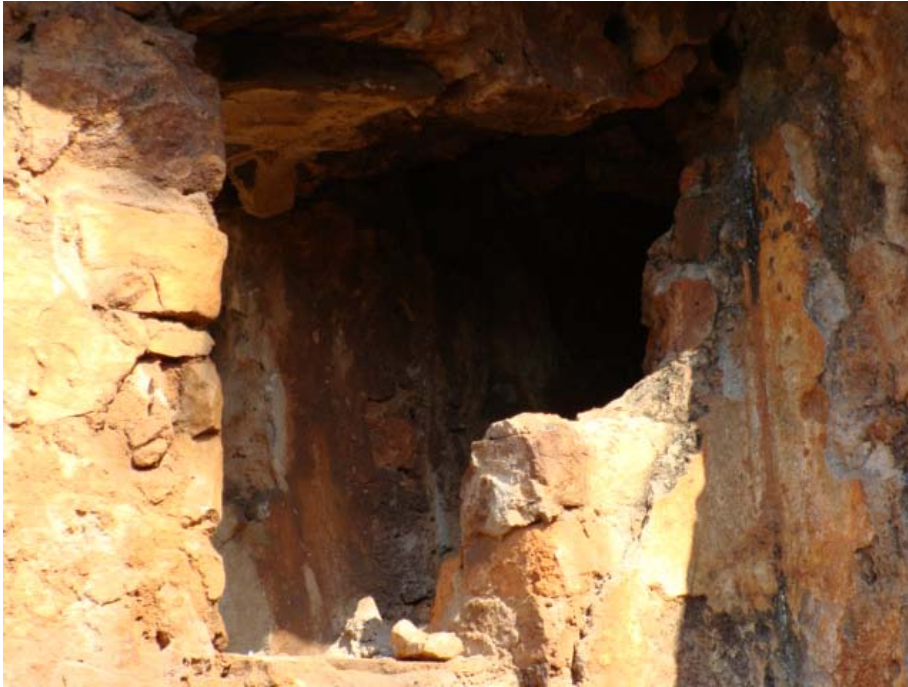
Figure 145 Another ventilation shaft at the fort.

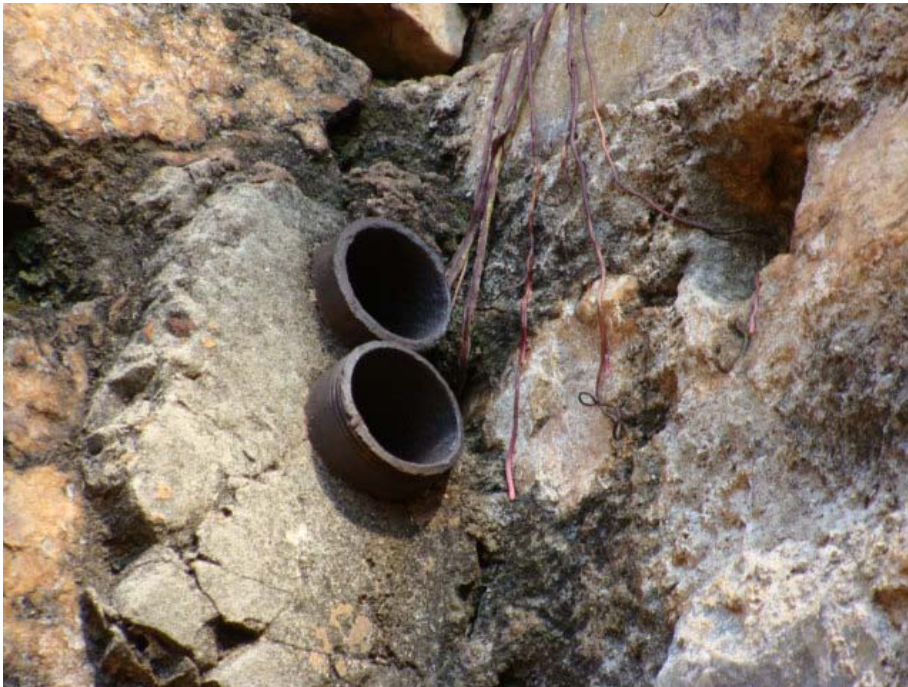
Figure 146 Metal pipes used to protect the electricity wiring of the fort.

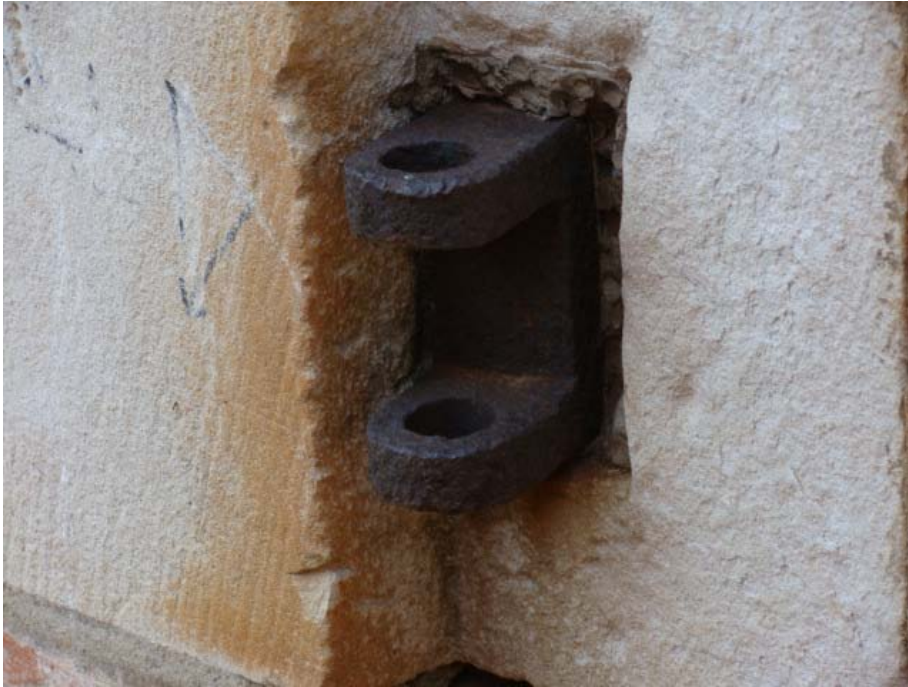
Figure 147 Window/ door hinge at one of the rooms at the fort.

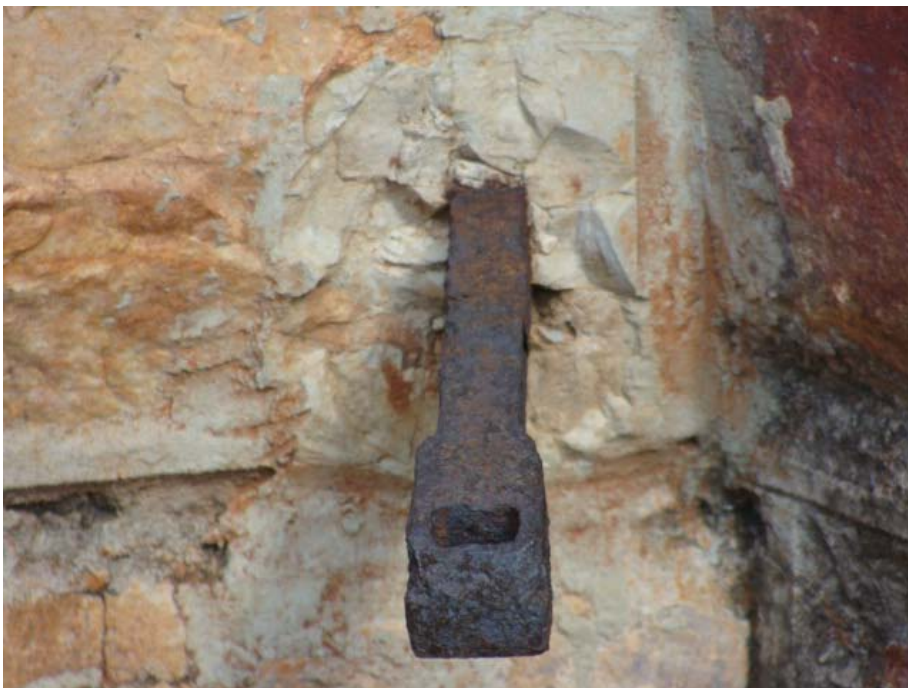
Figure 148 Window/ door latch at one of the rooms at the fort.

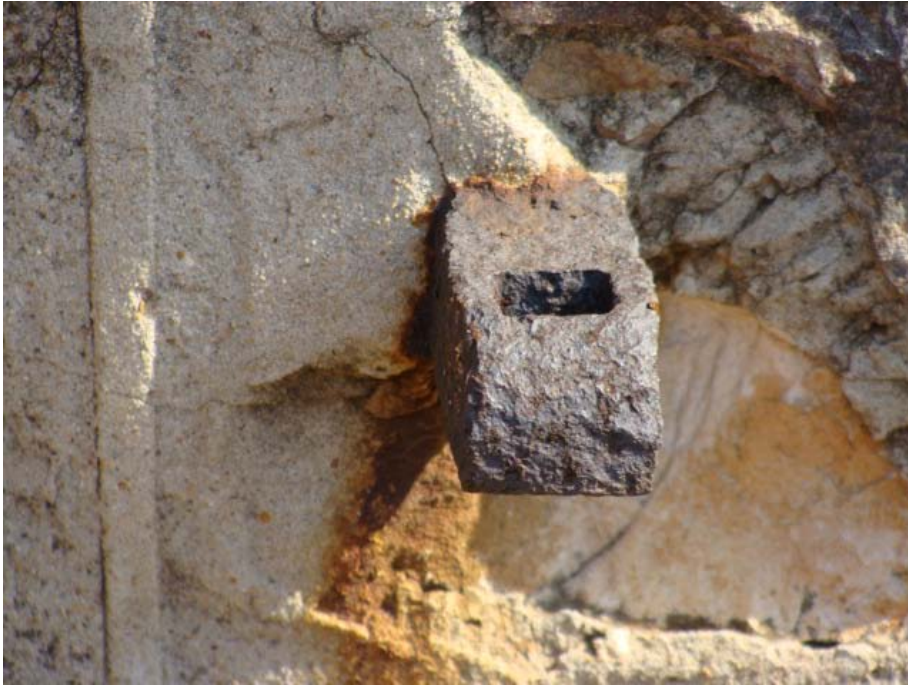
Figure 149 Window/ door latch at one of the rooms at the fort.

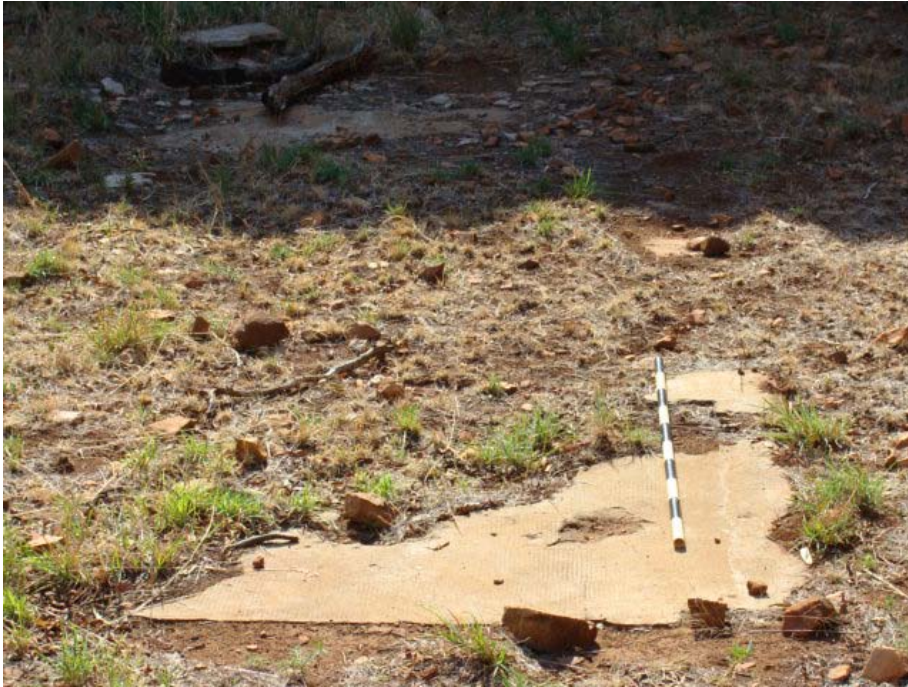
Figure 151 Another view of the floor indicated. Note the damage on its furthest side.

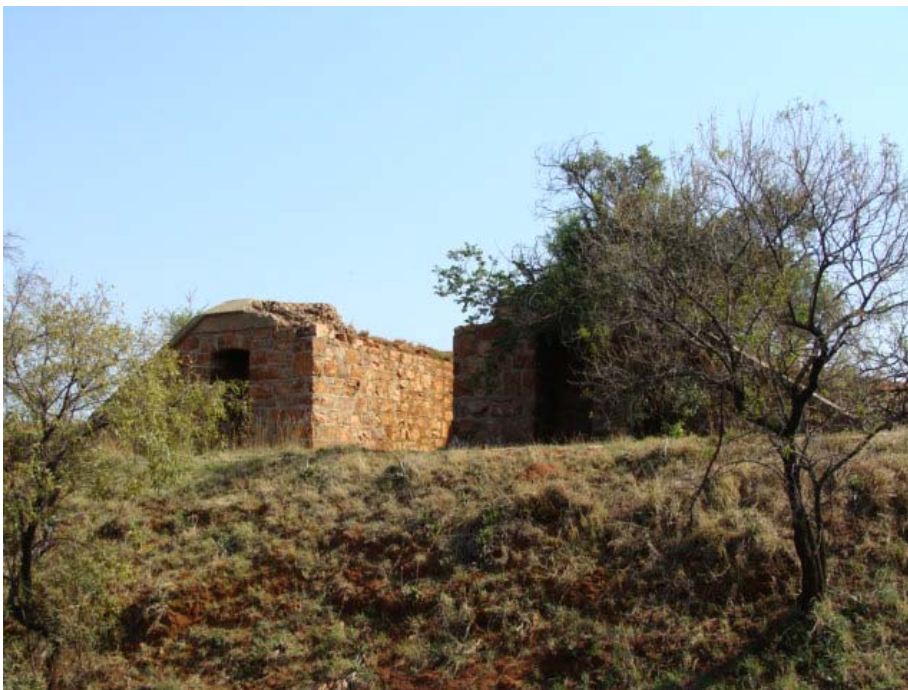
Figure 152 Storage area for canons with niches for first line ammunition.

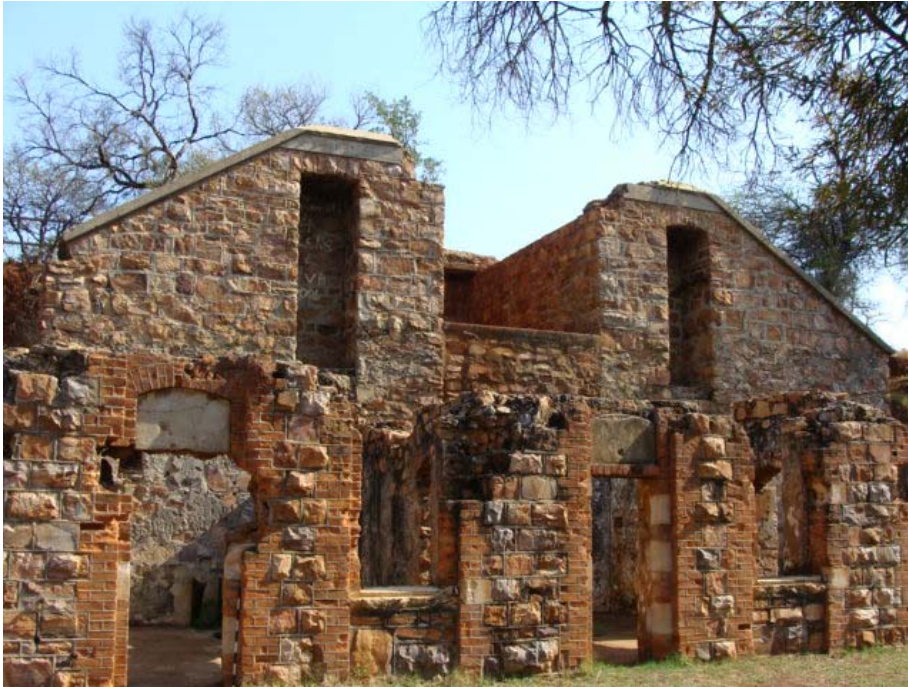
Figure 153 Close up view of the storage area for canons.

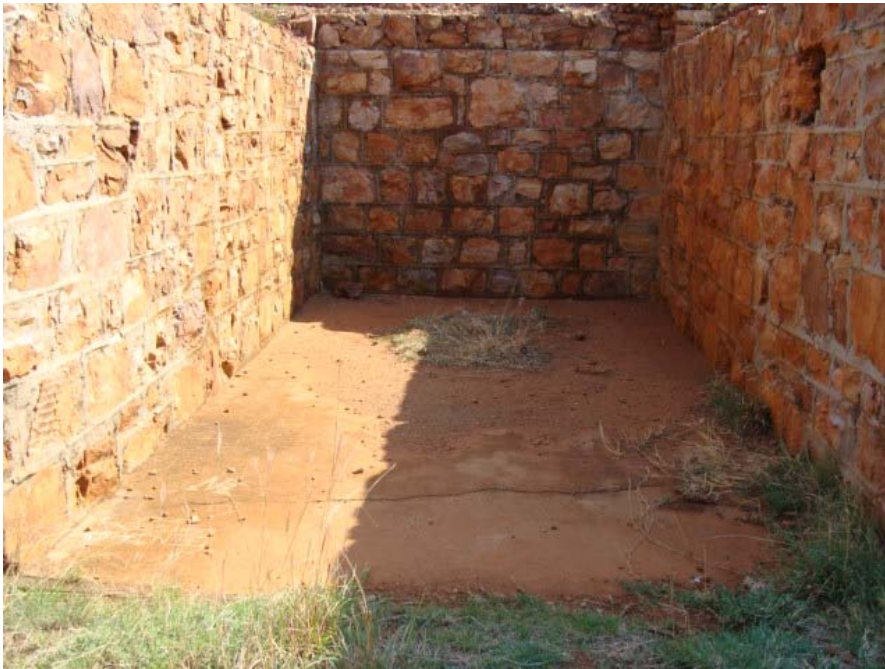
Figure 154 Original floor at the storage area for canons on the roof of the fort.

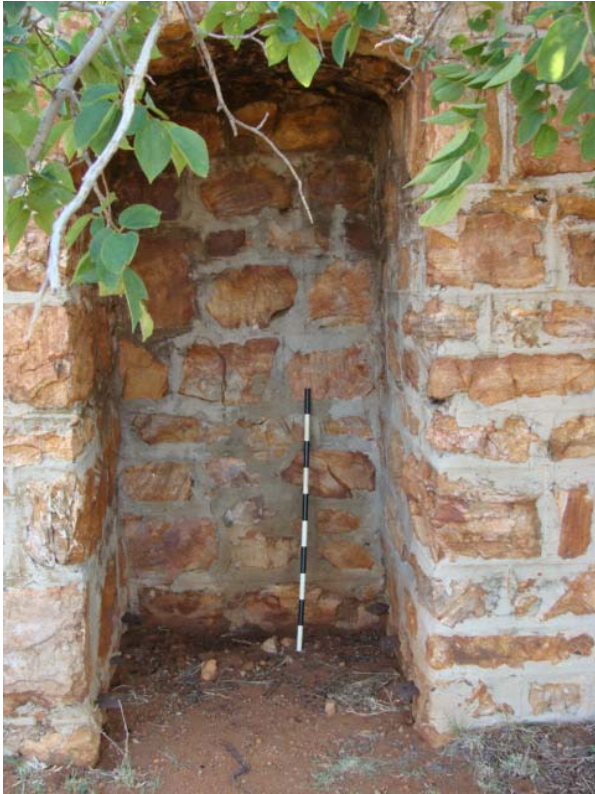
Figure 155 Storage niche for first line ammunition.

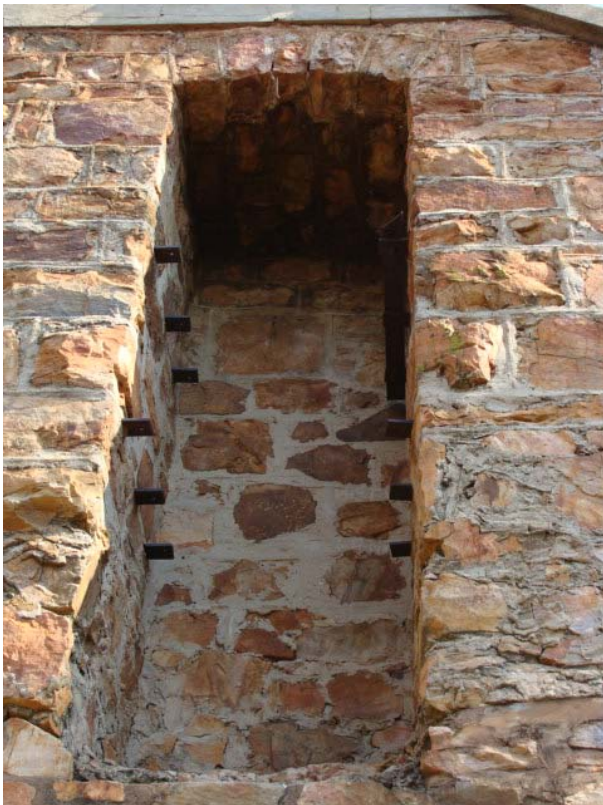
Figure 156 Another view of the storage niche for first line ammunition. Note one of the metal bars of the shelves are still in position.

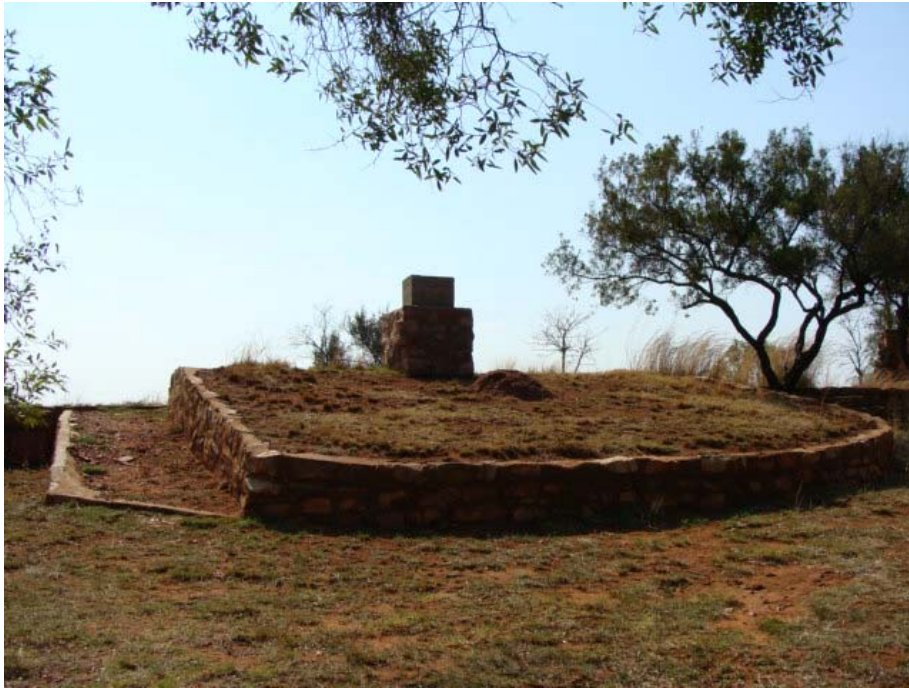
Figure 157 Stone walling on the roof of the fort which probably dates from a later period in time as the Anglo Boer War as the style differs from other stonework.

1. No developments should be allowed here except if it is done to enhance the historical fort and associated features.
2. In the event of any such developments be planned here the site should be re-evaluated and incorporated within such a development plan.
4. The site should be interpreted within the context of all other fortifications and associated features.
5. The recent graffiti at the fort should be cleaned with a substance that will not damage the building.
5. Continuous research especially with regards to detail aspects should be supported. Information obtained from this and even a display of artifacts can be used in a visitor's centre to be placed close to the entrance gate. Information signs on site may be considered, but it is always difficult to maintain.

6. The fort does not need to be restored. In fact it is the only one of the forts where the original fabric is in such a good condition and this is what improves the value of this fort.
7. Visitors to the site should be monitored. No visits to the fort and associated features should be allowed without supervision of trained guides.

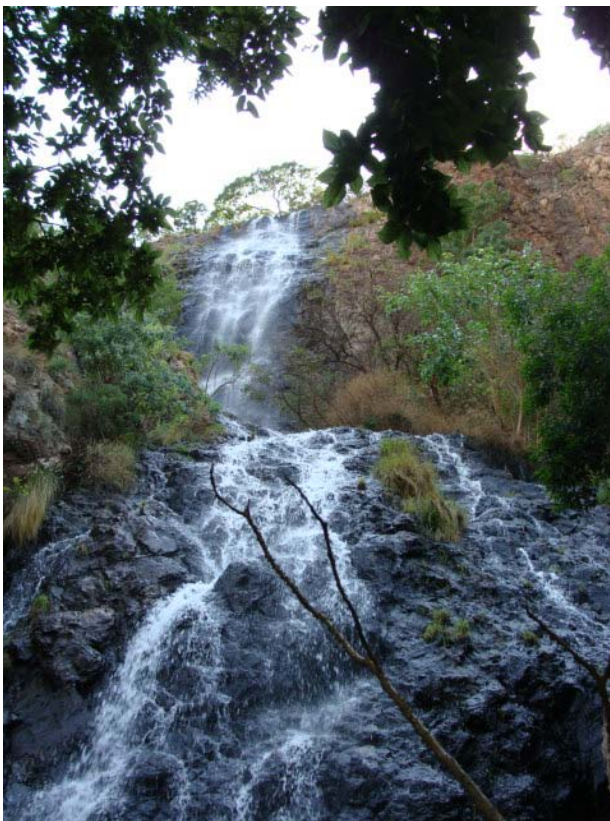
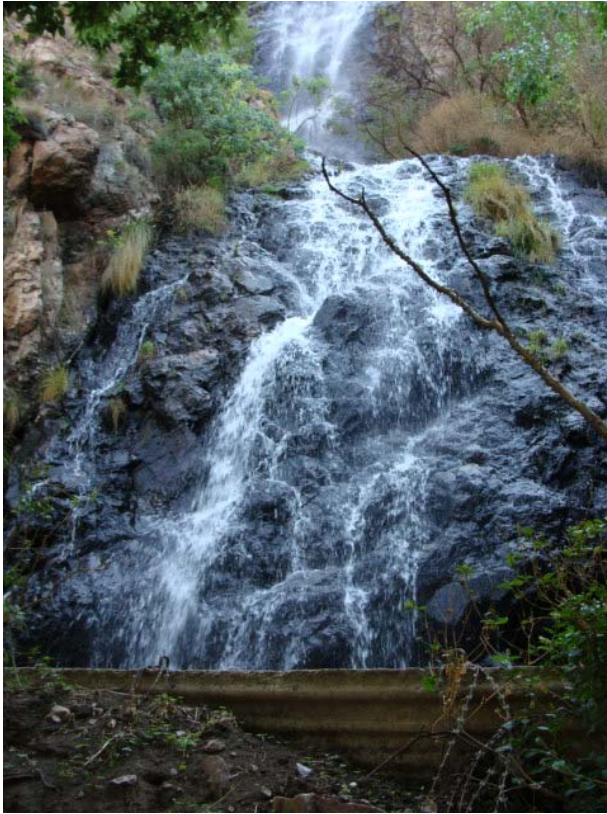
This feature consists of the man-made waterfall on the western side of the mountain (Figure 158-159).

Figure 158 Top part of the waterfall.

Figure 159 Bottom part of the waterfall.

The feature is of a high cultural significance as it was made as a monument to the 50 years celebrations of the Union of South Africa in 1960 (Wiese n.d.: 38). Today it also is a well known feature in the city.

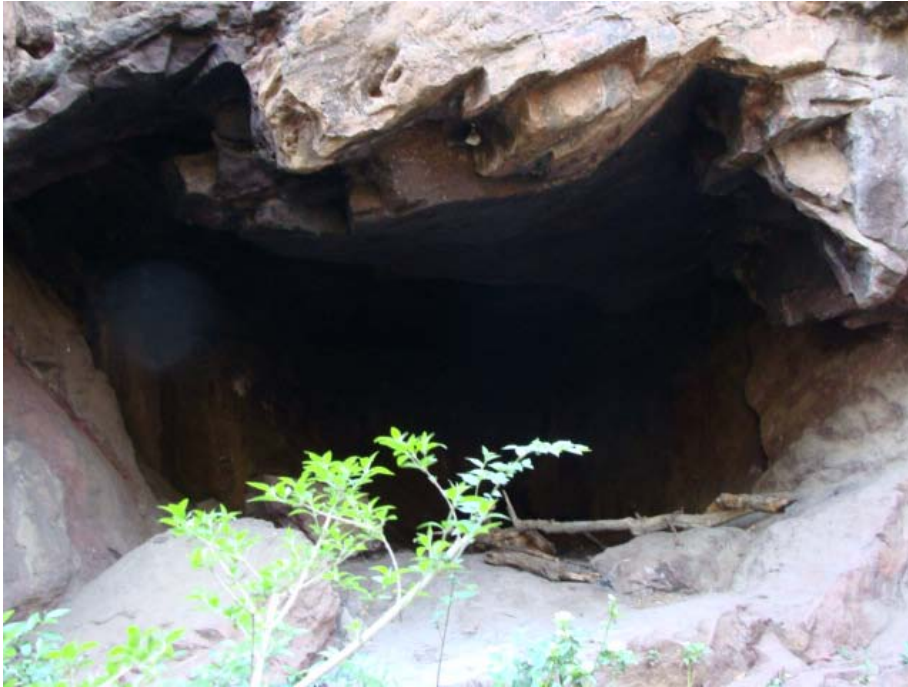
This is a cave below the waterfall and to the south thereof. It is much smaller than the other one (Figure 160). No cultural remains could be identified, but it may be concealed under ground as Stone Age people would undoubtedly have utilized this cave. It also may have been used during later periods.

Figure 160 Cave below the waterfall.

The site is of a medium cultural significance as it may contain many layers of cultural deposit below the top layer. Should this be determined the cultural significance will be increased to high. These layers most probably are undisturbed and therefore may contain valuable information on past people.

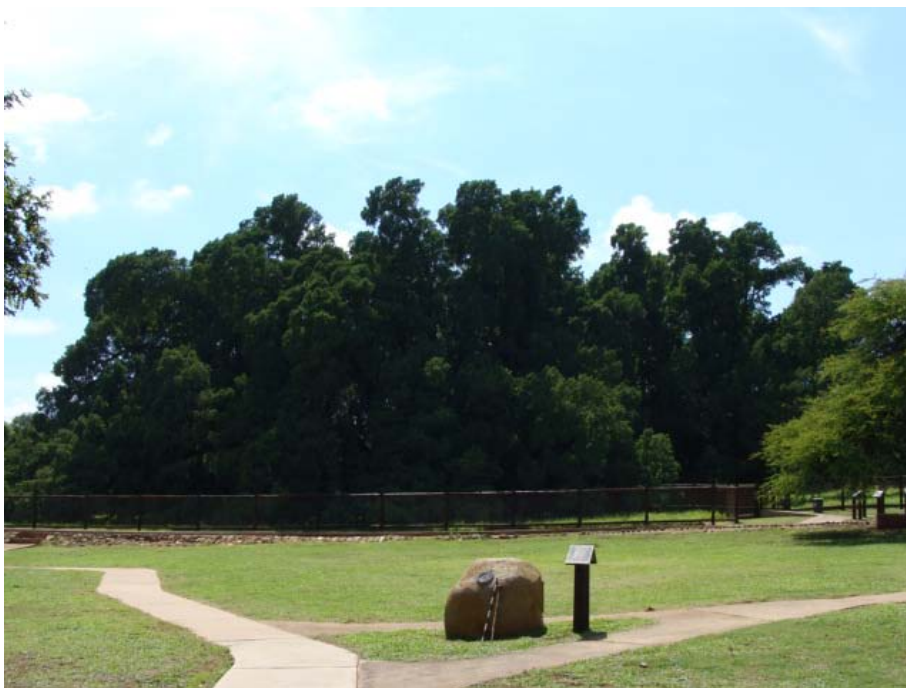
This is the famous and well known Wonderboom tree (*Ficus salicifolia* vahl). Although it is a natural resource it had meaning for many people in the past and present and therefore also is considered a cultural resource (Figure 161). It was declared a national monument in 1980.

The tree has been dated by C^{14} method and proved to be older than 1000 years. Unfortunately it has been damaged many times and has therefore lost some of its beauty and splendor (Wiese n.d. : 7-10).

Figure 161 The Wonderboom tree.

1. The tree should be fenced off as is currently the case in order to protect it.
2. The information panels should be maintained, but it should at least be replaced once every five years as it is not durable for a longer period. This would allow the opportunity to add and update information from recent research projects.
3. Archaeological test excavation may be considered in order to determine whether indeed graves can be found. However it should not be a priority and should not damage the tree as the tree on its own is important enough.
4. After excavation the site should be re-evaluated, but the tree will always remain of high cultural importance.
5. Visitors should be monitored.
6. An addition to this management plan can be done once a decision regarding the above mentioned has been taken.

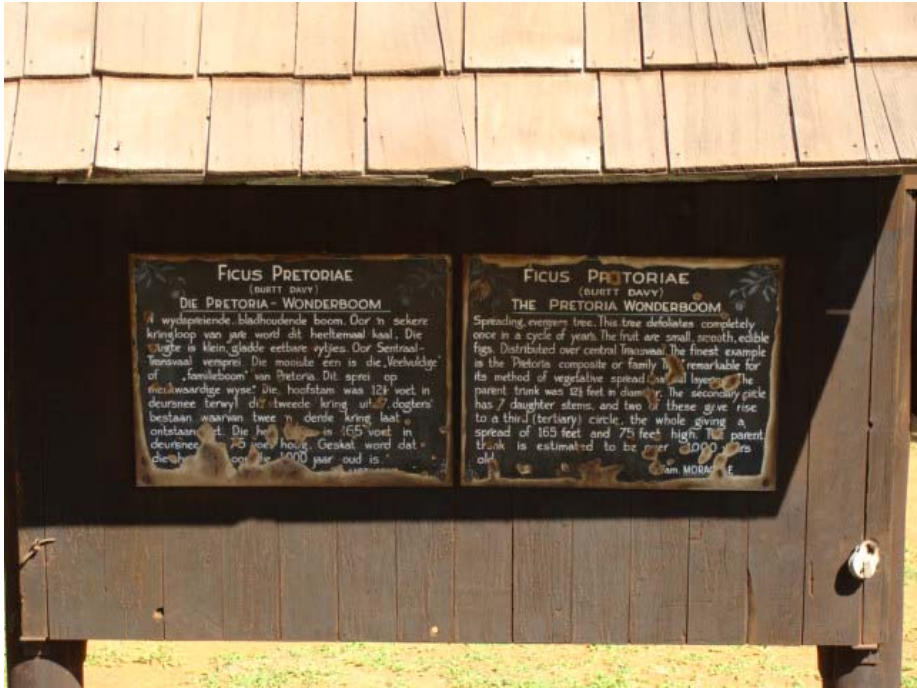
Due to the uniqueness of the tree it even received its own scientific name, being *Ficus Pretoriae* as indicated on an old information board on the site (Figure 162). This name is not used much nowadays as the correct scientific name, indicated above, is rather used. The tree consists of a mother tree with daughters and even granddaughters.

Figure 162 Old information board with information regarding the Wonderboom tree.

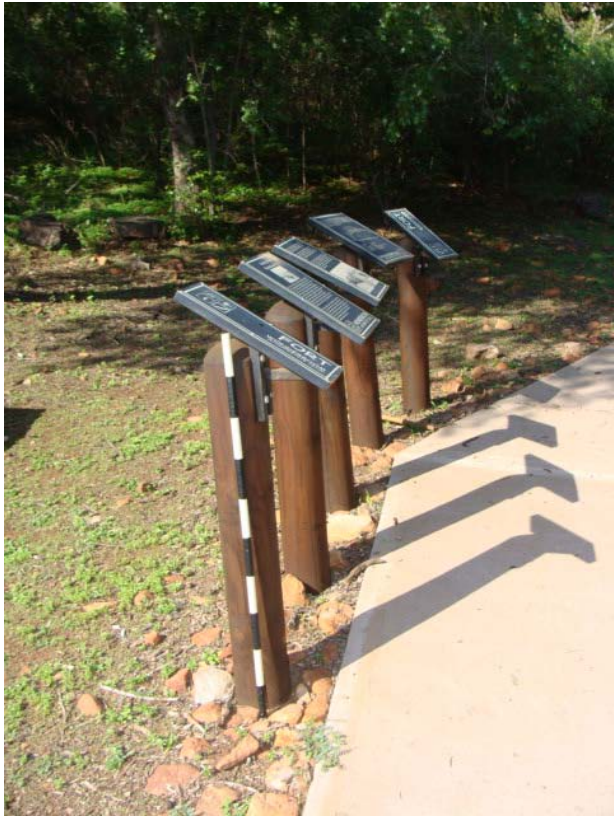
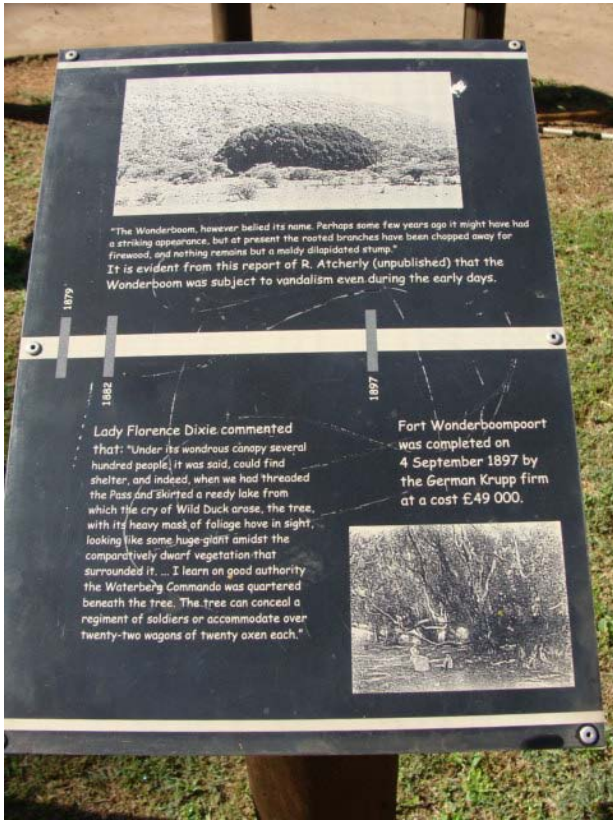
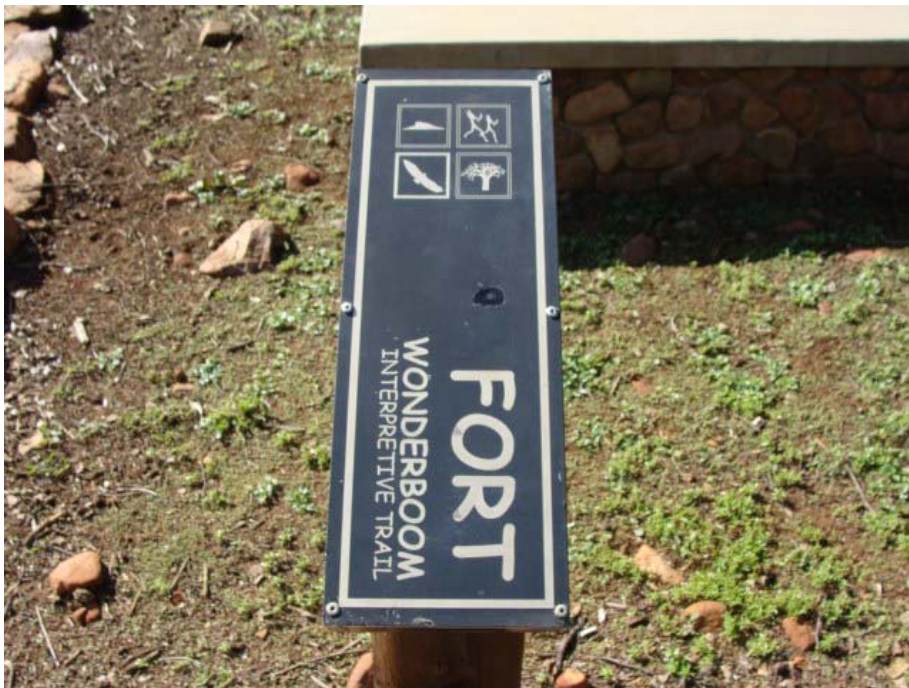
Figure 163 Information posts and signs at the Wonderboom Nature Reserve.

Figure 164 Information panel with specific information regarding the Wonderboom tree.

Figure 165 Information panels, such as this one, indicate different topics.

6. The current information panels should be upgraded and in future this should be replaced at least every five years.
7. That funds be sources to assist with the important research questions posed in the management plan reserve (see management guidelines at each individual site). The most important issues here relate to the large Iron Age site, the large cave, the fort (including other military structures) and the Iron Age site close to the Wonderboom tree.

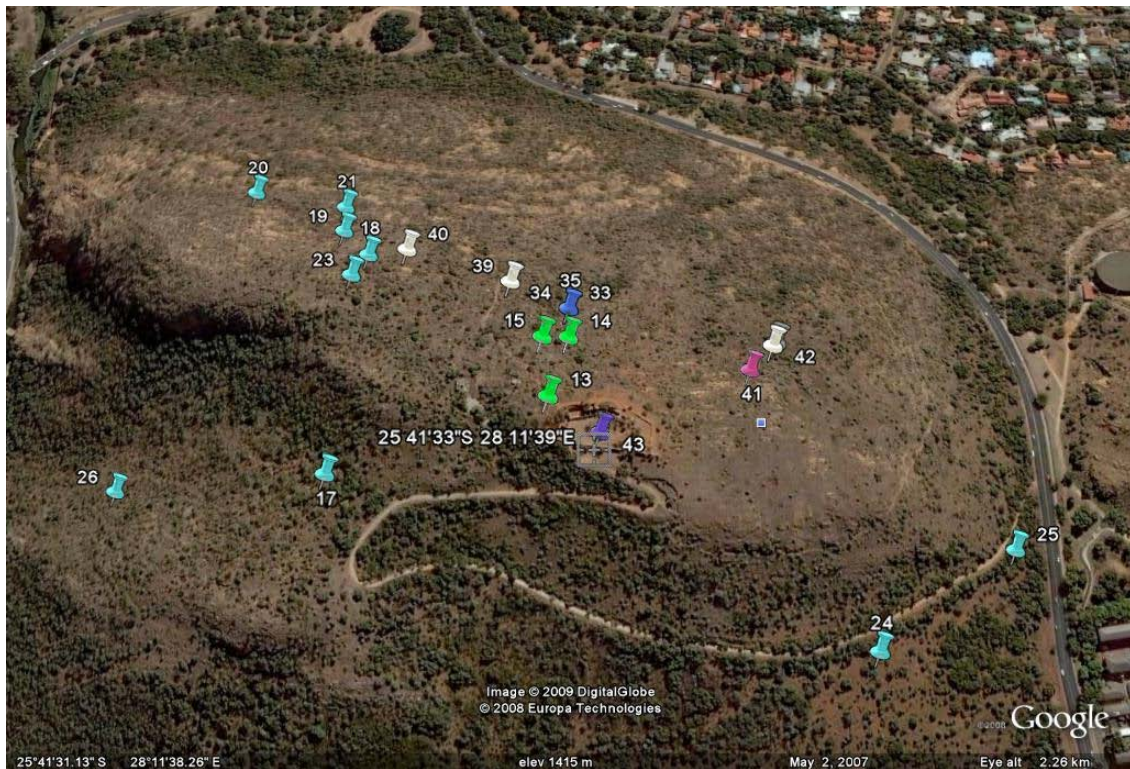
Figure 169 Military features at the Wonderboom Nature Reserve.

- White – blockhouses
- Purple – Fort Wonderboompoort
- Light blue – fortification walls
- Green – man-made holes
- Dark blue – furrows
- Pink – other features
