PHASE 1b ARCHAEOLOGICAL MONITORING – FINAL REPORT

**CLUSTER 9 – BULK WATER SUPPLY BACKLOG, NEAR TSOMO,
CHRIS HANI DISTRICT MUNICIPALITY, EASTERN CAPE, SOUTH AFRICA**

DATE: 2014-02-05

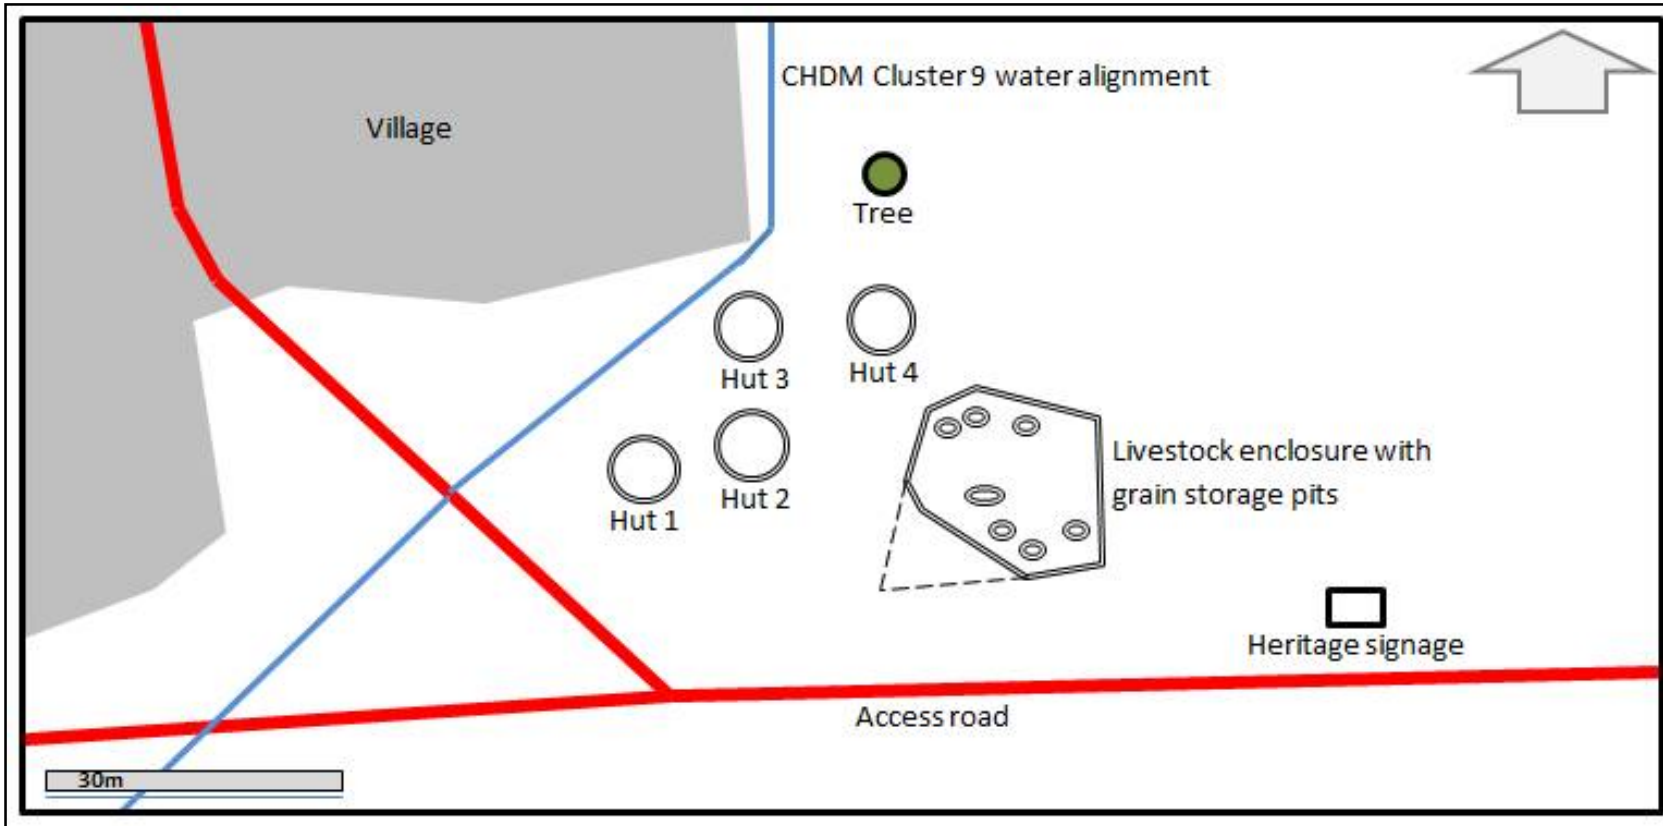
Archaeological monitoring and recording resulted in the identification of an additional hut mound, bringing the total of hut mound remains at Site T1 to 4. Seven grain storage pits were recorded within the stock enclosure with the central, larger of these being either reworked, or a new pit directly associated with refuse management. A flat stone grain storage pit lid is present among the southern pits. In addition, the site has been sign-posted, clearly indicating the heritage status thereof at a primary location along the main access road, without any impact on Site T1 itself.

Figure 1: Schematic representation of Site T1

Despite close proximity of the CHDM Cluster 9 water alignment to the hut mounds, excavation impacted on no site features and no artefacts were recorded from within the trench. From an Integrated Environmental Management (IEM) point of view development, considering engineering specifications, natural environmental requirements and minimum standards as well as archaeological legislation (no impact on a formally protected heritage site) was met by the final water line route, despite the fact that the heritage 'buffer zone' practice was compromised for purposes of development.

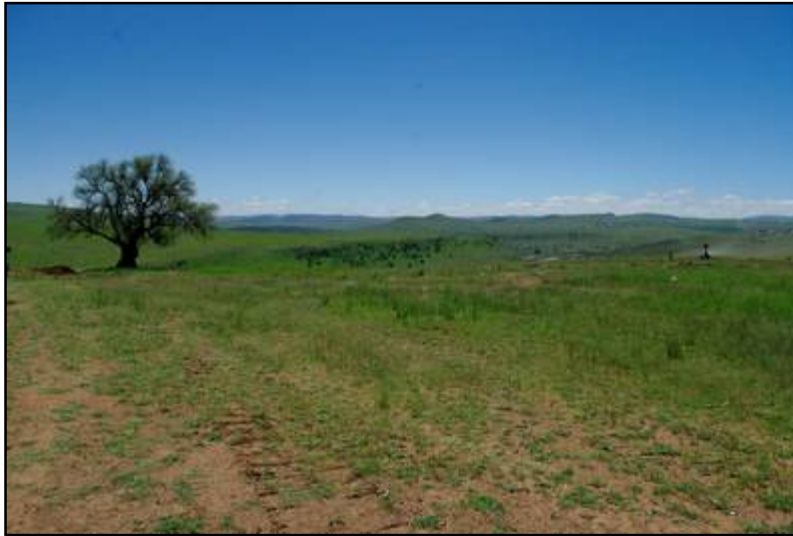
Plate 1: General view of Site T1

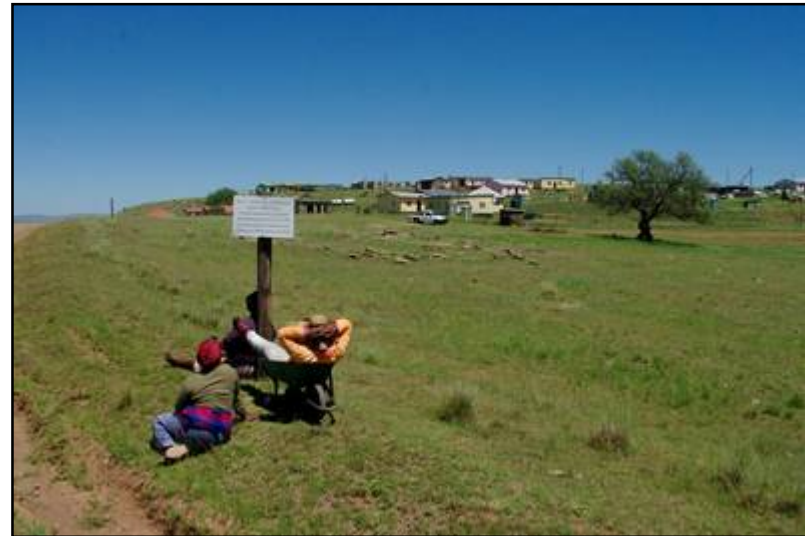
Plate 4: View of Site T1 from the heritage site sign post

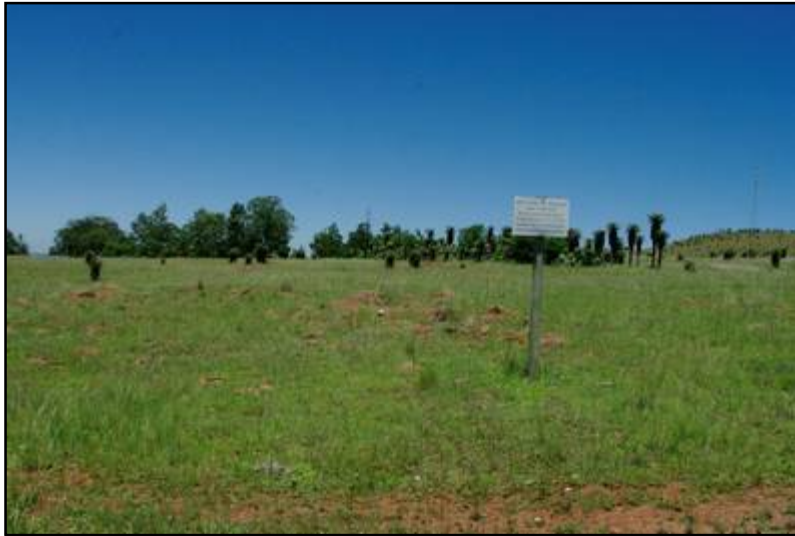
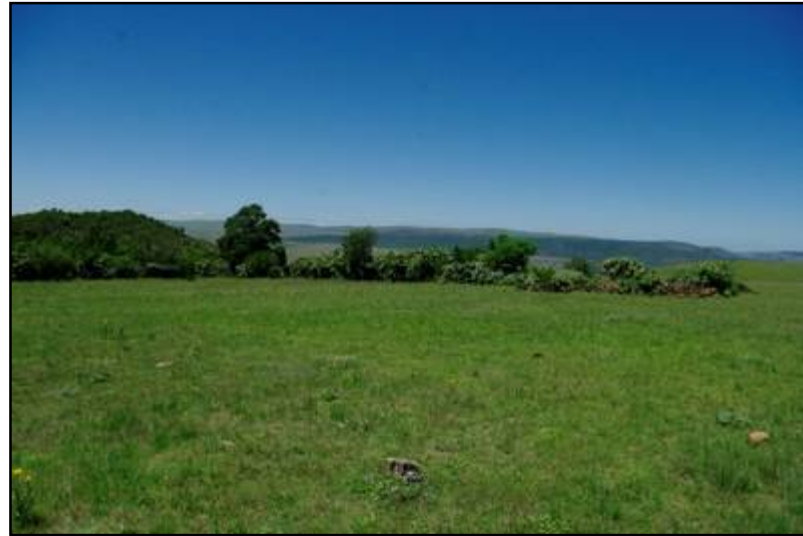
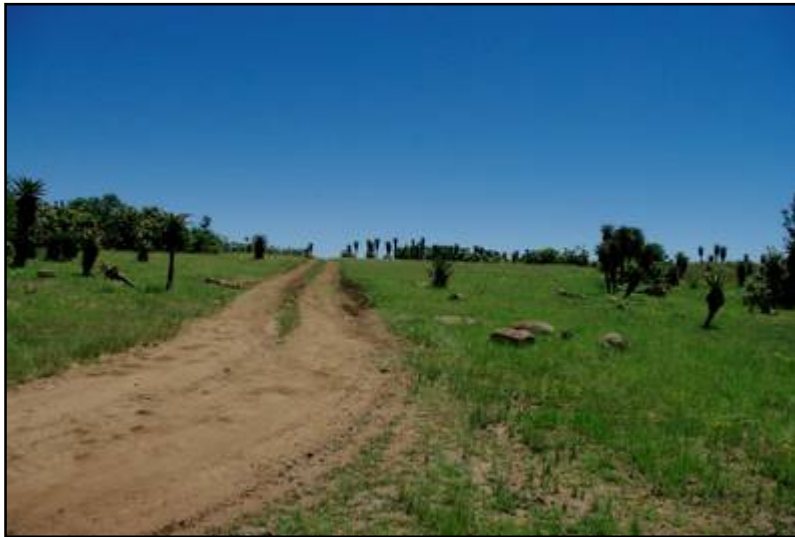
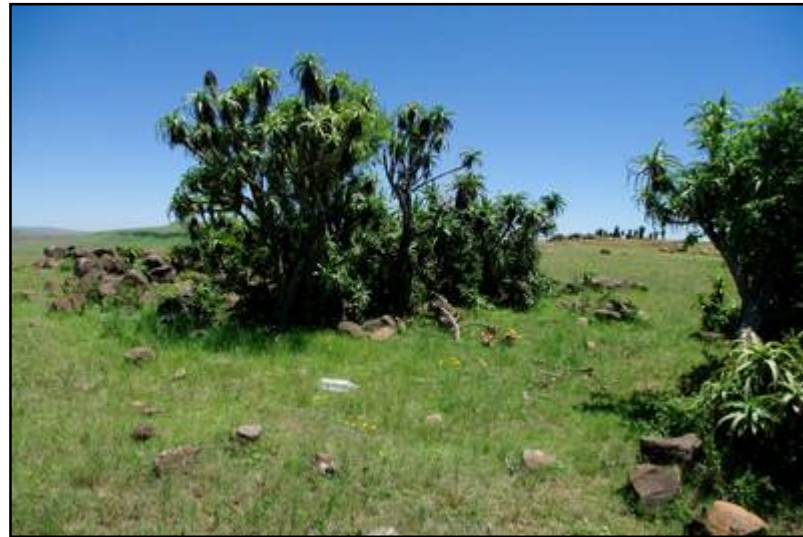
With reference to the SAHRA requirements, Site T8 has already been described in the relevant Phase 1 AIA report including site photographs (van Ryneveld 2011a): There is no additional information on the site and no additional information came to the fore during site monitoring. Photographic documentation included in this section documents site details after construction.

Plate 5: View of Site T8 [1]

Plate 7: View of Site T8 [3]

Plate 6: View of Site T8 [2]

Plate 8: View of Site T8 [4]

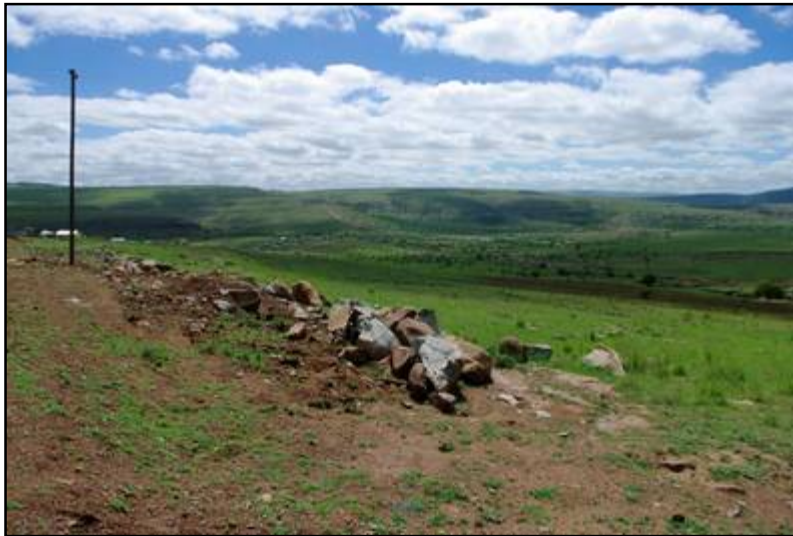
Site T16 was identified during the construction phase of the project. The site comprises of the foundation and low rising remains of a large stone wall, situated in fairly close proximity to the tributary of the Ngcongcolora River, approximately 150m south to south-east of the indicated site locale and access road. Closer to the road the remains of at least 2 smaller rectangular stone built livestock enclosures are present, but remains are rather weathered, making it difficult to discern both the exact number of enclosures as well as their sizes, but estimated at an average of 6x6m to 8x8m in size. Development did not impact on any of the site features. A bell was however identified in the construction trenches, in the immediate vicinity of the Site T16 co-ordinate. The bell was claimed by Nombeko Sylvia Madotyeni (Sylvia Madotyeni), and as such handed by the developer to her.

Plate 9: View of the area where the Site T16 bell was discovered looking over the valley of the main site

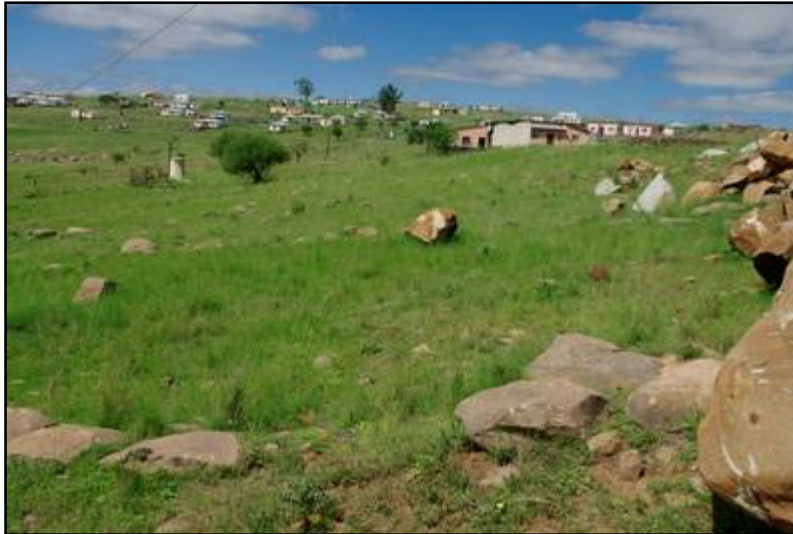
Plate 10: Remains of smaller livestock enclosures closer to the access road

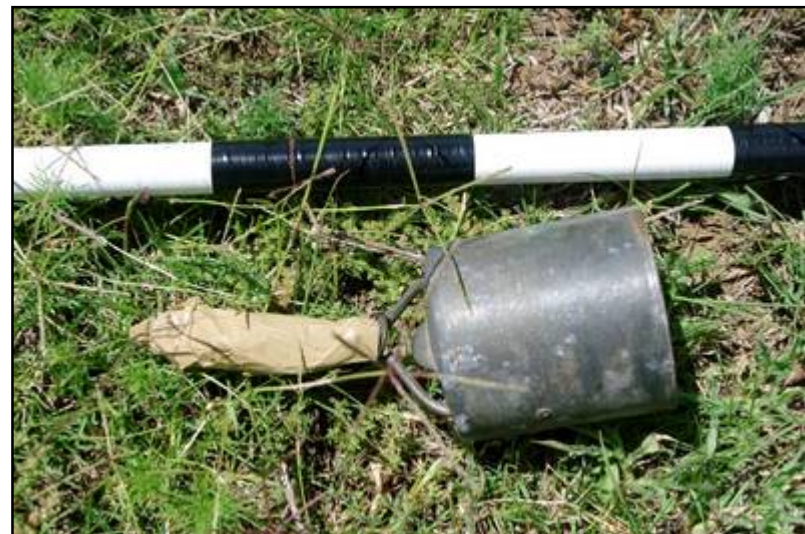
Plate 12: Close-up of the recovered bell

The single artefact would comprise of a heritage object. Considering the circumstances it is not recommended that the artefact be deposited for curation at a SAHRA accredited repository. Should the EC PHRA require a private collection registration for the object, such a registration can be completed for the artefact.
