**USE OF EXISTING P73 BORROW PIT, HLOKOZI,  
UBUHLEBEZWE LOCAL MUNICIPALITY, KWAZULU-  
NATAL**

**Phase 1 Heritage Assessment**

**11 September 2017**

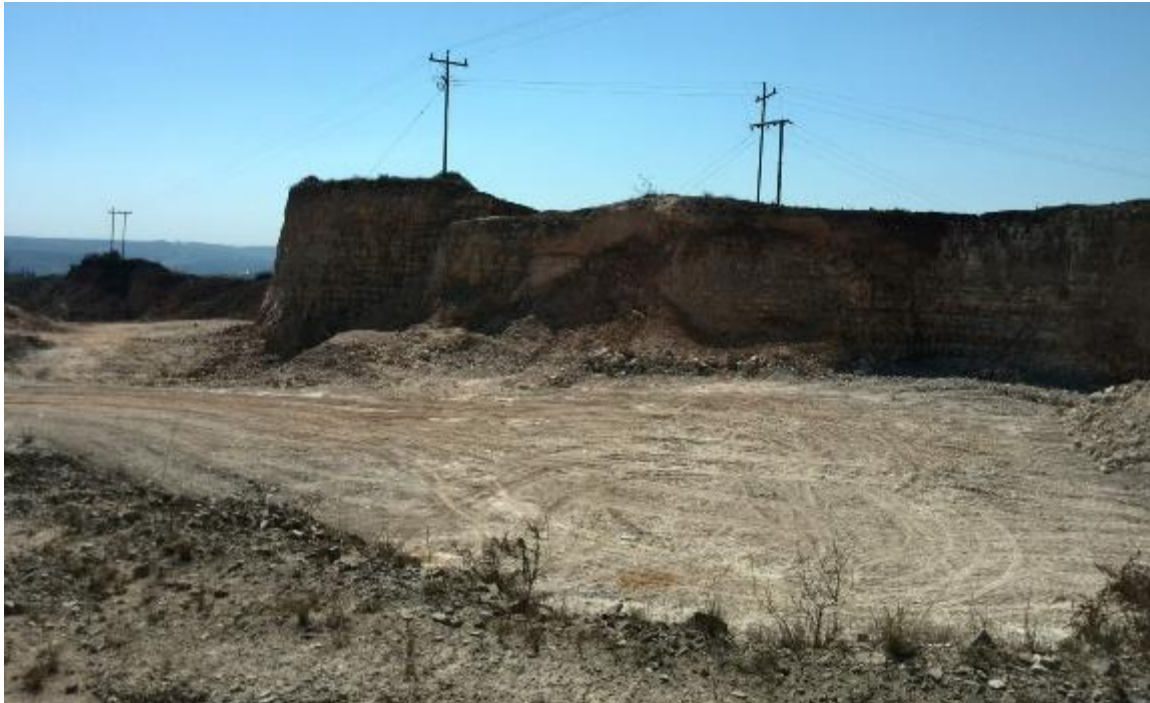
**Figure 3: Existing borrow pit**

As can be expected, the area of the existing borrow pit is extensively disturbed by previous quarrying activities. The surrounding area is also disturbed with residences, Hlokozi high school and a power line which is located on the eastern boundary of the borrow pit.

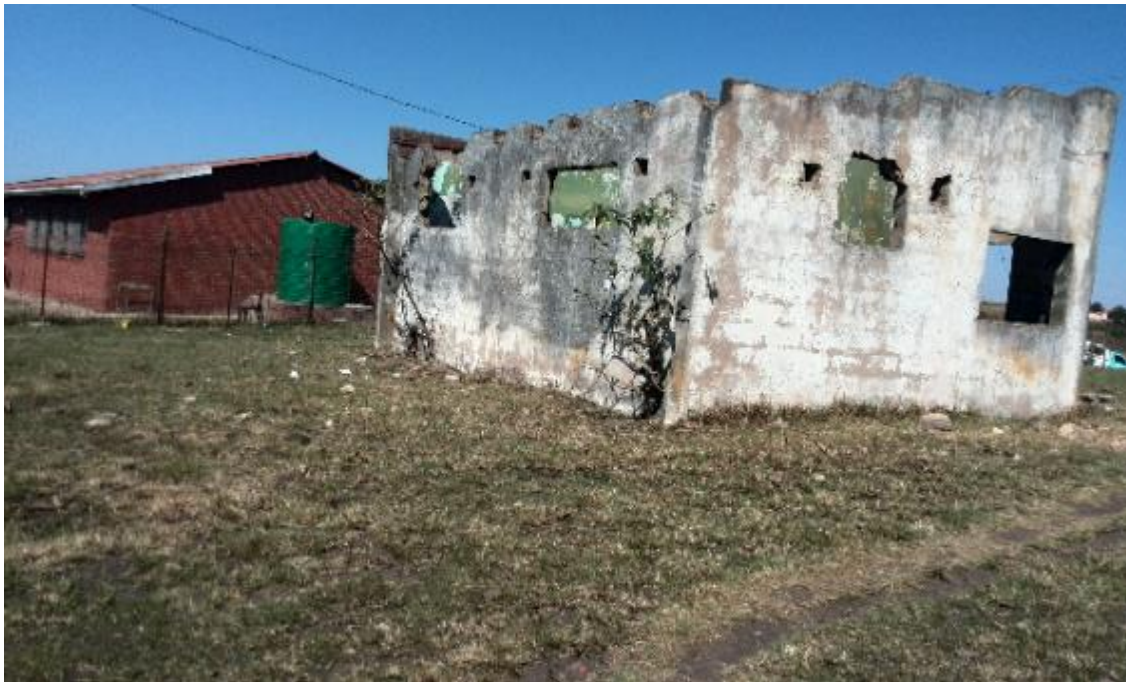
**Figure 4: Remains of general dealership**

Between the borrow pit and high school, an abandoned building was found. According to a local resident, Mr. Mzamazisi Mtolo, the building was a general dealership/store before it was abandoned. Residents did not know the age of the building and it is possible that the building is more than 60 years of age and is therefore protected by 33 (1) (a) of the KZN Heritage Act which states that no structure which is, or which may reasonably be expected to be older than 60 years, may be demolished, altered or added to without the prior written approval of the Council having been obtained on written application to the Council.

Due to the poor condition of the building as well as the existence of many such structures in KwaZulu-Natal, the building is considered to be of low heritage significance. If the quarry is to extend into this area and impact on the structure, then application for a permit to destroy the building must be obtained from Amafa before the destruction of the building.

A structure that could be older than 60 years is located between the borrow pit and Hlokozi High School. If the structure is to be impacted by the utilisation of the borrow pit, then application must be made to Amafa for a permit to demolish the building.

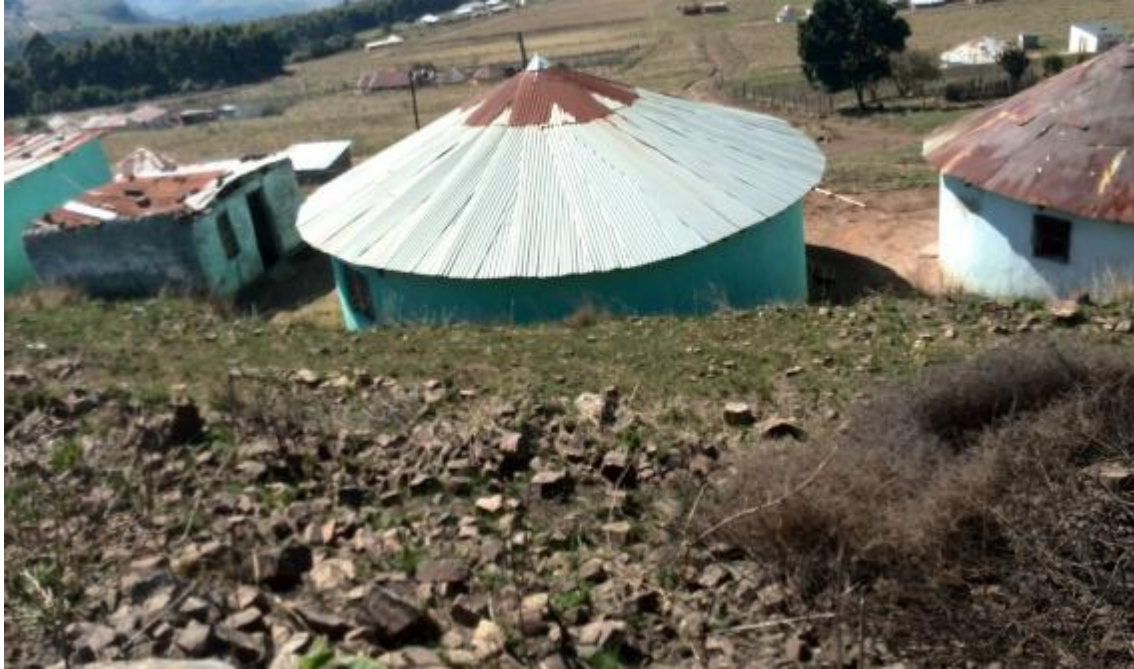
**Figure 6: Houses located close to eastern boundary of borrow pit**

There are a number of residences / houses situated just over 15 m from the borrow pit's eastern boundary. The houses are occupied. An inspection of the area around the houses was made and no graves nor other heritage sites were found. The occupants were not at home during the site inspection. Both Mr. Mtolo and Ms Khonzani Gombela (a local resident) indicated that to their knowledge there were no graves in the area close to the borrow pit.

The impact of the borrow pit extending into or moving closer to the above-mentioned cluster of houses and thereby destroying the structures would be highly negative to the owners / occupants and is therefore not recommended.

There are a number of residences situated just over 15 m from the borrow pit's eastern boundary. The houses are occupied. It is recommended that the proposed utilisation of the borrow pit does not impact on these houses nor on any other houses located close to the borrow pit.

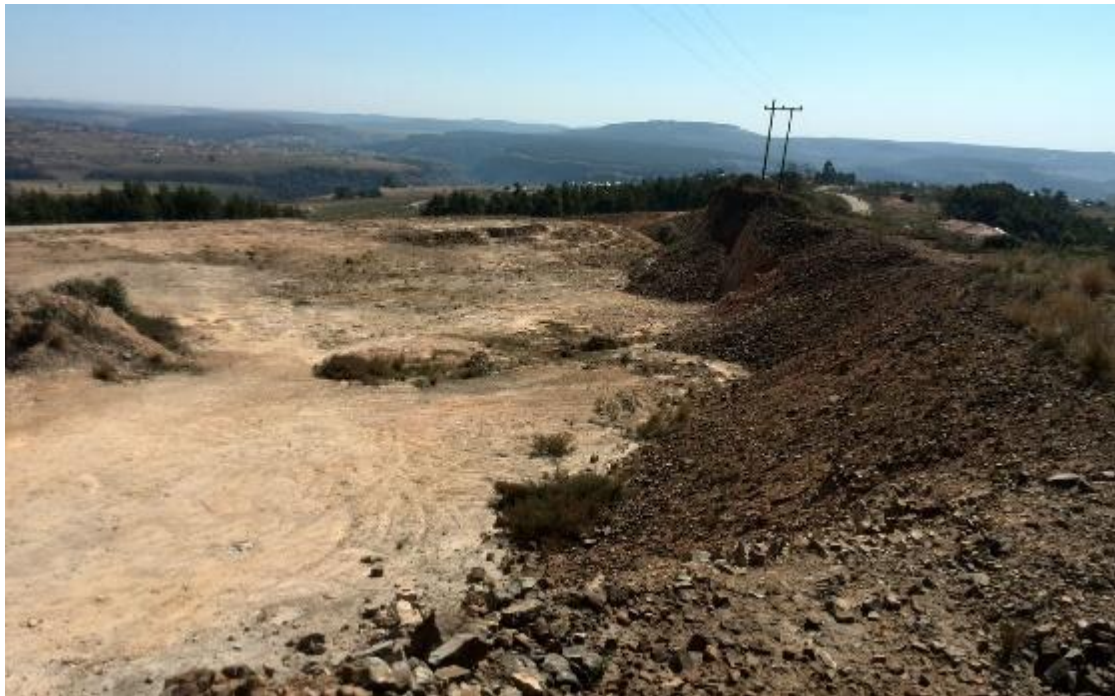
**Figure 7: Northern extent of borrow pit**

There are several other houses situated east and west of the borrow pit that fall within a 50 m radius of the borrow pit. It is also recommended that these residences are not impacted by utilisation of the borrow pit.
