# HERITAGE ASSESSMENT (ARCHITECTURAL) OF BUILDINGS ON THE FARM MOOIFONTEIN – MIDDELBURG-ARNOT (MPUMALANGA PROVINCE)

*Date: June 2013*

*Project by: M. Naude*

For  
PGS HERITAGE

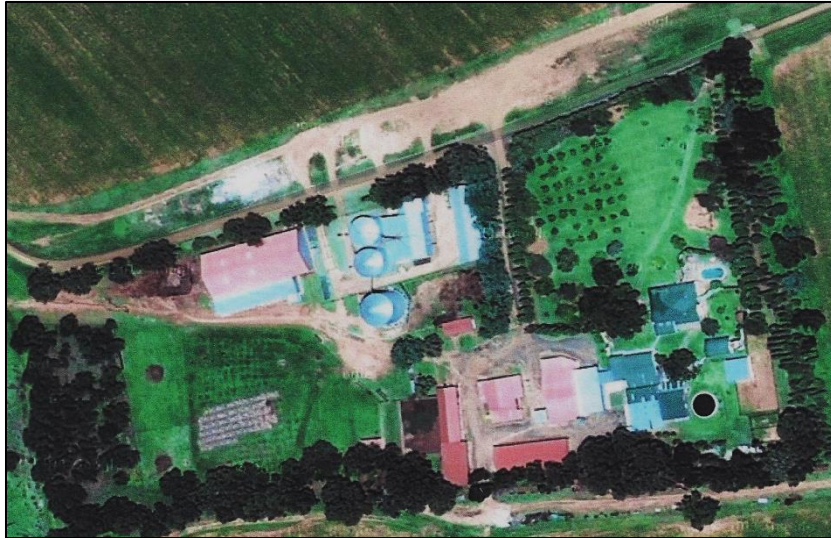
Figure 1. Plan of the farmstead indicating the location of buildings, structures and infrastructure (photograph: old Google image as some buildings and structures have not been recorded on this image).

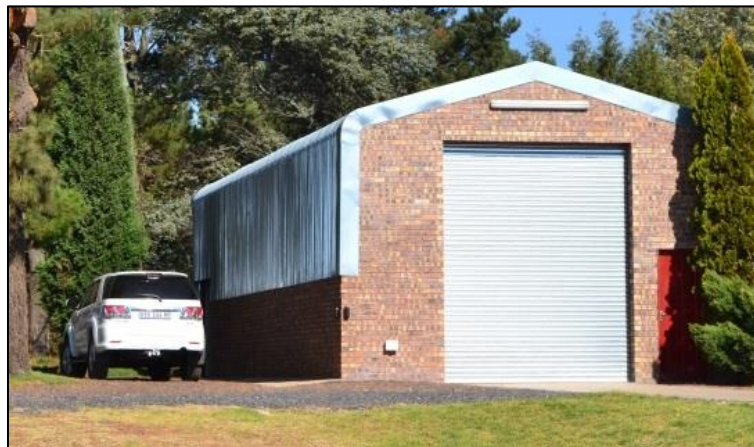
Building 1 - Plane hangar:

Small hangar used as a closed shed for a helicopter, located on the north-eastern periphery of the farmstead. The building is of recent origin (period: 2005-2009), constructed with face bricks and covered with galvanized IBR sheet iron with a galvanized rolling door.

Figure 4. Northern elevation of small helicopter hangar on the north-eastern corner of the farmstead

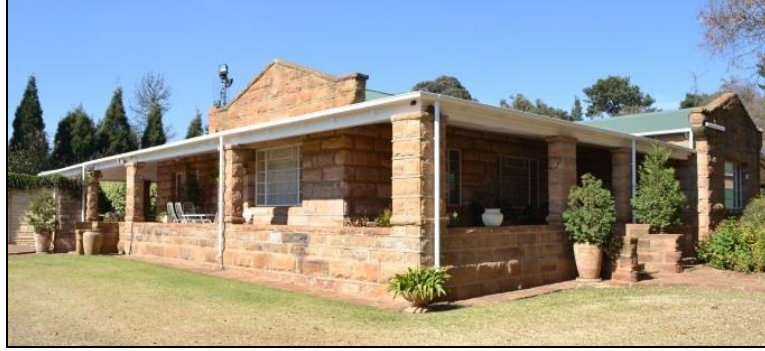
Building 2 - Sandstone dwelling:

This building forms the core of the farmstead, the historic social centre and most prominent of the sandstone buildings in terms of vernacular architectural significance. The exact date of the building is unknown, but it is assumed that it post-dates the garage building that contains a door lintel dating to 1904.

**Figure 5. Principal dwelling of the landowner, which has served as a dwelling for two generations**

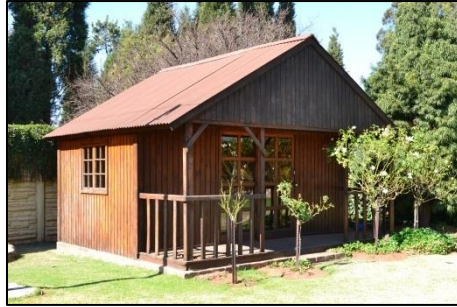
**Building 3 - Timber portable hut:**

This is a temporary building and of recent date. It is completely constructed of timber and may be classified as a ‘catalogue’ building (ie, “can be ordered from a catalogue”).

**Figure 6. Small timber building located in the backyard**

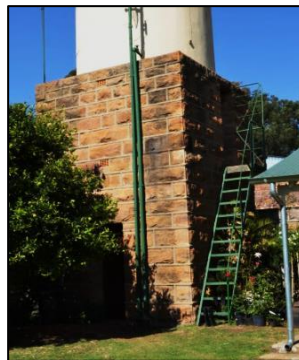
**Building 4 - Sandstone water reservoir tower:**

The base of this water reservoir is constructed with neatly dressed sandstone blocks and can be reached via the use of a steel frame ladder along the western elevation.

**Figure 7. Sandstone structure supporting a water reservoir on top**

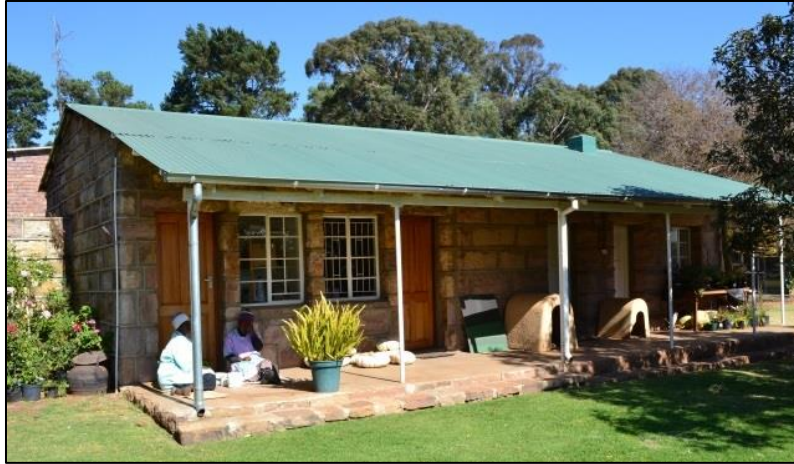
Building 5 - Sandstone cottage:

Small cottage at the back of the dwelling constructed with neatly dressed sandstone. Currently used as a laundry. It may have been used originally as supporting outbuilding serving some of the spatial needs of the kitchen as meat or milk rooms.

**Figure 8. Small sandstone cottage serving as support building to the kitchen**

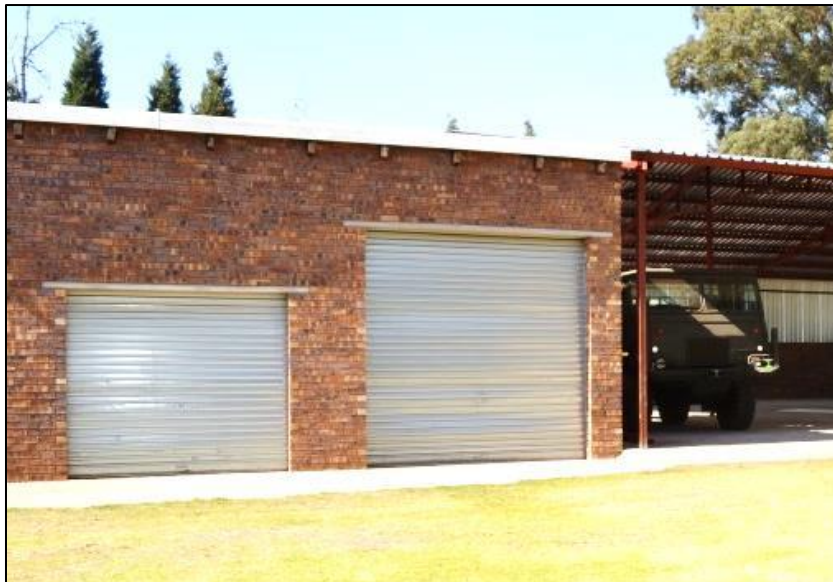
Building 6 - Face brick storage shed:

New face brick building with corrugated iron roof and steel plated garage doors serving as a garage. It forms the core to which another open shelter was added.

**Figure 9. Face brick garages serving as annex to the large open sided shelter**

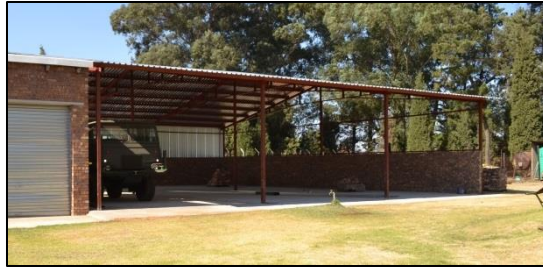
Building 7 - Open sided steel frame shelter:

Steel frame shelter of recent origin and IBR sheet iron roofing added as an annex to the face brick garage.

**Figure 10. Open-sided steel frame shelter used as parking for utility vehicles**

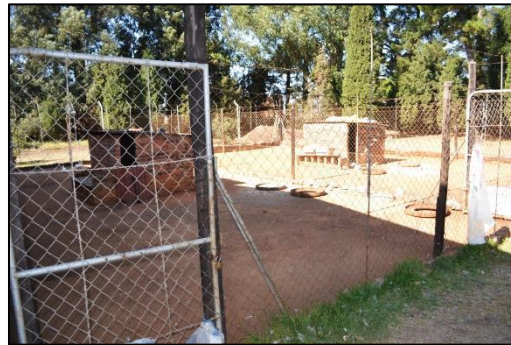
Building 8 - Chicken coops:

Large area fenced-off as chicken coops with two covered coops inside.

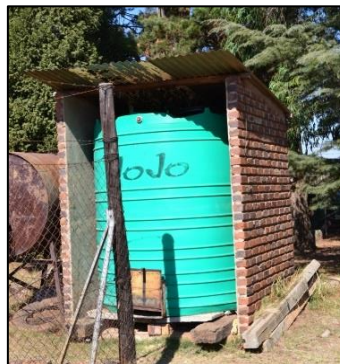
Building 9 - JOJO water reservoir:

Protective shelter constructed with face bricks and corrugated iron roof, for JOJO water reservoir.

**Figure 11. Small single brick layer protective shelter for JOJO reservoir**

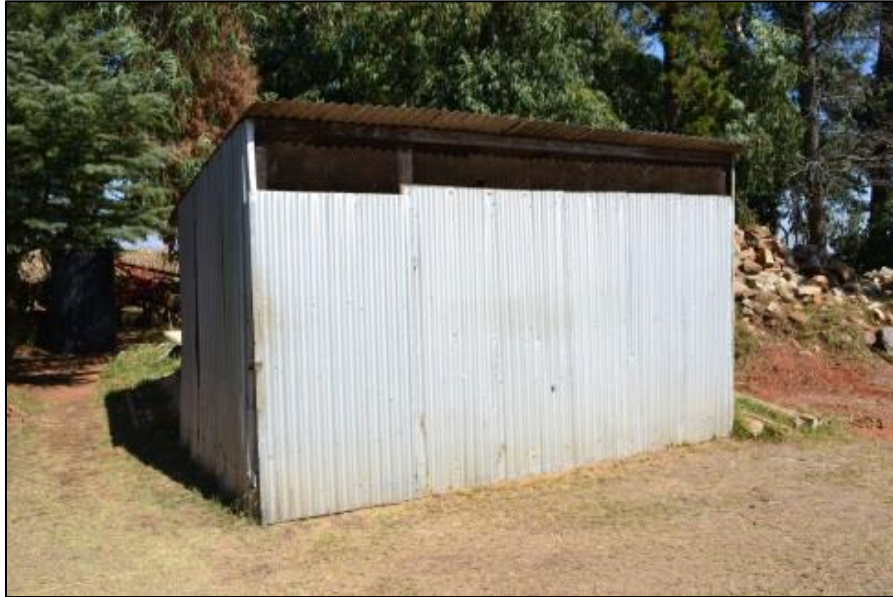
Building 10 - Corrugated iron clad structure

Timber frame structure with corrugated iron sheeting cladding used as ablution facility.

**Figure 12. Timber frame corrugated iron ablution**

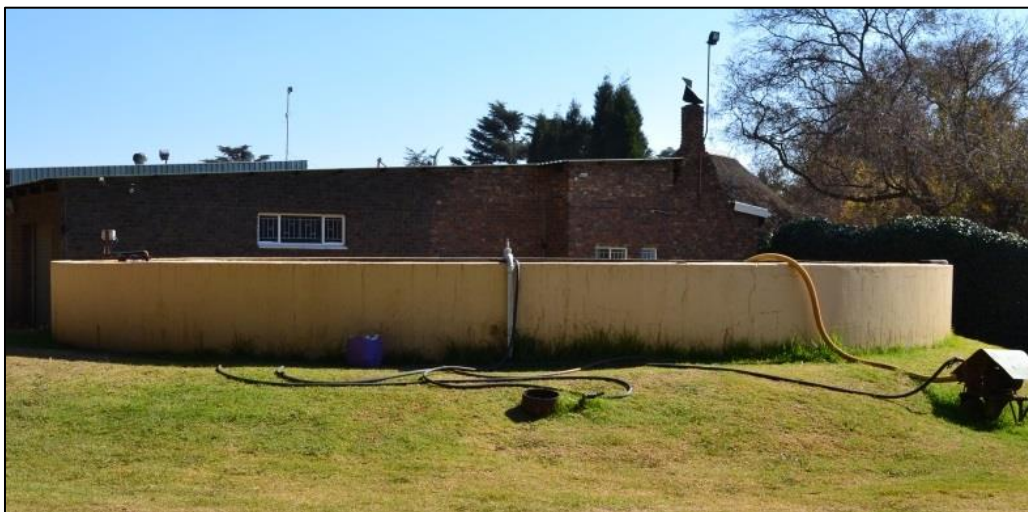
Building 11 - Circular dam:

Engineering structure – large circular dam. Although not classified as a building it remains a structure that needs to be assessed and that has added value to the farmstead and is of economic value to the sustainability of the setting.

**Figure 13. Circular plastered brick dam at the back of the office complex**

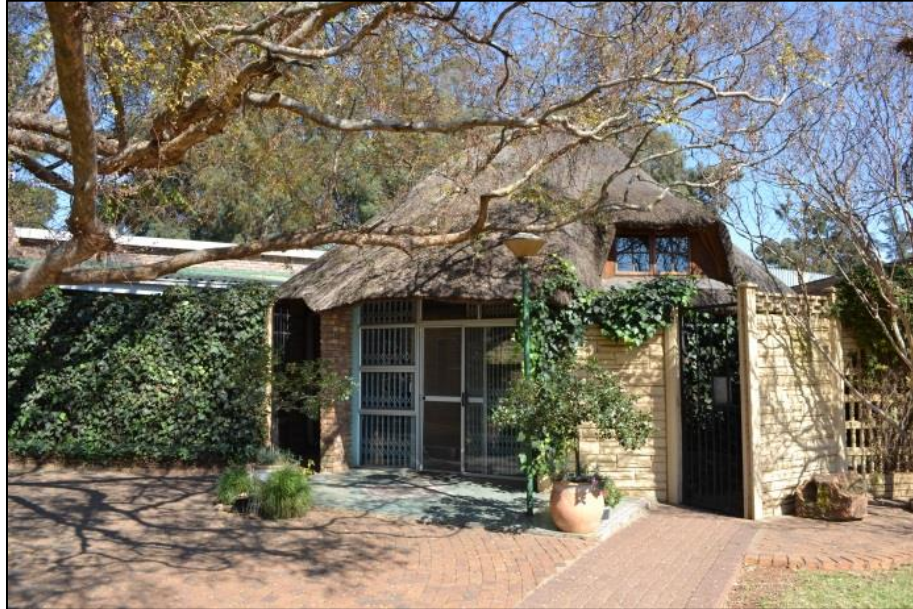
Building 12 - Office complex:

Current administrative hub for the farming activities and farmstead with residential characteristics but used as an office building. It is constructed with face bricks with corrugated iron roofing and a single section reminiscent of a rondavel with a thatched roof. The building consists of a core with several later additions and extensions.

**Figure 14. Entrance to office complex**

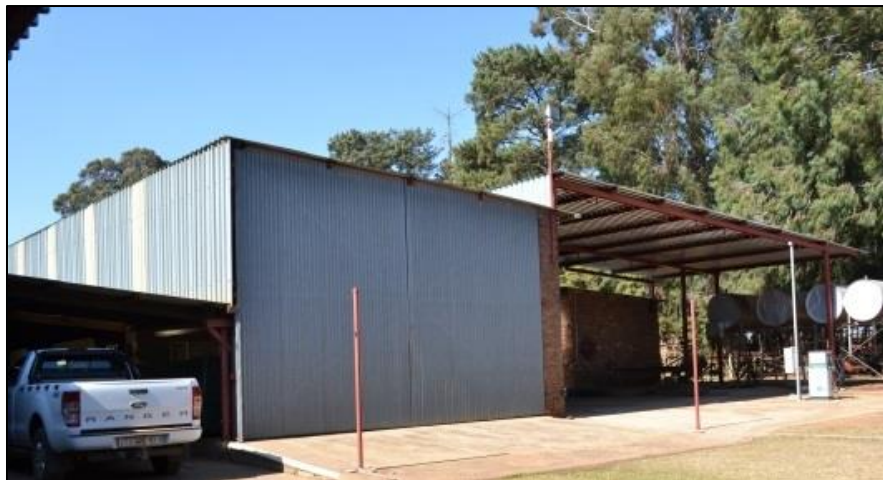
**Figure 15. Steel frame galvanized sheet iron shed**

Building 13 - Open sided steel frame shed:

Steel frame shed structure with sheet iron cladding.

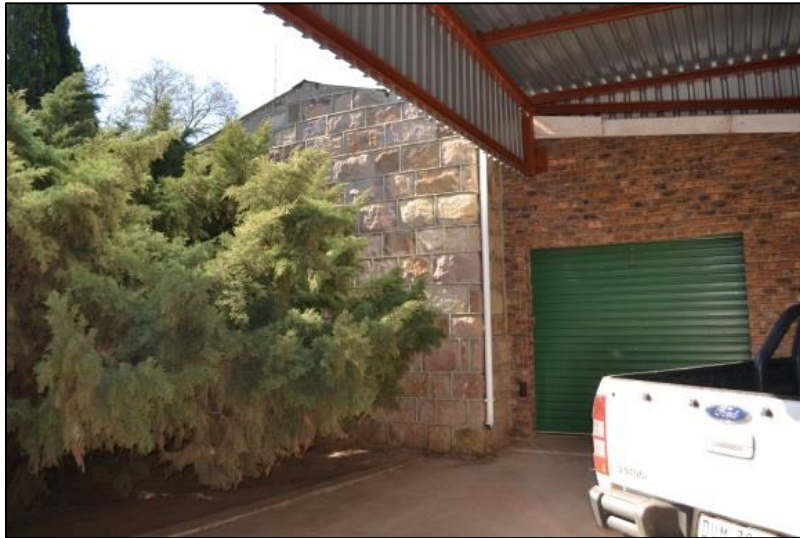
Building 14 - Sandstone garage now storage:

Obscured old sandstone waenhuis-cum-garage that later became a closed space and storage facility. It forms a core to which later additions and extensions were made to accommodate the expansion of the storage needs.

**Figure 16. Back of sandstone garage (left, obscured behind the conifer) now used as storage facility**

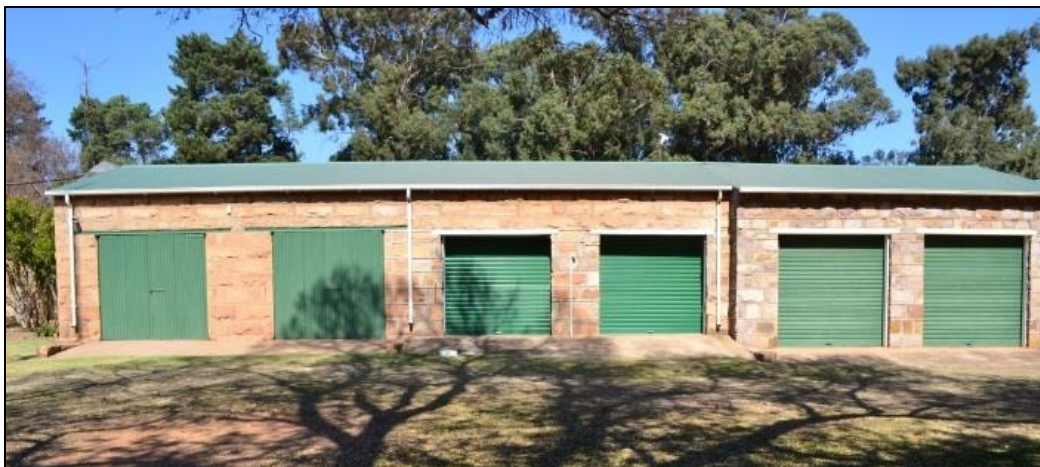
Building 15 - Sandstone garages:

Long elongated rectangular building constructed with sandstone. It consists of a core building with later additions executed with the same sandstone but in a different vocabulary. The later additions were merely added to the sides of the previous garages. The oldest part of this building is the section to the left where the door lintels with the date 1904 appear. These lintels are cocopan rails with the date cast in the iron rail. Later additions have concrete lintels and new plated steel doors. According to the current owners, the oldest section was used as the original house and was built in the 1930s.

**Figure 17. Series of sandstone buildings erected at different periods, now used as garages**

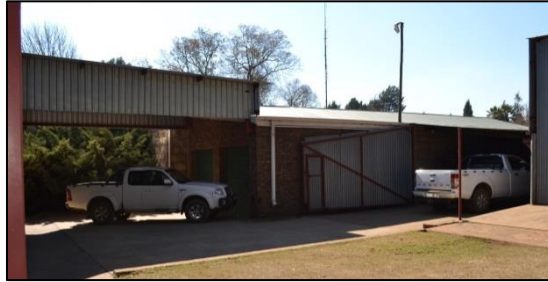
**Figure 18. Open-sided parking serving as node for the landowner and service vehicles**

Building 16 - Open-sided parking:

To link the various historic buildings, a large area has been covered with steel frame and sheet iron cladding allowing ample parking for farm vehicles.

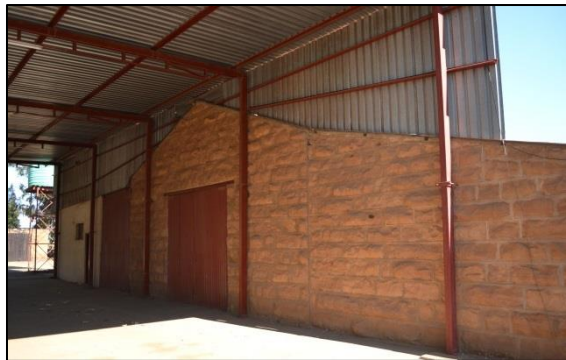
Building 17 - Old sandstone shed and annex:

The original sandstone waenhuis -cum -stables, which was apparently later used as a dwelling, have been included into the open-sided larger steel frame shelter. The historical building was constructed with neatly dressed sandstone and has been properly maintained and protected.

**Figure 19. Old sandstone shed - one of the former dwellings now incorporated into the a new steel frame shed structure**

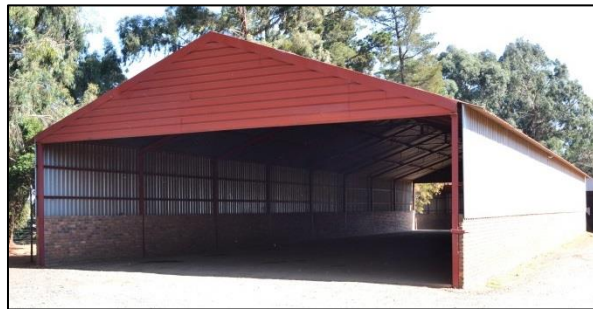
Figure 21. Large steel frame shed with open gable ends

Building 19 - Large steel frame closed shed:

Commercial semi-open steel frame multi-purpose engineering structure with sheet iron cladding and open gable ends.

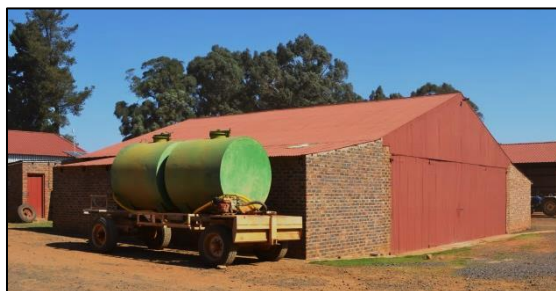
Building 20 - Face brick shed:

Face brick shed building with corrugated iron gable ends and large doors to allow maximum entry into the building. This building is also referred to as the hangar, as it was used in the past to accommodate a small plane.

Figure 22. Old face brick shed, also known as the plane hangar, with large doors in the gable end

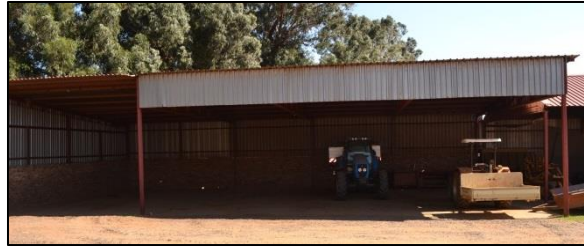
**Figure 23. Open-sided steel frame parking shelter**

Building 21 - Steel frame open parking shelter:

Commercial steel frame engineering structure erected to serve as semi-covered parking for farm vehicles.

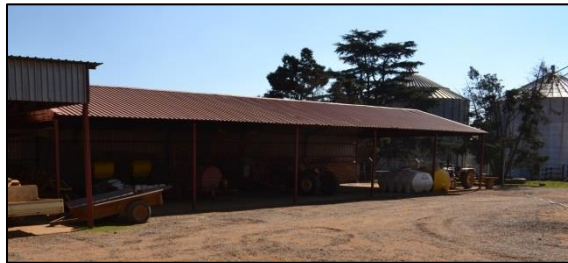
**Figure 24. Large steel frame open sided storage shelter**

Building 22 - Steel frame open storage shelter:

Open sided steel frame engineering structure used as storage facility for farming equipment.

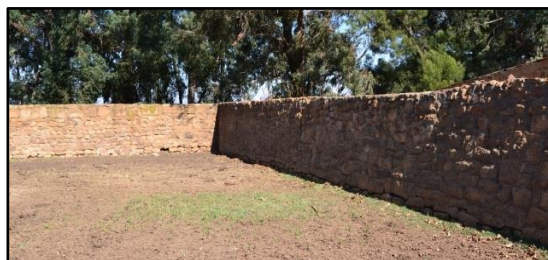
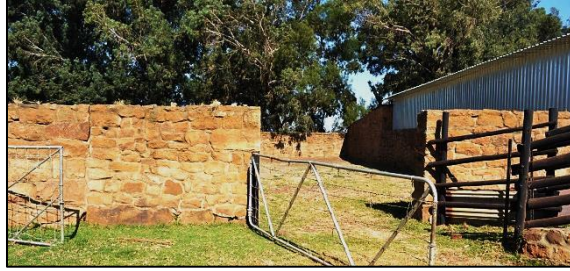
Building 23 - Double sandstone kraal for cattle:

Large sandstone cattle kraal complex. The complex consists of two enclosures, each with its own entrance but not connected to each other. The exterior wall of the western enclosure is used as a supporting wall for another sandstone building, while also serving as the lower section of a steel frame open sided annex.

**Figure 25. Remains of old sandstone cattle kraal**

**Figure 26. Second section of old sandstone cattle kraal**

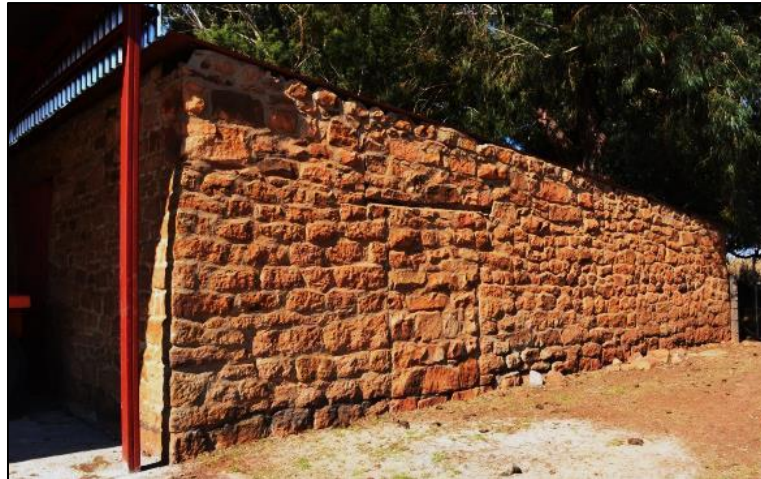
**Building 24 - Sandstone storage room:**

Large sandstone building adjacent to the sandstone cattle kraal. The original function of this building remains unknown until further investigation.

**Figure 27. Large sandstone storage shed**

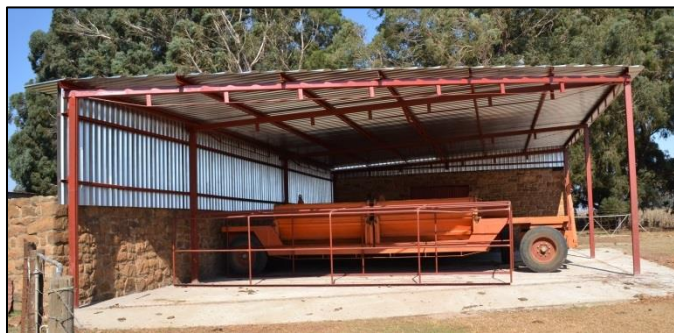
**Figure 28 New open sided steel frame parking shelter**

**Building 25 - Steel frame open parking shelter:**

Open-sided steel frame engineering structure used as parking for farming vehicles.

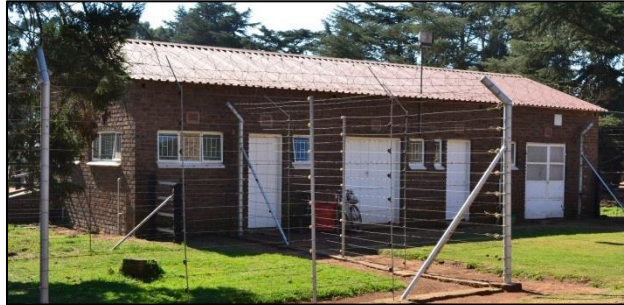
**Figure 29. Dairy and milking facility**

Building 26 – Dairy:

Small modern face brick building where cows are milked and milk is stored and collected.

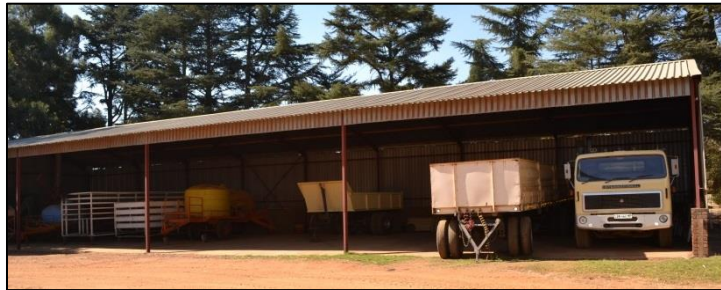
**Figure 30. Large steel frame semi-open parking facility**

Building 27 - Steel frame open parking shelter:

Large steel frame open sided shelter protecting farming vehicles.

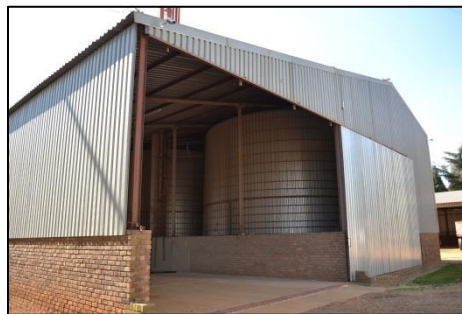
**Figure 31. Large steel frame covered storage facility accommodating silos and loading bay**

Building 28 - Steel frame closed storage shed and loading bay:

Specialized steel frame shed with closing doors used as storage facility for silos

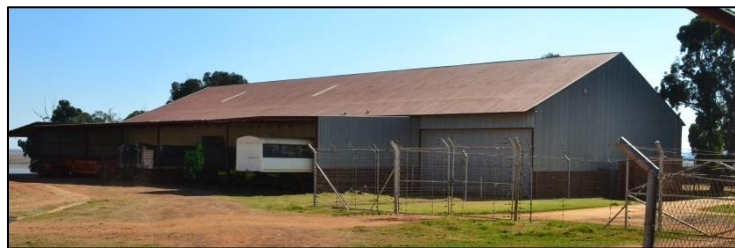
**Figure 32. large steel frame storage sheds and open-sided parking shelter**

Building 34 - Large steel frame storage shed:

Large steel frame shed with open sided steel frame shelter used for vehicle parking
