PHASE 1 HERITAGE IMPACT ASSESSMENT

Proposed Establishment of Goudrand Ext. 5, Goudrand Ext. 6, Goudrand Ext. 7, Goudrand Ext. 8, Goudrand Ext. 9, Goudrand Ext. 10, Goudrand Ext. 11, Goudrand Ext. 14, Goudrand Ext. 15, Goudrand Ext. 16, Goudrand Ext. 17, Goudrand Ext. 18 and Goudrand Ext. 19, located in the Roodepoort Magisterial District, City of Johannesburg Metropolitan Municipality, Gauteng Province

Issue Date: 20 June 2018
Revision No.: 2
Client: Hunter Theron Incorporated

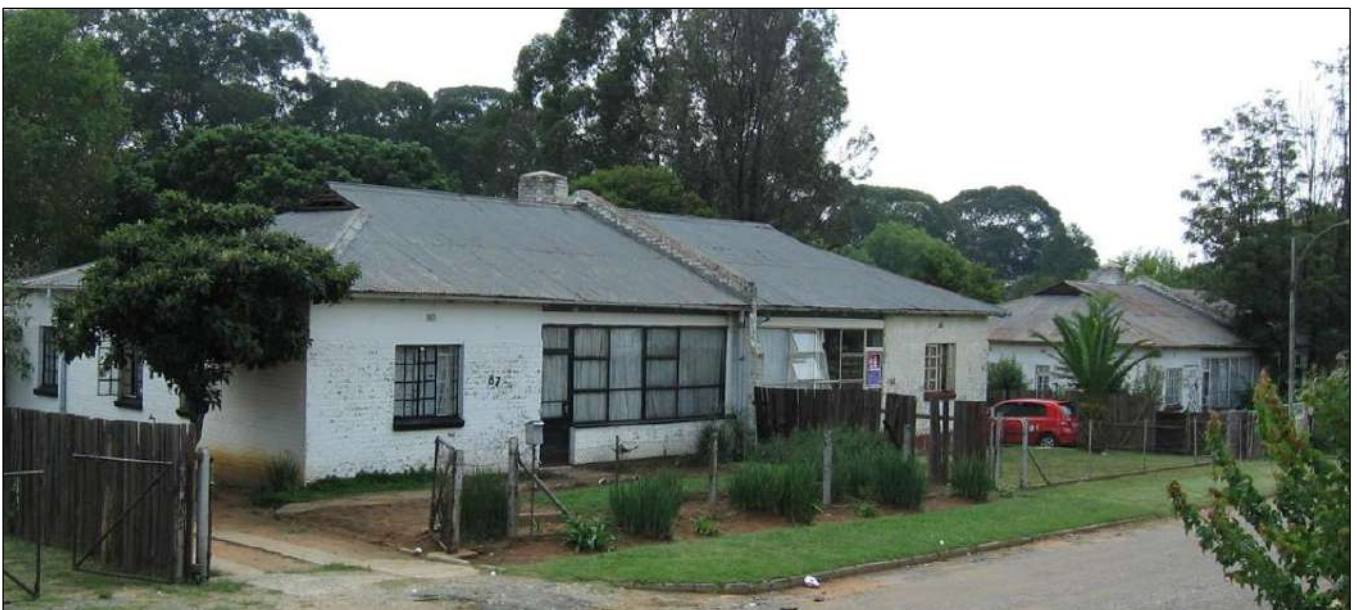
Figure 5 – General view of a section of the study area showing the residential character of large components of the study area. These semi-detached dwellings are located within the north-eastern section of the study area.

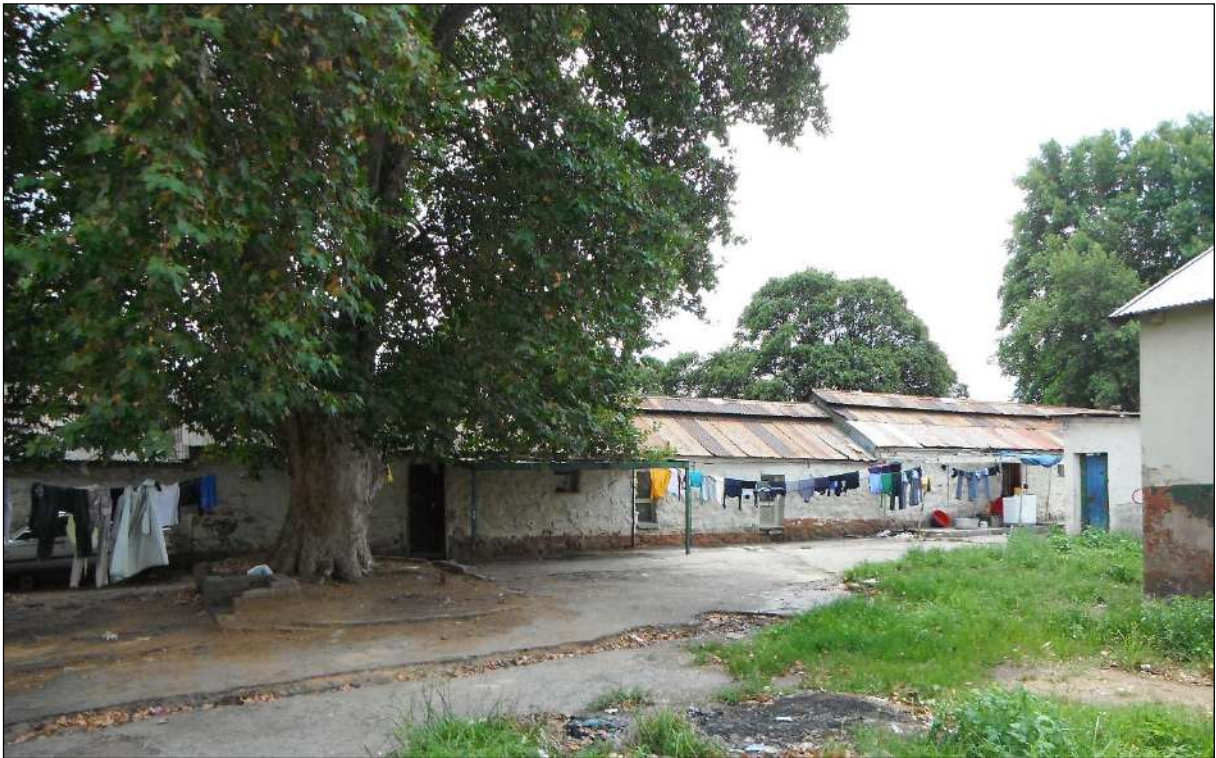
Figure 6 – General view of a section of the study area showing a section of the historic compound located near the north-western end of the study area. An extensive cemetery is associated with this compound.

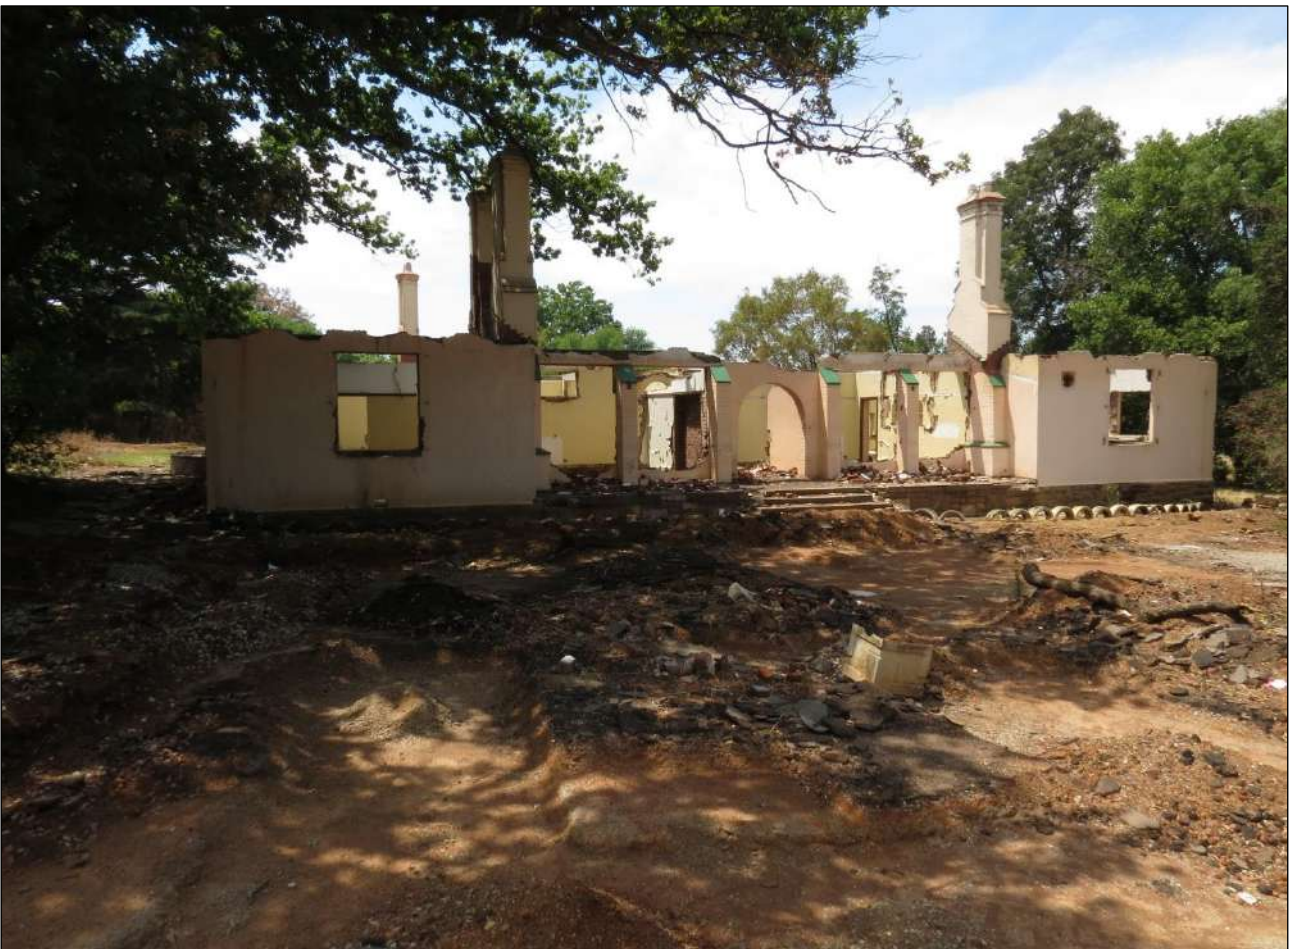
Figure 9 – The current condition of the mine village and buildings is very poor, with a number of buildings currently only consist of ruined structures.

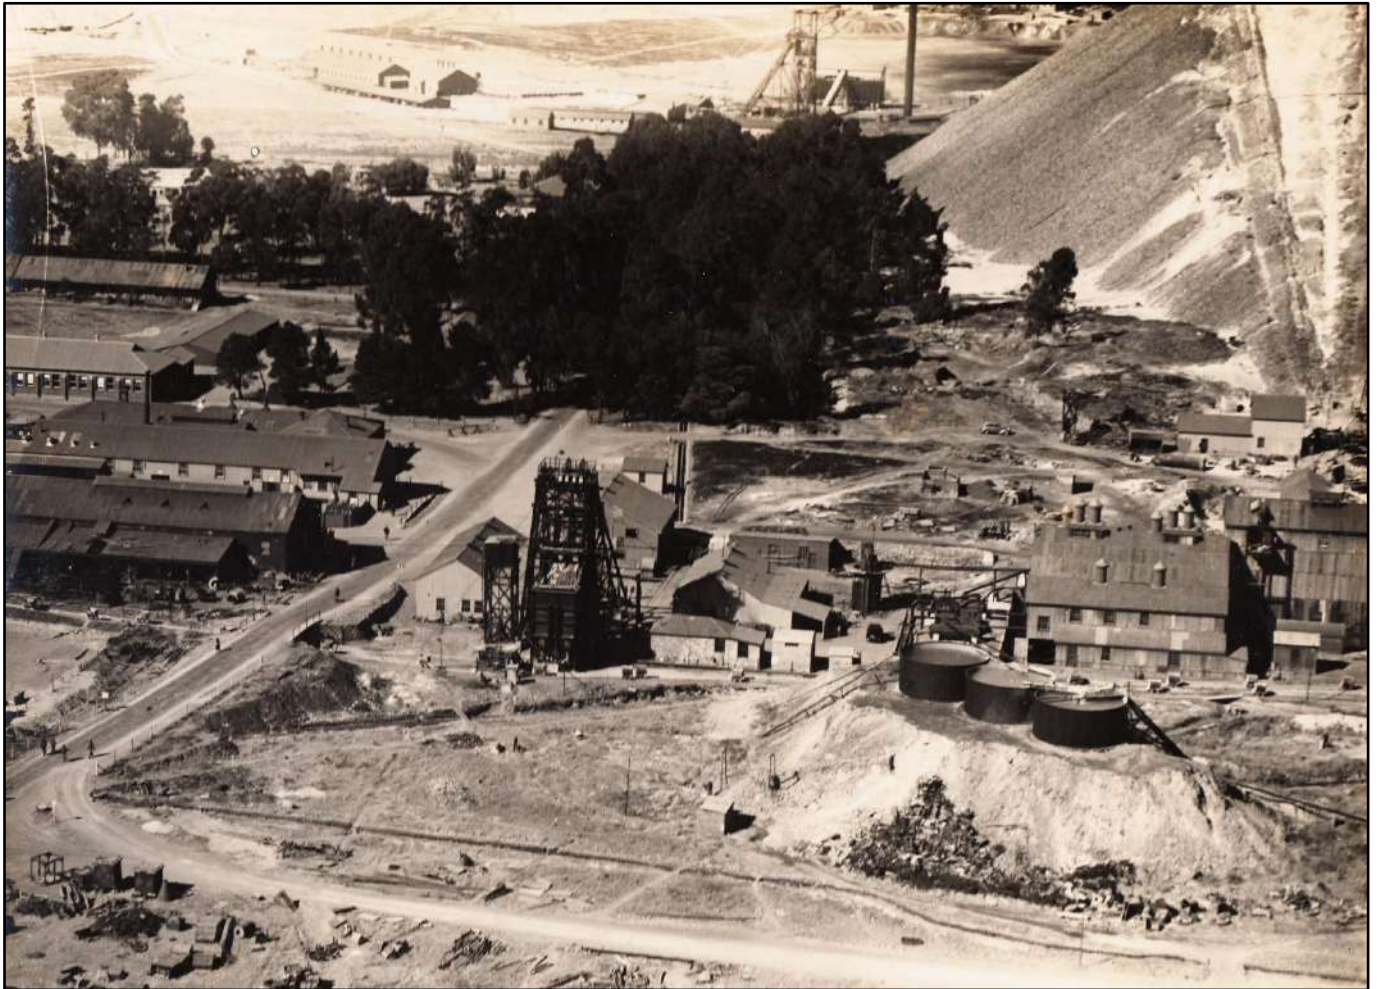
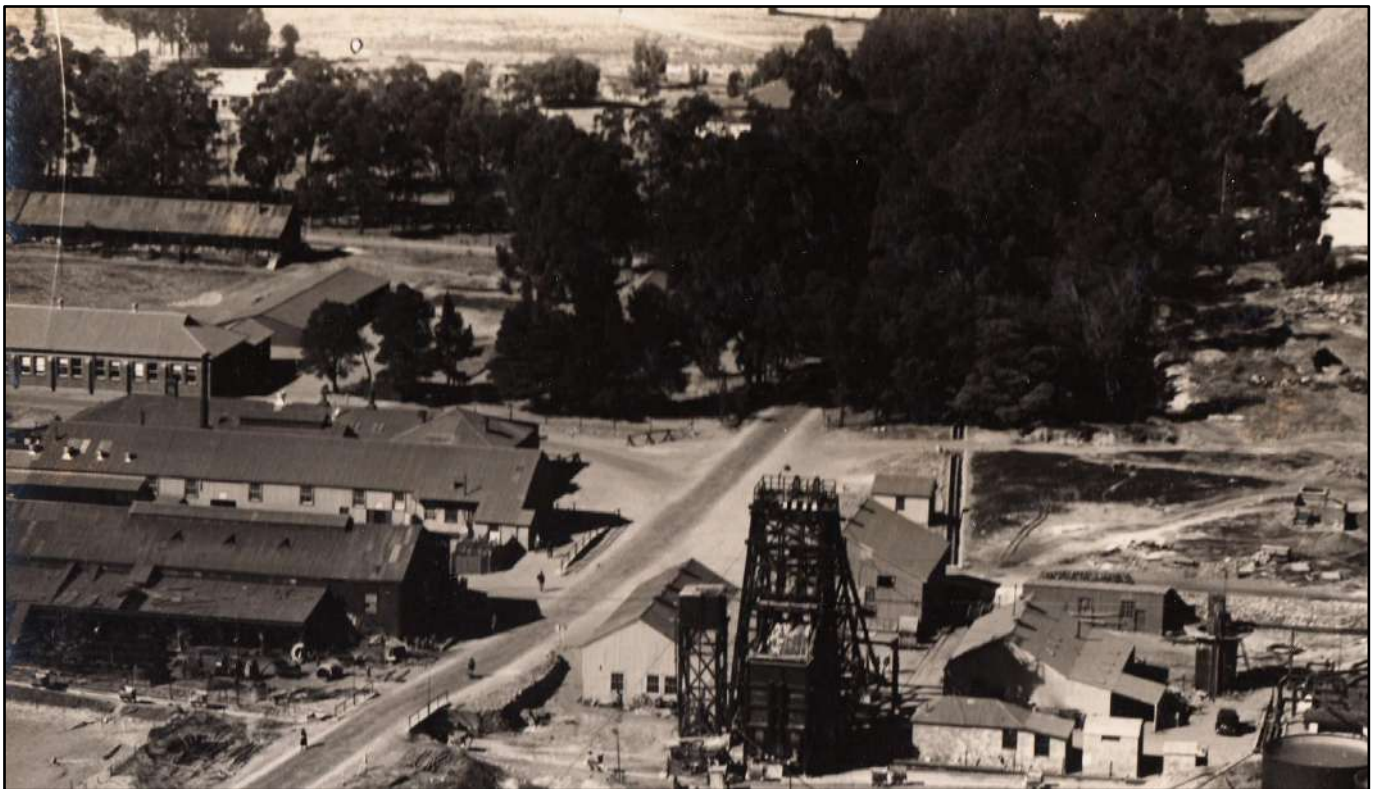
Figure 19 – These cropped versions of a historic photograph provide an early view of Durban Roodepoort Deep’s No. 2 Shaft and its associated buildings, with some of the mine’s offices and stores visible on the left. Photograph obtained from the Barloworld Archives.

- No. 2 Shaft and its associated plant can be seen in the middle foreground. It can be surmised that this mine shaft was the second one to be developed at the mine. Although the shaft and plant depicted here would be located within the present study area, no evidence for these features could be found during the fieldwork.

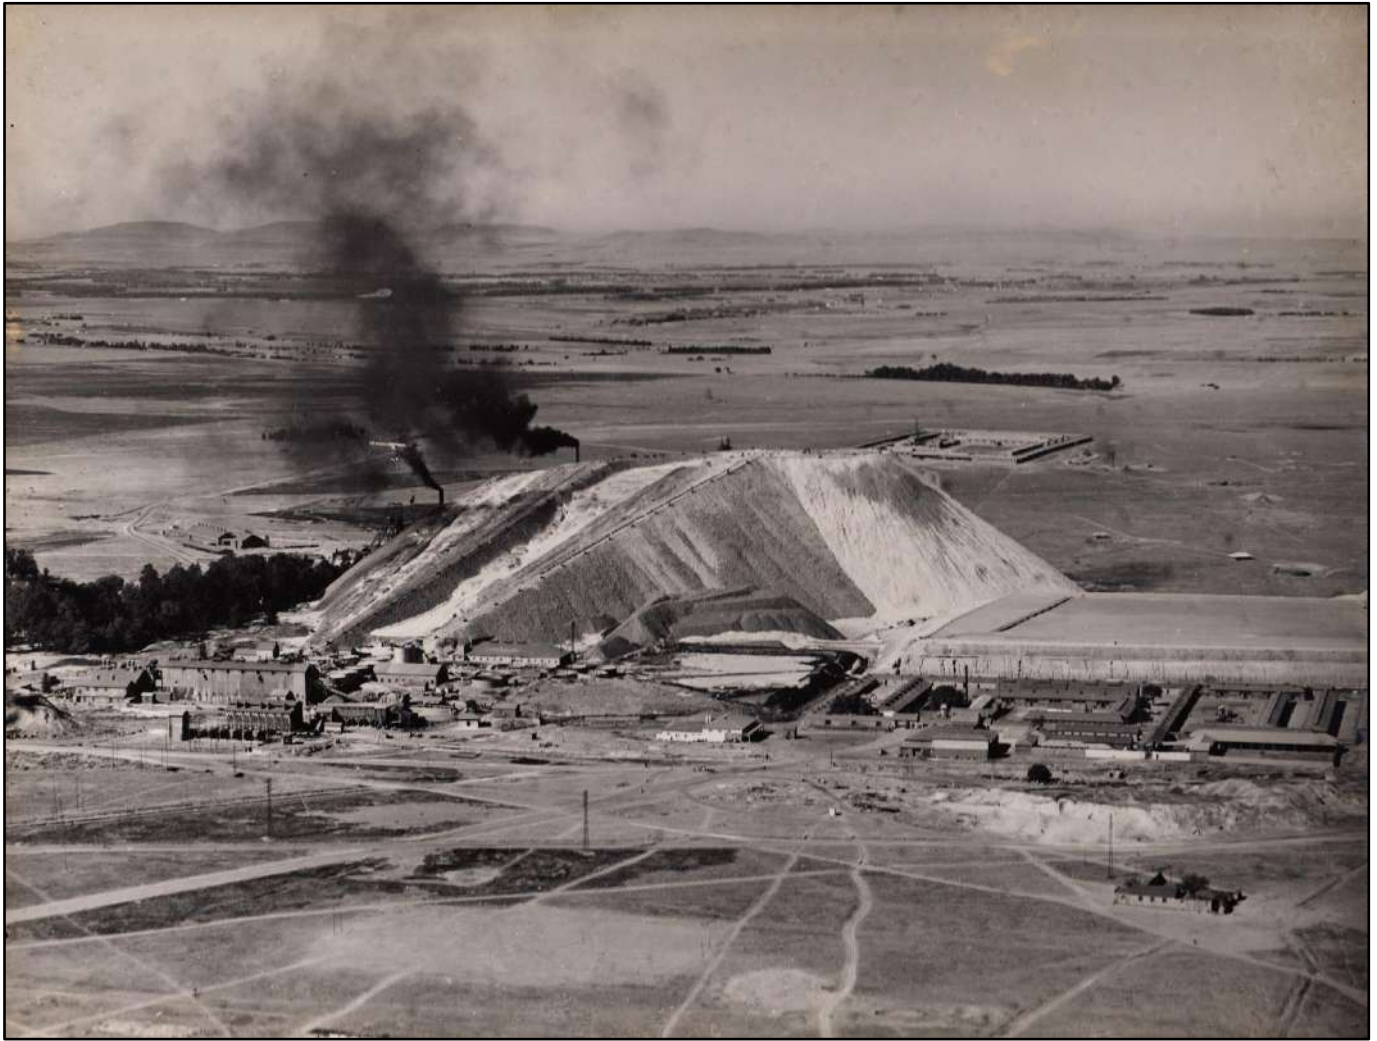
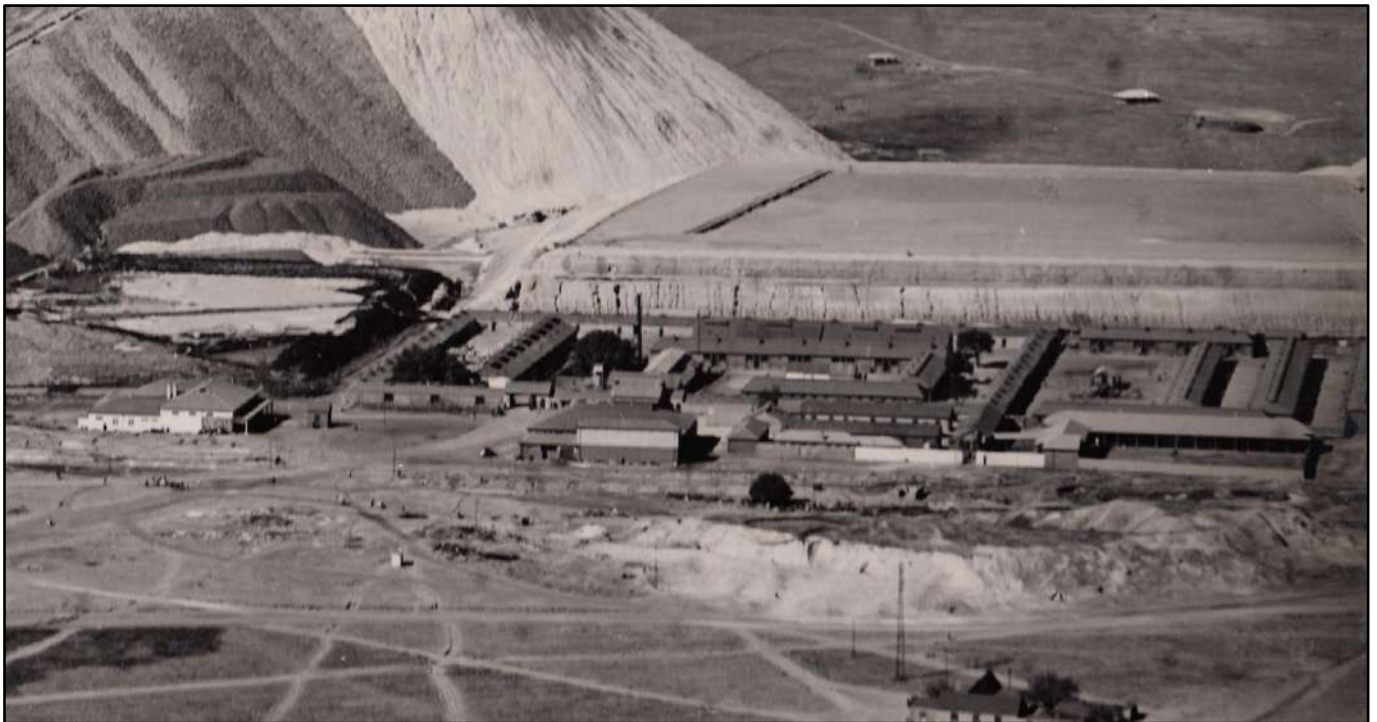
Figure 20 – The historic photograph shown at the top provides an early view of Durban Roodepoort Deep's reduction works and compound. The cropped section below shown just the mine compound. Photograph obtained from the Barloworld Archives.

- Immediately in front of the old mine compound, another large building is shown. This building was identified during the fieldwork undertaken in 2012, and is included in this report as Building Type 53, which is an Eating House. This building still exists today.

- The mine compound depicted on this historic photograph exhibits strong similarities to the mine compound located within the study area today. All the elements of the compound included in this report as Building Type 49, Building Type 50, Building Type 51 and Building Type 52 are depicted on this photograph. These building components still exist today.

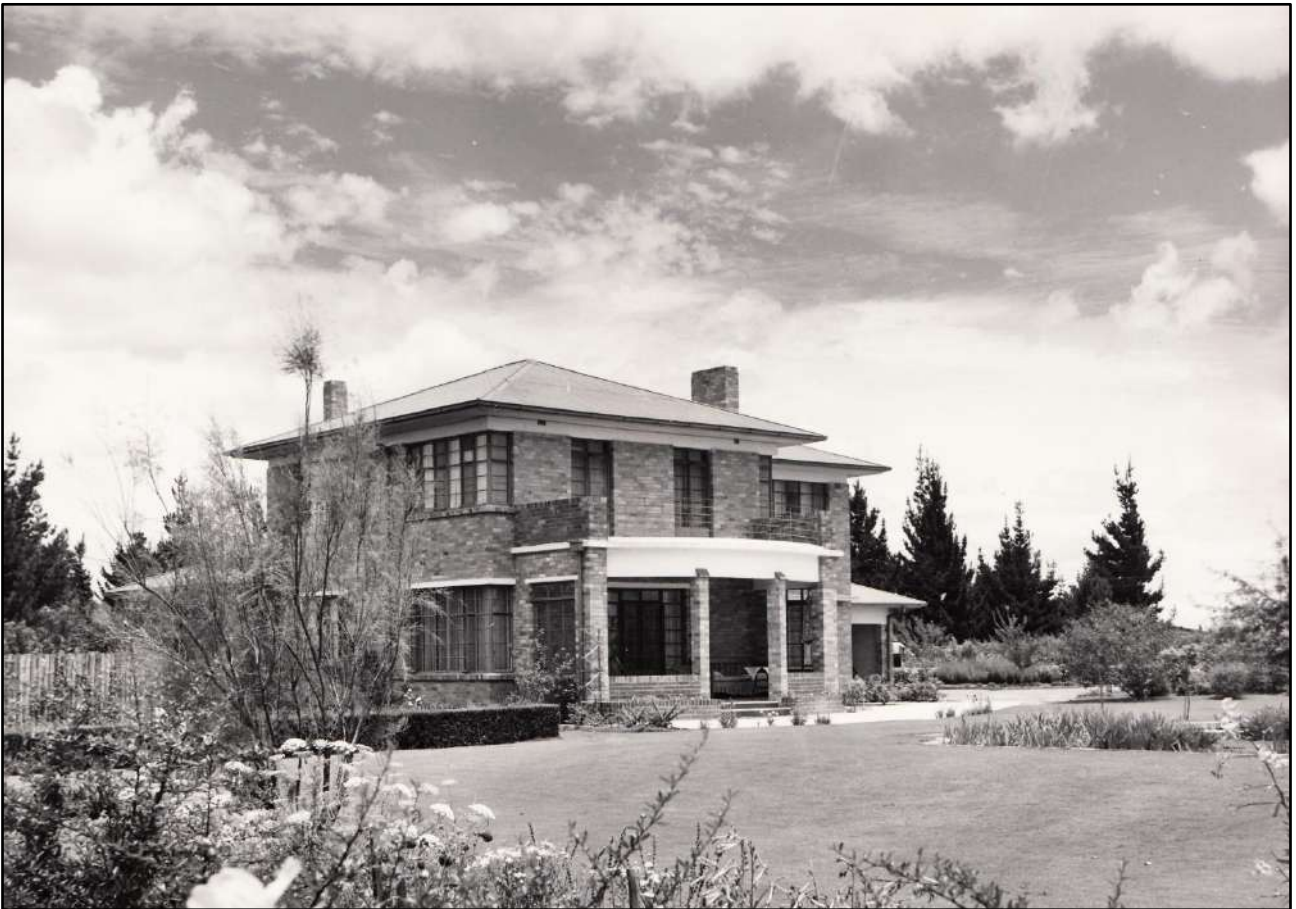
Figure 24 – Historic photograph taken in 1948. Obtained from the Barloworld Archives.

Another general view of one of the double storey dwellings that were erected between 1947 and 1948 for senior staff members of the mine. As mentioned above, during the fieldwork undertaken in 2012, five of these double storey buildings were identified. Between 2012 and 2014, all five these dwellings were demolished / vandalised.

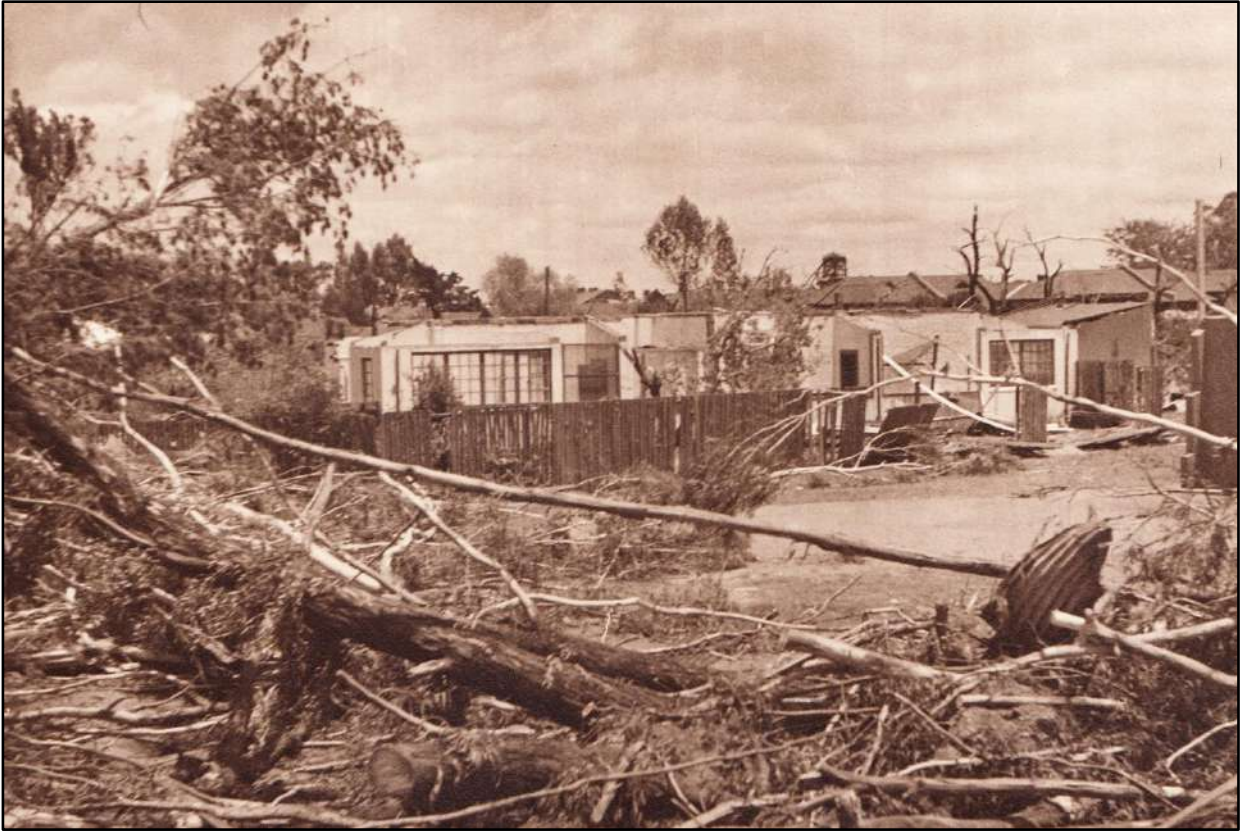
Figure 30 – Historic photograph taken in November 1948. Obtained from the Barloworld Archives.

An extensively damaged semi-detached dwelling is shown. It is not presently clear exactly which dwelling was destroyed in this fashion by the tornado of 1948.

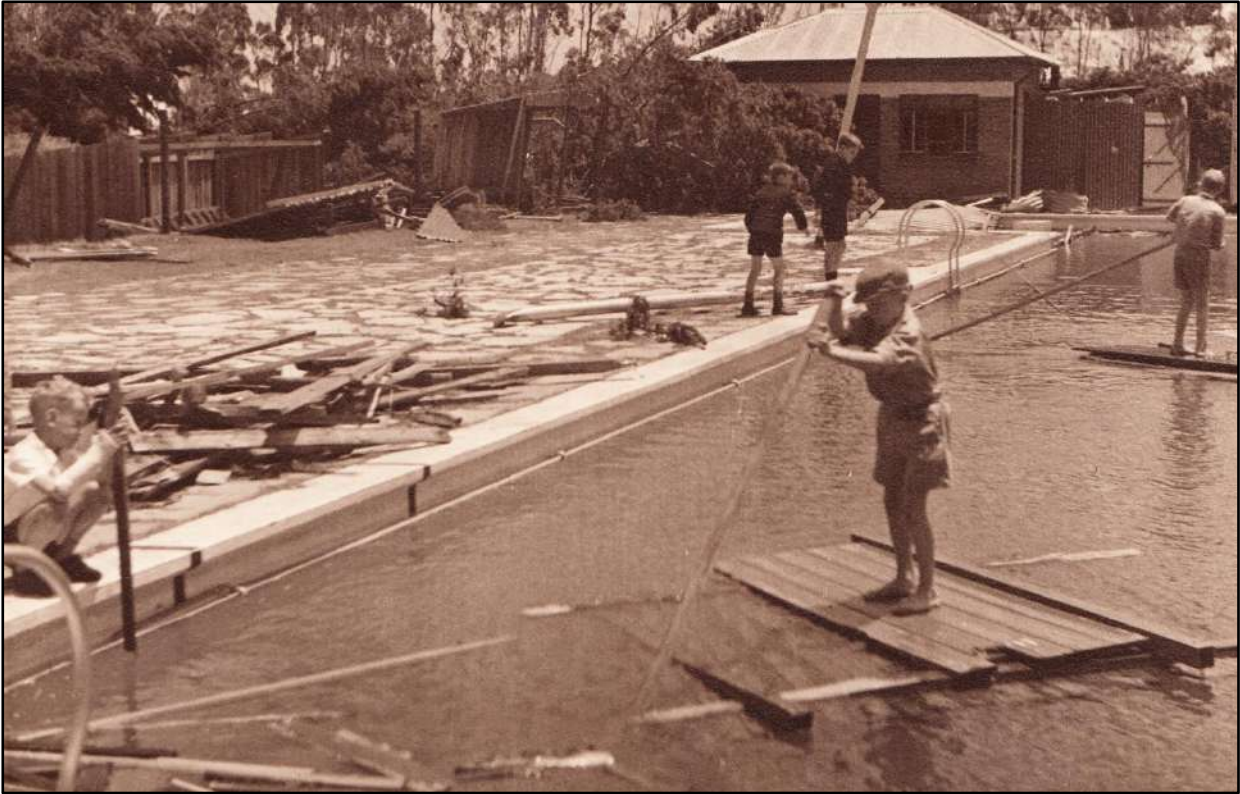
Figure 32 – Historic photograph taken in November 1948. Obtained from the Barloworld Archives.

It is clear from this photograph that while the swimming pool of the Durban Roodepoort Mine Village remained largely unscathed from the tornado, the wooden fencing enclosing the swimming pool was badly damaged. In this photograph sections of the damaged wooden fencing are used as rafts by the intrepid school boys.

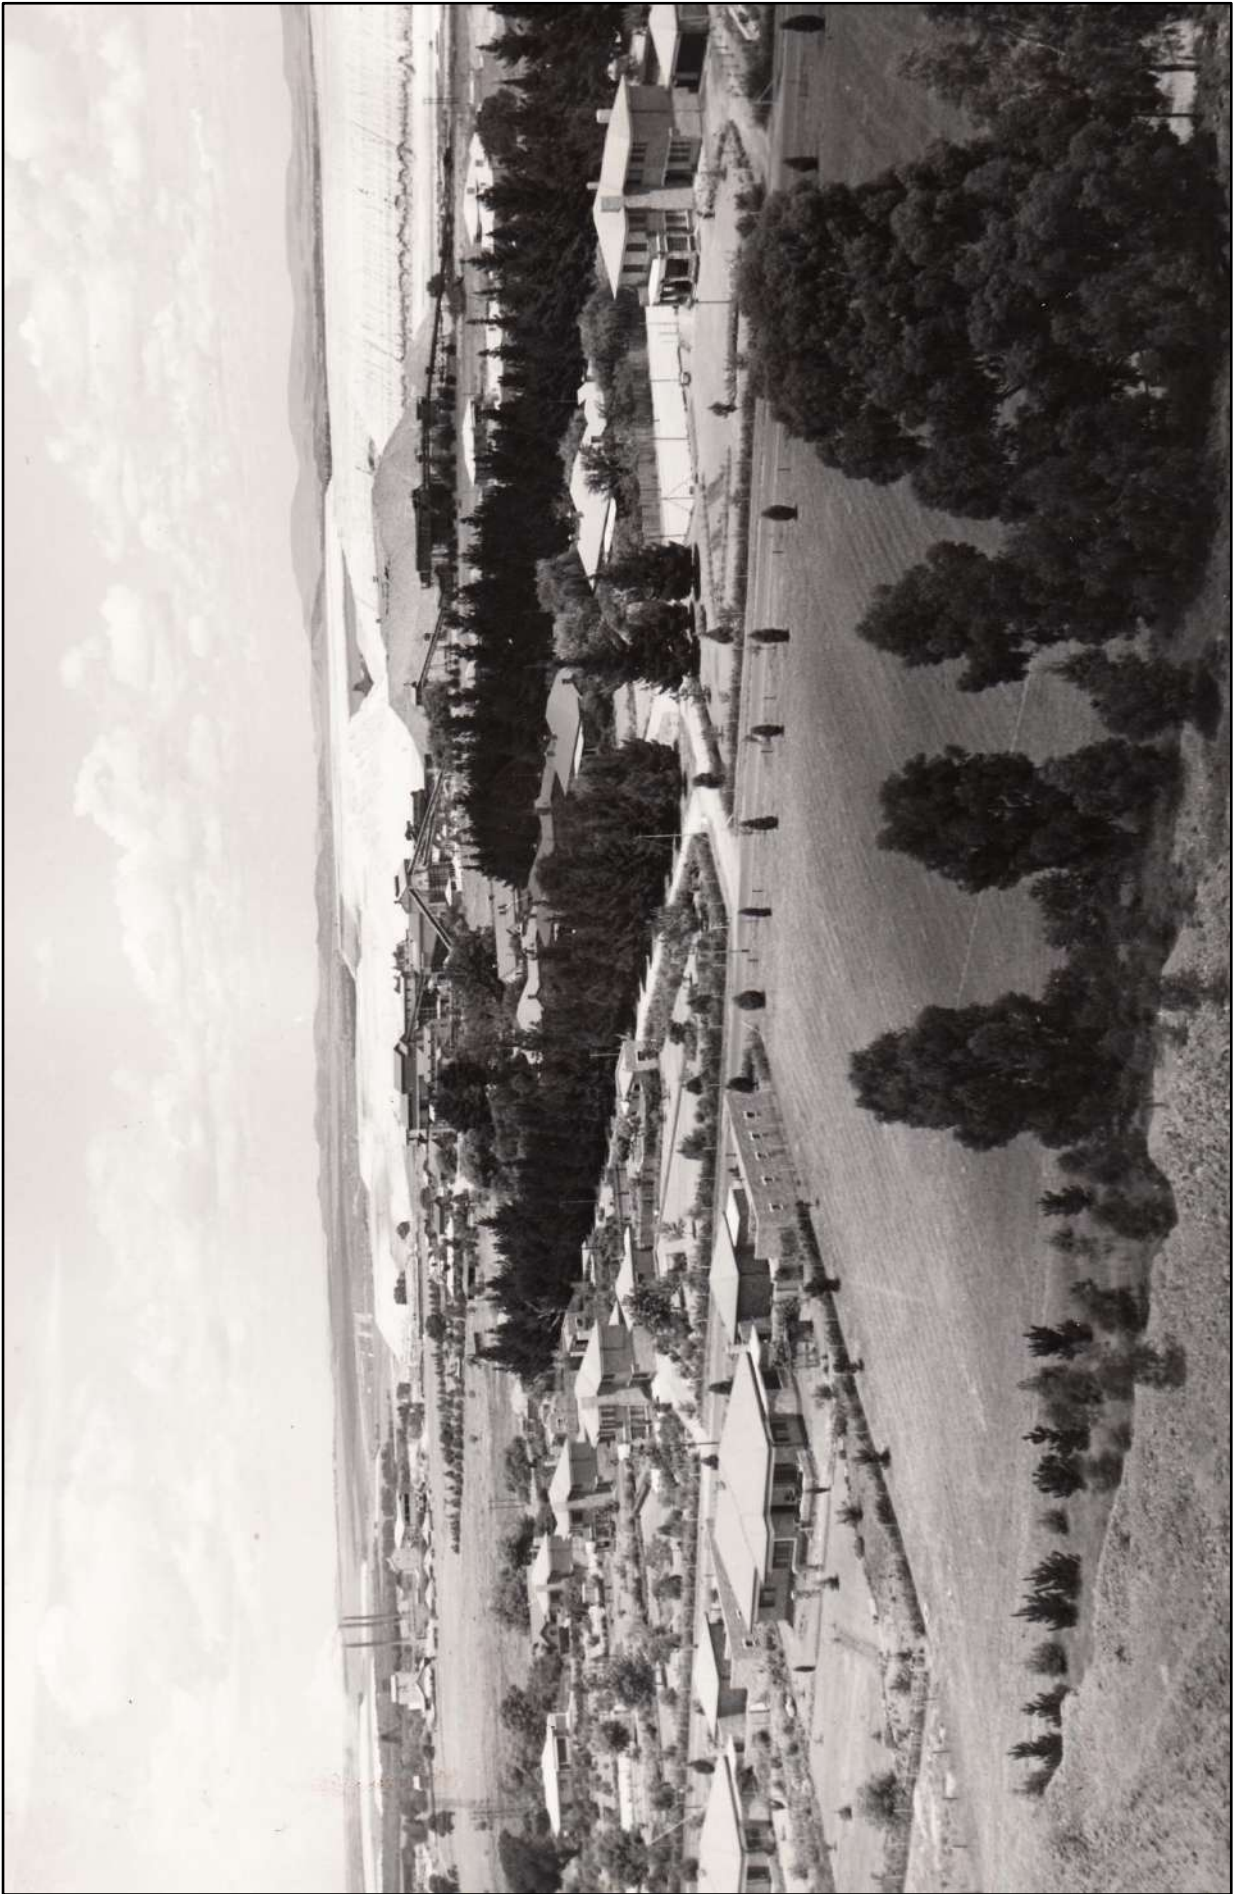
Figure 33 – Historic photograph depicting sections of the study area. This photograph was obtained from the Barloworld Archives.

- In the middle background on the left, immediately behind the row of three double storey Building Type 17 structures, the only example of a Building Type 7 structure from within the study area can be seen. This building was identified during the fieldwork undertaken in 2012 as building numbers DRD56 and DRD57, but sadly had since been demolished / vandalised.

- In the middle background, immediately left of the Building Type 7 structure, one of the numerous examples of the Building Type 1 structures can be seen. This building was identified during the fieldwork undertaken in 2012, and is included in this report as building number DRD55. This building still exists today.

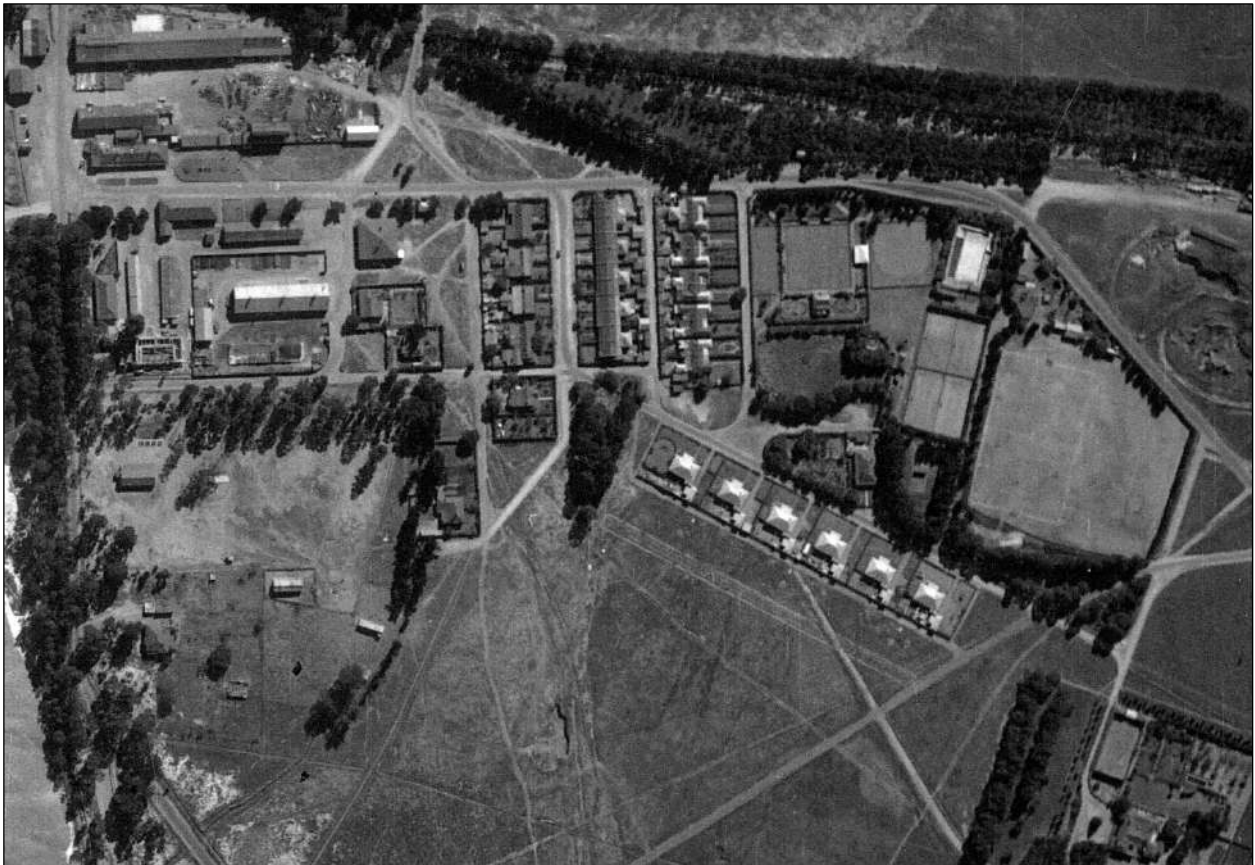
Figure 34 – Depiction of a section of the study area taken in 1938. This section of the study area includes the mine offices, sports fields and houses. Note the undeveloped spaces at the lower end and to the right of this image.

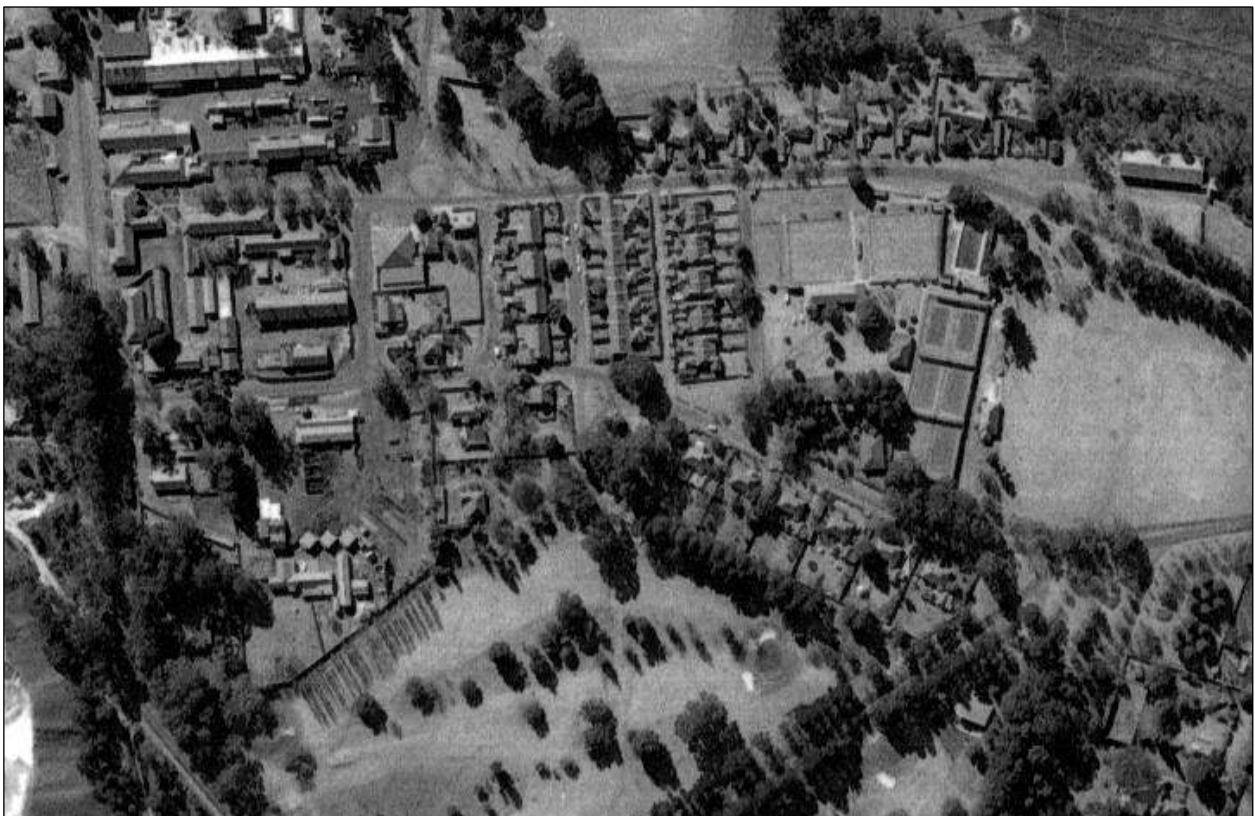
Figure 35 – Depiction of the same section of the study area taken in 1991. Note the increased number of buildings within this section, as well as the use of components of the study area as a golf course.

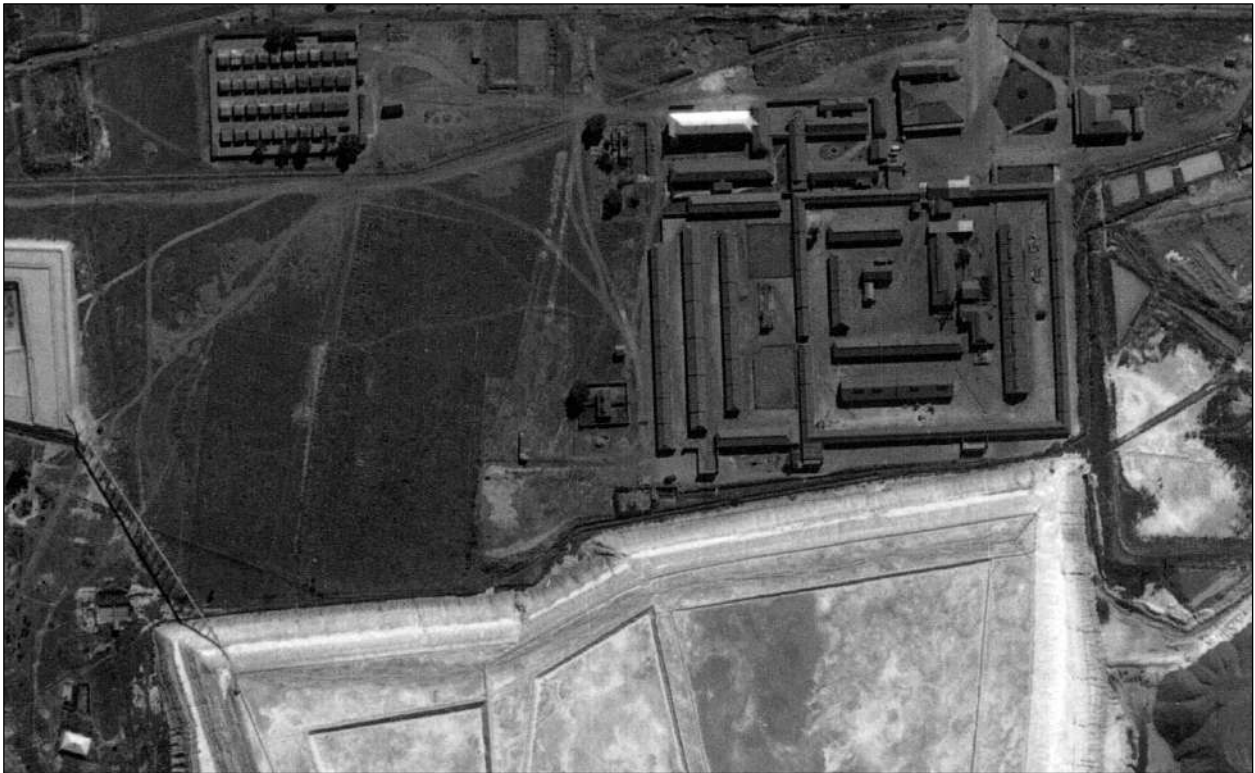
Figure 36 – Depiction of a section of the study area taken in 1938. This section of the study area includes the compound and associated buildings. A cemetery was identified in the field west of the compound buildings.

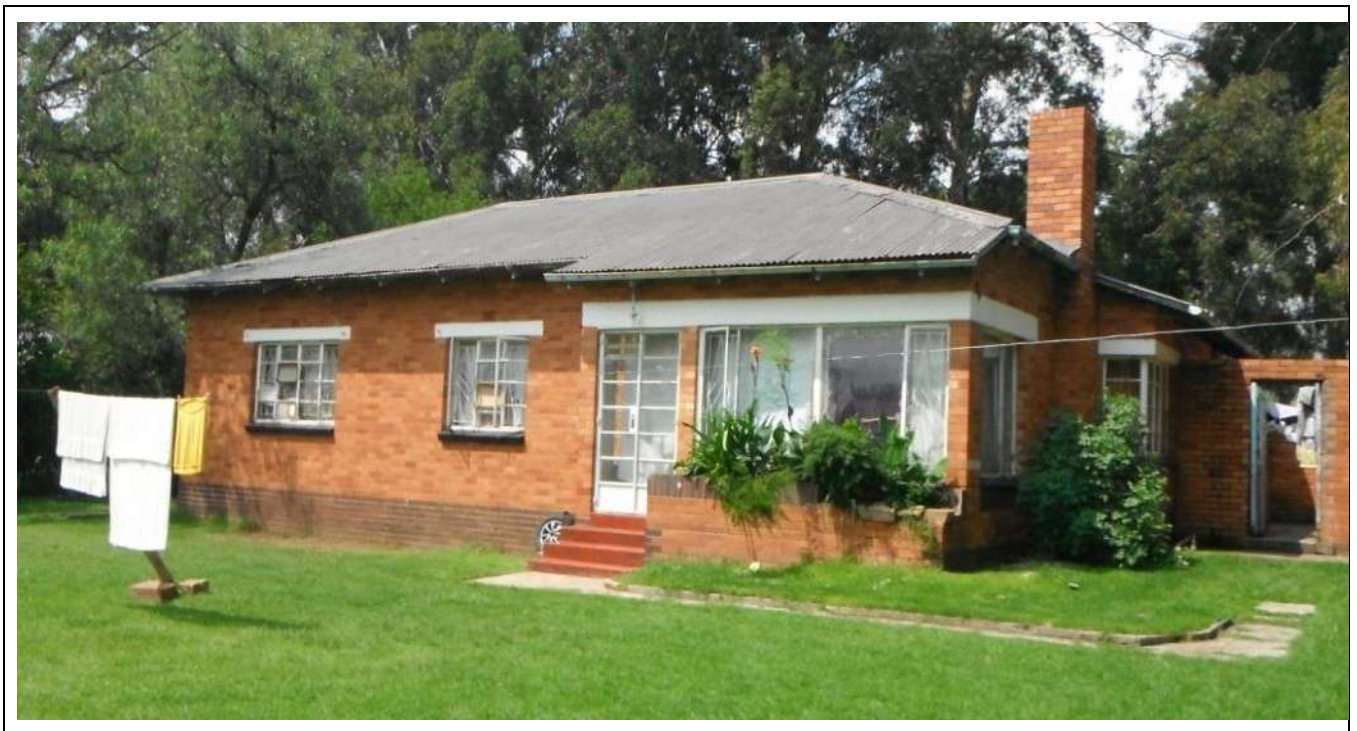
This building type comprises a single storey dwelling built of yellow face brick with steel framed windows and a corrugated iron roof. The building type has a L-shaped plan with one protruding gable wing extending towards the road. Typical of mining-related architecture is the presence of concrete lintels across the doors and windows. A small separate face brick structure is located on its western end and likely provided accommodation and toilet facilities to the domestic workers.

Figure 38 – General view of the front (northern) façade of one of the buildings classified as a Building Type 1 structure.

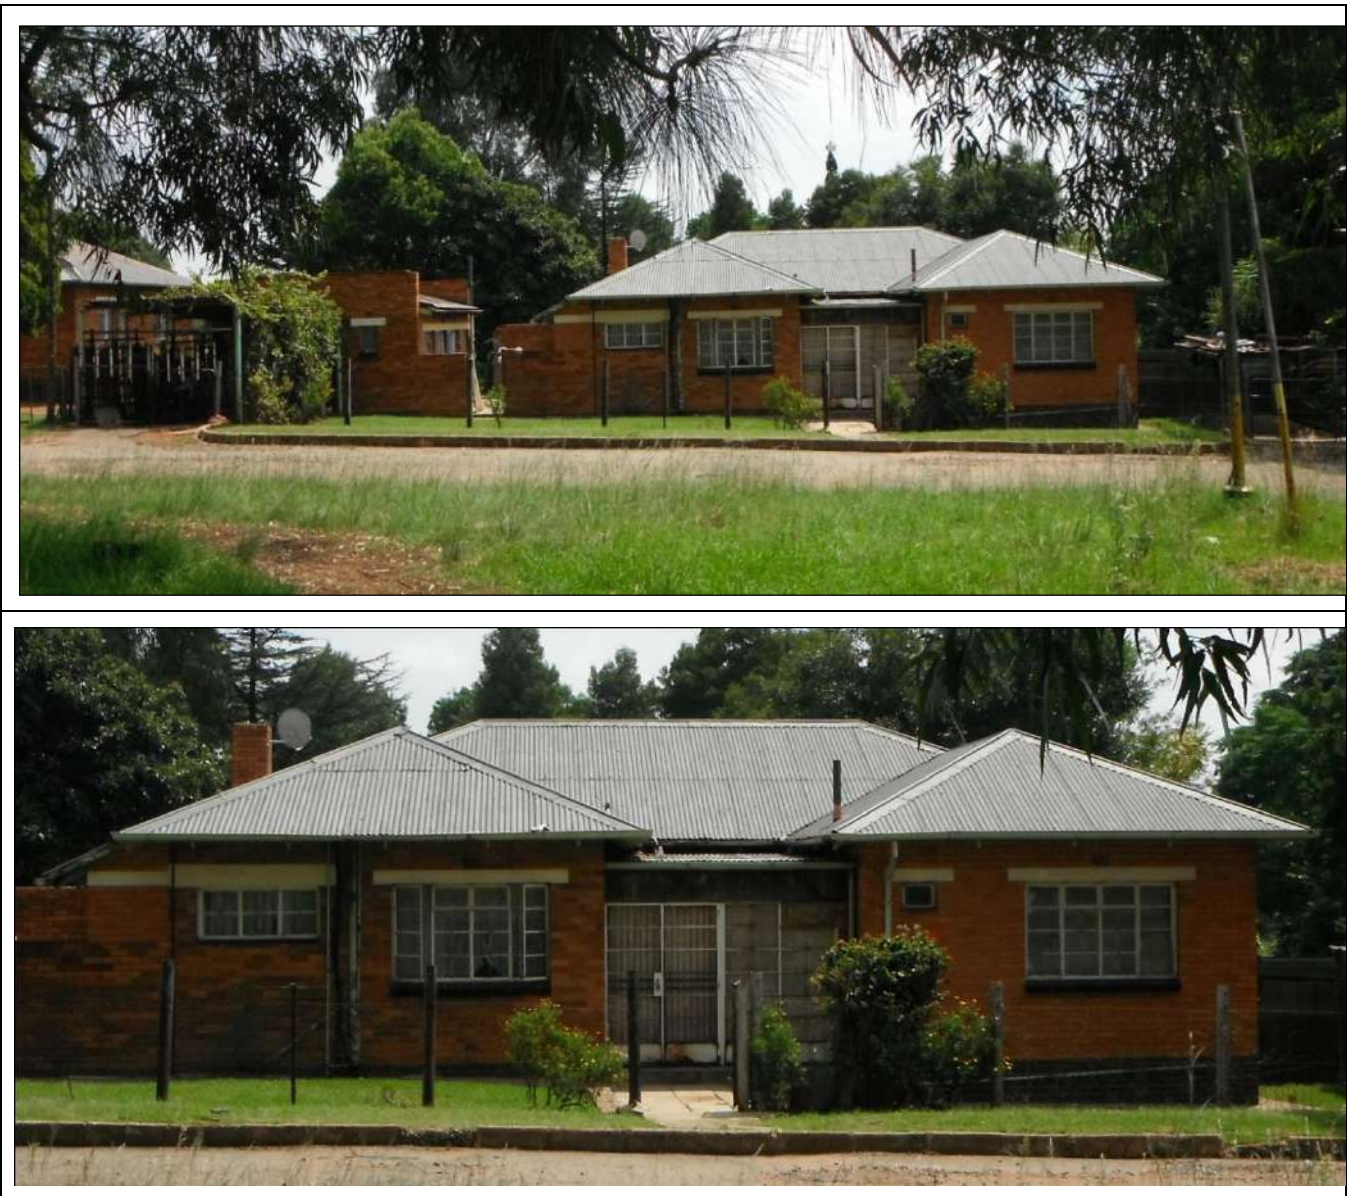
This building type was originally exactly the same as Building Type 1. The only difference is that it has two extending front gables instead of one, giving the building a U-shaped plan. Only four of the Building Type 1 dwellings were converted into Building Type 2 structures by adding another wing to the front of the building. This extension was likely undertaken in cases where the families residing in these dwellings required more sleeping rooms or space. Individuals such as senior fitter and turners (for example Mr Rudling and his family who resided in dwelling 116) and senior carpenters (for example Mr Willie Oesch and his family who resided in dwelling 122) lived in these houses.

Figure 39 – Two general views of Building Type 2.

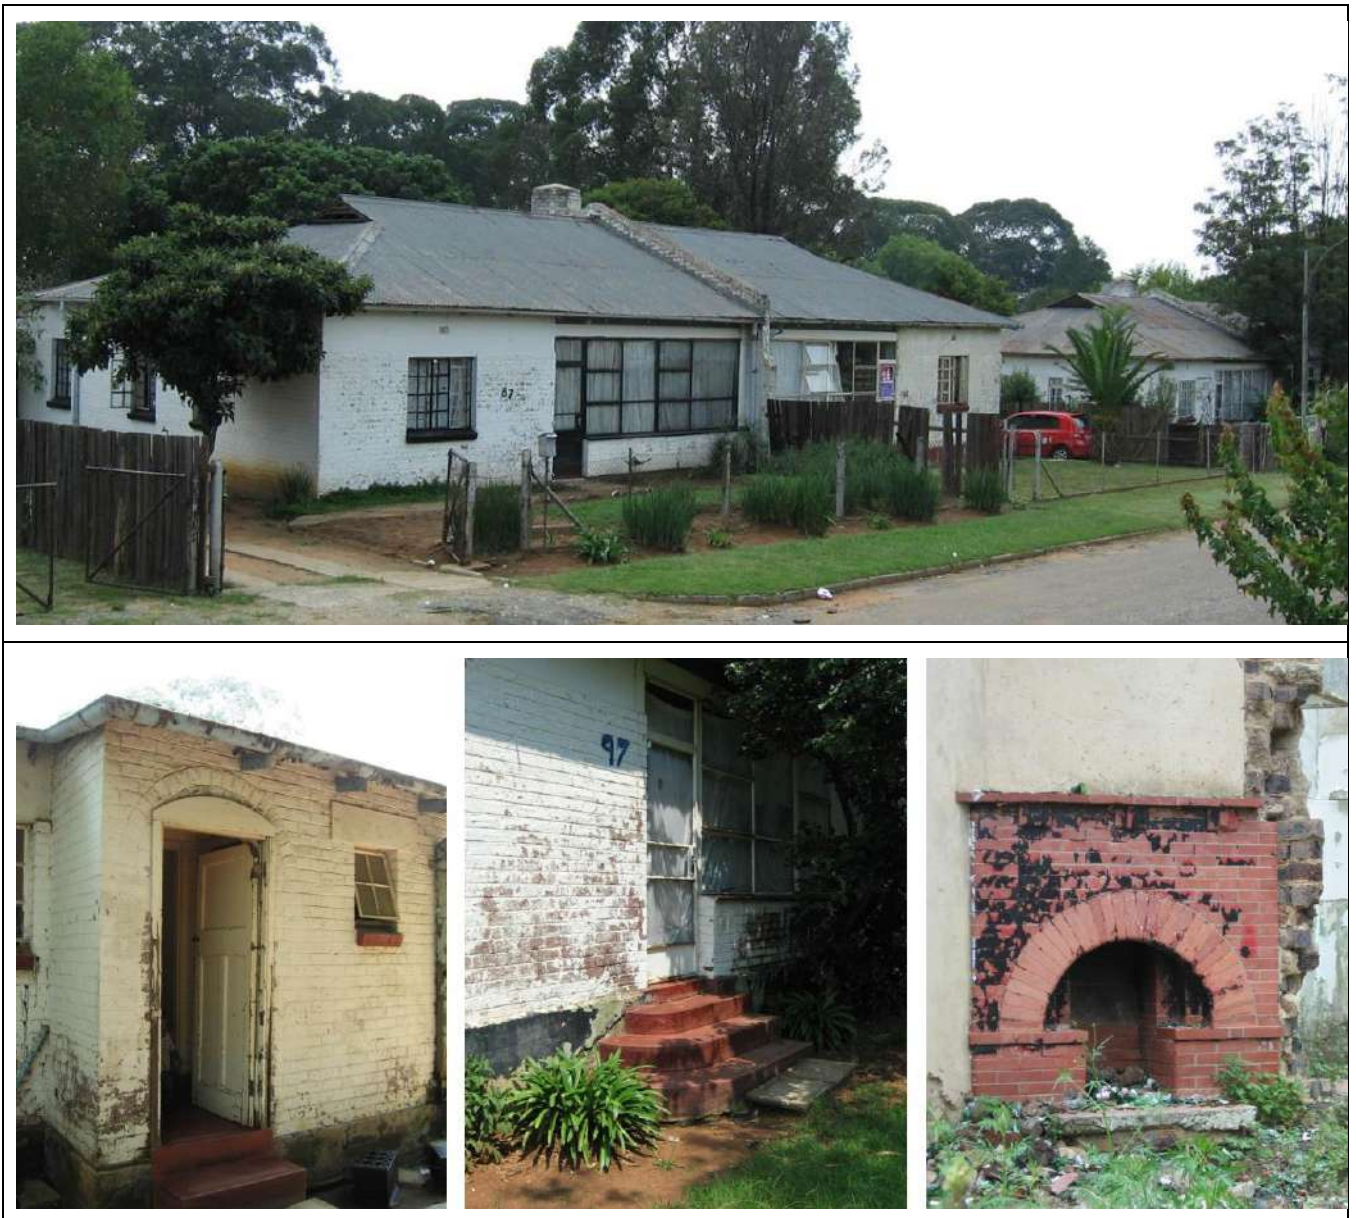
Building Type 3 comprises rectangular semi-detached buildings, each of which contains two individual dwellings. Thirteen complete buildings of this type are located north of Main Reef Road, with three complete buildings located south of the road. Three semi-demolished buildings comprising one remaining half of this building type are located north of the road and one to the south of it. The building is a rectangular, plastered, brick building divided in the middle into two separate dwellings. The window frames are of steel, with concrete lintels. Some entrances have ornamental arched brickwork. The roofs are of corrugated iron with open ventilated ridging. Of exceptional significance is the occurrence of Kirkness brick fireplaces.

Figure 40 – General and detailed views of Building Type 3.
