PHASE 1 HERITAGE IMPACT ASSESSMENT

Proposed Establishment of Goudrand Ext. 5, Goudrand Ext. 6, Goudrand Ext. 7, Goudrand Ext. 8, Goudrand Ext. 9, Goudrand Ext. 10, Goudrand Ext. 11, Goudrand Ext. 14, Goudrand Ext. 15, Goudrand Ext. 16, Goudrand Ext. 17, Goudrand Ext. 18 and Goudrand Ext. 19, located in the Roodepoort Magisterial District, City of Johannesburg Metropolitan Municipality, Gauteng Province

Issue Date: 20 June 2018
Revision No.: 2
Client: Hunter Theron Incorporated

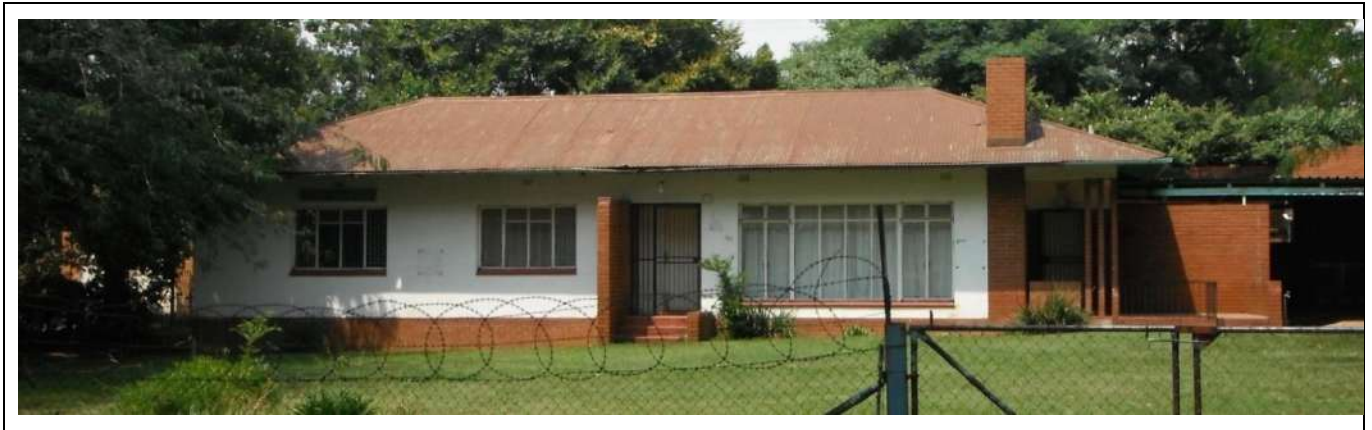
One example of this building type is located within this precinct. It comprises a square-shaped brick building with steel framed windows and hipped corrugated roof. The building has a brick wall adjacent to its back door and one face brick chimney. Three protruding vertical face brick pilasters are located on the corner closest to the chimney.

Figure 41 – General view of Building Type 4.

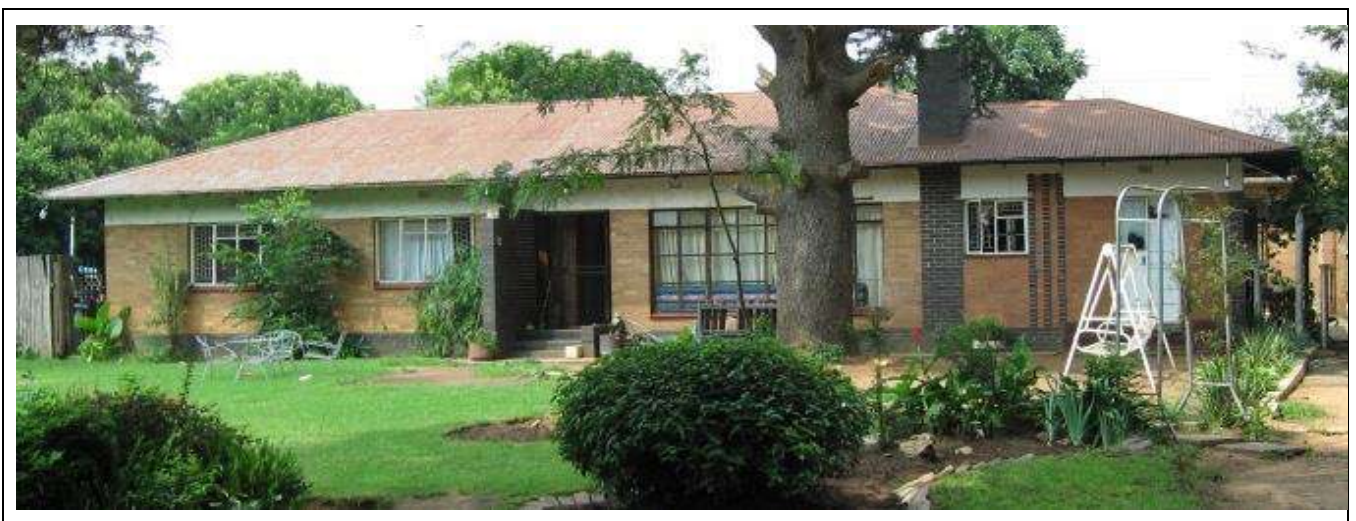
One example of this building type is located within this precinct. It comprises the same core floor plan as is the case with Building Type 4. The only difference is that it has an added section on the one side (chimney end) of the original building. Although the three protruding vertical face brick pilasters can still be identified, they are both structural and aesthetic elements and form part of the wall of the added section.

Figure 42 – General view of Building Type 5.

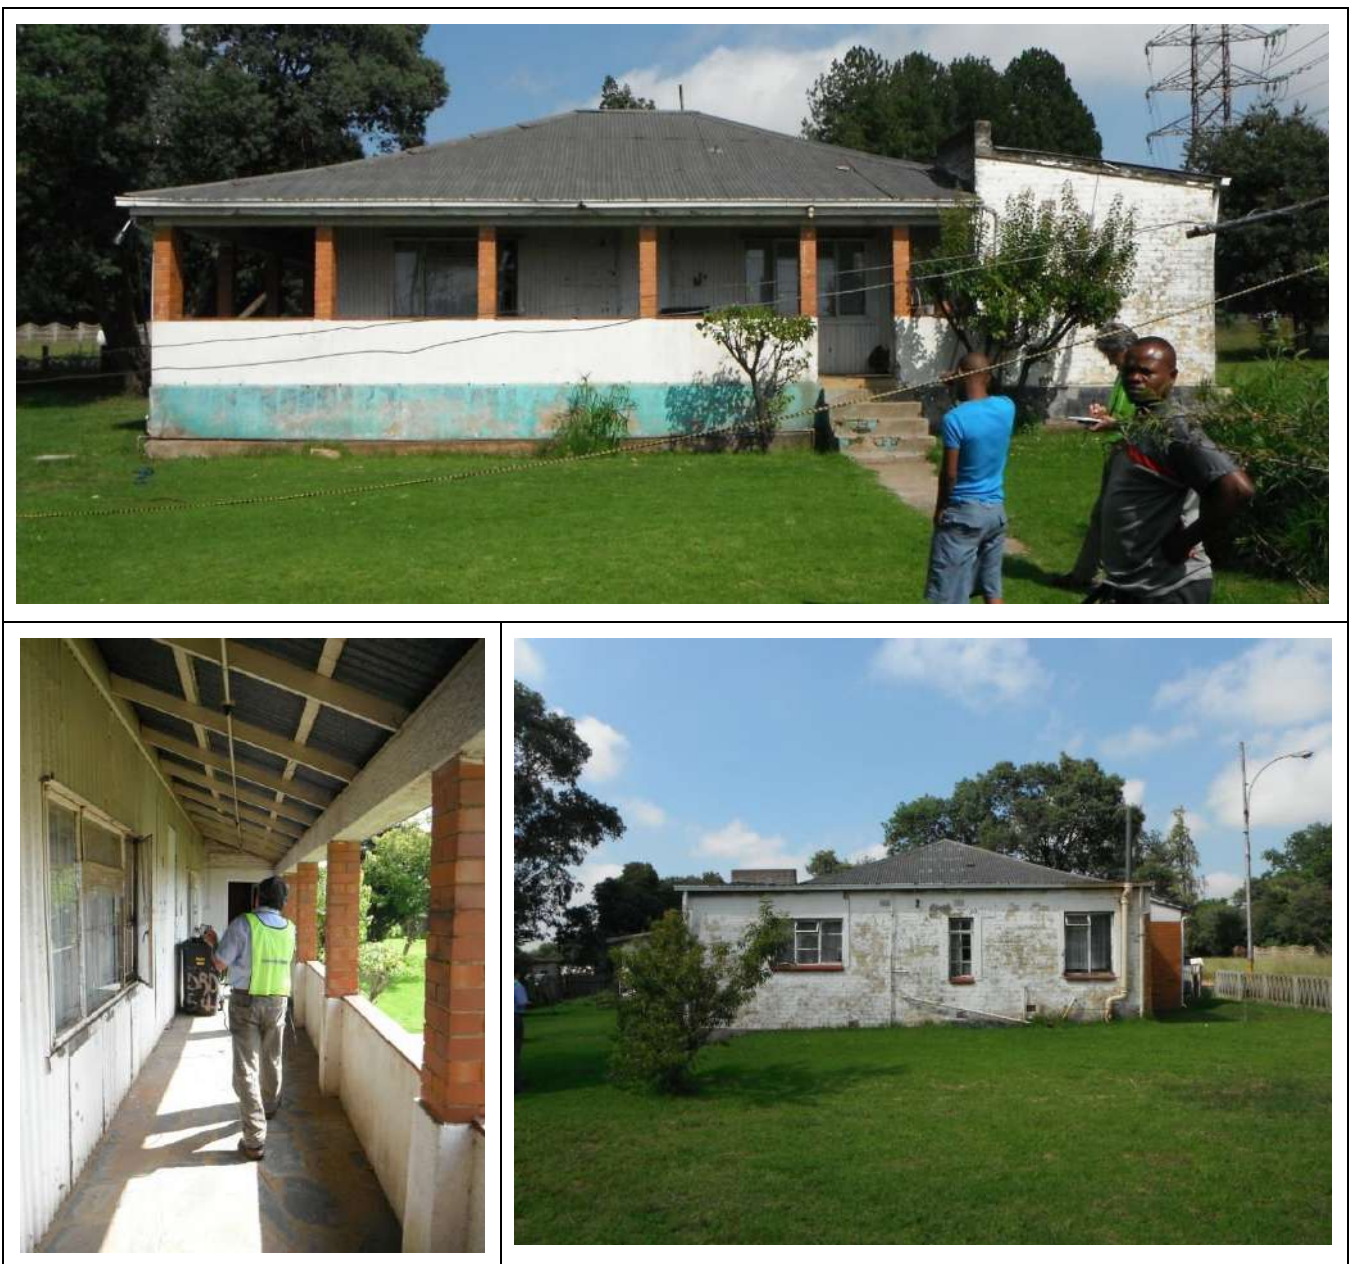
Only one example of this building type was found within the study area. It comprises a square-shaped brick building with a wrap-around verandah on its southern and eastern ends. A number of building phases can be identified in the structure. The original core structure probably had a square floor plan of brick with a L-shaped verandah and a hipped corrugated roof. The walls of this original structure are exceptionally thick. A kitchen with a lean-to roof was added along the northern facade. The supporting columns of the verandah – which may have been of wood - were replaced by yellow face bricks. This modification could have been contemporary with the addition of a new room using the same face bricks along the western facade.

Figure 43 – General and detailed views of Building Type 6.

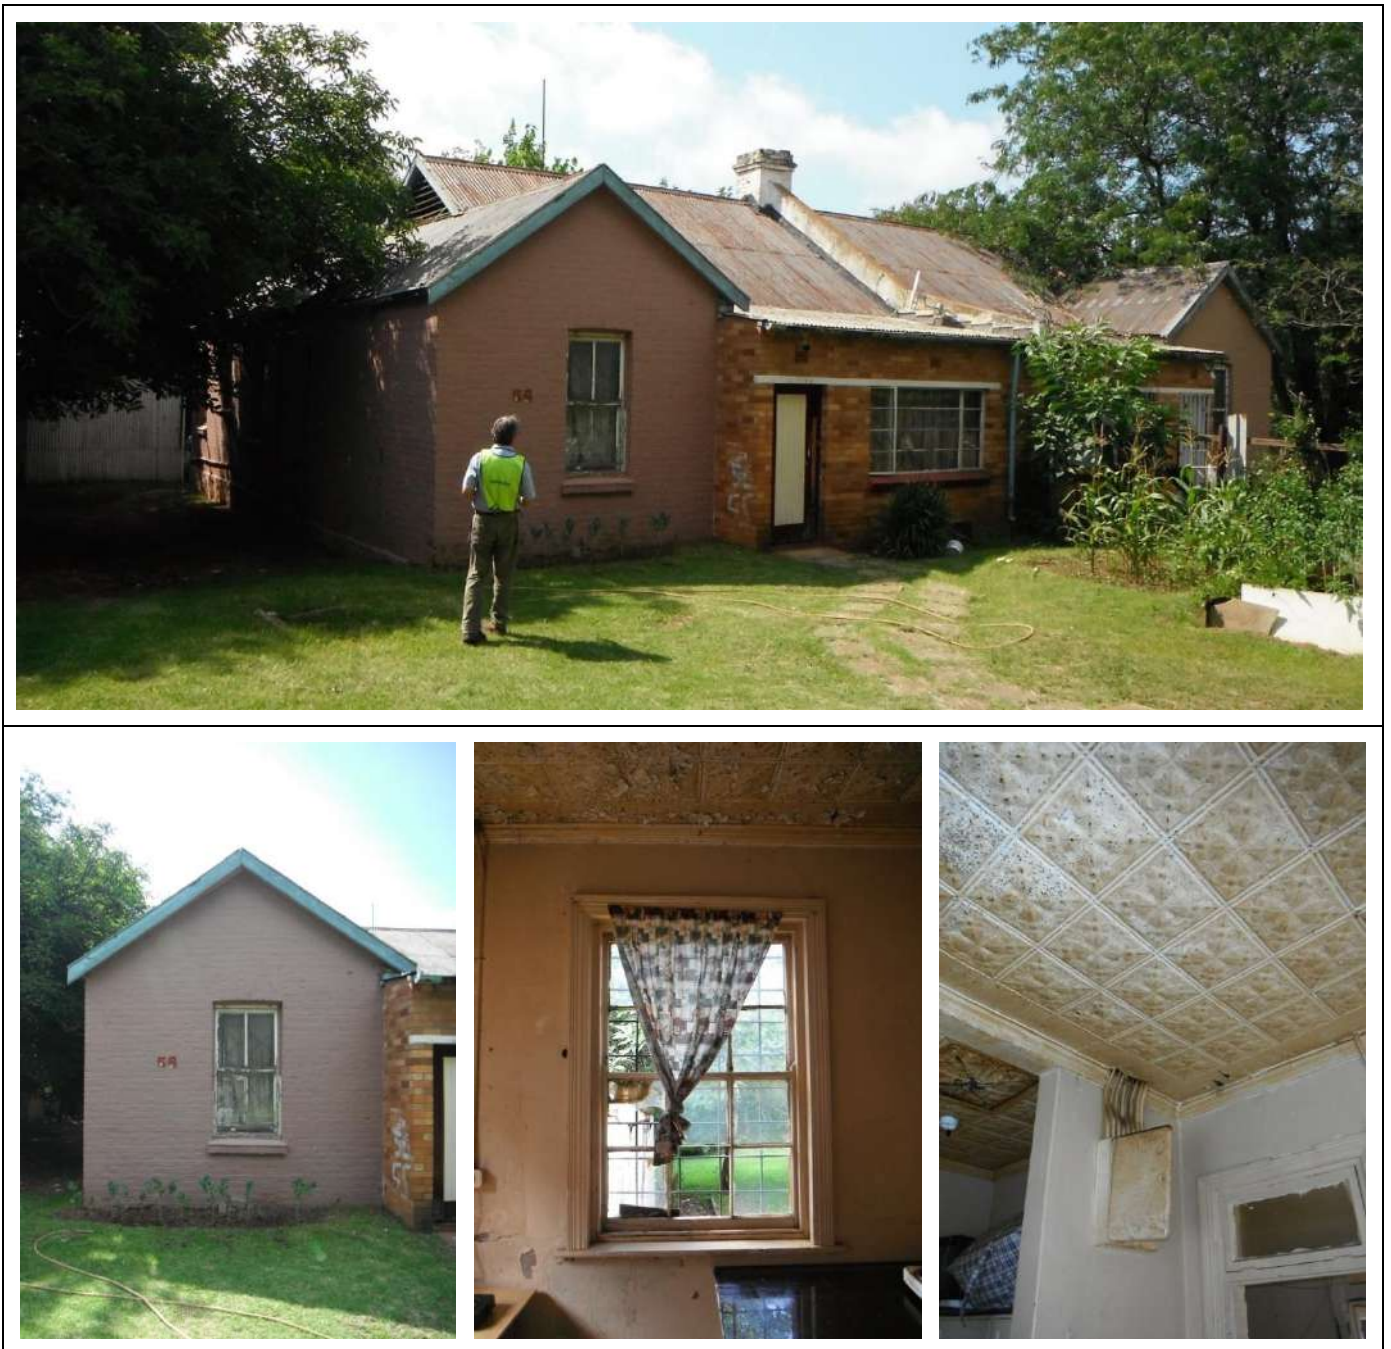
Only one example of this building type was found within Precinct 1 and within the study area. Building Type 7 comprises a semi-detached building consisting of two dwellings. It is a rectangular building with two gabled wings on the ends. The building has a stone foundation, brick walls and sash windows. The only exception is on the closed face brick porch where face bricks and steel-framed windows were used. The interior of the building includes pressed ceilings and timber planking floors.

Figure 44 – General and detailed views of Building Type 7.

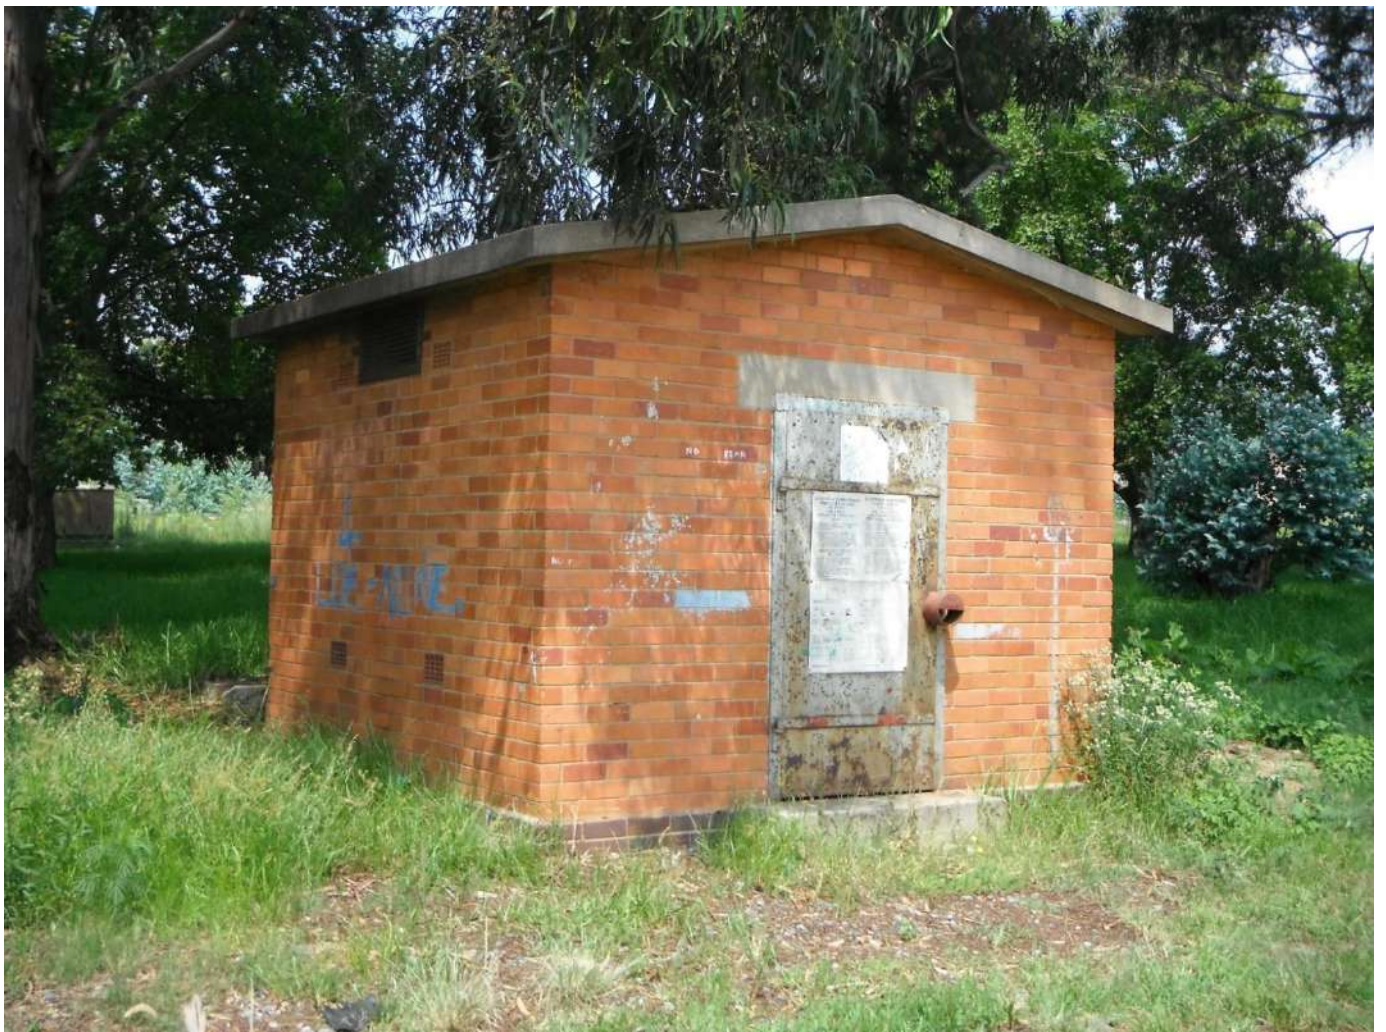
One example of this building type was identified within Precinct 1. It is a small rectangular structure with walls of yellow face brick and a pitched corrugated iron roof. The building is associated with the electrification of the mine village and more than likely housed an electrical substation.

Figure 45 – General view of Building Type 8.

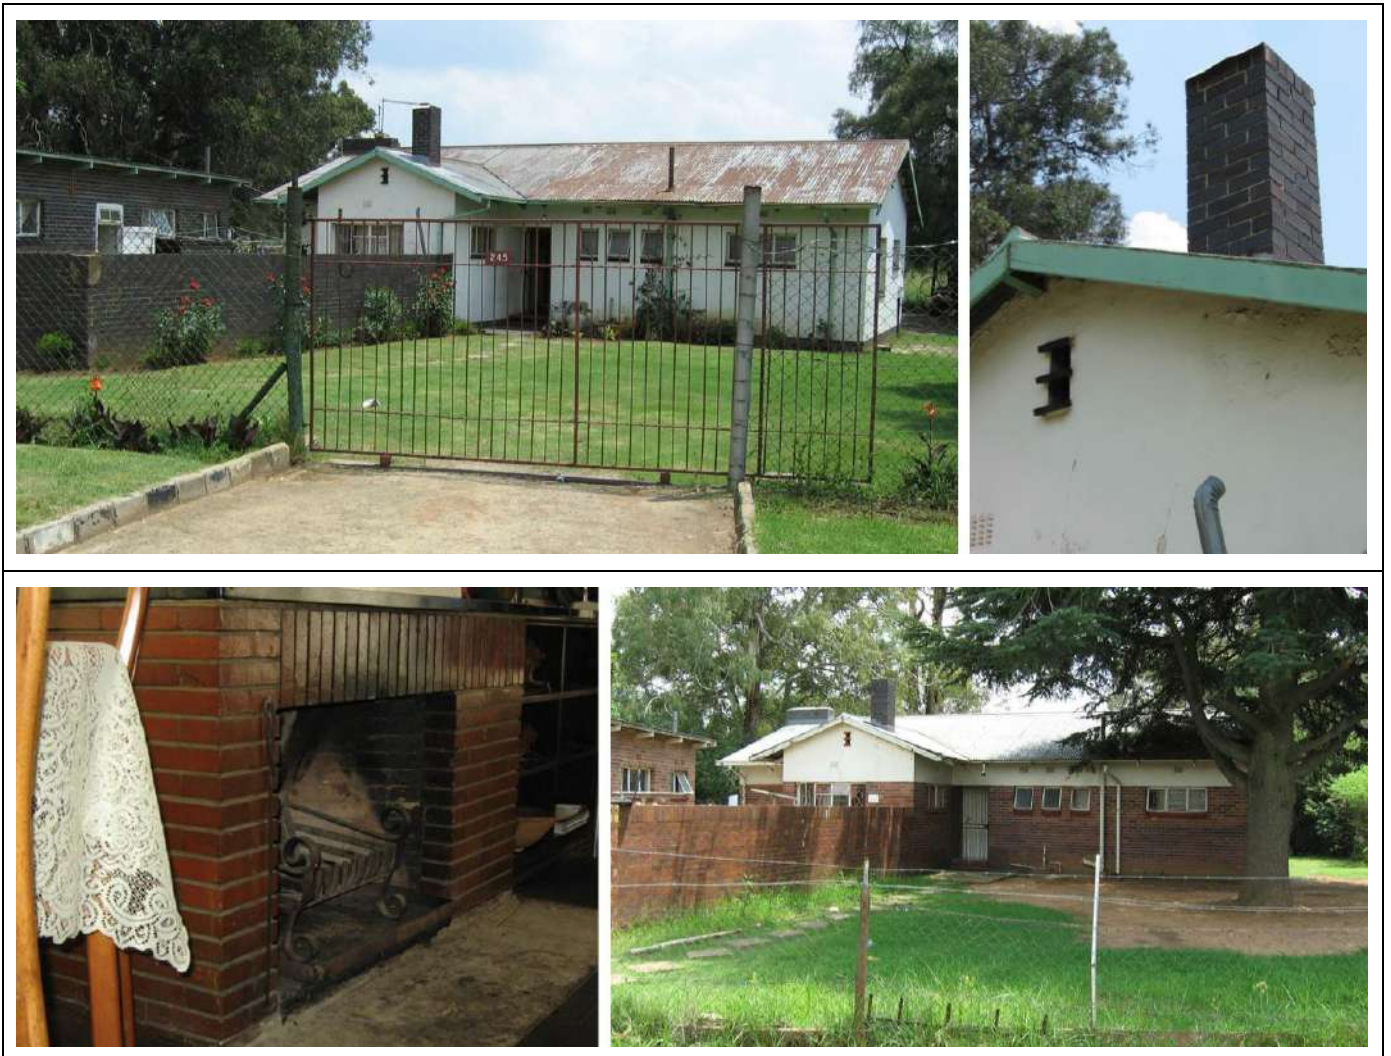
Five examples of this building type were located within Precinct 2. It comprises an L-shaped floor plan with a saddle corrugated iron roof. Some of the dwellings of this type were constructed with face brick while others were plastered and painted. A rectangular structure located directly south-west of the dwelling includes a single garage and room for domestic staff. An L-shaped wall leads from the one side of the front gable to the front right corner of the garage, creating a small courtyard towards the back door. The windows of all the buildings are steel-framed. The exceptional elements of the dwellings interiors are the fireplaces and parquet floors.

Figure 46 – General and detailed views of Building Type 9.

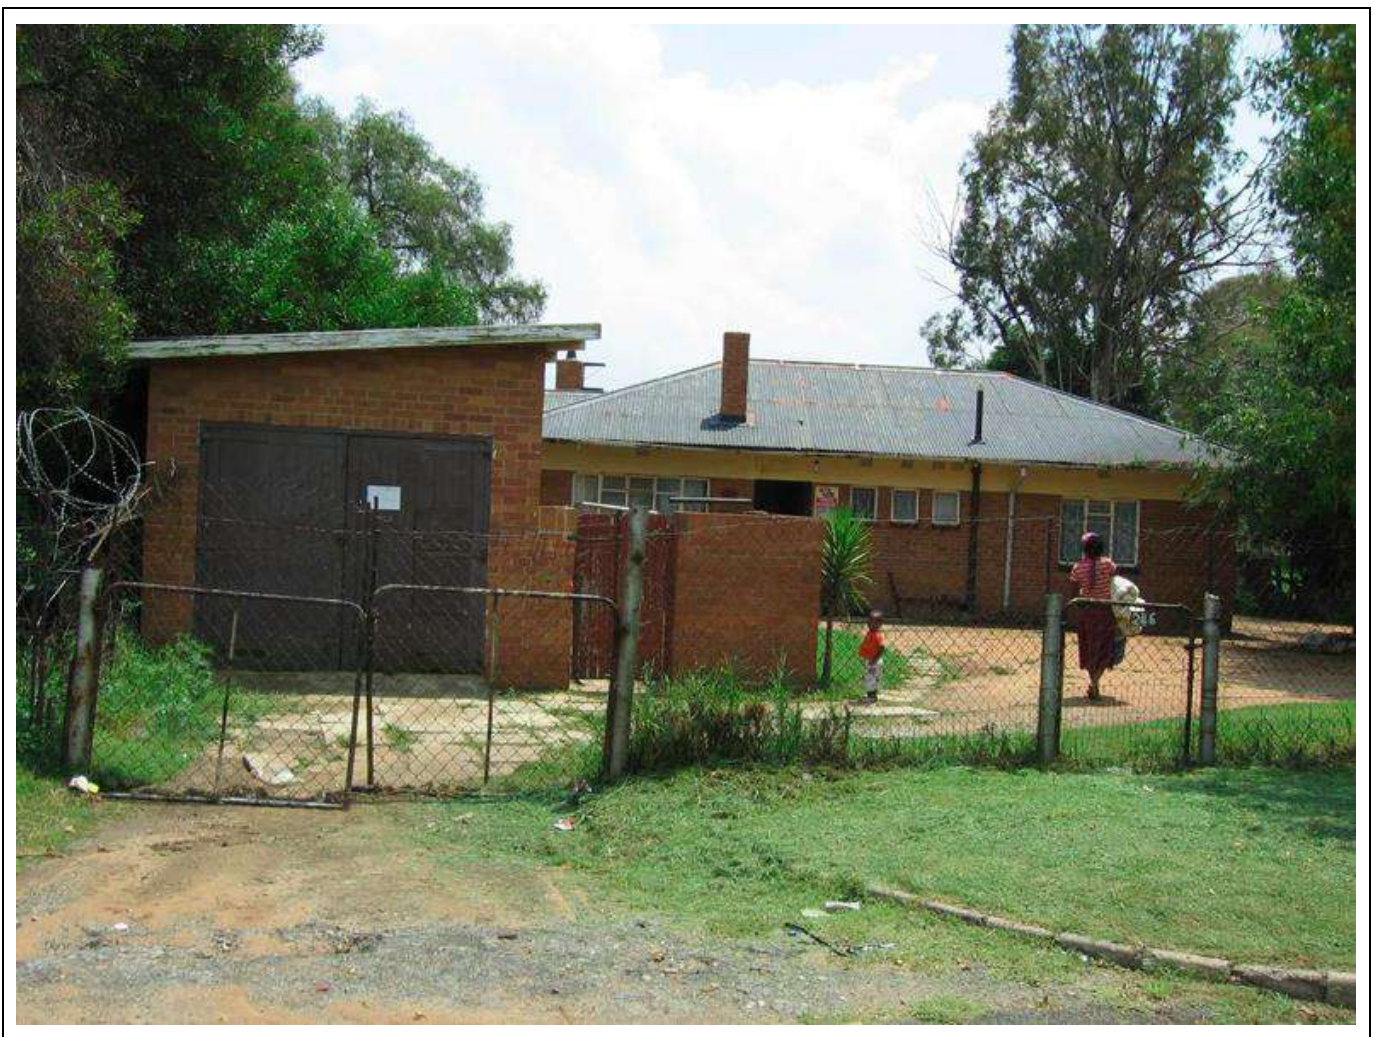
Three examples of this building type were identified within Precinct 2. Although the general character and orientation of the building is very similar to Building Type 9, there are some differences. The two most obvious differences are the rectangular floor plan covered with a hipped roof (not pitched) and without another room with gable protruding along the front facade. The rest of the dwelling (and its outbuildings) appear very similar. This building also has steel frame windows. The outbuilding consists of a single garage and room for a domestic worker.

Figure 47 – General view of Building Type 10.

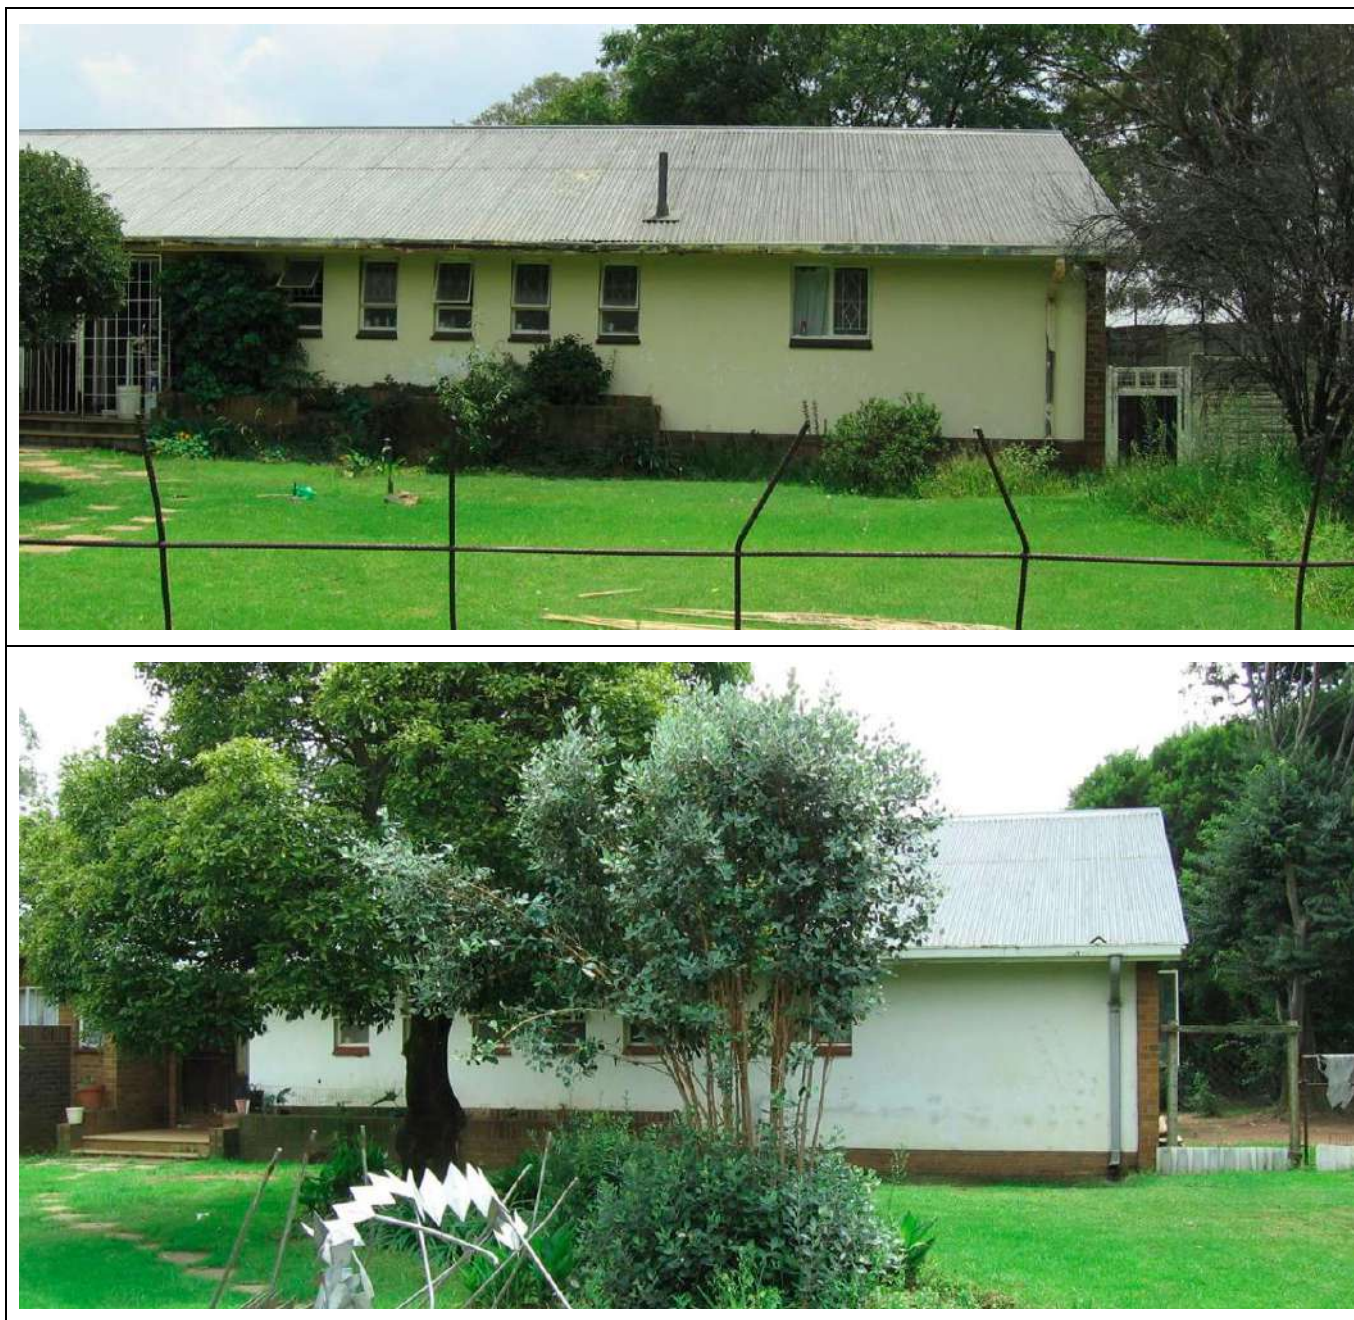
Two examples of this building type were identified within Precinct 2. The dwelling has an elongated rectangular floor plan with plastered brick walls and saddle corrugated iron roof with steel frame windows.

Figure 48 – General views of Building Type 11.

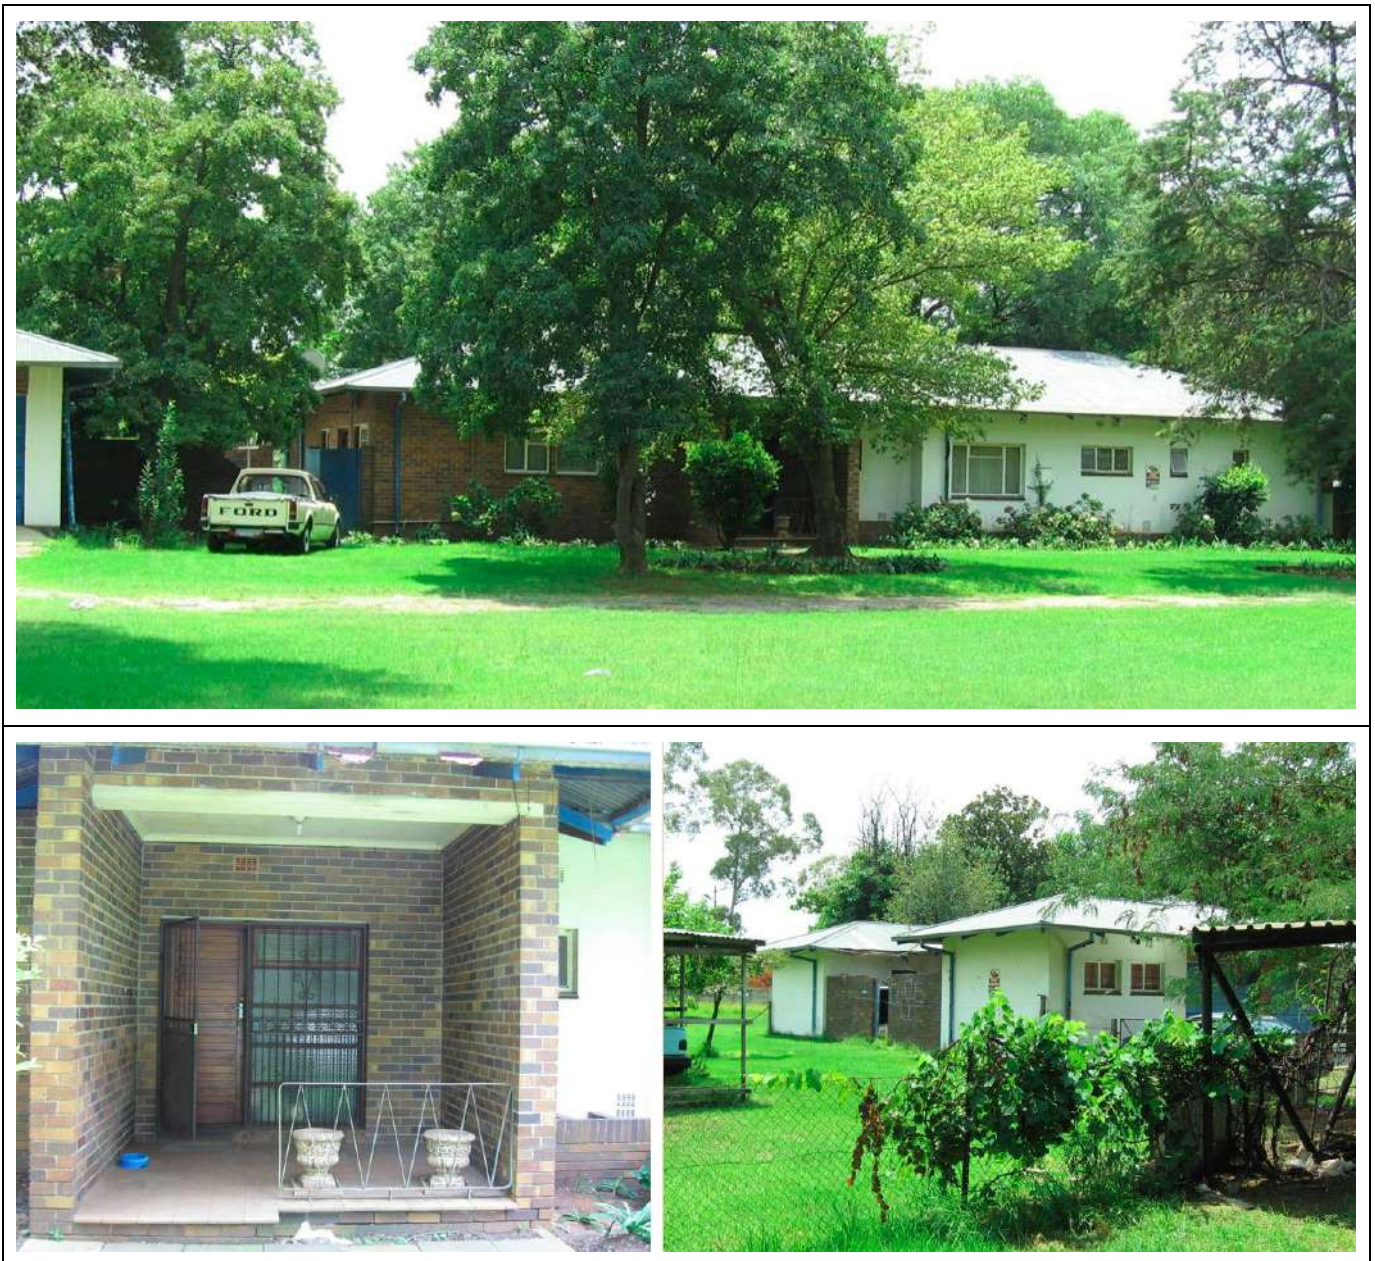
Two examples of this building type were identified within Precinct 2. The dwelling has a U-shape floor plan with plastered brick and some face brick walls. The dwelling has a hipped corrugated iron roof and steel frame windows. The front door is defined by a face brick porch. The site also contains one U-shape outbuilding consisting of a garage and room for domestic worker. The building type is set inside a large garden.

Figure 49 – General and detailed views of Building Type 12.

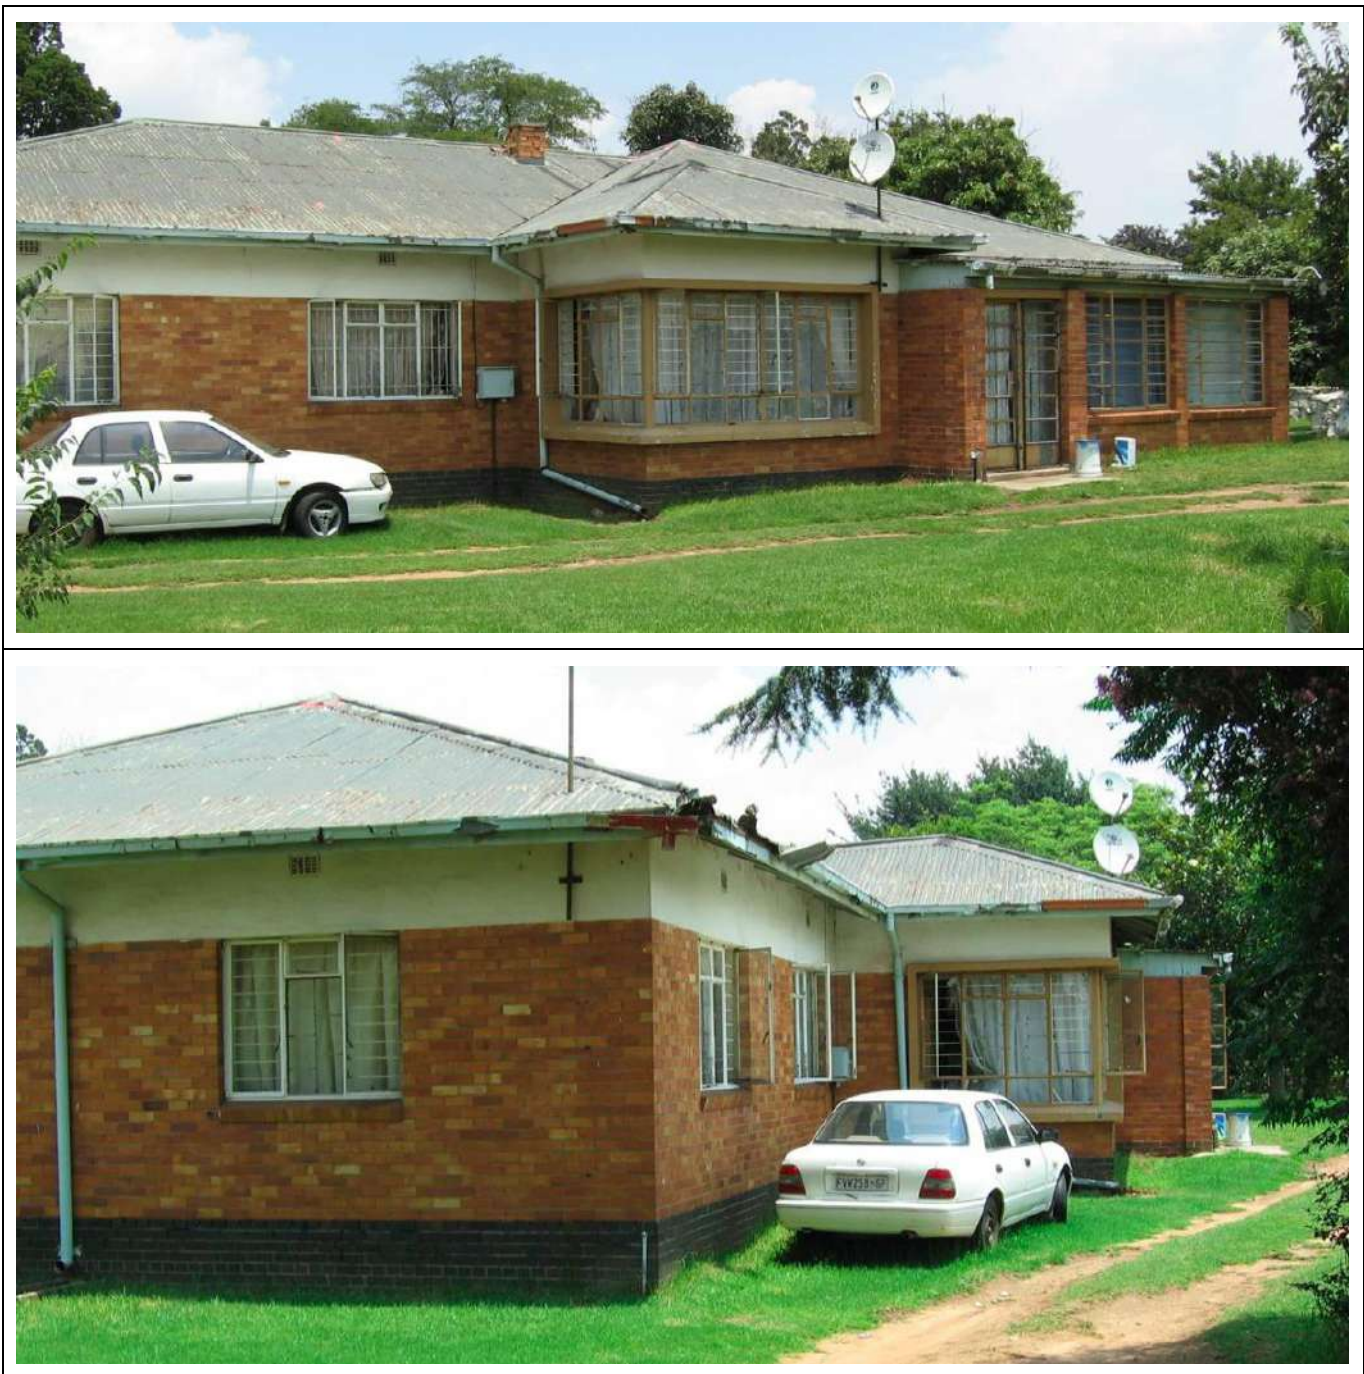
Three examples of this building type were identified within Precinct 2. The dwelling has a decadent L-shape floor plan, with walls of yellow face and plastered brick above the window lintels. It has hipped corrugated iron roof and steel frame windows. The front facade of the dwelling is characterised by a protruding room with hipped roof and closed porch with a flat pre-stressed concrete roof.

Figure 50 – General views of Building Type 13.

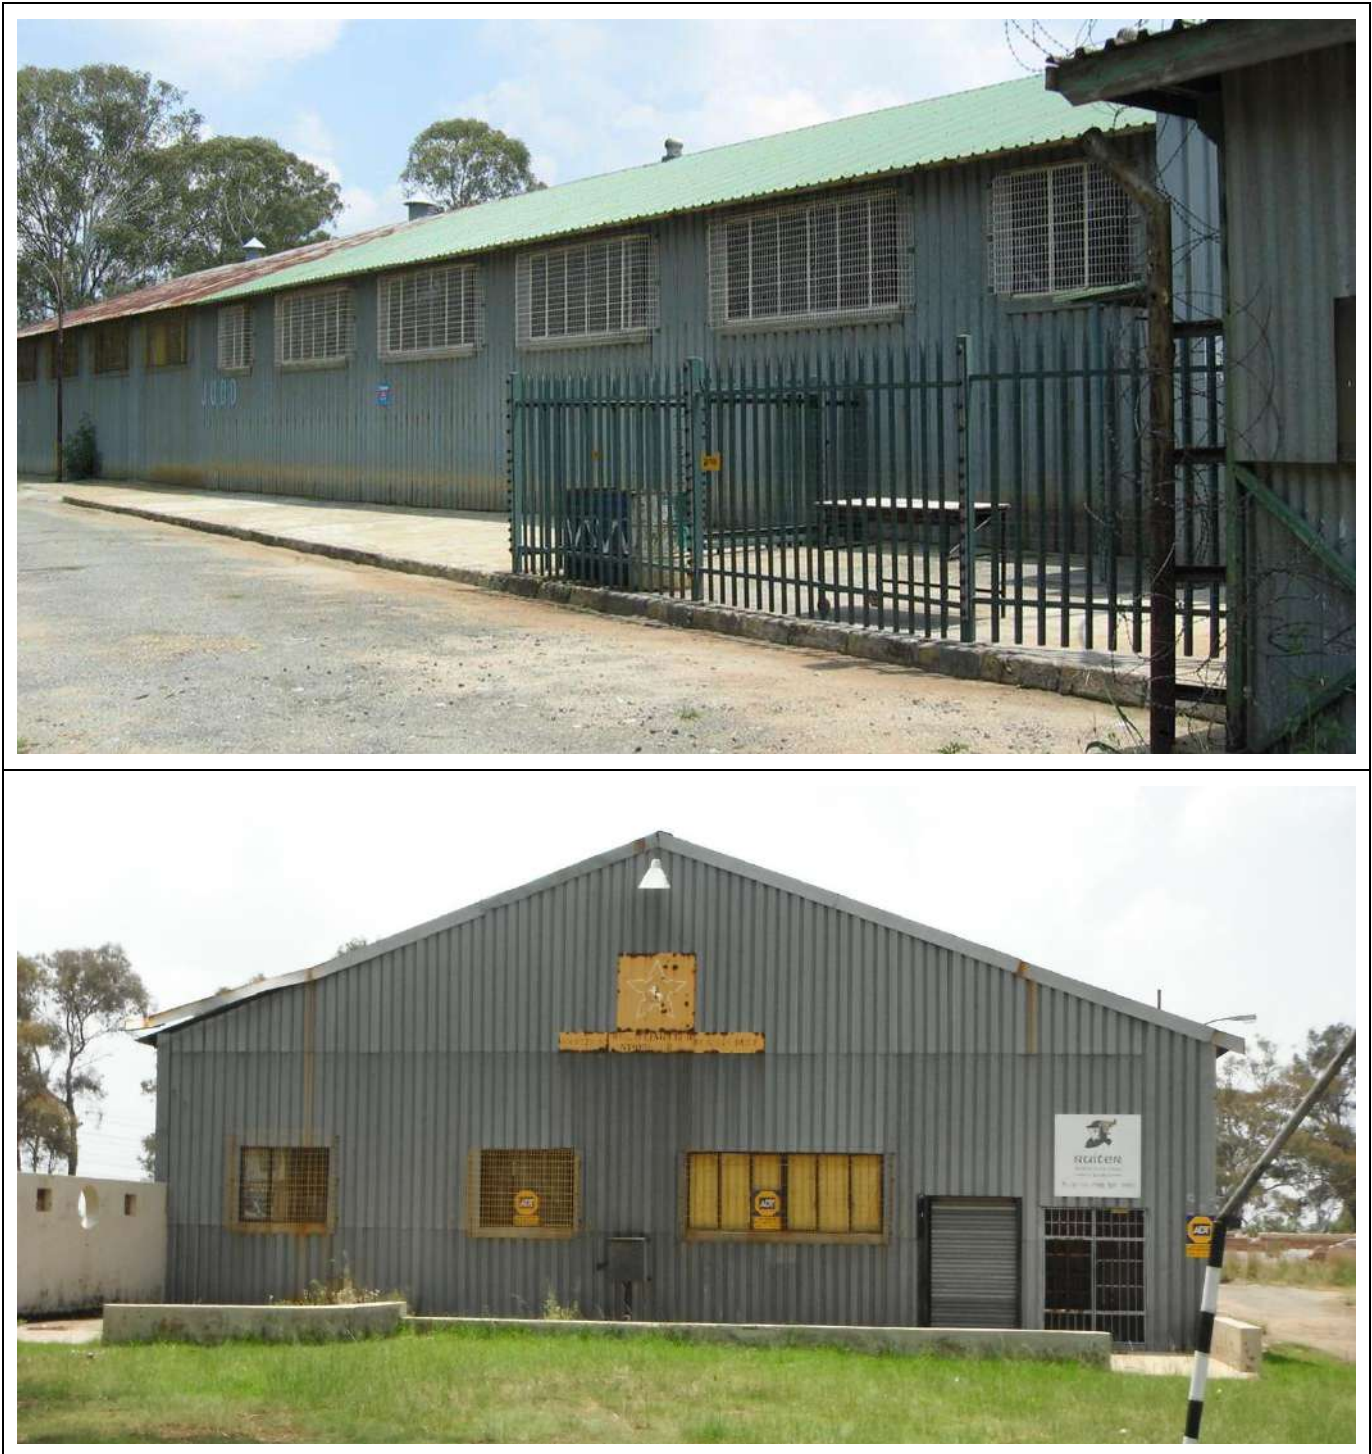
One example of this building type was identified within Precinct 2. It is a large rectangular IBR sheet iron building with a pitched roof. The building resembles the size and scale of an industrial shed or workshop but is used by the local wrestling club as a gymnasium.

Figure 52 – General views of Building Type 15.

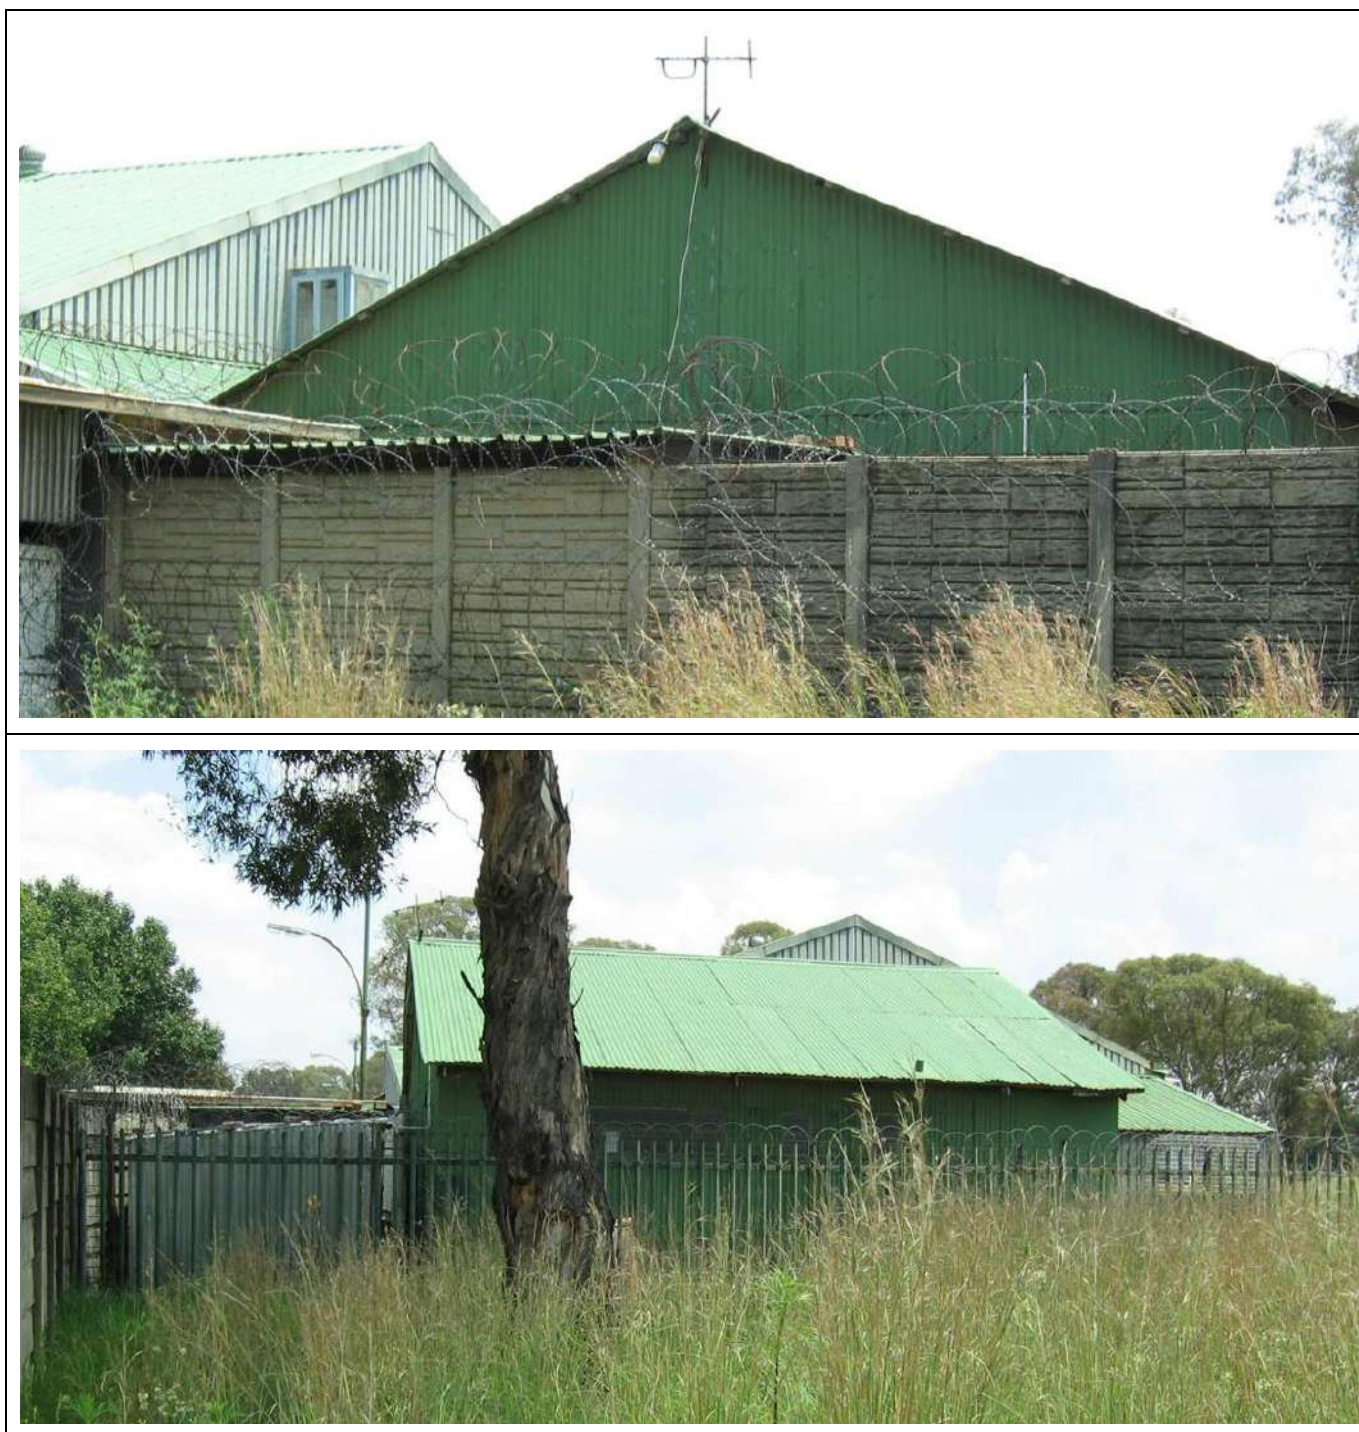
One example of this building type was identified within Precinct 2. It is a small rectangular corrugated iron building with a pitched roof. The building has the appearance of wood and iron structures associated with the original mine workings and industrial architecture.

Figure 53 – General views of Building Type 16.
