PHASE 1 HERITAGE IMPACT ASSESSMENT

Proposed Establishment of Goudrand Ext. 5, Goudrand Ext. 6, Goudrand Ext. 7, Goudrand Ext. 8, Goudrand Ext. 9, Goudrand Ext. 10, Goudrand Ext. 11, Goudrand Ext. 14, Goudrand Ext. 15, Goudrand Ext. 16, Goudrand Ext. 17, Goudrand Ext. 18 and Goudrand Ext. 19, located in the Roodepoort Magisterial District, City of Johannesburg Metropolitan Municipality, Gauteng Province

Issue Date: 20 June 2018
Revision No.: 2
Client: Hunter Theron Incorporated

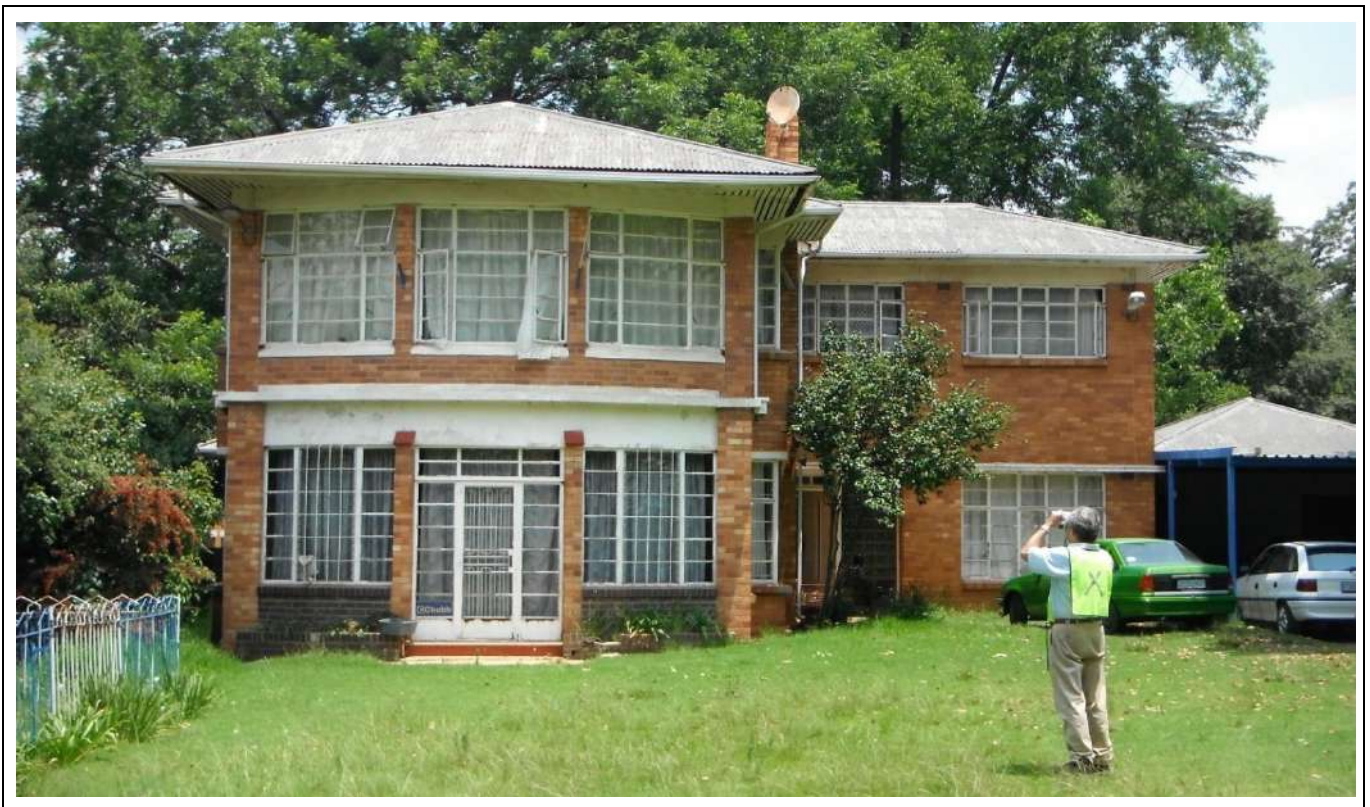
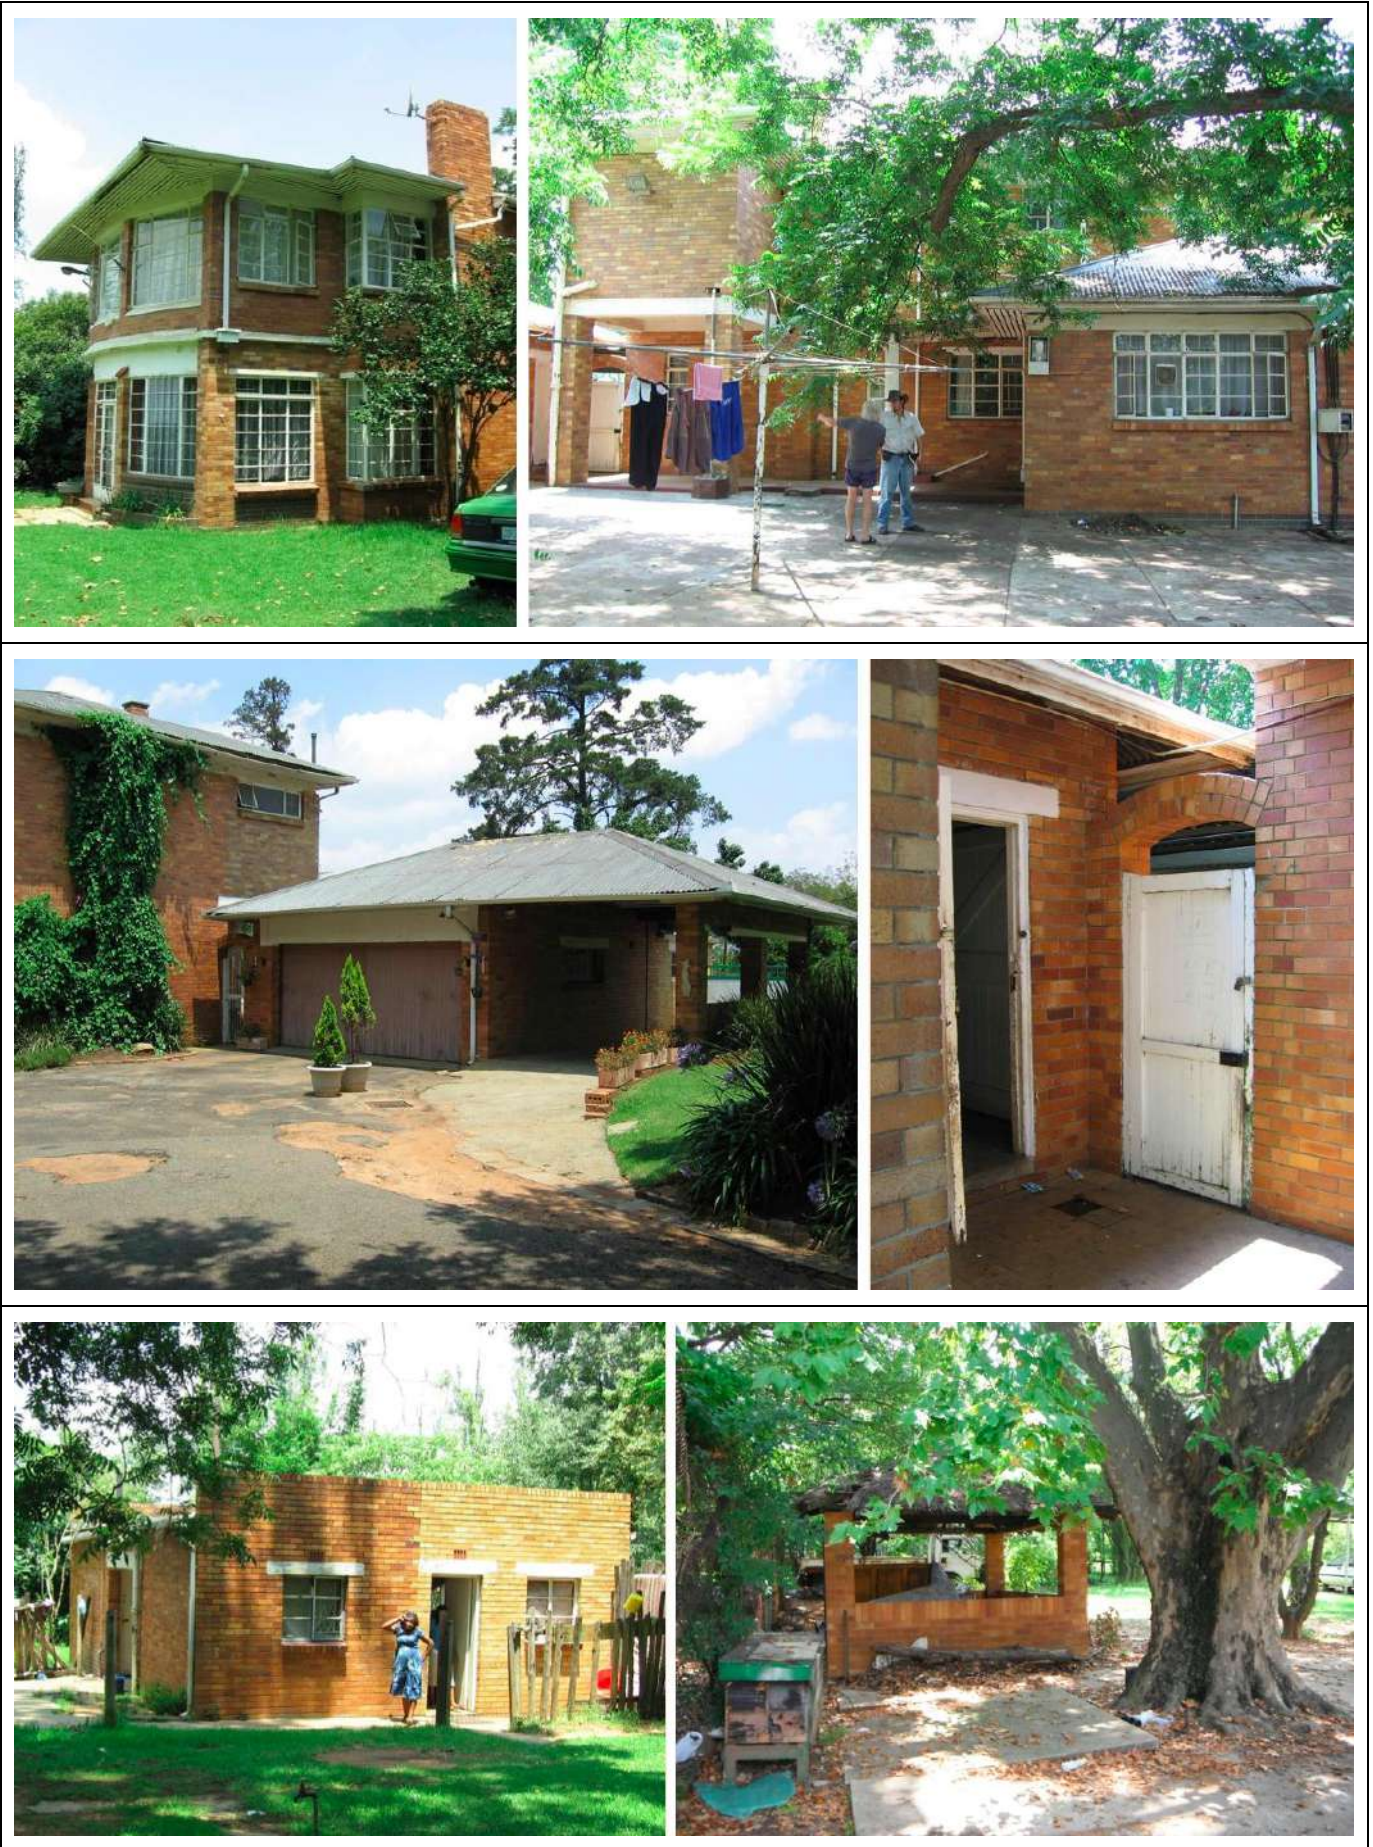
The building type comprises a large double-storey face brick dwelling with a corrugated iron roof. The building was originally L-shaped and at a later stage another section containing an upper-storey en-suite bathroom was added giving the building a Z-shape. The front facade is dominated by the curved protruding wing with large steel frame windows on both floors. The main bedroom (upper floor) and living space (ground floor) were located here to utilise the light and to enjoy the views towards the landscaped garden. The building has four bedrooms, one en-suite toilet-bathroom, another separate toilet and another separate room with a bath. The lower level has a study, open living room-dining room (with covered porch to the front) with a large kitchen in the back. The building is located on a large property that includes a number of other buildings and features such as a closed garage, patio, tennis court and swimming pool. It is evident from the size and layout of the house and stand that these buildings were used to accommodate senior staff members of the mine, including possibly the Mine Manager, the Surface Manager, the Underground Manager and the Chief Surveyor.

Figure 54 – The front façade of one of the examples of Building Type 17.

Figure 55 – General and detail views of Building Type 17.

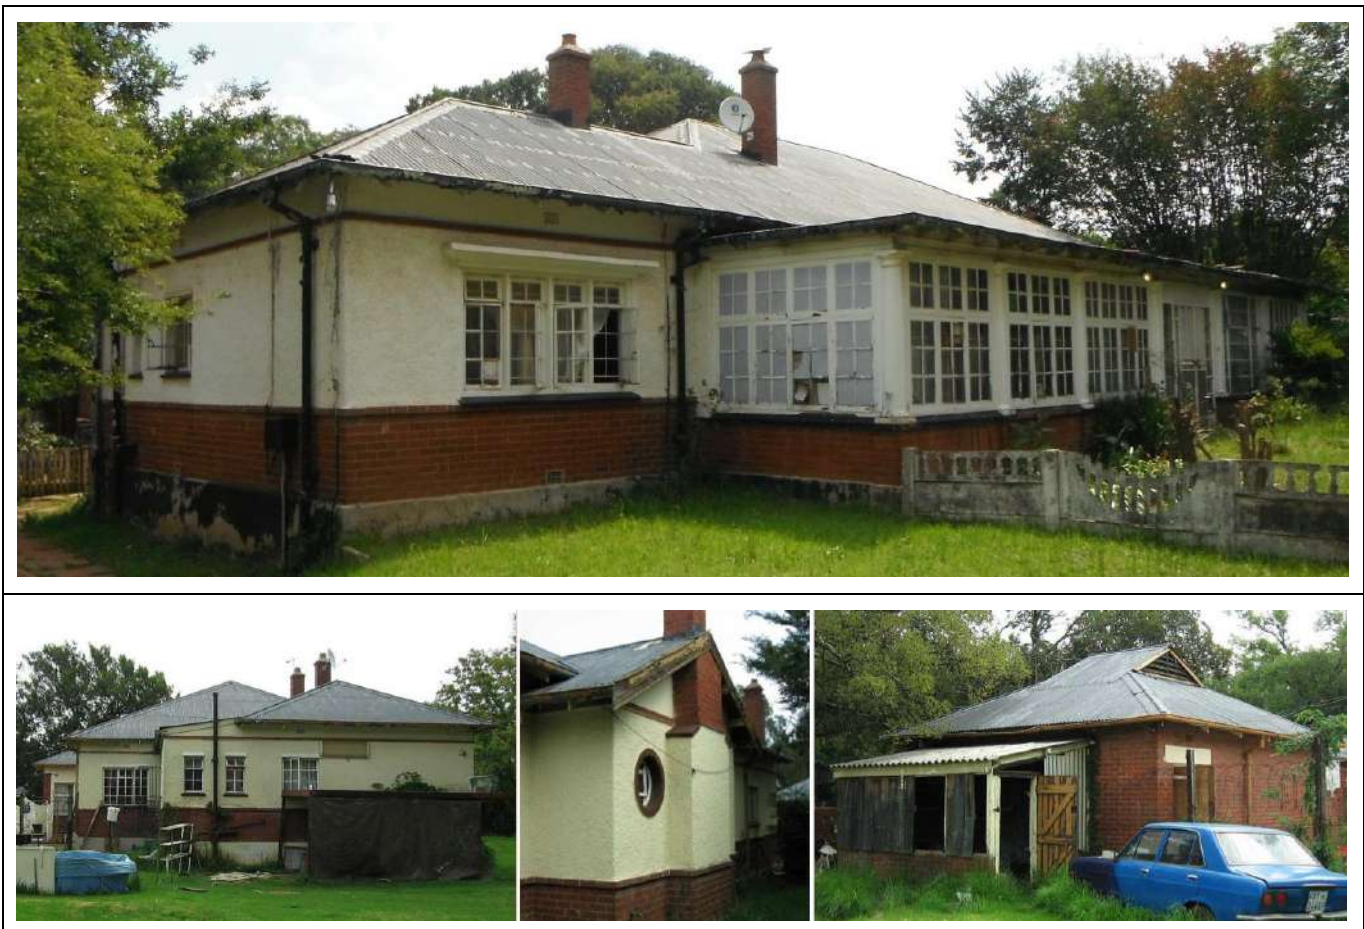
Only four examples of this building type were found within Precinct 4. These are quite stylish dwelling units with several outstanding architectural features. The floor is irregular in shape but a central passage defines the arrangement of the interior. The building is set on a concrete foundation with red face bricks above the foundation defining the plinth and filling the area from the plinth to the window sills. It is defined and framed by a single row of protruding dark blueish face bricks. The entire area above the window sills is constructed with plastered brickwork with another single row of protruding face bricks located above the windows. Of exceptional significance is the prominent concrete cornice above the windows. These are the only dwellings with this feature. The dwelling has a hipped corrugated iron roof with two red brick chimneys. Steel frame windows occur in the entire building. Other outstanding features are the face brick chimney stack and the small circular windows located directly adjacent to it.

Figure 56 – General and detail views of Building Type 18.

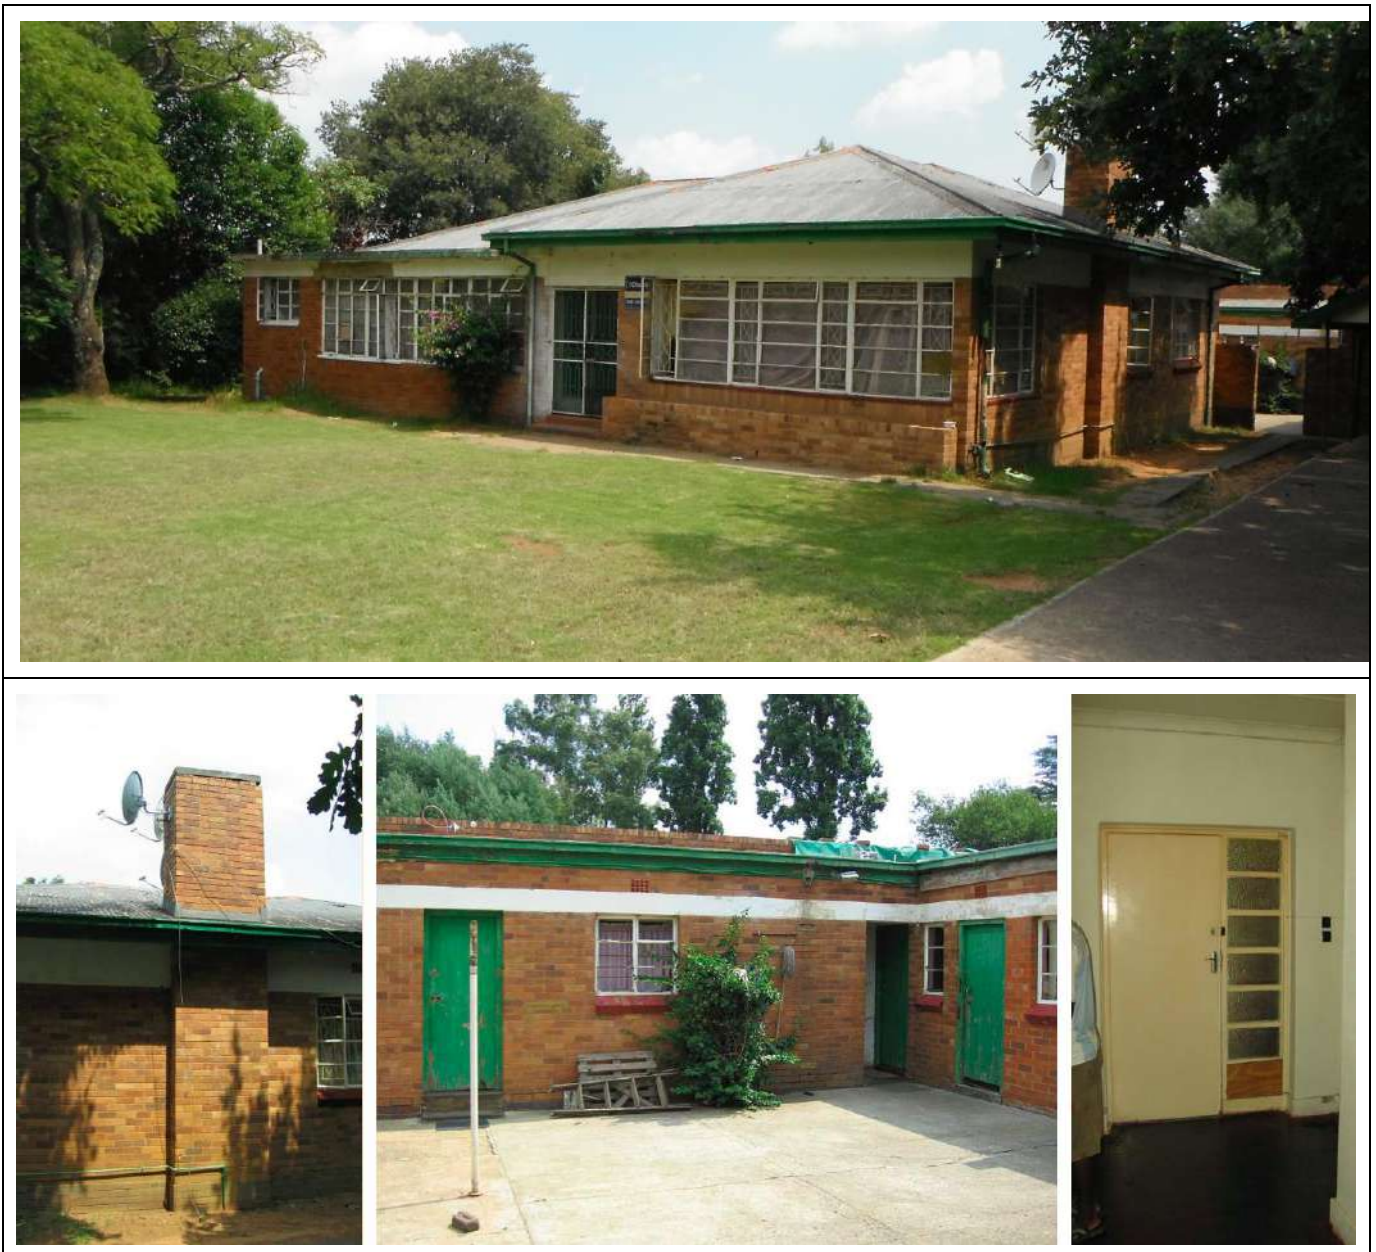
Eight examples of this building type were identified within the study area. The building type has an irregular L-shape plan with rooms protruding along the front facade. It is constructed with face brick at the bottom to window lintel height with a hipped corrugated iron roof. A prominent feature is the yellow brick chimney located at the one end of the dwelling. An open enclosure links the dwelling with the outbuildings at the back. The enclosed area is defined by a number of structures including the dwelling, staff quarters, washing/ironing rooms and a covered garage.

Figure 57 – General and detail views of Building Type 19.

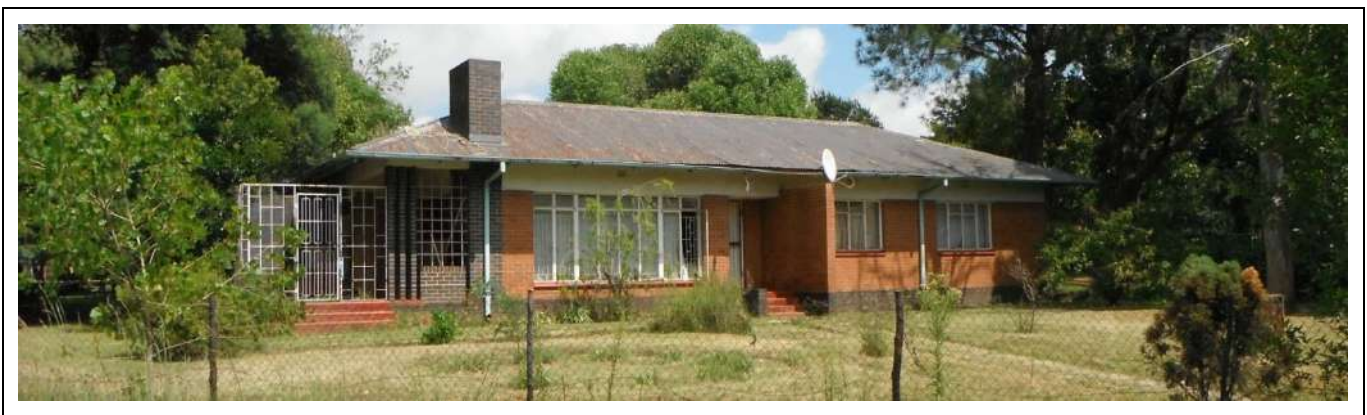
One example of this building type is located within this precinct. The floor plan and architecture is the mirror image of a dwelling type described in Precinct 1.

Figure 58 – The front façade of the Building Type 4 structure from within Precinct 5.

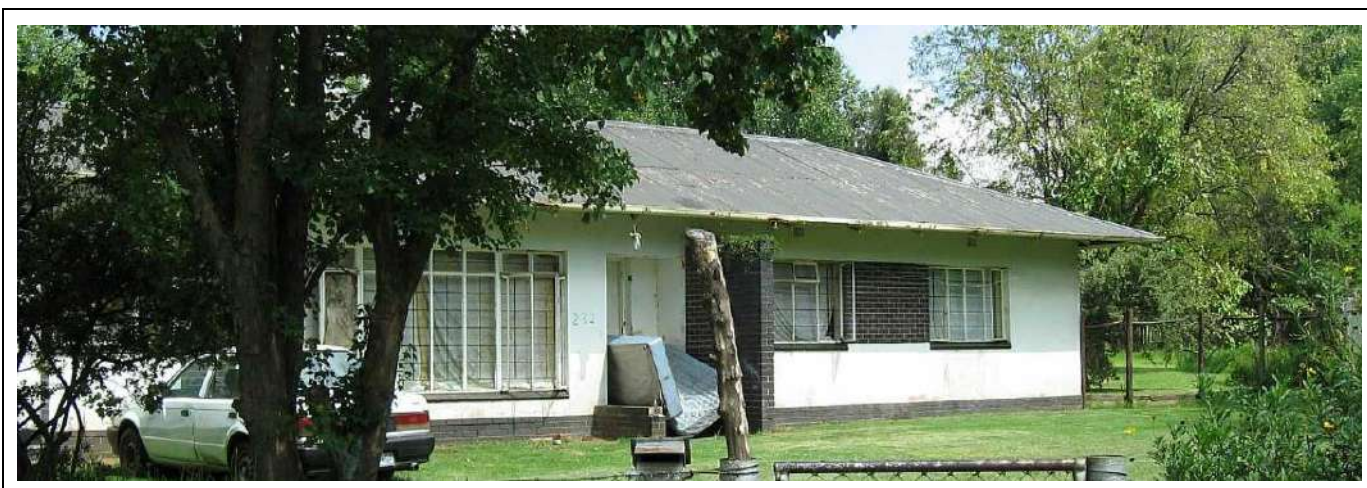
One example of this building type is located within this precinct. The building type is described under Precinct 1.

Figure 59 – The front façade of the Building Type 5 structure from within Precinct 5.

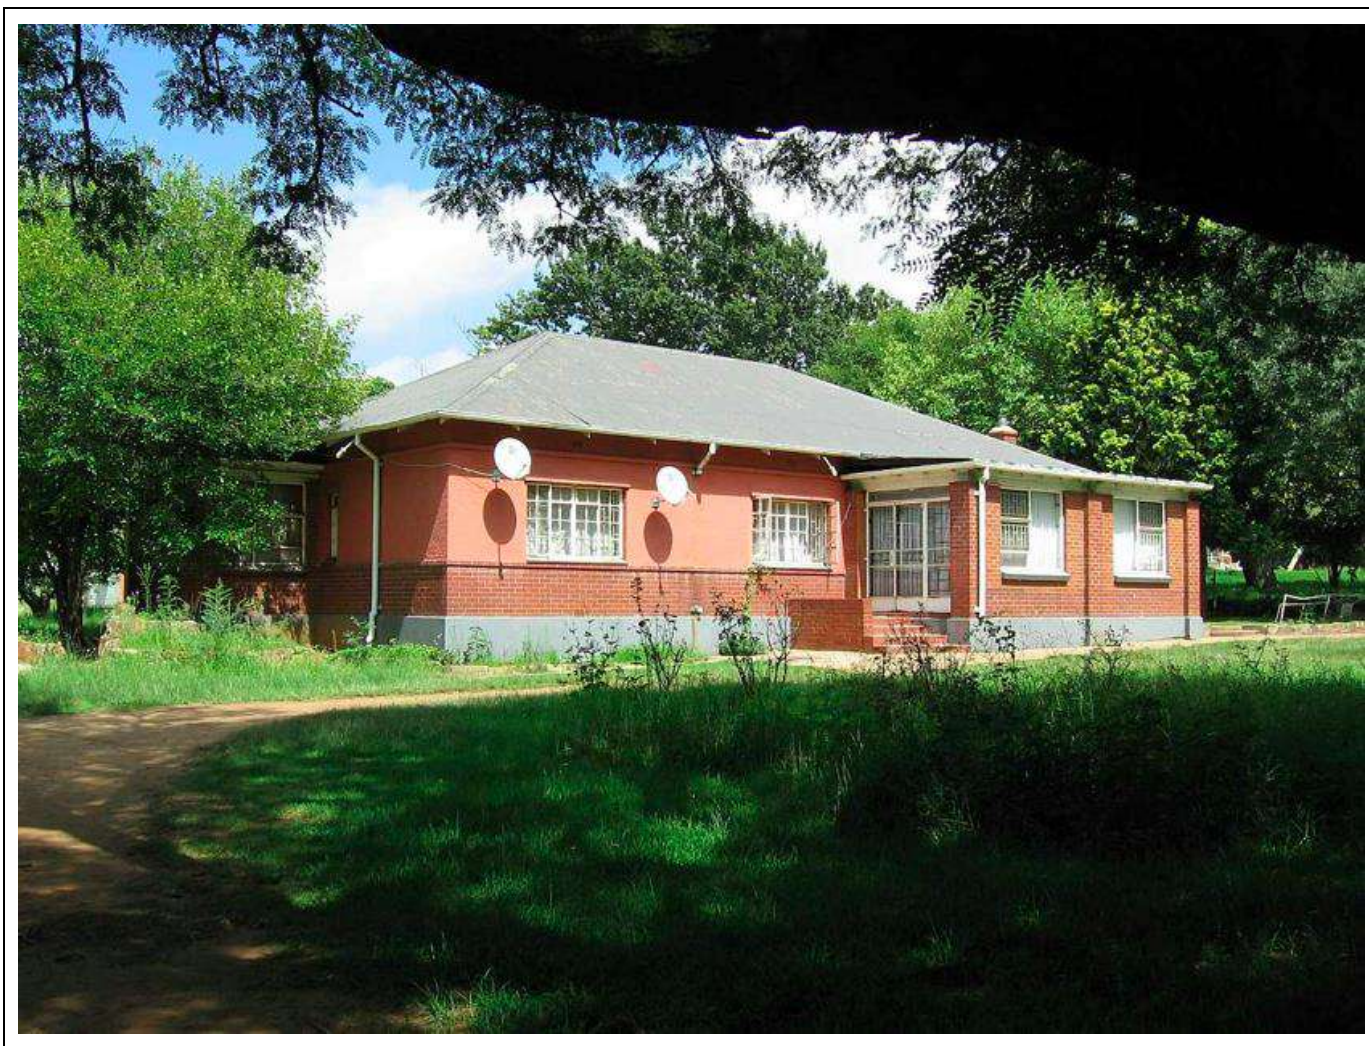
Only one example of this building type was found within this precinct. The type is described under Precinct 4.

Figure 60 – General view of the Building Type 18 structure that was identified within Precinct 5..

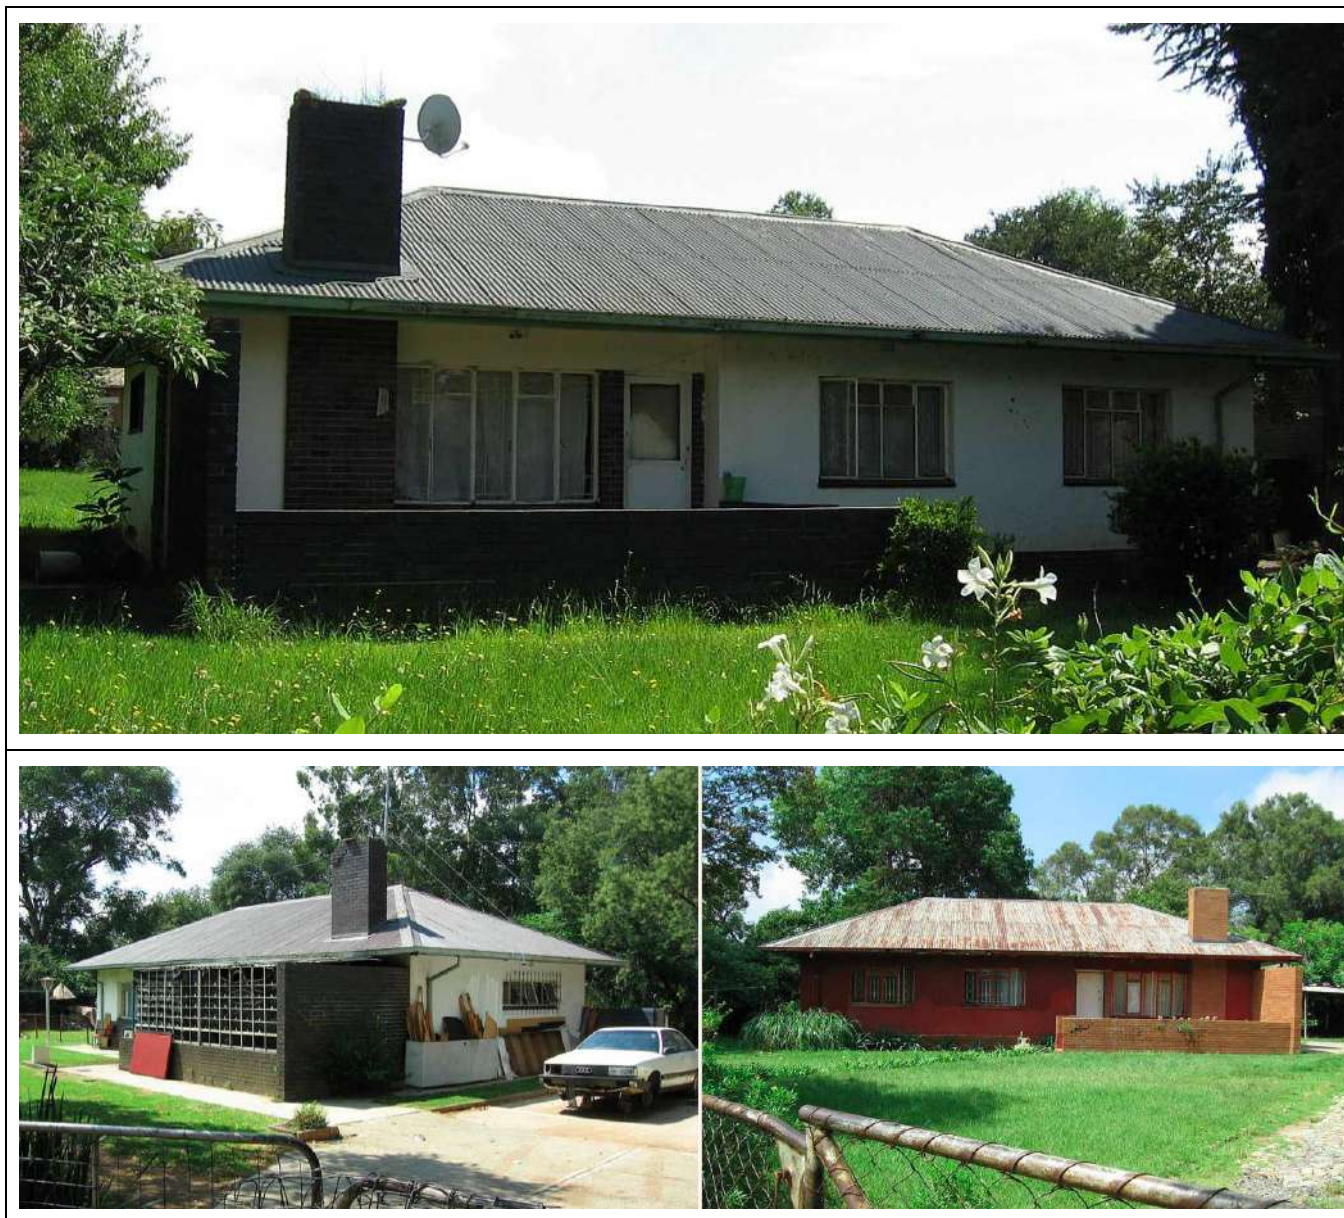
Four examples of this building type are located within this precinct. The building type comprises a rectangular floor plan constructed with plastered brick, a hipped corrugated iron roof (with prominent face brick chimney) and steel frame windows. The front facade of the building is characterised by a low face brick wall defining a stoep. The stoep is partially enclosed with a single face brick wall at one end, (probably for privacy and protection against the wind and sun). Some variation of this type also occurs namely the closing of the sides of the open stoep with steel and plastic and covering it with plastic corrugated sheets. Three of the buildings of this type from this precinct were constructed with a dark face brick and one was constructed with a yellow face brick.

Figure 61 – General views of Building Type 20.

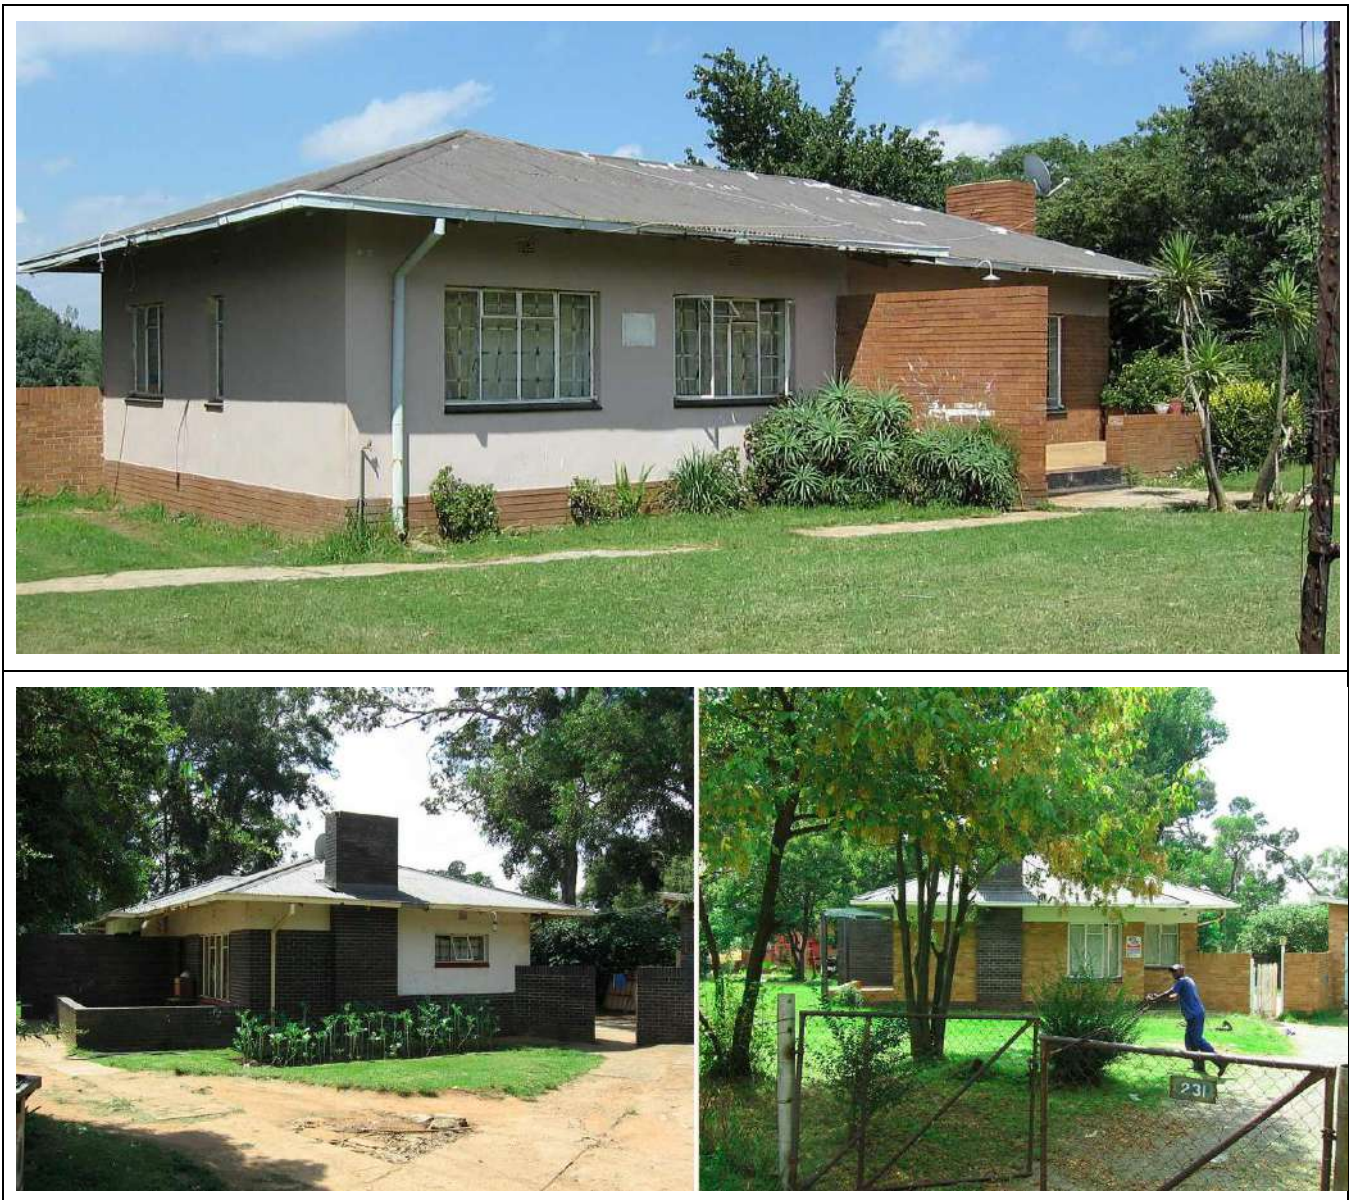
Four examples of this building type are located within this precinct. The building type comprises a rectangular floor plan constructed with plastered brick with some sections executed with yellow face brick. It has a hipped corrugated iron roof and a single prominent chimney at one end and steel frame windows throughout the entire building. The front facade of the building is characterised by a low yellow face brick wall defining the open stoep. The main entrance and front door is defined by a tall yellow face brick wall that also forms part of the stoep, (for privacy and protection against the wind and sun). The four buildings of this type are built with face bricks, varying in colour. One of these buildings is built with both a yellow and darker face brick.

Figure 62 – General views of Building Type 21.

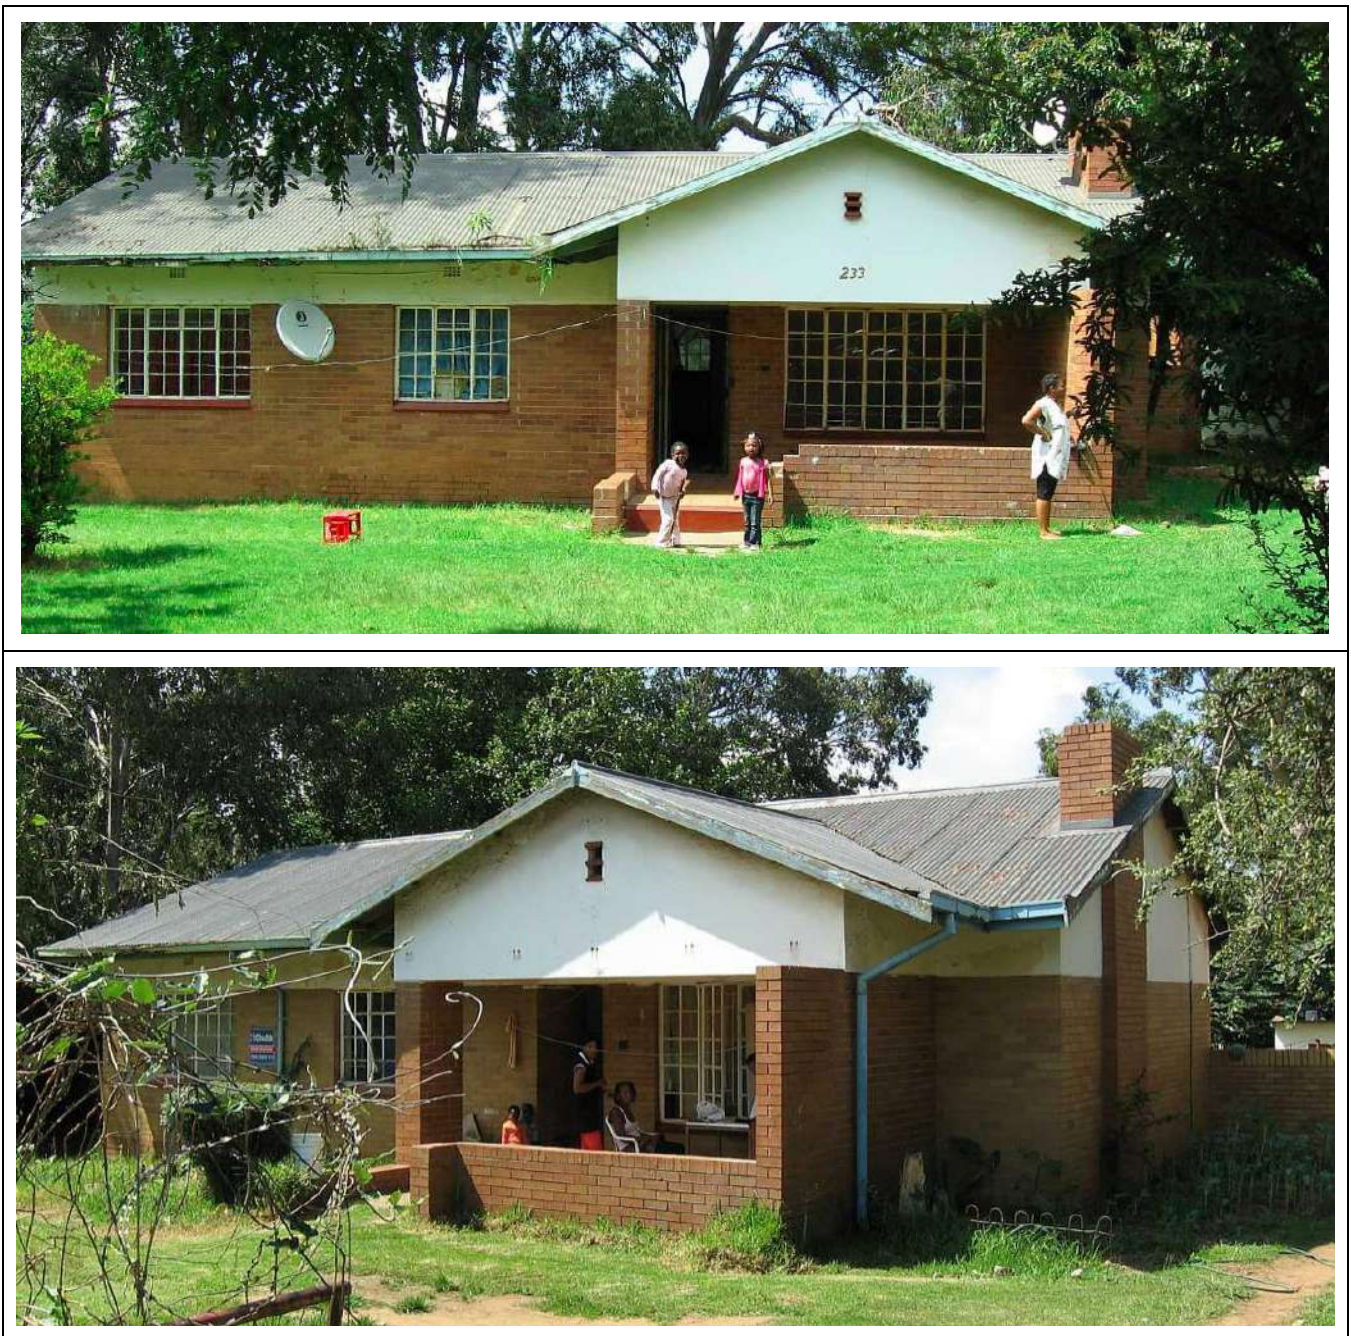
Three examples of this building type are located within this precinct. The building type is an offset T-shaped construction of yellow face brick with a saddle shaped corrugated iron roof with a single chimney and steel frame windows. The front facade of the building is characterised by a covered porch with a gable. Both yellow and darker face bricks were used for the construction of the three buildings.

Figure 63 – General views of Building Type 22.

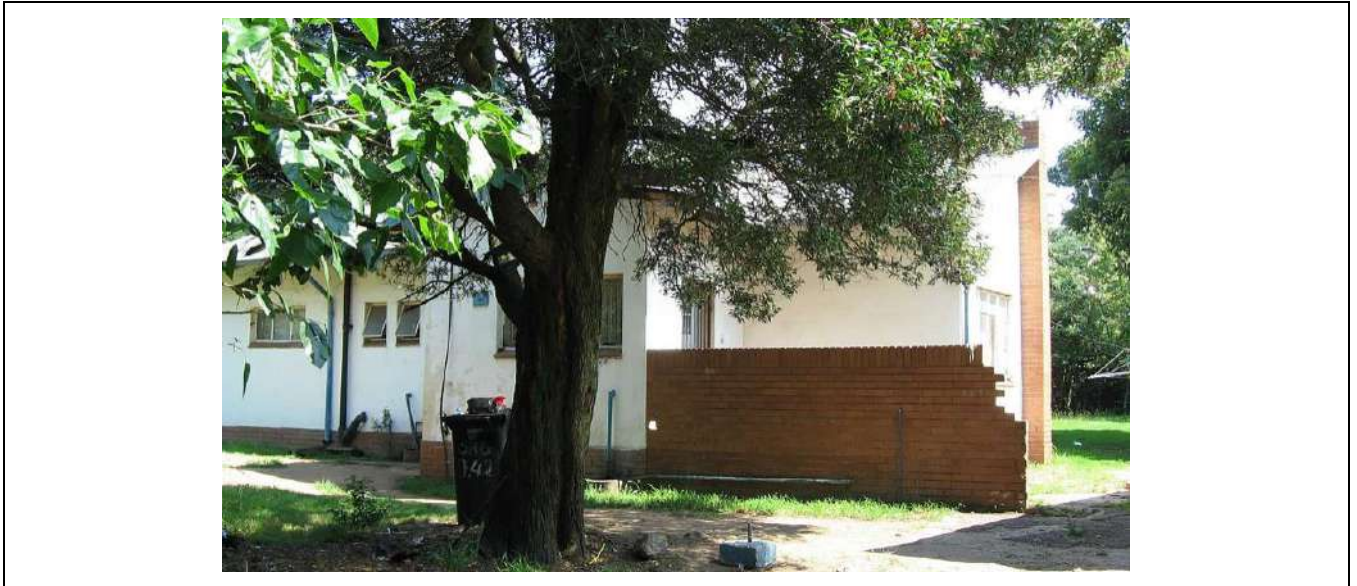
Figure 64 – Building Type 23.

One example of this building type is located within Precinct 5. The building type comprises a rectangular brick structure with a pitched corrugated iron roof, a single chimney and steel frame windows.

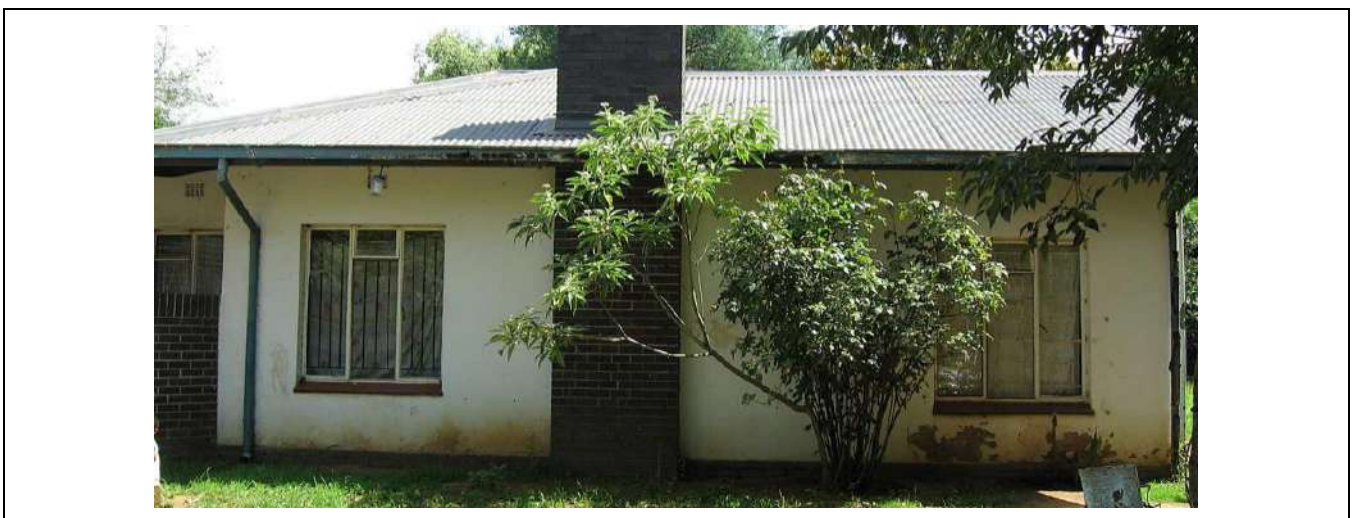
Figure 65 – Building Type 24.

One example of this building type is located here. It has a rectangular floor plan, constructed with plastered bricks, a hipped corrugated iron roof with an extended gabled wing located on one side and steel frame windows.

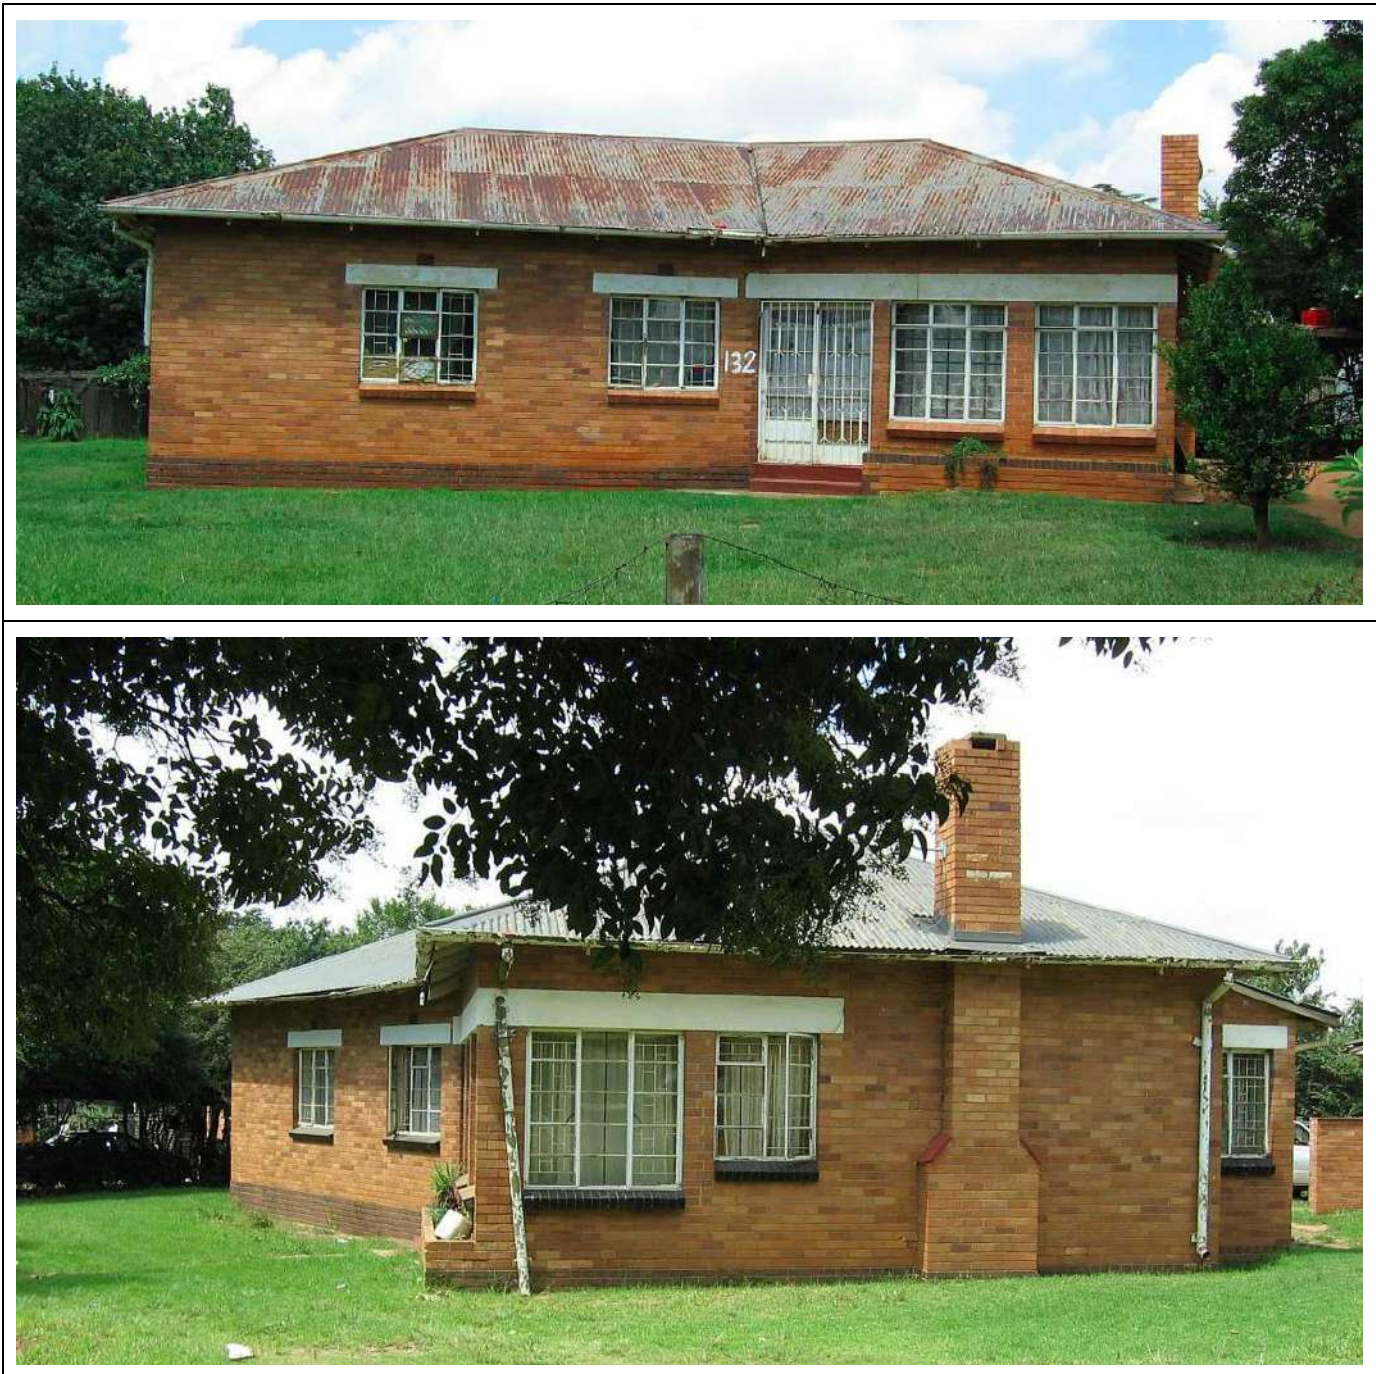
Three examples of this building type are located within this precinct. The building type has an open V-shape floor plan (rectangular floor plan with a slight angle in the centre – almost like a bent rectangle). These buildings are entirely constructed with yellow face bricks and have a hipped corrugated iron roof with a chimney to one side. The structure is dominated by the extensive concrete lintels above both windows and doors.

Figure 66 – General views of Building Type 25.

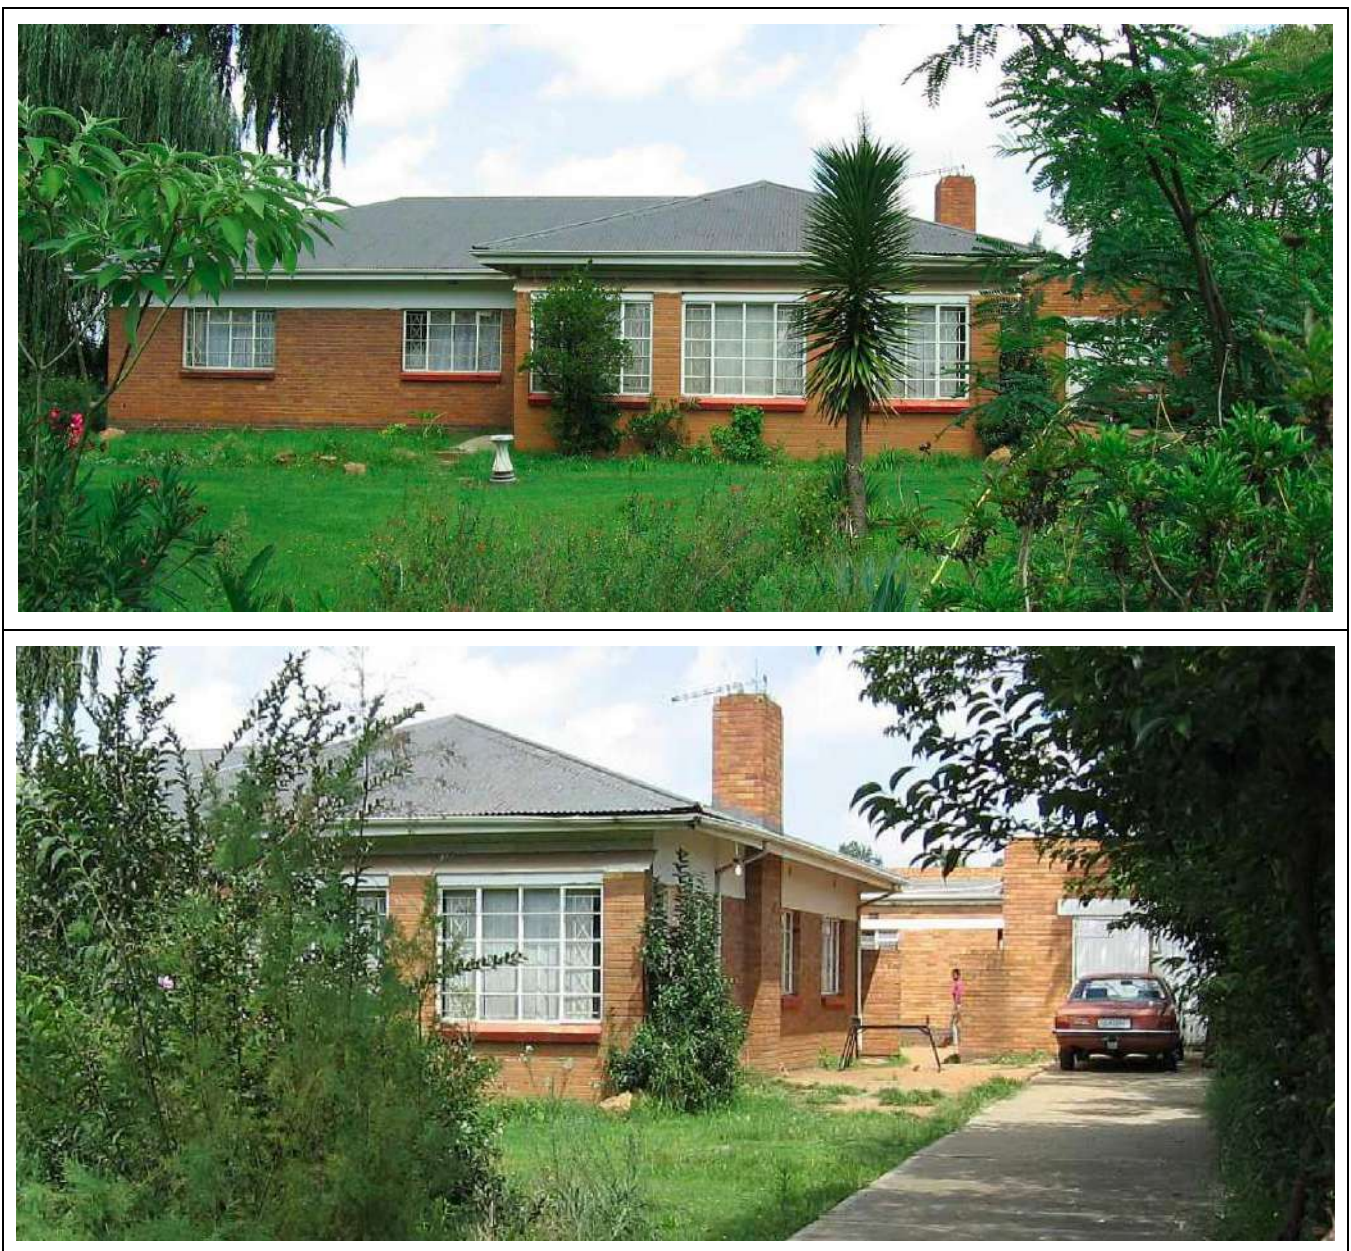
Four examples of this building type are located within this precinct and are arranged into a crescent. The floor plan is L-shaped with a prominent protruding section along the front façade containing three large symmetrically arranged steel-frame windows. The entire façade is subdivided into two sections, one half consisting of the protruding rooms and the other set back containing the remainder of the bedrooms. The dwelling and prominent chimney are constructed with yellow face bricks and the hipped roof is of corrugated iron. The outbuilding consists of a single garage with a room for a domestic worker.

Figure 67 – General views of Building Type 26.
