PHASE 1 HERITAGE IMPACT ASSESSMENT

Proposed Establishment of Goudrand Ext. 5, Goudrand Ext. 6, Goudrand Ext. 7, Goudrand Ext. 8, Goudrand Ext. 9, Goudrand Ext. 10, Goudrand Ext. 11, Goudrand Ext. 14, Goudrand Ext. 15, Goudrand Ext. 16, Goudrand Ext. 17, Goudrand Ext. 18 and Goudrand Ext. 19, located in the Roodepoort Magisterial District, City of Johannesburg Metropolitan Municipality, Gauteng Province

Issue Date: 20 June 2018
Revision No.: 2
Client: Hunter Theron Incorporated

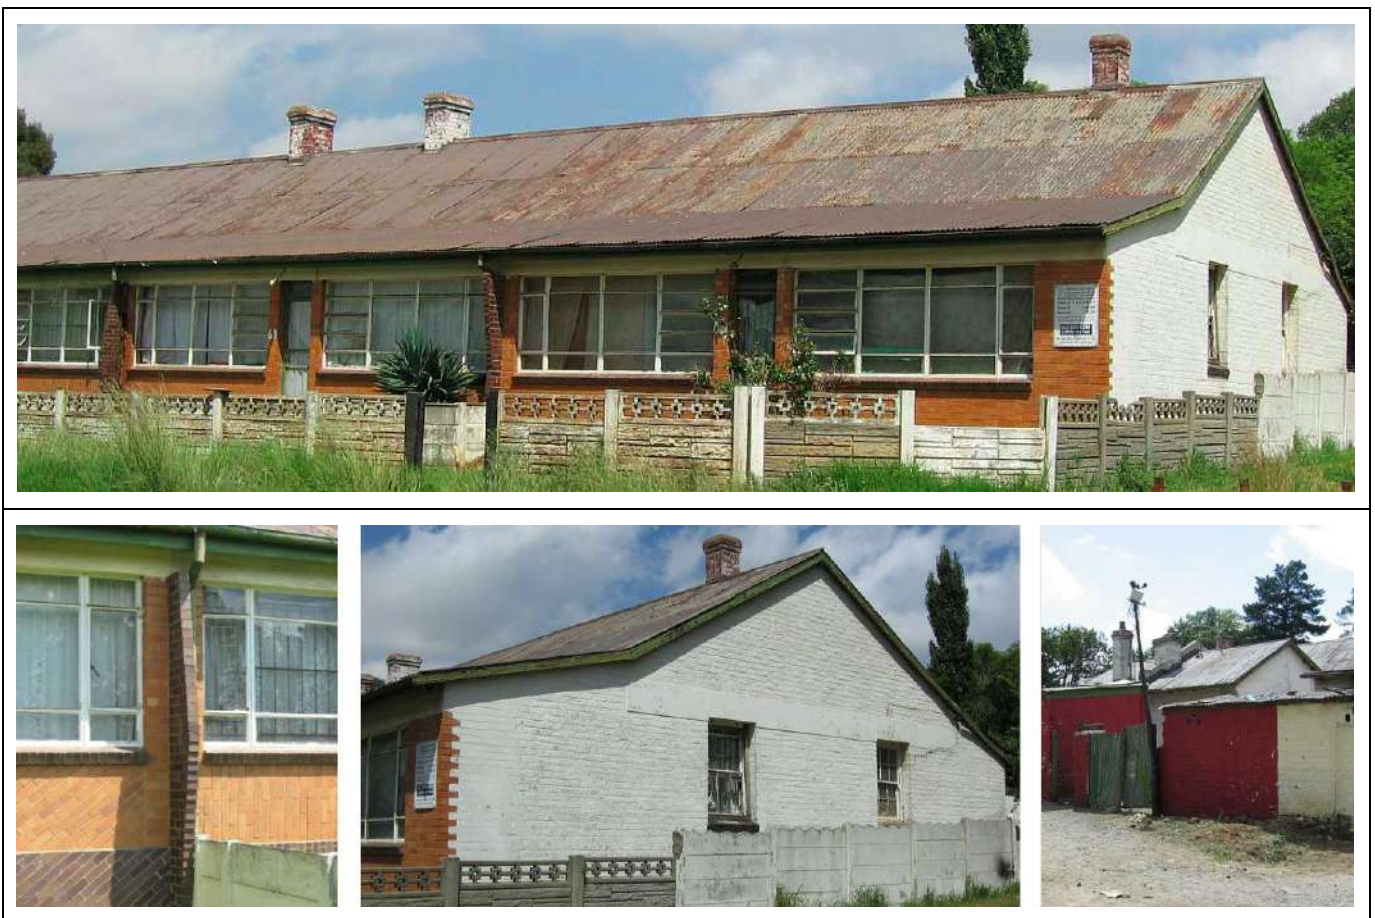
Only one example of this building type was found within the entire study area and it is the only building located in Precinct 6. It consists of a large single storey complex containing several dwelling units under a single roof. The complex has a corrugated iron saddle roof with a lean-to verandah section along the entire length of the front facade. The entire verandah used to be a semi-open space but was later closed-off. An exceptional element and detail of the building are the use of face bricks along the façade mimicking the various methods bricks can be laid and perhaps mimicking folk patterns of brick masonry (bricks were laid vertically horizontally and diagonally). Each of the dwelling units has its own brick chimney and enclosure or courtyard at the back. The courtyard is defined by plastered and face brick outbuildings serving as rooms for domestic workers and as outdoor toilets. The more recent windows along the façade where the stoeps were closed-off are of steel whilst the windows of the original exterior walls are wooden sash ones.

Figure 68 – General and detail views of Building Type 27.

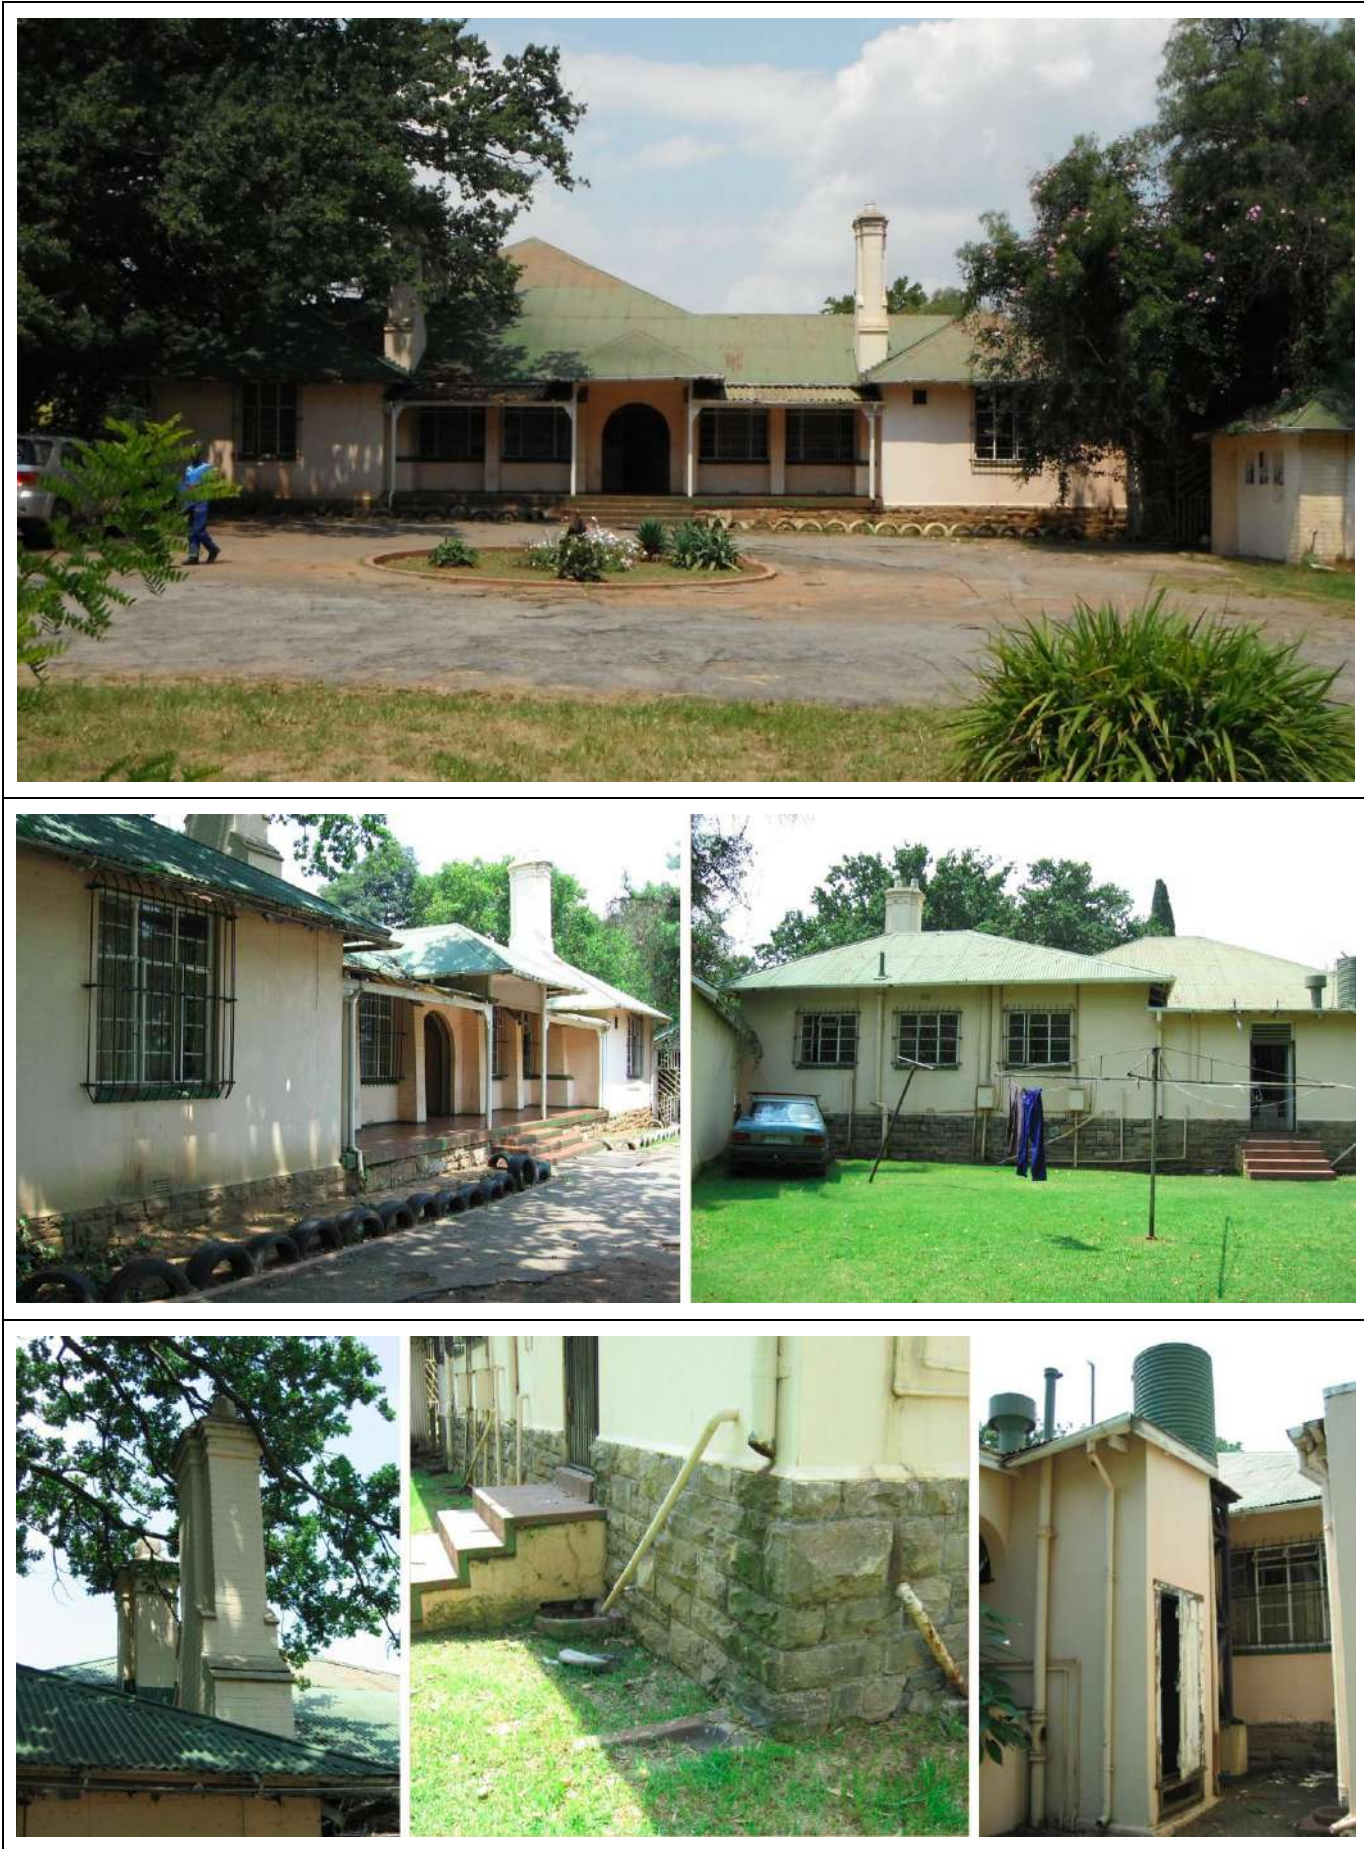
Directly south-west of the building a corrugated iron garage is located, with another one further to the south-west. Both these structures still contain the original intricate folding door systems. A more recent less inspiring rectangular block on the southern end of the building must have functioned as domestic servant quarters.

Figure 69 – General and detail views of Building Type 28.

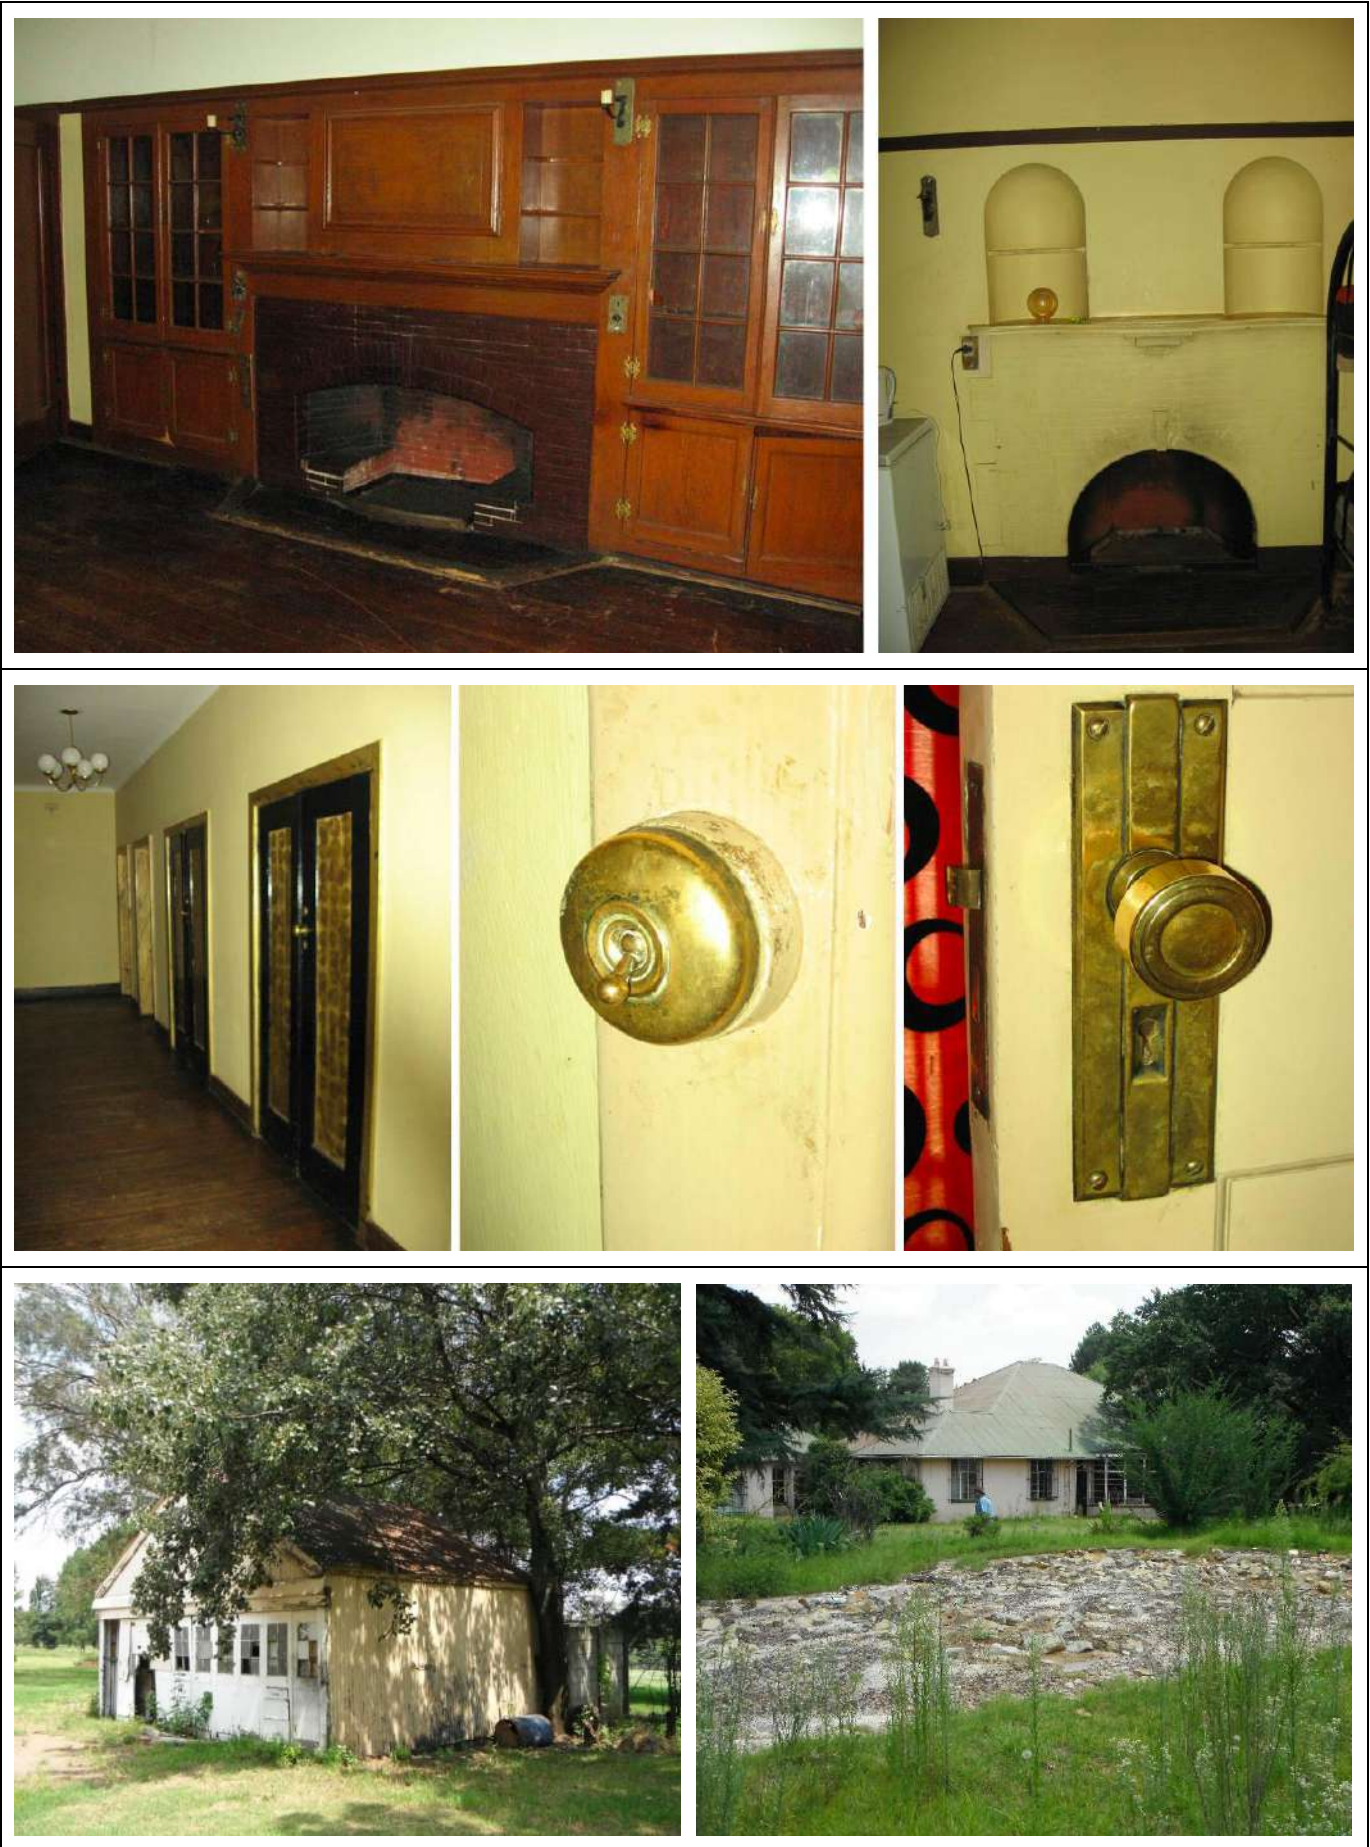
Figure 70 – Detail views of the interior of Building Type 28 as well as a general view of an associated garage.

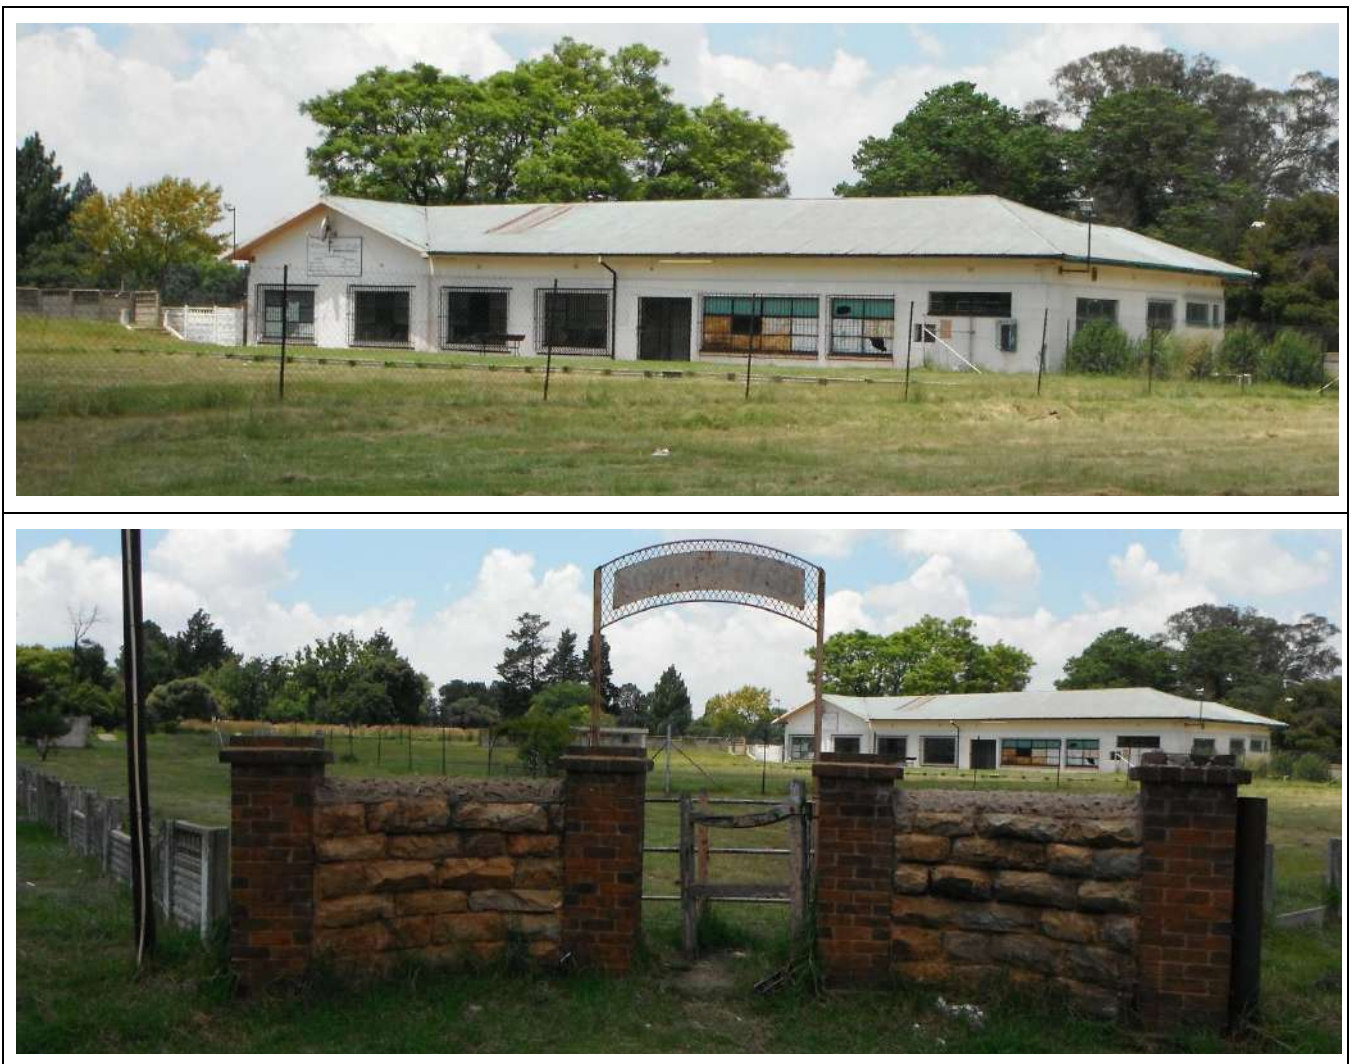
The bowling clubhouse is located here. It comprises a large rectangular brick building with a hip and gable corrugated roof. The front facade is characterised by large rectangular windows with steel frames. A stone and brick pedestrian entrance gate holding a sign containing the faded words “BOWLING CLUB” is located west of the building. The flat and open lawn located between this sign and the clubhouse is where the bowling greens used to be located.

Figure 71 – General views of the structure as well as the main entrance gate at Building Type 29 .

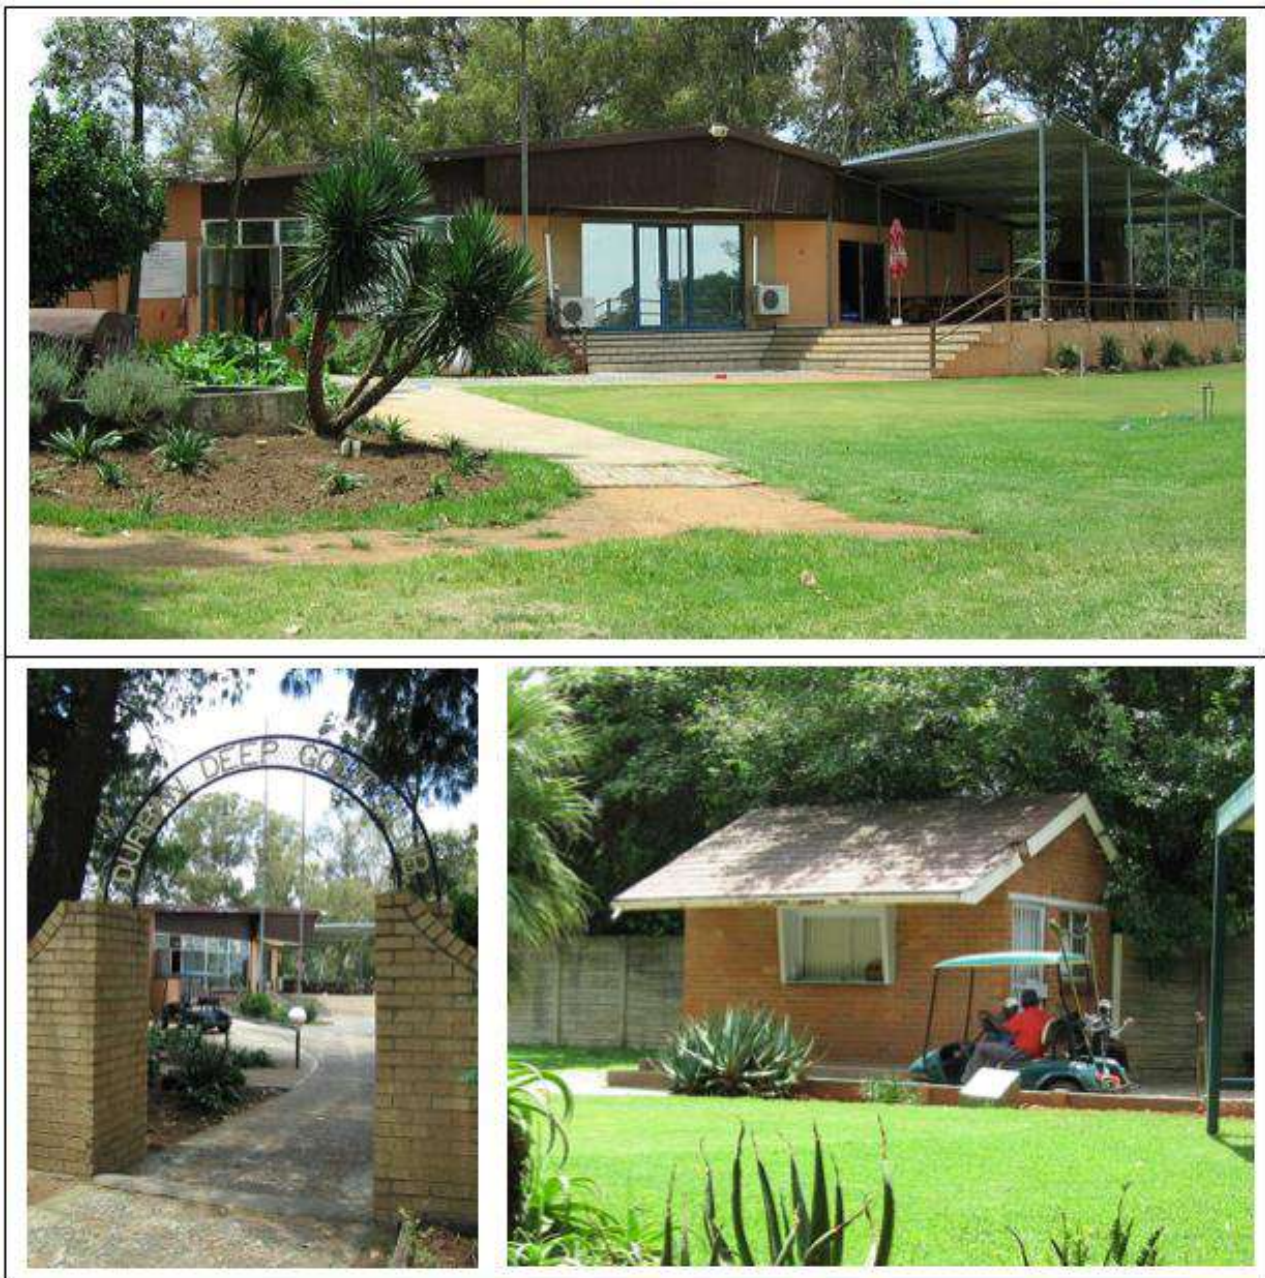
One example of this building type is located within the site. It comprises the Durban Roodepoort Deep Golf Clubhouse and Course. The clubhouse is a prefabricated structure with a covered porch in the front. A yellow face brick building not unlike a small reception office is located a short distance away from the clubhouse. In the surrounding landscape a 9-hole parkland type golf course is located. The golf course was established by Durban Roodepoort Deep in 1957 (www.durbandeepgolf.co.za).

Figure 72 – General views of the various structures identified at Building Type 30.

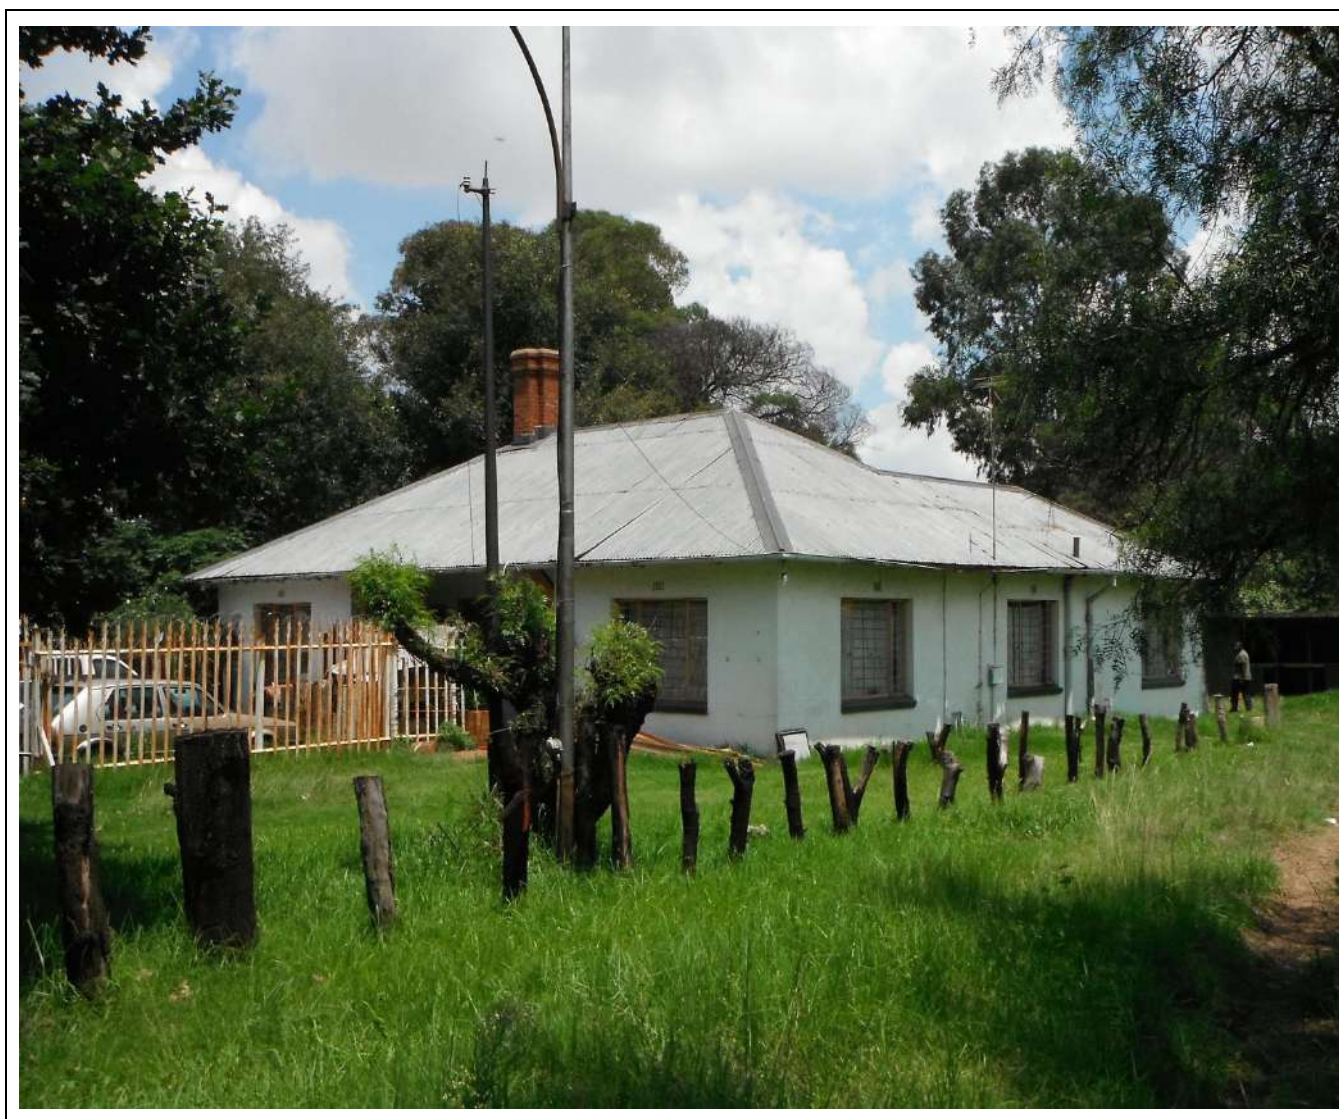
Only one example of this building type is located within the precinct and study area. The building has been extensively altered. One of the outstanding elements on this dwelling is the Oregon pine arch or supporting detail on the front porch. No other building in the study area has this element.

Figure 74 – General view of Building Type 31.

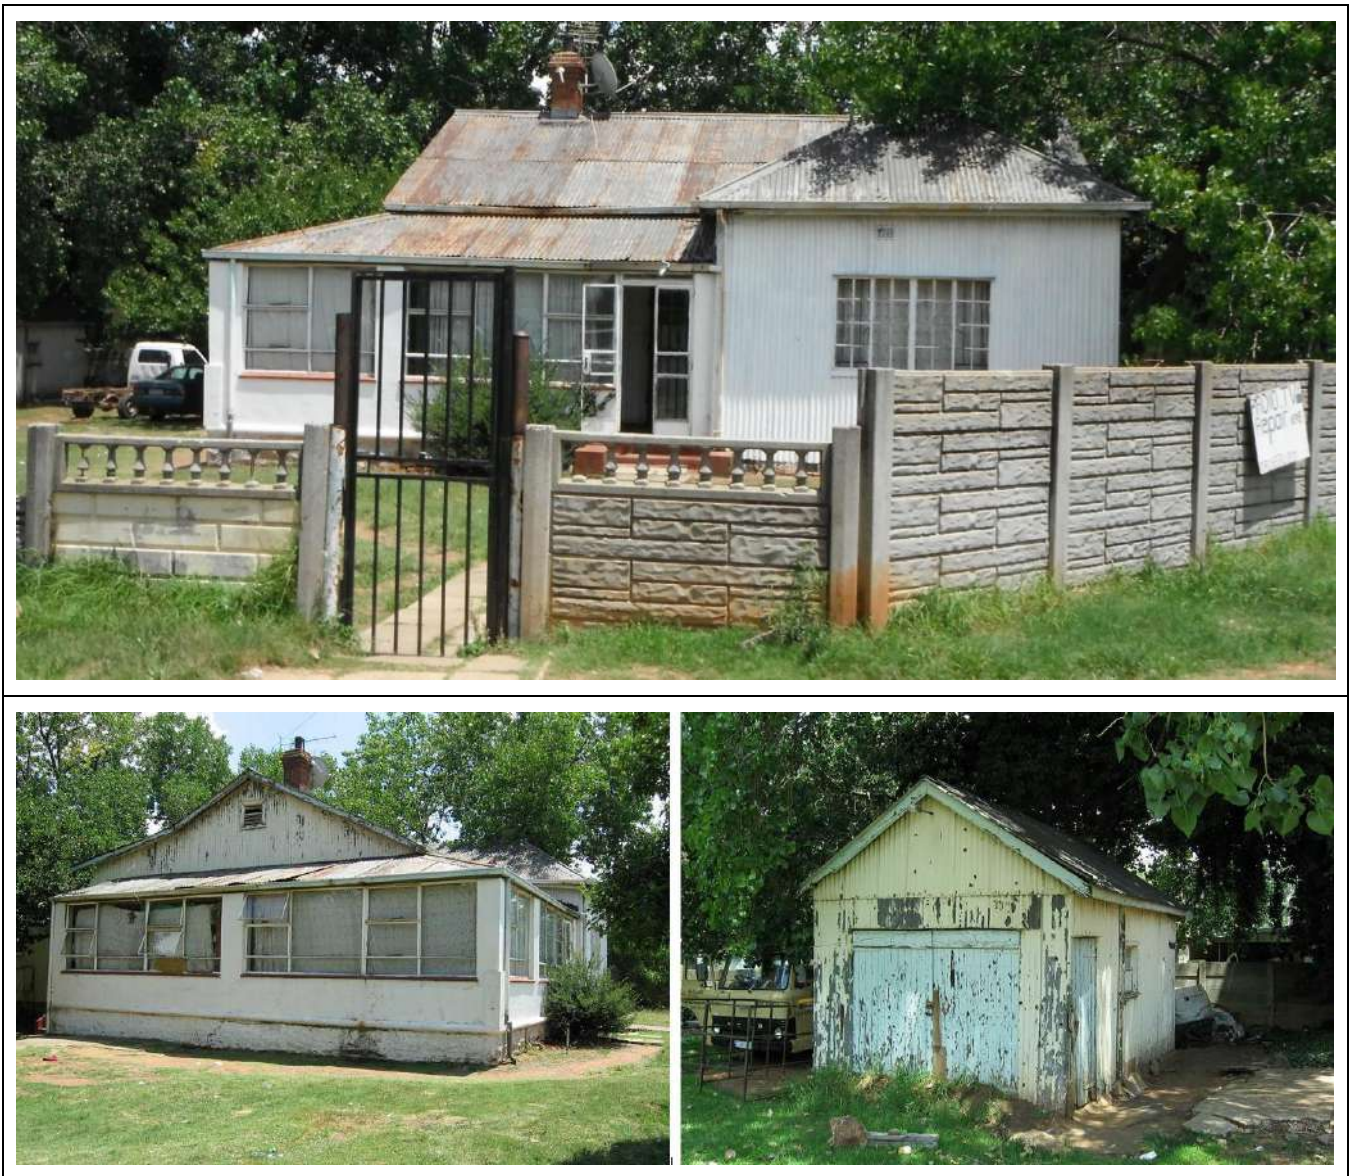
One example of this building type is located within the precinct. It comprises a square corrugated iron (wood and iron) dwelling, set on a stone masonry foundation with a single chimney. The building has a saddle roof with a protruding room along the front façade with a hipped roof. The porch was originally an open covered porch, but at a more recent time it had been closed with steel frame windows. The floor plan includes an L-shaped verandah which was later closed-off with steel frame windows. It is suspected that the existing steel frame windows replaced the original wooden sash windows. A number of detached outbuildings are associated with the dwelling, including a timber and iron garage and rectangular corrugated iron room for a domestic worker. These buildings still have their original wooden framed windows.

Figure 75 – General views of Building Type 32.

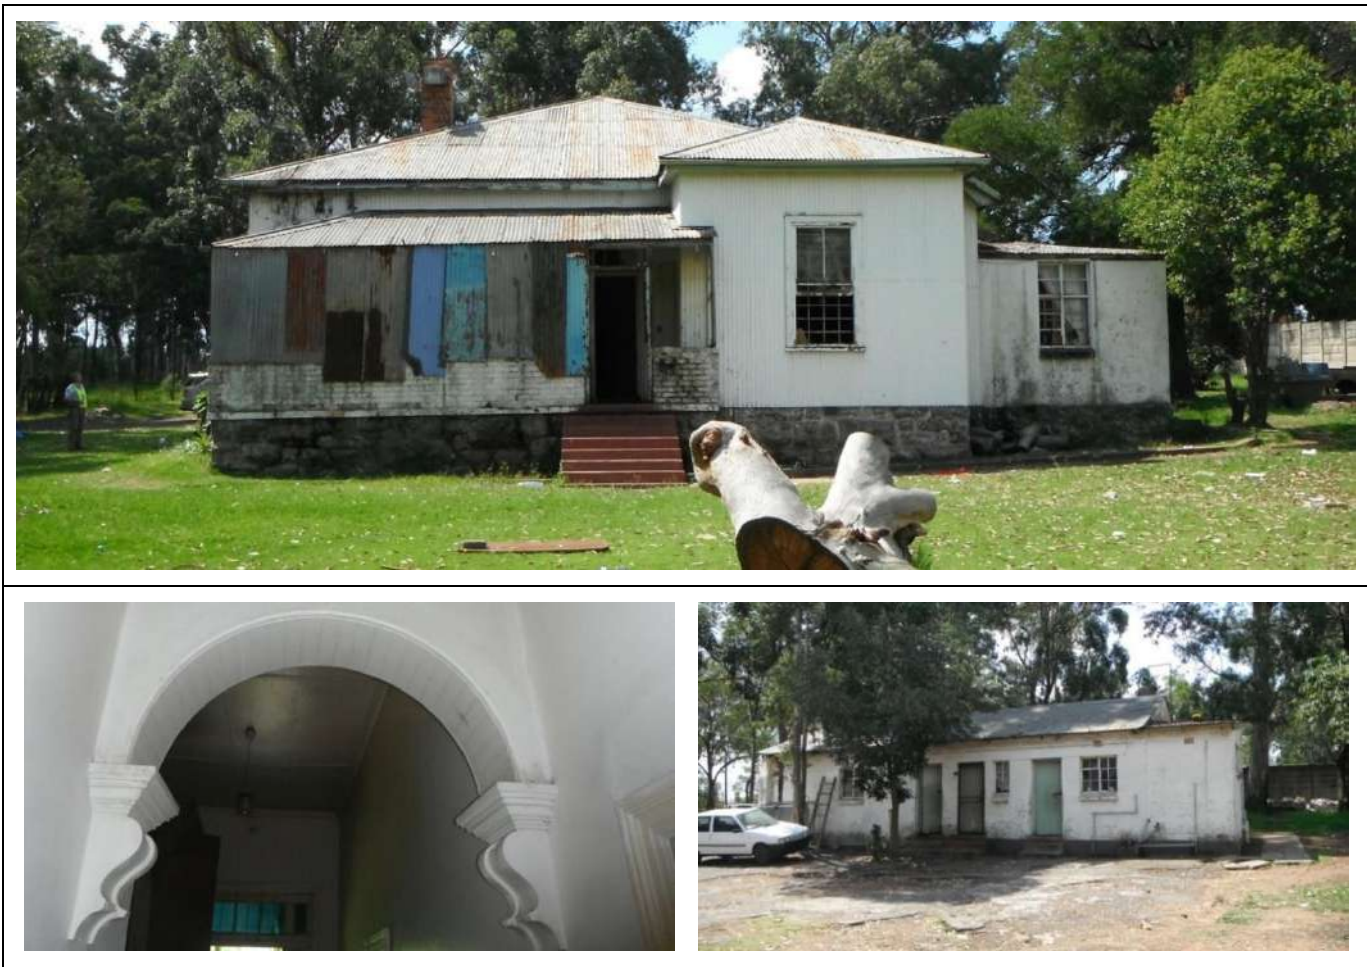
One example of this building type is located within the precinct. It is very similar to Building Type 32, with which it represents the only corrugated iron-type dwellings from within the study area. It must have been quite a stylish dwelling at the time, but has been extensively altered. The dwelling consists of a core building constructed with corrugated iron with a combination of a saddle and hipped corrugated iron roof and a single chimney. The building is set on a stone foundation and plinth. A prominent element is the L-shaped covered verandah which was later closed-off with sheets of corrugated iron. Its front facade is characterised by a small pitch-roofed wing on the right and a closed porch on the left. The porch was originally an open covered porch, but more recently had been closed with corrugated sheets. A small rectangular brick building was added at a later stage to the eastern end of the dwelling. While the windows from the core building are all wooden sash ones, the ones from the annex are all steel framed. The floor plan is dominated by a passage through the centre of the dwelling with the various rooms (including a kitchen and bathrooms) leading from it. A more contemporary addition is the rectangular structure with brick walls, lean-to corrugated roof and steel framed windows with concrete lintels - probably used as housing for staff.

Figure 76 – General views of Building Type 33.

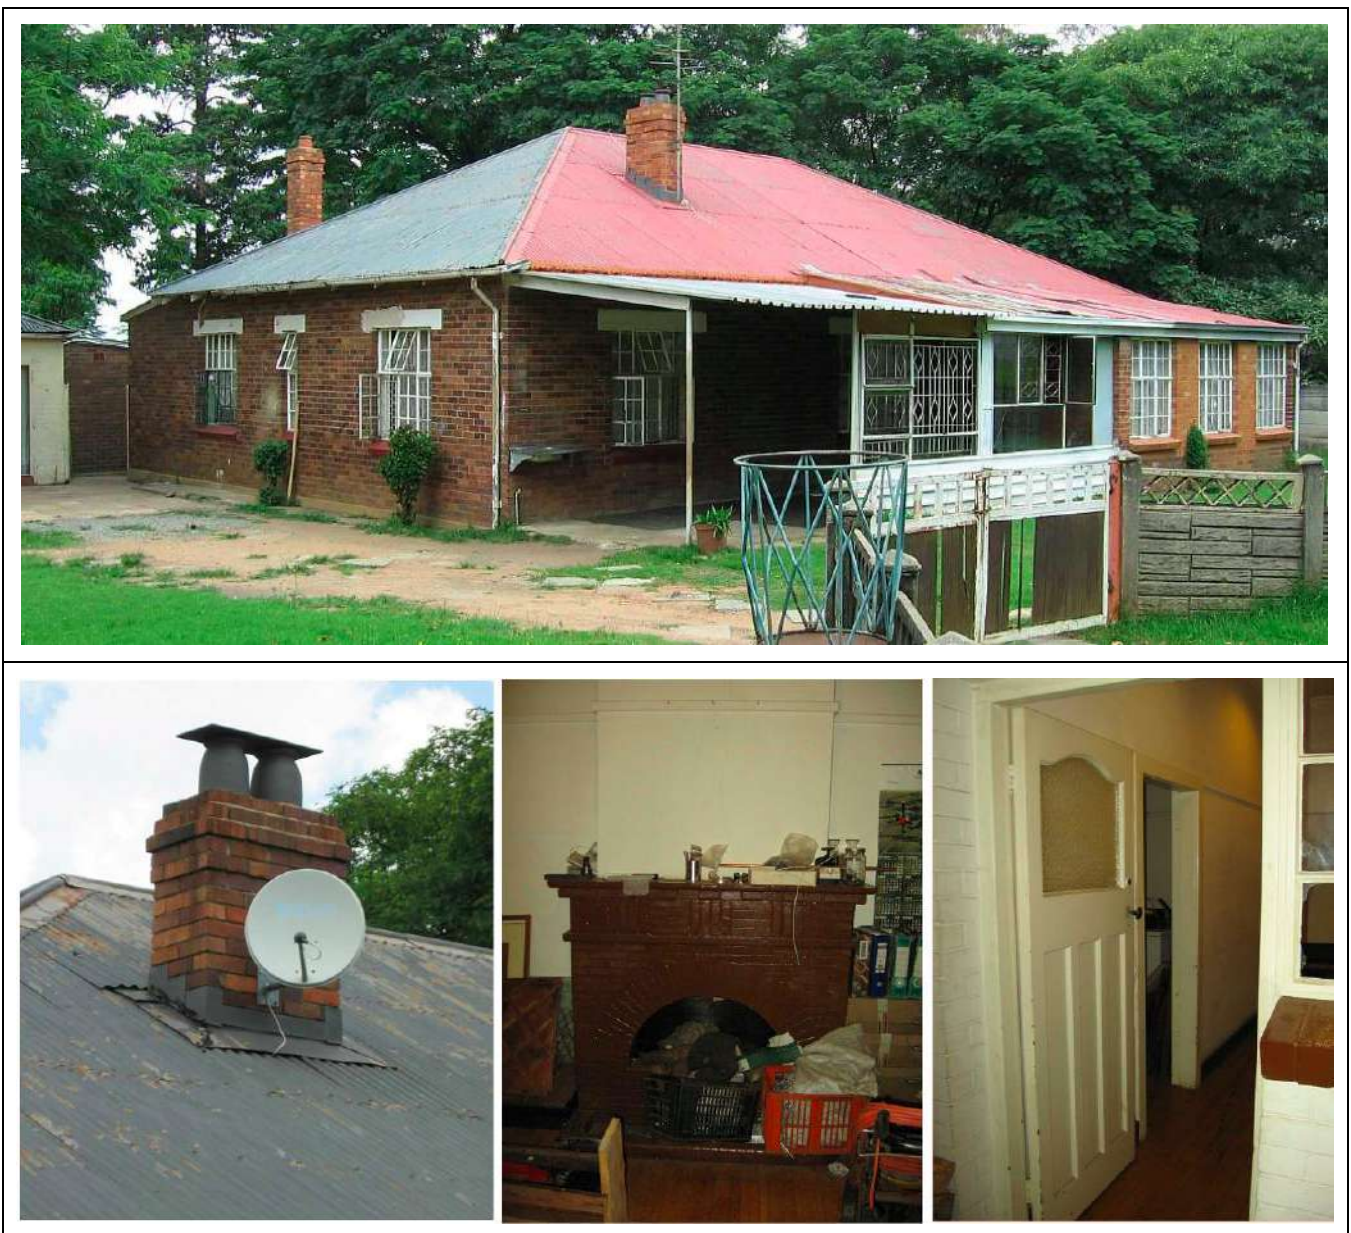
Four examples of this building type are located within the precinct. It consists of a rectangular floor plan and was constructed with face bricks. The dwelling has a hipped corrugated iron roof with two chimneys whereas industrial steel-framed windows are covered with large concrete lintels. The front facade is characterised by a verandah with one section closed-off with steel frame windows to form another room. Both the verandah and additional room were later added as their architectural vocabulary and building materials are different from the original core dwelling. Some outbuildings are associated with the dwelling.

Figure 77 – General views of Building Type 34.

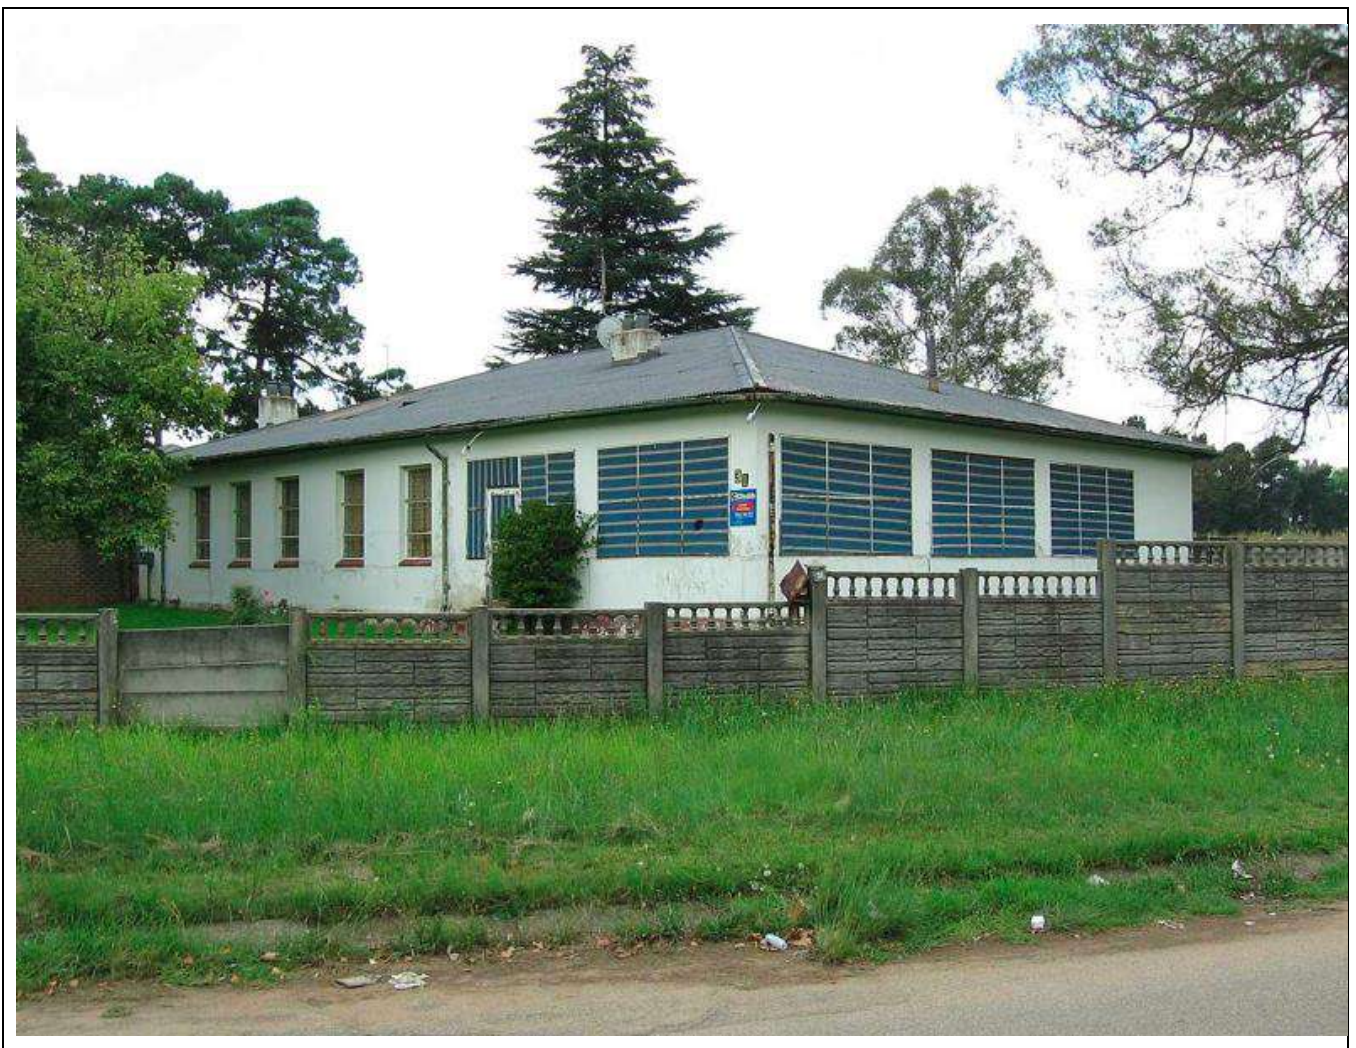
One example of this building type is located within the precinct. It is one-of-a-kind and consists of a rectangular floor plan constructed with plastered brick, with a hipped corrugated iron roof, two chimneys and steel frame windows. It is currently used as dwelling but it contains elements of other functional types such as those of a sports hostel (to accommodate visiting sporting teams) or a clubhouse.

Figure 78 – General view of Building Type 35.

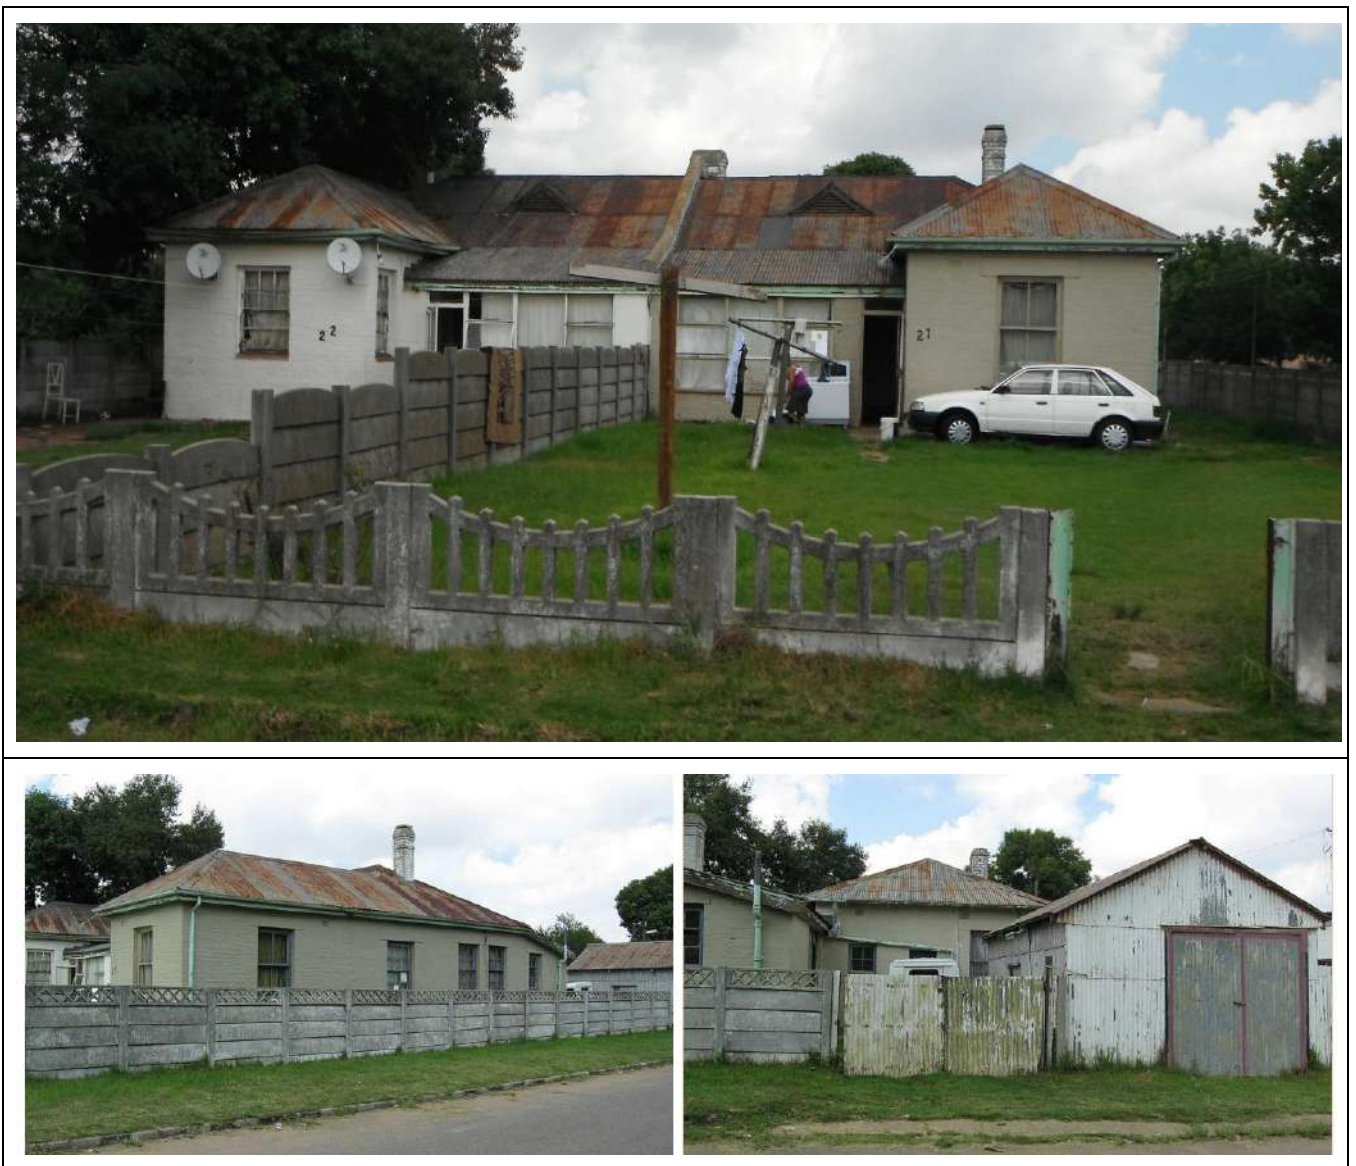
Five examples of this building type are located within the precinct. These dwellings are semi-detached types constructed with plastered brick with a basic U-shaped floor plan. The void between the two dwellings used to be an open verandah but these spaces have over time been filled in and closed-off to become rooms. Each dwelling has two fireplaces with one separate chimney and one sharing the same vertical funnel (in the centre along the dividing firewall). The five examples described here consist of five half-sections (each of which represents an individual dwelling of a single building unit). The original wooden sash windows are intact but in the more recent additions in the centre of the front facade steel frame windows were installed. A detached corrugated iron garage is located at the back of each unit.

Figure 79 – General view of Building Type 36.

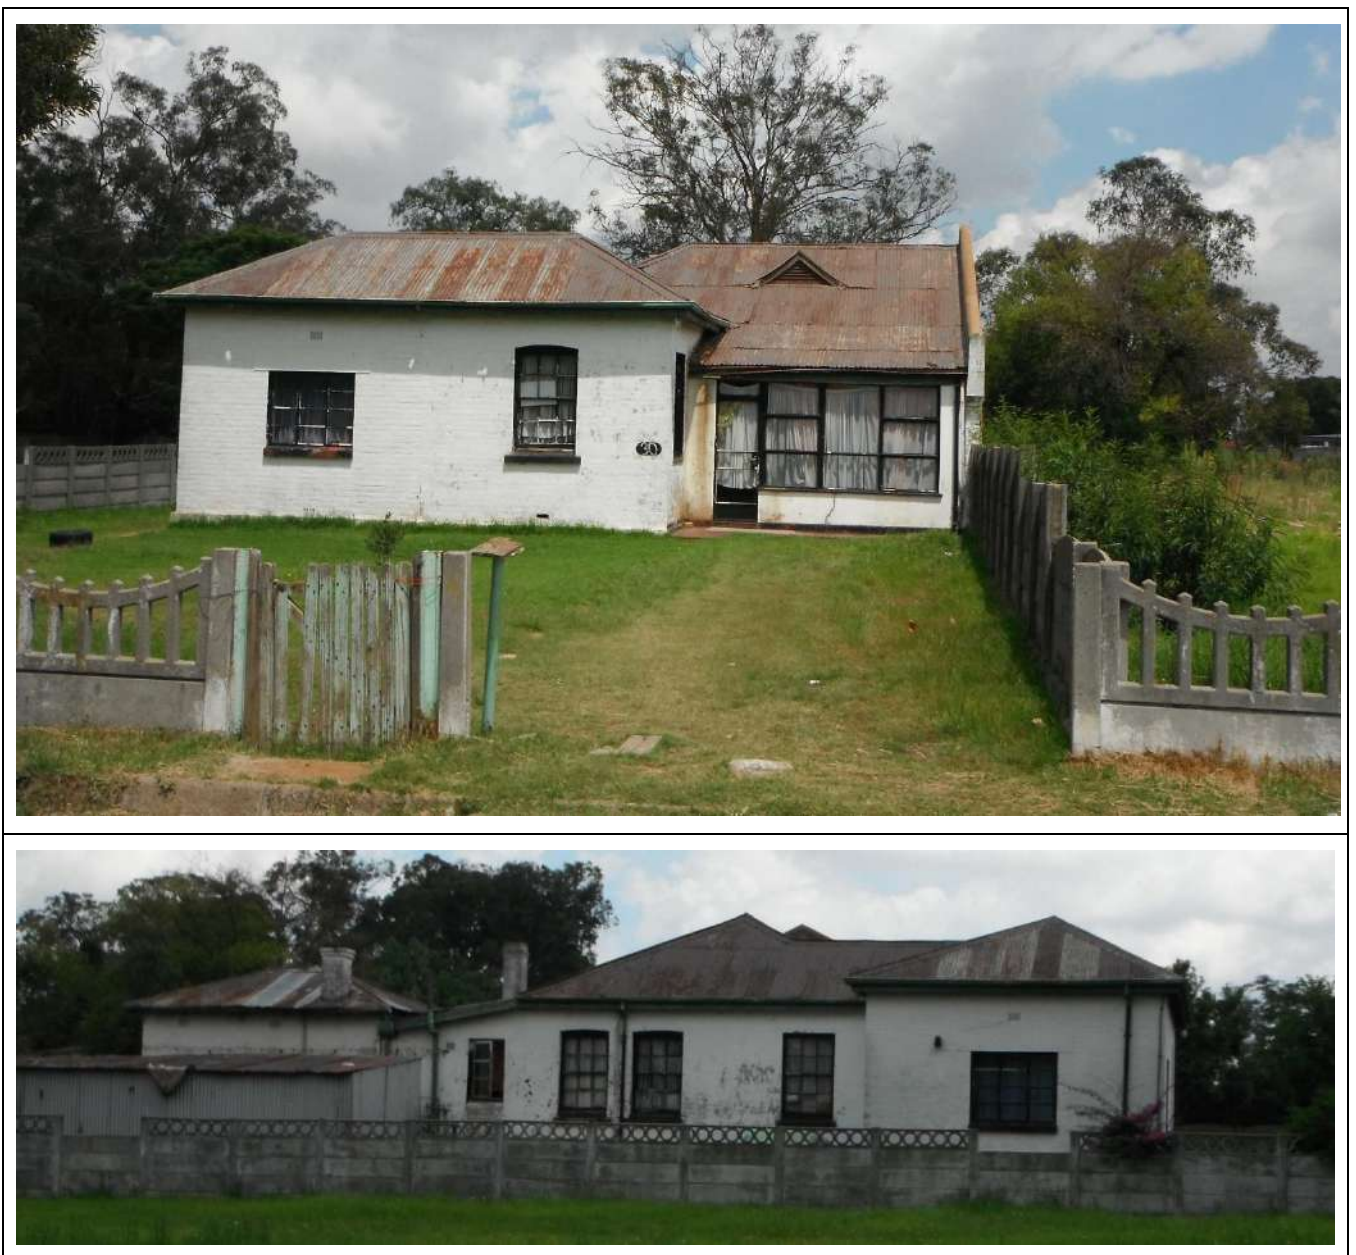
Only one example of this building type is located within the study area. The core of the floor plan is the same as Building Type 36. However, an additional room was added to the front facade where the single room gabled wing is located on a Building Type 29. The building has been altered several times with verandahs closed and rooms added. Steel frame windows have replaced the original sash windows. One of the outstanding elements is the occurrence of arches in the brickwork above the windows which is not repeated on other dwellings in the study area. The building also contains small dormer air vents on the roofs rendering this type exceptional and a-typical.

Figure 80 – General view of Building Type 37.
