PHASE 1 HERITAGE IMPACT ASSESSMENT

Proposed Establishment of Goudrand Ext. 5, Goudrand Ext. 6, Goudrand Ext. 7, Goudrand Ext. 8, Goudrand Ext. 9, Goudrand Ext. 10, Goudrand Ext. 11, Goudrand Ext. 14, Goudrand Ext. 15, Goudrand Ext. 16, Goudrand Ext. 17, Goudrand Ext. 18 and Goudrand Ext. 19, located in the Roodepoort Magisterial District, City of Johannesburg Metropolitan Municipality, Gauteng Province

Issue Date: 20 June 2018
Revision No.: 2
Client: Hunter Theron Incorporated

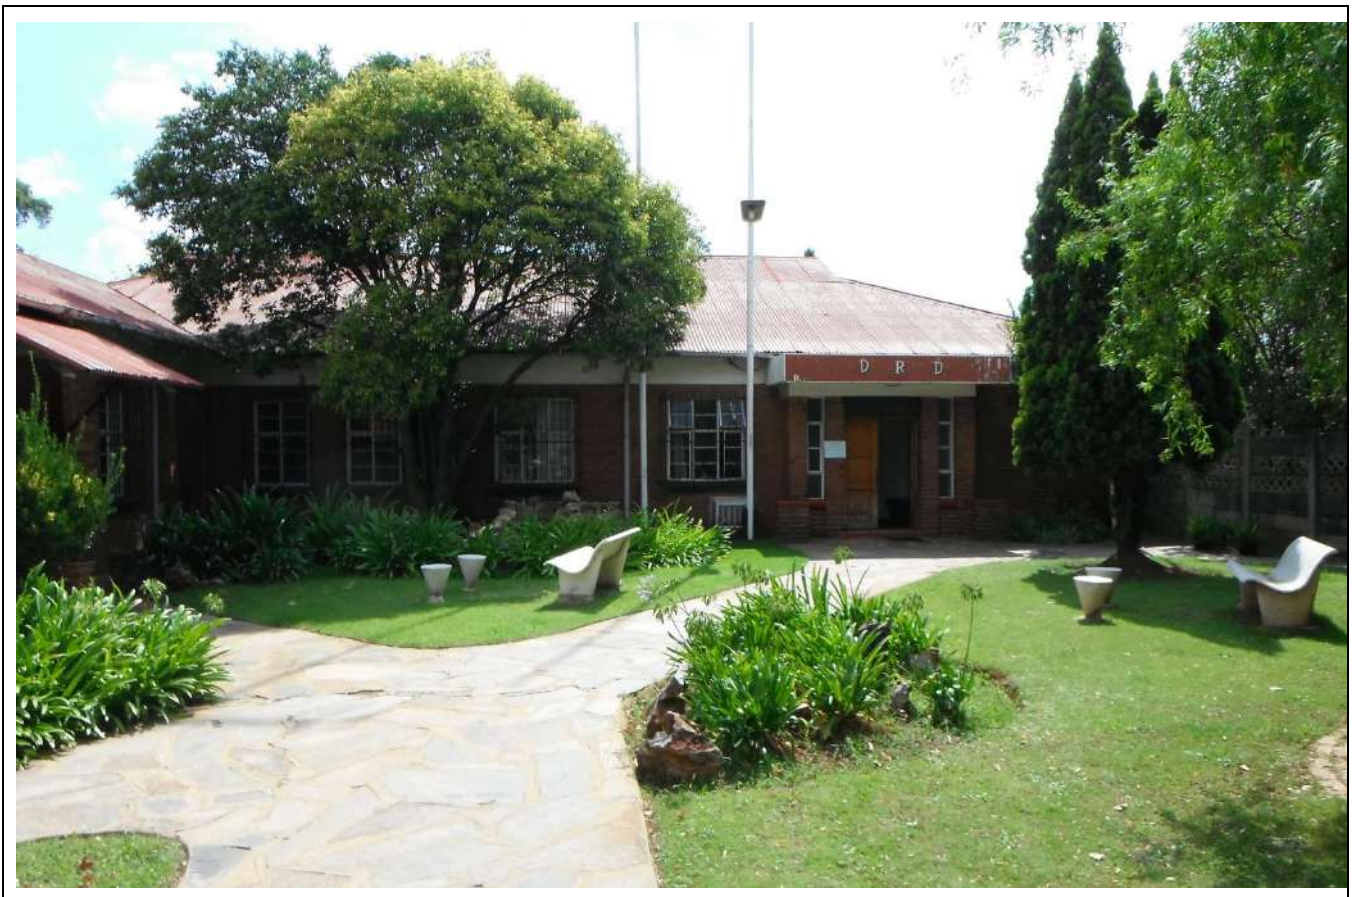
One example of this building type is located within this precinct and indeed within the study area. It has a T-shaped floor plan and is constructed with red face brick. The building has a combination of a hipped and saddle corrugated roof with six chimneys. The steel frame windows are covered by steel burglar proofing. The front entrance has a tiny roof of concrete and teak front door crowned by the acronym “DRD” above the entrance. The interior reflects the characteristics of a typical mine office of this period. The building has a long staggered passage in order to serve all the offices and supporting rooms. Each of the larger offices has a fireplace while some offices are still furnished with desks, chairs and cupboards. The building also contains supporting rooms such as a reception area, bathrooms, a boardroom and an underground cellar where records and the archives were kept. Of special significance are the various types of brass door knobs still intact in the building.

Figure 81 – General view of the front entrance of the old DRD office building at Building Type 38.

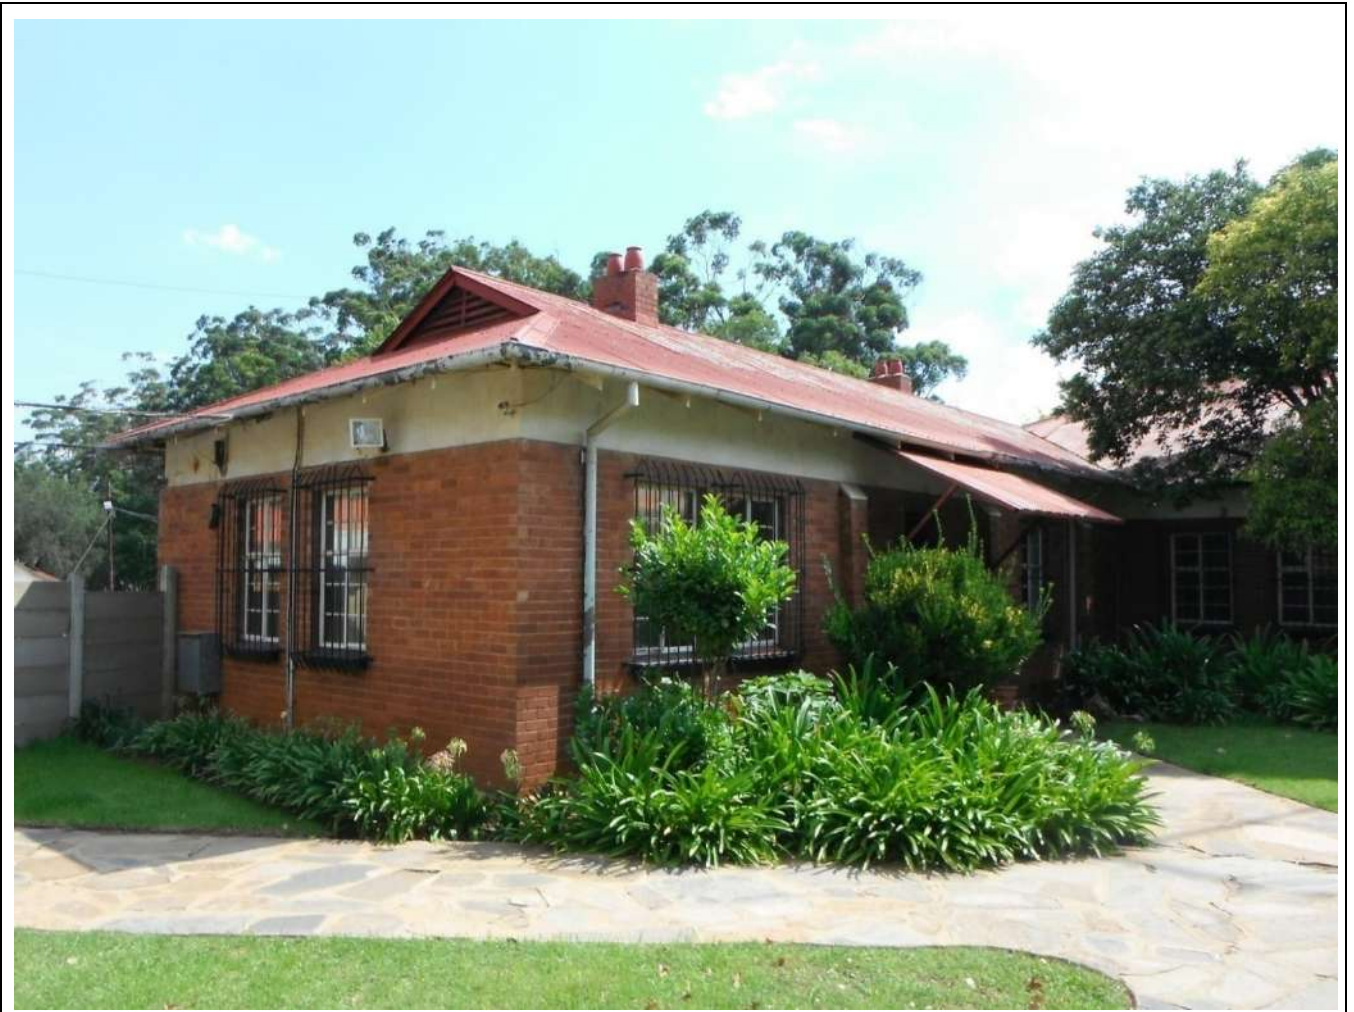
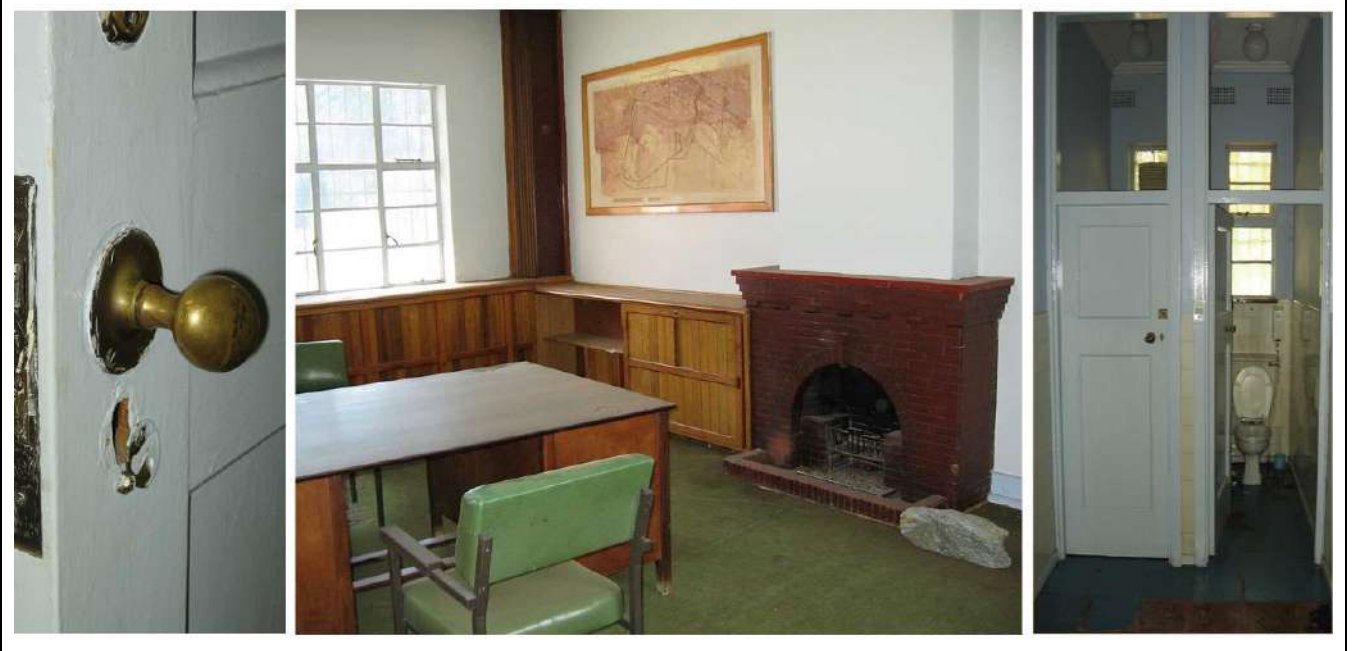
Figure 82 – Exterior and interior views of the old DRD office building at Building Type 38.

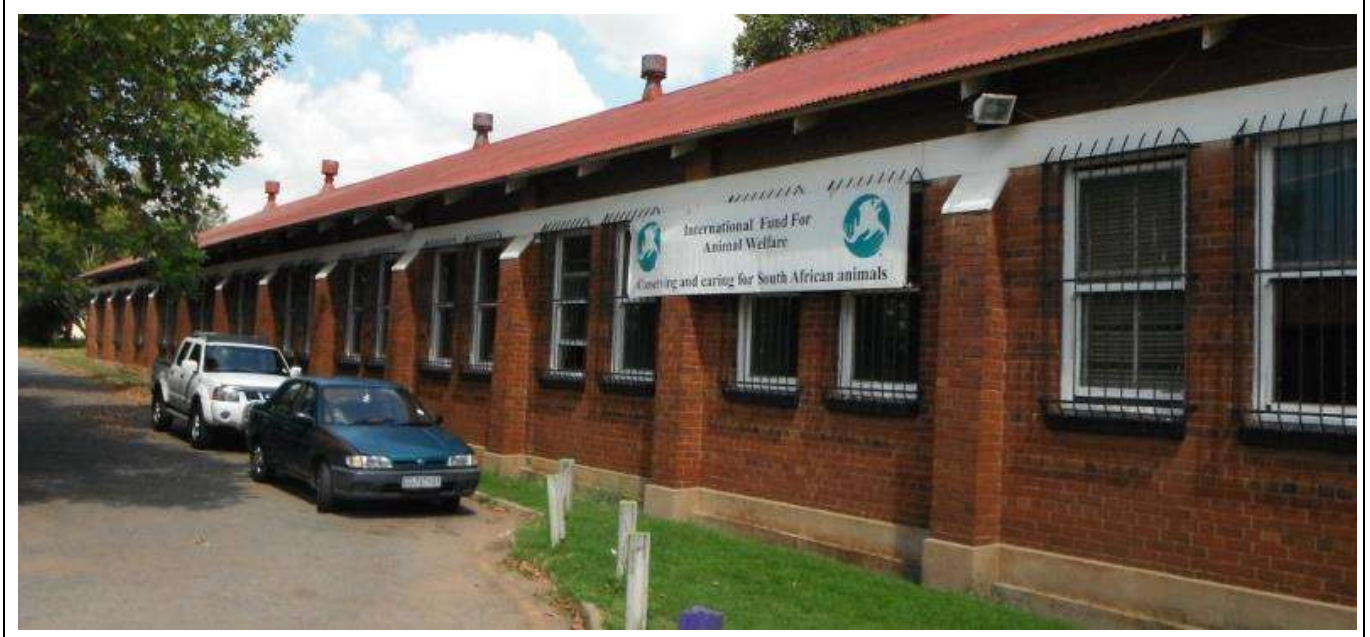
The building was used as offices by the survey department of the mine. It is the only one of its kind in the study area. The building has a long rectangular floor plan constructed with red face bricks with a broken hipped corrugated roof with ventilator openings at the end of the ridging and five air turrets arranged along the ridging. Large sash windows are arranged intermittently with red brick buttresses (set of two windows between each buttress). A single concrete lintel serves all the windows and doors.

Figure 83 – General views of Building Type 39.

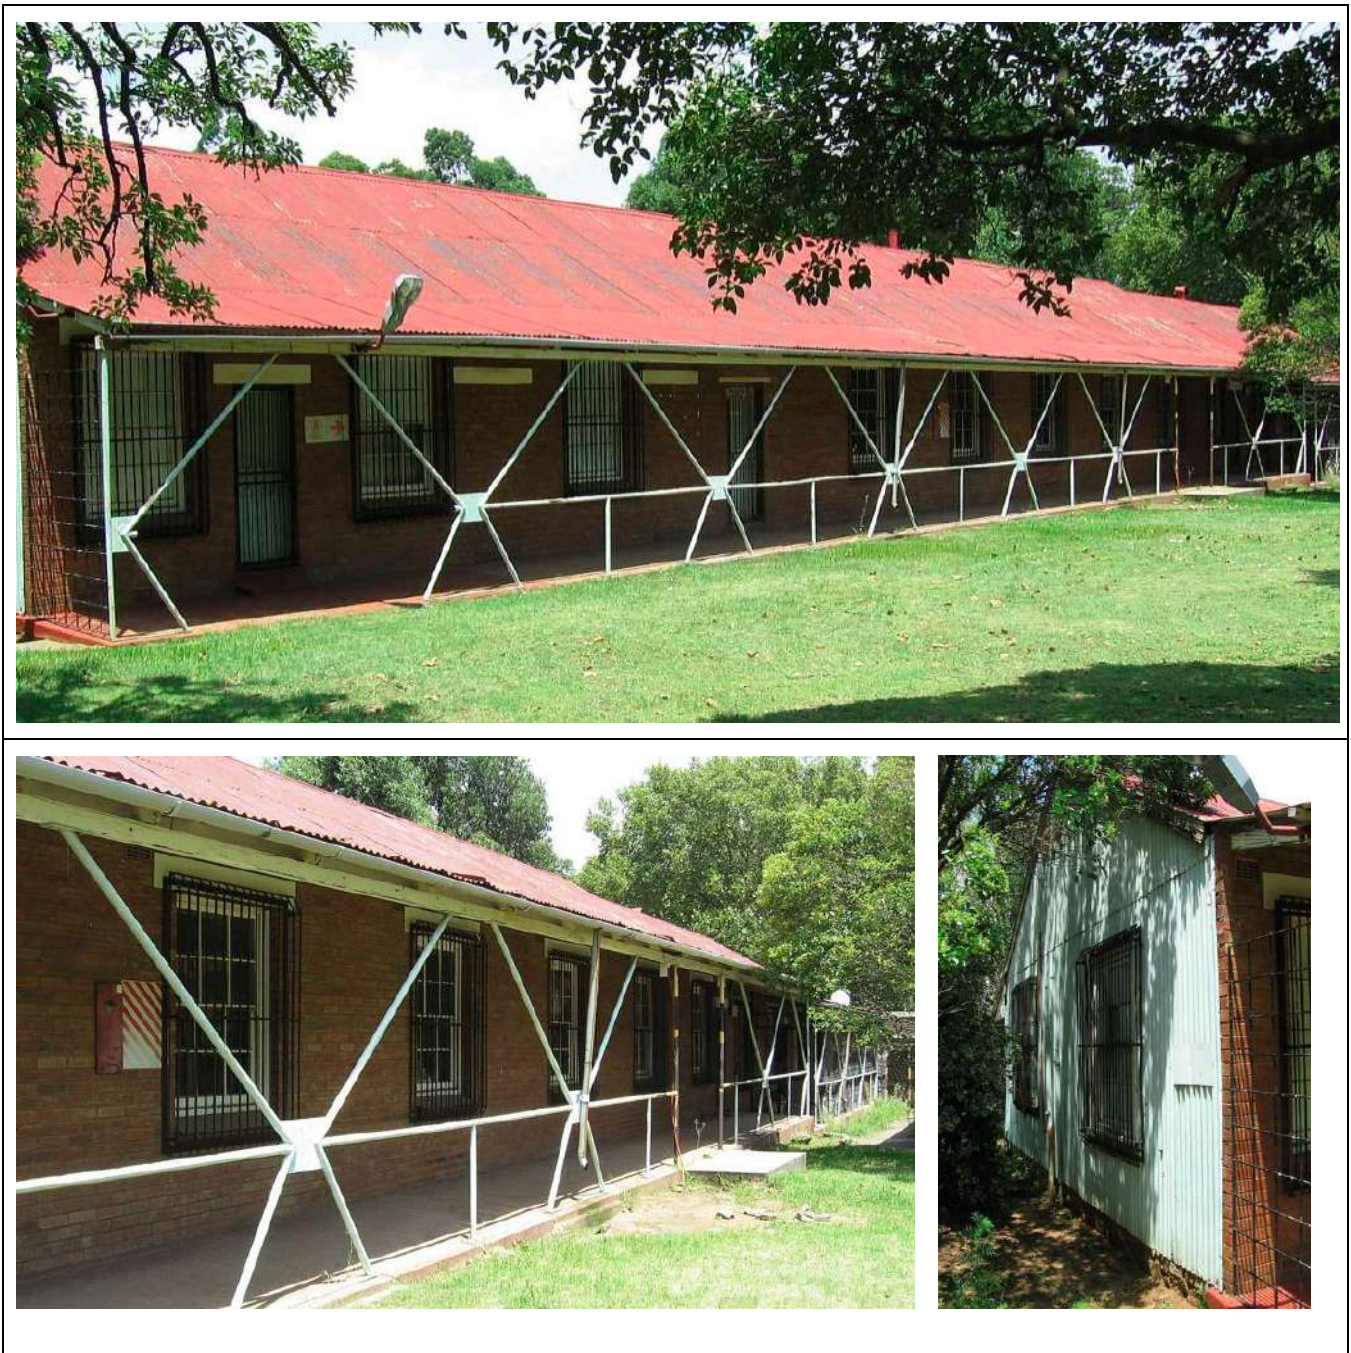
One example of this building type is located within Precinct 10 and the entire study area. It has an elongated rectangular floor plan constructed with red face brick and a saddle corrugated iron roof. The roof along the entire front façade extends to form a verandah roof over what must have served as an exterior passage way linking all the offices. Large wooden sash windows with concrete lintels occur along both facades. The northern end of the building is clad with corrugated iron sheets.

Figure 84 – General views of Building Type 40.

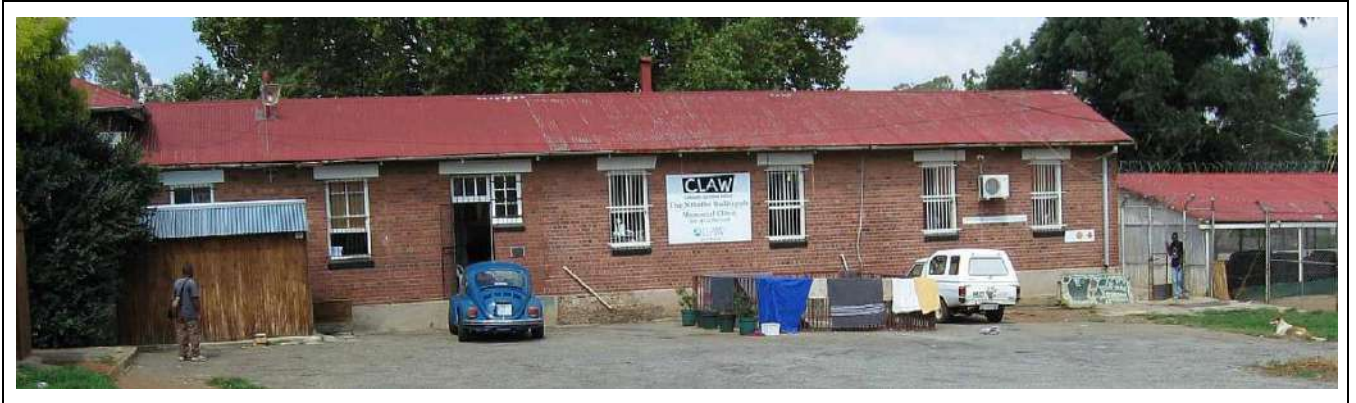
A narrow rectangular office block of face brick with a saddle corrugated roof is located here. The western facade contains six large wooden sash windows, two smaller windows and a single entrance suggesting its use as support buildings to the main office complex but also serving as minor offices. The windows and door are defined by prominent concrete lintels.

Figure 85 – General view of Building Type 41.

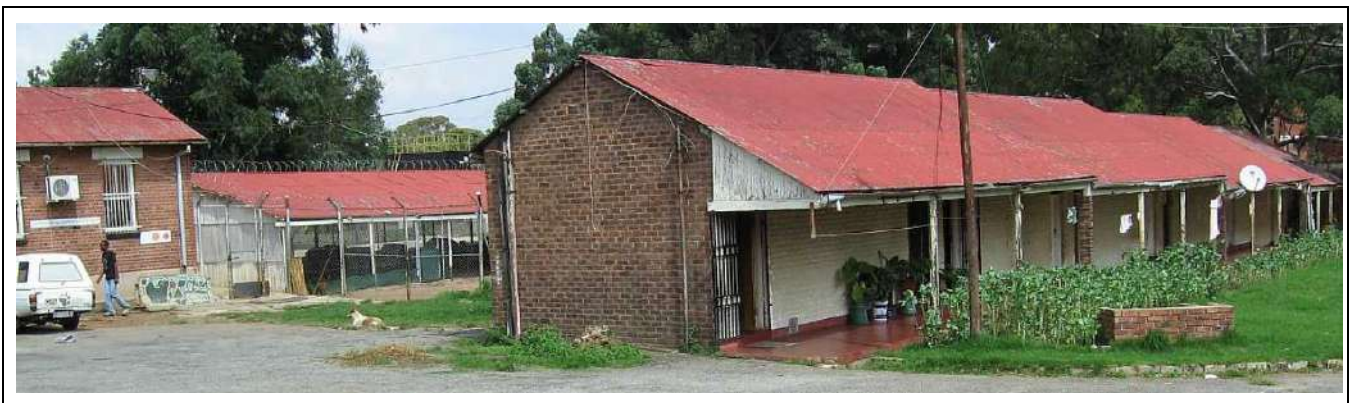
A narrow rectangular office block, slightly different from the first office block in terms of form and spatial arrangement, is located here. It consists of several rooms arranged along a stoep but as the building slopes from one end to the other the roof structure is stepped along the slope. The entire complex has a saddle roof of corrugated iron. The western facade has a covered verandah serving as a passage to and from the various rooms. Each of the four units has two doors, one on each end.

Figure 86 – General view of Building Type 42.

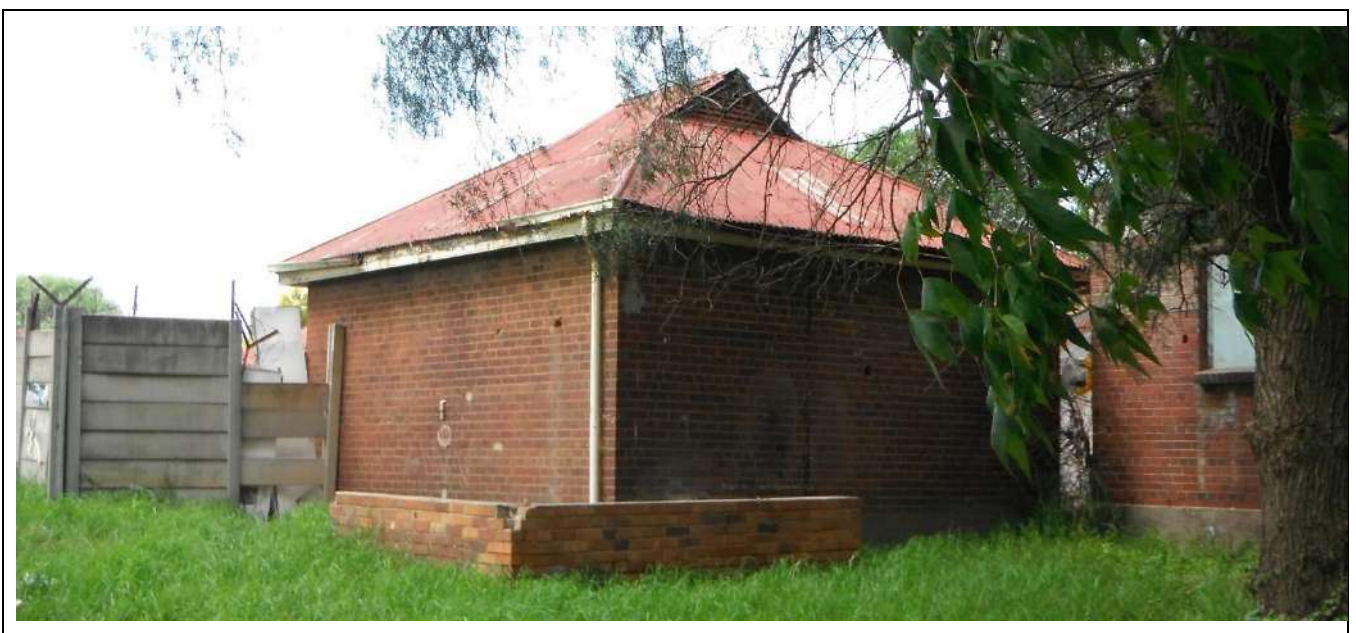
A square storage building of red face brick is located here. It has a broken hipped roof and ventilators at the end of the ridging. The lack of windows suggests that it was used as a storage space.

Figure 88 – General view of Building Type 44.

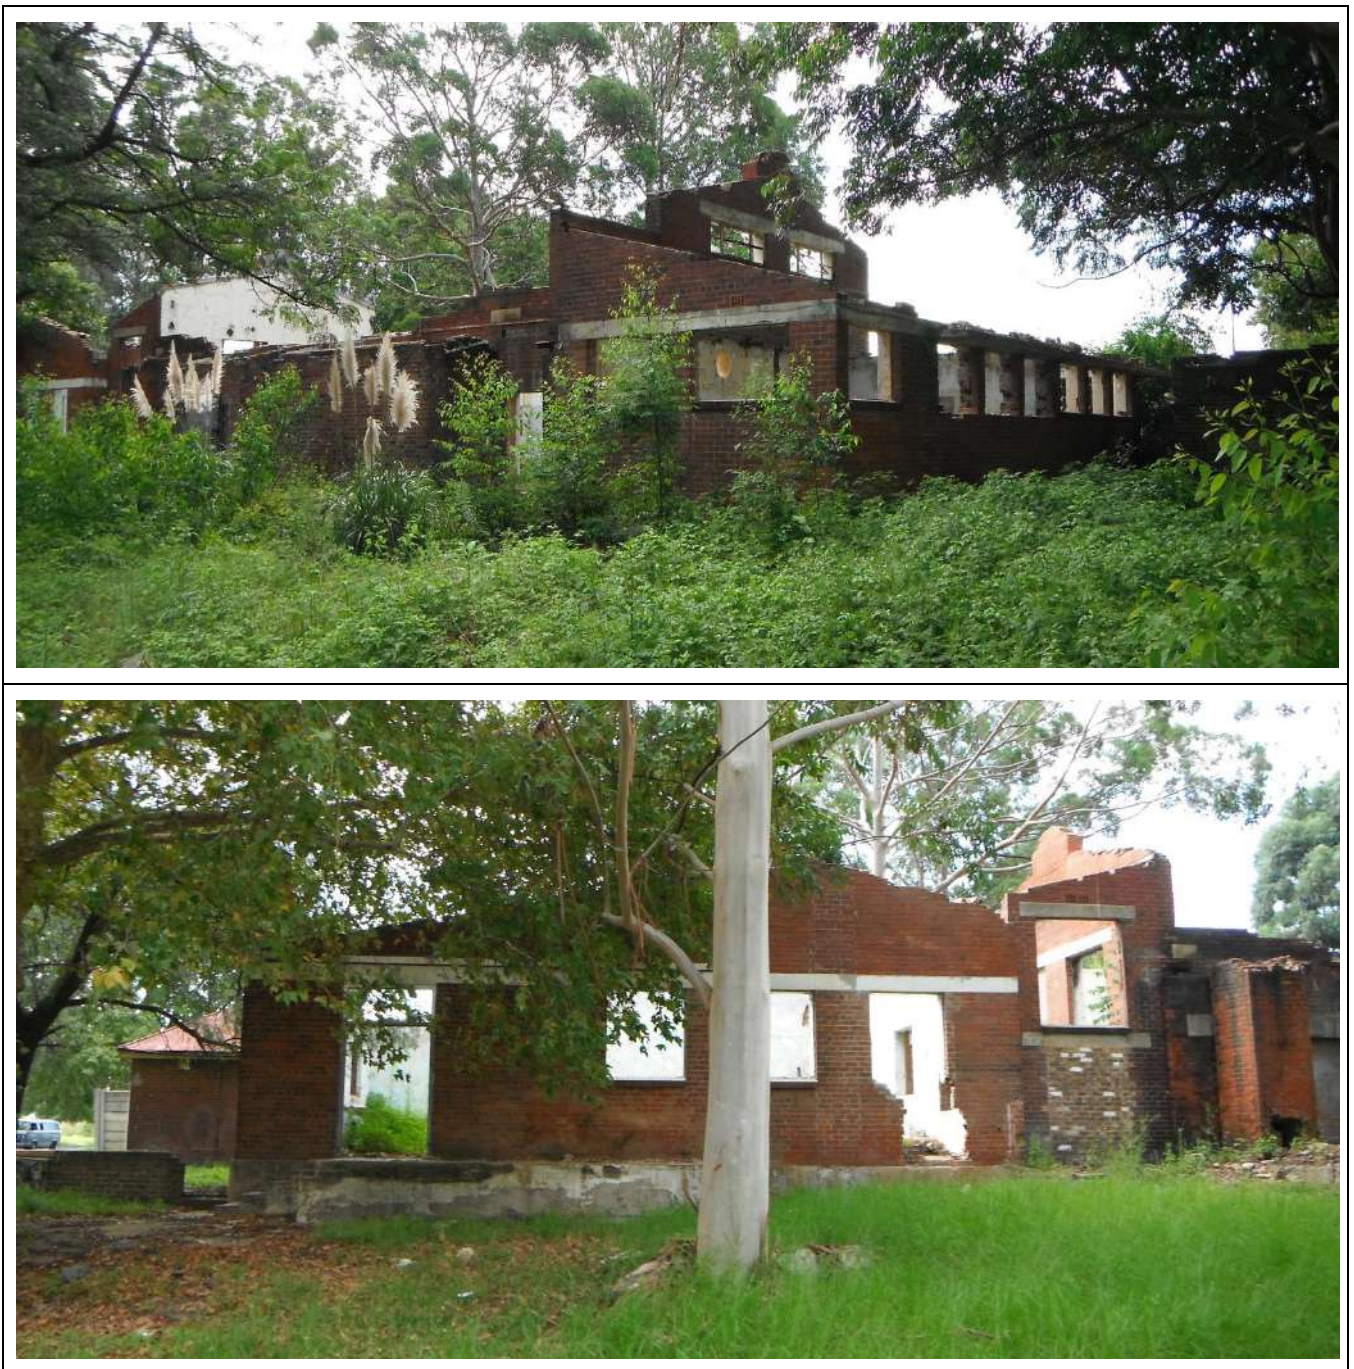
Remains of a red face brick building of which the function remains unknown. The entire roof structure and all the windows and doors have disappeared. It is a large rectangular block with concrete lintels serving as lintels for all the windows and doors. The building's function is difficult to ascertain due to the present condition, but it could have been used as a 'change room' complex.

Figure 89 – General view of Building Type 45.

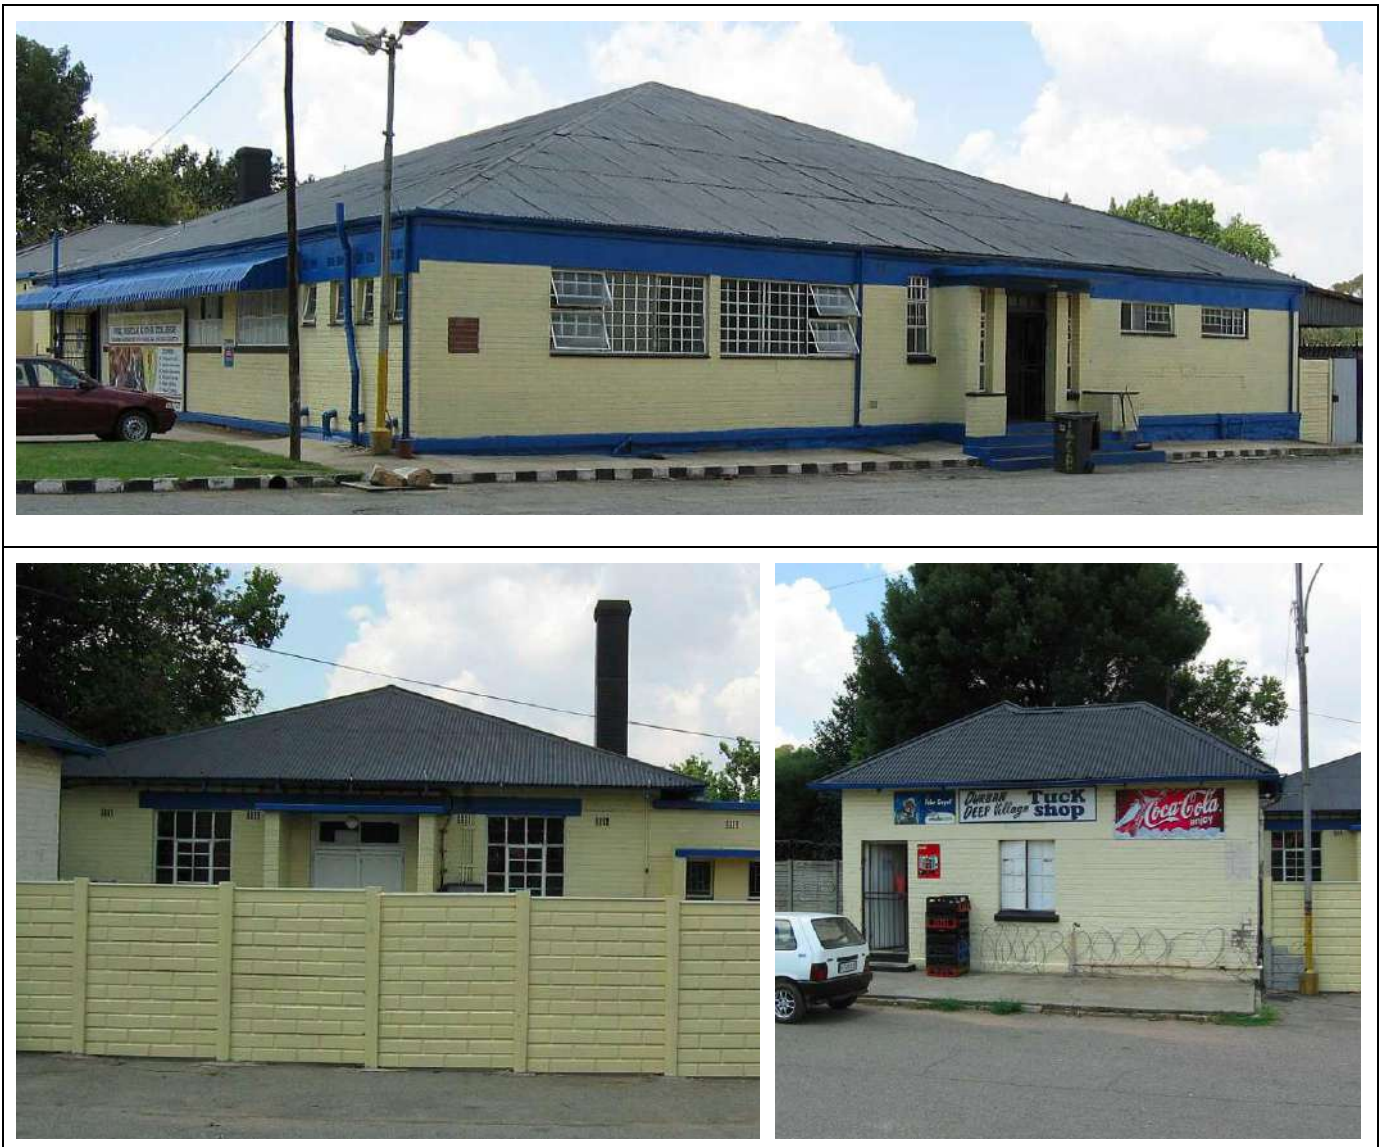
The building was used as the DRD Recreation Hall where mine functions, dances and dinners took place. Weddings of mine employees and their families also took place here (James, 2012). It is a large square building with a pyramid-shaped corrugated iron roof. The building is constructed with plastered face bricks with steel frame windows.

A dwelling is located north of the recreation hall, and must have been a residence for the caretaker cum manager of the recreation hall. The dwelling has a pyramid-shaped corrugated iron roof with steel framed windows and a single brick chimney. A small kiosk, with a hipped corrugated iron roof is the third in the cluster of these buildings.

Figure 90 – General views of Building Type 46.

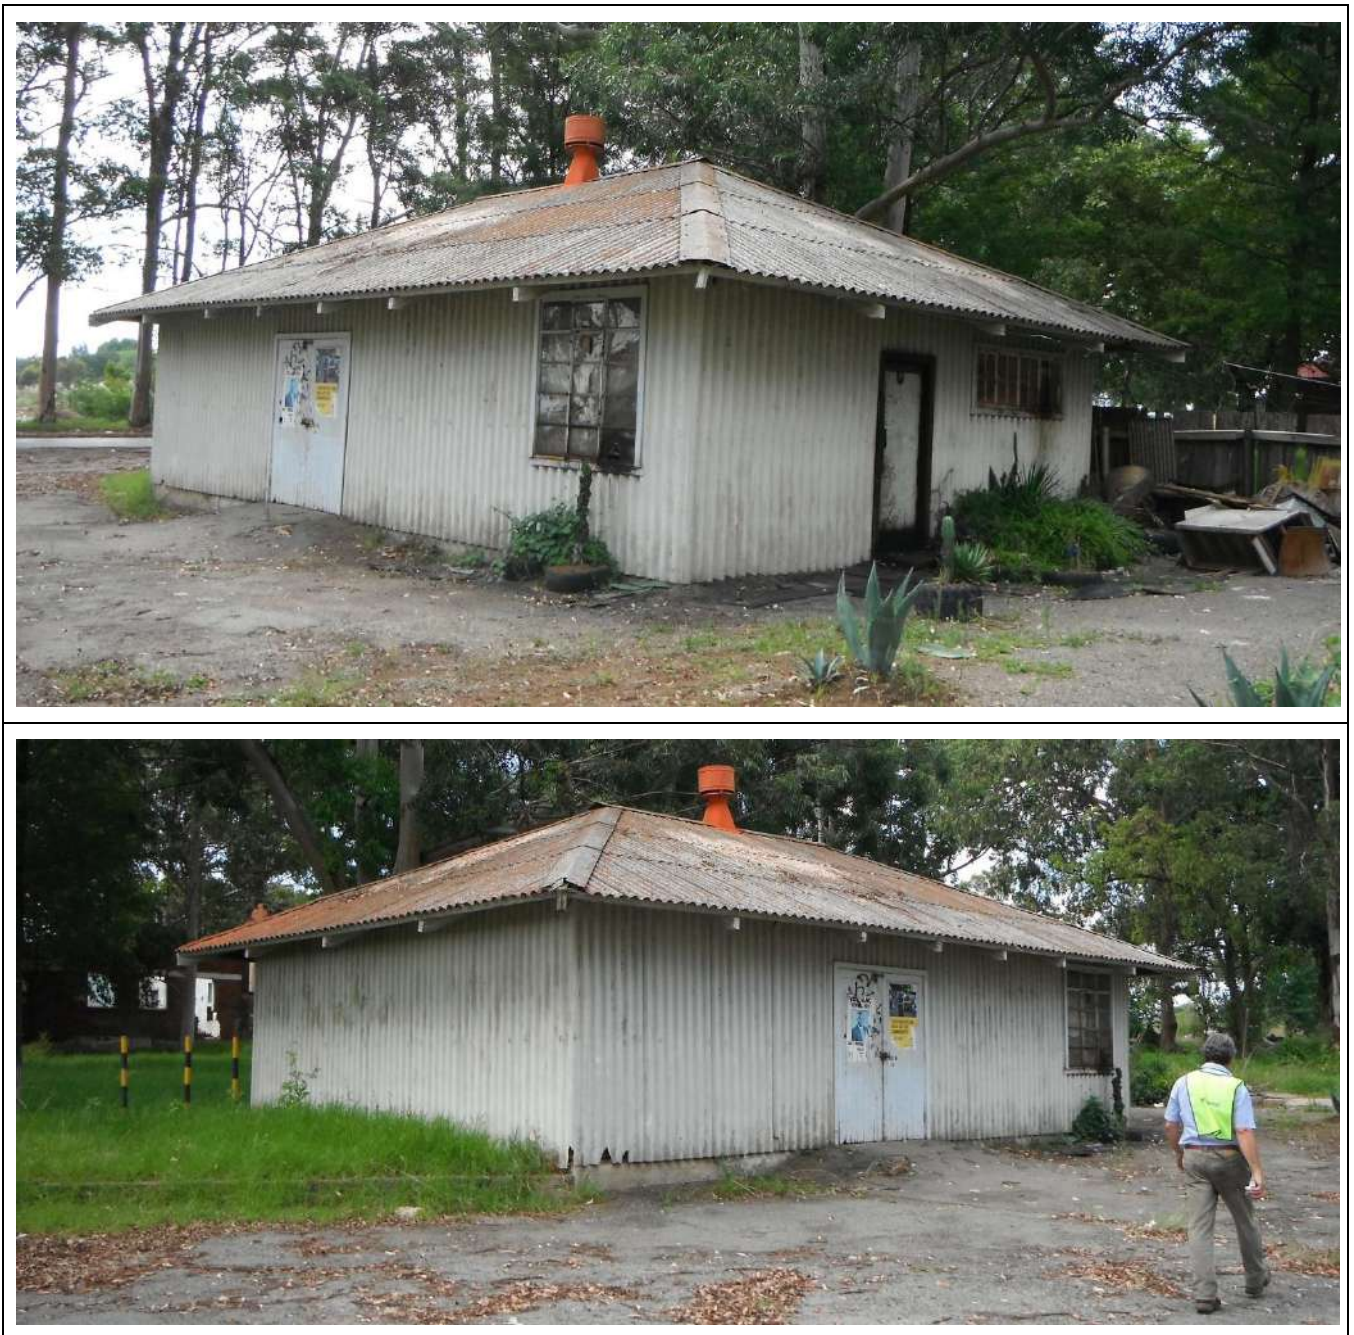
This is a unique building as it is the only one of its kind. It is a small rectangular structure constructed with corrugated ferro-cement (or asbestos) sheets (walls and roof). Steel frame windows and doors are installed in the building. The building has a hipped roof with a single cylindrical plate metal turret located on the ridge in the centre of the roof. The building is located between the DRD offices and the compound to the south-east and may have been an office building for black senior employees of the mine.

Figure 91 – General views of Building Type 47.

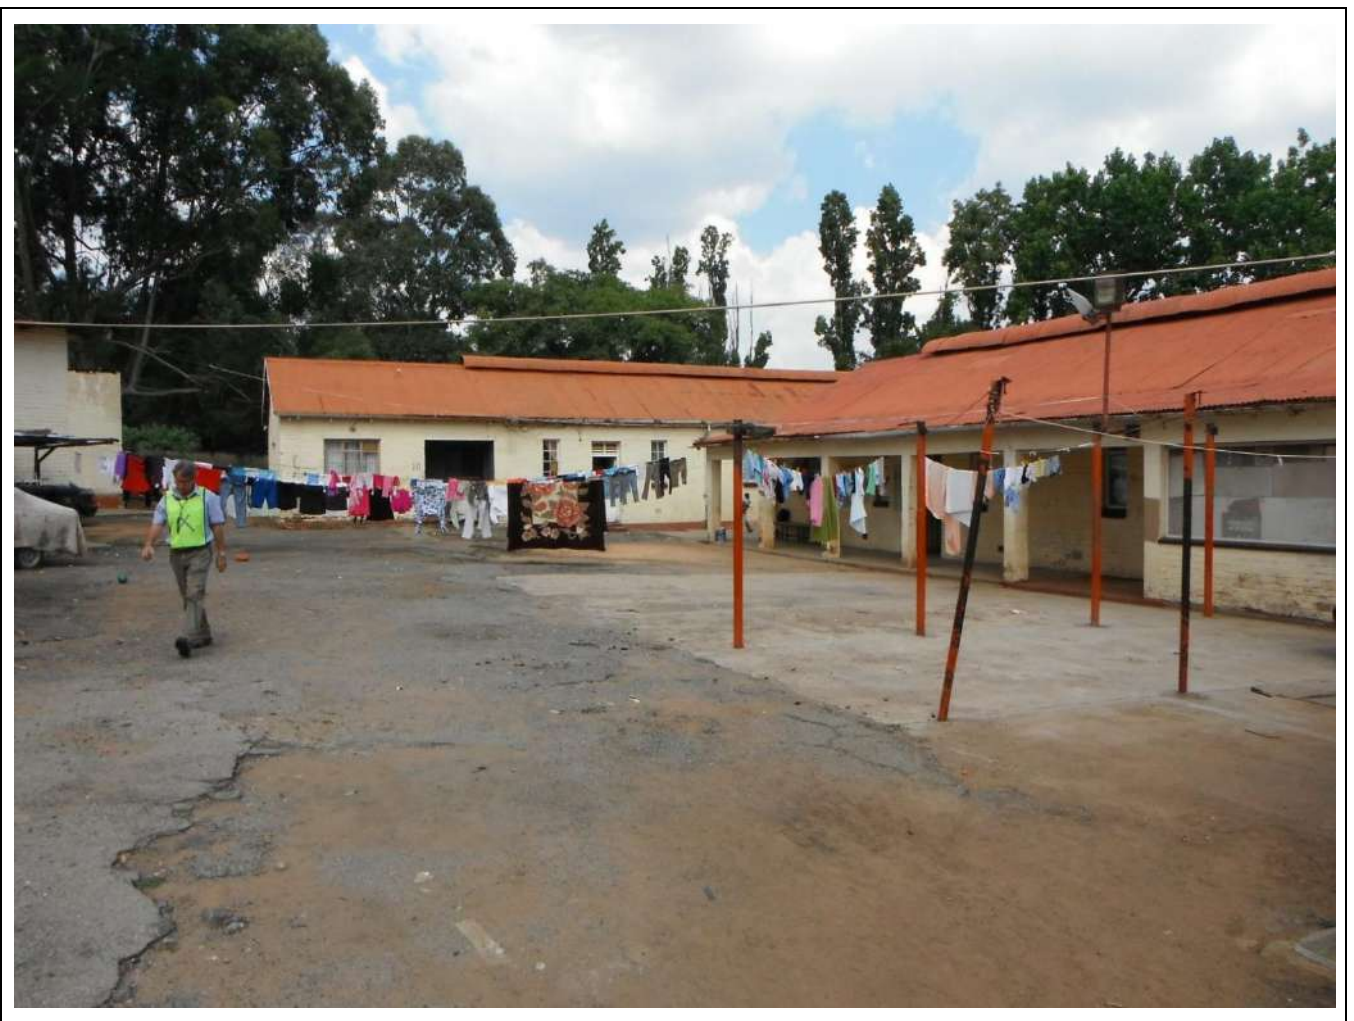
This is not a single building but a complex of six buildings used as housing (formerly referred to as a mining compound). The two most prominent (and extensive) buildings are two rectangular residential blocks with pitched corrugated iron roofs with arched ridge vents along sections of each roof. Some variations in the style of the buildings occur, with a section of one building having a hipped roof and another having a parapet roof. All the buildings are constructed with plastered brickwork and have steel frame windows.

Figure 92 – General view of Building Type 48.

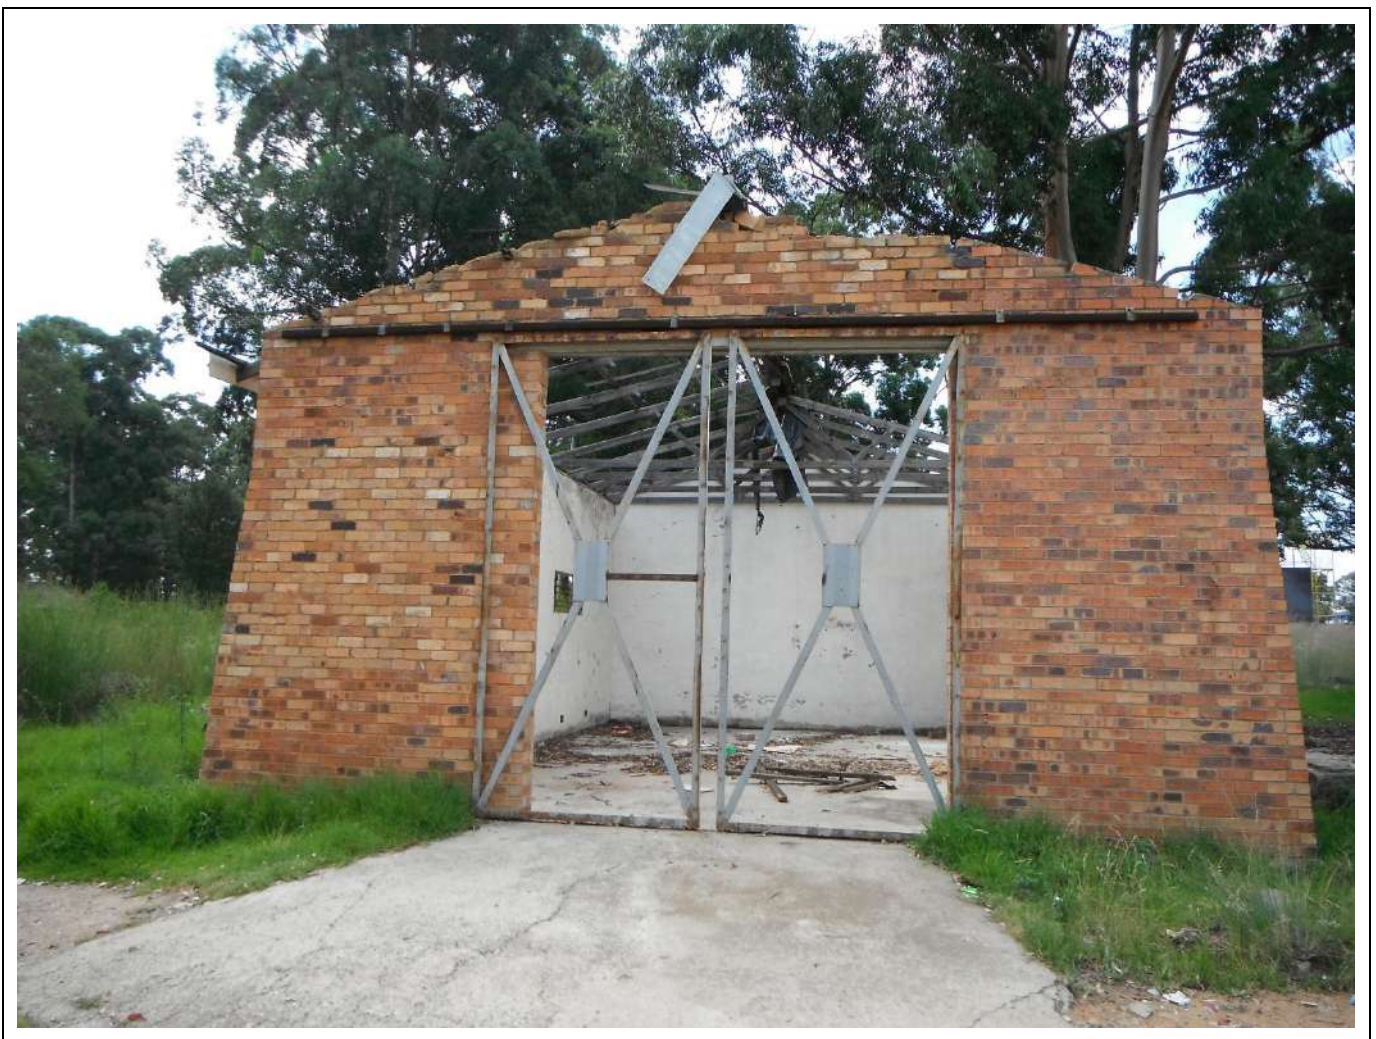
It is the only one of its kind in Precinct 10. Another example occurs in Precinct 2. It is a rectangular structure with walls of yellow face brick and pitched corrugated iron roof. The exterior corners taper towards the roof creating an illusion of buttressing. The building is associated with the electrification of the mine village and more than likely housed an electric transformer.

Figure 93 – General view of the Building Type 14 structure that was identified within Precinct 10.

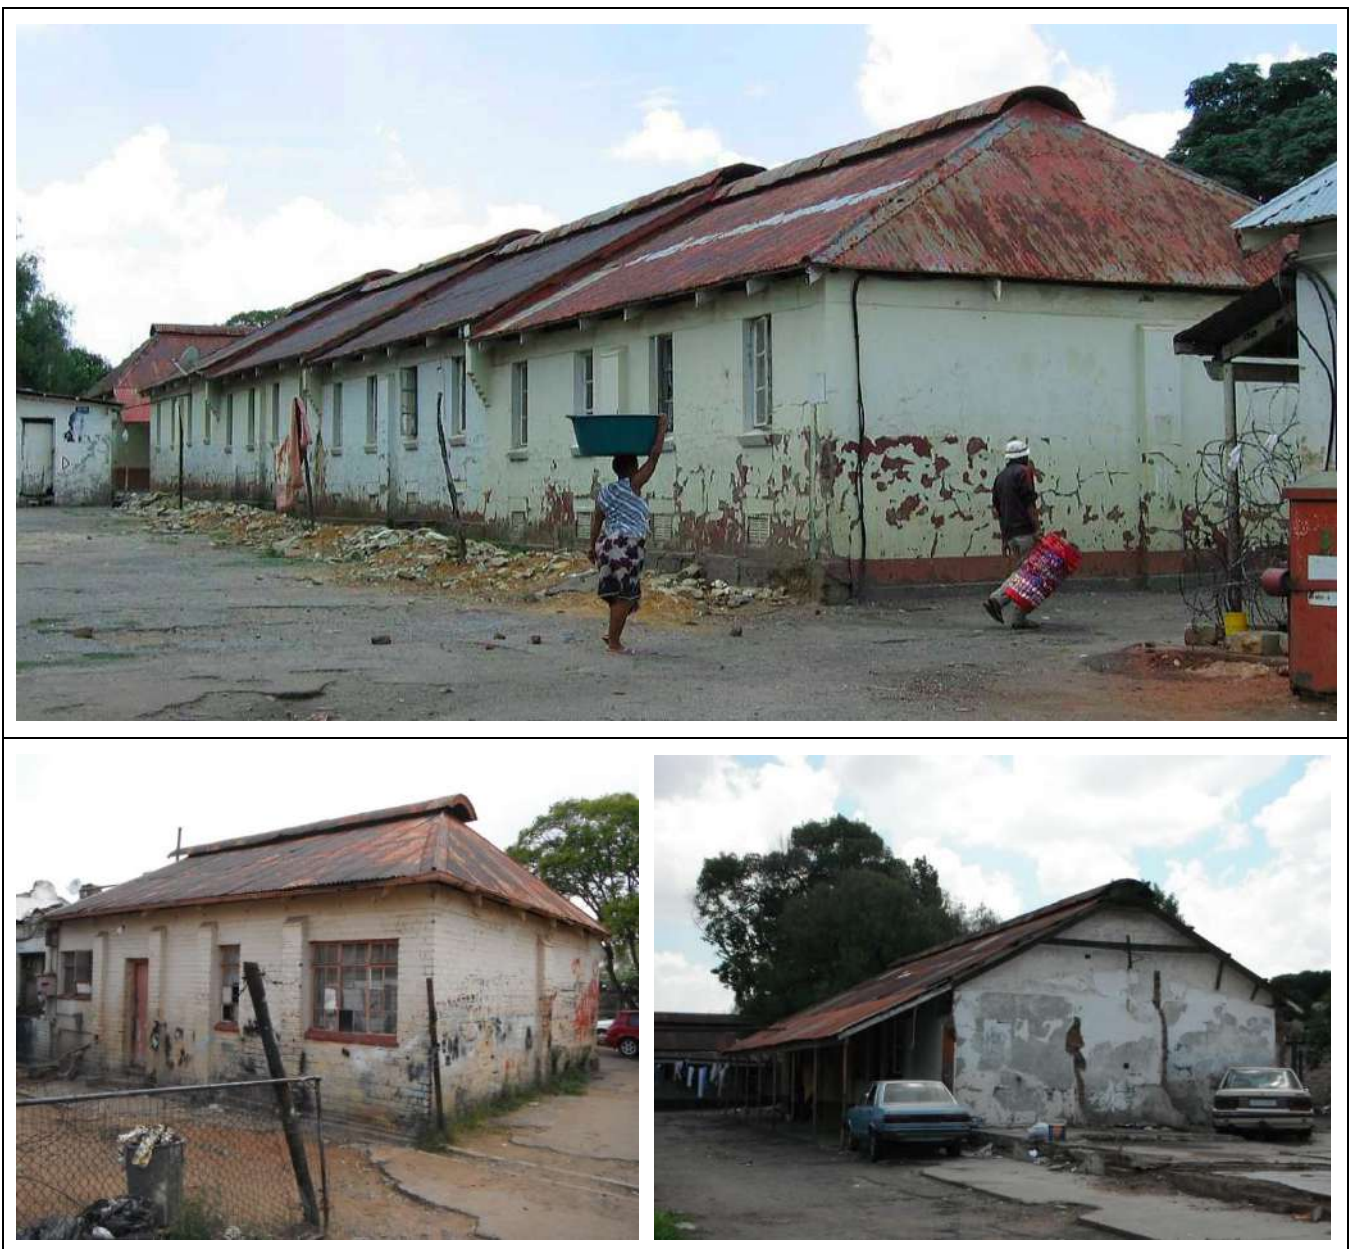
Four examples of this building type are located within Compound 2. It contains architectural elements of the original stone compound in terms of the roof structure with arched corrugated iron vents but was constructed with plastered brick and are located inside the original stone compound. However it is wider and the roof and ceilings are higher. Small almost decorative corbelling occurs along the facades. The building is also divided into rooms that were once used to accommodate black mineworkers. The corrugated iron roof on one of the buildings of this type was recently replaced, although the general characteristics of the roof had been retained.

Figure 95 – General views of Building Type 50.

“Four examples of Building Type 50 are located within Compound 2. It contains architectural elements of the original stone compound in terms of the roof structure with arched corrugated iron vents but was constructed with plastered brick and are located inside the original stone compound. However, it is wider and the roof and ceilings are higher. Small almost decorative corbelling occurs along the facades. The building is also divided into rooms that were once used to accommodate black mineworkers. The corrugated iron roof on one of the buildings of this type was recently replaced, although the general characteristics of the roof had been retained.”

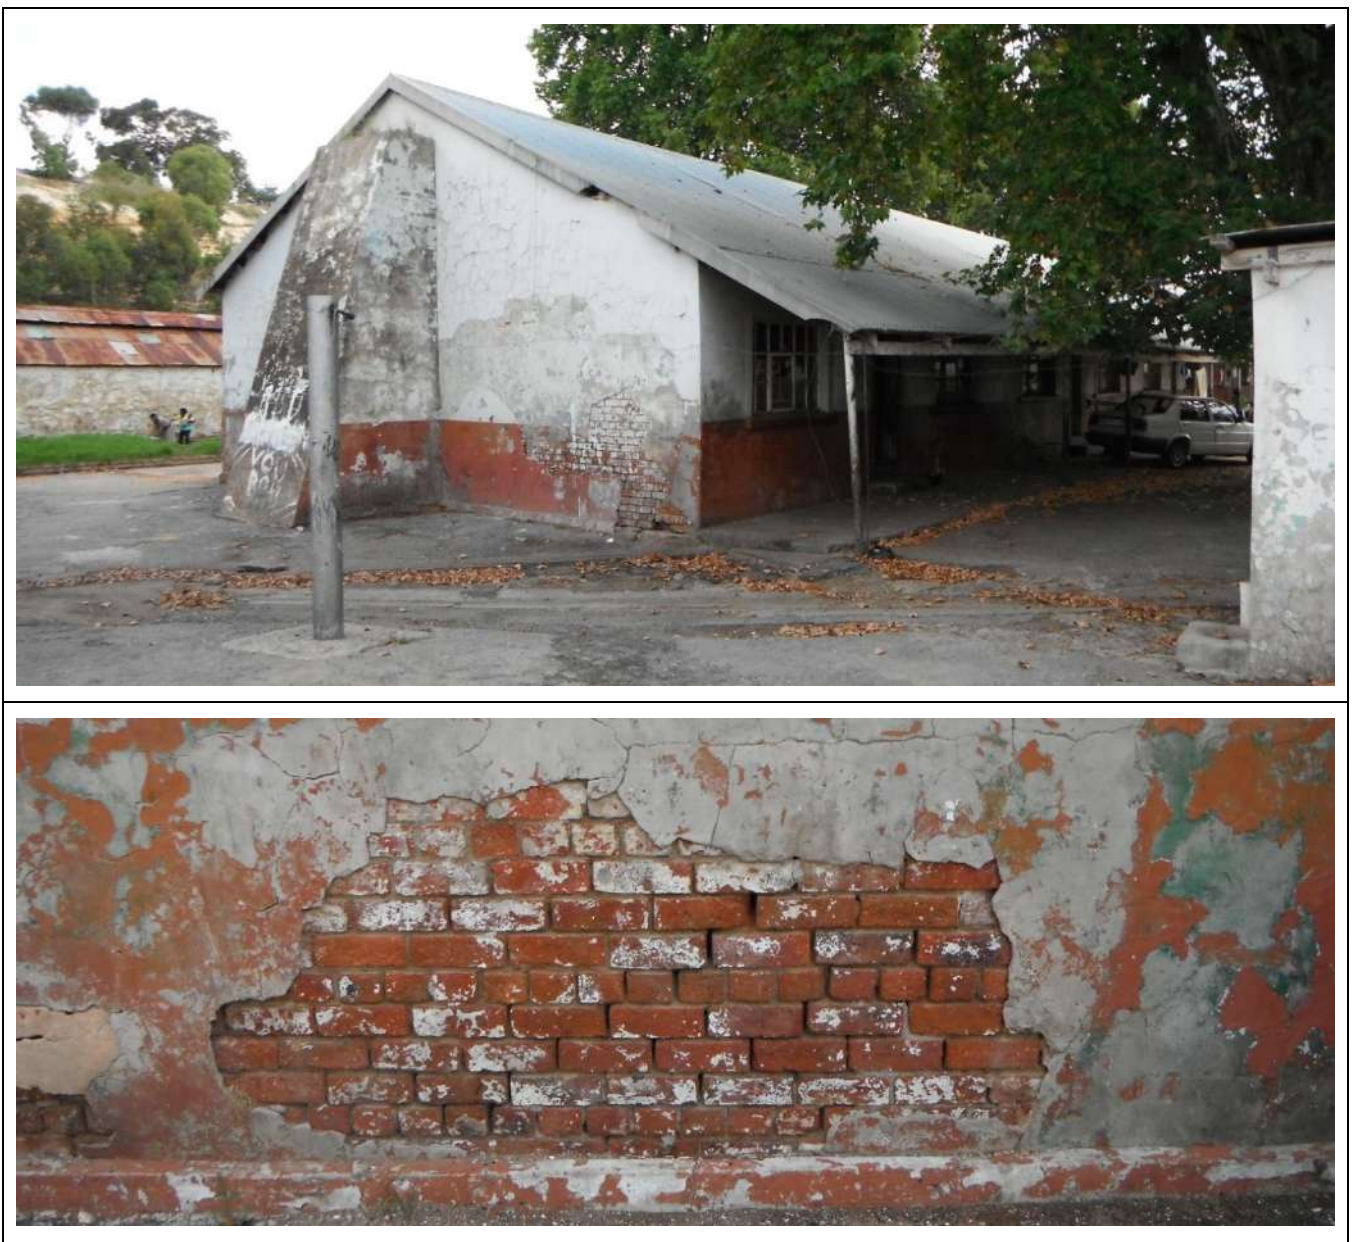
One example was located of the third building type identified within the compound area. It has a saddle roof with verandah extending directly along the gradient of the principal roof. The building is an elongated rectangular one constructed with plastered brick. A monumental buttress (which may have been a chimney stack) is located along the one gable end. The entire building has steel frame windows. Although the building is plastered and painted, English bond brick masonry was exposed in a small area where these have peeled off. One of the facades is covered with a verandah serving as walkway to reach the rooms and a social area facing the open enclosure.

Figure 96 – General views of Building Type 51.
