PHASE 1 HERITAGE IMPACT ASSESSMENT

Proposed Establishment of Goudrand Ext. 5, Goudrand Ext. 6, Goudrand Ext. 7, Goudrand Ext. 8, Goudrand Ext. 9, Goudrand Ext. 10, Goudrand Ext. 11, Goudrand Ext. 14, Goudrand Ext. 15, Goudrand Ext. 16, Goudrand Ext. 17, Goudrand Ext. 18 and Goudrand Ext. 19, located in the Roodepoort Magisterial District, City of Johannesburg Metropolitan Municipality, Gauteng Province

Issue Date: 20 June 2018
Revision No.: 2
Client: Hunter Theron Incorporated

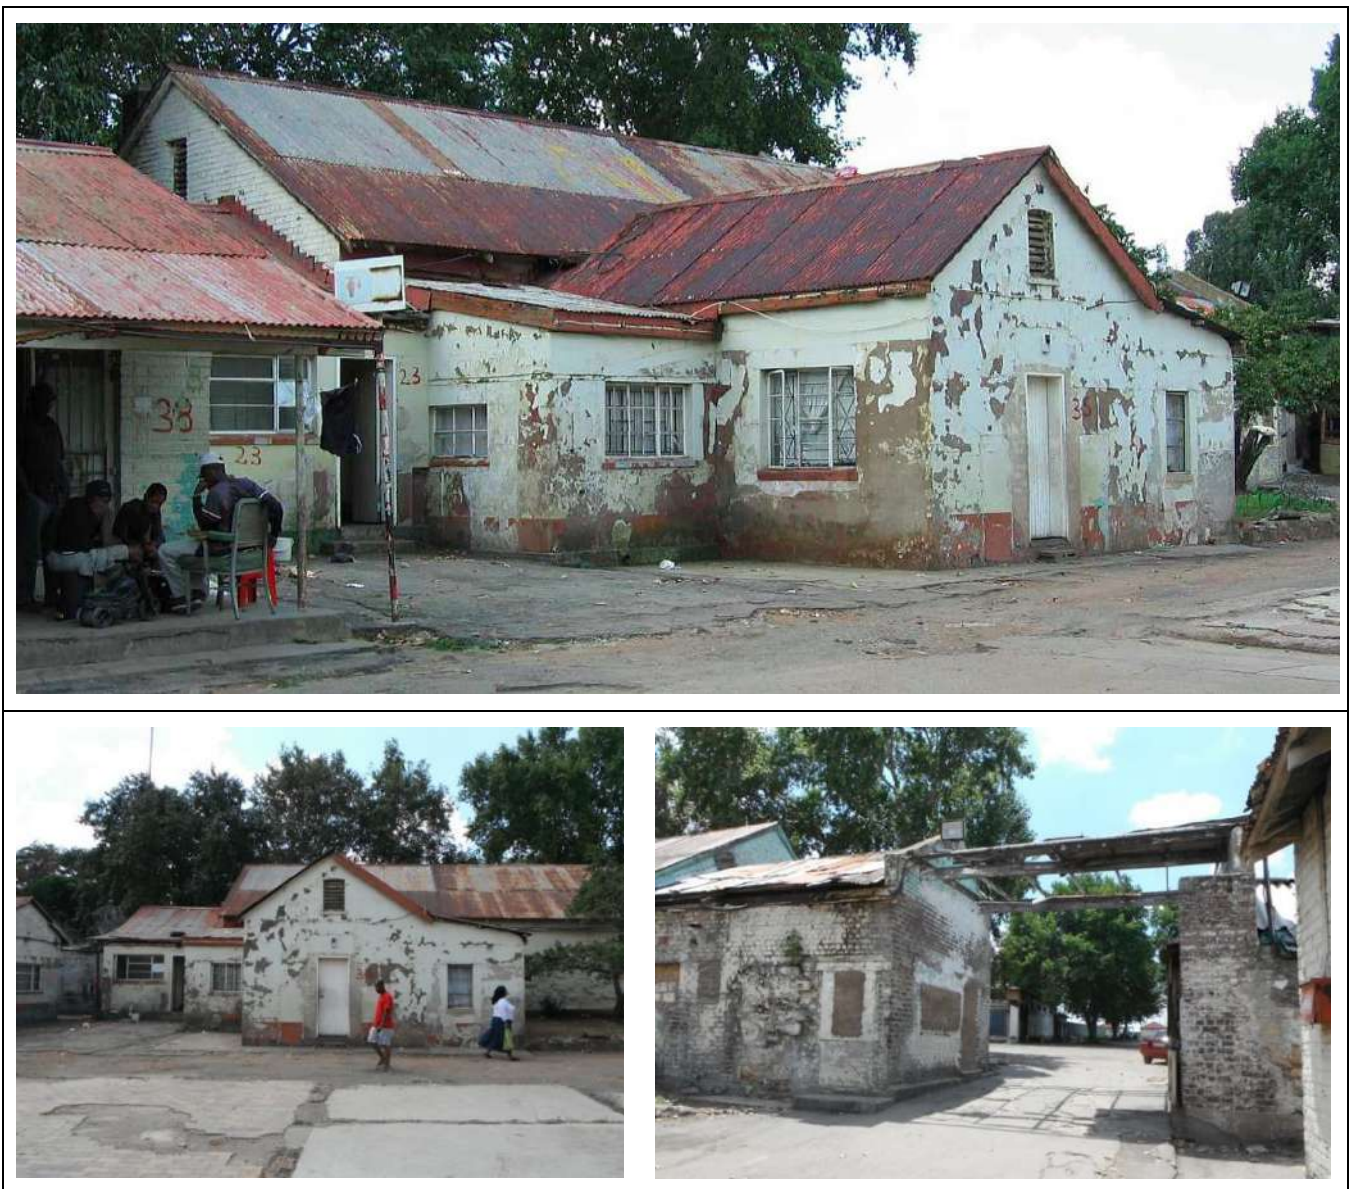
One example of this building type - the fourth one to be identified within the compound area - is located here. It comprises a cluster of four individual buildings associated with the main entrance of the compound. The first of the buildings (not illustrated) is a small rectangular brick structure with a pitched corrugated iron roof which is situated directly inside the entrance. The second building appears to be a dwelling with a pitched corrugated roof and a closed verandah at its eastern facade. The tallest building is located behind this building. The latter building has a pitched corrugated iron roof and plastered brick walls. The fourth component of this cluster type is the entrance itself, which is flanked by two single storey brick buildings.

Figure 97 – General views of Building Type 52.

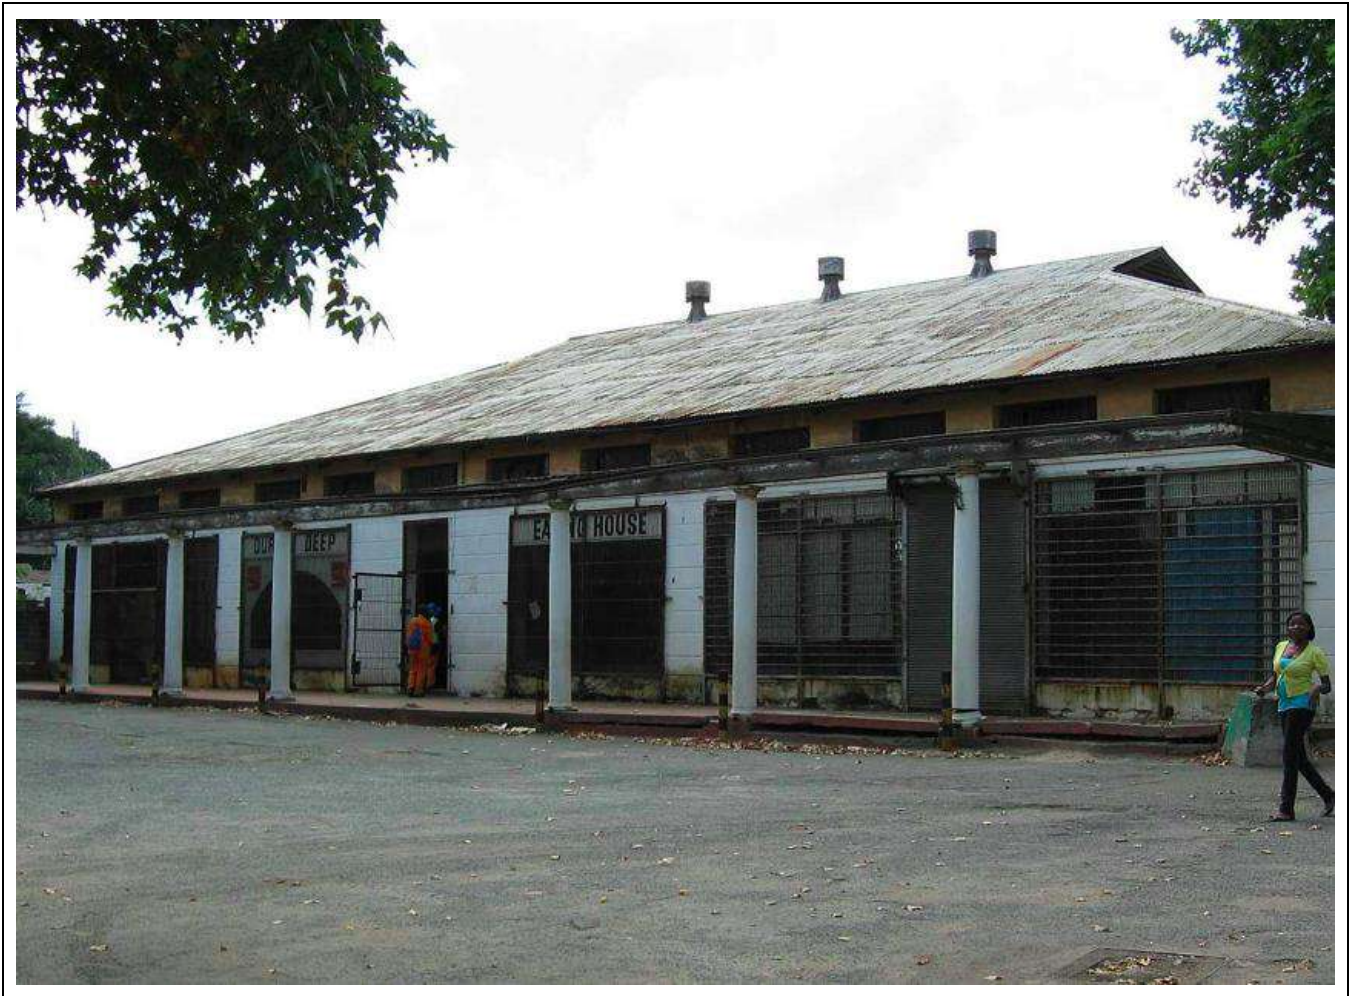
This building is located some distance (north-west) of the main entrance into Compound 2 and is known as the “Durban Deep Eating House”. It is a large building with a broken hipped corrugated iron roof with three turret vents arranged along the ridge of the roof. The ridging ends in two wooden air vents. The front facade of the building is characterised by a row of industrial vent windows almost under the eaves and six white columns supporting what must have been a verandah roof but it has been removed. The building functioned as an eating facility for the residents of the compound.

Figure 98 – General view of Building Type 53.

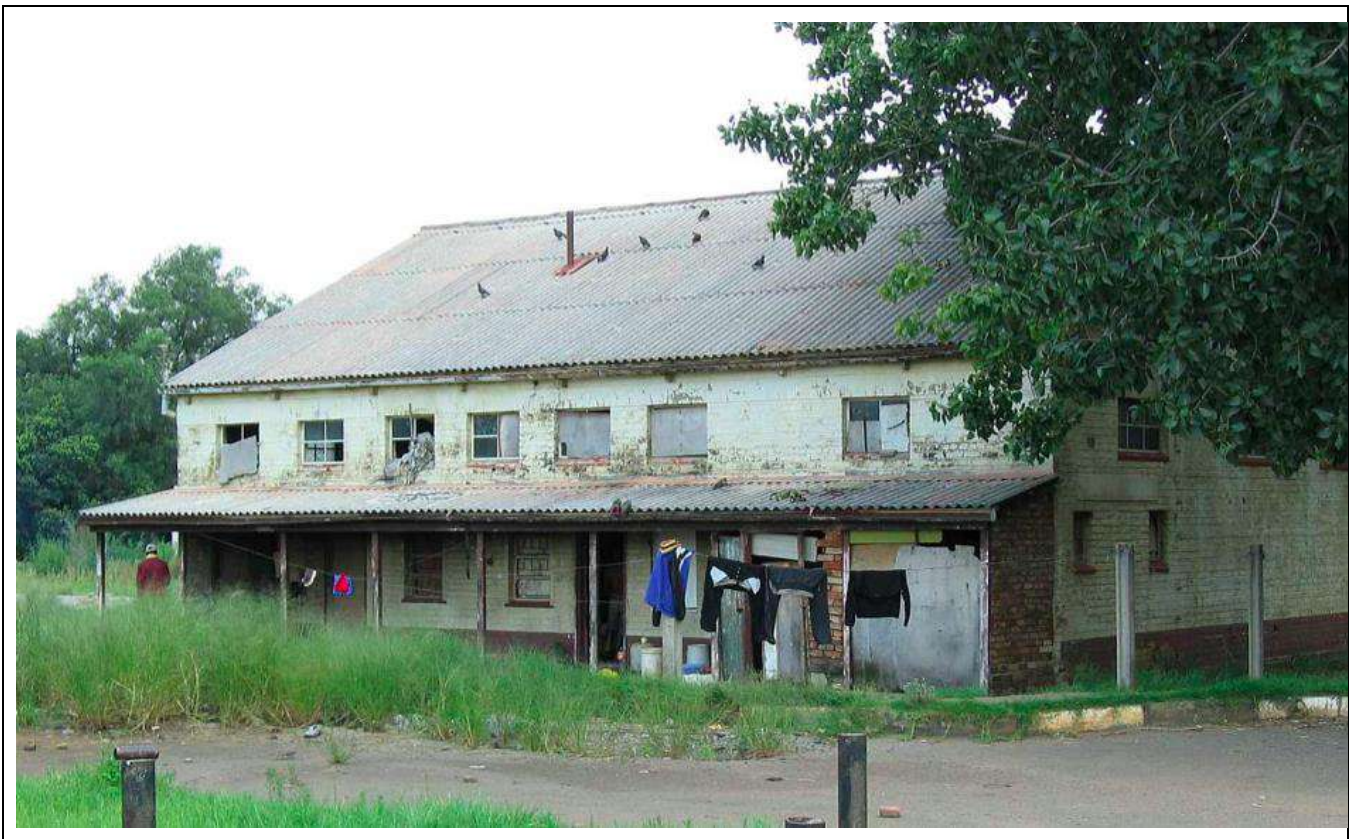
A short distance north-east of the main entrance to Compound 2 is a large rectangular double storey, brick building with a pitched roof. The building has a narrow covered verandah along the entire northern facade which provides access into the building from this side. Steel frame windows were installed throughout the building. Although the exact function of the building is not presently known, it may have been used as offices.

Figure 99 – General view of Building Type 54.

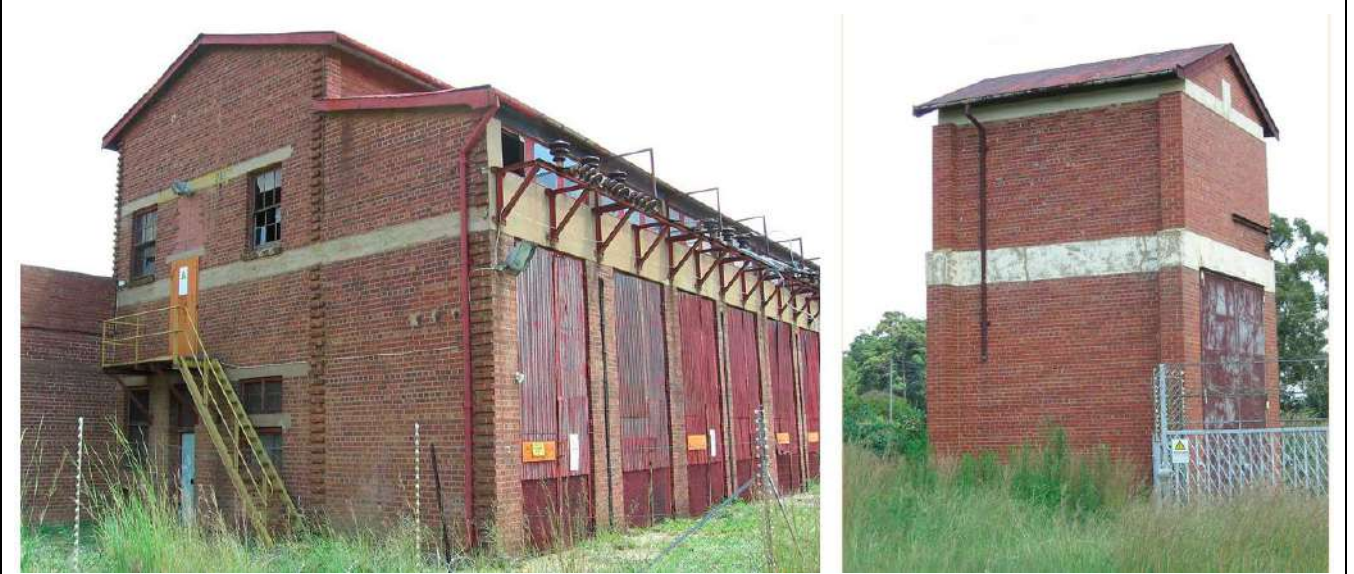
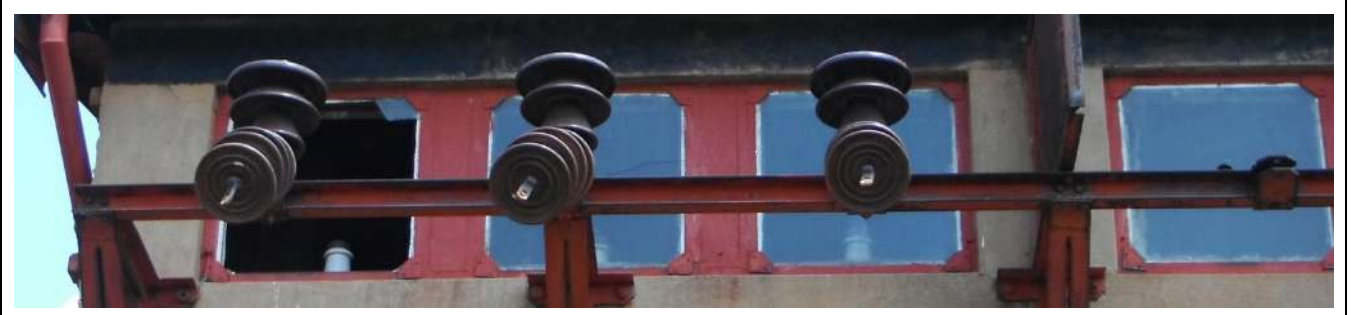
One example of this building type is located within the entire study area. It consists of a tall red face brick building that was used as an electrical substation. Insulators are still visible along the front facade of the building. The insulators are grouped into clusters of three, each cluster located in front of three small openings. The electrical supply line led from the building through the opening, passing the insulator and out towards the required transmission line. The area to be served by a cluster of three lines is indicated in white lettering on a dark strip of concrete directly above the openings.

Figure 100 – General and detailed views of Building Type 55.

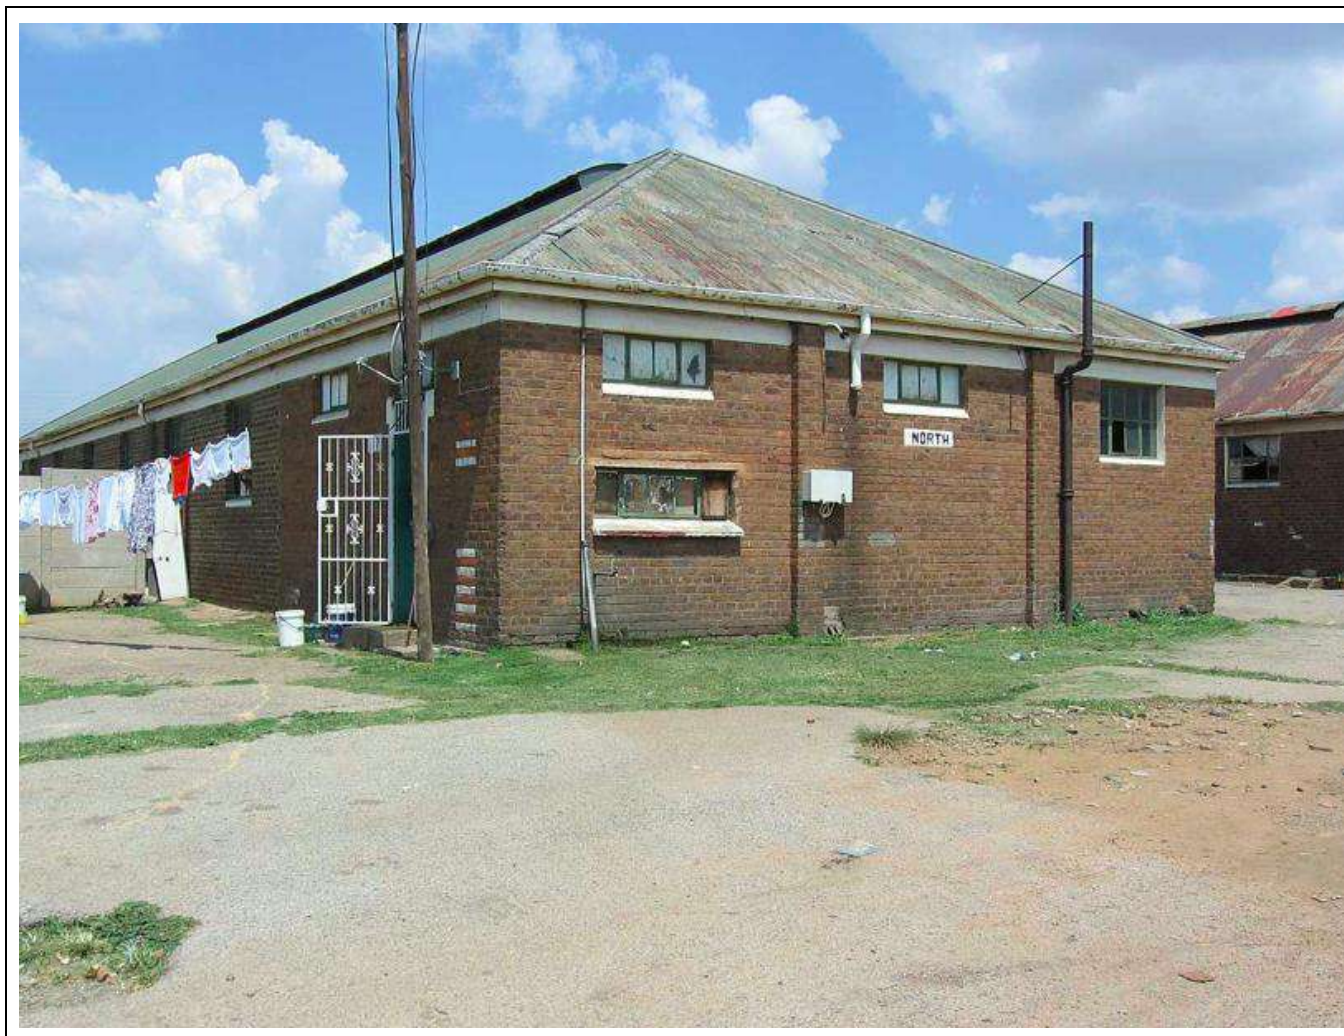
Two buildings of this building type are located within this precinct. They are of different scale and length. Both buildings are constructed with brown face bricks and have hipped corrugated iron roofs with a vent along the ridging. Steel-frame windows were used with large concrete lintels. The two buildings seem to be the oldest in the complex and would have been the first accommodation for black mineworkers in this compound.

Figure 101 – General view of Building Type 57.

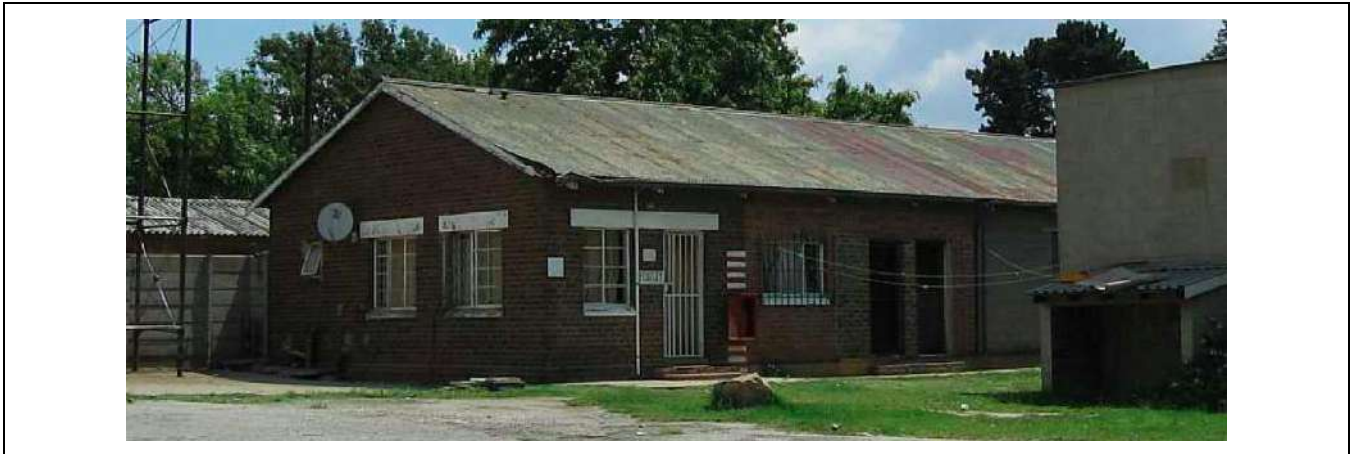
One building of this building type is located within this precinct. It consists of a rectangular face brick building with a pitched corrugated iron roof. Steel-frame windows were installed under large concrete lintels.

Figure 102 – General view of Building Type 58.

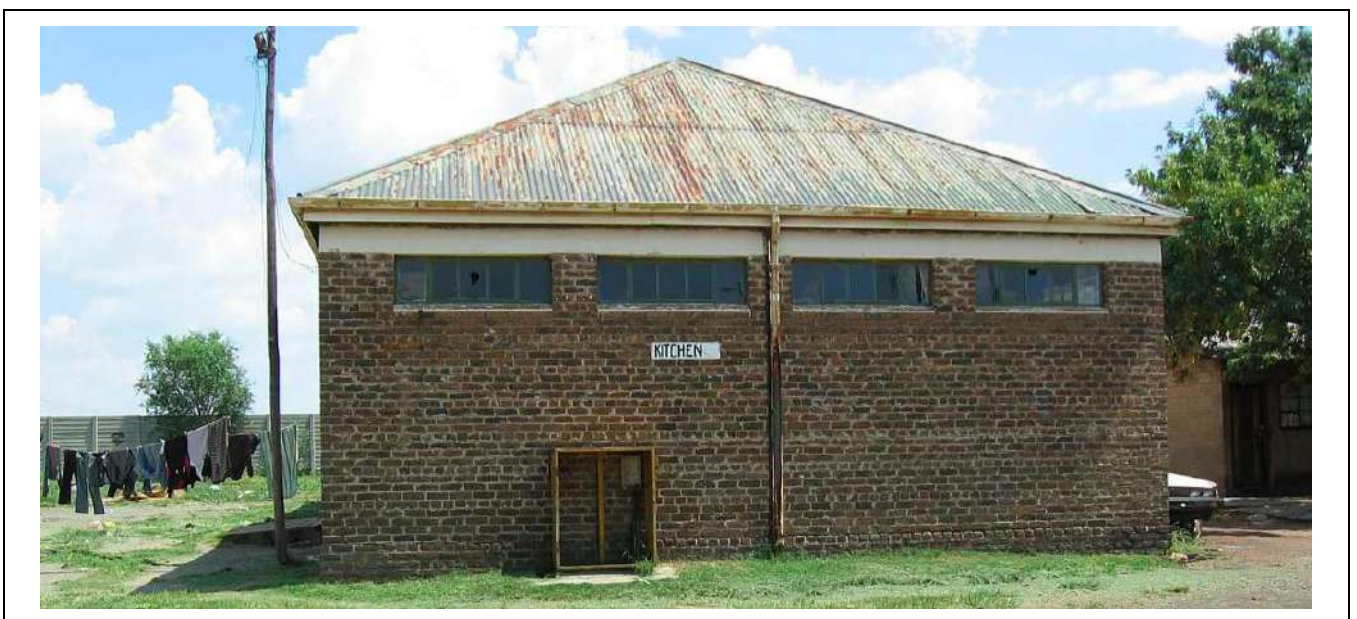
One building of this building type is located within this precinct. It comprises a rectangular face brick building with a hipped corrugated iron roof. The windows are all steel-framed and a single concrete beam serves as lintel for both doors and windows.

Figure 103 – General view of Building Type 59.

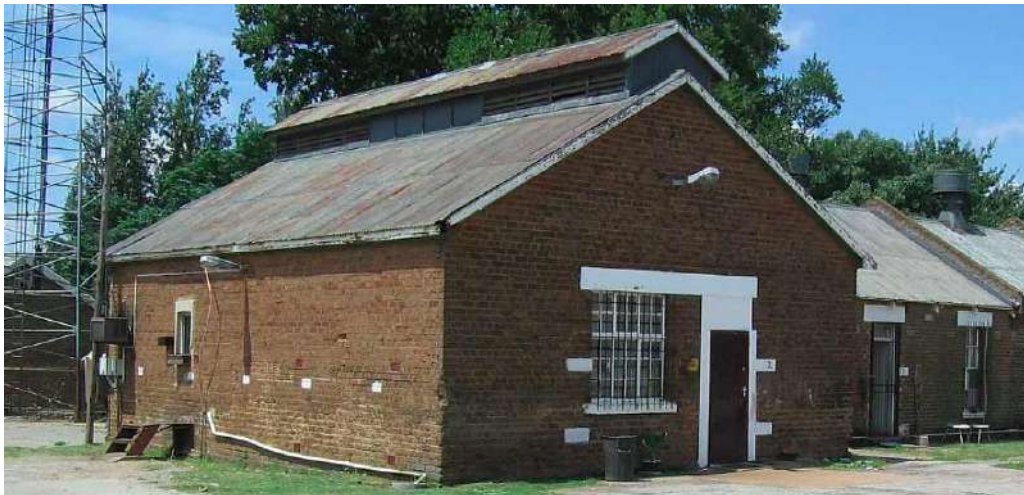
One building of this type is located within this precinct. It is a rectangular face brick building with a pitched corrugated iron roof containing an elevated chicken coop air vent along the ridging. Steel frame windows were installed under large concrete lintels.

Figure 104 – General view of Building Type 60.

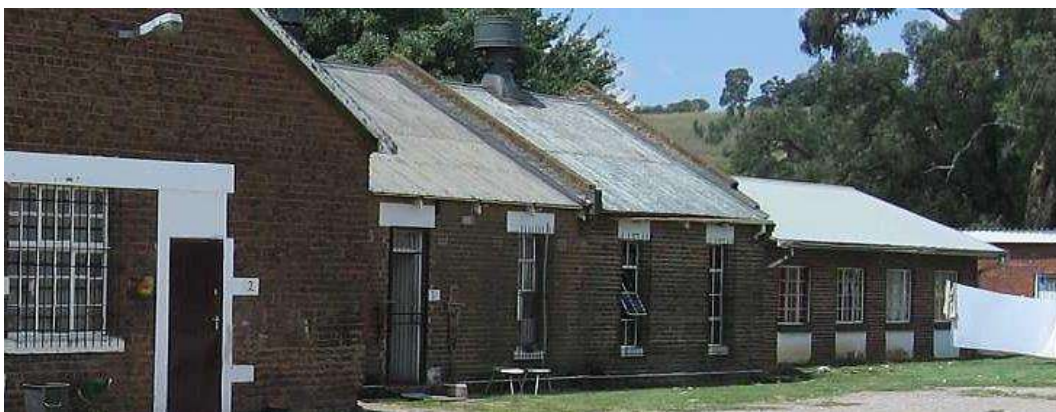
One building of this type is located within this precinct. It consists of a rectangular face brick building with a pitched corrugated iron roof divided into two sections by firewalls protruding above the roof. The roof also has sheet iron turret vents in the centre of each of the two sections. Steel frame windows are installed under large exposed concrete lintels.

Figure 105 – General view of Building Type 61.

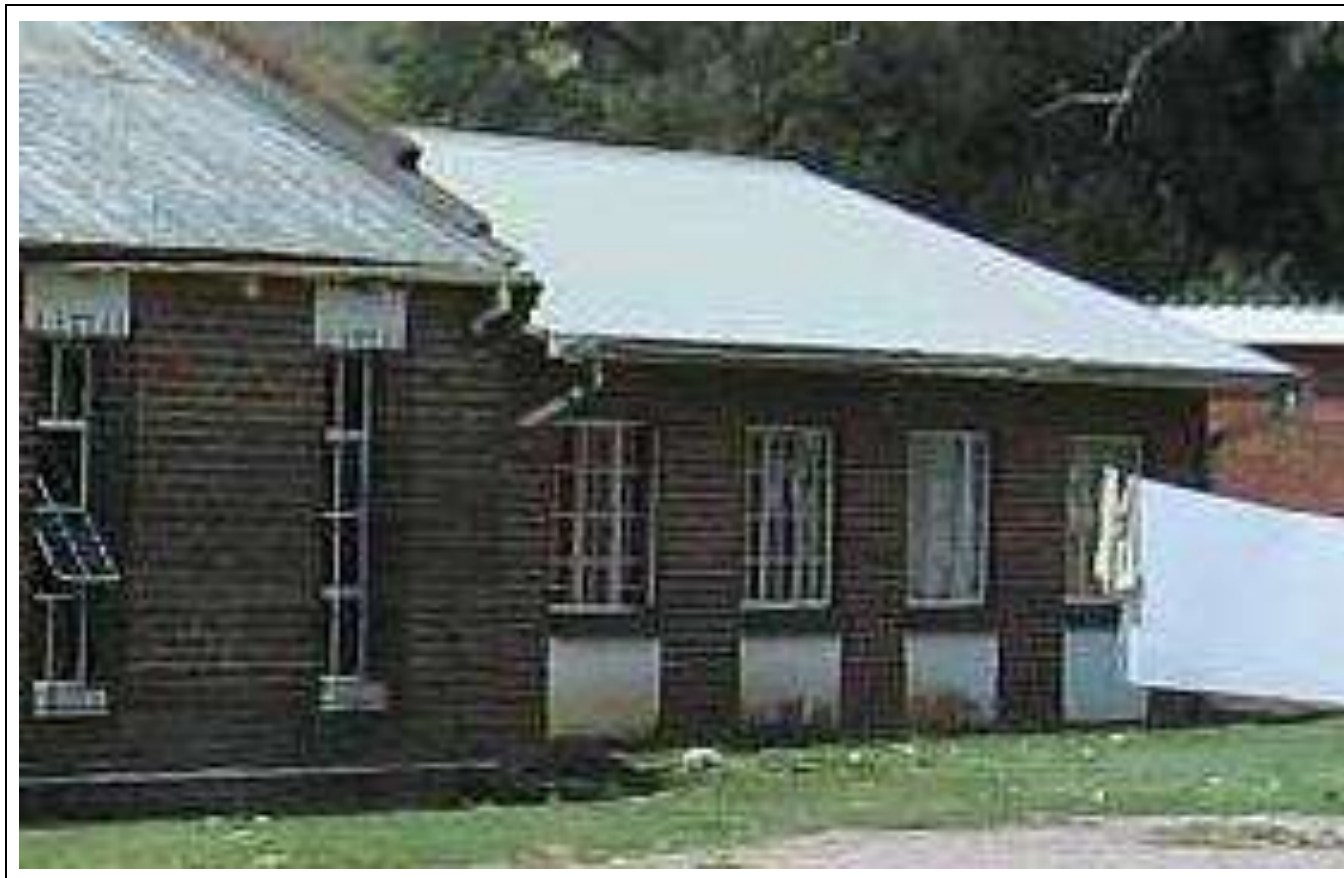
One building of this type is located within this precinct. It comprises a rectangular face brick building with a pitched corrugated iron roof. The windows are all steel-framed with concrete slabs as lintels.

Figure 106 – General view of Building Type 62.

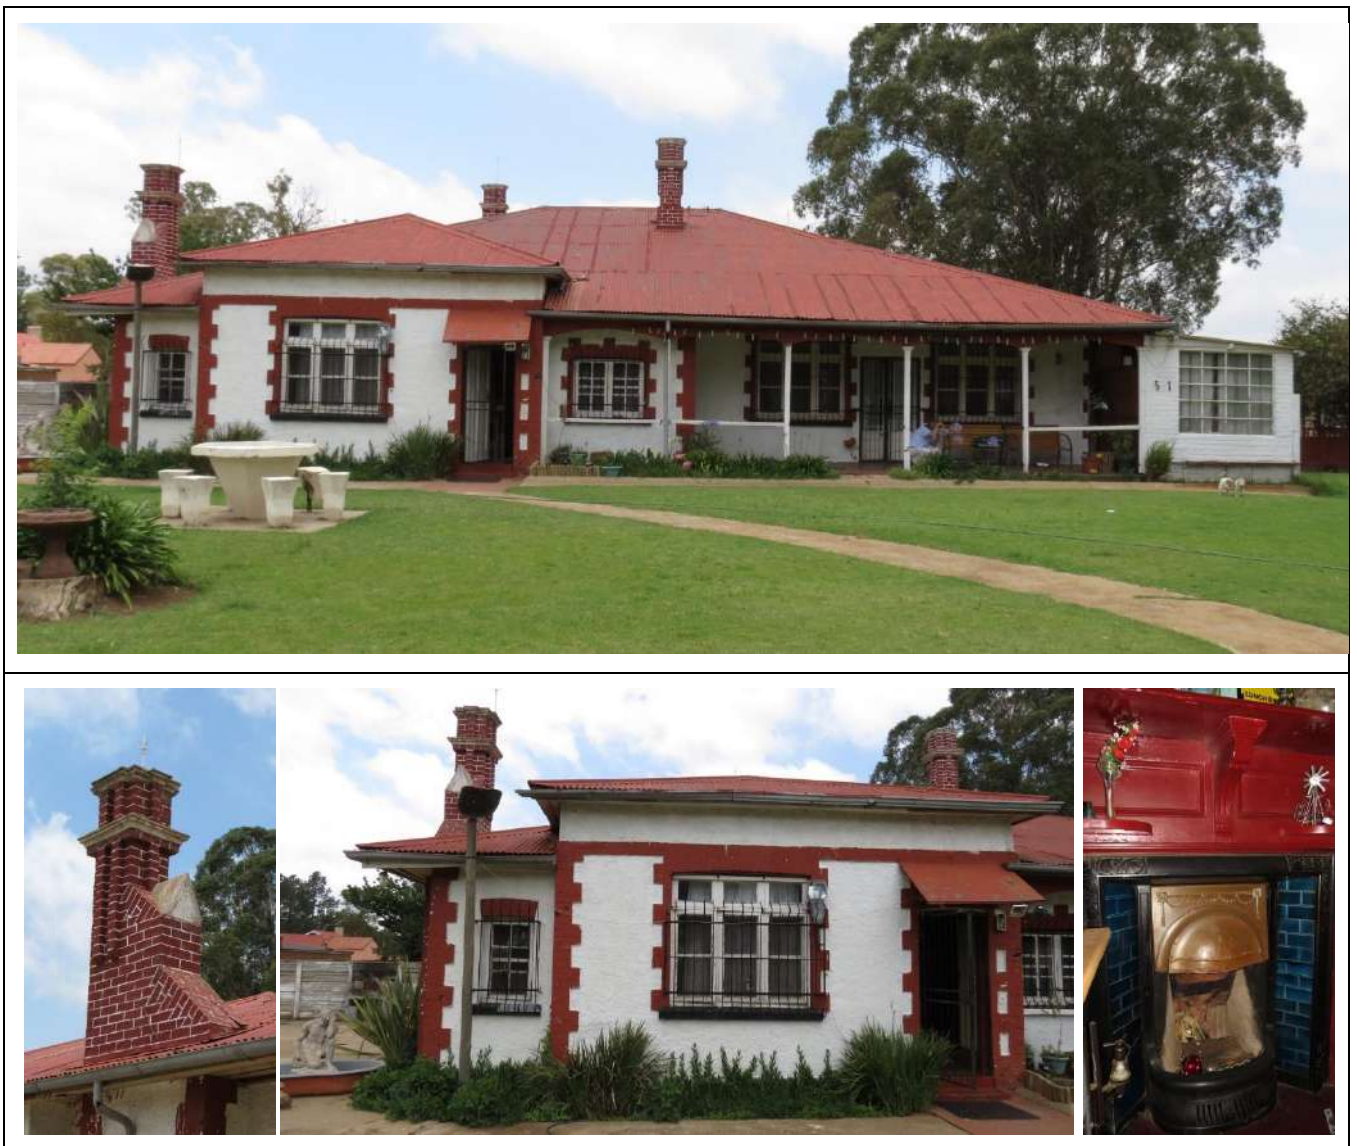
One example of this building type was identified within the study area. It is a single storey dwelling still used as dwelling at the time of the fieldwork in 2014. The building forms part of the original design of the mine village and was built around 1930. The dwelling has plastered brick walls with exposed brick quoining around corners, windows and doors combined with planes of painted plastered brick. The structure has wooden frame windows and doors. Decorative features identified here include arts and crafts brick work, decorative plastering and paintwork along the shafts of the chimneys as well as patterned and etched glass panes in the French doors along the verandahs.

Figure 109 – General views of Building Type 68.

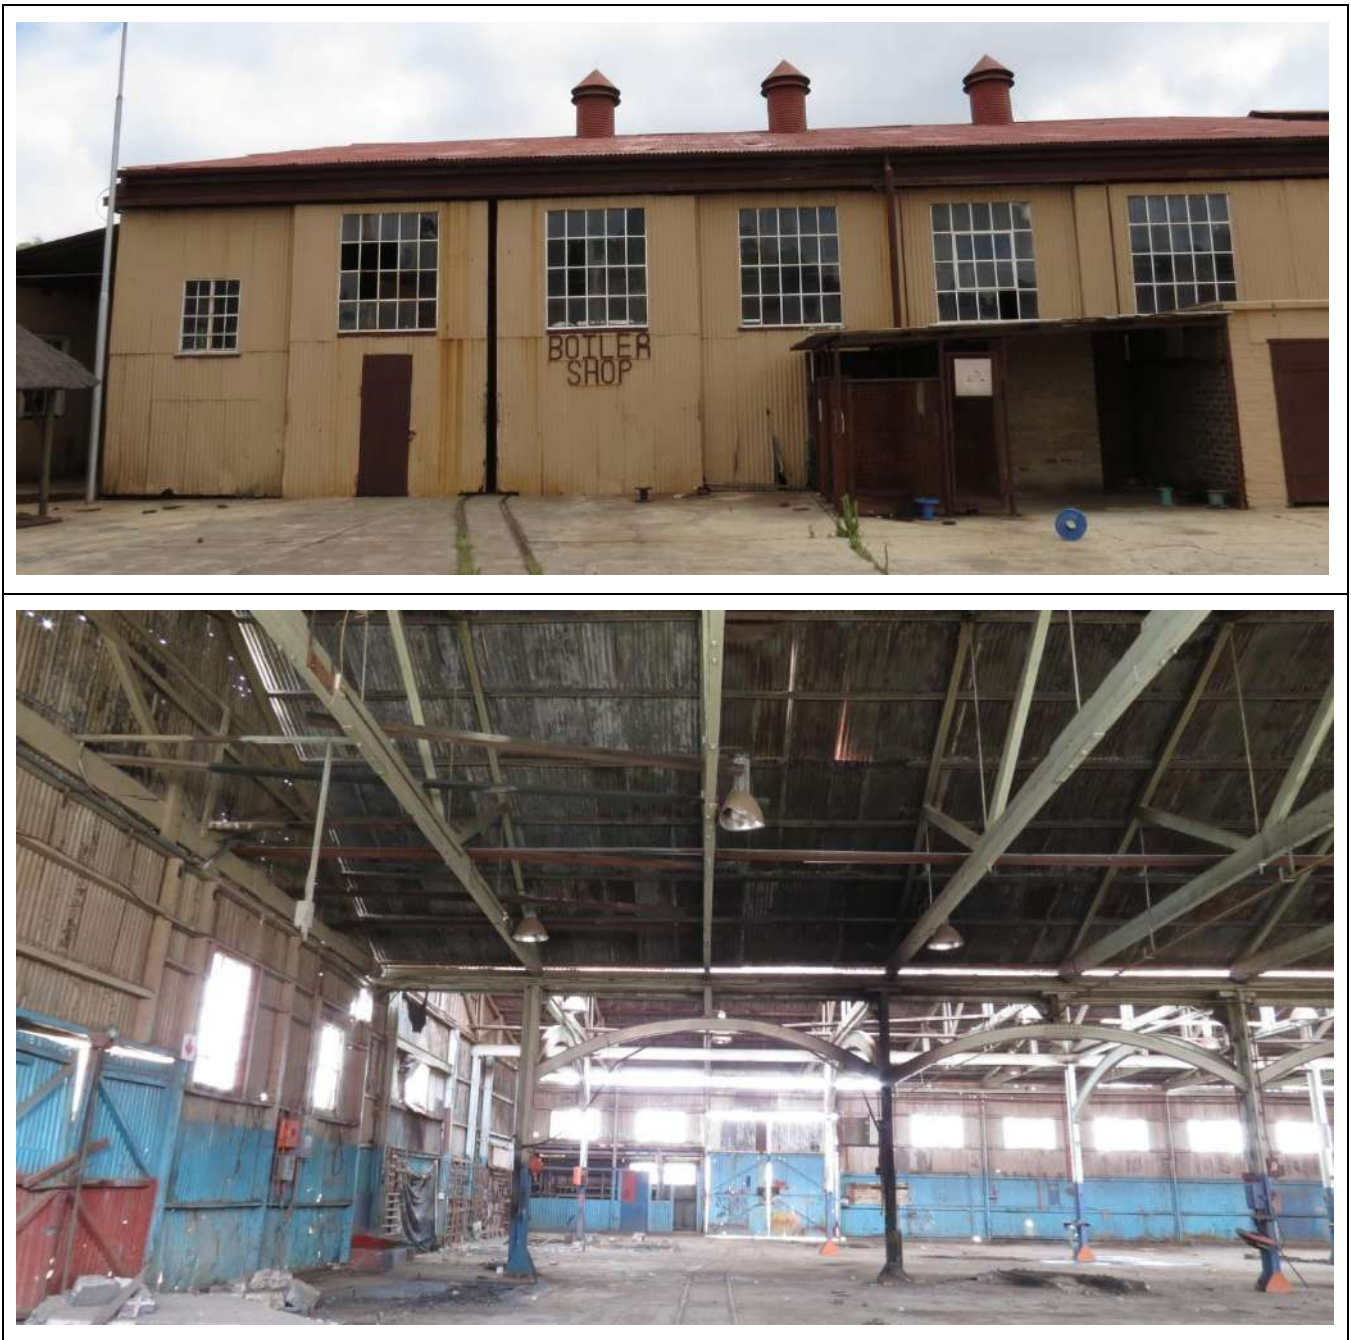
One example of this building type was identified within the study area. It comprises a double storey shed that was used as a Boiler Shop. The building forms part of the original complex of shed and warehouses located east of the DRD Offices. The building has a unique and exceptional iron superstructure comprising of an iron and timber combined superstructure clad with corrugated iron sheeting. The structure has steel frame windows and doors. A large extension at the back of the building obscures the side elevation of the original building.

Figure 110 – General views of the exterior and interior of Building Type 69.

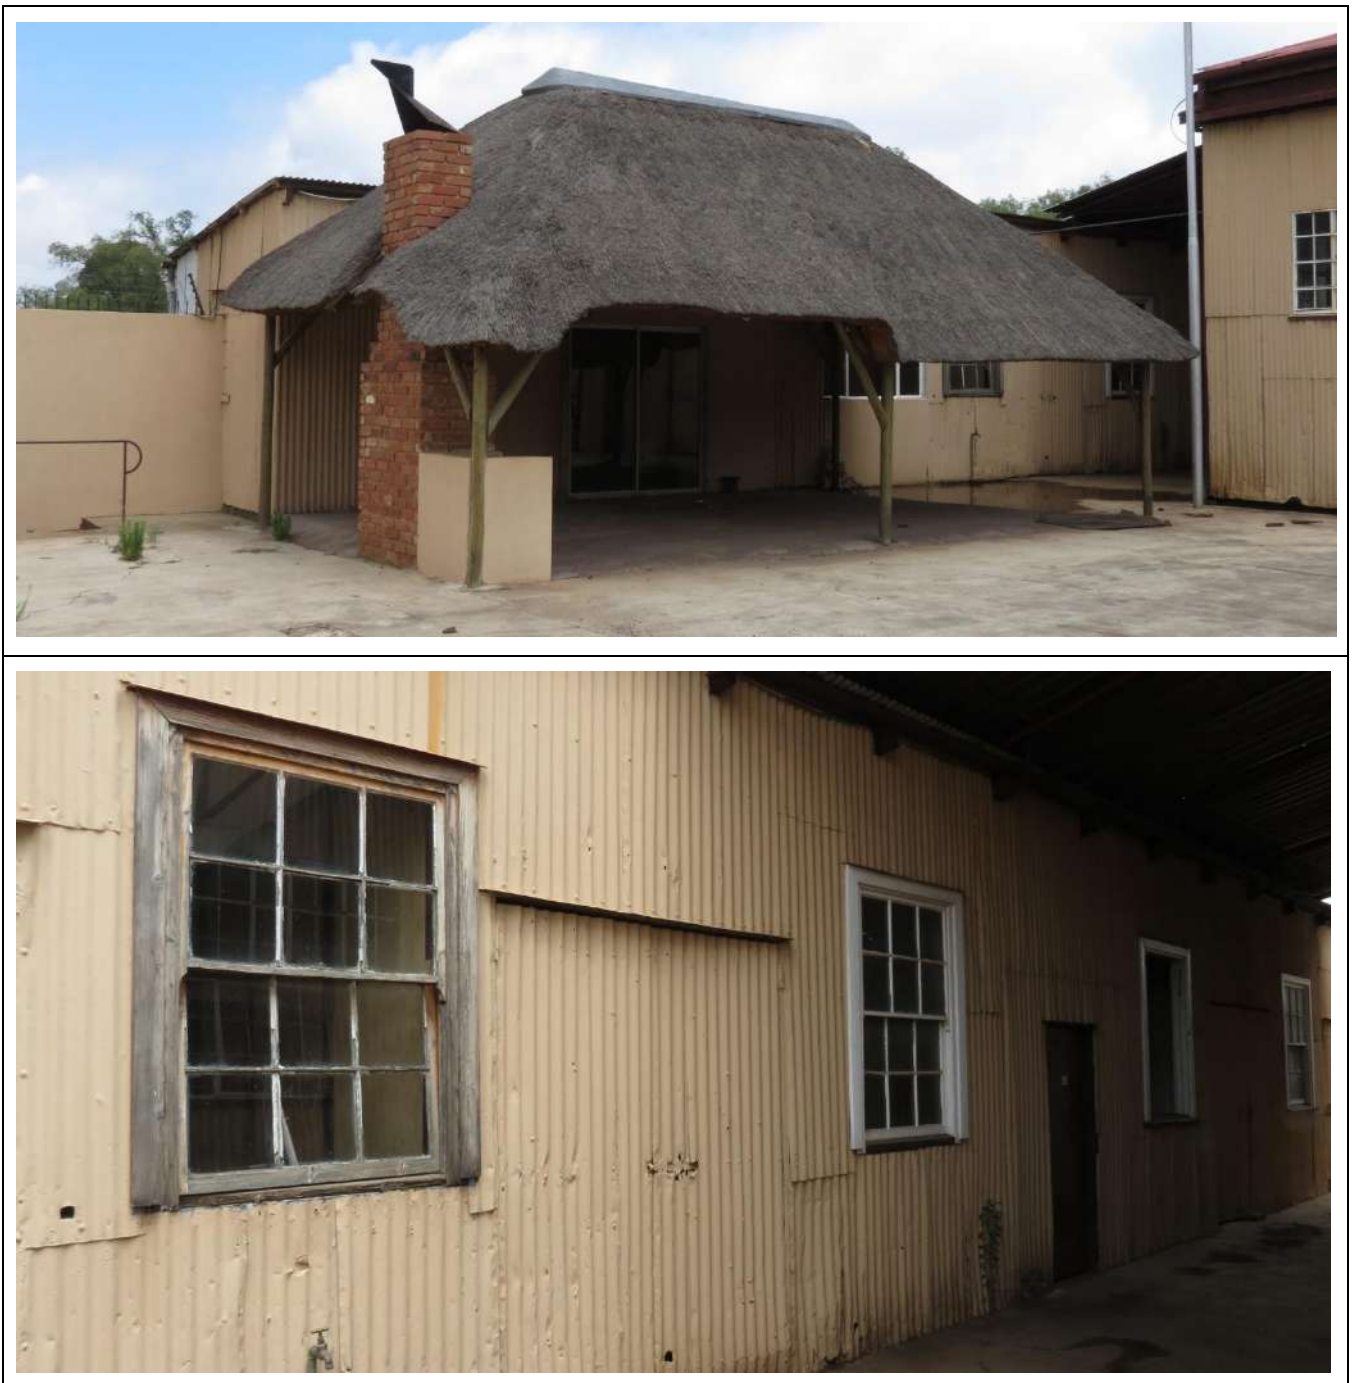
One example of this building type was identified within the study area. It comprises a one and half volume building used as recreation area with a detached timber structure with thatched roof added to the complex. The recreation building has a timber frame with corrugated iron cladding and wooden sash windows and wooden door frames.

Figure 111 – General views of Building Type 70.

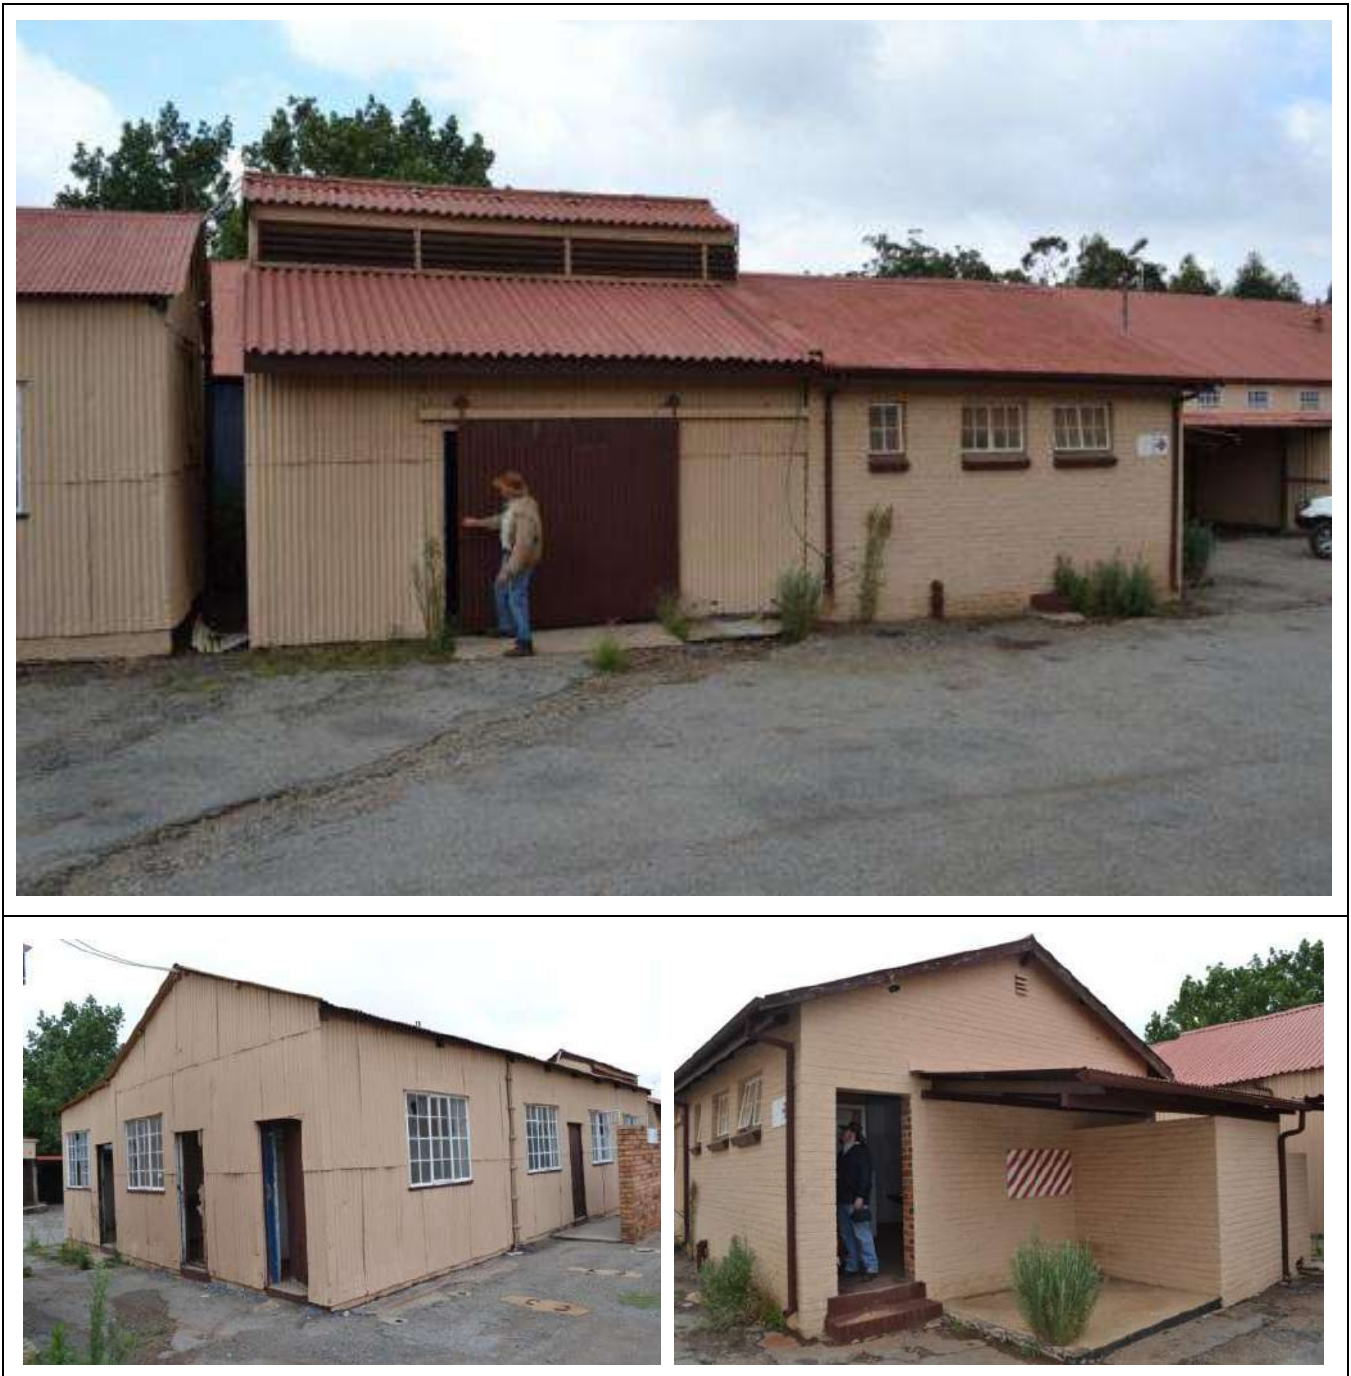
One example of this building type was identified within the study area. The building type consists of two single storey buildings adjacent to each other that were used as workshops and ablutions. One of the buildings has a timber frame with corrugated iron sheeting and roof. This building also has steel frame windows and doors.

Figure 112 – General views of Building Type 71.

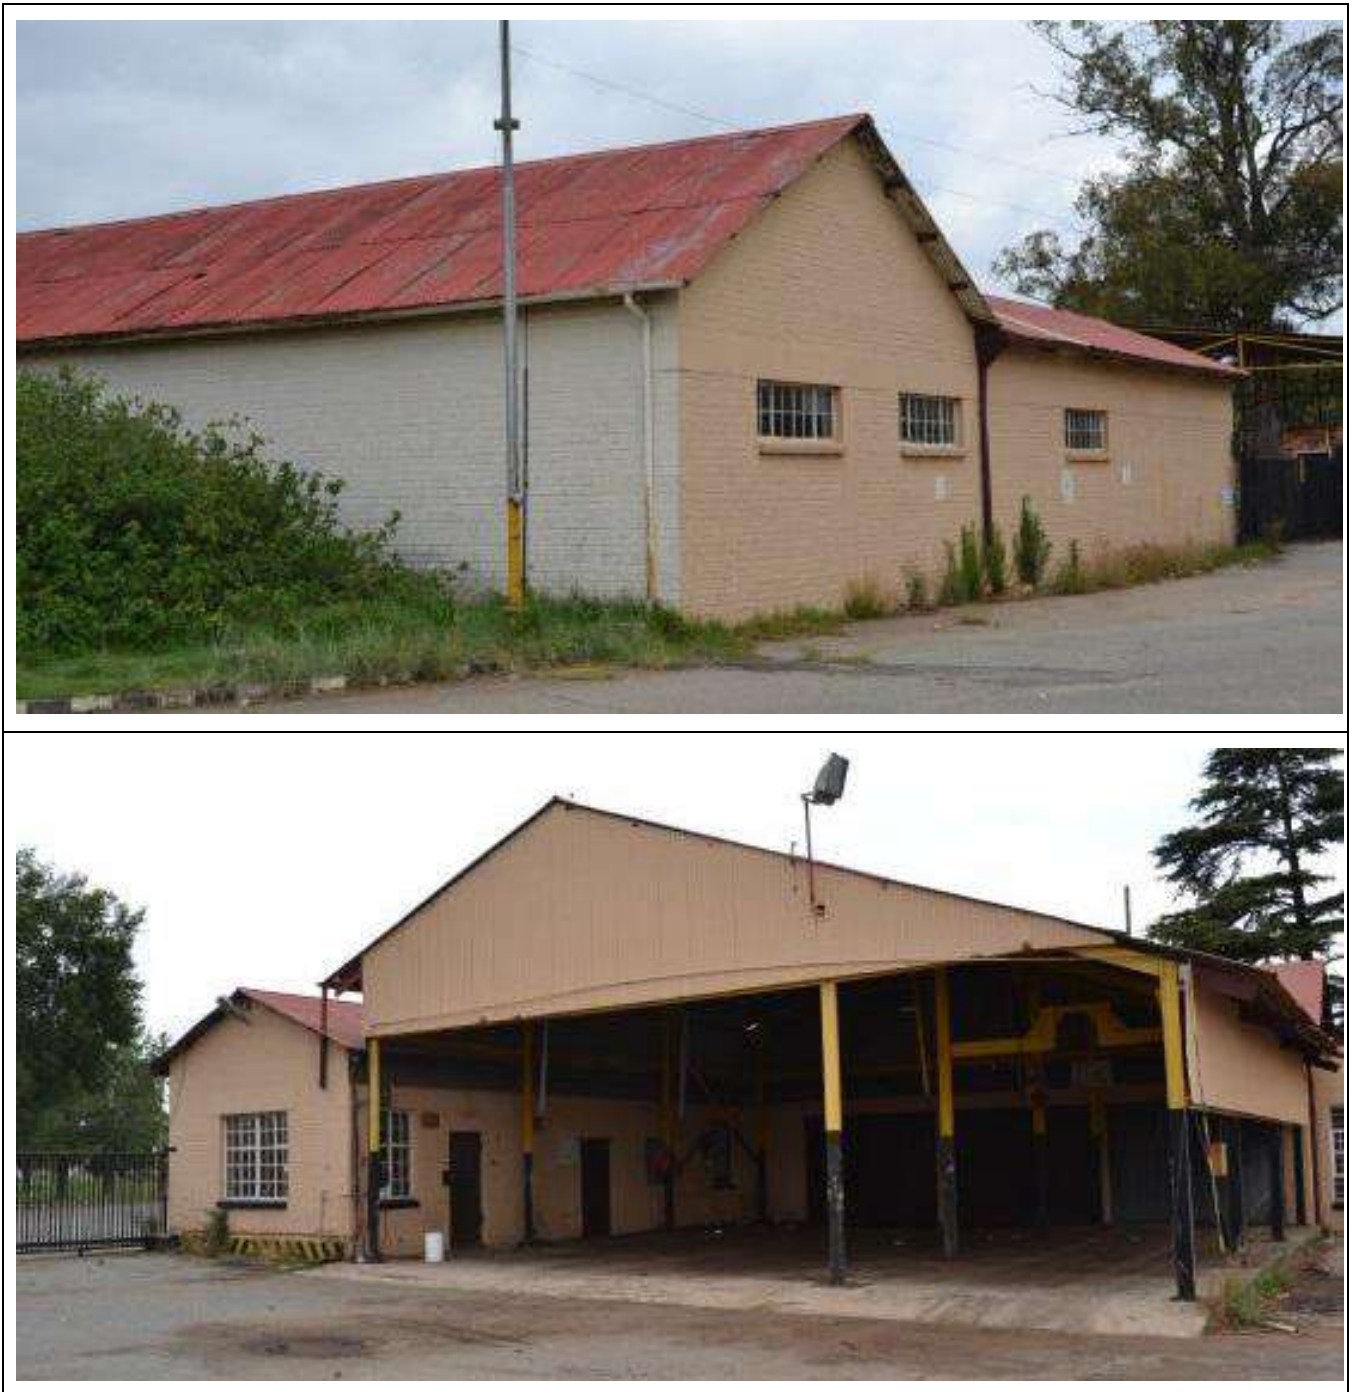
One example of this building type was identified within the study area. It comprises an original single story building that was used as offices as well as a later extension which is a double volume with open sides to allow vehicles to enter and park. The original building has plastered brick walls with a sheet iron gable roof. It has steel frame windows and doors. The later extension is a steel frame construction with sheets.

Figure 113 – General views of Building Type 72.
