PHASE 1 HERITAGE IMPACT ASSESSMENT

Proposed Establishment of Goudrand Ext. 5, Goudrand Ext. 6, Goudrand Ext. 7, Goudrand Ext. 8, Goudrand Ext. 9, Goudrand Ext. 10, Goudrand Ext. 11, Goudrand Ext. 14, Goudrand Ext. 15, Goudrand Ext. 16, Goudrand Ext. 17, Goudrand Ext. 18 and Goudrand Ext. 19, located in the Roodepoort Magisterial District, City of Johannesburg Metropolitan Municipality, Gauteng Province

Issue Date: 20 June 2018
Revision No.: 2
Client: Hunter Theron Incorporated

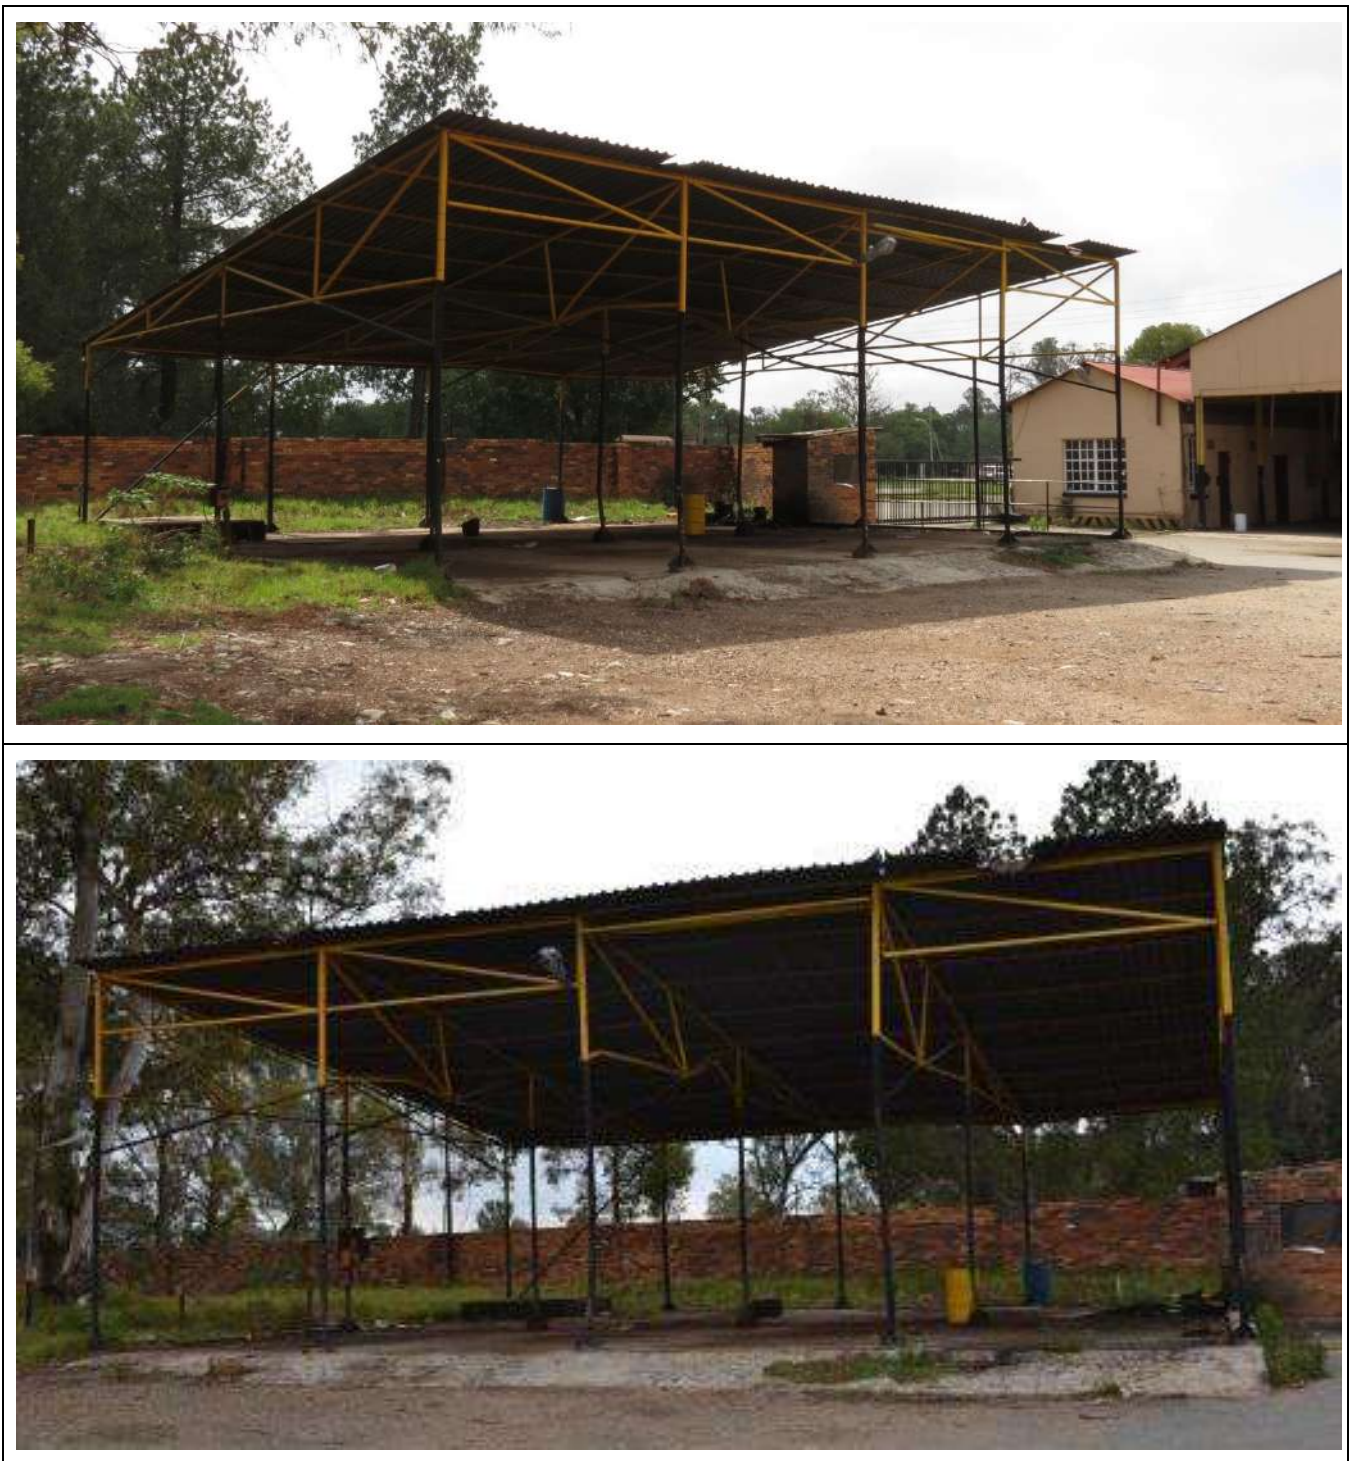
One example of this building type was identified within the study area. It comprises a double volume steel framed structure with sheet iron roof and open sides.

Figure 114 – General views of Building Type 73.

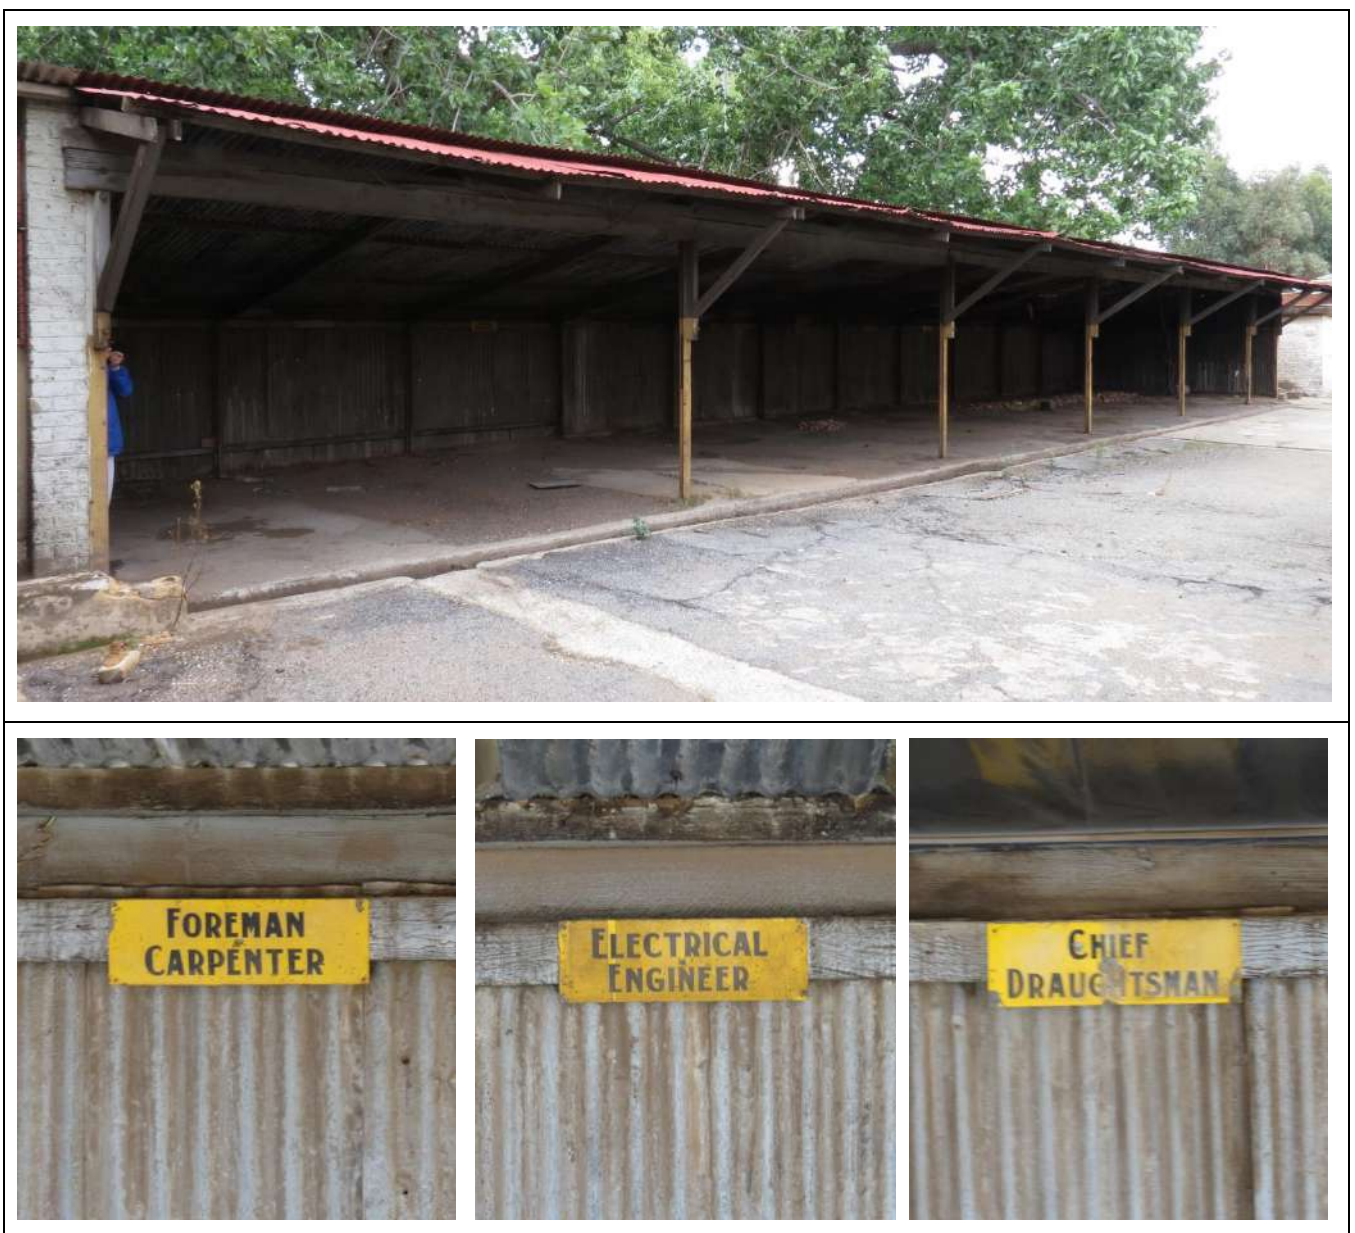
One example of this building type was identified within the study area. It comprises a single storey building erected and used as car ports. The structure is only painted on the outside. A number of designated parking signs were identified within the car port at the time of the fieldwork. These designated which parking was reserved for which person including the 'Foreman Fitter', 'Mechanical Engineer', 'Electrical Engineer', 'Chief Draughtsman', 'Engineer's Clerk', 'Foreman Electrician', 'Foreman Boiler Shop', 'Foreman Carpenter' and 'Foreman Fitter'. It is therefore evident that the senior staff of the warehouse complex used this car port as parking space.

Figure 116 – General views of Building Type 75.

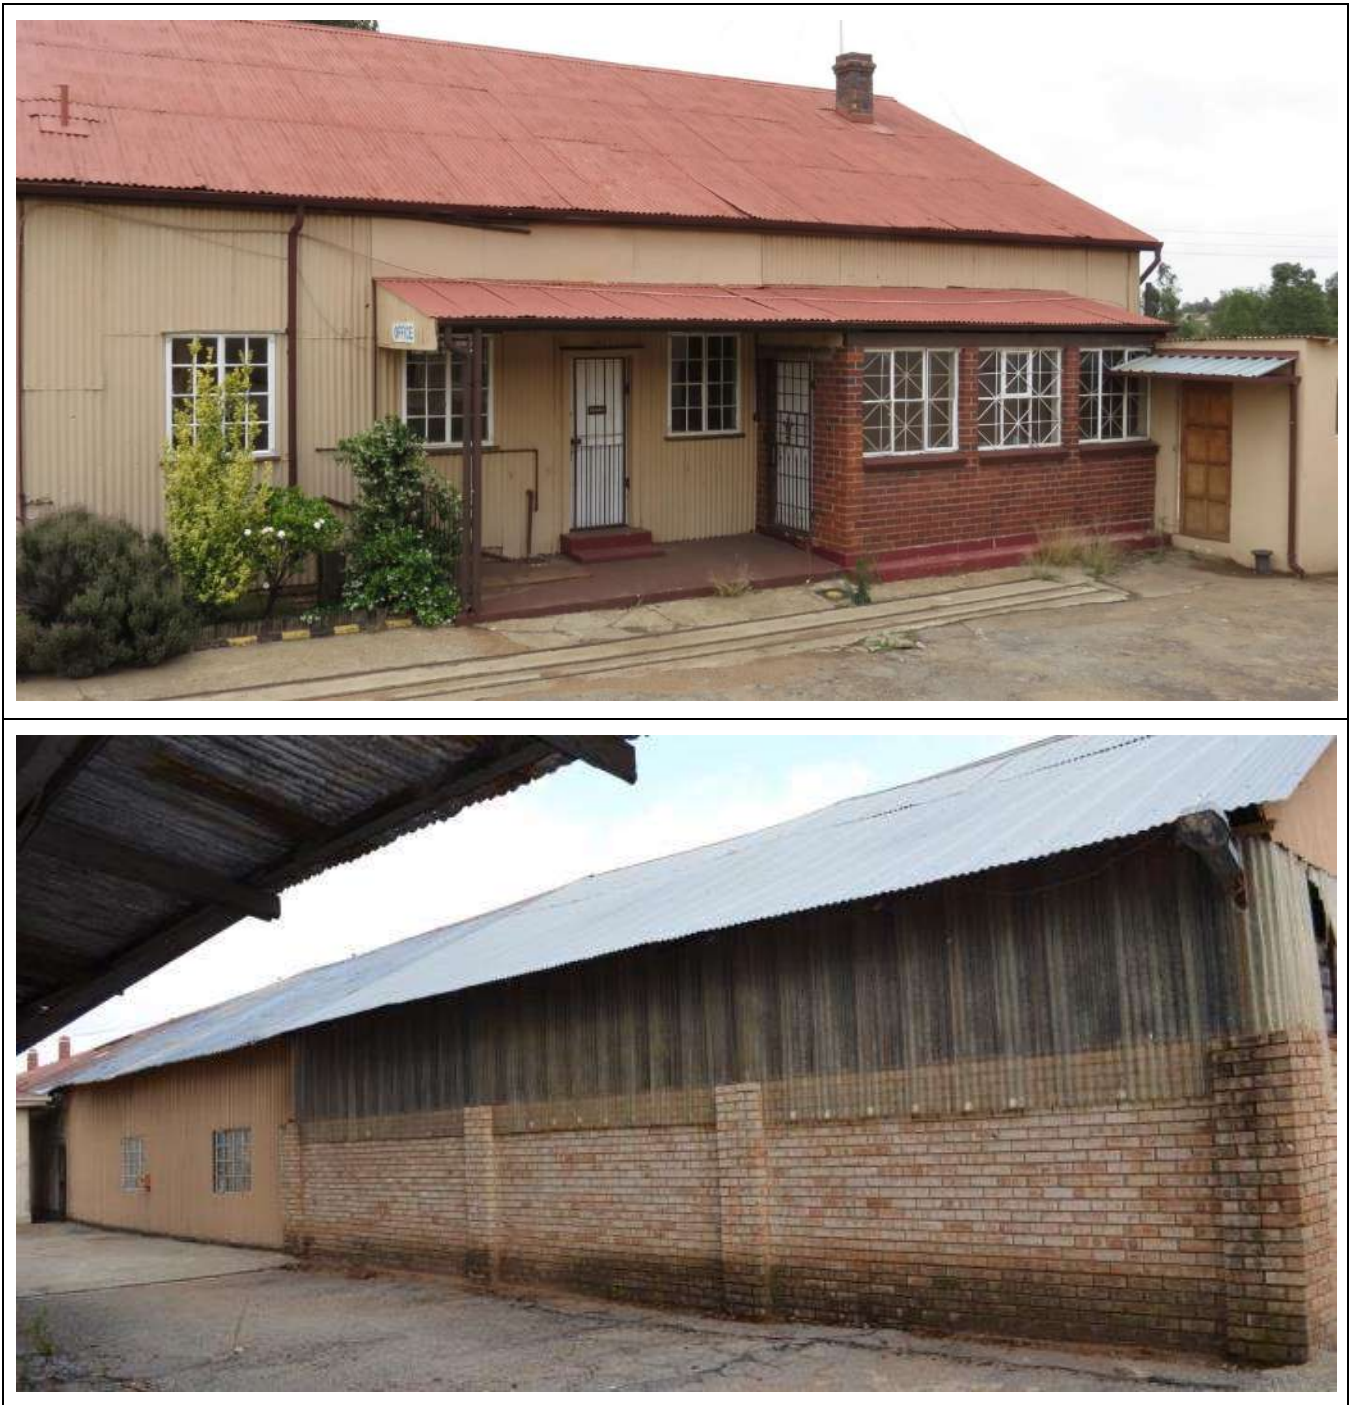
This building type comprises a double volume building complex used as workshops. Some sections of the building do not form part of the original design and built complex. The building was erected with yellowish-brown face bricks and has steel frame windows and doors. The greatest part of this complex was part of the original mining building complex as reflected in the timber frame structures covered with corrugated iron sheeting.

Figure 117 – General views of Building Type 76.

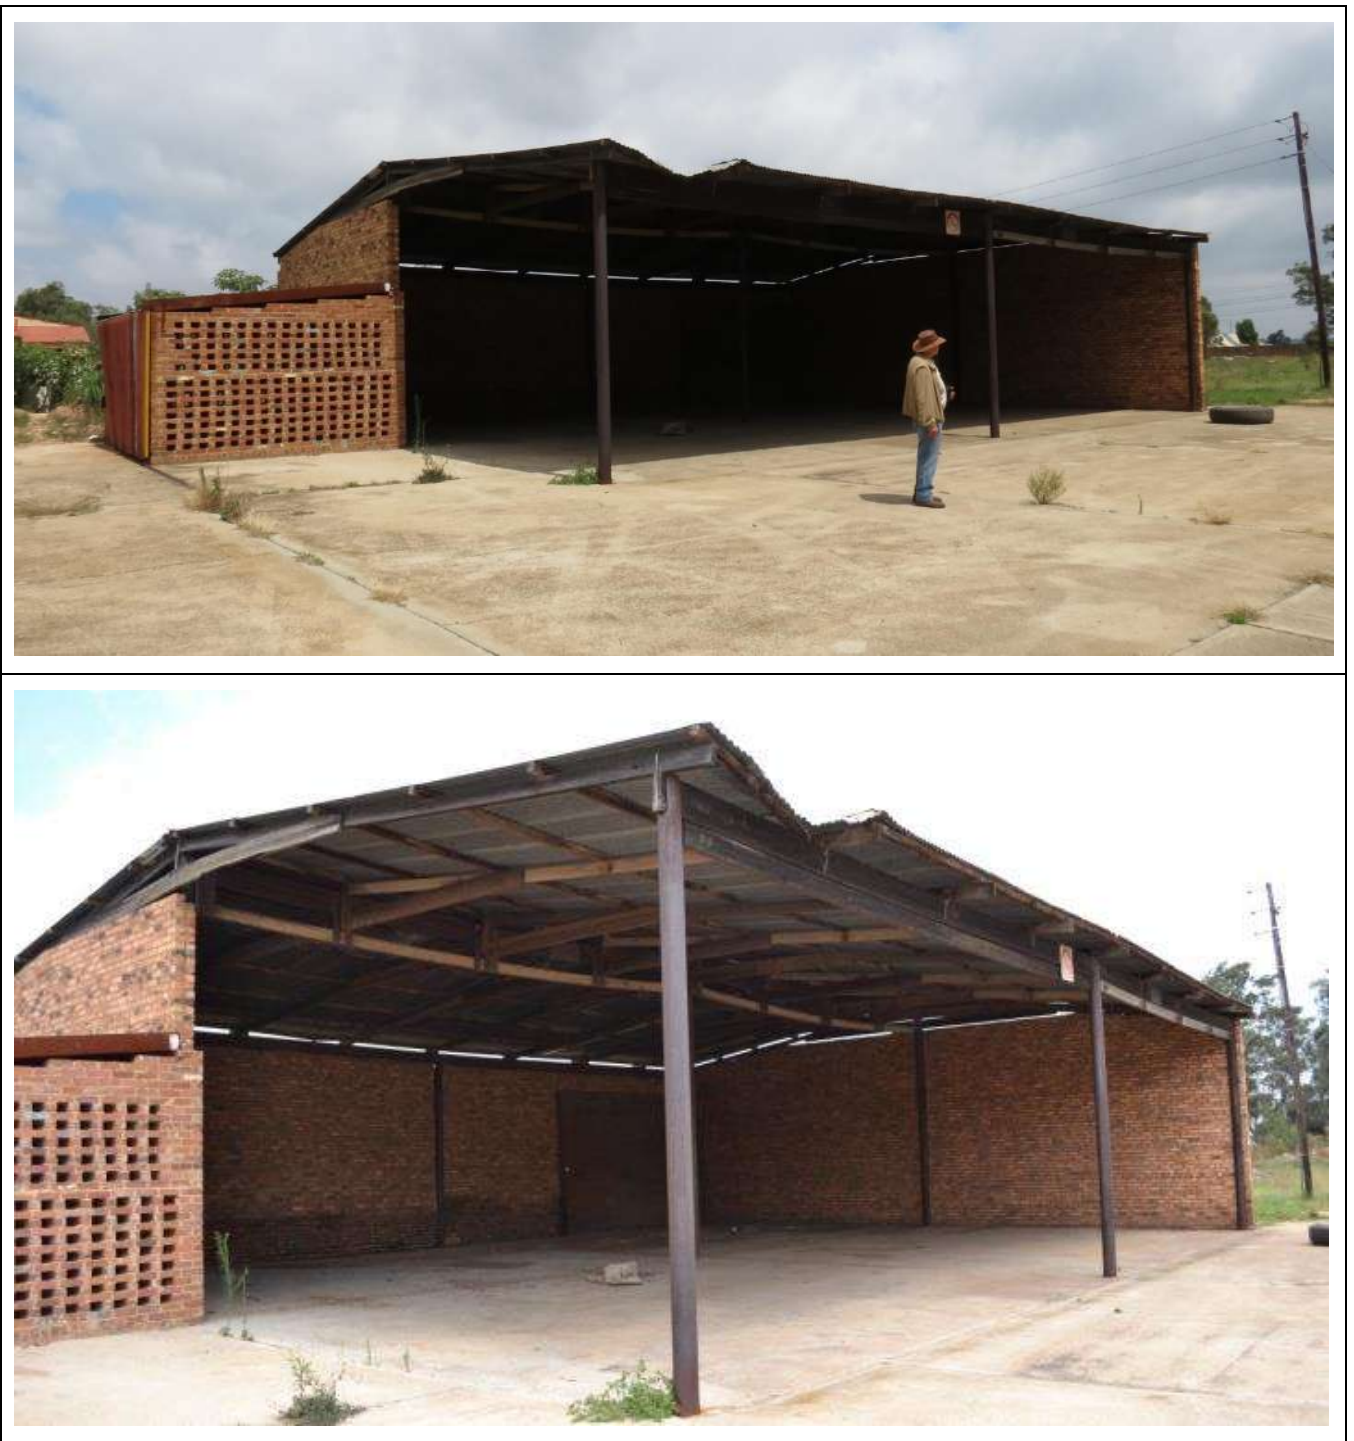
The building type comprises semi- open carports. It does not form part of the original design of the complex. The building was constructed with orange brownish face bricks.

Figure 118 – General views of Building Type 77.

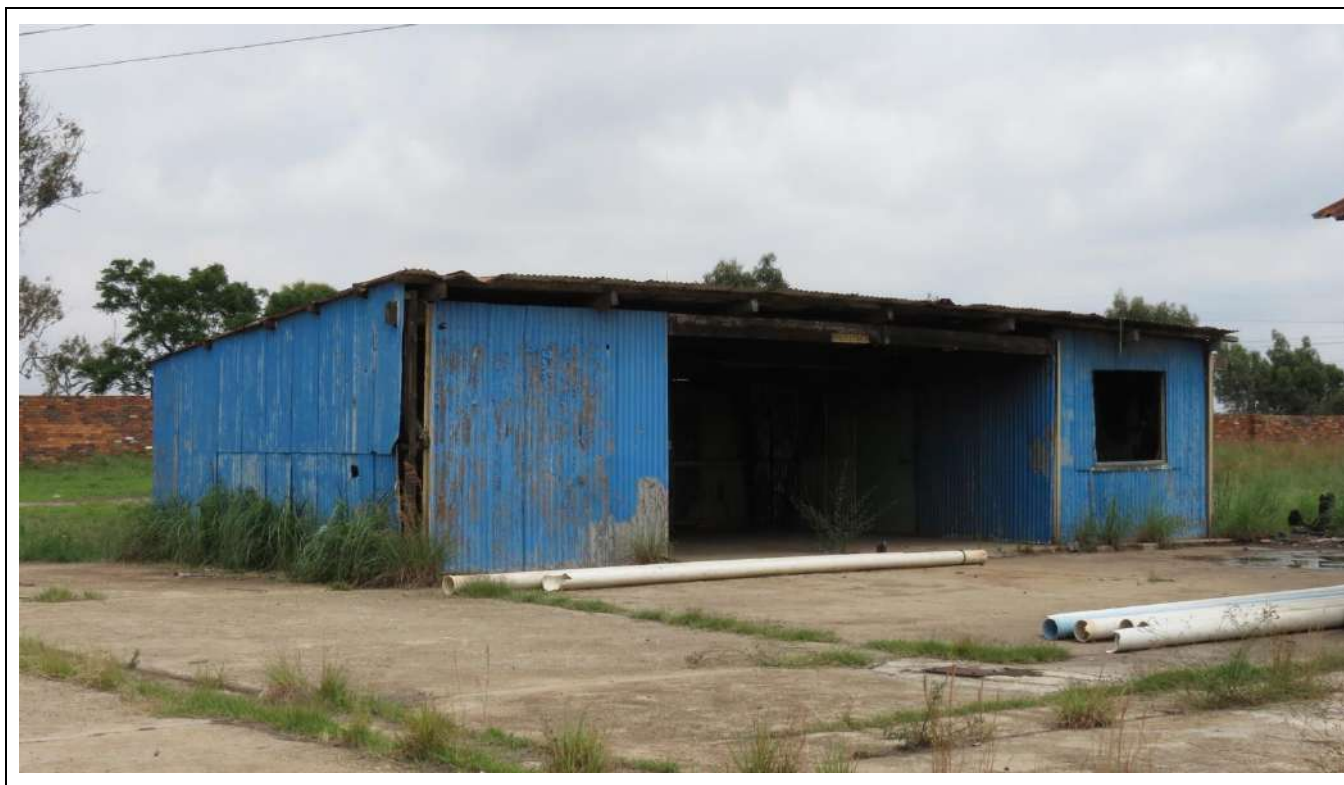
The building type comprises a single storey flat roofed building that was constructed with corrugated iron sheeting. The building has steel frame doors. It was not part of the original design of the warehouse complex.

Figure 119 – General view of the front façade of Building Type 78.

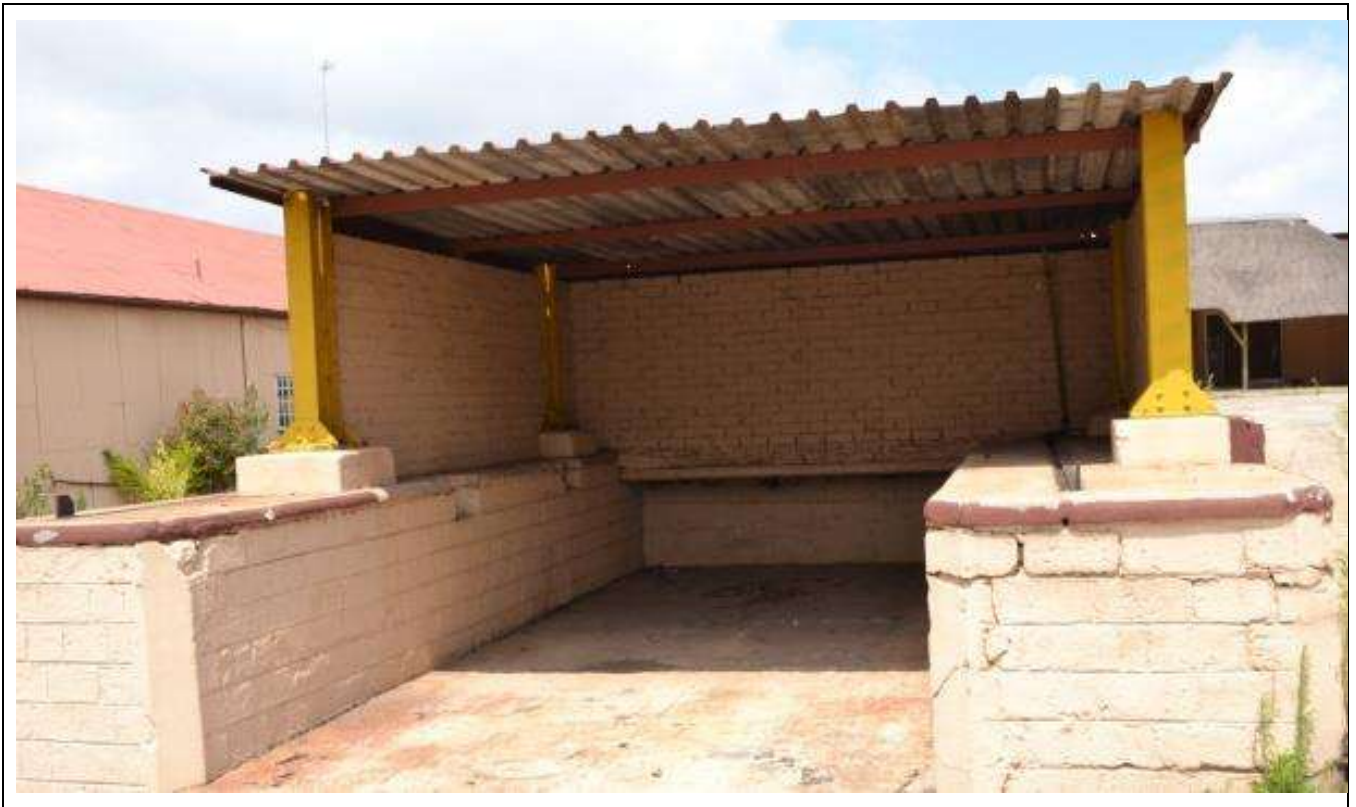
The building type comprises a single storey building used as a loading area. The building does not form part of the original design of the complex. The base of the building was constructed of cement bricks that were painted whereas the remainder of the building comprises a steel frame with IBR galvanized sheeting.

Figure 121 – General view of Building Type 80.

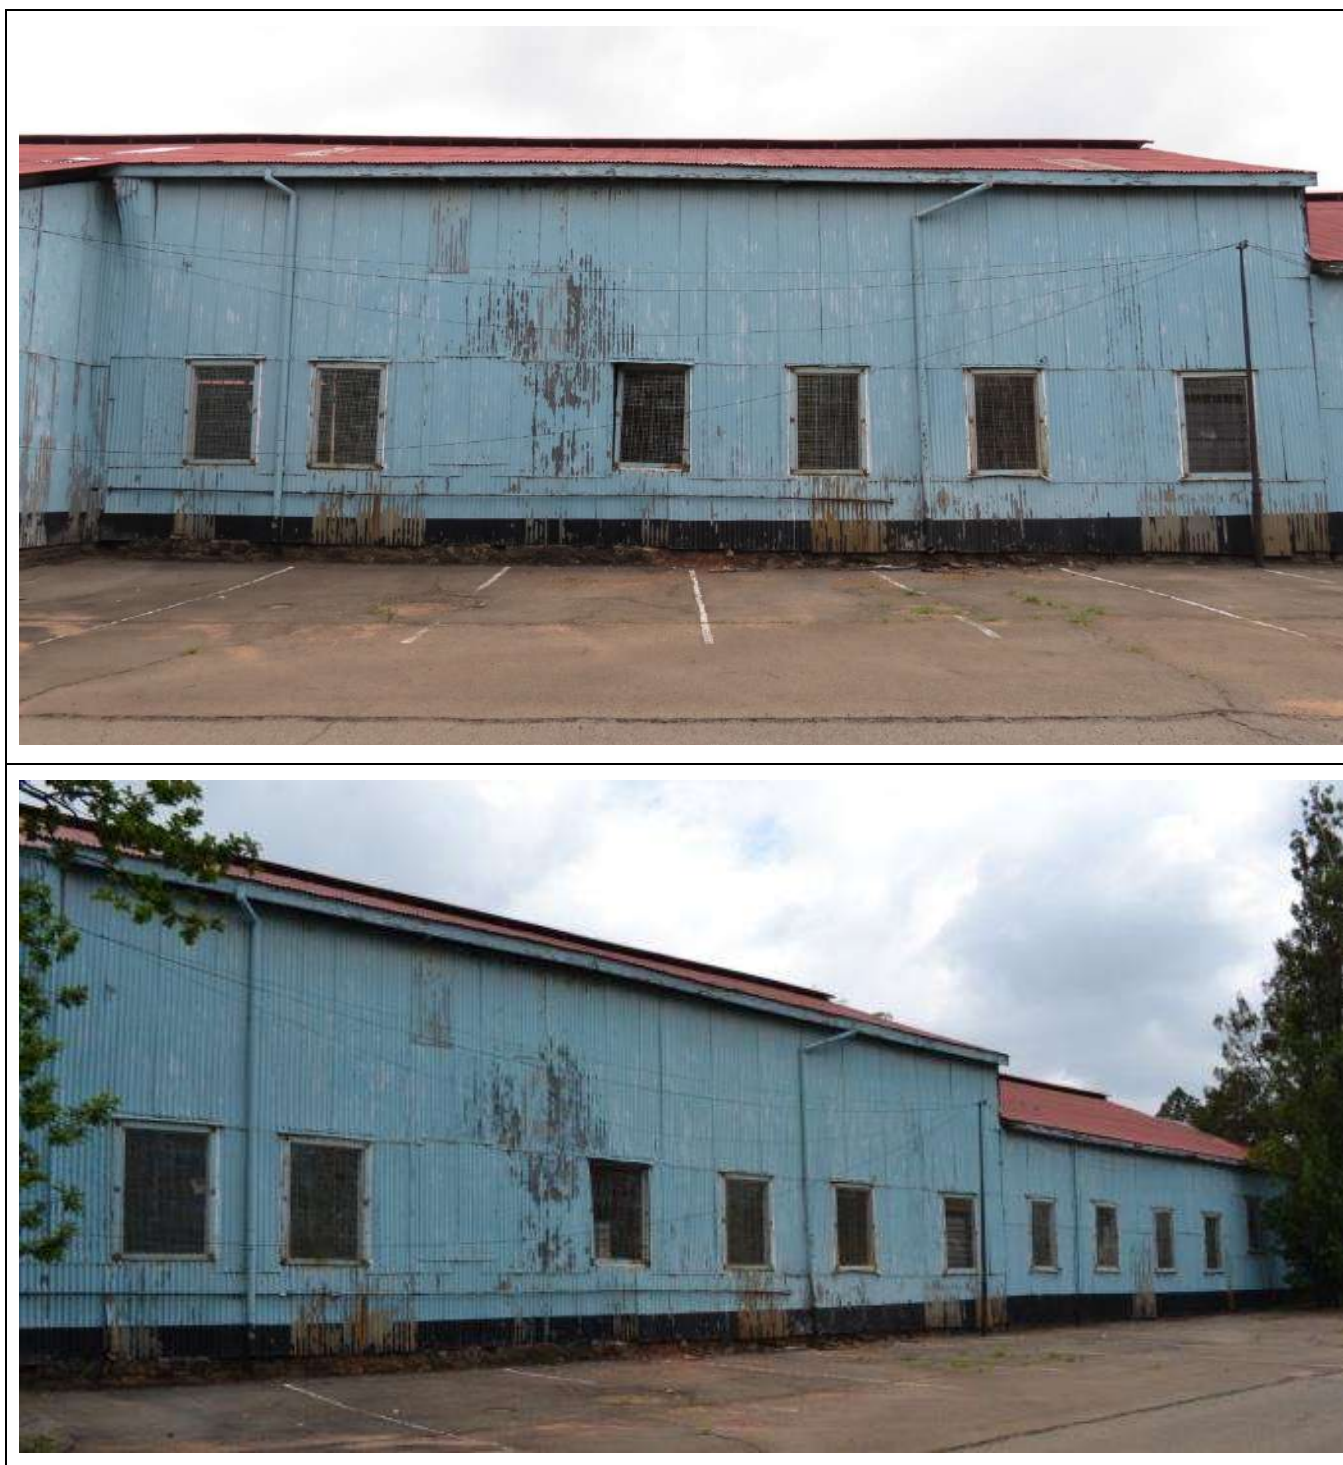
The building type comprises a double volume structure that was used as a workshop. The building formed part of the original design of the built complex within which it is located. It has steel frame windows and doors.

Figure 122 – General views of Building Type 81.

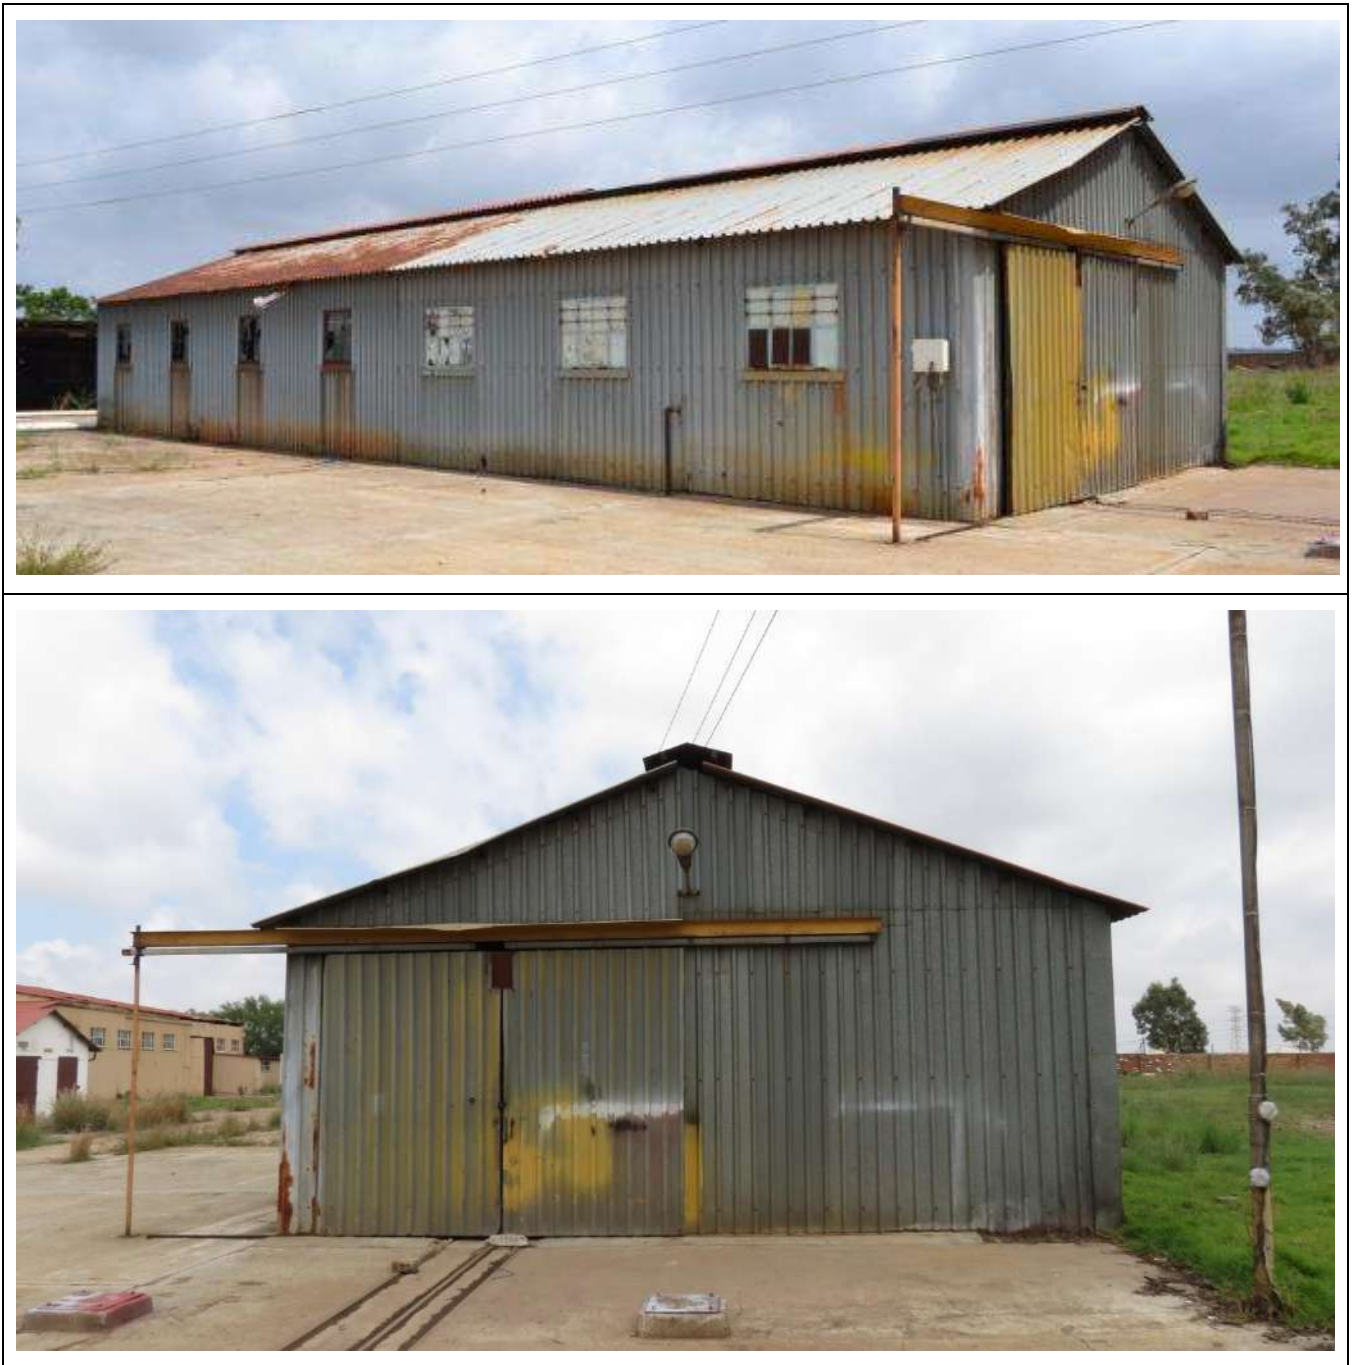
The building type comprises a single storey building that was used as a workshop. The building was not part of the original design but represents a later addition which still formed part of the built complex. It has a steel frame covered with IBR sheet iron and has steel frame windows and doors.

Figure 123 – General views of Building Type 82.

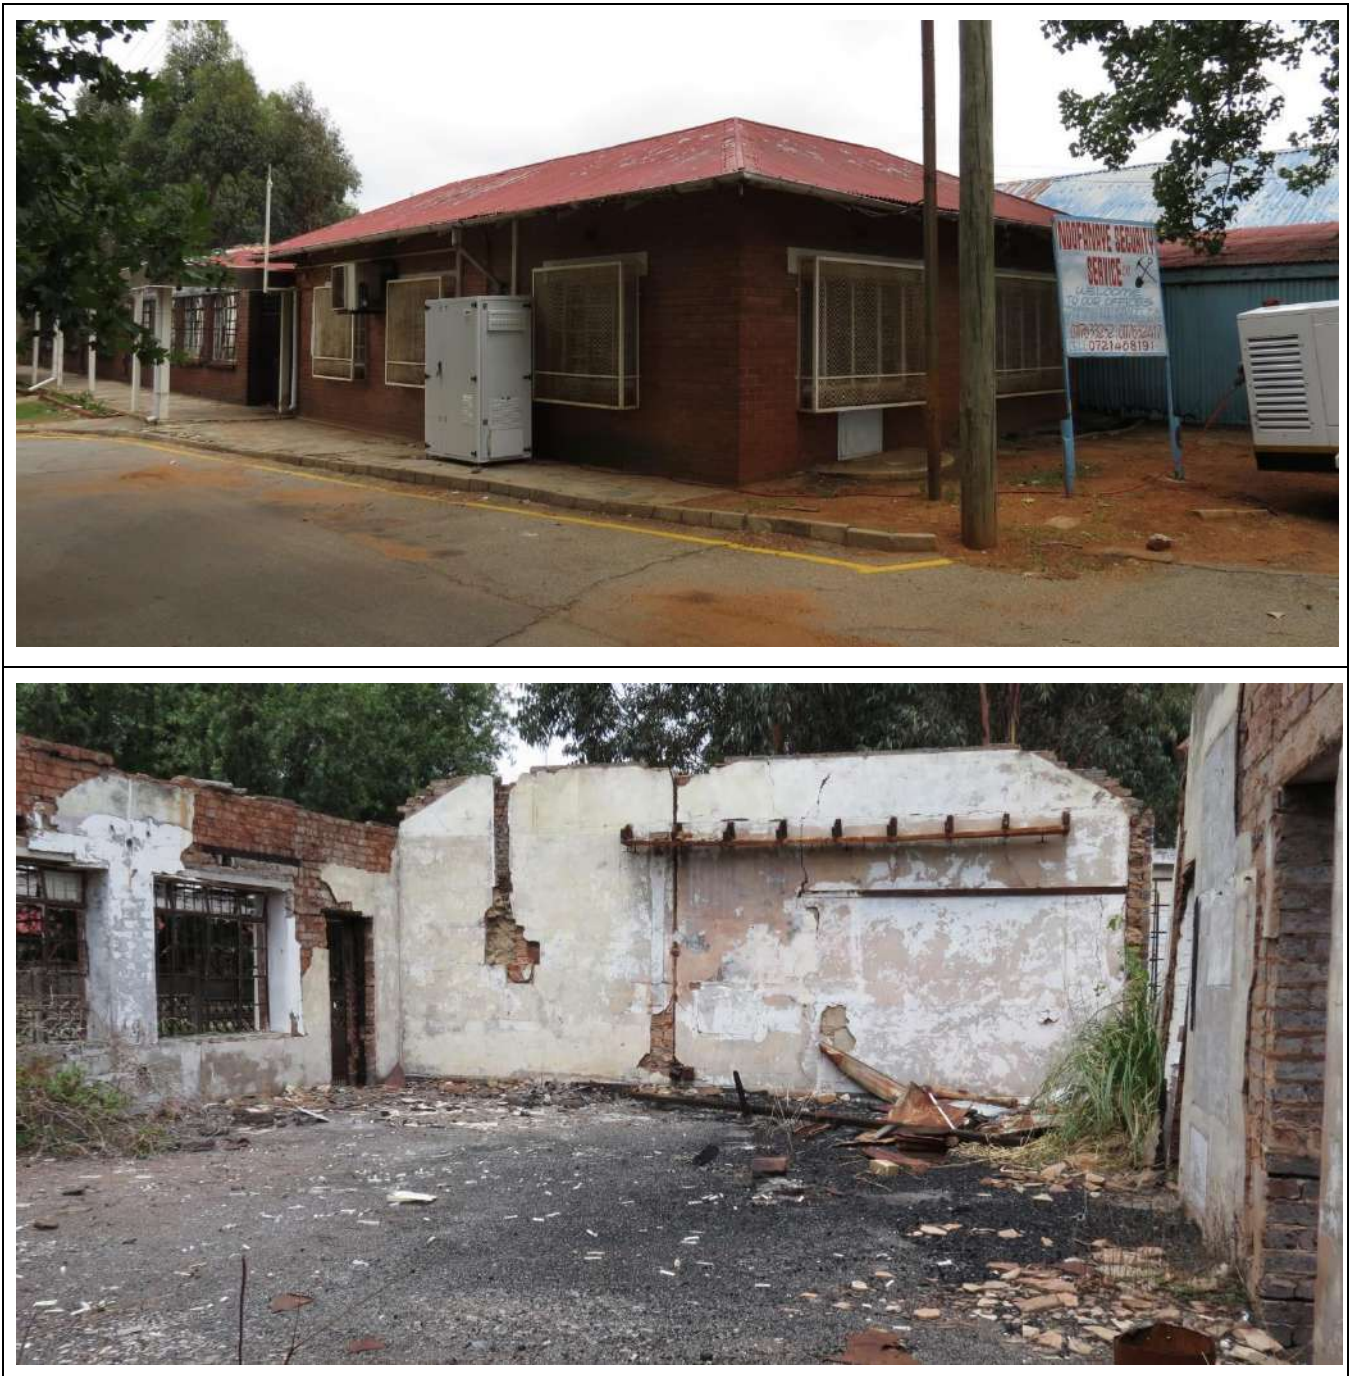
The building type comprises a single storey cluster of buildings that was used as offices and an administration complex. This building type formed part of the original design of the overall built complex within which it is located. The building was constructed with reddish face bricks and has steel frame windows and doors. Some sections of the building cluster had burnt down and had been extensively vandalized.

Figure 124 – General views of Building Type 83.

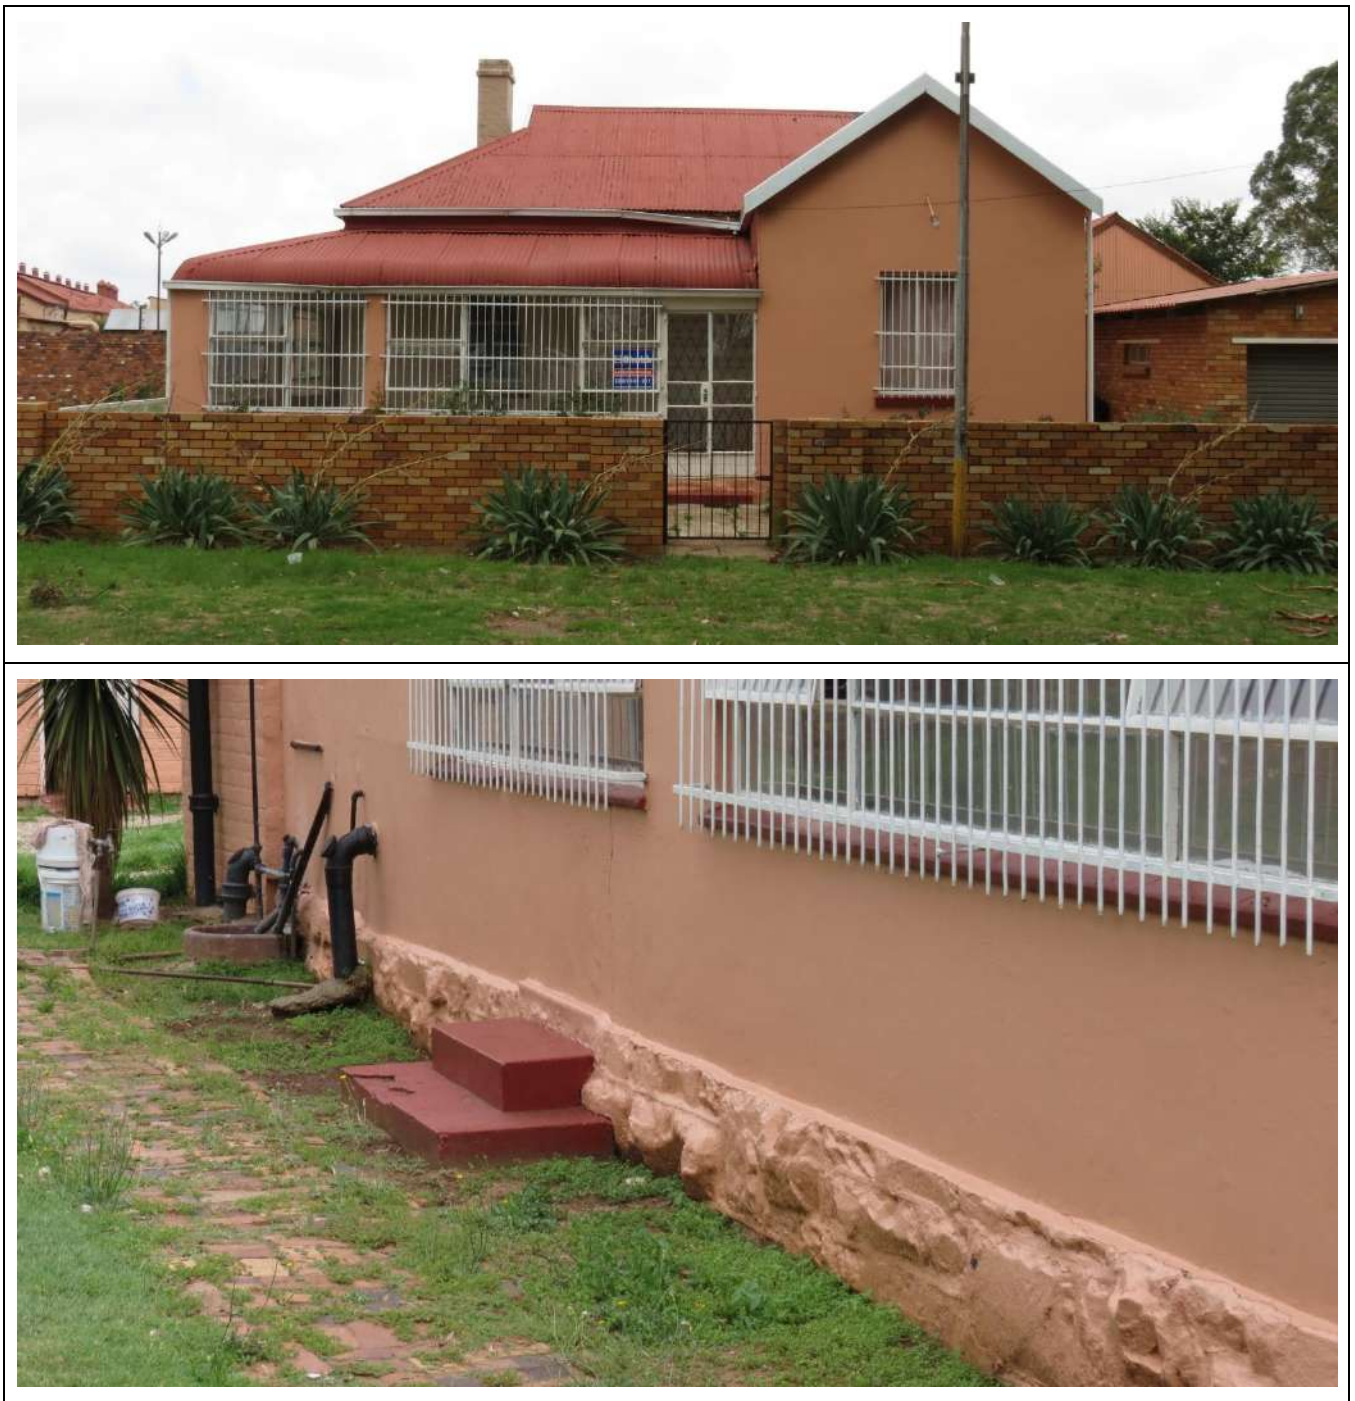
The building type comprises a single storey dwelling that was still used as a dwelling at the time of the site visit. The building has plastered brick walls constructed on a stone foundation and has a corrugated iron roof. It has a gable with covered verandah on one façade. Two examples of this building type exist within the study area.

Figure 125 – General views of Building Type 84.

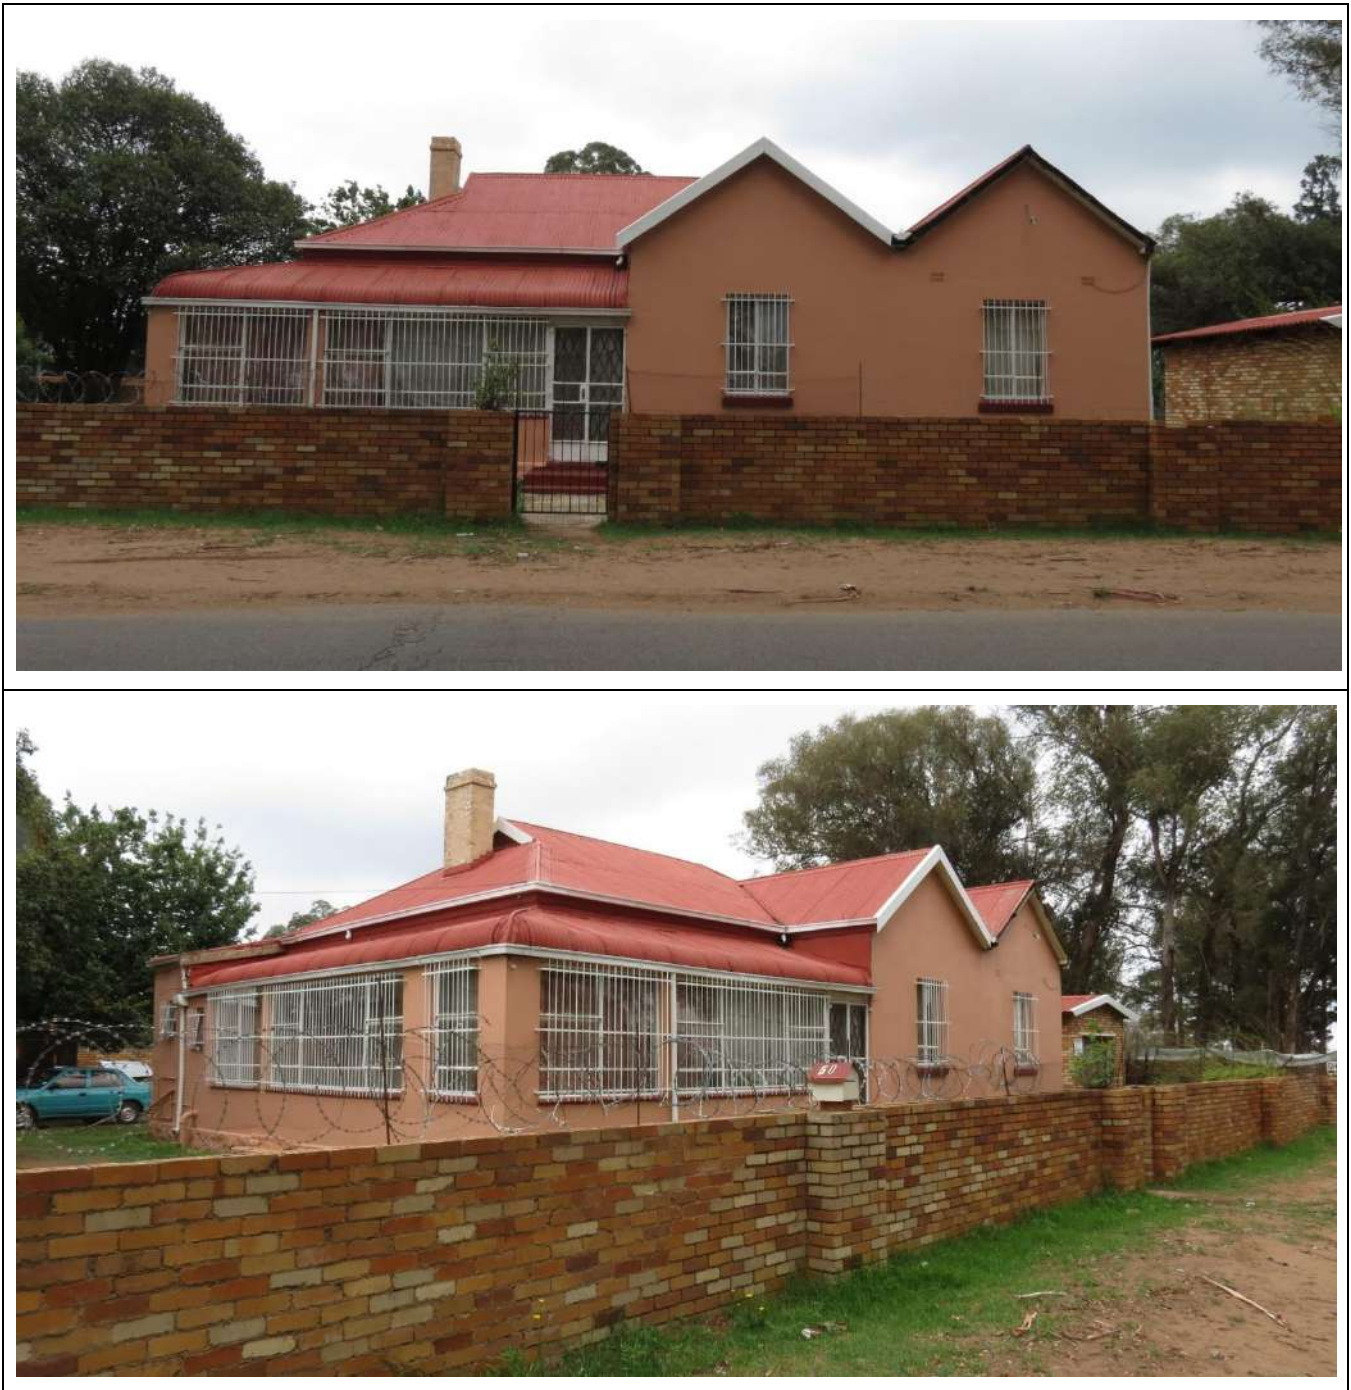
The building type comprises a single storey dwelling that was still used as a dwelling at the time of the site visit. The building has plastered brick walls and a corrugated iron roof. The building has a double gable and covered verandah on one façade.

Figure 126 – General views of Building Type 85.

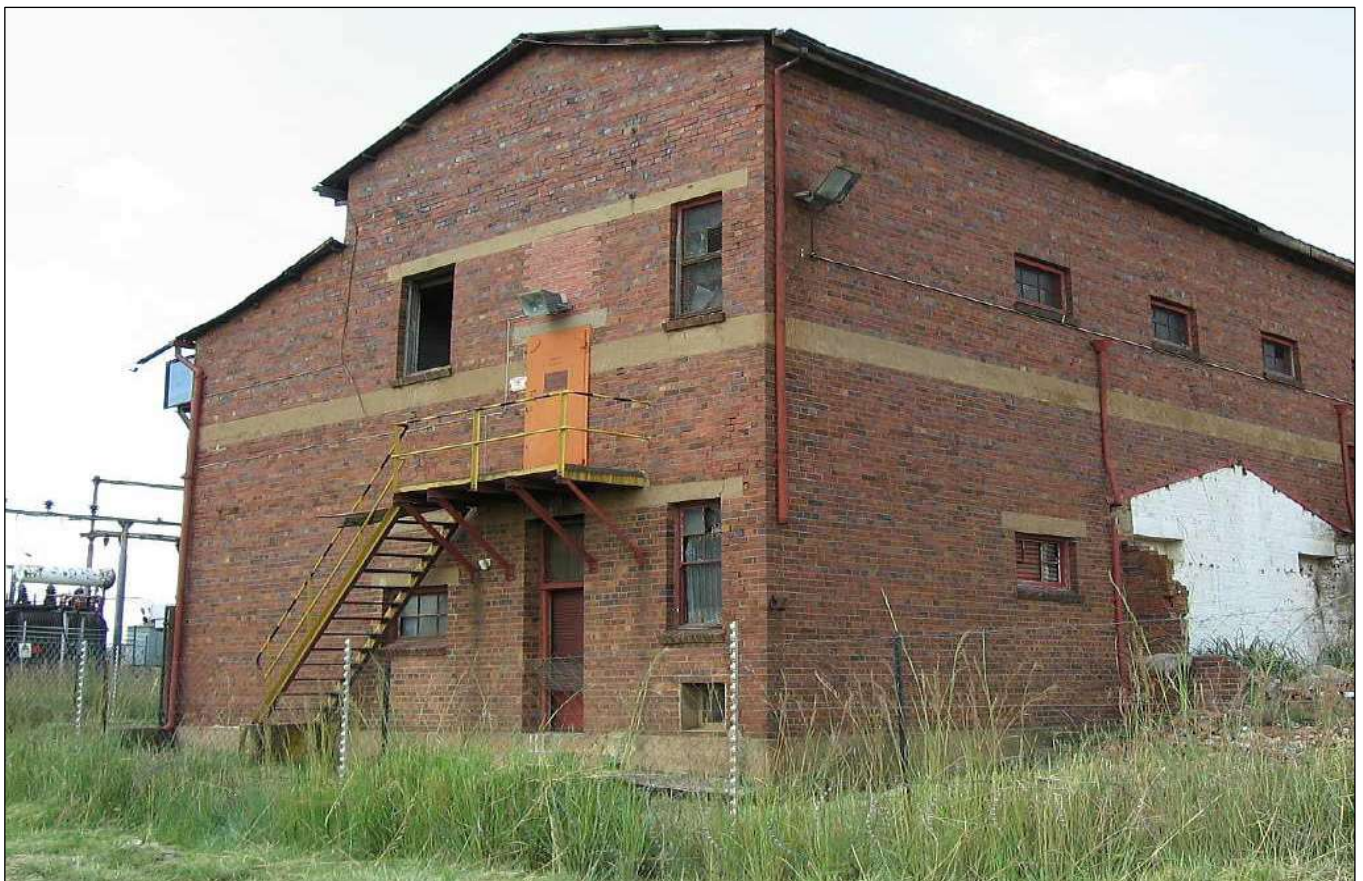
Figure 128 – General view of the electrical substation included in this report as Building Type 55. This photograph was taken during the fieldwork of December 2013.

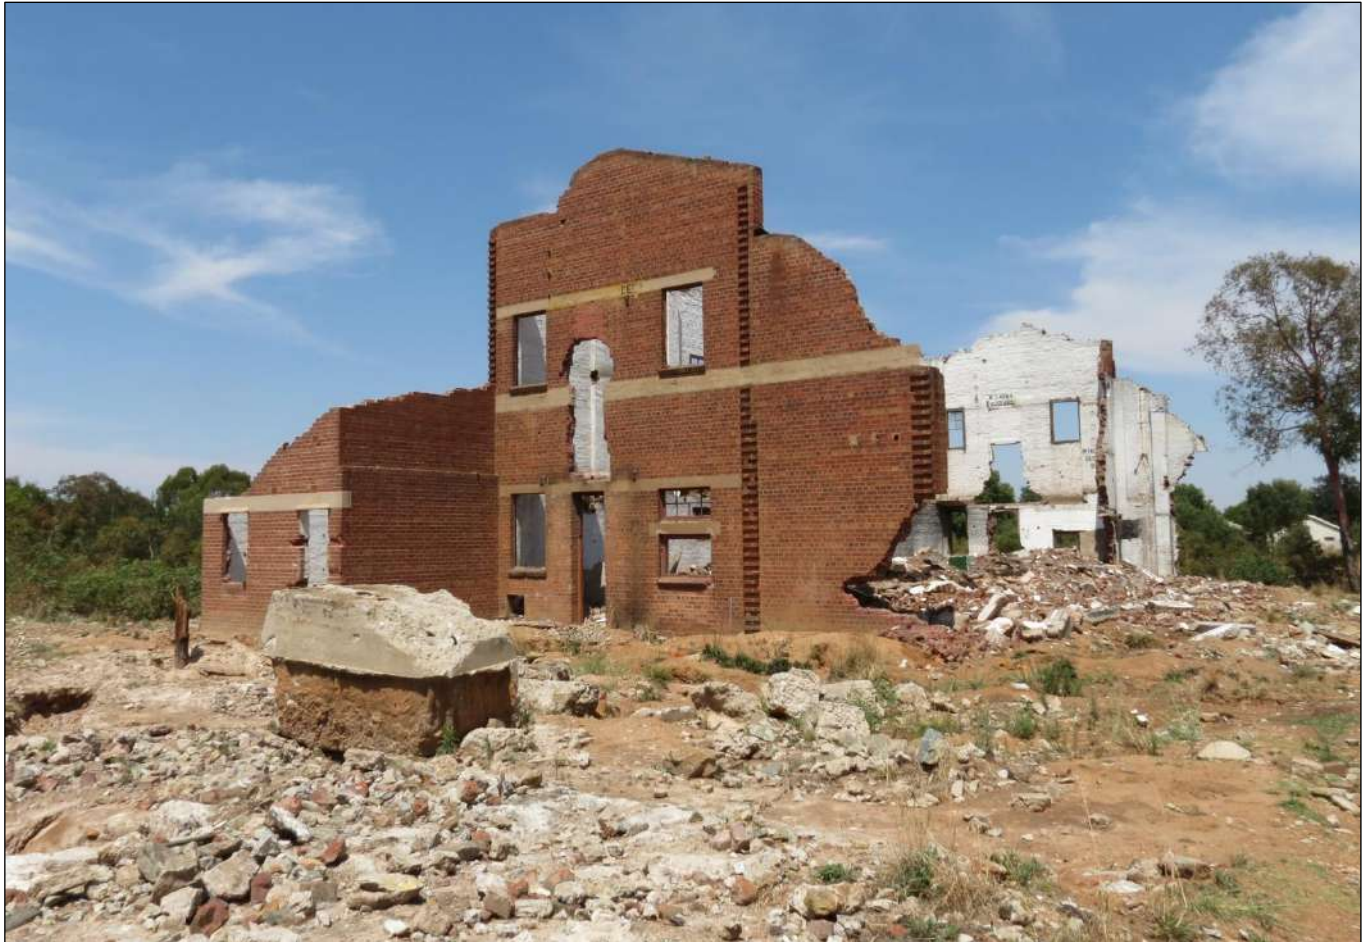
During the site visit of 28 October 2014, it was found that all the buildings from the site had been vandalized to such an extent that very little remains.

Figure 129 – General view of the electrical substation included in this report as Building Type 55. This photograph was taken during the site visit of Tuesday, 28 October 2014.
