PHASE 1 HERITAGE IMPACT ASSESSMENT

Proposed Establishment of Goudrand Ext. 5, Goudrand Ext. 6, Goudrand Ext. 7, Goudrand Ext. 8, Goudrand Ext. 9, Goudrand Ext. 10, Goudrand Ext. 11, Goudrand Ext. 14, Goudrand Ext. 15, Goudrand Ext. 16, Goudrand Ext. 17, Goudrand Ext. 18 and Goudrand Ext. 19, located in the Roodepoort Magisterial District, City of Johannesburg Metropolitan Municipality, Gauteng Province

Issue Date: 20 June 2018
Revision No.: 2
Client: Hunter Theron Incorporated

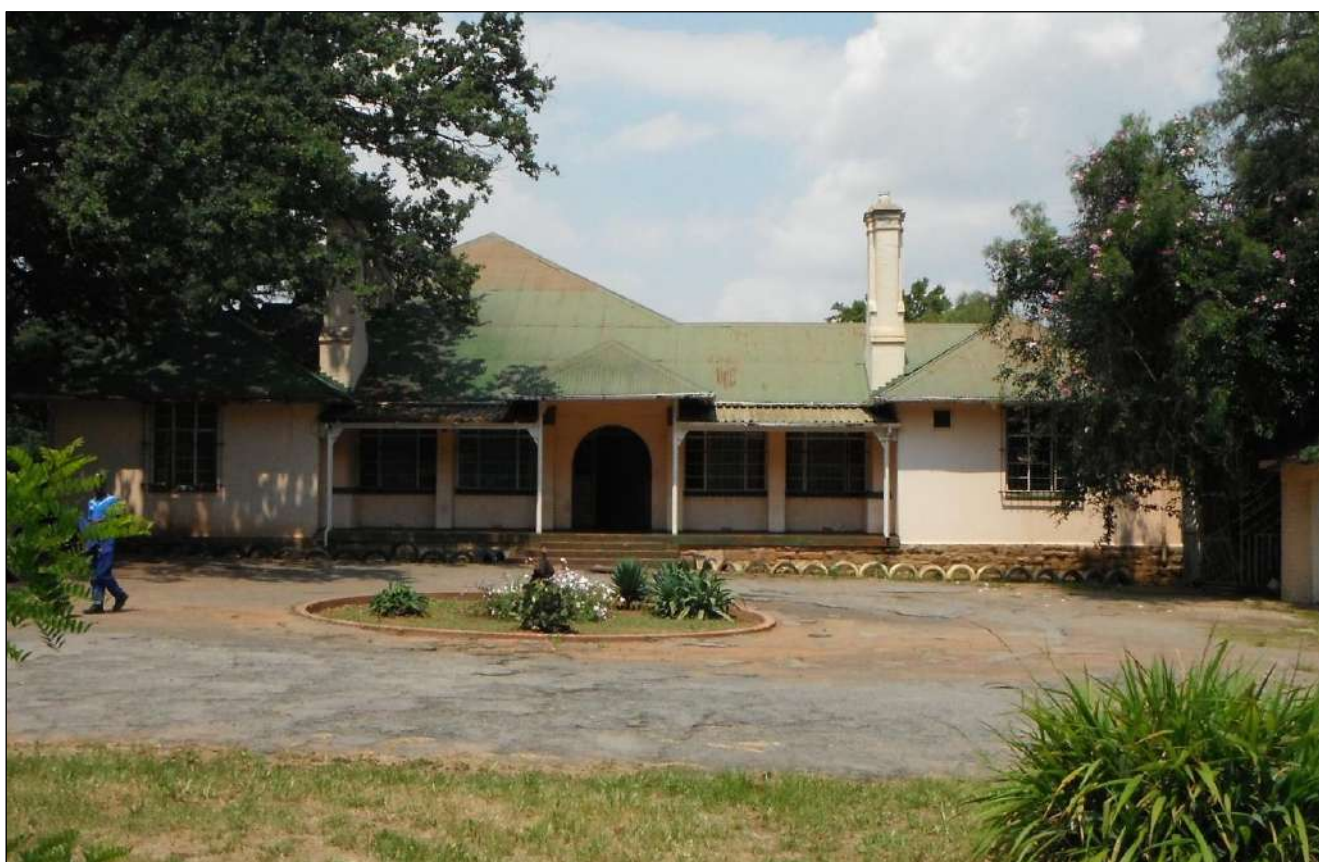
Figure 130 – General view of the General Manager’s Residence included in this report as Building Type 28. This photograph was taken during the fieldwork of 2011.

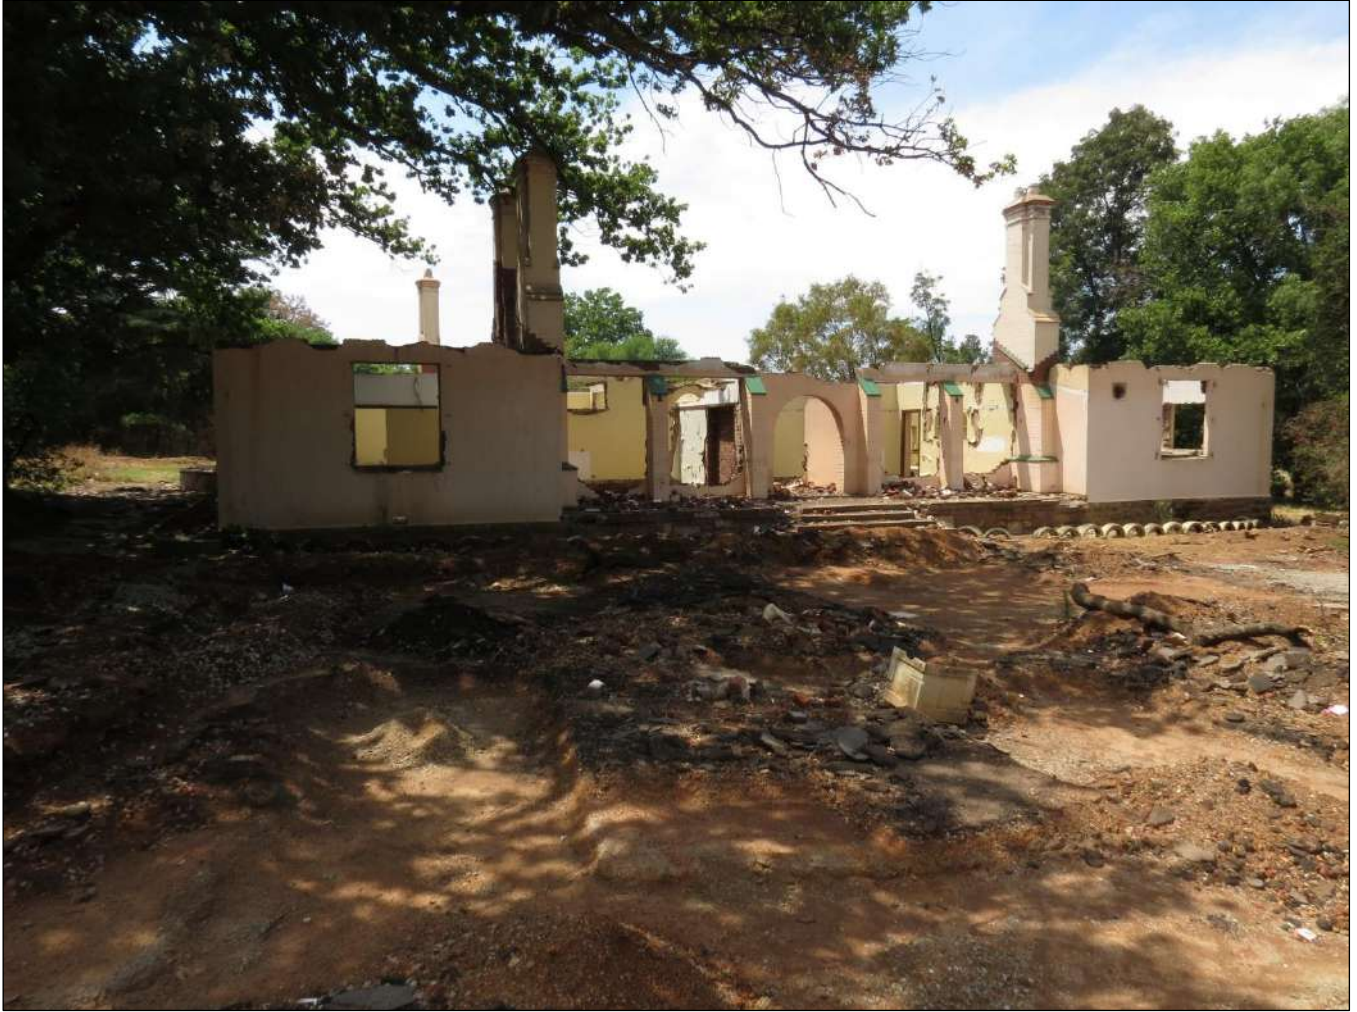
During the site visit of 28 October 2014, it was found that the building has been extensively vandalized with only sections of the walls still remaining. The driveway and parking area in front of the building had also been ripped apart by illegal gold miners. The building is in a very poor condition.

Figure 131 – General view of the General Manager’s Residence included in this report as Building Type 28. This photograph was taken during the site visit of Tuesday, 28 October 2014.

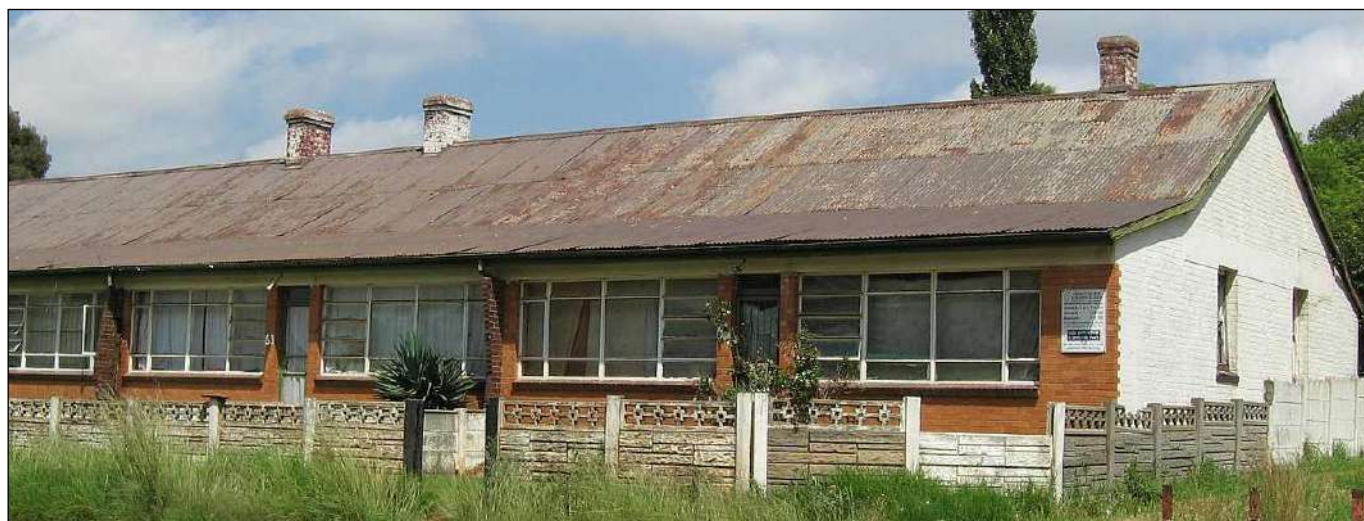
Figure 132 – General view of Building Type 27 as seen during the fieldwork of 2011.

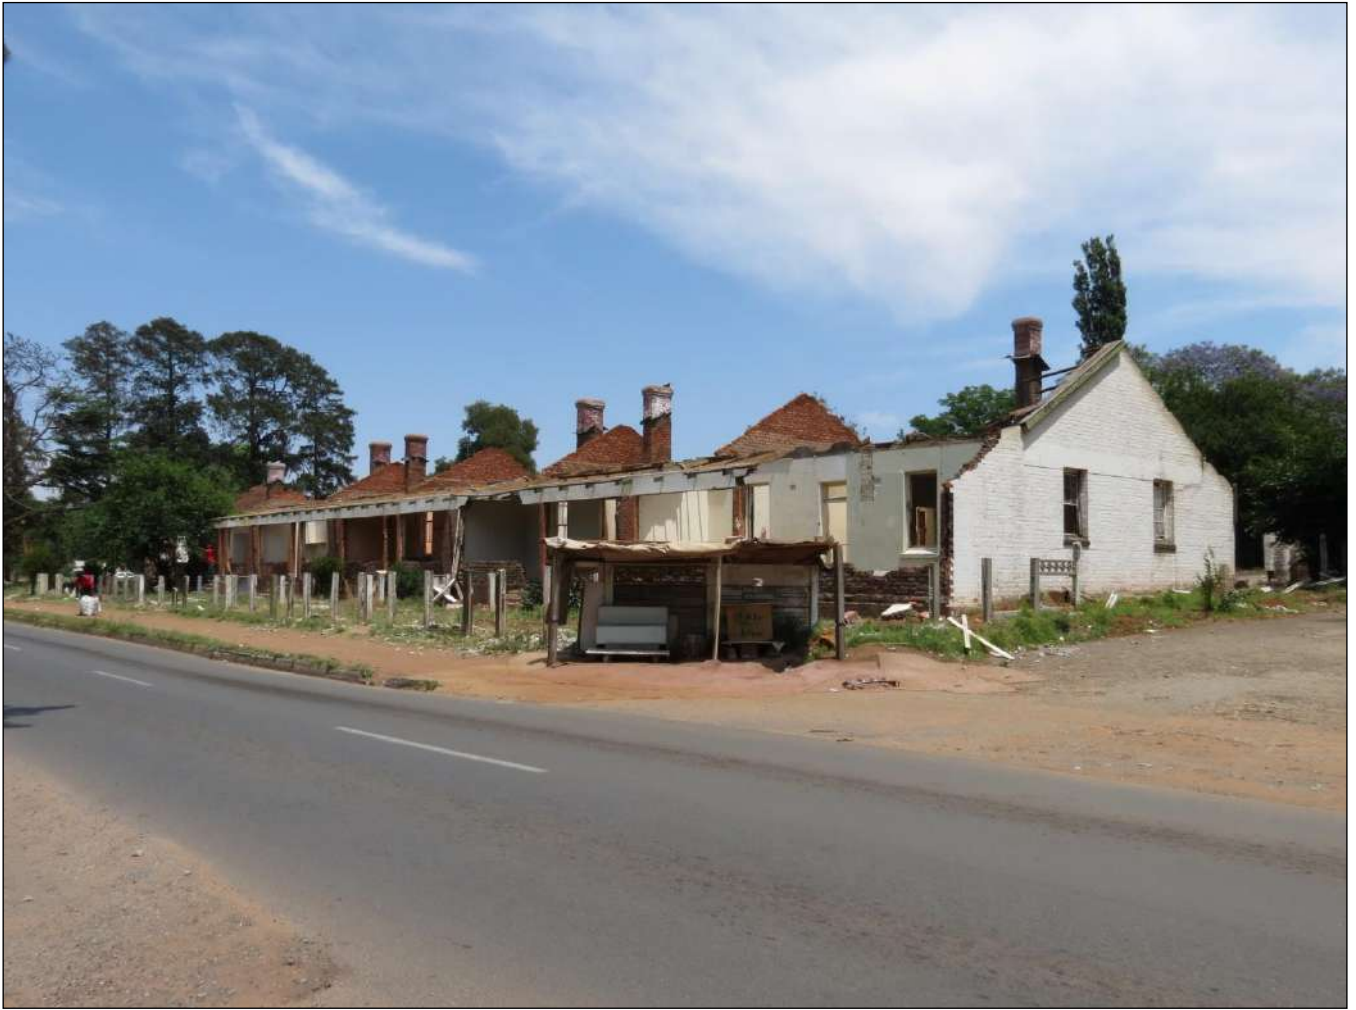
During the site visit of 28 October 2014, it was found that Building Type 27 had been extensively vandalized with only sections of the walling still intact. All examples of Building Type 19 had similarly been extensively vandalized. Furthermore, three of the four examples of Building Type 26 had also been extensively vandalized. The only buildings still in the same state of preservation as what was observed during 2011 are the three examples of Building Type 25 as well as one example of Building Type 26.

Figure 133 – General view of Building Type 27 as seen during the site visit of Tuesday, 28 October 2014.

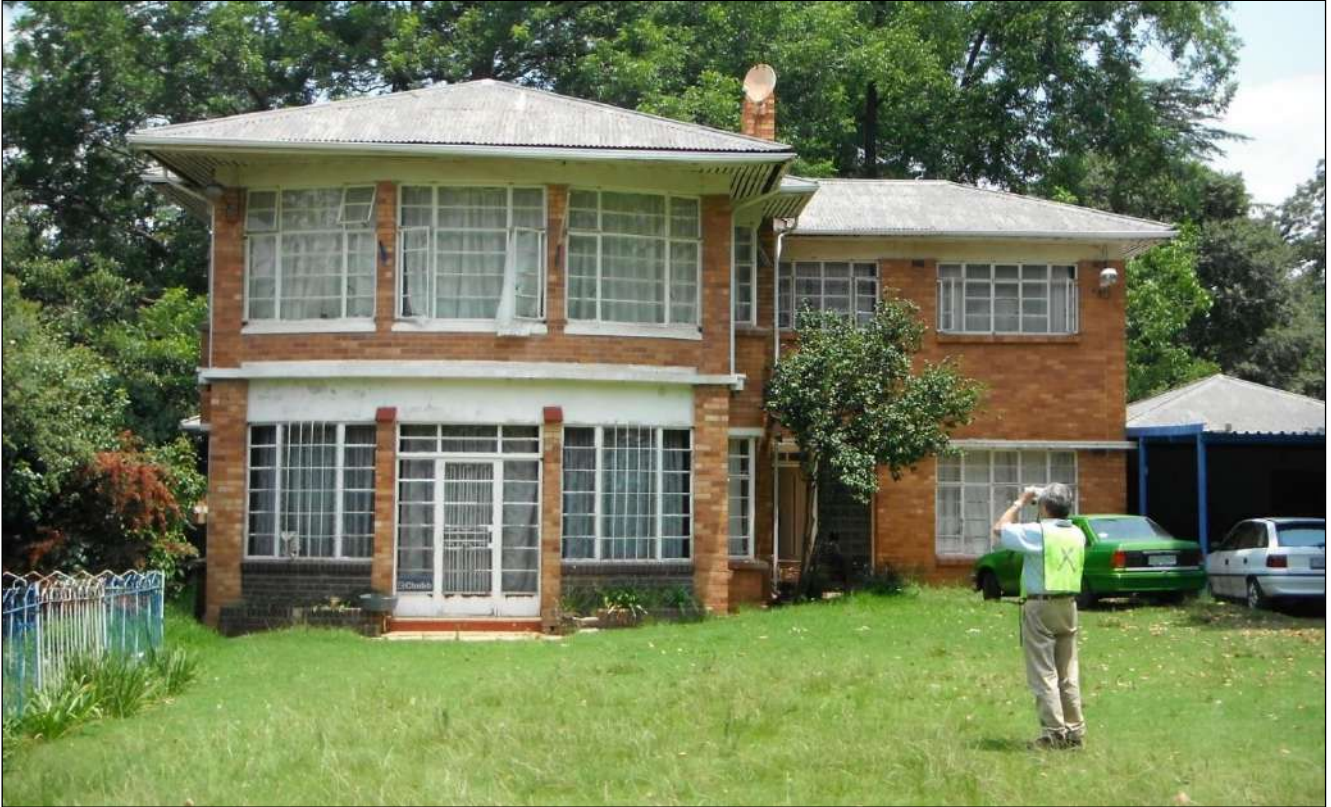
Figure 134 – General view of one of the examples of Building Type 17 as seen during the fieldwork of 2011.

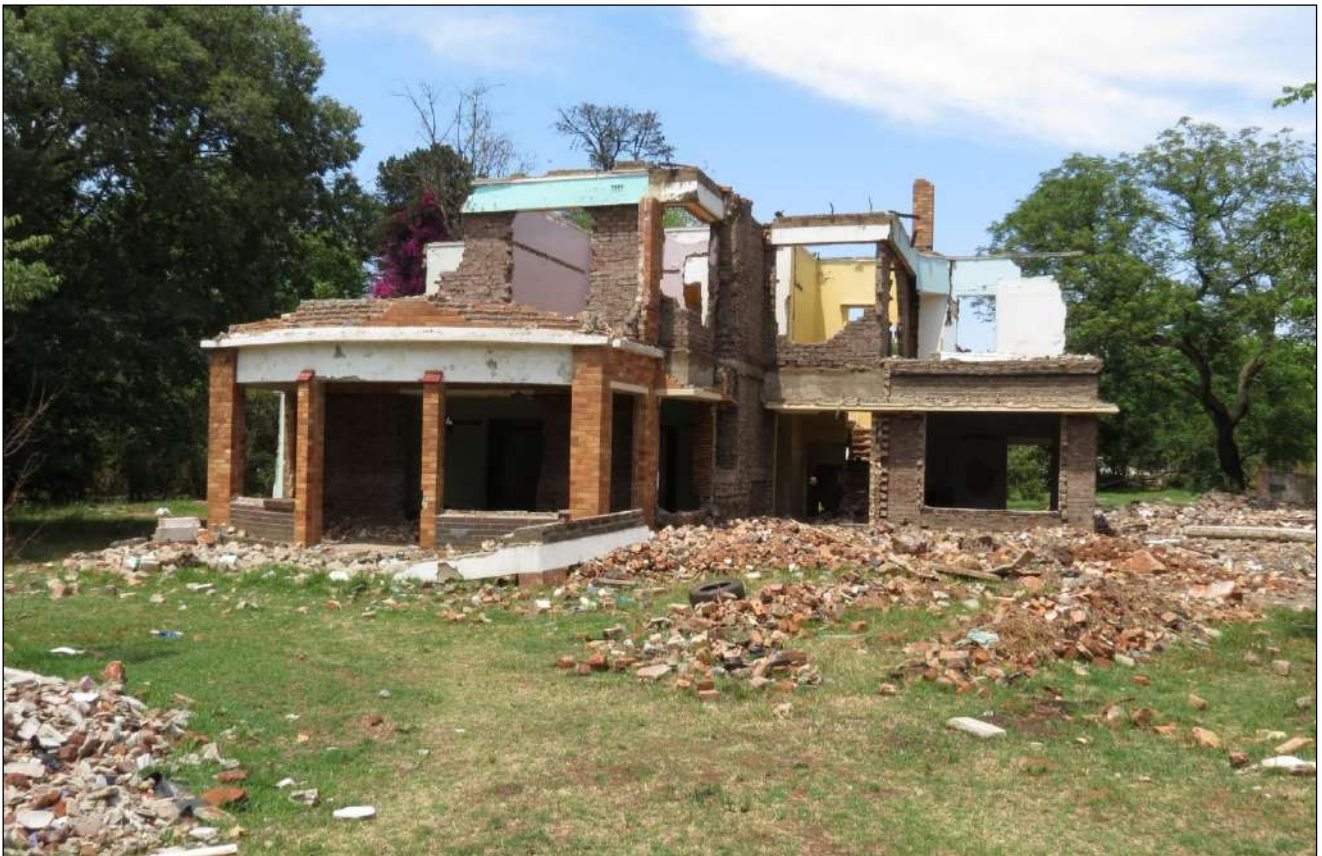
During the site visit of 28 October 2014, it was found that both examples of this building type were vandalized to such an extent that only sections of the walling have remained. The same holds true for the remaining three examples of this building type.

As a result, no intact examples of this building type still remain within the study area.

Figure 135 – General view of one of the examples of Building Type 17 as seen during the site visit of Tuesday, 28 October 2014.

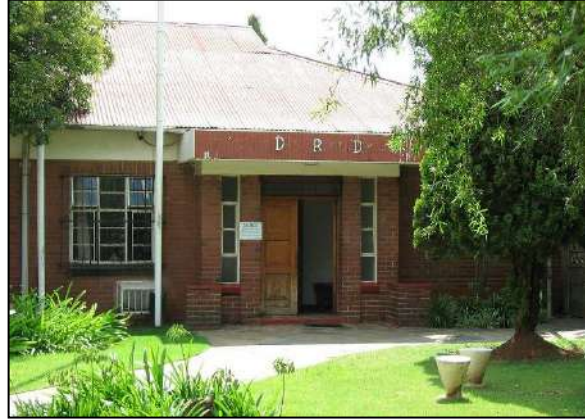
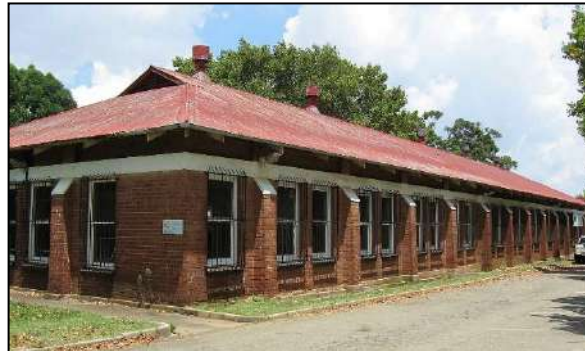
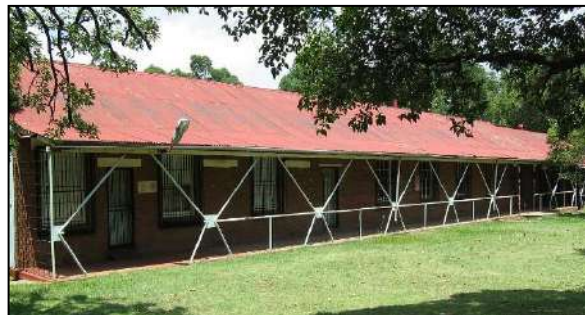
village exceptional is the large typology of dwellings that were erected over a period of 100 years, reflecting an exceptional large variety of styles and building trends. One cluster of buildings reflecting solid and well-crafted buildings is the cluster of administration building executed in red face bricks categorized as Types 38, 39 and 40.

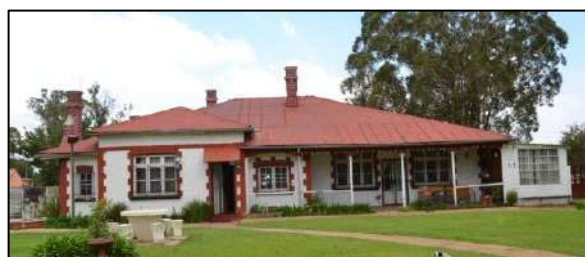
One of the remaining buildings is of special architectural significance namely the dwelling categorized as Type 68. It forms part of the cluster of dwellings but it is the only one of its kind in the entire village

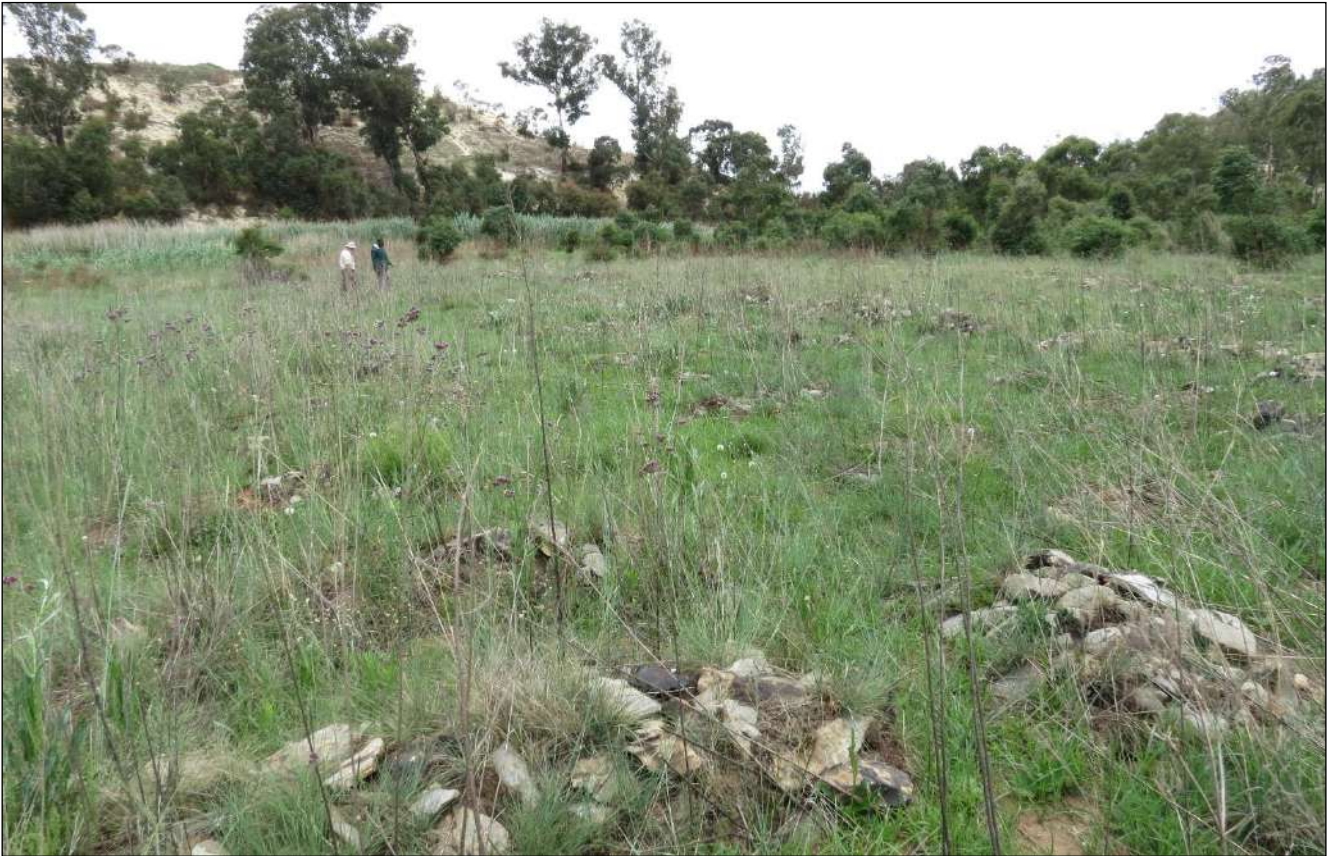
Graves and burial grounds have high levels of emotional, religious and historical significance. Furthermore, the cemetery identified at DRD 1 represents a place of burial for mine workers and their families and is directly associated with the long history of the Durban Roodepoort Deep Gold Mine. As a result, the site has a **GP. A - High Significance**.

Figure 137 – General view of a section of the cemetery at DRD 1. The extent of the cemetery, as well as the high number of graves only marked with uninscribed stone dressings, can be seen.

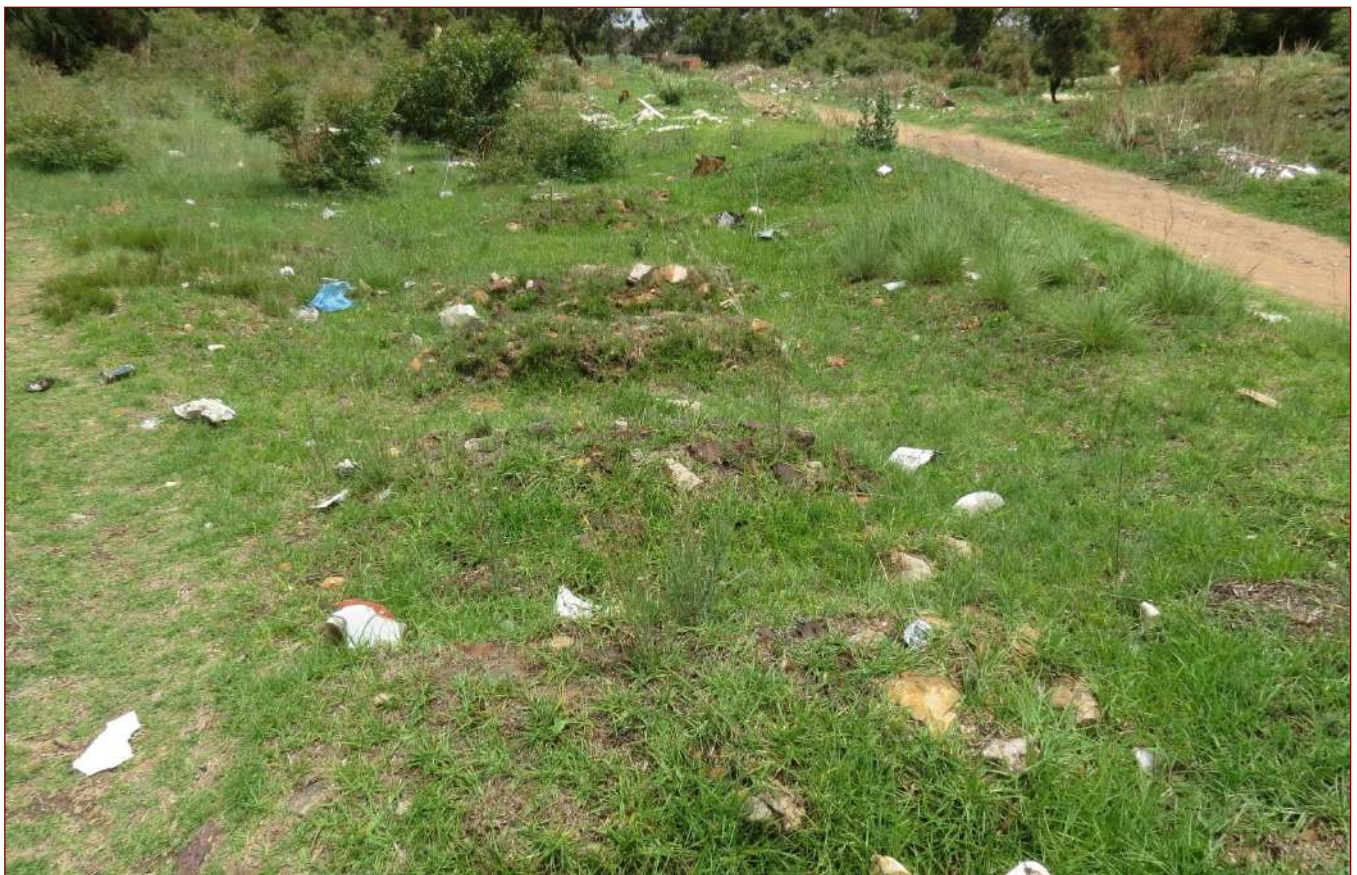
Figure 138 – General view of another section of the cemetery at DRD 1.

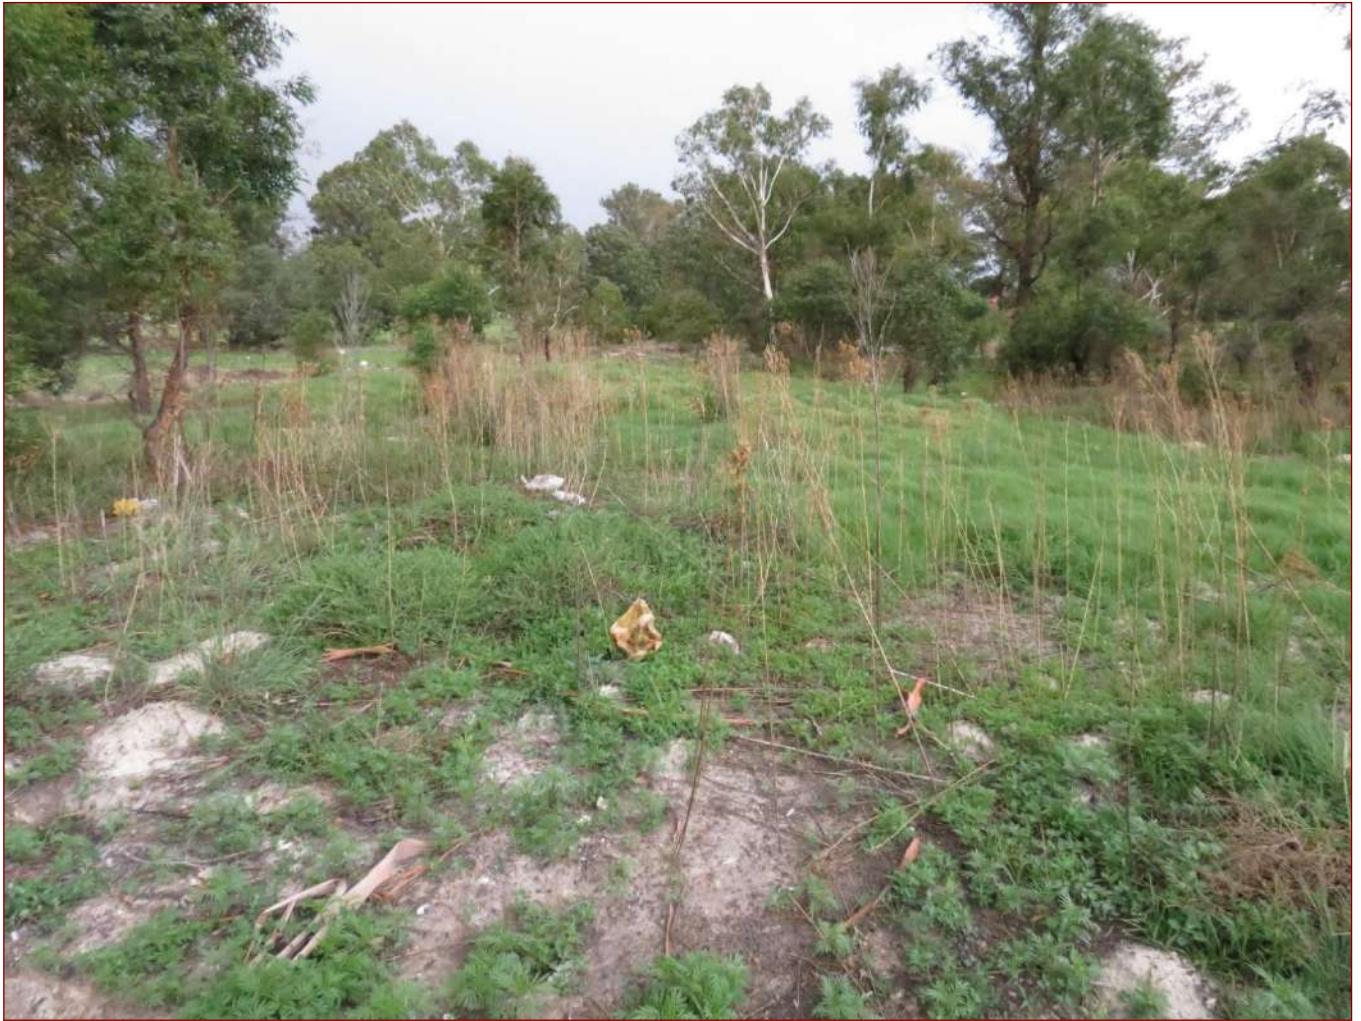
A historic midden was identified on the northern end of the study area, roughly 190 m south-west of Randfontein Road. It comprises a reasonably extensive low heap of material covered by vegetation. Although more recent artefacts were also observed here, at least one fragment of a glass mineral water bottle commonly known as a 'Codd' was observed on the surface of the site. These 'Codd' bottles are associated with the 1890s and early 1900s, and as a result indicate that sections of this midden is certainly older than 100 years. It seems plausible for more material of this age and older to be located within the lower sections of the midden's stratigraphy.

It is clear that the site does not represent an undisturbed archaeological midden. However, the possible presence of archaeological material associated with early gold mining activities in general, and mining activities of the Durban Roodepoort Deep Gold Mine in particular, necessitates a higher level of significance. As a result, the site has a **GP. B - Medium Significance.**

Figure 141 – General view of a section of the midden located at DRD 2.

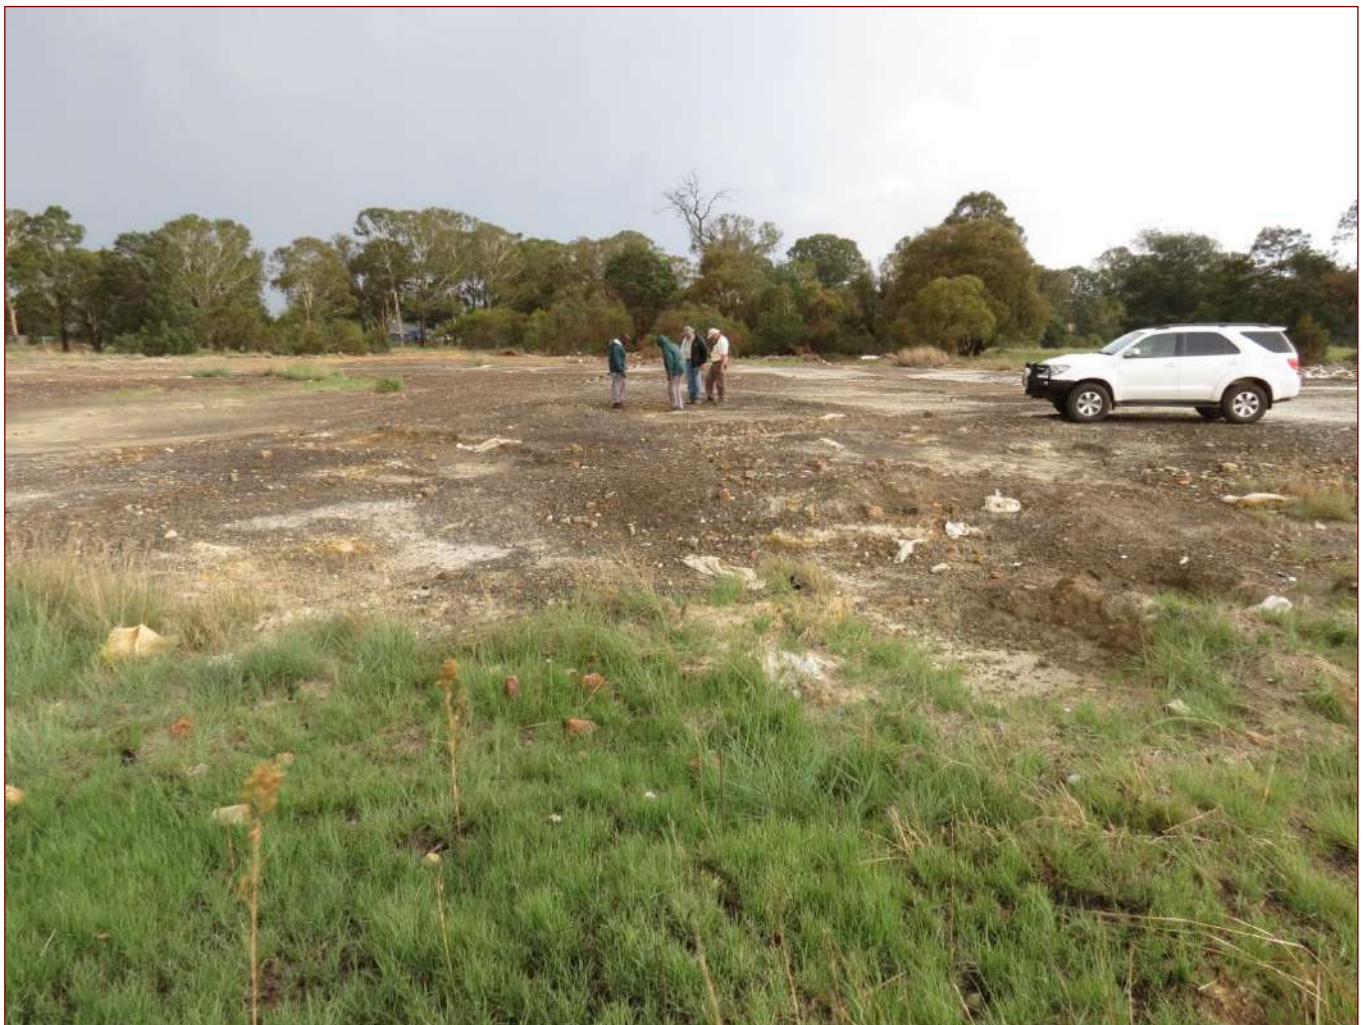
It is clear that the site does not represent an undisturbed archaeological midden. At the time of its original identification in December 2013, the site was already disturbed by grading activities with a second disturbance taking place during the middle of 2015 with the construction of a nearby water reservoir. Despite the disturbance to the site, the possible presence of archaeological material associated with early gold mining activities in general, and mining activities of the Durban Roodepoort Deep Gold Mine in particular, requires that the site has a **GP. B - Medium Significance**. This means that mitigation will be required before the site may be destroyed.

Figure 142 – General view of a section of site DRD 2 during its identification in November 2013.

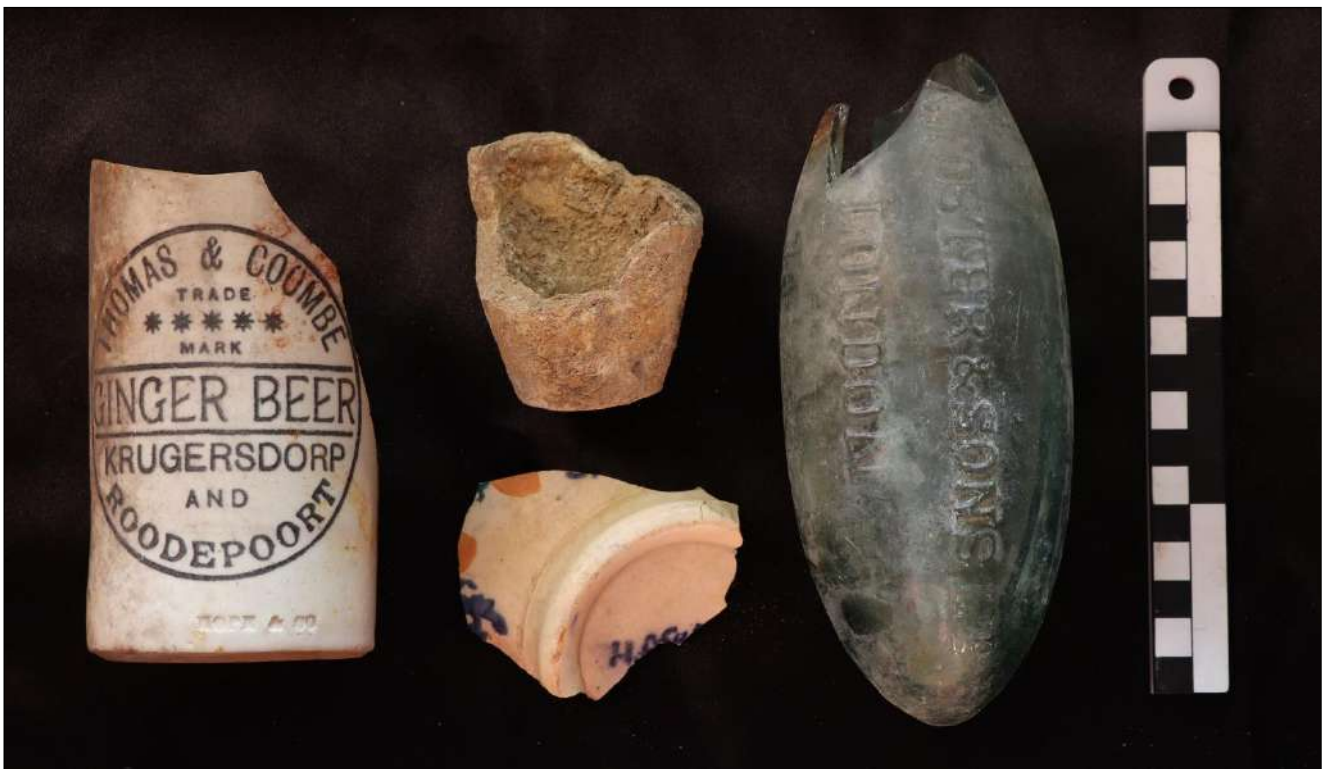
Figure 144 – Sample of artefacts observed on the surface of the site. The items include a ginger beer bottle, torpedo-shaped 'Codd' bottle, crucible and imported ceramic fragment. Scale is in 1cm increments.

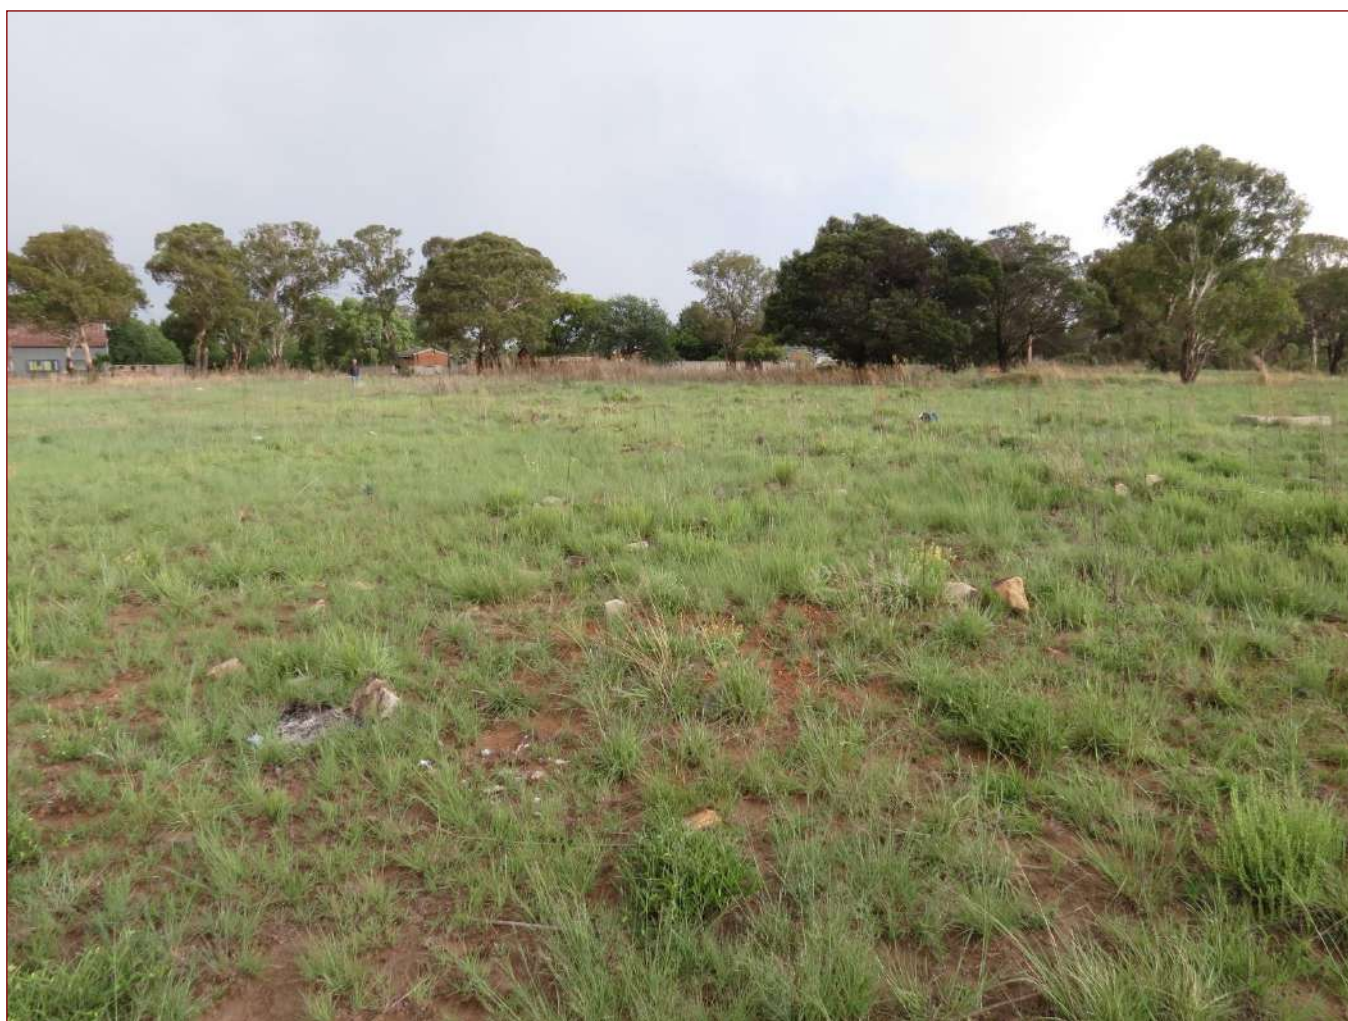
Graves and burial grounds have high levels of emotional, religious and historical significance. Furthermore, the cemetery identified at DRD 4 appears to represent a place of burial for mine workers and their families and is more than likely directly associated with the Durban Roodepoort Deep Gold Mine. As a result, the site has a **GP. A - High Significance**.

Figure 145 – General view of a section of the cemetery at DRD 4. The high number of graves with dressings comprised of single stones or small clusters of stones can be seen in the foreground. In the background to the right the cement and brick lined dressing can be seen.

In this section the impact of the proposed development on site DRD 4 will be established. According to the available development layout plan, the cemetery will be preserved within the proposed development. Although a limited buffer area will be kept free of development around the cemetery, the only proposed development still to take place in the surroundings of the cemetery are water reservoirs and associated infrastructure. In the experience of the authors, unmarked graves have been found in association with historic cemeteries such as the one at DRD 4. The calculation below includes this possible risk.

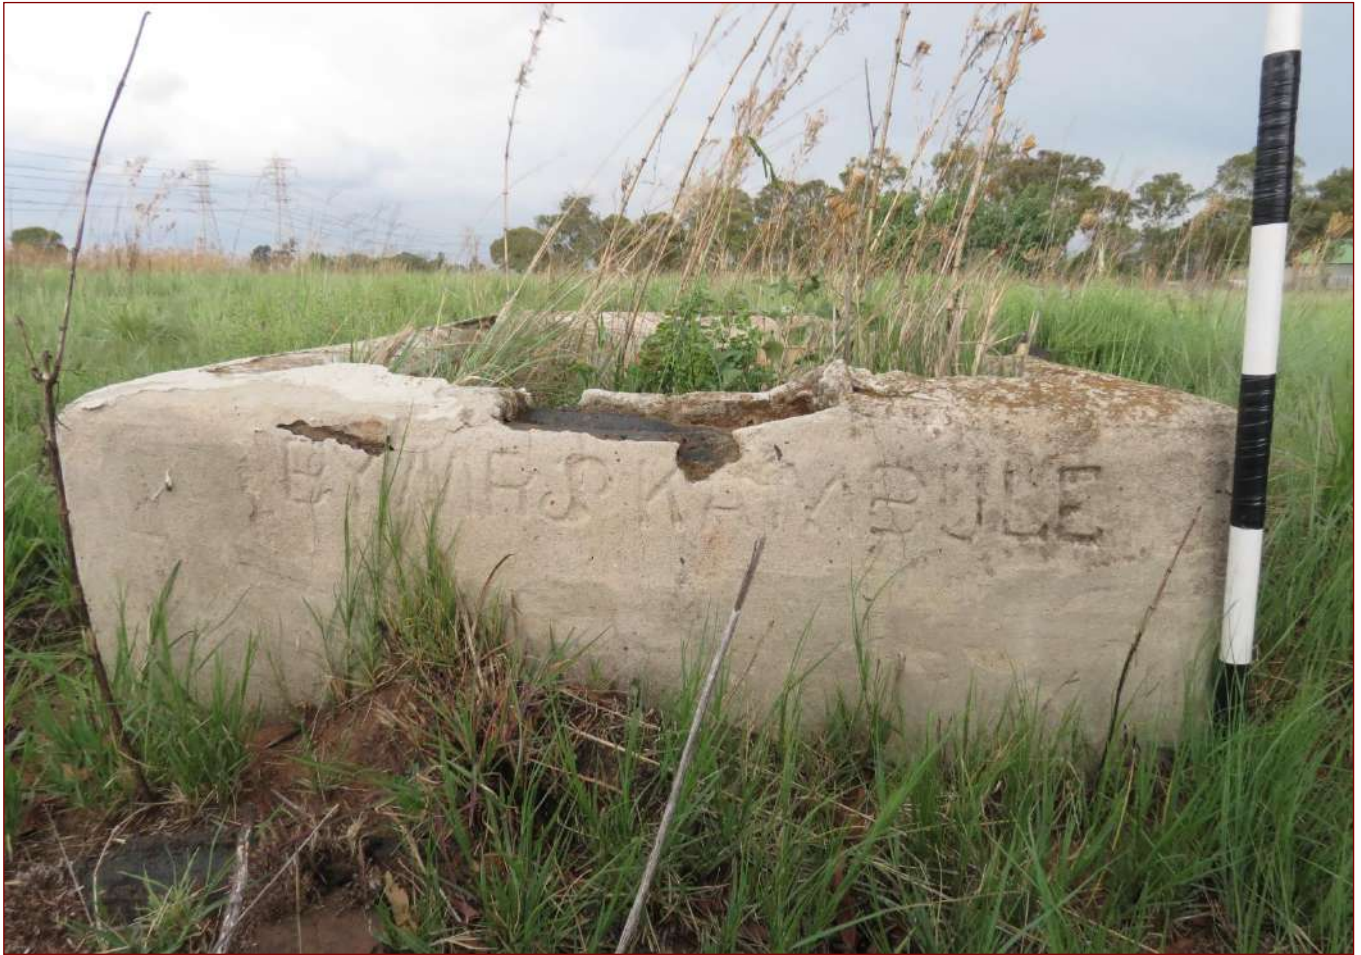
Figure 146 – Close-up view of the western end of the cement and brick lined dressing on which the only inscription from the entire cemetery at DRD 4 could be found.

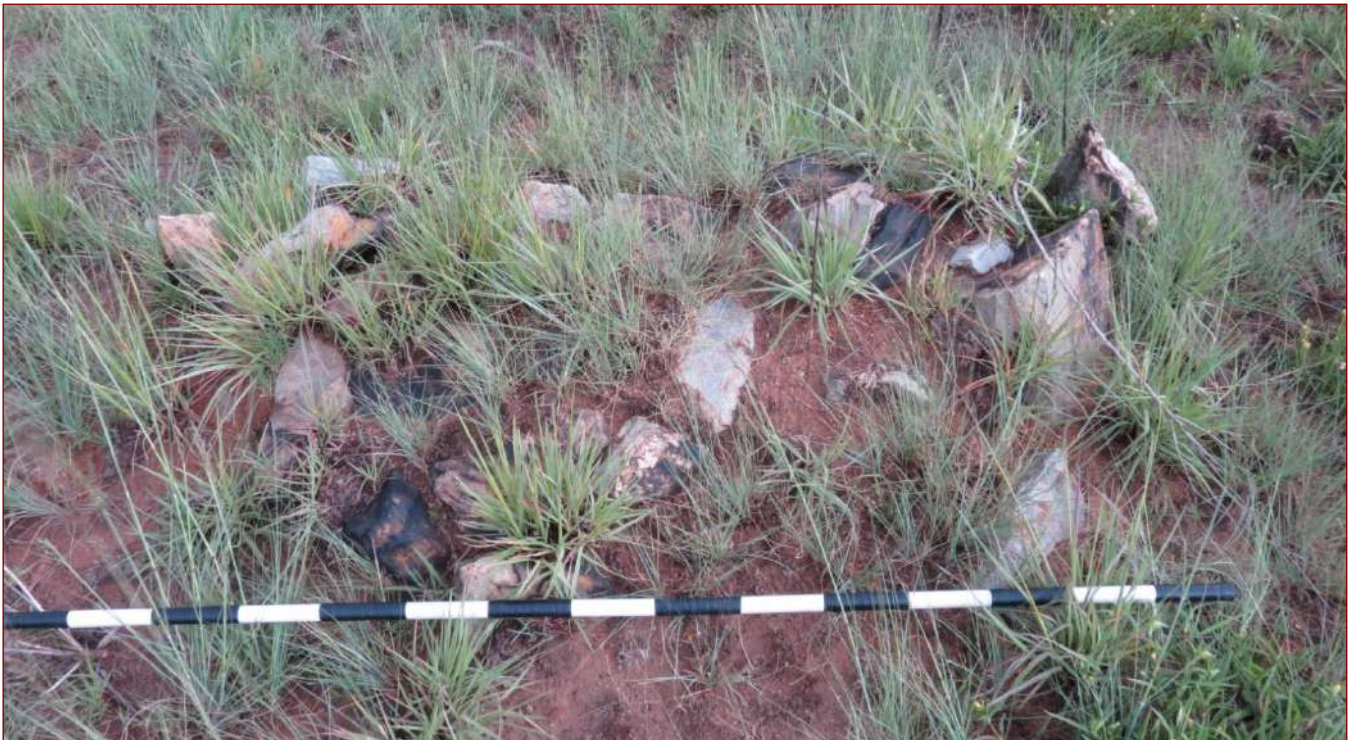
Figure 147 – One of the stone packed dressings identified at DRD 4.
