**PHASE 1 HIA REPORT FOR THE PROPOSED
MALEKANE BRIDGE & UPGRADES OF PORTIONS OF ROADS D2219 (R579), D1392 AND
P169-2 (R555).
MALEKANE, NEAR STEELPOORT, LIMPOPO**

REPORT: **APAC019/95**

***A.J. Pelser
Accredited member of ASAPA***

September 2019

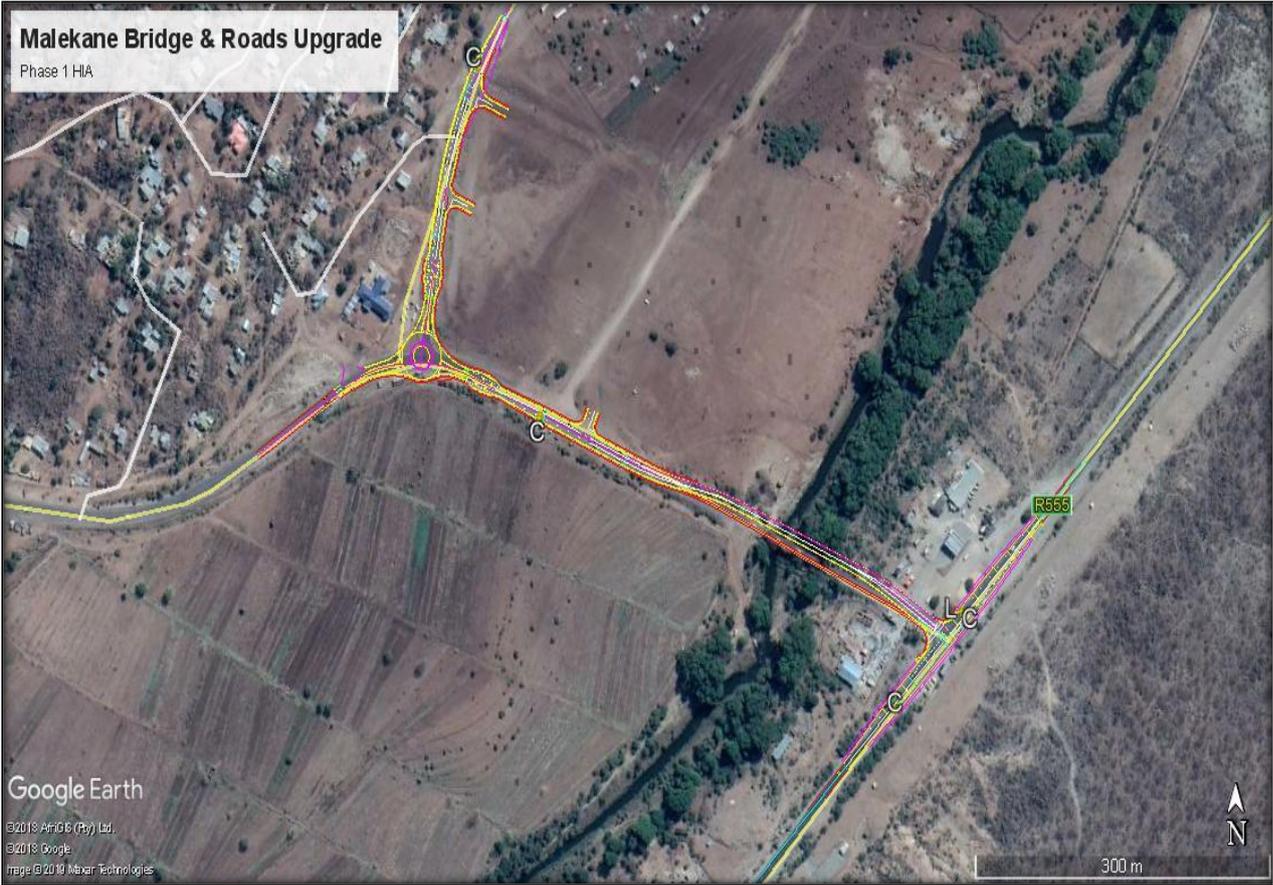
Figure 3: Closer view of study area showing road sections and bridge crossing that will be upgraded (drawing courtesy Bokamoso Landscape Architects & Environmental Consultants CC).

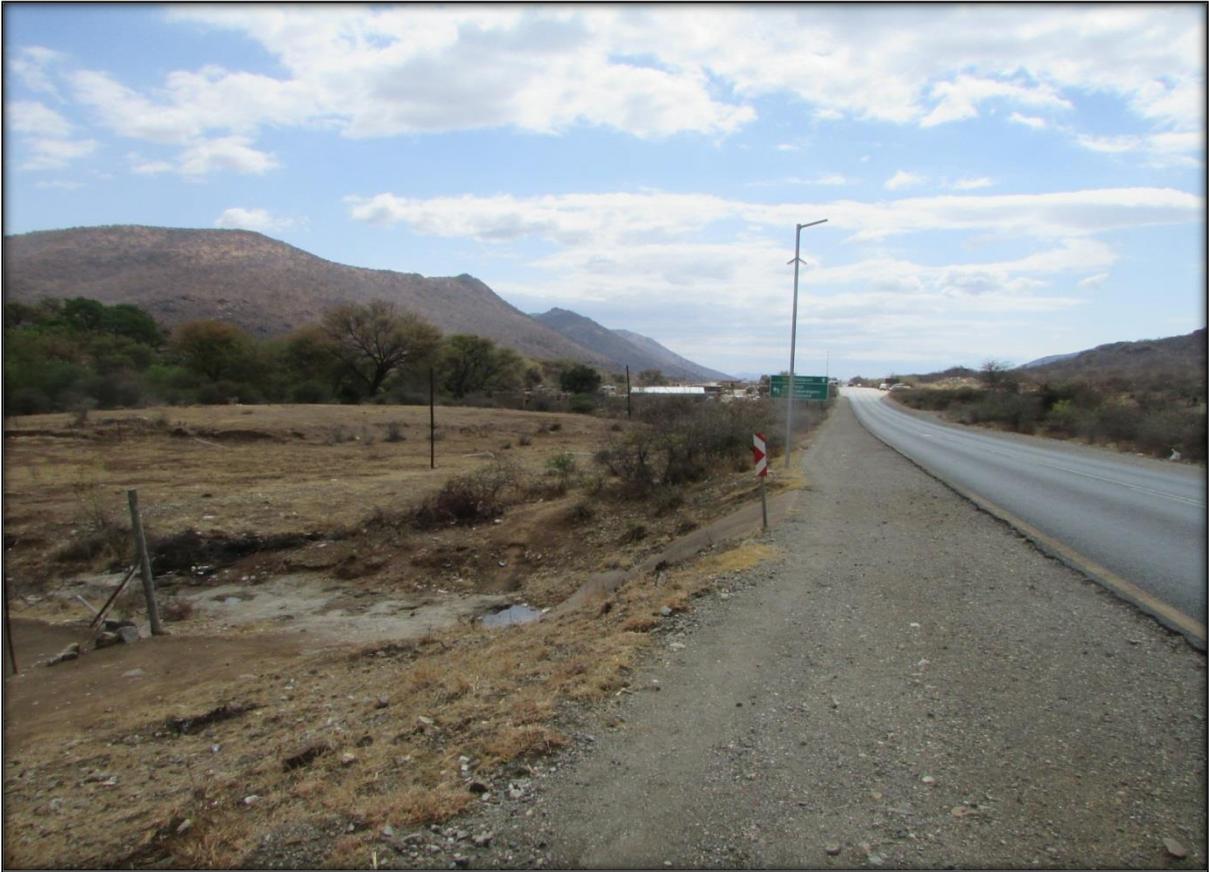
Figure 6: A view of a section of the R555 road that will be upgraded.

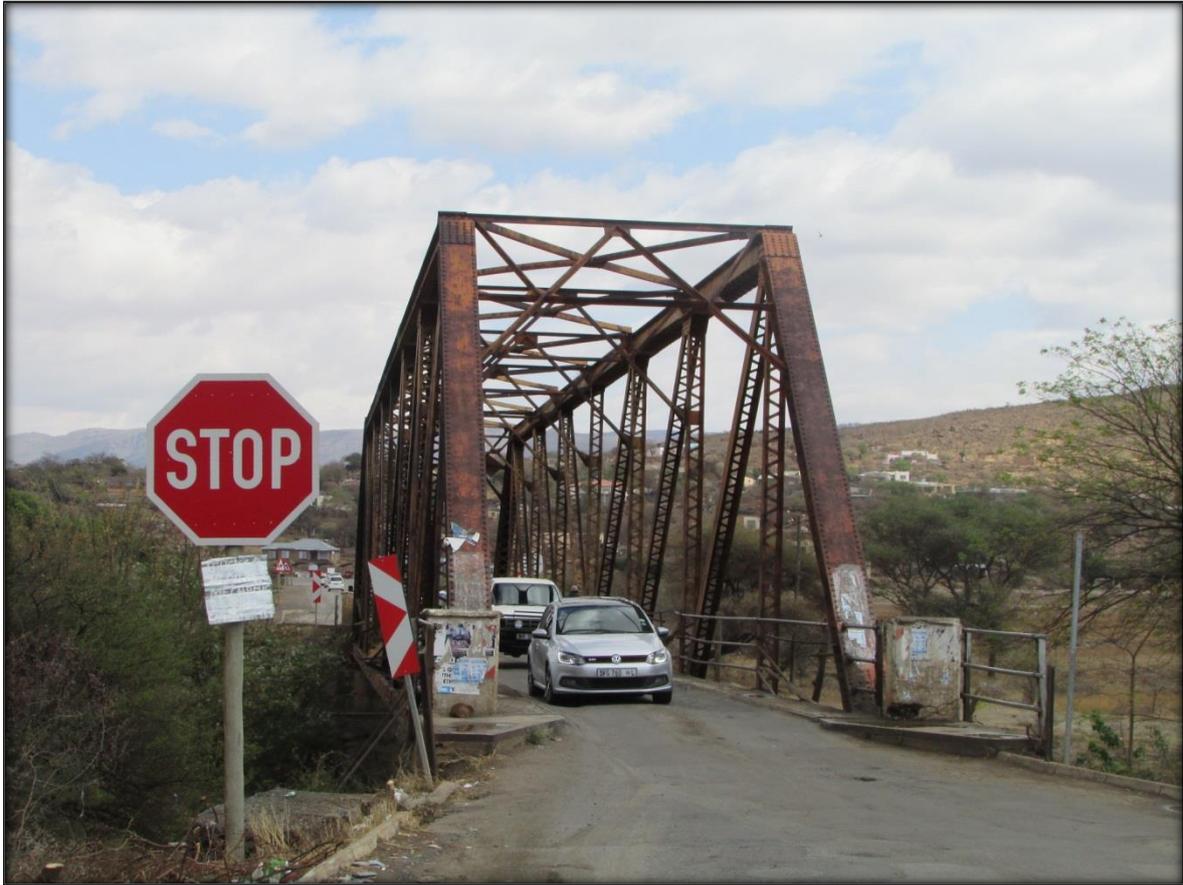
Figure 7: A view of the current Malekane Bridge crossing the Steelpoort River.

The only site or features of any cultural heritage significance identified in the study area during the assessment was the old Malekane Steel Bridge crossing the Steelpoort River. The bridge has been part of the historical landscape here since the 1920's and is therefore a fairly significant heritage feature. A metal plaque on one of the bridge trusses gives the following information:

"Patent Shaft & Axletree Co Ld, Wednesbury England. 1926". From this it can be deduced that the metal for the bridge was at least manufactured in and around 1926. Although the bridge might have been completed at a later date it can be assumed that it was not much later in time. The bridge is therefore older than 60 years and protected by the National Heritage Act and needs be preserved and not negatively impacted or demolished by the proposed upgrade of the road sections OR the intended upgrade work.

It has been indicated that a new steel bridge will be constructed separate from the old one. However this, as well as the upgrading of the old bridge needs to be done taking the historical nature and significance of the existing bridge into consideration. The following is recommended before the proposed upgrade work is undertaken:

1. A structural assessment of the bridge should be undertaken by an Industrial/Architectural Historian to determine the significance of the bridge
2. Detailed photographic documentation of the bridge should be undertaken so that images of the bridge can be preserved for future generations
3. The bridge should also be mapped and drawn in detail for the same purposes
4. The bridge should be kept intact as far as possible and utilized as part of the traffic flow in and out of Malekane

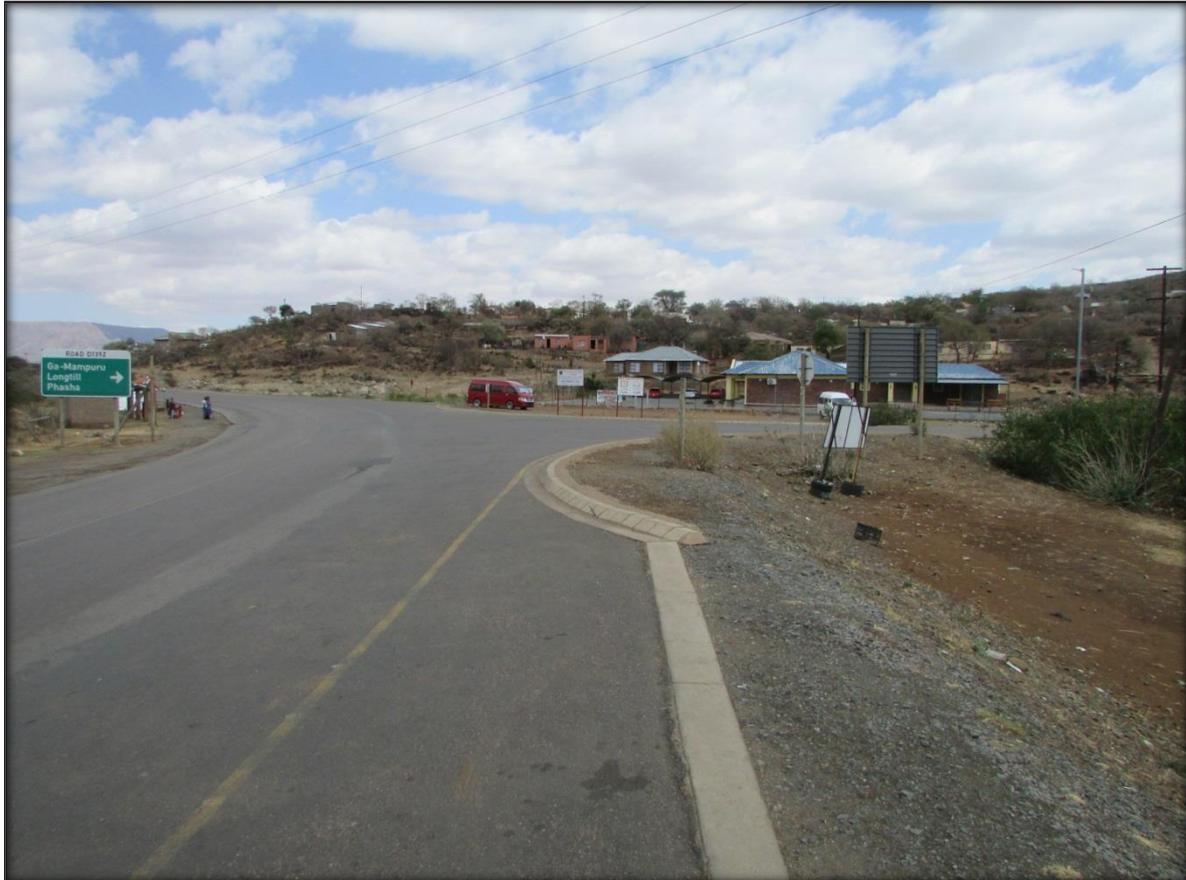
Figure 10: A view of a section of the road into Malekane & leading to Jane Furse. This section will be upgraded to include a traffic circle as well.

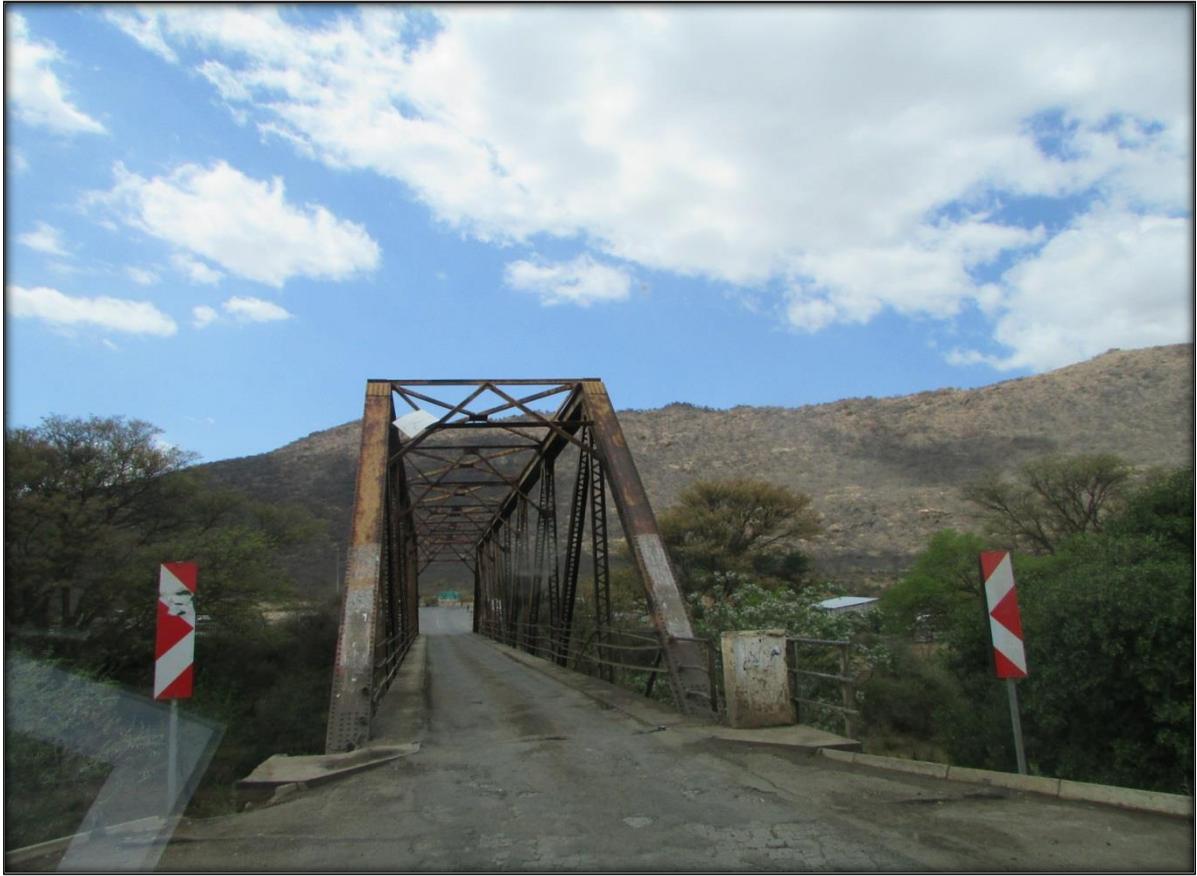
Cultural Significance: High

Heritage Significance: Grade III: Other heritage resources of local importance and therefore worthy of conservation

Figure 11: Another view of the Malekane Bridge.

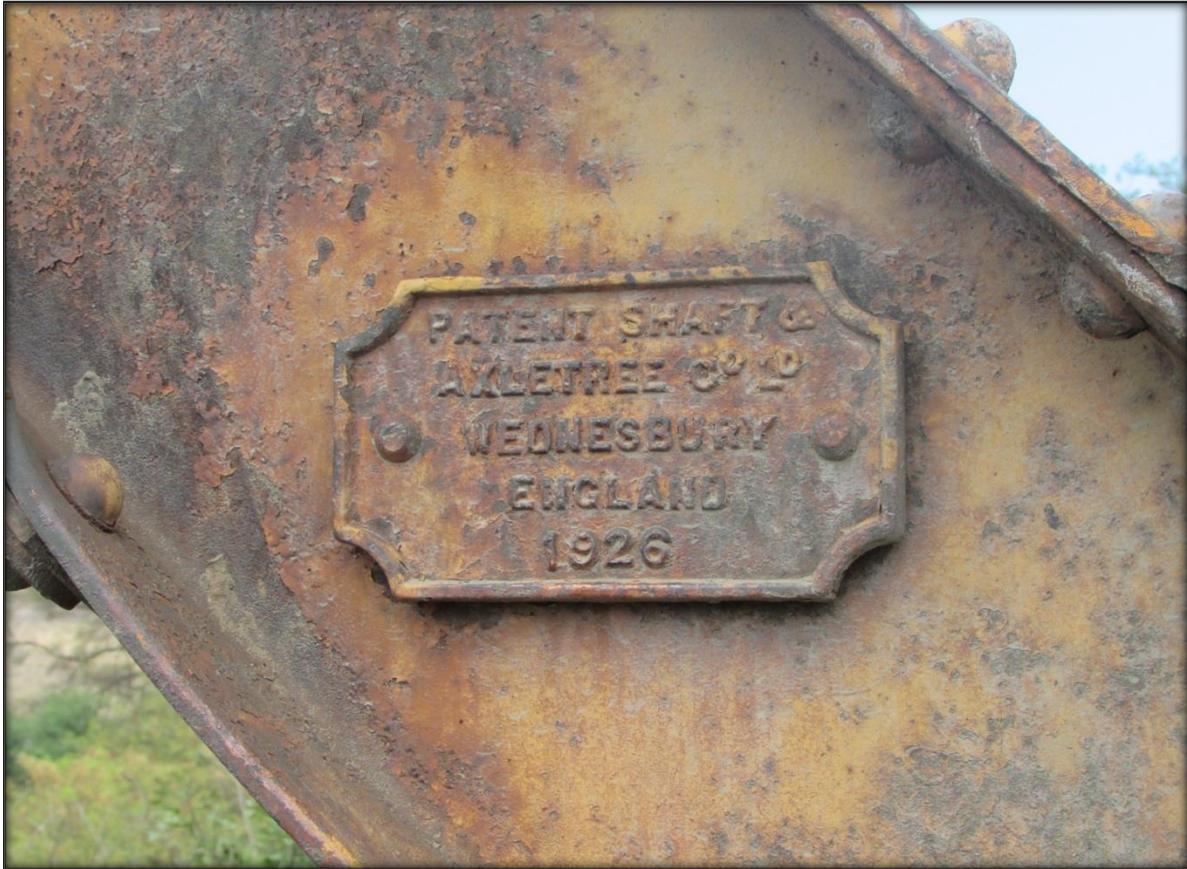
Figure 12: Close-up of the metal plaque on the bridge showing the age of the metal construction of the bridge.
