PHASE 1 FIELD REPORT SUMMARY FOR THE HISTORICAL ASSESSMENT OF MOSALA HOUSE DINGLETON

ASSESSMENT OF SIGNIFICANCE OF THE “MOSALA HOUSE” SITUATED ON THE FARM
GAMAGARA NO 541 PORTION 2 RESTANT 12, DINGLETON, KHUMBA IRON ORE
MINE, IN THE GAMAGARA LOCAL MUNICIPALITY, JOHN TAOLO GAETSEWE DISTRICT
MUNICIPALITY, NORTHERN CAPE.

HISTORICAL BUILDINGS/ARCHITECTURAL FEATURES SITE RECORDING

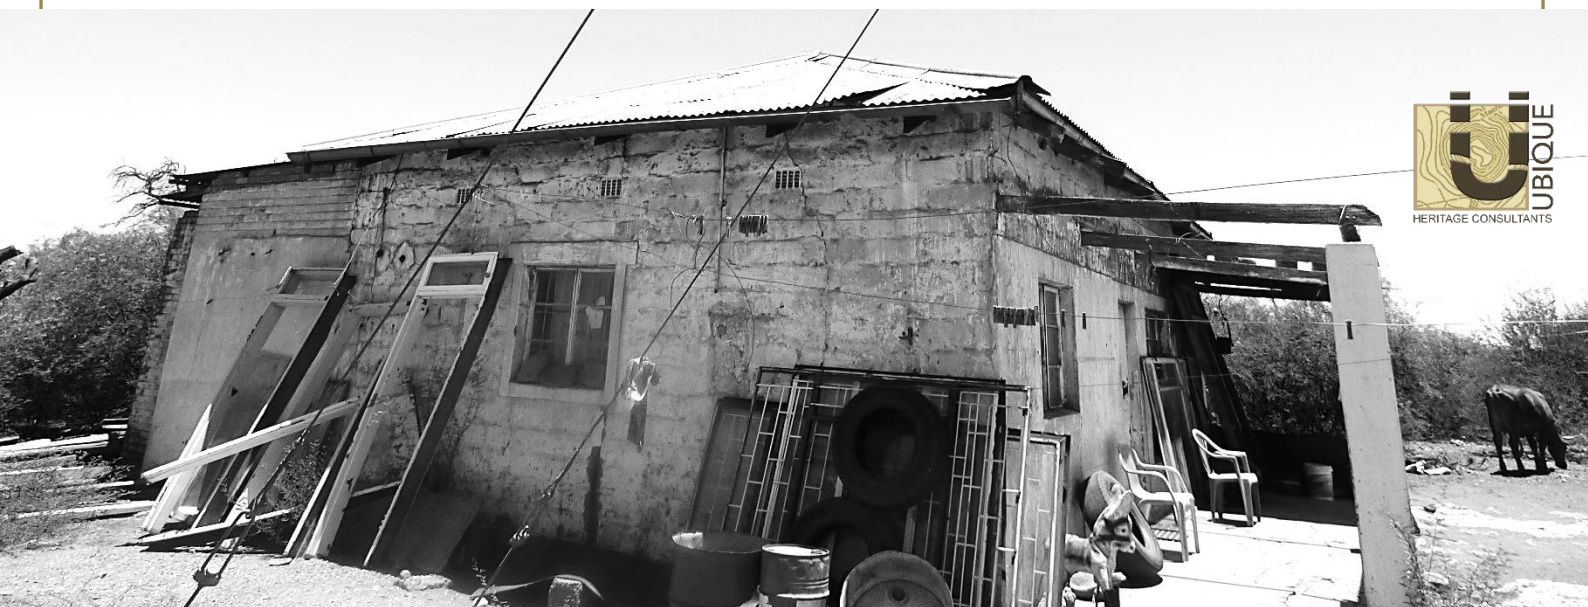
SITE DESCRIPTION								
Date Built	1940s-1960s	Over 60	YES	NO	Style	Simple Edwardian bungalow	Period	Post-War Modern
Description of Architectural Features	Small north-facing square house, pitched corrugated-iron roof. A cement veranda with five square pillars in front of the house, only part of the roof remaining, probably not the original roof. Stone and cement with large aggregate foundation with large vitrified mud bricks on the original structure. The windows are deep-seated with visible lintels: original wooden roof rafters and support beams in place. The metal-framed windows appear to date of construction, whereas the door has been replaced. There are alterations and an addition towards the back with modern bricks.							
Environmental Landscape	House is in the context of a small farmyard with livestock pens and chicken coops, made of fencing material and found/re-used objects. Thorn bushes and collections of building material surround the house. Animals have disturbed the soil with repeated movement within a small space. Modern cultural material and litter are distributed horizontally across the yard space, with concentrated dumping regularly burnt areas.

Cultural Landscape	On the periphery of the old Dingleton settlement area.							
Condition	Cracks in the plaster, broken window panes, rusting and lifting corrugated-iron roof, and degraded wooden beams.							
Past Renovations, Alterations, Restorations	Alterations at the back of the house, pipes added and removed.			Identified Threats	Fire with the closeness of brush to the house. Imminent demolition.

1. The house is NCW (Not Conservation Worthy) and is awarded a field rating of IVC (the structure is deemed of low significance, and Phase 1 is considered sufficient recording of said structure, and it may be demolished).
