**A PHASE 1 HERITAGE IMPACT ASSESSMENT & REPORT FOR  
THE PROPOSED NAUDES BANK MINING DEVELOPMENT  
ON PORTIONS OF THE FARMS VAALBULT 31IT, VAALWATER 173IS, TWYFELAAR 171IS  
AND NAUDES BANK 172IS  
LOCATED BETWEEN HENDRIN AND CAROLINA IN THE MPUMALANGA PROVINCE**

REPORT: **APAC023/52**

***May 2023***  
***Amended June 2023***

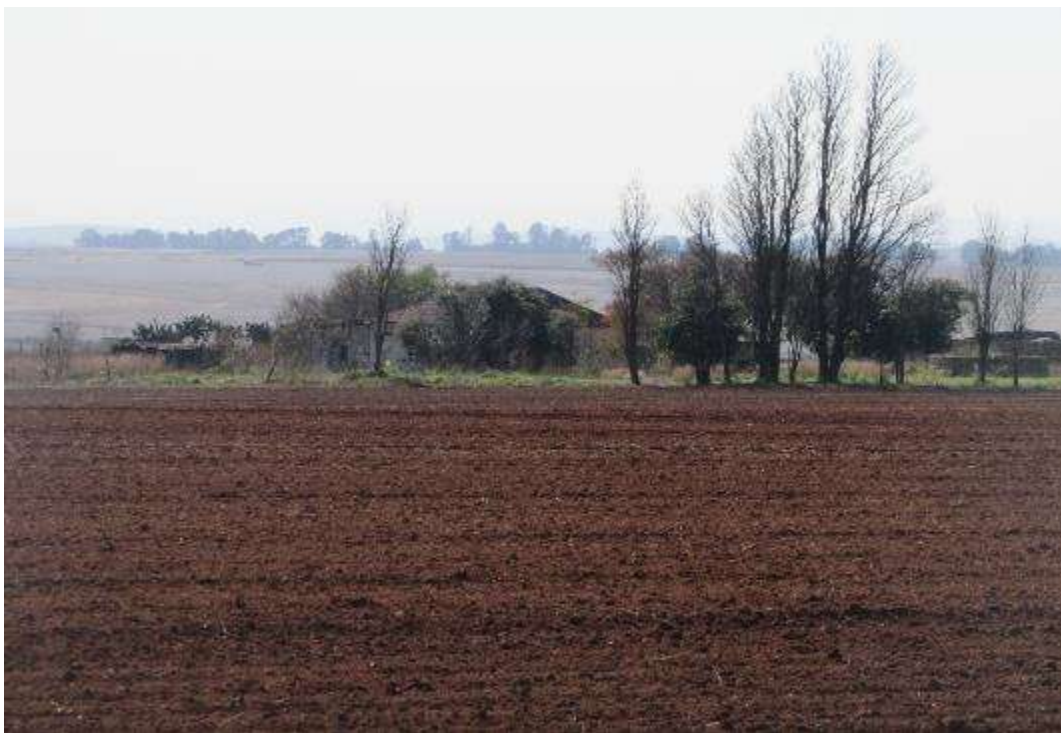
Site FS1 is an old farmstead and related infrastructure. It consists of a number of structures and foundations, including an old shed/kraal, farm dam and homestead. It is currently occupied by someone who assumedly are family members of farm workers in the area. The old lady present could not be interviewed as she cannot speak English or Afrikaans it seemed. A detailed assessment of the site was not undertaken. Some of the structures and foundations could be older than 60 years of age, and although in a largely dilapidated state should be assessed by an Architectural Historian to determine its cultural heritage significance and recommend on the way forward should the site be directly and negatively impacted by the proposed mining development.

**Figure 9: An old farmstead/homestead (FS1) with the remnants of related infrastructure recorded in the area.**

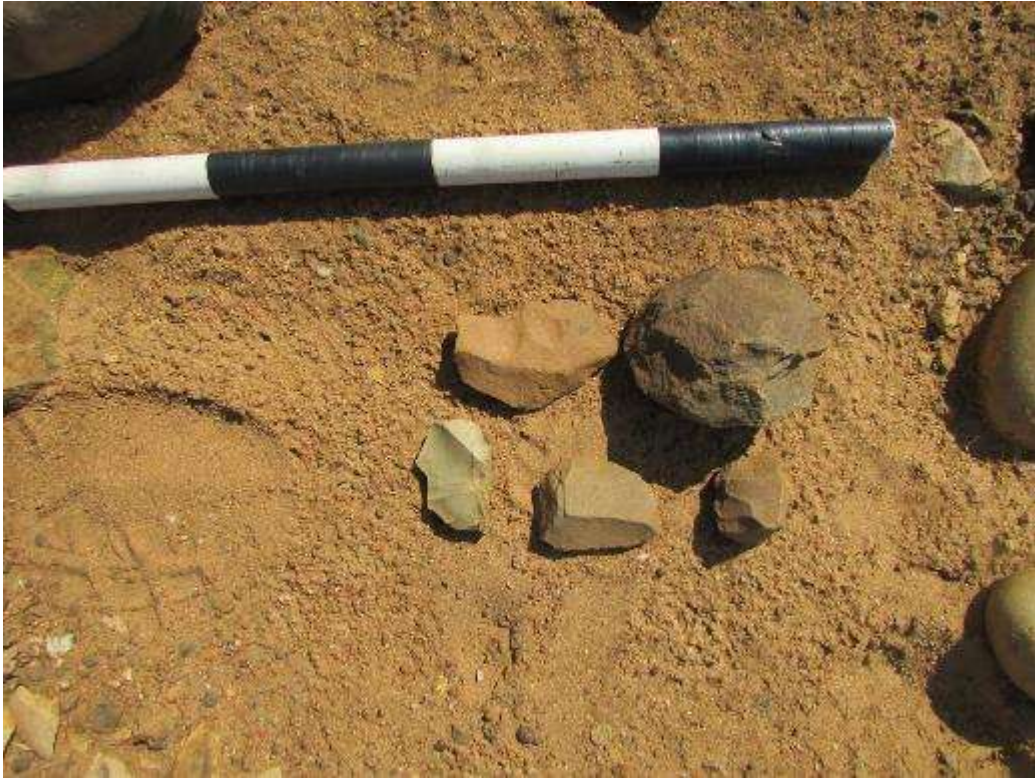
The first sites/finds that will be briefly discussed here are the Stone Age ones. Two (2) areas with individual tools and small scatters of MSA/LSA stone tools were identified during the assessment. The 1<sup>st</sup> is located outside (on the boundary) the area, with the 2<sup>nd</sup> one found inside. Both sites are situated next to the main dirt road that crosses through basically the central part of the area (north of the R38), and in areas where the underlying weathered

**Figure 10: Small scatter of MSA/LSA tools found just outside of the area.**

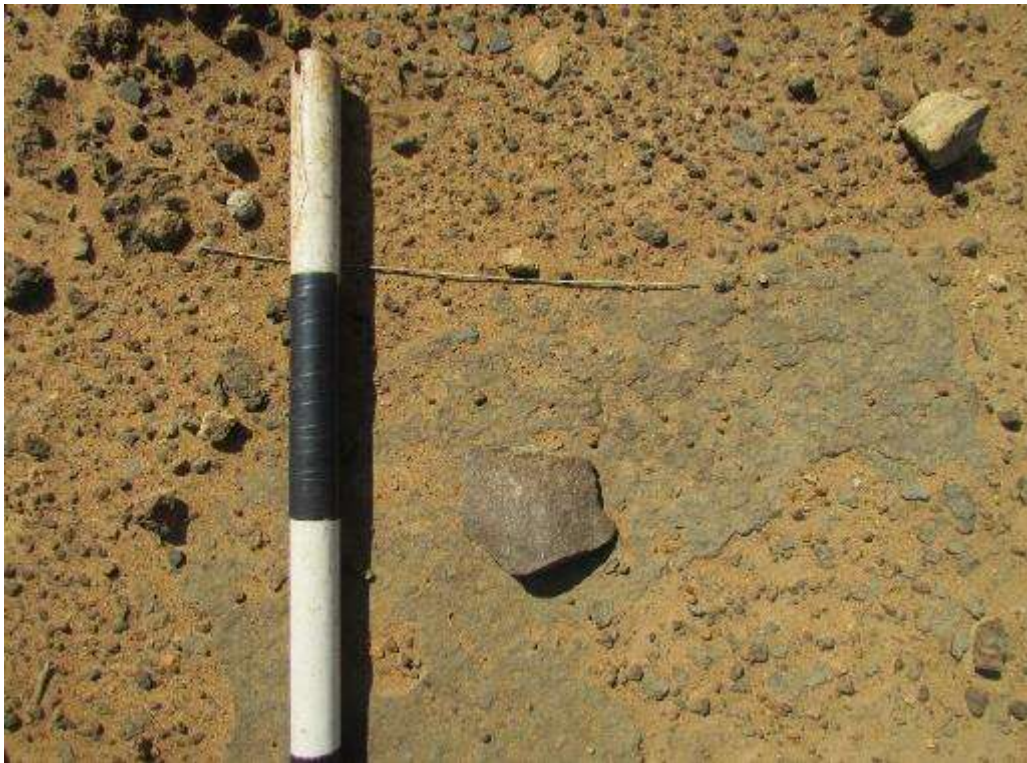
**Figure 11: A single MSA/LSA flake-tool recorded in the area.**

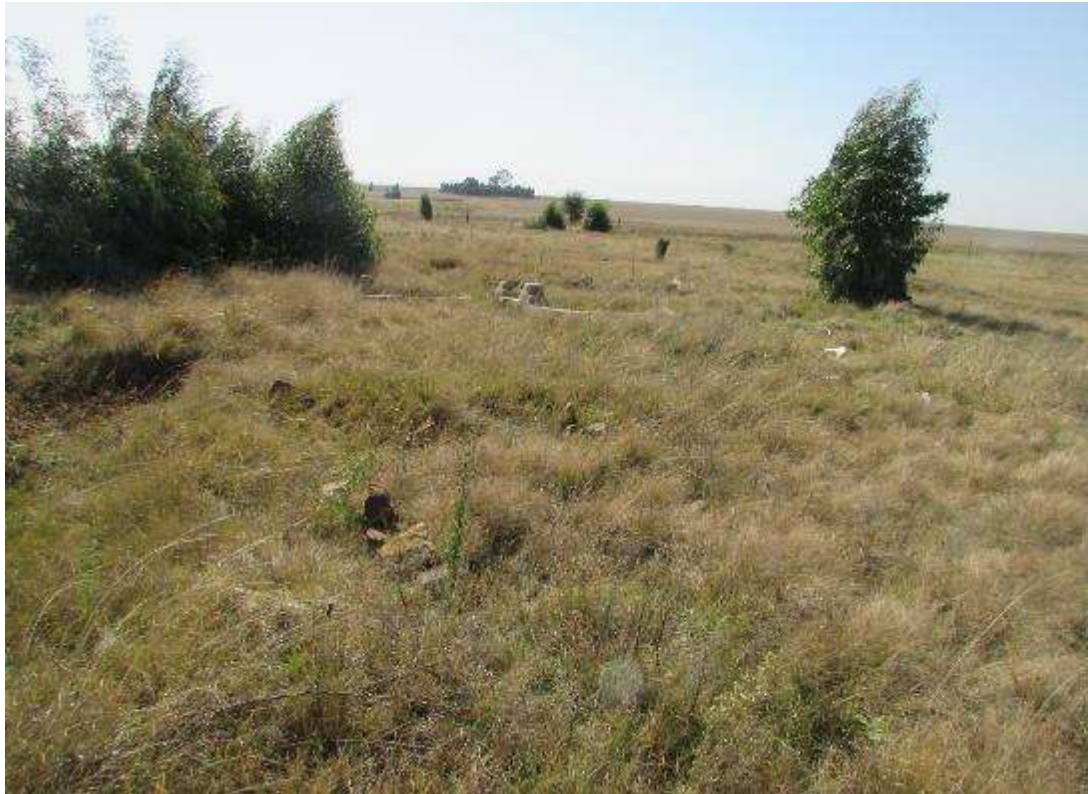
**Figure 12: A view of one of the informal cemeteries (C1) recorded in the area.**

**Option 1:** Leaving the sites and the graves in situ. This will entail fencing the sites properly, with an access gate to provide entry to descendants to visit the graves. The sites should be cleaned under supervision, each grave should be numbered and a Grave Site Register be drafted and kept. A Grave Sites Management Plan needs to be drafted and implemented as part of the Development Plan.

**Option 2:** Exhuming and relocating the graves if it cannot be left in situ. This will entail detailed Public Participation/Social Consultation to identify the descendants of the deceased individuals buried there in order to obtain their consent for the exhumation and relocation work to be undertaken. Permits also need to be applied for and obtained from various authorities including COGTA, Provincial Department of Health, Local Municipality and the SAP. For all graves unknown in age and older than 60 years of age a permit from SAHRA is also required.

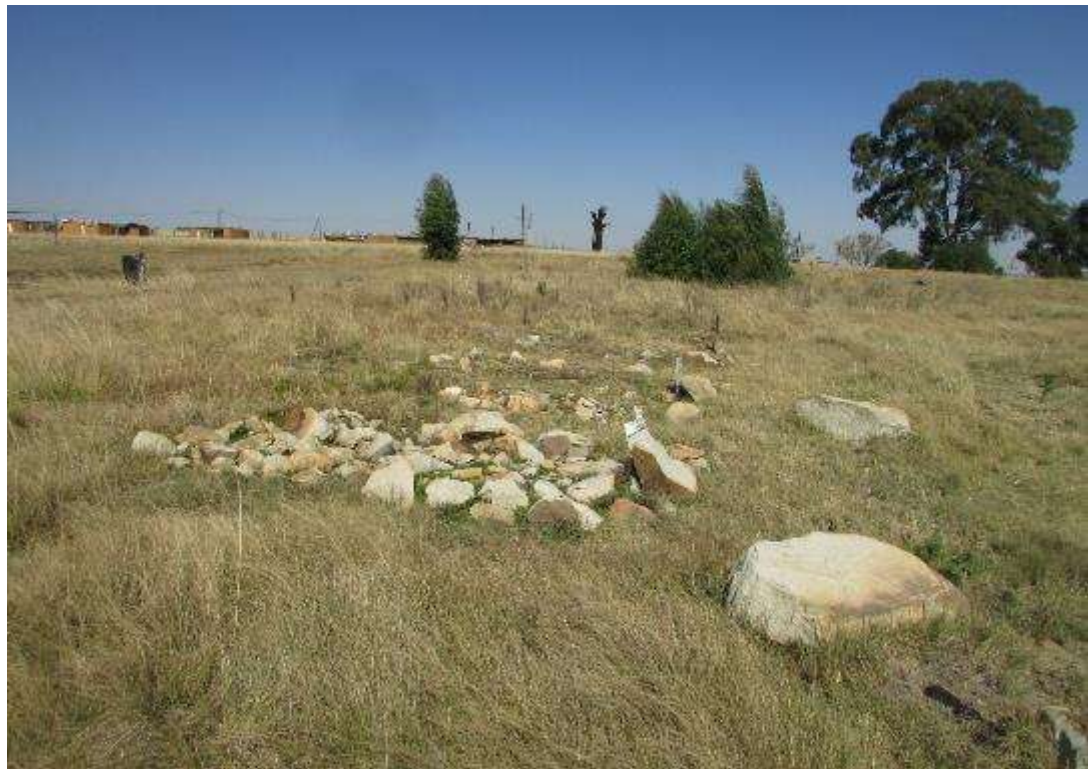
**Figure 13: Most of the graves on C1 are only stone-packed.**

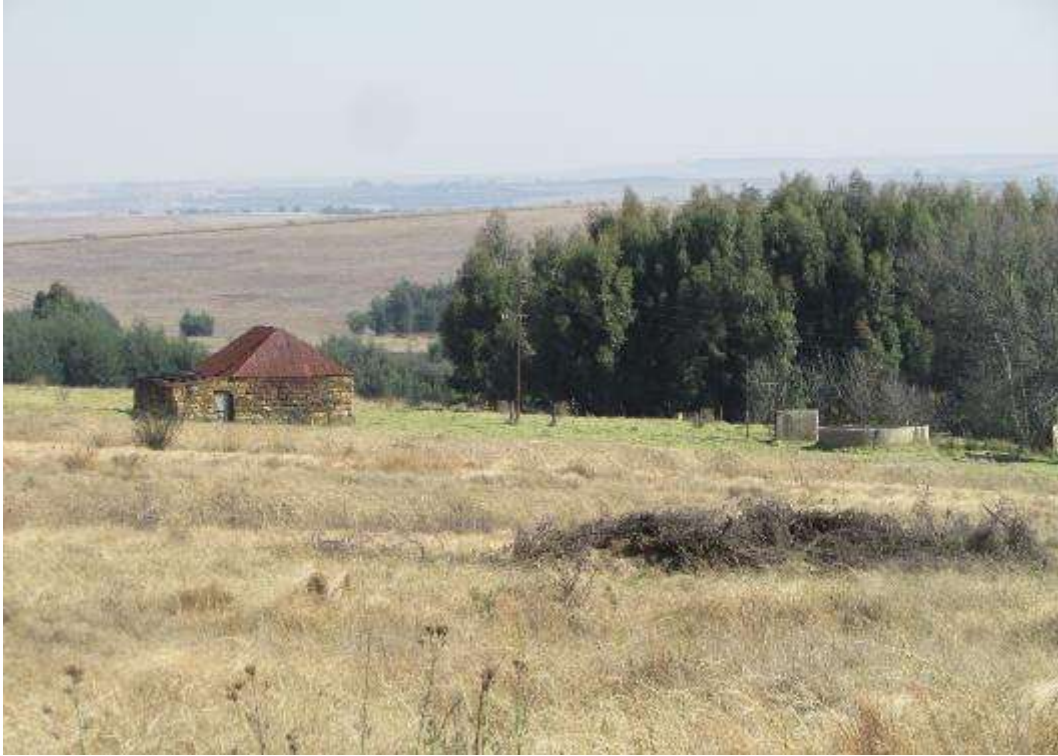
Site FS2 is an old sandstone homestead/farming-related structure on Naudesbank. The structure is typical of the late 19<sup>th</sup>/early 20<sup>th</sup> century sandstone-built homesteads in the Highveld of the old Eastern Transvaal and is therefore fairly significant from a Cultural Heritage point of view. The site was not assessed in detail during the recent fieldwork, and it is recommended that an Architectural Historian undertake a detailed assessment of it should it be impacted by the mining development, and before it is either earmarked for demolition, re-purposing or alteration.

**Figure 18: Late 19<sup>th</sup>/early 20<sup>th</sup> century farmstead building of sandstone identified in the Naudesbank area (Site FS2).**

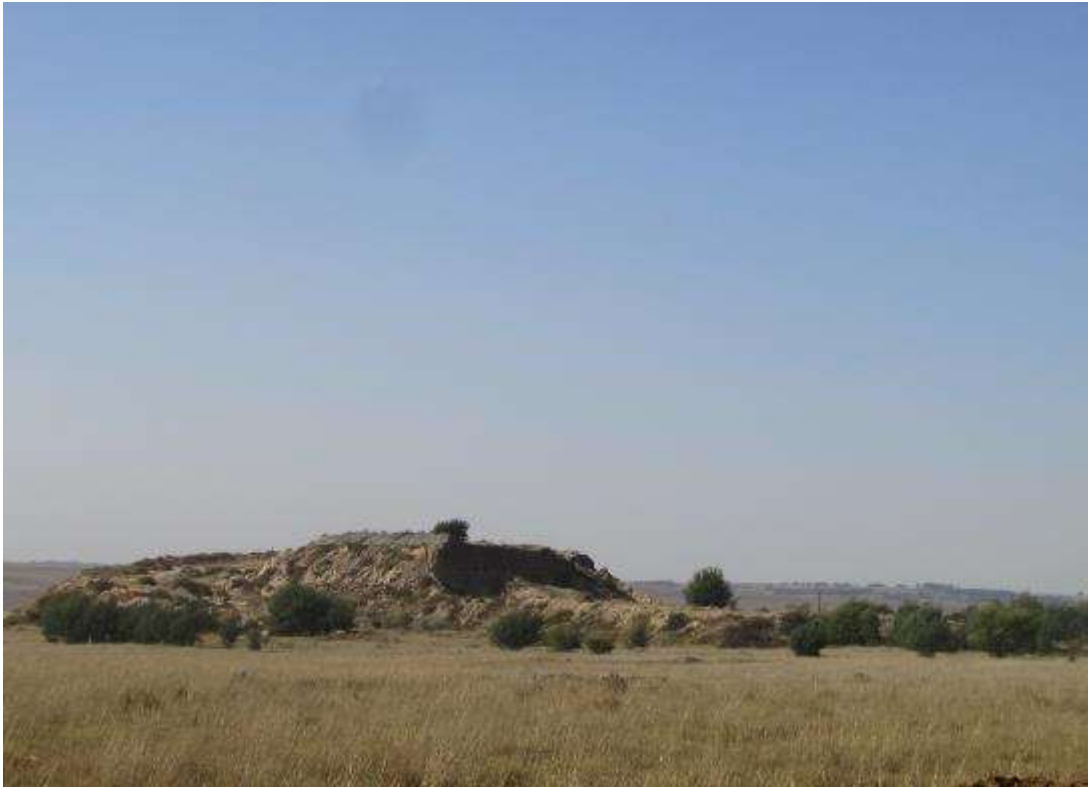
**Figure 19: Old mining impacts in the area.**

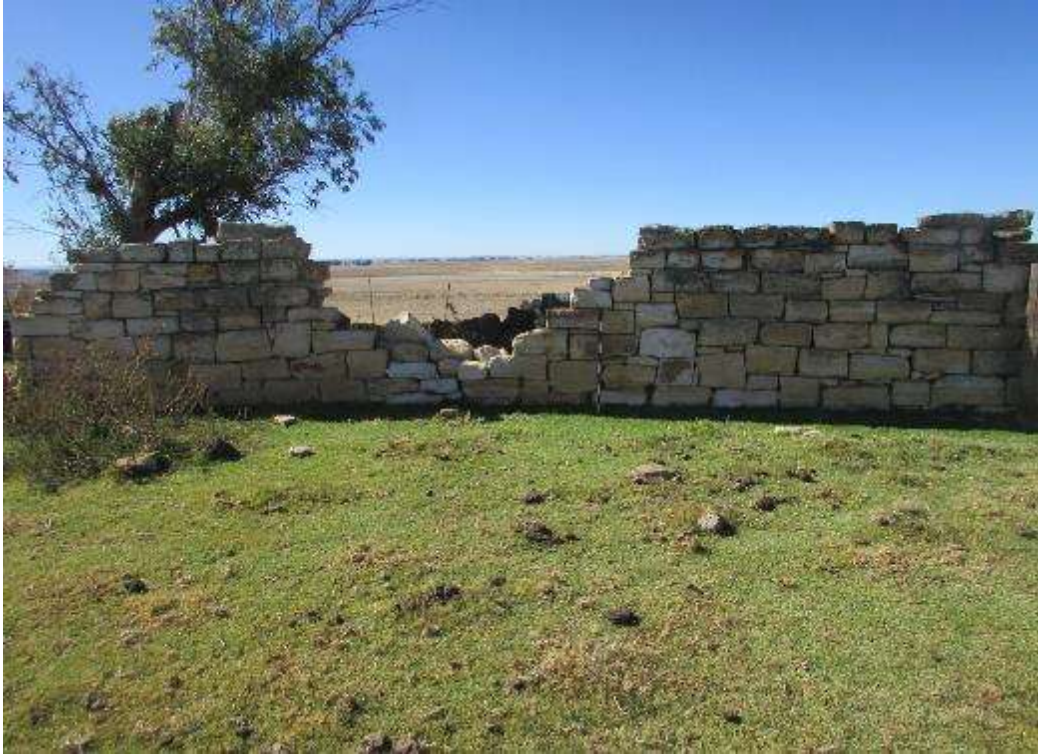
**Figure 24: Sandstone enclosure at FS3.**

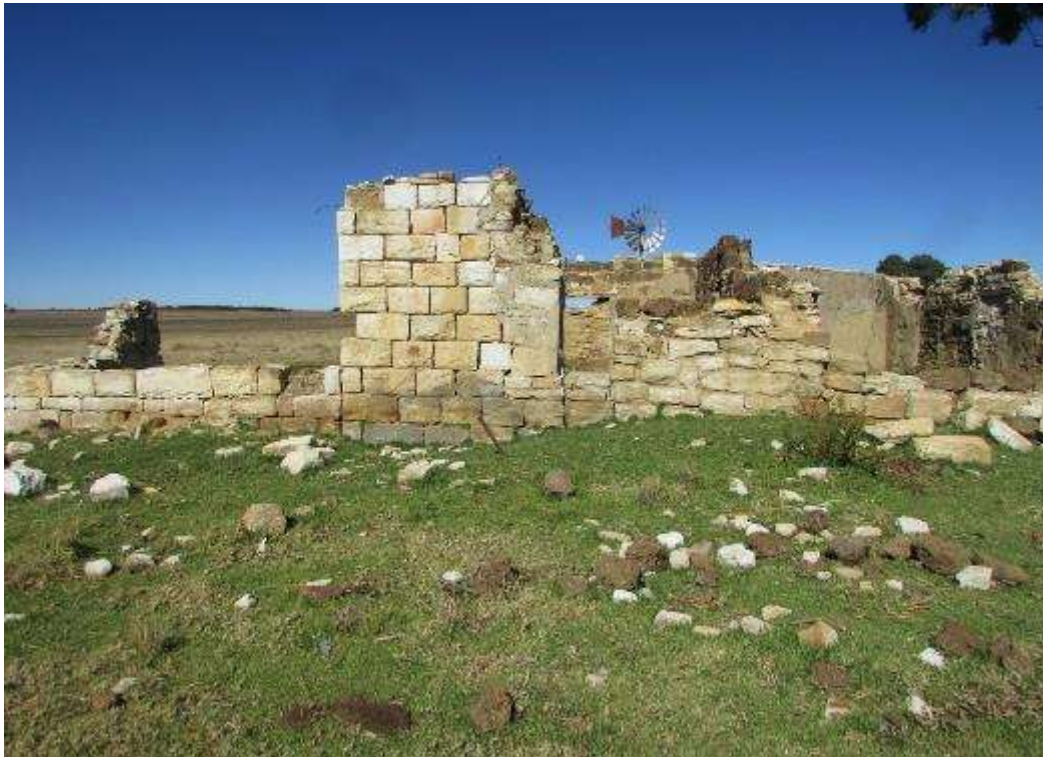
FS3 contains an old sandstone enclosure and the remains of an old sandstone-built farmstead that probably originally dated to the late 19<sup>th</sup>/early 20<sup>th</sup> century. It had been altered and changed over the years as evident from the assessment, and as a result a large section could be less than 60 years of age, diminishing its cultural heritage significance. The structure is in a bad state of preservation, with it being largely vandalized for its roof sheeting, doors and window frames. What remains of the structure is largely foundations and some sections of walling. From this point of view its heritage significance is seen as Low and no further mitigation is required.

**Figure 25: The sandstone homestead structure at Site FS3.**

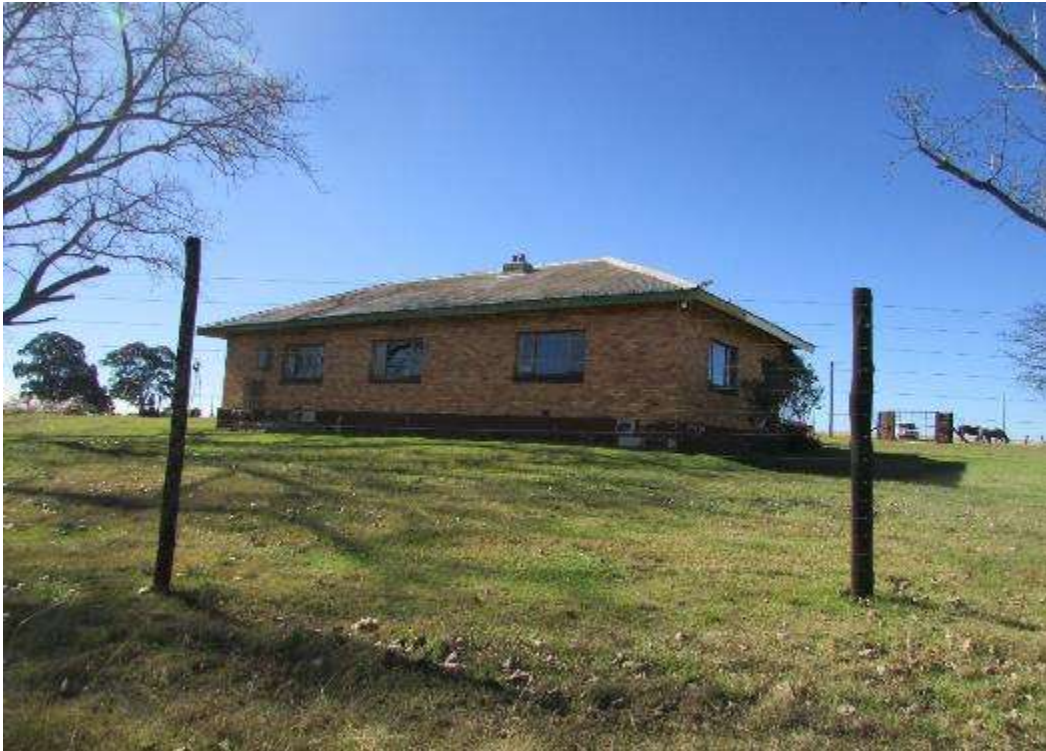
Site FS6 consists of a number of farming-related structures and homestead located not far from the farm workers settlement (FWD2) on this farm portion. Many of the structures (including the homestead) are fairly modern brick constructions, although there are some earlier (early to mid-20<sup>th</sup> century) structures that have been altered and changed over the years. Although this diminishes their heritage significance, it is however recommended that should the proposed mining development negatively impact on this site and it needs to be demolished, that an Architectural Historian conduct a more detailed assessment. This will help determine the sites significance and provide recommendations on the required mitigation measures if needed.

**Figure 36: The main homestead at Site FS6.**

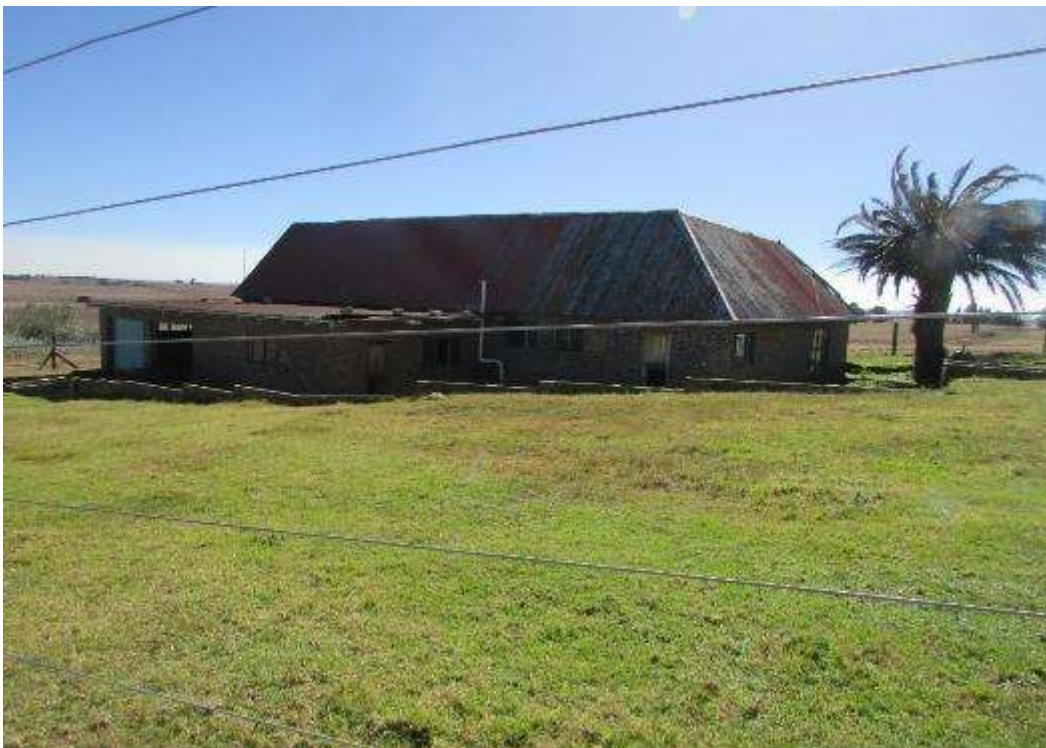
**Figure 37: Another structure at Site FS6. Parts of this could be older than 60 years of age.**

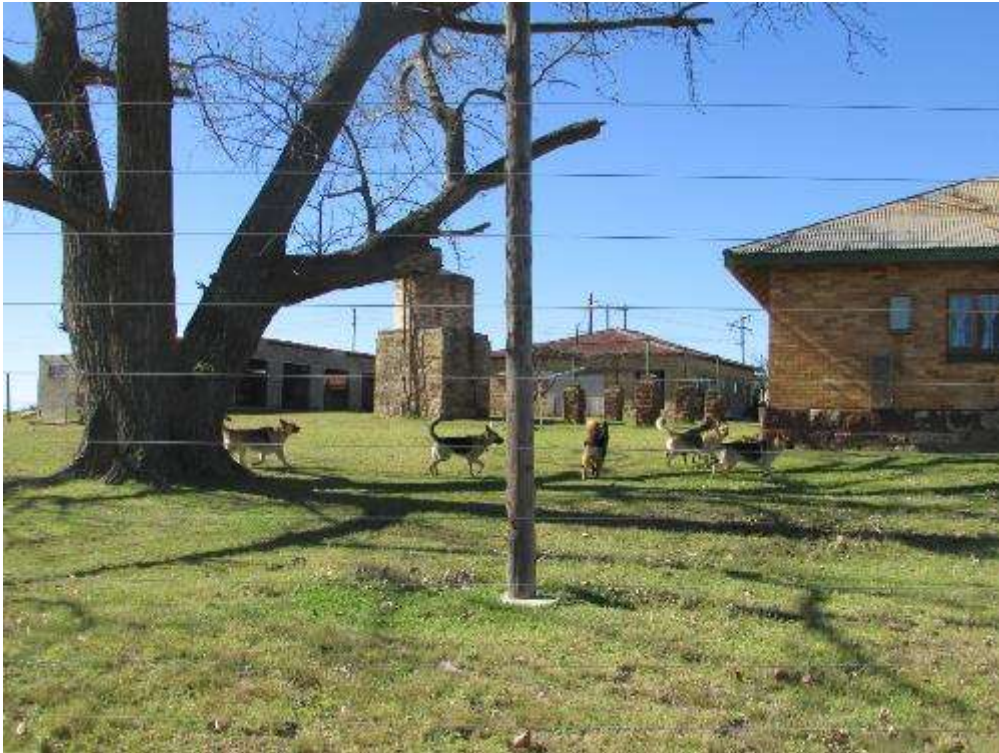
**Figure 38: Another view of some structures at FS6.**

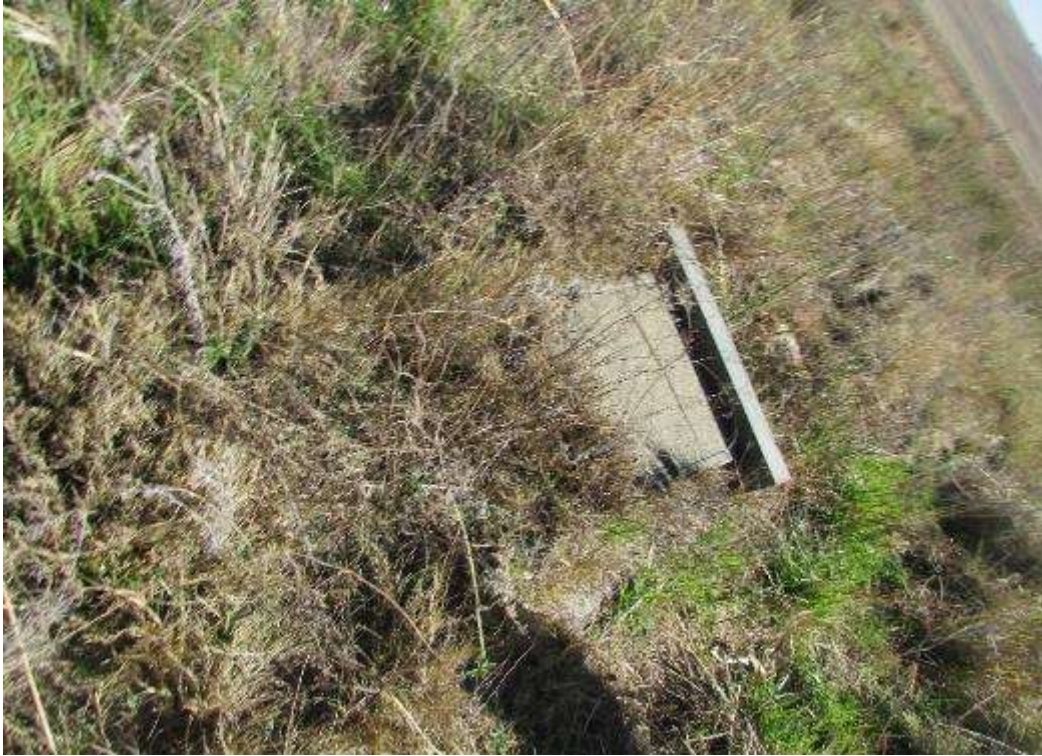
**Figure 40: The grave with the collapsed granite headstone at C5.**

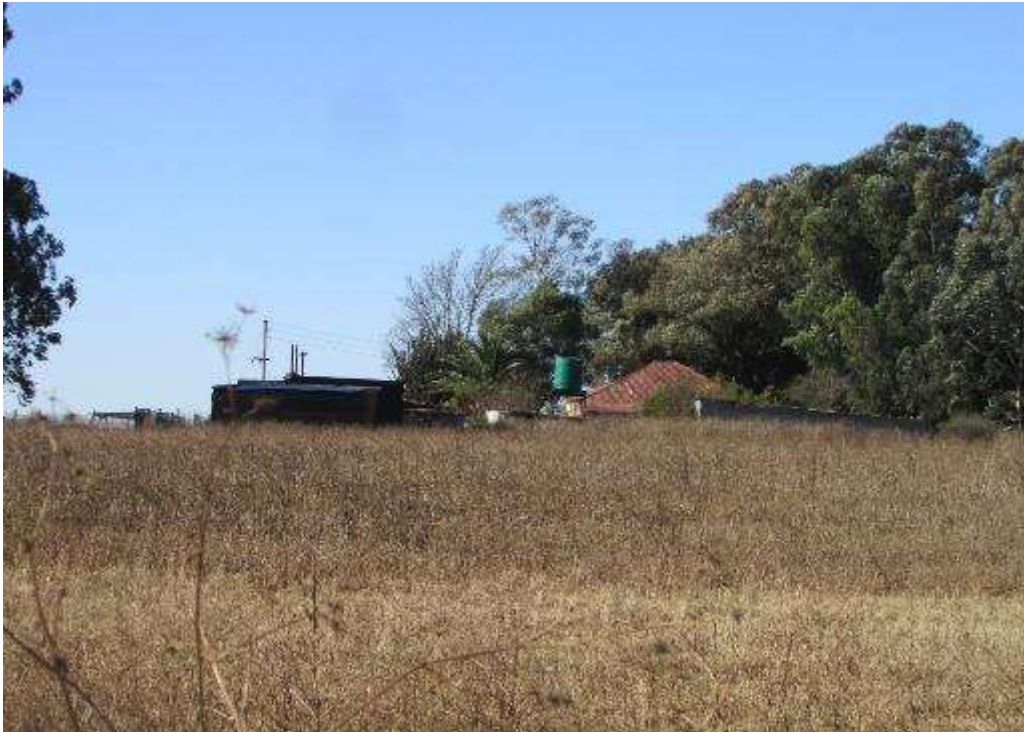
Site FS8 is another farmstead that consists of a homestead and other related farming-related structures. The site is located on the Gebhardt's portion of Naudesbank. Some of the structures (including the homestead) could be older than 60 years of age and of some heritage significance. If the proposed mining development is going to impact negatively on it, then it is again recommended that an Architectural Historical conduct a detailed assessment to determine its significance and the way forward before it is demolished or re-purposed.

**Figure 44: Partial view of Site FS8.**

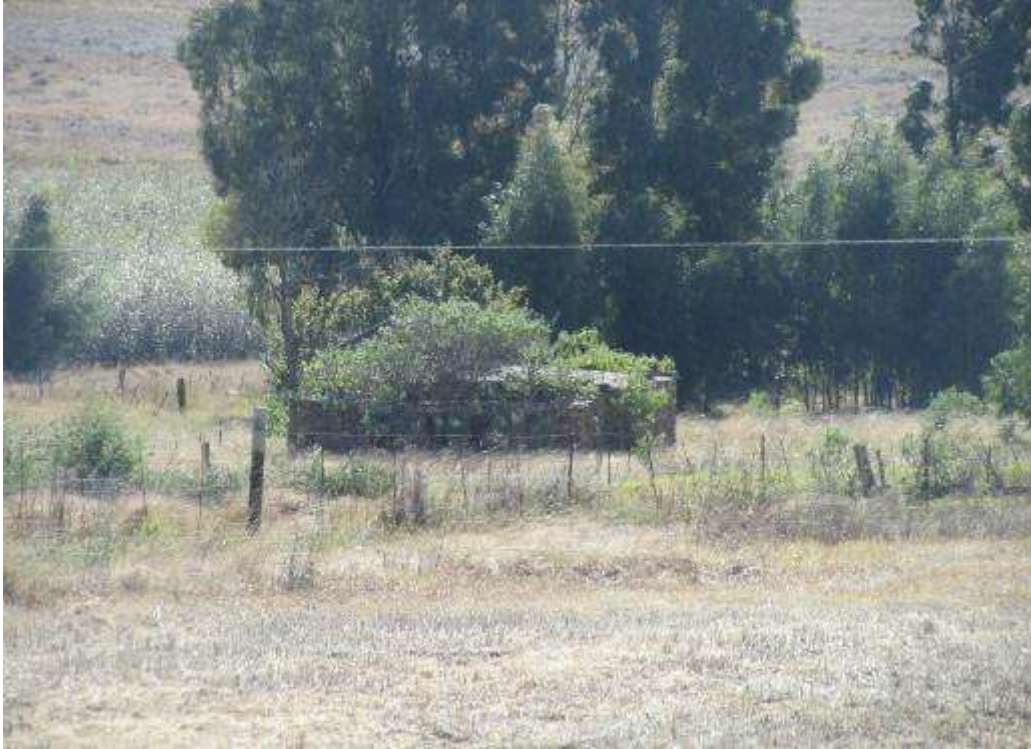
Site FS9 is represented by a single structure (homestead), similar to that of FS2. It is of sandstone and likely dates to between the late 19<sup>th</sup> and mid-20<sup>th</sup> centuries. Although it is fairly overgrown and abandoned, it is in a fair state of preservation. It is recommended that the structure be assessed in detail by an Architectural Historian should the proposed mining development negatively impact on it and it needs to be demolished as a result.

**Figure 45: The sandstone structure at Site FS9.**
