UNDERWATER ARCHAEOLOGICAL IMPACT ASSESSMENT FOR THE
PROPOSED GAS TO POWER POWERSHIP PROJECT AT THE PORT OF
SALDANHA
Western Cape
South Africa

UNDERWATER ARCHAEOLOGICAL IMPACT ASSESSMENT FOR THE PROPOSED GAS TO POWER POWERSHIP PROJECT AT THE PORT OF SALDANHA, WESTERN CAPE**Report #:** 2021/SALD/001**Status:** Draft**Revision #:** 0**Date:** 31 March 2021**Prepared for:** Triplo4 Sustainable Solutions (Pty) Ltd**Representative:** Shanice Singh**Tel:** +27 (32) 946 3213**Address:** Suite 5, The Circle Business Centre, Douglas Crowe Drive, Ballito 4420**E-mail:** shanice@triplo4.com**Prepared by:** Vanessa Maitland**ASAPA Registration #:** 326**Field:** Maritime Archaeology**Address:** 203/71 Elandskraal, Sedgefield Rural, 6573**Tel:** 082 490 4066**E-Mail:** vanessa@cocojams.co.za**Declaration:**

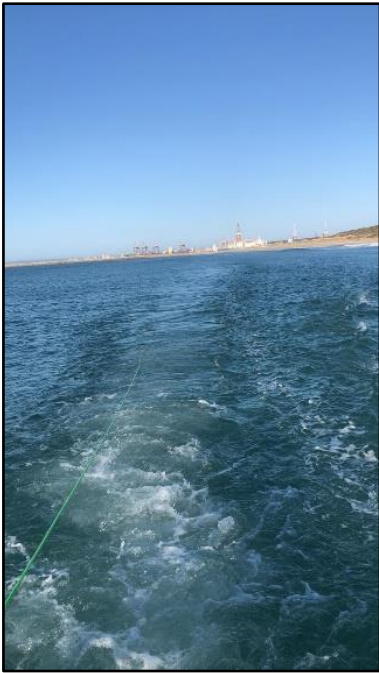
Figure 1: Deployed magnetometer (Maitland, A 2020)

The magnetometer data collected by MagLog® software was analysed twice. The first or field analysis is performed as the magnetometer is towed (Figures 1- 3). Possible sites are tabulated and analysed according to the environmental conditions in the field. The post-field analysis was interpreted with geophysical software (Surfer), with knowledge of the environmental conditions. The analyses were compared, and a final analysis completed.

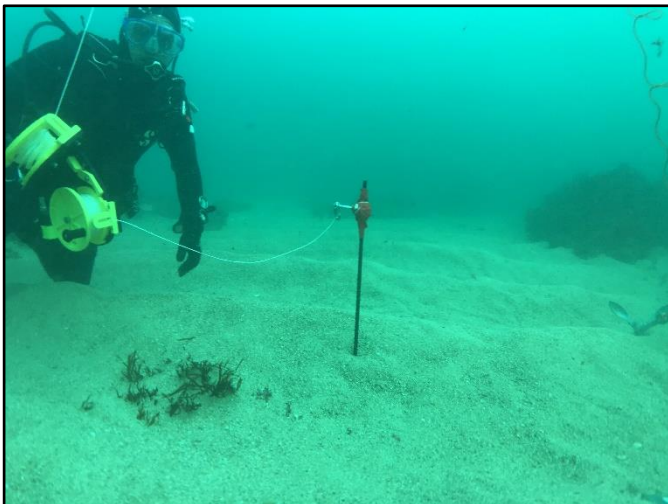
Figure 4: Marker buoy and attached search reel (Maitland 2018)

From the analysis of the magnetic data, anomalies are plotted. These need to be investigated by divers. A marker buoy is dropped on the coordinates and a circular search is conducted from this central point (Figure 4 and Figure 5). Results are recorded. A buoy with a handheld GPS attached is held by the diver, this tracks the location of the search (**Error! Reference source not found.**).

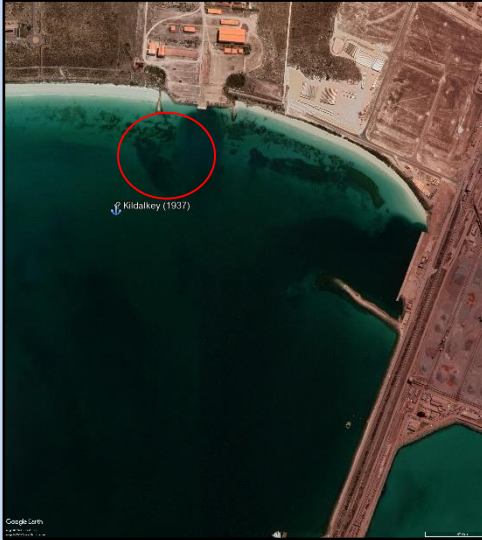
<p>Figure 16: Possible wreck of the <i>Kildalkey</i></p>	West of Iron Ore Jetty	None

#	Name	Events	Date	Type	History	Area may be found	Probability
18	<i>Karatara</i>	Fire, converted to jetty	1921-05-16	Steam coaster	This vessel was built for the sealing trade. While in Table Bay, she caught on fire. Although the fire was put out, the vessel was scuttled at the Donkergat Whaling Station, as part of the jetty (van den Bosch 2009).	Donkergat Whaling Station	None
19	<i>Kildalkey</i>		1936-11-18		<p>This steamship was built during WWI and was built with her stern and bow identical. This was in order to confuse enemy submarines. After the war she was converted into a tanker and used in the sealing trade. Later she transported whale oil. She had a cargo of whale oil when, during a heavy fog, she hit the rocks known as the Seven Blinders. The wreck may have been removed in 1974 (van den Bosch 2009; Levine 1987).</p> <p>Although if one looks at the Google Earth image, in the reported vicinity of the wreck, a wreck may be visible (Figure 16).</p>

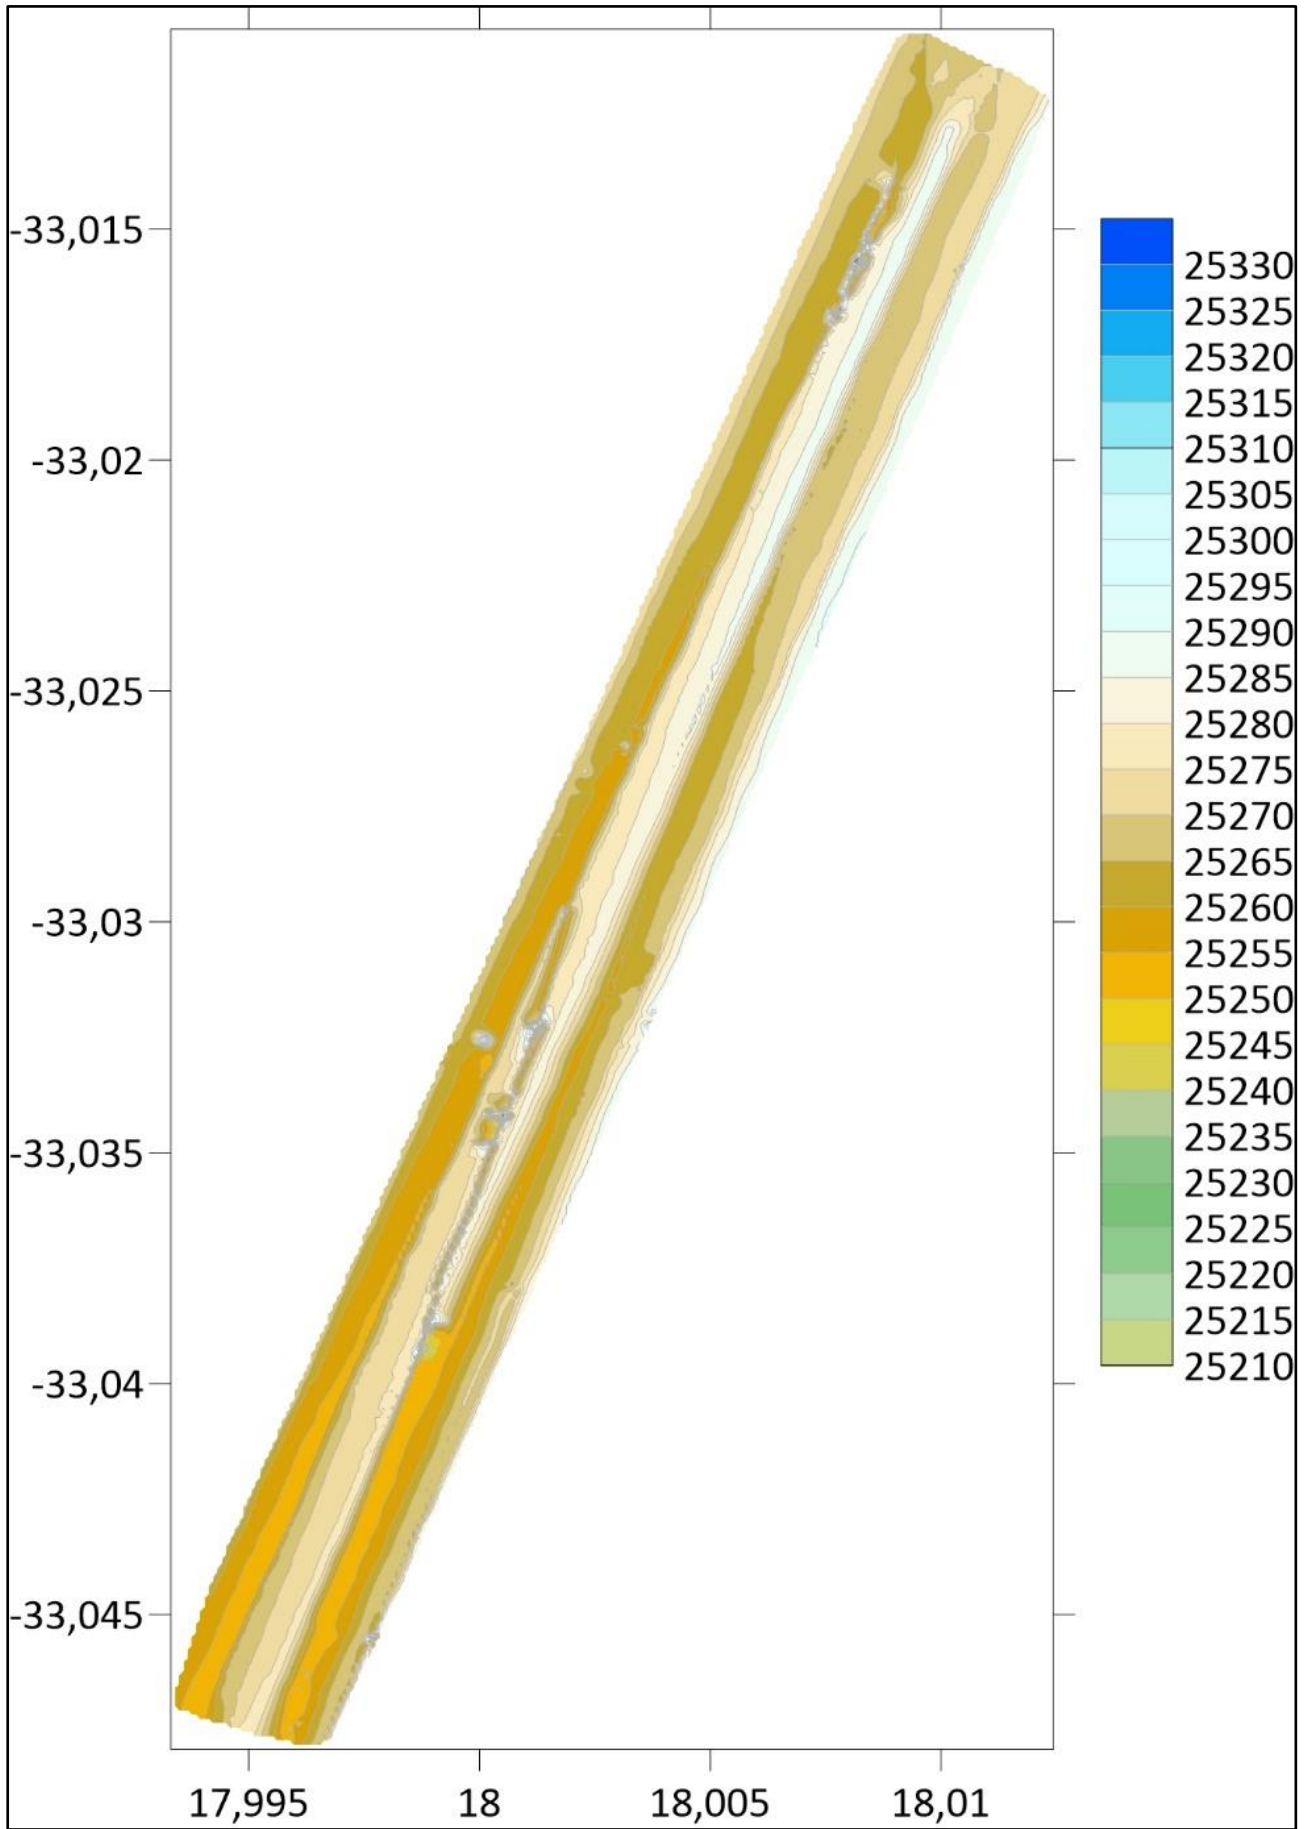
Figure 18: Surfer Survey Plot using contour intervals of 5 nT

As mentioned in Section 5.1, the bathymetry of the Impact Zone is -1.5 near the shore to -17 at the end of the Impact Zone. Big Bay has a tidal range of approximately 2 m and we went as close to the shore as safety dictated (Figure 17).
