**Phase 1 Palaeontological Impact Assessment of the
proposed new Meerkat Hydroelectric facility on the
Orange River between Douglas and Hopetown, NC
Province.**

Report prepared for:
Enviroworks Environmental Consultants
By
L. Rossouw
National Museum Bloemfontein

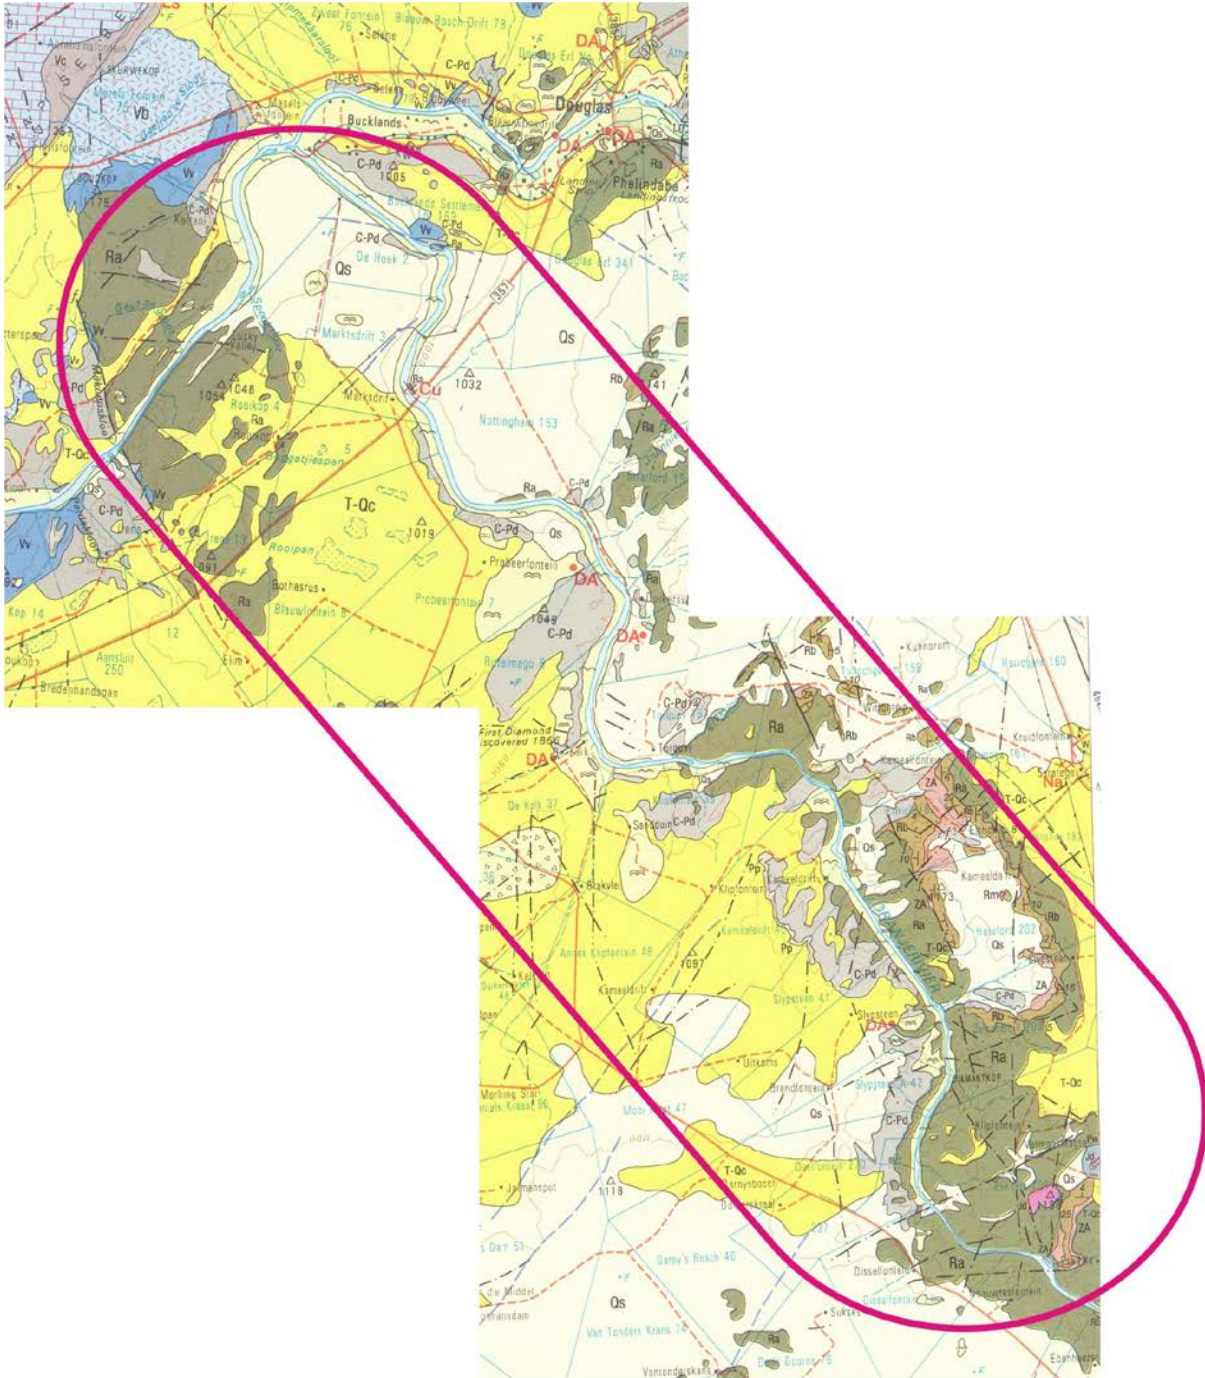
Figure 2. Portion of 1: 250 000 geological map 2922 Prieska (Council for Geoscience, Pretoria) showing approximate location of the proposed hydroelectric facility 26 km south of Douglas. The study areas are underlain at depth by Precambrian lavas of the Allanridge Formation (Ventersdorp Group, *Ra*) as well as Dwyka tillites (Mbizane Formation, *C-Pd*) and basal Ecca mudrocks (Prince Albert Formation, *Pp*) of the Karoo Supergroup. The basement lavas and Karoo sediments are largely overlain by Late Cenozoic superficial deposits made up of cf. Plio-Pleistocene or older terrace gravels, aeolian sands (*T-Qc*, *Qs*) and geologically recent alluvium.

The geology of the study area is shown on the 1: 250 000 geology map 2922 Prieska (**Fig. 2**). The affected areas are underlain by Precambrian, Ventersdorp Supergroup lavas (Allanridge Formation, *Ra*), composed of resistant-weathering, dark green lavas and associated pyroclastic rocks. The lavas are exposed along stream incisions (**Fig. 3**) and high-lying outcrops where the formation is represented by coarse and blocky surface gravels that resulted from *in situ* weathering and downwasting (**Fig. 4**). The Ventersdorp lavas are unconformably overlain by Dwyka Group tillites of the Mbizane Formation, (*C-Pd*, Visser *et al.* 1977-78, 1990; Johnson *et al.* 2006) which represents valley and inlet fill deposits left behind on Ventersdorp basement rocks by retreating glaciers about 300 million years ago. While the lavas are not palaeontologically sensitive, glacial pavements that record the movement of the Dwyka ice sheets across the Ventersdorp basement rocks needs to be preserved as geological sites. Weathered Dwyka sediments contain bluish-grey unbedded tillite with sparse to concentrated boulder-sized and smaller erratics which are occasionally capped by well-developed and crudely bedded calcrete hardpan (**Fig. 5**). Locally laminated lenses of bedded tillites are ascribed to glaciolacustrine and fluvio-glacial origin (Visser *et al.* 1977 – 78) (**Fig 6**). The glacial tillites of the Dwyka Group are not considered to be palaeontologically sensitive. Fossil-bearing, laminated basinal mudrocks of the Prince Albert Formation from the lowermost Eccca Group (*Pp*) have been recorded near Douglas, containing petrified wood, invertebrates, fish, coprolites and palynomorphs from calcareous concretions (McLachlan and Anderson 1973, Visser *et al.*, 1977-78). No evidence of Lower Eccca sediments to be impacted by the proposed development was found during the field study. The Precambrian basement lavas and overlying Karoo Supergroup rocks are mantled by polymict surface gravels made up of Plio-Pleistocene or older terrace gravels, calcretized terraces (*T-Qc*), red brown aeolian sands (*Qs*) and alluvium (**Fig. 7**). No fossils have been explicitly reported from Plio-Pleistocene fluvial sediments between Douglas and Hopetown yet, but a variety of fossil fauna have been retrieved from alluvial gravel terraces along the Lower Vaal River basin (Cooke 1949; Maglio and Cooke 1978; Partridge and Maud 2000). Here, gravel terraces between 21m and 30m above present river level, contain frequent sandy lenses and have yielded vertebrate fauna such as the extinct proboscidian, *Mammuthus*

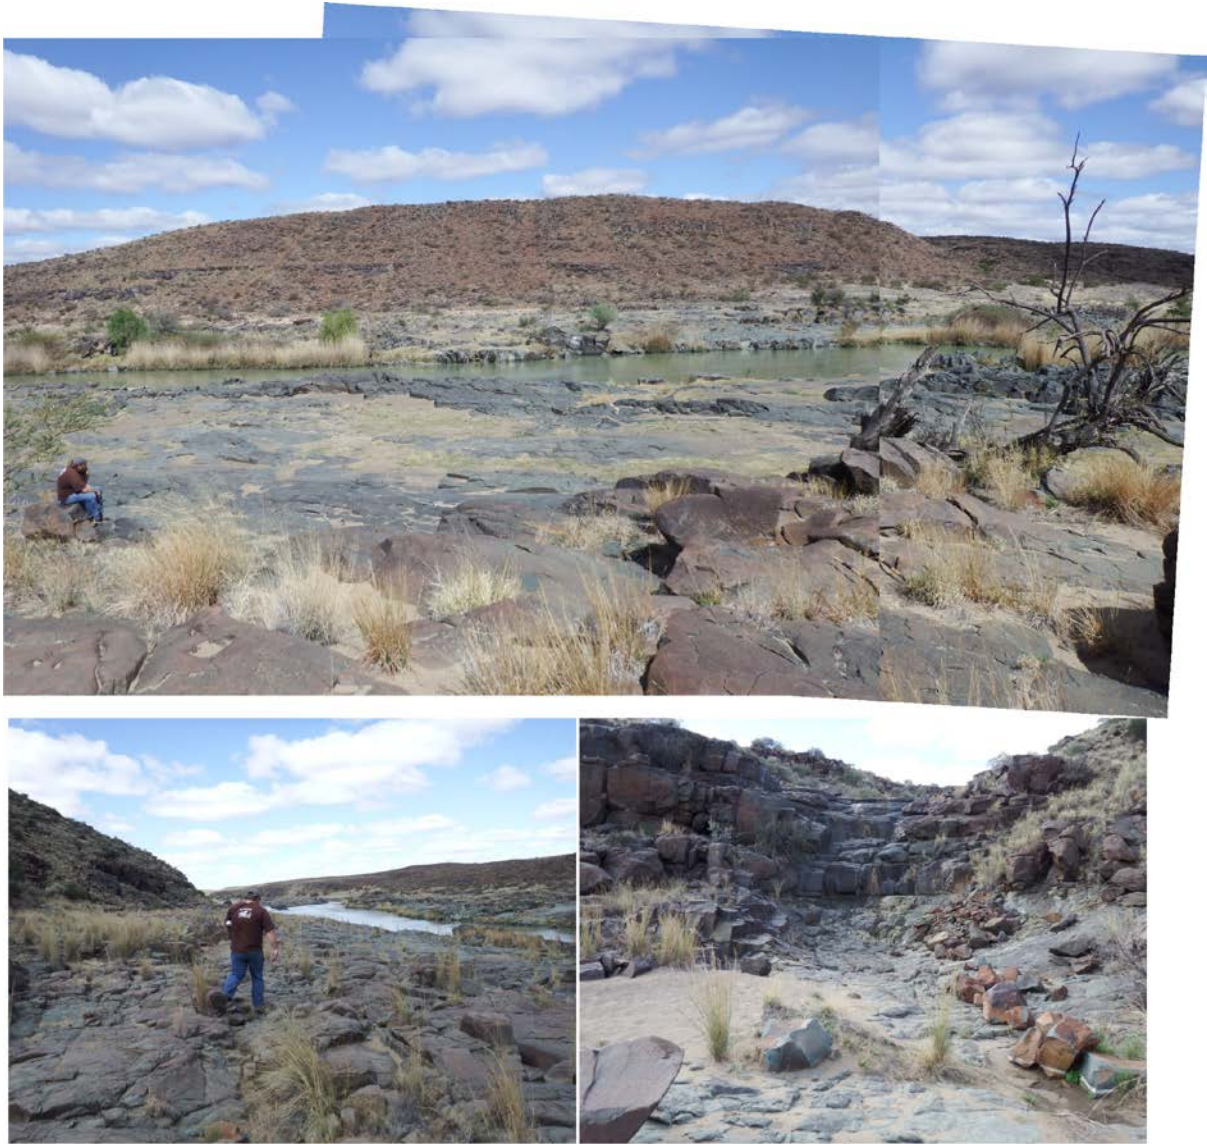
Figure 3. Blocky jointed lavas of the Allanridge Formation (Ventersdorp Supergroup) exposed by stream incision.

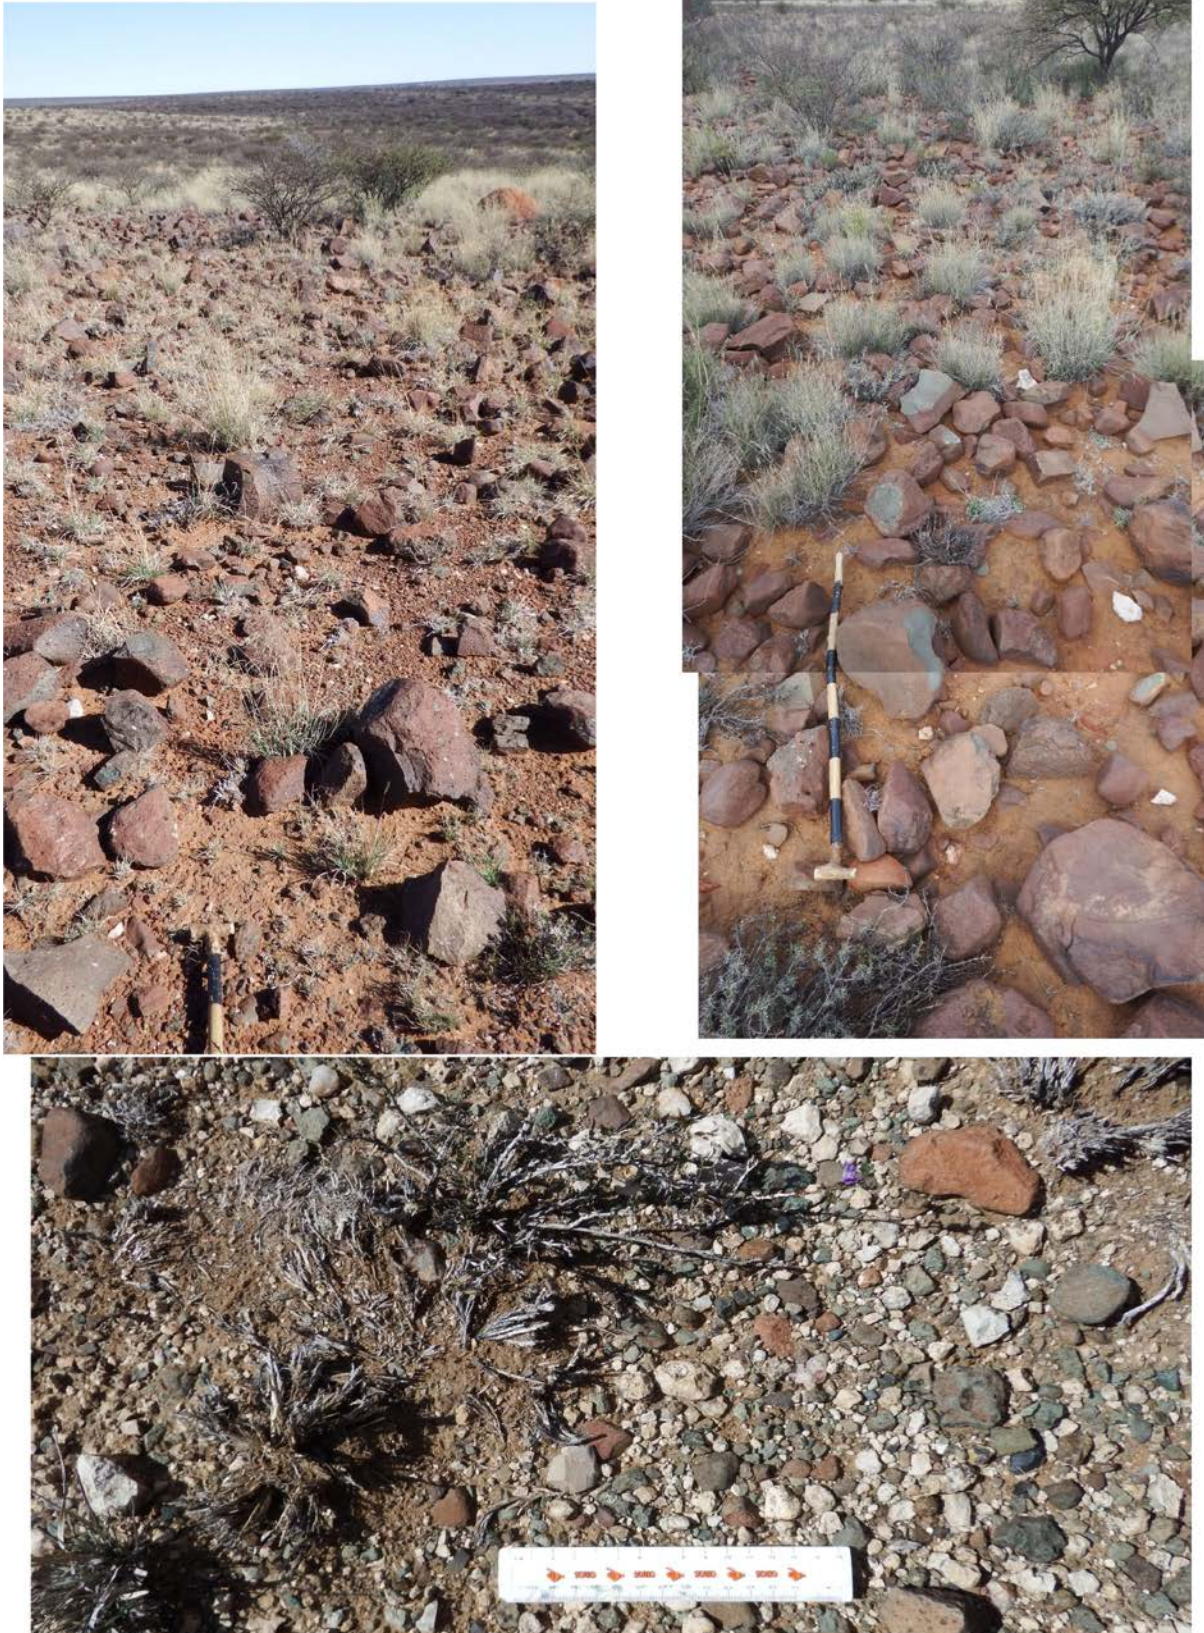
Figure 4. Angular and blocky (top left and right) and polymict surface gravels (bottom) overlying Allanridge Formation outcrop south and north of the proposed dam wall footprints.

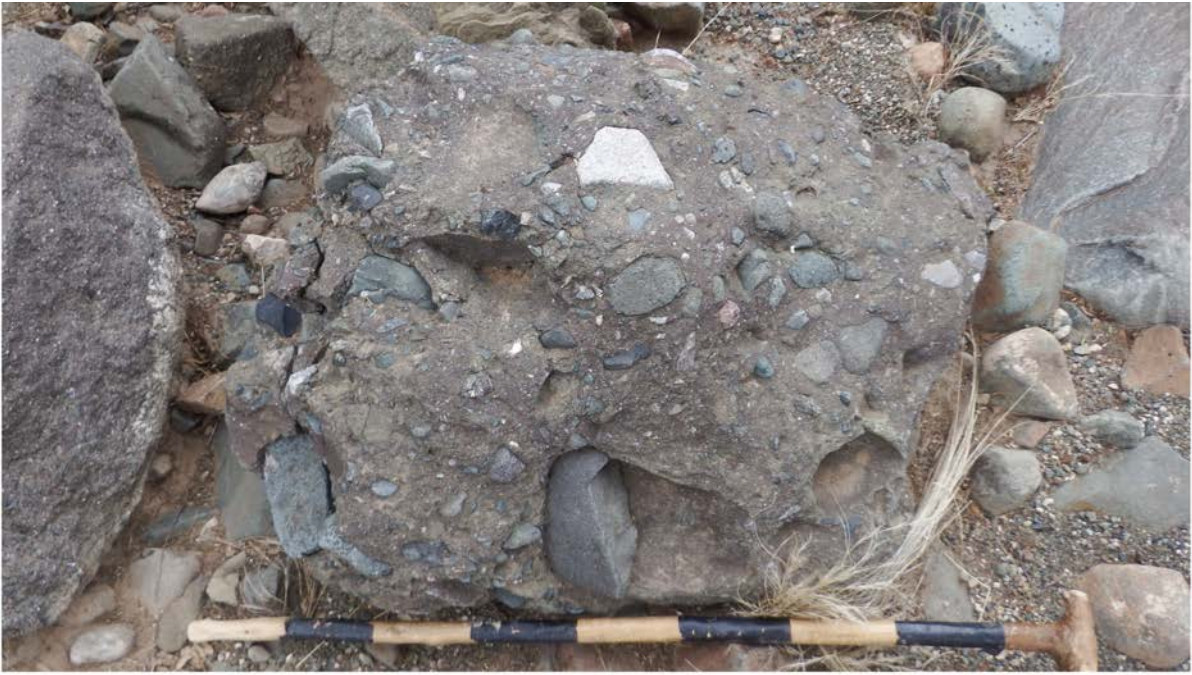
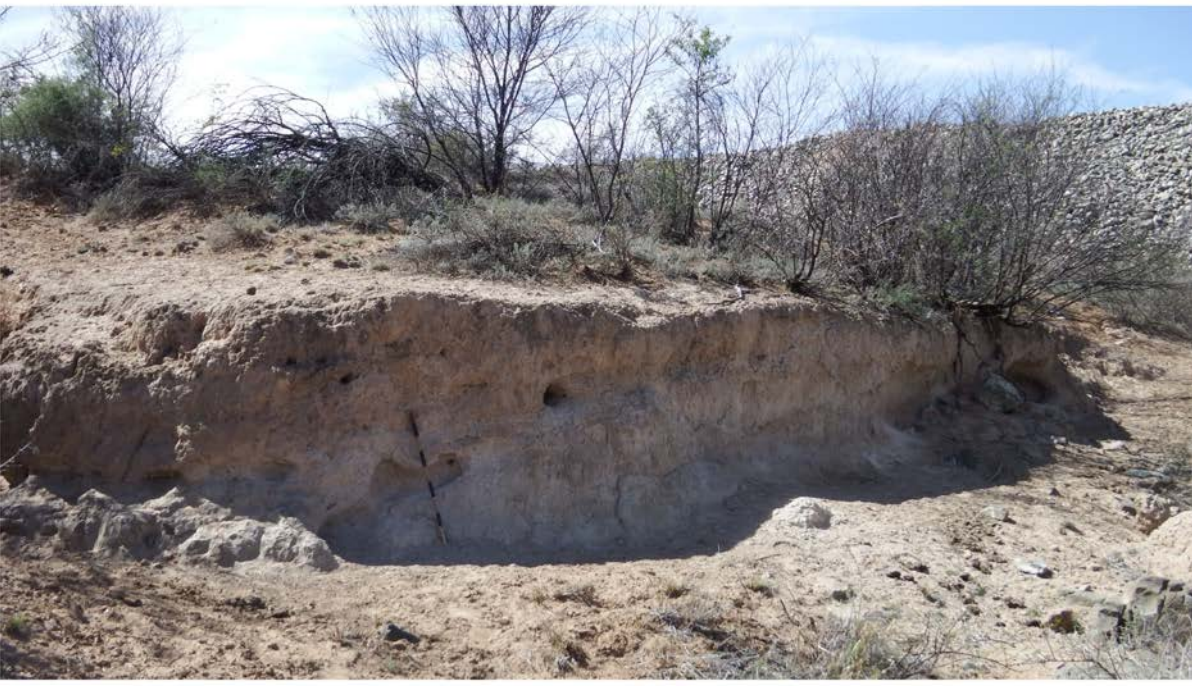
Figure 5. Weathered Dwyka sediments contain bluish-grey unbedded tillite with concentrated erratics (top) and capped by thick calcrete hardpan (bottom).

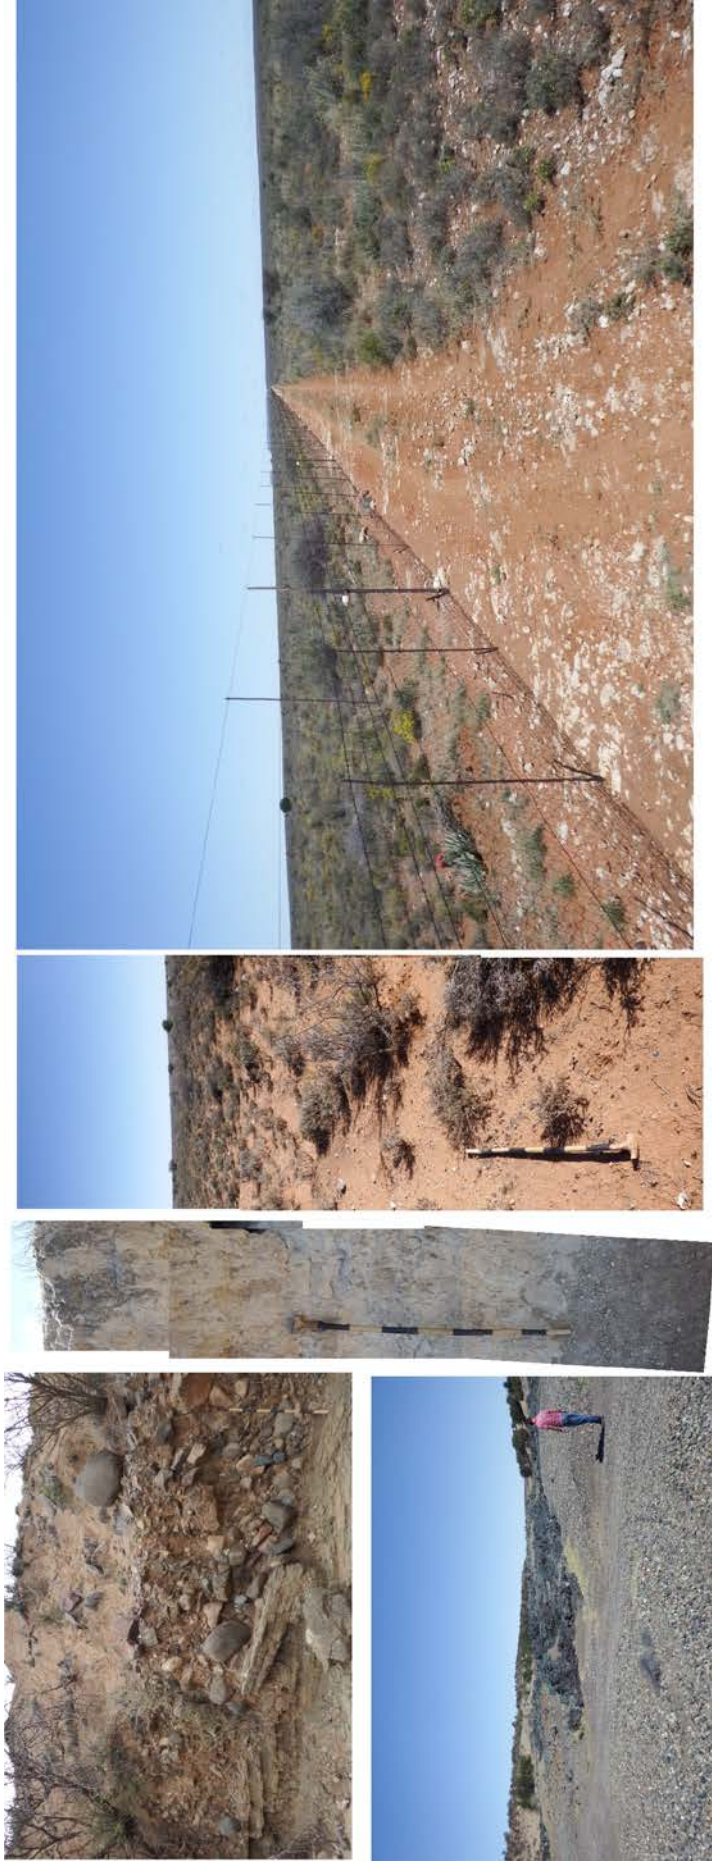
Figure 7. Alluvial gravels (left), calcrete terraces (middle left) and red brown aeolian sands (middle right) with calcrete exposures and reworked calcrete nodules (right).

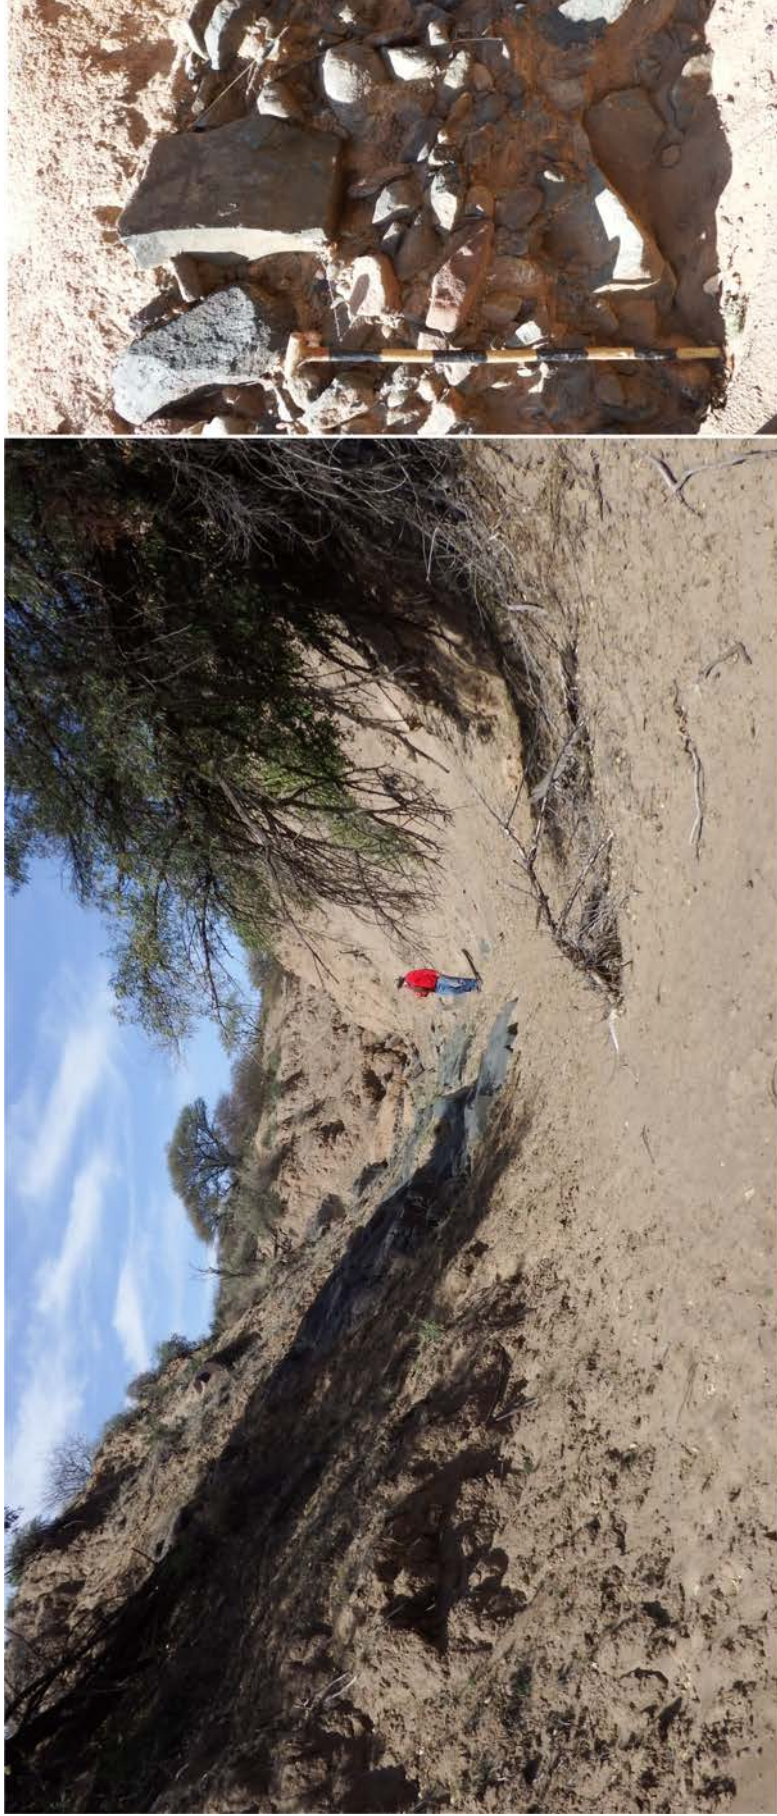
Geologically recent alluvium with gravel to boulder size lenses made up of reworked Dwyka Group and Allanridge Formation material.
