Phase 1 Palaeontological Impact Assessment of the Boundary PV solar facility on farm Karreeboom 1716, Boshof District, FS Province.

Report prepared for Savannah Environmental Consultants P O Box 148 Sunninghill 2157

By
Paleo Field Services
PO Box 38806 Langenhovenpark
Bloemfontein, 9330

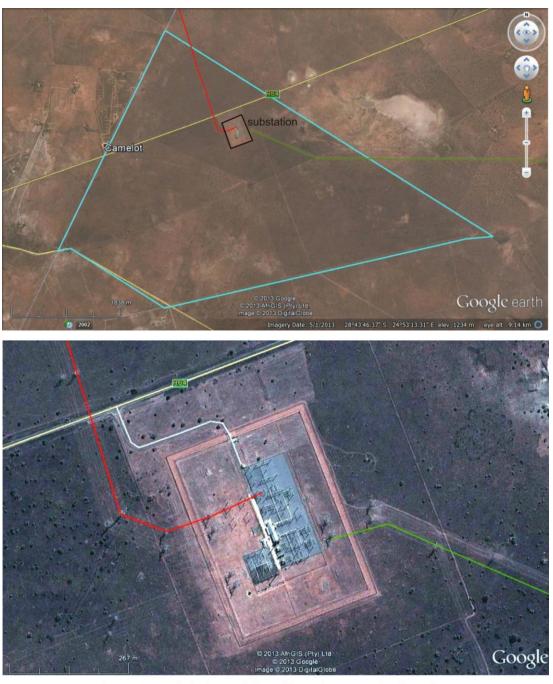
Figure 2. Aerial view of the affected area and substation.

At the request of Savannah Environmental Consultants, a Palaeontological Desktop Assessment was carried out at the proposed new 75MW Boundary Photovoltaic (PV) facility located in the Boshof district in the western Free State Province (**Fig.1**). The development involves the construction of a photovoltaic solar facility and associated infrastructure that will connect to the ESKOM grid via the Boundary Substation that is situated on-site (**Fig 2**).

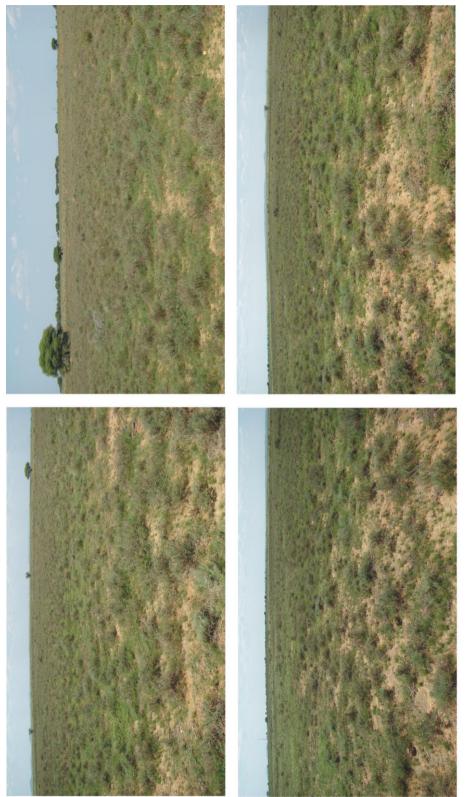
Figure 4. The affected terrain is made up of flat, open veld with no visible outcrop, looking north, east, south and west.

The affected terrain is made up of flat, open veld with no visible outcrop. There are no springs or alluvium within the confines of the area where the photovoltaic solar facility and associated infrastructure will be constructed; however there is a pan present next to where the layout is proposed. In the absence of some of the above erosional features, common intrusive features like springhare hollows and aardvark dugouts were investigated for tell-tale signs of excavated palaeontological material (**Fig. 6**). Pedestrian survey indicates that the photovoltaic panels, associated buildings and access roads will be constructed on Quaternary-aged residual soils largely represented by calcrete-rich aeolian sand (red-brown Kalahari sands, *Qs*) (**Fig. 7**). There is no indication for the accumulation and preservation of intact fossil material within the Quaternary sediments (unconsolidated topsoils). Impact on Quaternary sediments within the footprint will be extensive, but impact on potential *in situ* Quaternary fossils, within the confines of the affected area is considered unlikely.

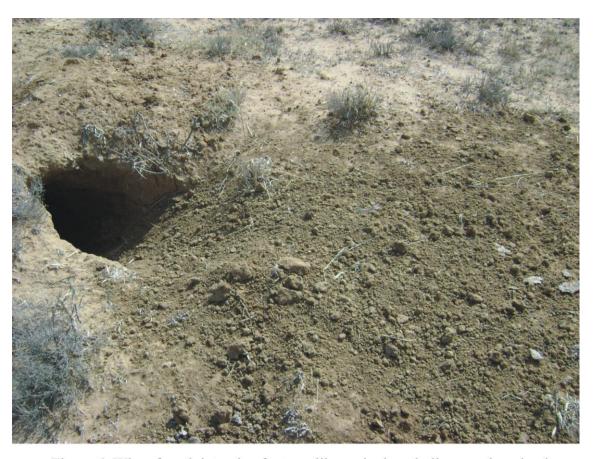
Figure 6. When found, intrusive features like springhare hollows and aardvark dugouts were investigated for tell-tale signs of excavated palaeontological material.

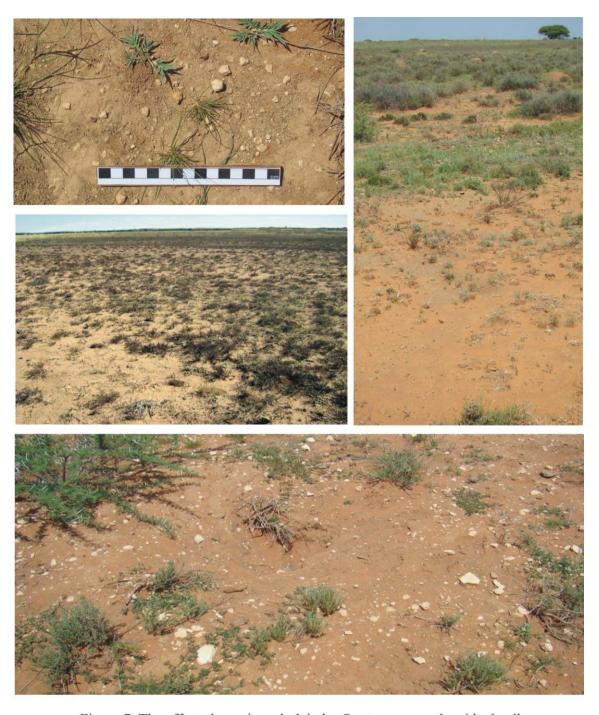
Figure 7. The affected area is underlain by Quaternary-aged residual soils largely represented by calcrete-rich aeolian sand (red-brown Kalahari sands).

It is expected that infrastructure development will involve installation of multiple photovoltaic panels, underground cables and new buildings, resulting in construction activities extending over a relatively large surface area. The field assessment indicates that construction will primarily impact on Quaternary-age surface deposits (*Qs*). There is a **low probability** that Quaternary fossil remains will be adversely impacted during the construction phase of the photovoltaic panels and associated infrastructure. Basement rocks, made up Ecca Group shales (Tierberg Formation), are generally considered to be of low palaeontological sensitivity.
