**HERITAGE IMPACT ASSESSMENT: PROPOSED PERDEKRAAL WIND AND SOLAR
ENERGY FACILITY , WESTERN CAPE PROVINCE**

(Assessment conducted under Section 38 (8) of the
National Heritage Resources Act as part of an EIA.)

Prepared for:
Mainstream Renewable Power South Africa
ERM Southern Africa

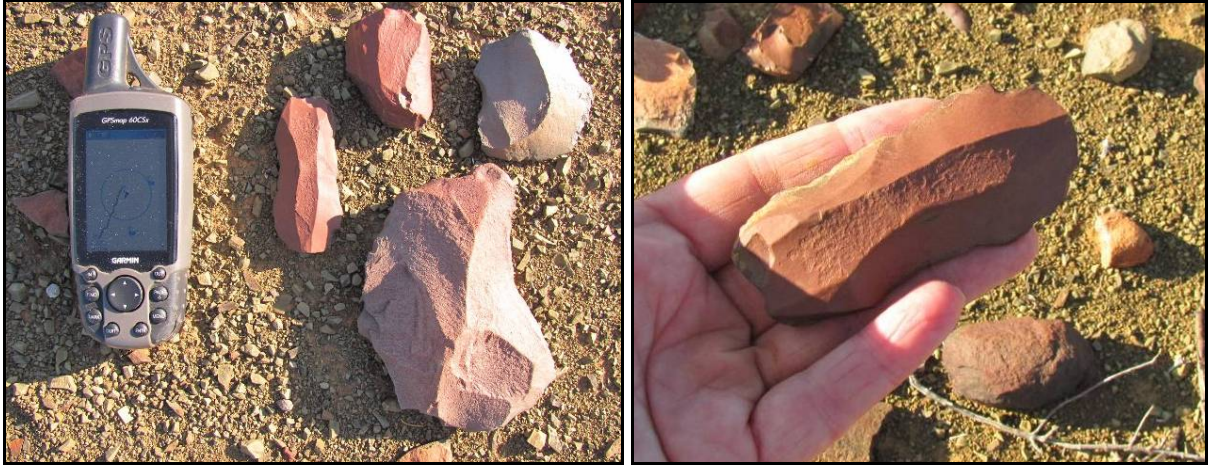
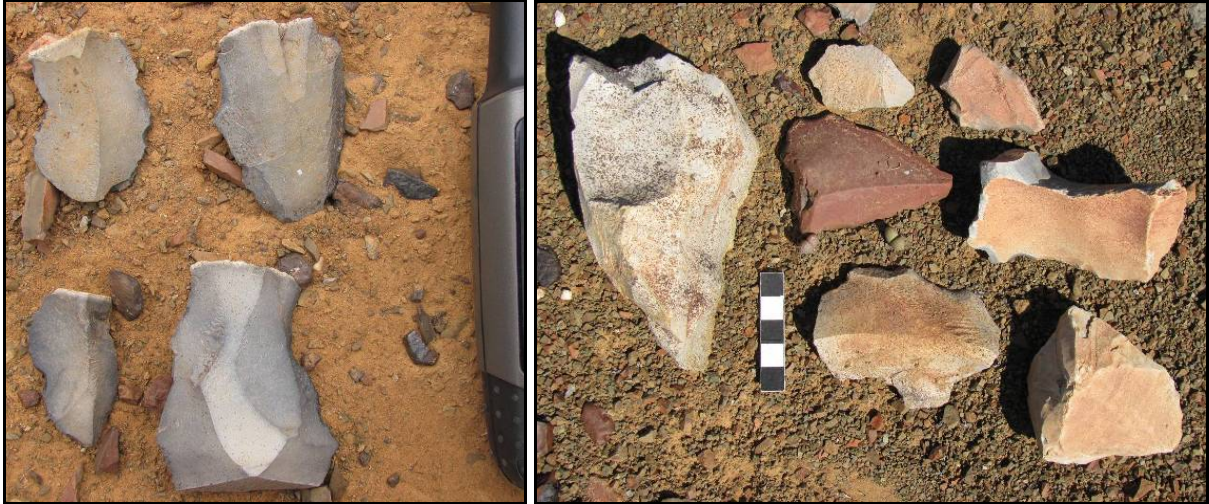
Plates 3-6: Middle Stone Age artefacts recovered from the study area.

Most of the material we observed can probably be ascribed to the Middle Stone Age (MSA). A few isolated large implements were recovered which resembled incomplete bifaces (ESA) but the observations remain equivocal. There were also some scatters of indurated stone tools which appeared to have recent flake scars and which could be interpreted as Late Stone Age (LSA), although no distinctive LSA implements were recovered or noted. The patination on many of the artefacts is consistent with significant vintage. Flakes, blades, chunks and cores make up the majority of the scatters, and retouch was present on some items. Raw material was almost exclusively hornfels of various colours in the grey to dark black band. There is a characteristic brown to red/orange patina evident on some of the older worked and unworked material. Yellow chert is also used to a lesser degree.

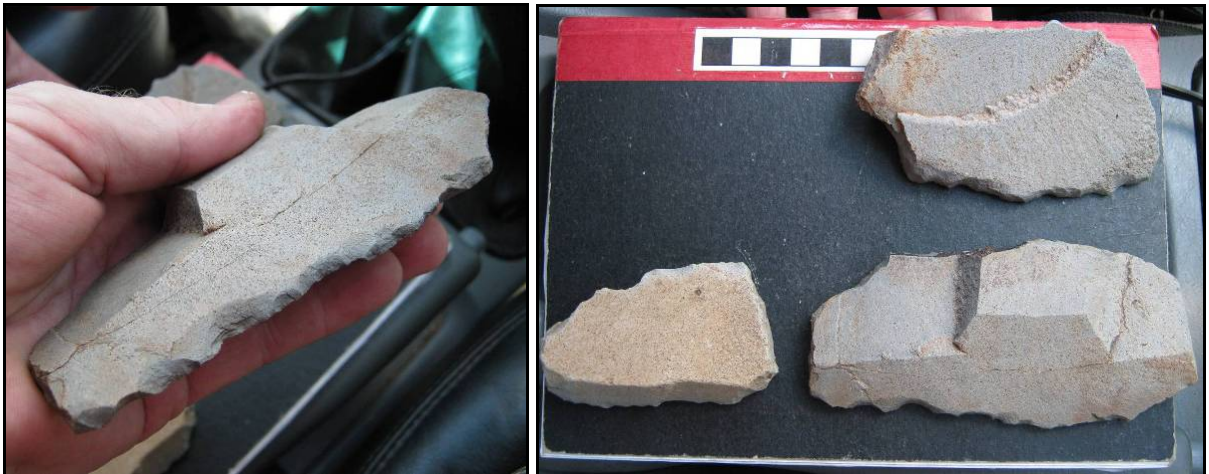
Plates 7& 8: Middle Stone Age artefacts made on natural rock slabs

In addition to the typical Middle Stone Age material found widely in the region, we also recovered some retouched implements which appear to have been manufactured on rectangular slabs of indurated shale, in other words the implement are not made on flakes (Plates 7 & 8).

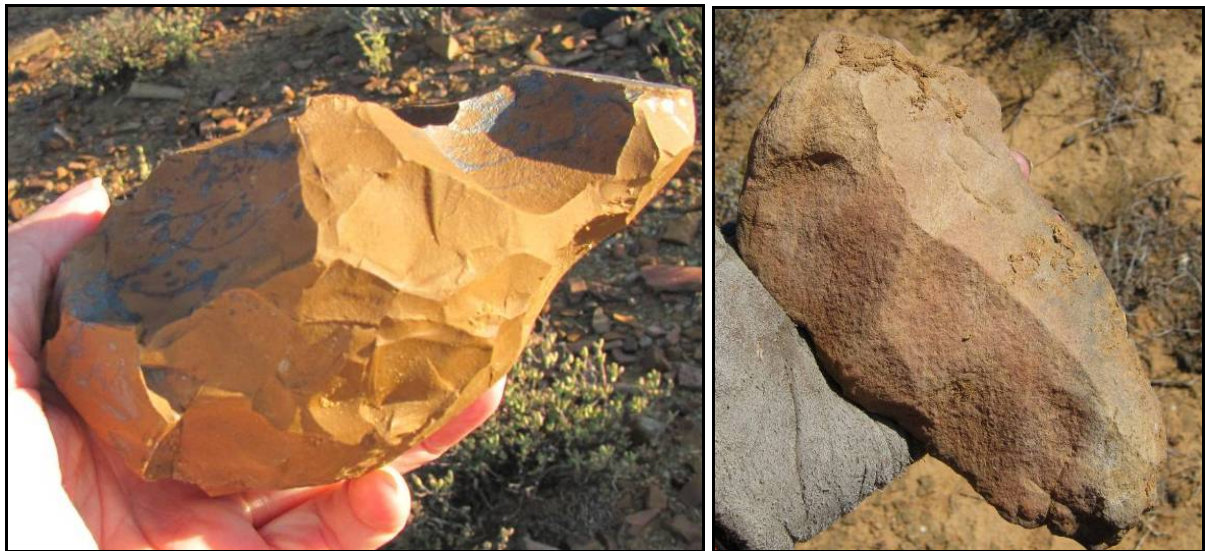
Plates 9 & 10: These artefacts appear to have some Early Stone Age characteristics.

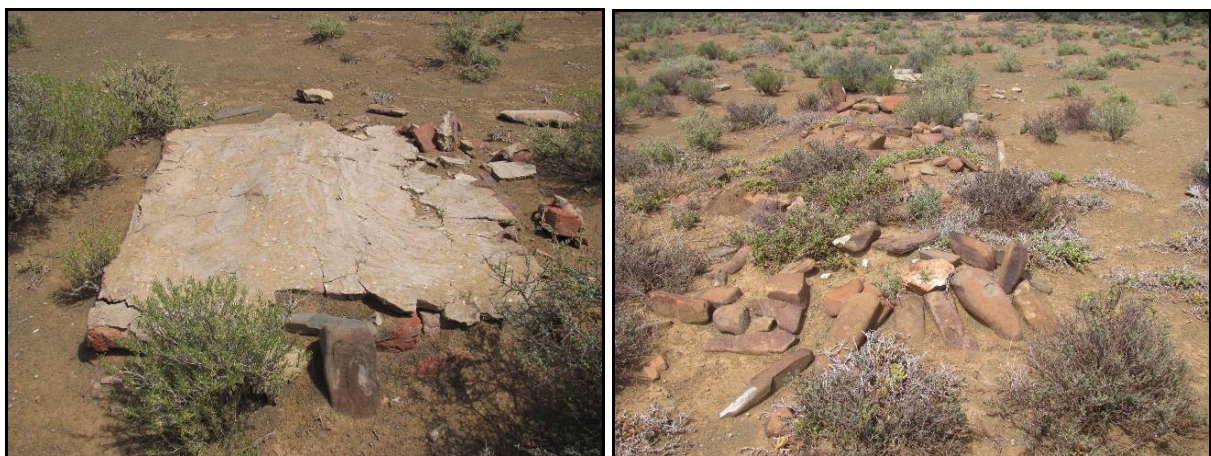
Plates 11 & 12: Graves from the Rietpoort family cemetery

A single, unfenced, formal graveyard was recovered near the ruins of the Rietpoort farmhouse. This collection of 7 graves, arranged in a row facing east, comprised 5 of packed stone and 2 with cement casings. Two had engraved headstones. One contained a name, the other a more extensive inscription in Dutch. However, the inscription was weathered and no date could be found on it (Appendix 1).

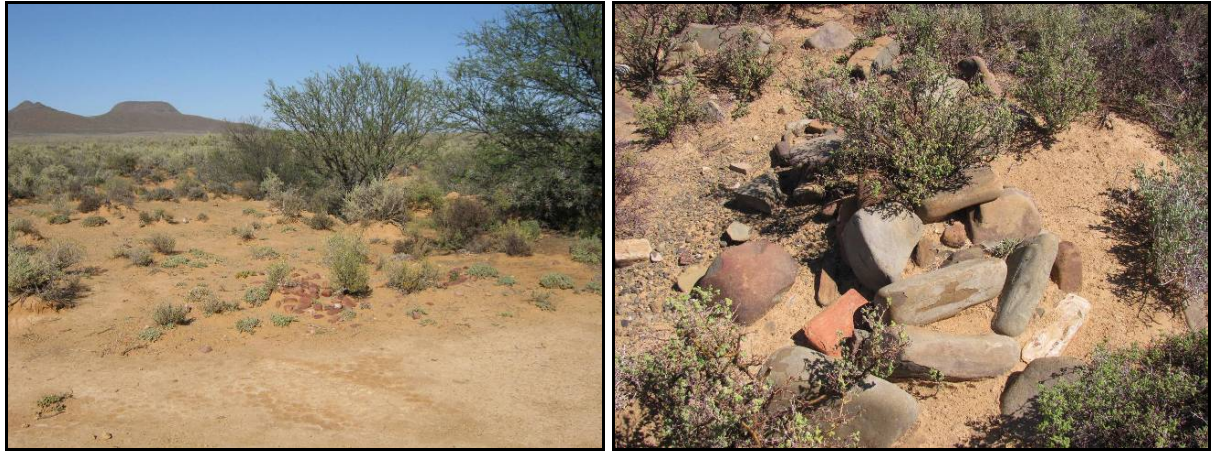
Plates 13-14: Informal graves marked by stone cairns on the margins of river beds

Further collections of stone cairns, which are interpreted as graves, were found near ruins of settlements, and predominantly situated on the margins of dry river beds. We have observed this pattern of burial in the soft river sands, elsewhere (Appendix 1).

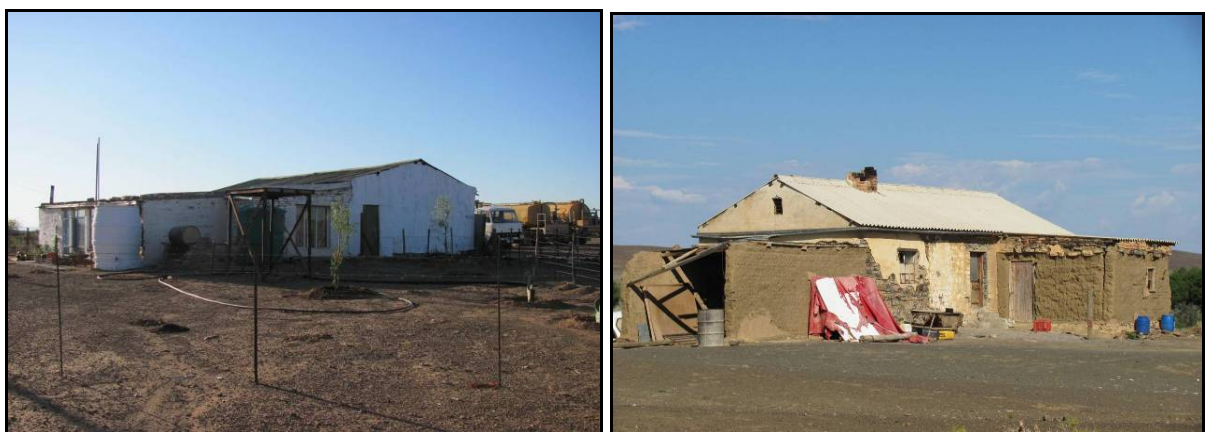
Plates 15&16: The Perdekraal farmhouse (left) and the Rietpoort farmhouse (right). The original Rietpoort farmhouse, as appears on the 1:50 000 map, is closer to Perdekraal and was washed away by a flash flood coming down the Groot River. We have recorded the remains as a site.

There are two extant buildings, one on Rietpoort and one on Perdekraal, both of which are currently occupied. The Perdekraal farmhouse has some early 20th century attributes but has been substantially transformed by later additions. The Rietpoort farmhouse, also at least 80 years old, is constructed from stone and mud brick and is in a good condition.

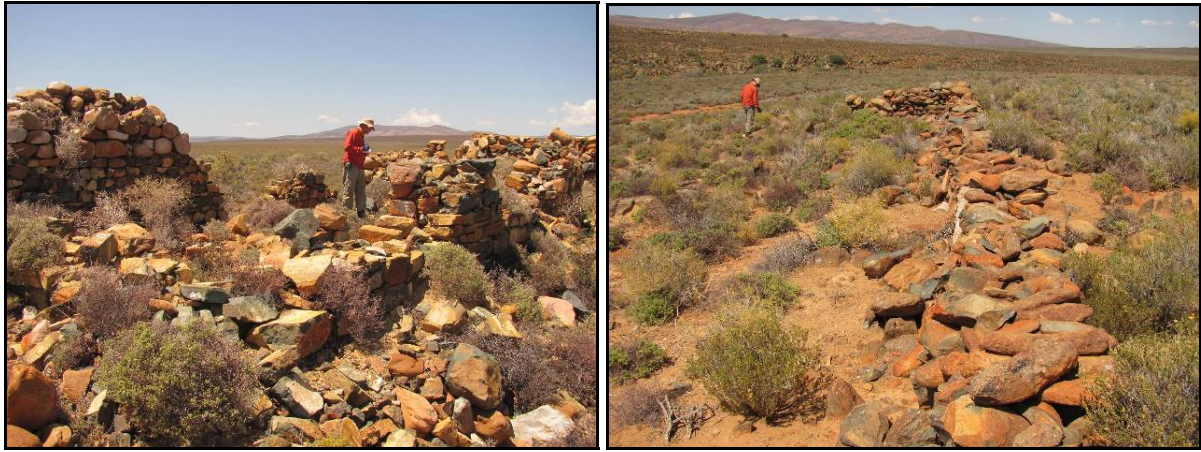
Plate 17: The ruins of a stone house on Perdekraal. **Plate 18:** Three sides of a stone kraal on Perdekraal

In addition to the above, there are the remains of stone structures on both farms. These include the ruins of a stone house, foundations of rectangular stone structures (possibly workers cottages), stone kraals, a stone oven, a stone windbreak, a possible stone threshing floor and a well (Appendix 1).

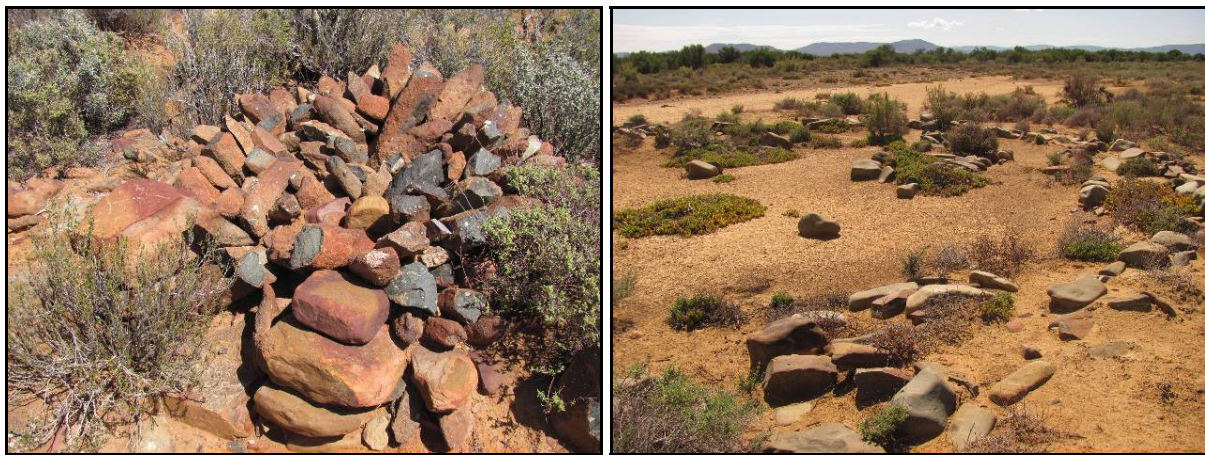
Plate 19: A collapsed stone oven on Perdekraal. **Plate 20:** A circular stone feature (possibly a threshing floor) on Rietpoort.

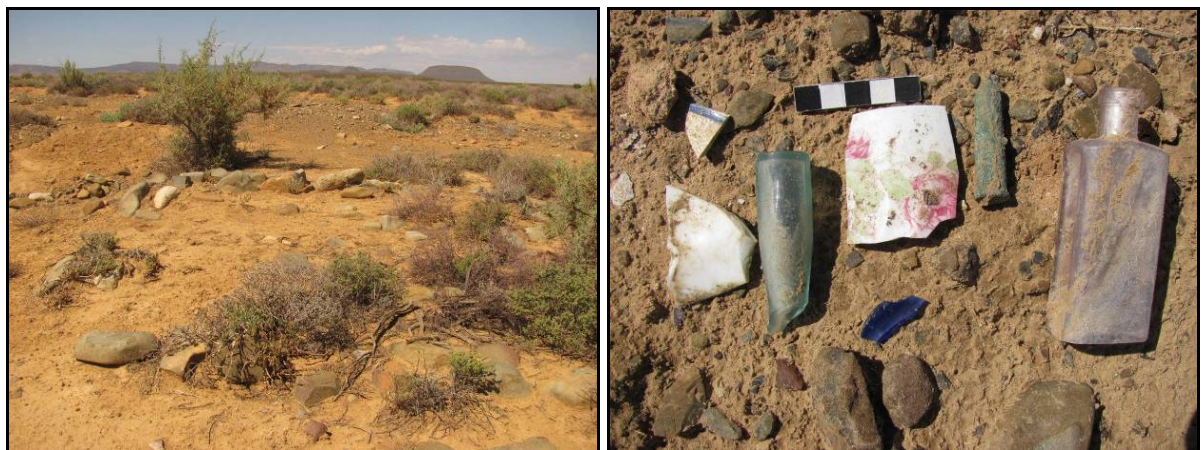
Plate 21: The stone foundations of a house; **Plate 22:** Associated historical material.

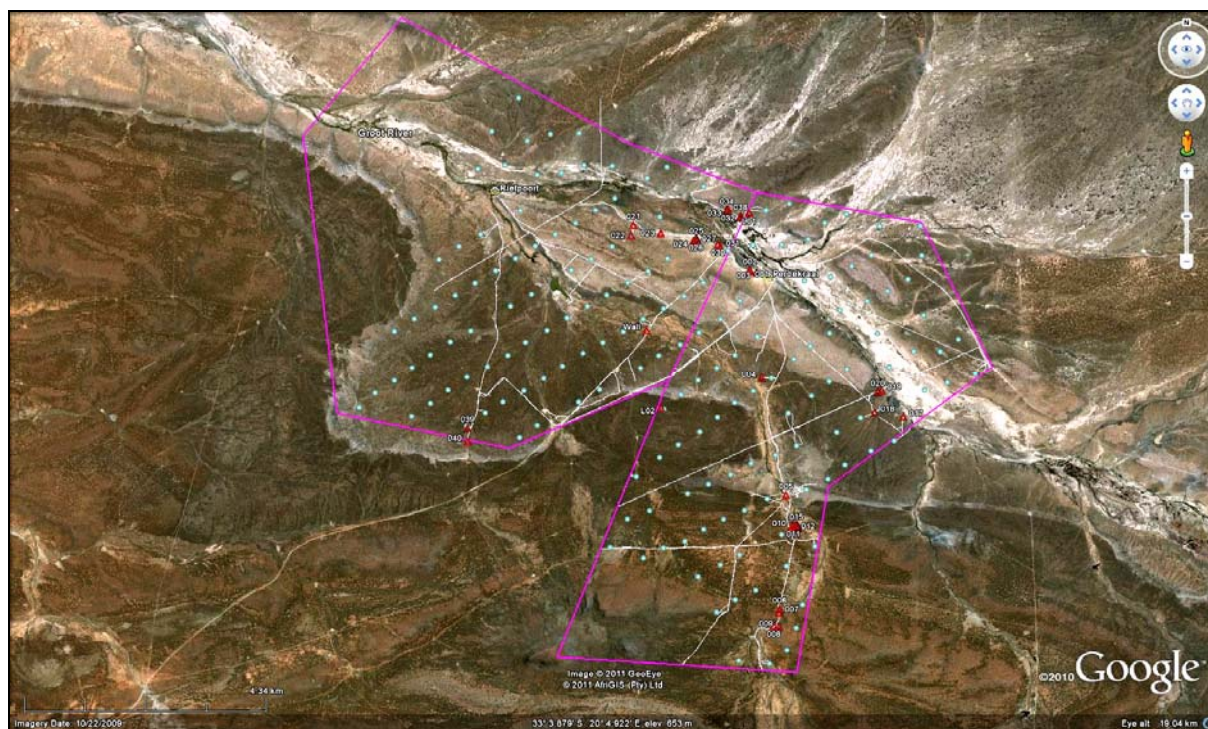
Figure 3: Map of survey tracks (white) and location of archaeological sites (red triangles) property boundaries (purple), turbines (blue circles). Note the concentration of sites along dry river channels.

Numerous scatters of stone artefacts were recorded across the study area, although predominantly located on ridges in close proximity to dry river beds (Figure 3 and Appendix 1). All of our observations relate to the surface, but we saw no indication to lead us to expect significant deeply stratified material anywhere on the site. No associated organic remains were noted with any of the stone scatters.

Our main concern is the banks of the dry river beds, namely the Groot River and Andrieskraal Rivier (Figures 2 & 3). The distribution of ESA and MSA stone artefacts are found on the higher lying areas near the rivers, while evidence for colonial settlement (ruined structures, kraals, well, ovens, threshing floors, etc) are all found in proximity to rivers. In particular, cairns/graves are found in the soft soils on the margins of the river beds.
