# PARLIAMENT PRECINCT: AFRICA HOUSE

Subject : PERMIT APPLICATION FOR ALTERATIONS AND

ADDITIONS TO AFRICA HOUSE TO MAKE THE BUILDING COMPLIANT FOR PERSONS WITH

Date : 22nd September 2023

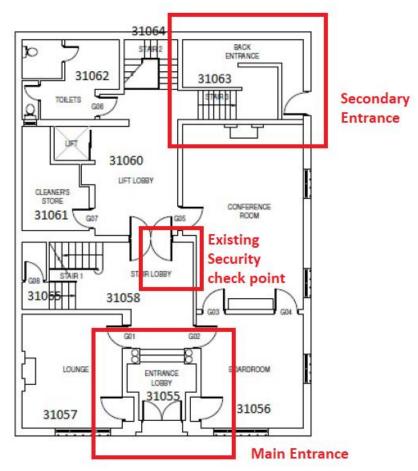
Fig 3: Existing Ground floor layout

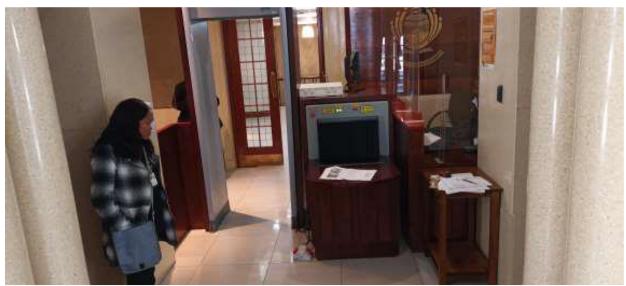
The only provision made for persons with disabilities is the existing external ramp in front of the building. The main entrance is through a system of double doors and a sequence of lobbies. In between these lobby spaces is a change in level (2 steps leading downwards) which approximates 450mm in height. There are both physical and electronic security controlled access in the Entrance Foyer. Findings:

Fig 4 : Main Entrance Lobby : View from entrance doors towards the security access control/checkpoint

- The existing Main Entrance Lobby to remain as is in terms of its configuration. It cannot be adjusted because of space and heritage constraints.
- The secondary entrance on the South West side of Africa House was recognized for further development to make it fully compliant for persons with disabilities.

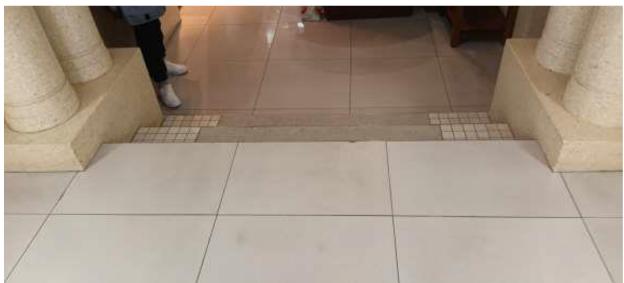
- No provision was made for access for persons with disabilities in the Main Entrance lobby.
- The Lobbies within the Main Entrance area are small and restricted, making it difficult to implement disabled facilities of any kind. Placing a temporary metal ramp over part of the steps will not work the gradient will be too steep to navigate.
- As indicated earlier, the Ground floor Foyer is a prominent part of the circulation space in the interior and cannot be adjusted.

Fig 5: Main Entrance Lobby: Steps dividing the two lobbies

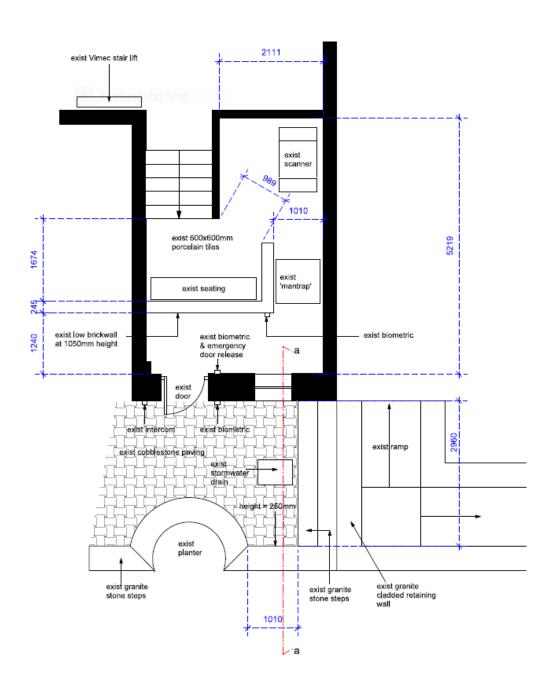
- a) The small size of the Lobby with the low L-shape wall as well as the existing electronic security equipment, restricts the movement of wheelchairs, eg. making maneuvering around corners very difficult.
- b) The position of the existing access control biometrics is too high for persons in wheelchairs.
- The security personnel currently utilizes a small area of the space to rest during breaks. There is no other areas available for this purpose.
   External
- d) The existing intercom and biometric panel is too high for persons in wheelchairs.
- e) Wheelchair bound persons has to access this entrance by travelling along the side of the building (distance = +- 24 meters from the front entrance door). There are existing steps opposite the door, not good for wheelchairs.
- f) See fig 6 below for existing layout

Fig 6: Existing Secondary Entrance layout

- 6.3 The following proposal was presented to Parliament regarding changes to the Secondary Entrance Lobby: Demolition of the existing low-wall and re-configuration of the security equipment.
  - a) Remove existing seating
  - b) Demolish the bulk of the low L-shape wall, but allow for +- 450mm length of wall to remain and made good.
  - c) The Existing 'Mantrap' and scanner to remain. The scanner can be positioned next to the 'Mantrap' to utilize the space more efficiently.
  - d) Allowance to be made for the inspection and servicing of the chair lift to a functional and proper operational state.
  - e) Fit a new 1318mm L x 1100mm H stainless steel paraplegic gate with glass insert panel, operable at 90 degrees in both directions.
  - f) Gate to be connected to the existing access control in the building.
  - g) Allowance to be made for power supply to the gate.

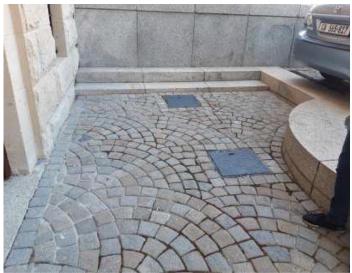
Fig 9: Location of Proposed Ramp along the retaining door wall at the back. Secondary Entrance door to the left – step on the right to be dropped down by 50mm. Furthest stormwater drain to be raised.

- The following method of construction is proposed for the construction of the ramp:
  - a) Remove the existing cobblestone pavers to the right of the entrance door (when facing the door).

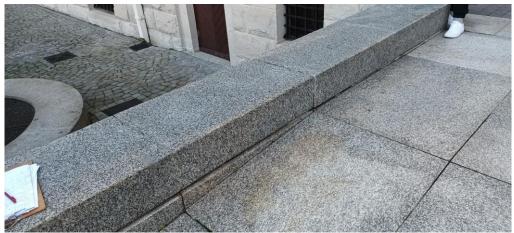
Fig 11: Looking down from the existing ramp onto the area where the new ramp is proposed

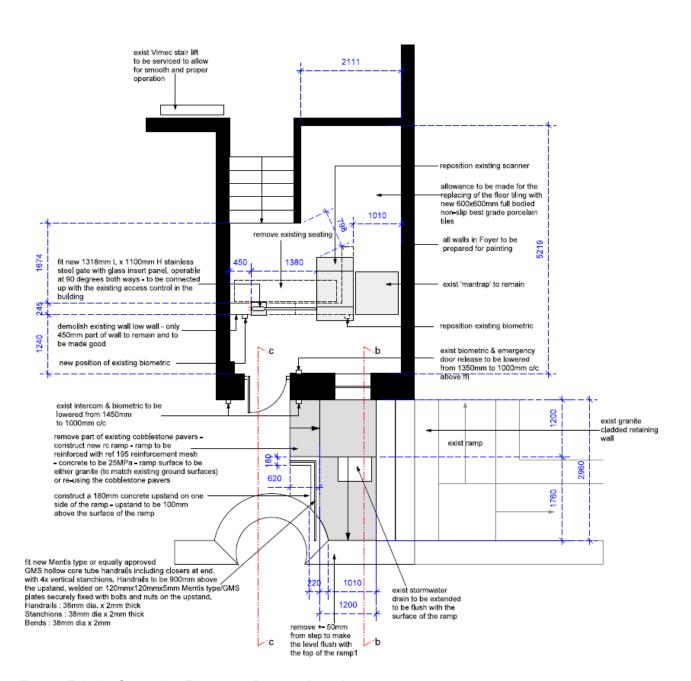
Fig 12: Existing Secondary Entrance - Proposed new layout

- Reposition the existing biometric access control panel to be closer to the gate (to be positioned on the 450mm wall).
- Lower the existing biometric access control panel and emergency door release at the entrance door from 1350mm height to 1000mm, center of the units.
- j) Allowance to be made for the fitting of new 600x600mm full-bodied non-slip best grade porcelain tiles for the whole Lobby area to match existing.
- k) Allowance to be made for stainless steel edging strips to the edges of each step/landing.
- Allowance to be made for the preparation and painting of the Lobby walls.

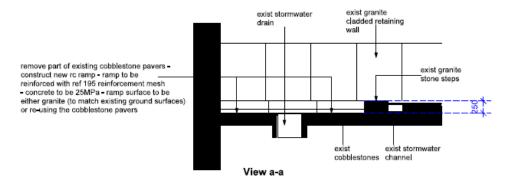
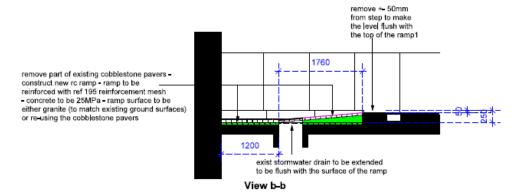
Fig 13: Section through the ramp

- b) Construct a reinforced concrete ramp with up-stand, and new Mentis type or equally approved GMS hollow core tube handrails and stanchions fitted securely to the up-stands.

- c) Surface finish on the ramp to be either granite slabs or re-using the existing cobblestone pavers.
