Agency for Cultural Resource Management

20 August, 2009

ARCHAEOLOGICAL MONITORING THE CONSTRUCTION OF THE PADDAVLEI STORMWATER PIPELINE IN HAWSTON

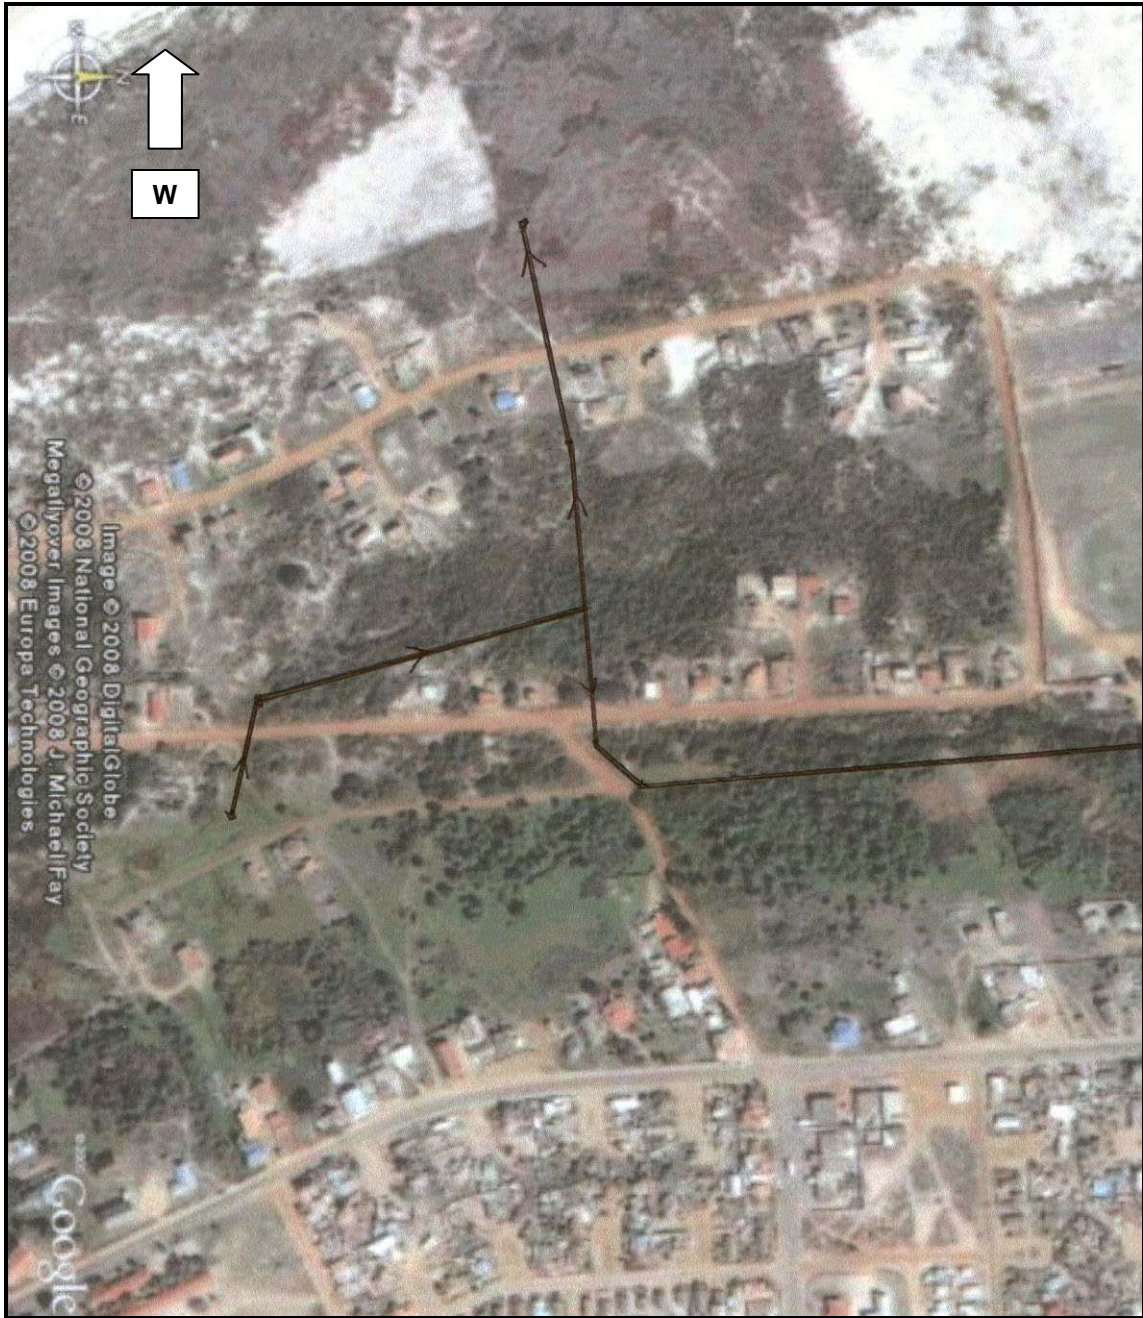
Figure 2. Aerial photograph indicating the pipeline route

The location of the proposed Paddavlei stormwater drainage pipeline is from the Paddavlei, situated mainly along Marine Drive in Hawston, near Hermanus. The proposed pipeline is intended to discharge excess stormwater into the sea. The pipeline has become necessary, partly brought about as a result of increasing development in Hawston.

Due to the sandy nature of the receiving environment the excavations needed to install the pipeline caused disturbance of areas up to about 40 m wide. The length of the pipeline is about 1 km long.

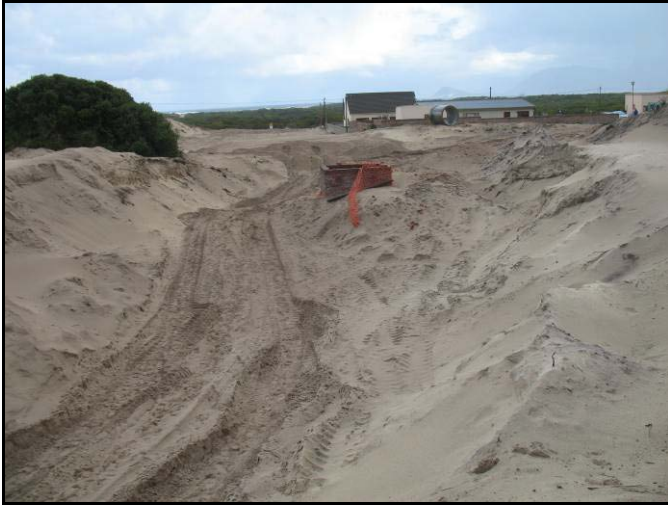
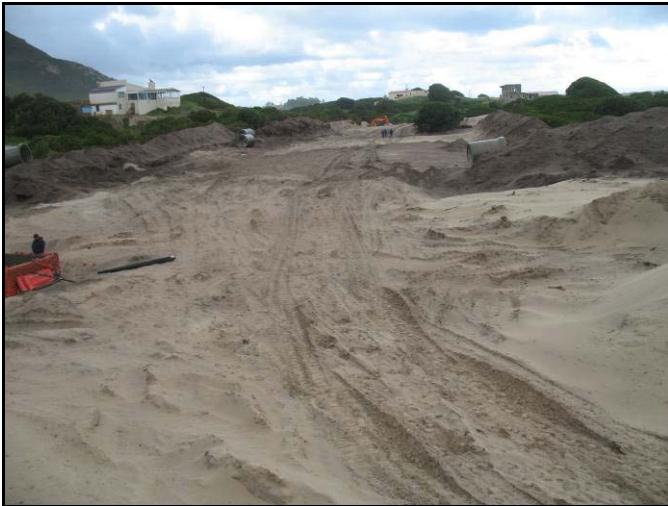
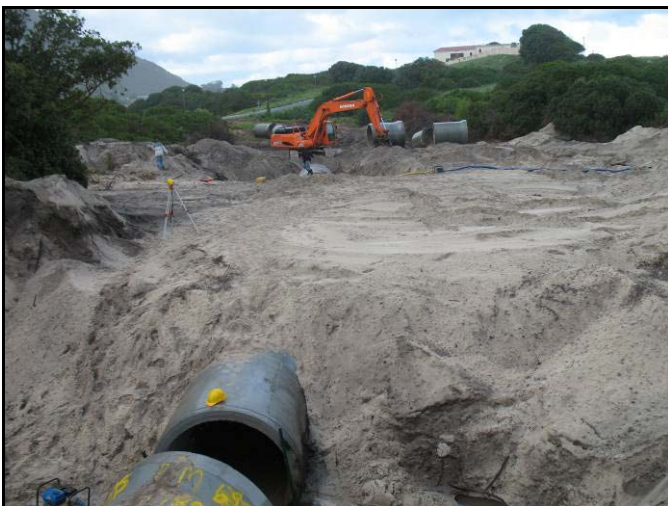
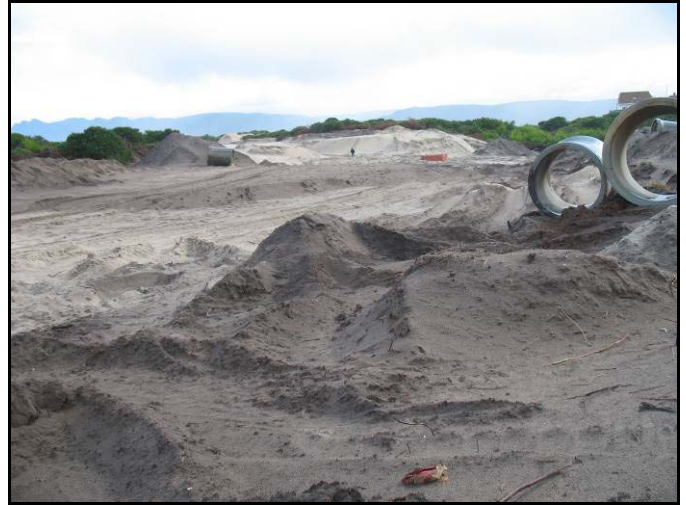
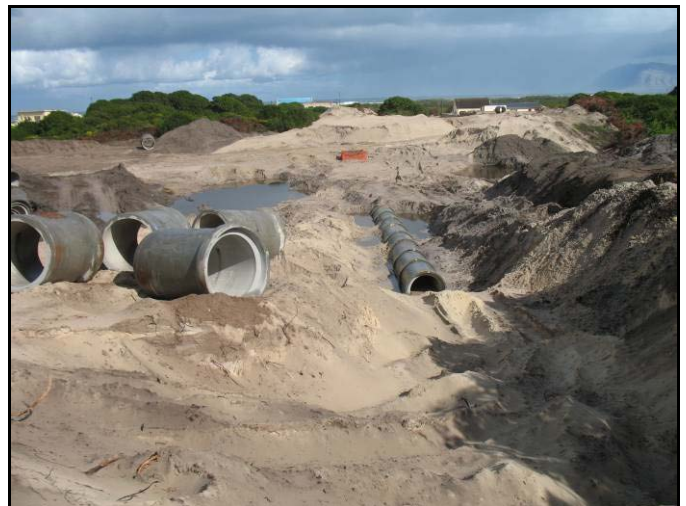
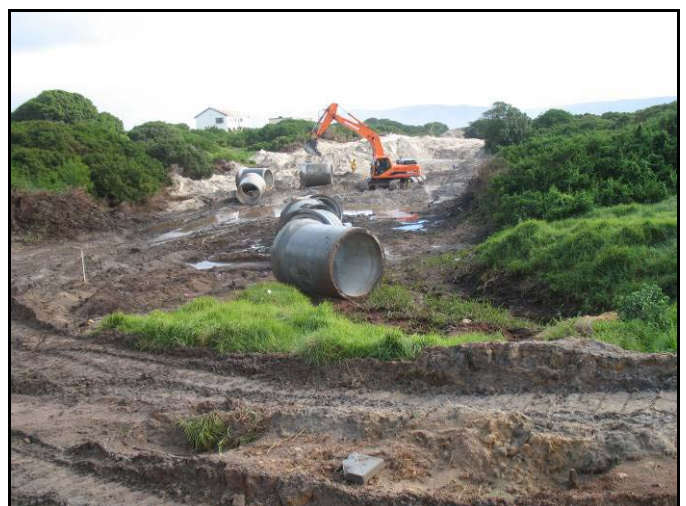
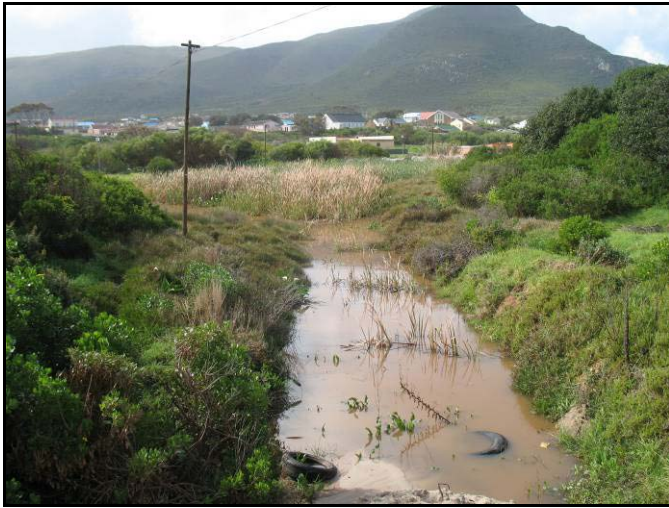
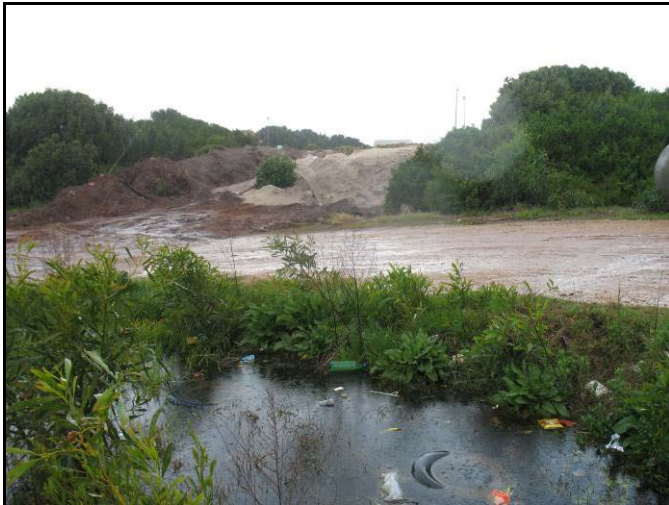
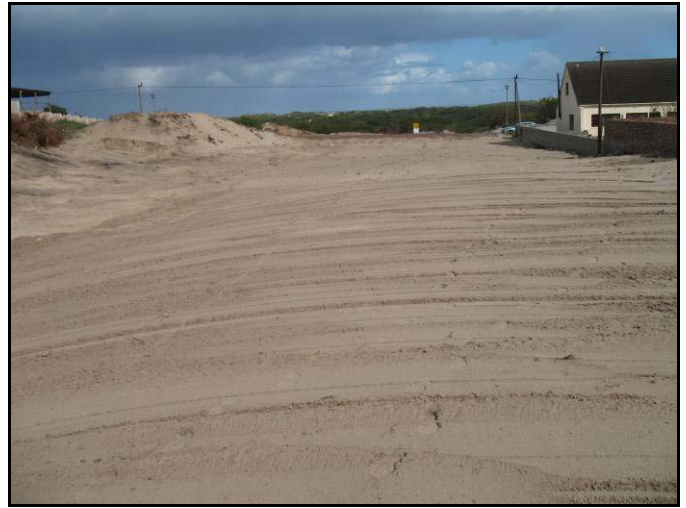
Figures 3-11 illustrate the nature of the receiving environment and the current construction activities.

No shell lenses, or dispersed pieces of shellfish were found in any of the trench/excavation cuttings, nor among the large sand spoil dumps situated on the construction site.

Some (modern) building rubble and domestic waste was also noticed over some portions of the cleared site.

Excavations and installation of the final section of the pipeline is ongoing. The contractor has been briefed by the archaeologist and should any archaeological and human burial remains be exposed, the archaeologist will be notified immediately.

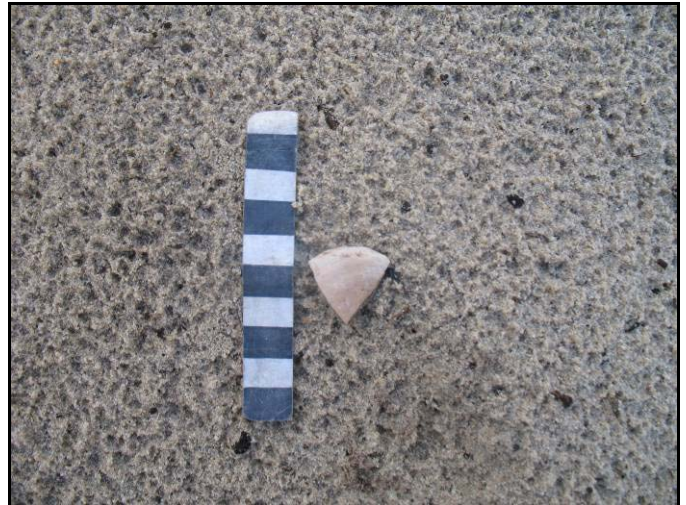
One broken, White Sand mussel (Donax Serra) scraper was found during the site inspection (Figure 12). The location of the scraper (HWS 1) has been marked with a GPS waypoint, set on map datum wgs 84.

In addition to the above, a few dispersed fragments and pieces of shellfish were also found during the site inspection. These included a few fragments of the limpet Scutellastra argenvillei, a few pieces of Cymbula oculus, and several larger pieces of unworked White Sand mussel.

The few pieces of shellfish found appears to confirm the assumption made in an earlier report, that the paucity of archaeological sites alongside long sandy beaches is well represented along the South African coastline². Most coastal shell middens are associated with rocky shorelines, headlands and wave cut platforms³.

Figure 12. Donax scraper. Scale is in cm
