**Final Archaeological Monitoring & Salvage
Excavation: Granger Bay Boulevard
Green Point, Cape Town**
(HWC Permit No 2006-04-011)

Report Prepared for the Ninham Shand (Pty) Ltd (Contract Q08/01)

October 2009

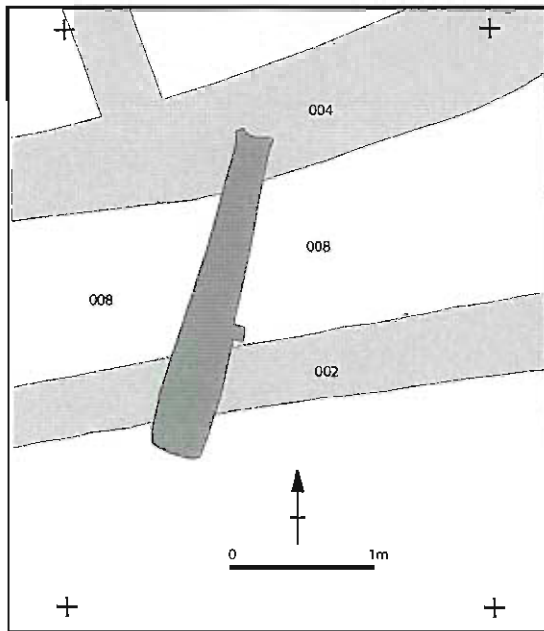
Figure 3: Pre-excavation plan of area surrounding the cannon.

A substantial and sterile sandy brownish yellow clay deposit (008) abutted the cannon, into which the service trenches had all been cut (Photograph 1; Figure 3). There was no observable cut for the cannon in the clay deposit and it did not appear to lie within any of the modern service trenches. This indicated that the clay, which pre-dated the service trenches, actually built up after the cannon had been deposited in this position.

It was, however, difficult to ascertain the exact stratigraphic sequence from analysis of the surface alone as most of the deposit that abutted the cannon had been dug away before archaeological work began (Photograph 1). To further investigate the burial sequence of the cannon, a small programme of controlled stratigraphic excavation was undertaken. Box sections of the modern service trenches were excavated to examine the clay deposit into which they were cut, and also to see if a cut was visible for the cannon.

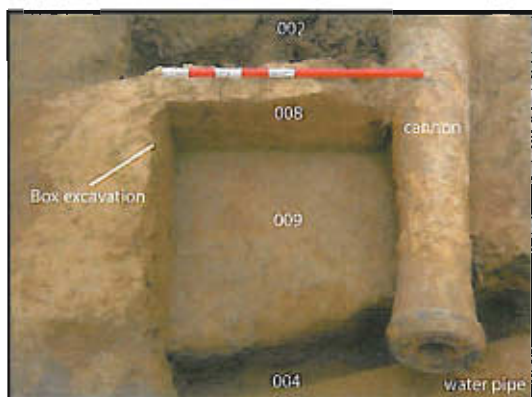
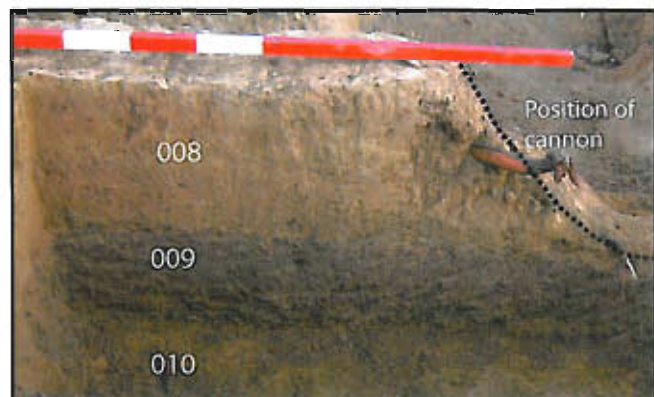
Photograph 3 (Left): Oblique view looking south over the cannon and excavated box-sections through service trenches 002 and 004 and clay deposit 008. The 1 m scale is in 0.50 m and 0.10 m increments. Photograph 4 (Right): North facing section of the box-excitation after the cannon had been removed. The scale is in 0.50 m and 0.10 m increments.

No such cut was found. The box section excavated in the modern service trench 004 was then extended by 1.10 m x 0.90 m into the clay deposit 008. Following these excavations, there was no doubt that the clay had built up naturally around the cannon. This in turn demonstrated that the water pipe (004) and electricity cable (002) must have been threaded under the cannon, presumably because the object was too heavy to move by hand and possibly because it was mistaken for an old water pipe. The clay itself was excavated to a depth of 0.25 m and no artefacts were recovered. Underneath the clay deposit (008) was a compact and gravel-rich material (009) that had the appearance of a metallised surface (Photograph 2). The excavation proved that that the cannon was lying directly on top of this compacted gravel layer. This gravel deposit was 0.15 m thick and lay on top of a homogenous and sterile, naturally deposited gritty sand (010) (Photograph 3). Only 0.05 m of this sand was excavated.

The controlled excavation stopped at this depth, 0.85 m below the present road surface. The cannon was removed using a winch with canvas straps and transported to Fort Wynyard Museum. The cannon was not associated with any other iron objects and there was no evidence that it had served a military function in this location. Iron cannons were commonly used in Cape Town as bollards, gate posts and other boundary markers. The location of the cannon close to the main thoroughfare from central Cape Town to Sea Point and the western coastline of the Peninsular, which had been in existence from the late 17th century, suggests that the cannon was likely to have been used as some kind of marker along the road. Unfortunately, the area around the southern end of the cannon was highly disturbed so it was not possible to tell if there was a post-hole to hold it upright, but the compact gravel that the cannon was lying on may well be an old road surface. The limited excavation did not yield any artefacts from the deposit underlying or immediately overlying the cannon. Only fragments of 20th-century pottery and glass were observed from the modern service trenches. These were not collected.

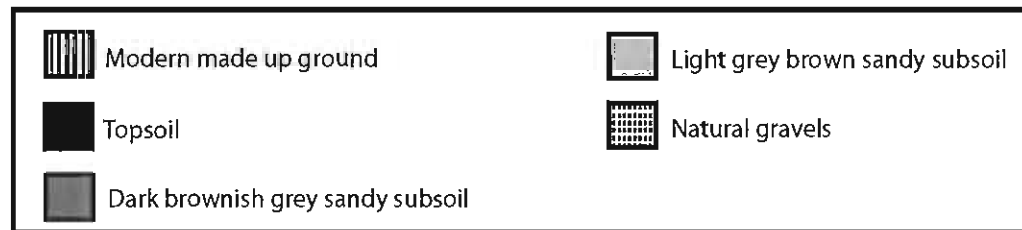
Figure 5: Sections A–D of the north-western (south-west-facing) section of the storm-water trench. See Figure 4 for exact locations of each section shown above.

The storm-water trench provided an opportunity to observe the soil profile through the centre of the GBB route. The section drawings above (Figure 5) show the varying soil profile along the length of the trench. In the first 60 m at the south-west end of the trench, the upper part of the profile, consisted of late 20th-century dumps to a depth of a metre below the present ground level (Section A). Fragments of tarmac were visible in the very base of these 'make-up' layers. Underneath these modern layers was a substantial, but discontinuous, 0.40–0.50-m-thick gravel layer. This naturally deposited gravel varied in composition. Along some parts of the section it consisted entirely of angular fragments of sandstone (<0.15 m in length) (Section A). Elsewhere, the angular component was thinner and the lower half gradually graded into a rounded gravel (<0.03 m in diameter). Underneath the gravels, at a depth of 1.40 m below the present surface, was a bright yellow, sandy clay, which in turn lay on top of the bedrock, the top of which was reached at between 2.00 m and 4.50 m in the south-western half of the storm-water trench.

Forty metres from the south-western end of the storm-water trench, a dump of 19th-century bottles was recovered from the excavation spoil. This dump was not visible in either of the section faces so it must have been a localised occurrence. Diagnostic base and rim fragments were collected. At the 60 m mark (moving north-east), there was the first sign of an undisturbed soil profile. The soils consisted of a dark grey sand overlying a lighter grey sand, which itself lay on top of the naturally deposited gravels and sands (Section B). In places, the bedrock was visible underneath either the clay or sand. This relatively undisturbed profile was recorded for a further 40 m.

A second series of modern levelling dumps was observed beginning at the 135 m mark (Section C). These began at the same point at which the present ground level begins to slope up from the present site compound area to the cricket pitch and therefore most likely represent levelling layers for the construction of this recreation area. These modern dumps continued up to the line of trees shown on Figure 4. After this point the undisturbed profile returned and continued until 200 m (Section D). At 200 m the natural sands separate into three main bands, although more lenses are visible in places. A discontinuous lens of calcrete was recorded in the middle band of sand in the section between 204 m and 208 m. The calcrete lens was cleaned up and investigated but also appeared to be naturally deposited.

A small shallow cut feature, filled with a similar greyish-brown sand as the subsoil and capped with a lens of ash, was recorded in the section at 206 m. The feature was investigated and thoroughly cleaned in section. One small fragment of clear glass, dating from the second half of the 20th century was recovered from the ashy lens, proving that this feature was modern in date and thus of low archaeological significance. Beyond this feature, the undisturbed profile with deep, sterile sands continued until the end of the trench.

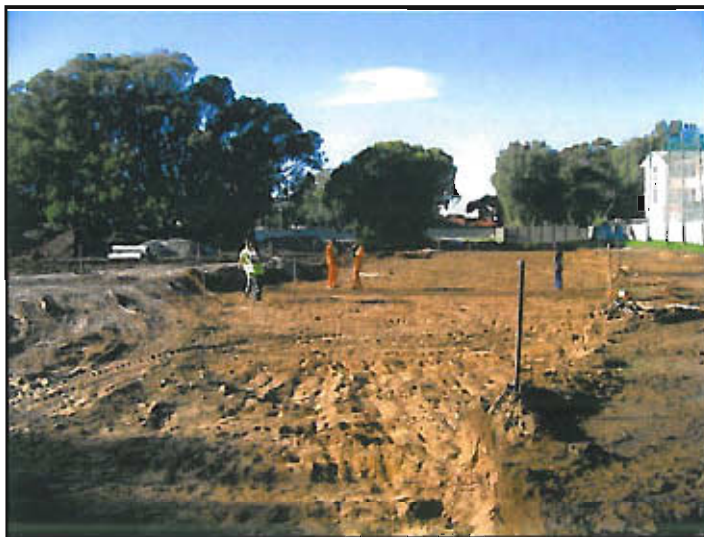
Photograph 5: The box-cut excavations along the route of the Granger Bay Boulevard.

Between the 24th June and the 14th July, a CAS archaeologist was present on-site during all excavations associated with the foundation trench ('box-cut') for the Granger Bay Boulevard route. The excavations extended for 305 m between Fritz Sonnenberg Road and Fort Wynyard Street (Figure 4). The excavated area measured 20 m in width along most of its length, although between 40 m and 150 m, from the south-western end, the route included an extra lane for buses (Figure 4). The box-cut was deepest at the south-western end, measuring a maximum of 1.20 m below the present ground surface.

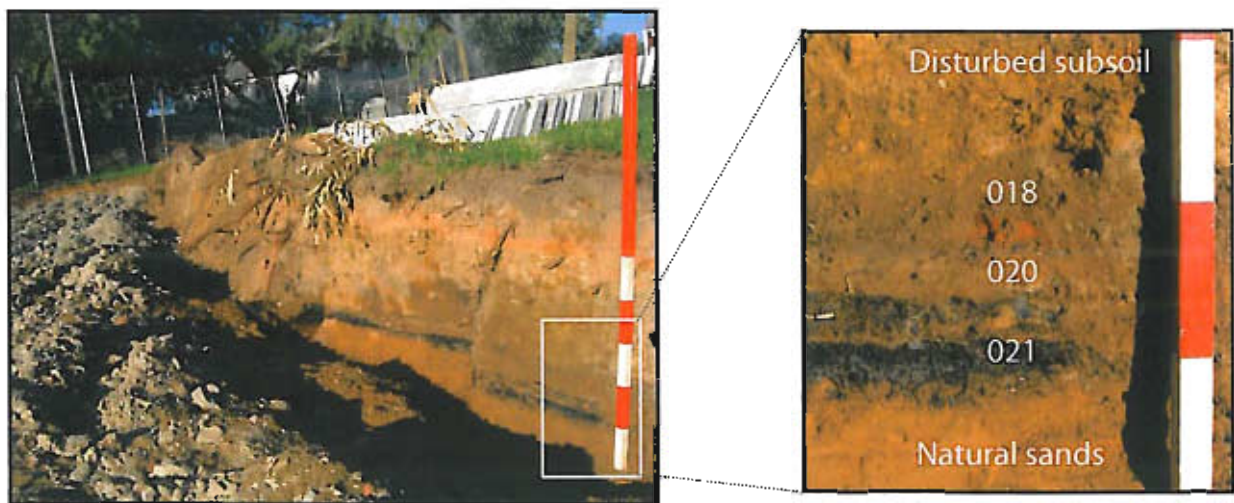
Photograph 7: The south/east section of the drainage trench showing layer of burnt material 021. The fence in the background (left) is Fort Wynyard Street.

Perhaps the most archaeologically important observation of the Phase 2 monitoring was the identification of an extensive area of burnt material at the north-eastern end of the box-cut and in the drainage trench, aligned parallel, and immediately to the south-east of the box-cut (Figure 4; Photograph 7). The burnt material consisted of lenses containing varying concentrations of charcoal and clinker. Unfortunately, the box-cut was only excavated to 0.40 m below the present surface and therefore not quite deep enough to expose the full extent of the burnt material, the top of which was between 0.40 m and 0.60 m below the surface. It was just visible at the very bottom of the north-eastern section of the box-cut, 8.20 m from the north-eastern corner of the excavated area, suggesting that it did, in fact, extend over this whole area (Figure 4). The topsoil exposed in section was quite disturbed, consisting of clayey sand with crushed brick.

Underneath, between 0.30 m and 0.35 m below the surface, was a mixed yellowish-brown fine sand (018) with moderate amounts of charcoal and animal burrows. At 0.55 m below the present surface, and extending for 7.80 m in section, was a thin lens of dark brownish-grey sand, 019, with frequent charcoal and clinker inclusions. This layer of burnt material was lying on top of a 0.05 m thick layer of brownish-yellow coarse sand (020) that was almost devoid of evidence for burning, containing only occasional flecks of charcoal and small fragments of clinker. Next in the sequence was another layer of burnt material (021), 0.60 m below the surface. In the south-western end of the area of burnt material (Figure 4) layer 021 was recorded as a thin, 0.04-m-thick deposit with moderate clinker and charcoal inclusions, lying on

top of an old soil horizon. About halfway along its length, 021 was visible as a much more substantial layer, 0.10 m thick, and consisting of almost 100 percent charcoal (Photograph 6).

After forty-five minutes of cleaning the section, few finds were retrieved. Importantly however, one shard of refined earthenware (whiteware), dating from the late 19th/early 20th century, was collected from layer 021, the most intense layer of burning. Other finds consisted of small irregular lumps of iron measuring no larger than 0.03 m in size, and one fragment of diagnostic animal bone, a possible nail and a fragment of mortar, all from layer 019. All these finds were collected.

The size of this burnt deposit and the inclusion of industrial waste such as clinker and small iron fragments strongly suggests that these layers are the result of dumping of industrial waste associated with metal working. This correlates well with the results from the Green Point Stadium monitoring programme during which large dumps of iron were recorded. Due to the military nature of much of the iron material and the historical evidence for an army camp in the vicinity of Fort Wynyard from the late 19th century onwards, the nearby forge would almost certainly have been associated with the camp. Although it is difficult to prove beyond doubt from these limited findings, the available evidence strongly suggests that the area of burning identified during the GBB monitoring is related to a military forge. The identification of two substantial layers of burnt material separated by a cleaner layer of sand further raises the possibility of two phases of intense activity. Further investigation may well be able to link these two phases to the two periods of military activity known to have taken place in this area: the Anglo-Boer War and the First World War. The late 19th-century/early 20th-century ceramic fragment from layer 021 does not conflict with this interpretation. These archaeological deposits continued north-eastwards beyond the extent of the GBB monitoring planned for 2008.

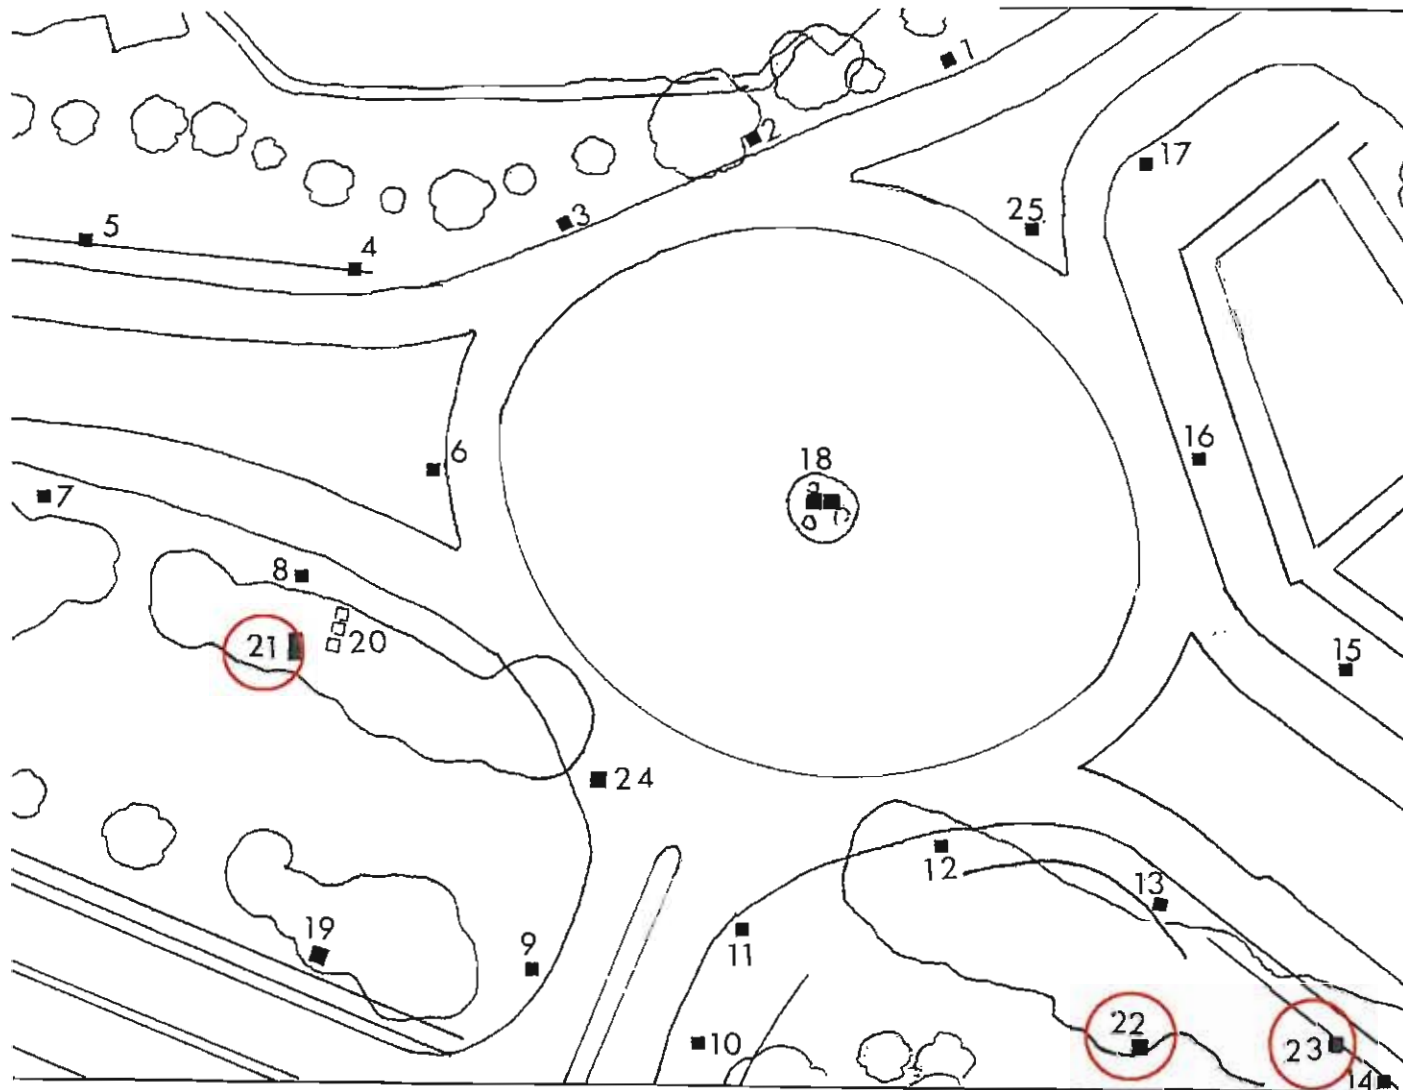
Fig. 6: 1:10,000 scale drawing of the main intersection between Granger Bay and Western Boulevard showing the location of lampposts and trenches surveyed during the archaeological monitoring brief.

The first 30 cm of grass cover and topsoil was removed from around the lampposts at No's 1–7, and none of these excavations contained cultural material. Only lampposts 21, 22 and 23 exposed artefacts of archaeological interest. At the bottom of trench 21, paving and road drainage slabs were found *in situ*, located in a north–south direction. The same paving slabs were also noted in trench 23. It is possible that they may belong to the old Somerset Road. In trench 22, an archaeological horizon with a substantial amount of bone, 19th-century porcelain, bottle glass and iron fragments was noted.

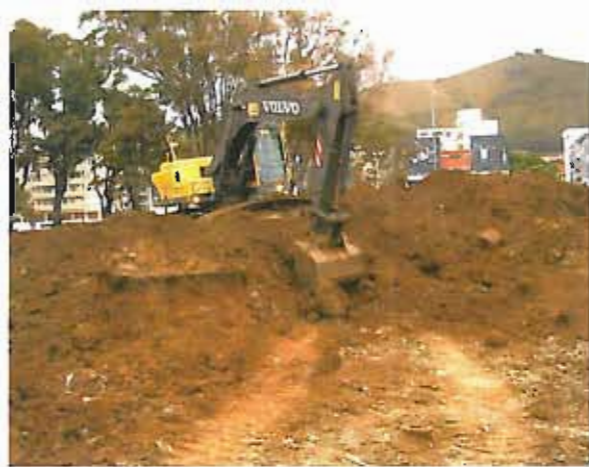
Photograph 8: Granger Bay Blvd. Excavation behind McDonald's restaurant, exposing service cables; reddish-brown soil above degraded Malmesbury shale.

An additional area was monitored close to the McDonald's restaurant (see Figure 8), where the footing for a flyover bridge was being constructed. Several electrical cables were removed as part of this process, providing an opportunity to describe the stratigraphy of this area, which is composed of brown sandy loam above a lighter clayey material, overlying degraded Malmesbury shale bedrock, with very little cultural debris.

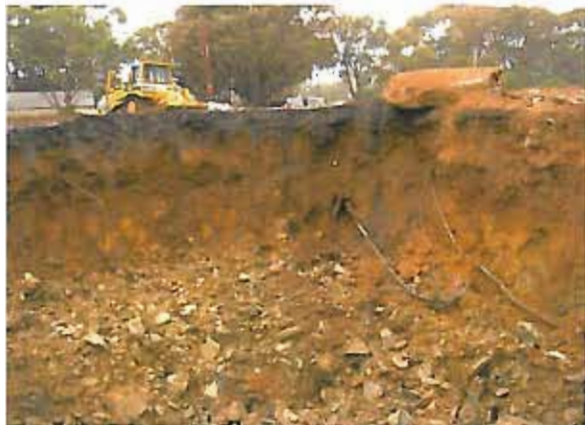
Photograph 9: Granger Bay Blvd. Excavation showing 'islands' of unexcavated material and original land surface.

A number of *in situ* baulks had been left with wooden stakes to show the height of the original land surface (see Figure 9). These offered a window of opportunity to view the stratigraphic sections. A survey of these excavated areas showed very little in the way of cultural debris, other than some bricks and broken water pipes, but remarkably almost no domestic garbage.

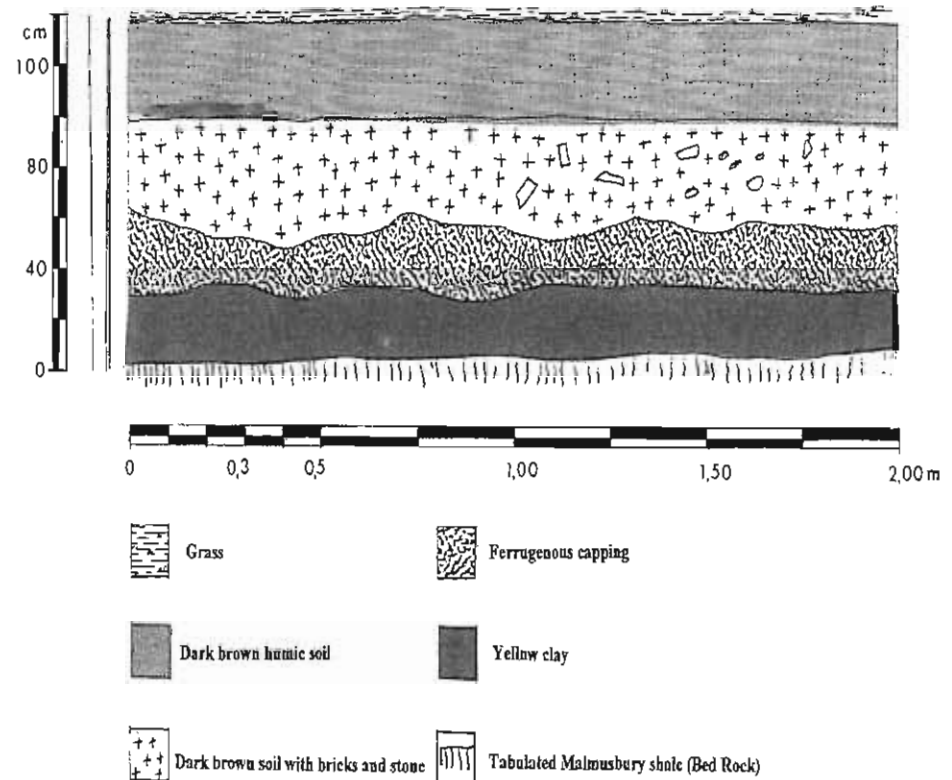
Figure 7: Profile on the main circle at Green Point Stadium.

Several shards of Oriental porcelain were found on the surface south from the circle in the direction of the Traffic Department (13.15), but no faunal elements were found. A large pit, 4 m wide and 1.50 m deep, was excavated by the contractor in the centre of the traffic circle in order to remove a large palm tree. These deposits were examined and an archaeological profile developed for the area (see Figure 7). No archaeological material was noted.

The stratigraph for this area is made up in the following way; located directly below the topsoil, at 20 cm, is the upper deposit, made up of dark brown humic soil, which we believe was used as a bedding material to plant grass. Below this is a dark brown loamy soil with bricks and stone, which seems *in situ*. Below these deposits lies a ferrugeneous capping that overlies a yellow clay deposit, which is sterile. Bedrock lies below, which is tabulated Malmesbury shale.
