K2 REHABILITATION PROJECT
PROGRESS REPORT
2001

A report prepared for the ATG, SANParks, VUKA and SAHRA

Professor TN Huffman
Mr TM Murimbika

Archaeological Resources Management
School of Geography, Archaeology & Environmental Studies
University of the Witwatersrand
Johannesburg

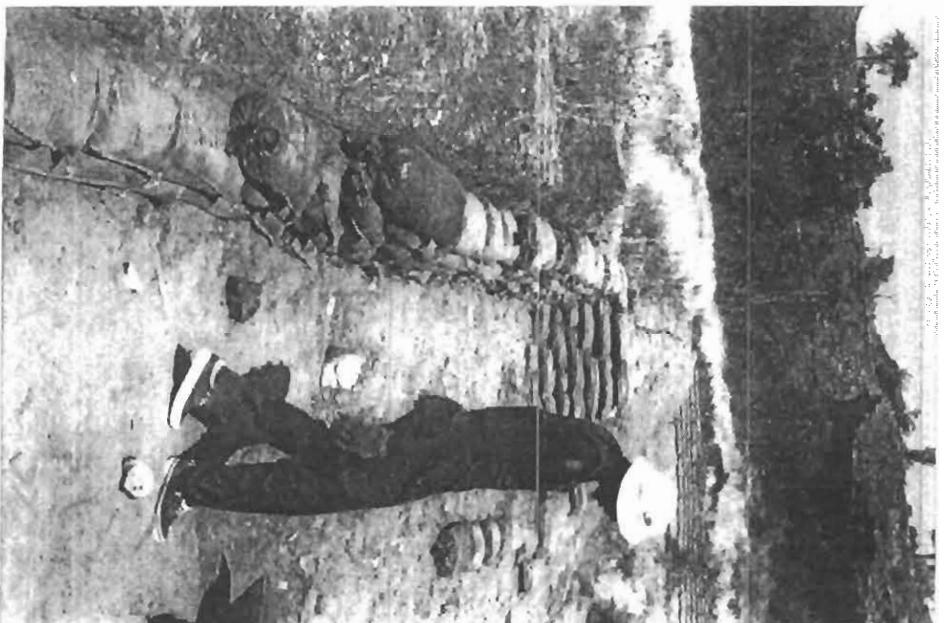
Figure 3. Stabilisation at K2: sandbagging the south wall.

The soil was used to stabilize the sides of Gardner's large block excavation (Figures 3 - 5). The northern section had been recorded by the Anatomy Department, UP, and so the ARM team concentrated on the remaining three sides. The east section exposed the remains of the central cattle kraal under the large central midden, as well as a series of superimposed hut floors near a pit (Figure 6). ARM staff made a rubberized "peel" of this area for future display. The south end mostly exposed midden deposit, marking the edge of the residential zone in this area. Some of the artefacts from the residential zone, both in the sections and midden, show that copper was smelted there.
