PHASE 2 ARCHAEOLOGICAL EXCAVATIONS: NORTH EAST WERF  
VALKENBERG

Prepared for  
The University of Cape Town  
February 1993

Prepared by  
Archaeology Contracts Office  
Department of Archaeology  
University of Cape Town  
Private Bag  
Rondebosch  
7700

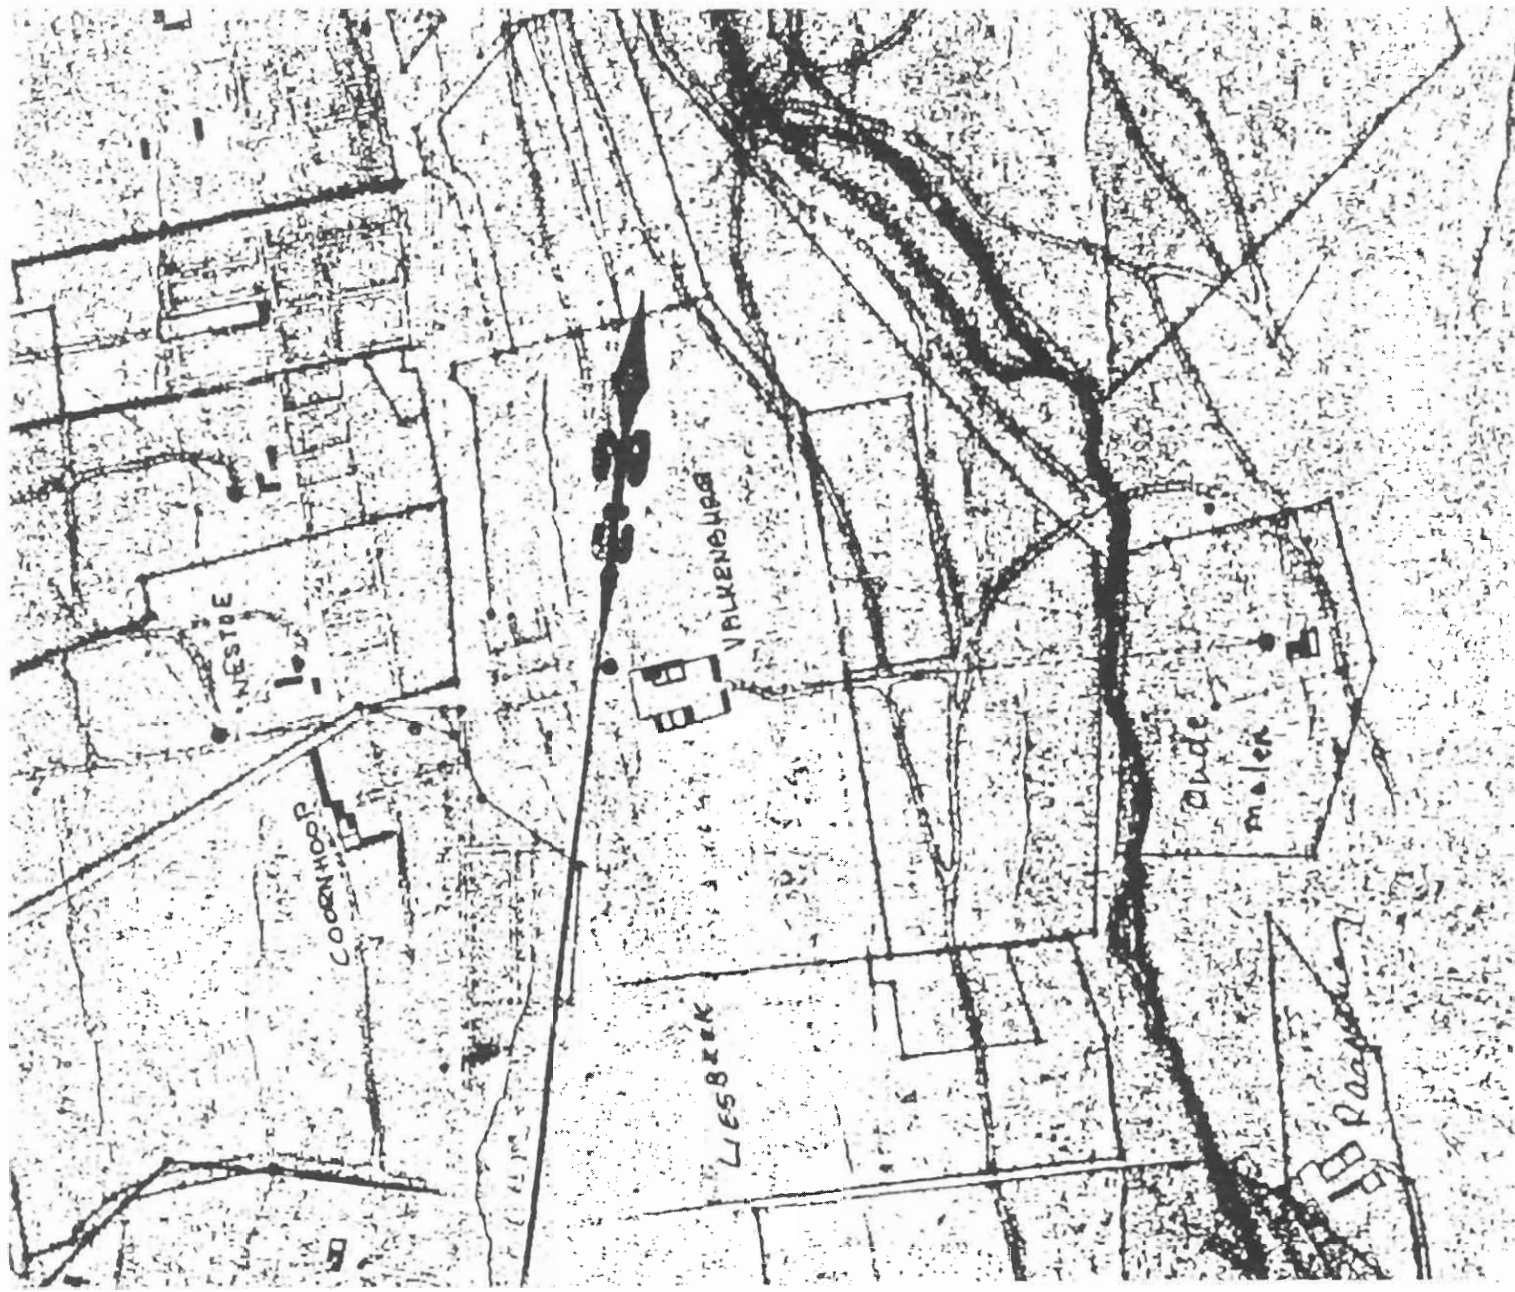
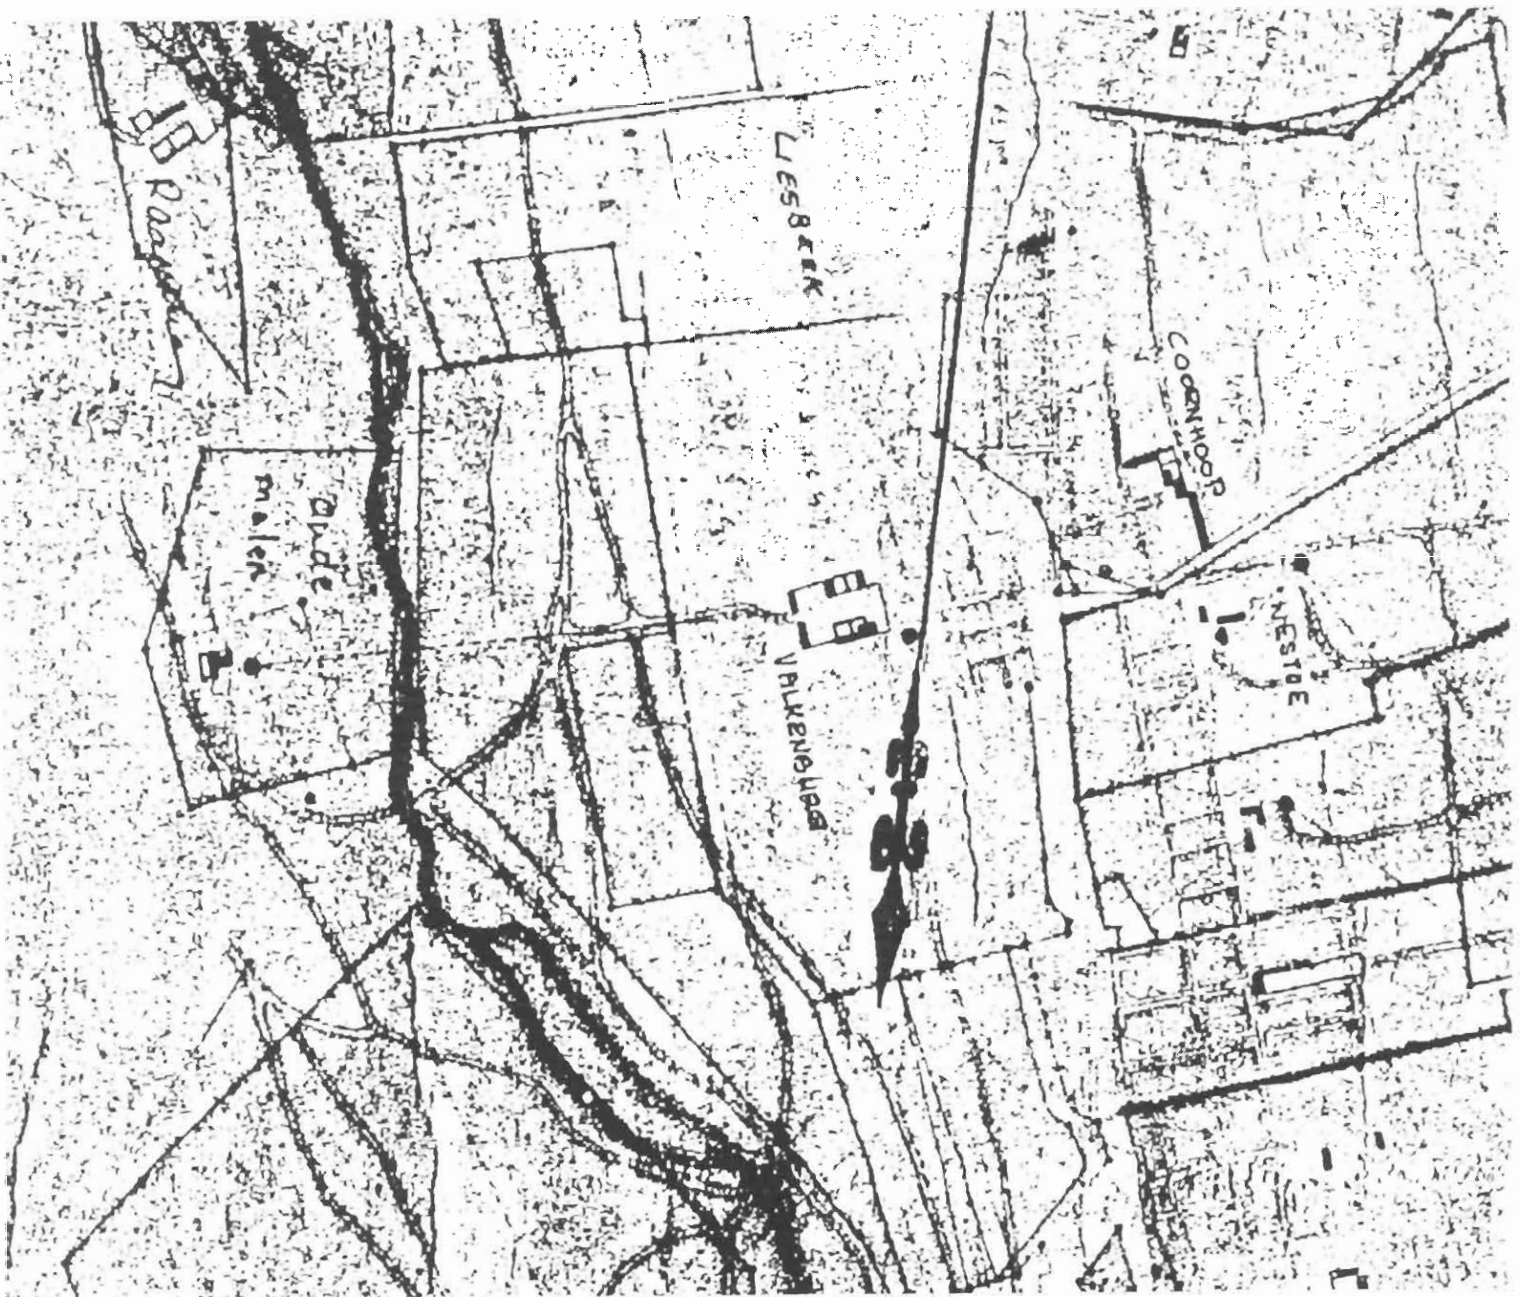
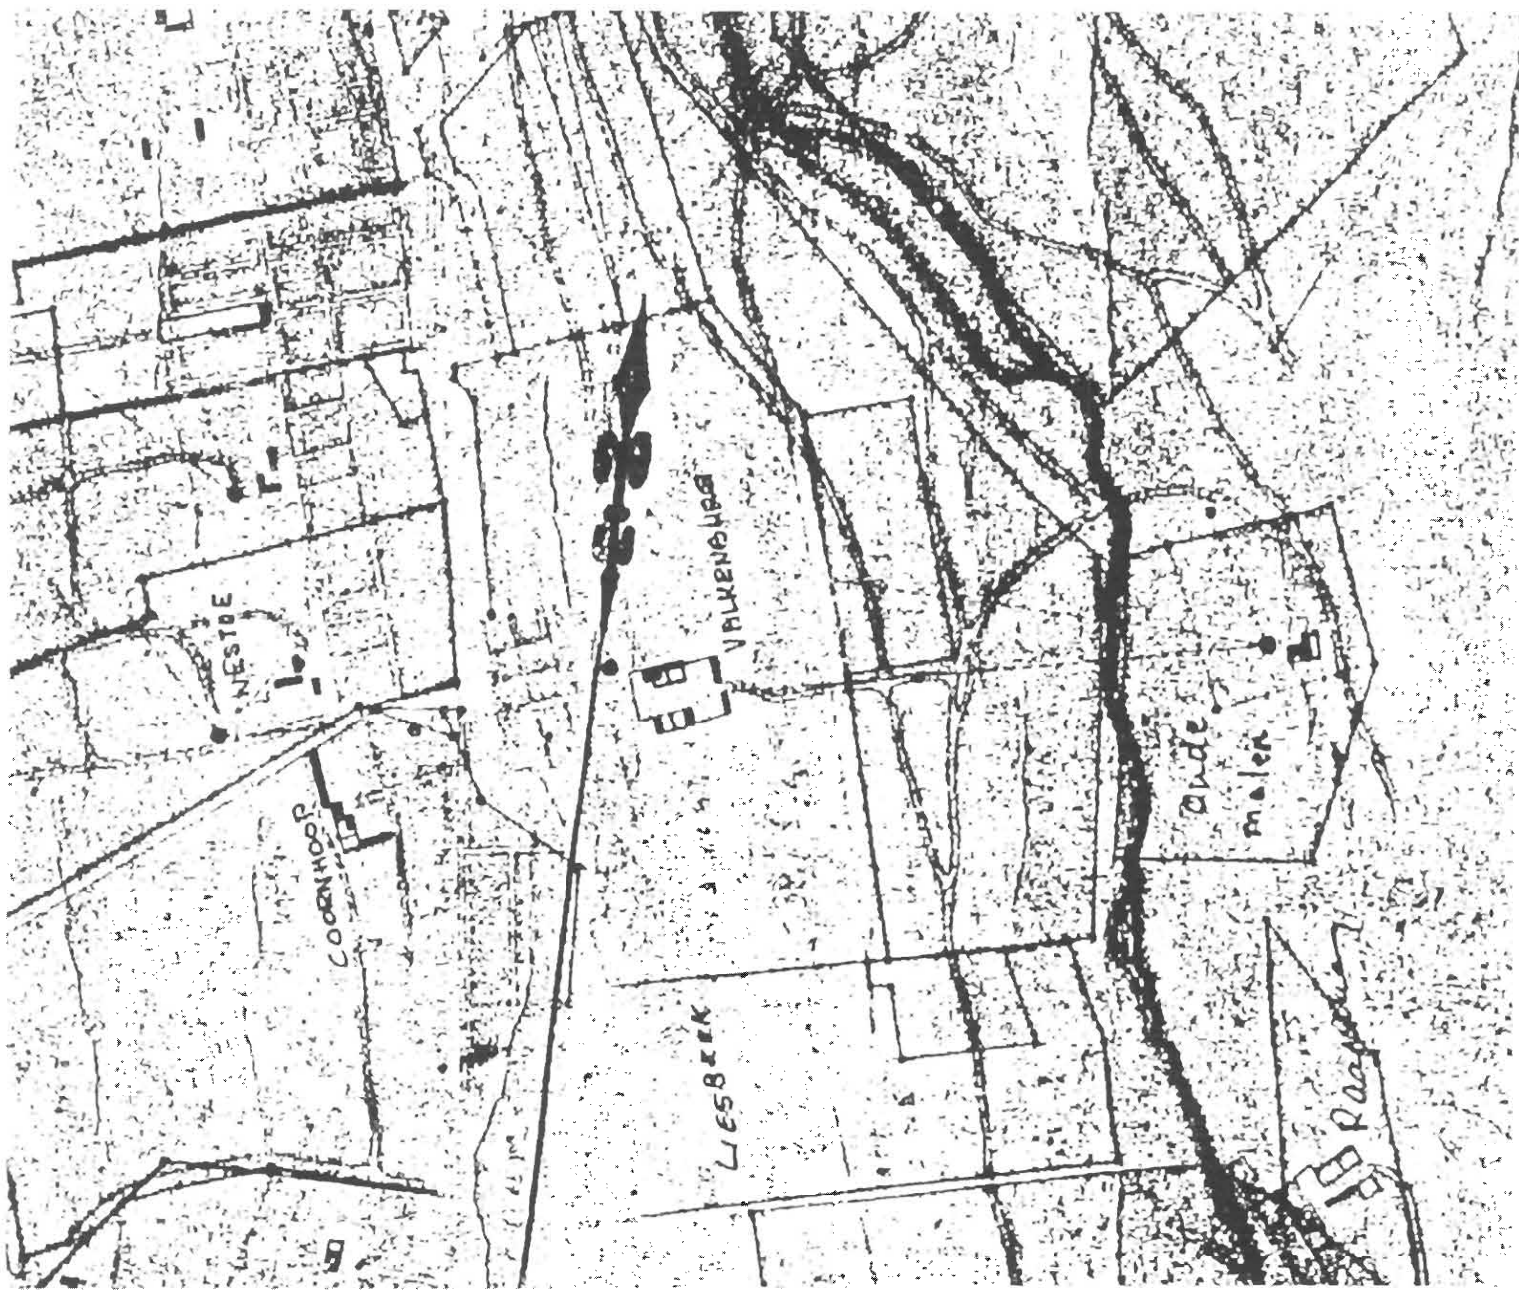
Figure 3.1

Thibault's survey of 1812<sup>7</sup> (Figure 3.1) shows the Valkenberg *werf* together with the *werf* wall and a number of structures. The buildings now known as the barn and Wild Fig were in existence as was a long building along the northern perimeter of the *werf* adjoining the rear of the homestead. A building (now demolished) orientated on a north south axis existed in roughly the position of the Stellenbosch Farmers Winery building. A further building was situated along the south side of the east gate in an analogous position to the barn. The *werf* wall encompassed the complex with access to the *werf* being via the eastern gate (a portion of which still exists) and the existing north west and west entrances. Figure 3.2 depicts the *werf* in the latter half of the 19th century before the building of the hospital.<sup>8</sup> Additions have been made to the homestead and an elongated structure has been erected across the northern half of the barn.
