HERITAGE SURVEY OF THE PORT DURNFORD STATE FOREST

For: Exxaro (Pty) Ltd

Date: 29 November 2007

**Historical and Architectural Impact Assessment Report for the
Port Durnford State Forest, Umhlatuze, Uthungulu District
Municipality**

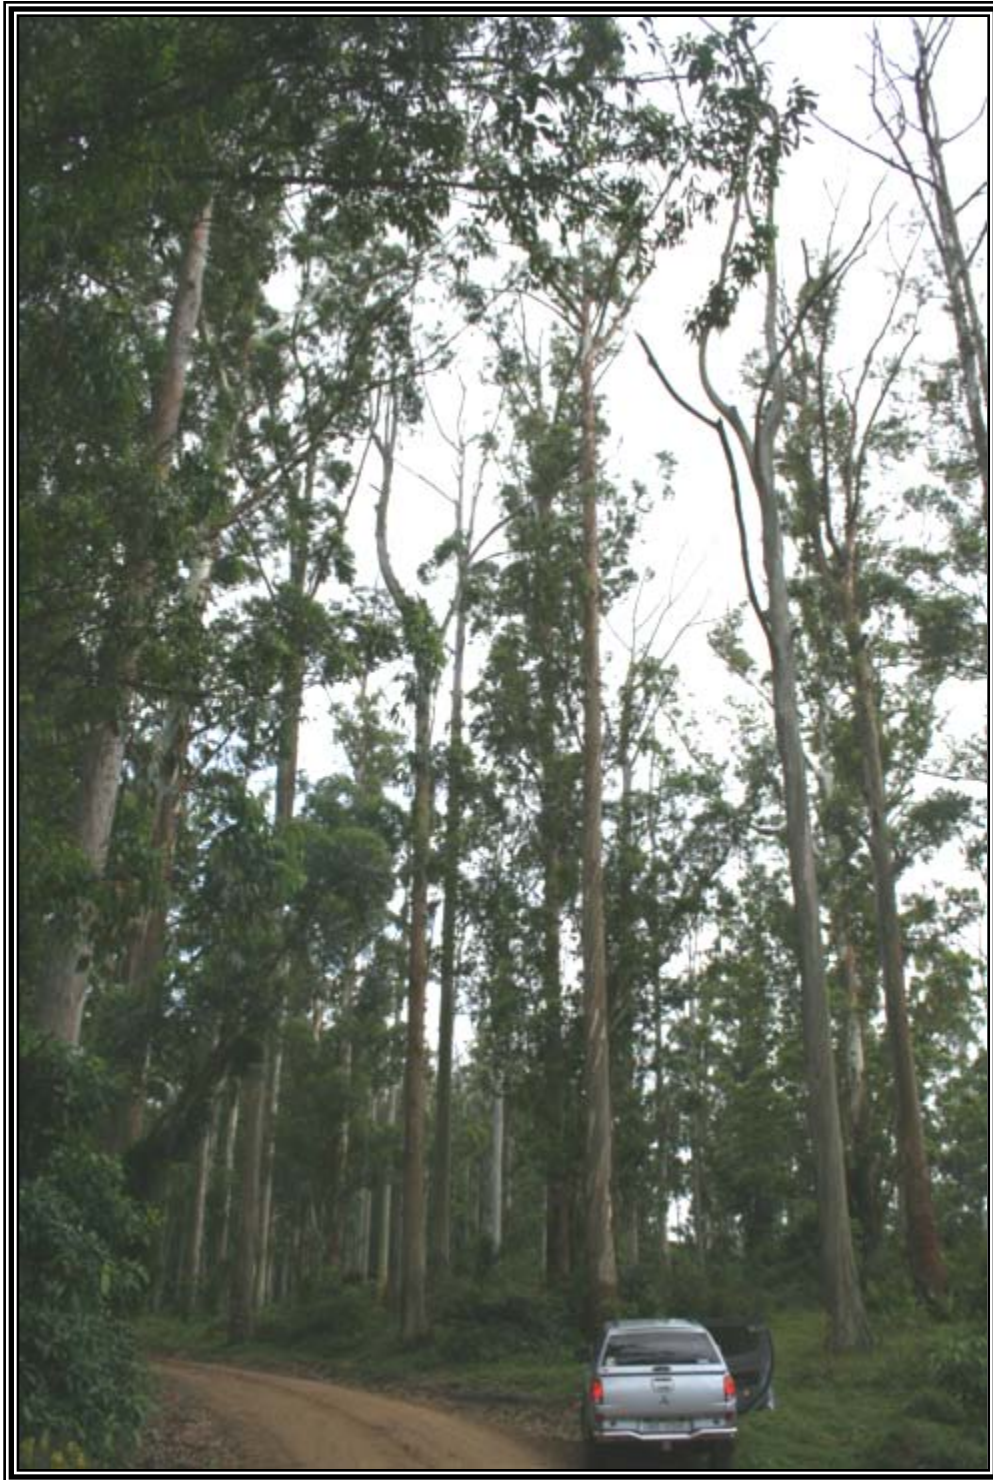
FIGURE 2: SELECTION OF BLUE GUMS AT PD15

PD15 Site is the location of blue gum trees planted in the early 1920s. Some of these are ~60m tall (fig. 2). These trees form part of the history of early afforestation and are a legacy to these foresters.

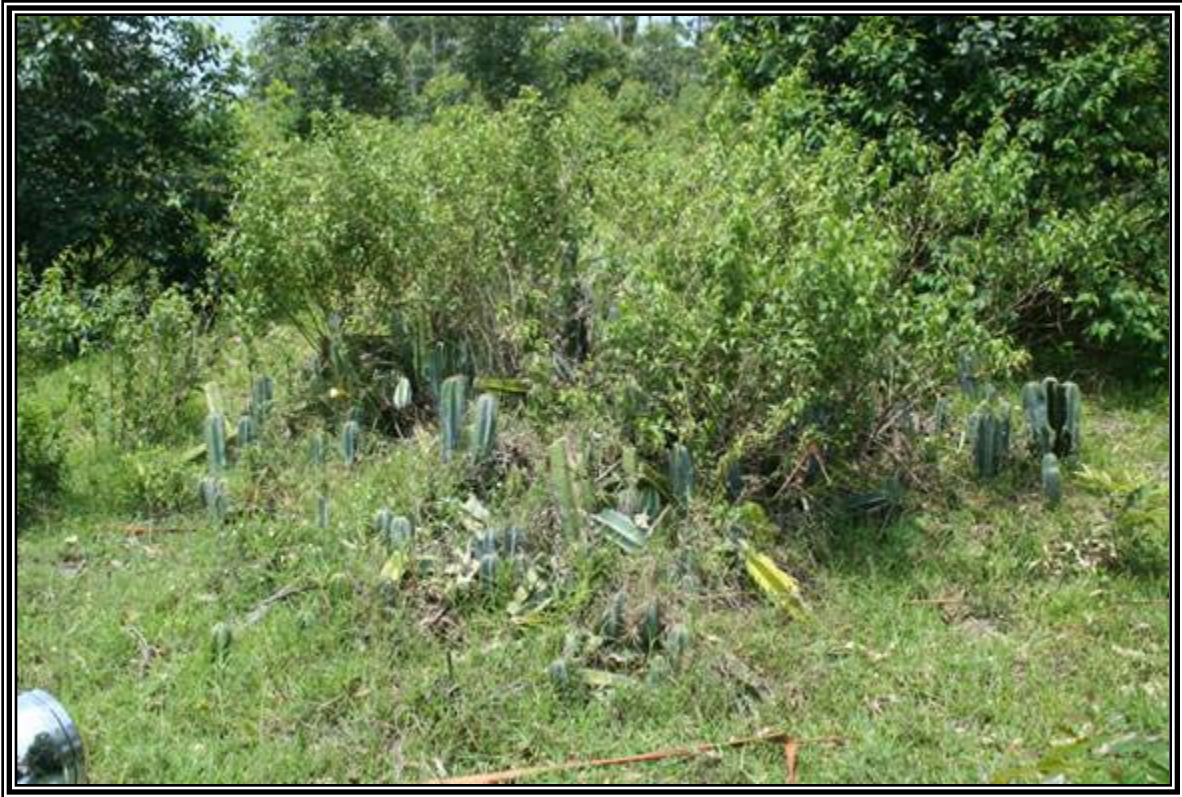
FIGURE 3: EUPHORBIAS AND POSSIBLE FEATURE AT PD18

PD18 is a small area of *Euphorbia spp.*, that appears to be a grave (fig. 3). There are no definite signs etc. around it, however, it stands out as being different. This may be a natural phenomenon.

Required mitigation: if it is a grave then the human remains will need to be removed. Consultation with the community would need to occur.

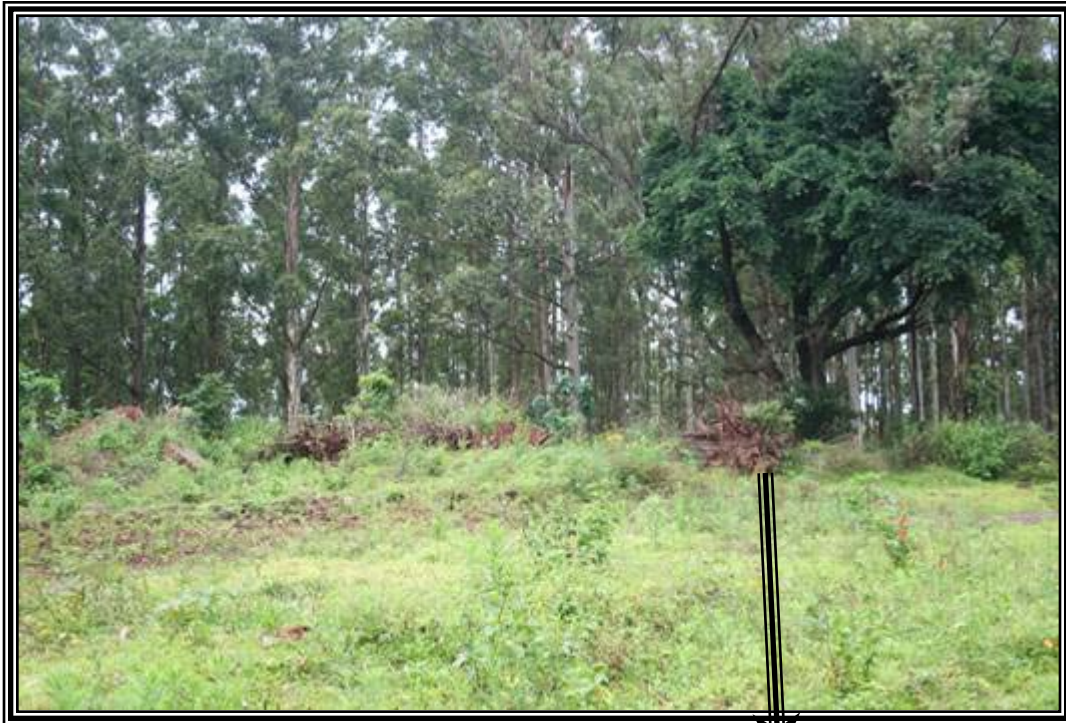
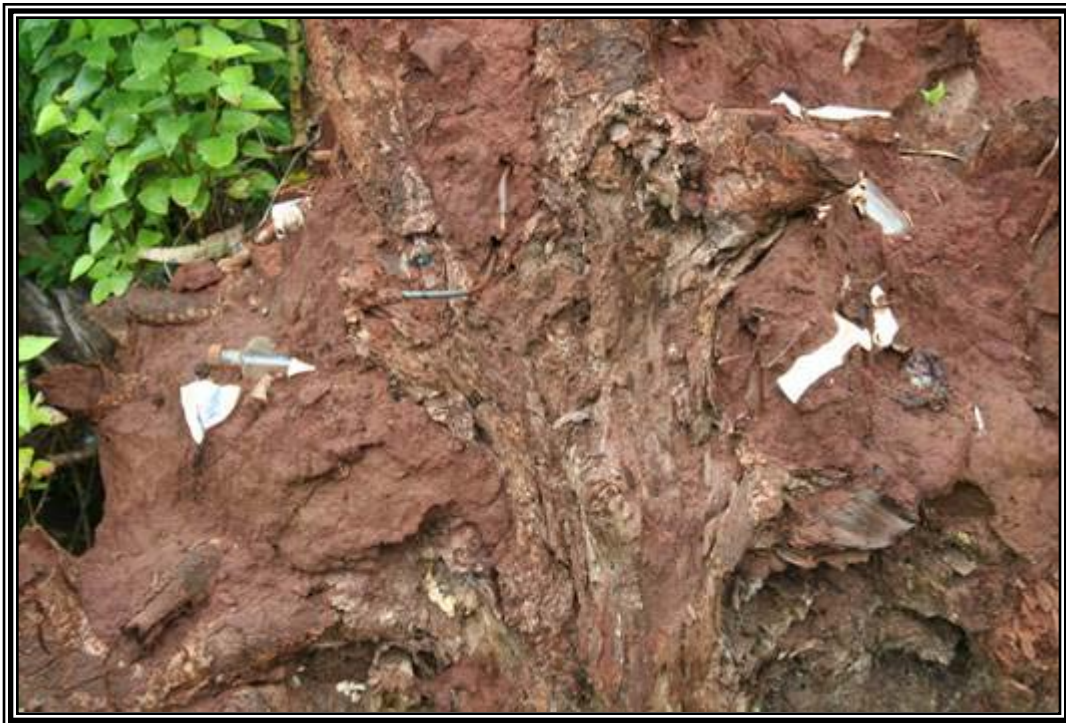
FIGURE 4: RUINS AT PD20 AND ARTEFACTS IN THE GROUND

PD20 is part of the area of the forester's encampment from 1920s. There are some old bottles, plates, etc. on the surface and underneath the ground (fig. 4). The house has been recently bulldozed however the foundations and rubbish dump still remain. The bricks are Coronation bricks.

Required mitigation: Whilst the building has been destroyed, the foundations and rubbish dump may be in tact. These foundations should be mapped and the rubbish dump should be partially excavated or sampled.

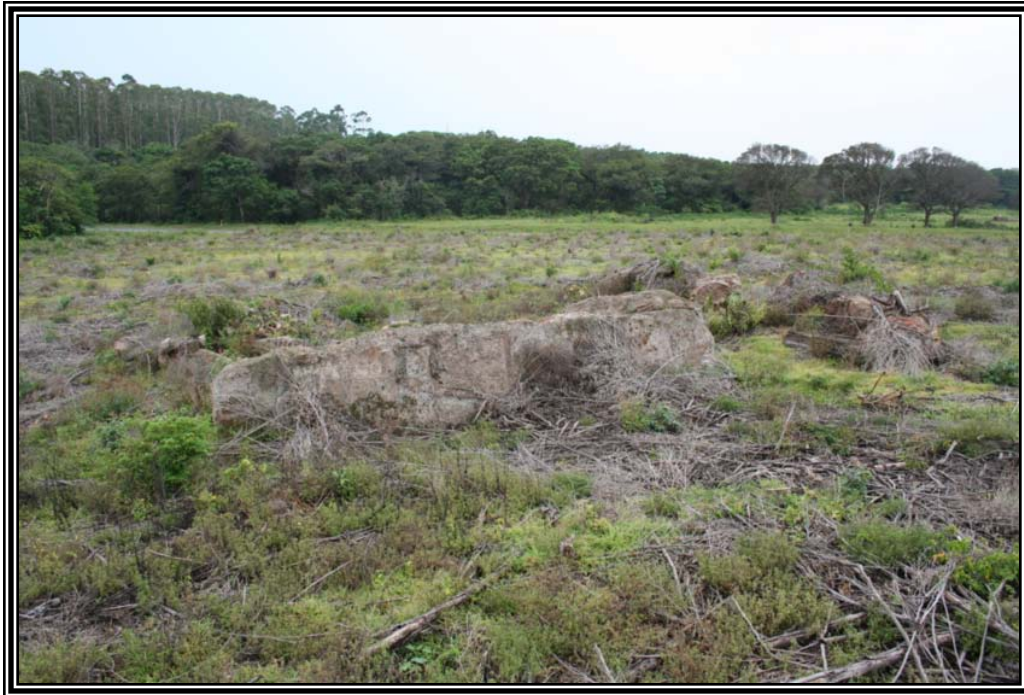
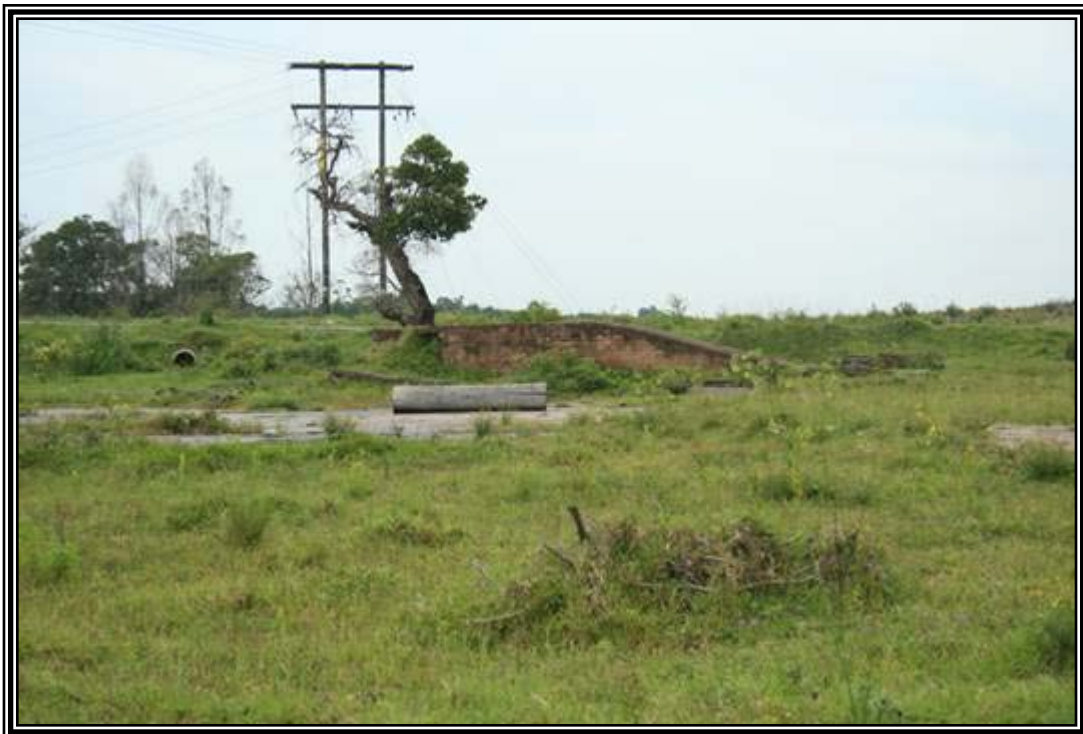
FIGURE 5: PD22a AND PD22b – OLD SAW MILL

PD22a-b is in the area of the sawmill (fig. 5). The original sawmill occurred in the general area as early as 1915. It has relocated since then, and the current sawmill (ruins) are the remains of the last sawmill, dating to the 1950s. There are some old oak trees on the border of the saw mill area. See Appendix A for further historical details.

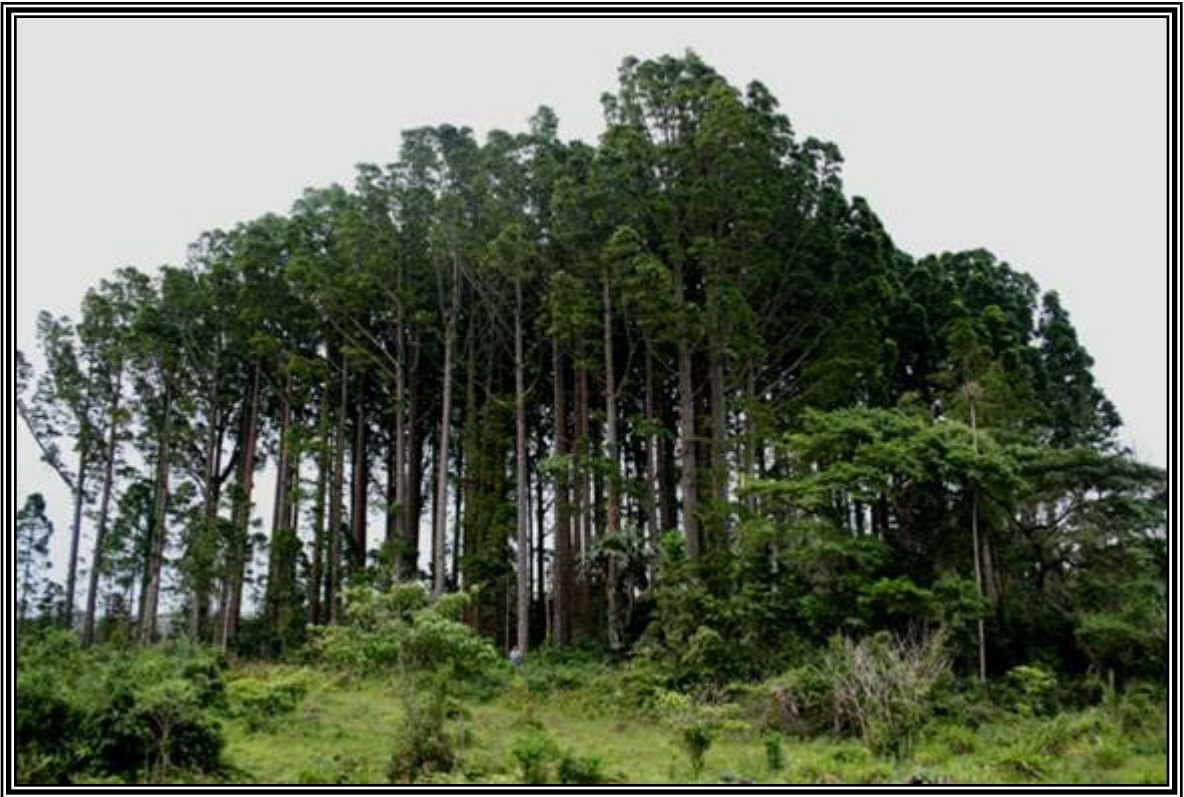
FIGURE 6: KAURI PINES (*Agathis robusta*) AT PD24

PD24 is a small plantation of Kauri Pine (*Agathis robusta*), presumably from the 1920s (fig. 6). Some of these are ~60m tall. These trees form part of the history of early afforestation and are a legacy to these foresters.

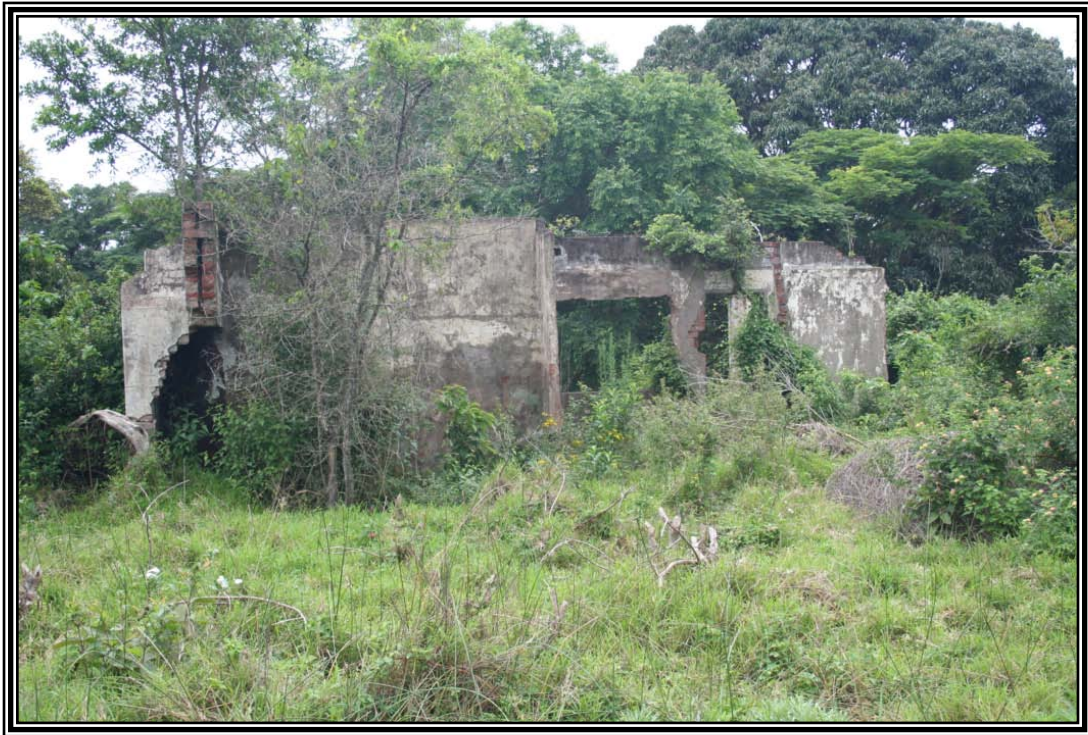
FIGURE 7: RUINS OF HOUSE AT PD27

PD27 is an old (bricked) homestead in the indigenous forest. Most of the buildings have been damaged; however some walling still remains (fig. 7). The houses appear to have been occupied up to recent times. The remains of a garden, water tanks, and other features still occur and these are probably recent.

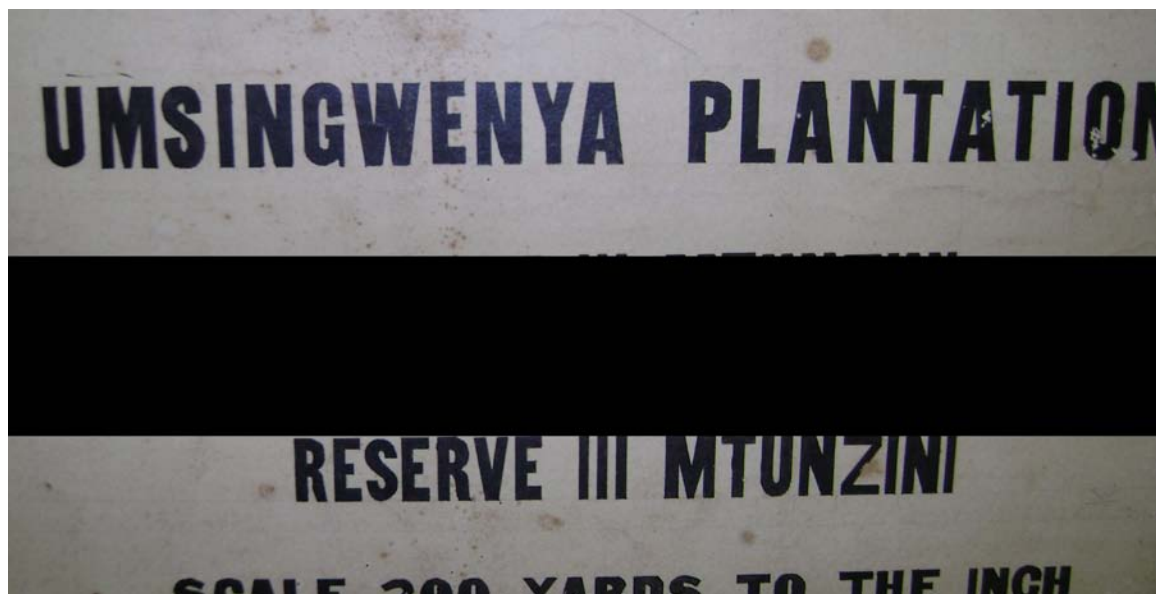
Fig 1: Map from 1930 showing site

Certainly, the forests around that which forms Port Durnford, Ungoye and Mzingwenya form part of a combined history. From the extract from the 1930 map below, the Ungoye Norwegian Mission (1882) is evident. This is corroborated in the later document discussing this. (CNC /1731914/898 Norwegian mission station on Port Durnford forest reserve.) Archival evidence also points to the lengthy process that established it as a railway sleeper reserve in 1911. (SGO/III/1/304/SG2311/1911)

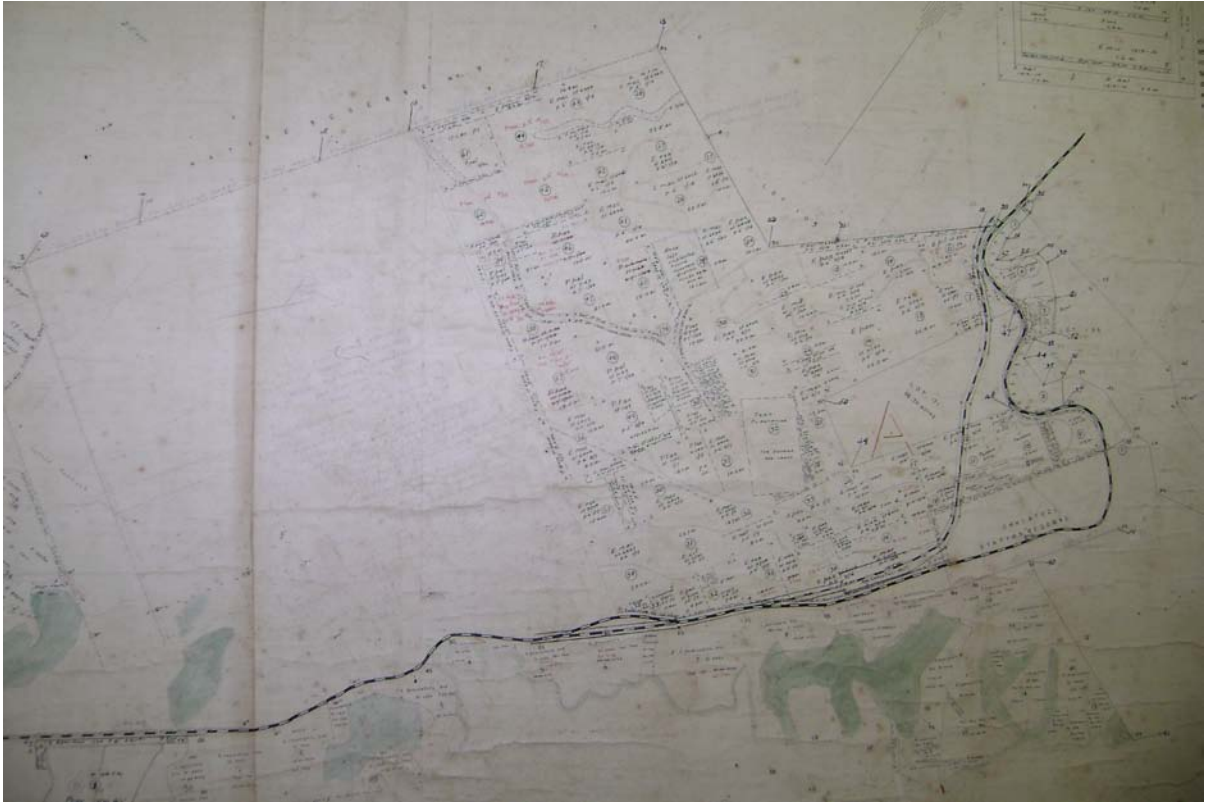
Fig 2: Northern end of Port Durnford Forest Reserve, showing planting beds and railway line

Much experimentation took place at Port Durnford, and the maps on Fig 2 and 3 bear testament to the manner in which this was handled.

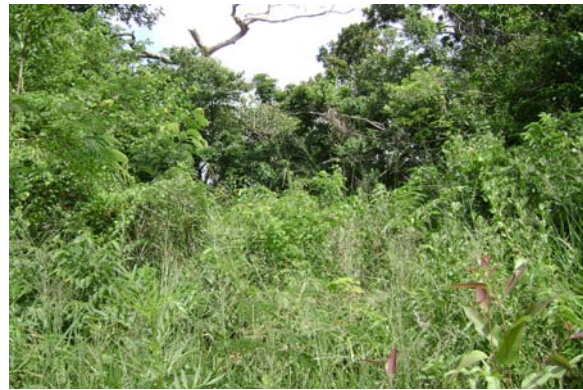
This is the first of the sites which has been demolished and bulldozed, and is really only evident from the uneven ground covering foundations, and the established trees. It appears as an early site from two pieces of evidence: the map above compiled in 1934, shows the forester's house in between the rail reserve and the adjoining Lot 171. In addition, Marwick notes in his volume, *KwaMahlathi*, that Forester F Noffke took up residence in Block A (this site) in 1915. However, what the material condition of this building was is uncertain, particularly as Marwick talks of the early foresters living in wattle and daub huts. "This officer eventually took up residence at Block A on 1 September 1915.'(Marwick:1984:42) The 1937 Aerial photographs shows an indistinct but substantial building at this spot, and also a collection of buildings at the position on Fig A which shows the Umhlatuze Station. In addition, there exists a potential site which would also have been demolished, as seen on Fig 7.

Fig 4: Showing site

Fig 5: Showing site and vegetation

Fig 6: Showing site overgrown with grass

Condition of site: ruin

Recommendations: since this seems to be the oldest habitation site, the presence of an archaeologist during site clearing is recommended.

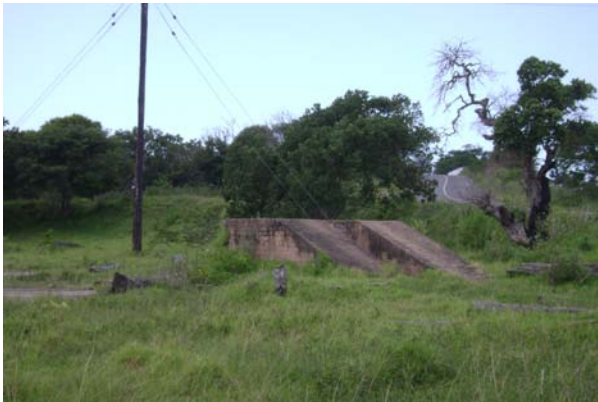
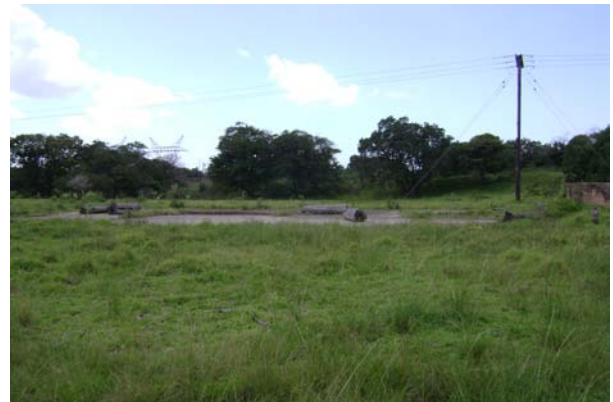
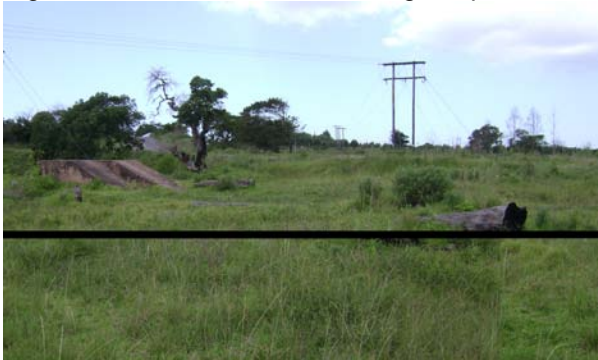
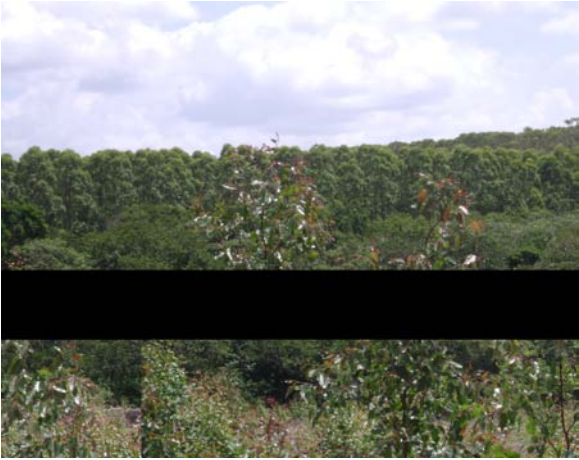
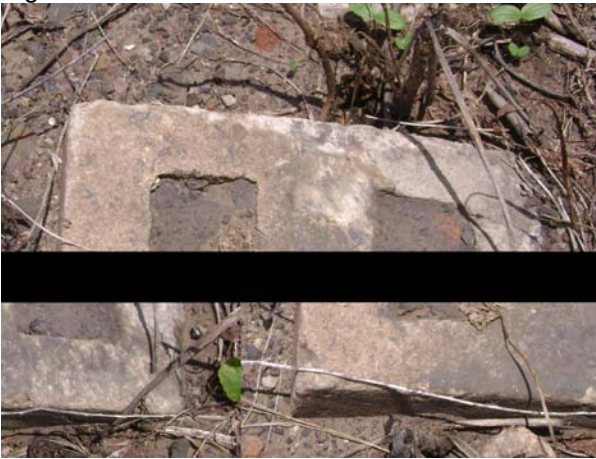
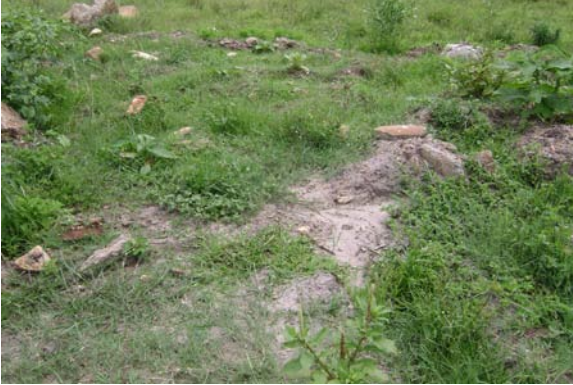
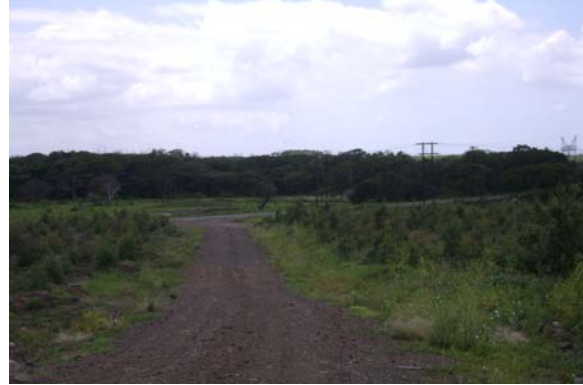
Fig 13: remnant of sawmill- loading ramps

Fig 14: concrete platform and ramp (right)

Fig 15: looking towards elevated road level

Fig 16: new trees over rubble

Fig 17: concrete block

Fig 18: debris on site

Fig 19: view back towards site of sawmill

Condition of site: ruin except for loading ramps

Recommendation: none and demolition of the loading ramps is recommended

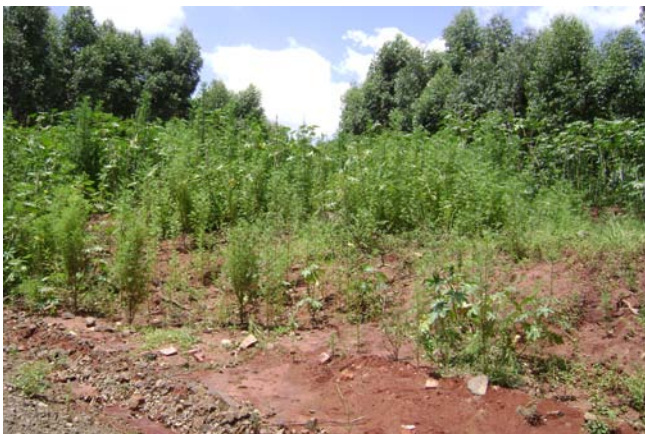
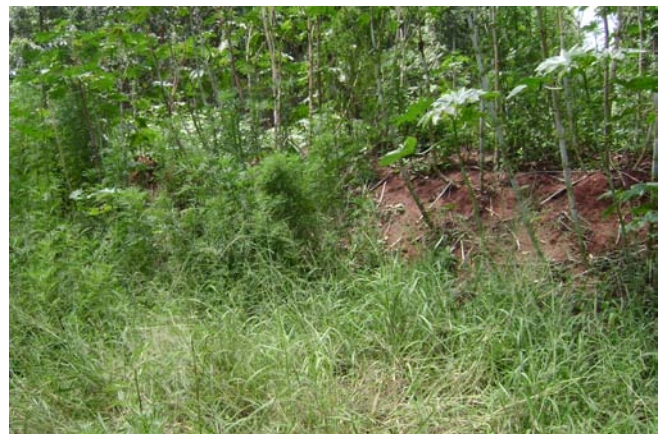
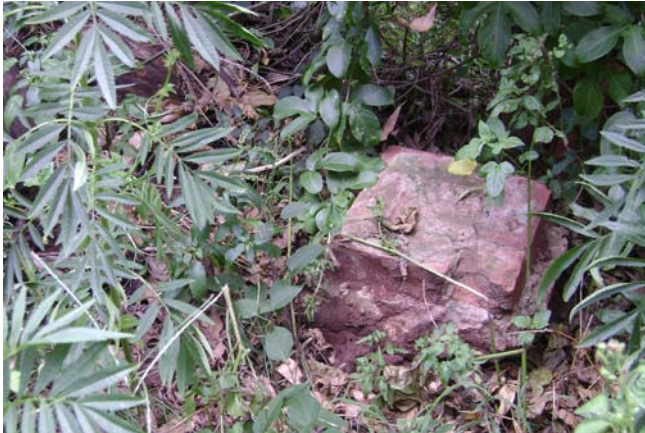
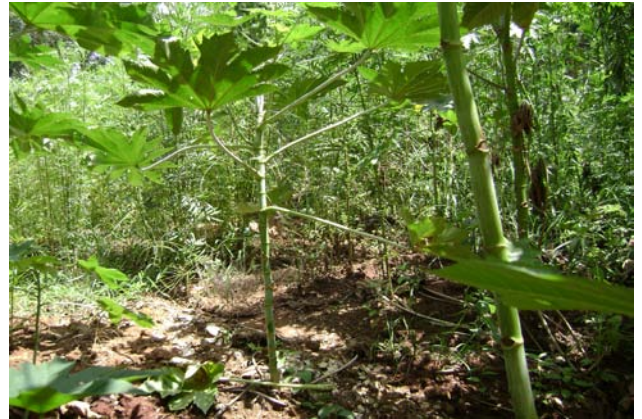
Fig 21: site of demolished house

Fig 23: remnant of pillar in undergrowth

Fig 24: edge of foundation below soil

Condition of site: overgrown ruin

Recommendation: none

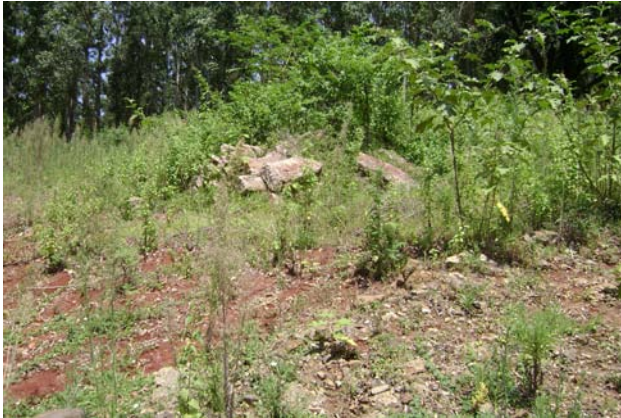
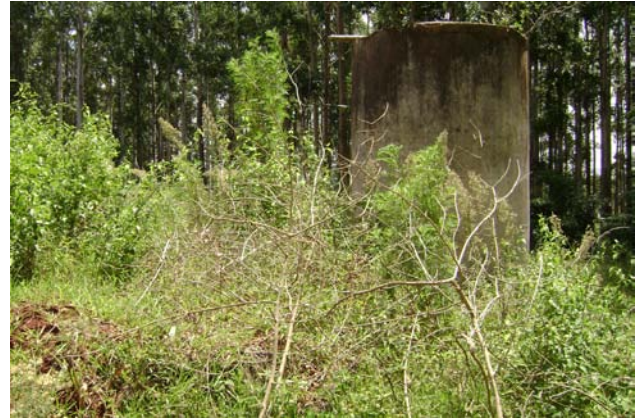
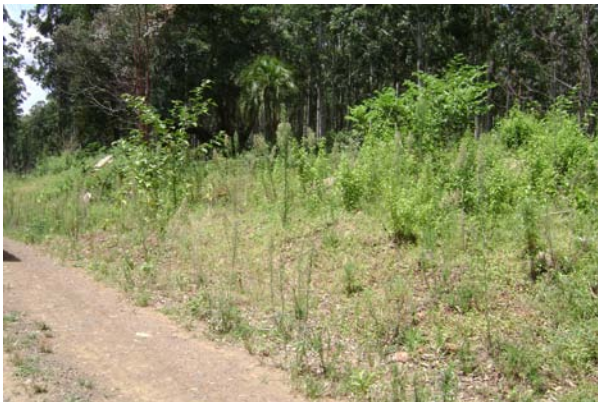
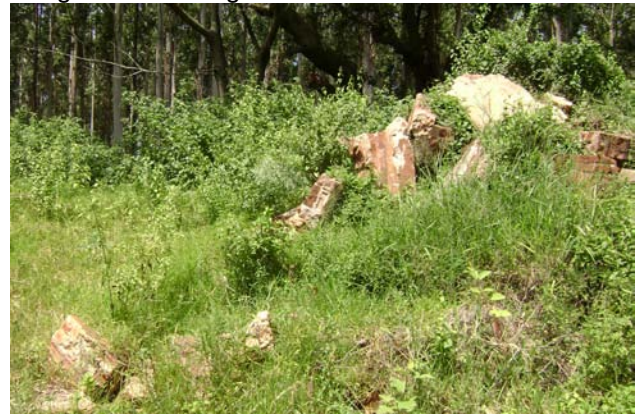
This site is identified as a Forester's encampment on the maps in Fig 2 and 3. Extensive bits of brick walling exist on the surface which has been extensively bulldozed. A water tower still stands.

Fig 26: bulldozed foundations with rubble on top

Fig 27: remaining water tower

Fig 29: close up of foundation rubble

Condition of site: overgrown ruin

Recommendation: none

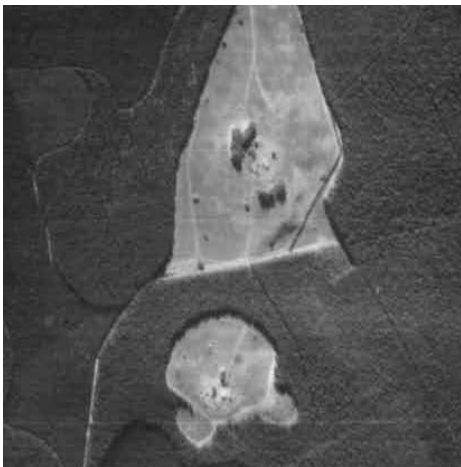
The aerial photo to the left (fig 30) shows site PD 19 below and the structure on PD 20 above.

The structures that were demolished and bulldozed on the site date back to pre-1937 (being evident on the photo's) and should not have been demolished without a permit from either *Amafa*, or its progenitor, the National Monuments Council.

Fig 30: showing site PD 20

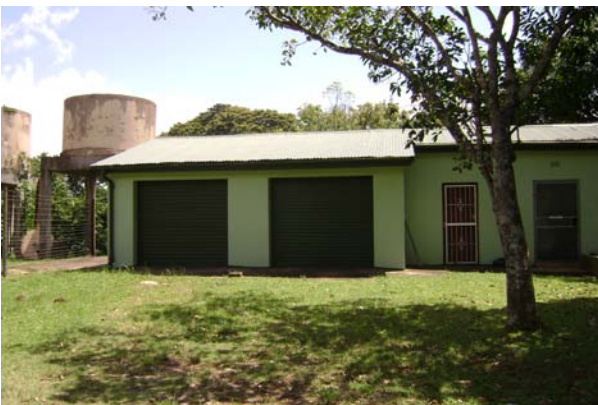
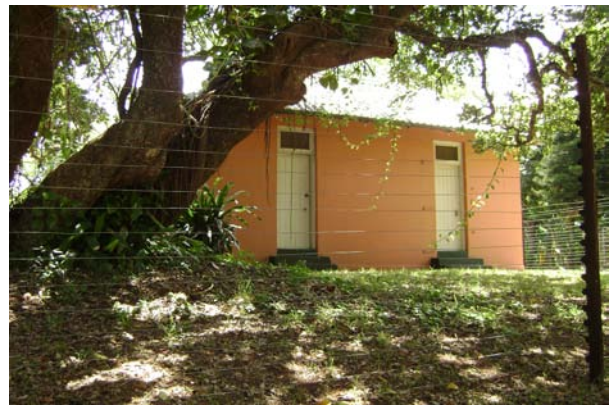
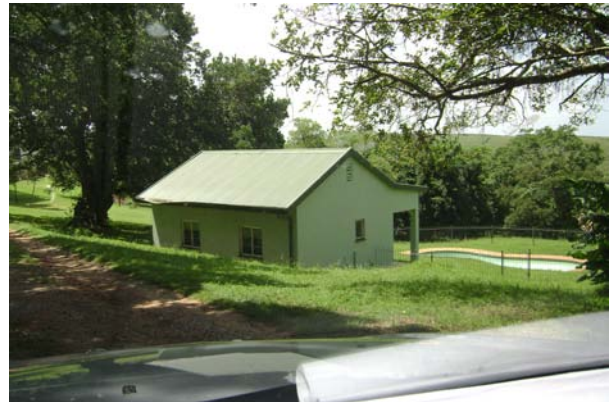
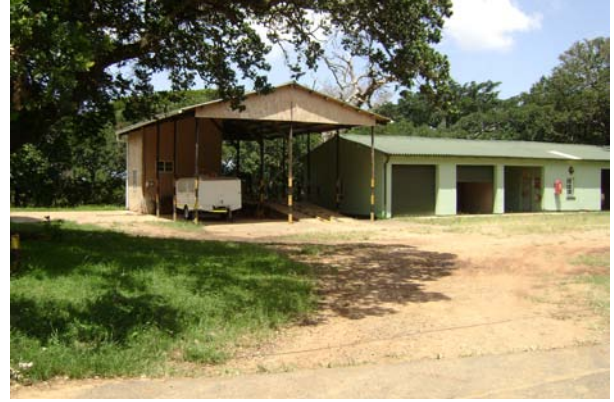
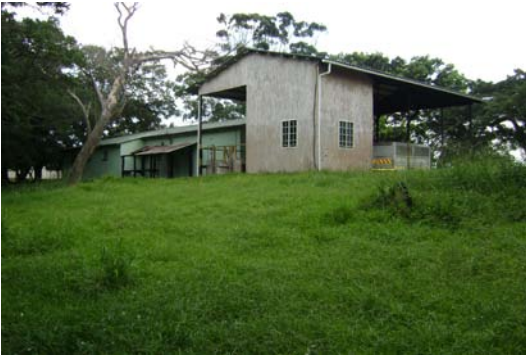
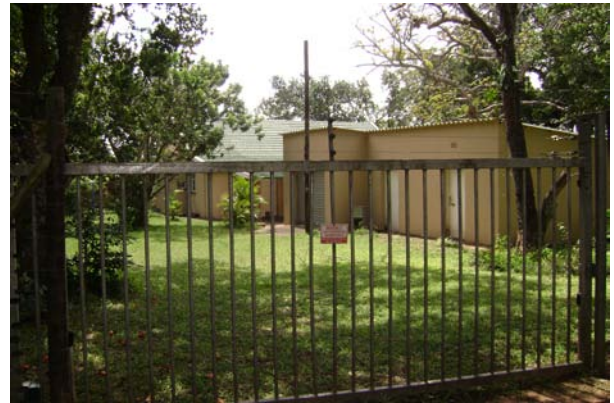
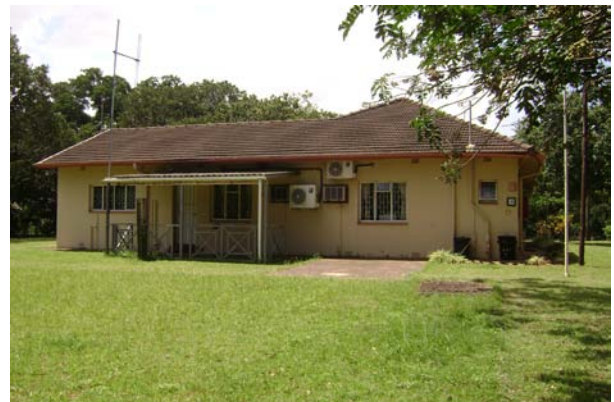
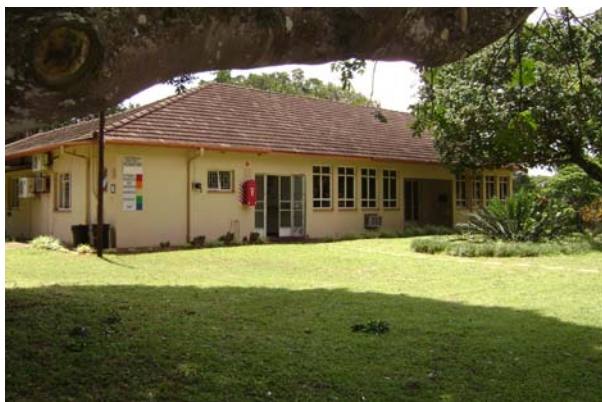
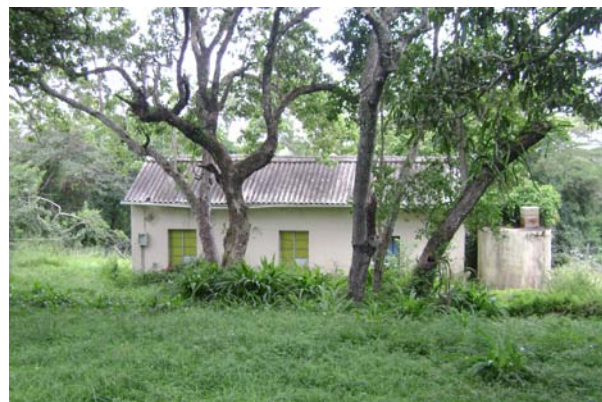
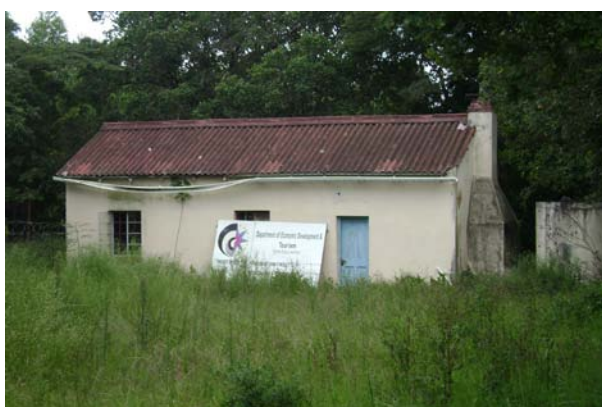
Condition of site: the buildings are generally in good order. They are architecturally not significant, although they are good examples of functional buildings. They do not operate as a group, do not form streetscape, and are not associated with any major event nor person. They are remote from Empangeni and Mtunzini and their situation limits alternative uses.

Recommendation: should demolition be requested, this group of buildings is not significant with regards to the heritage of the province of KwaZulu-Natal.

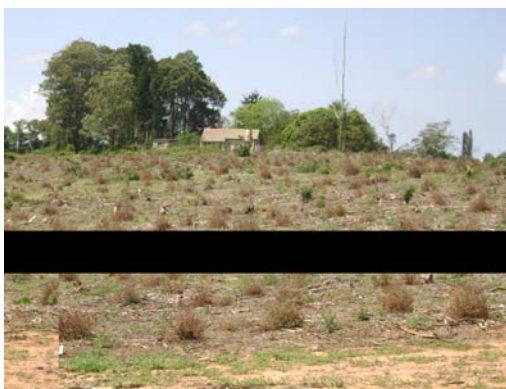
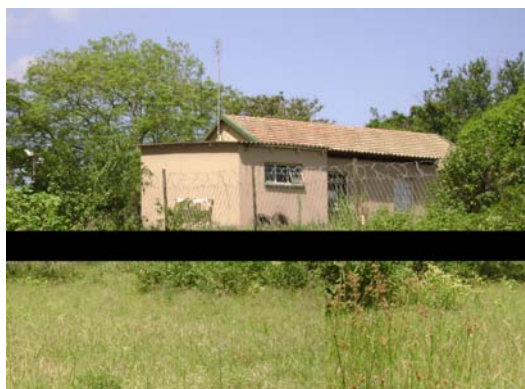
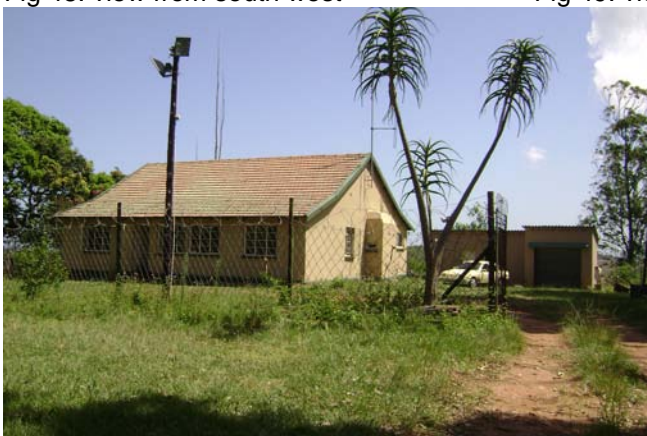
This structure was not identified in the Umlando report but does form part of the architectural impact assessment. It is of the same period as complex no 7 in the previous section, a simple tiled, saddled roof over a masonry structure. It is suspected that the building is either older than 60 years, or constructed soon after World War II.

Condition of site: the building is generally in good order. It is architecturally not significant. It does not operate as part of a group, nor does it form streetscape. It is not associated with any major event nor person.

Recommendation: should demolition be requested, this building is not deemed significant with regards to the heritage of the province of KwaZulu-Natal.

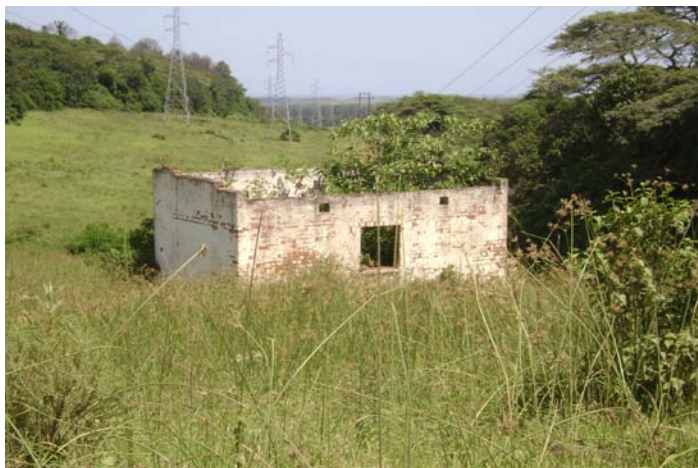
Fig 51: ruined structure

This is a partly demolished structure south of the main entrance. It was no identified as part of the archaeological impact assessment. It was built in around 1940.

Condition of site: ruin

Recommendation: should demolition be requested, this ruin is not significant with regards to the heritage of the province of KwaZulu-Natal.

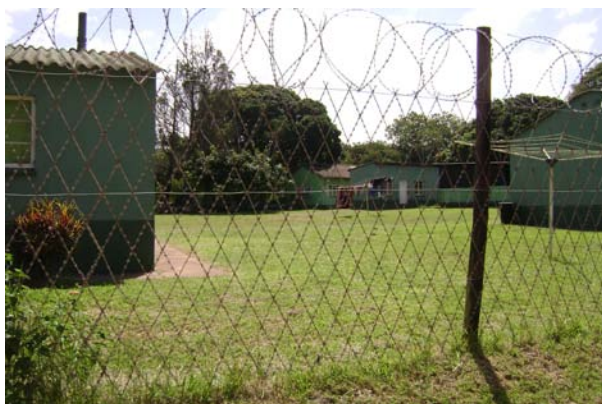
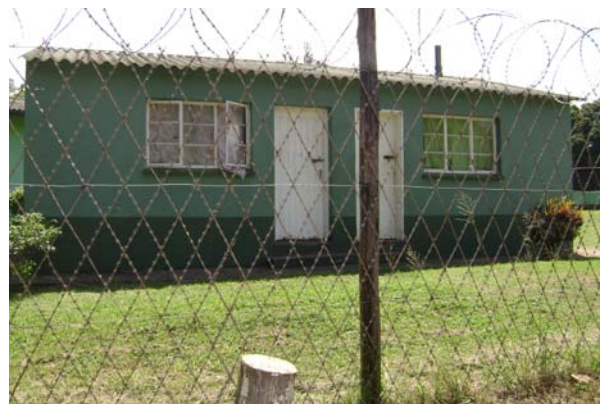
As with the previous structure, this was not identified under the archaeological impact assessment. It is a workers camp, of itinerant construction, with some of the older buildings being constructed out of asbestos sheeting. They are constructed of concrete block with steel windows.

Condition of site: the buildings are generally in good order. They are architecturally not significant, although they are good examples of functional buildings. They do operate as a group, but not as a streetscape, and are not associated with any major event nor person. They are remote from Empangeni and Mtunzini and their situation limits alternative uses. They are constructed of mixed materials, but largely concrete block and asbestos. It is suggested that they were constructed post-war.

Recommendation: should demolition be requested, this group of buildings is not significant with regards to the heritage of the province of KwaZulu-Natal.
