Phase II (follow-up) Archaeological Permit Mitigation Report
Erf 3032, 150 Buitengracht, Cape Town,

Part 2 (follow-up)
Phase II Archaeological Permit Mitigation Report
Excavation Permit No 2007-08-001
HWC Application No 2007/08/APM 001
HW Ref No C13/3/6/2/1/1/1/1/A1

ERF 3032
150 Buitengracht
CAPE TOWN

A report prepared for
Western Investment Company (PTY) Ltd

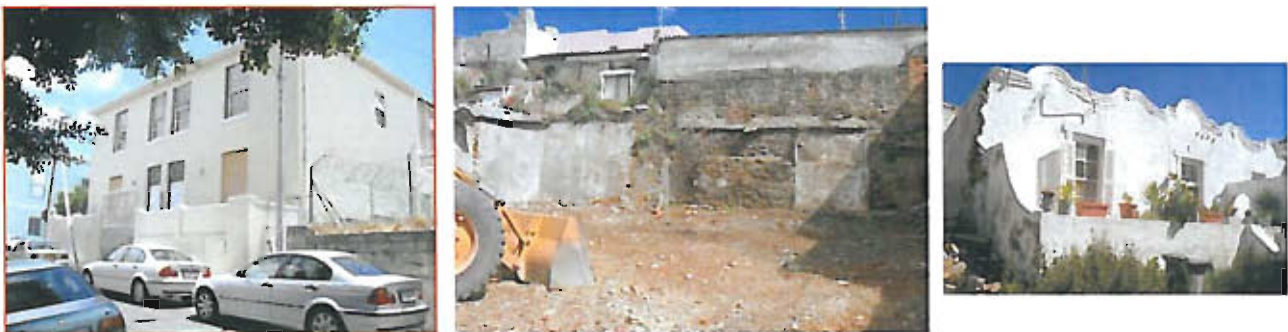
Fig. 2. Erf 3032, 150 Buitengracht, Cape Town (2008), situated between the double storey Georgian building on the left and the curvilinear flat-roofed dwelling on the right. Both are declared National Monuments.

To the left of the site a double storey Georgian building dominates the corner of Buitengracht / Leeuwenstraat. To the right a curvilinear parapet, flat-roofed house, 148 Buitengracht, is one of the oldest in town (built in the 1770s). Both have been declared National Monuments.

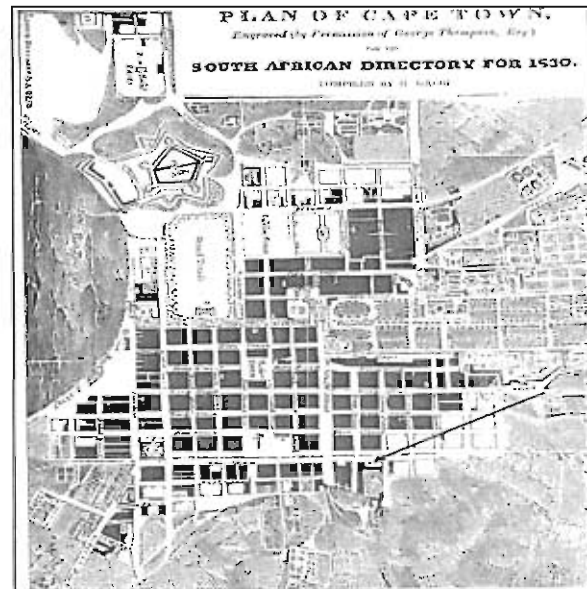
Fig. 5. Portion of the Plan of Cape Town, 1830, showing the grid layout. 150 Buitengracht located on lower part (arrow) with an open *gracht* running down the middle of the Buitengracht. The Schotsche Kloof Gardens are still extant. (Reference: South African Directory for 1830, compiled by G. Greig).

By the early 19th century Upper Dorp and Upper Leuwen Streets had come into existence. The street map of the Cape Town Almanac of 1830 shows conclusively that the site, now erf 3230, still contained only the rear building (Fig. 5).

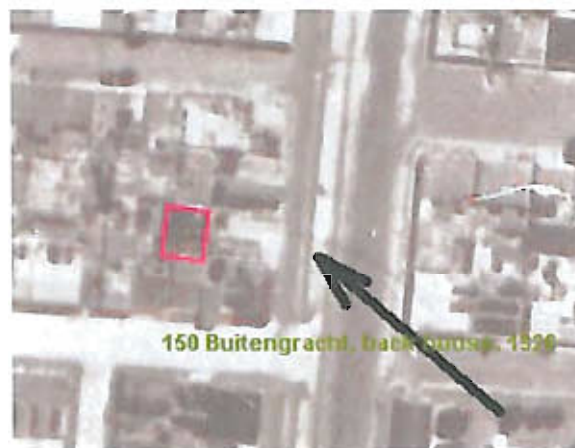
Fig. 7. Aerial photograph dated 1926. (Arrow points to No's 148 to 152 Buitengracht. (Reference: Chief Directorate of Surveys and Mapping, Mowbray, strip 5, Photo 861, date 1926).

In 1926 the first aerial photographs of Cape Town were taken (Fig. 7).

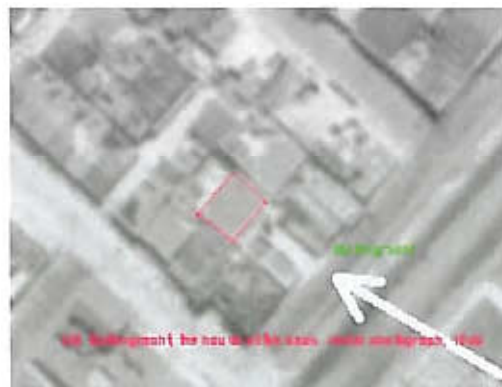
Fig. 8. Portion of an aerial photograph of Cape Town dated 1945. The arrow points to erf 3032, main gate.

The aerial photograph dated to 1945 (Fig. 8) seems to show that the dwelling 148 Buitengracht is still standing, 152 Buitengracht, however, is demolished.

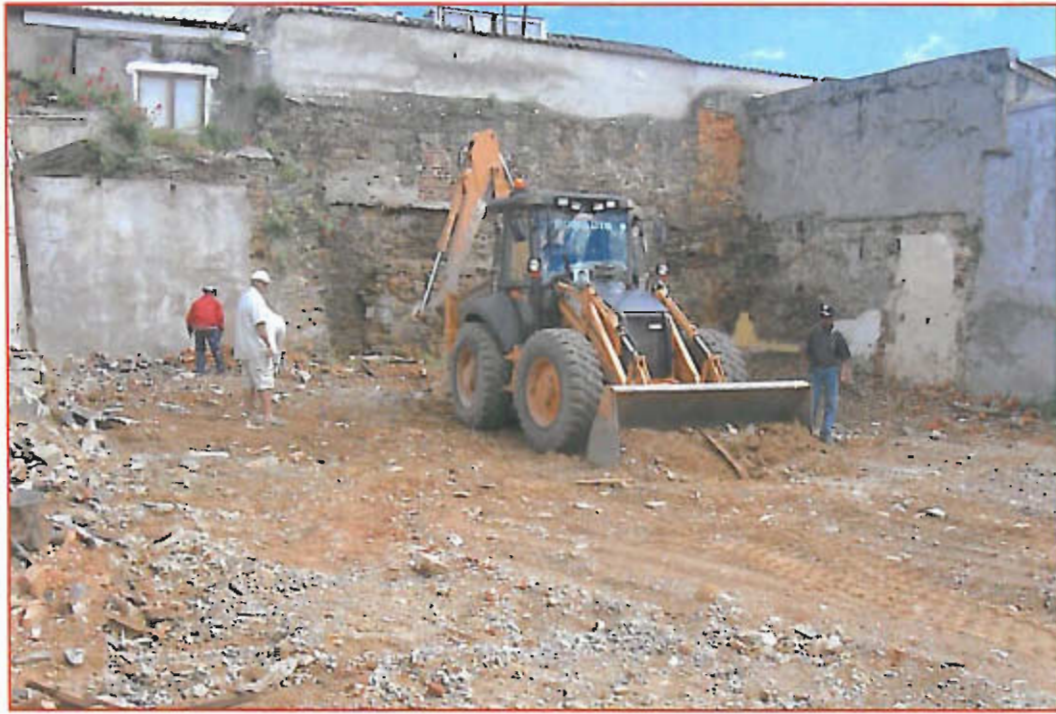
Fig. 11. The site after demolition of the car workshop and outbuildings, 2008.

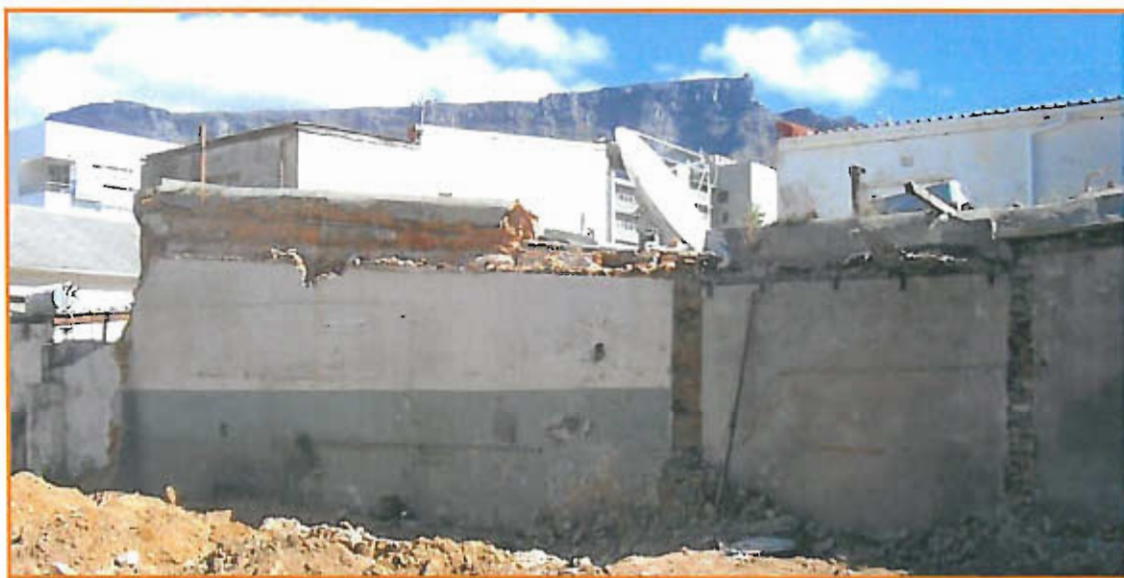
Fig. 12. The south-west side wall of the dwelling was left standing. Note the front and back wall remains abutting the wall, as well as the outline of two roof heights.

The two continuous roof lines suggest that the outer extent of the ground plan of the original dwelling was retained until demolition in 2008. The upper roof line contained a piece of corrugated iron roofing sheet, it is therefore assumed to be the later one. This is corroborated by mid-late 19th century bricks used to raise the south-west wall to accommodate the raised roof. Note the mud *dagga* (mortar) repair work.

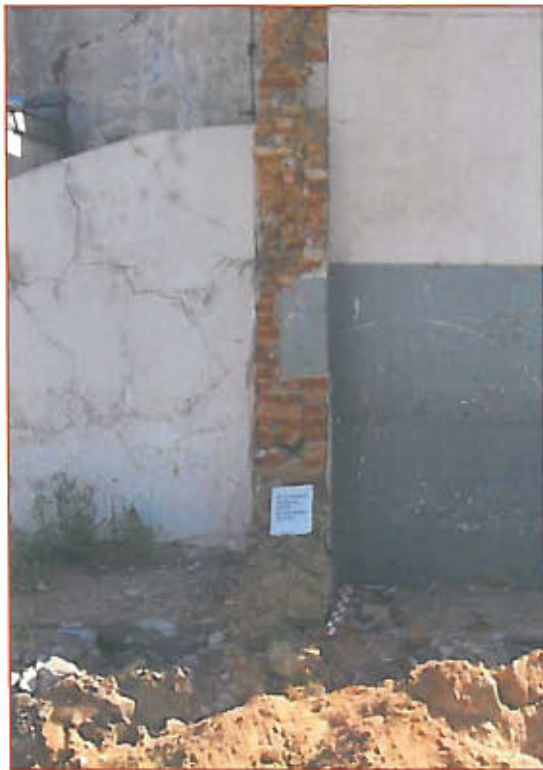
Fig. 14a. Remains of the front wall. Note the orange low fired bricks and mud / *dagga* filling (mortar).

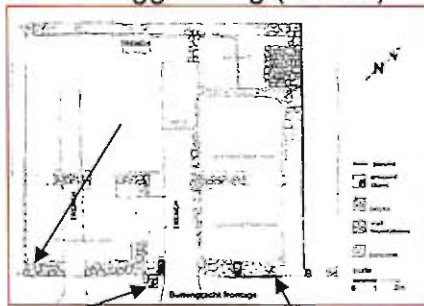
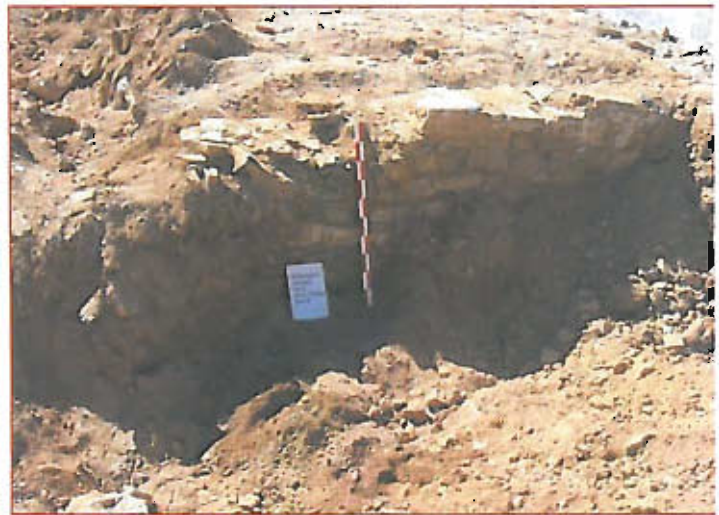
Fig. 14b. Detail of the front wall foundations at the former entrance, 2008.

below the first course of the front brick wall (Figs. 14b and 14c). Further evidence for steps leading up to the house are remains of outside plaster to the right of the assumed front door covering the wall footing to a depth of about 300 mm from the top of the wall footing (Fig. 14d). This outside plastering contained very fragmented sea shell remains pointing to a late 18th century construction (Fig. 15).

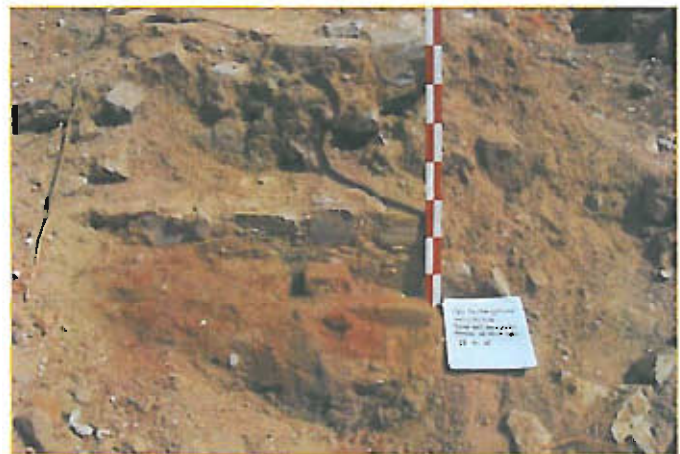
Fig. 14c. Possible remains of former entrance steps in the foreground, 2008.

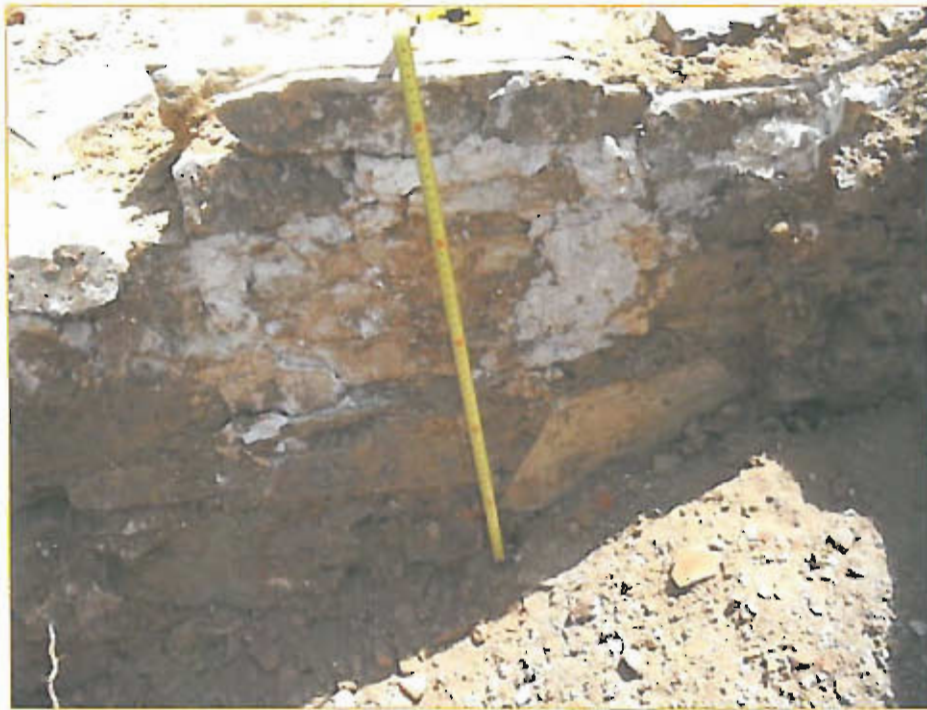
Fig. 15. Remains of plaster on the front wall foundations, covered later by a 19th century raised cement *stoep*. Bottom: the sterile gritty soil / ironstone fragments / shale layer.

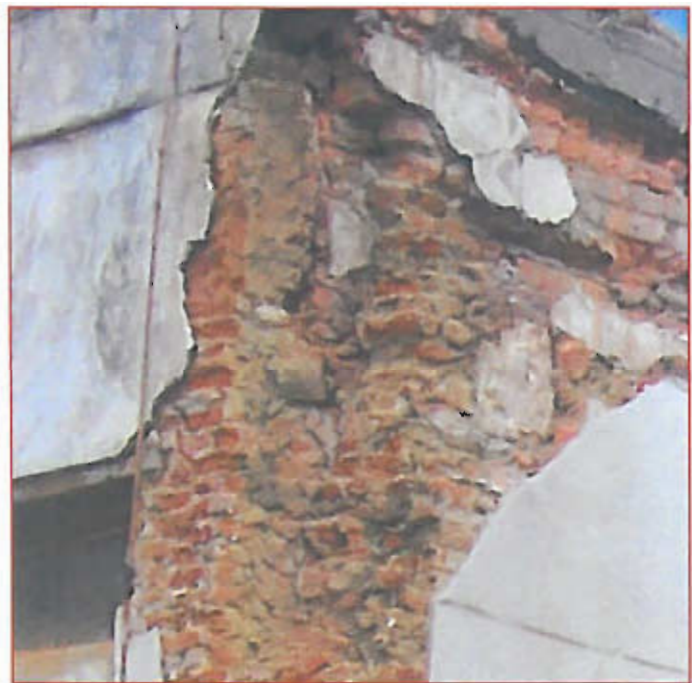
Fig. 16. Corner of front and south west wall.

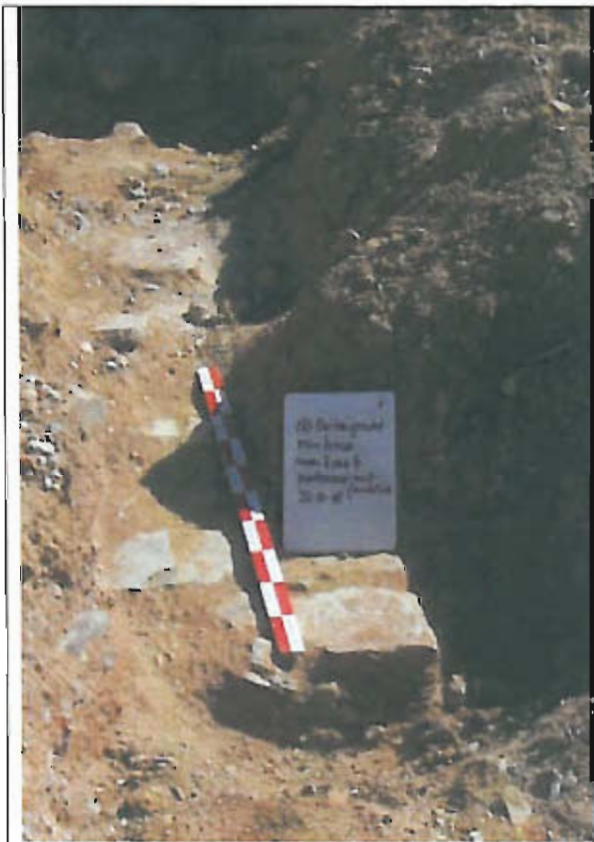
Fig. 17a. This corner of the interior wall footing occurs at the junction left hand front room and *voorkamer*.

Interior wall footings were partly exposed. It became possible to delineate three rooms to the right of the building as seen from the entrance, the fourth being the room on the left side. The second room to the right contained a cement floor, which was not uncovered due to time constraints.

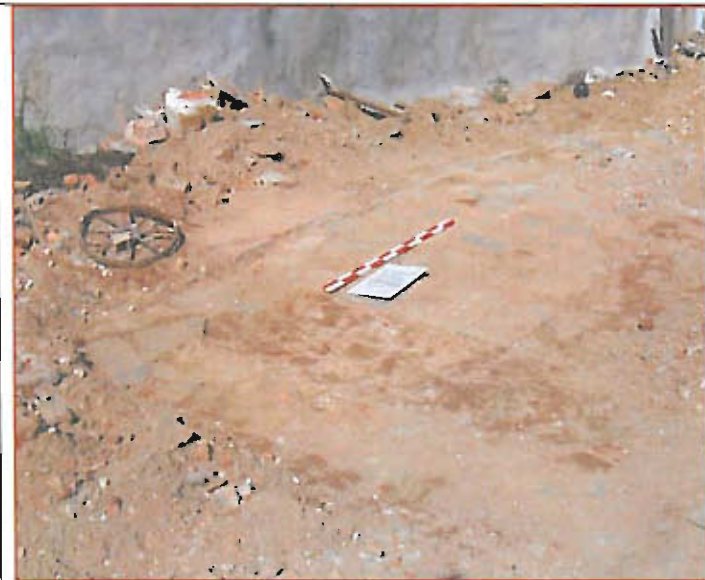
Fig. 18a. The paving in the back room / kitchen?. Carefully dressed blue/grey shale was used. The paving was surrounded by an orange brick fragmented stamped floor.

The back room contained a paved area. This was exposed and it was found that two layers, both constructed from carefully dressed shale (or "bluestone") existed. Several artifact fragments were found *in situ*.

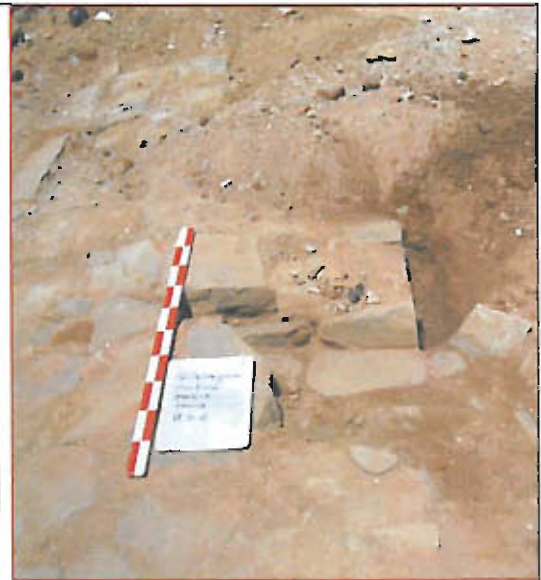
Fig. 18b. Detail of the bluestone paving. The artefacts were collected between the first and second paving layer.

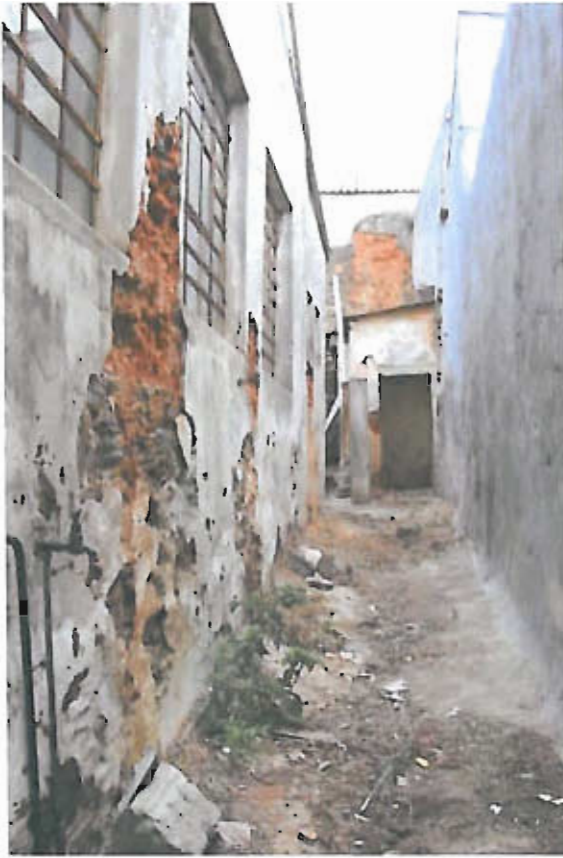
On this pre-demolition photograph it is clearly seen that the side brick wall above the footings are of late 18th century low-fired orange bricks, with mud and shell lime mortar, as well as outside plastering. The window frames are obviously mid 20th century.

Fig. 19. The historic passage to the back yard at the right hand side of the former workshop. At the back the window of the room with the bluestone paving. To the right the wall of the dwelling 148 Buitengracht, dating from about 1770.

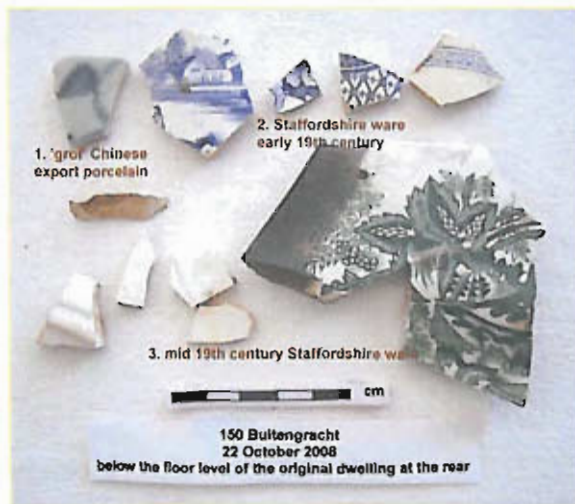
Fig. 20a.

1. 'Grof' Chinese export porcelain, probably kitchen ware. 19th century.
 2. British import. Refined earthenware, creamware, blue underglaze transfer printed, mass produced, Staffordshire ware, first quarter of 19th century. Tableware.
 3. Mid 19th century Staffordshire ware. Green underglaze printed large platter fragments.

Fig. 20. Artefacts from below the floor of the original dwelling. Note: only about half the area was excavated.

One assemblage comes from below the floor of the original house (see Fig. 20a-d), and – in a separate bag – another from between the two layers of paving in the right hand back room / kitchen (Fig. 21).

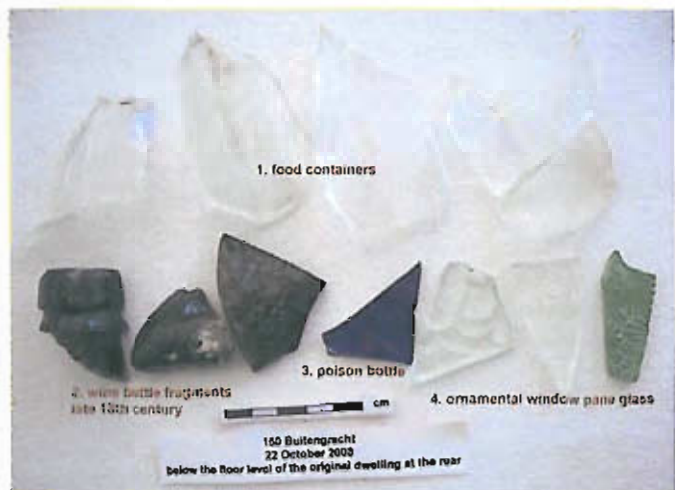
Fig. 20b.

Glass collection.

1. Food containers, 19th and 20th century, two-piece mould.
 2. Wine bottle fragments with hand-blown neck, probably 'Constantia bottle'. Late 18th century.
 3. Blue poison bottle fragment, 19th/20th century.
 4. Ornamental pressed glass, often used for front door window panes.

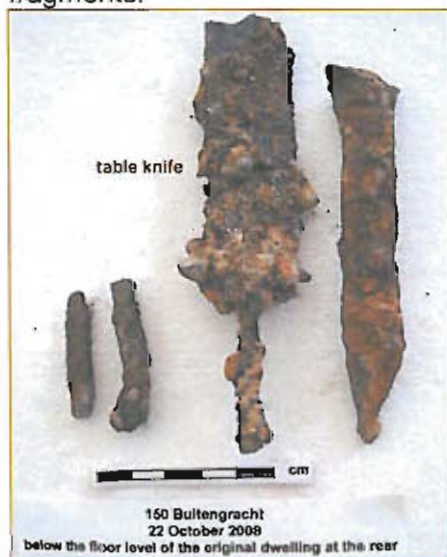
Fig. 20c.

Left: nails, middle a table knife fragment.

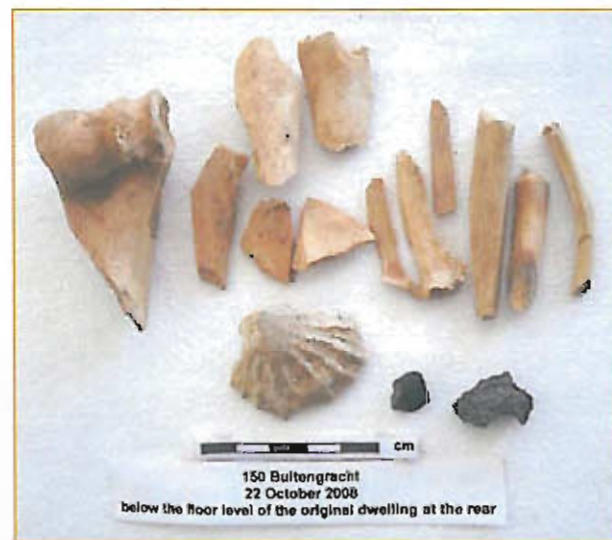
Fig. 20d.

Bone fragments, 50g.
 Left: sheep - Right: fowl
 Below: limpet shell and charcoal.

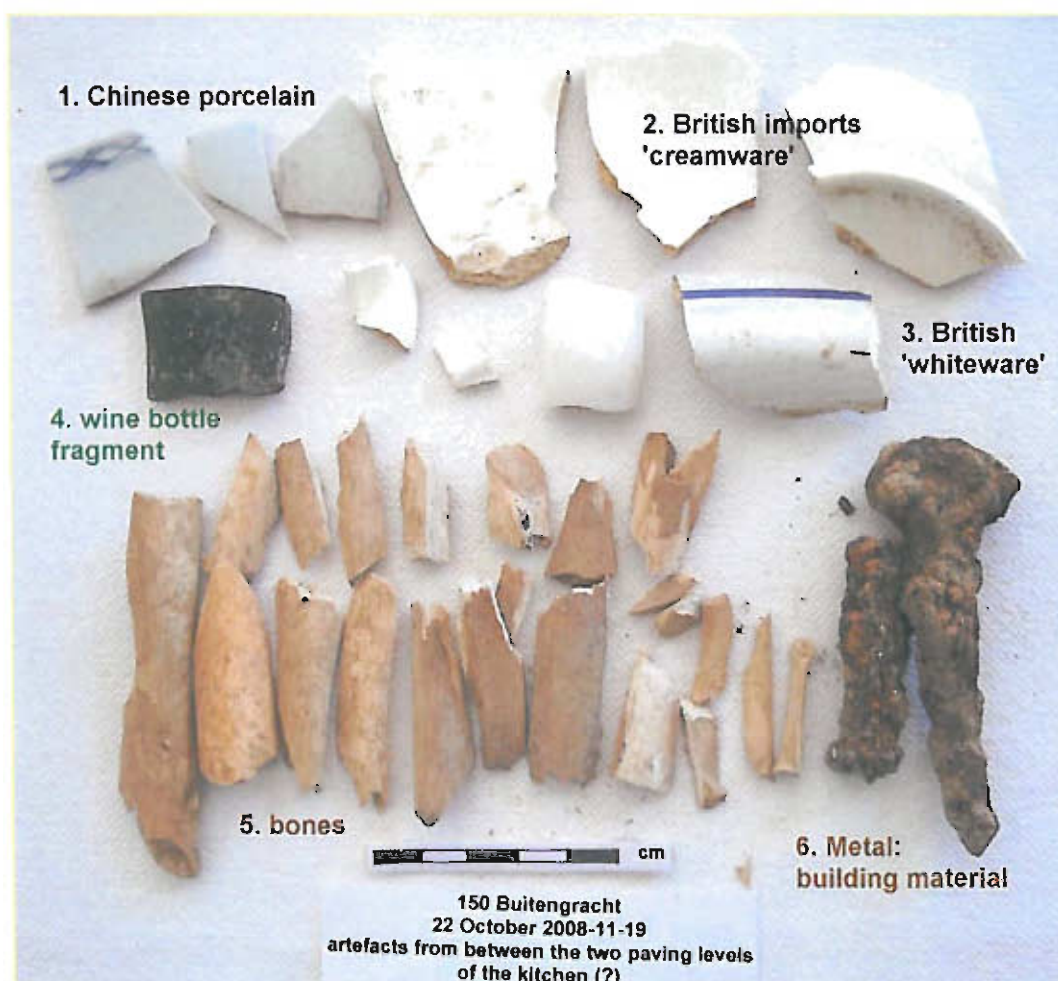
Fig. 21. Artefacts from inbetween the two paving layers in the kitchen(?) at the right hand back of the dwelling.

1. Two fragments of fine Chinese export porcelain (tableware), 'trellis border' and one fragment 'grof' porcelain, used in the kitchen. All late 18th / early 19th century.
2. British imports, 2 creamware kitchen bowl fragments, late 18th / early 19th century.
3. British imports, 'whiteware', one pitcher and one cup handle fragment, one blue-banded "potty" rim (?) fragment, late 19th century.
4. wine bottle fragment.
5. 50g of bones: sheep and fowl.
6. Building material, 19th century.
