Archaeological Impact Assessment (AIA)

For the Proposed Rehabilitation and Refurbishment of the existing Latimer's Landing jetty
at the Port of East London

Version 1.0
20 July 2015

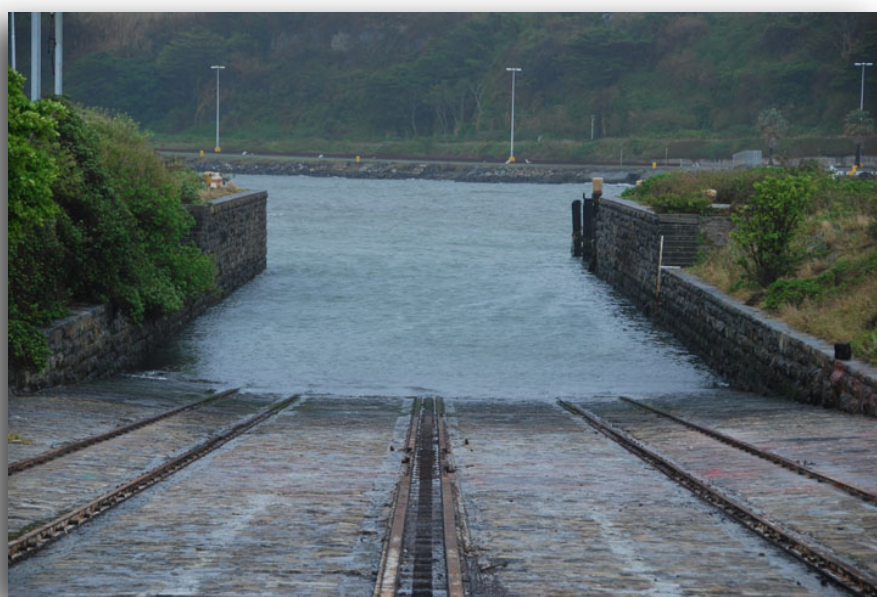
A patent slipway to facilitate ship-building was constructed in 1896 on reclaimed land on the western bank of the river with walls constructed of hammer dressed dolerite blocks and the cradle using timber. The Victoria Slipway was officially opened by Sir

Figure 10: Victoria slipway [Martinson 2013]

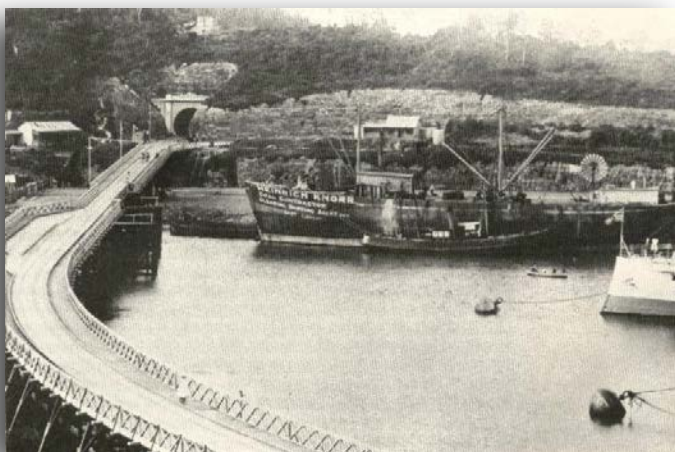
Figure 18: Original Molteno Bridge over Buffalo Rive(1870s) [SAR&H]

The historic Pontoon Road or Bruce-Bays double-decker bridge adjacent Latimer's Landing forms the northern border of the harbour. The original bridge was built by the Molteno Government in the 1870s as part of its East London – Queenstown line [See figure 18].

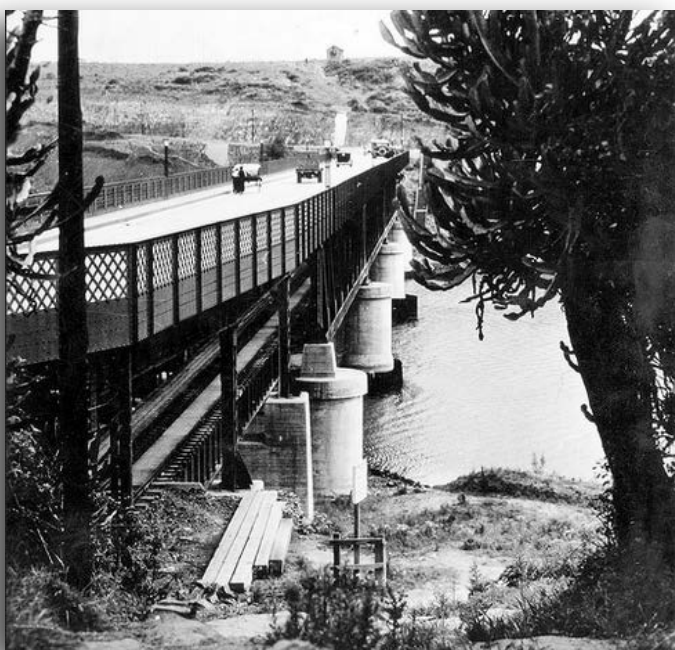
Figure 19: Bruce-Bays Bridge constructed in 1935 [SAR&H]

In 1935 it was replaced by the Bruce-Bays bridge (Dr James Bruce-Bays was the mayor at the time), a double-decker bridge carrying rail on the lower deck and a road at the upper deck. [Figure 19]

It is claimed to be the only double-decker bridge in southern Africa.

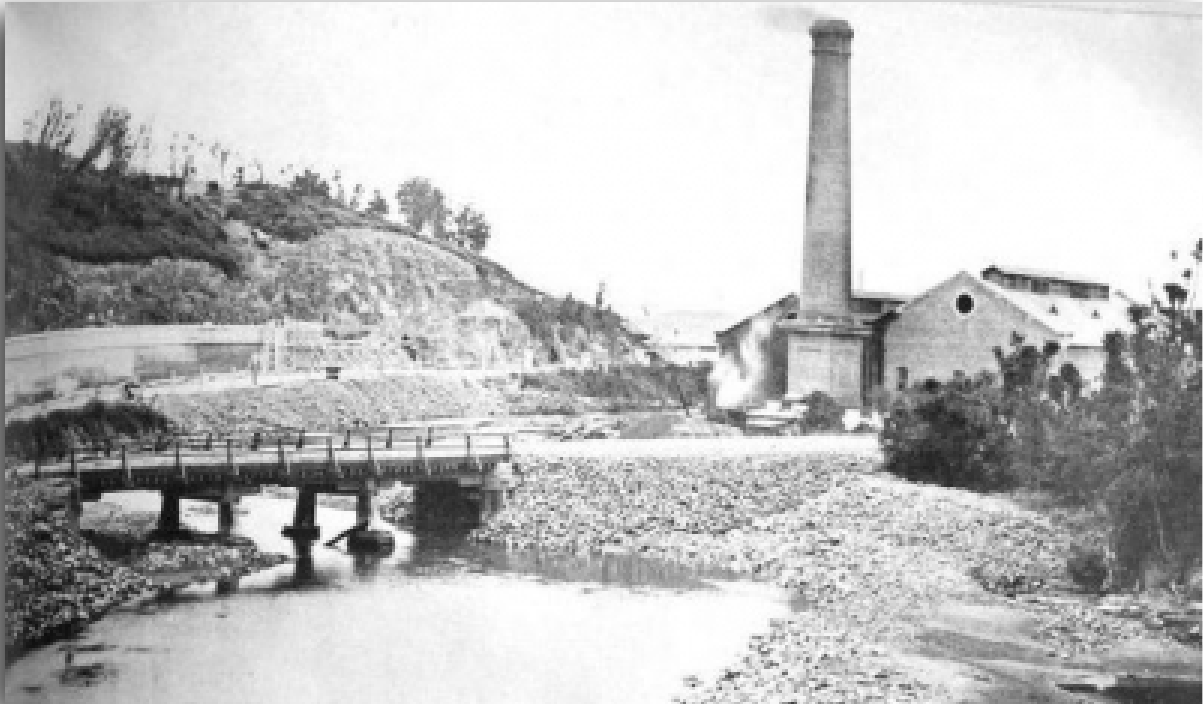
In a section under the jetty where a storm water outlet feeds water into the river, the concrete has sufficiently eroded to reveal gravel with bigger rocks at the bottom of the scarp. The revetment, therefore, was already in place by the time the jetty was built and all that was required was to put up the structure.

What is of importance in this observation is that the area under the revetment is likely to have originated from either the bottom of the river or the nearest quarry site which would be, as can be seen in this early photograph of First Creek, the hills behind the creek.

Figure 23: The Municipal Power Station in First Creek, 1902. Note the gravel along the banks of the creek and the carved out section of the hill for the road beneath it, Pontoon Road [East London Library]

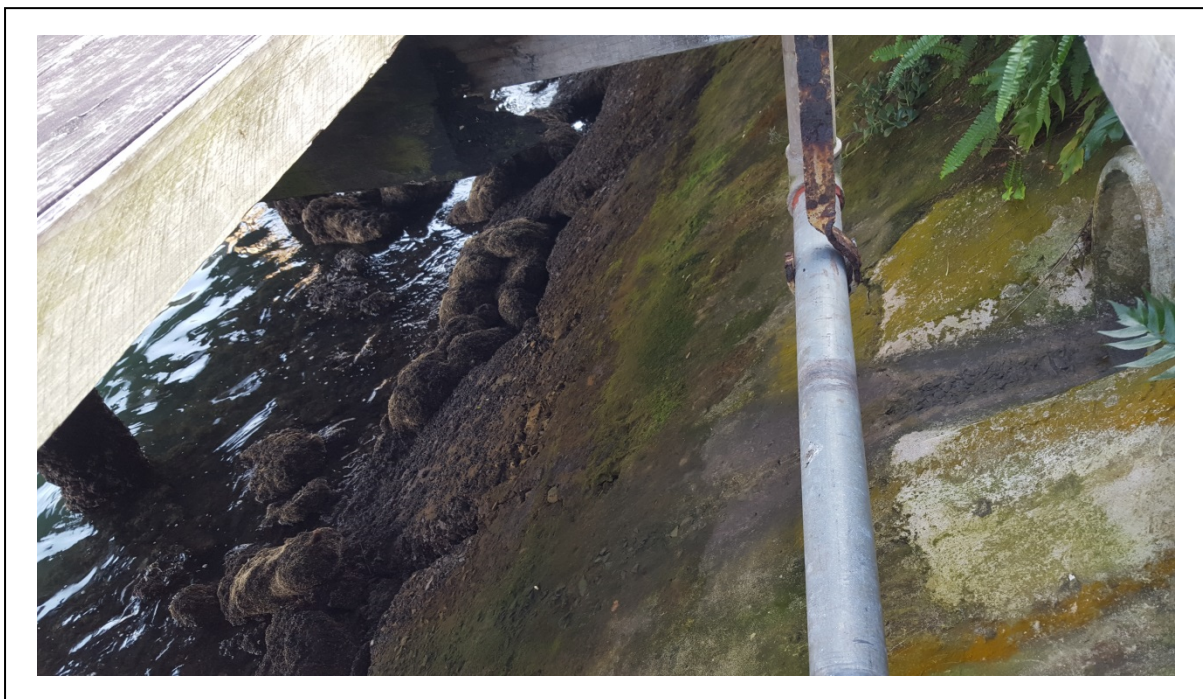
Figure 24: Exposed gravel at the mouth of the outlet as well as the bottom of the scarp with larger rocks immediately beneath that. [National Museum 2015]

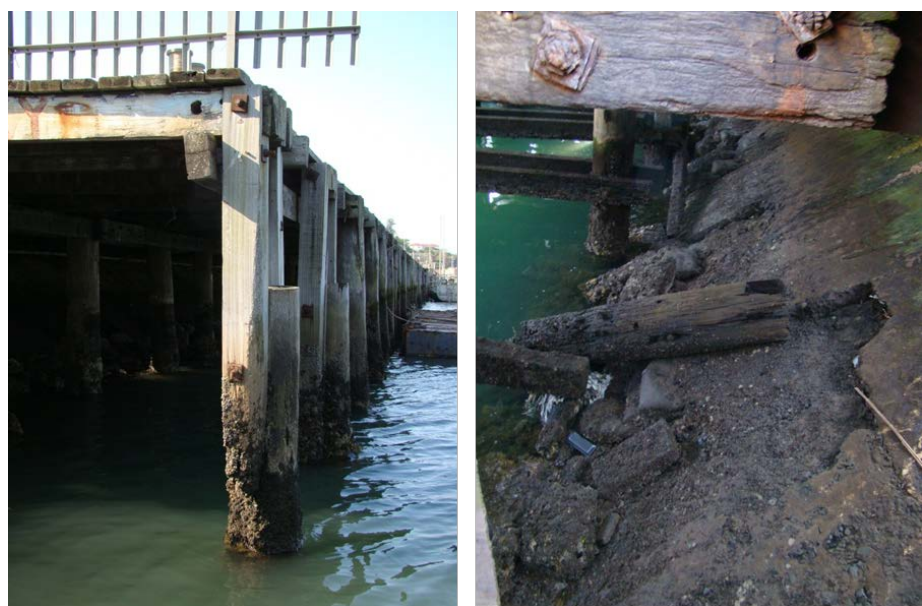
Figure 25: Collapsed pile (right) and reinforced corner pile (left)[National Museum 2015]

Piles: The condition of the support posts is of particular concern. Several of the piles show severe deterioration which in itself is sufficient to render the jetty unsafe. At least one post has already collapsed. The culprit in this case is most likely marine borers which can be divided into Molluscs and Crustaceans. Marine borers are found all over the world and are, accordingly, also found along the South African seashore. They are most active in tropic zones and in particular in large river estuaries where the lower salinity is more conducive to their growth. Unlike molluscs which often leave the surface of the wood intact, the damage caused by Crustaceans is not concealed. They work mostly between the high and low water mark and eat the pile away until it develops a typical 'hourglass' appearance [See Fig.26]

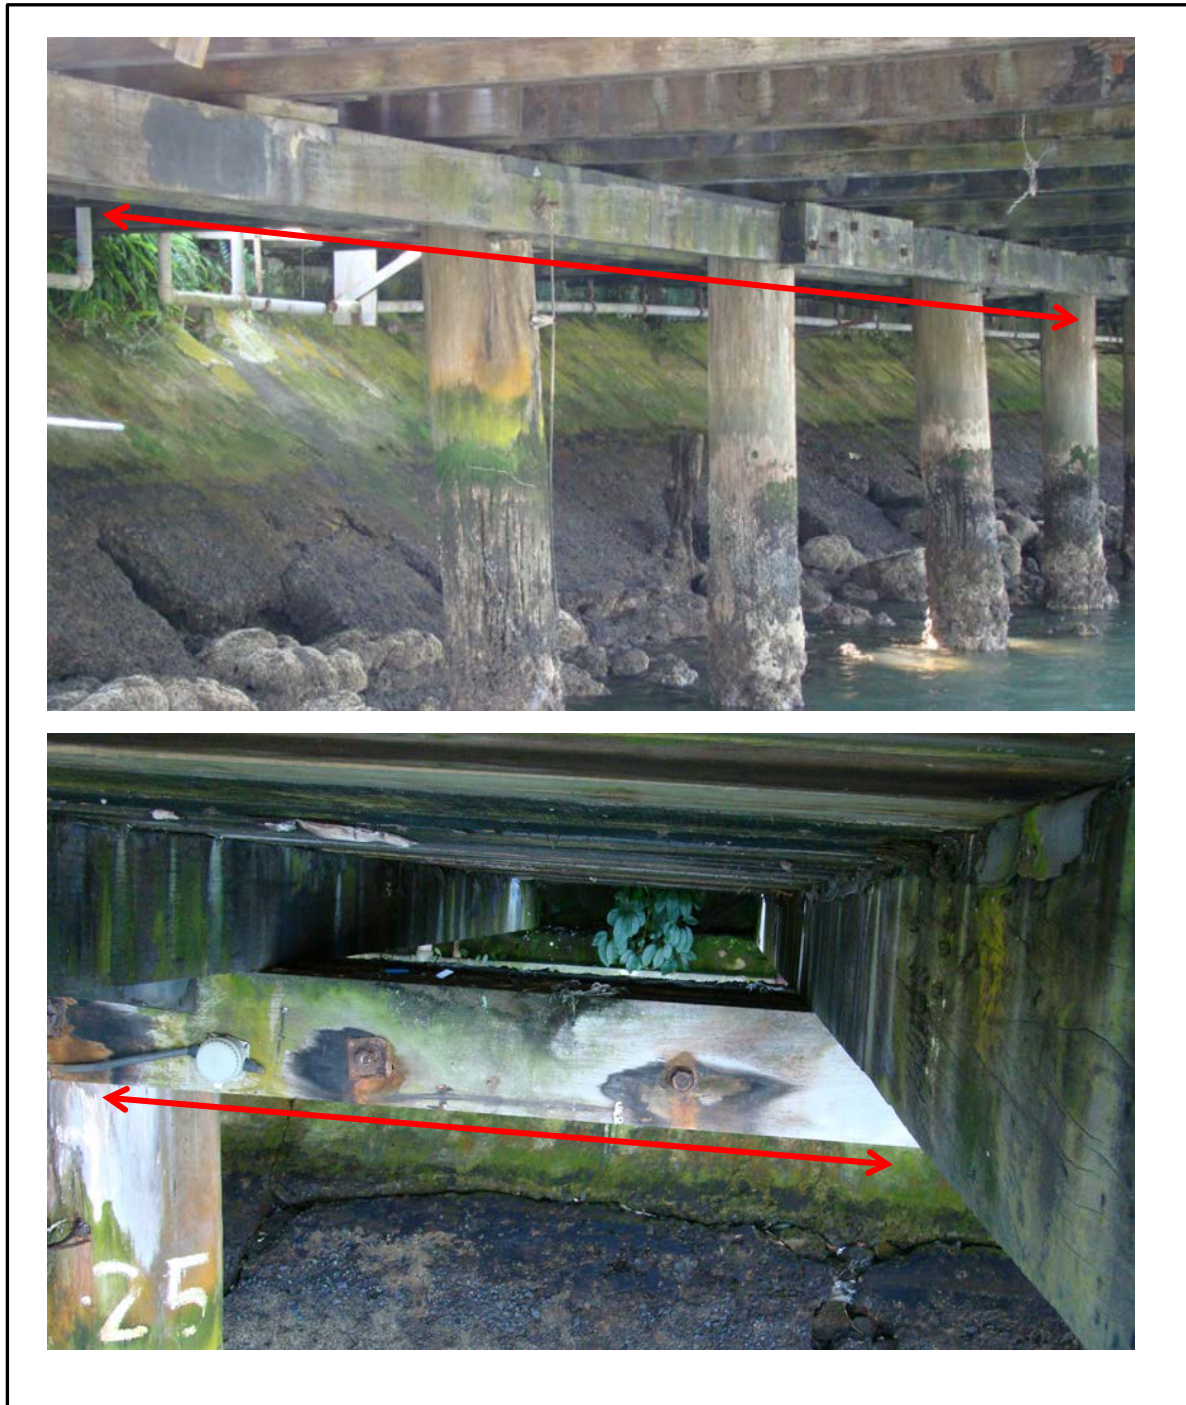
Figure 27: Upper support beams indicated with red line [National Museum 2015]

Support Beams: The upper support beams are least affected which can be attributed to the fact that it is to some extent protected from both heat (sun) and water on account of its location. It would therefore be less susceptible to fungi infection. It should be noted that these sections of the current jetty might be used to cut new sections for the deck to replace those sections which have deteriorated beyond repair. The lower support beams, however, have suffered the same fate as the piles. The piles are supported by double beams on both upper and lower ends although not all piles have lower support beams.

Joists run parallel to the lower support beams as can be seen in Fig 27.

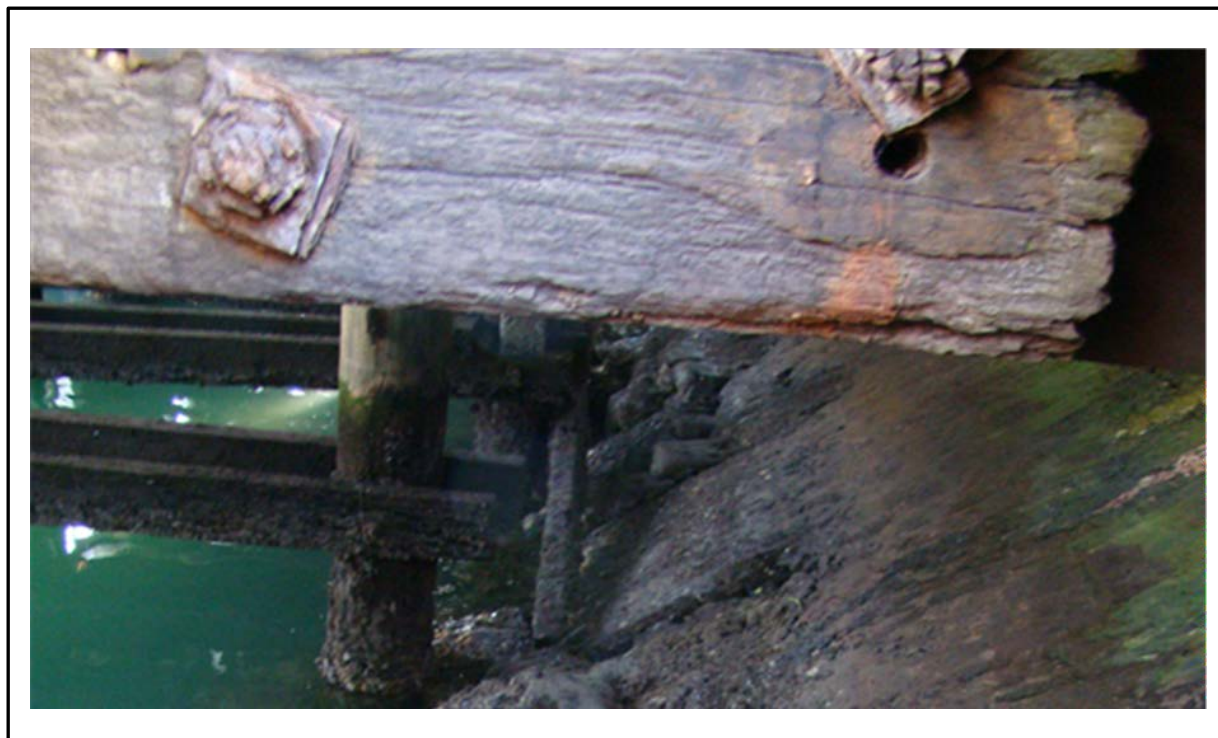
Figure 29: Joist end on revetment side showing an advanced stage of decay [National Museum 2015]

The sections of joists closest to the revetment wall on the one end and on the waterside on the other end, seem most affected. Conditions on the revetment side would be more humid during hot days where moist hot air would be trapped and thus create ideal circumstances for fungi growth than it would be, for instance in the middle section where the air can freely circulate to cool it down.

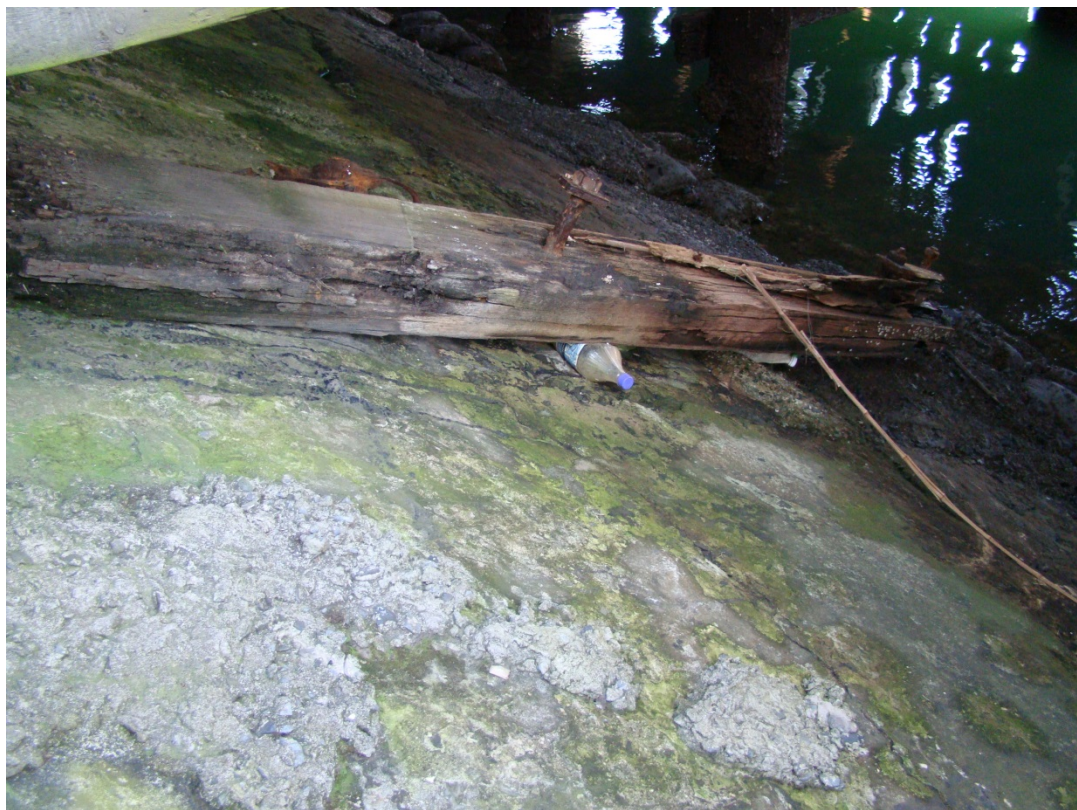
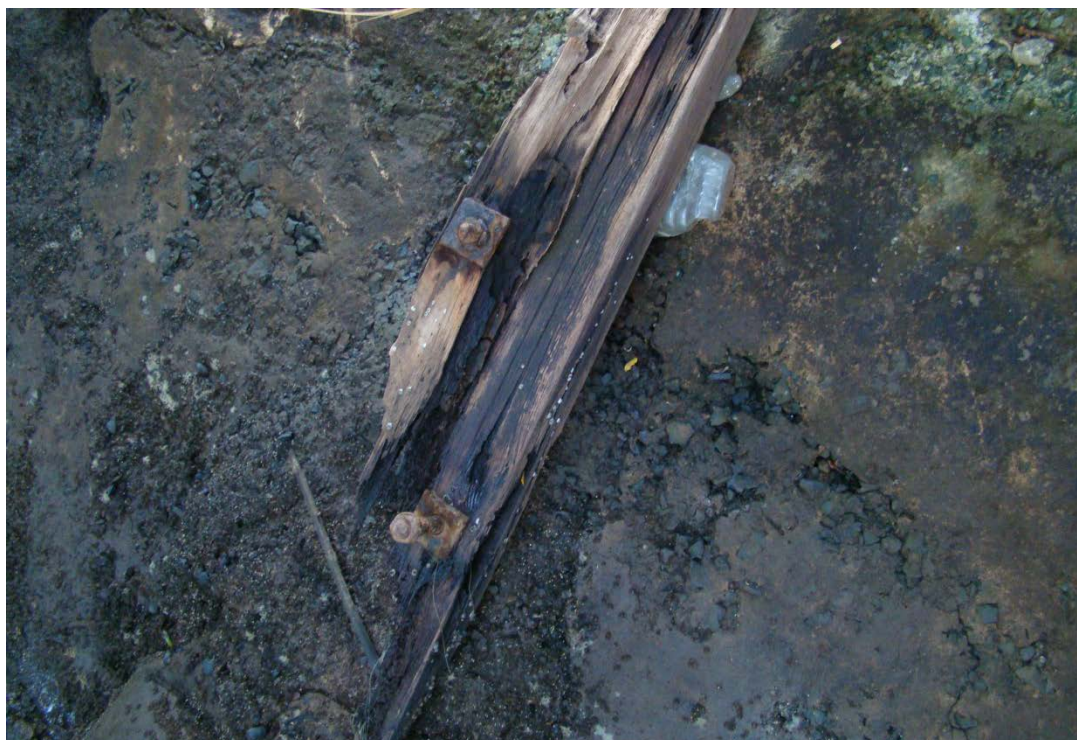
Figure 31: The collapsed pile showed in Fig 23 appears to have taken down a section of the joist it was attached to which indicates that the joist was also infected at the time and thus not able to withstand the gravitational force [National Museum 2015]

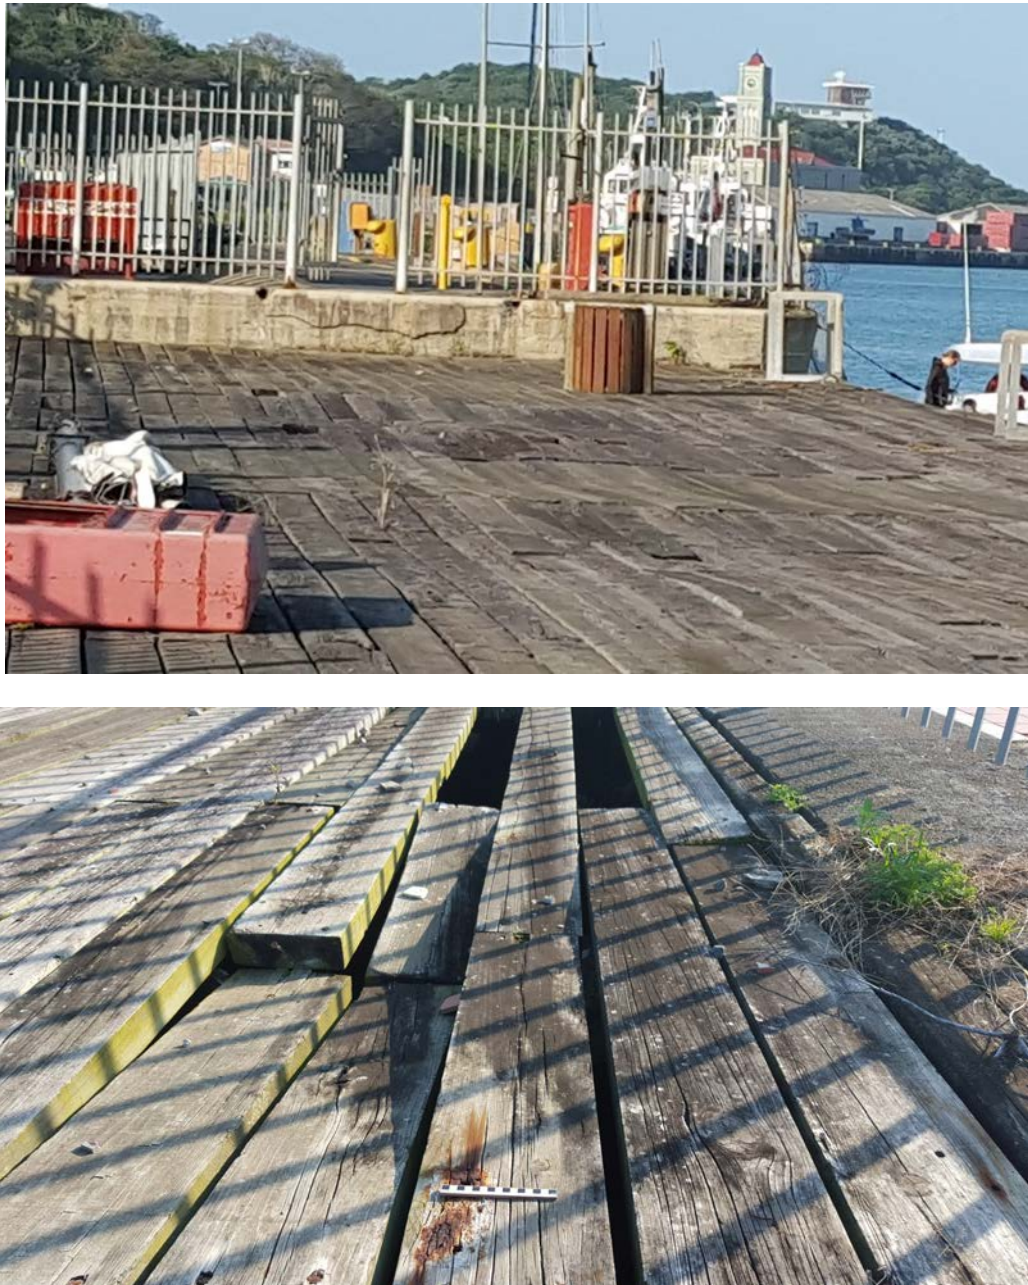
Figure 32: Decking showing sagging and rising sections with missing panels [National Museum 2015]

Deck: The deck is in a very poor condition. Not only is it the most accessible section of the jetty and therefore the area that could be most thoroughly inspected, but is it also the section that is most exposed to the elements and therefore has the most favourable conditions for decay. Several sections of decking material are missing and the remainder rise and fall from one end to the other to create a ripple effect. The deck is clad with deck boards of varying lengths with an average width of 22 cm and a diameter of 7 cm.

Unlike the case with the riverbed-lodged piles which have been damaged by marine borers, the likely culprit with the deck boards is fungi and potentially more than one kind. Fungi that can cause decay in timber are mainly classified in two groups namely wood destroying fungi and wood disfiguring fungi, although some fungi can be representative of both groups. With the evidence at hand the focus in this case will be on wood destroying fungi. These fungi feed on the compounds of the cell wall of wood and as a consequence can weaken the structure of the wood to such a degree that the wood breaks and crumbles away. There are mainly three groups of wood destroying fungi namely (1) brown rots, (2) white rots, and (3) soft rots. In advanced stages of decay it could be more readily distinguished from one another but microscopic inspection will confirm any prognosis.

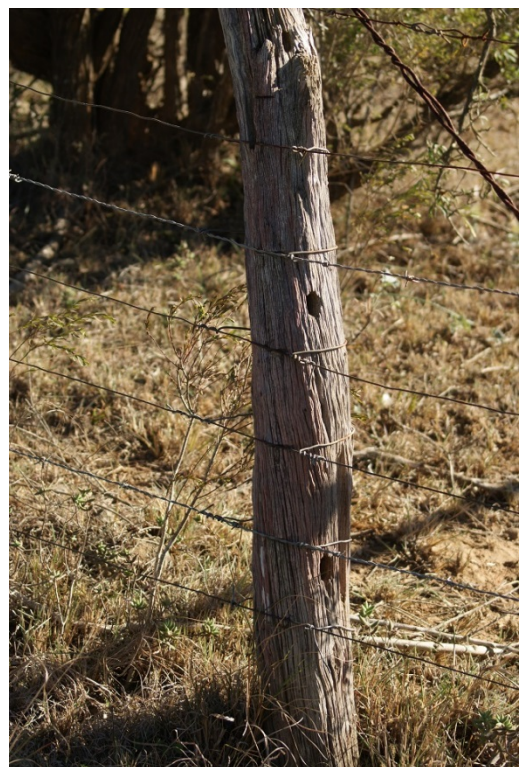
Figure 33: A weathered historic Sneezewood fence post

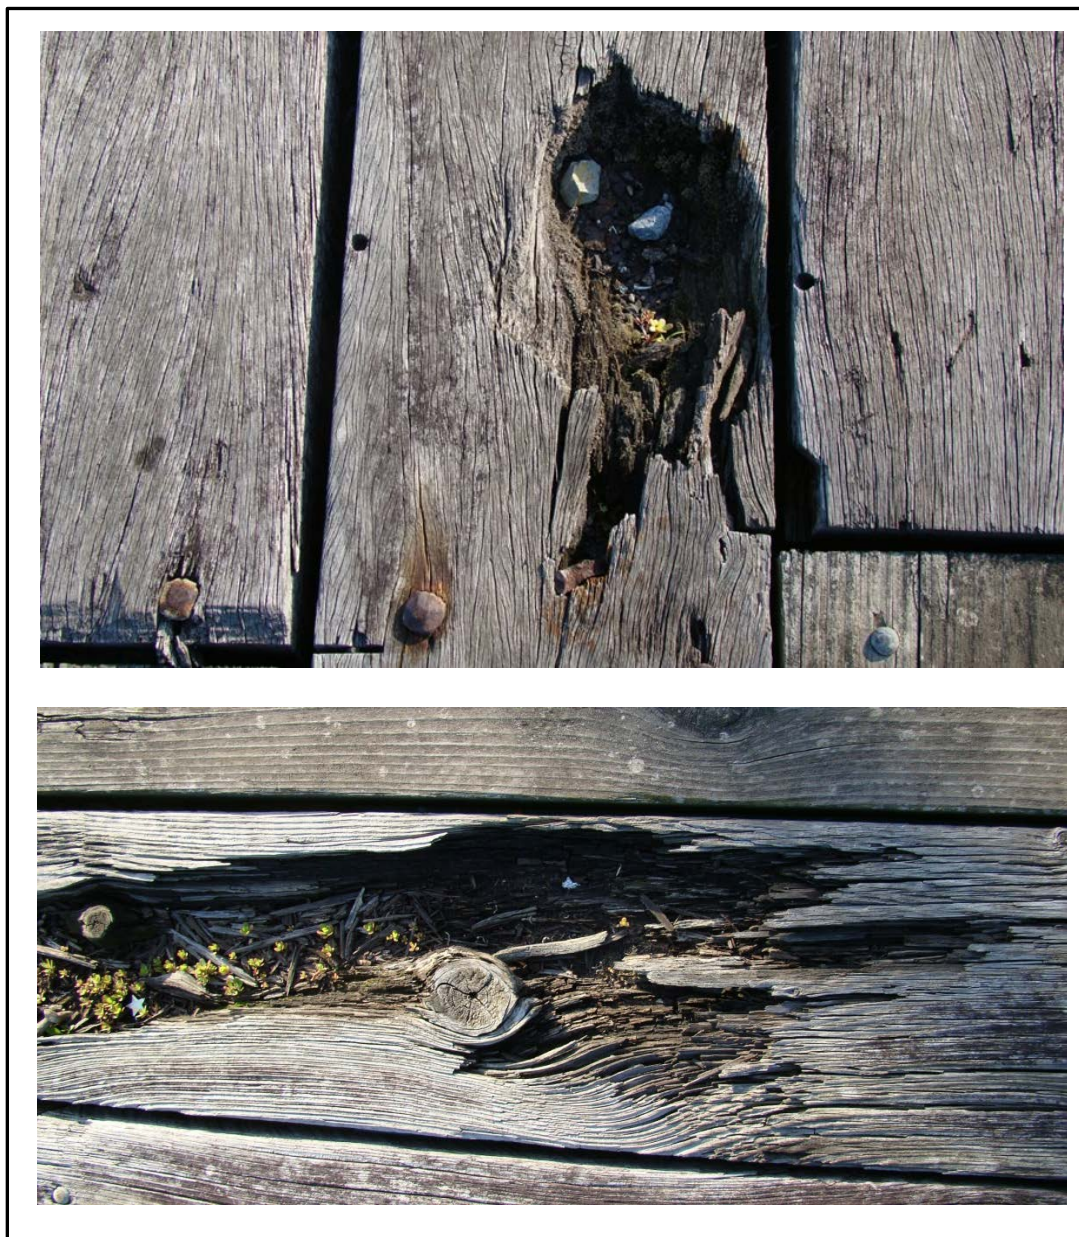
Figure 34: Exposed pockets of decayed wood [National Museum 2015]

White rots, on the other hand, does not crack in the same way as brown rots in badly decayed timber and the wood become lighter instead of darker. The timber breaks down in a longitudinal direction and there may be pockets of decayed wood between apparently sound areas.

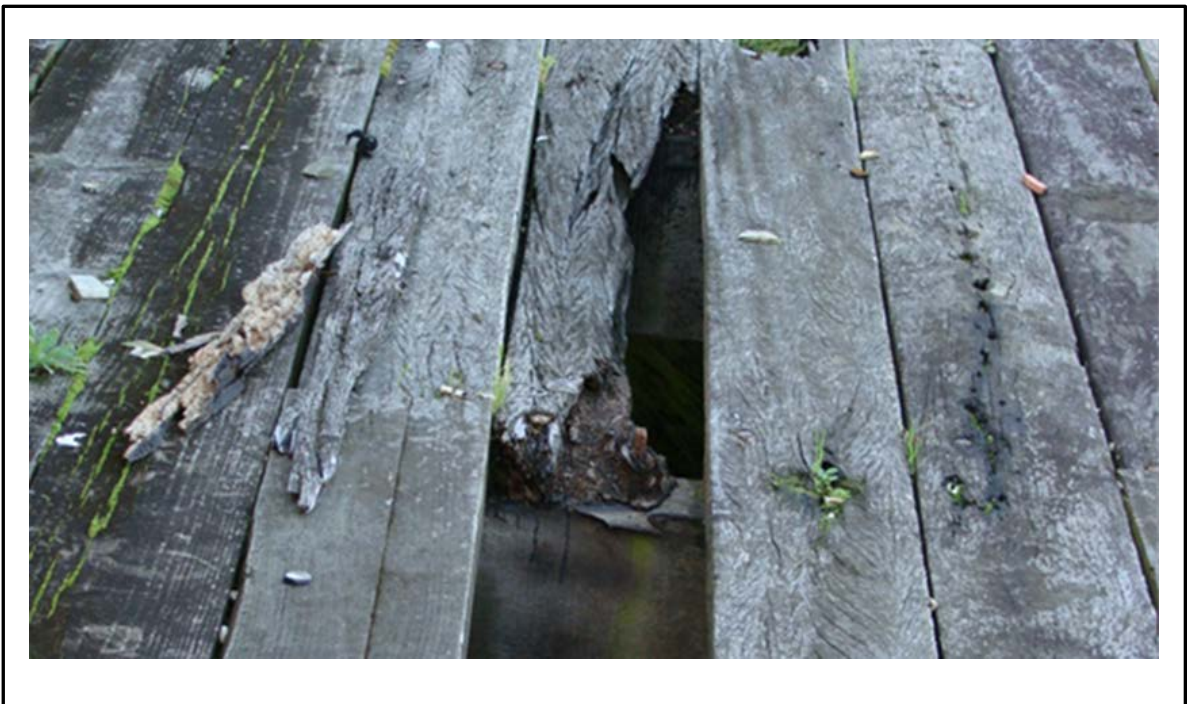
Figure 36: Sections of wood (left) showing signs of tunneling, a section of severely decayed wood (middle), and a row of boring holes (right)

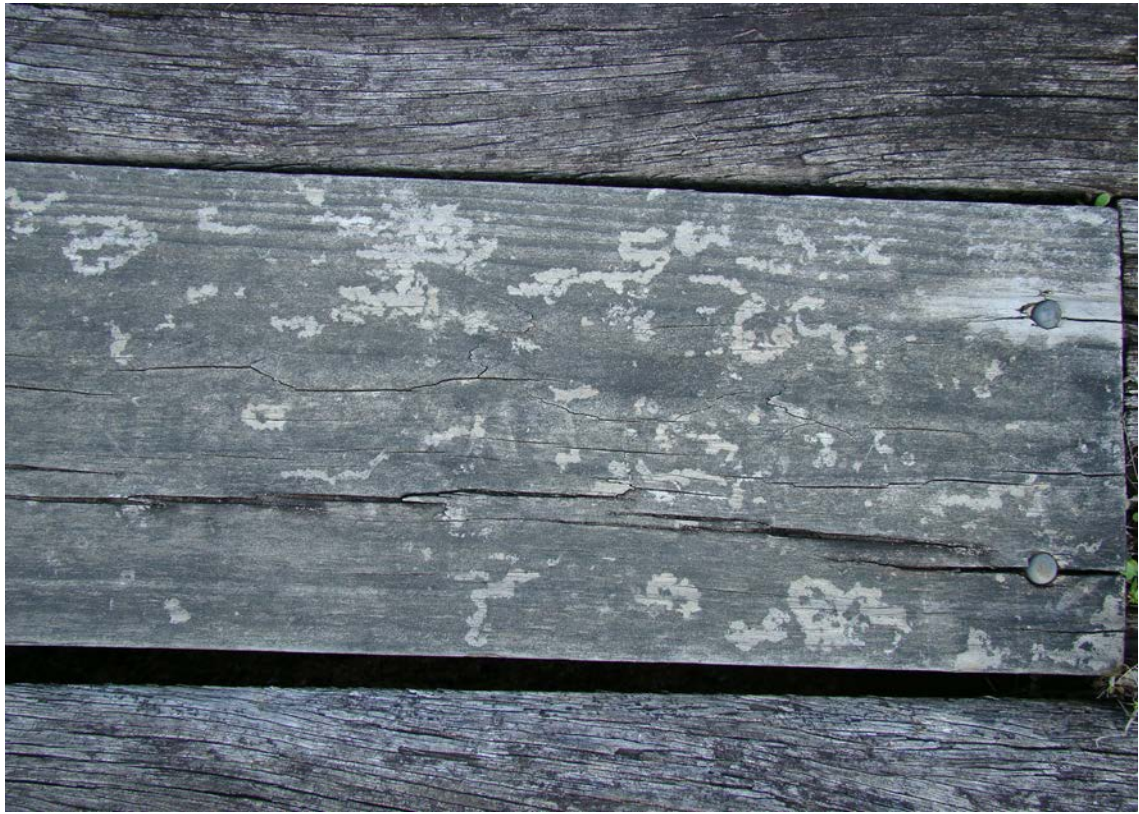
Figure 38: Slug and Snail trails could be a sign of fungal infection as snails feed on fungi [National Museum 2015]

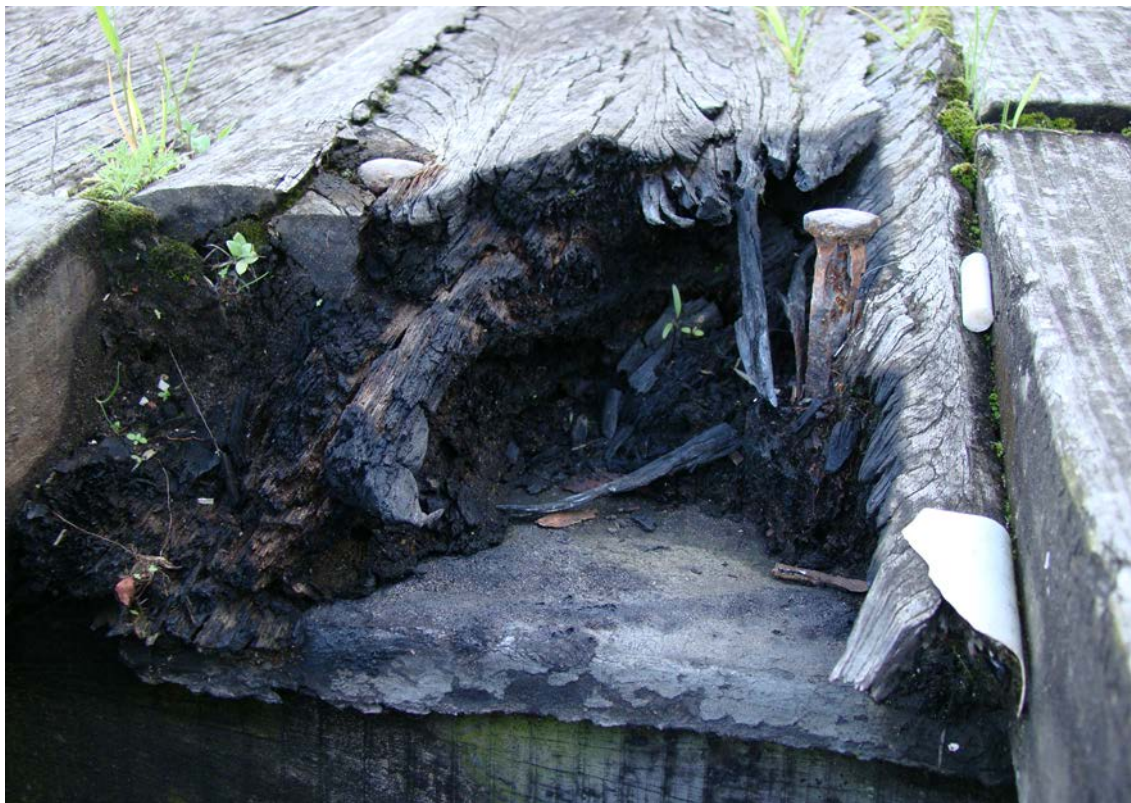
The characteristic feature of brown rot fungi is that the decaying wood is brown and shows brick-like cracking. Softwood and the lighter hardwoods are most often attacked by this type of fungi. In an advanced stage the surface can become badly broken by deep transverse and longitudinal cracks and appears similar to wood that has been charred by a fire.

Figure 39: Rotten interior section resembles burnt wood. Exposed nail indicates this board section to be part of the original jetty [National Museum 2015]

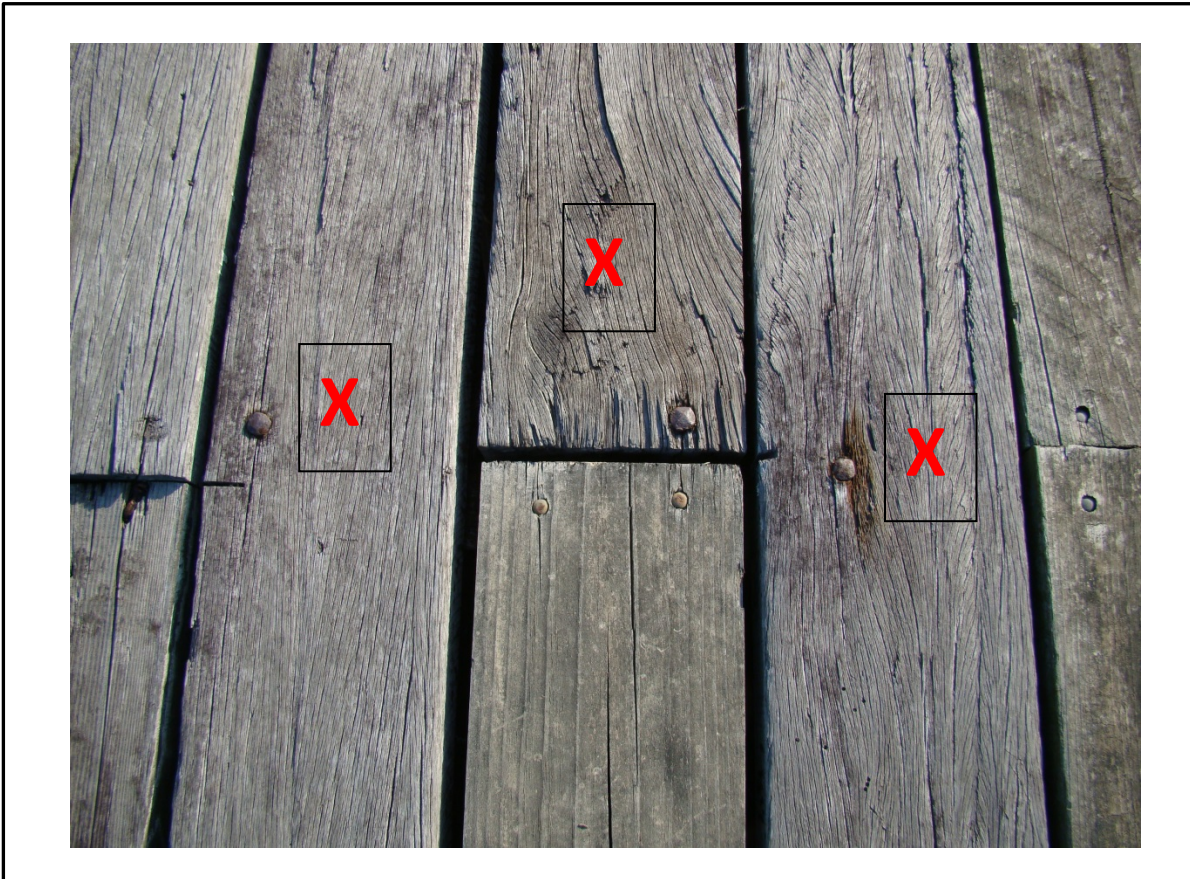
Figure 40: Decking boards marked with an 'X' appear to be older than the unmarked ones. The majority of boards marked with an 'X' are fixed to the joists by older nails and most likely originates from the first construction phase of the jetty in 1898. [National Museum 2015]

The jetty has seen some repair work over the years as difference in wear and weathering on the various deck boards confirm. In Figure 40 this can be deduced from the following signs:

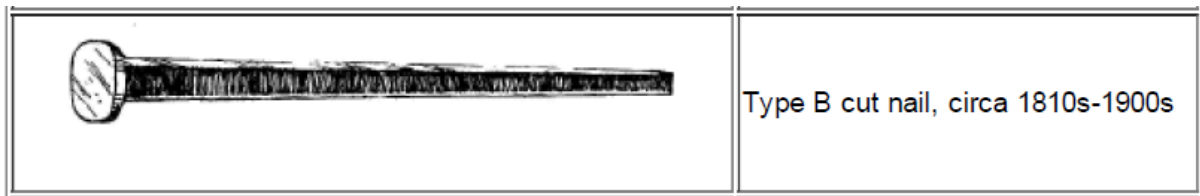
Figure 41: The exposed nails could be identified as Type B cut nails which is a time-fit for the original construction

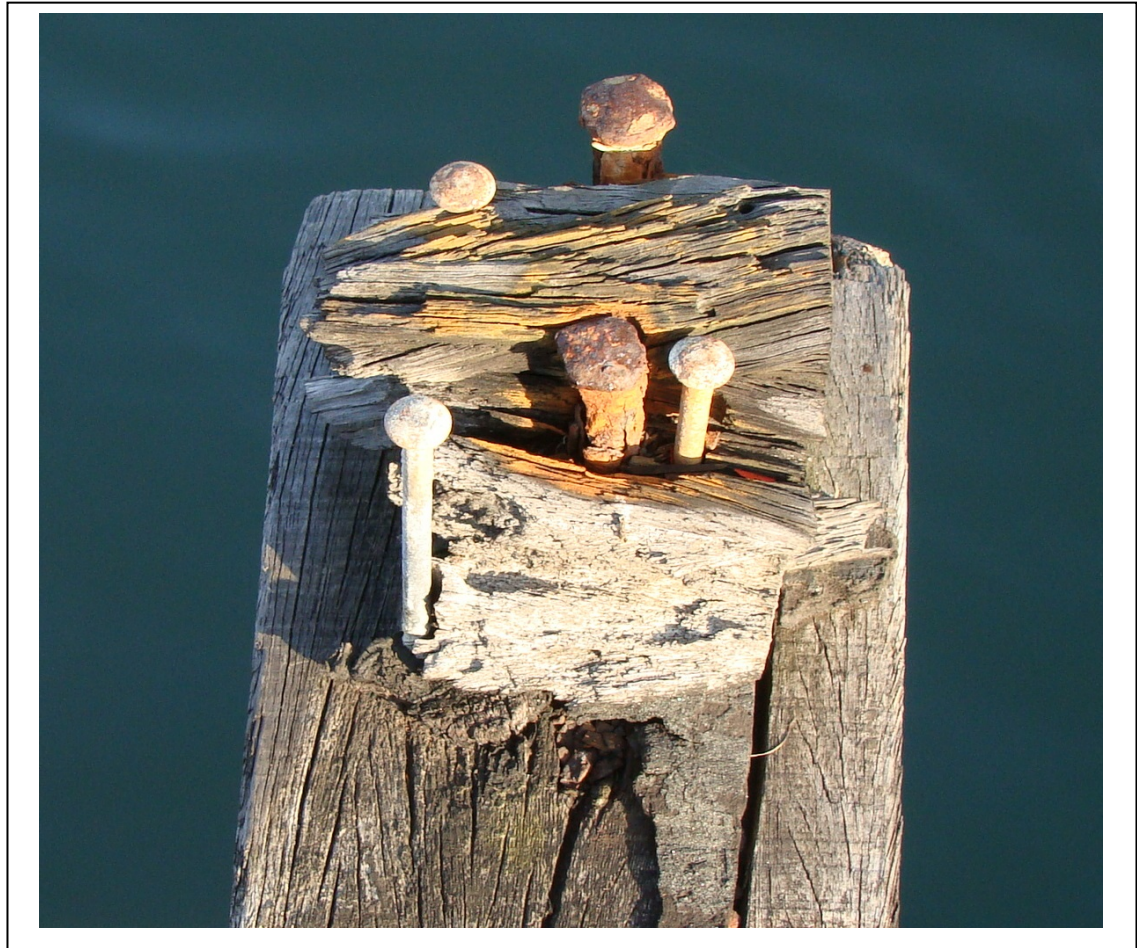
Figure 42: Exposed joist end with a section of wood attached by both Type B nails and Galvanised nails (dating to a later period) [National Museum 2015]

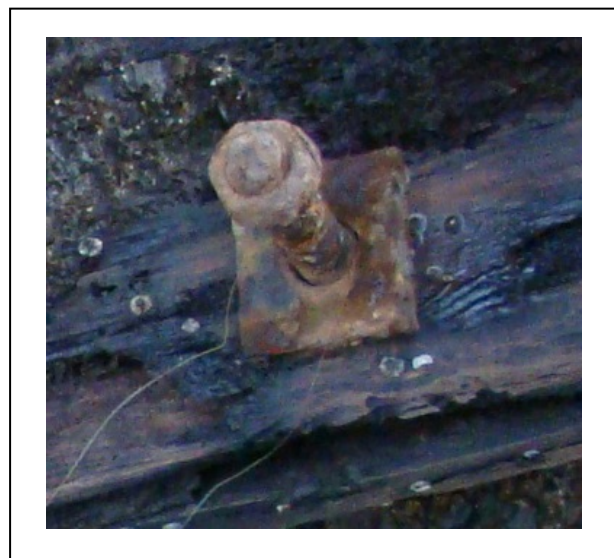
Bolts used to fix the joists to the piles are domed hex head bolts with square washers and secured on the other end with a hex nut and square washer. All of these are of iron and show varying degrees of rust and flaking.

Figure 43: Fasteners for Joists and beams

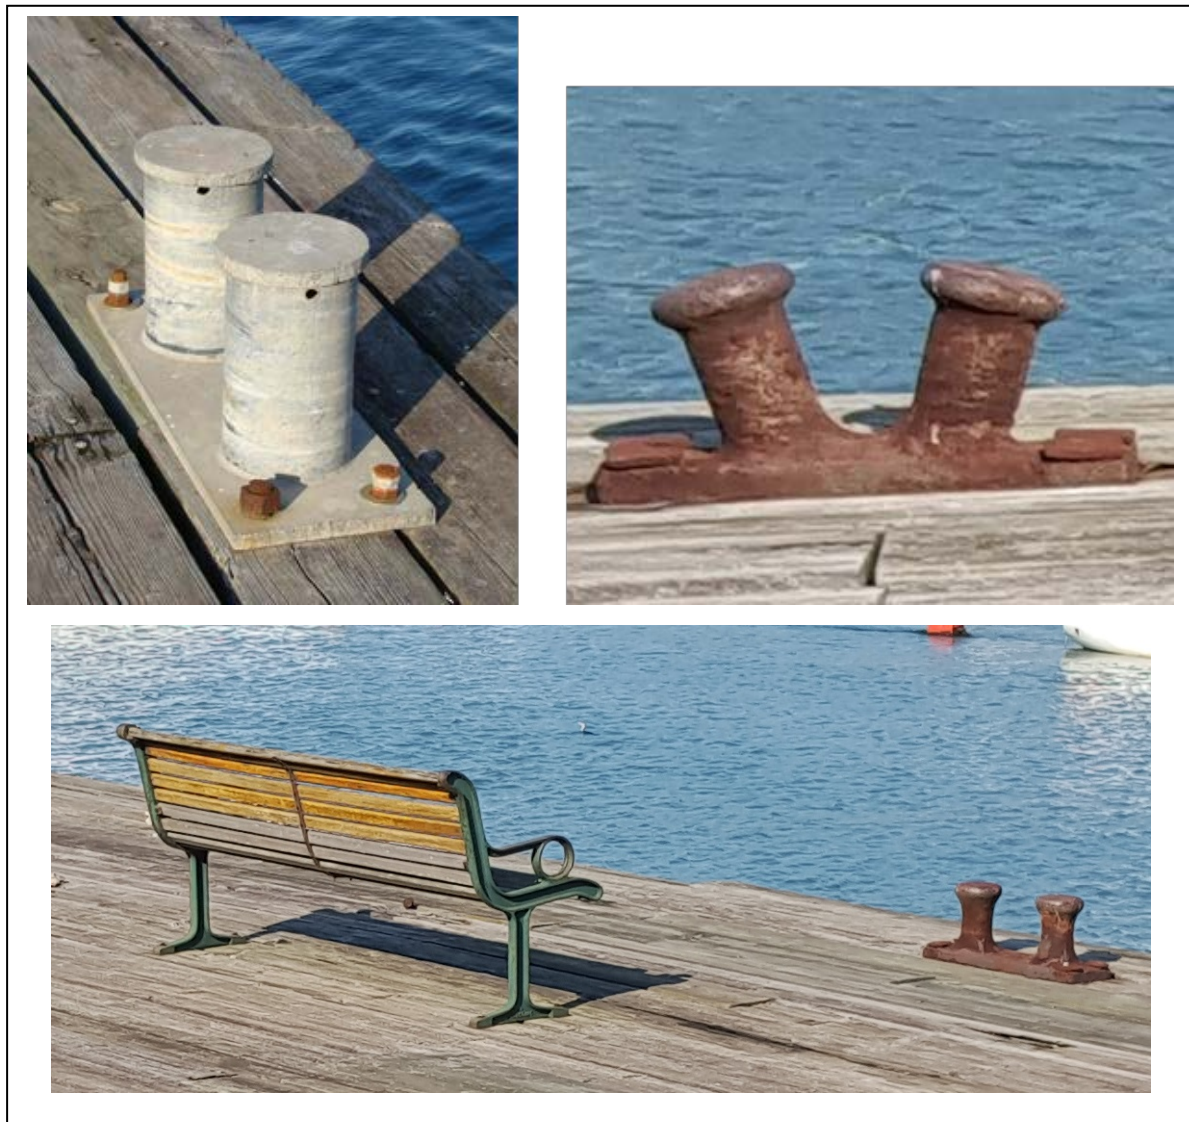
Figure 44: Jetty furniture and fittings [National Museum]

The jetty has two kinds of mooring posts, iron and concrete. The iron mooring posts are likely to be the original mooring posts at the time of its construction in 1896. At some stage cast iron benches were added (bolted to the deck).
