PHASE 2 ARCHAEOLOGICAL IMPACT ASSESSMENT: DROSTDY HOTEL, GRAAFF REINET, EASTERN CAPE PROVINCE

(Permit Number: 2/2/APM-PERMIT/13/08/002 issued by Eastern Cape Provincial Heritage
Resources Authority)

October 2013

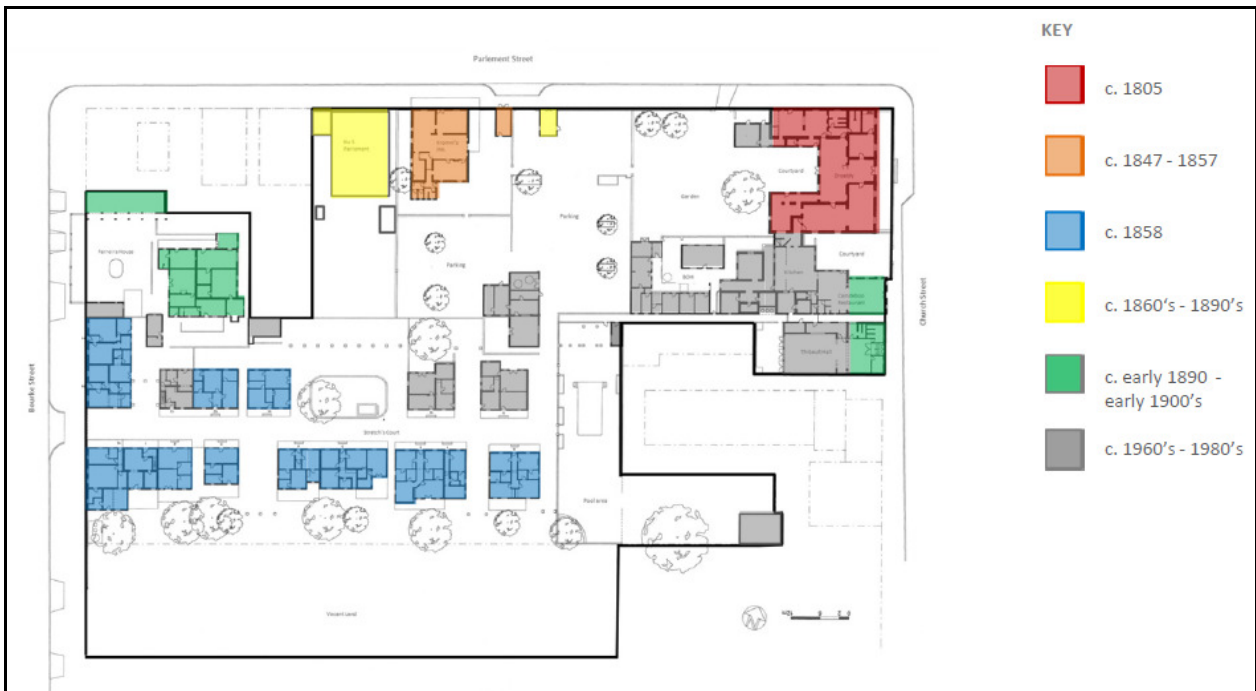
Figure 3: Site chronology (Urban Concepts) indicating the relative ages of the buildings discussed in the text.

In addition to the Drostdy Hotel, the current property includes a number of other buildings (Figure 2) which were built after 1804 (Figure 3) and are briefly described below.

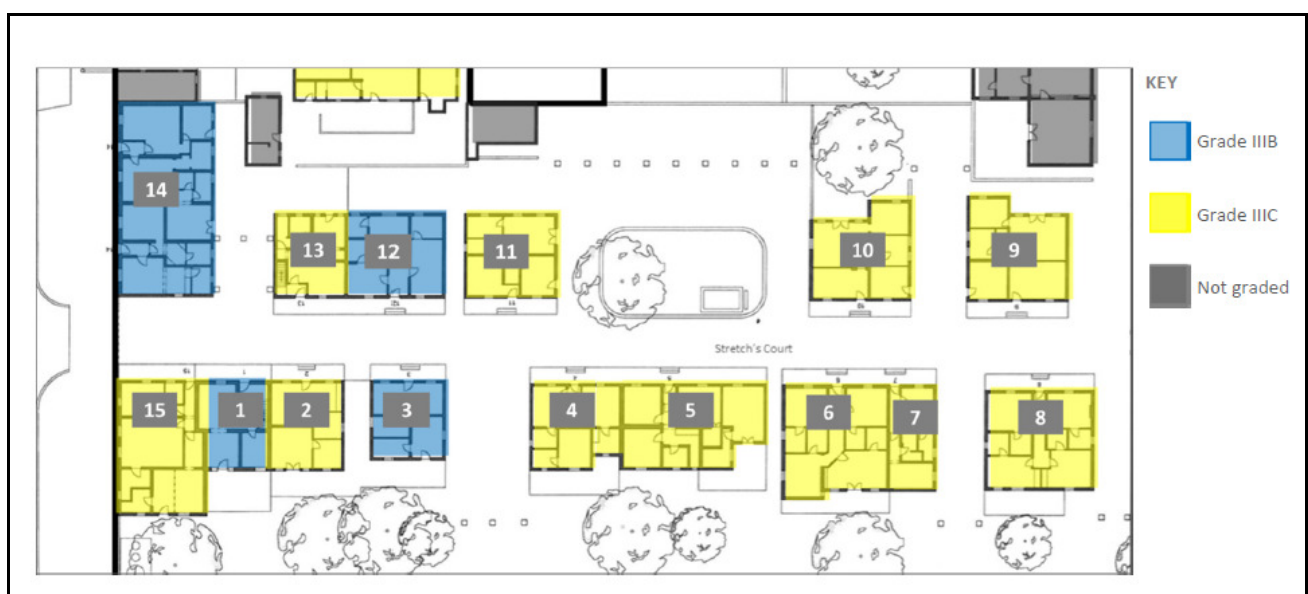
Figure 5: Stretch’s Court numbering and grading (Urban Concepts 2013)

The Draft HIA (Urban Concepts 2013) examined the degrees of intactness of each of the 15 cottages and assigned them an historical grading (Figure 6).

It was suggested that fabric analysis/plaster stripping of the historic wall fabric in particular of the interiors of cottages 1, 3, 12 and 14, which have been identified as having possible Grade III B status due to their degree of intactness, should be undertaken.

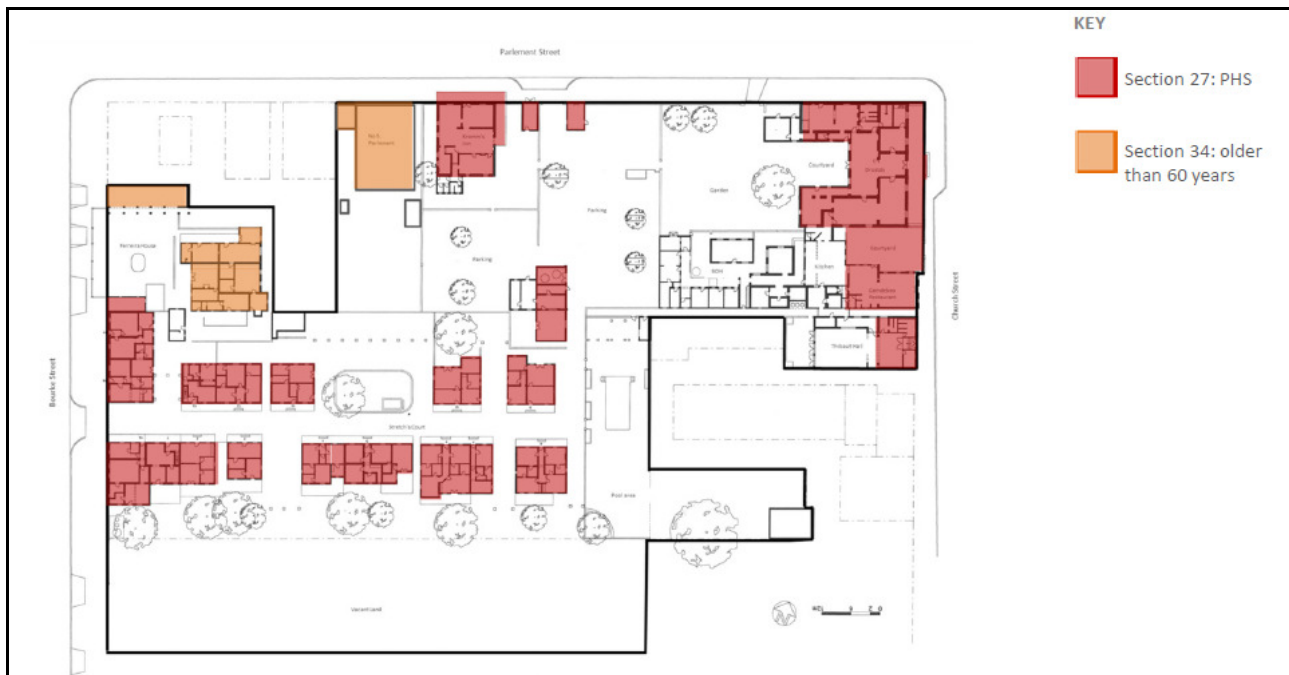
Figure 6: Heritage buildings protected by the NHRA (Urban Concepts 2013).

Various portions of the Drostdy Hotel complex (namely the Drostdy Hotel, Kromm's Inn and Stretch's Court) were declared National Monuments (i.e. Grade 1 sites) between 1981 and 1992 under the old National Monuments Act (No 28 of 1969). Under the National Heritage Resources Act (No 25 of 1999) they have reverted to Provincial Heritage sites (PHS) (Grade 2) and the heritage authority which is responsible for issuing comments and permits with respect to alterations to the Provincial Heritage sites is the Eastern Cape Provincial Heritage Resources Agency (ECPHRA).

Plaster stripping was also proposed for the interior of the Stretch's Court cottages 1, 3, 12 and 14 which have been identified as having possible Grade III B status (Figure 6) and which will be impacted by the proposed renovations.

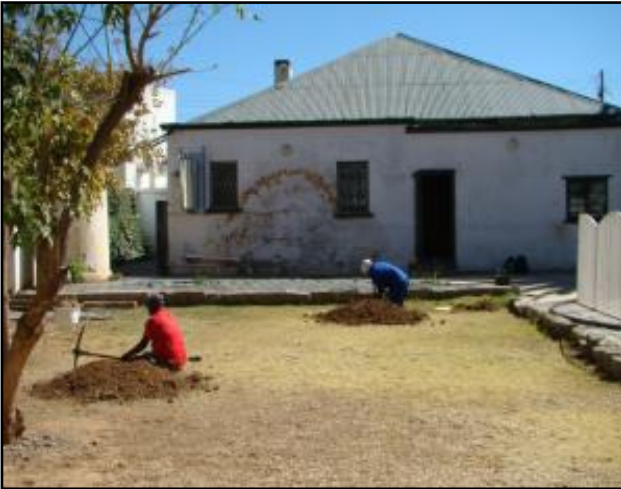
Test Pit 1: was excavated right up against the raised back *stoep* which was covered in black slate roof tiles. It was excavated to a depth of 50 cm and was sterile except for a few pieces of metal (Figure 8).

Test Pit 2: was excavated in the middle of the lawn (Figure 8). It was dug to a depth of 40 cm and contained a few fragments of bone and a single cartridge case.

Figure 8: Excavating Test Pits 1 and 2.

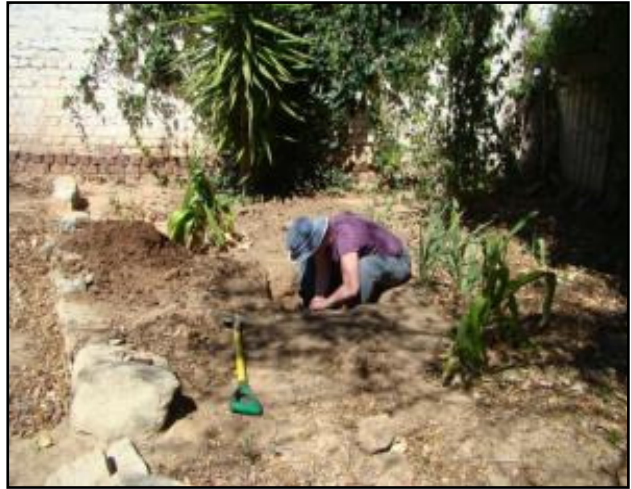
Test Pit 3: was dug in the back garden close to the fence (Figure 9). It contained quite a bit of builders' rubble as well as evidence of a pole sunk into a concrete sleeve to a depth of 40 cm. A portion of a buried cat was found in the section wall at a depth of 40 cm and left *in situ*.

Figure 9: Excavating Test Pit 3.

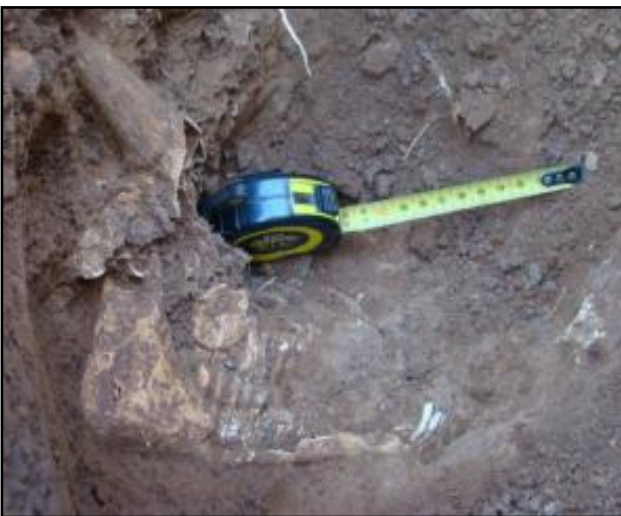
Test Pit 4: was dug in the one corner of the property, in the flower bed. While similar to the other test pits, this one contained some black charcoal fragments, some fragments of bone and glass, and a marble. The ceramics included a piece of flow ware and industrial slipware. The artefactual density, however, is very low. The test pit was extended in size to understand the stratigraphy and get a bigger sample of material. The artefactual material was recorded in the top hard brown soil. Below about 40 cm, there is a large concentration of bone, mainly ribs, but also some long bones standing upright. The localised nature of the bone collection, including the apparent *in situ* jaw bone, suggested that this is another burial – probably that of a small ungulate (Figure 10 & 11). There is evidence for a domestic rubbish dump.

Figure 10: Mammal remains from Test Pit 4.

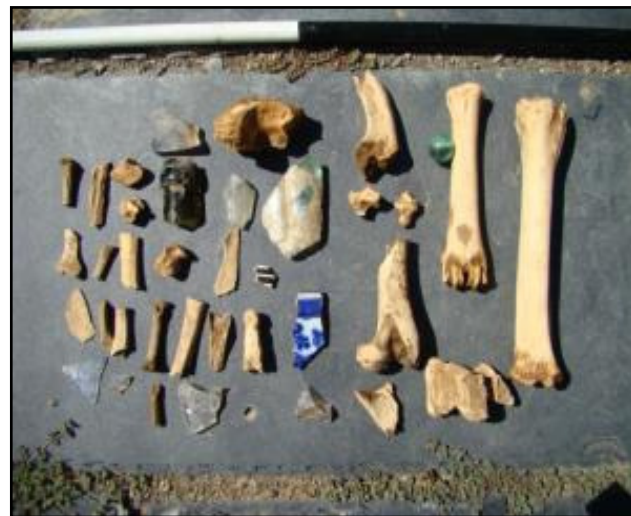
Figure 11: Archaeological remains from Test Pit 4.

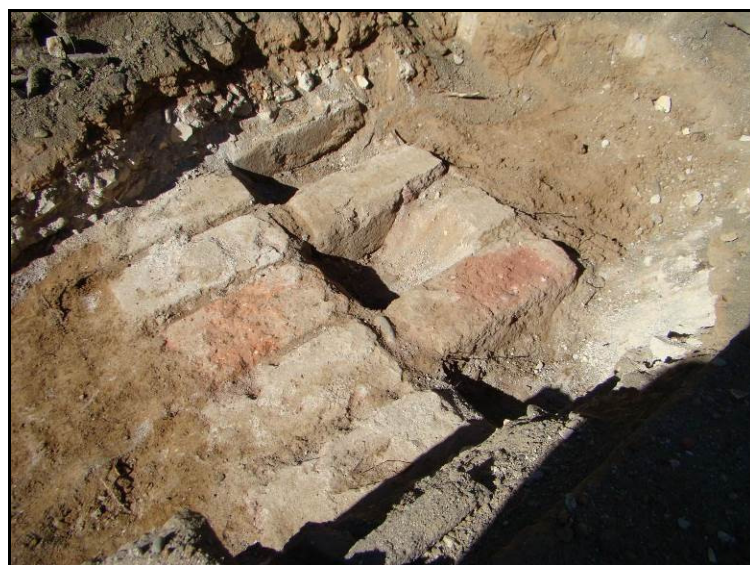
Figure 13: The rows of red bricks with V "frogs" from Test Pit 4 under the existing paving.

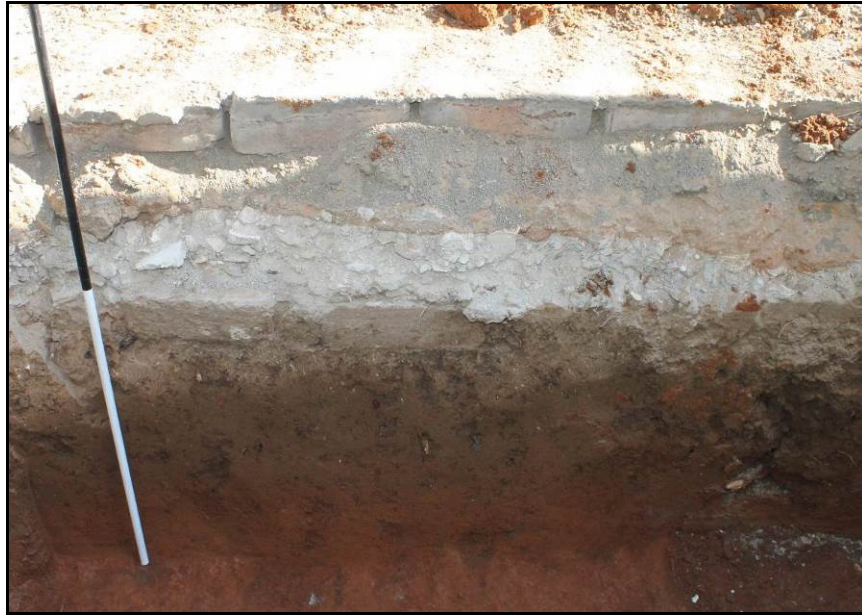
Figure 14: Profile of Test Pit 4 indicating the layer of building rubble under the brick paving and below this another layer of bricks. These lower bricks contain the V incised “frogs”.

Test Pit 4: is located in the centre of the paved area. Below the red brick paving is a dense layer of builders rubble, including bricks, fragments of hard grey mortar and some fragments with at least two layers of cream coloured paint/white wash. The rubble is clearly derived from previous renovations. In this rubble, and only about 10cm below the paving, is two rows of bricks. These bricks, when taken out and cleaned, include a V-shaped incised ‘frog’ (Figure 17) which according to Mr Whitlock (pers. comm.) are an identification mark of a brick company in Graaff Reinet. These bricks, when broken open, contain a white fleck which is also observed in a number of bricks during the plaster stripping.

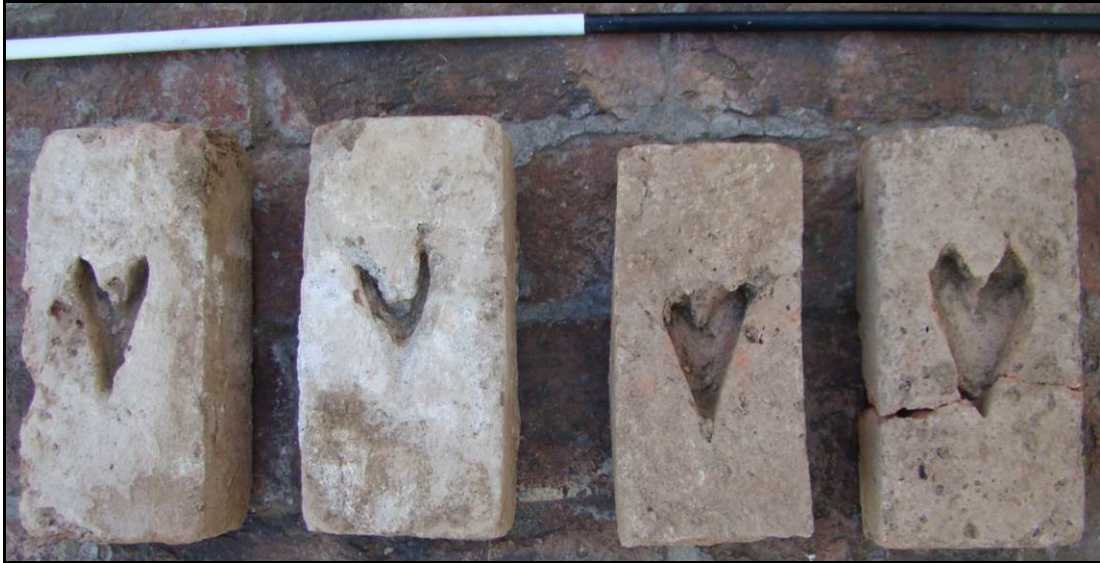
Figure 17: The bricks with the V incised “frogs” found in Test Pit 4.

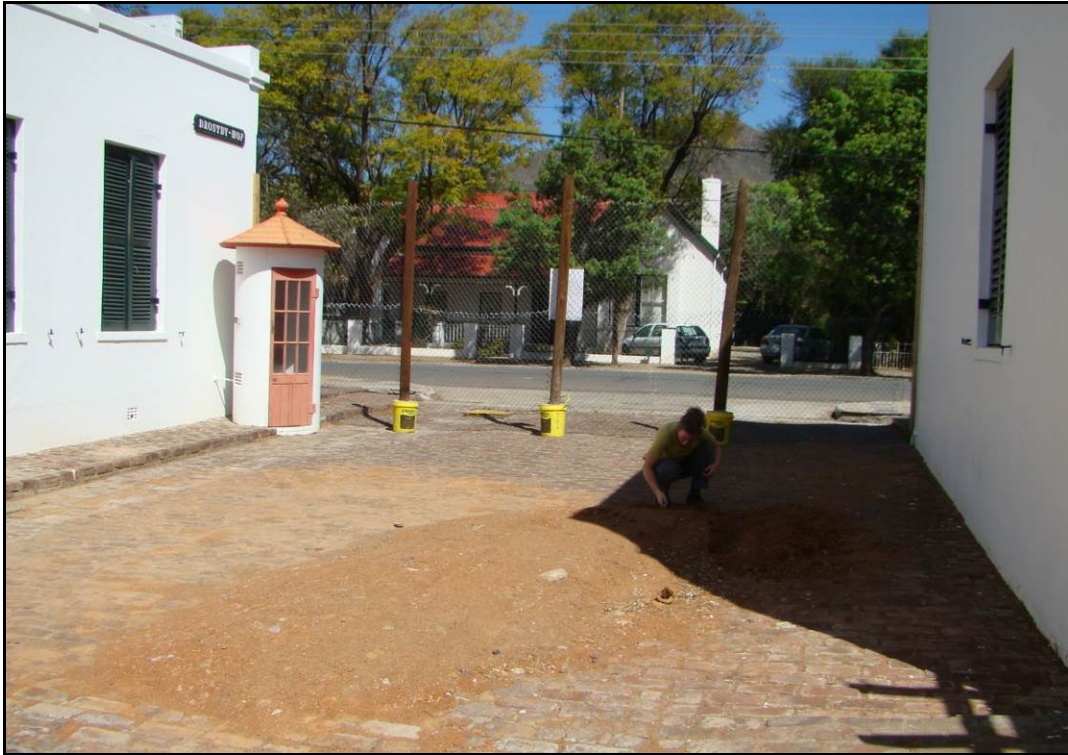
A large heap of soil containing 19th century historic material was recorded at the entrance to the brick road (or “Vrystraat”) between the cottages (Figure 18).

Figure 18: The location of the spoil heap at the Bourke Street entrance to Stretch's Court.

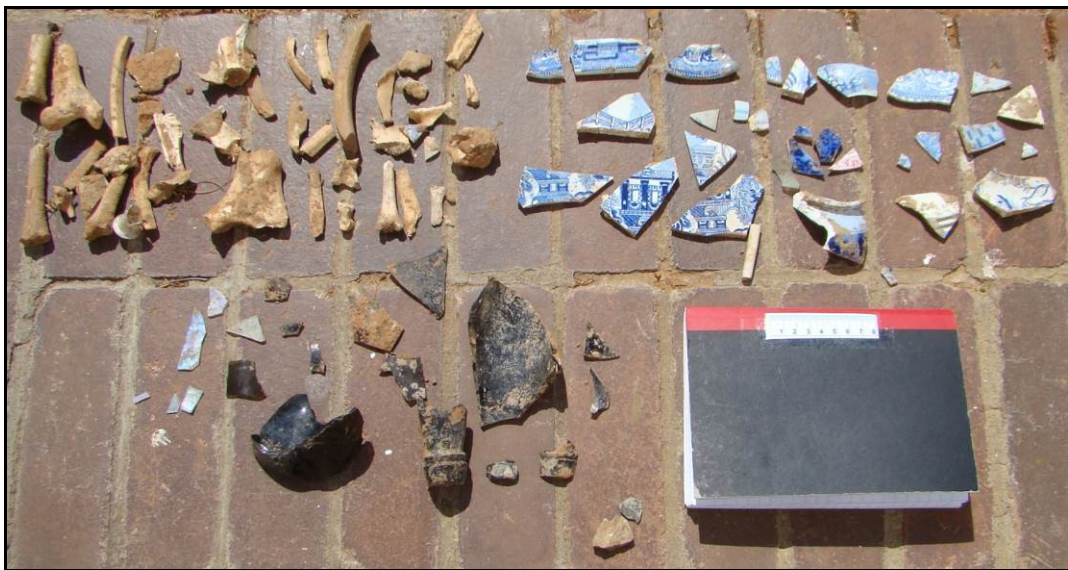
The collection includes British refined earthenware with predominantly blue transfer under-glaze, with the Willow Pattern in particular being preferred. There was only one fragment of industrial slipware. The green bottle fragments include one “kick-up”, there is a single fragment of a clay pipe stem and a small collection of bone (Figure 19).

The collection can be approximately dated to the second half of the 19th century and reflects the remains of domestic refuse. In all likelihood, these derive from the Stretch’s Court cottages.

Figure 19: Sample of material collected from the spoil heap.

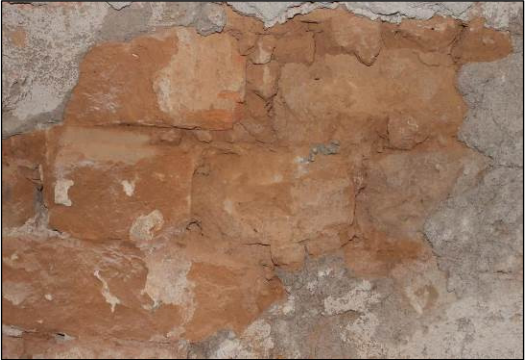
<p>This is the walling from the exterior back wall of the Drostdy Hotel and represents the oldest section of the wall. The red bricks are soft and bonded with a red clay mortar.</p> <p>These bricks appear hand made as they are irregular in size and shape. Their orange-red colour suggests that they were fired, but possibly at a low temperature which would explain why they are so soft. There is some evidence at the Drostdy for a mortar or a plaster of lime.</p>

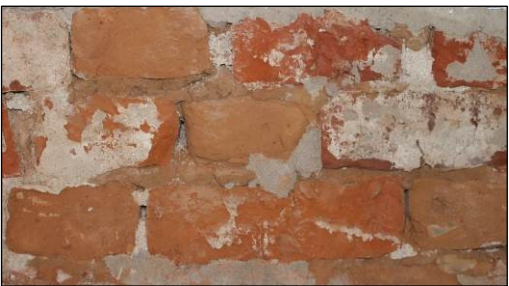
<p>The red bricks in this courtyard wall of the Drostdy Hotel are larger than the current standard brick size. They are bonded with red clay mortar.</p>

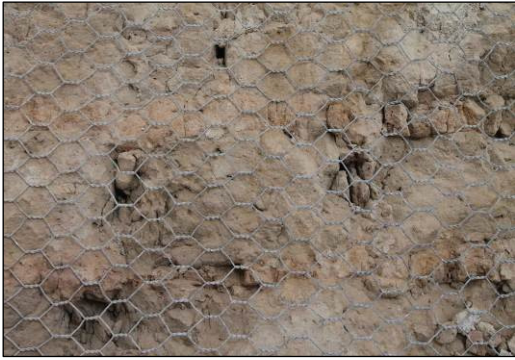
Walling from plaster strip 5B in Cottage 5. The bricks are an “olive/brown” colour and appear unfired. They are bonded with thick red clay mortar and held together with chicken wire.

These bricks are hand-made and unfired – they may have been sun dried.

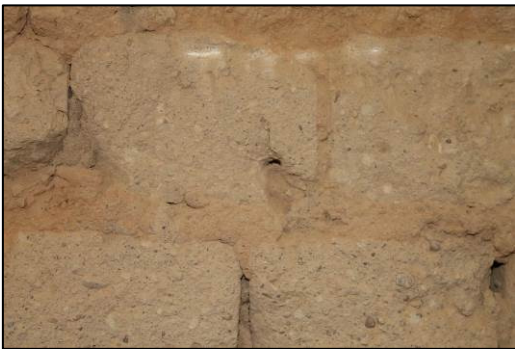
Walling from plaster strip 14E in Cottage 14. The bricks are similar to those above, they are a pale “olive/brown” colour and contain small gritty admixture. They are bonded with a red clay mortar.

Similar walling recorded from plaster strips 14D; 14K and 14L (the latter two are behind chicken wire) in Cottage 14.

They are also hand-made and unfired.

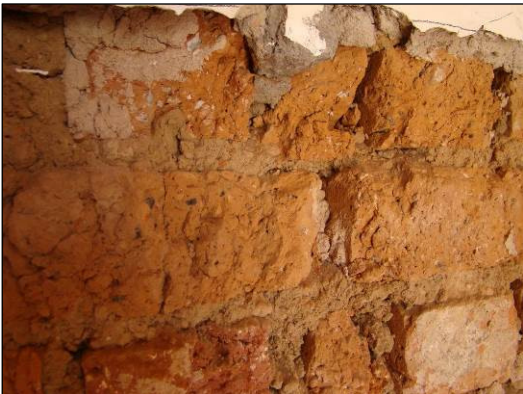
Walling from plaster strip 3A in Cottage 3. Friable red brick with a white fleck, bonded with red clay mortar.

Similar walling recorded from plaster strips 3B, 4 A, 4 B, 5A, 14F and 14G (Cottages 3, 4, 5 and 14).

The interior walling in cottages 12A, 12B and 12C consists of friable red brick with white fleck, but they are bonded with grey cement. The walling of cottage 14M is similar to 12 above.

These red bricks with white flecks resemble the bricks with the V-incised “frogs” recovered from Kromm’s Inn courtyard.

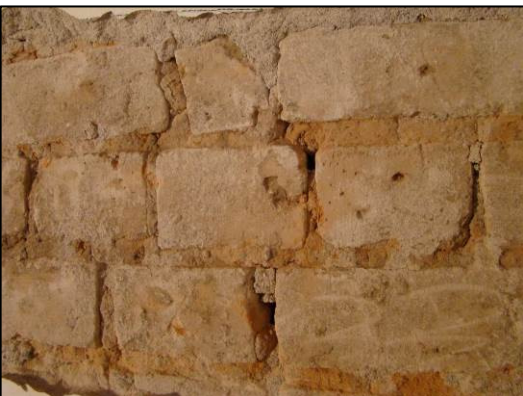
Walling from plaster strip 14A in Cottage 14. Standard red brick in good condition with red clay mortar.

Similar walling recorded at from plaster strips 14B and 15A in Cottages 14 and 15.

These bricks are machine made and they are fired.

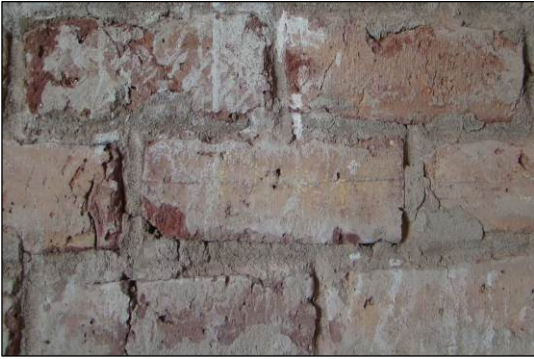
Walling from plaster strip 5C in Cottage 5. Standard red brick with white fleck in good condition, bonded with grey cement plaster.

Similar walling was recorded from plaster strips 14C, 14 H, 14I and 14J (Cottage 14).
