Phase One Cultural Heritage Impact Assessment of the Proposed Development of Erf 458 (653 Town Bush Road), and Erf 1988 (12 Craigie Drive), Umgungundlovu Local Municipality Pietermaritzburg.

For (Re)invention Studio Architects.

Active Heritage CC and Cultural Solutions Heritage

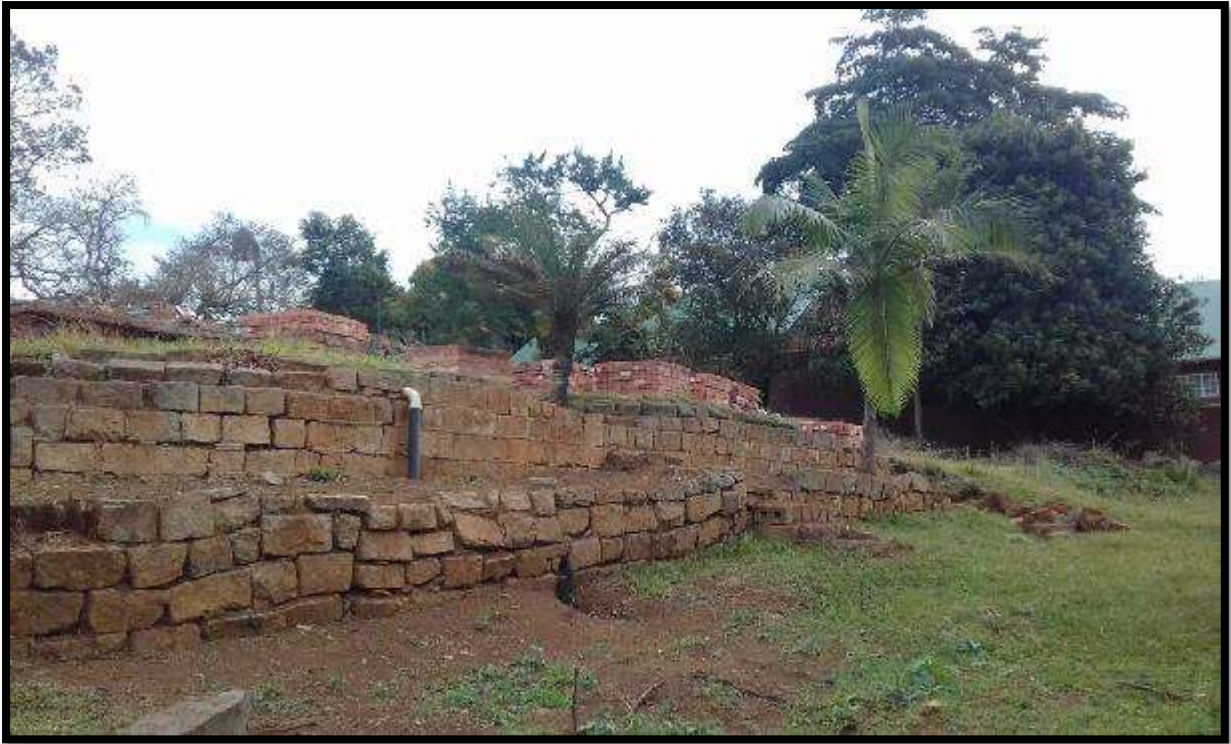
Plate 1. The retaining walling below the foundations of the demolished house. These large blocks created terracing leading to the demolished house. These large, undressed blocks are quite typical of the older properties in the KZN Midlands. One can see just above the stone walling bricks which were obtained from the house stacked up around it. Old cycads can be seen to the right of the photo. Photo: Frans Prins.

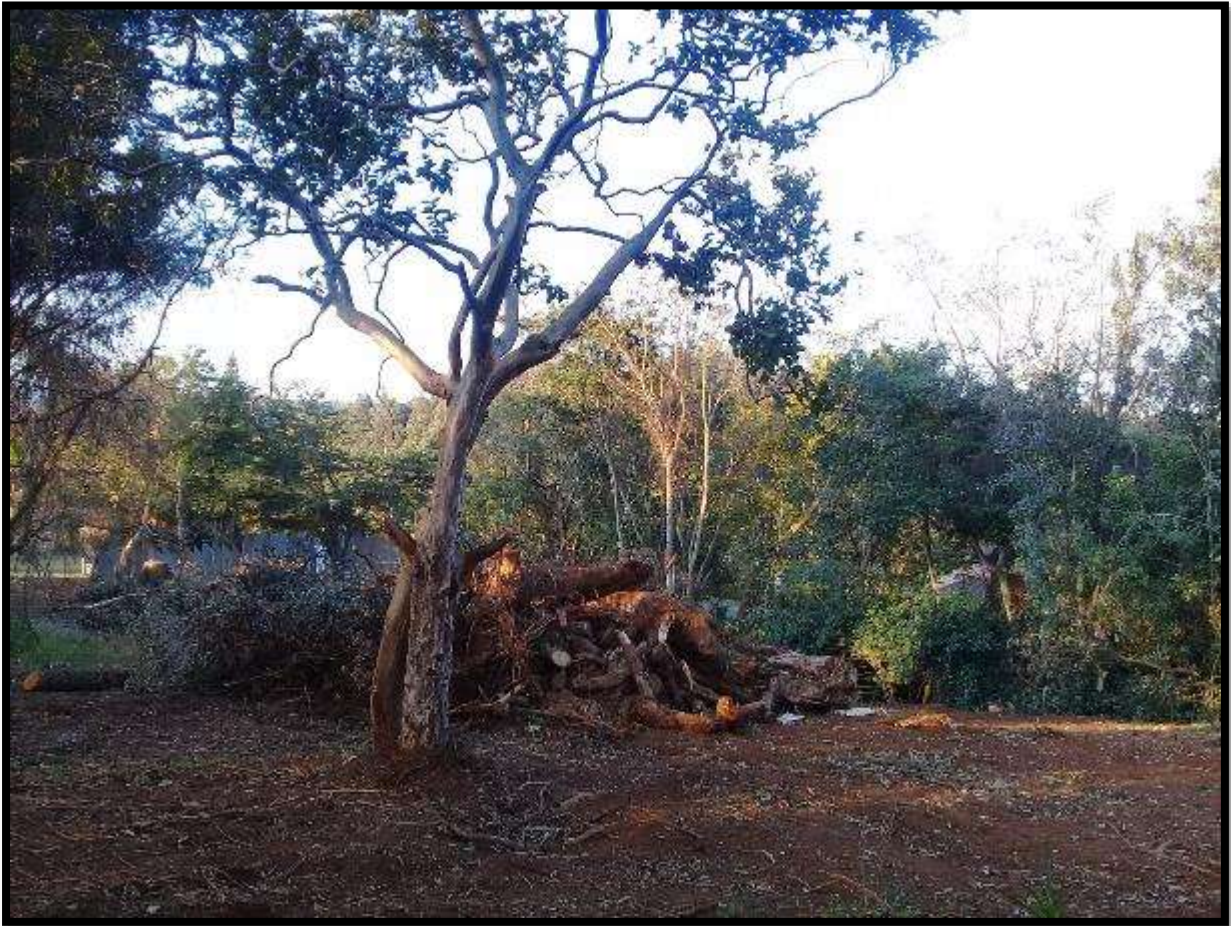
Plate 2. The large tree which had been felled on site. This tree is likely to be more than 60 years in age, and as such is protected by the National Heritage Resources Act. Photo: Sian Hall.

We also noted during our first visit on site that a very large tree had also been felled. This is unfortunate since this tree must surely have been more than 60 years old in age. Two more

trees, very likely exceeding 60 years⁶, were pointed out on both visits to architect and developer, and it was requested that these be retained since they gave a typical “Sense of Character”, and Olde World Victorian-Edwardian charm, to the area. This is a “Sense of Place” that is noticed, familiar, and appreciated, by European descendant residents of the area, and which they have asked, in interviews, to be retained.

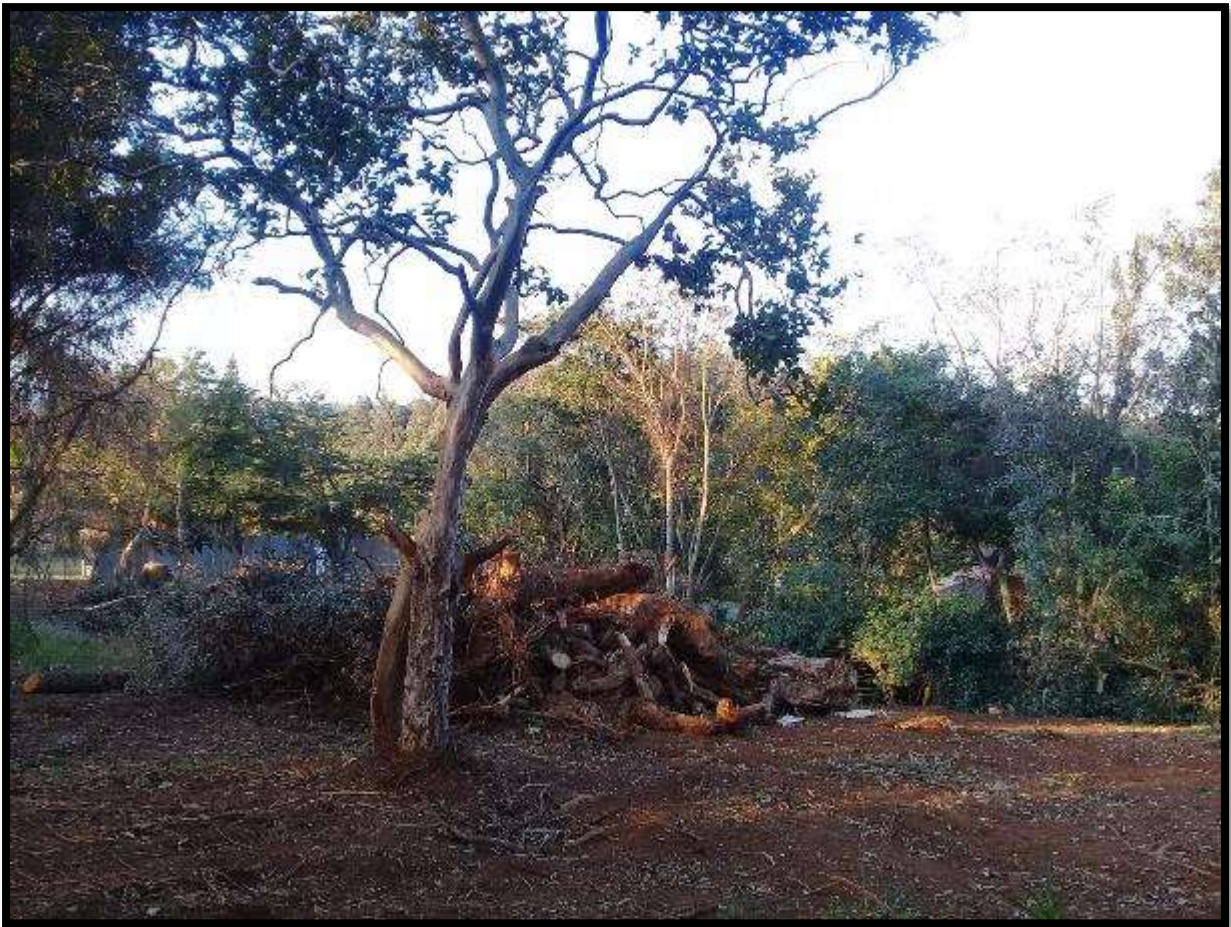
Plate 3. Photo taken a little further back provide an impression the size of the branches which belonged to the felled giant tree on the proposed development footprint. Photo: Sian Hall

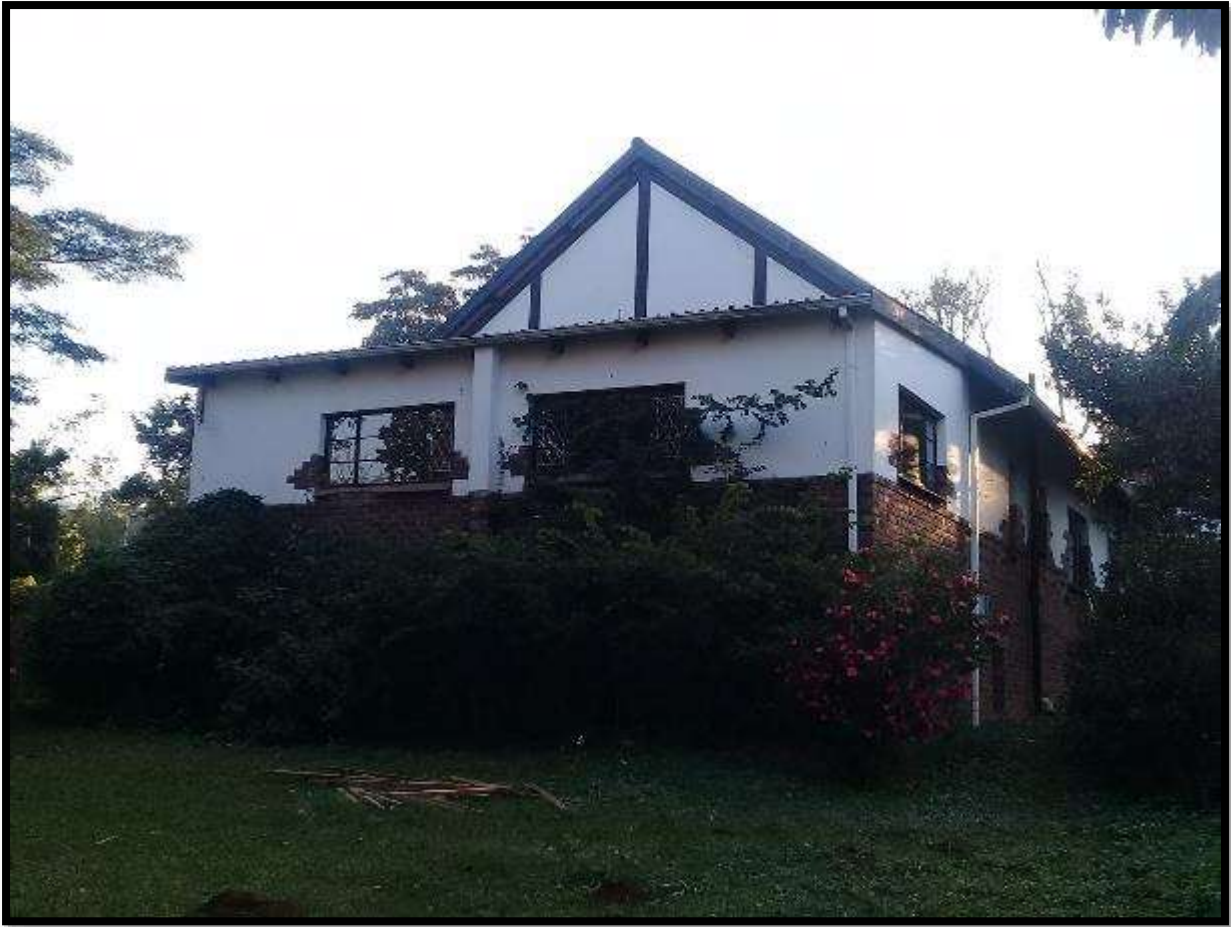
Plate 4. The intact house at 635 Town bush Road, built in the Tudor Revival style, and with Union style influence as made popular by Sir Herbert Baker. Note the characteristic Tudor Style elements such as the high-pitched roof and the wooden decorative elements (as seen on Elizabethan buildings). It is enfolded within hydrangeas, and other garden vegetation, as typical of the British country gardens which is informed by the British concept of “Controlled Wilderness”, or “Tamed Nature”, and which contributes to the British Country Landscape of the Midlands in general. Photo: Sian Hall.

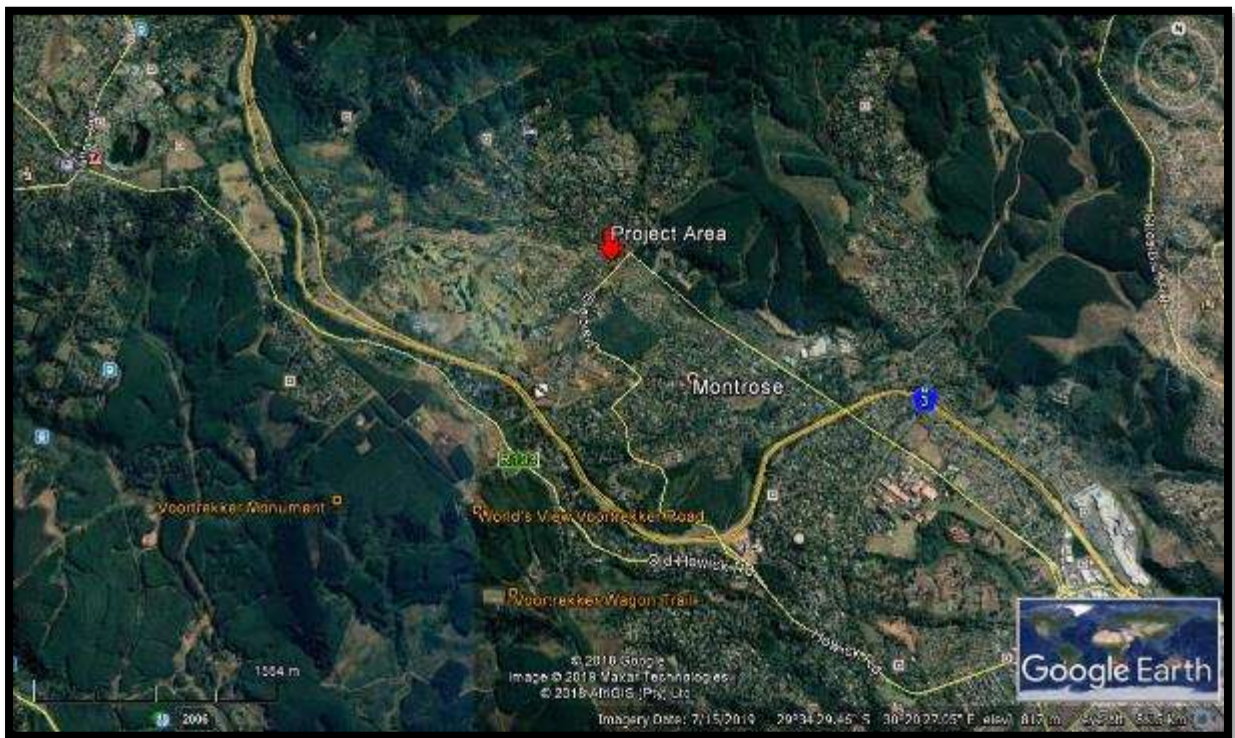
The study footprint lies within a broad valley with heavily forested mountains running along a north-south axis to the east and to the west. It snuggles up closely to the eastern line of mountains, and close to the neighbouring suburb of Montrose to the south-east.

Photo 5. Google Earth Photograph. The proposed development footprint in relation to other important historic sites in the general Pietermaritzburg area. This photo also shows the study footprint lies in a broad valley with heavily forested mountains running along north-south to the east and to the west. The footprint itself, nudges up against the eastern line of mountains. It lies very close to the neighbouring suburb of Montrose.

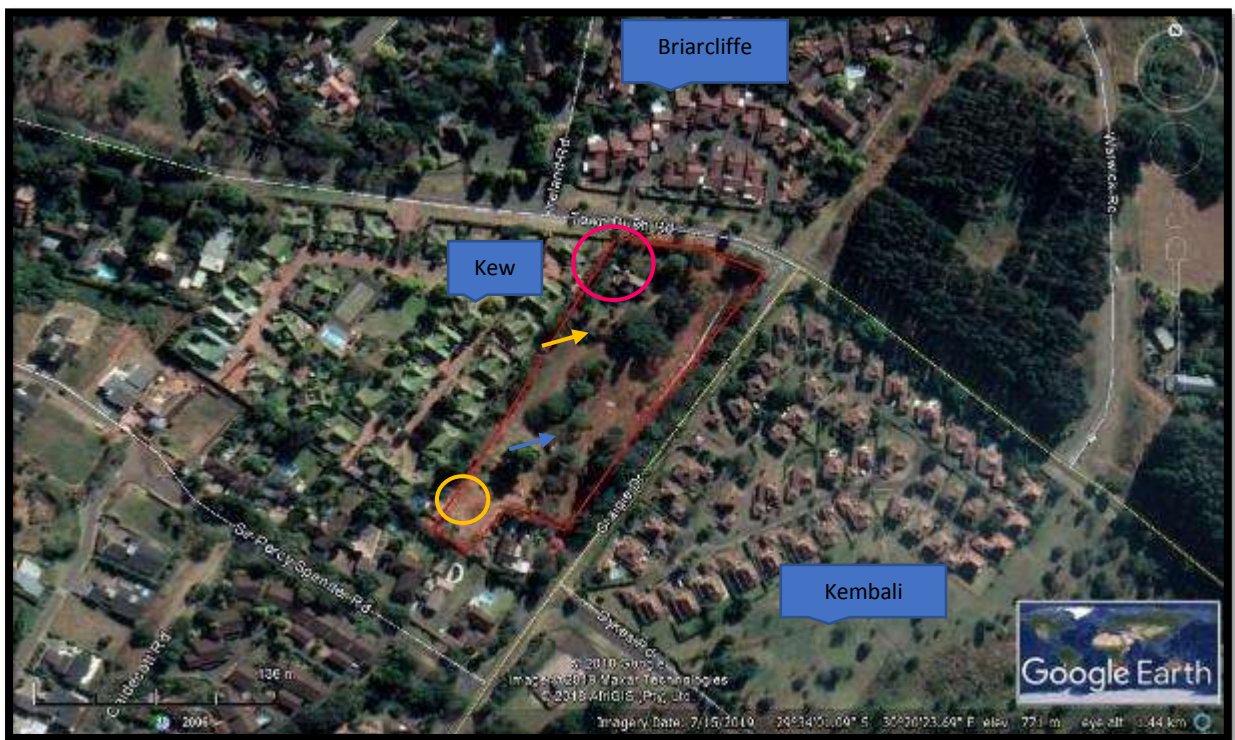
Plate 7. Google Earth Photograph. The study footprint, outlined in red. Within the yellow circle the foundations of the demolished building are evident, and within the pink circle the standing Tudor Revival style house and its associated outbuilding are evident. Just below the pink circle the large tree which was felled is visible. The yellow arrow indicates the very large tree which was felled while the blue arrow indicates another large tree which should probably be left standing in order to retain something of the Olde World country character that this property presented, and which is evident in the wider area. This photo also shows how the study footprint is surrounded by various other townhouse development of various styles.

Plate 7. below, also displays just how forested the footprint is, or was. Large trees are noticeable, most especially the large tree towards Town Bush Road, which has subsequently been felled. Also visible is the thick border of indigenous vegetation along Craigie Drive, much of which has also been cleared. The foundations of the historic house which was demolished can be seen within the yellow circle to the south-west of the footprint, while the standing historic Tudor Revival style house is located to the north-west of the footprint

within the pink circle. Town Bush Road runs along the northern boundary of the study footprint, while Sir Percy Spender runs parallel to it to the south of the study footprint. Craigie Drive runs along the eastern boundary. Our interviews with residents residing within 100 metres of the property were conducted on these roads.

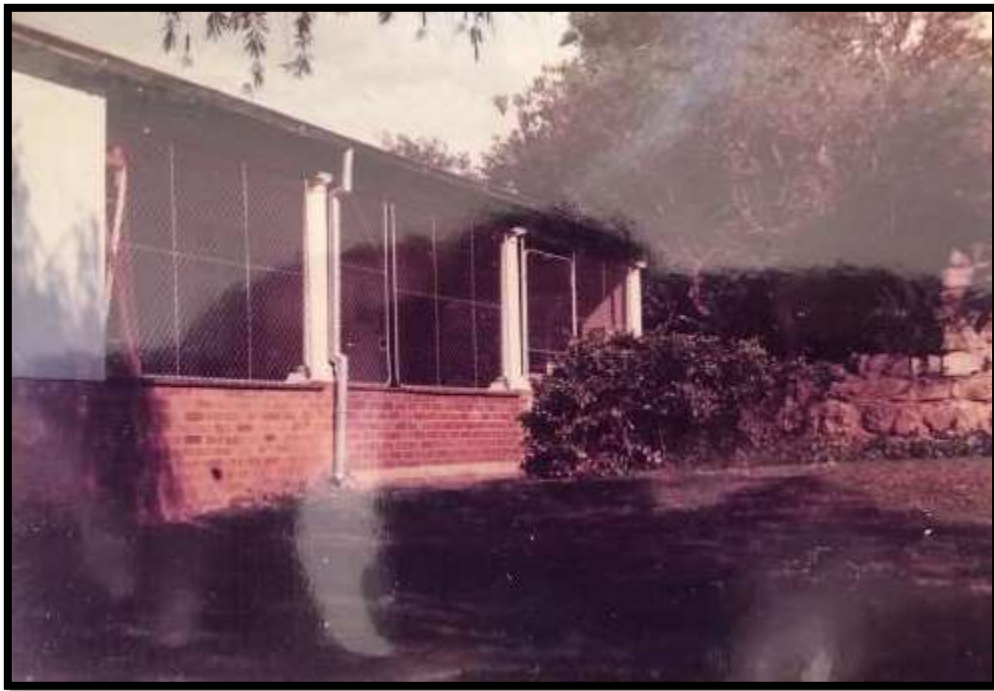
Plate 8. The back of the house at 12 Craigie Drive in the past, before it was demolished. This photo tends to support the information that the house was originally a farmhouse since many farmhouses in the region have long enclosed fenced back verandas just such as this one.

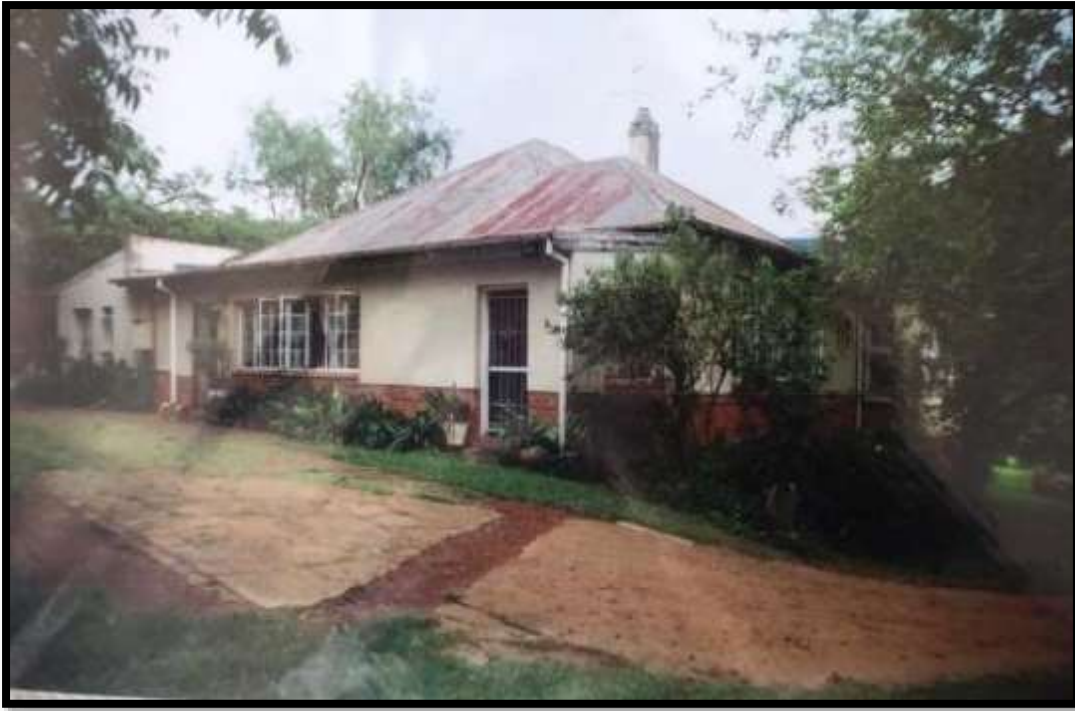
Plate 9. The high-pitched roof, and high, embellished chimney are typical of Victorian-Edwardian architecture in this region. Other Edwardian features include red brickwork, as can be seen on the lower level of this building. Photo: courtesy Mohammed Moosa.

Features that suggest the Victorian and Edwardian influence in this old farmhouse house include the high-pitched roof; the tall and rather ornate chimney; the red brickwork on the lower level of the wall; the rather squat and roomy design and large windows. Other revealing elements of the Edwardian period include the house's placement well within the garden, so as to afford privacy from the street view (Mason, 2019).

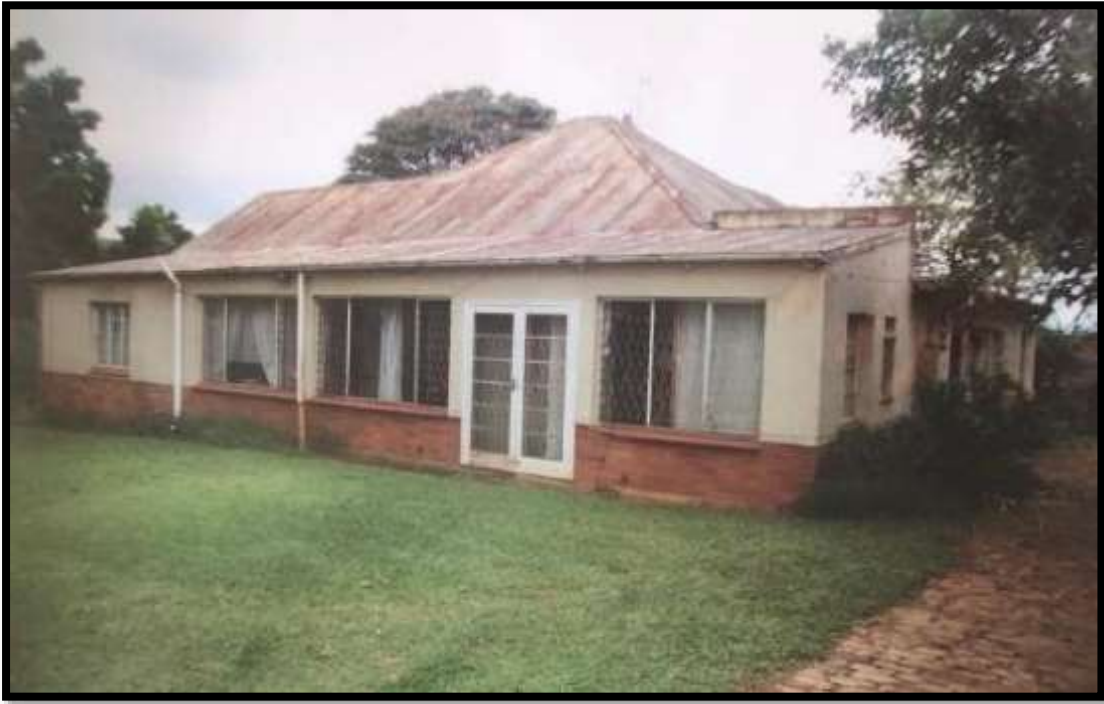
Plate 10. A better view of the same side of the house, but without the chimney. The rambly, ad-hoc, and organic style of the house is typical of influence from the Picturesque Movement in house styles, discussed earlier in the text. A building does not have to be symmetrical, or beautiful, to be considered heritage. Photo: courtesy Mohammed Moosa.

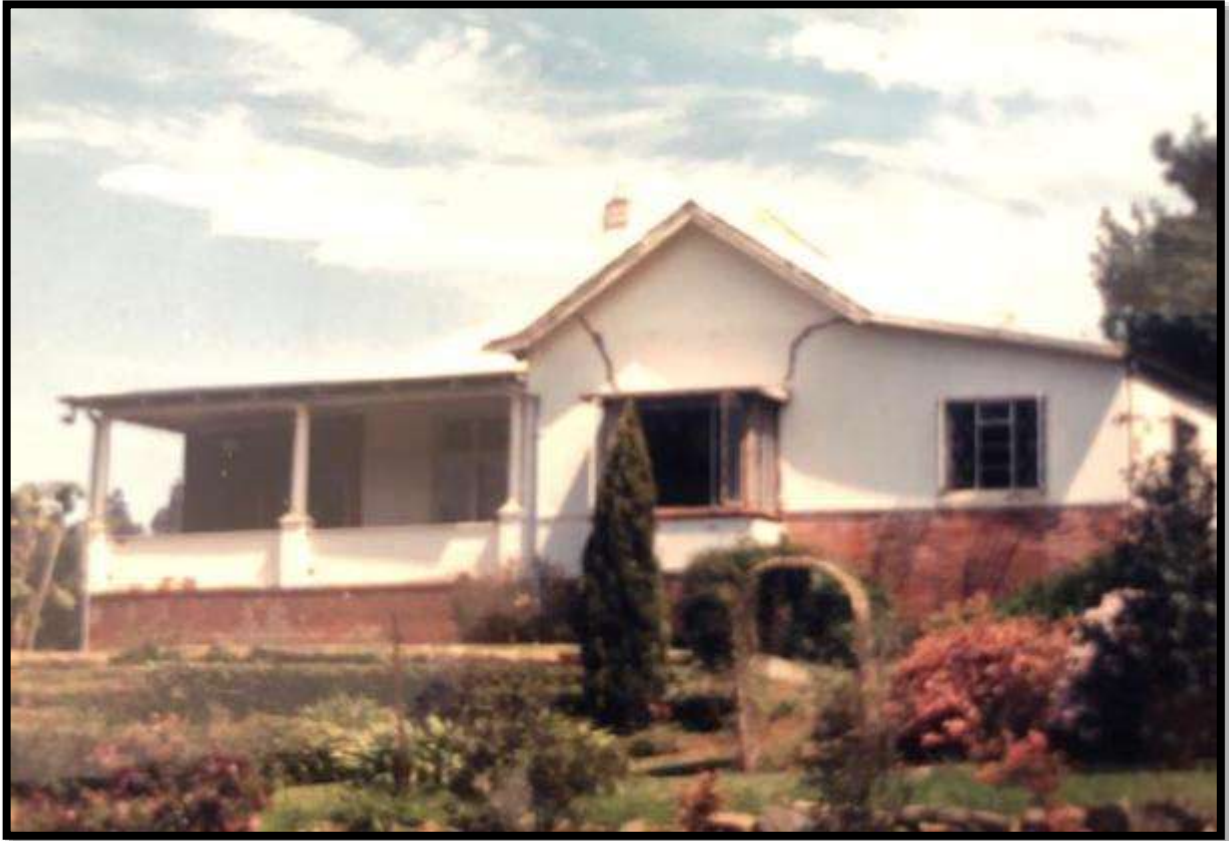
Plate 11. In this photo the Victorian-Edwardian pitched roof, high chimney, deep columnaded verandah and red brickwork are all apparent. While perhaps not an aesthetically pleasing house, this house is very typical of farmhouses in this region. The cracks in the walls of the house are also very apparent. Photo: courtesy Mohammed Moosa.

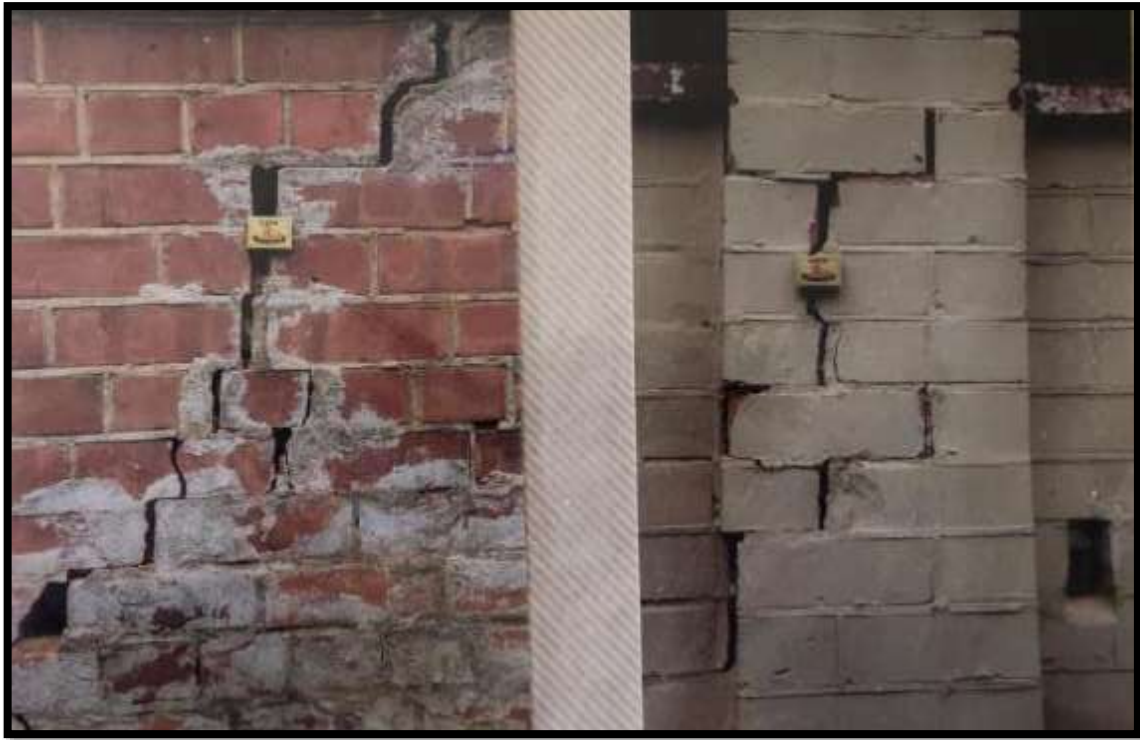
Photo 12. These are photos of a brick wall in which there are large cracks. These photos were provided by Mr Mohammed Moosa, stating that they are of the walls of the house at 12 Craigie Drive. Photo: courtesy Mr Mohammed Moosa.

¹³ Mr Mohammed Moosa mentioned telephonically in November 2019 to Sian Hall that when the house at 12 Craigie Drive had accidentally been partially knocked down with his equipment, he summoned an engineer who advised him to demolish the building since it now presented a safety hazard. Sian Hall requested an official letter from the Engineer by way of explanation, but this has not been forthcoming.

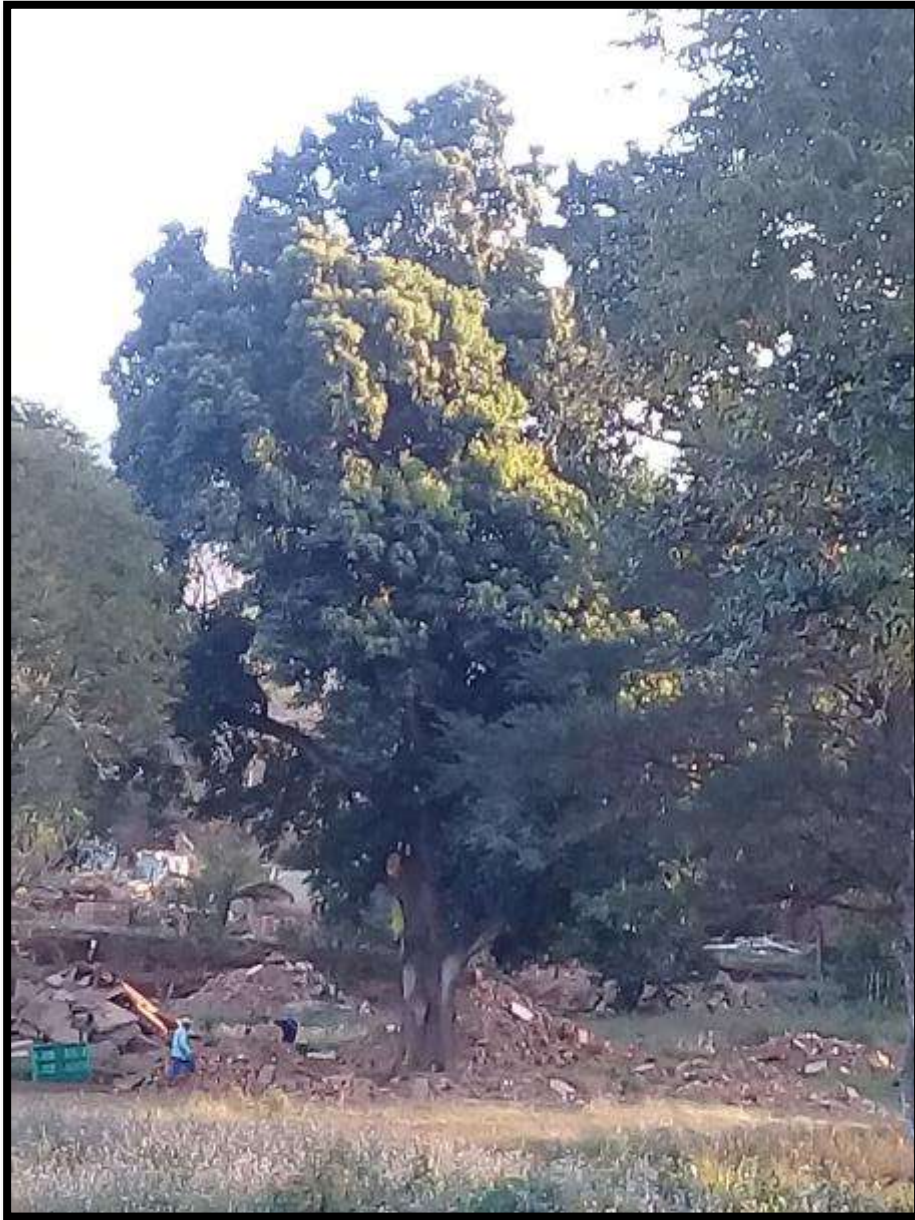
Plate 13. The largest remaining tree on the proposed development footprint. The presence of the workers in the image provide a reliable scale on just how enormous this tree is. It is an absolute living monument, which should not be felled. Heritage Law dictates that such trees, rich in meaning for the people around them, should be protected as heritage features. This tree is clearly more than 60 years of age. Photo: Sian Hall.

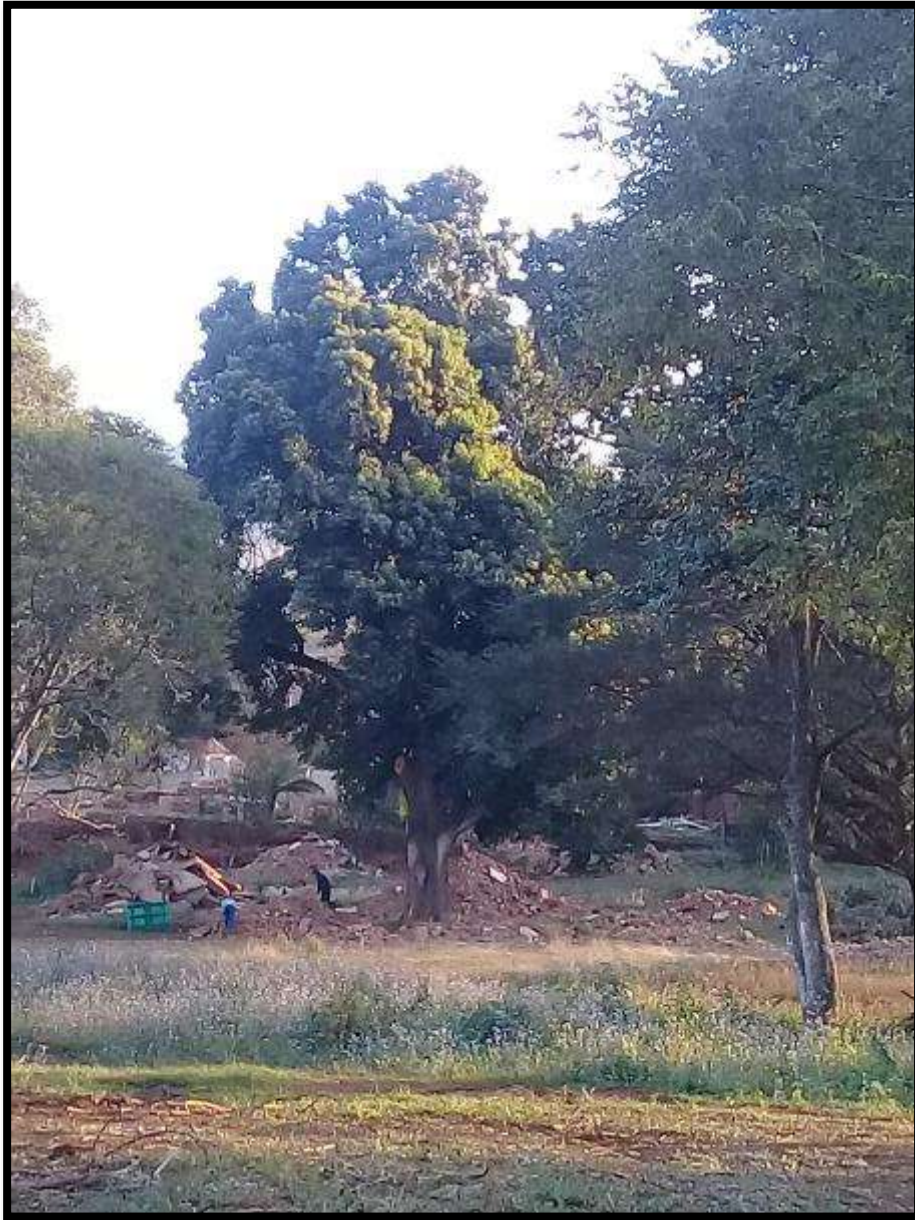
Plate 14. Another photograph of the very large tree that should be protected. Also, some examples of other trees on the property, which provide the feeling of a “domestic wilderness” – a landscape much sought after, since it characterises the “Cultural Landscape” typical of this region. Photo: Sian Hall.

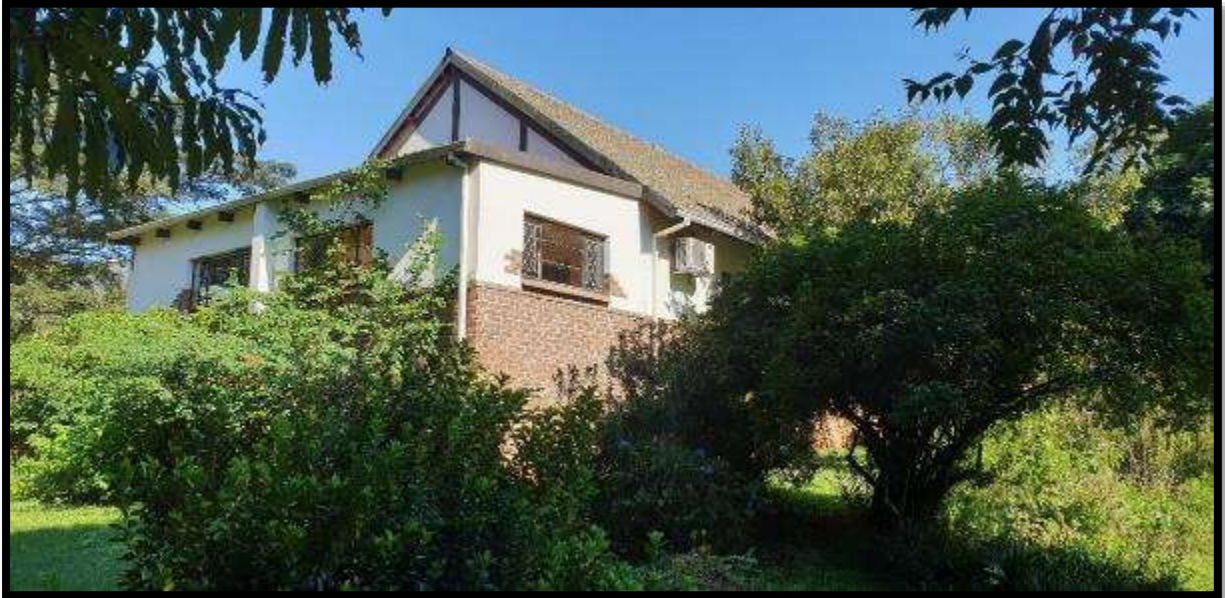
Plate 15. The Tudor Revival Style house at 653 Town Bush Road. This photo clearly shows how a purposefully created, yet controlled domesticated wilderness characterises this property. The house is enshrouded by shrubbery and growth. This was a trend that emerged, and became popular, during the “Picturesque Period” of British Architecture, and creative thought ¹⁴. Photo: Mr Ridwaan Essa.

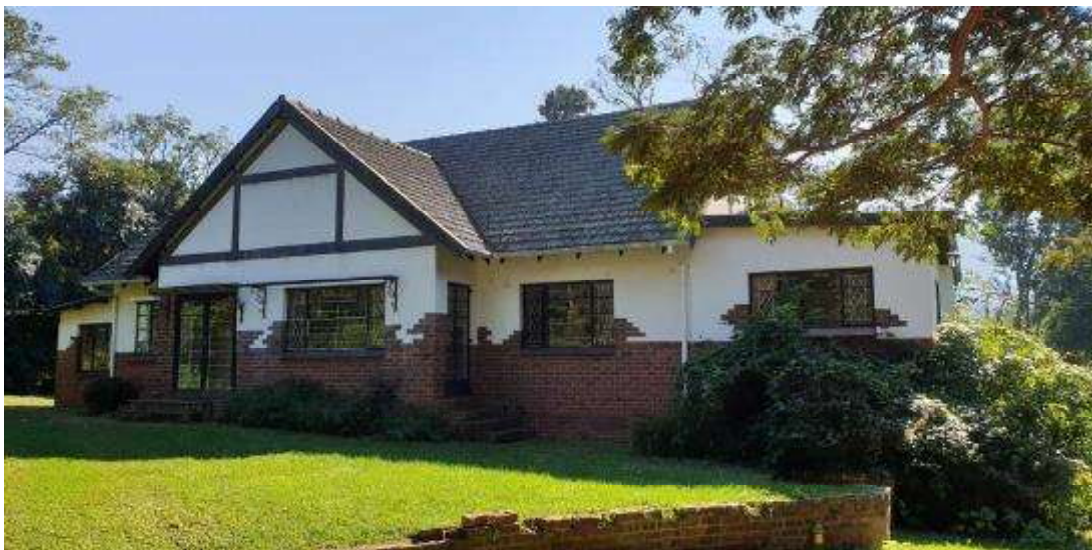
Plate 16. Another photograph of the Tudor Revival Style house snugly wrapped in shrubbery to the one side. Photo: Courtesy Mr Ridwaan Essa.

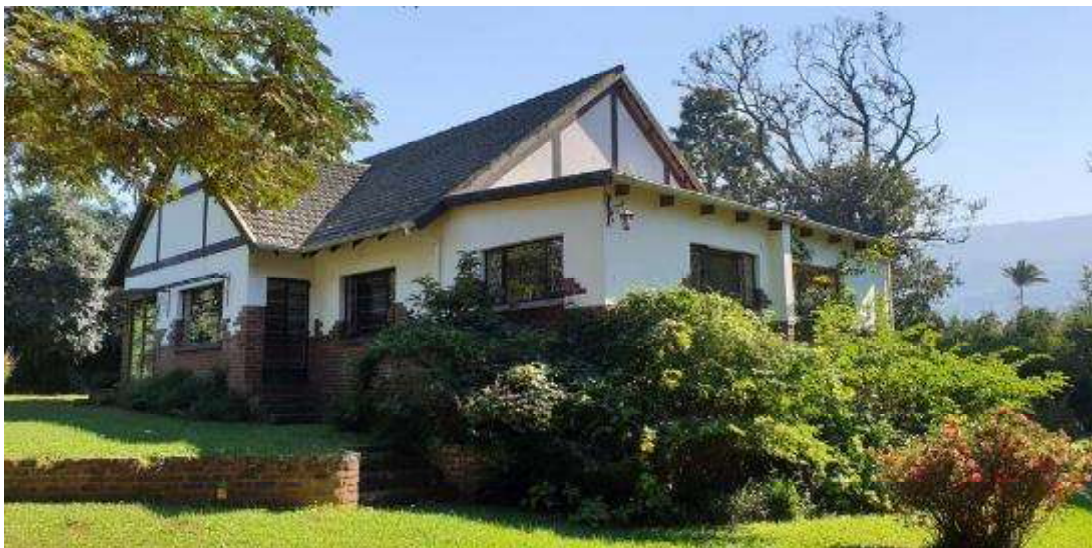
Photo 17. The Tudor Revival Style house at 635 Town Bush Road. The Victorian and Edwardian Tudor Style elements are apparent in the steeply-pitched roof; the wooden Tudor (stucco) decoration (half-timbering effect) on its upper walls; the half brick on its lower walls; and an overall suggestion of quaintness. Southern corner. Photo: courtesy Mr Ridwaan Essa.

The intact house that stands at 635 Town Bush Road is a historical home in the Tudor Revival Style. In this initial Phase 1 report we would argue that it could be classified as a Heritage Home. The Tudor Revival Style is a style that was very popular in Britain during the latter part of the 19th century. This style formed part of the domestic architecture of this period, and is based upon vernacular architecture of the Middle Ages in Britain, and which was strongly present during the Tudor Period, and for which it is named after. This influence of this style became evident in the British Colonies (https://en.wikipedia.org/wiki/Tudor_Revival_architecture), including South Africa, and specifically in the Cape and Natal.

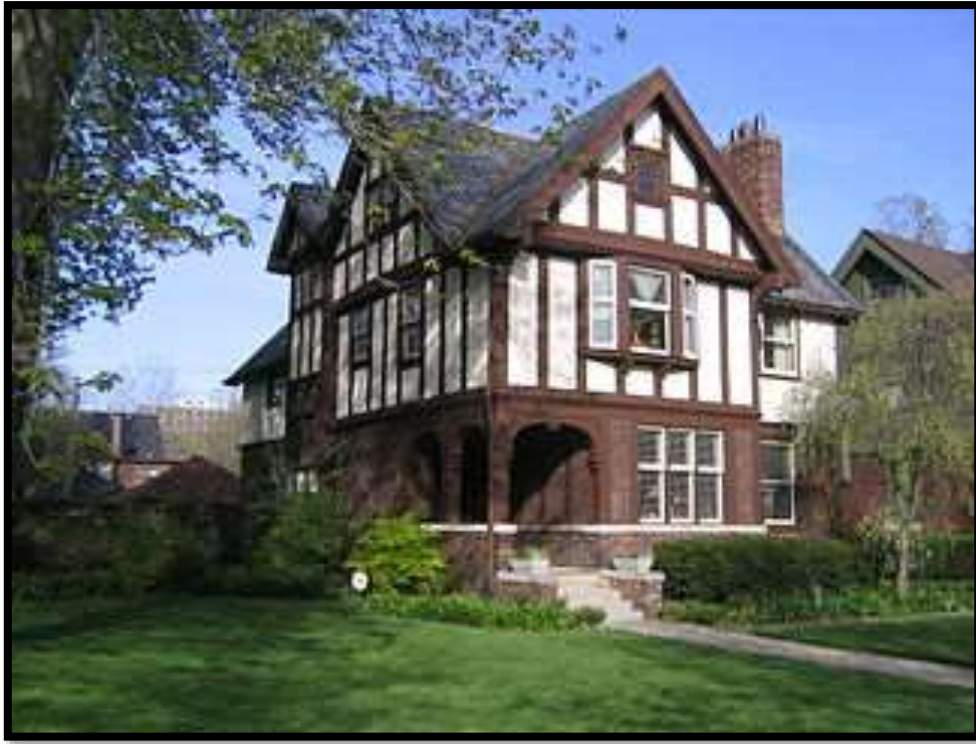
Photo 18. A Tudor Revival Home in Michigan. Although double-storied, it is very similar in appearance to the house at 653 Town Bush Road in appearance. Photo: <https://study.com/academy/lesson/tudor-style-homes-characteristics-design-interiors.html>

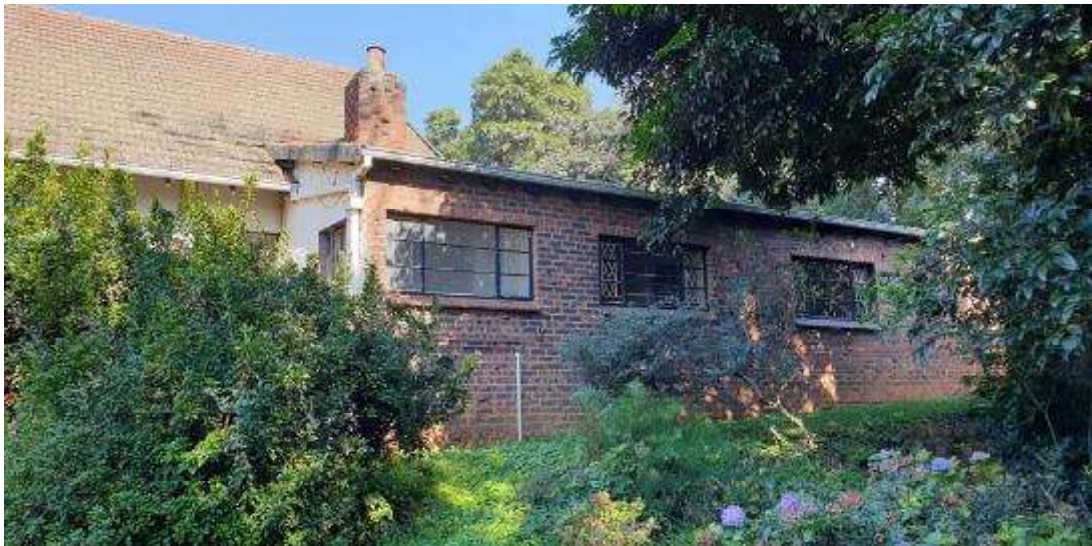
Photo 19. The eastern façade of the Tudor Revival home. Note the high rather ornate brickwork chimney with a chimney pot. This is very typical of the Tudor Revival Style, and of Edwardian homes as a whole. The reddish brickwork is also very typical of historic homes in this region, even though it is not of the old salmon-coloured brickwork seen during the deep Victorian and Edwardian period in this area. Photo: courtesy Mr Ridwaan Essa.

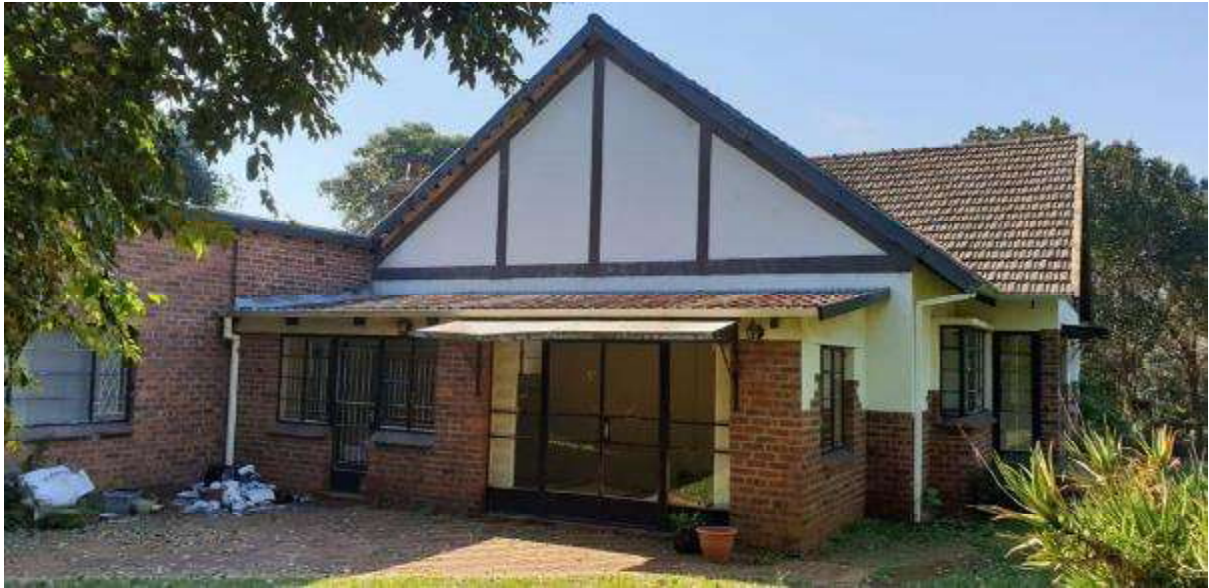
Photo 20: The western corner of the house. Note the stucco decoration is further reflected in the glass doorways, and windows so typical of this style. Also note the tall, rather narrow windows, in a simulation of the Gothic Style, typical of the Tudor Style; and of the jutting, and stepped side façade of the house, in the creation of an impression of bay windows, as well as the actual bay window. Western corner. Photo: courtesy Mr Ridwaan Essa.

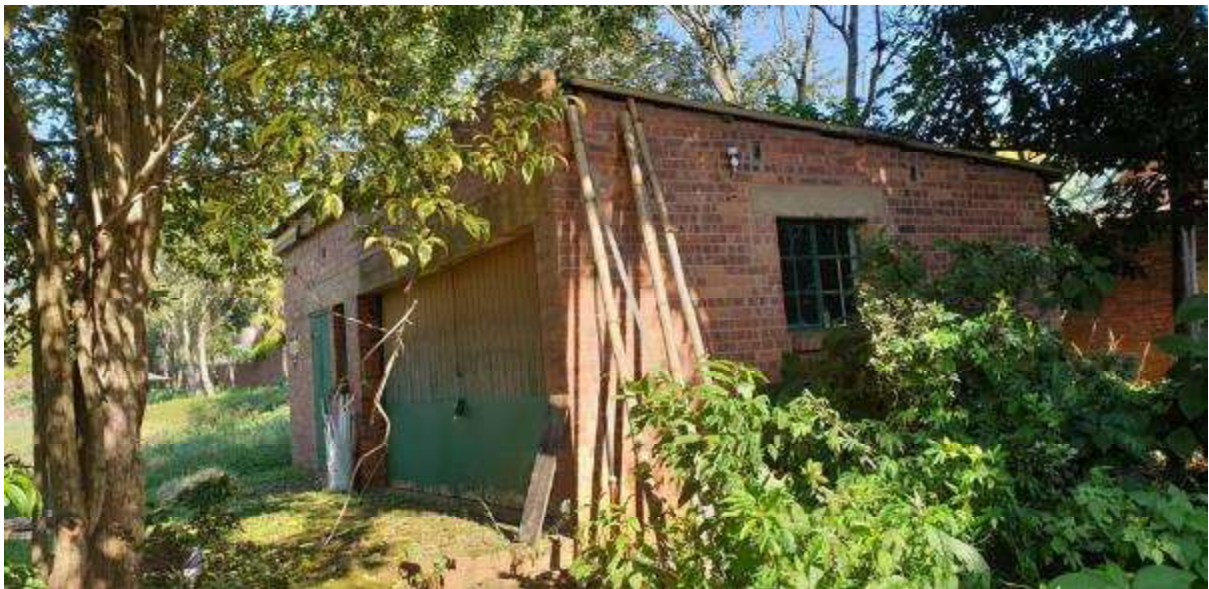
Photo 21. The red rick out-building at 653 Town Bush Road. A typical Edwardian style structure so typical of farm properties in the region. Photo: courtesy Mr Ridwaan Essa.

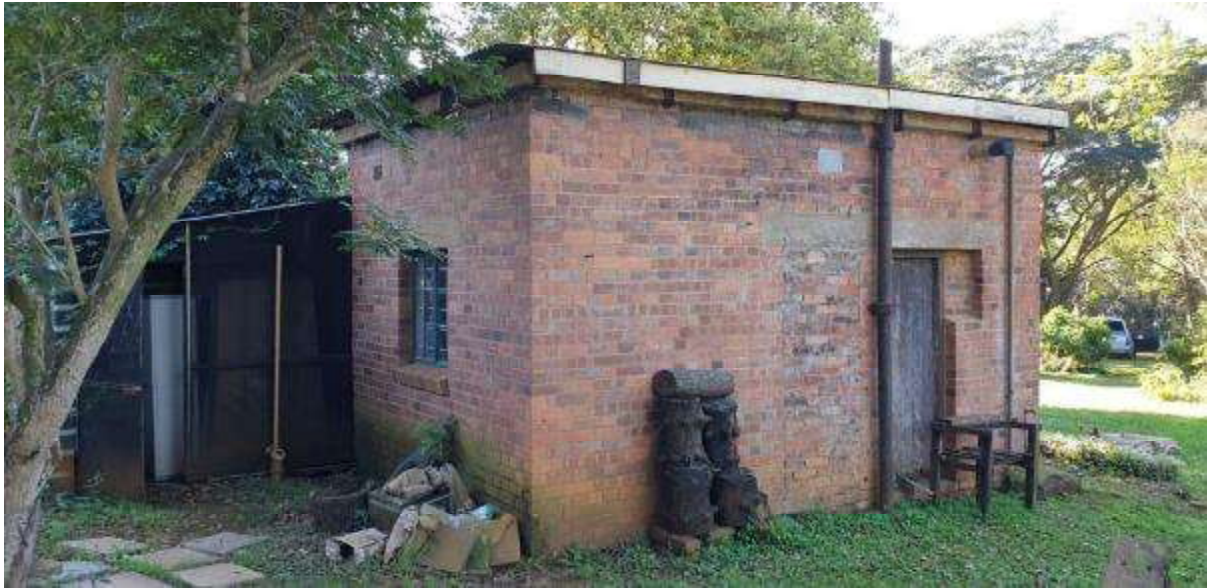
Photo 22. An alternate view of the out-building. Photo: courtesy Mr Ridwaan Essa.

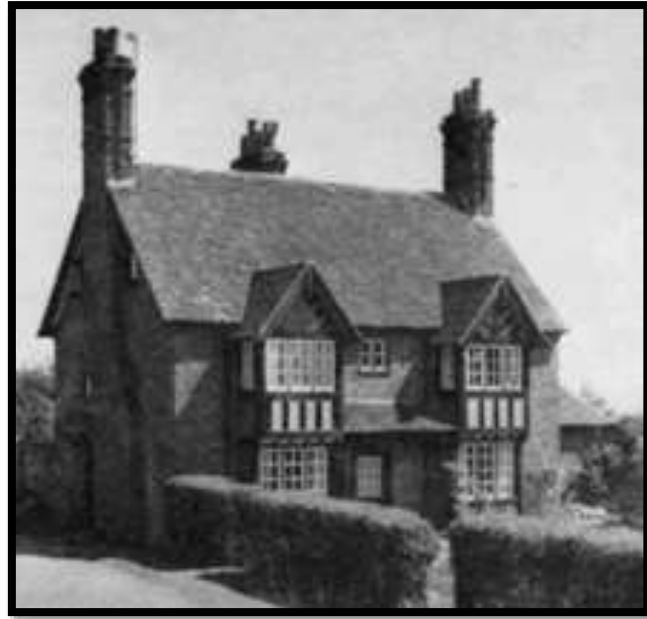
Photo 23: Built circa 1870 two semi-detached cottages at Mentmore appear as one Tudor style house. Source: Wikipedia.

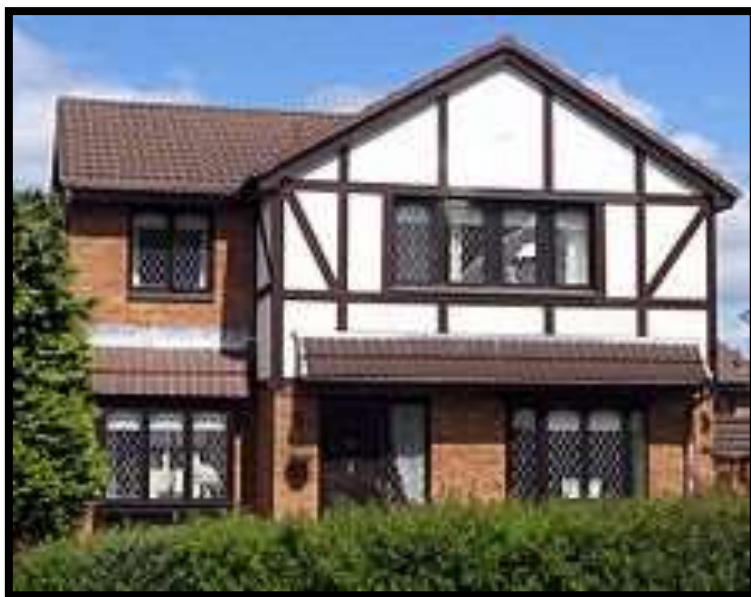
Photo 24: Tudor style house in Greenock, Scotland. Source: Wikipedia.

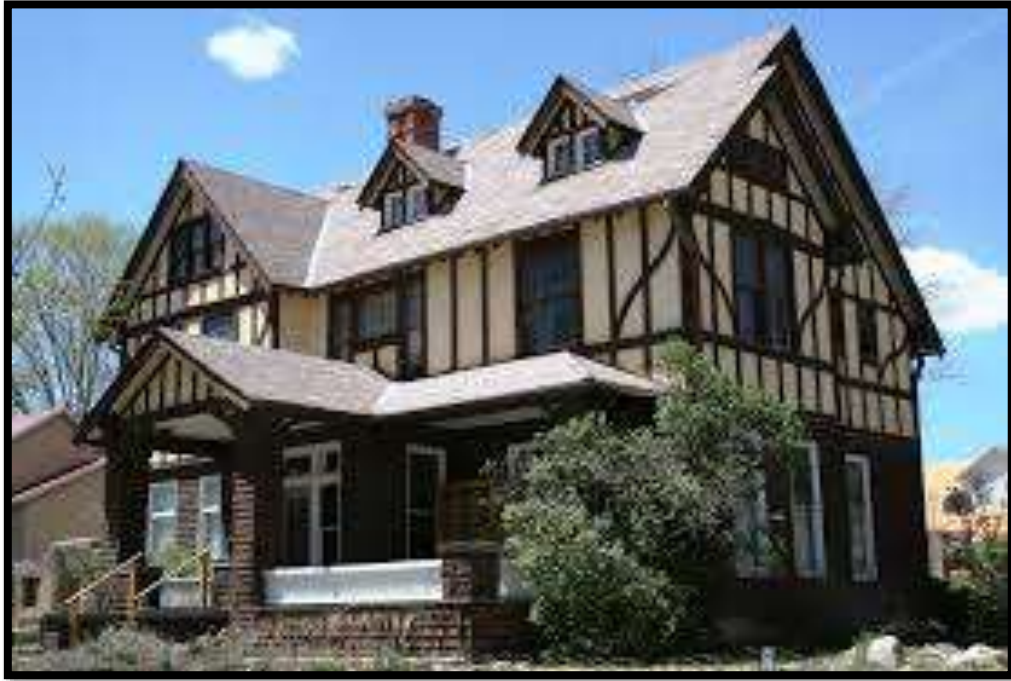
Photo 25. Tudor Revival Style House. Photo: Wikipedia.
