Phase One Cultural Heritage Impact Assessment of the Proposed Development of Erf 458 (653 Town Bush Road), and Erf 1988 (12 Craigie Drive), Umgungundlovu Local Municipality Pietermaritzburg.

For (Re)invention Studio Architects.

Active Heritage CC and Cultural Solutions Heritage

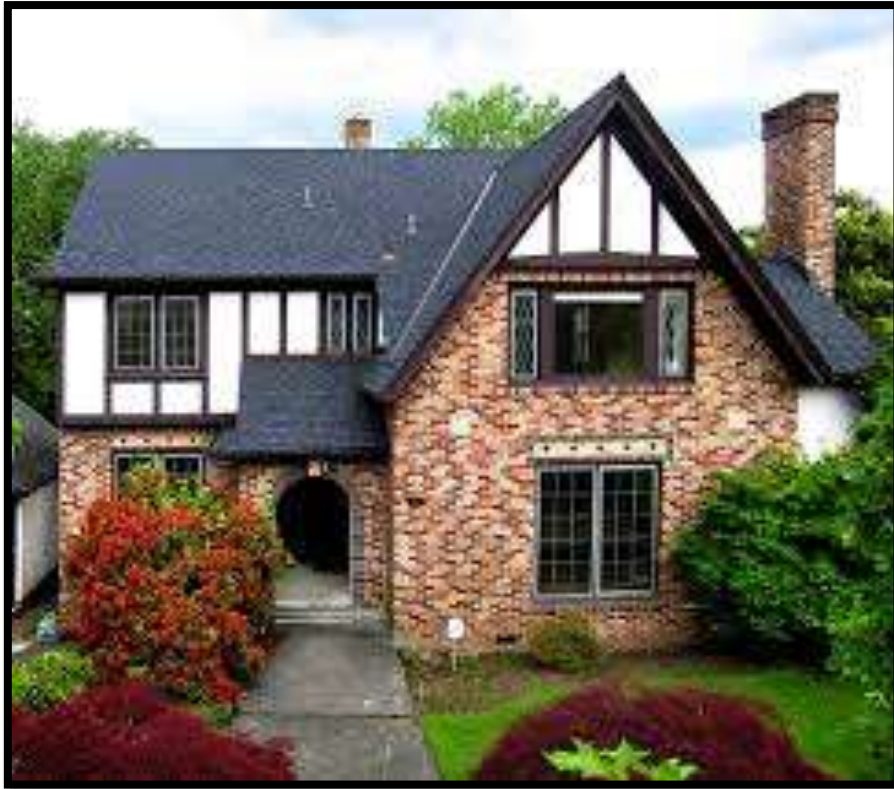
Photo 26. Tudor Revival Style House. Photo Wikipedia.

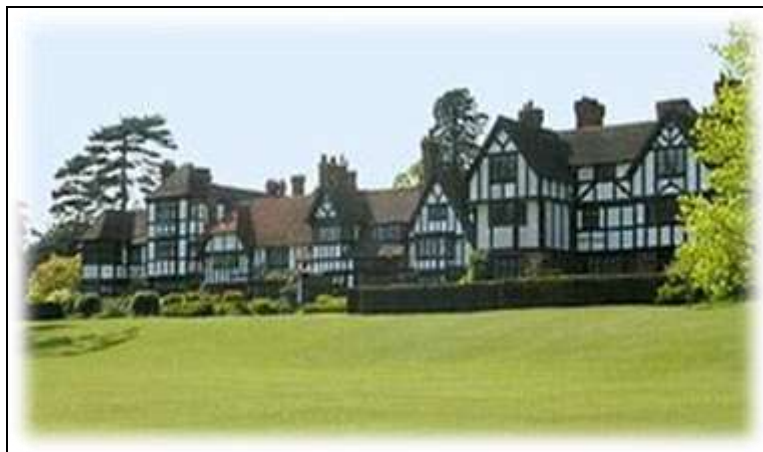
Photo 28. [Ascott House, Buckinghamshire](#). Designed circa 1876 by George Devey. Source: Wikipedia.

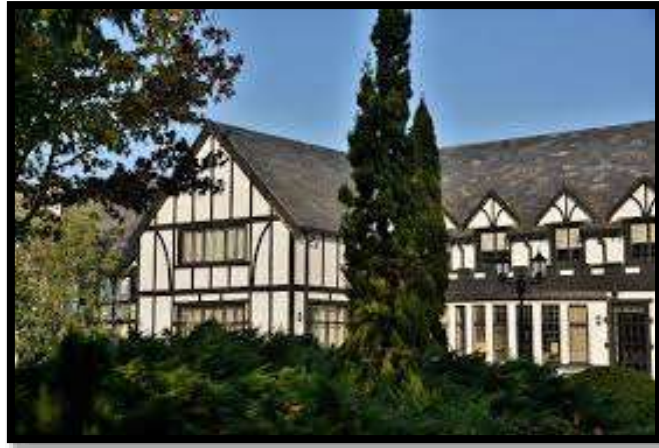
Photo 29. Protea Hilton Hotel in Hilton, Pietermaritzburg. A very good example in the KZN Midlands of a Tudor Revival Style Building. Photo: web.

There are only a number of examples of Tudor Revival buildings in the KZN Midlands. One very good example is of the Protea Hilton Hotel in Hilton. This building displays many Tudor Revival elements, such as steeply pitched roofs, “leaded” gable windows, clusters of ornamental chimneys and applied wooden stucco. Buildings such as this, depicting a style prevalent Britain, has been recreated in the Anglicised landscape of the KZN Midlands, to lend a “sense of Place”, and a uniquely English Olde World character to the Midlands region. It is for just such a reason that Townbush has been so named.

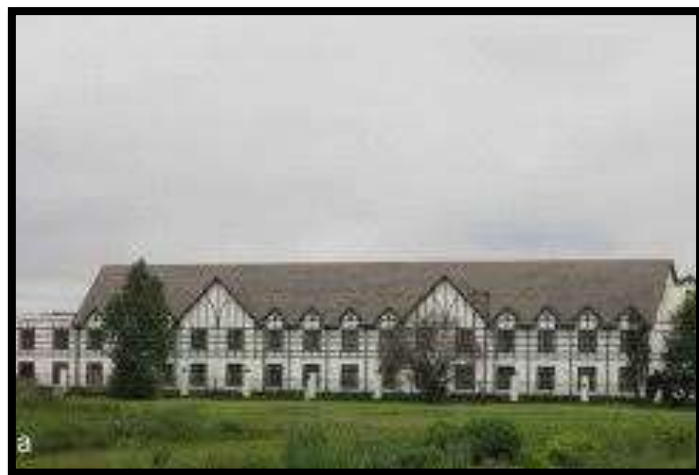
Photo 30. Protea Hilton Hotel. Showing detailing of the wooden stucco decoration. Photo: web.

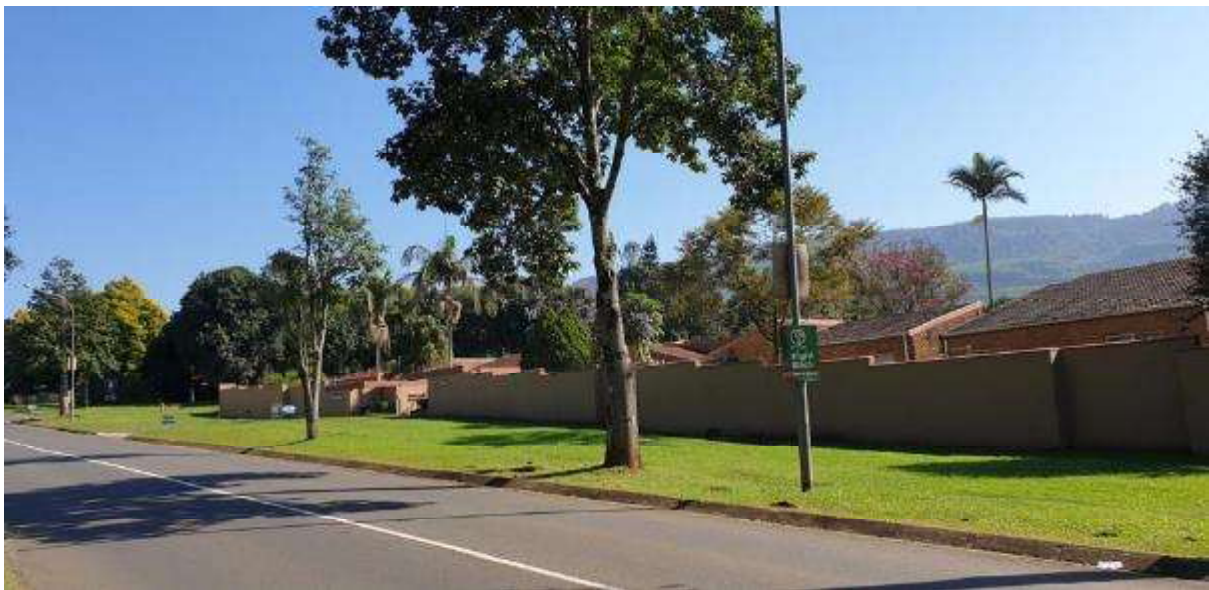
Town Bush Road acts as a main access road, linking the suburbs of Montrose, Town Bush Valley, Oak Park and Ferncliff with the Pietermaritzburg CBD and the N3 Highway. It is typified by wide verges¹⁵

Photo 31. Photo demonstrating the wide verges typical of Town Bush Road. Photo: (Re) invention Studio Architects.

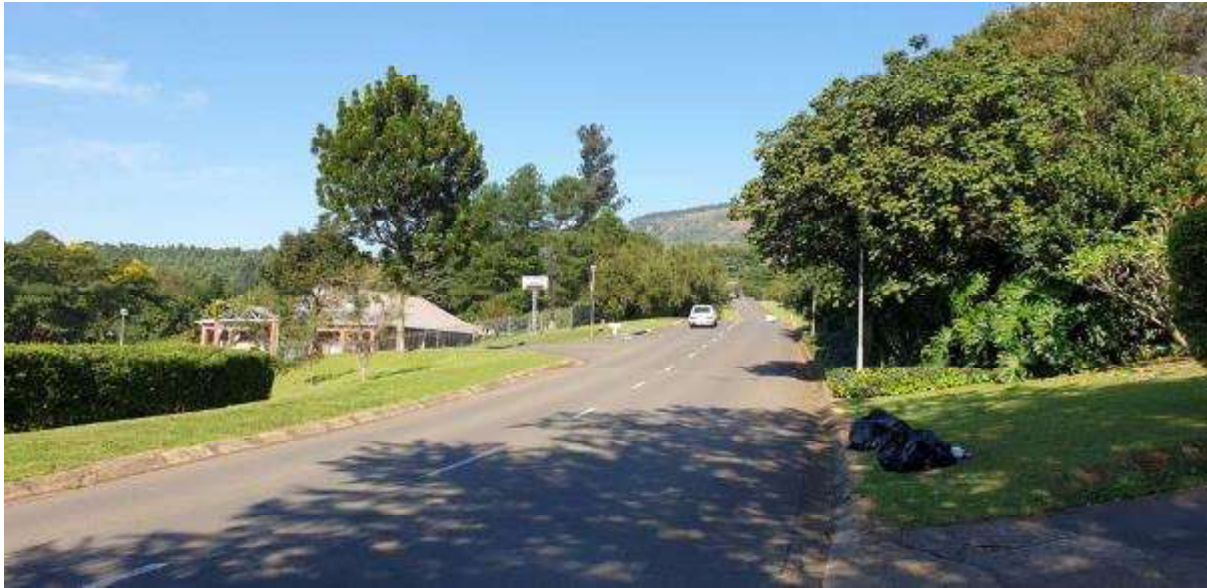
Craigie Drive separates the suburbs of Town Bush Valley from Montrose. It is also typified by wide grass verges, often planted, that distance the adjoining properties from the road.

Photo 32. Craigie Drive. In this photo the wide verges, mostly planted with buffering vegetation which hides the houses from the road can be seen. Photo: (Re) invention Studio Architects.

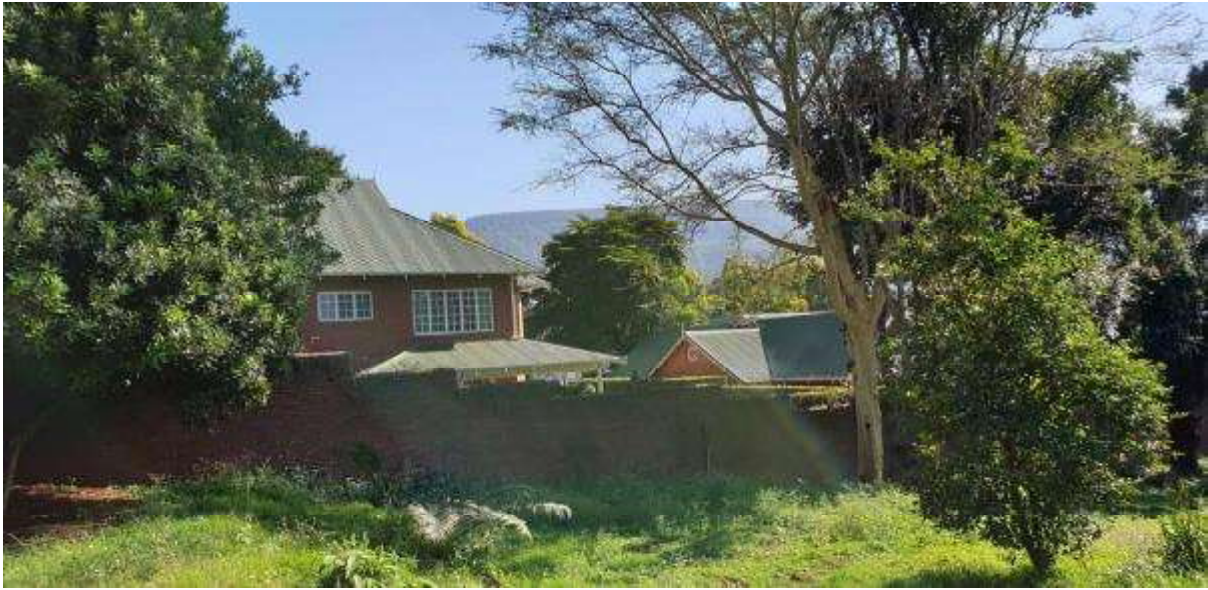
Plate 33. *Kew Gardens* residential estate to the north-west of 635 Town Bush Road. A Victorian-style residence, which architecture reflects back to the Victorian and Edwardian built heritage of the Midlands, and which strives to retain something of this innate and “genteel” character of this particular Cultural Landscape. Photo: Ridwaan Essa, (Re)invention Architects.

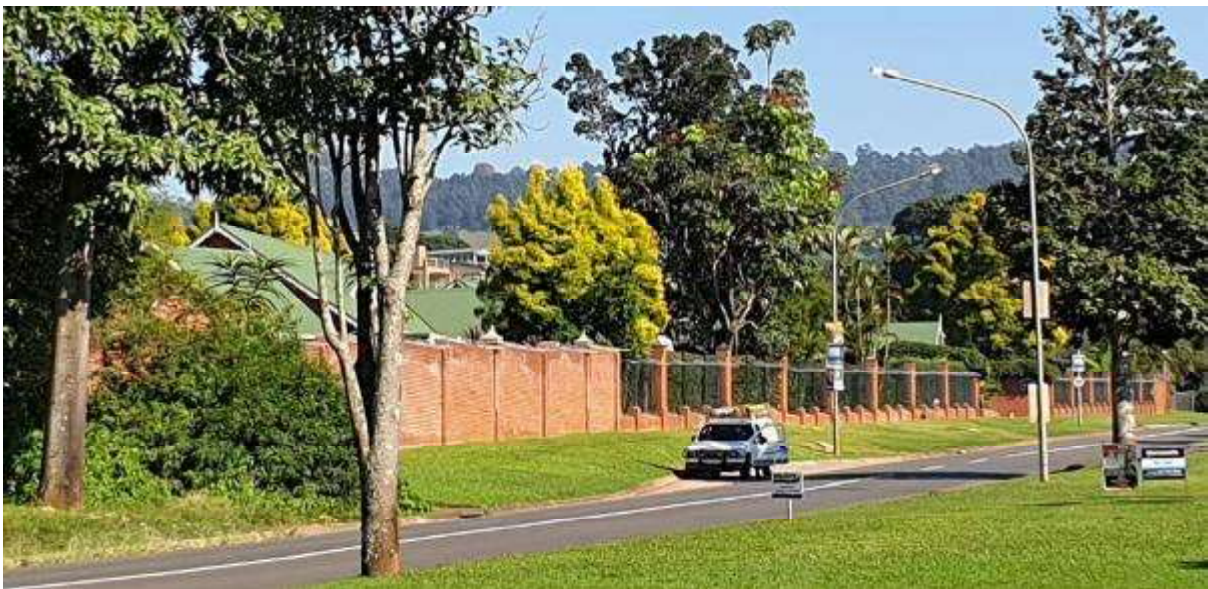
Plate 34. *Kew Gardens residential estate*. In this photo elements associating the architecture with Victorian and Edwardian Pietermaritzburg are evident, such as the red brick boundary walling, the green (wrought iron) palisading, the steep pitched green roofs made up of corrugated sheeting, the white detailing, and the gables. Photo: Ridwaan Essa, (Re)invention Studio Architects.

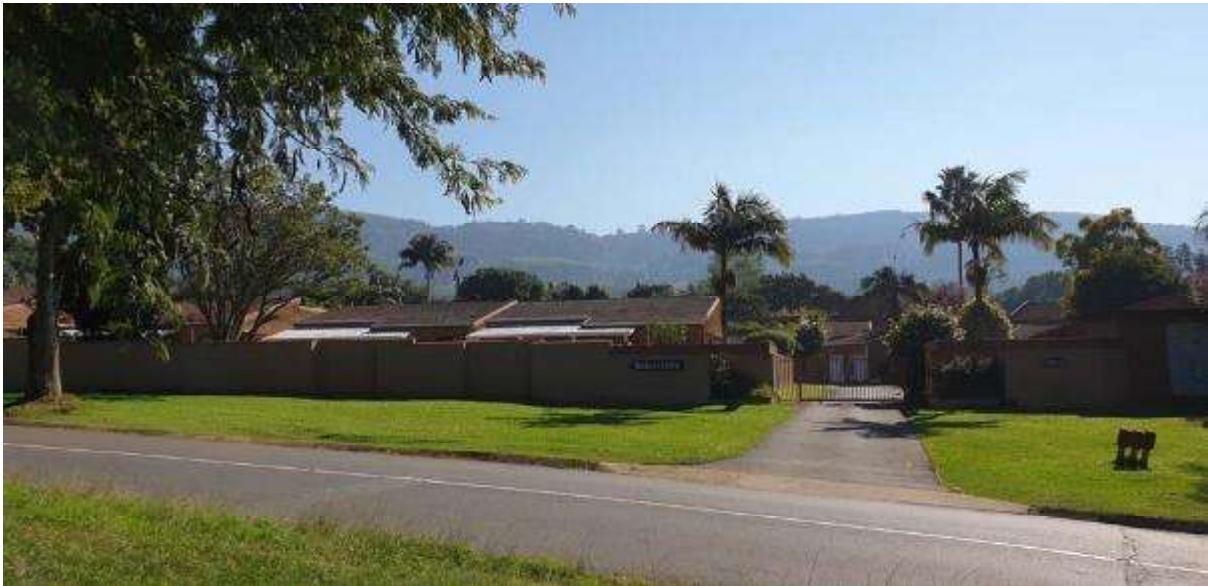
Briarcliffe residential estate at 590A Town Bush Road has approximately 16 town house units. It is surrounded by a rough-plastered boundary wall capped with red precast coping. The buildings are built from a honey-bronze coloured face brick, with a “mixture of mono and double pitched red concrete tile roofs, and matching fascias, and white IBR profile lean-to verandas, as well as classically-styled columns”¹⁹ This development hints at a Victorian and Edwardian past in its mix of Victorian, Edwardian, Georgian and Classical elements in its architecture. In this manner, it too attempts to align with the general historical character of the general Cultural Landscape of this region.

Plate 35. *Briarcliffe* residential estate. This photo provides a glimpse of the palm trees which were initially introduced by the Victorian residents of Pietermaritzburg, and so placed to fit in with the historical foliage of the once-Victorian city, and of the red brick, suggestive of the salmon-coloured red brick buildings of the Victorian and Edwardian buildings of the region. Photo: (Re)invention Studios.
