Excavations at Delta Farm, Franschoek: Report 2008

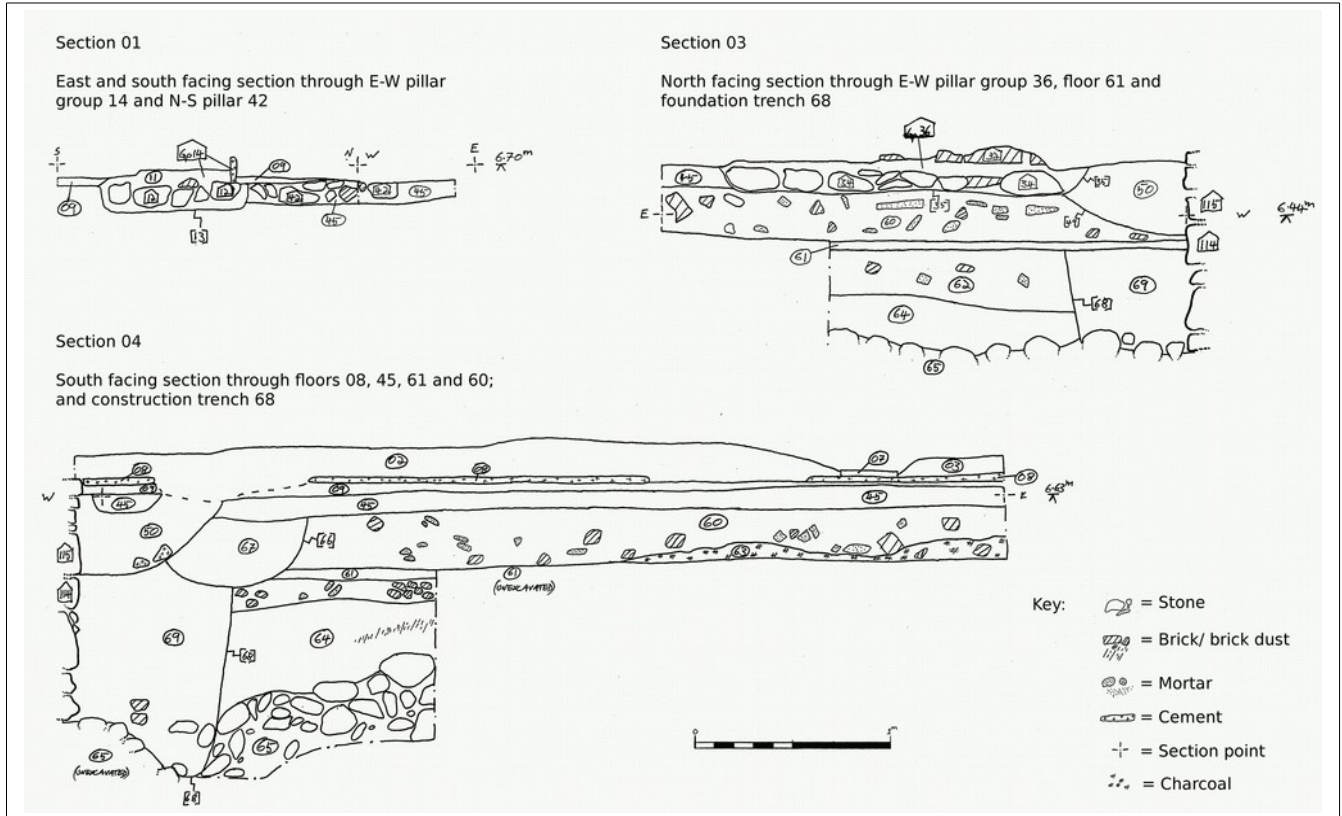
Figure 7: Illustration of trench profiles excavated in Areas 1 and 2

Sections 01, 03 and 04 (see Fig 7 for Section locations).

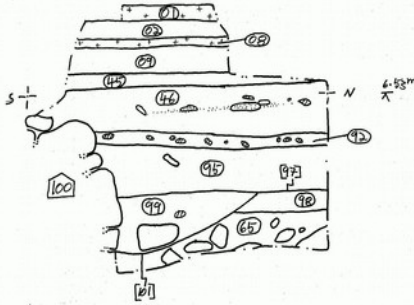
Section 06

East facing trench profile showing sequence of deposits north of E-W wall 100

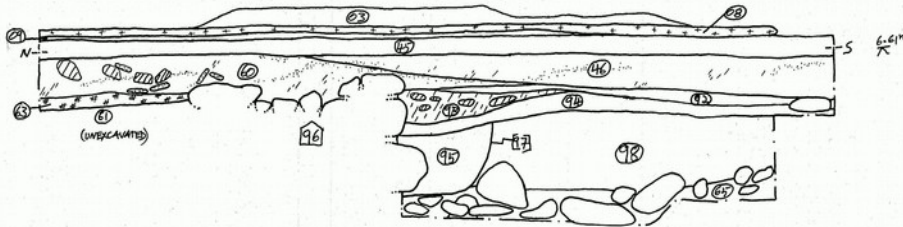
Section 10

West facing cross-section of wall 96 overlain by floors 08, 45 and 46/ 60; with floor 61 to the north (unexcavated), and floor 92 overlaying foundation cut 97 to the south

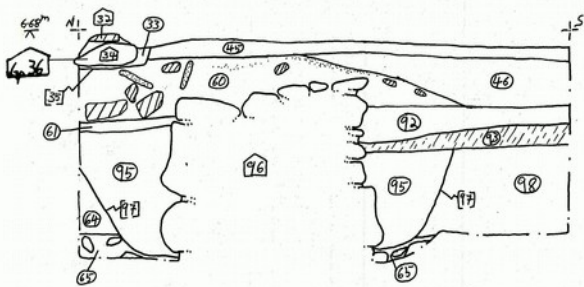
Section 11

West facing trench profile showing cross-section of wall 96, with floor 61 to the north overlying backfill 95 of foundation cut 97

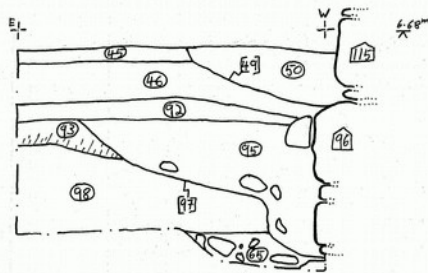
Section 11

North facing trench profile showing deposits adjacent to western building wall: foundation 97 for wall 96, overlain by later rebuild 11.

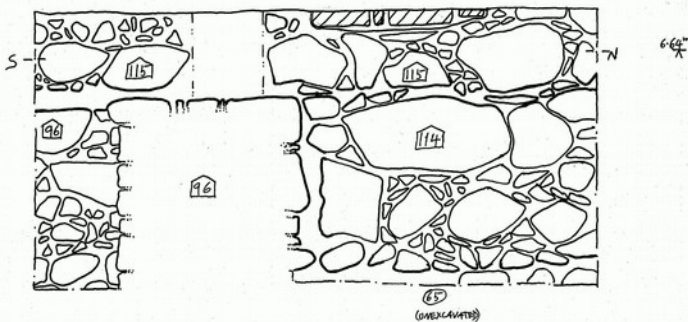
Section 18

East facing elevation showing cross-section of E-W wall 96 and its relationship with the western building wall; abutted by wall 114 to the north and overlain by rebuild 115

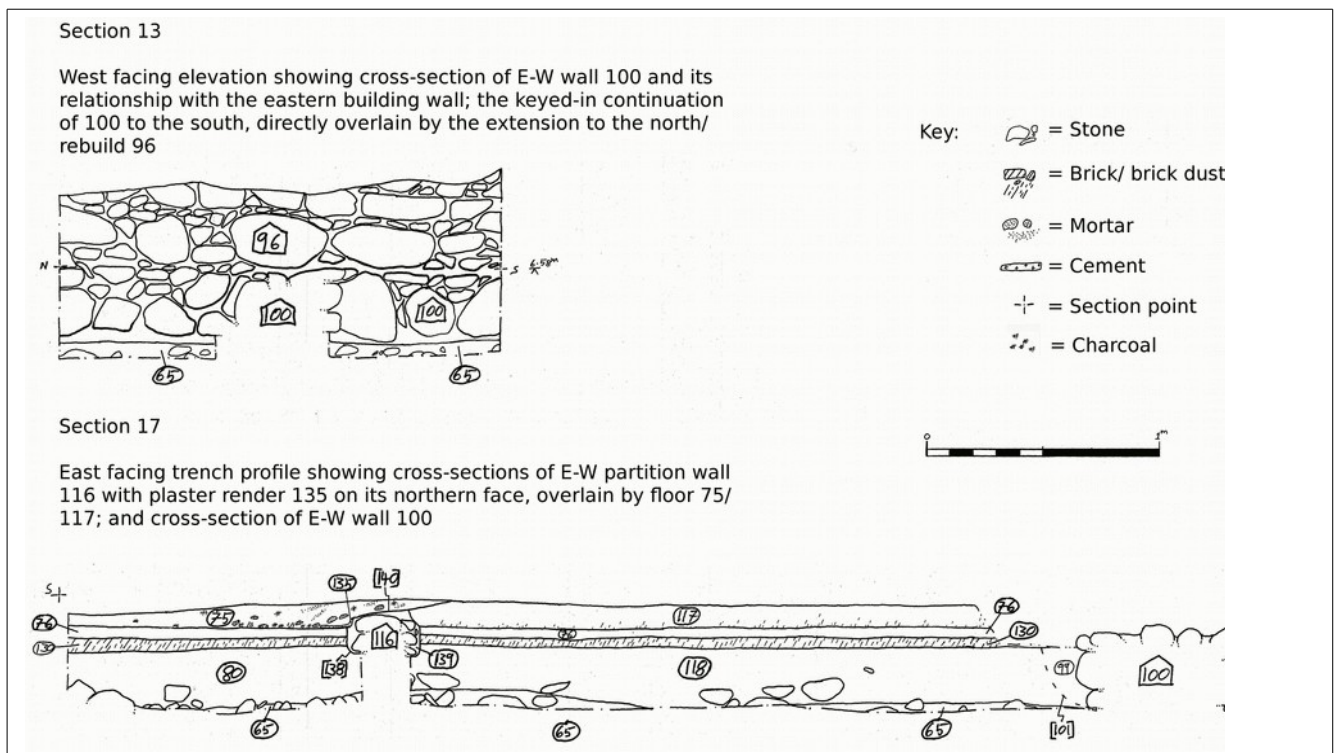
Figure 12: Illustration of trench profiles excavated in Area 6
Sections 13 and 17 (see Fig 11 for Section locations).

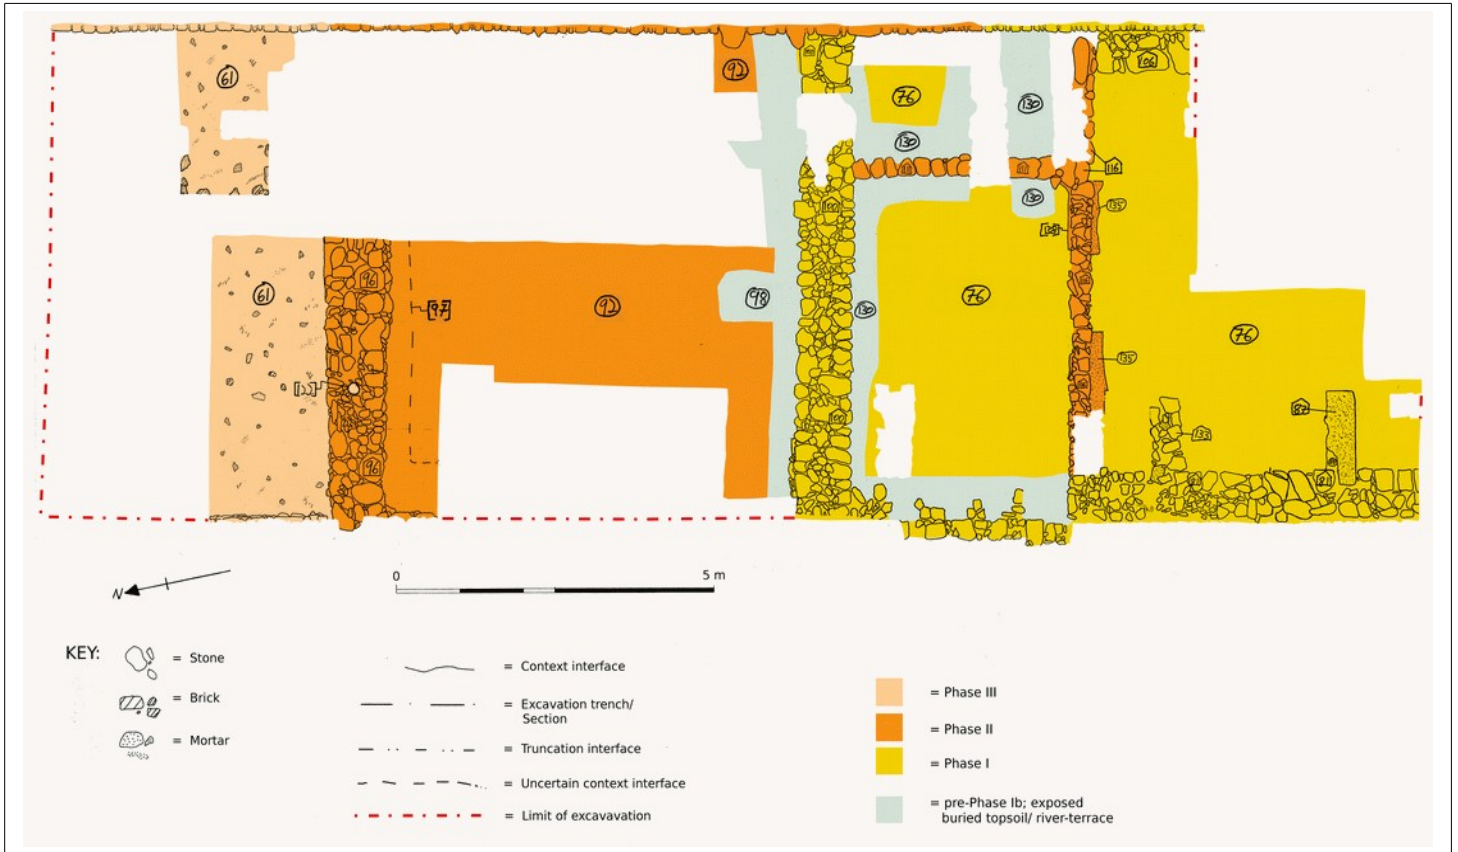
Figure 15: Plan of features during Phase III.

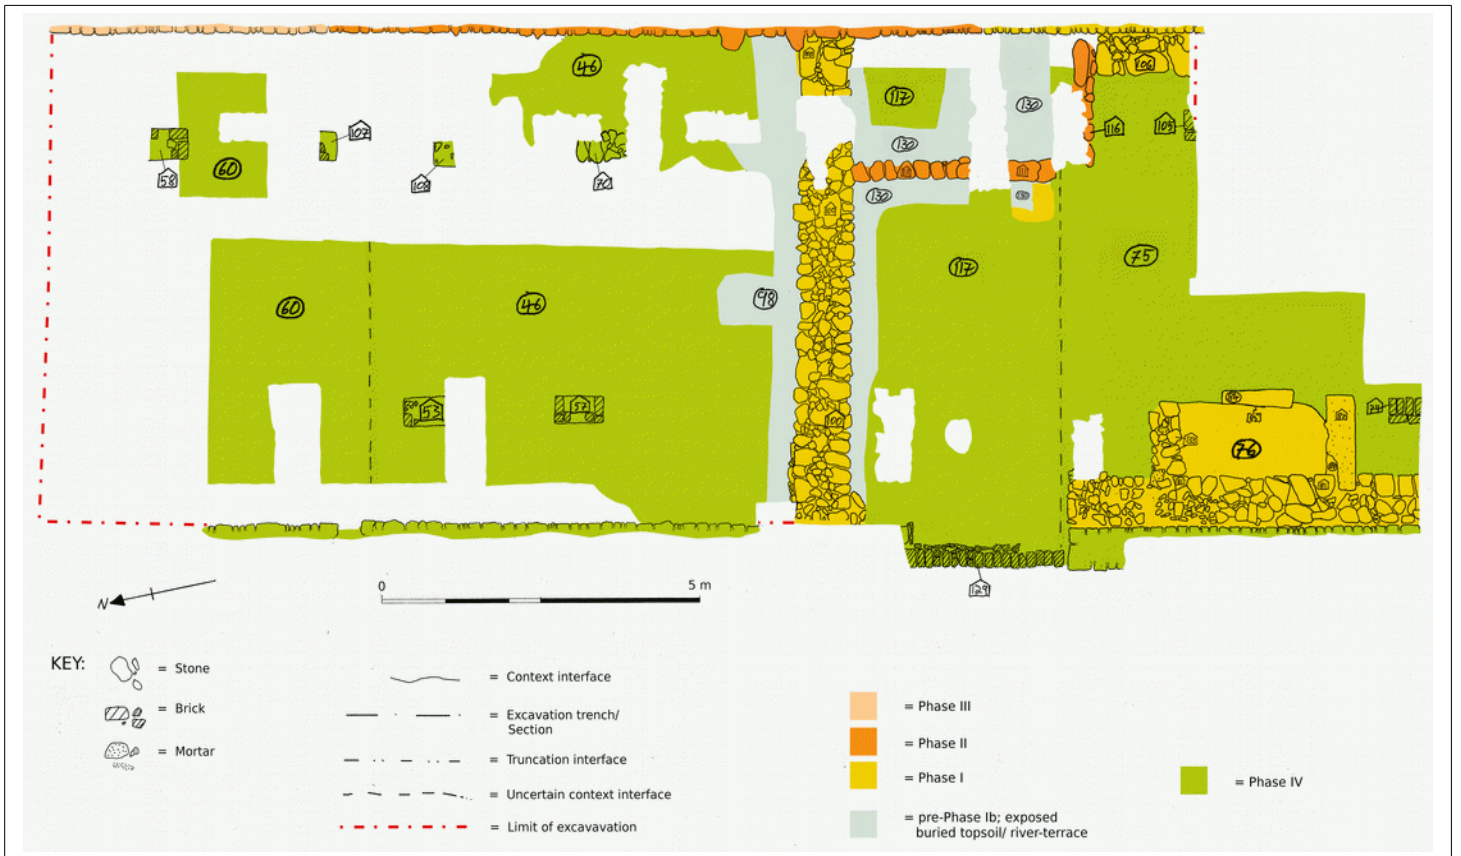
Figure 16: Plan of features during Phase IV.

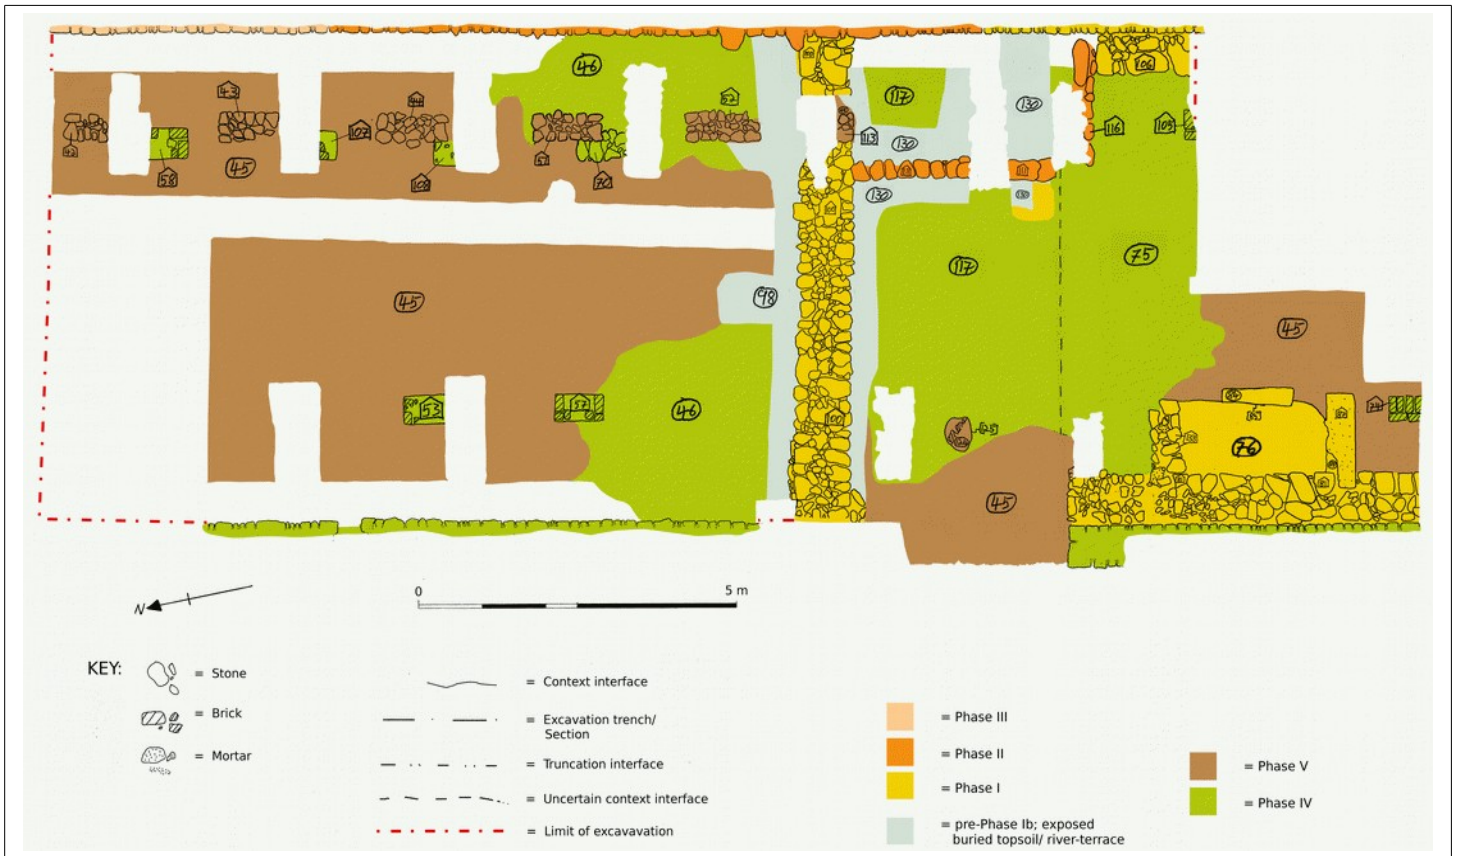
Figure 17: Plan of features during Phase V.

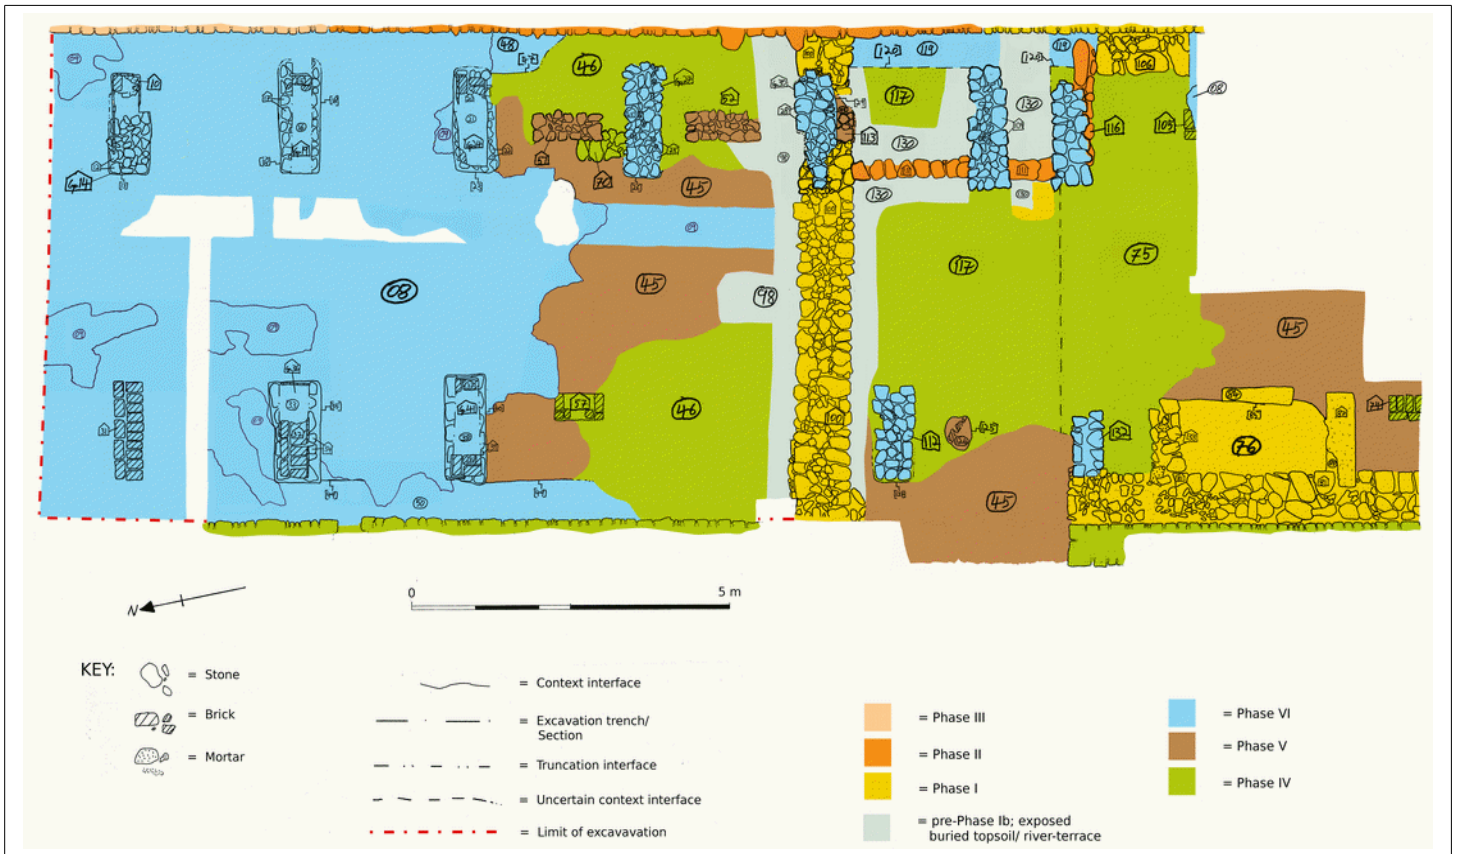
Figure 18: Plan of features during Phase VI.

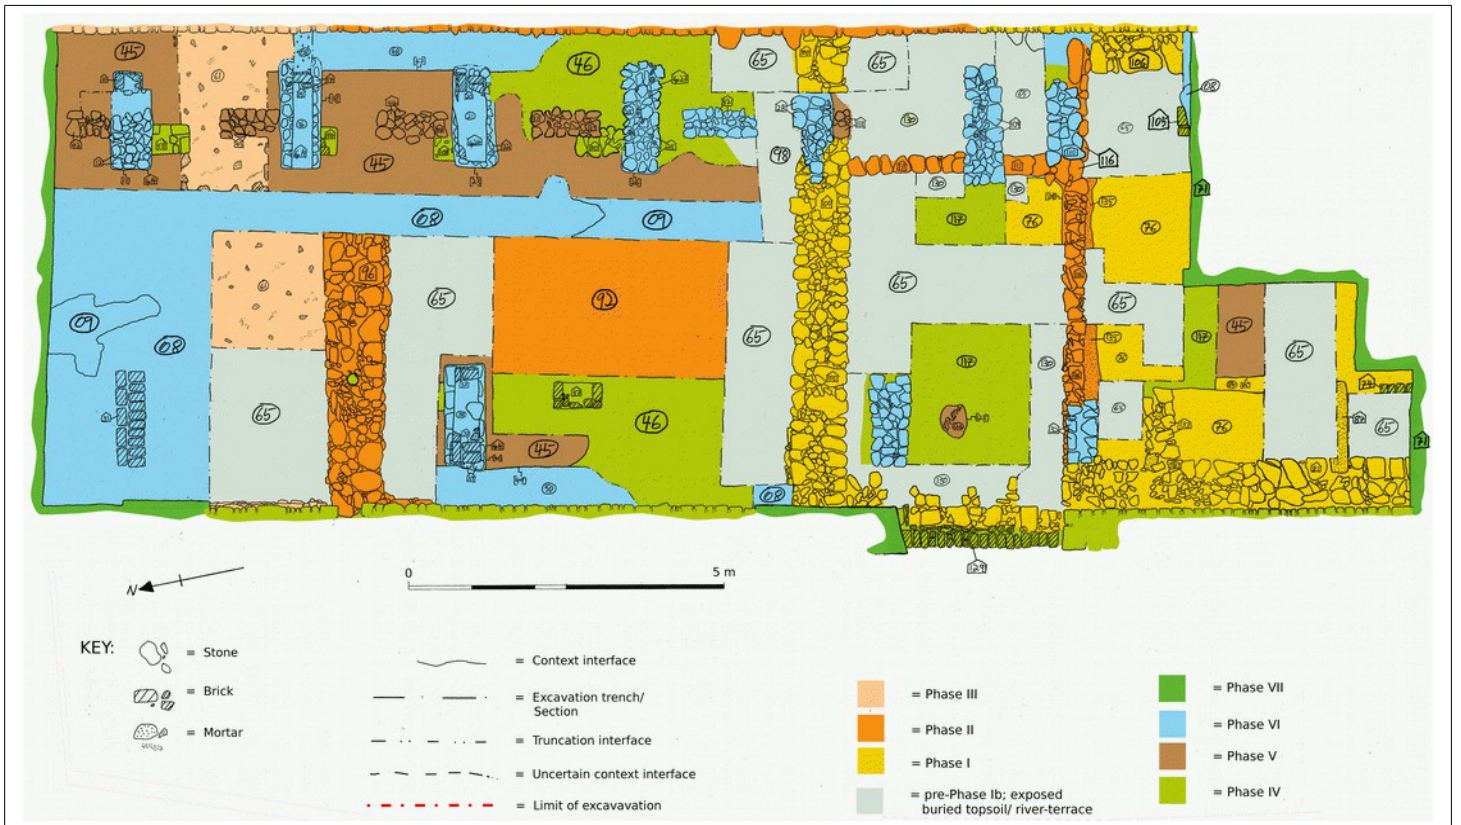
Figure 20: Phased plan of archaeological deposits left exposed beneath current glass floor.
