Archaeological Impact Assessment of a building on the historic Fredericksburg Farm No 1602, Franschoek

11 March 2013

This report presents the results of structural analysis of a building on Fredericksburg Farm (No 1602) in the Drakenstein Valley, Franschhoek. It is proposed this building be developed into residential accommodation.

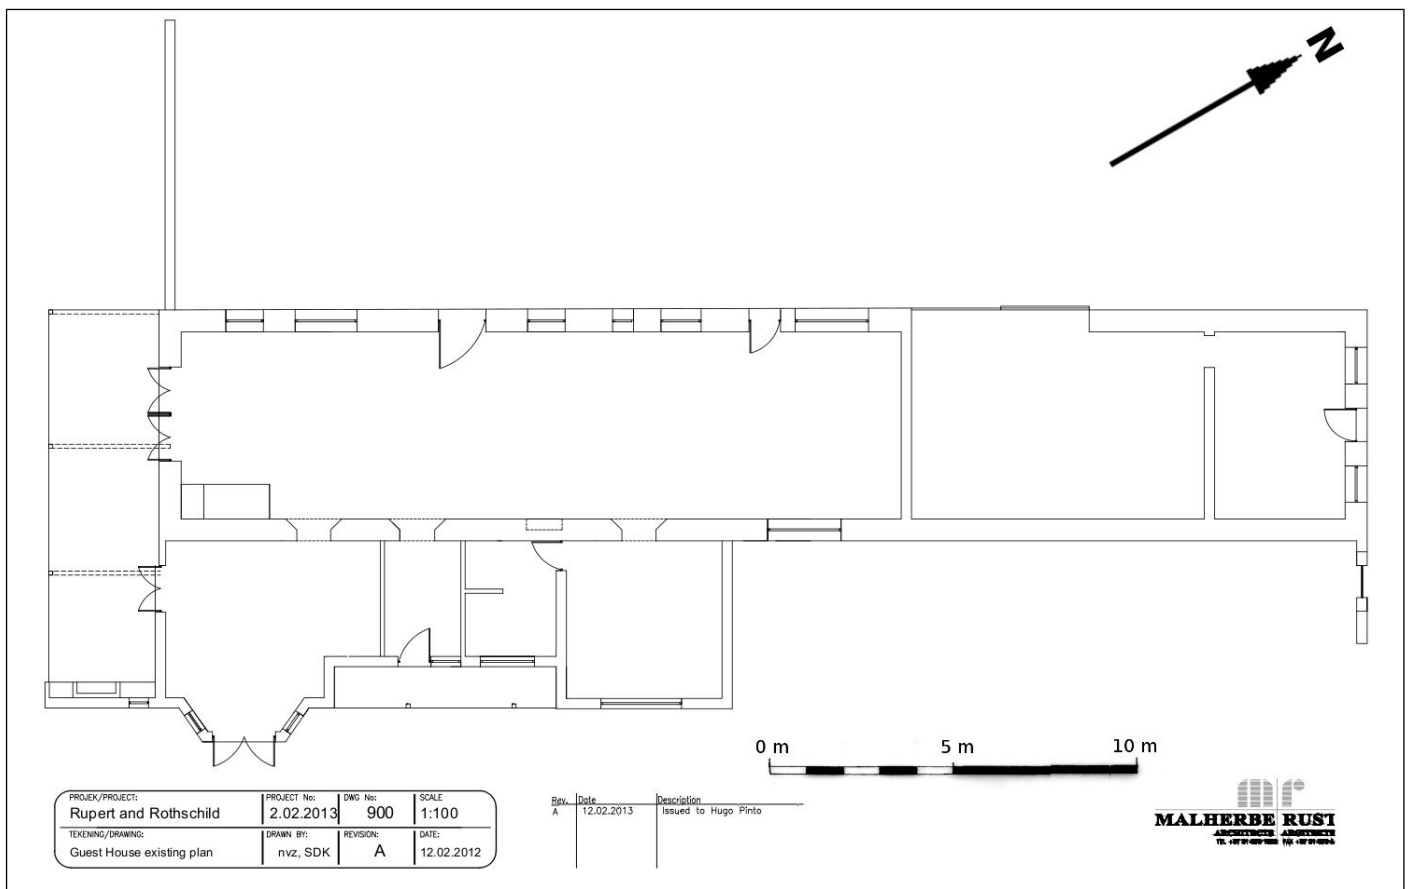
Fig. 3: Architects 2013 survey of investigated building; © Malherbe Rust Architects.

wall within the garage at the north-eastern end of the building. A measured plan of the current building was undertaken by Malherbe Rust Architects and is presented as Figure 3. This has been used as the basis for further survey and plans of the site.

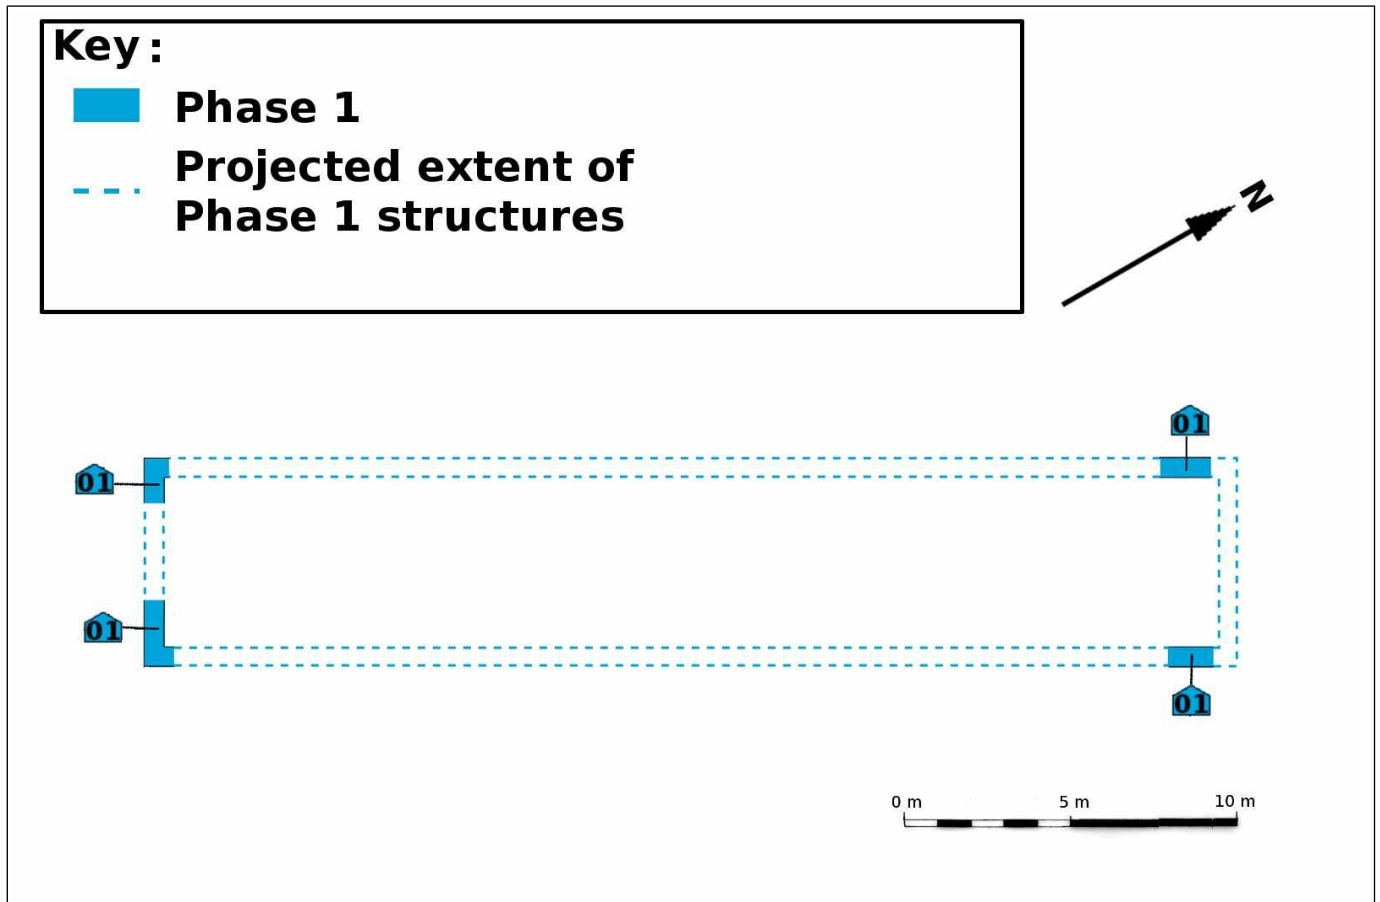
Fig. 7: Plan of Phase 1 structures.

The earliest construction at the site was wall 01, forming the external wall of the main rectangular (I-plan) building footprint (Fig. 7). This was built with irregular sub-angular sandstone blocks (average size of 330mm by 230mm) that had been selected from a quarry site, with most blocks faced on at least three sides (the upper, lower and wall-face sides of the blocks as laid). Some smaller blocks (average 90mm by 60mm) were not deliberately faced and were used as packing for levelling the bed of the overlying stone in the wall. The blocks were set in a soil mortar, consisting of a pale yellow sandy-silt. They were generally uncoursed, with the only exception to this being larger quoin blocks (maximum dimension: 1000mm

x 200mm x 280mm) at the southern corners of the building, faced on at least four sides and laid horizontally in alternating courses, first left then right about the corner of the building. Wall 01 was built with an overall thickness of 620mm.

Wall 01 represents the footprint of a rectangular building, measuring c. 33.0m in length (NE by SW) and 6.4m in width (NW by SE). The main sections of fabric from this original building surviving in the current structure comprise remnants of the southern gable wall and the corners at either end of this wall built with quoin stones. Short length returns of wall 01 continue along both side walls for less than a meter from building's south-west corners. Mirroring this construction at the north-eastern end of the building, both side walls have short 1.5m and 1.7m tracts built in stone (eastern and western elevations respectively). These are situated close to the north-eastern gable wall, but do not survive as the building's current corners and gable wall itself, as these were re-built in a later phase. However, the presence of stone fabric to roof height adjacent to both gable walls at either end of the building indicates the Phase 1 structure, represented by wall 01, extended the length of the building's current footprint. This means the length and overall form of this building, with the exception of minor additions in later phases, was established in Phase 1 and has remained largely unchanged throughout its history.

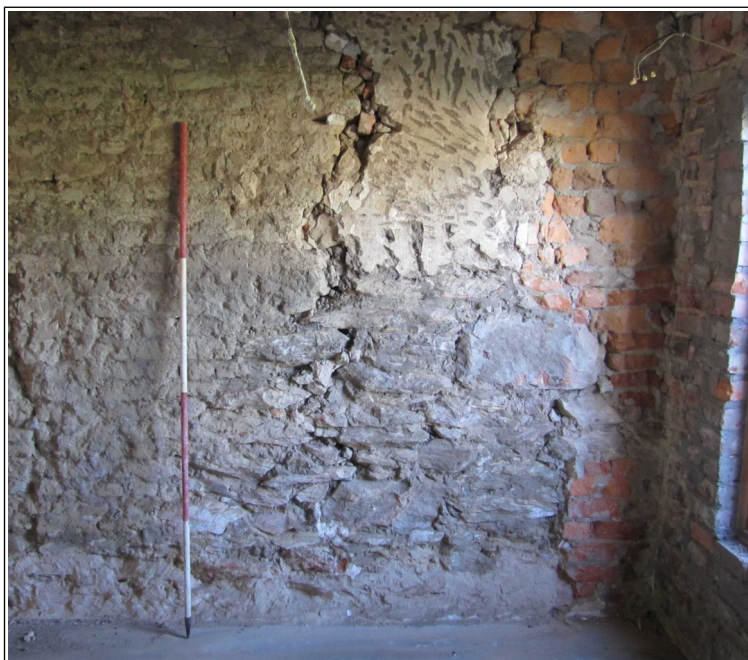
Plate 1: North-west corner of building: sun-dried brick wall 02 on the left; overlying the robbed edge of stone-built wall 01 in the centre; which is overlaid by red-brick gable wall 03 on the right. View to the north-west.

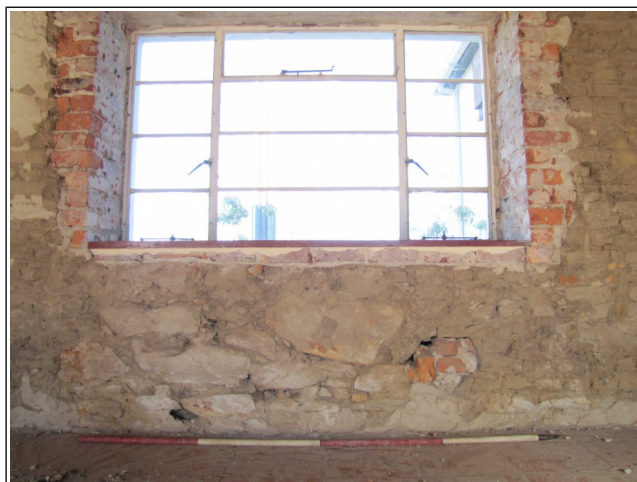
Plate 2: Stone-built wall 01 along eastern elevation. Shows wall 01 (centre) was originally built to higher level along the side building walls than the 150mm high footing continuing to either side; overlain by sun-dried brick wall 02; both truncated by red-brick window 06. View to south-east.

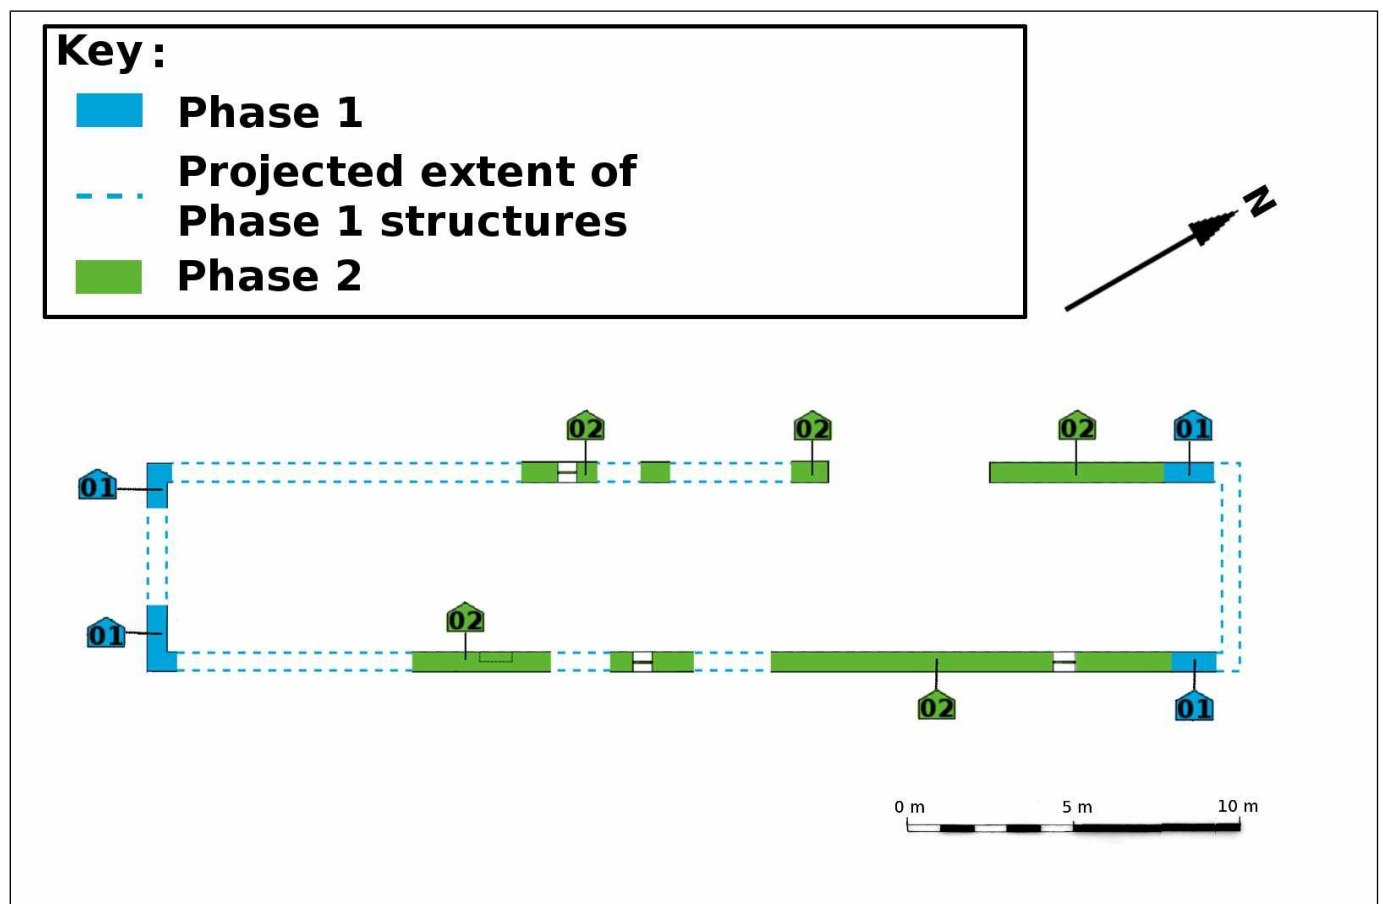
Fig. 8: Plan of Phase 2 structures.

Phase 2 is represented by wall 02, surviving as tracts along the building's north-west and south-east side elevations (Fig. 8). It was built to the same 620mm thickness as wall 01 at both ends of the building. Wall 02 was built with yellow/ brown sun-dried bricks, set in a similar coloured soil mortar. The bricks were of irregular dimensions (average 230mm x 120mm x 70mm) and had weathered, rolled edges. They are of artisanal manufacture and were most likely produced locally on the farm.

Wall 02 represents the reconstruction of the building's side walls. These were built directly onto the surviving stone-built 150mm high footing of wall 01 left after the building's stone was robbed at the end of Phase 1. Wall 02 was built onto and to the same 2.70m height as the higher sections of wall 01 close to the building's corners at both ends of the building (Plate 1). This re-building would have comprised the entirety of the building's side elevations, although alterations to the building's configuration in subsequent phases have truncated the majority of wall(s) 02 in the south-western half of the building.

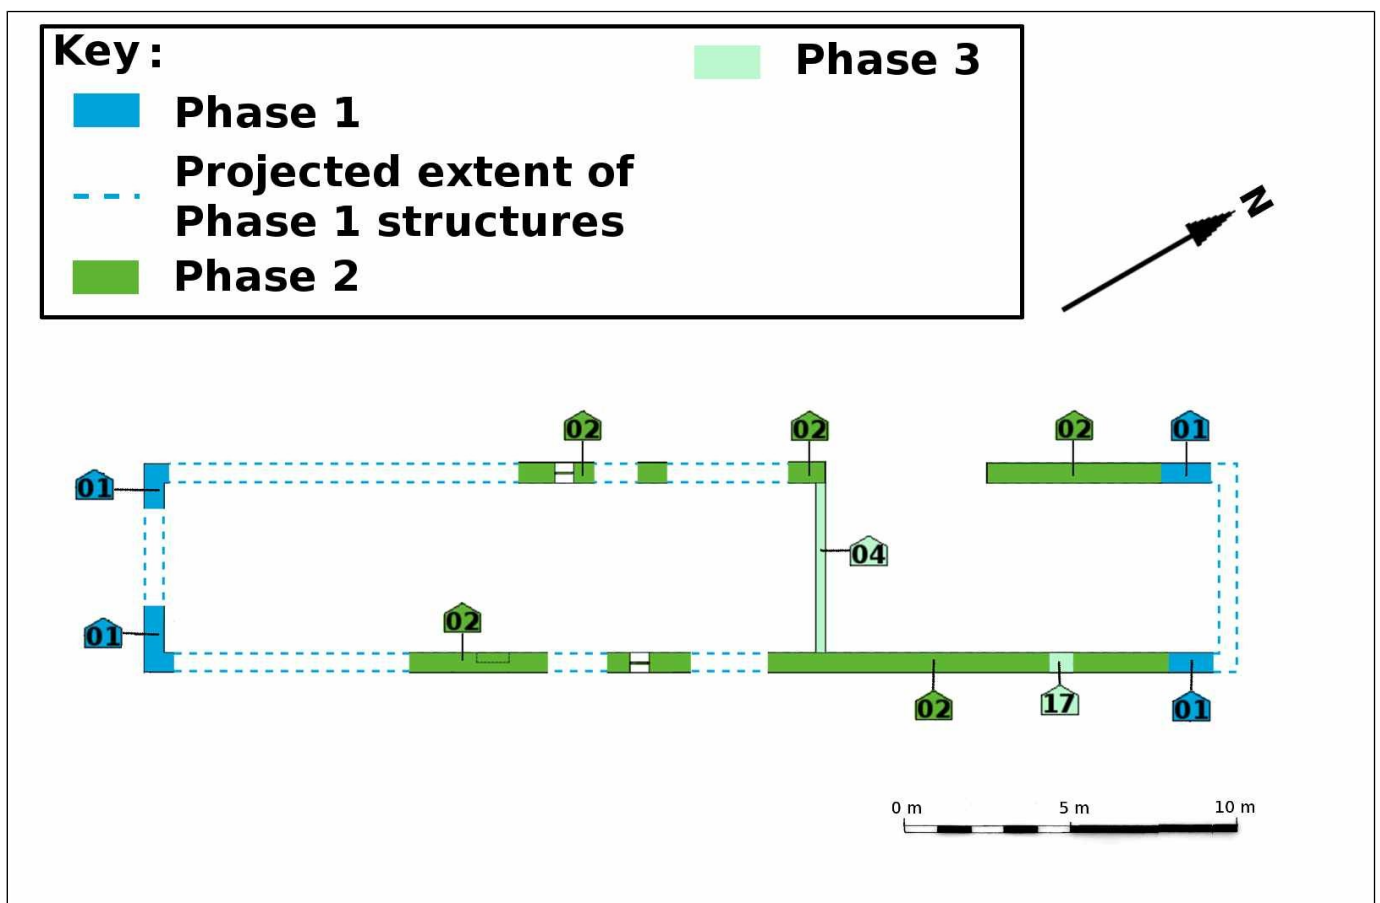
Fig. 9: Plan of Phase 3 structures.

Phase 3 is represented by internal dividing wall 04. This structure was built with brownish/ yellow bricks that appear to have been low-fired but are relatively robust and not friable under hard finger pressure. Some pale orange, fired bricks were also used in the lower part of the wall, indicating at least two different batches were used in the construction of wall 04. Both types were set in hard soil mortar, consisting of a pale grey silty-sand. The bricks were of artisanal manufacture, with rounded edges, and of slightly varying

It should be noted that because wall 04 is not keyed-in to the outer building walls (represented by wall 02), it is correctly recorded as abutting building wall 02 and has therefore been assigned to a later phase. It is nevertheless possible that wall 04 could be contemporary with wall 02, as it is not unusual in historic farm buildings for internal divisions to be built after the outer walls have been completed, even if both form part of the planned building layout (Smuts 2012b; Smuts and Clift 2010b). As a result, internal dividing walls aren't necessarily keyed-in to the external building walls even though they may be a contemporary construction. In this regard it is even conceivable that wall 04 could be contemporary with the original Phase 1 construction, where it would have abutted the outer stone building walls and was then more easily retained in place during the demolition of wall 01 and its reconstruction as wall 02.

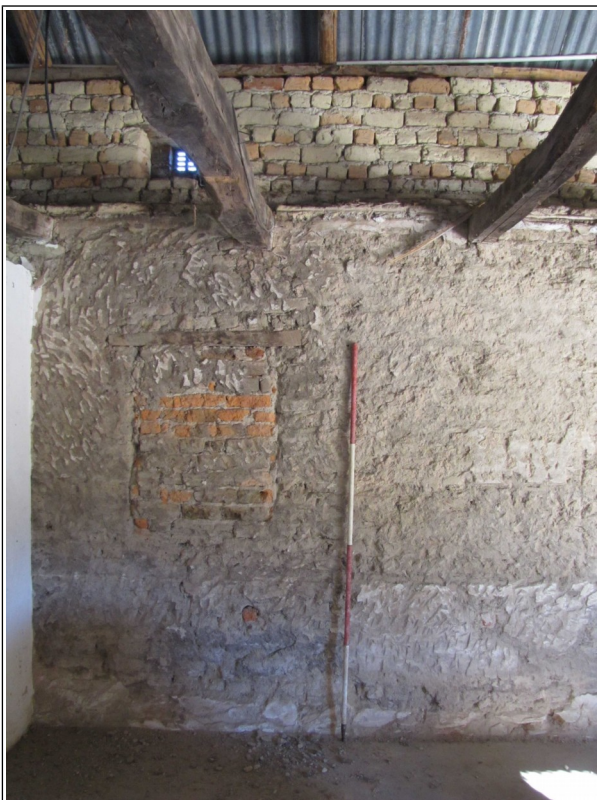
Plate 3: Eastern elevation. Stone-built wall 01 up to 200mm; overlain by wall 02 with window; window blocking 17; overlain by roof support 19. View to south-east, 2.0m scale.

At some point the roof level of the building was raised by approximately 850mm, raising the outer building walls to an overall height of c. 3.55m (Plate 3). This construction is represented by structure 19 (Fig. 11), built with sun-dried and low-fired bricks, set in a yellow/ brown soil mortar. Of the bricks in wall 19 that were fired, most were unevenly so. Individual bricks in structure 19 would often have one half remaining a sun-dried brown colour and the other half showing an oxidised orange colour (Plate 3). This again indicates an artisanal manufacture that most likely took place locally on the farm.

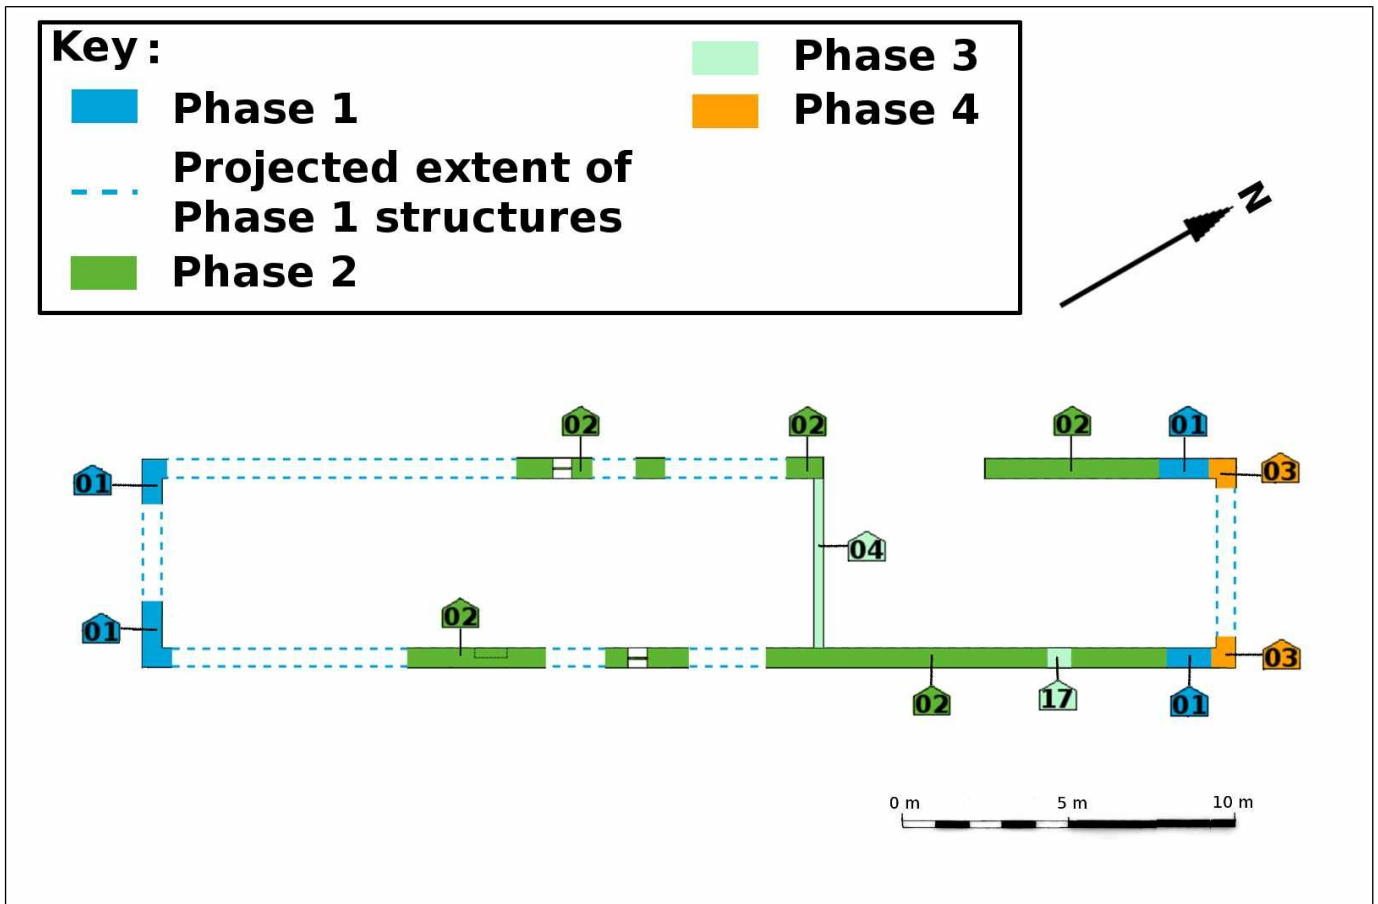
Fig. 10: Plan of Phase 4 structures.

Phase 4 comprises the re-building of the northern gable, represented by wall 03 (Fig. 10). This was built with moderately well-fired orange bricks, containing small white grit inclusions, and measuring 225mm x 105mm x 75mm. These were evenly fired throughout and at higher temperatures than bricks from previous phases. Wall 03's bricks were, however, still slightly friable and not quite uniform enough to suggest they were modern mass-produced materials. These were set into a pale grey/ white silty-sand mortar, containing white grit inclusions and possibly some lime mixed in, although no shell fragments were apparent as inclusions. The composition of the soil mortar is similar to that used in the manufacture of the bricks.

The northern gable wall was probably rebuilt as wall 03 after the partial collapse or other structural problems with what had up to that point been the stone-built Phase 1 wall 01. Wall 03 was built directly onto the surviving remnants of wall 01 at the northern end of the building (Plate 1), forming the two corners at that end of the building that survive in the current building (Fig. 10). The central section of gable wall 03 was truncated by alterations to it in subsequent phases.

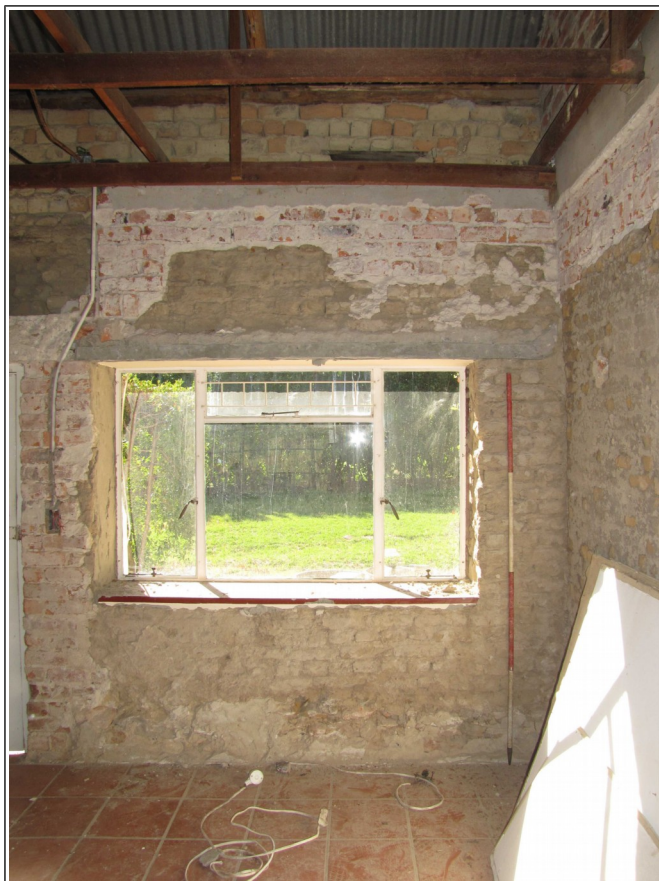
Plate 4: Western elevation. Phase 5 window 05 inserted into sun-dried brick of wall 02. View to the north-west, 2.0m scale.

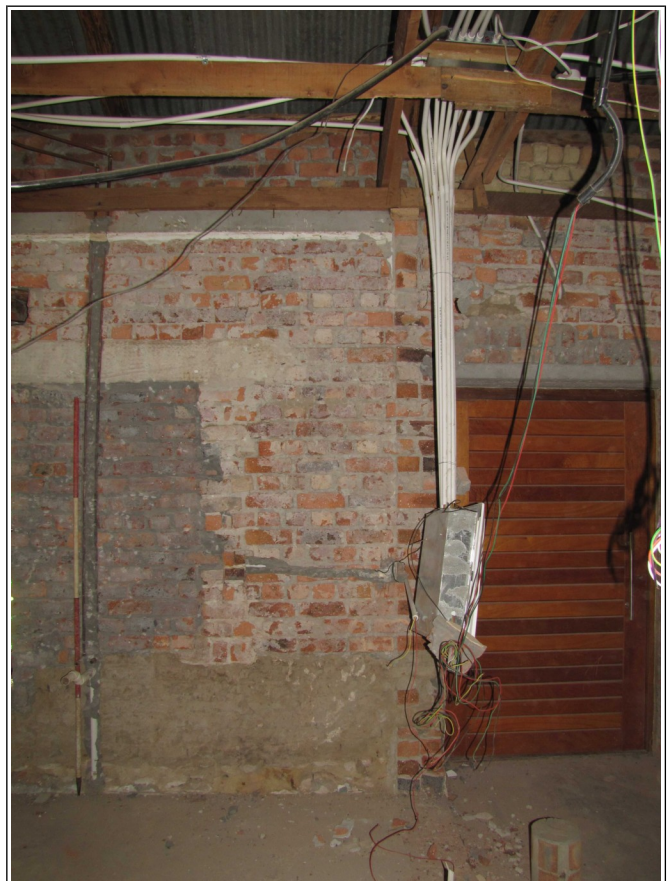
Plate 5: Western elevation showing structures from Phases 5 and 6. Note the more lime-based cement used in Phase 5 (centre) compared to the grey cement of Phase 6 window blocking on left. View to north-west, 2.0m scale.
