# APPENDIX D.1: Heritage Impact Assessment

**HERITAGE SPECIALIST REPORT CONDUCTED AS PART OF A BASIC  
ASSESSMENT FOR A PROPOSED NEW LIGHTHOUSE ON ERF 335,  
BEACH STREET, PORT NOLLOTH.**

Draft Basic Assessment Report for the Proposed Port Nolloth Lighthouse –  
near Port Nolloth, Northern Cape

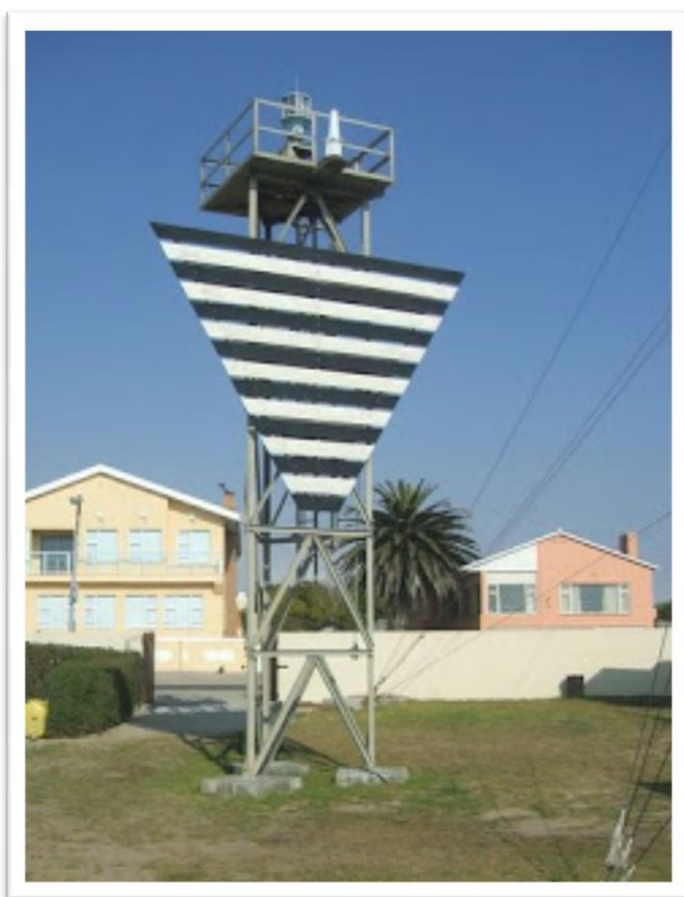
*Figure 2 The existing lighthouse.*

The existing aluminum lighthouse expresses itself as a utilitarian and somewhat odd structure does not “read” as a lighthouse to the casual observer. It is without argument one of the most unappealing structures within the context of this country’s rich lighthouse heritage. The construction of a more formal and recognizable structure within the Transnet owned enclave will better the landmark status and add a feature of interest to the Beach Street precinct.

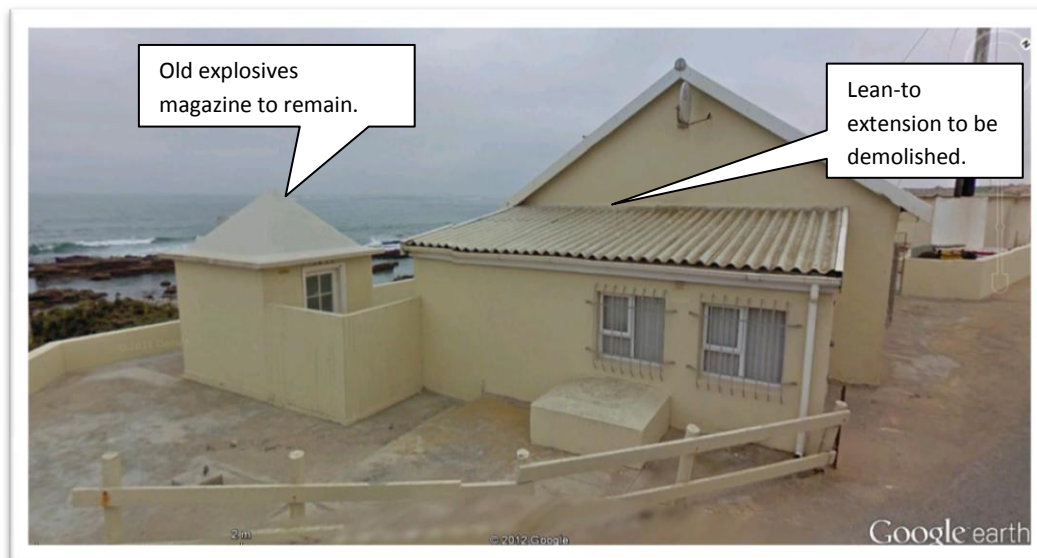
*Figure 3 The structure which is the subject of this enquiry. The lean-to extension to the building requires demolition. View is from south to north. The pitched roof bungalow and magazine is to remain.*

The structure in question is for the main part relatively recent and dubiously greater than 60 years of age. It has been maintained, modernized and in our opinion not worthy of inclusion of a regional heritage register nor is it worthy of formal grading. The only element worth grading is the explosive magazine (suggest III B-C). The proposed new lighthouse has minor consequences for the structure. The lean-to is quite recent and its removal will not detract from significance.

The proposed activity will have a negligible impact on all generally protected heritage. The site specific impact will be the demolition of a lean-to structure affixed to the south gable of the Transnet staff quarters. The main bungalow is of very low heritage significance, the demolition of the lean-to will have no negative impacts at all.

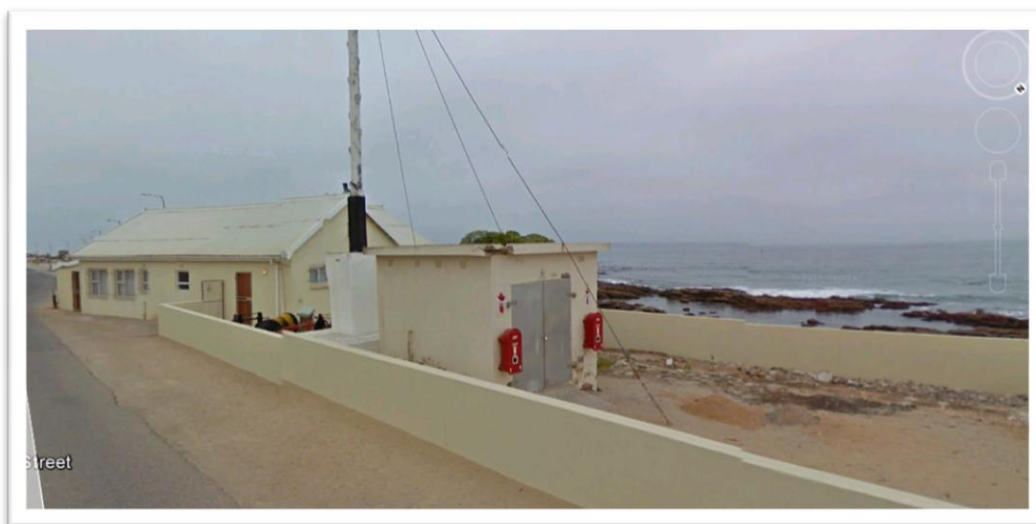
*Figure 4 View of the structure from north to south.*

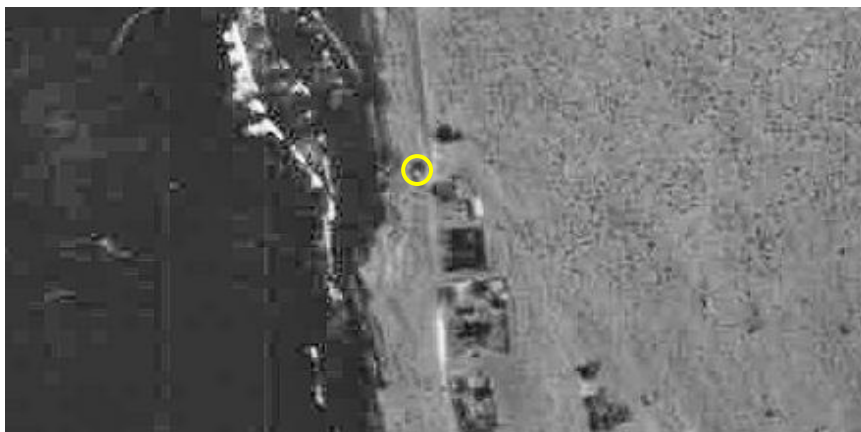
The study revealed that the bungalow was not present in 1937, but the adjacent magazine was in place (see *Figure 5*).

*Figure 3 Excerpt from 1937 aerial photograph indicating the magazine. This is the only structure visible on the western side of Beach Street.*

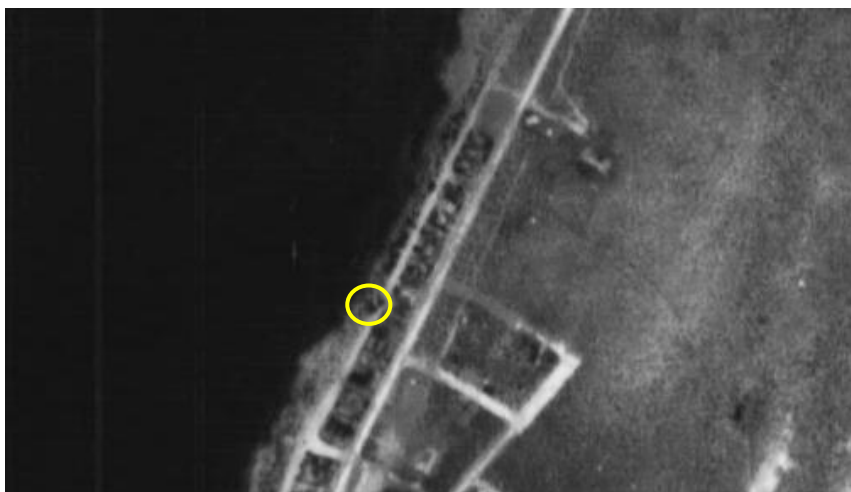
The aerial photograph of 1955 (*Figure 6*) indicates the presence of a structure of increased size which may be the beginnings of the bungalow in question. Beach Street is substantially more developed with noticeable densification.

*Figure 4 Notwithstanding the poor quality of this 1955 aerial photograph, there is an indication of a structure at the study area – it is unclear if this is the old light house or a building.*

In all likelihood the building in its present form postdates 1955. It could further be suggested that its presence correlates to attempts to regularize the Port after the shipping disasters of 1955 with the construction of a building – possibly to manage engineering and Port related activities.

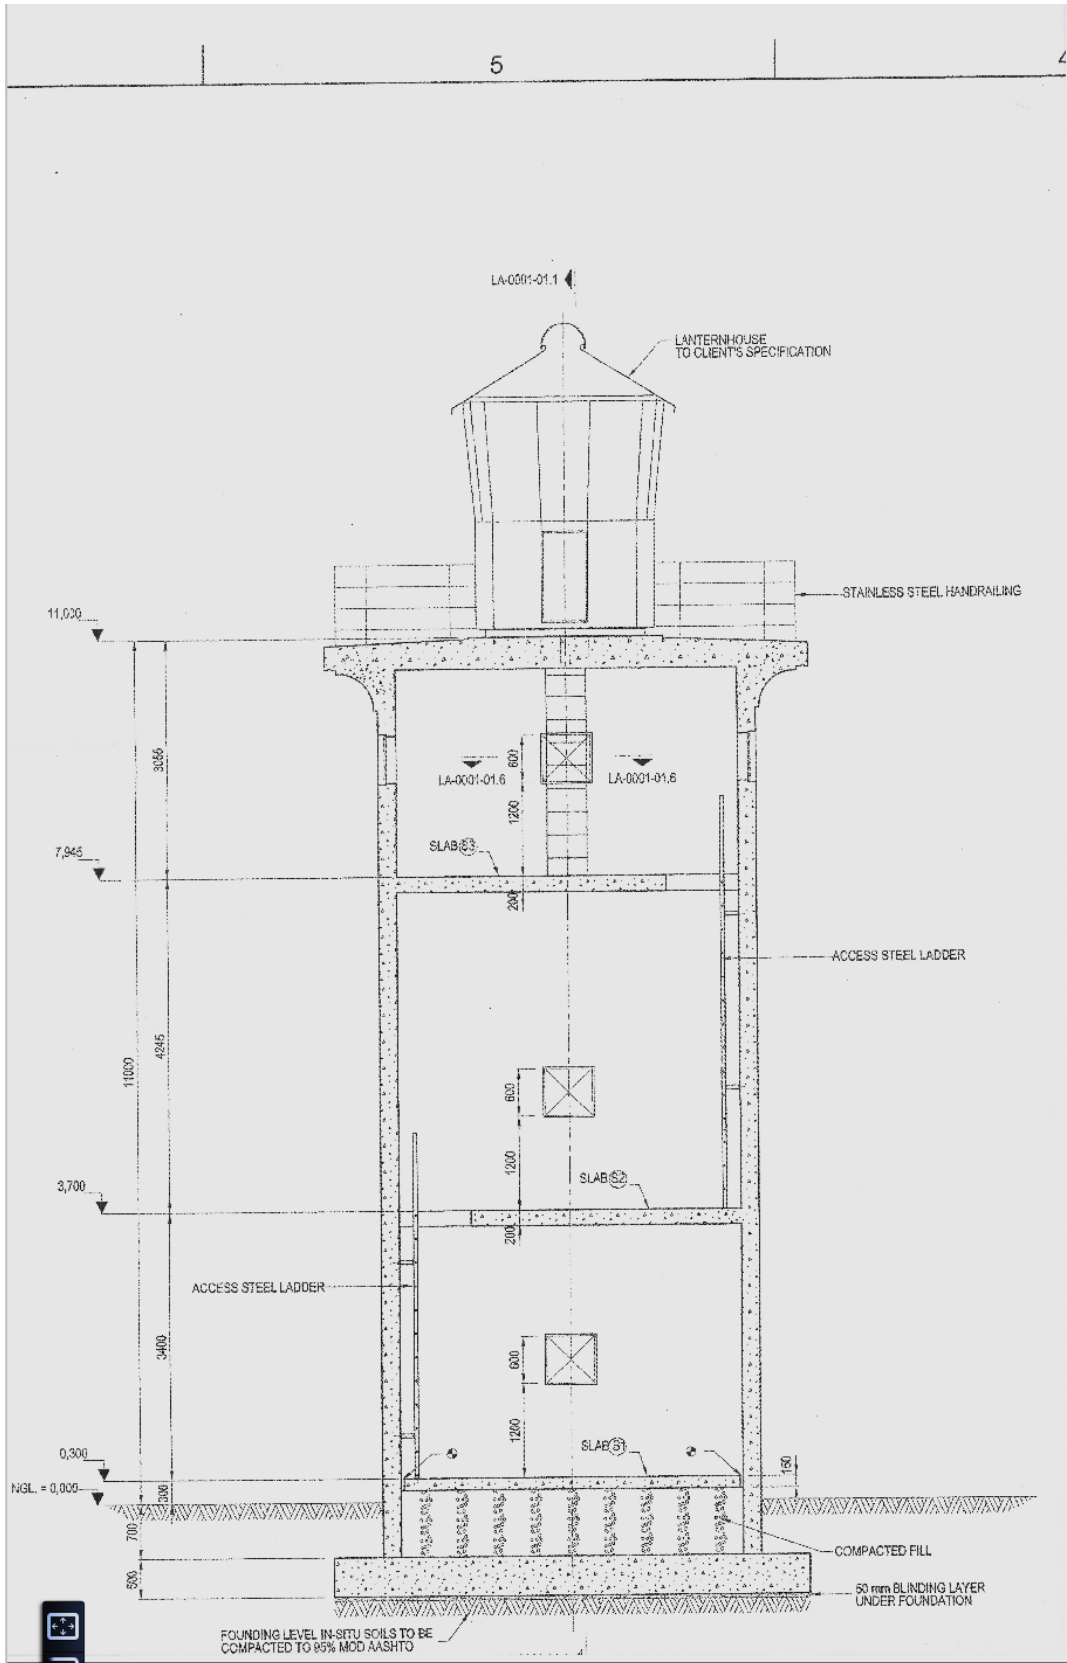
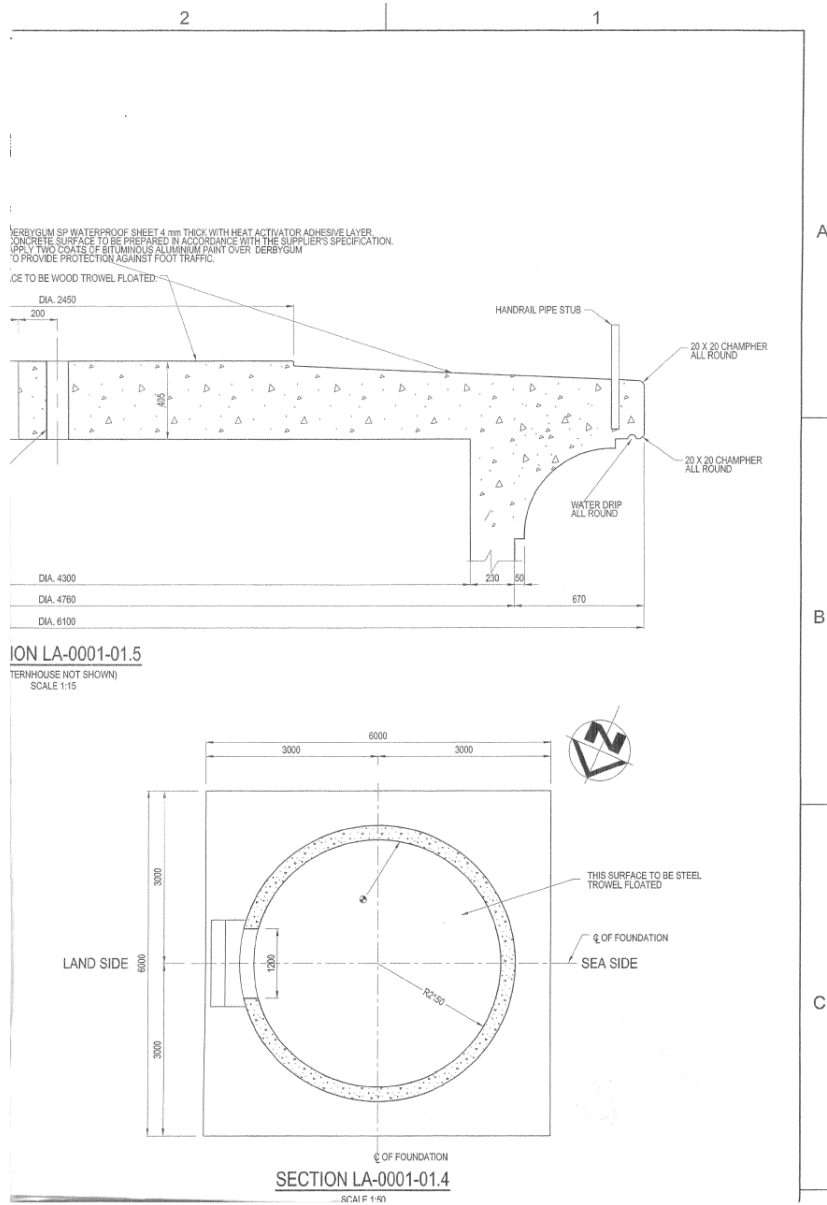
### **APPENDIX A**

Drawings of proposed site and structure provided by proponent.

- Site plan
- Elevation drawing of proposed lighthouse
- Sections of proposed lighthouse.
